VEHICLE SAFETY COMPLIANCE TESTING  
FOR OCCUPANT CRASH PROTECTION,  
WINDSHIELD MOUNTING, WINDSHIELD ZONE  
INTRUSION, AND FUEL SYSTEM INTEGRITY

VOLKSWAGEN AG  
1991 VOLKSWAGEN CABRIOLET  
2-DOOR CONVERTIBLE  
NHTSA NO. CM5805  
TRC TEST NO. 910725

FINAL REPORT

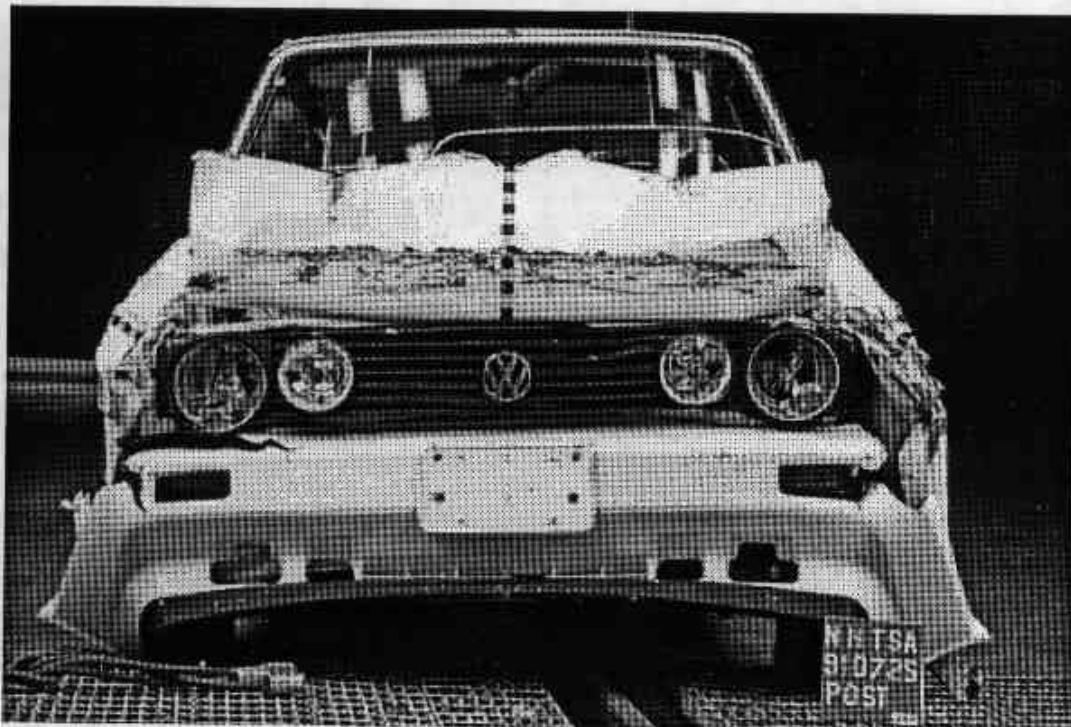
Figure A-2. POST-TEST FRONT VIEW

VEHICLE CONDITION: Vehicle has been subjected to a 30 mph frontal  
barrier crash test.

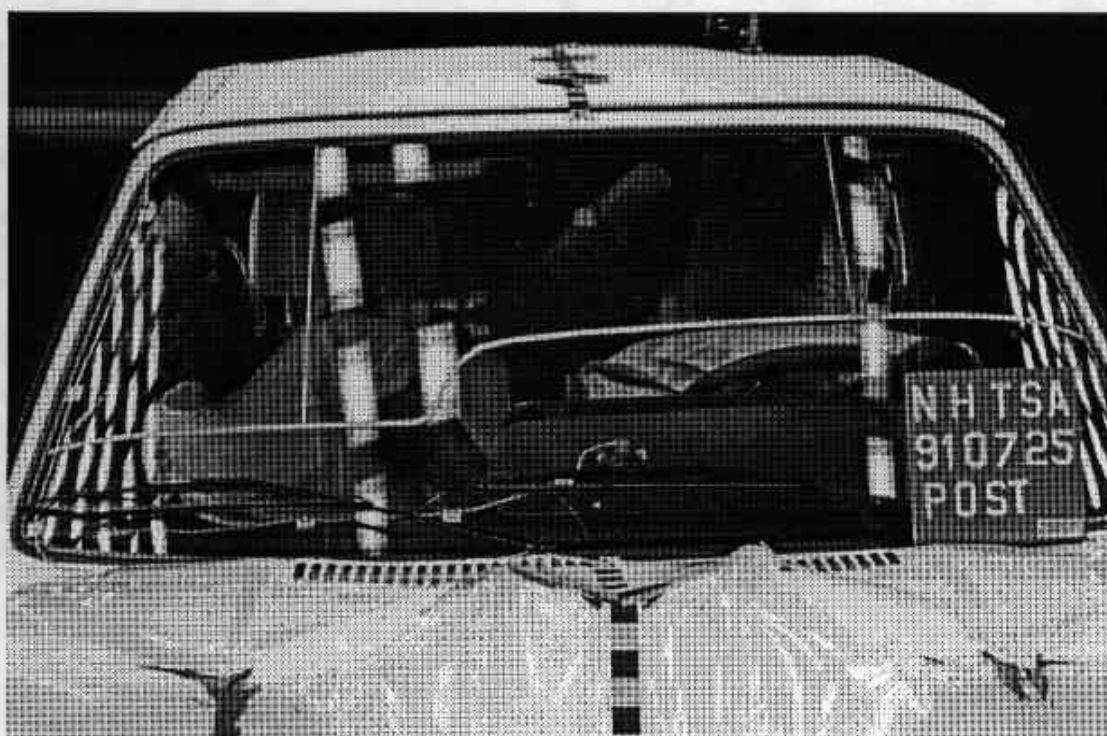
Figure A-14. POST-TEST WINDSHIELD VIEW

One crack in lower right center of windshield.
