**DOT HS 807 757
Final Report**

Final Report of Minicars RSV into 50% Left Offset Frontal Barrier

14. Sponsoring Agency Code DOT/NHTSA/VRTC	
15. Supplementary Notes					
16. Abstract One 50% left offset frontal barrier impact test was conducted to determine the structural integrity of the test vehicle. This test was conducted on a Minicars RSV, VIN A1035, at the Transportation Research Center of Ohio on July 1, 1991. TEST NUMBER: 910701 TIME: 1238 TEMPERATURE: 86° F SPEED: 49.8 MPH

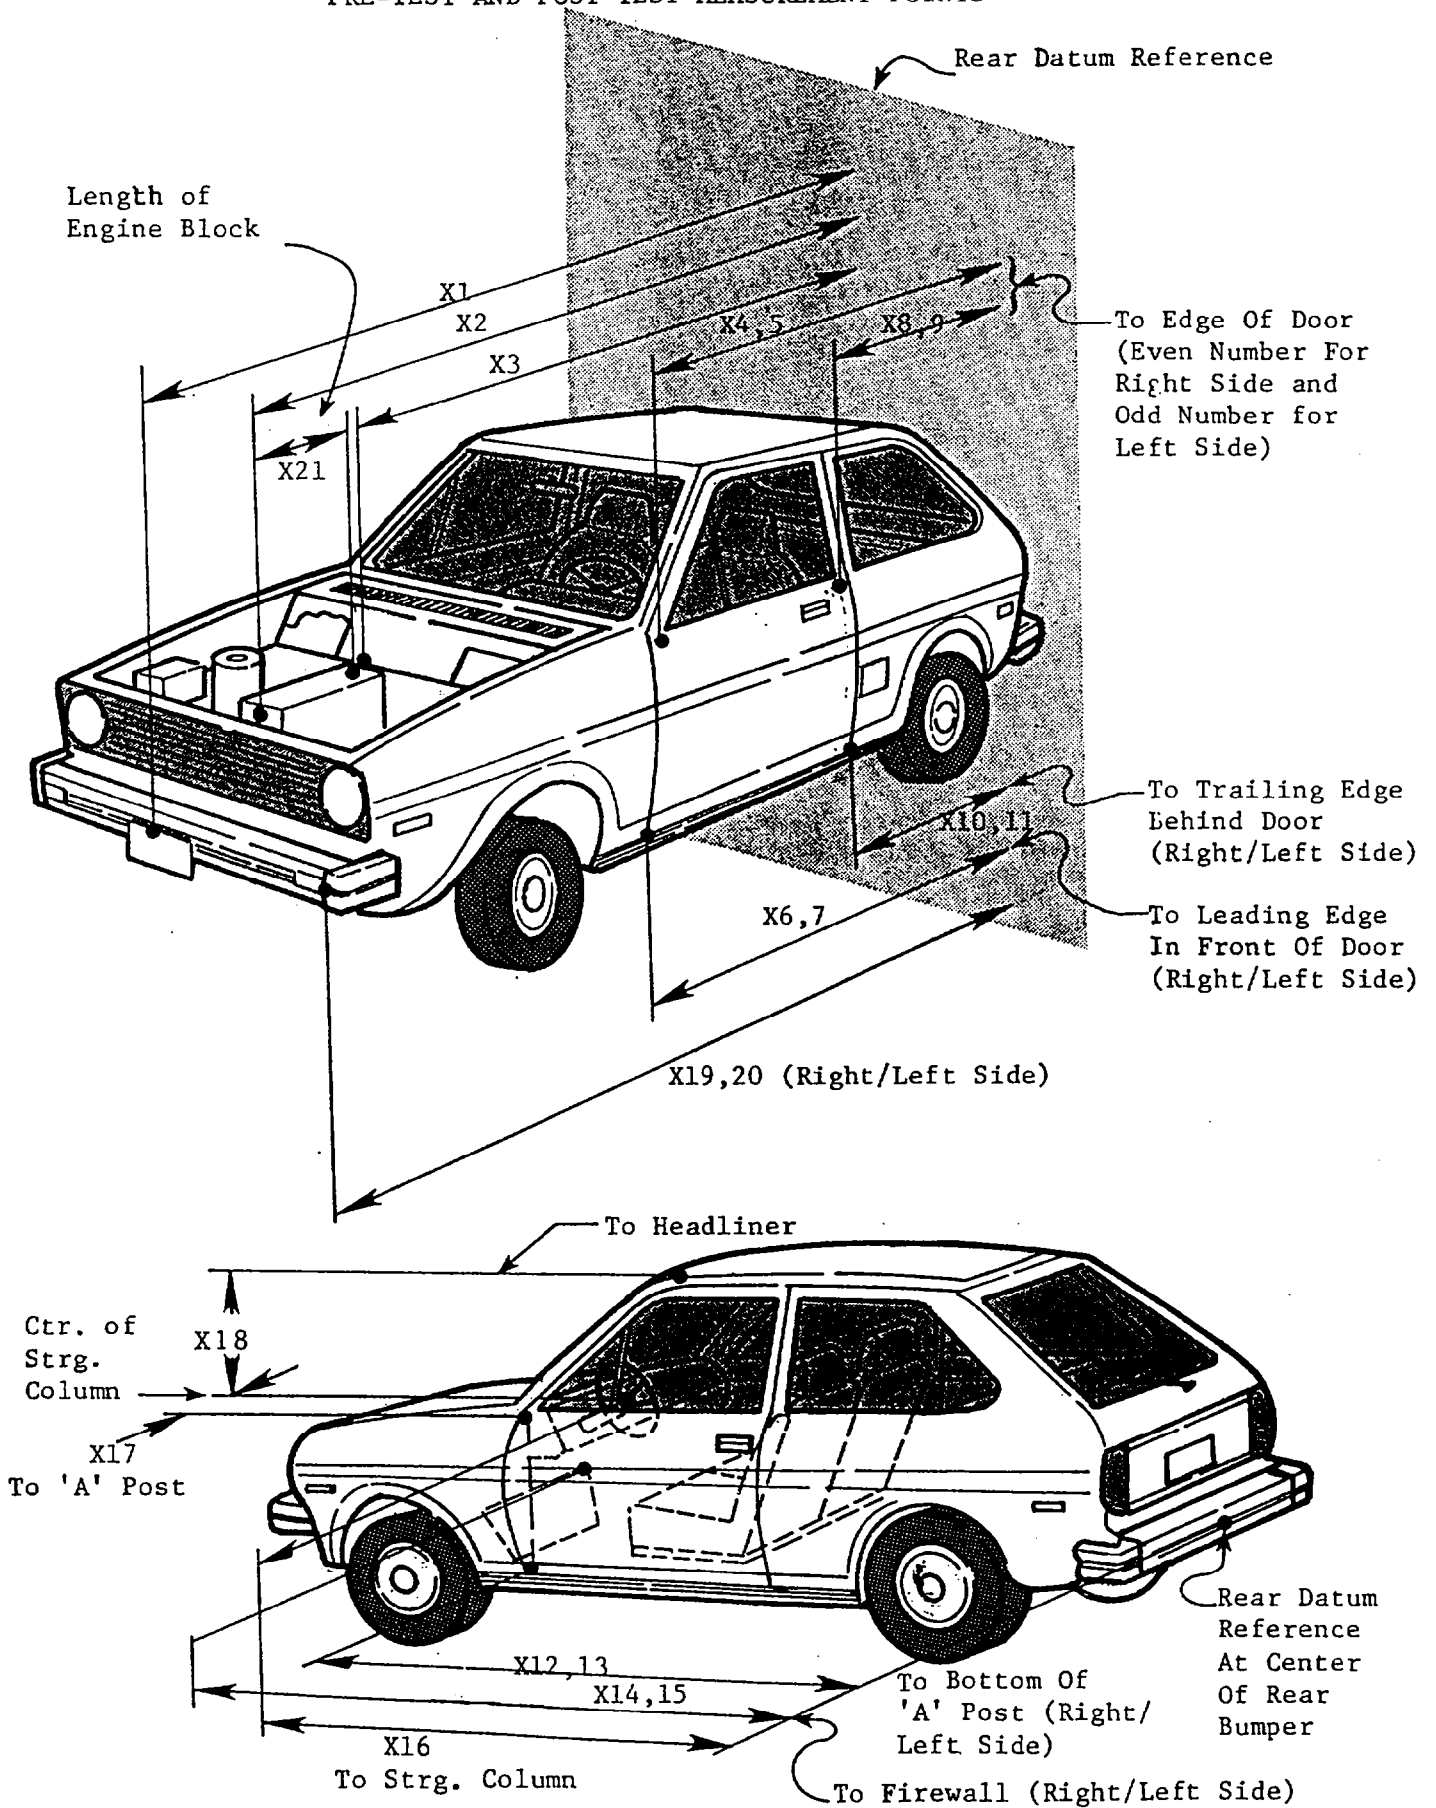
PRE-TEST AND POST-TEST MEASUREMENT POINTS

NO.	TYPE OF MEASUREMENT	ALL MEASUREMENTS ARE IN INCHES		
		PRE-TEST	POST-TEST	DIFF.
X1	TOTAL LENGTH OF VEHICLE AT CENTERLINE	177.5	124.6	52.9
X2	REAR SURFACE OF VEHICLE TO FRONT OF ENGINE BLOCK	34.2	34.2	0.0
X3	REAR SURFACE OF VEHICLE TO FIREWALL	125.1	119.0	6.1
X4	REAR SURFACE OF VEHICLE TO UPPER LEADING EDGE OF RIGHT DOOR	113.0	113.0	0.0
X5	REAR SURFACE OF VEHICLE TO UPPER LEADING EDGE OF LEFT DOOR	113.0	111.5	1.5
X6	REAR SURFACE OF VEHICLE TO LOWER LEADING EDGE OF RIGHT DOOR	113.0	112.8	0.2
X7	REAR SURFACE OF VEHICLE TO LOWER LEADING EDGE OF LEFT DOOR	113.1	100.0	13.1
X8	REAR SURFACE OF VEHICLE TO UPPER TRAILING EDGE OF RIGHT DOOR	48.6	49.0	-0.4
X9	REAR SURFACE OF VEHICLE TO UPPER TRAILING EDGE OF LEFT DOOR	48.9	47.5	1.4
X10	REAR SURFACE OF VEHICLE TO LOWER TRAILING EDGE OF RIGHT DOOR	56.0	55.5	0.5
X11	REAR SURFACE OF VEHICLE TO LOWER TRAILING EDGE OF LEFT DOOR	56.0	55.0	1.0
X12	REAR SURFACE OF VEHICLE TO BOTTOM OF "A" POST ON RIGHT SIDE	113.6	113.1	0.5

X13	REAR SURFACE OF VEHICLE TO BOTTOM OF "A" POST ON LEFT SIDE	113.8	100.5	13.3
X14	REAR SURFACE OF VEHICLE TO FIREWALL - RIGHT SIDE	125.8	123.1	2.7
X15	REAR SURFACE OF VEHICLE TO FIREWALL - LEFT SIDE	125.2	111.2	14.0
X16	REAR SURFACE OF VEHICLE TO STEERING WHEEL CENTER	91.2	79.4	11.8
X17	CENTER OF STEERING COLUMN TO "A" POST	11.9	20.4	-8.5
X18	CENTER OF STEERING COLUMN TO HEADLINER	18.2	18.2	0.0
X19	REAR SURFACE OF VEHICLE TO RIGHT SIDE OF FRONT BUMPER	175.0	149.8	25.2
X20	REAR SURFACE OF VEHICLE TO LEFT SIDE OF FRONT BUMPER	175.0	133.2	41.8
X21	LENGTH OF ENGINE BLOCK	16.0	16.0	0.0

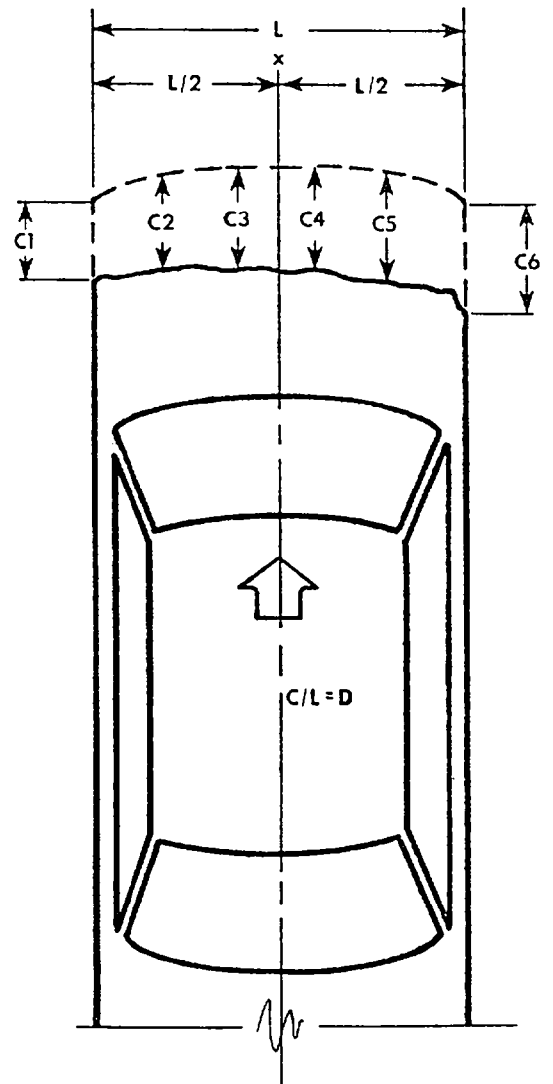
COLLISION DEFORMATION
CLASSIFICATION (CDC) CODE: 12FLEW5

CRUSH DEPTH
MEASUREMENTS:

C1 =	<u>41.8</u>	INCHES
C2 =	<u>46.3</u>	INCHES
C3 =	<u>50.3</u>	INCHES
C4 =	<u>47.1</u>	INCHES
C5 =	<u>37.8</u>	INCHES
C6 =	<u>25.2</u>	INCHES

MIDPOINT OF DAMAGE: D = VEHICLE CENTERLINE
(LONGITUDINAL)

LENGTH OF DAMAGED
REGION: L = 50.0 INCHES

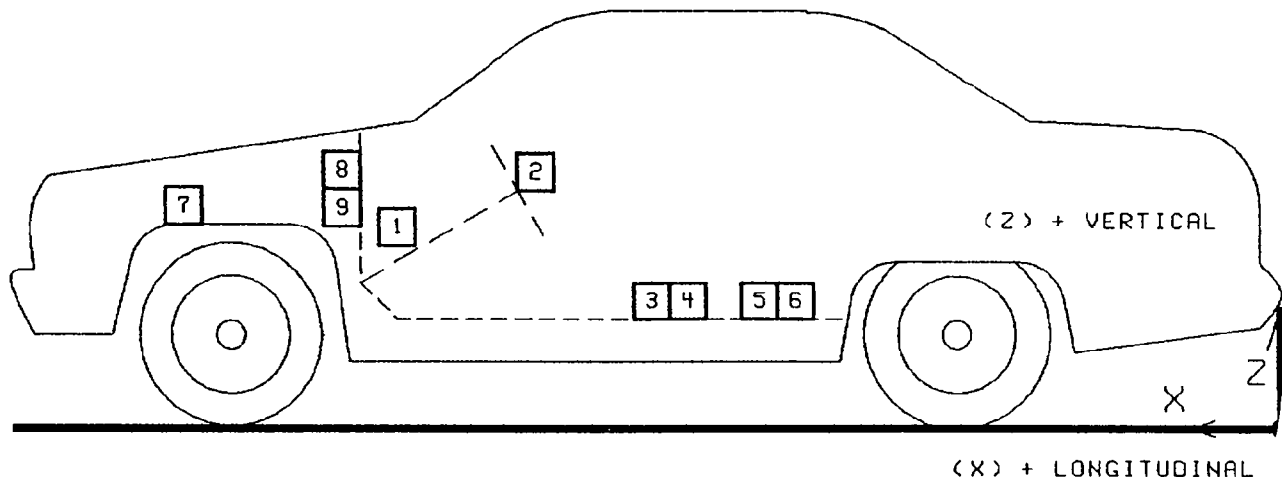
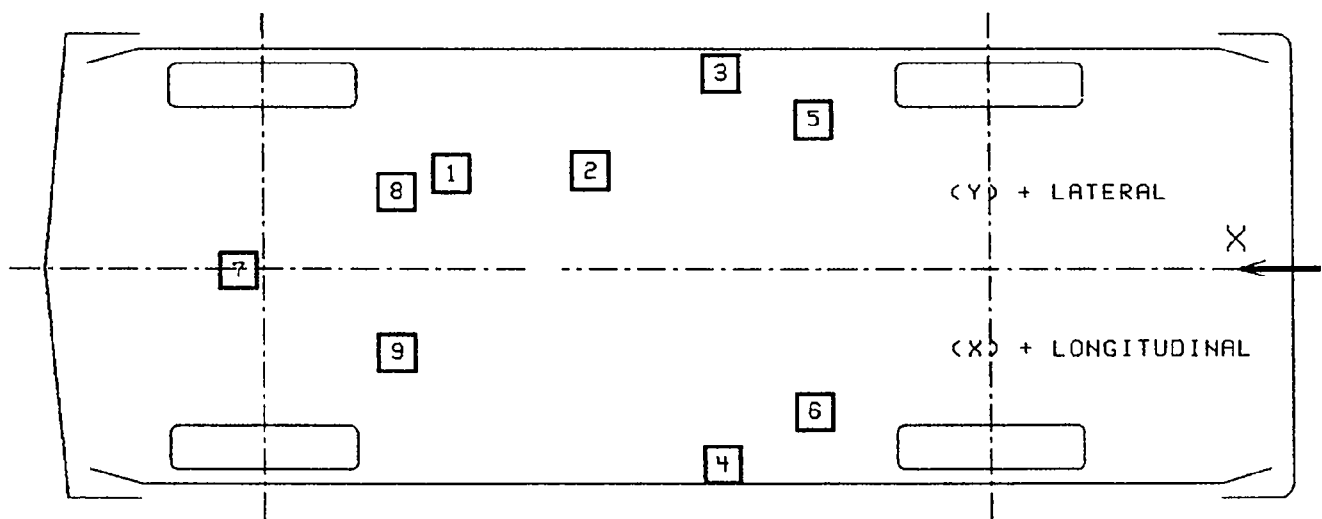
VEHICLE ACCELEROMETER PLACEMENT

SIDE VIEW

BOTTOM VIEW

No.	LOCATION	X*	Y*	Z*	POSITIVE DIRECTION		NEGATIVE DIRECTION	
					MAX G	MSEC	MAX G	MSEC
1	STEERING COLUMN LOWER A-P AXIS	108.9	14.2	34.2	7.3	93.1	84.0	70.5
2	STEERING WHEEL HUB A-P AXIS	98.5	11.5	37.0	26.4	78.3	72.7	71.3
	L-R AXIS				25.9	67.1	46.1	88.9
	I-S AXIS				44.6	71.3	52.0	97.8
3	LEFT B-PILLAR SILL LONGITUDINAL	60.5	22.8	13.8	2.9	187.0	29.2	55.1
4	RIGHT B-PILLAR SILL LONGITUDINAL	61.4	-22.6	8.0	1.8	229.0	25.3	63.5
	LATERAL				2.7	72.6	10.3	44.1
5	LEFT REAR SEAT CROSSMEMBER LONGITUDINAL	56.8	20.6	13.8	1.9	223.0	27.1	55.1
	LATERAL				3.3	72.9	6.8	44.4
6	RIGHT REAR SEAT CROSSMEMBER LONGITUDINAL	57.2	-20.3	14.0	1.9	244.1	32.0	85.3
	LATERAL				3.4	127.5	7.1	86.1
7	ENGINE BLOCK LONGITUDINAL	28.3	-1.0	25.2	3.2	231.8	26.5	72.0
8	LEFT FIREWALL LONGITUDINAL	120.2	17.0	22.2	---	---	Y	---
9	RIGHT FIREWALL LONGITUDINAL	121.2	-13.8	23.2	3.1	290.9	91.3	64.1

REFERENCE: X: + FORWARD FROM REAR BUMPER
 Y: + LEFTWARD FROM VEHICLE CENTERLINE
 Z: + UPWARD FROM GROUND LEVEL

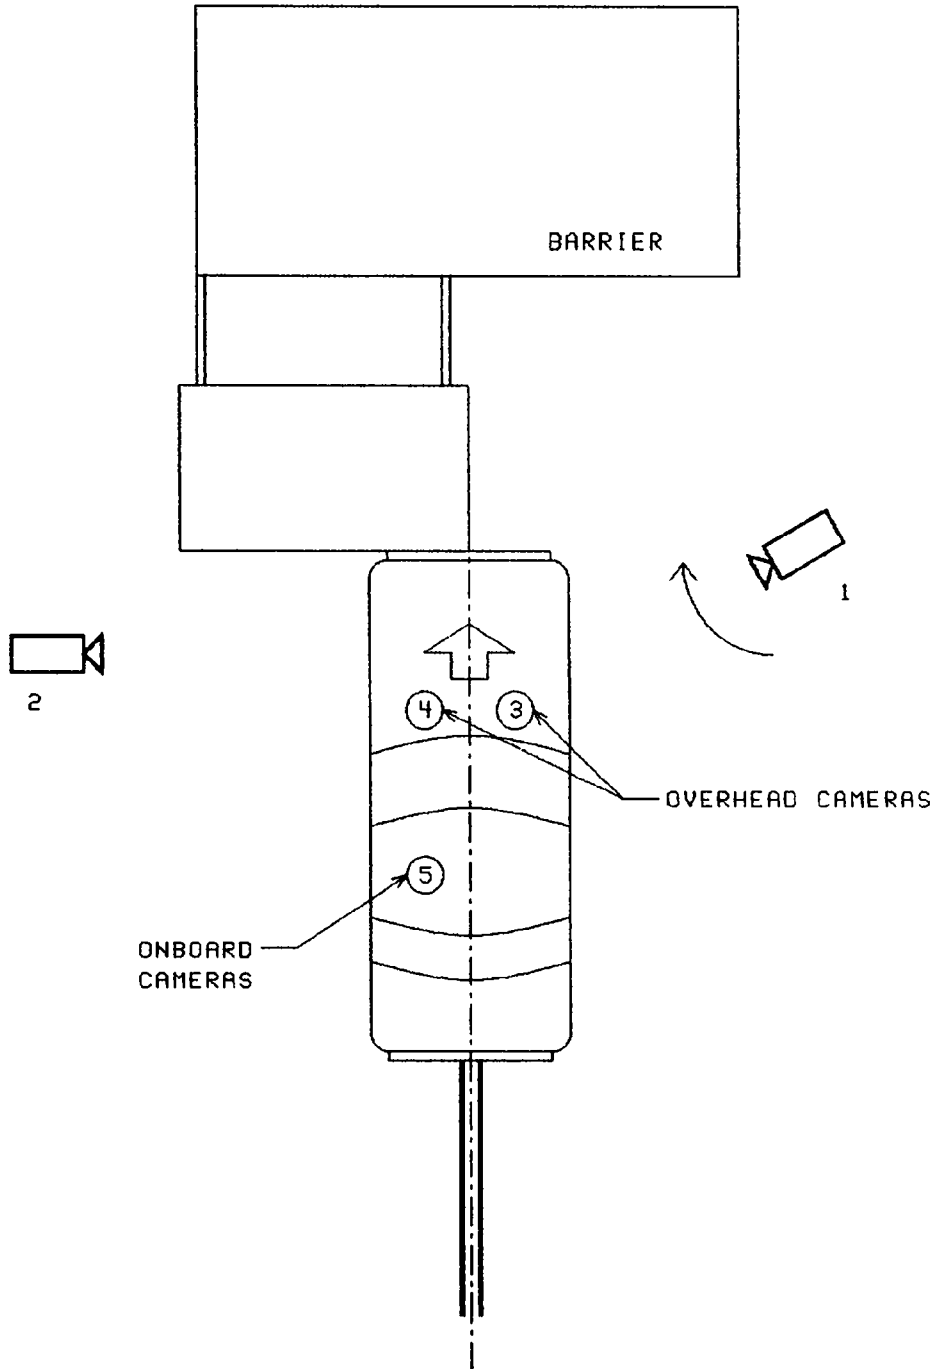
CAMERA POSITIONS

CAMERA NO.	LOCATION	TYPE	LENS (mm)	SPEED (fps)	PURPOSE OF CAMERA DATA
1	Right panning	Photosonic 1B	13	24	Vehicle dynamics
2	Left wide	Photosonic 1B	13	496	Impact overall
3	Overhead wide	Photosonic 1B	8.5	500	Impact overall
4	Overhead tight	Photosonic 1B	17	501	Impact close-up
5	Onboard	Photosonic 1B	8.5	500	Interior deformation

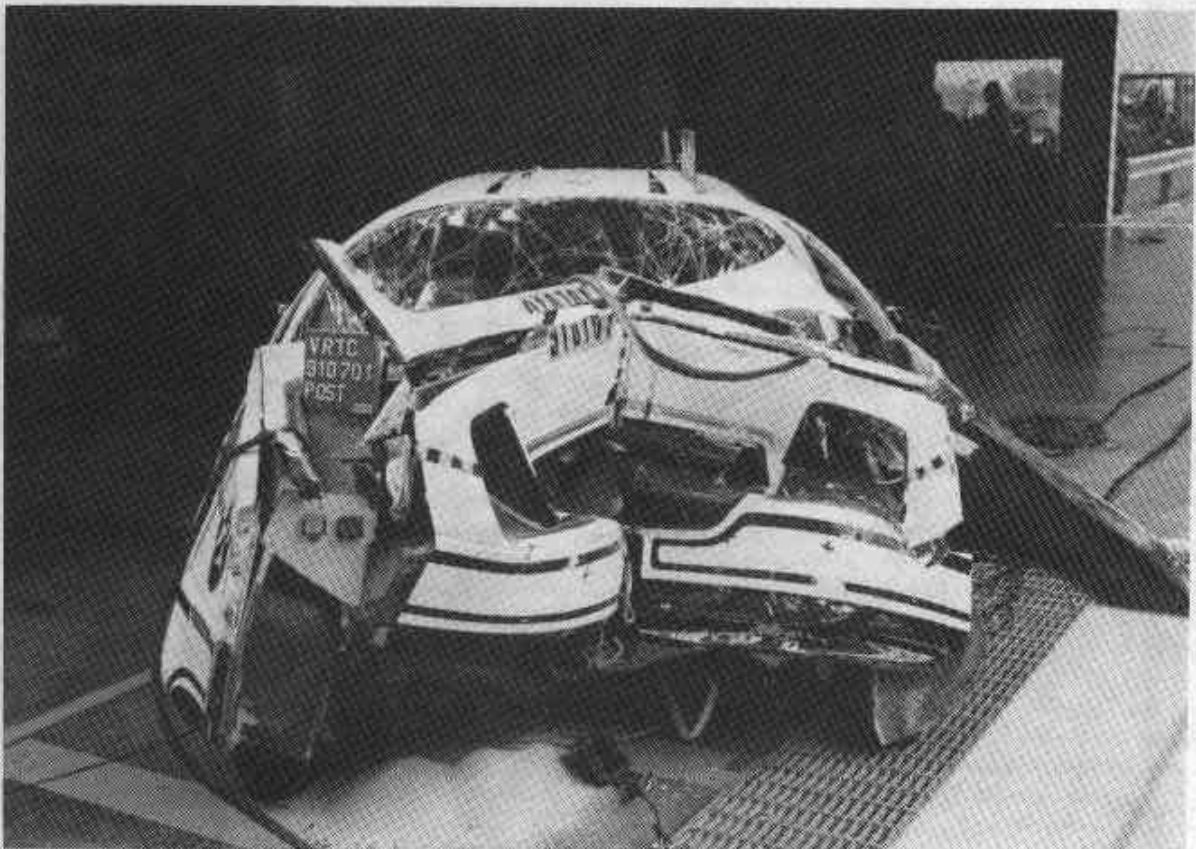
Figure A-2. POST-TEST FRONT VIEW

The entire windshield cracked upon impact.

The vehicle's hood came off on impact. The left

front tire was punctured on impact.

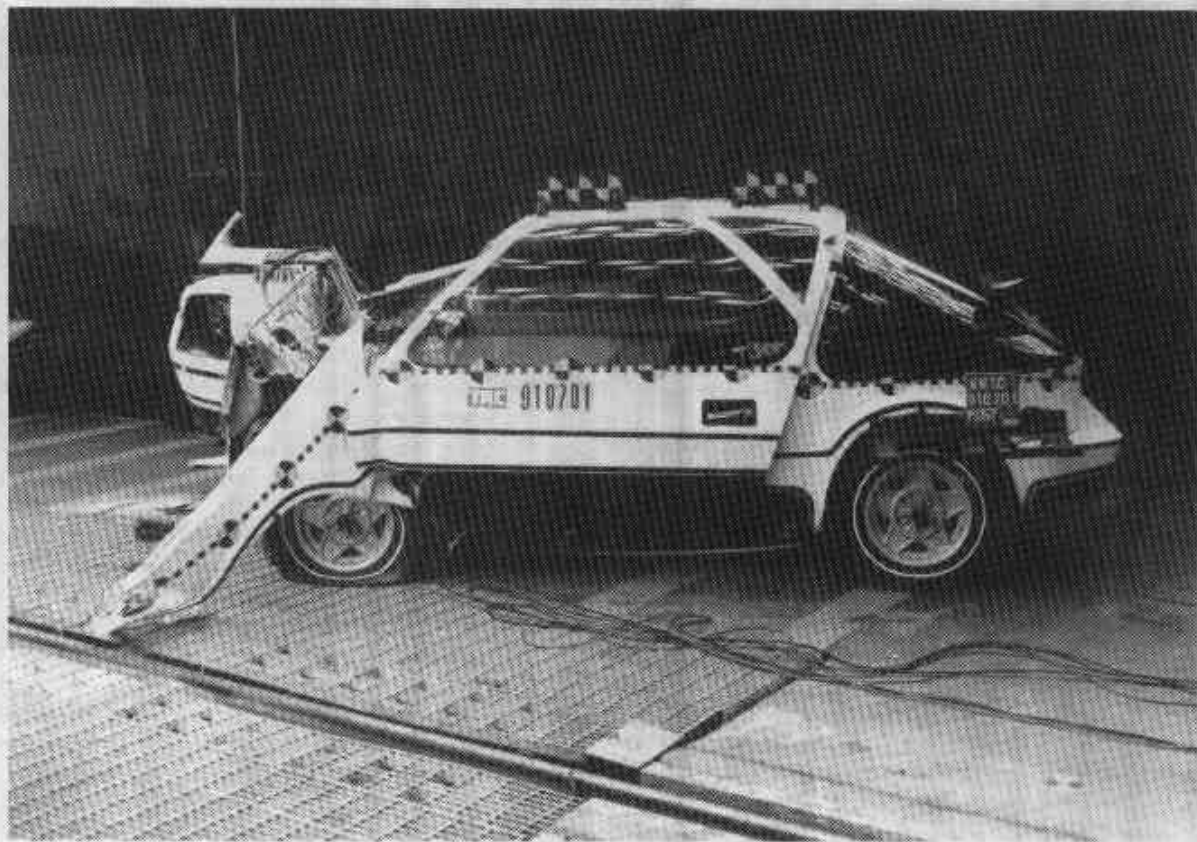
Figure A-8. POST-TEST LEFT SIDE VIEW

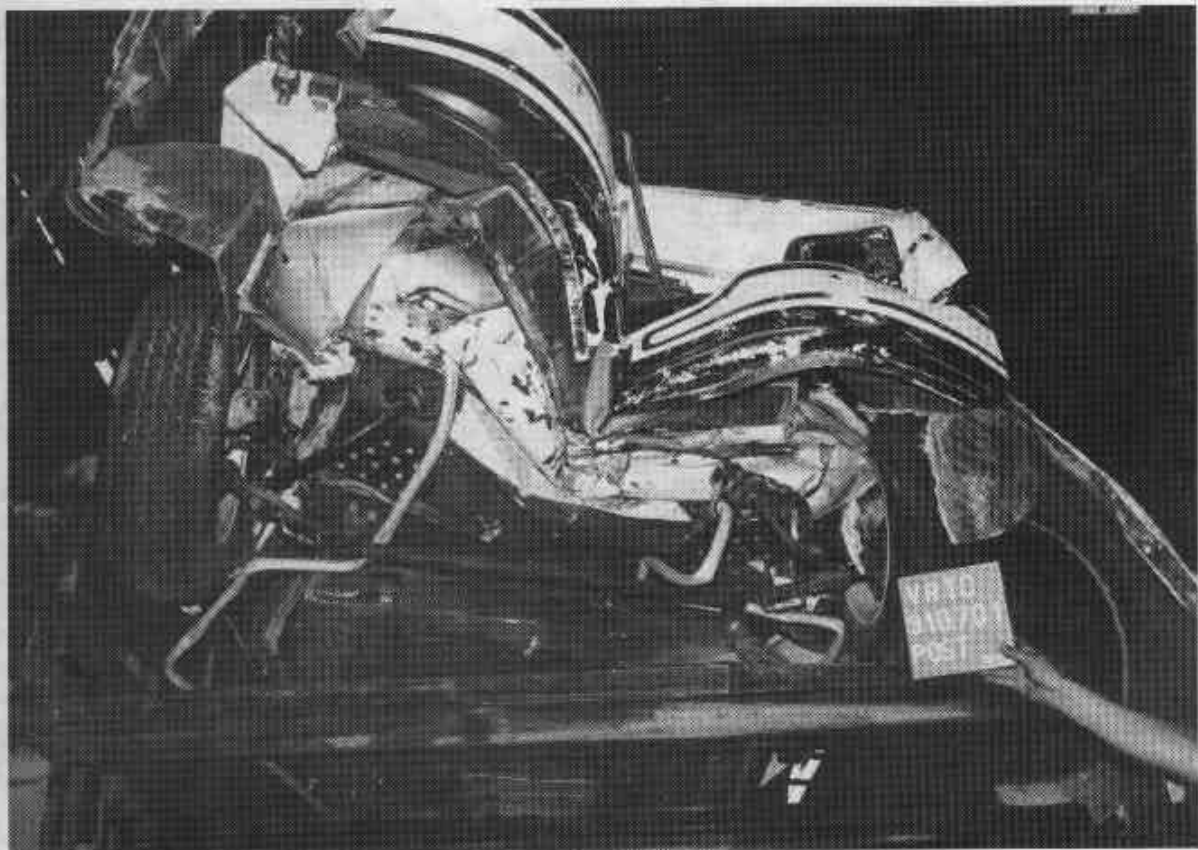
Figure A-18. POST-TEST FRONT UNDERBODY VIEW

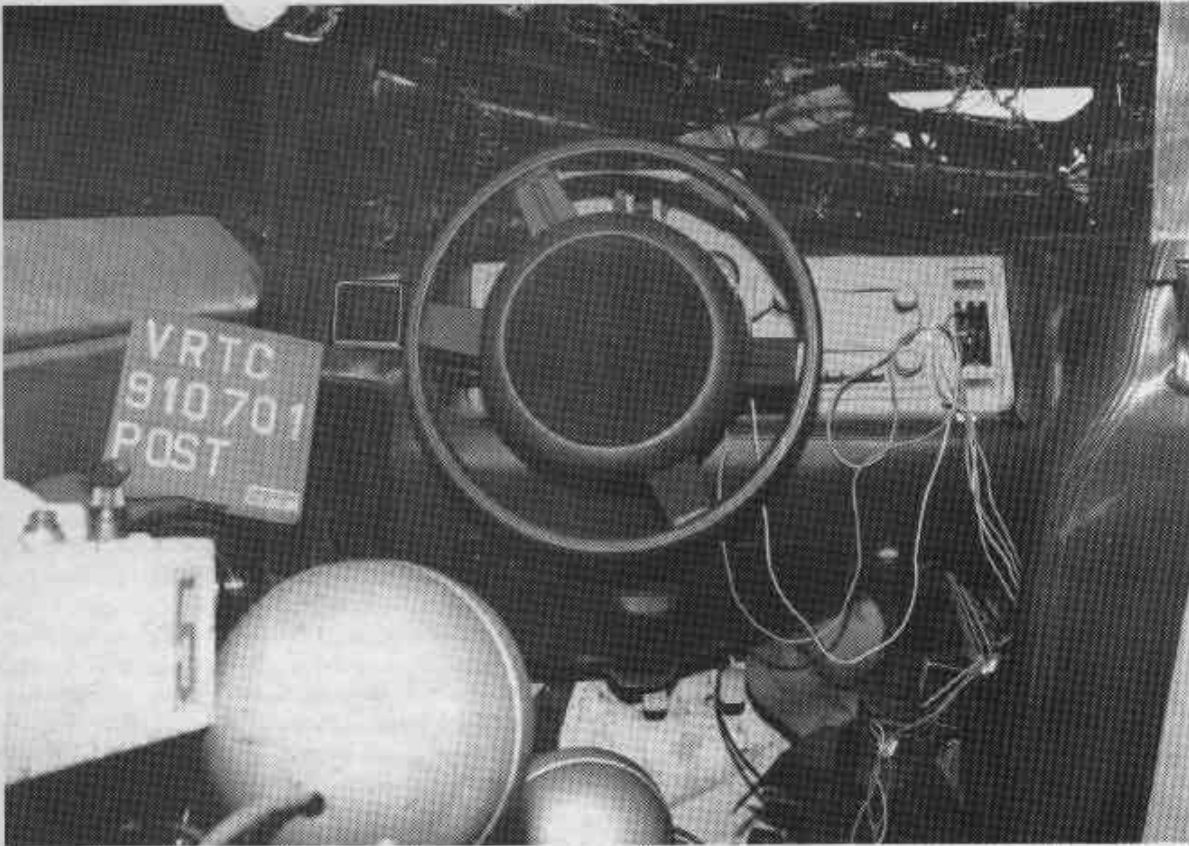
Figure A-21. POST-TEST INTERIOR VIEW

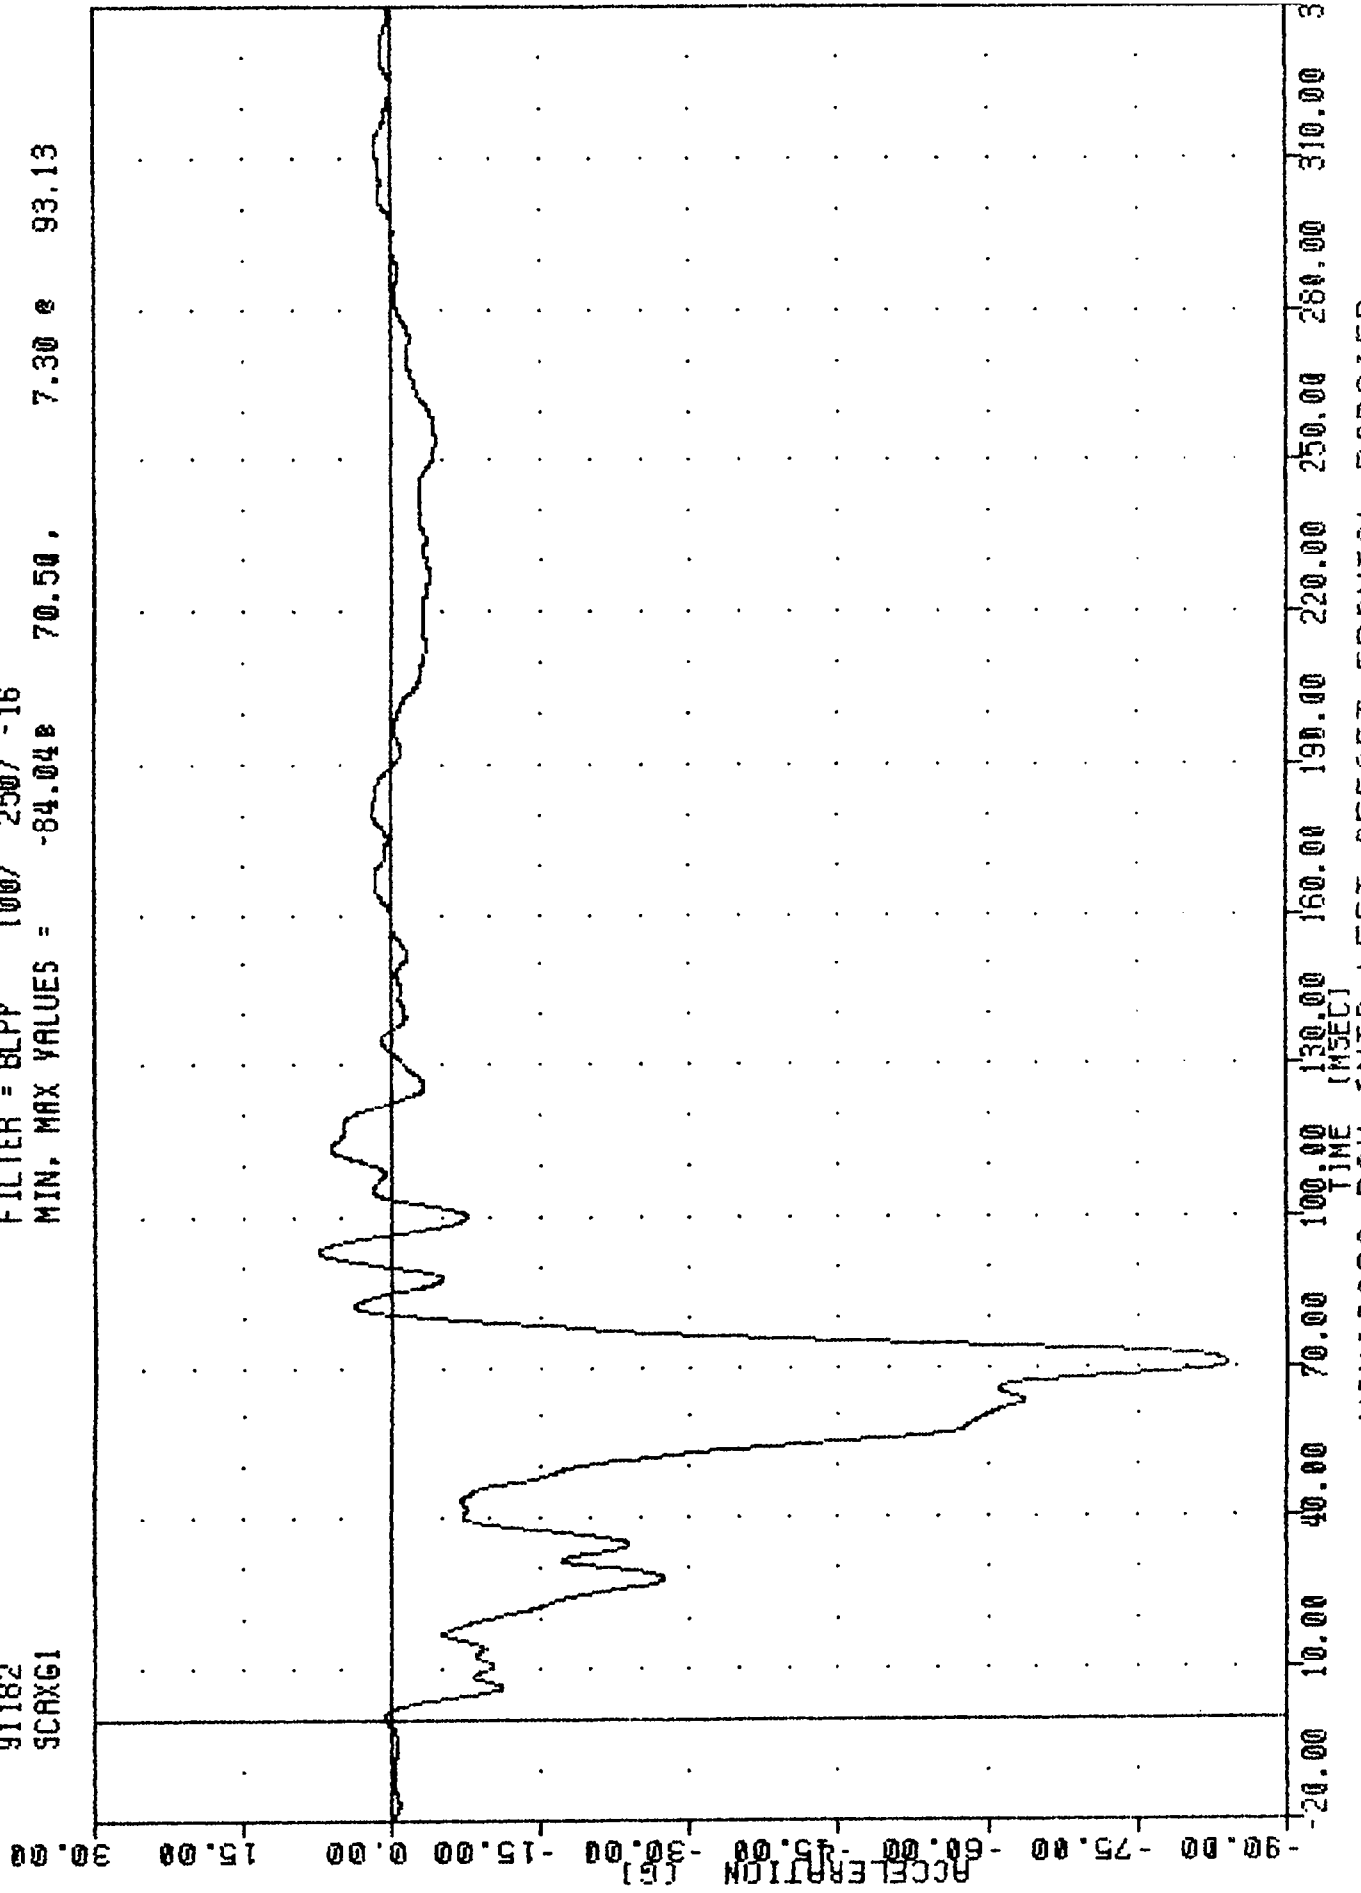
FILTER = BLPP 100/ 250/ -16
MIN. MAX VALUES = -84.048 70.50 . 7.30 e 93.13

MINICARS RSV INTO LEFT OFFSET FRONTAL BARRIER
STEERING COLUMN LOWER A-P AXIS ACCELERATION

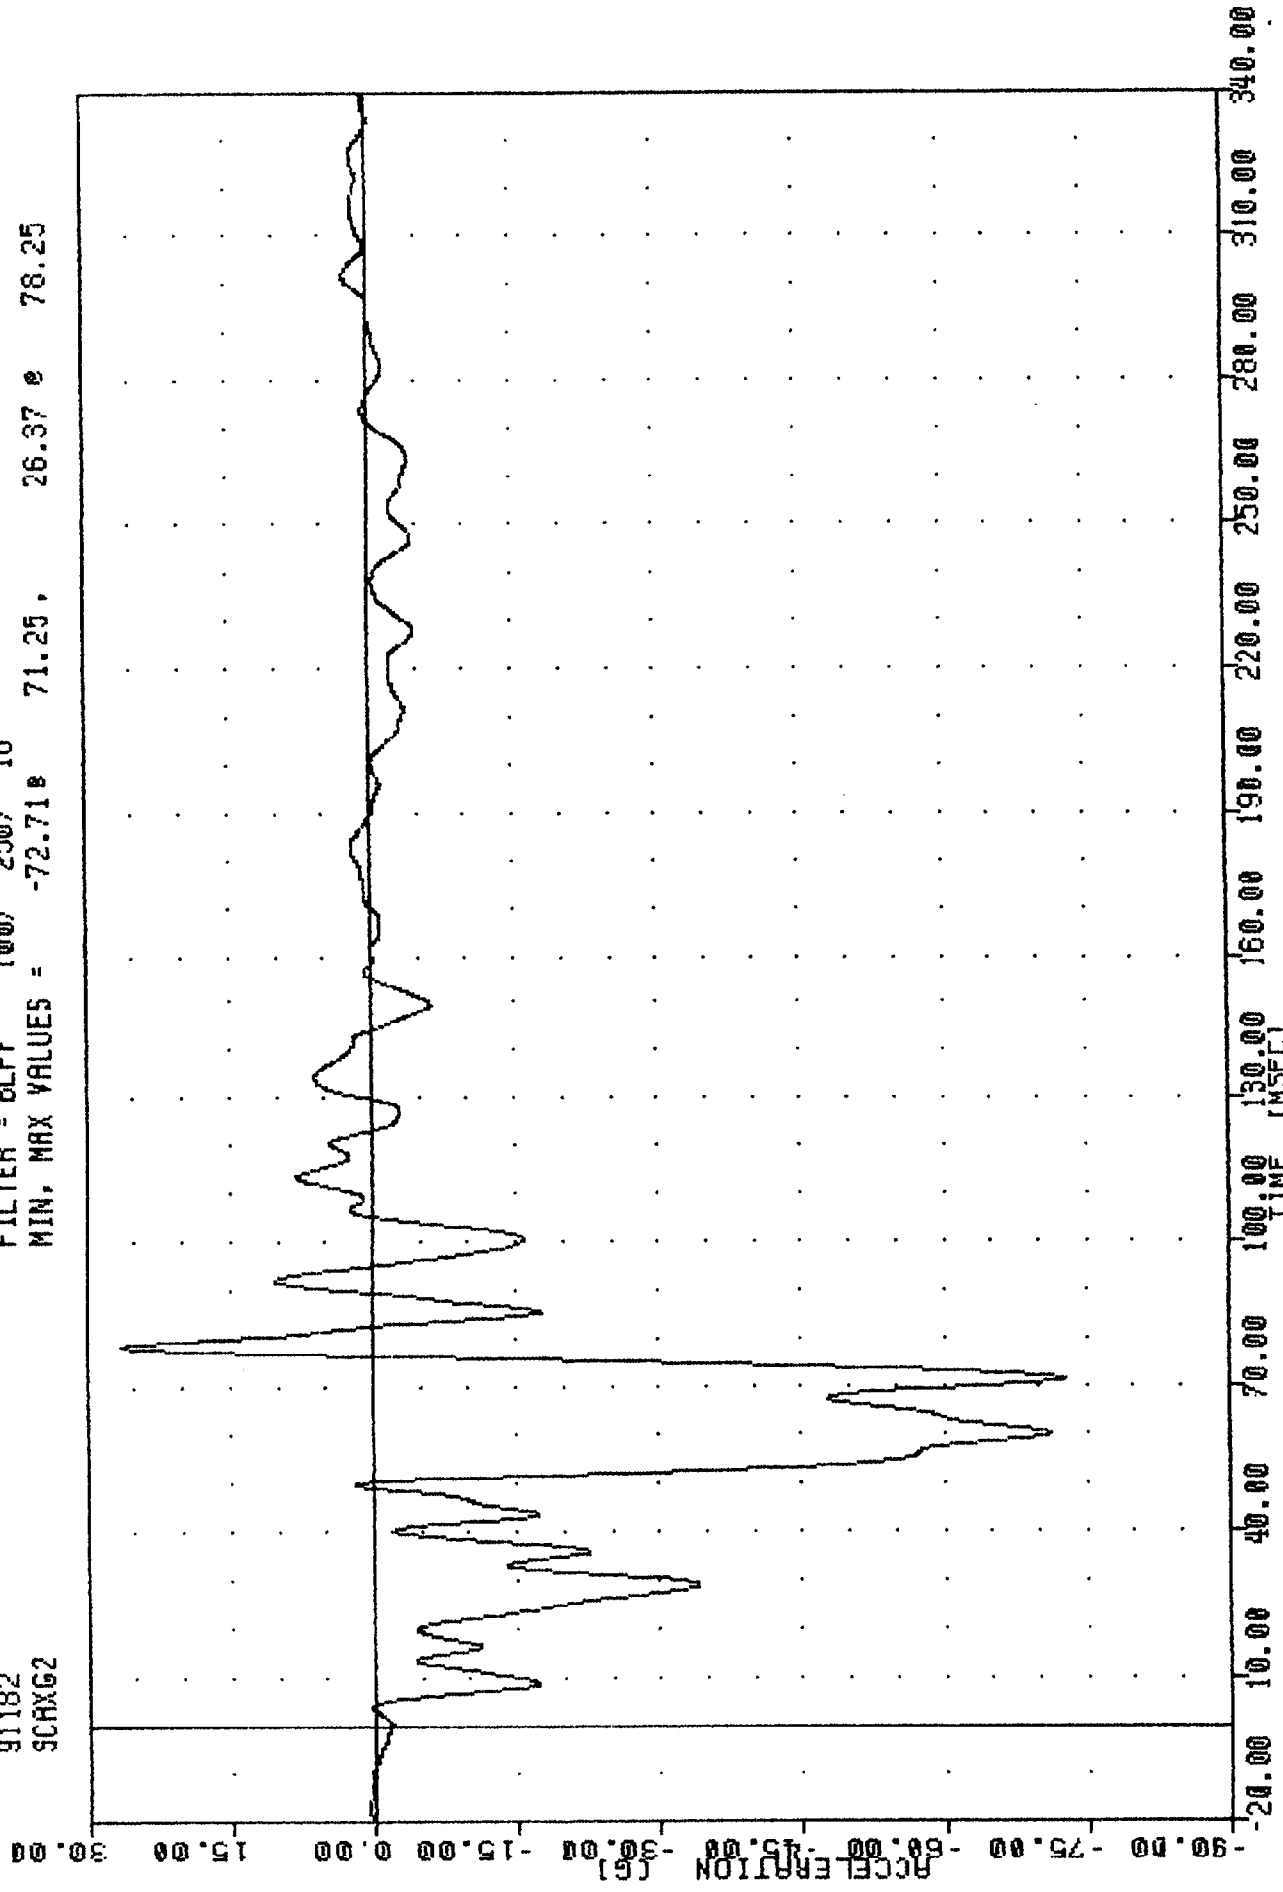
FILTER = BLPP 100/ 250/ -16
MIN, MAX VALUES = -72.71 71.25 26.37 78.25

MINICARS RSV INTO LEFT OFFSET FRONTAL BARRIER
STEERING WHEEL HUB A-P AXIS ACCELERATION

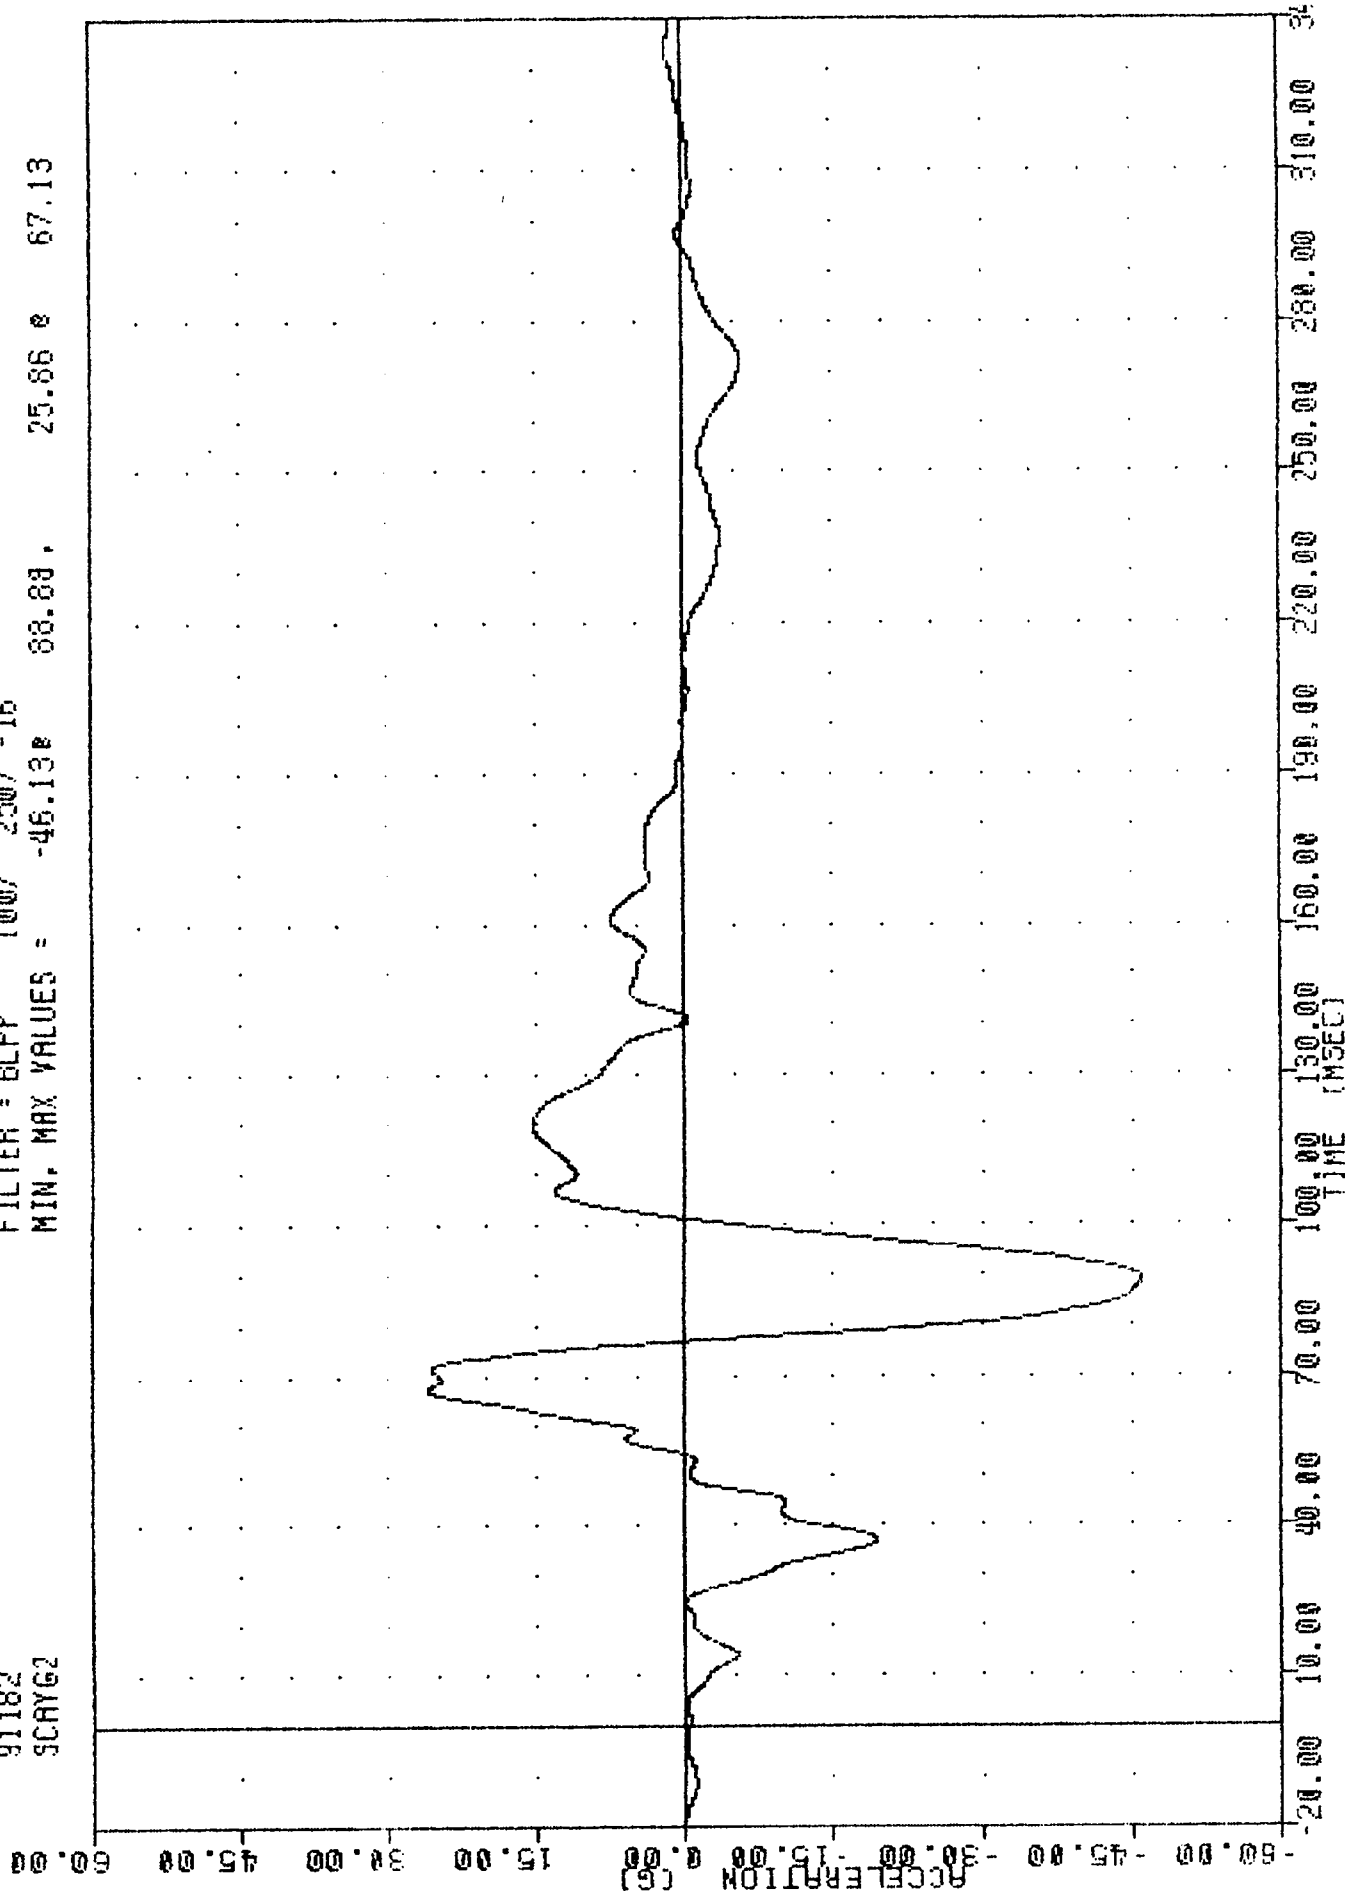
MIN. MAX VALUES = -46.13e 68.88, 25.86 e 67.13

MINICARS RSV INTO LEFT OFFSET FRONTAL BARRIER
STEERING WHEEL HUB L-R AXIS ACCELERATION

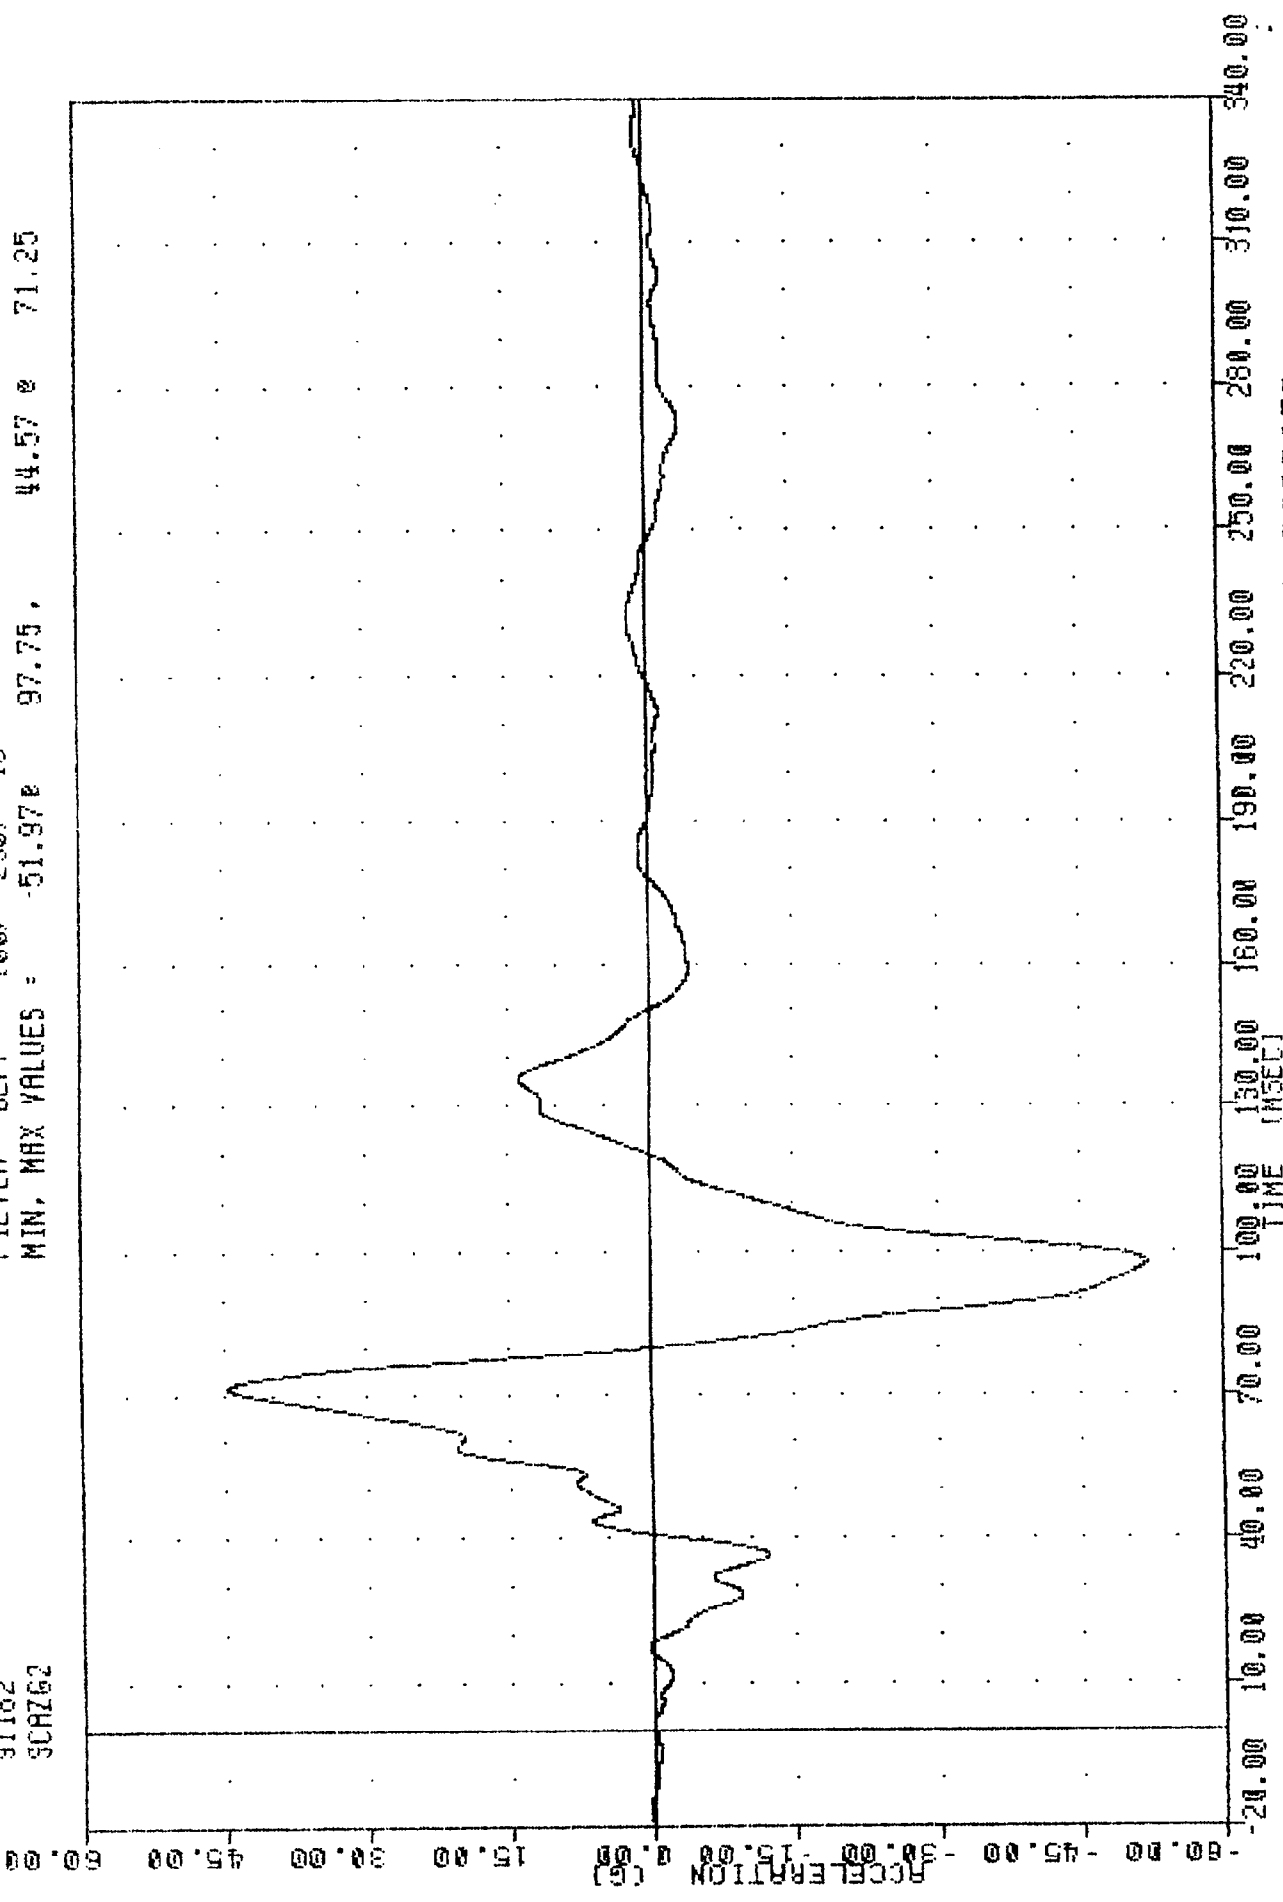
FILTER = 6LPP 100/ 250/ -16
MIN, MAX VALUES = -51.97e 97.75, 44.57e 71.25

MINICARS RSV INTO LEFT OFFSET FRONTAL BARRIER
STEERING WHEEL HUB I-S AXIS ACCELERATION
