**DOT HS 807 757
Final Report**

Final Report of Minicars RSV into 50% Left Offset Frontal Barrier

14. Sponsoring Agency Code DOT/NHTSA/VRTC	
15. Supplementary Notes					
16. Abstract One 50% left offset frontal barrier impact test was conducted to determine the structural integrity of the test vehicle. This test was conducted on a Minicars RSV, VIN A1035, at the Transportation Research Center of Ohio on July 1, 1991. TEST NUMBER: 910701 TIME: 1238 TEMPERATURE: 86° F SPEED: 49.8 MPH

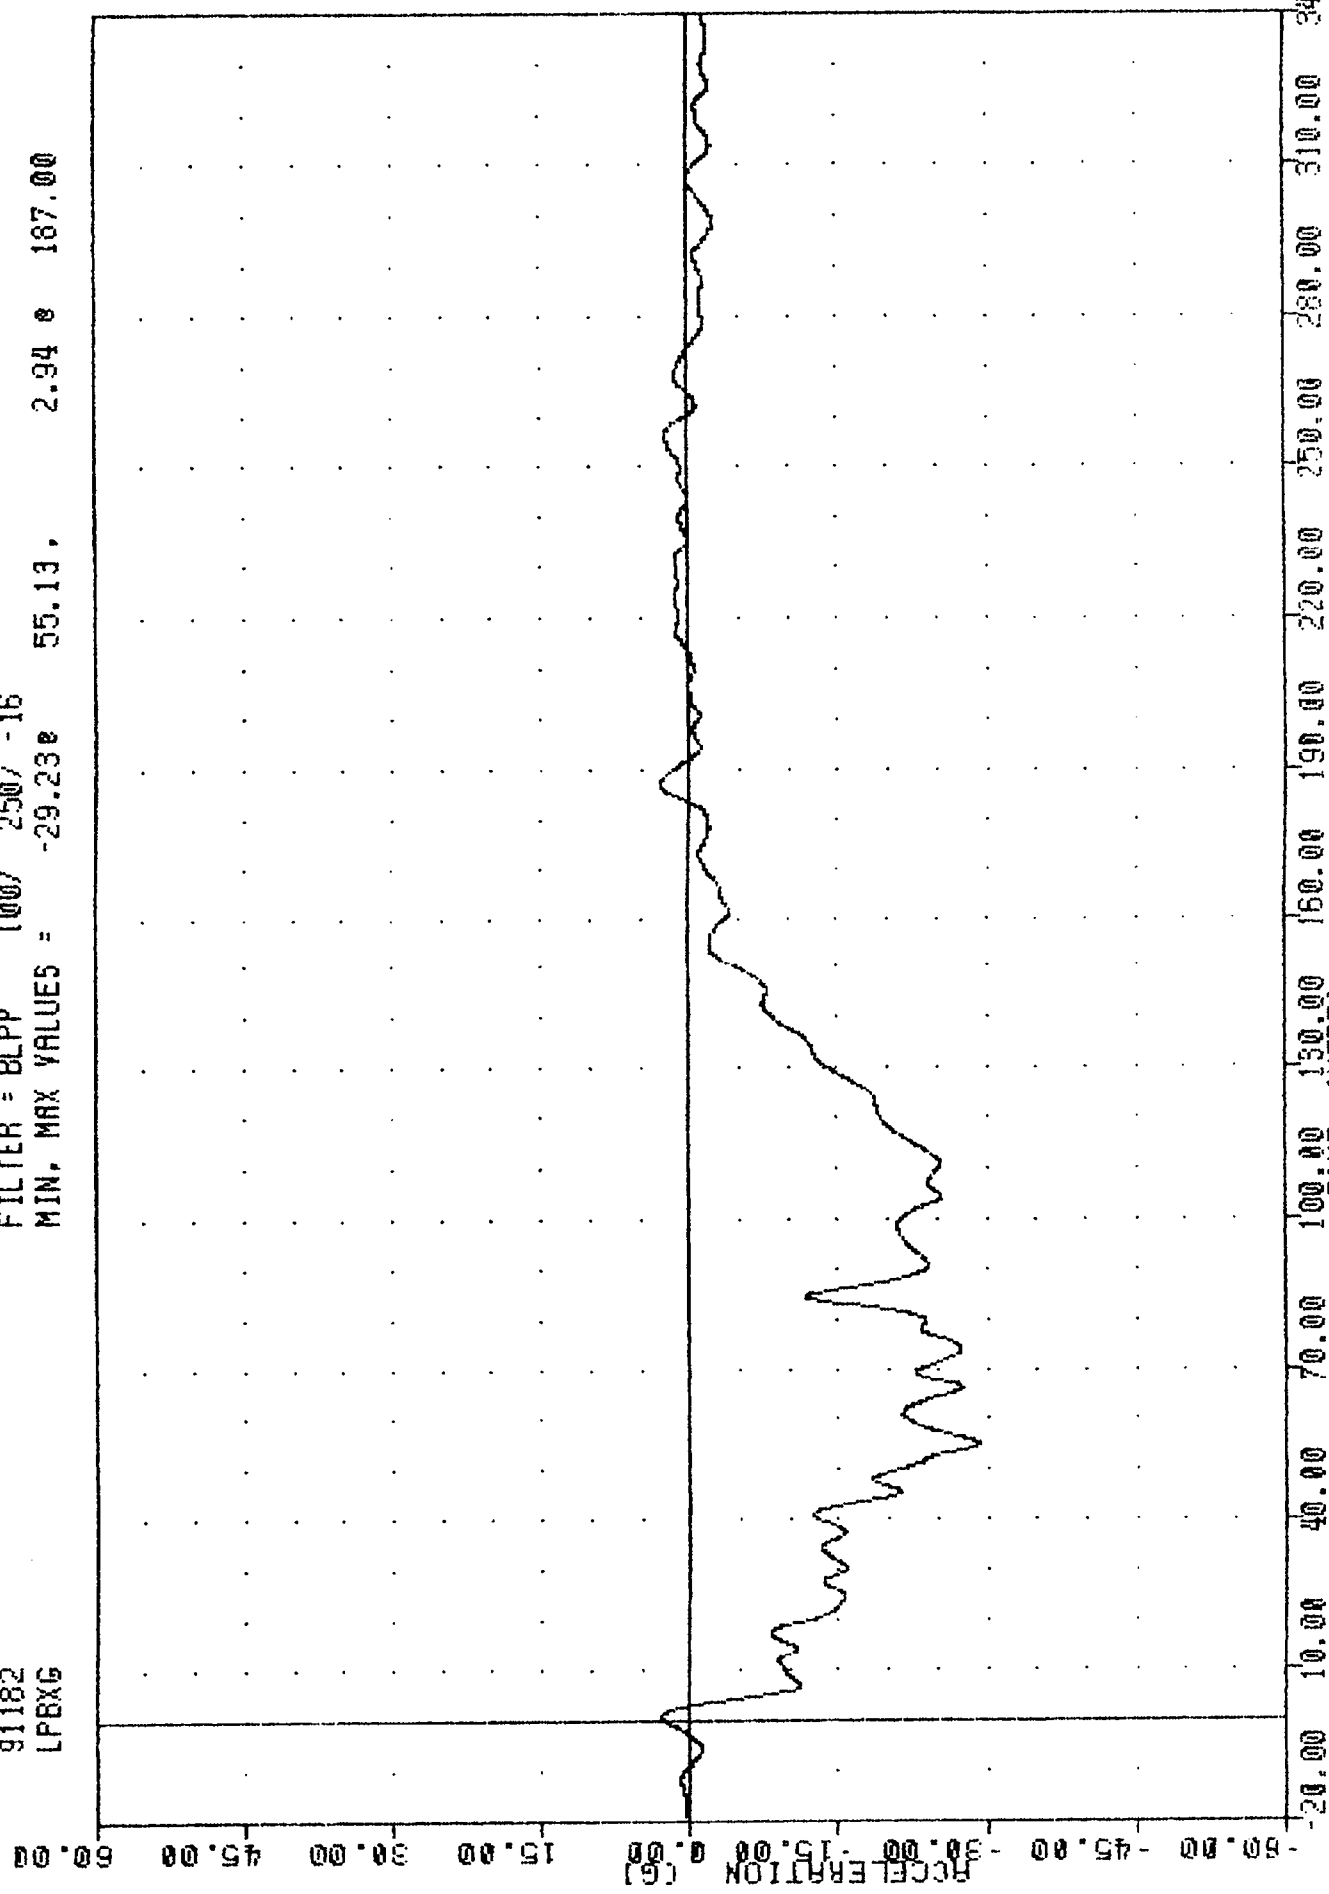
FILTER = BLPP 100/ 250/ -16
MIN. MAX VALUES = -29.23e 55.13.

MINICARS RSV INTO LEFT OFFSET FRONTAL BARRIER
LEFT B-PILLAR X-AXIS ACCELERATION

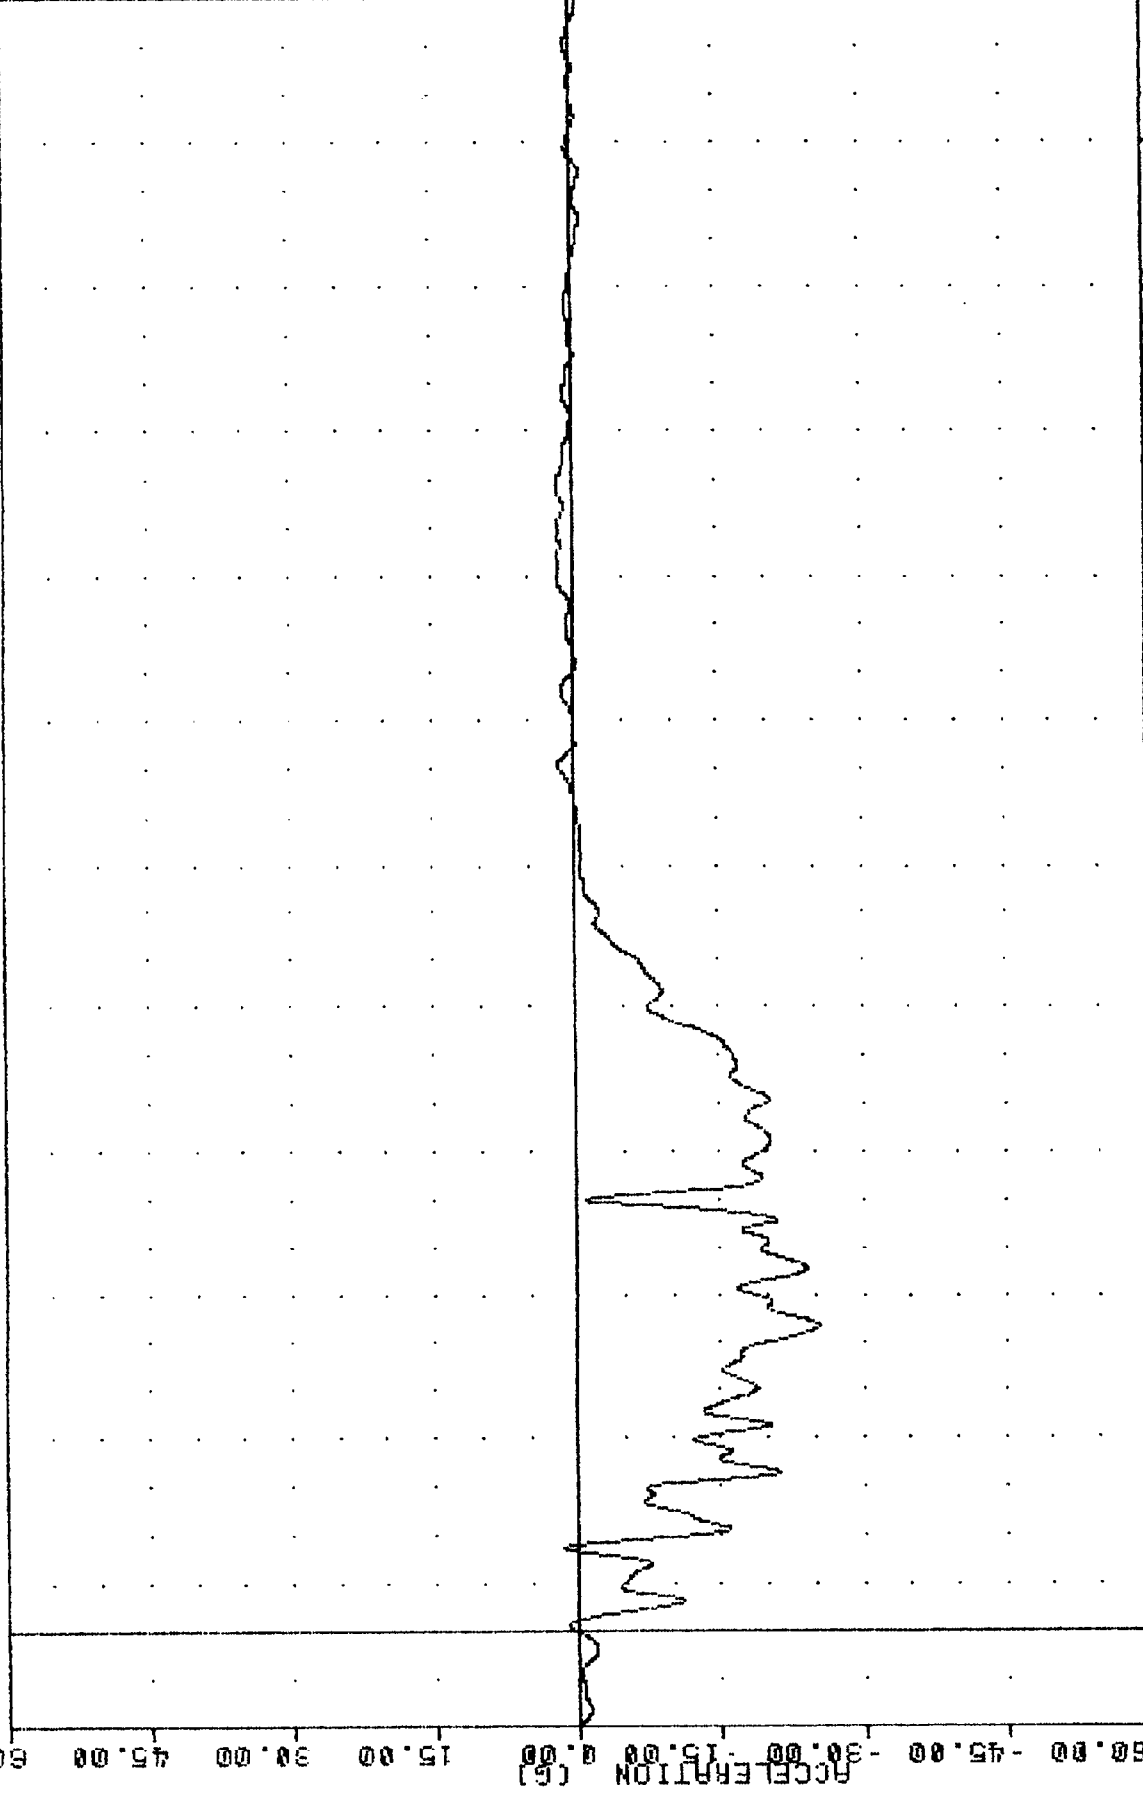
FILTER = BLPP 100/ 250/ -16
MIN. MAX VALUES = -25.27% 63.50, 1.76 @ 229.00

MINICARS RSV INTO LEFT OFFSET FRONTAL BARRIER
RIGHT B-PILLAR X-AXIS ACCELERATION

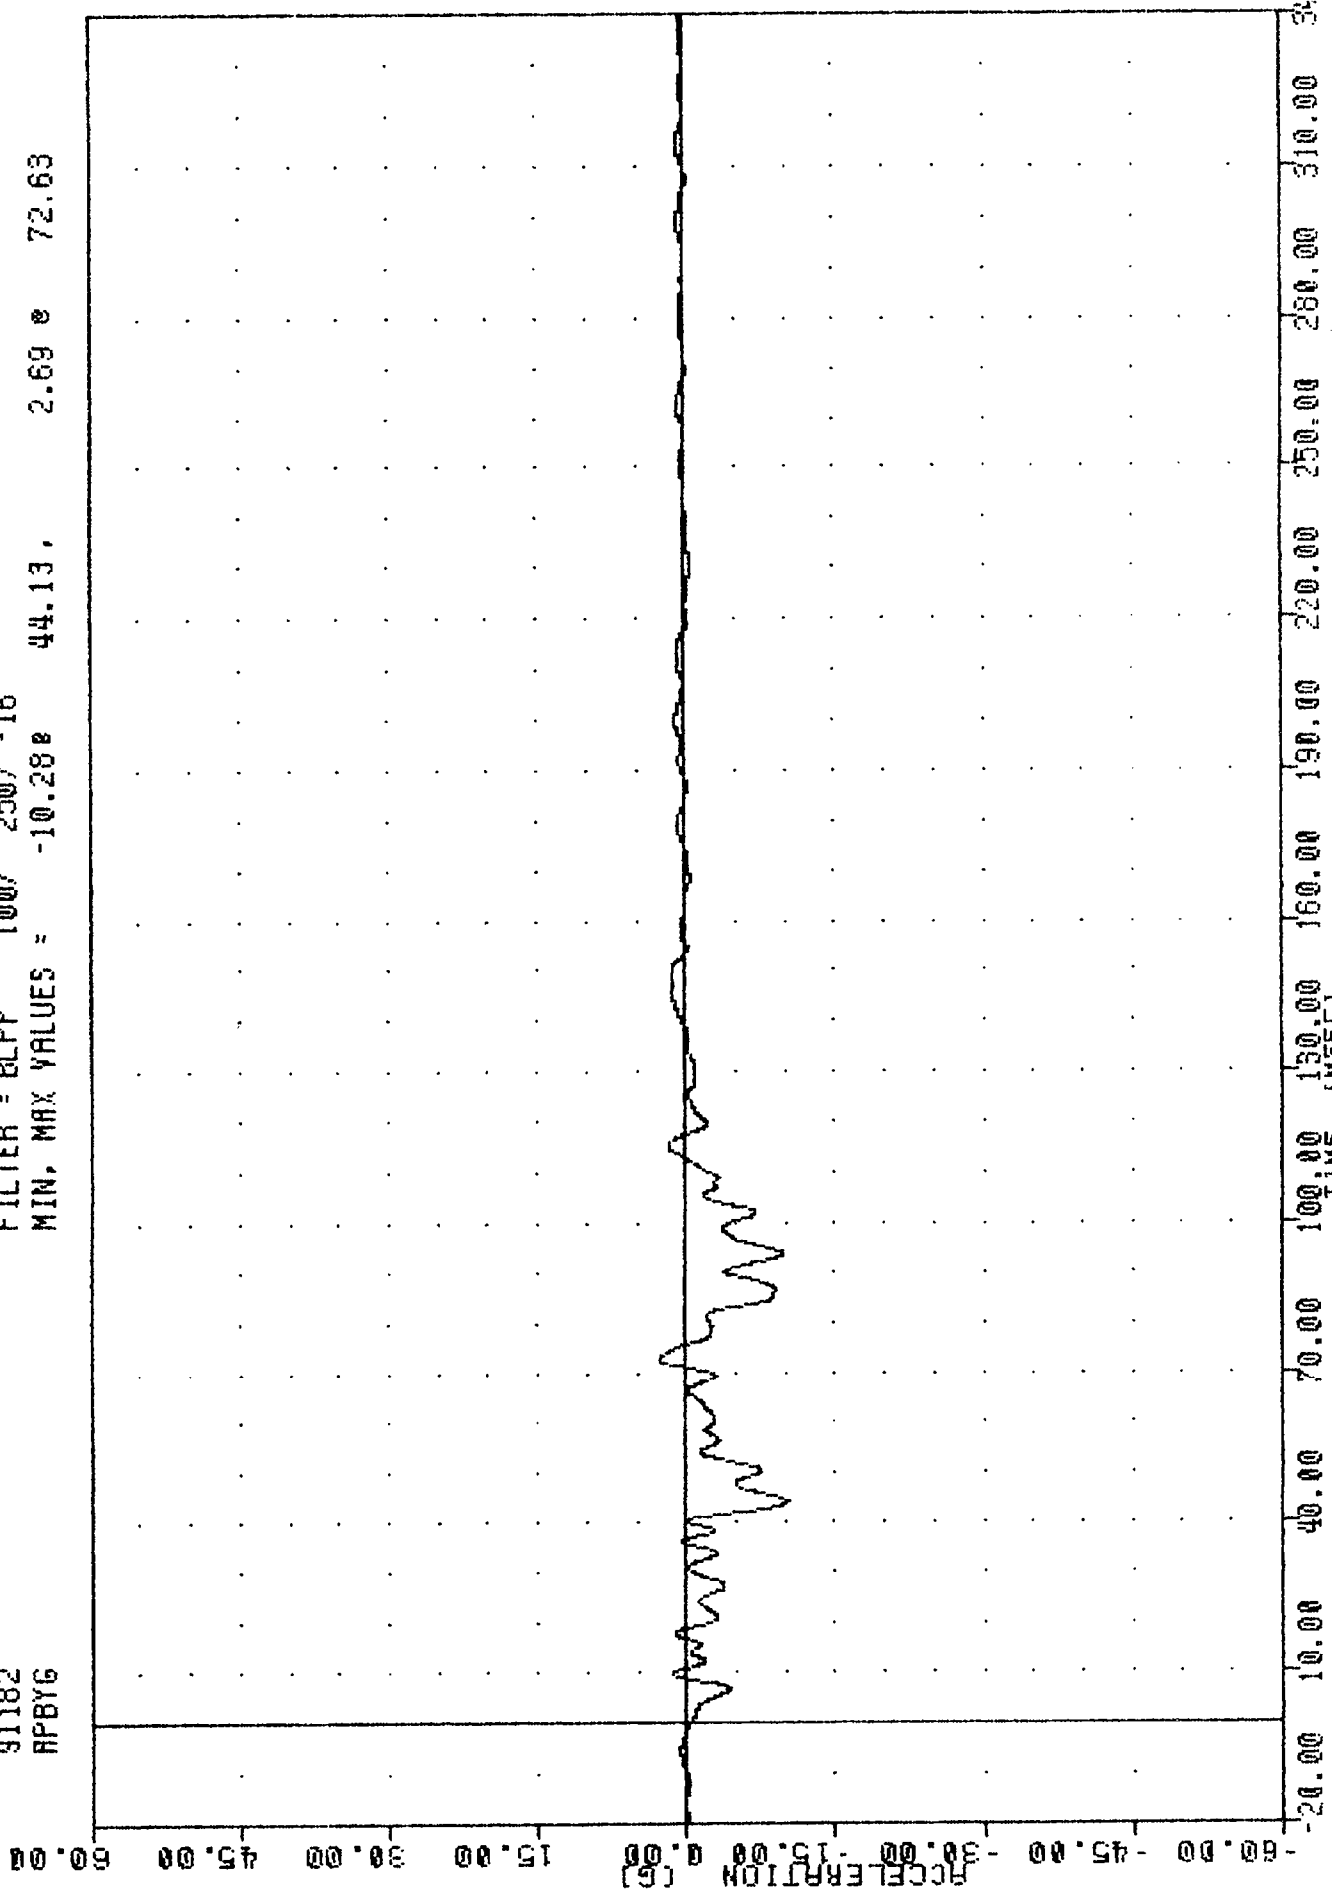
MIN. MAX VALUES = -10.28e 44.13, 2.69 e 72.63

MINICARS RSY INTO LEFT OFFSET FRONTAL BARRIER
RIGHT B-PILLAR Y-AXIS ACCELERATION

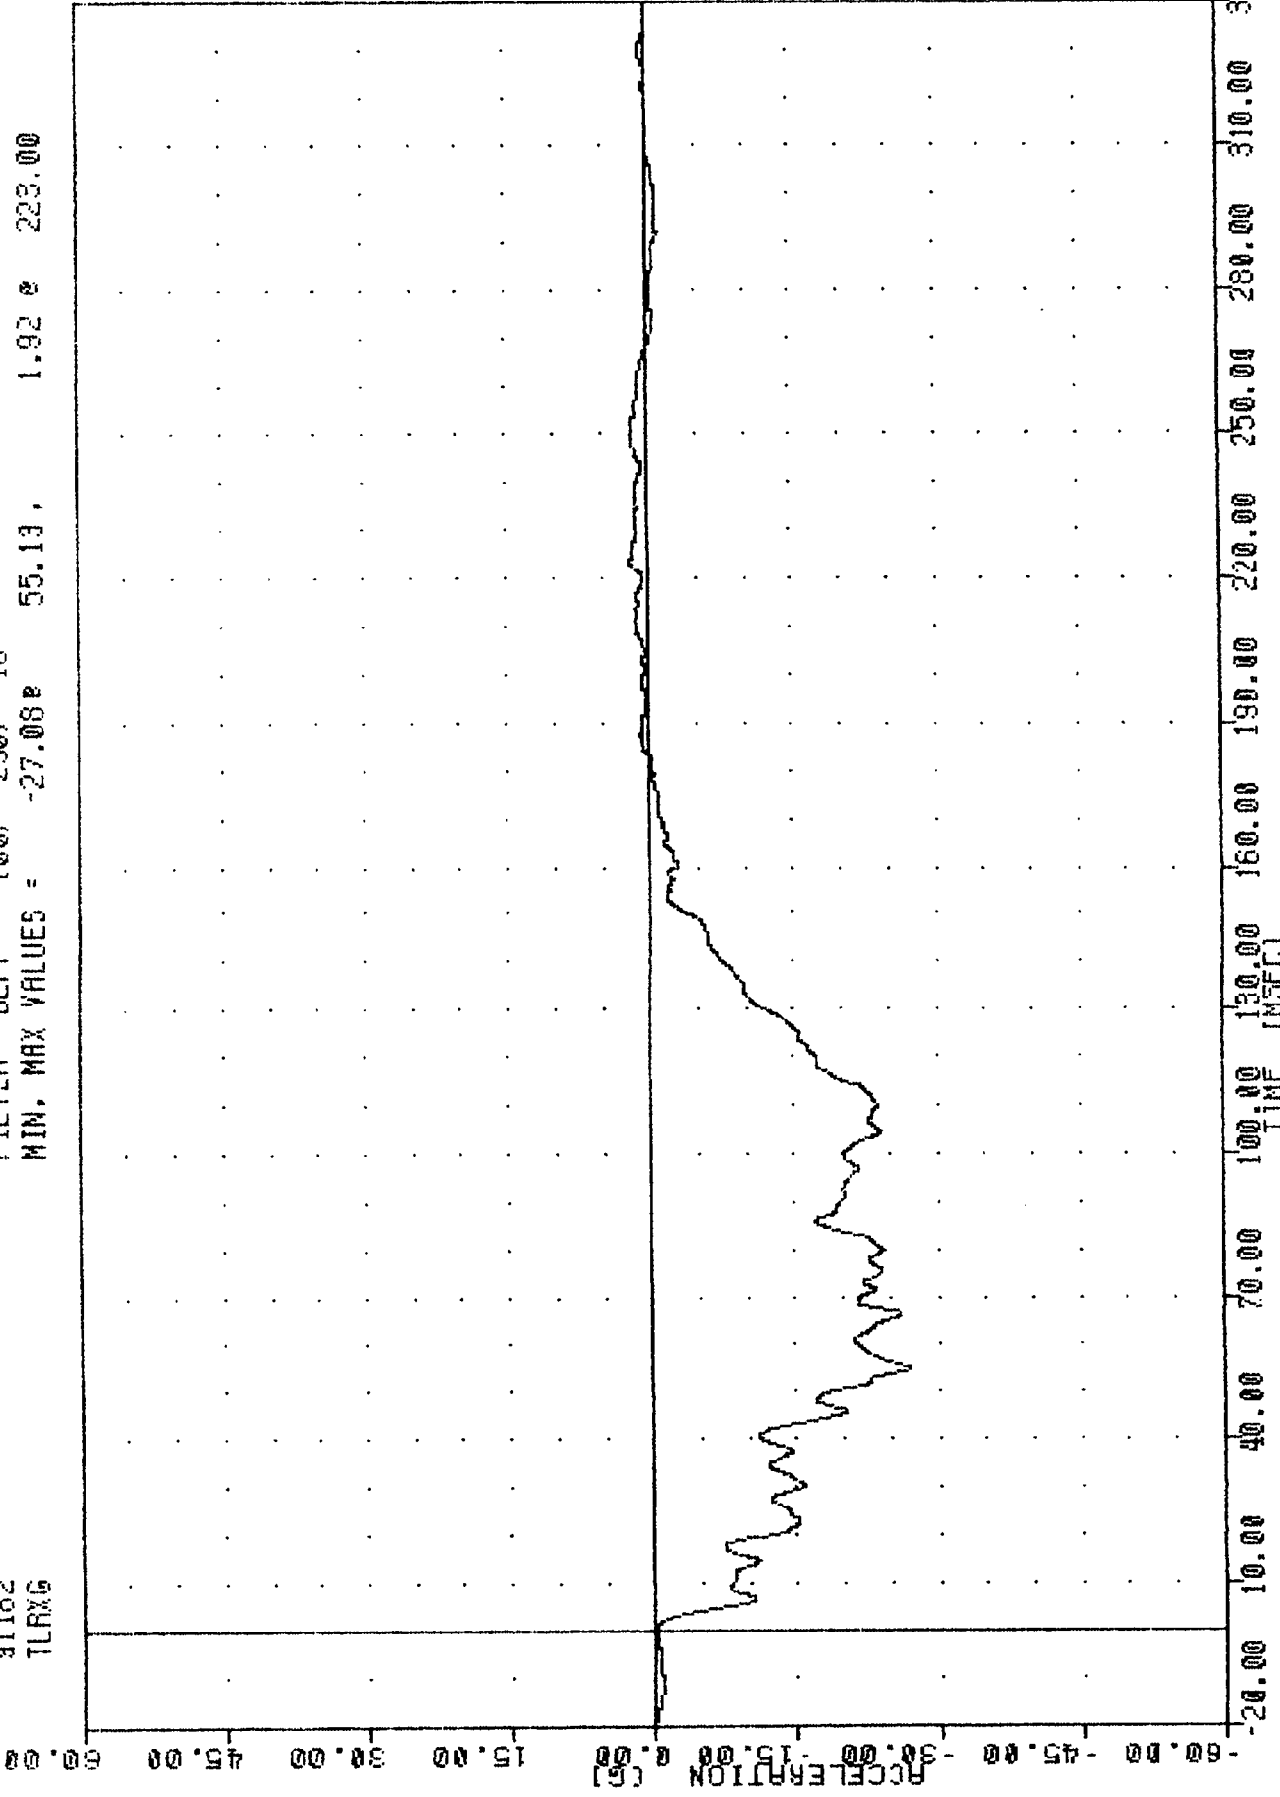
FILTER = BLPP 100/ 250/ -16
MIN. MAX VALUES = -27.08 e 55.13 , 1.92 e 223.00

MINICARS RSV INTO LEFT OFFSET FRONTAL BARRIER
LEFT, REAR SEAT CROSSMEMBER X-AXIS ACCELERATION

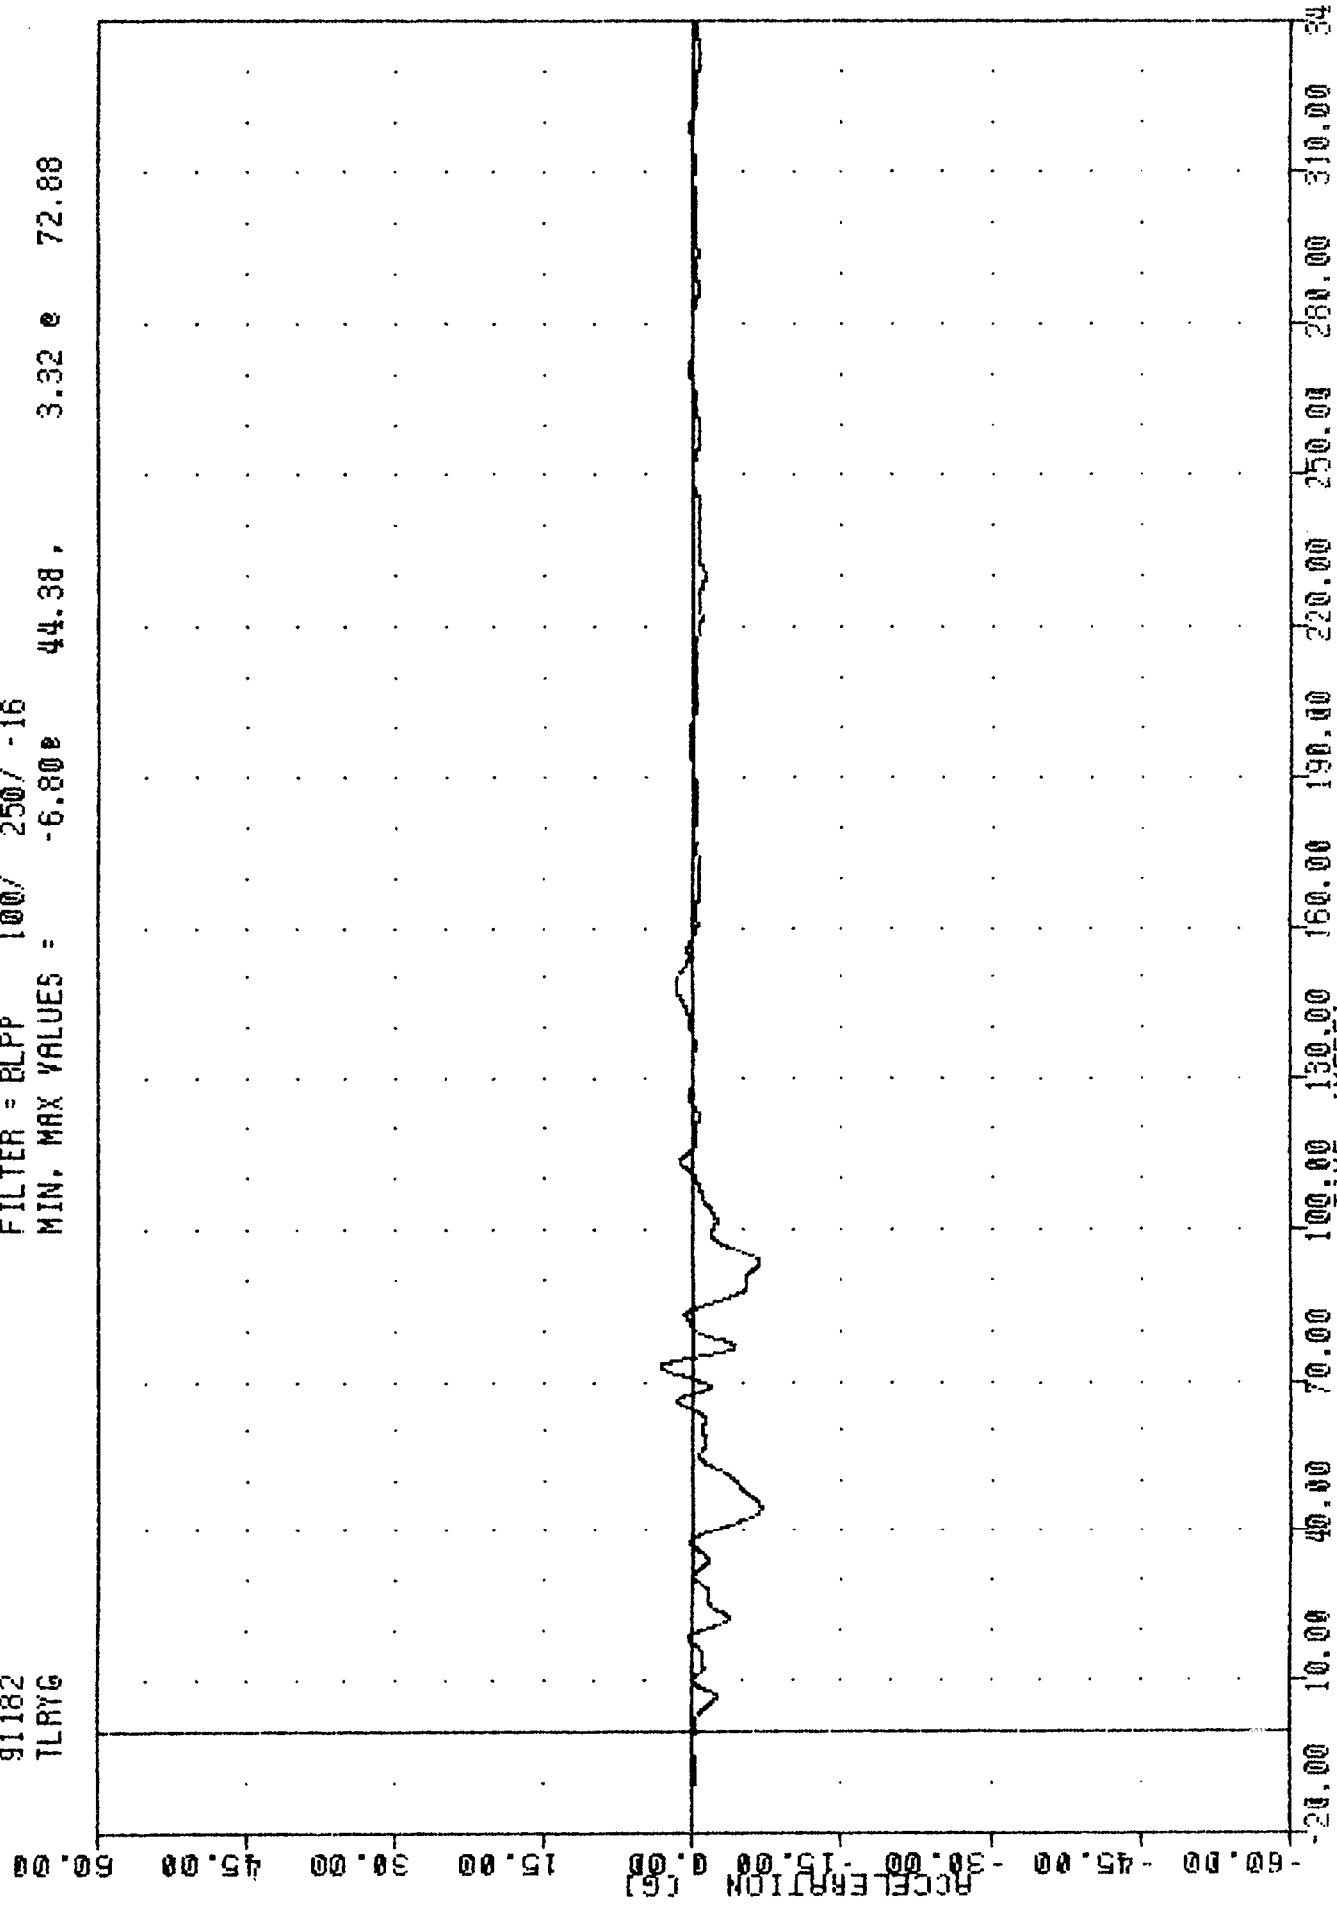
MIN. MAX VALUES = -6.80e 44.38, 3.32 e 72.88

MINICARS RSV INTO LEFT OFFSET FRONTAL BARRIER
LEFT REAR SEAT CROSSMEMBER Y-AXIS ACCELERATION

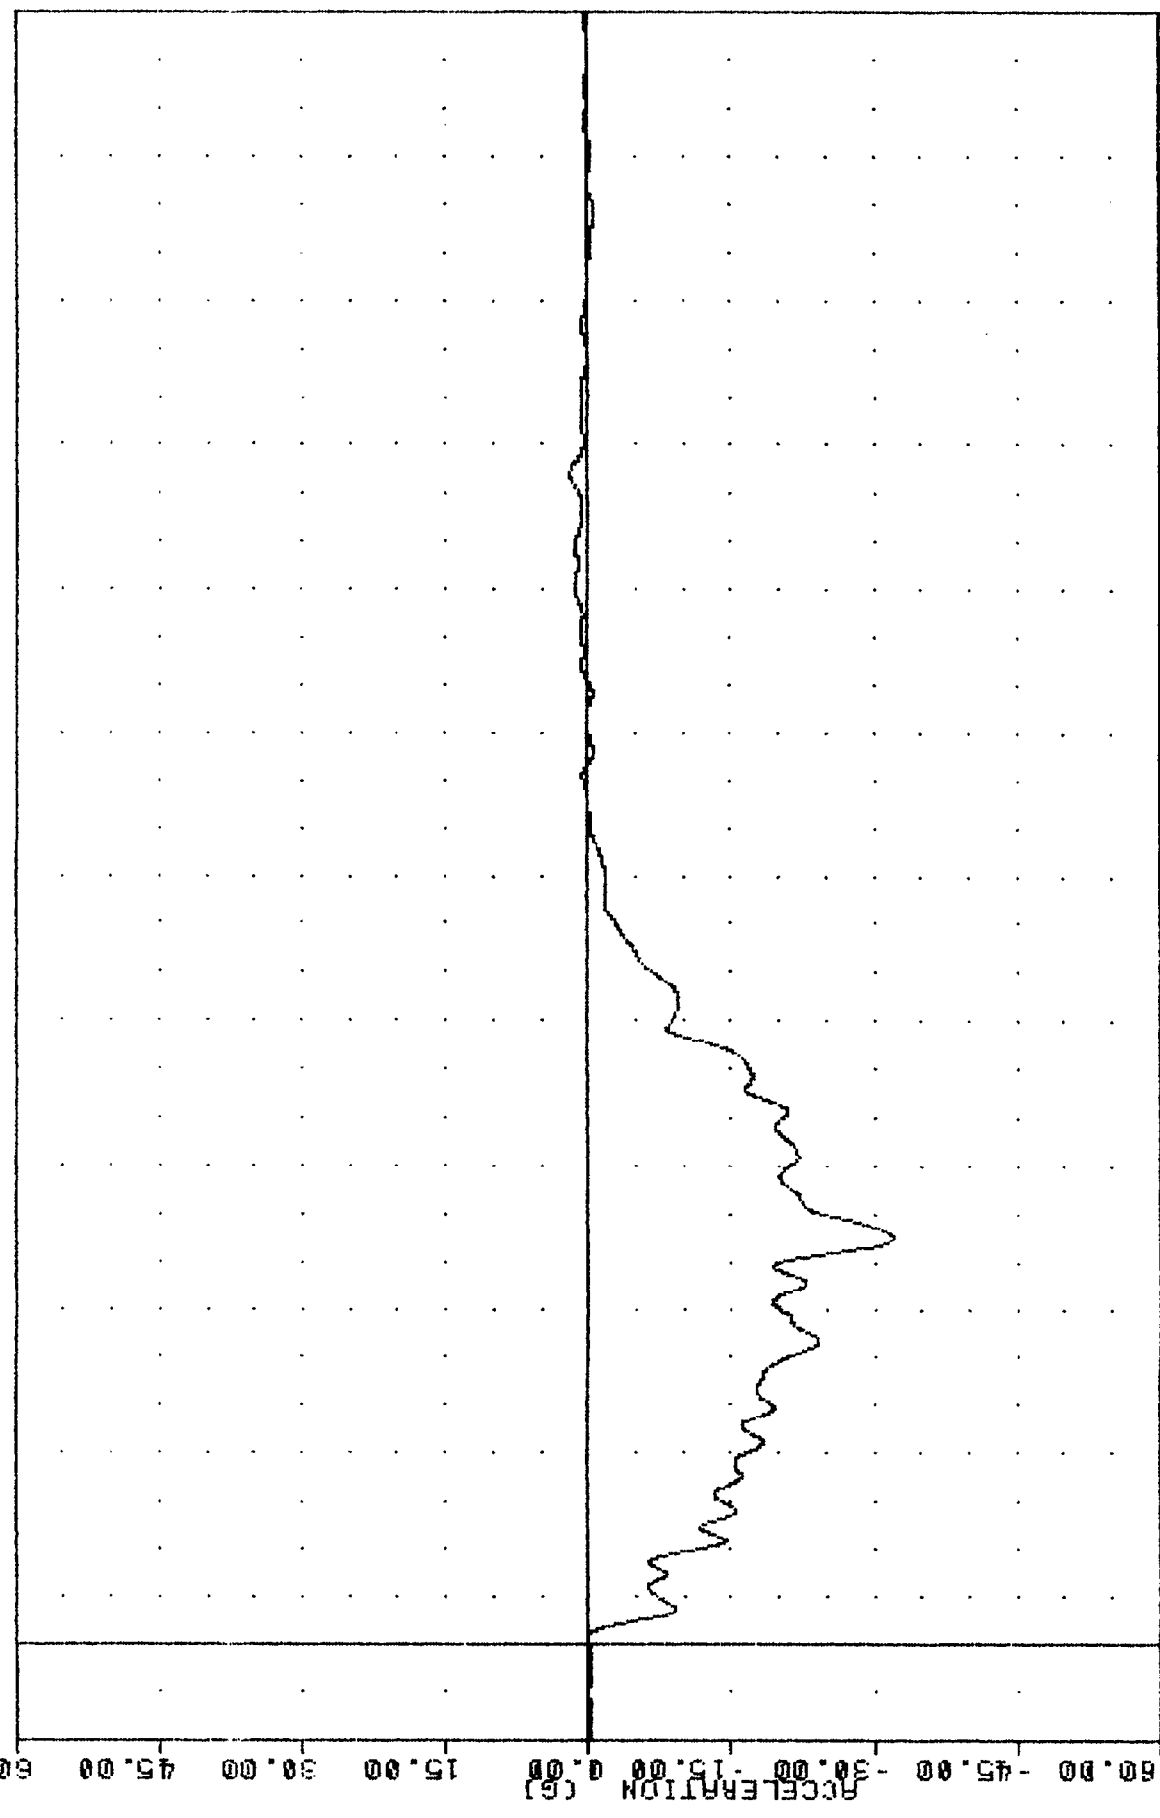
MIN, MAX VALUES = -31.98 85.25

MINICARS RSV INTO LEFT OFFSET FRONTAL BARRIER
RIGHT REAR SEAT CROSSMEMBER X-AXIS ACCELERATION

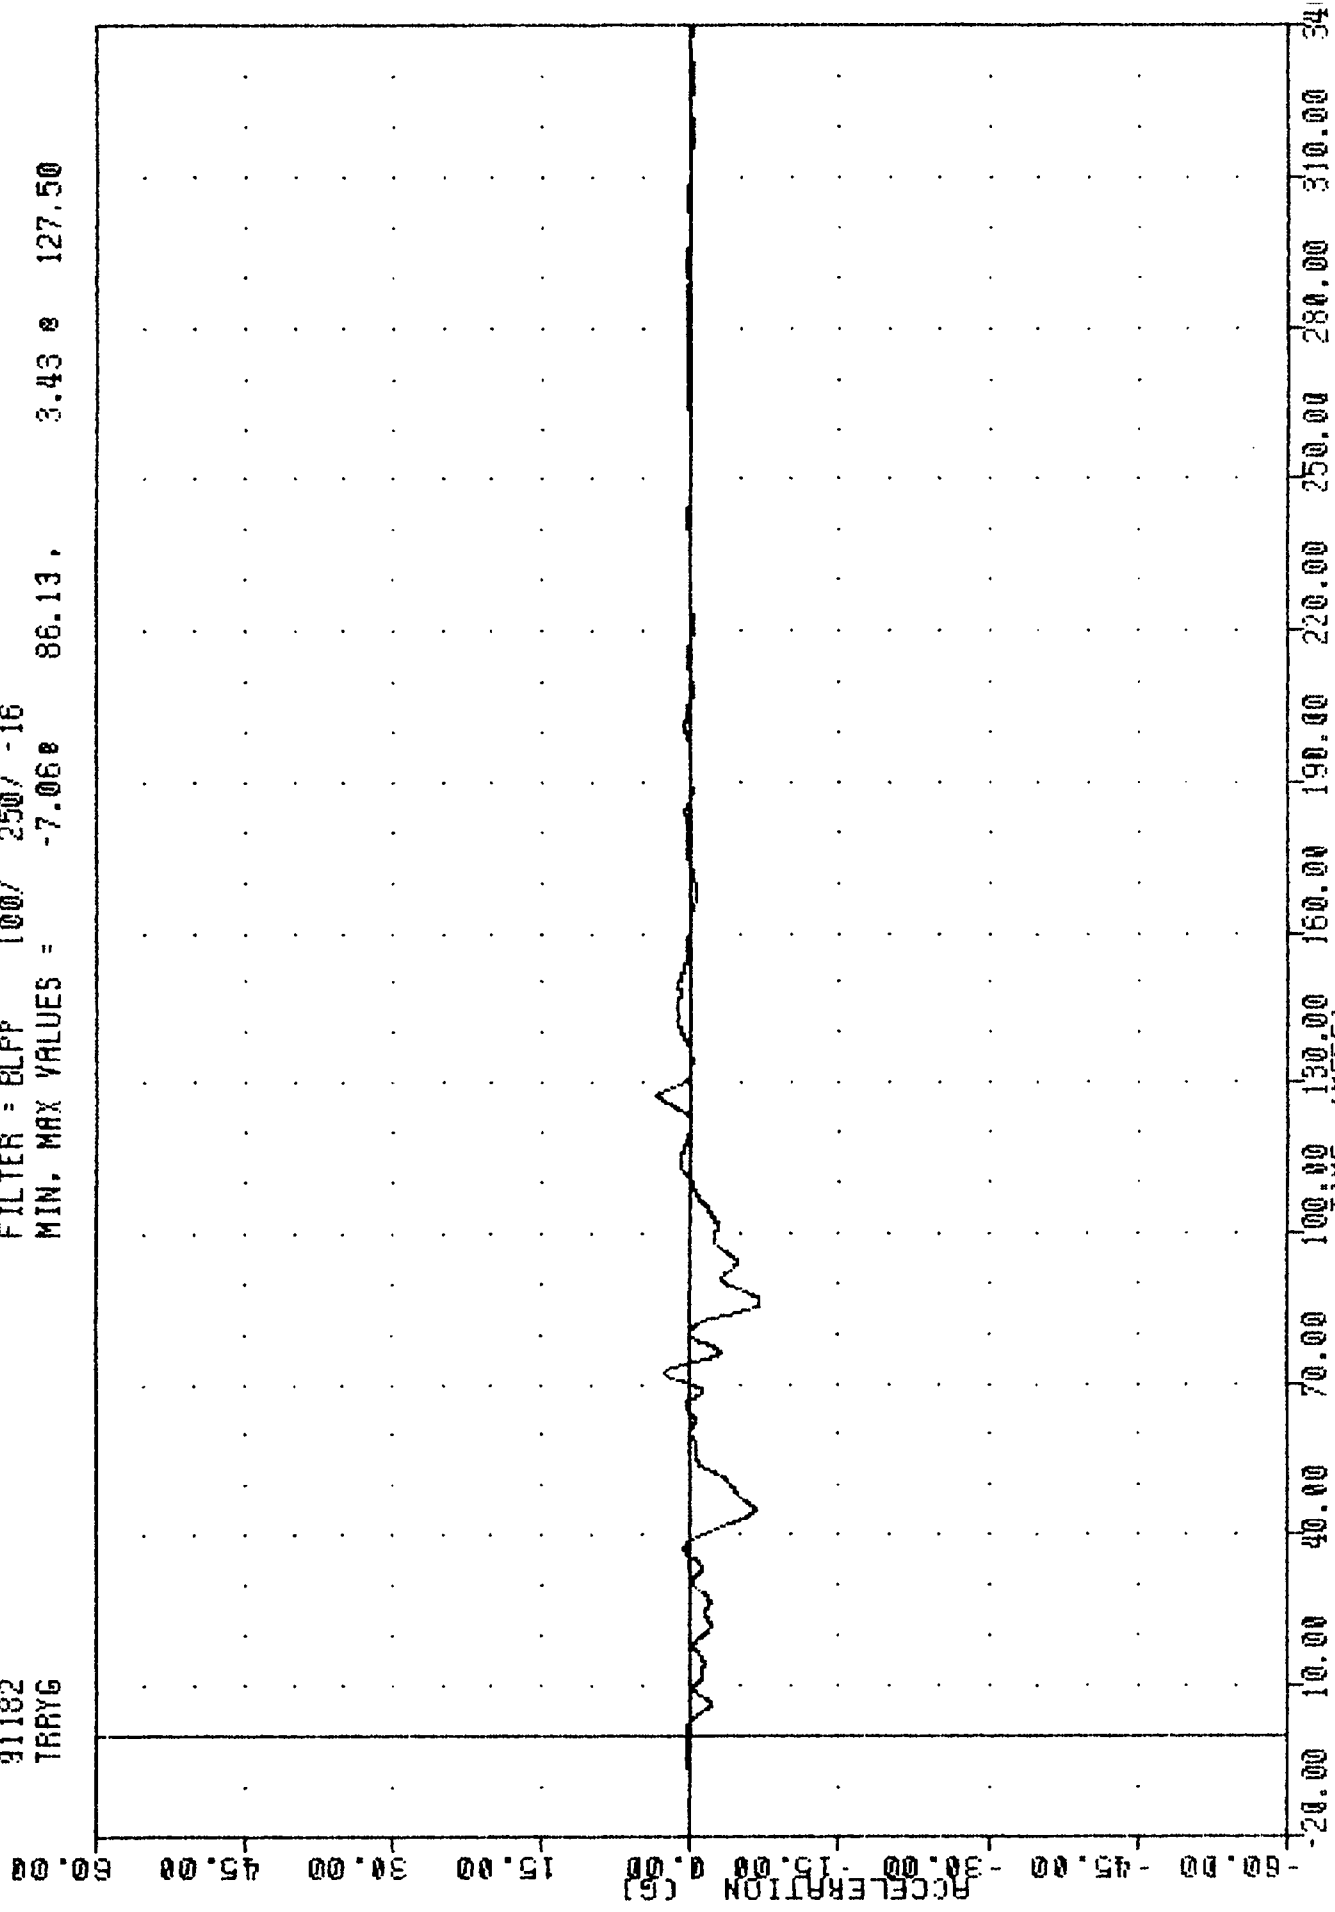
MIN. MAX VALUES = -7.06e 86.13, 3.43 e 127.50

MINICARS RSV INTO LEFT OFFSET FRONTAL BARRIER
RIGHT REAR SEAT CROSSMEMBER Y-AXIS ACCELERATION

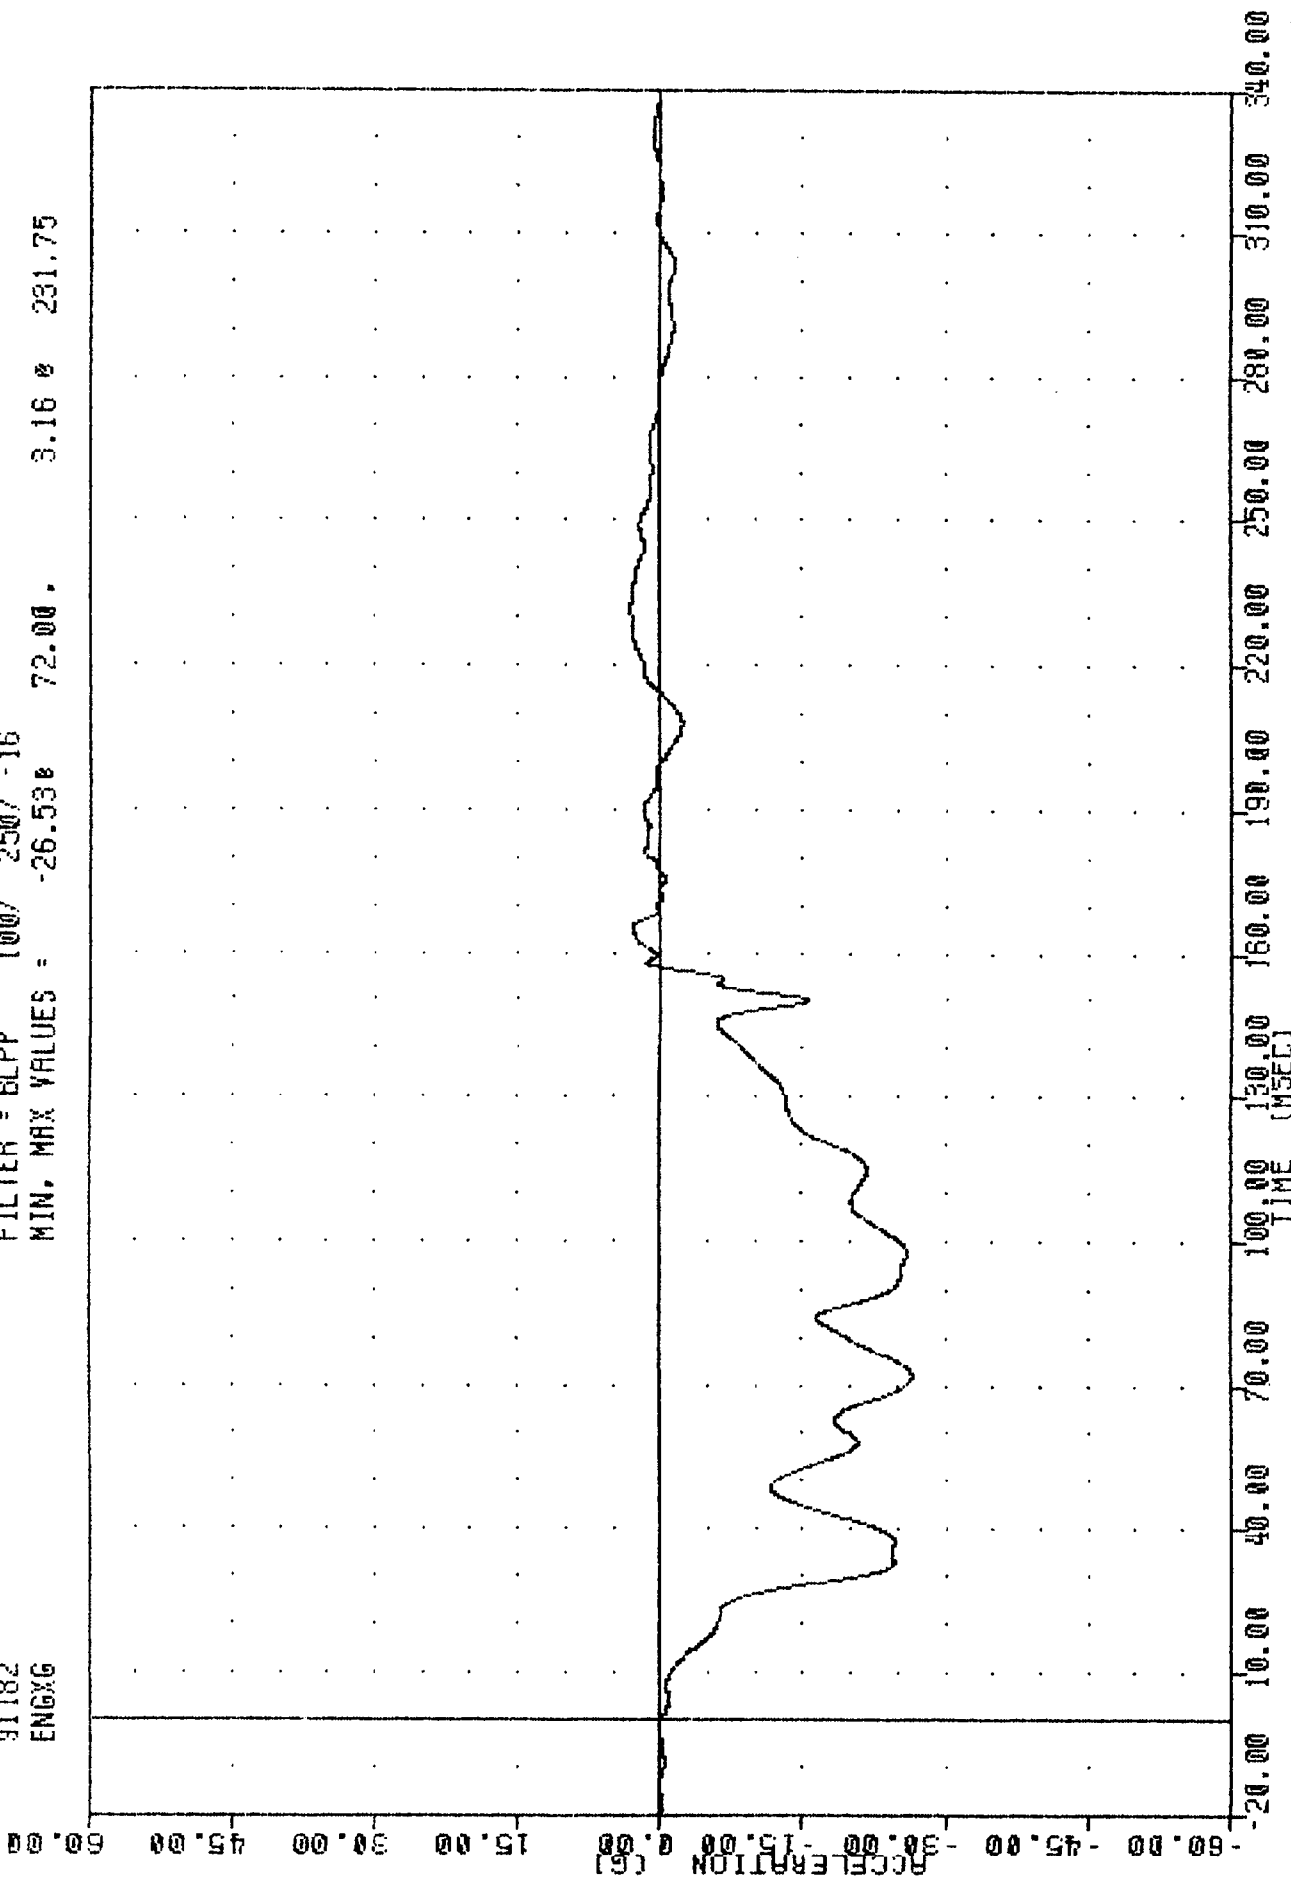
FILTER = BLPP 100/ 250/ -16
MIN. MAX VALUES = -26.53 72.00 . 3.16 231.75

MINICARS RSV INTO LEFT OFFSET FRONTAL BARRIER
ENGINE X-AXIS ACCELERATION

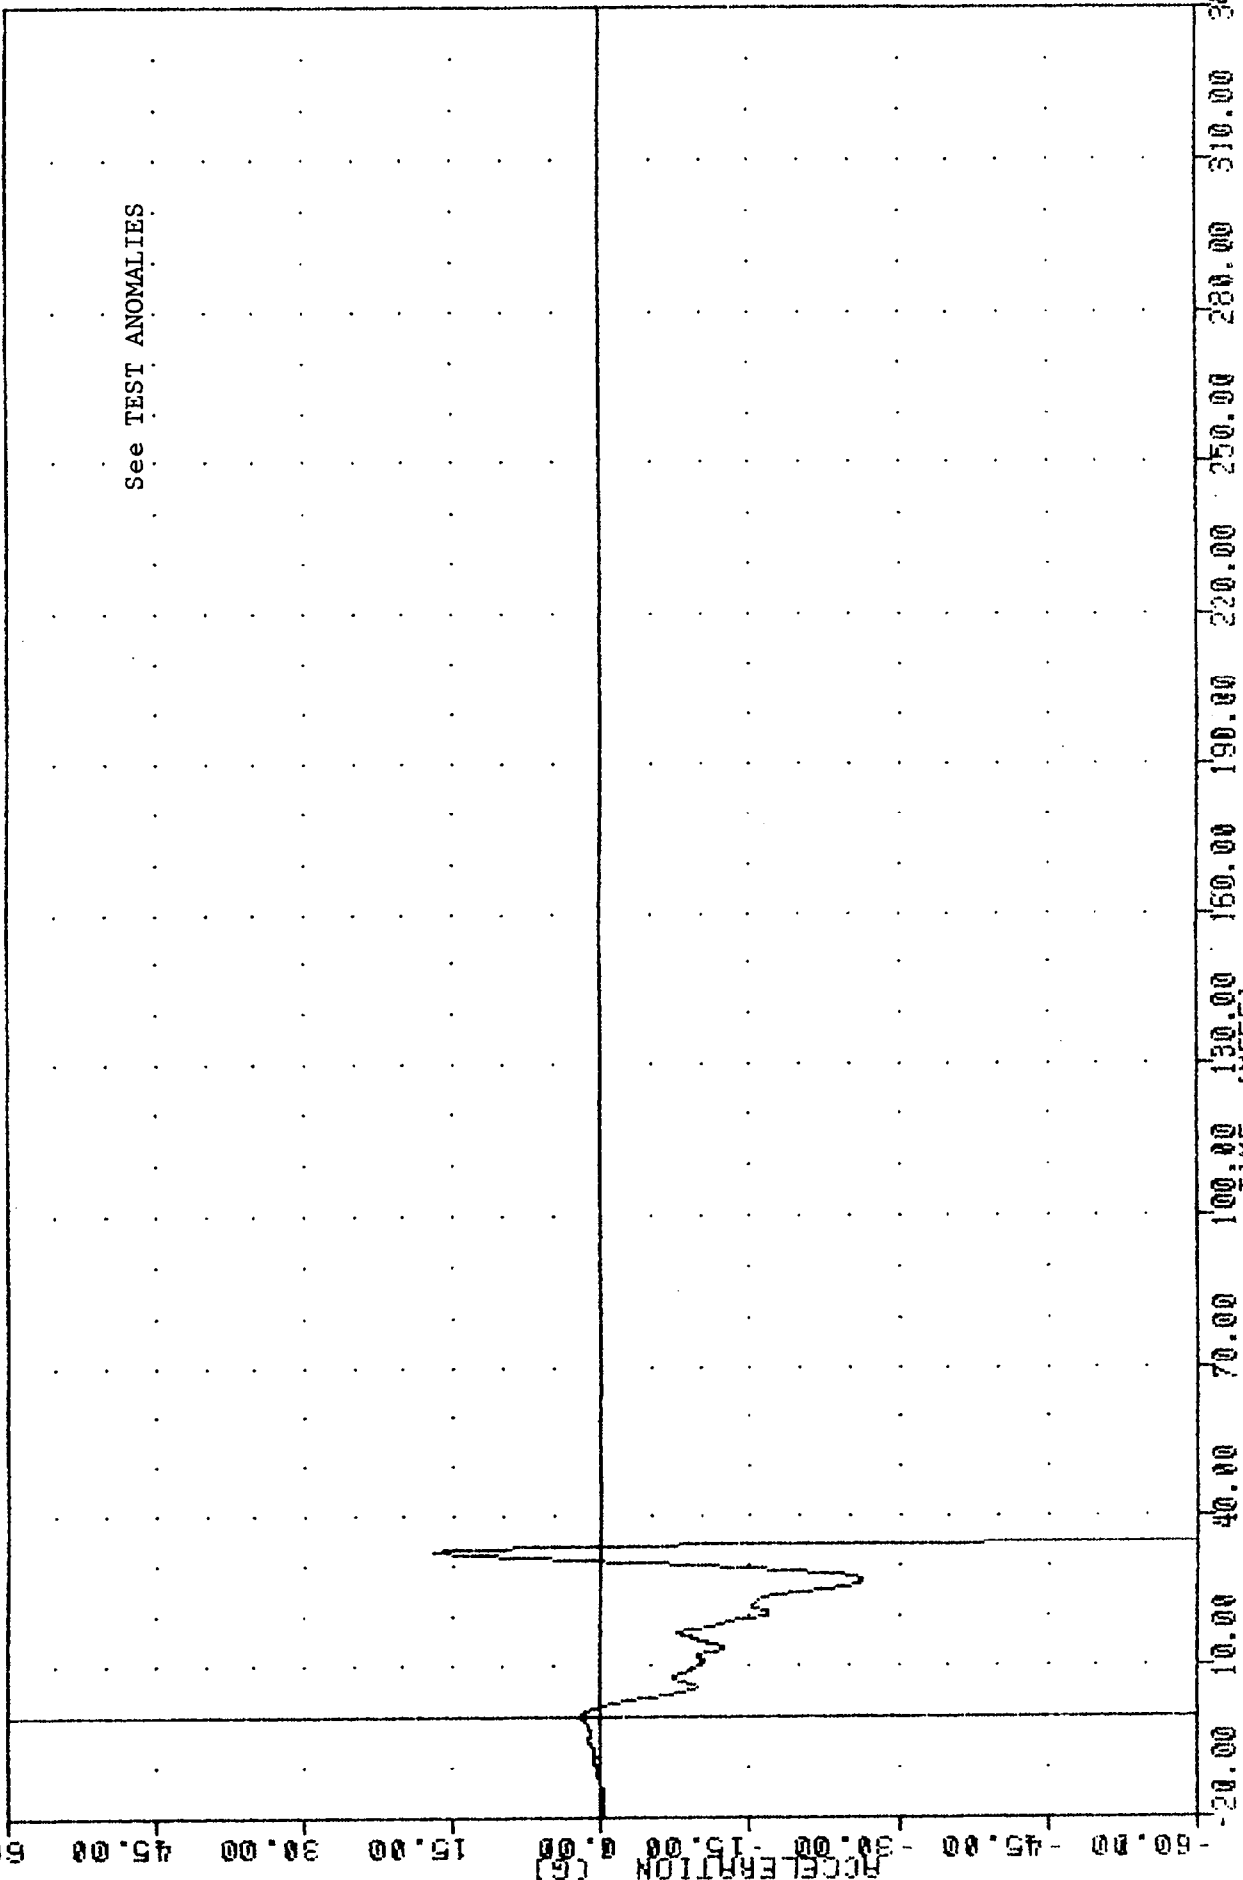
MIN. MAX VALUES = -1195.52e 295.00, 16.79 e 32.88

MINICARS RSV INTO LEFT OFFSET FRONTAL BARRIER
LEFT FIREWALL X-AXIS ACCELERATION

The left firewall X-axis accelerometer data, FWLXG1, was lost at approximately 34 milliseconds due to the accelerometer cable being damaged by the vehicle's crush during impact.
