**DOT HS 807 757
Final Report**

Final Report of Minicars RSV into 50% Left Offset Frontal Barrier

14. Sponsoring Agency Code DOT/NHTSA/VRTC	
15. Supplementary Notes					
16. Abstract One 50% left offset frontal barrier impact test was conducted to determine the structural integrity of the test vehicle. This test was conducted on a Minicars RSV, VIN A1035, at the Transportation Research Center of Ohio on July 1, 1991. TEST NUMBER: 910701 TIME: 1238 TEMPERATURE: 86° F SPEED: 49.8 MPH

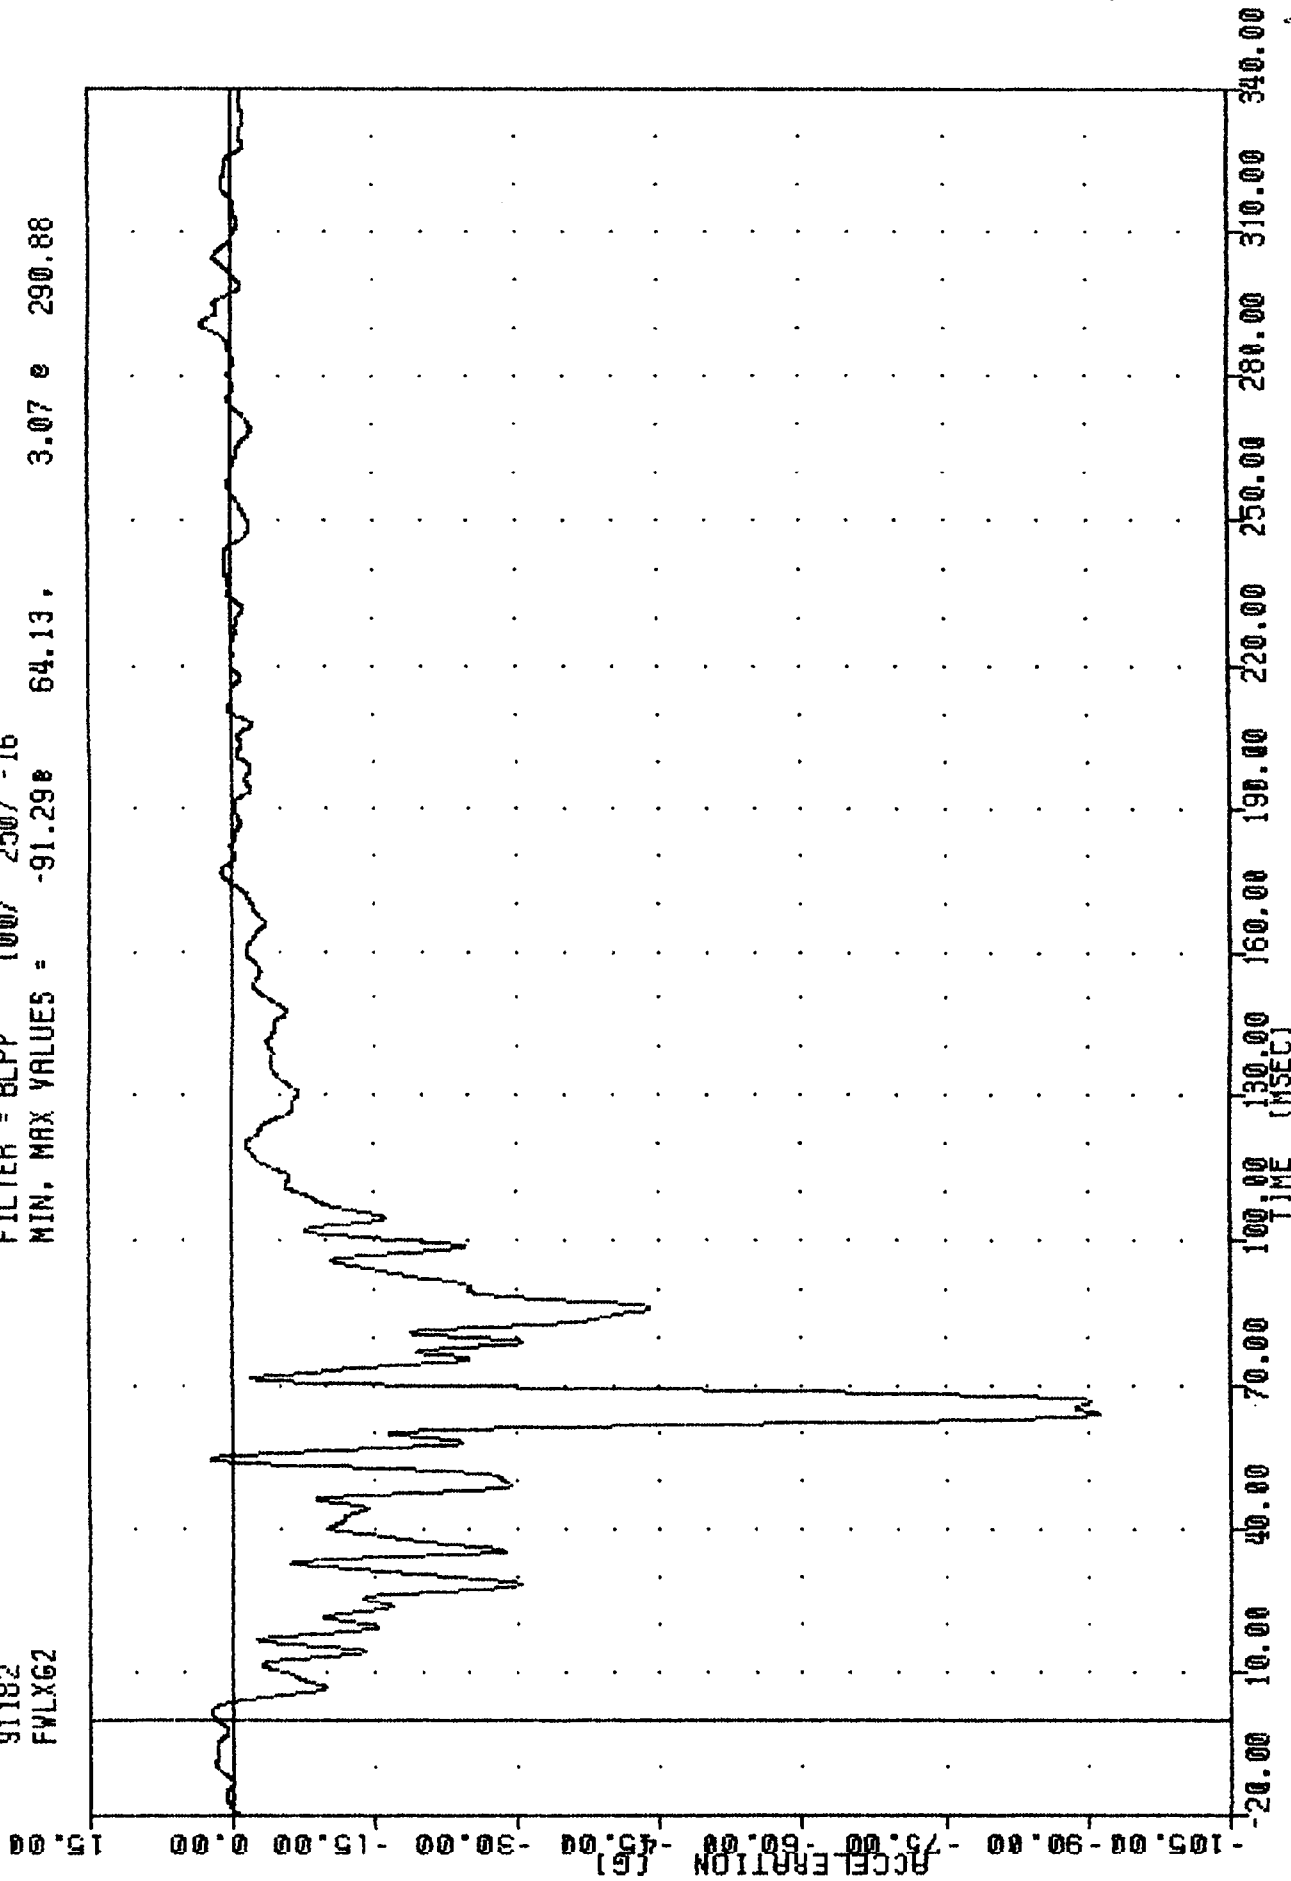
FILTER = BLPP 100/ 250/ -16
MIN. MAX VALUES = -91.29e 64.13, 3.07 e 290.88

MINICARS RSV INTO LEFT OFFSET FRONTAL BARRIER
RIGHT FIREWALL X-AXIS ACCELERATION
