**SIDE IMPACT PROTECTION  
IN PRODUCTION VEHICLES**

**MDB-TO-VEHICLE SIDE IMPACT TEST OF  
A 27° CRABBED MOVING DEFORMABLE BARRIER  
TO A 1989 DODGE RAM D50  
AT 33.5 MPH**

MOBILITY SYSTEMS AND EQUIPMENT COMPANY  
9920 LA CIENEGA BOULEVARD SUITE 708  
INGLEWOOD, CALIFORNIA 90301

**TEST REPORT**

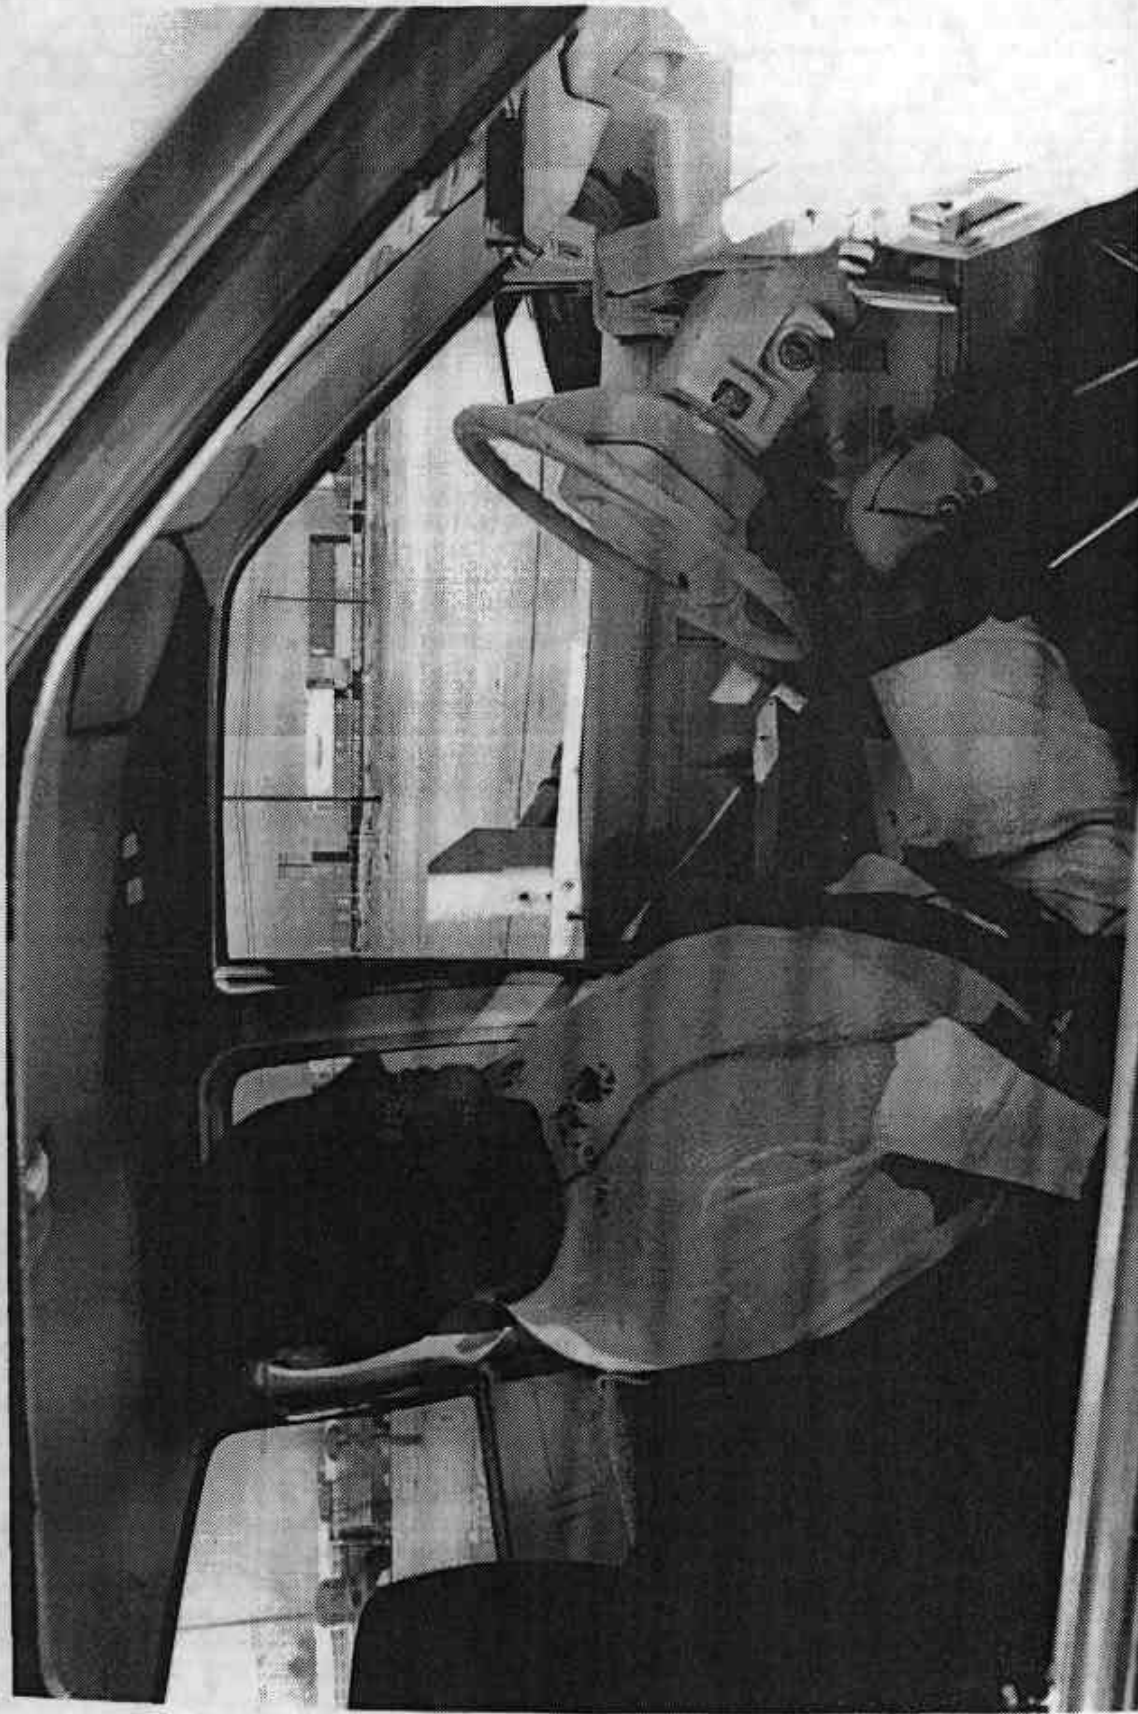
FIGURE A-13 SID FINAL POSITION - POSTTEST

- o The left knee also brushed against the steering column.
- o Contact of the door on SIDs left leg resulted in seperation of his left femer.
- o Fuel leakage was observed immediately after impact.
