DOT HS 807 771
Final Report

Final Report of 339° Contoured Moving Barrier Impact Into a 1985 Ford Escort 3-Door Hatchback in Support of Crash III Damage Algorithm Reformation

The purpose of the four 339° contoured moving barrier impact tests was research and development in support of the CRASH III damage algorithm reformulation.

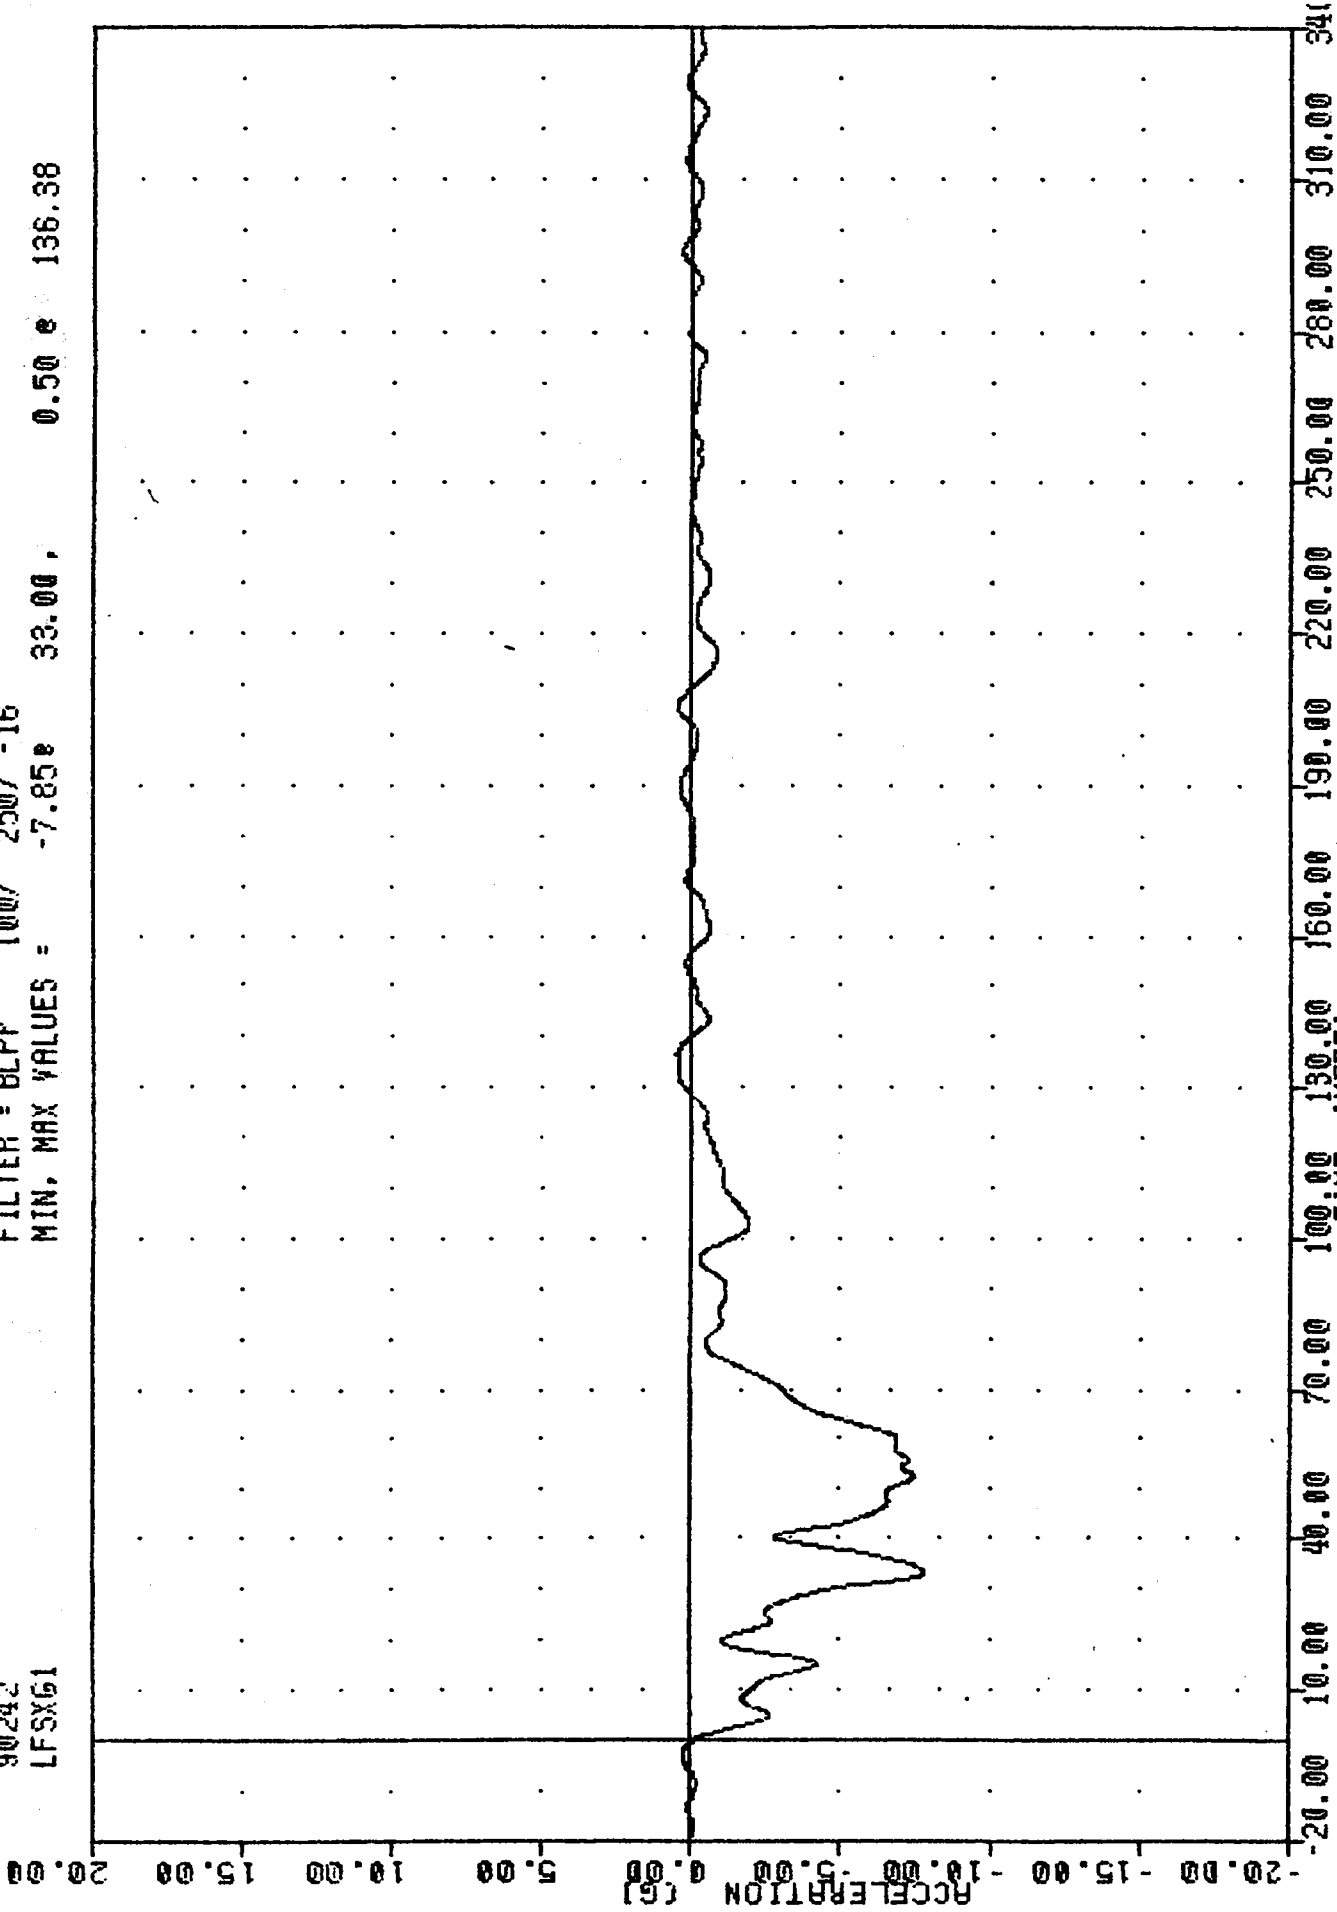
CONTOURED MOVING BARRIER INTO FORD ESCORT AT 14.2 MPH #1
LEFT FRONT SILL X-AXIS ACCELERATION

FILTER = BLPP 100/ 250/ -16
MIN. MAX VALUES = -3.54 50.00 2.29 101.88

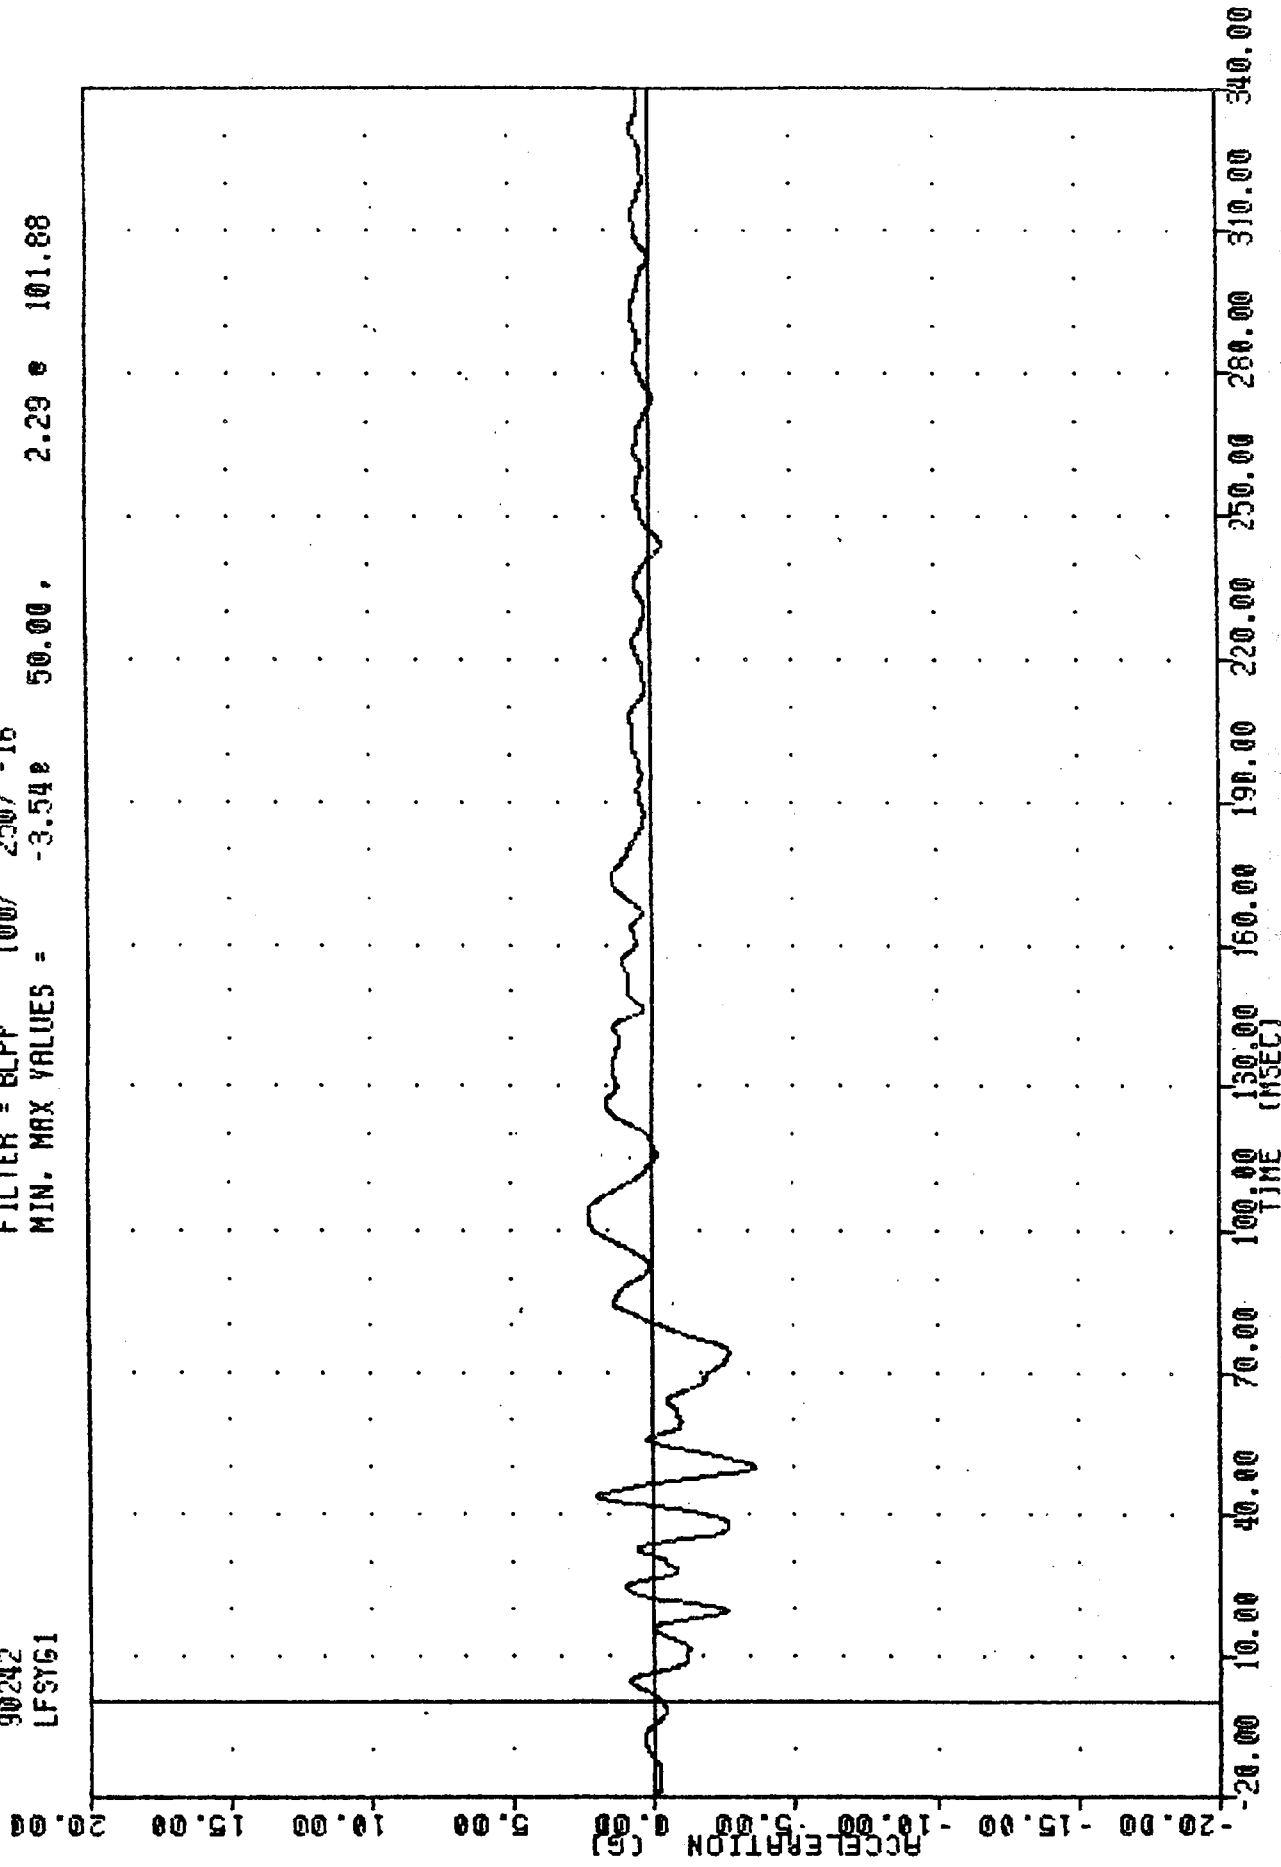
CONToured MOVING BARRIER INTO FORD ESCORT AT 14.2 MPH #1
LEFT FRONT SILL Y-AXIS ACCELERATION

FILTER = BLPP 100/ 250/ -16
MIN. MAX VALUES = 0.04 247.25, 7.87 33.00

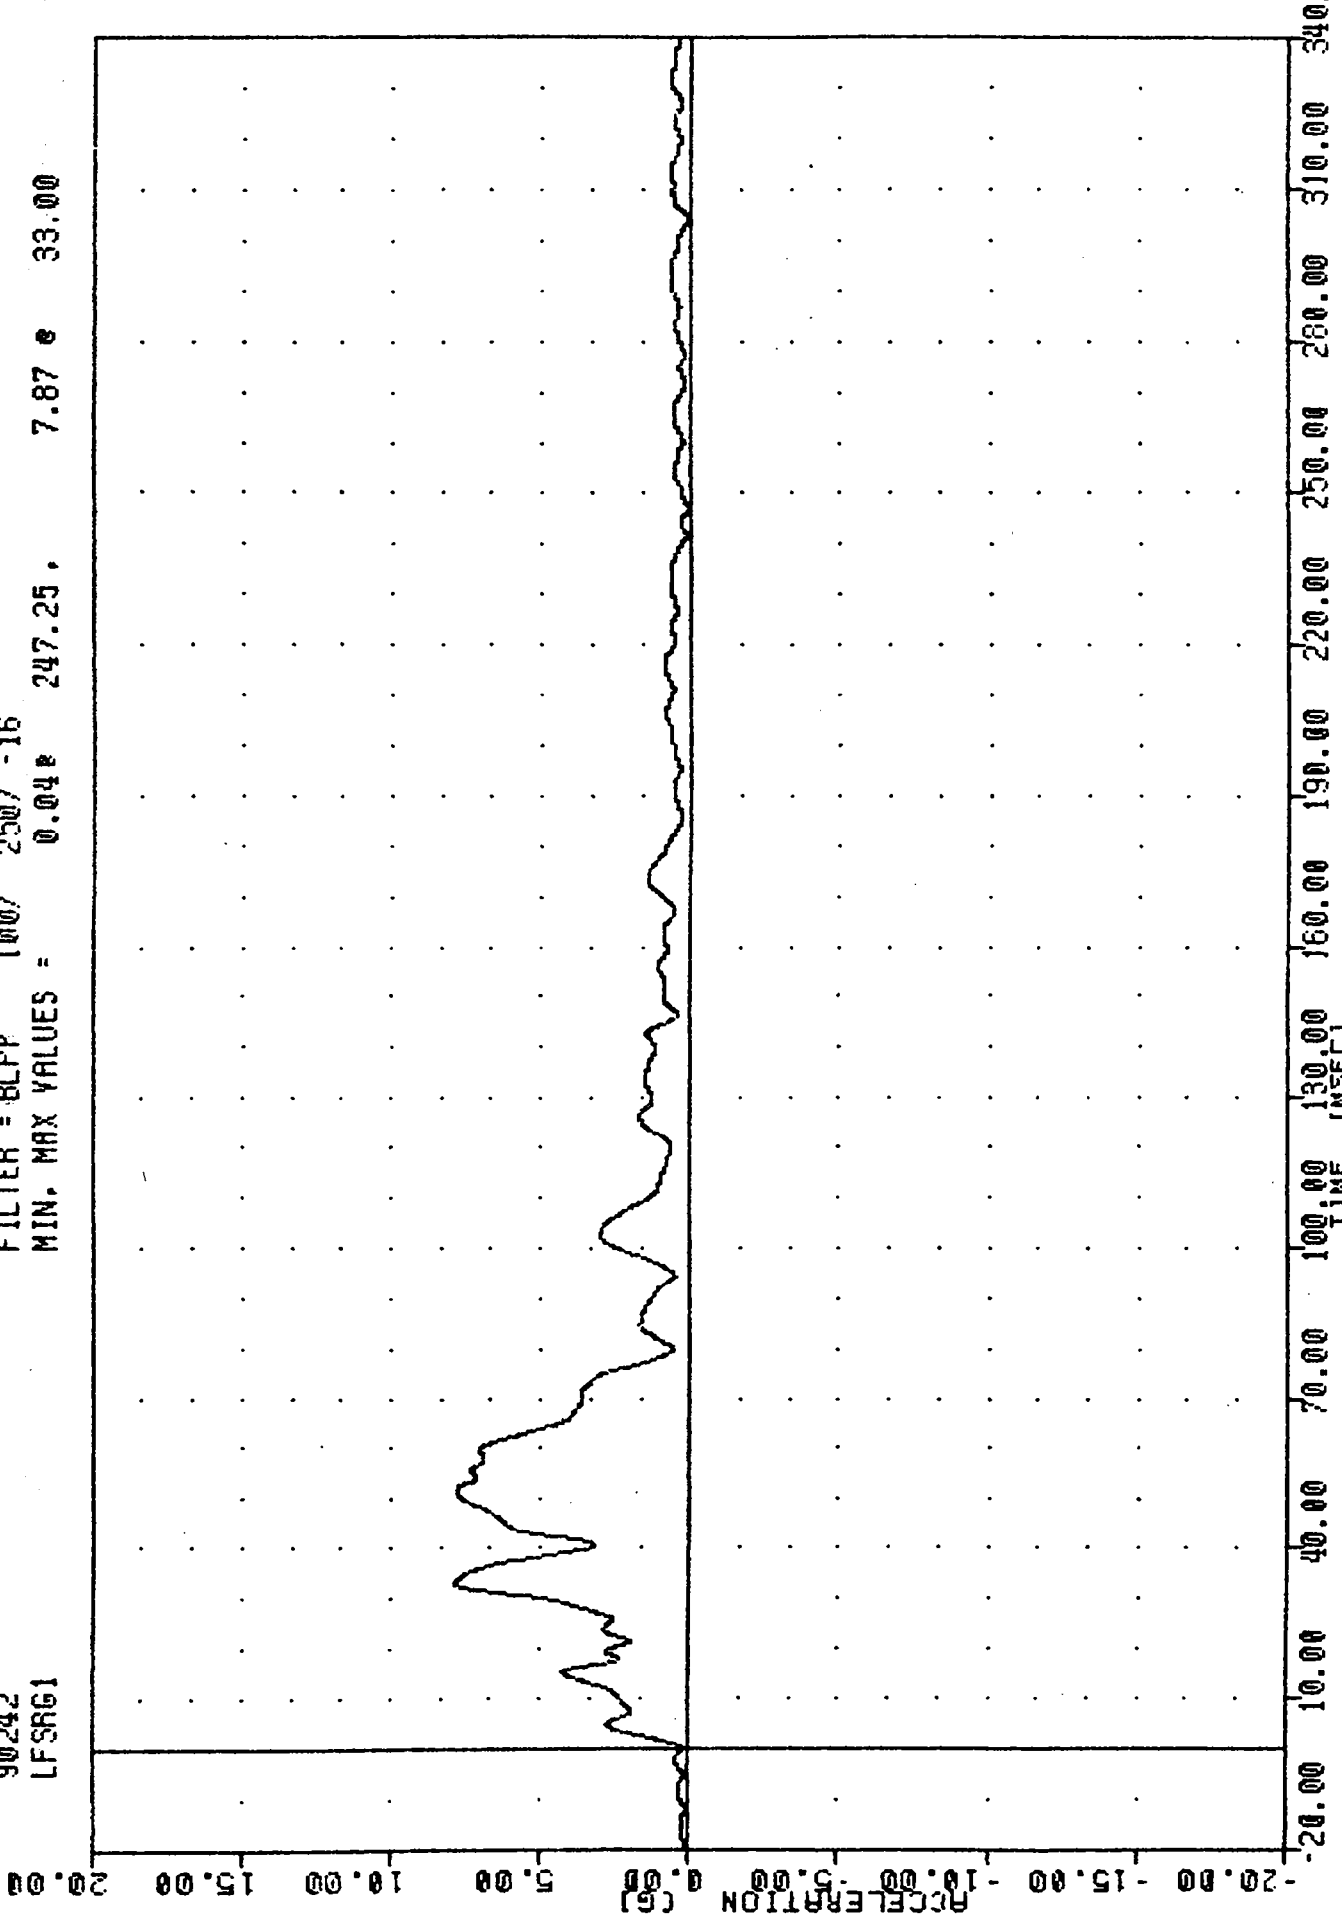
CONTOURED MOVING BARRIER INTO FORD ESCORT AT 14.2 MPH #1
LEFT FRONT SILL RESULTANT ACCELERATION

FILTER = BLPP 100/ 250/ -16
MIN, MAX VALUES = -8.57% 38.50, 1.13% 180.25

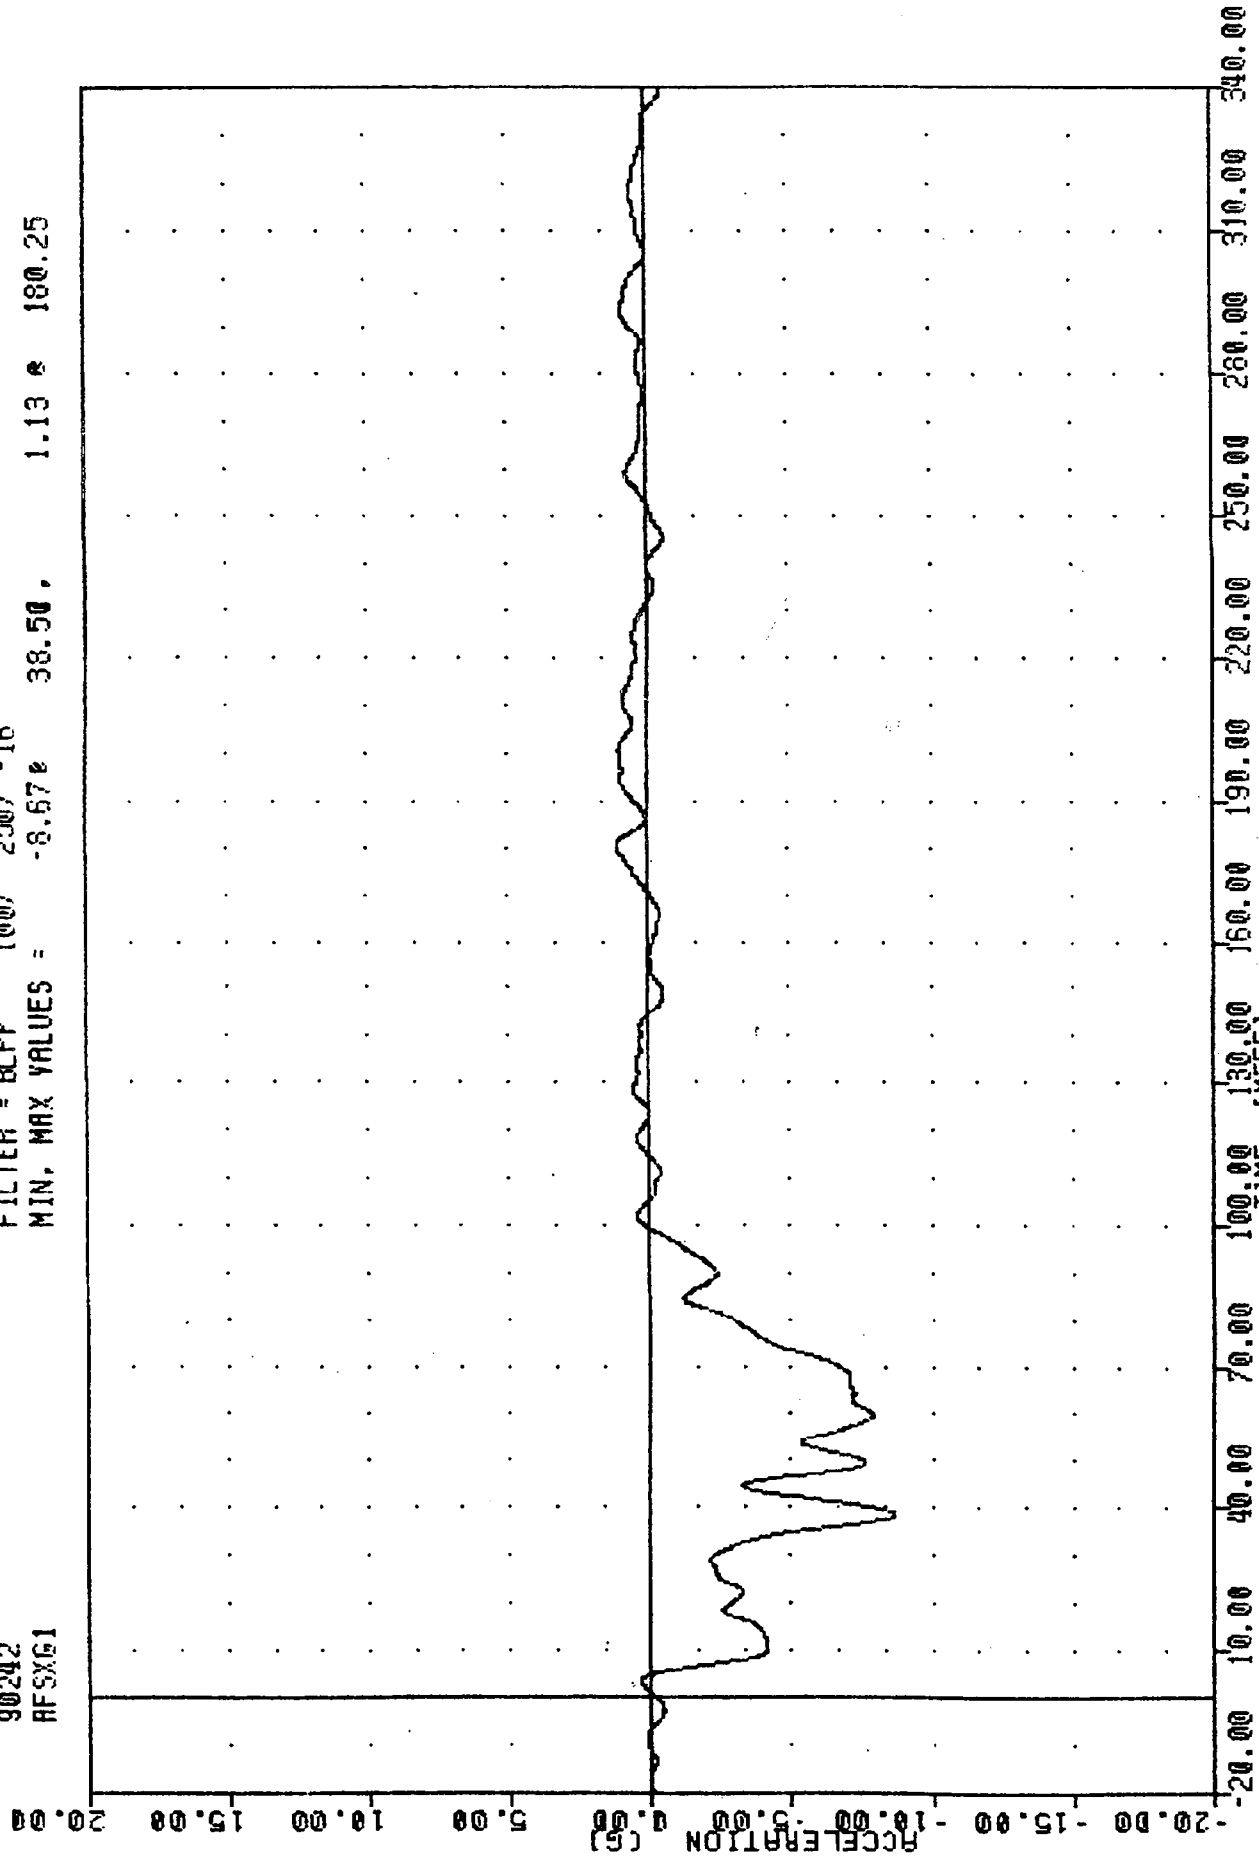
CONTOURED MOVING BARRIER INTO FORD ESCORT AT 14.2 MPH #1
RIGHT FRONT SILL X-AXIS ACCELERATION

FILTER = BLPP 100/ 250/ -16
MIN. MAX VALUES = -3.17e 21.50, 1.74 e 102.63

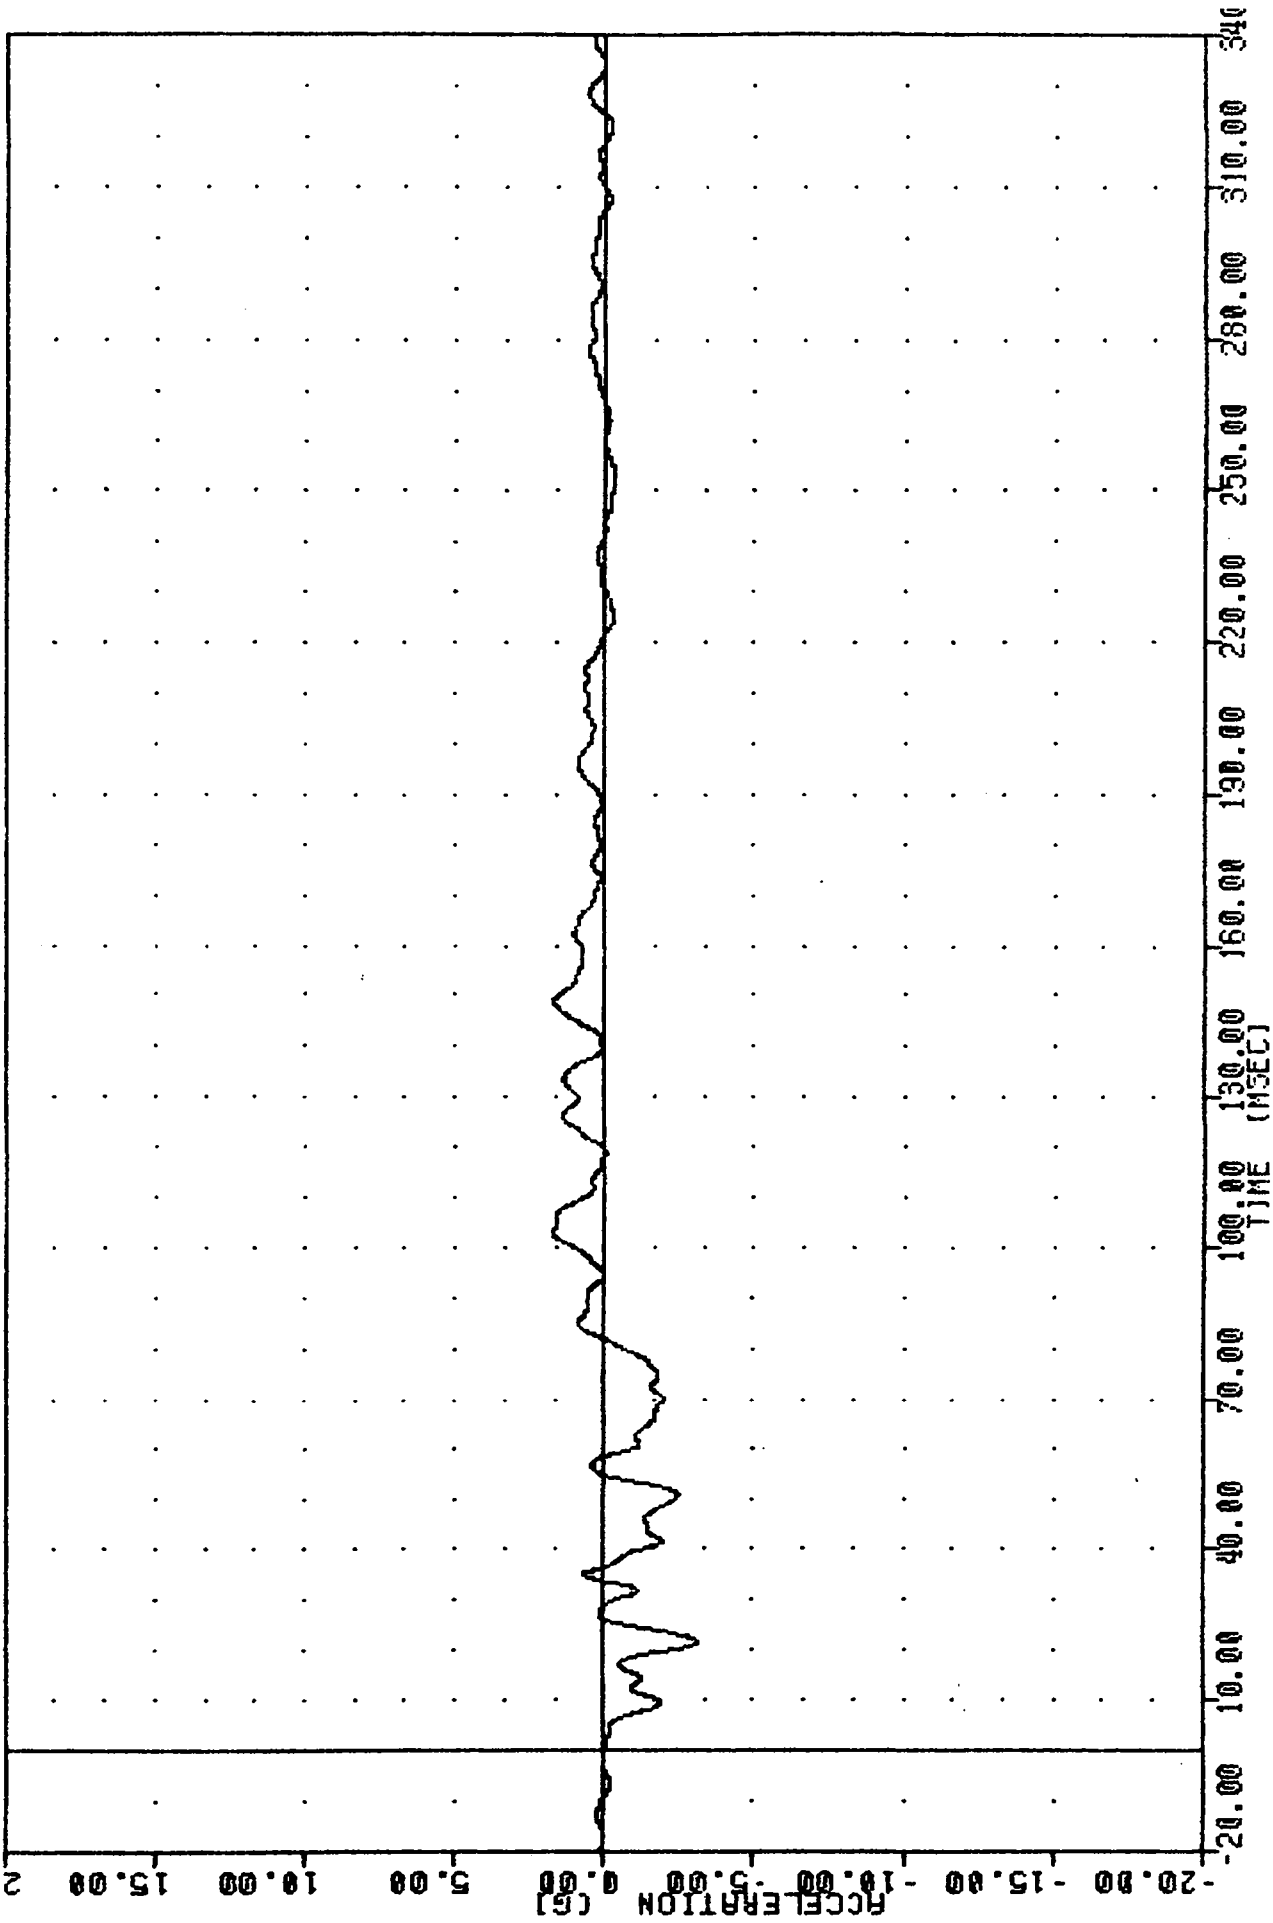
CONTOURED MOVING BARRIER INTO FORD ESCORT AT 14.2 MPH #1
RIGHT FRONT SILL Y-AXIS ACCELERATION

FILTER = BLPP 100/ 250/ -16
MIN, MAX VALUES = 0.02e 240.88, 8.70 e 38.50

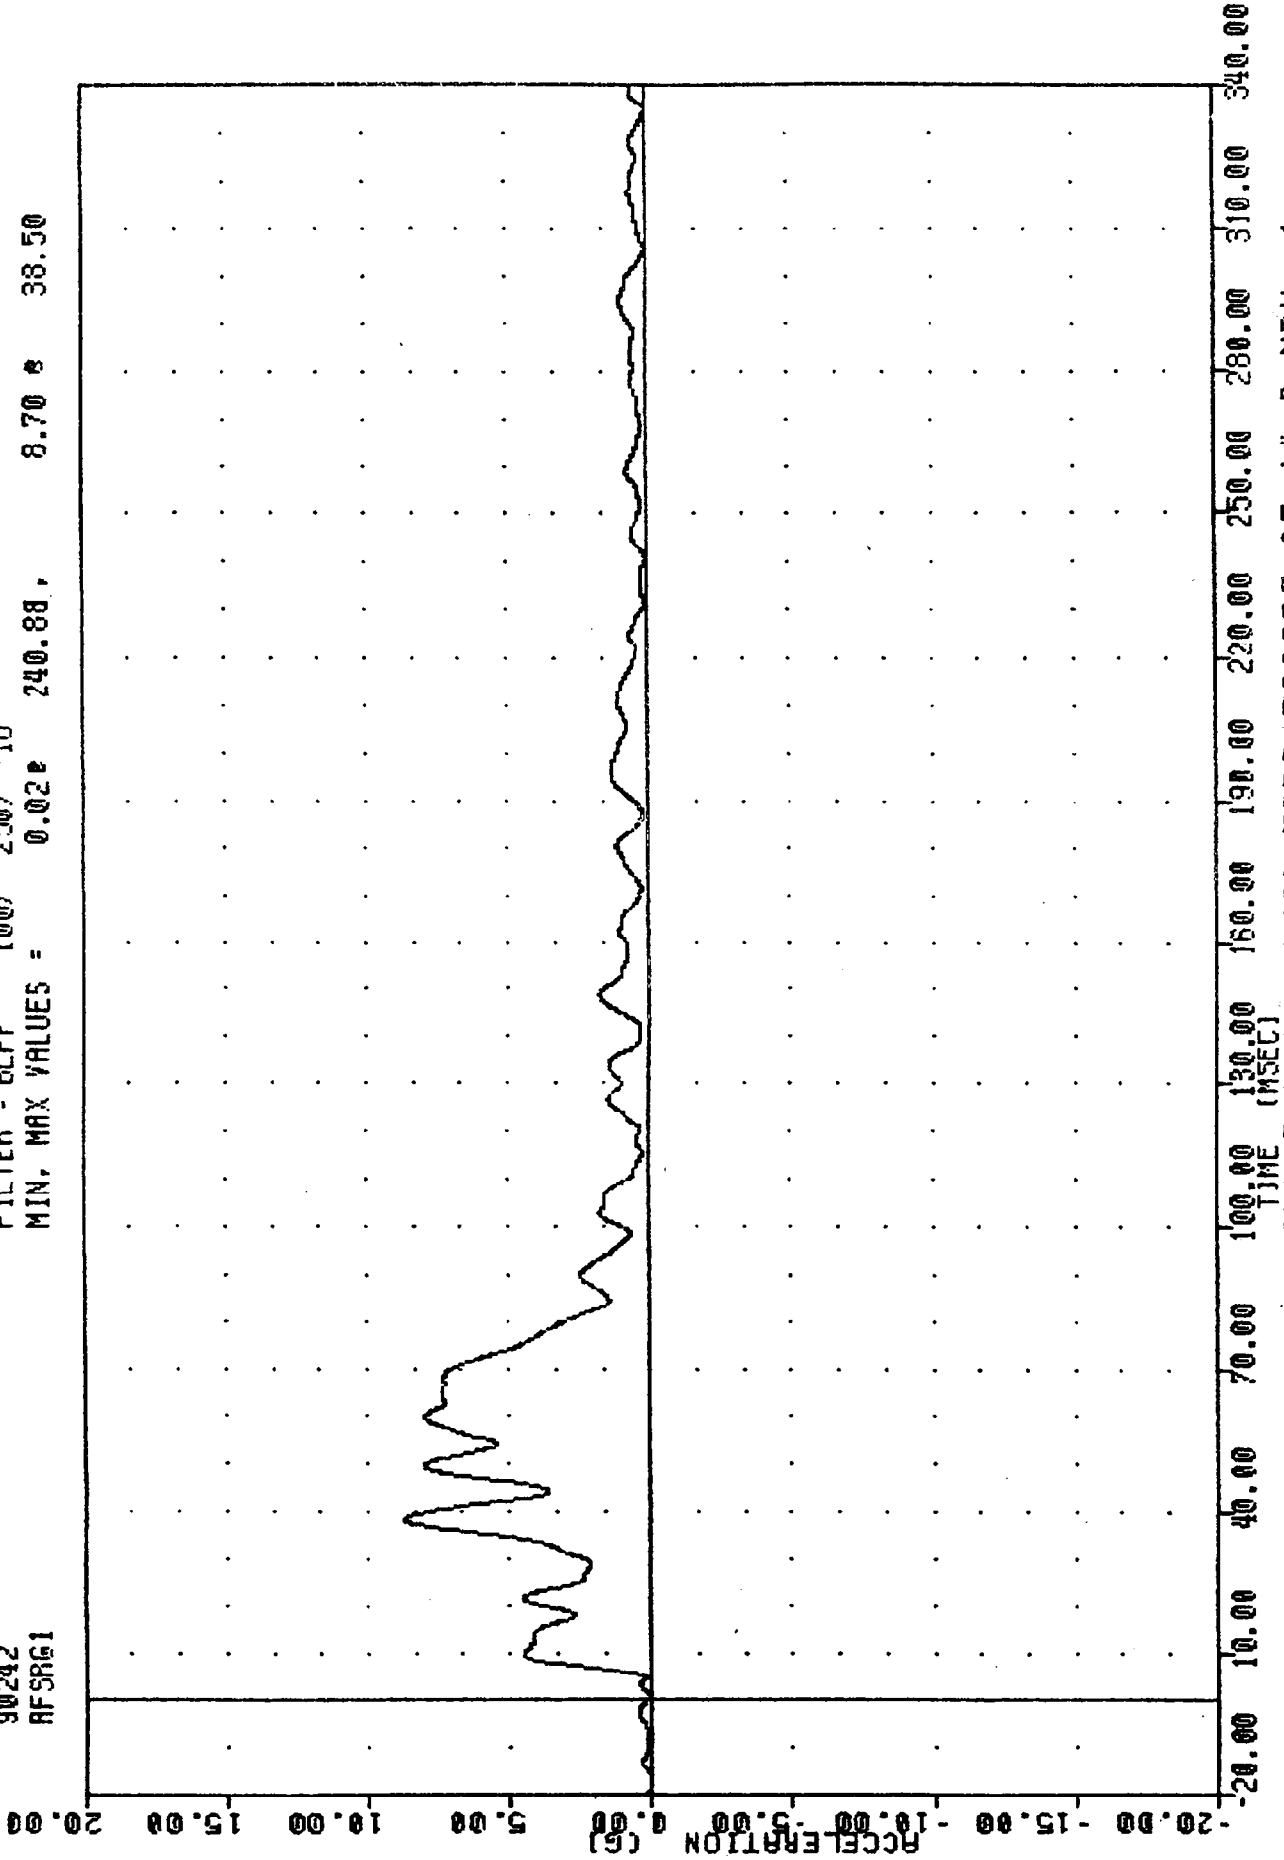
CONTOURED MOVING BARRIER INTO FORD ESCORT AT 14.2 MPH #1
RIGHT FRONT SILL RESULTANT ACCELERATION

FILTER = BLPP 100/ 250/ -16
MIN, MAX VALUES = -8.63E 42.13, 1.02E 125.38

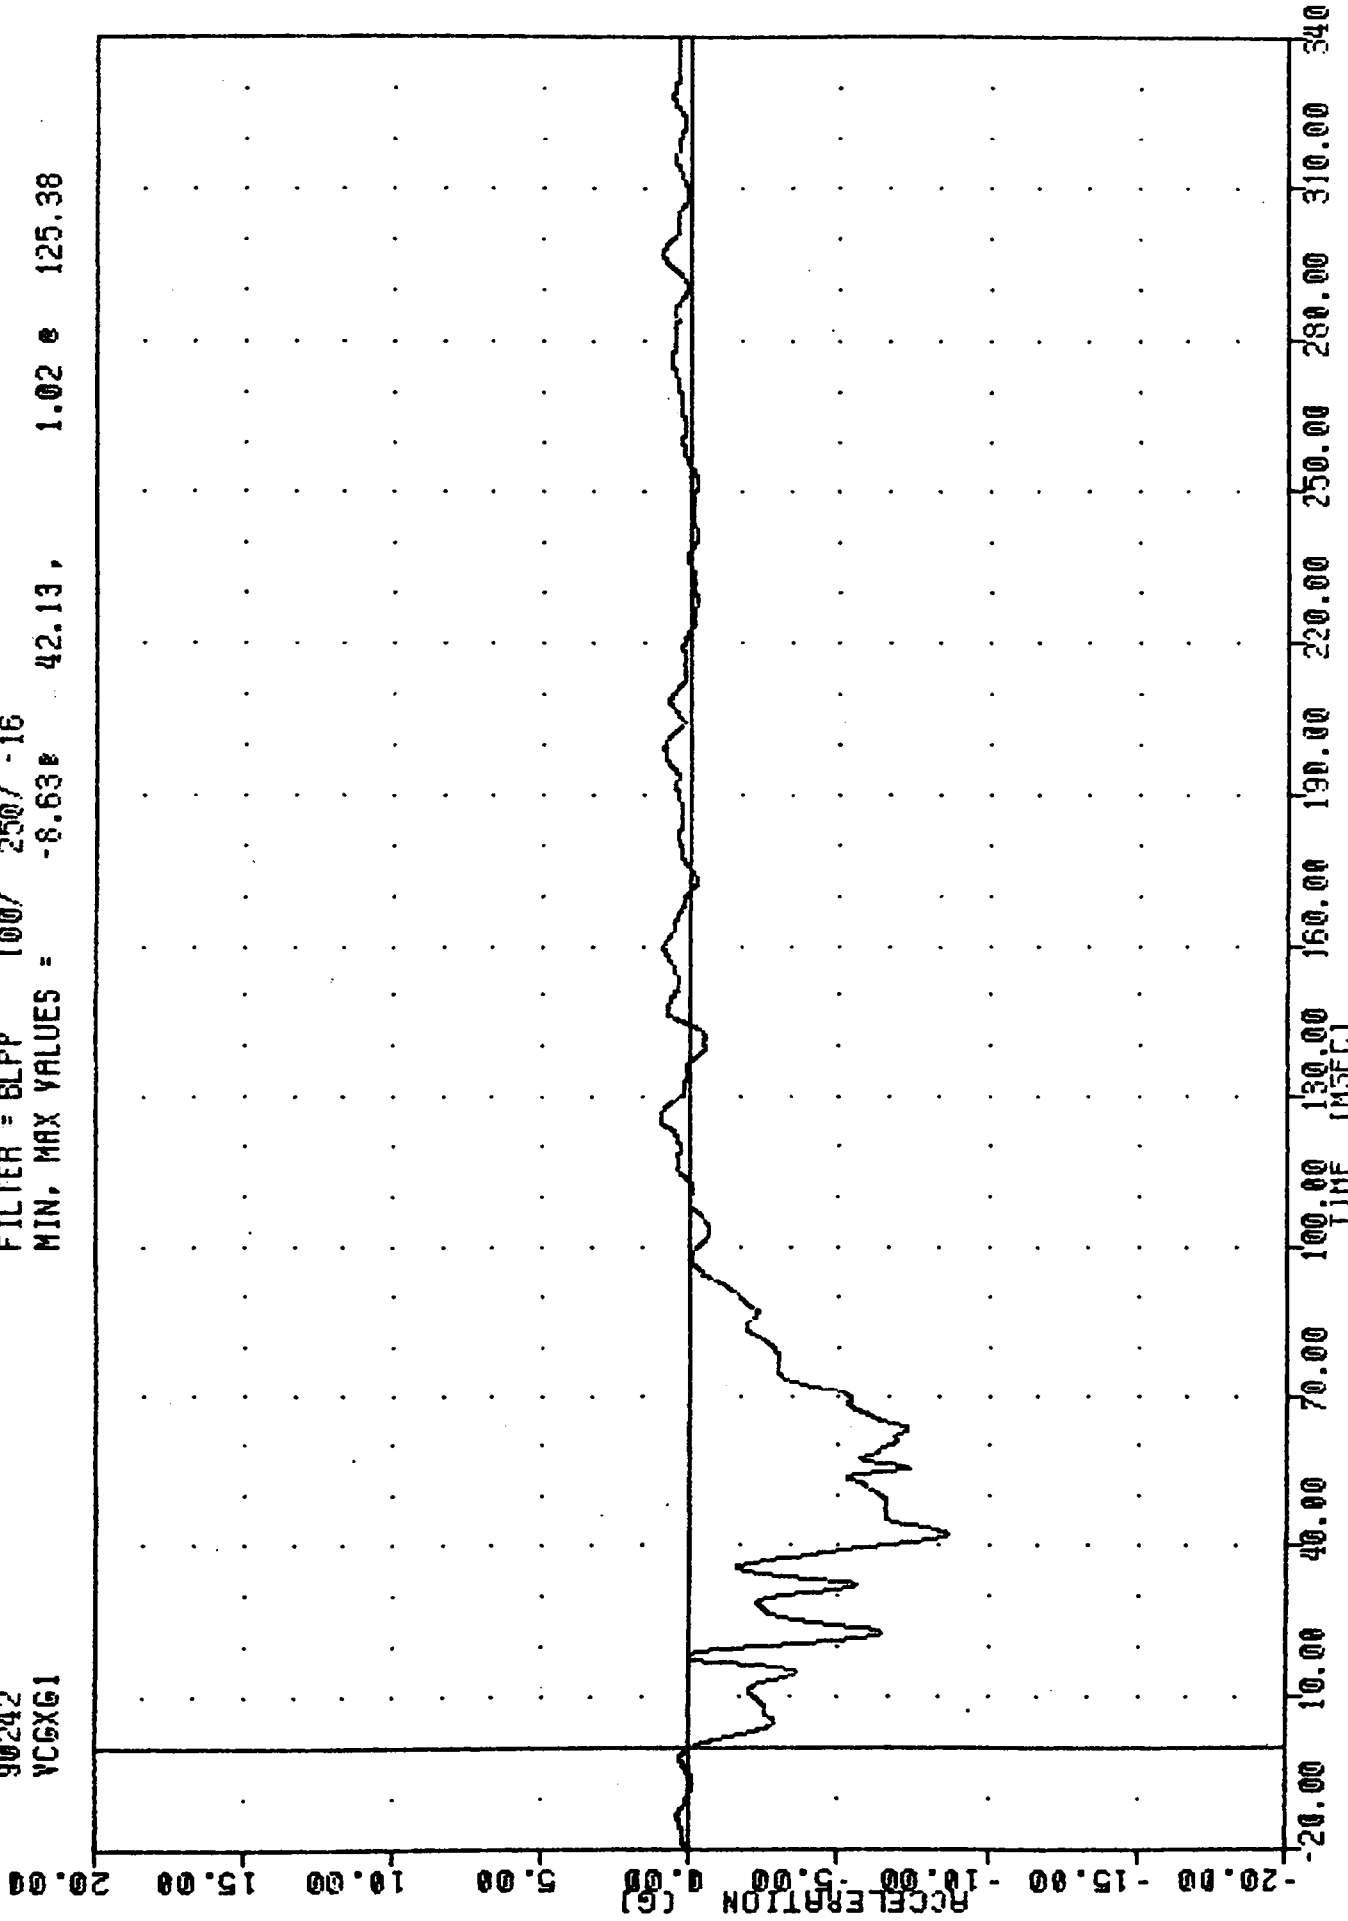
CONTOURED MOVING BARRIER INTO FORD ESCORT AT 14.2 MPH #1
VEHICLE CG X-AXIS ACCELERATION (IMPACT DIRECTION)

FILTER = BLPP 100/ 250/ -16
MIN, MAX VALUES = -3.21e 5.20 e 35.50

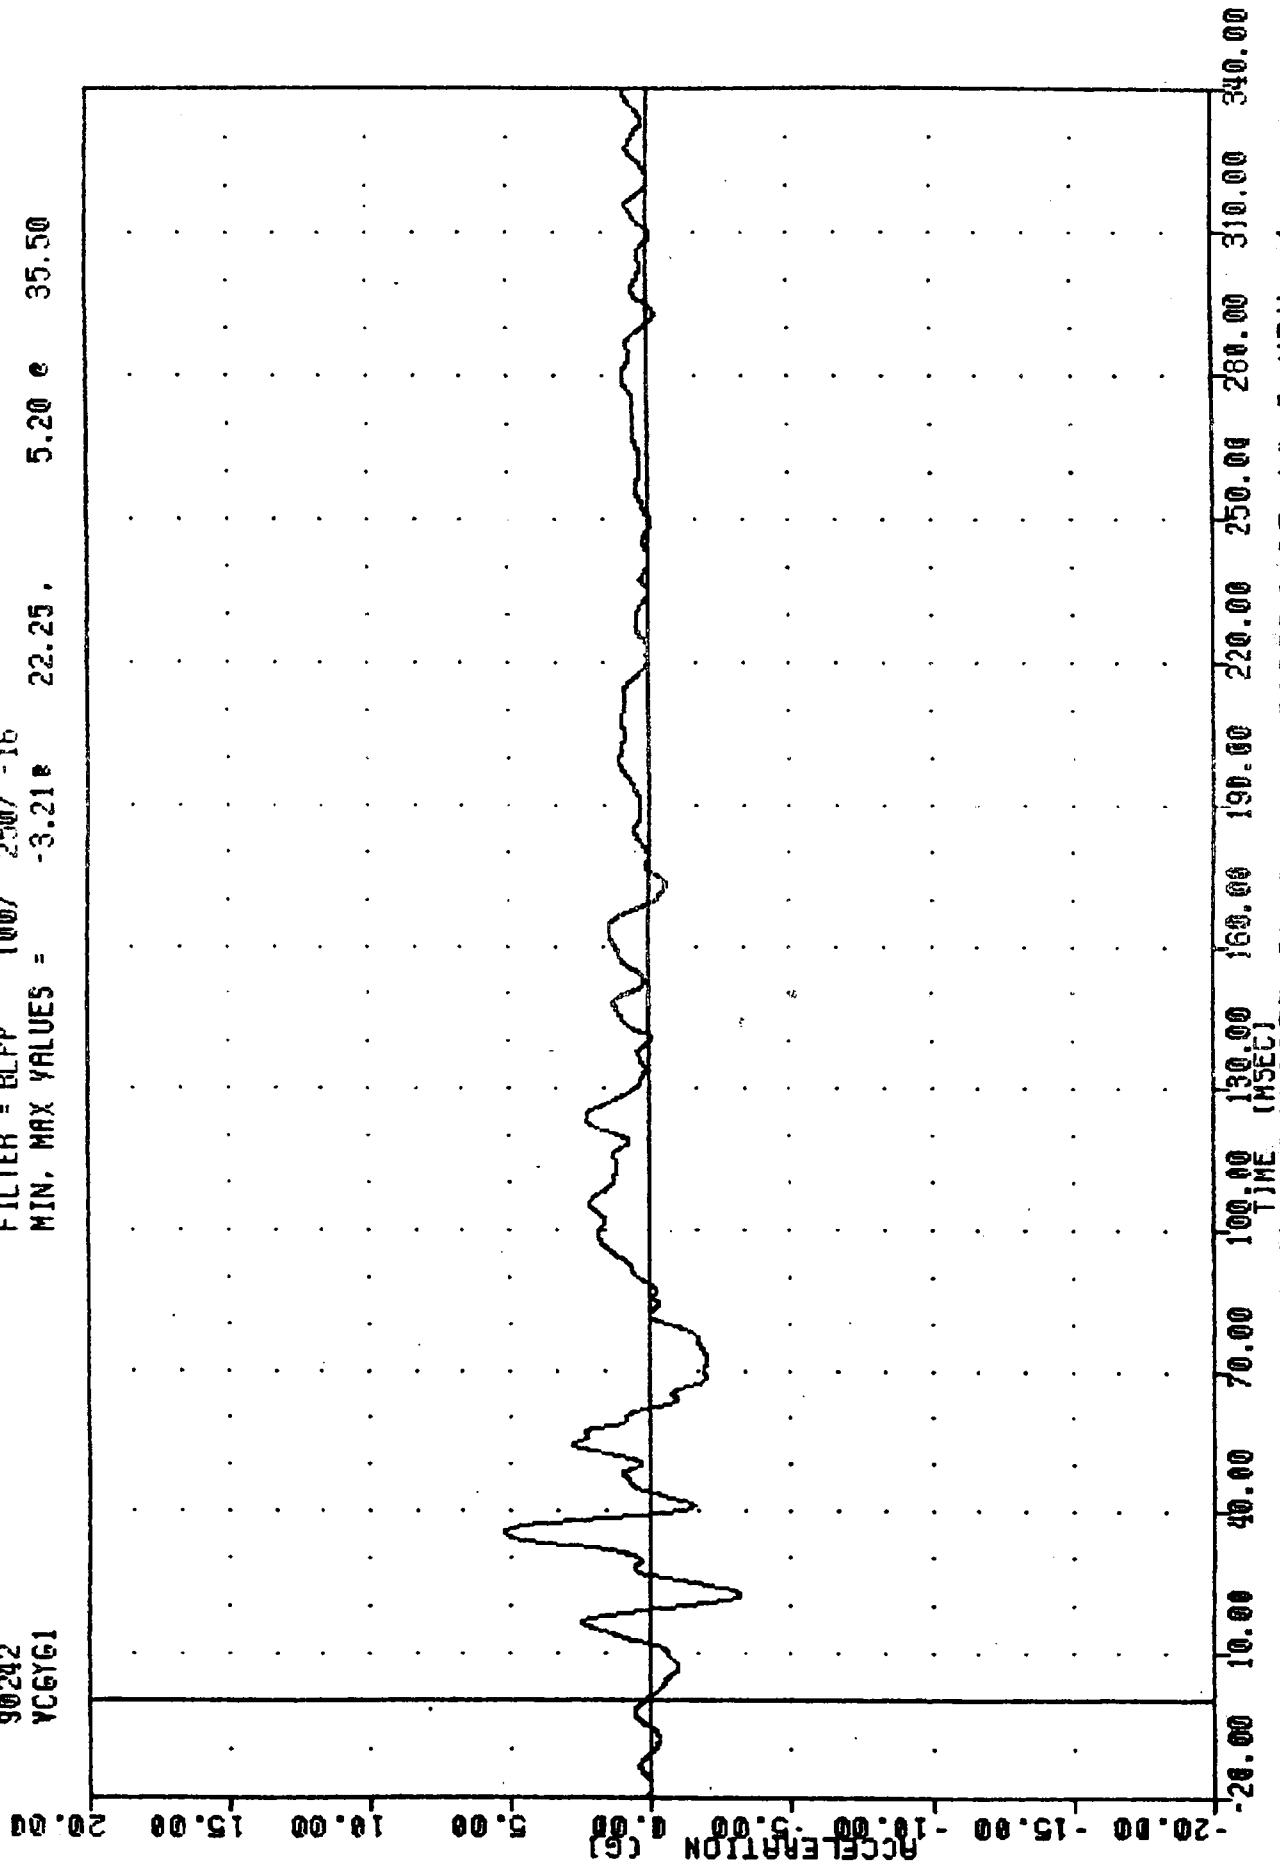
CONTOURED MOVING BARRIER INTO FORD ESCORT AT 14.2 MPH #1
VEHICLE CG Y-AXIS ACCELERATION (PERPENDICULAR TO IMPACT DIRECTION)

FILTER = 8LPP 100/ 250/ -16
MIN. MAX VALUES = 0.00 235.00, 8.71 42.13

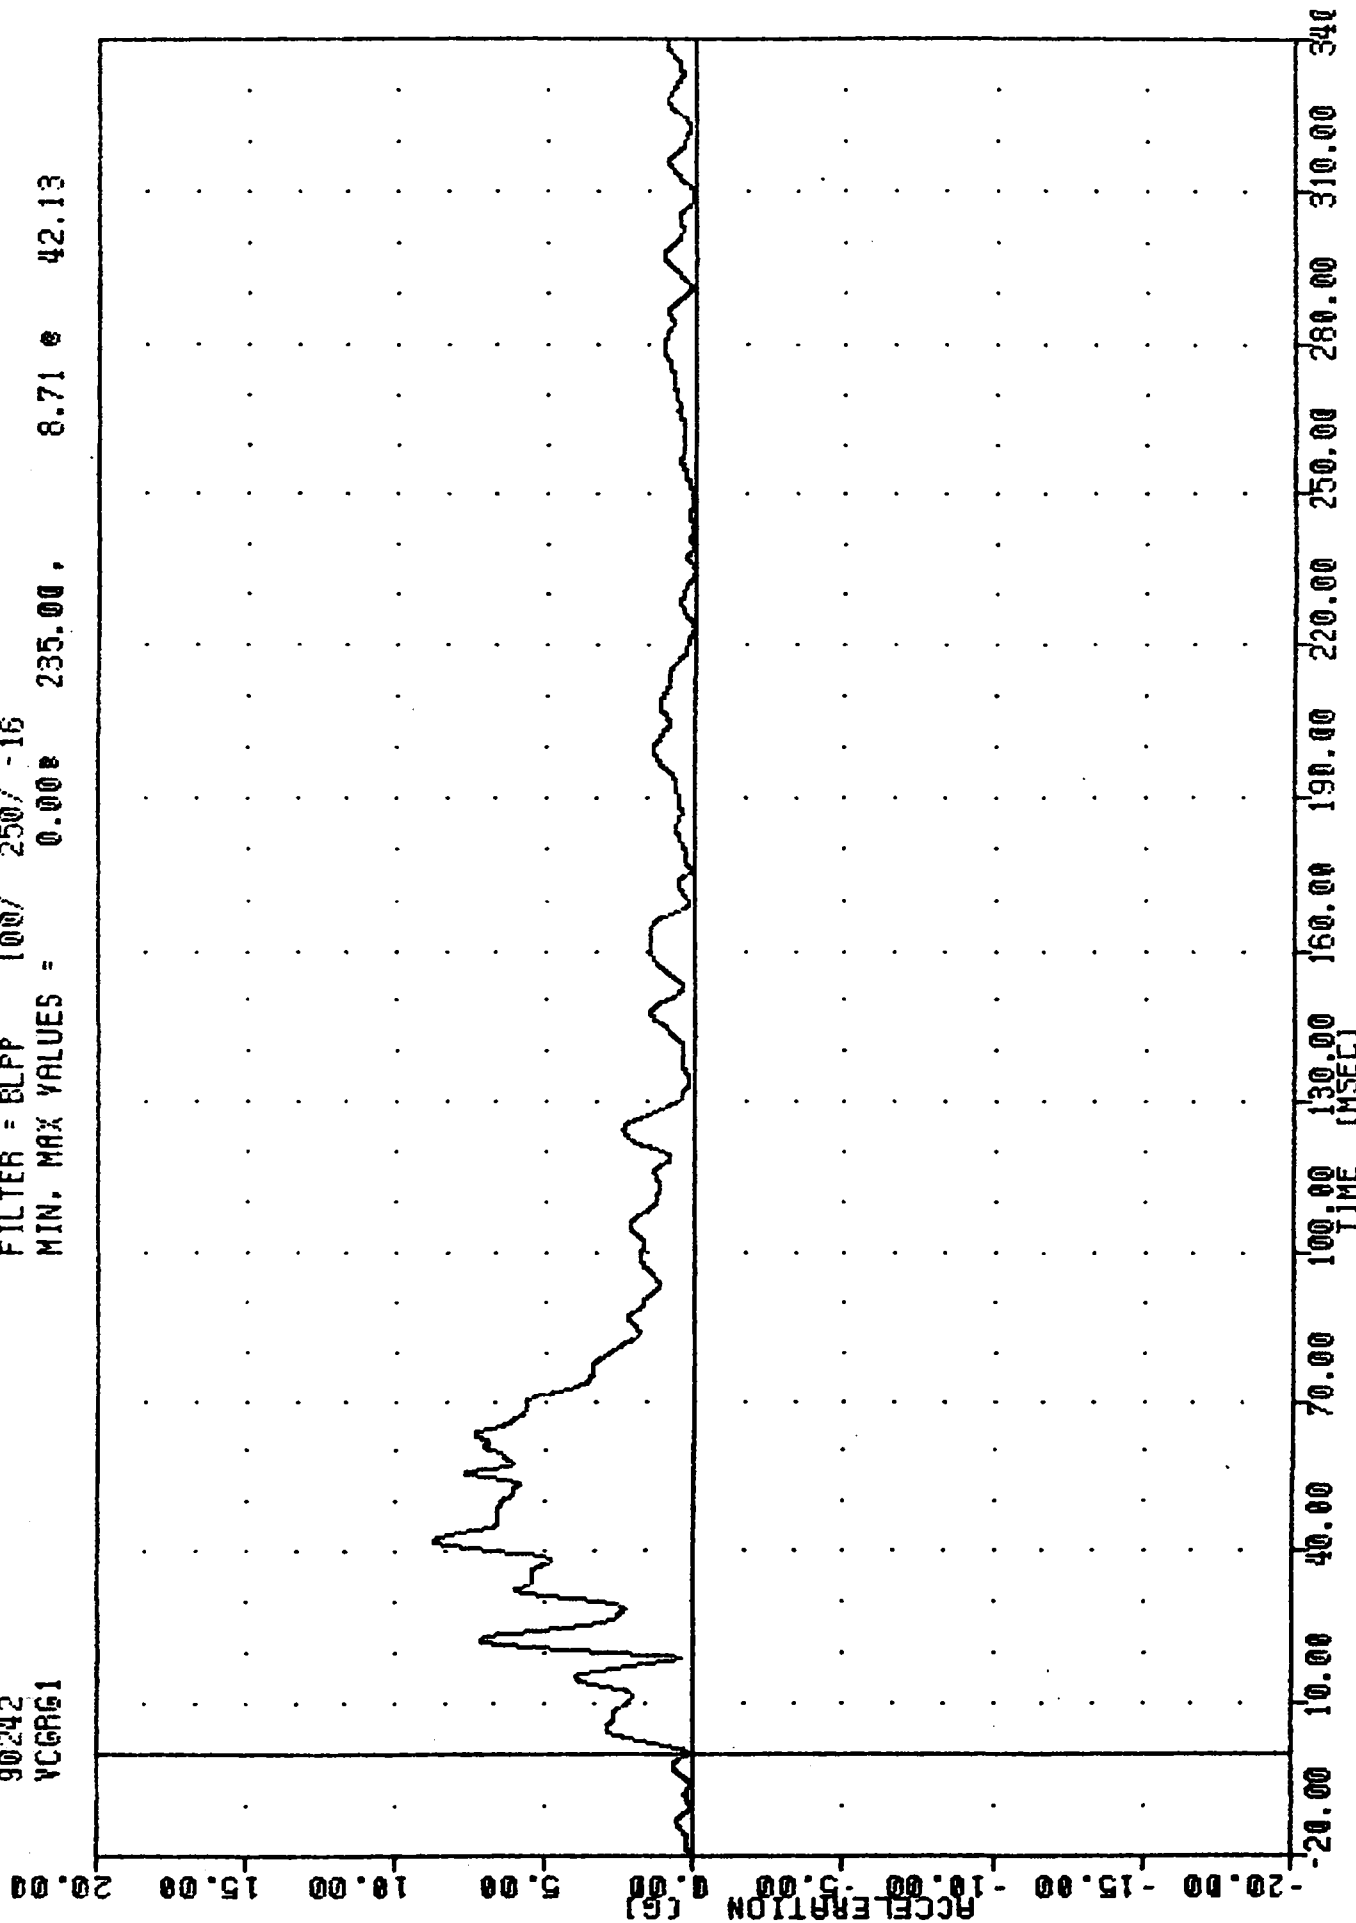
CONTOURED MOVING BARRIER INTO FORD ESCORT AT 14.2 MPH #1
VEHICLE CG RESULTANT ACCELERATION

FILTER = BLPP 100/ 250/ -16
 MIN. MAX VALUES = -8.35 57.25 0.45 e 200.25
