DOT HS 807 771
Final Report

Final Report of 339° Contoured Moving Barrier Impact Into a 1985 Ford Escort 3-Door Hatchback in Support of Crash III Damage Algorithm Reformation

The purpose of the four 339° contoured moving barrier impact tests was research and development in support of the CRASH III damage algorithm reformulation.

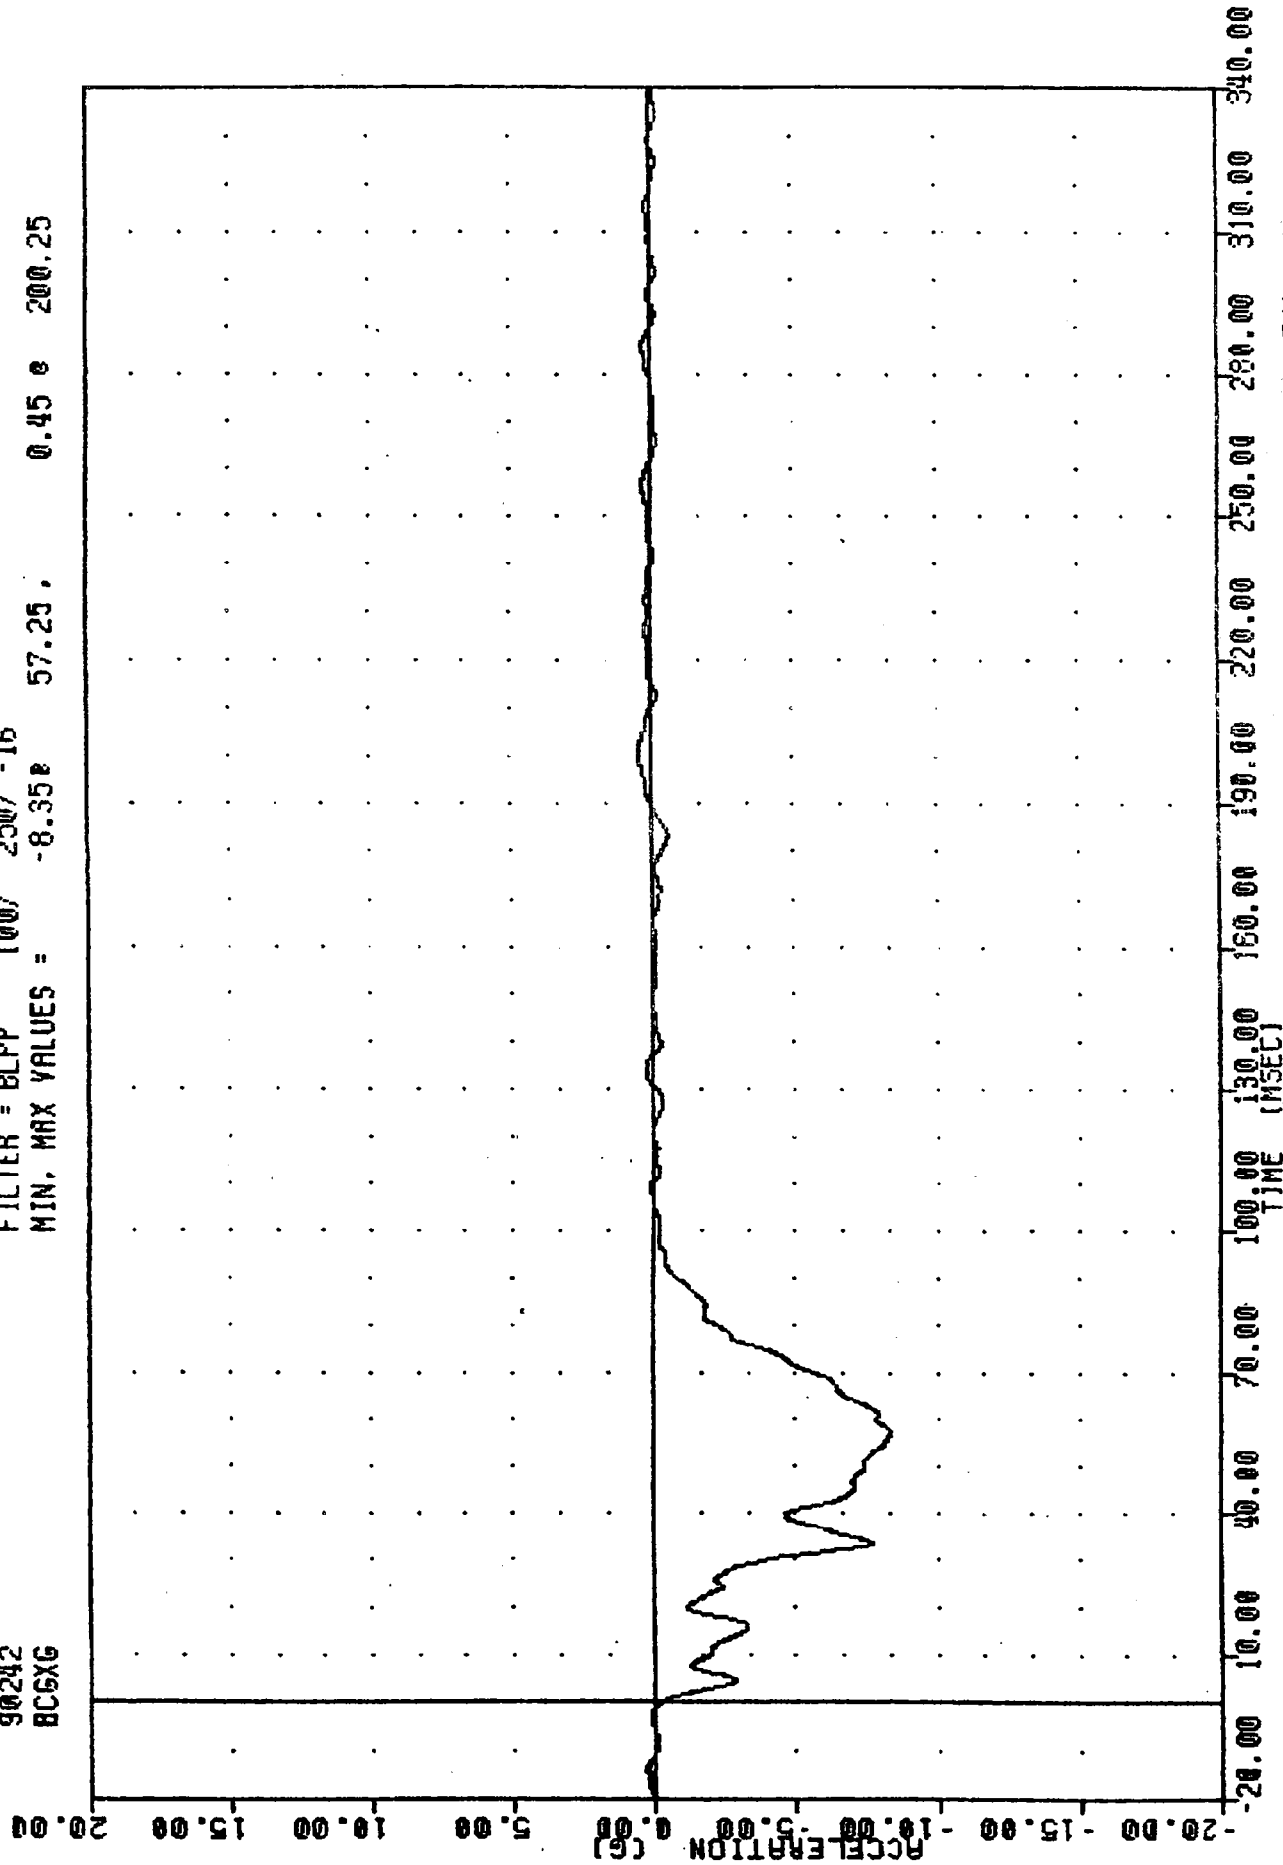
CONTOURED MOVING BARRIER INTO FORD ESCORT AT 14.2 MPH *1
 MOVING BARRIER CENTER OF GRAVITY X-AXIS ACCELERATION

FILTER = ELPP 100/ 250/ -16
 MIN. MAX VALUES = -0.73e 10.00. 0.88 e 165.13

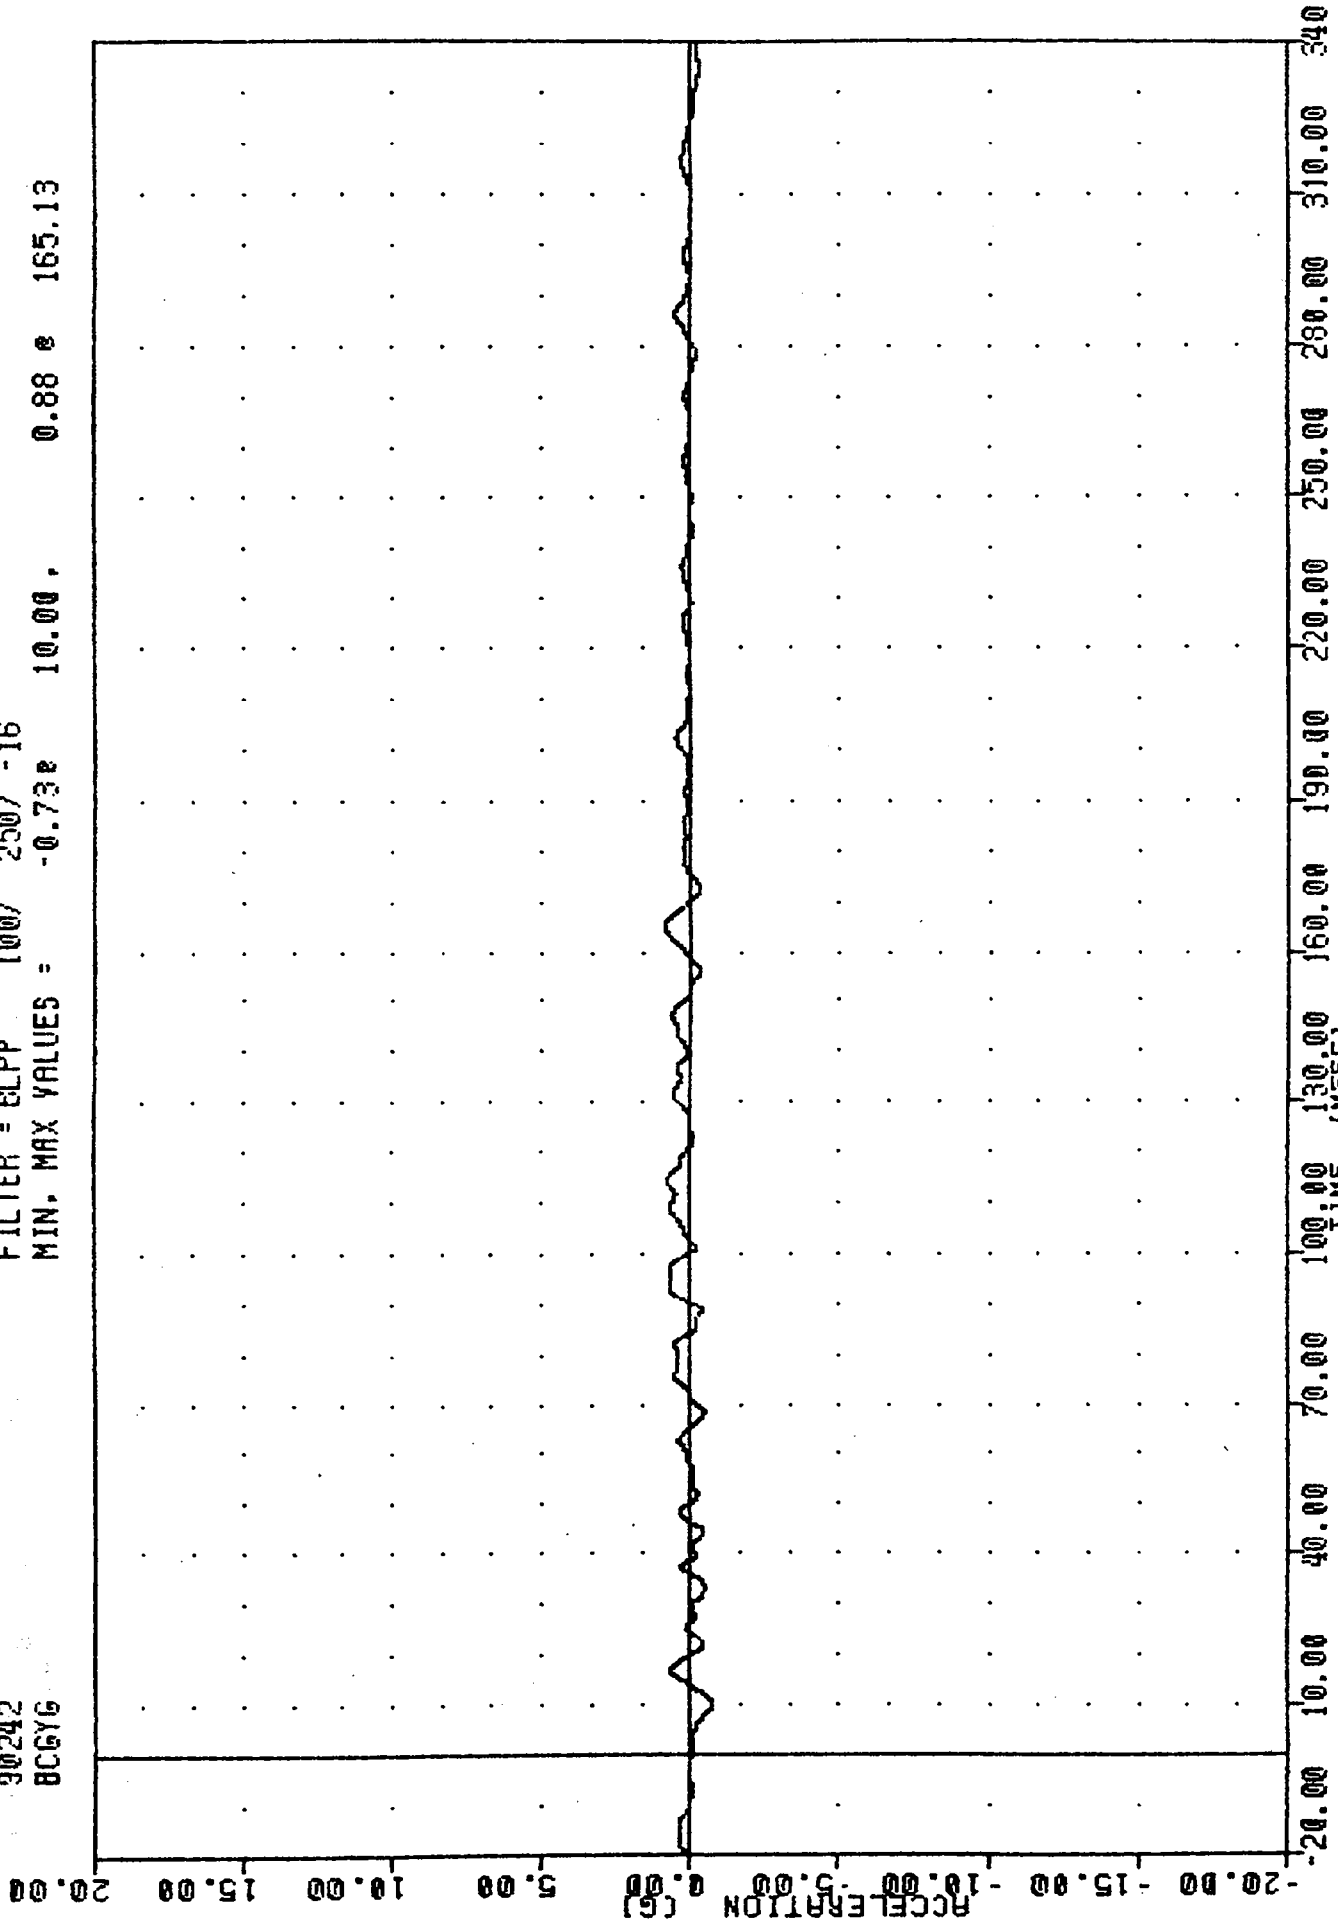
CONTOURED MOVING BARRIER INTO FORD ESCORT AT 14.2 MPH #1
 MOVING BARRIER CENTER OF GRAVITY Y-AXIS ACCELERATION

FILTER = BLPP 100/ 250/ -16
MIN. MAX VALUES = 0.00e -1.25, 8.35 e 57.25

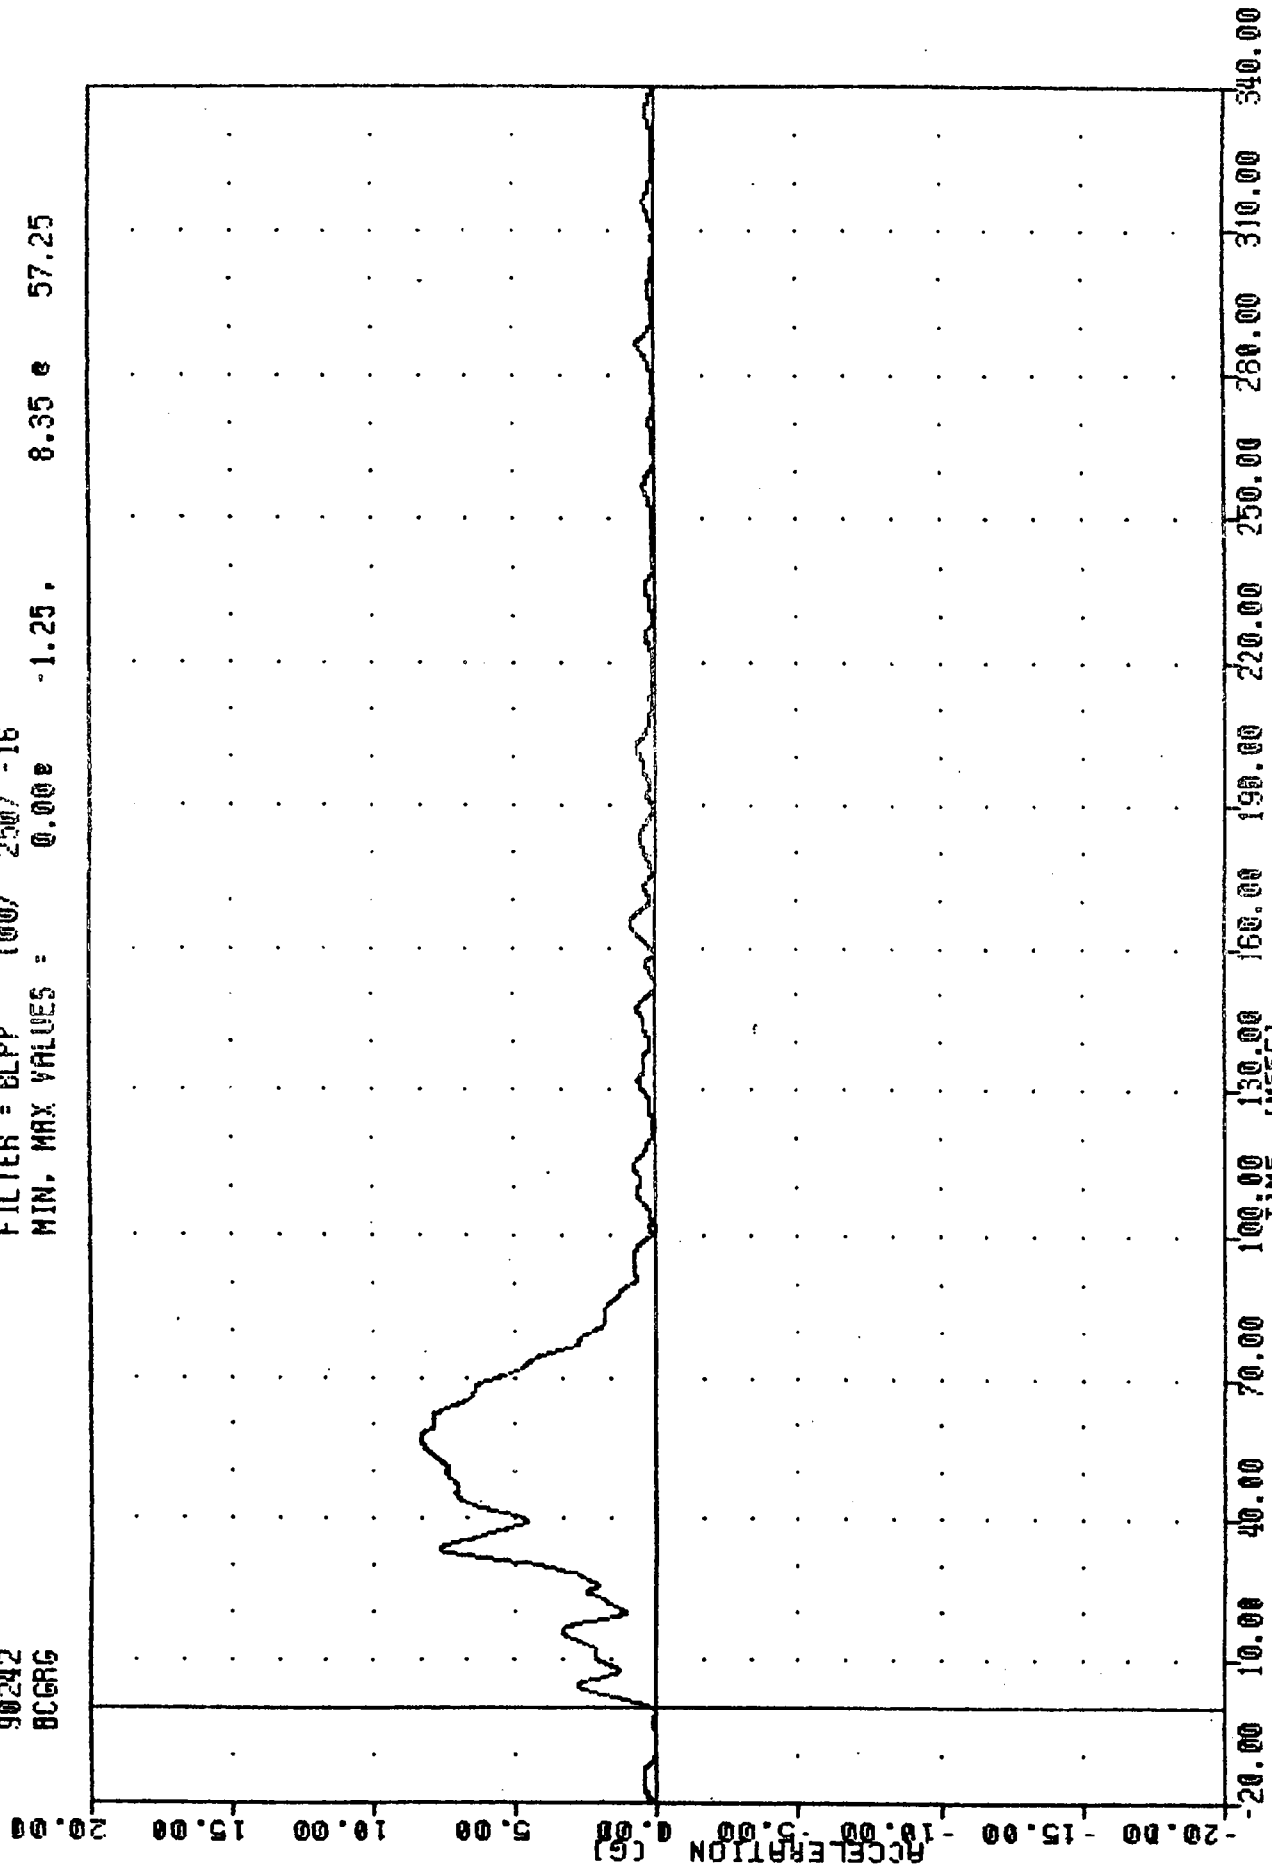
CONTOURED MOVING BARRIER INTO FORD ESCORT AT 14.2 MPH #1
MOVING BARRIER CENTER OF GRAVITY RESULTANT ACCELERATION

FILTER = BLPP 300/ 750/ -16
MIN. MAX VALUES = -8.56e 340.00, 0.00 e 0.00

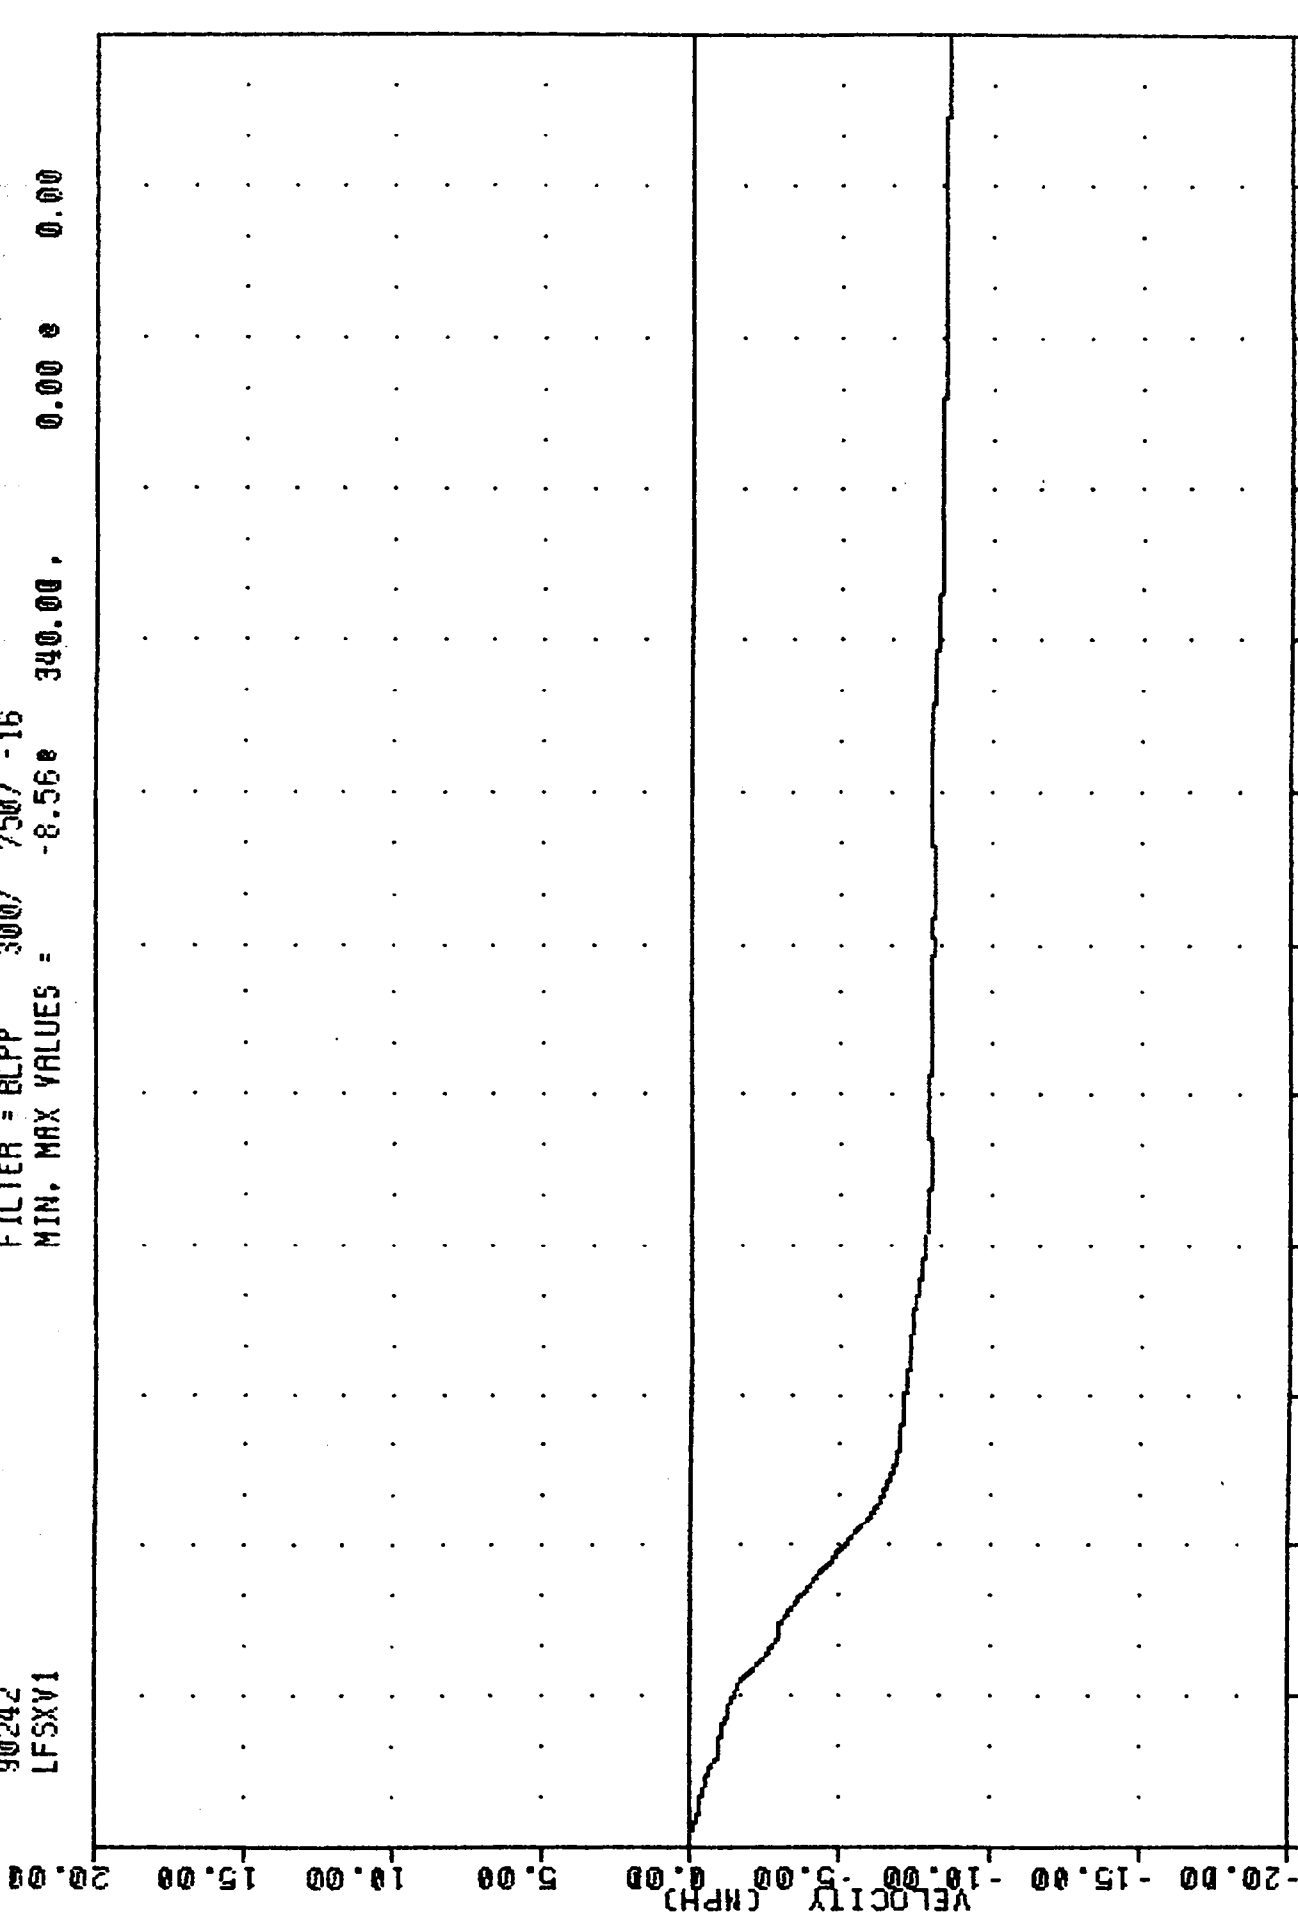
CONTOURED MOVING BARRIER INTO FORD ESCORT AT 14.2 MPH #1
LEFT FRONT SILL X-AXIS VELOCITY

FILTER = BLPP 300/ 750/ -16
 MIN. MAX VALUES = -1.55e 79.75, 2.04 e 340.00

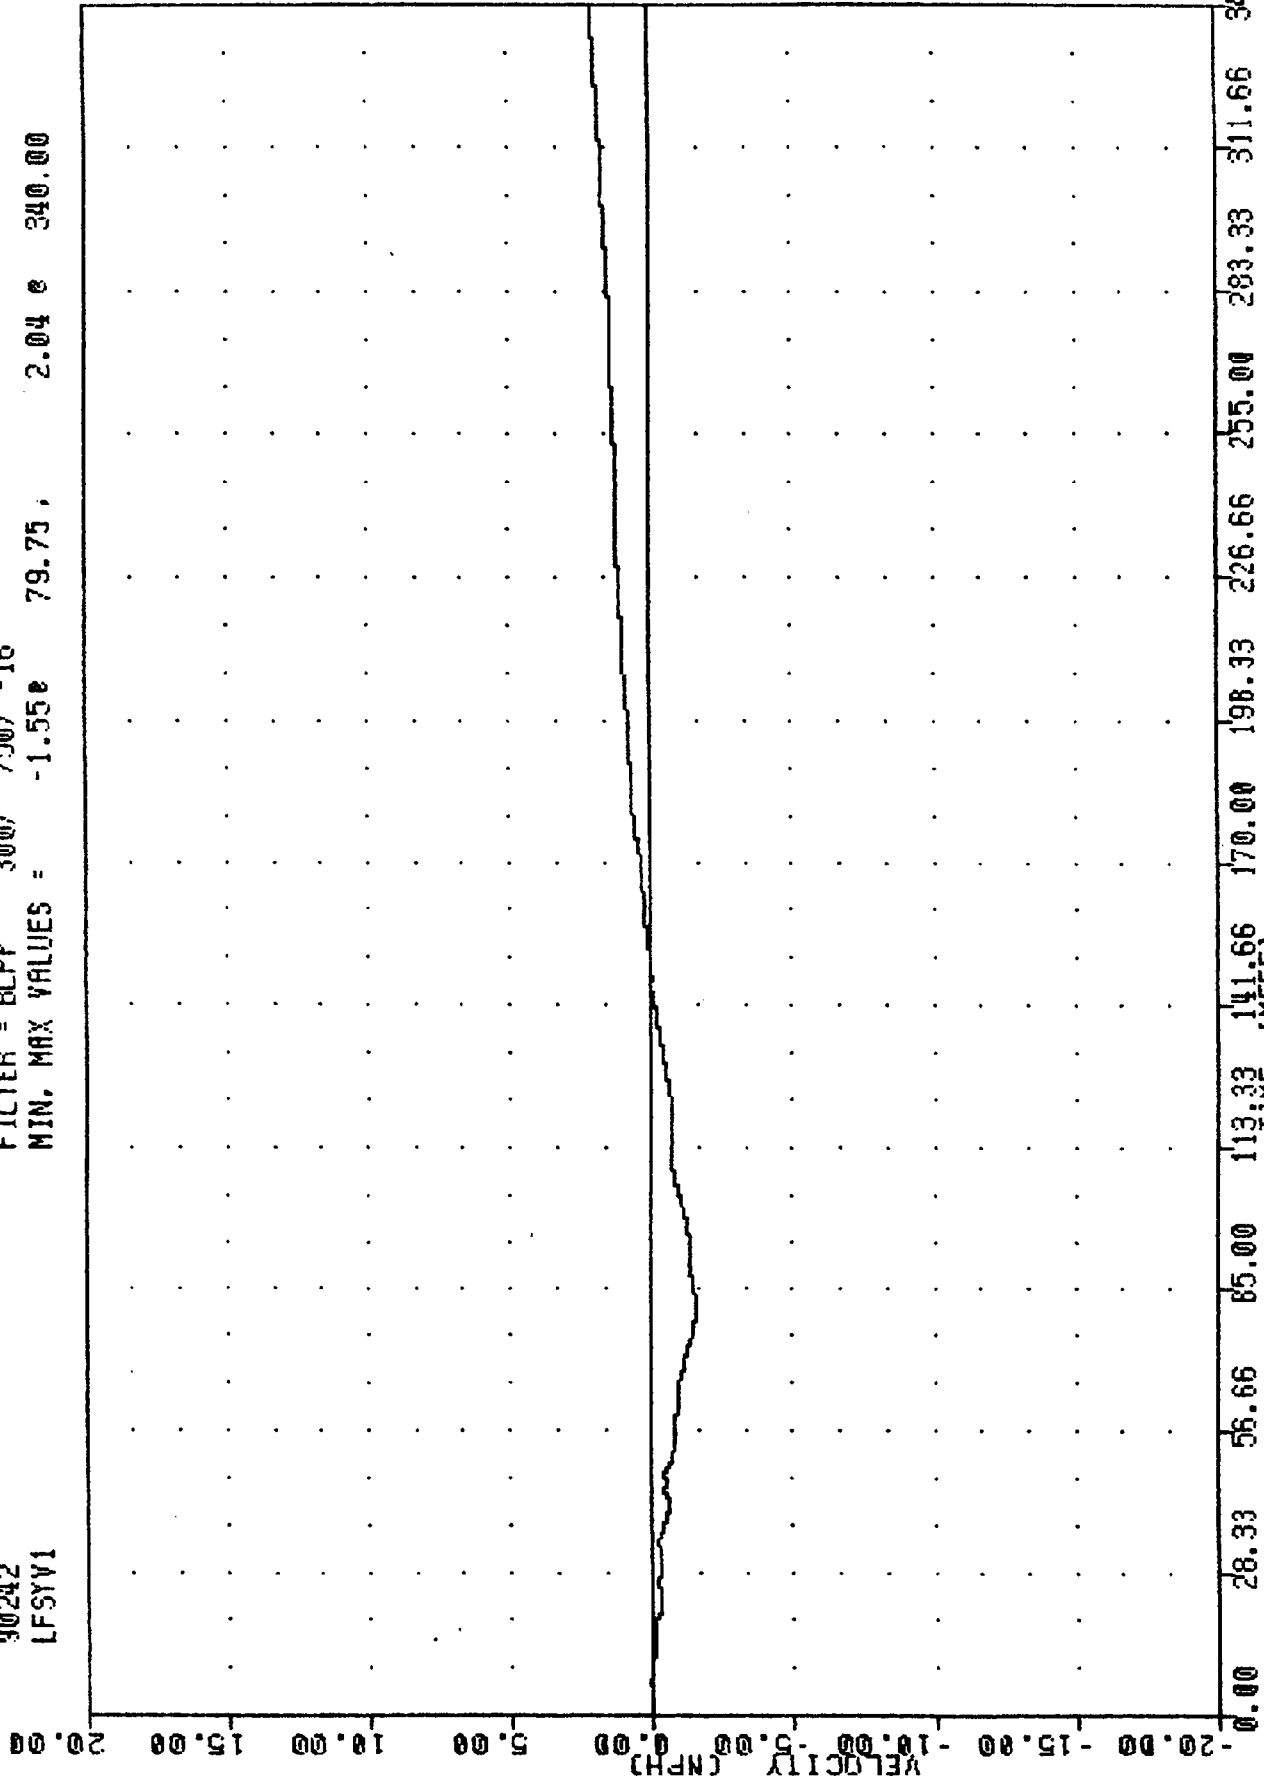
CONTOURED MOVING BARRIER INTO FORD ESCORT AT 14.2 MPH #1
 LEFT FRONT SILL Y-AXIS VELOCITY

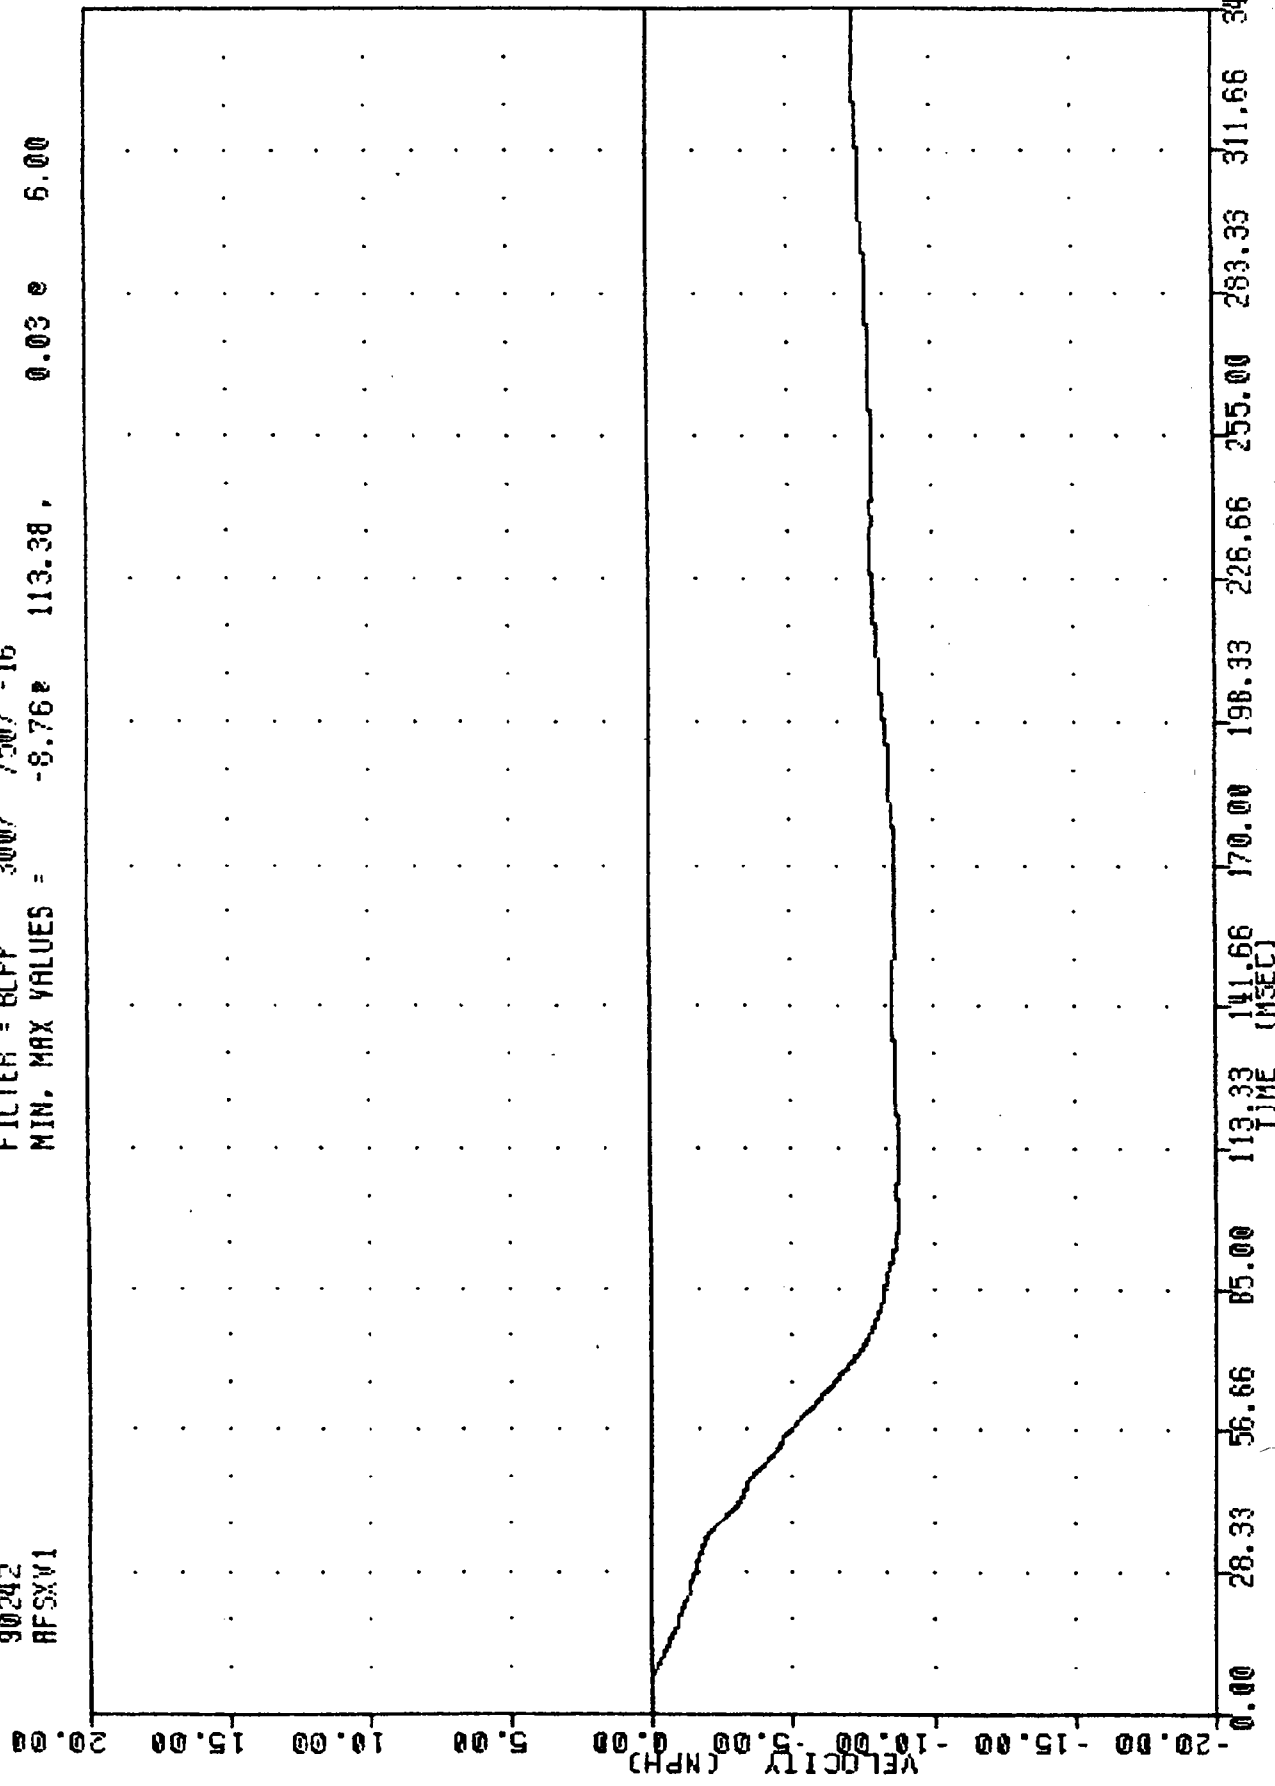
CONTOURED MOVING BARRIER INTO FORD ESCORT AT 14.2 MPH #1
 RIGHT FRONT SILL X-AXIS VELOCITY

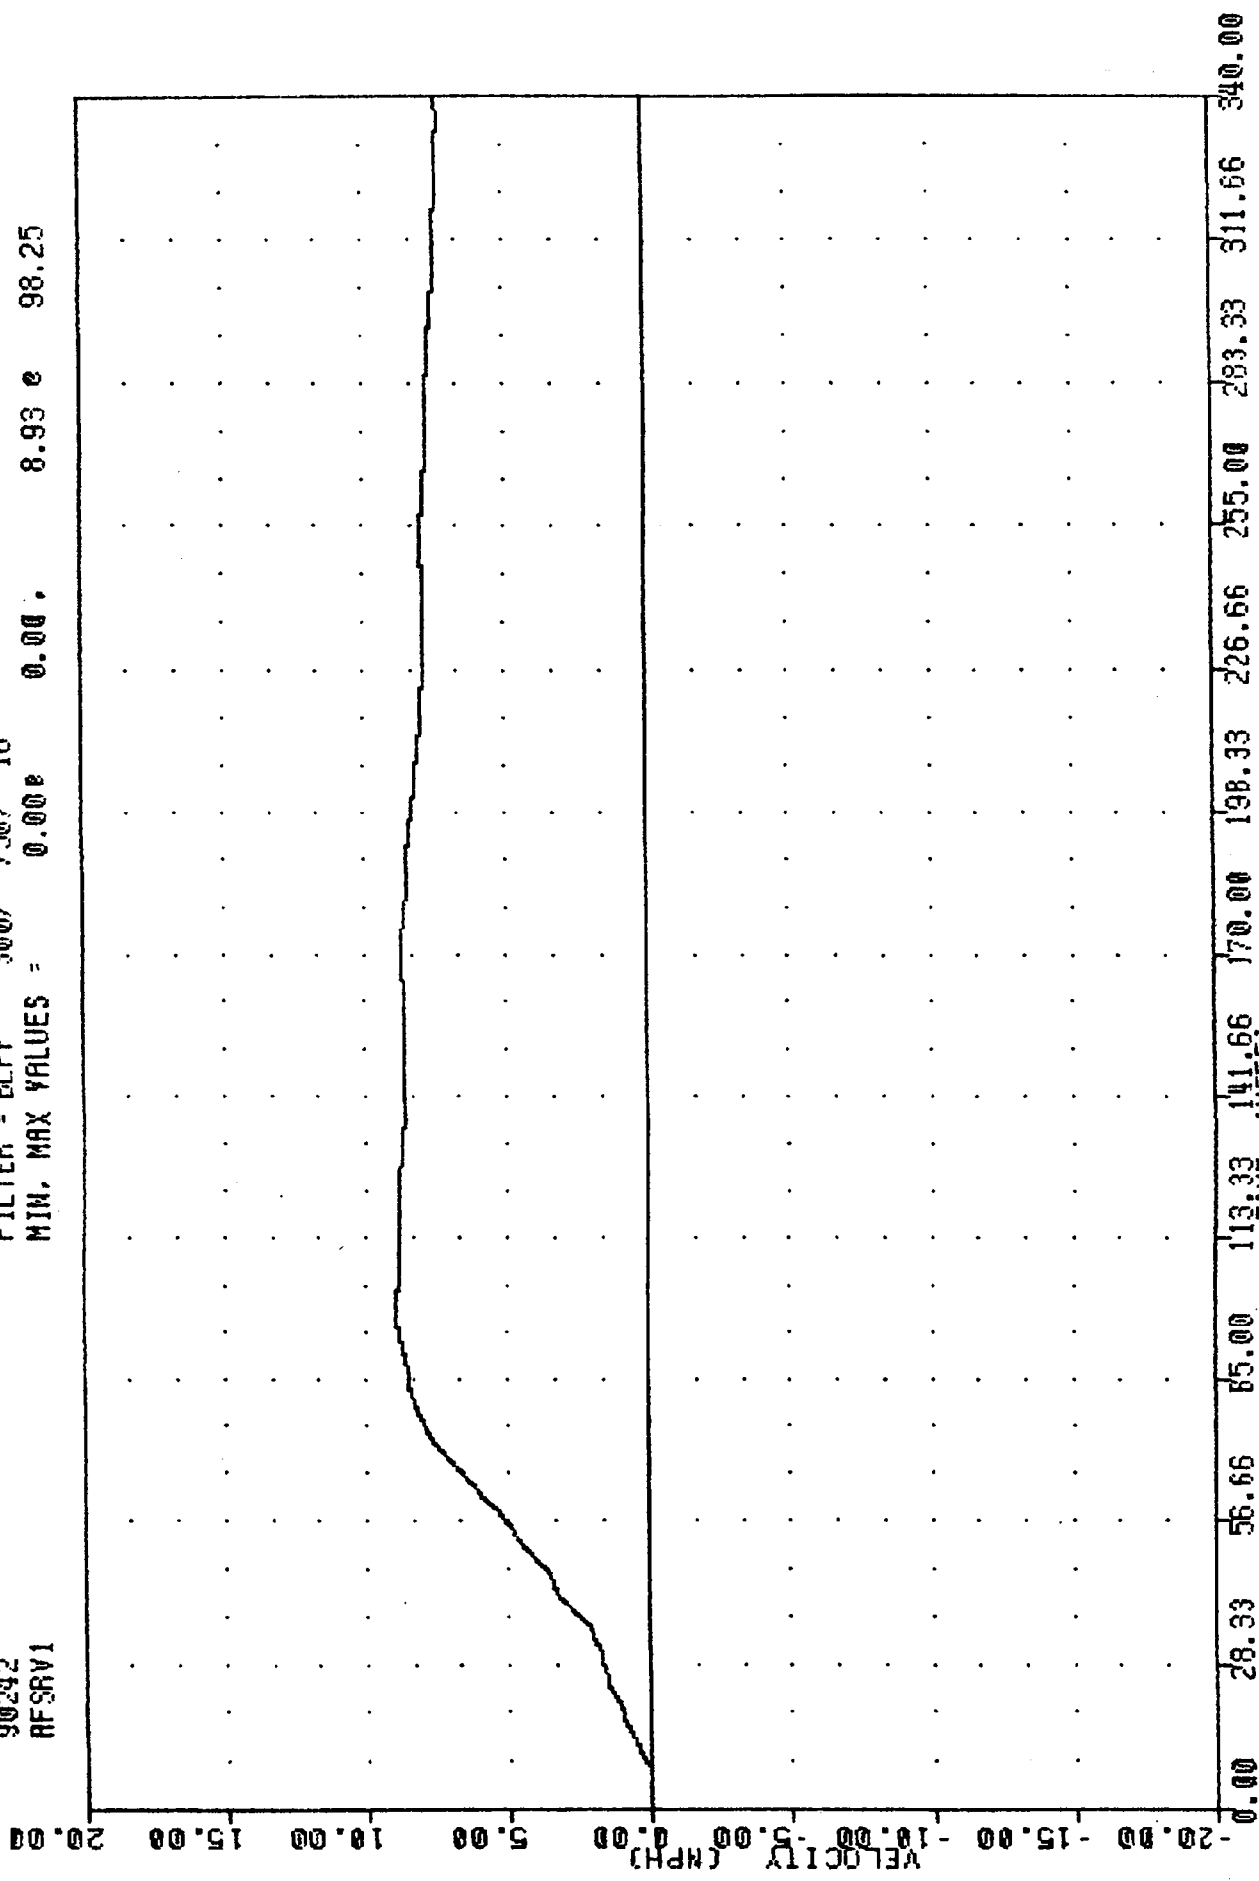
CONTOURED MOVING BARRIER INTO FORD ESCORT AT 14.2 MPH #1
 RIGHT FRONT SILL RESULTANT VELOCITY

FILTER = BLPP 300/ 750/ -16
MIN, MAX VALUES = -8.30e 113.75. 0.00 e 0.00

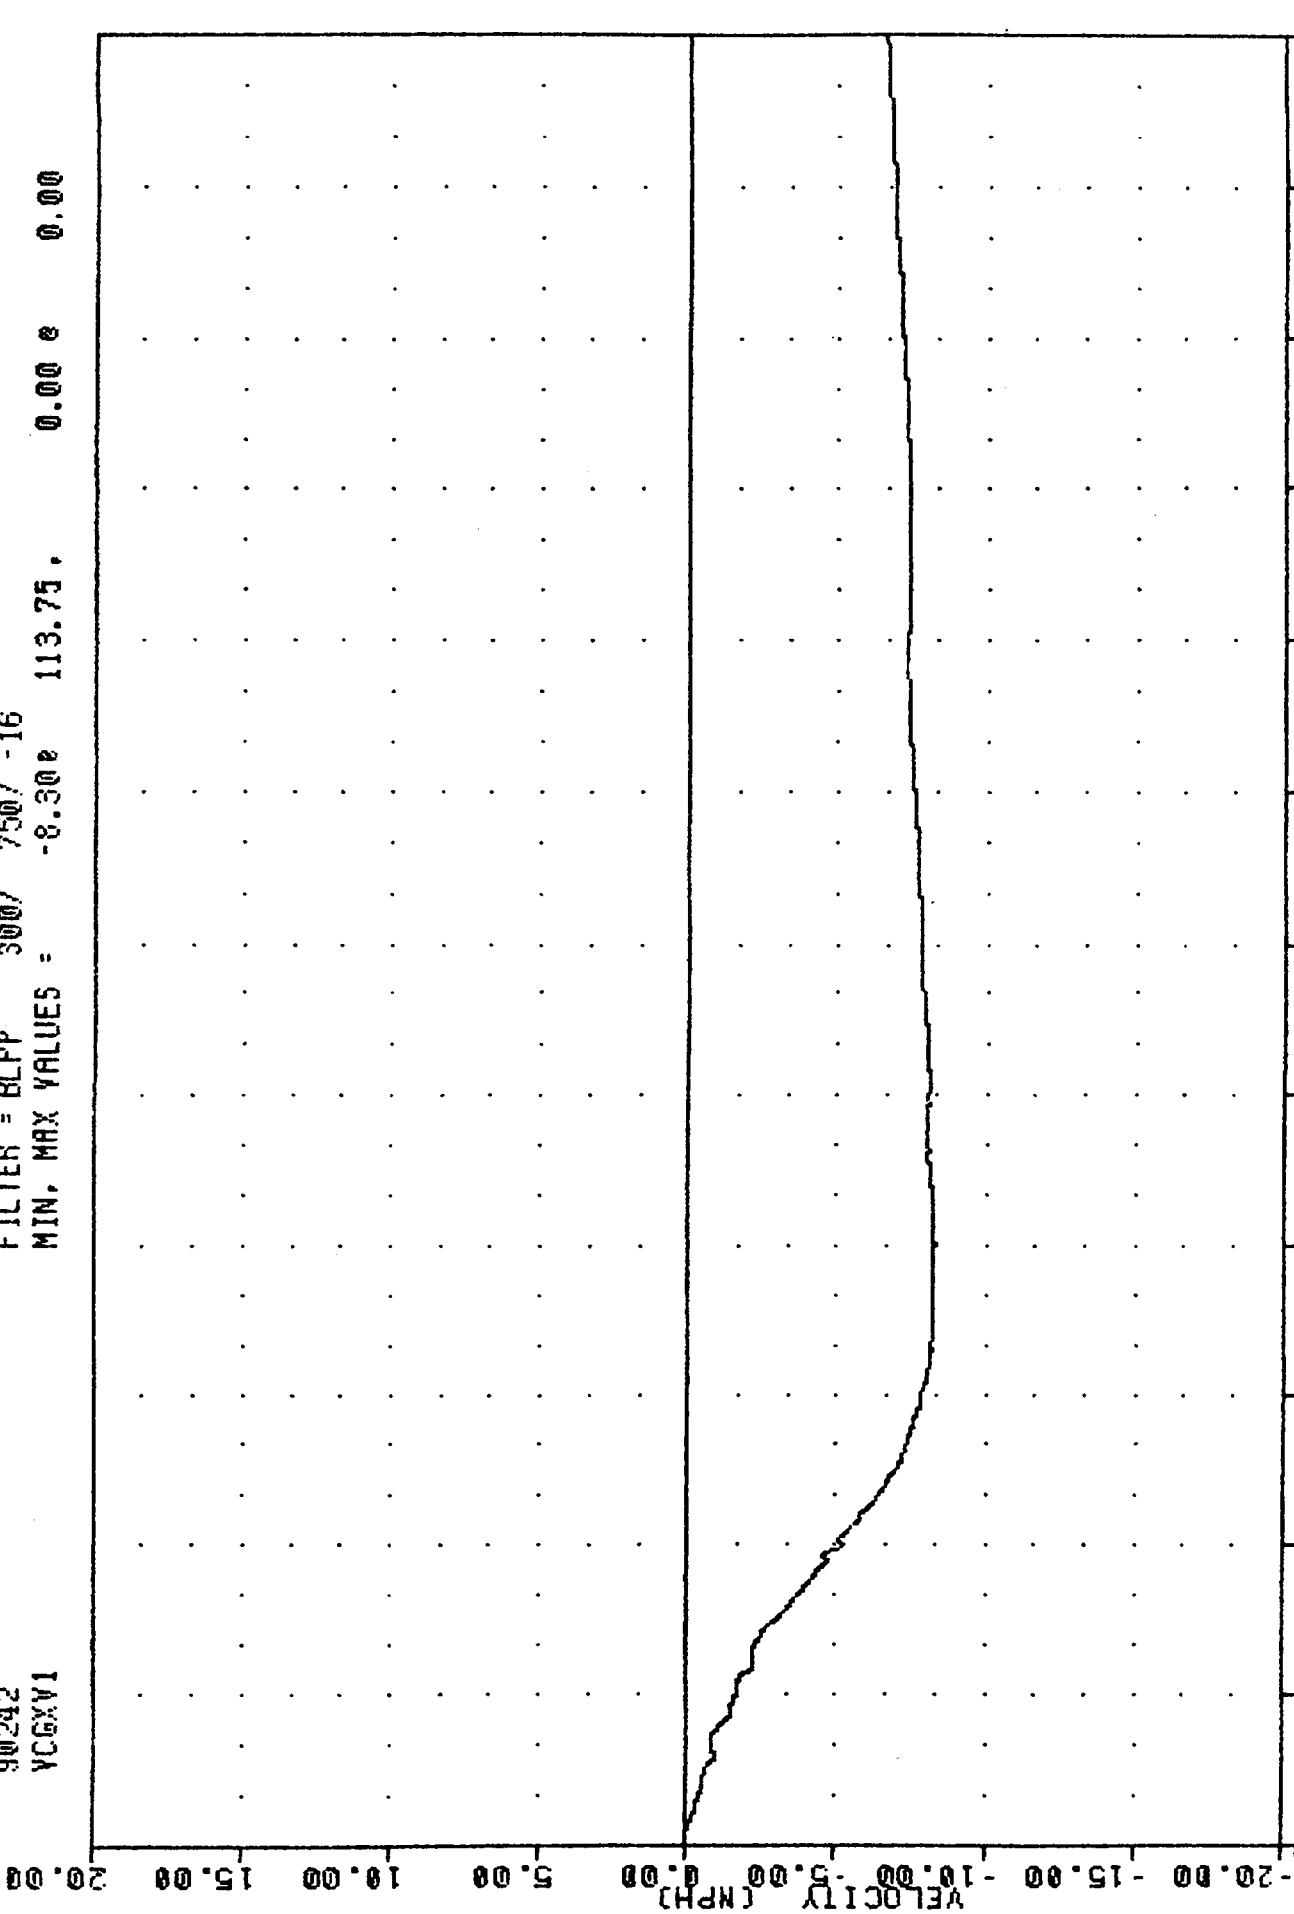
0.00 26.33 56.66 85.00 113.33 141.66 170.00 198.33 226.66 255.00 283.33 311.66 340
 TIME (MSEC)
 CONTOURED MOVING BARRIER INTO FORD ESCORT AT 14.2 MPH *1
 VEHICLE CG X-AXIS VELOCITY (IMPACT DIRECTION)

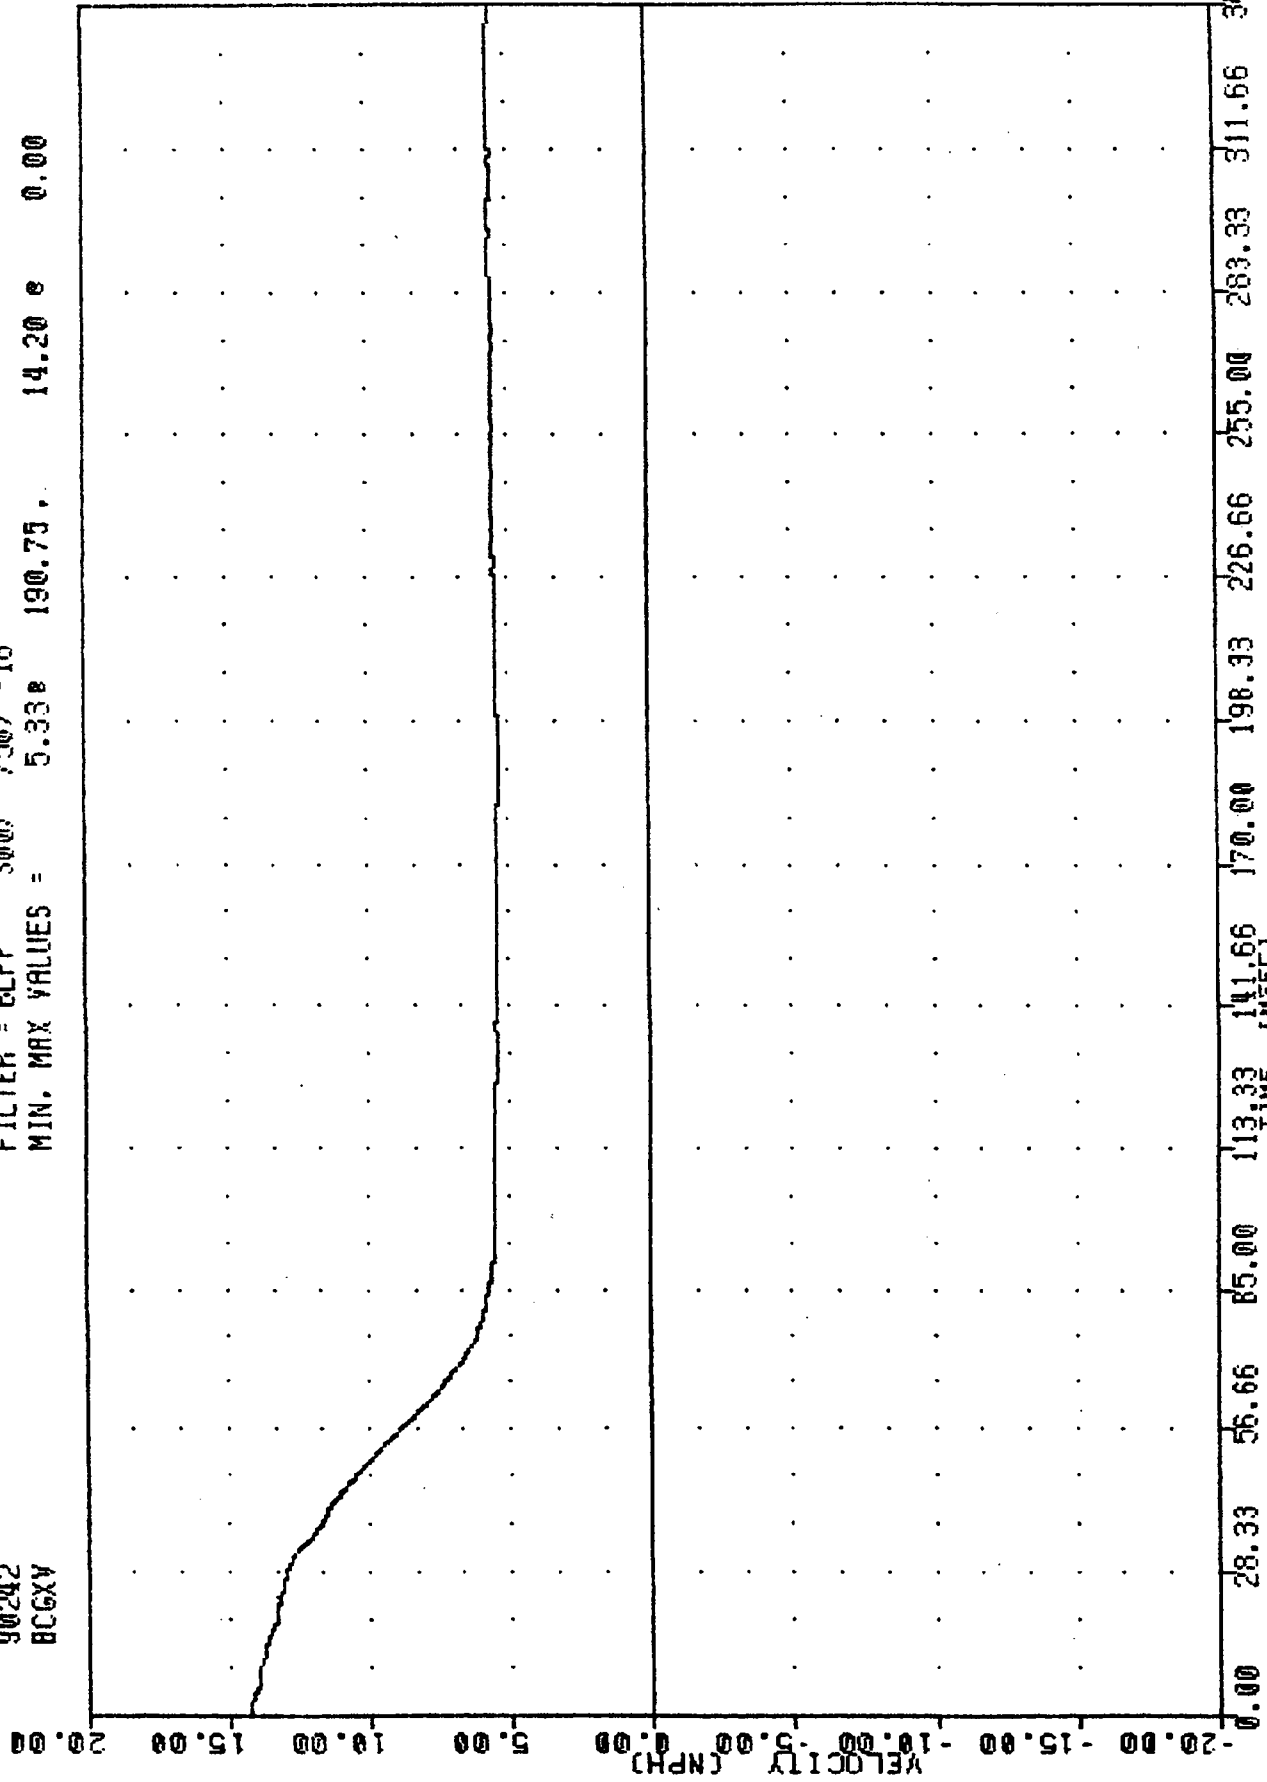
CONTOURED MOVING BARRIER INTO FORD ESCORT AT 14.2 MPH #1
 MOVING BARRIER CENTER OF GRAVITY X-AXIS VELOCITY.

FILTER = BLPP 300/ 750/ -16
 MIN, MAX VALUES = -0.16e 45.50, 0.92 e 324.63
