DOT HS 807 771
Final Report

Final Report of 339° Contoured Moving Barrier Impact Into a 1985 Ford Escort 3-Door Hatchback in Support of Crash III Damage Algorithm Reformation

The purpose of the four 339° contoured moving barrier impact tests was research and development in support of the CRASH III damage algorithm reformulation.

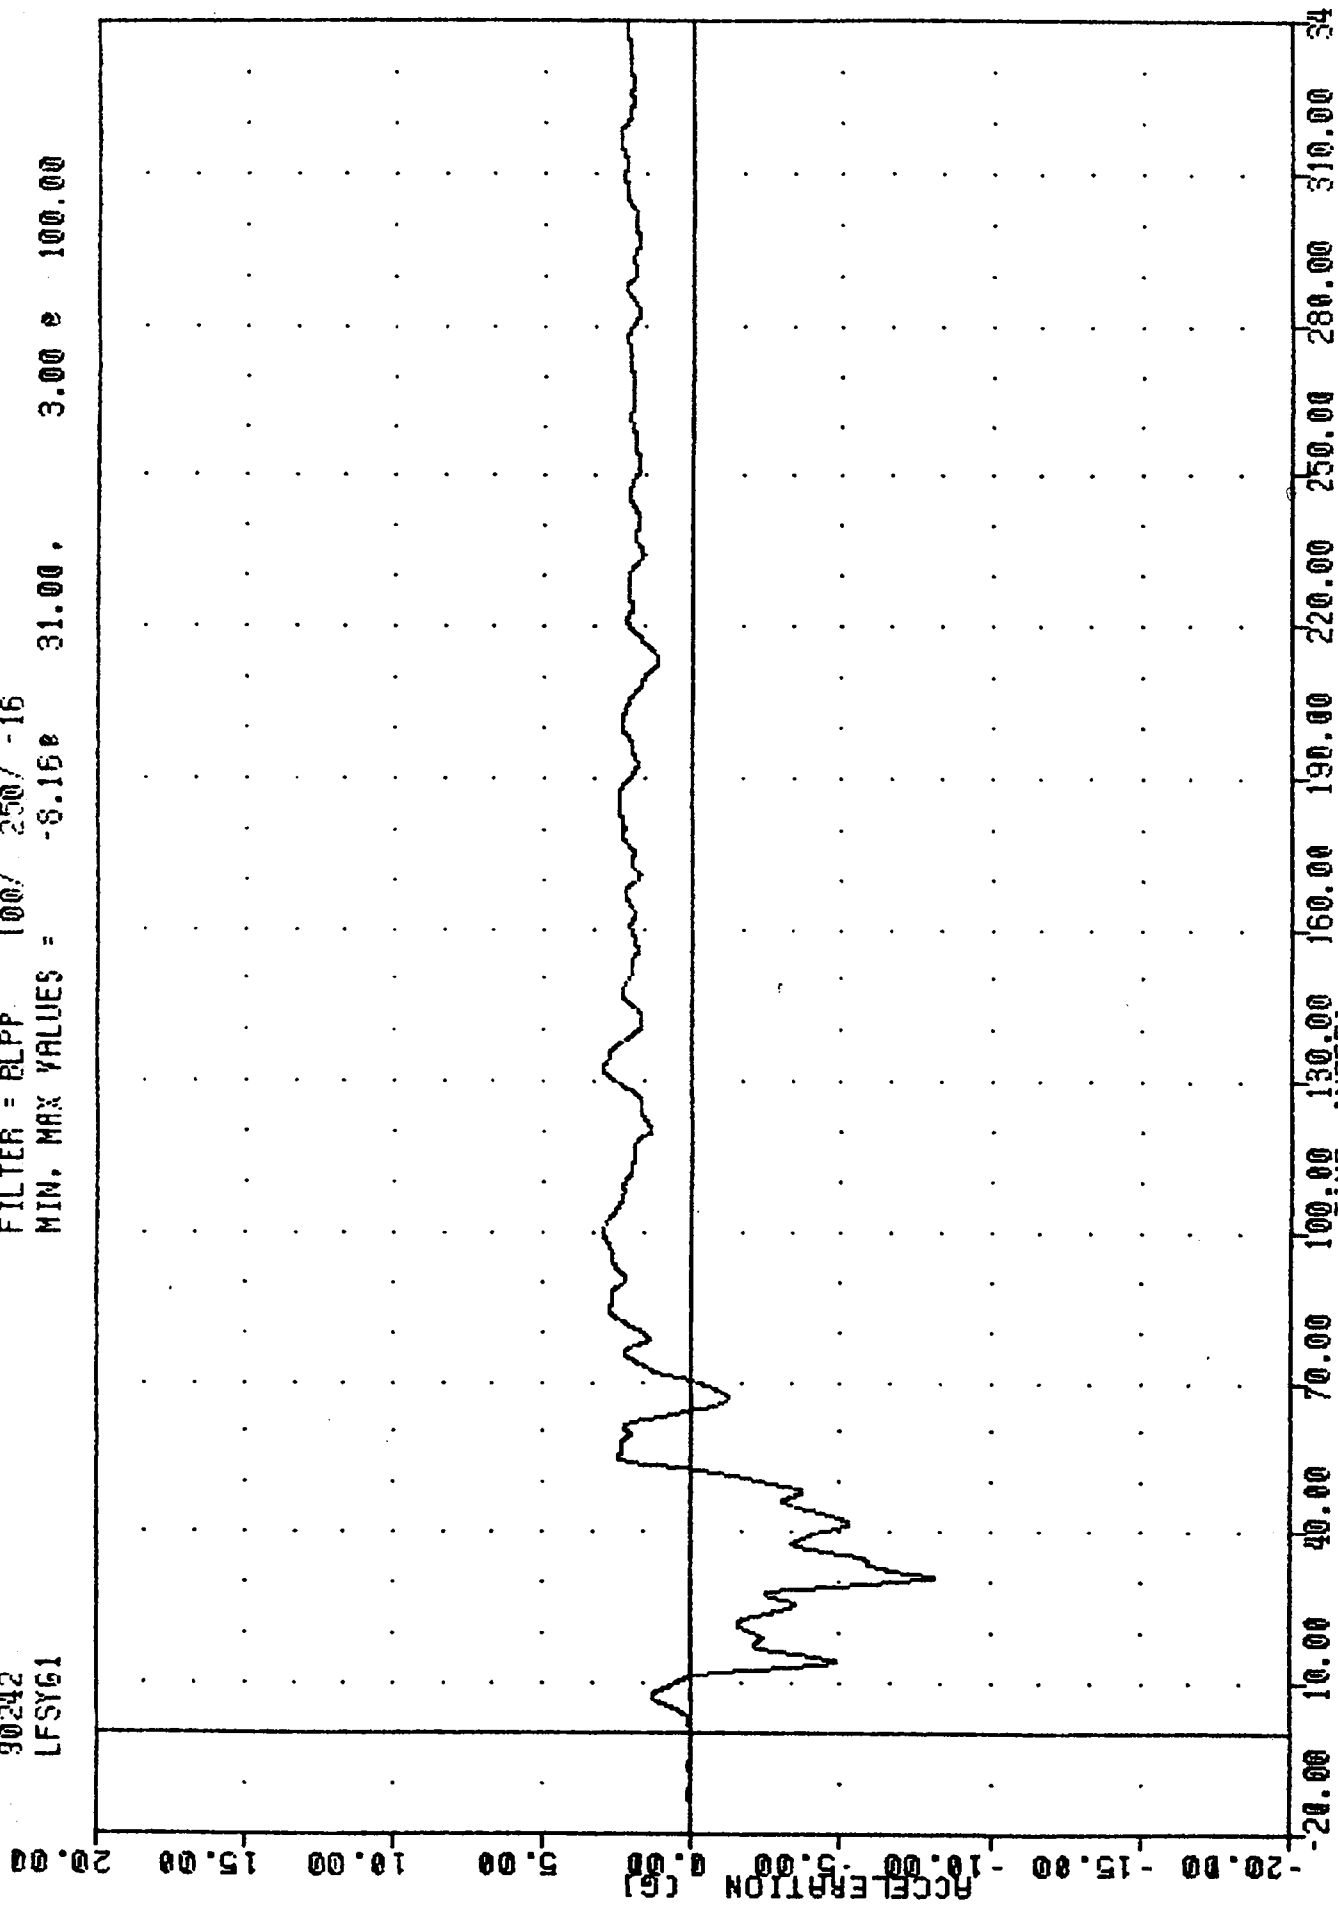
CONTOURED MOVING BARRIER INTO FORD ESCORT AT 28.1 MPH #2
LEFT FRONT SILL Y-AXIS ACCELERATION

FILTER = BLPP 100/ 250/ -16
 MIN. MAX VALUES = 0.01e -19.88. 14.63 e 28.25

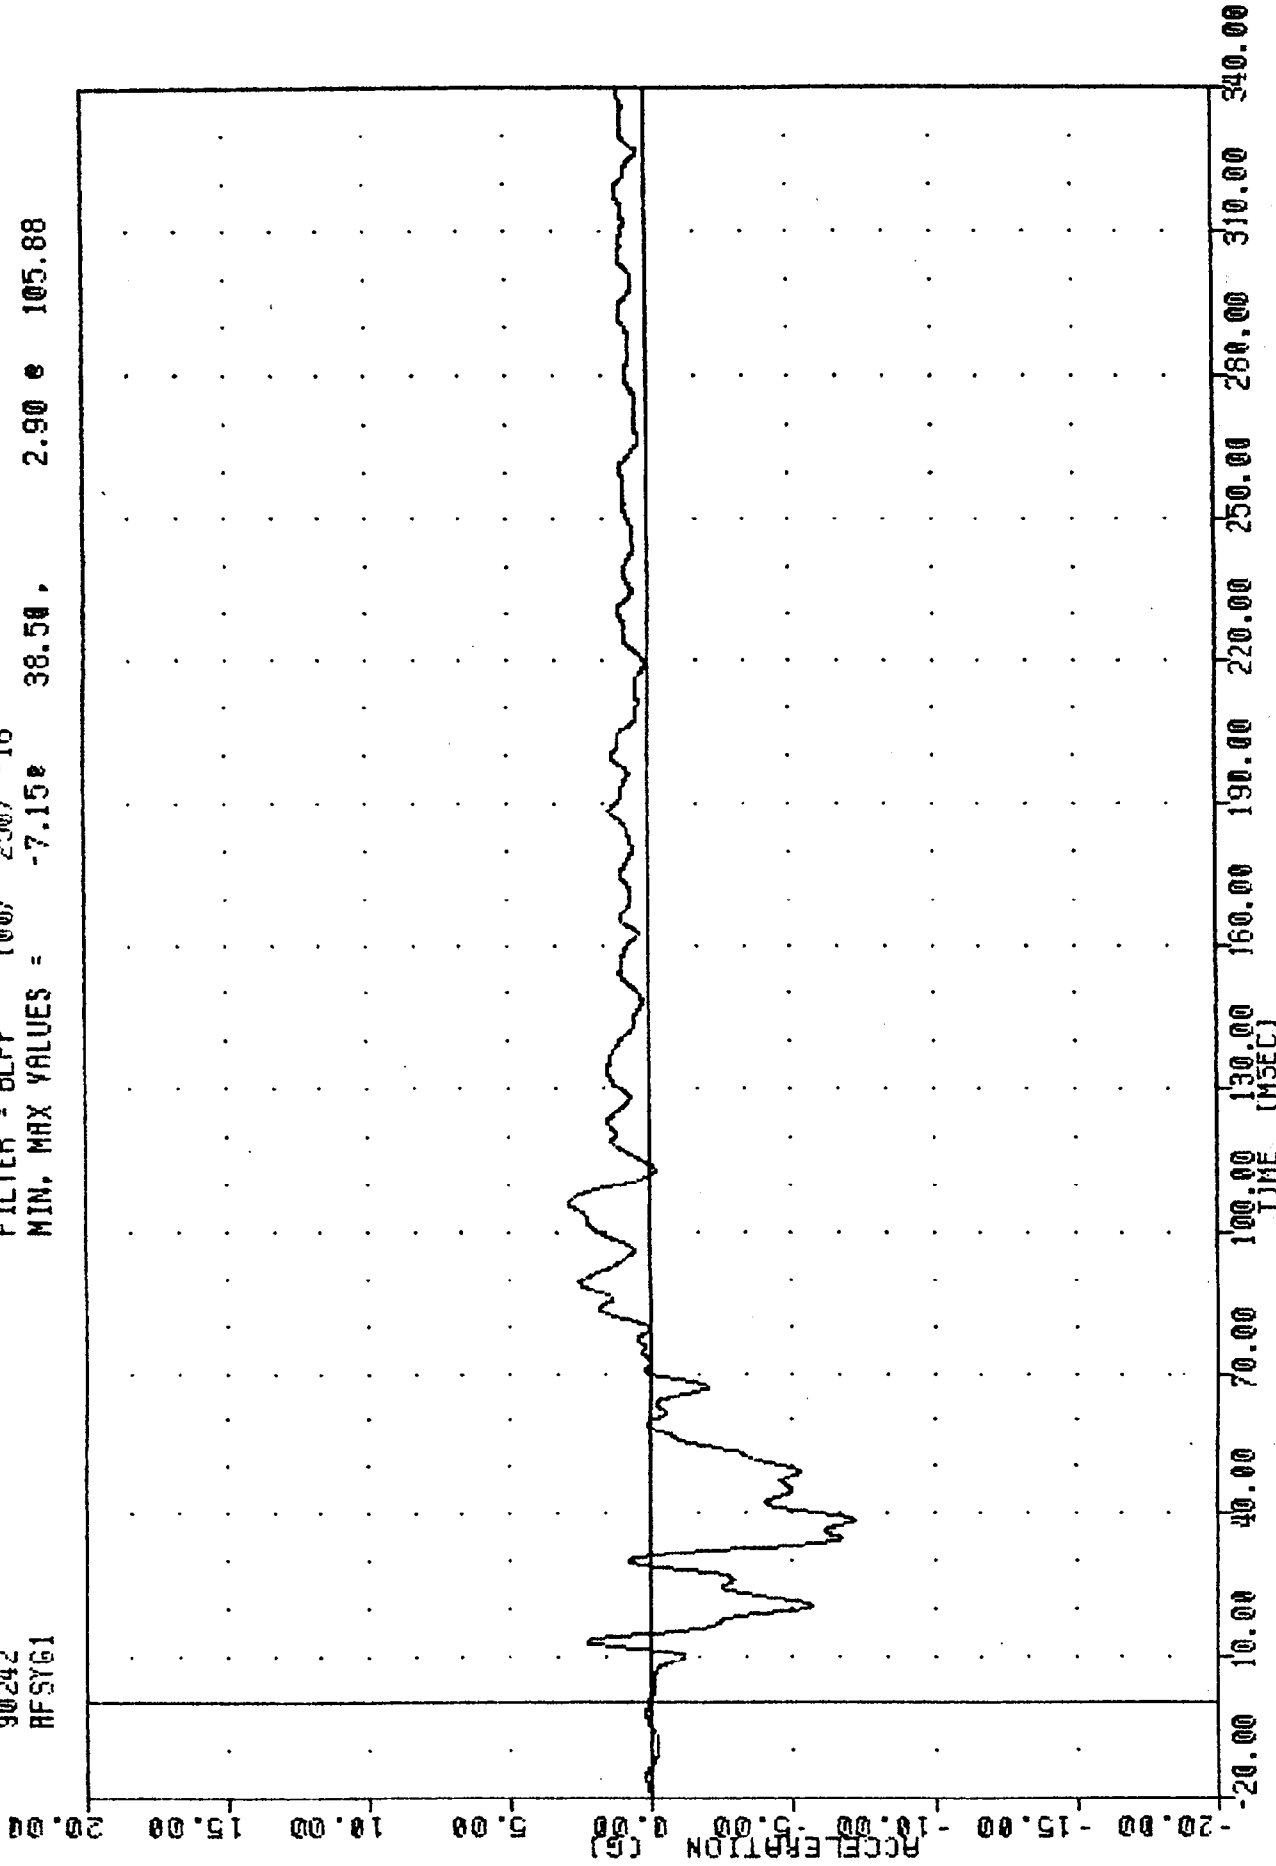
CONToured MOVING BARRIER INTO FORD ESCORT AT 28.1 MPH #2
RIGHT FRONT SILL Y-AXIS ACCELERATION

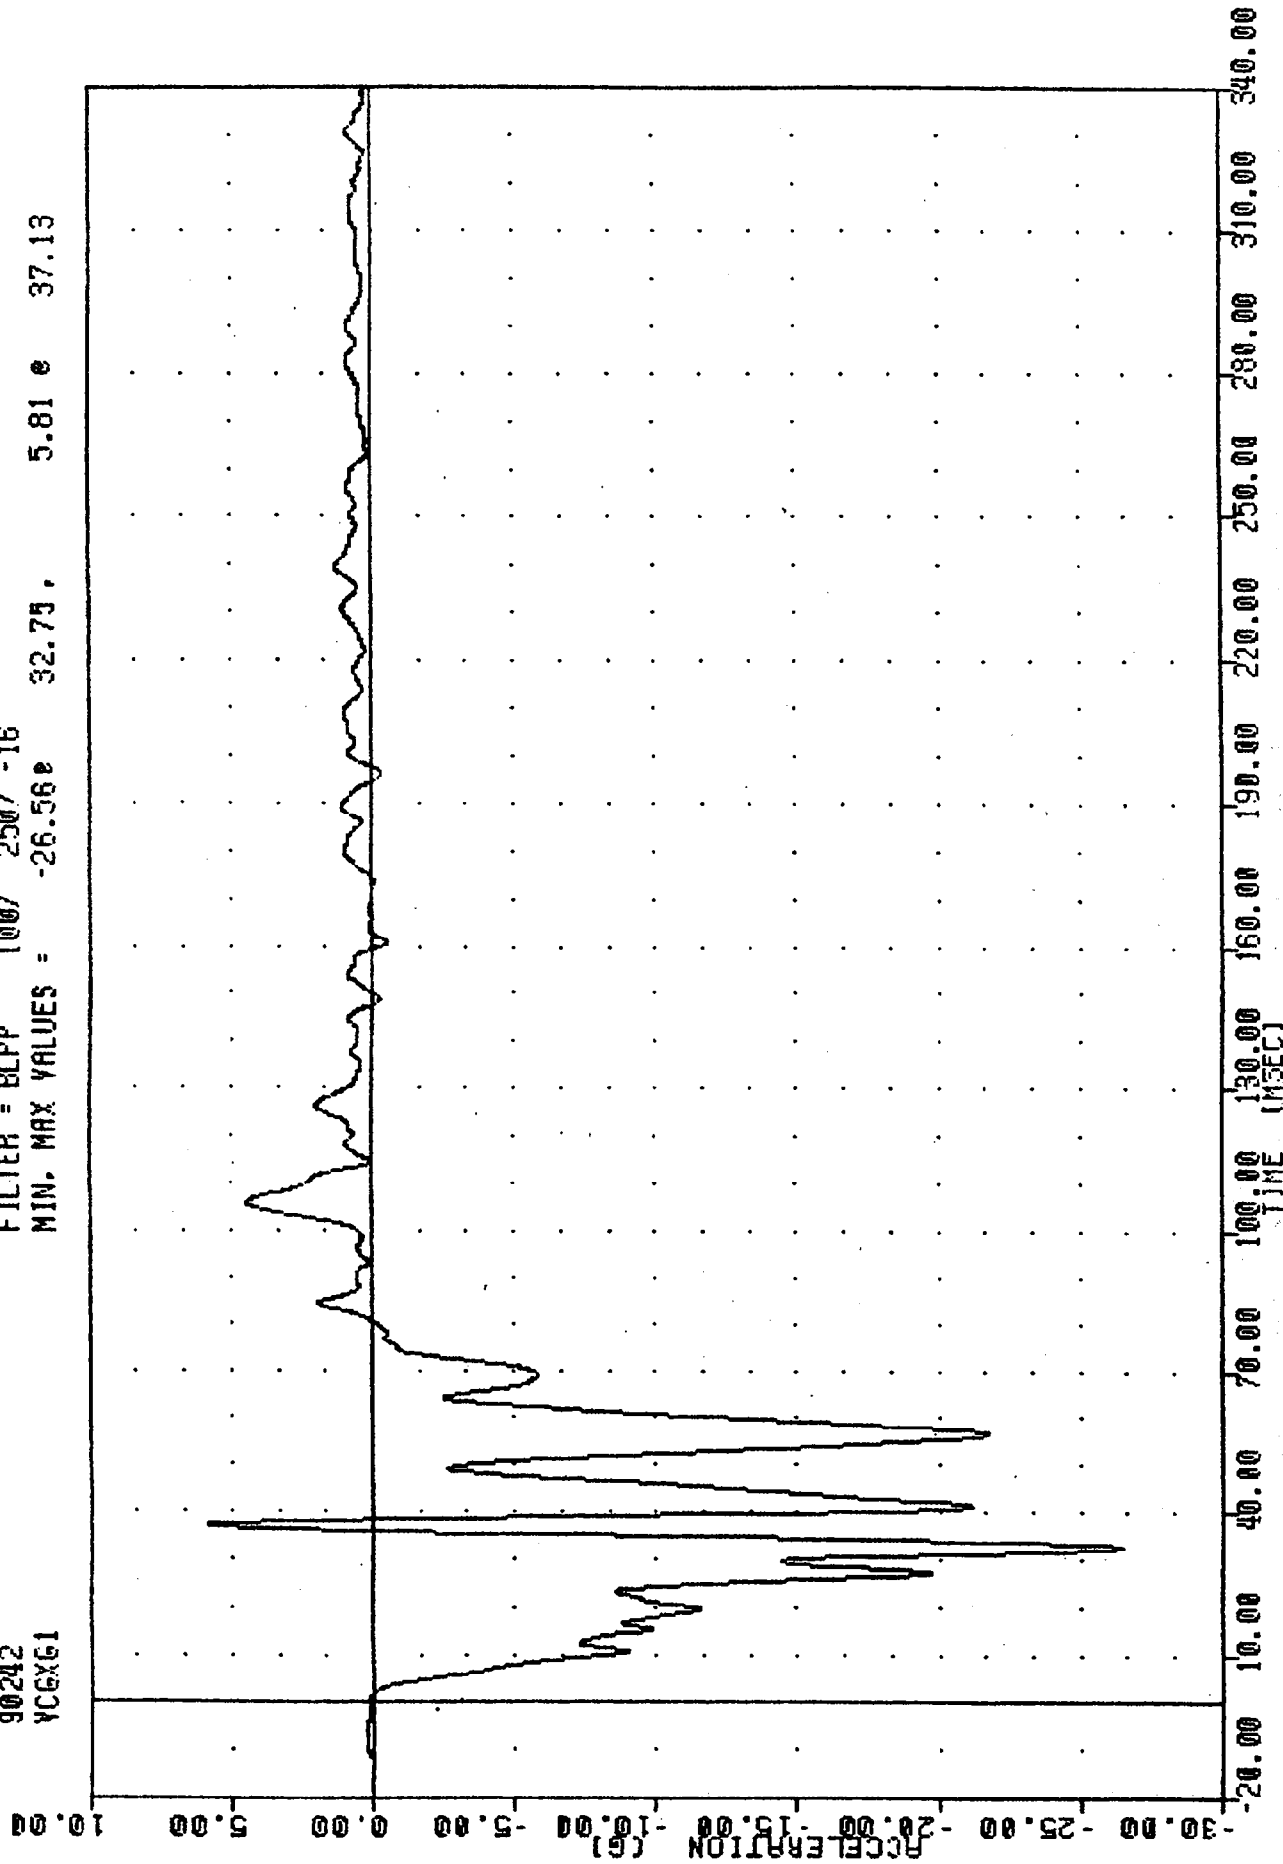
CONTOURED MOVING BARRIER INTO FORD ESCORT AT 28.1 MPH #2
VEHICLE CG X-AXIS ACCELERATION (IMPACT DIRECTION)

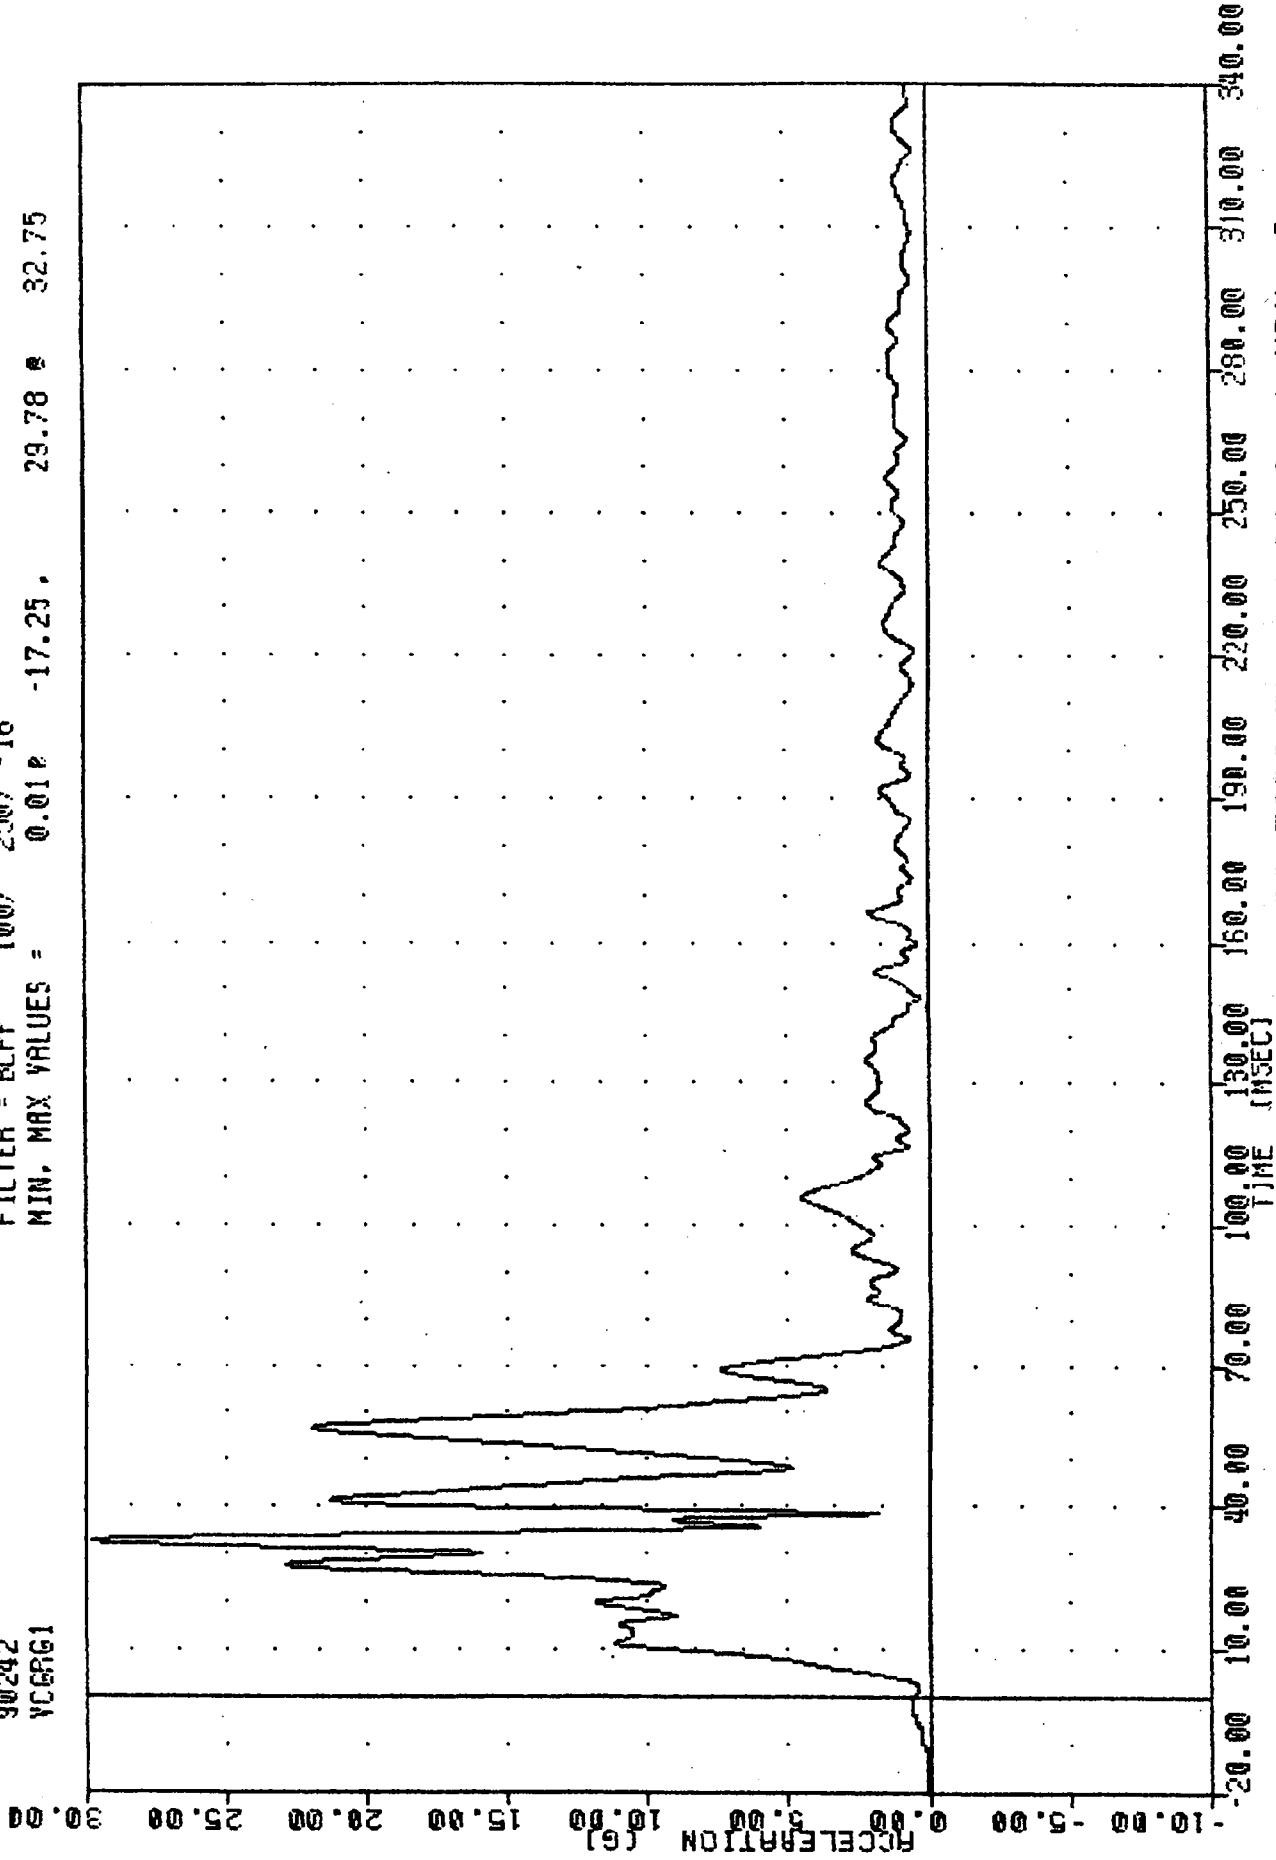
CONTOURED MOVING BARRIER INTO FORD ESCORT AT 28.1 MPH #2
 VEHICLE CG RESULTANT ACCELERATION

FILTER = BLPP 100/ 250/ -16
MIN. MAX VALUES = -22.57 26.50, 0.55 181.75

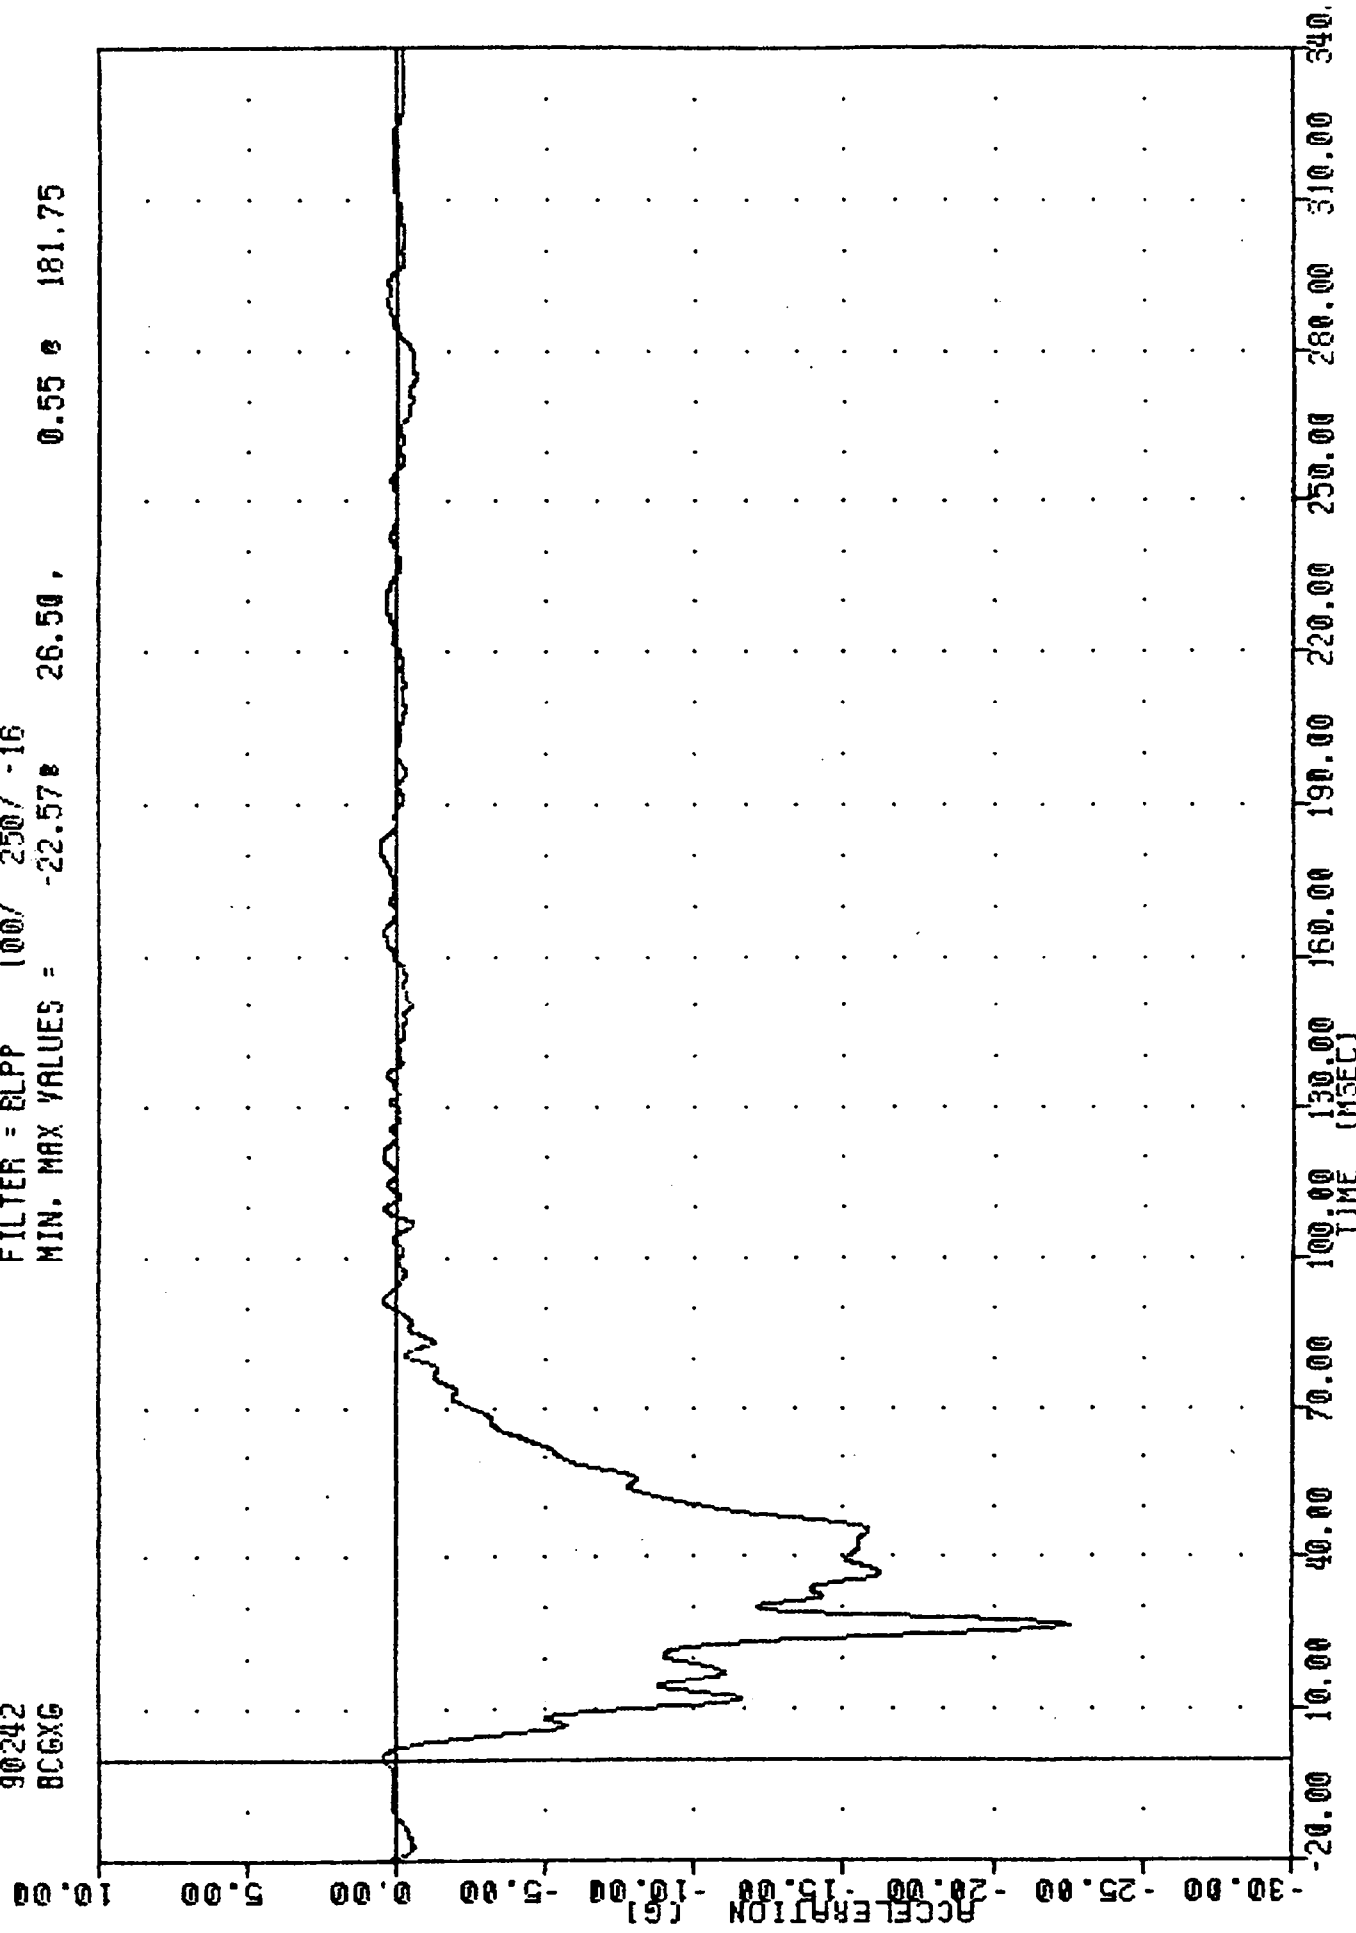
CONTOURED MOVING BARRIER INTO FORD ESCORT AT 28.1 MPH #2
MOVING BARRIER CENTER OF GRAVITY X-AXIS ACCELERATION

FILTER = BLPP 100/ 250/ -16
MIN. MAX VALUES = -3.53e 51.38, 4.26 e 58.00

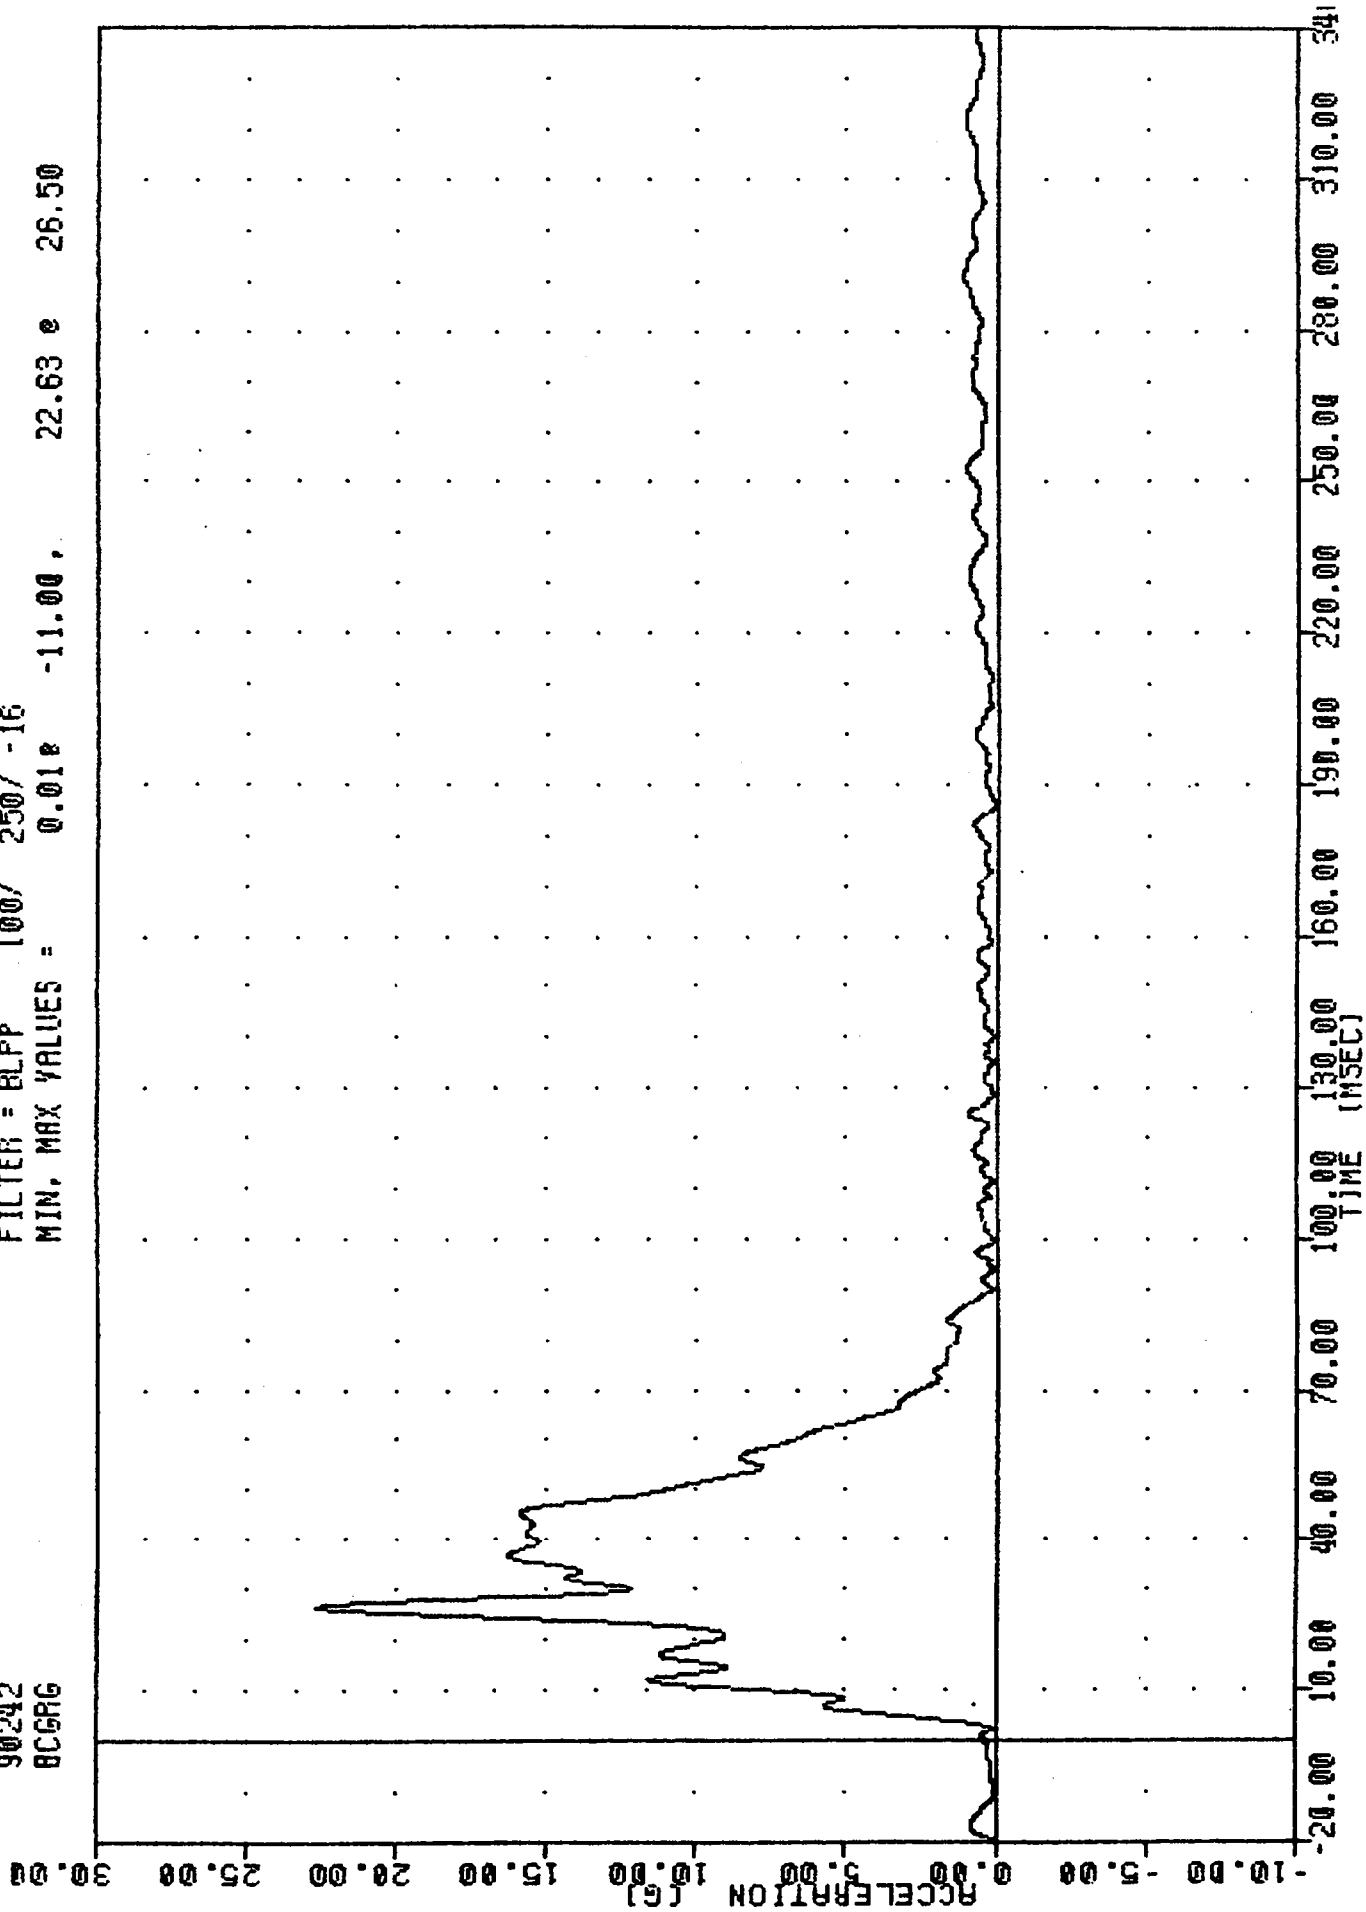
CONTOURED MOVING BARRIER INTO FORD ESCORT AT 28.1 MPH #2
MOVING BARRIER CENTER OF GRAVITY RESULTANT ACCELERATION

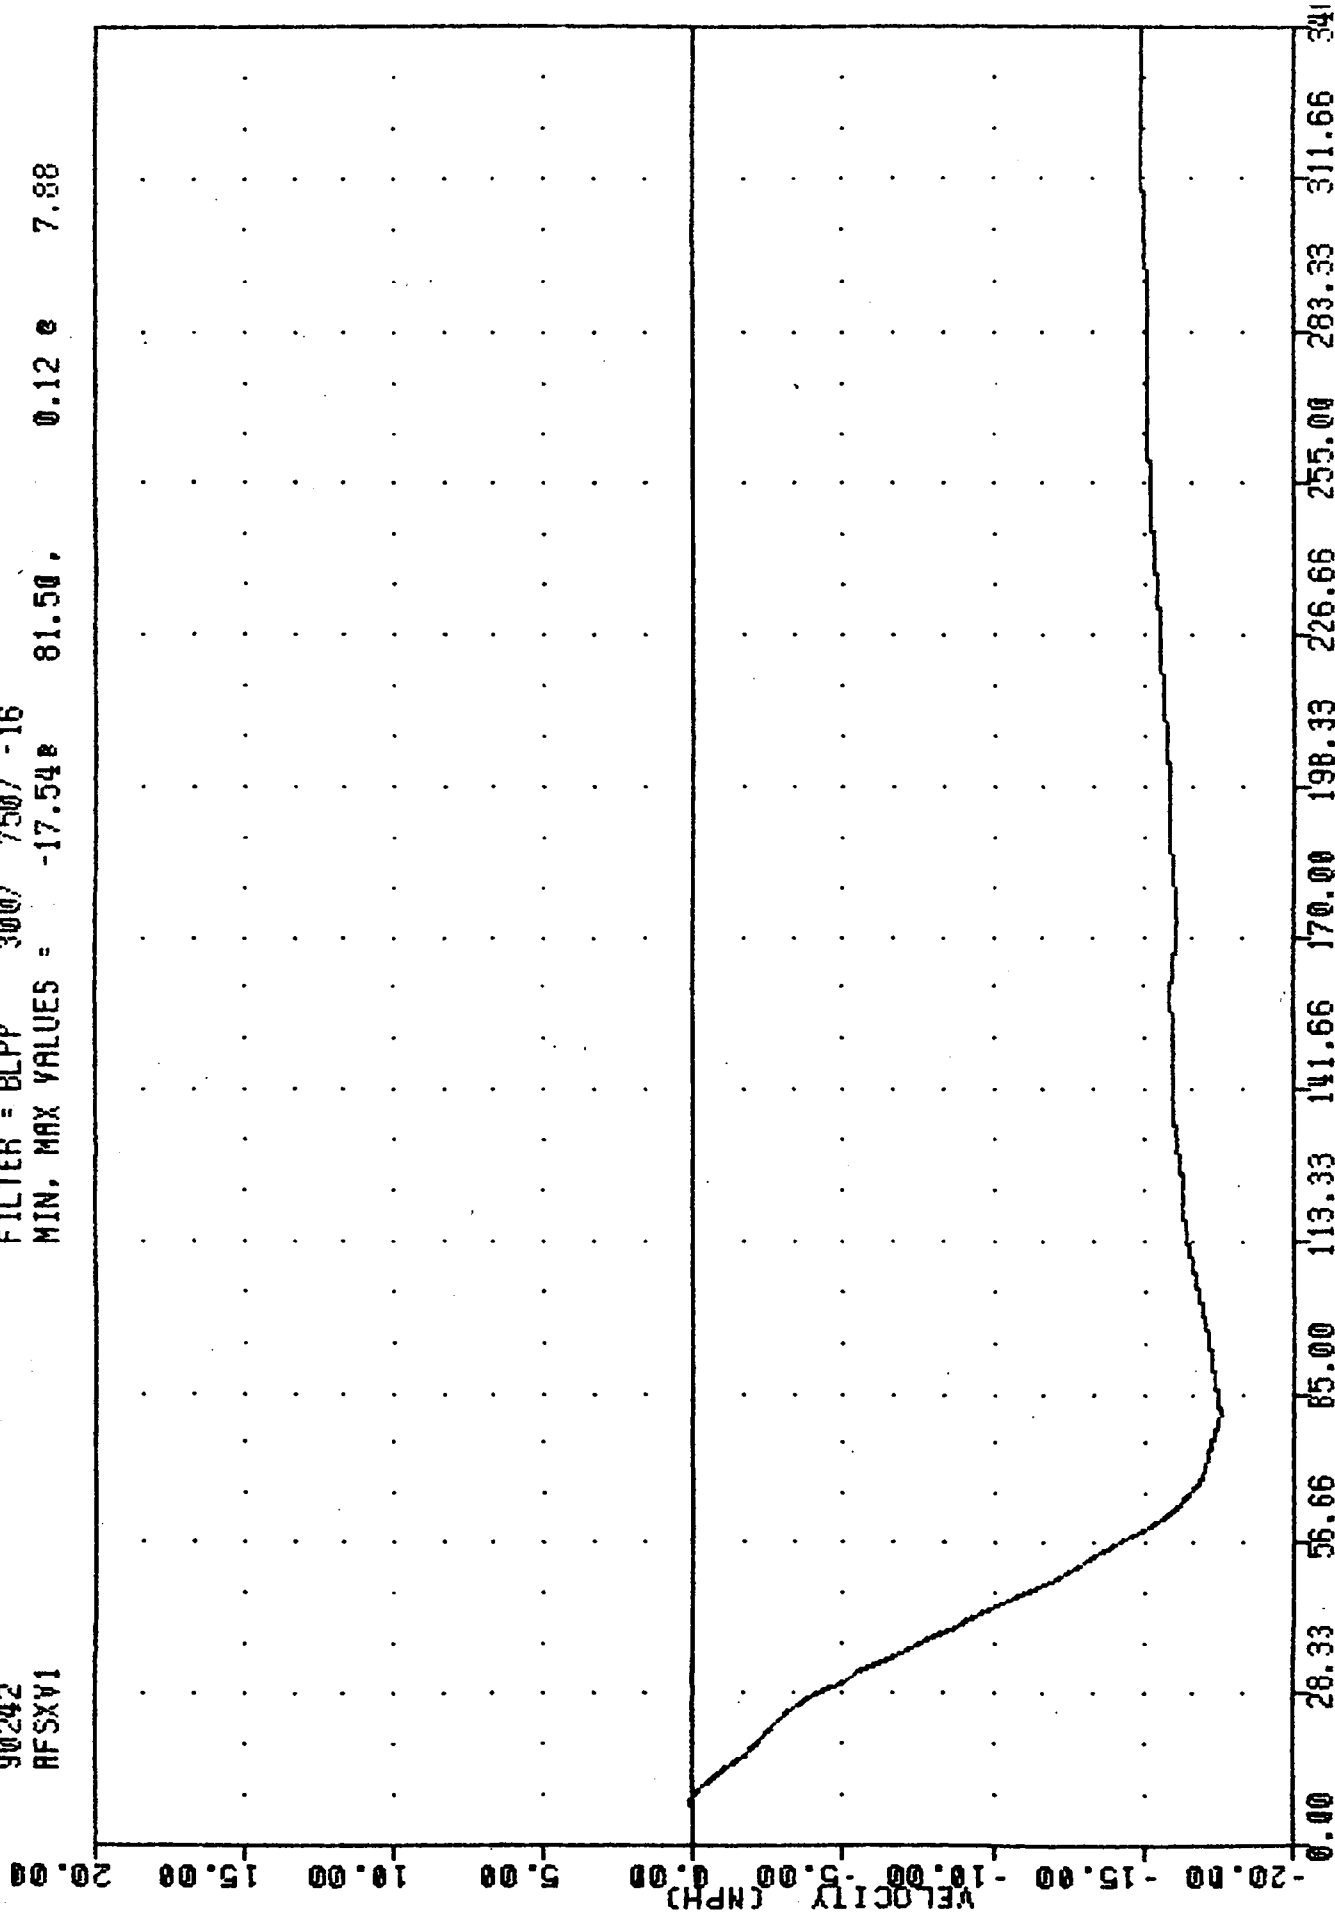
CONTOURED MOVING BARRIER INTO FORD ESCORT AT 28.1 MPH #2
RIGHT FRONT SILL X-AXIS VELOCITY

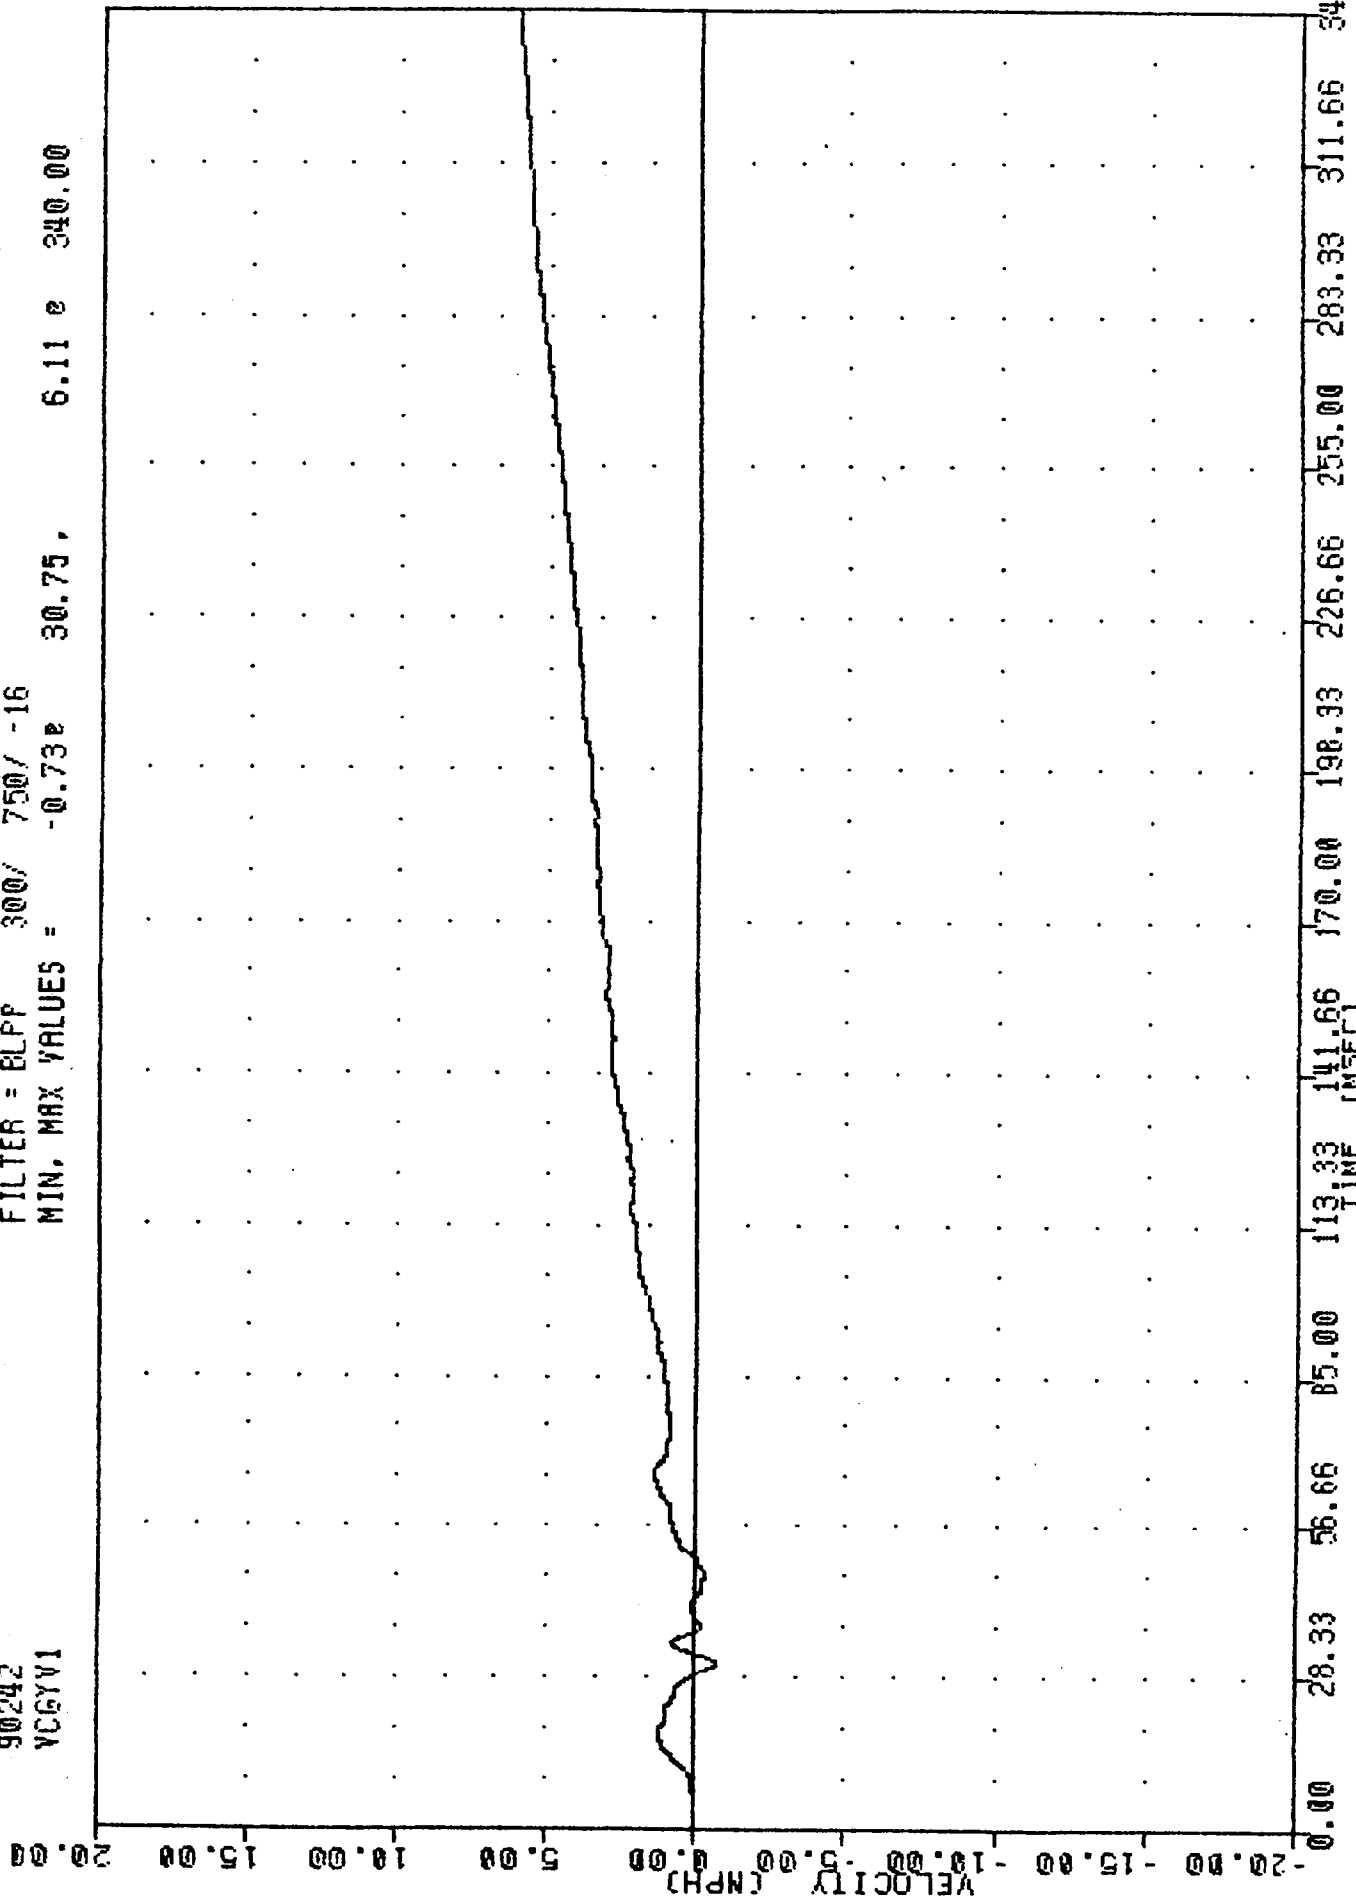
CONTOURED MOVING BARRIER INTO FORD ESCORT AT 28.1 MPH #2
 VEHICLE CG Y-AXIS VELOCITY (PERPENDICULAR TO IMPACT DIRECTION)

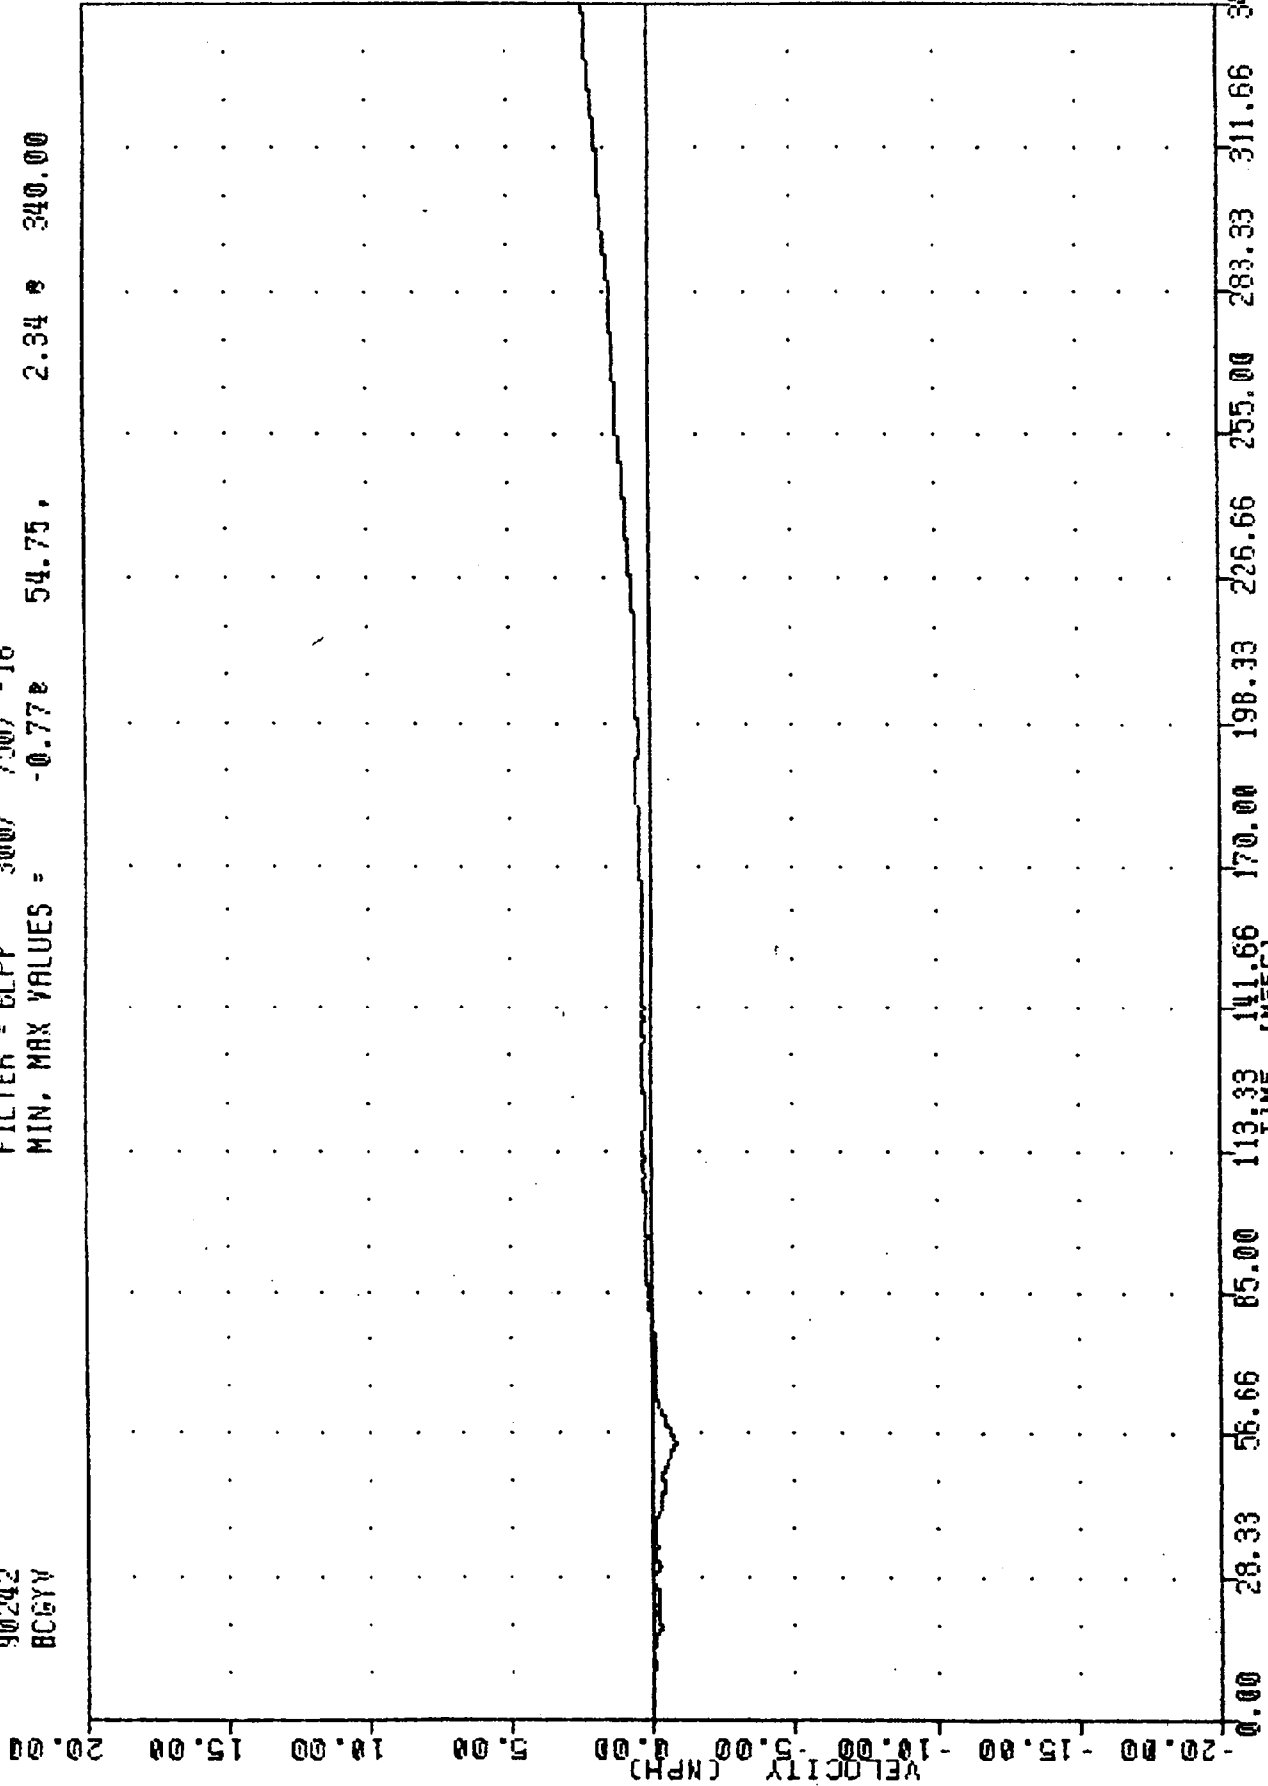
CONTOURED MOVING BARRIER INTO FORD ESCORT AT 28.1 MPH #2
 MOVING BARRIER CENTER OF GRAVITY Y-AXIS VELOCITY

FILTER = BLPP 300/ 750/ -16
 MIN. MAX VALUES = 12.26 282.13, 28.11 2.13
