DOT HS 807 771
Final Report

Final Report of 339° Contoured Moving Barrier Impact Into a 1985 Ford Escort 3-Door Hatchback in Support of Crash III Damage Algorithm Reformation

The purpose of the four 339° contoured moving barrier impact tests was research and development in support of the CRASH III damage algorithm reformulation.

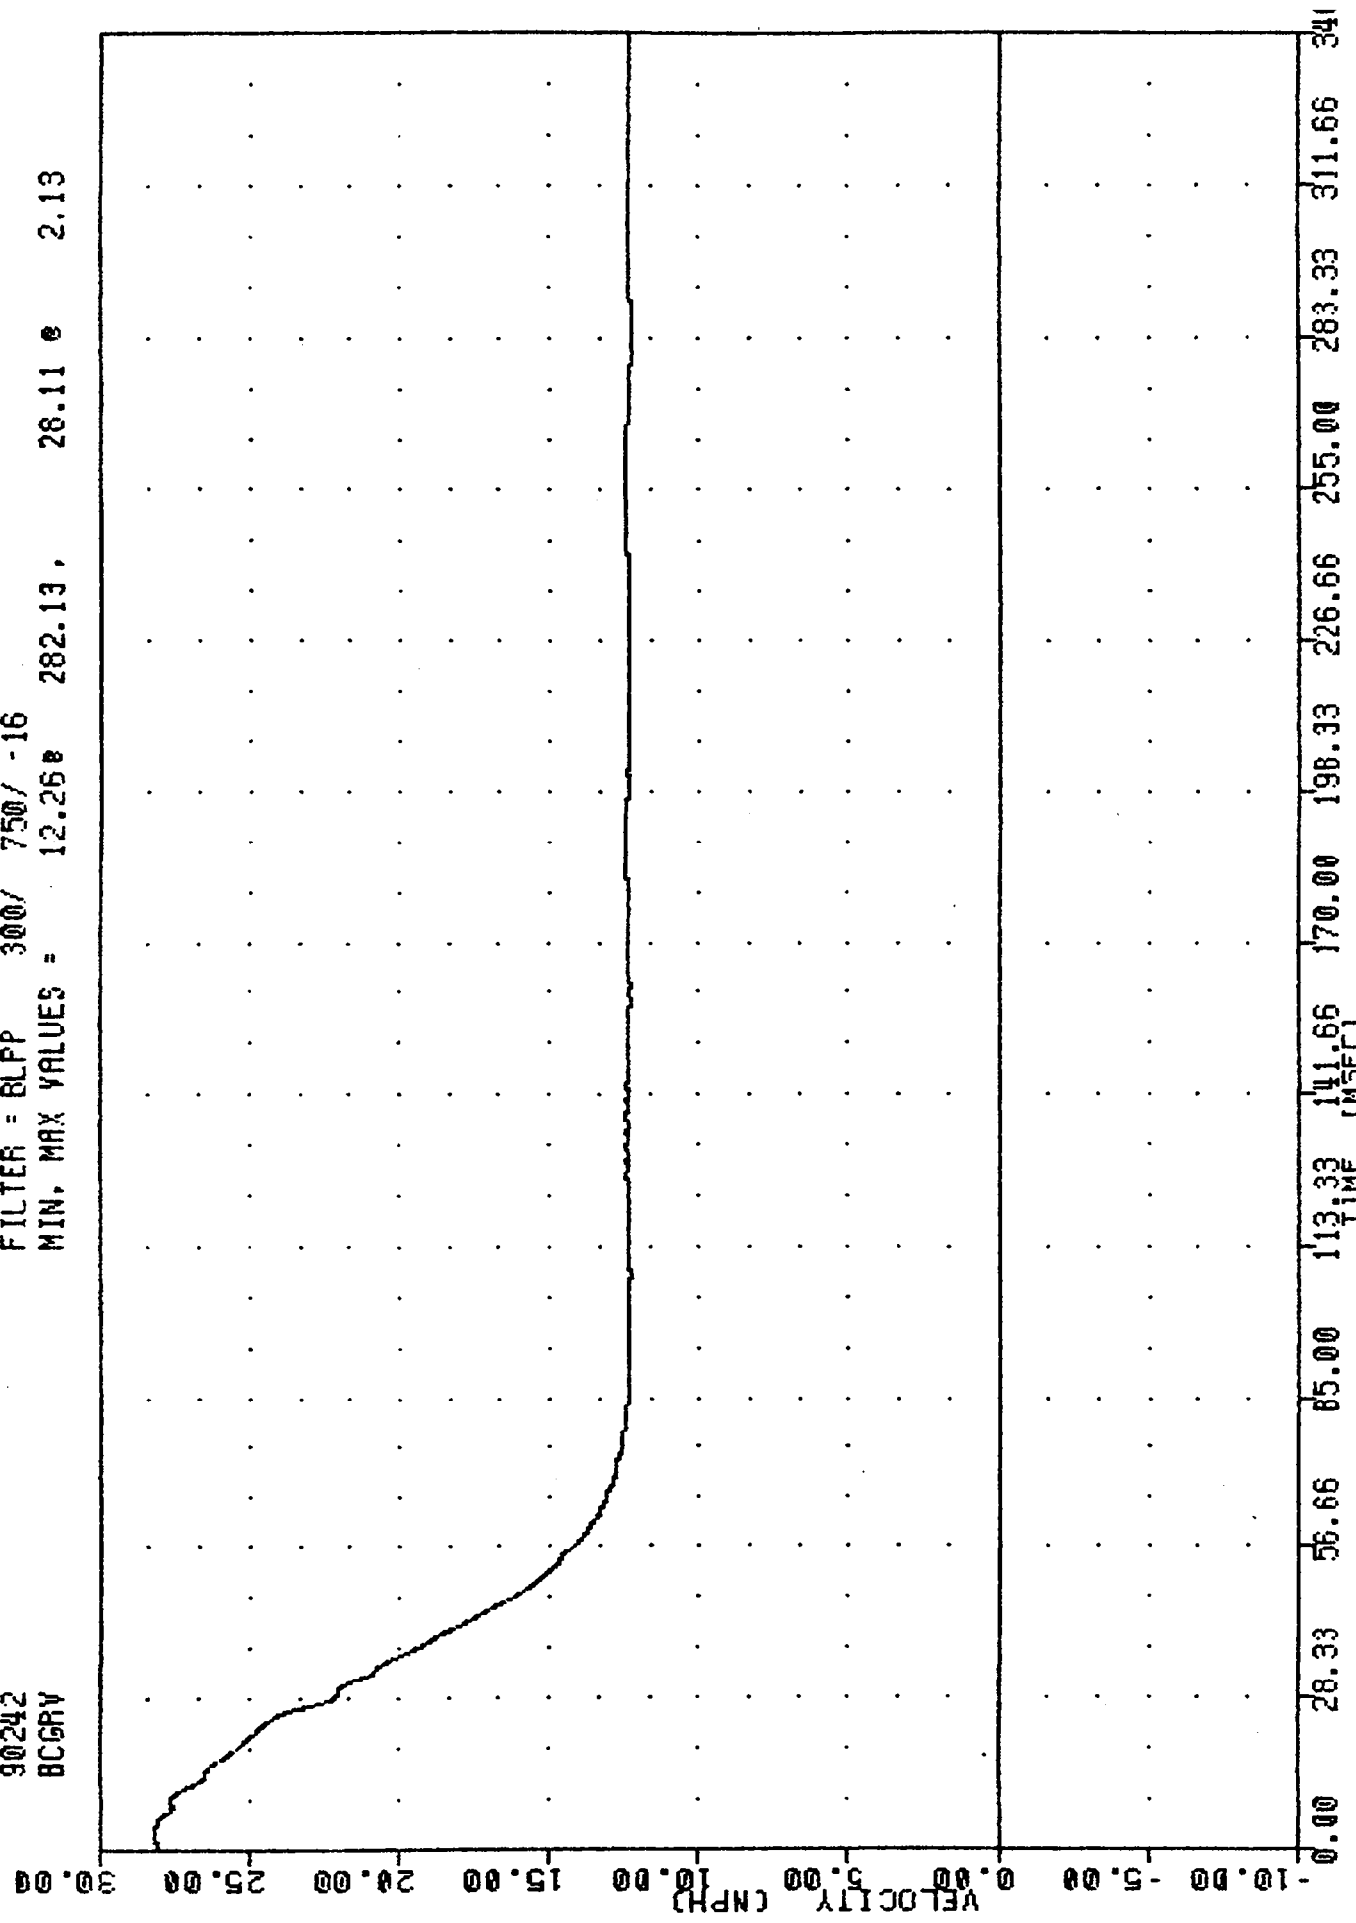
CONTOURED MOVING BARRIER INTO FORD ESCORT AT 28.1 MPH #2
 MOVING BARRIER CENTER OF GRAVITY RESULTANT VELOCITY

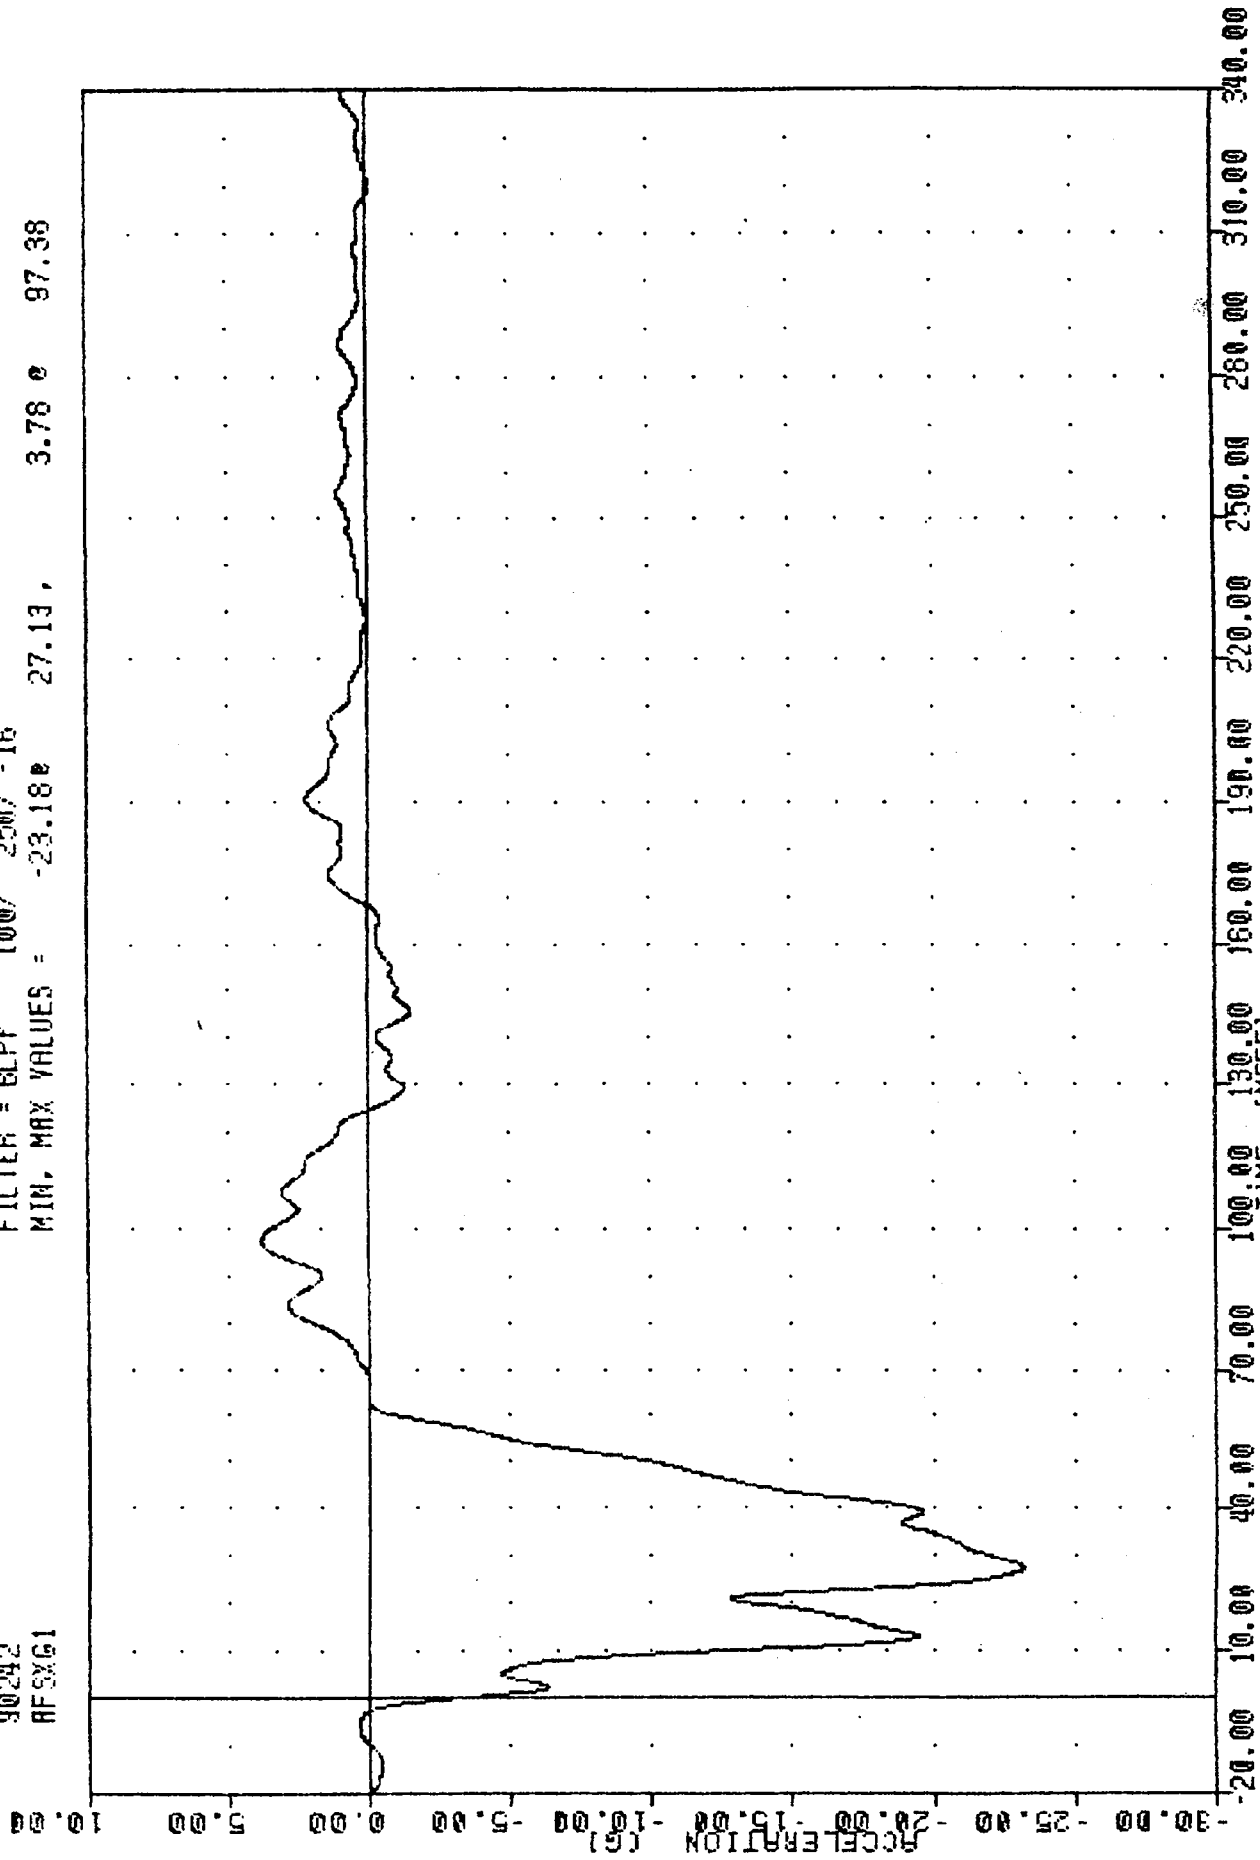
CONTOURED MOVING BARRIER INTO FORD ESCORT AT 28.3 MPH #3
RIGHT FRONT SILL X-AXIS ACCELERATION

FILTER = BLPP 100/ 250/ -16
MIN, MAX VALUES = -8.98 32.75 2.77 90.88

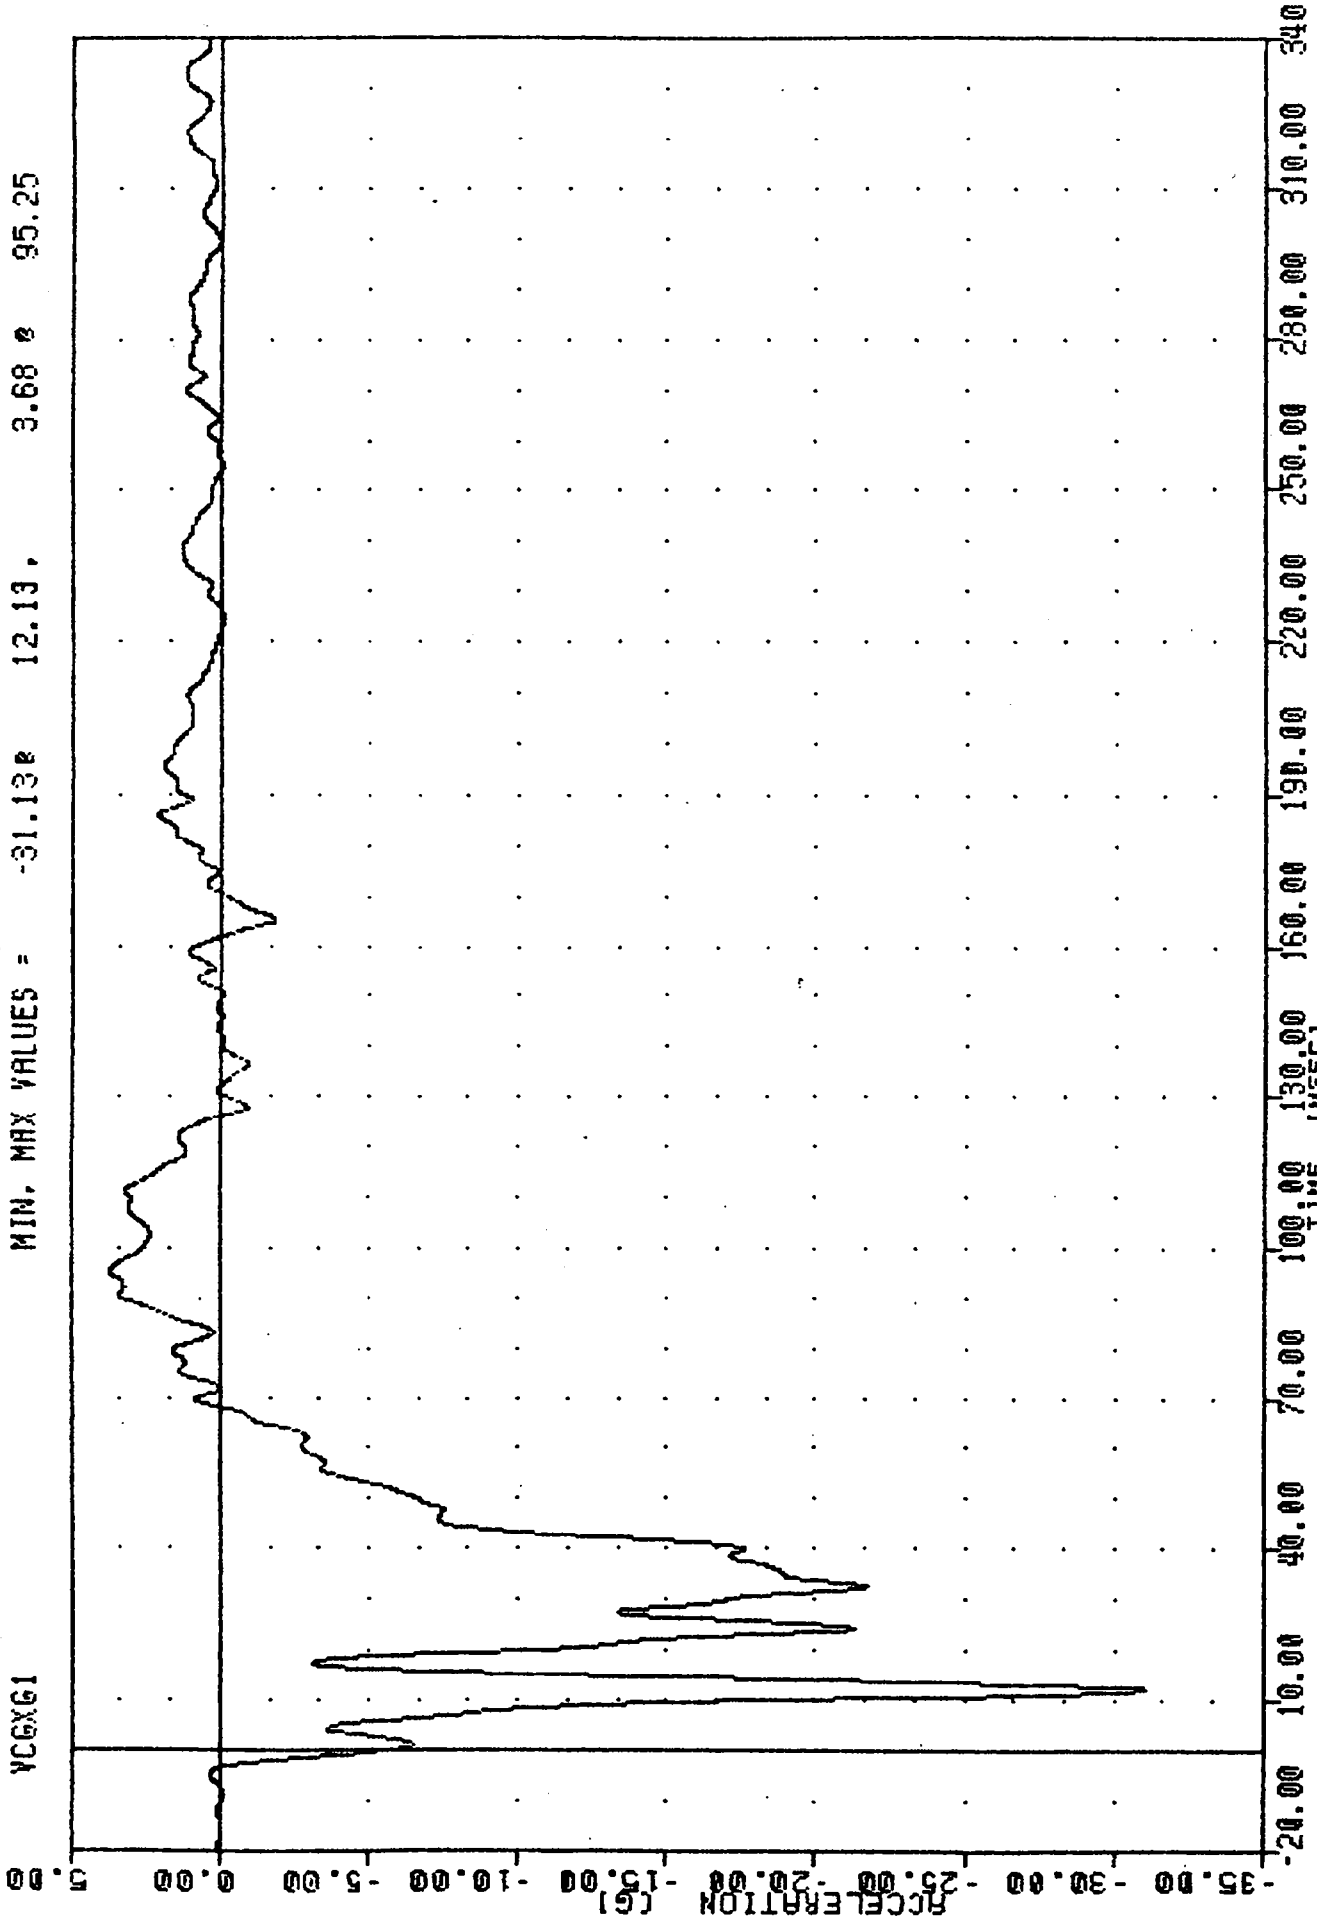
CONToured MOVING BARRIER INTO FORD ESCORT AT 28.3 MPH #3
VEHICLE CG X-AXIS ACCELERATION (IMPACT DIRECTION)

FILTER = BLPP 100/ 250/ -16
MIN. MAX VALUES = -6.65e 14.75 , 11.91 e 20.00

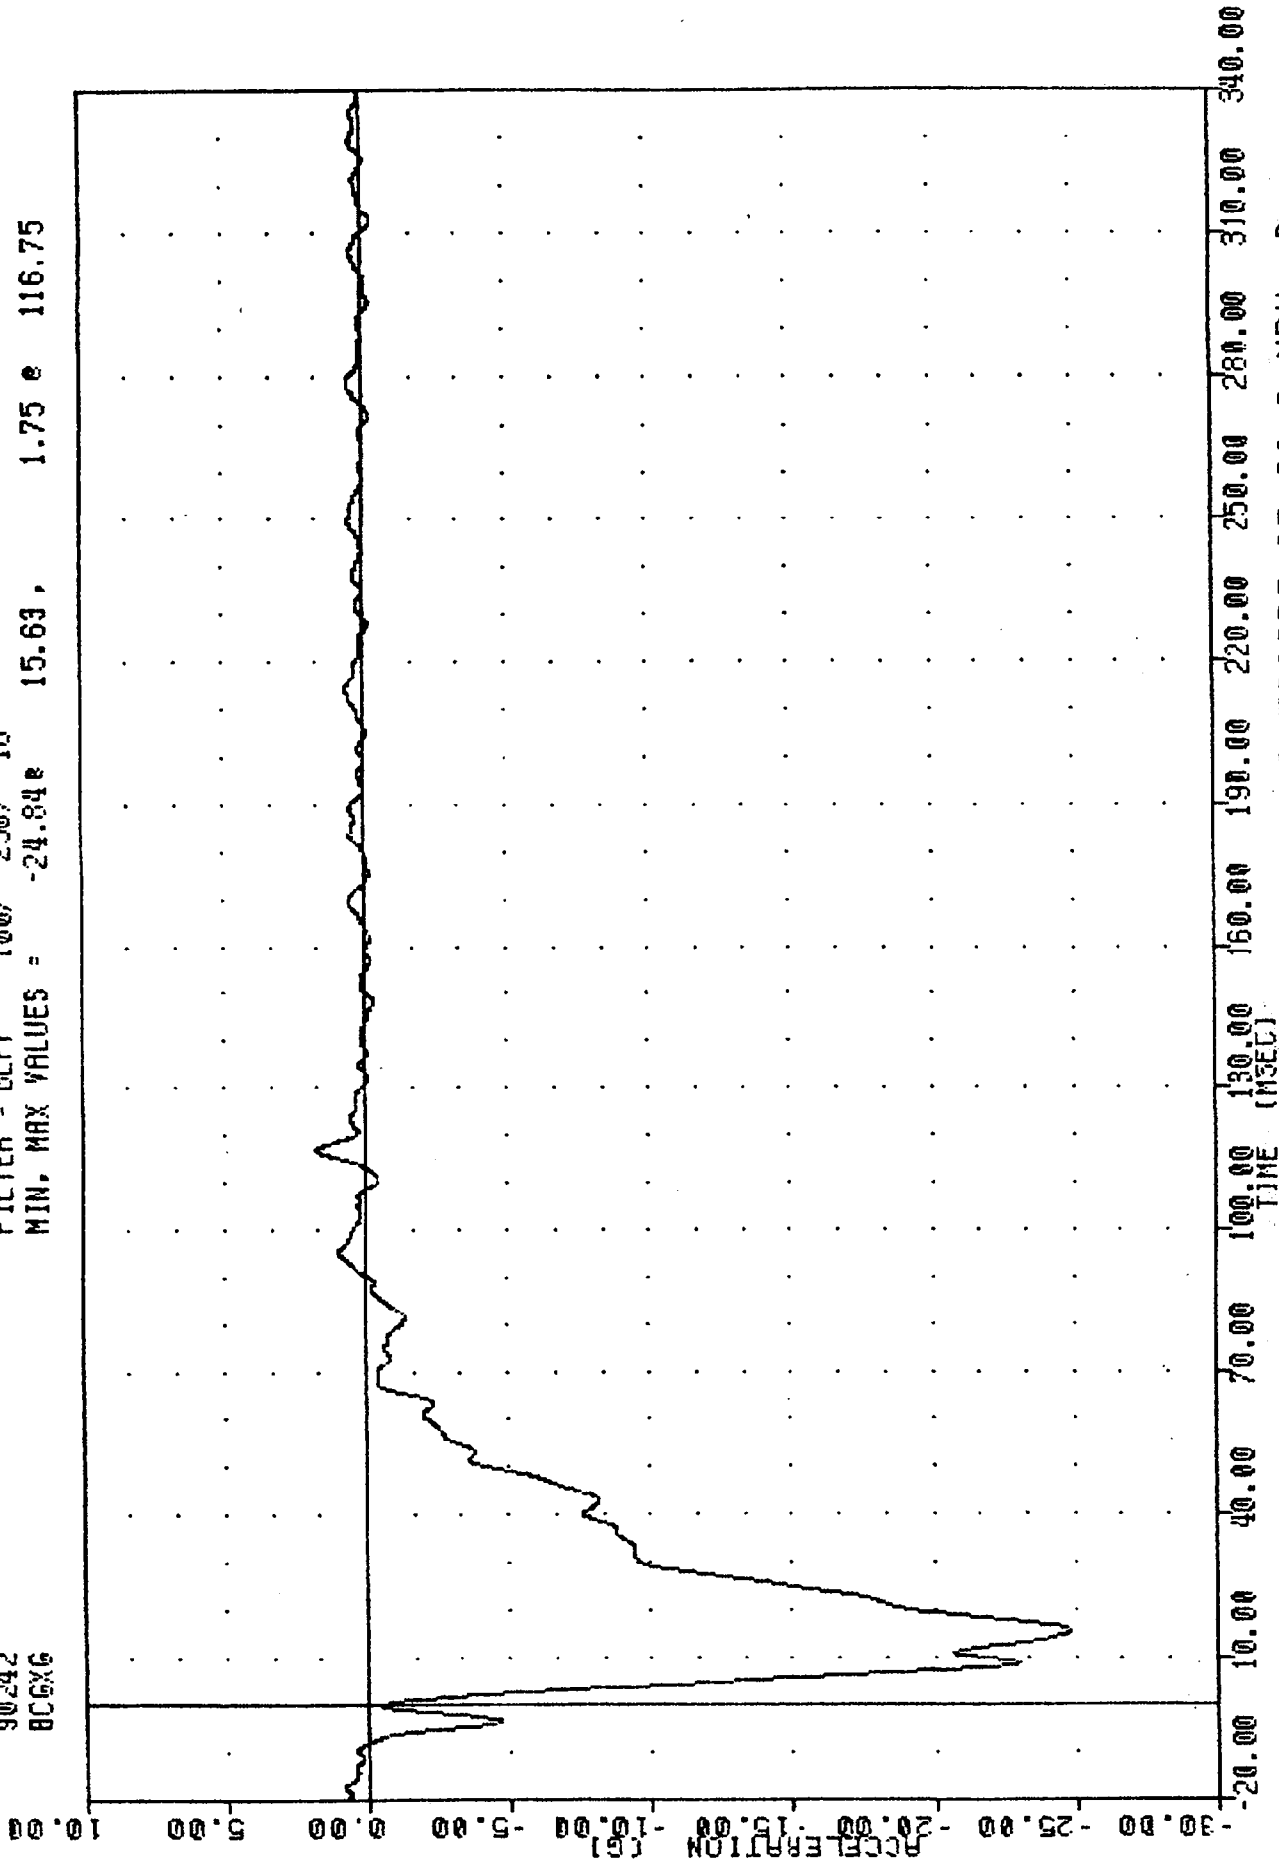
CONTOURED MOVING BARRIER INTO FORD ESCORT AT 28.3 MPH *3
MOVING BARRIER CENTER OF GRAVITY X-AXIS ACCELERATION

FILTER = BLPP 100/ 250/ -16
MIN. MAX VALUES = -8.11e 20.30, 5.31e 37.13

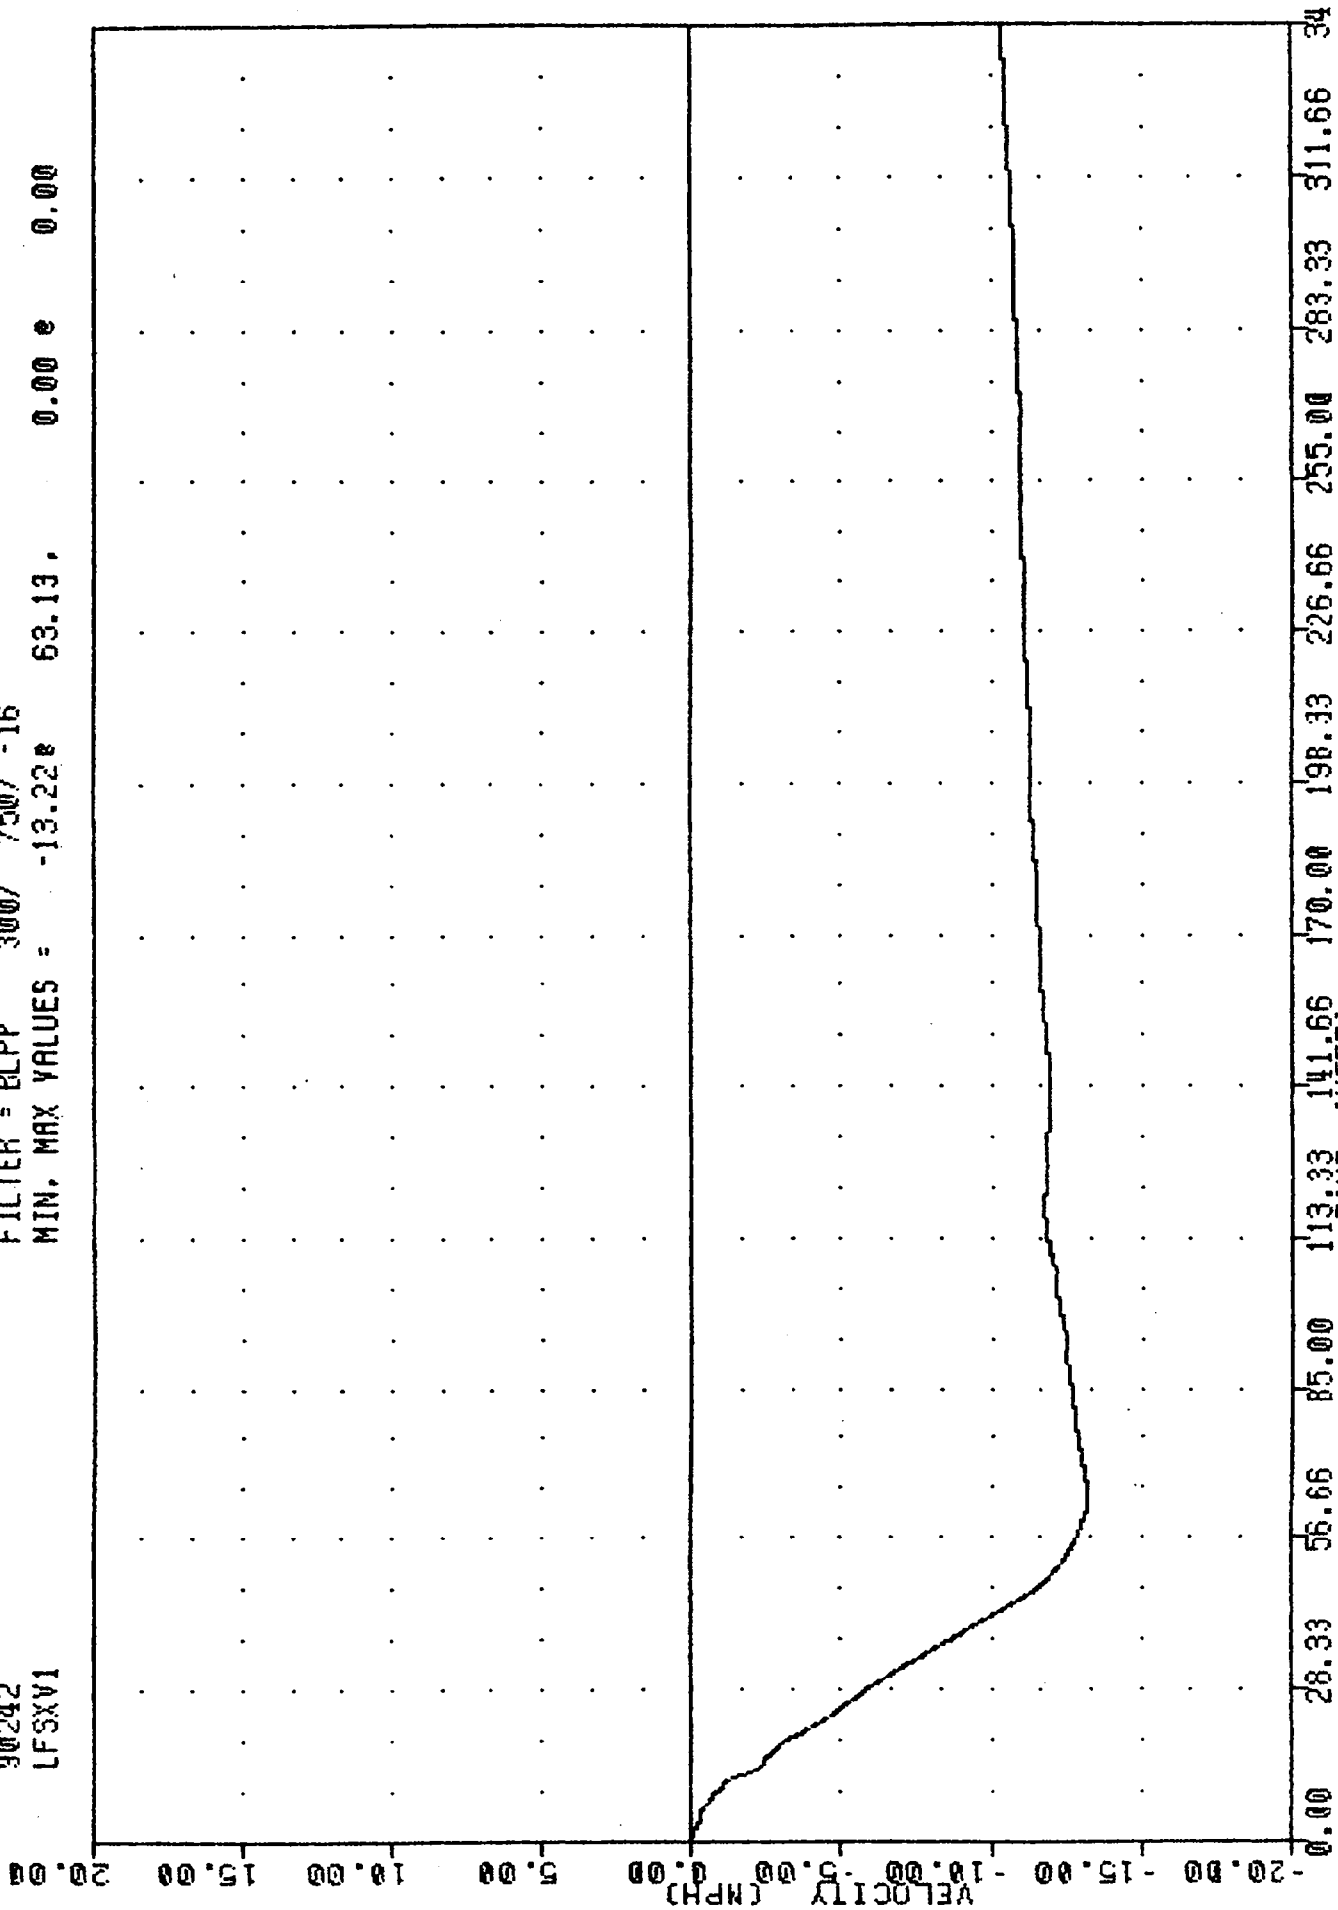
CONTOURED MOVING BARRIER INTO FORD ESCORT AT 28.3 MPH #3
 LEFT FRONT SILL X-AXIS VELOCITY

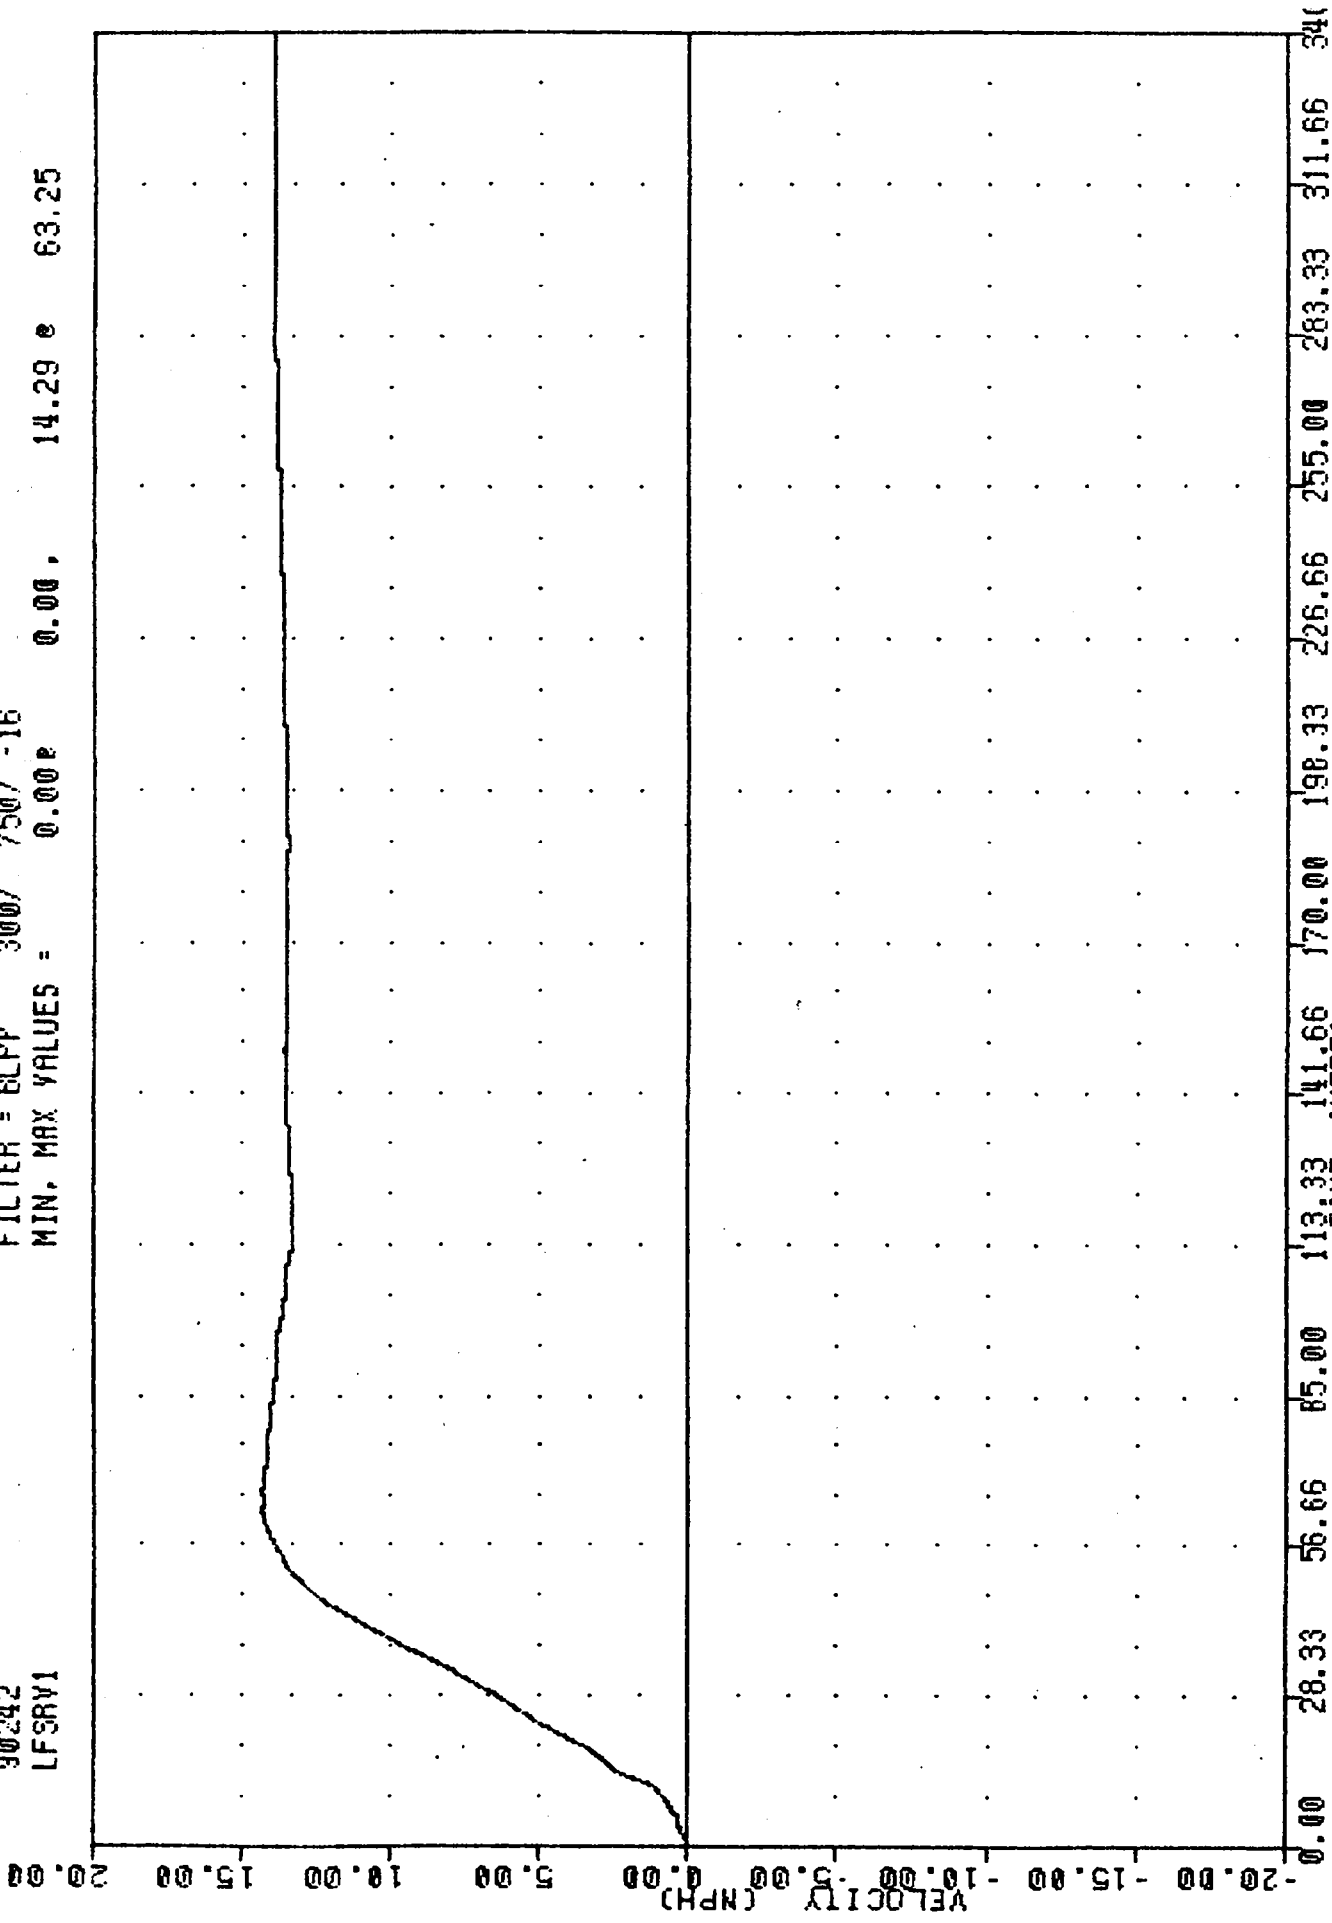
CONTOURED MOVING BARRIER INTO FORD ESCORT AT 28.3 MPH #3
 LEFT FRONT SILL RESULTANT VELOCITY

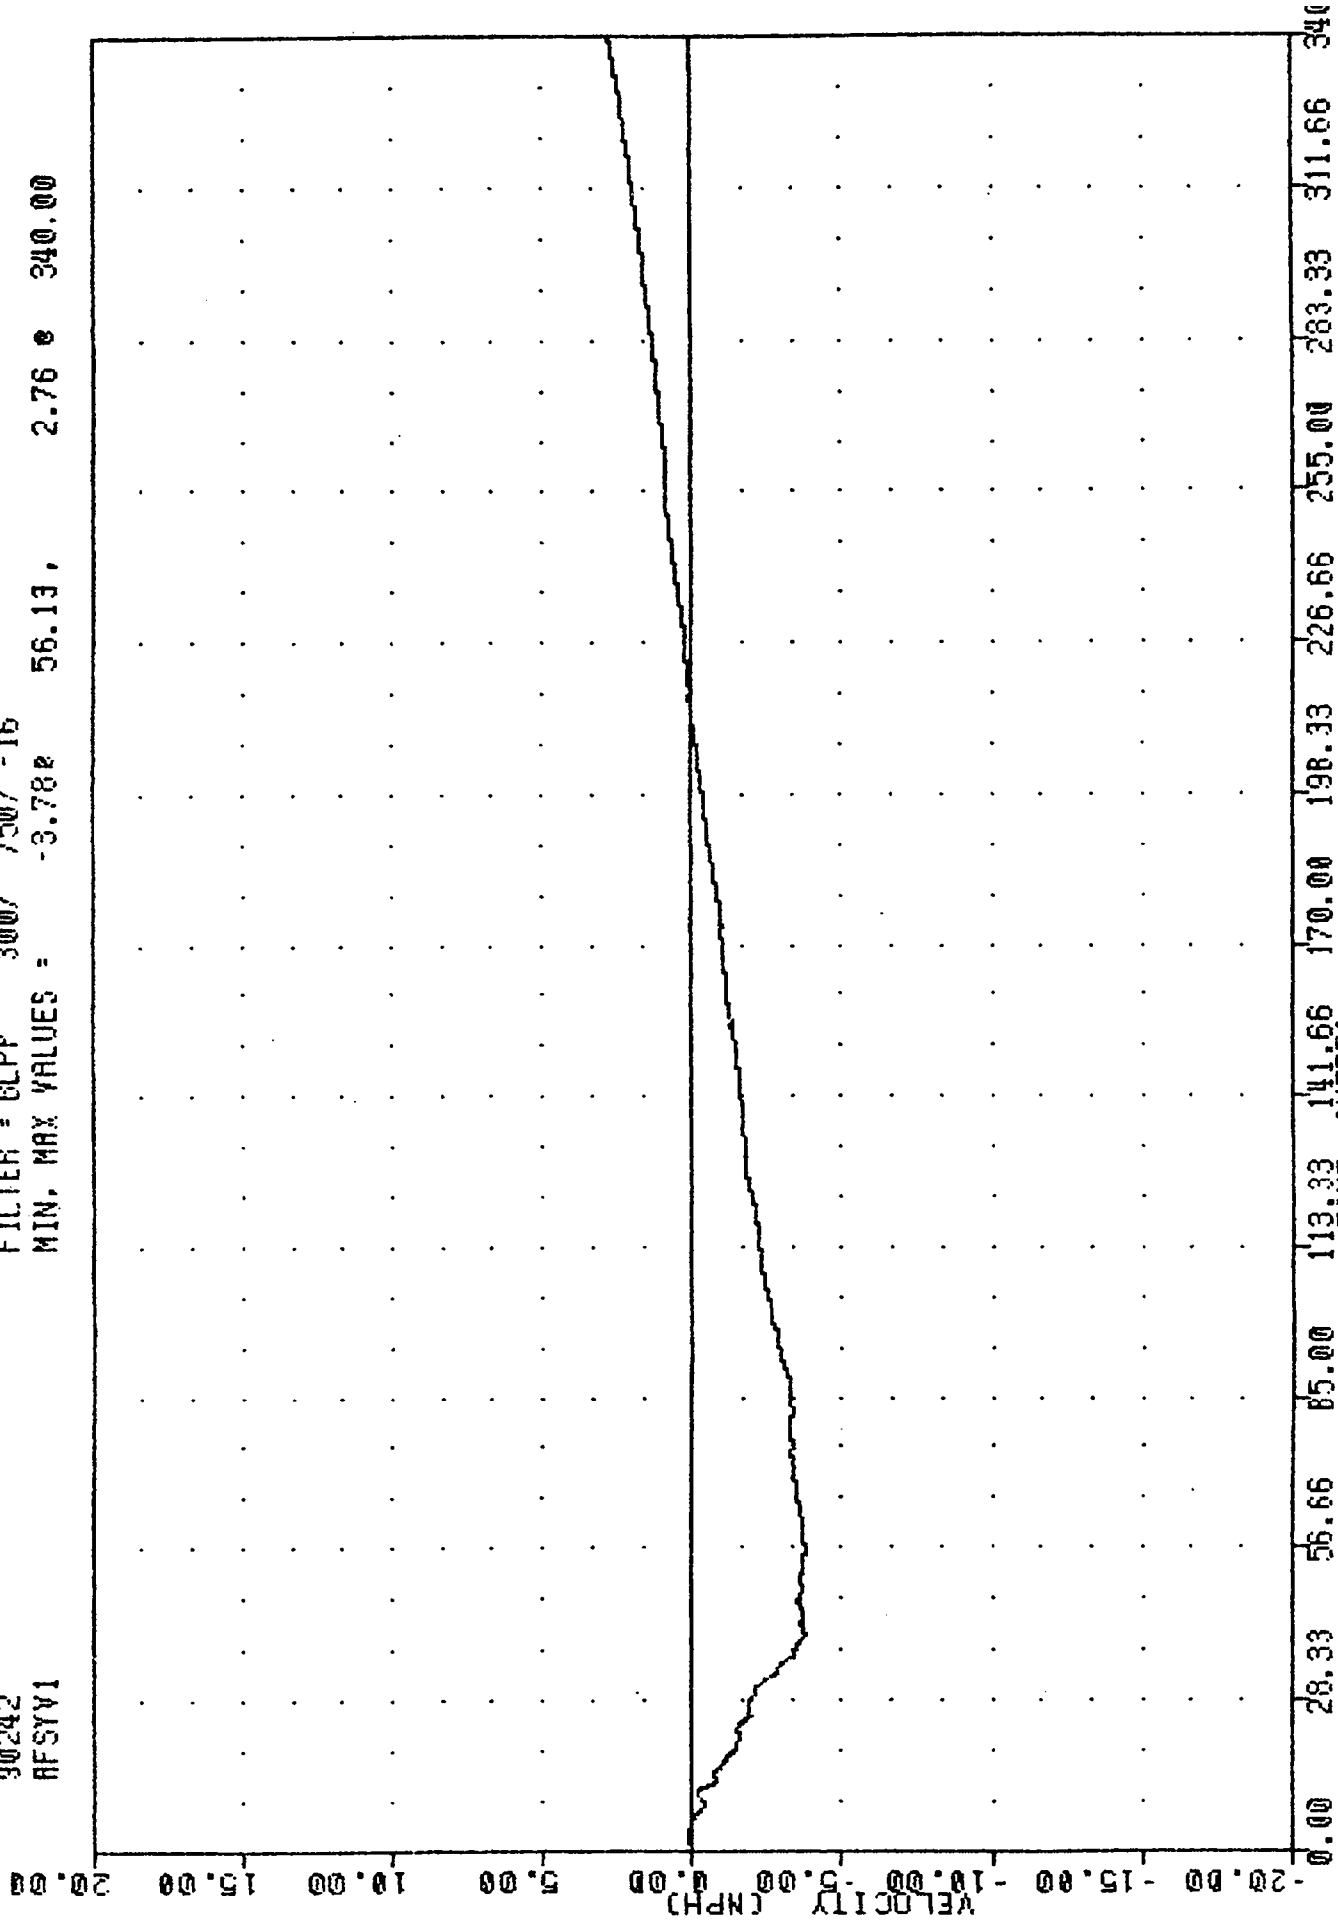
CONTOURED MOVING BARRIER INTO FORD ESCORT AT 28.3 MPH #3
 RIGHT FRONT SILL Y-AXIS VELOCITY

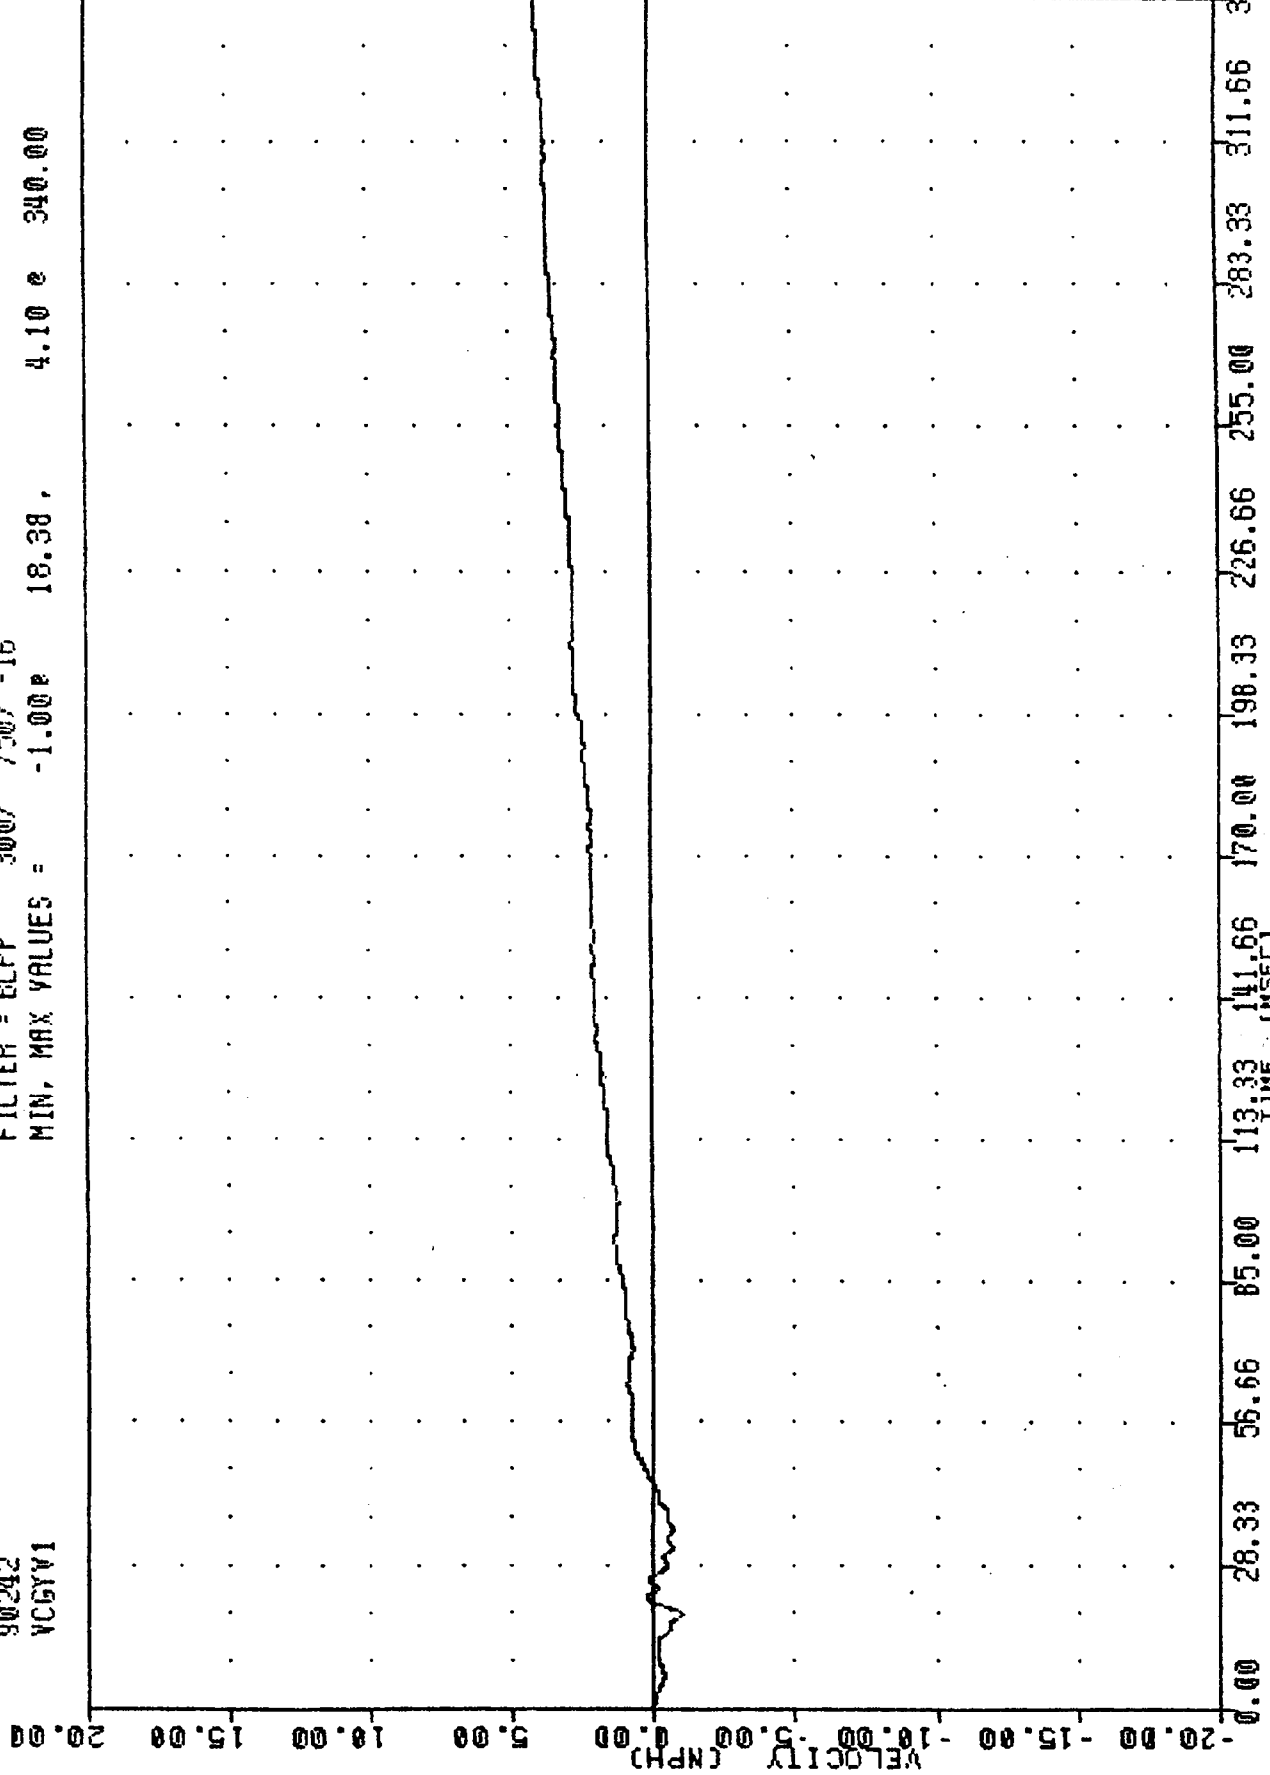
CONTOURED MOVING BARRIER INTO FORD ESCORT AT 28.3 MPH #3
 VEHICLE CG Y-AXIS VELOCITY (PERPENDICULAR TO IMPACT DIRECTION)

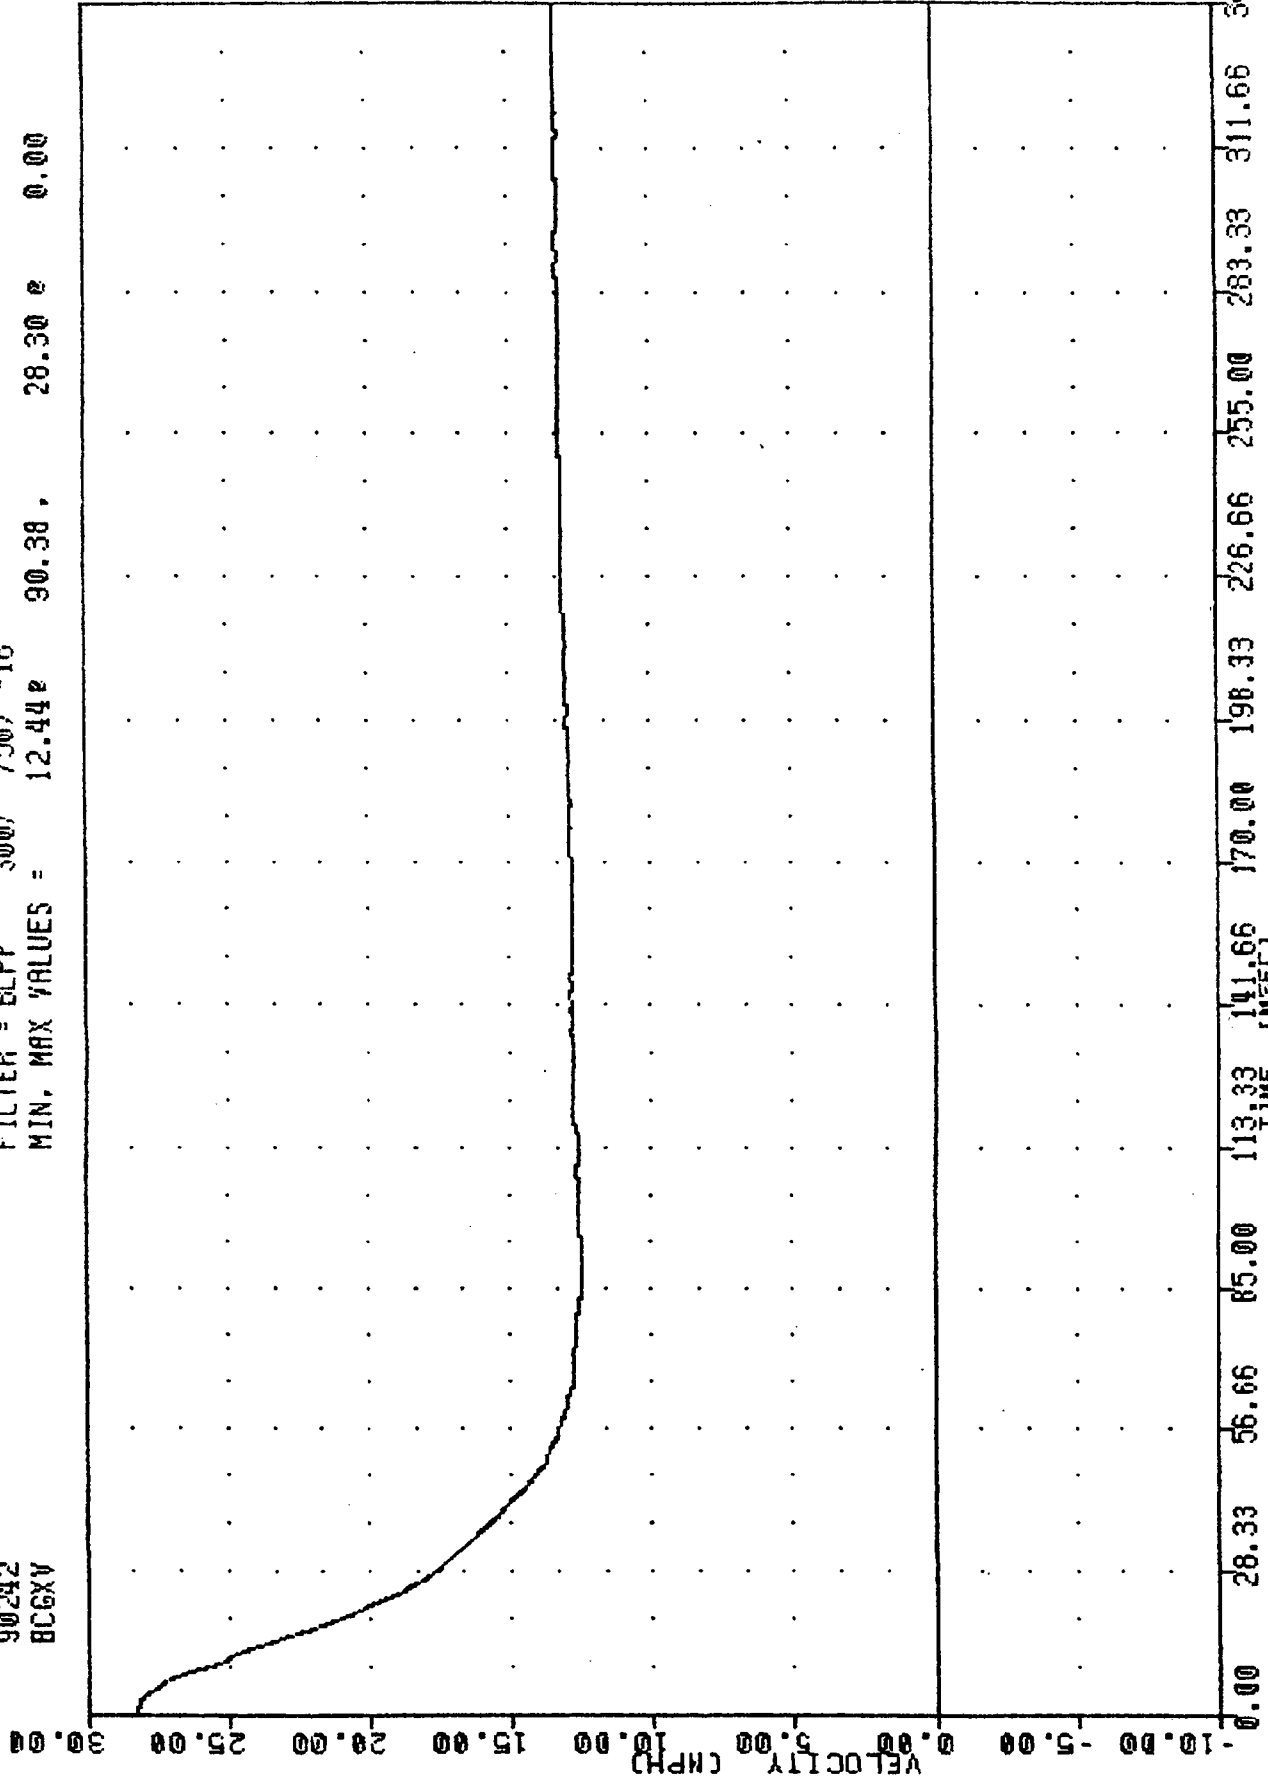
CONTOURED MOVING BARRIER INTO FORD ESCORT AT 28.3 MPH #3
 MOVING BARRIER CENTER OF GRAVITY X-AXIS VELOCITY

FILTER = BLFF 300/ 750/ -16
 MIN. MAX VALUES = -1.11e 27.88, 1.99 e 340.00
