DOT HS 807 771
Final Report

Final Report of 339° Contoured Moving Barrier Impact Into a 1985 Ford Escort 3-Door Hatchback in Support of Crash III Damage Algorithm Reformation

The purpose of the four 339° contoured moving barrier impact tests was research and development in support of the CRASH III damage algorithm reformulation.

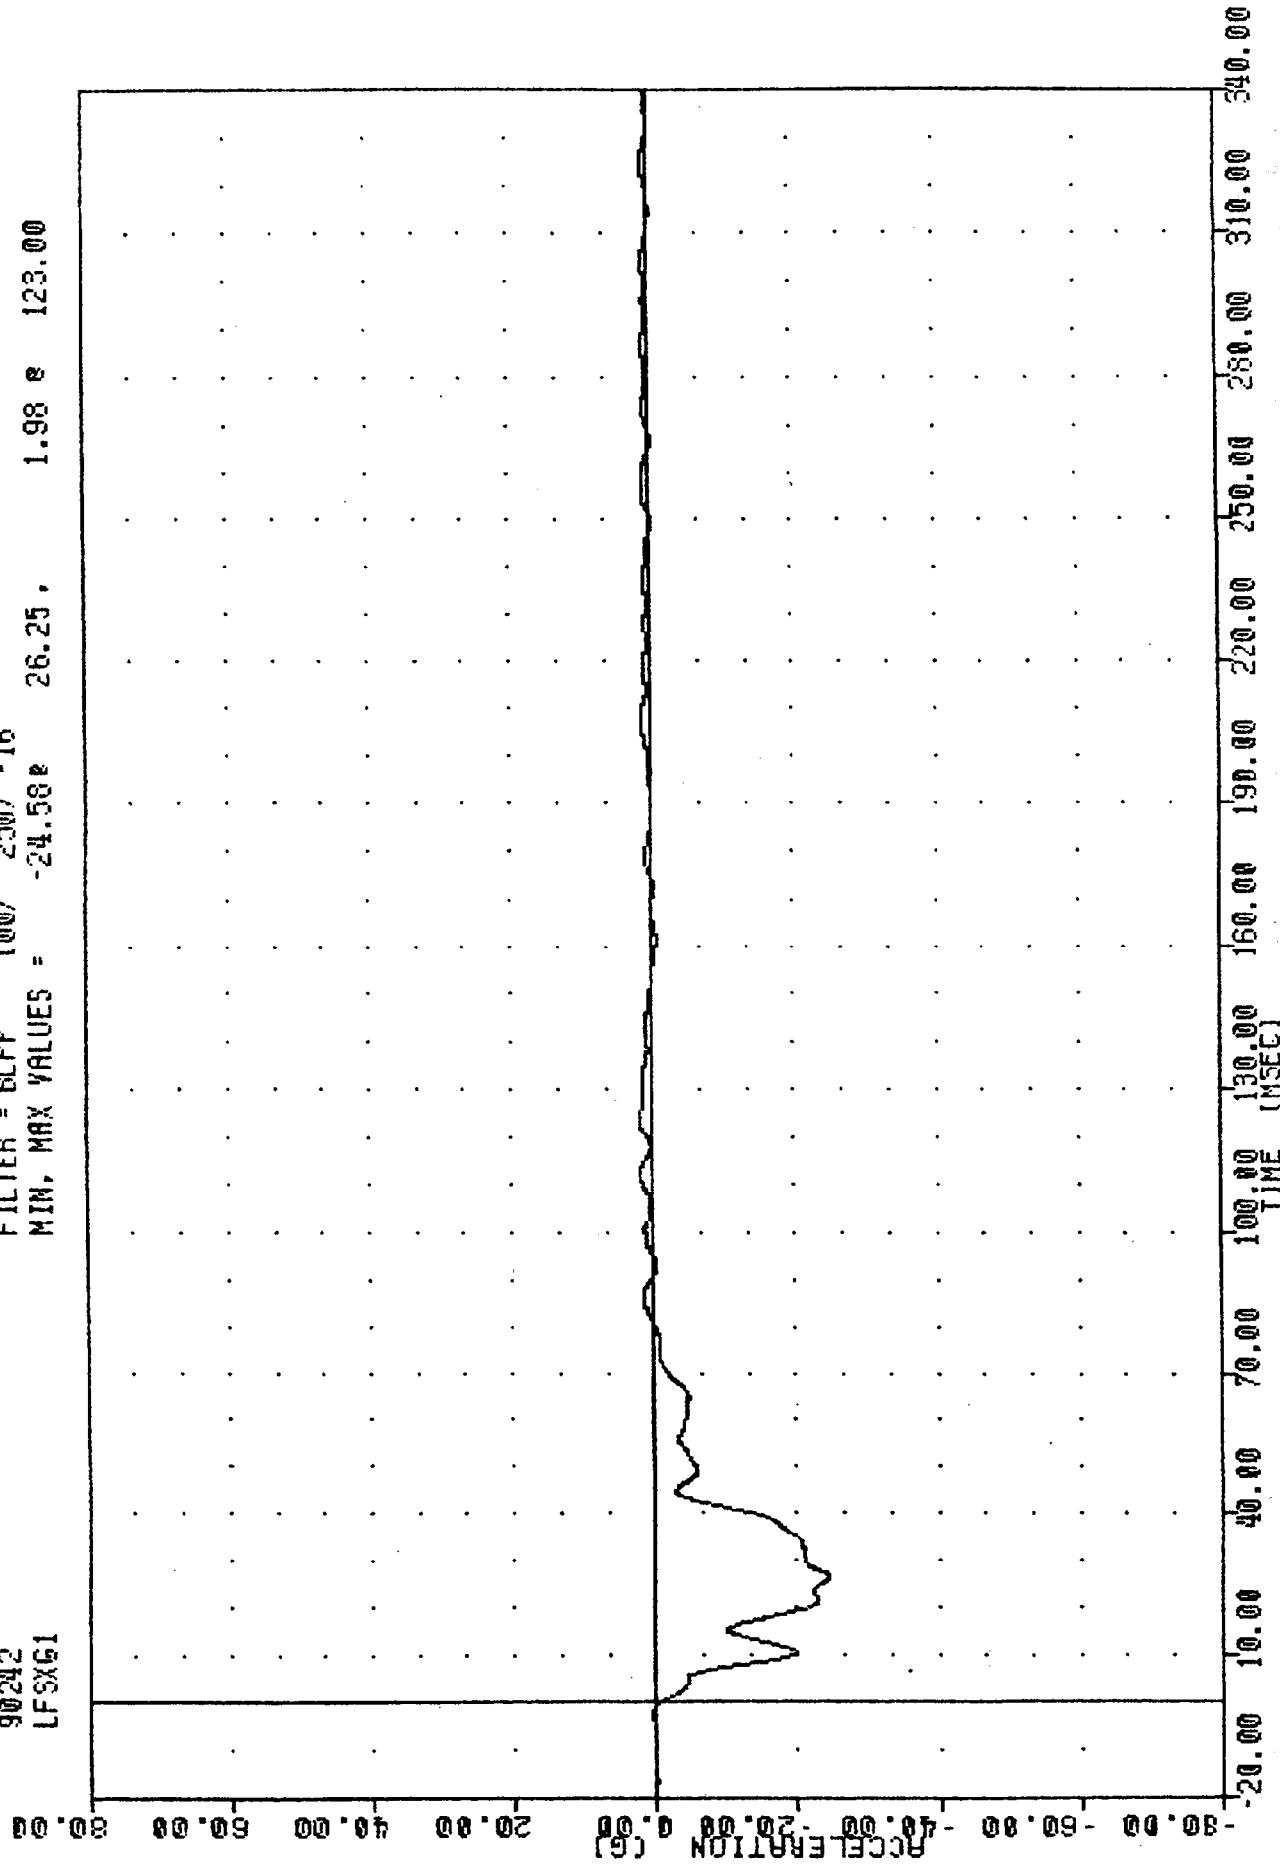
CONTOURED MOVING BARRIER INTO FORD ESCORT AT 39.8 MPH #4
LEFT FRONT SILL X-AXIS ACCELERATION

FILTER = BLPP 100/ 250/ = 16
MIN. MAX VALUES = -14.56e 34.13. 2.61 e 97.25

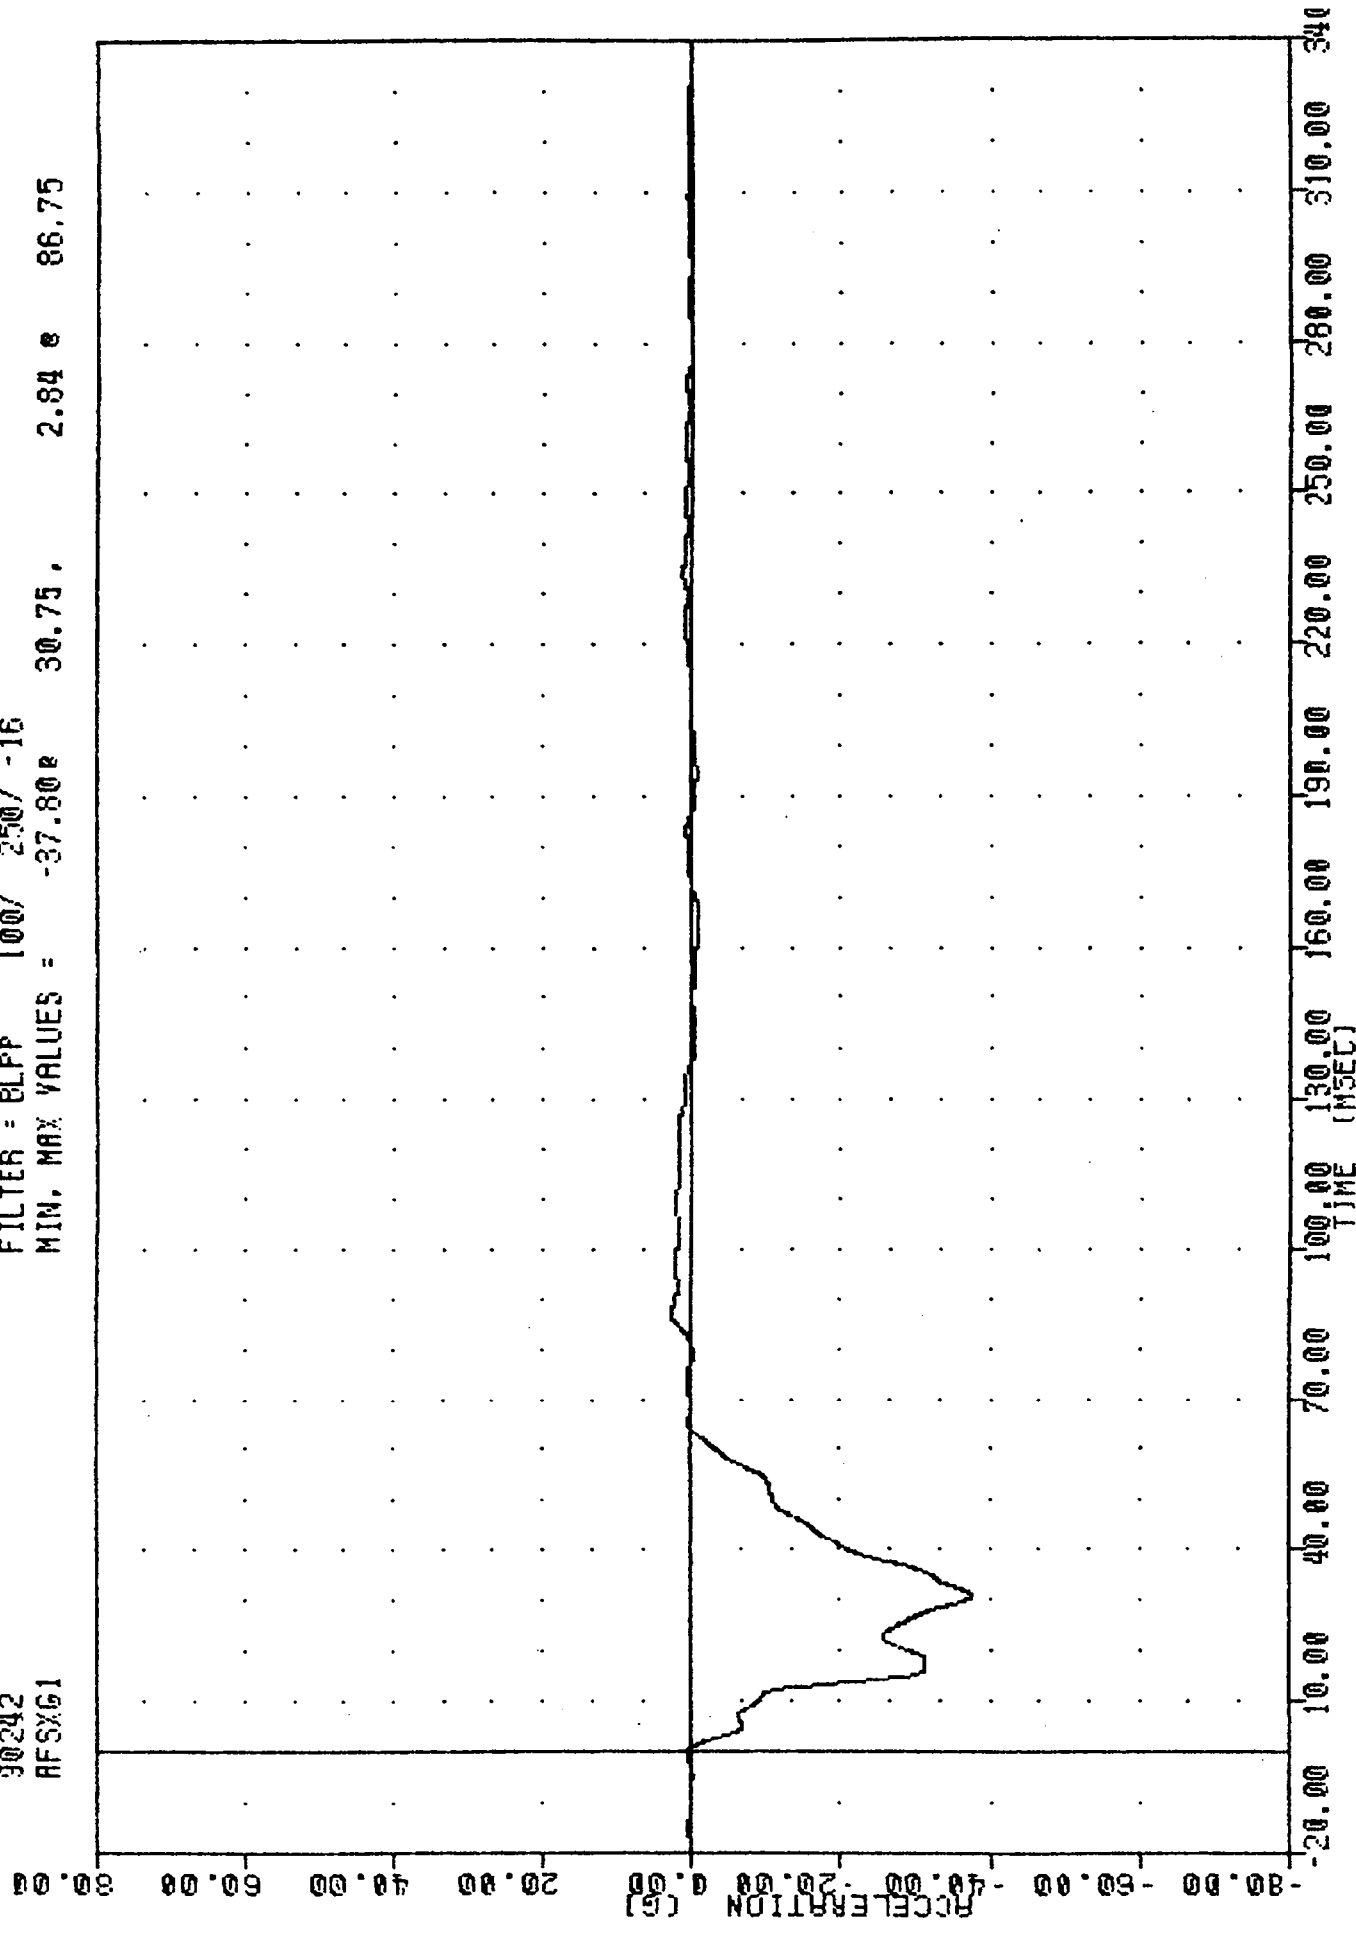
CONTOURED MOVING BARRIER INTO FORD ESCORT AT 39.8 MPH #4
 RIGHT FRONT SILL X-AXIS ACCELERATION

FILTER = BLPF 100/ 250/ -16
 MIN. MAX VALUES = -13.40e 10.80 e 31.38

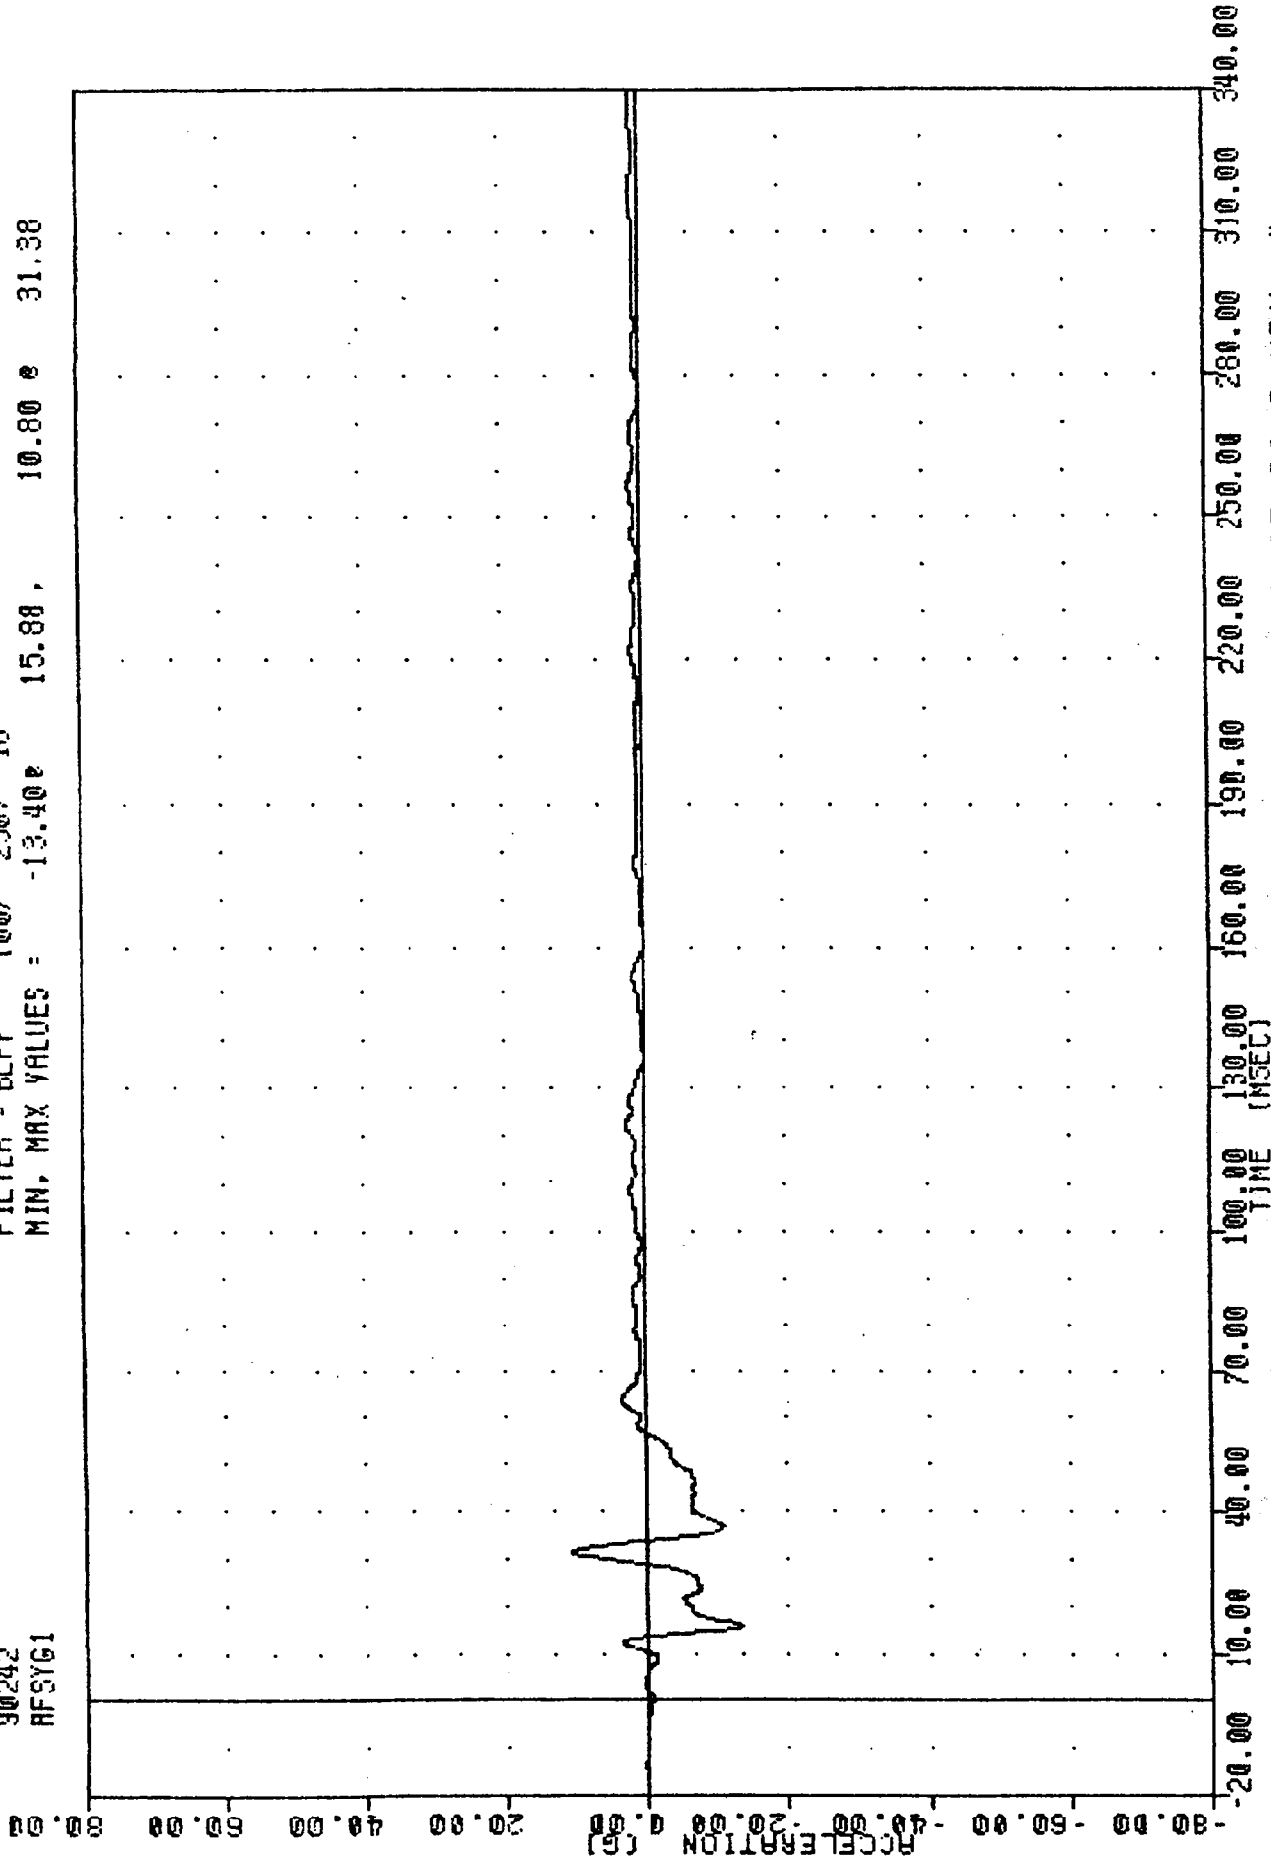
CONTOURED MOVING BARRIER INTO FORD ESCORT AT 39.8 MPH #4
 RIGHT FRONT SILL Y-AXIS ACCELERATION

FILTER = BLPP 100/ 250/ -16
 MIN, MAX VALUES = 0.000 -20.00, 39.08 e 31.00

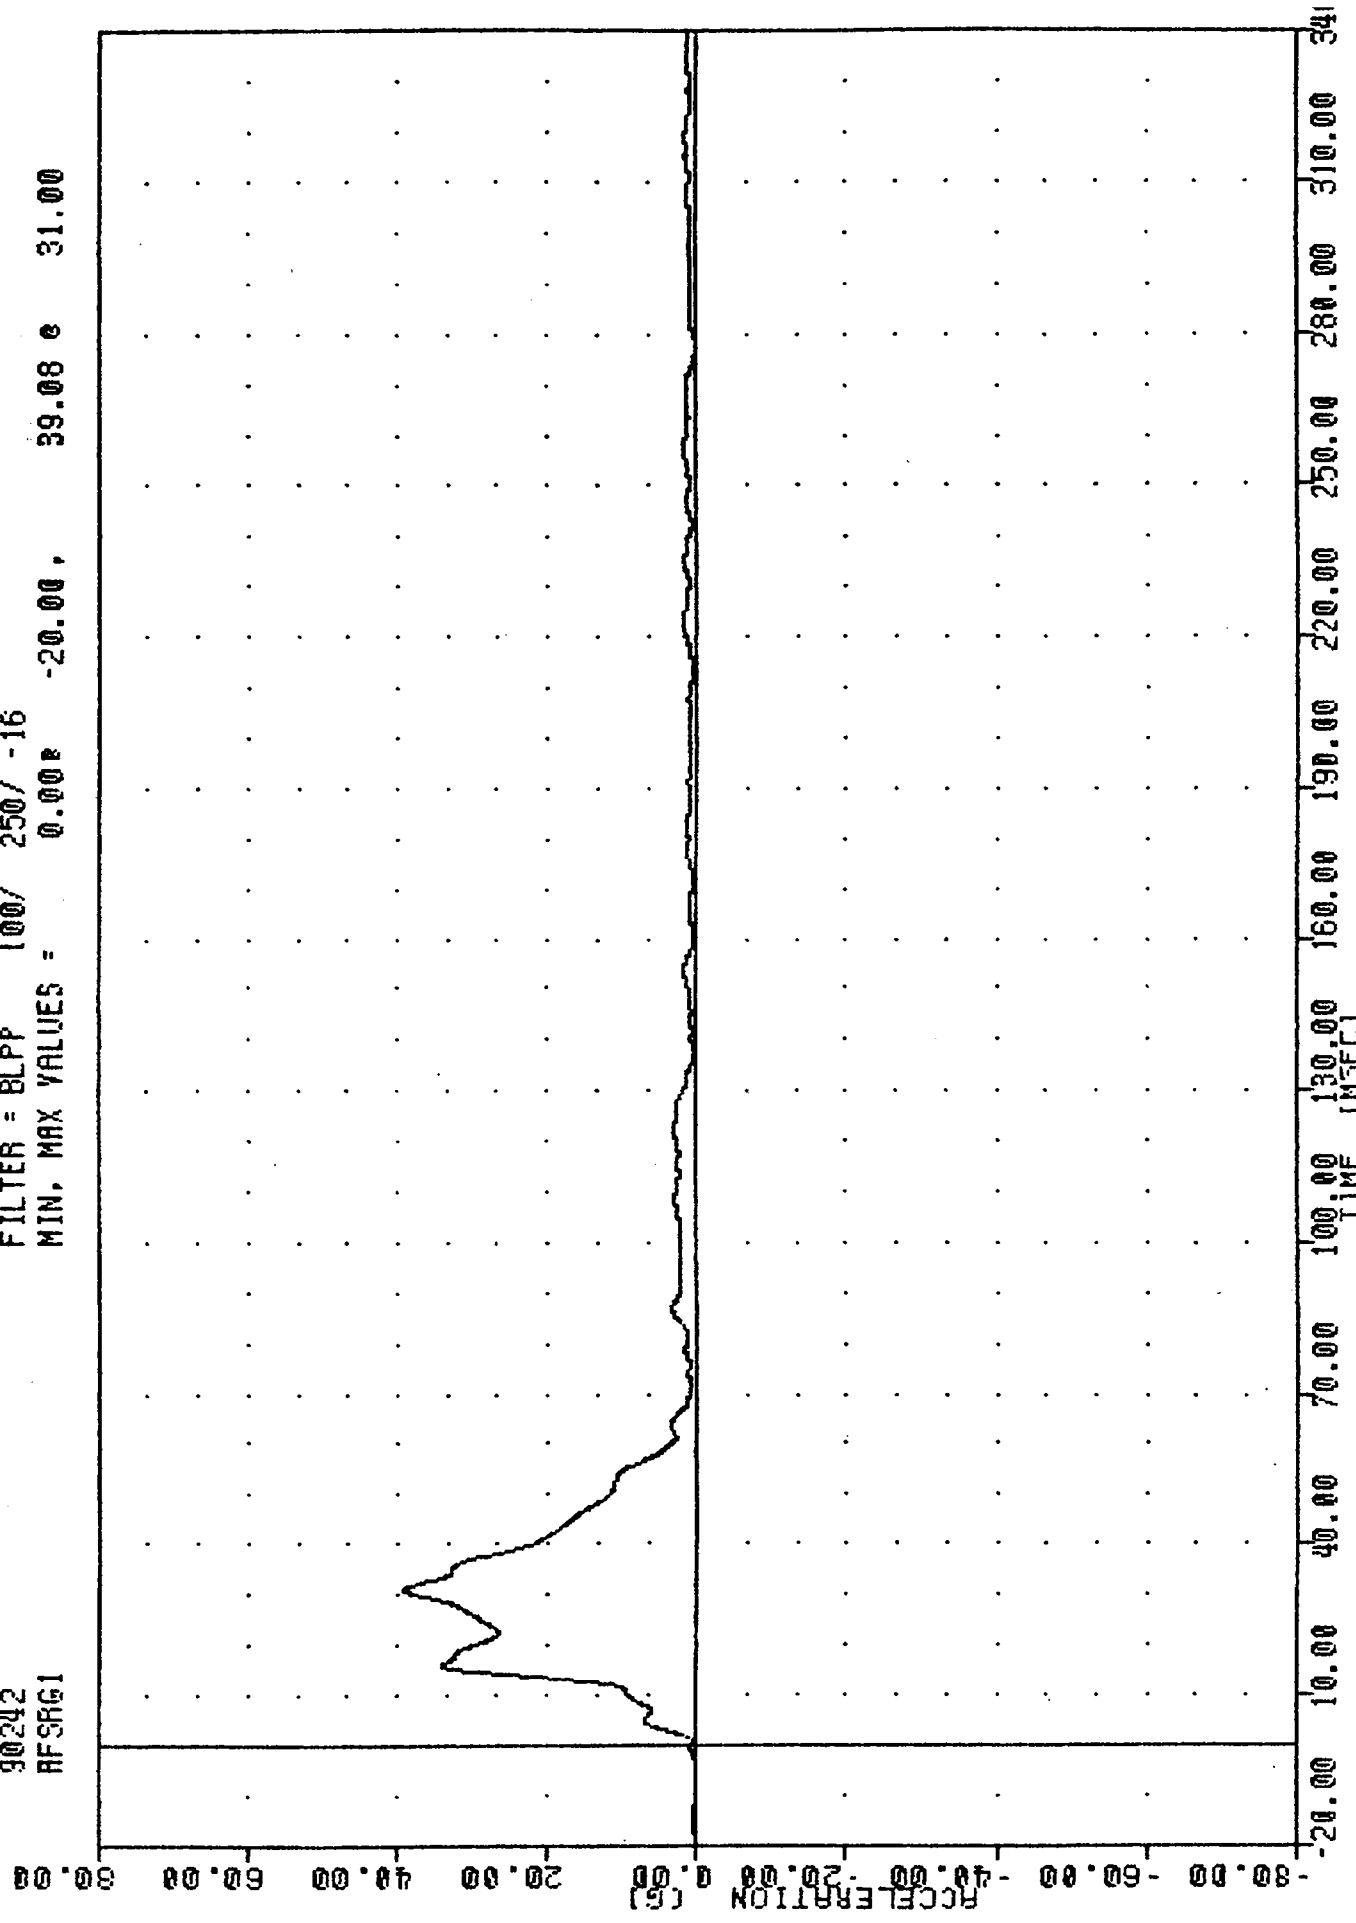
CONTOURED MOVING BARRIER INTO FORD ESCORT AT 39.8 MPH #4
 RIGHT FRONT SILL RESULTANT ACCELERATION

FILTER = BLPP 100/ 250/ -16
MIN. MAX VALUES = -48.91 e 19.38 , 4.15 e 100.88

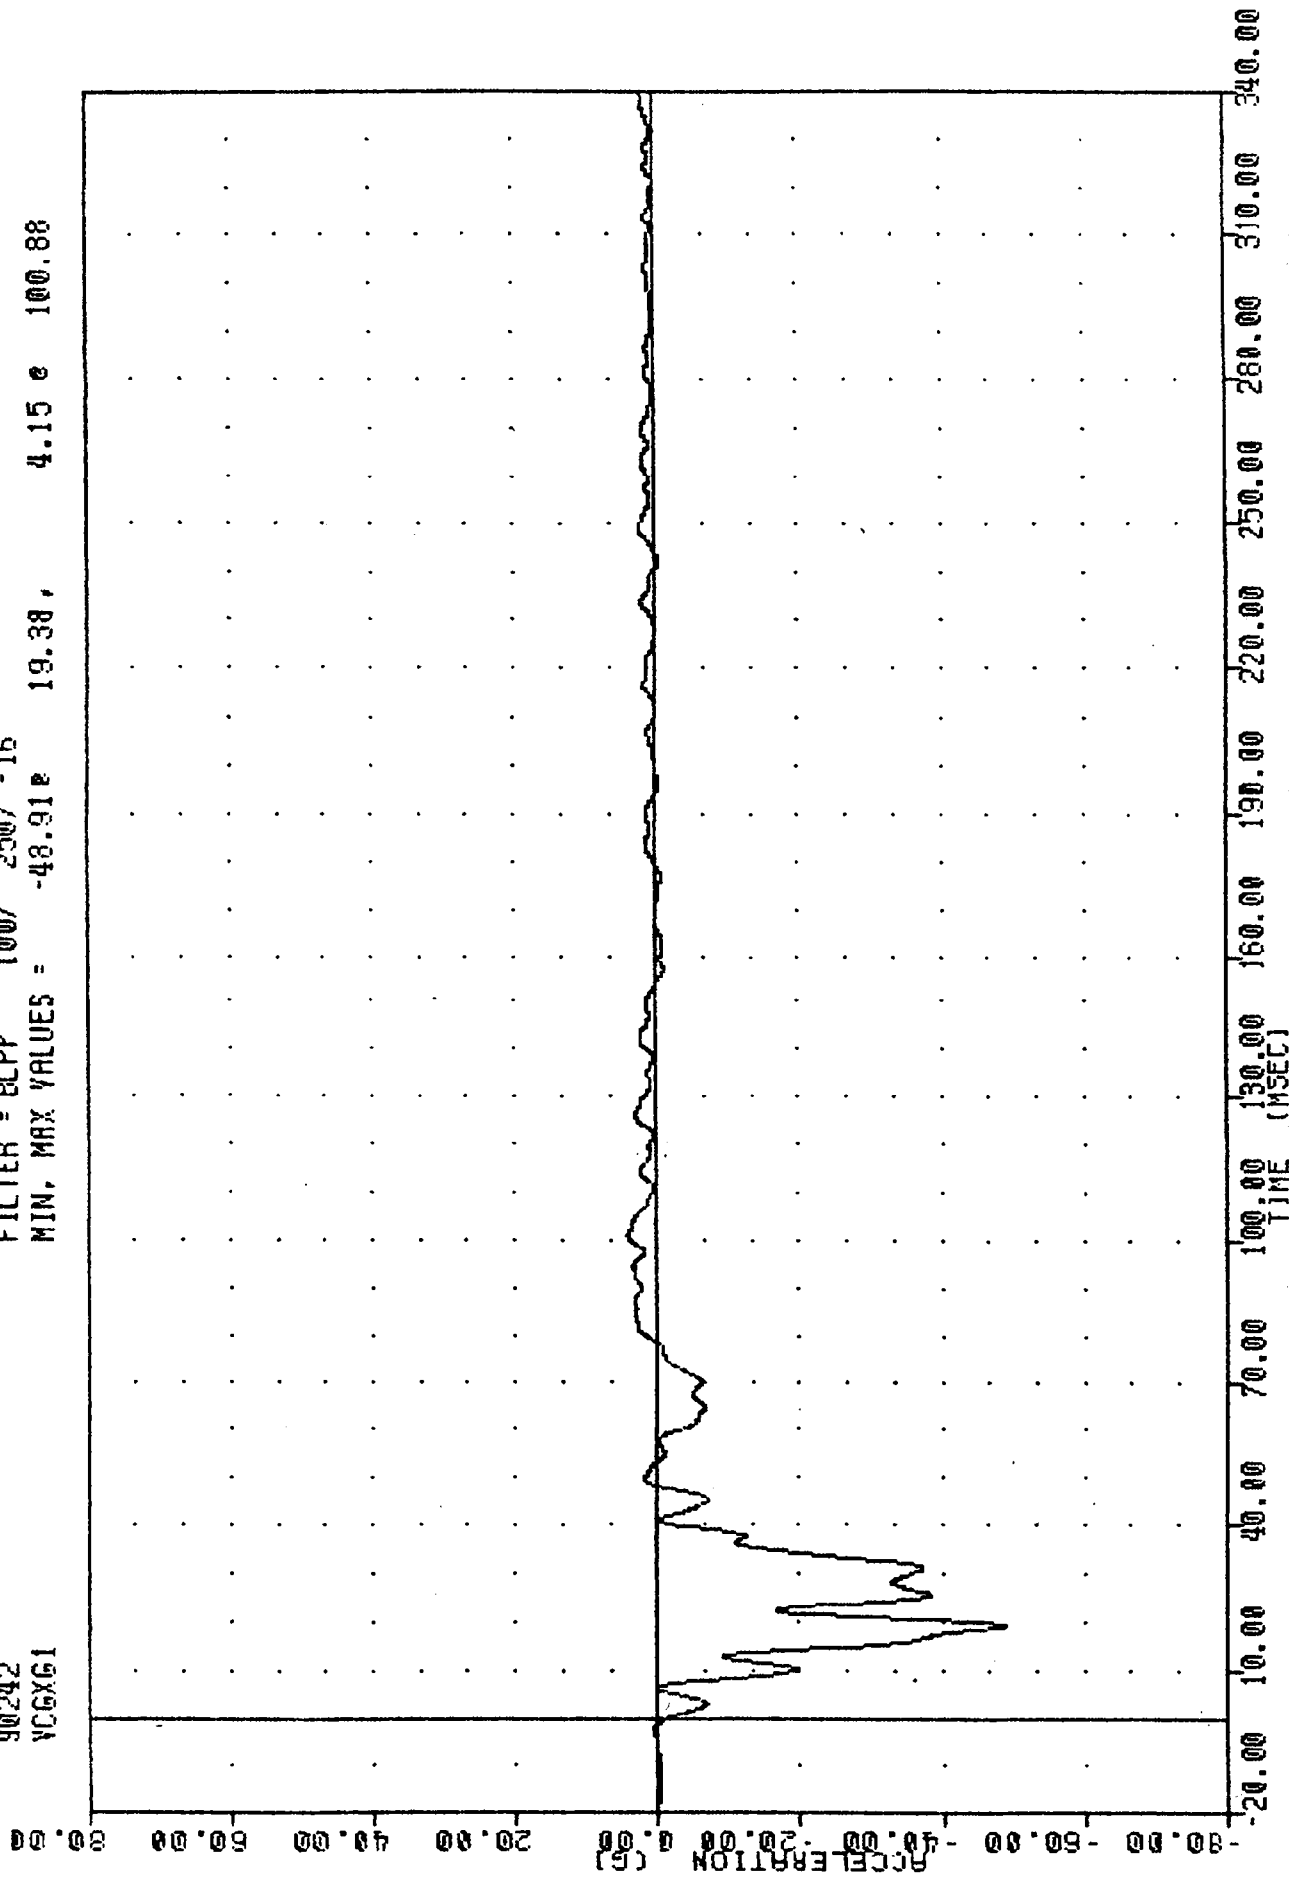
CONTOURED MOVING BARRIER INTO FORD ESCORT AT 39.8 MPH #4
VEHICLE CG X-AXIS ACCELERATION (IMPACT DIRECTION)

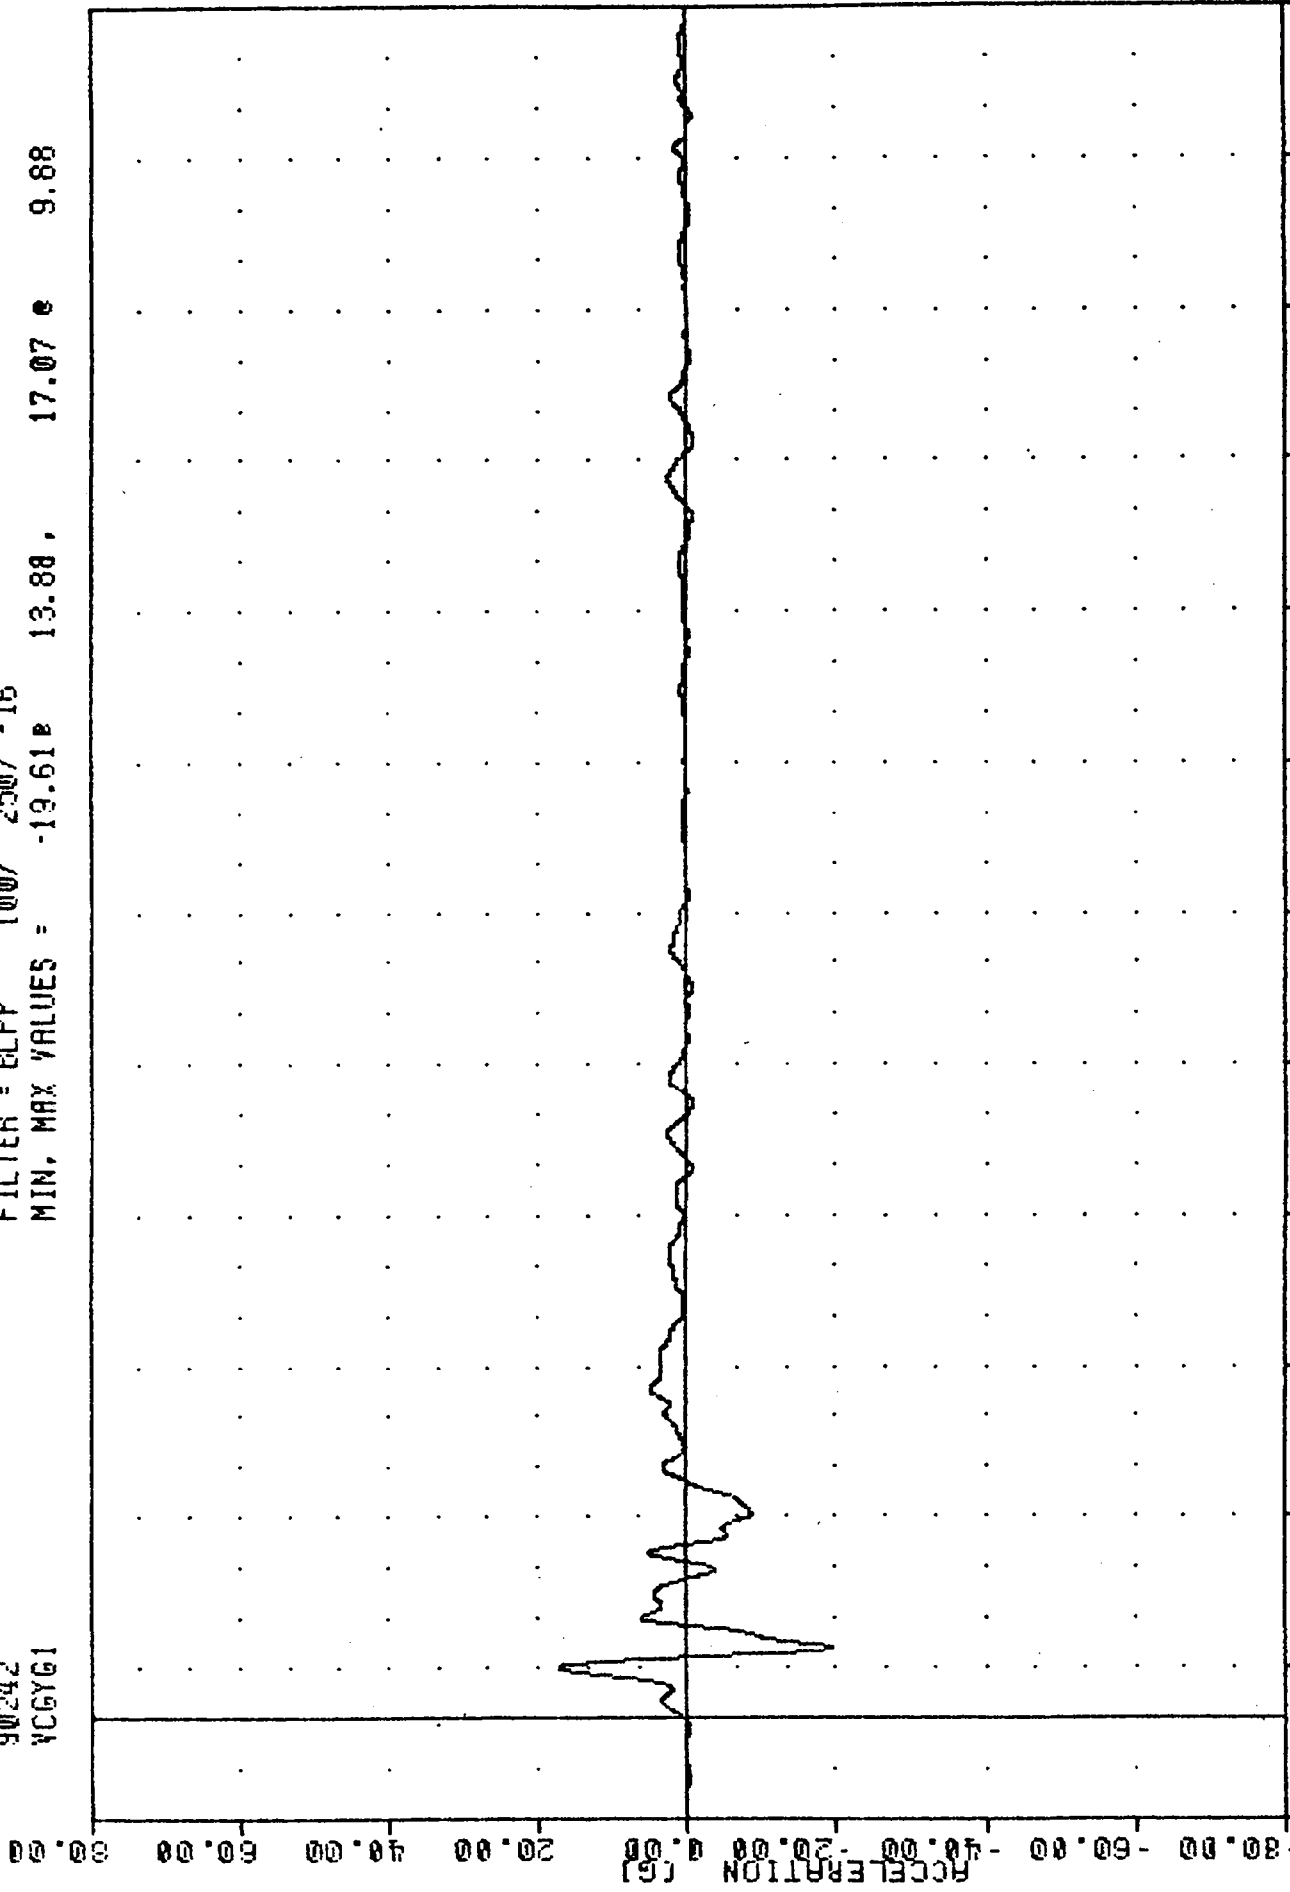
CONTOURED MOVING BARRIER INTO FORD ESCORT AT 39.8 MPH #4
VEHICLE CG Y-AXIS ACCELERATION (PERPENDICULAR TO IMPACT DIRECTION)

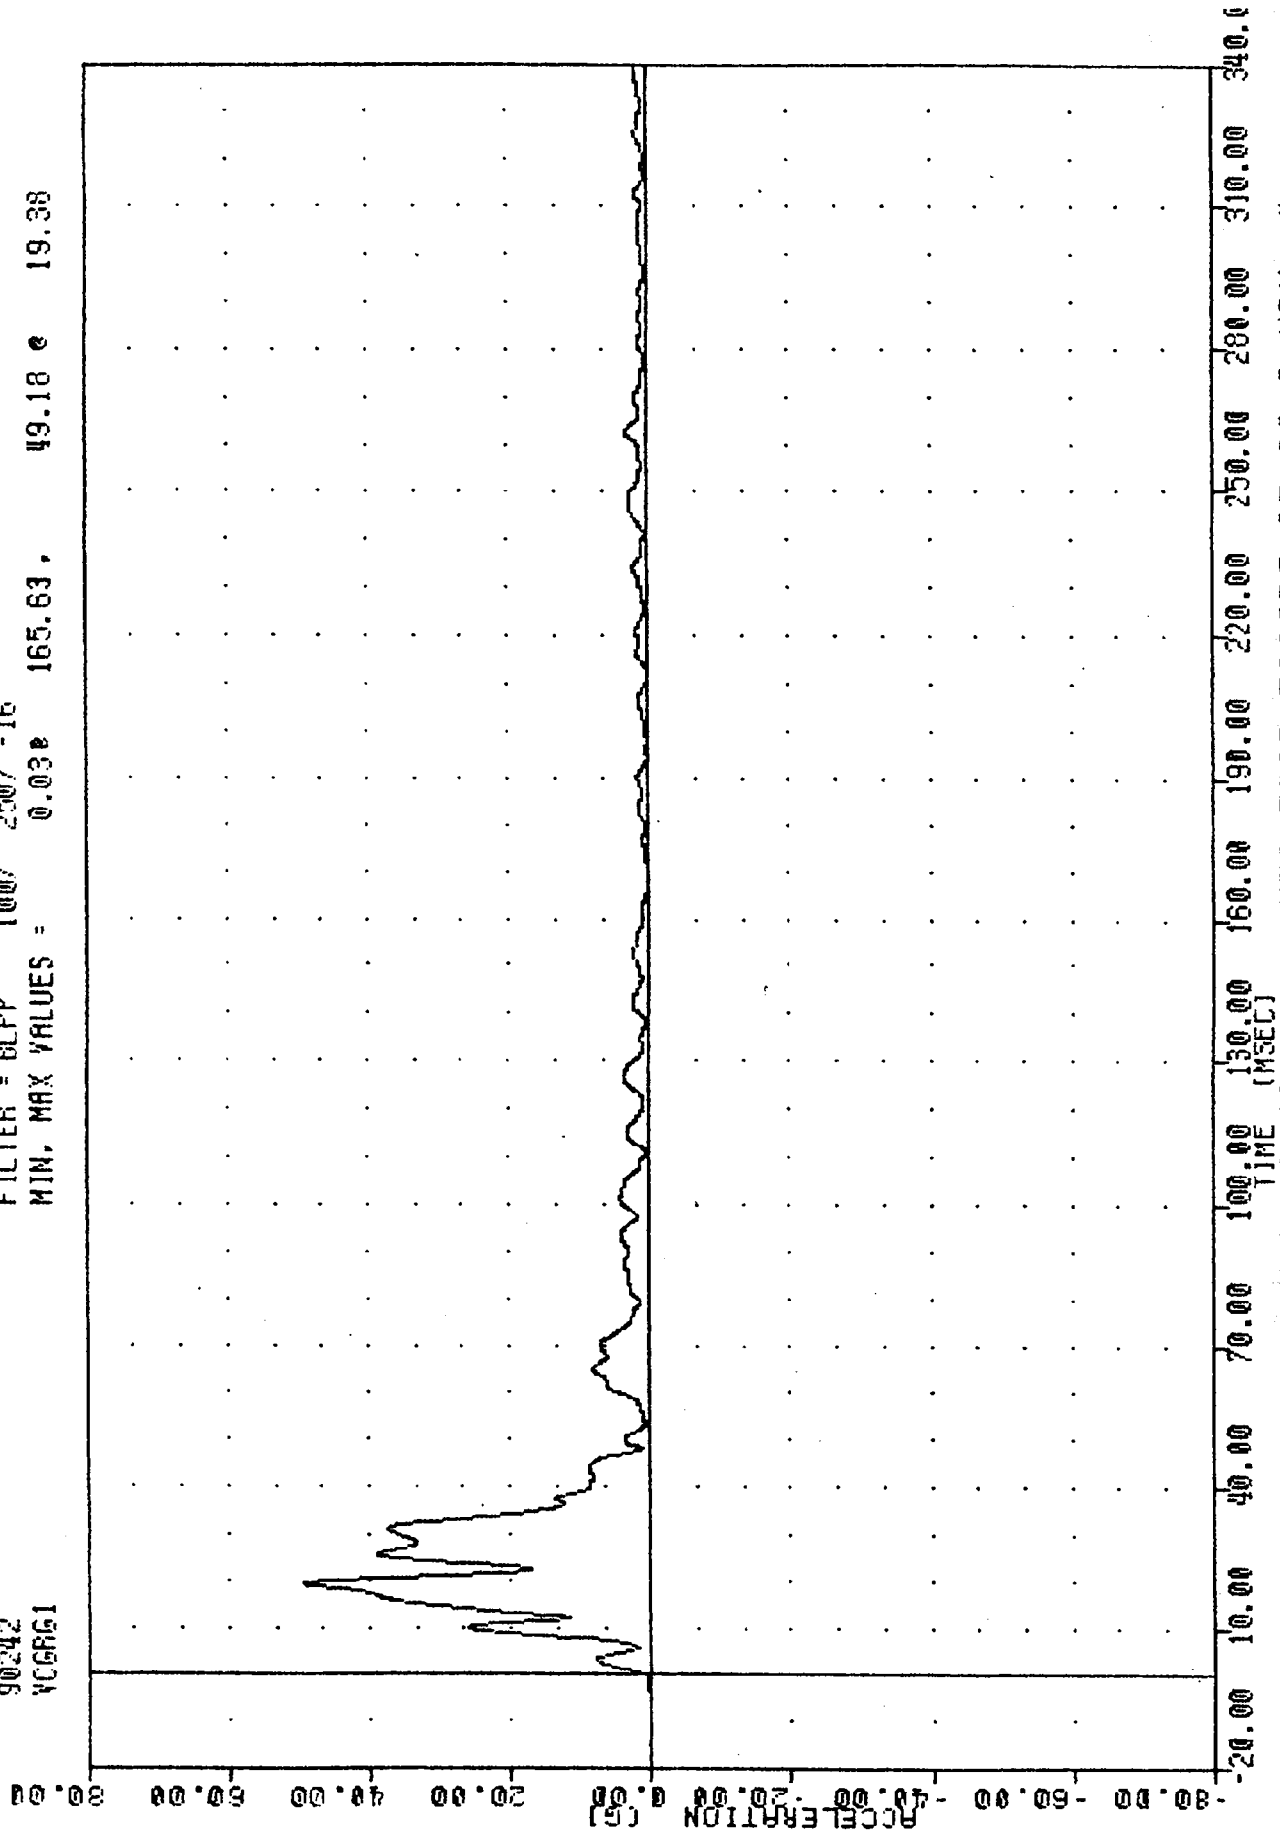
CONTOURED MOVING BARRIER INTO FORD ESCORT AT 39.8 MPH #4
VEHICLE CG RESULTANT ACCELERATION

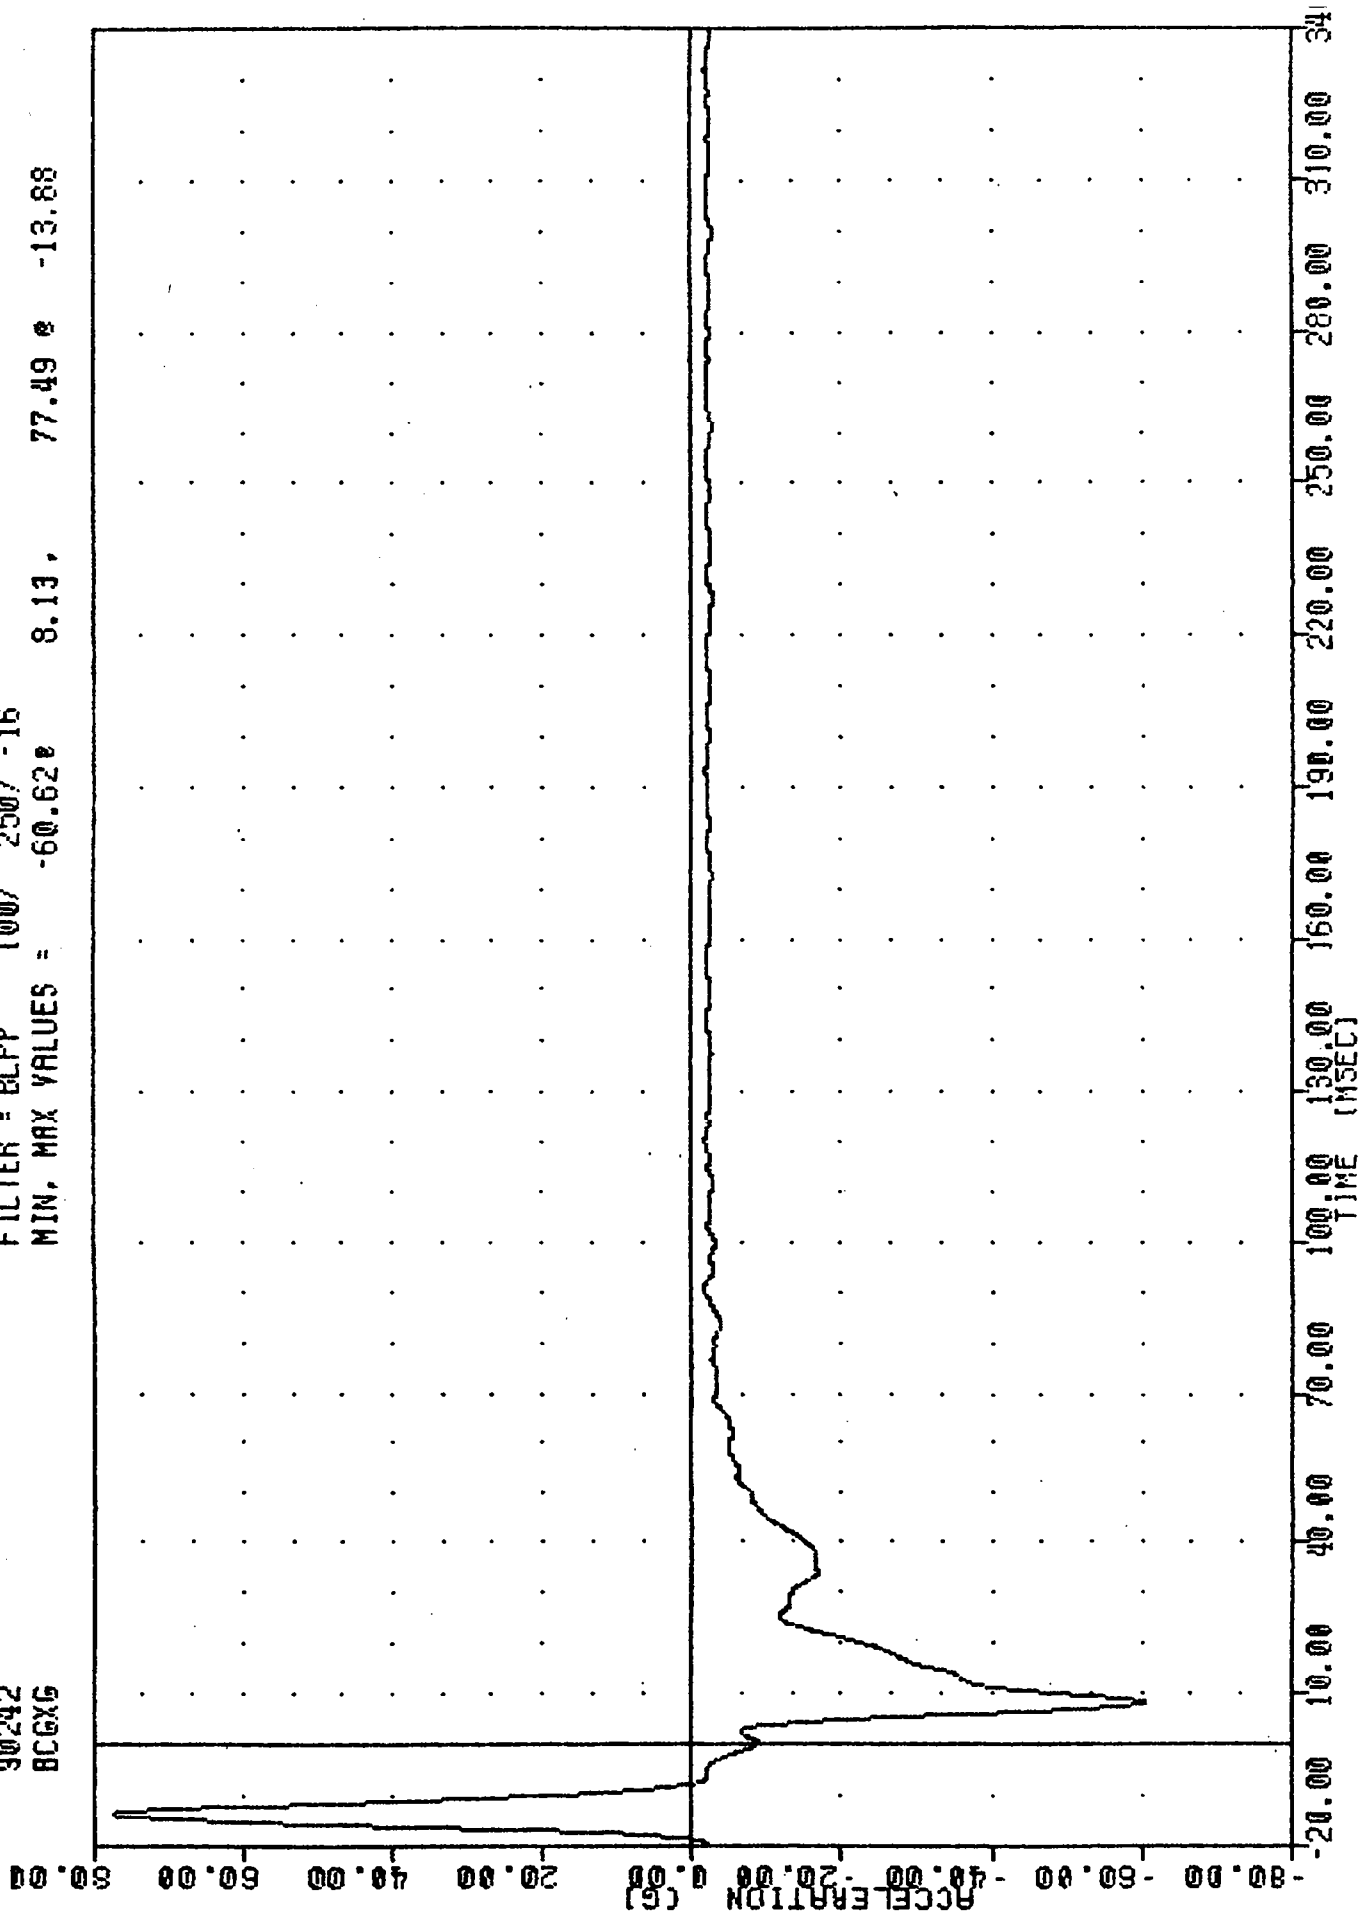
CONTOURED MOVING BARRIER INTO FORD ESCORT AT 39.8 MPH *4
MOVING BARRIER CENTER OF GRAVITY X-AXIS ACCELERATION

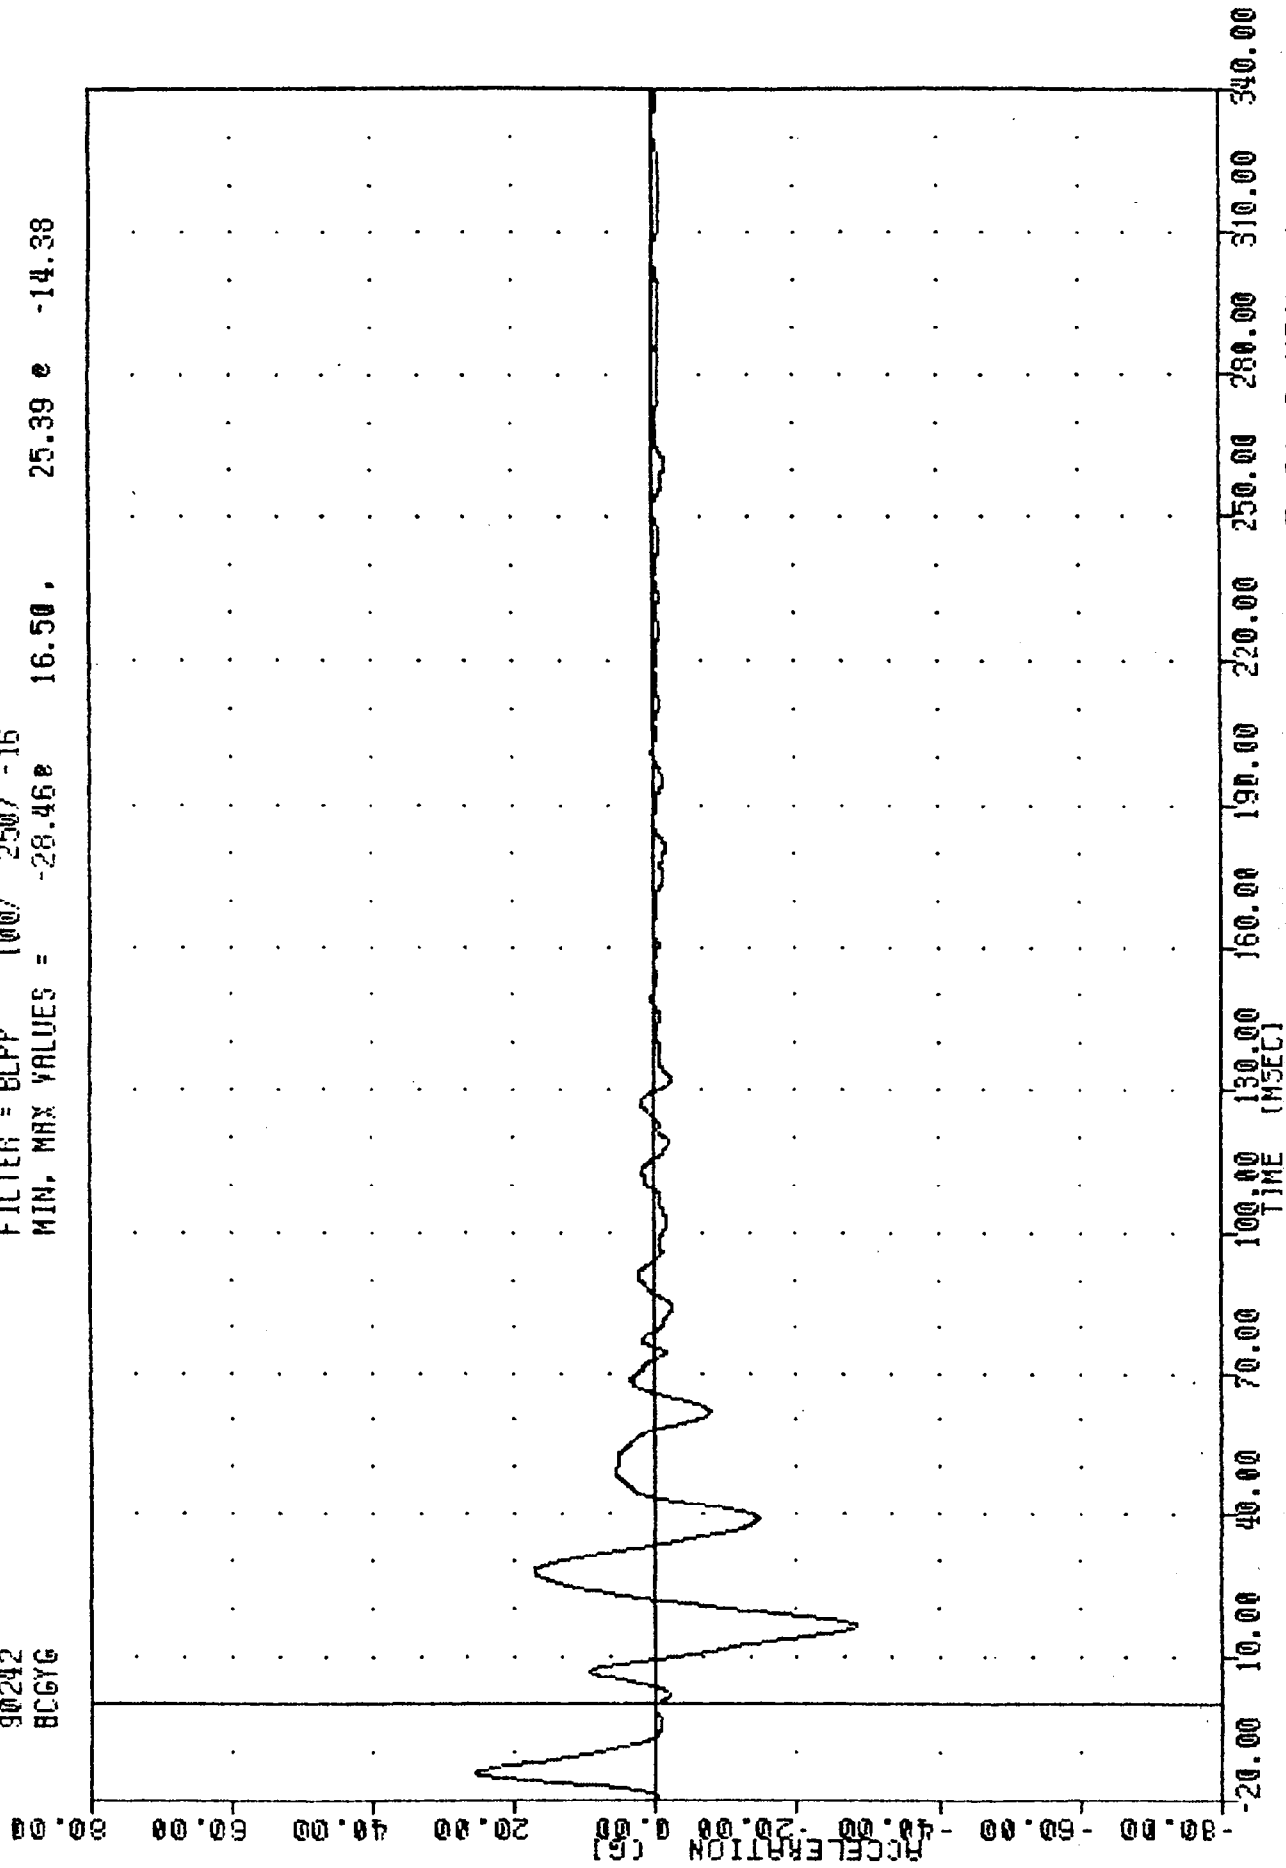
CONTOURED MOVING BARRIER INTO FORD ESCORT AT 39.8 MPH #4
 MOVING BARRIER CENTER OF GRAVITY Y-AXIS ACCELERATION
