DOT HS 807 771
Final Report

Final Report of 339° Contoured Moving Barrier Impact Into a 1985 Ford Escort 3-Door Hatchback in Support of Crash III Damage Algorithm Reformation

The purpose of the four 339° contoured moving barrier impact tests was research and development in support of the CRASH III damage algorithm reformulation.

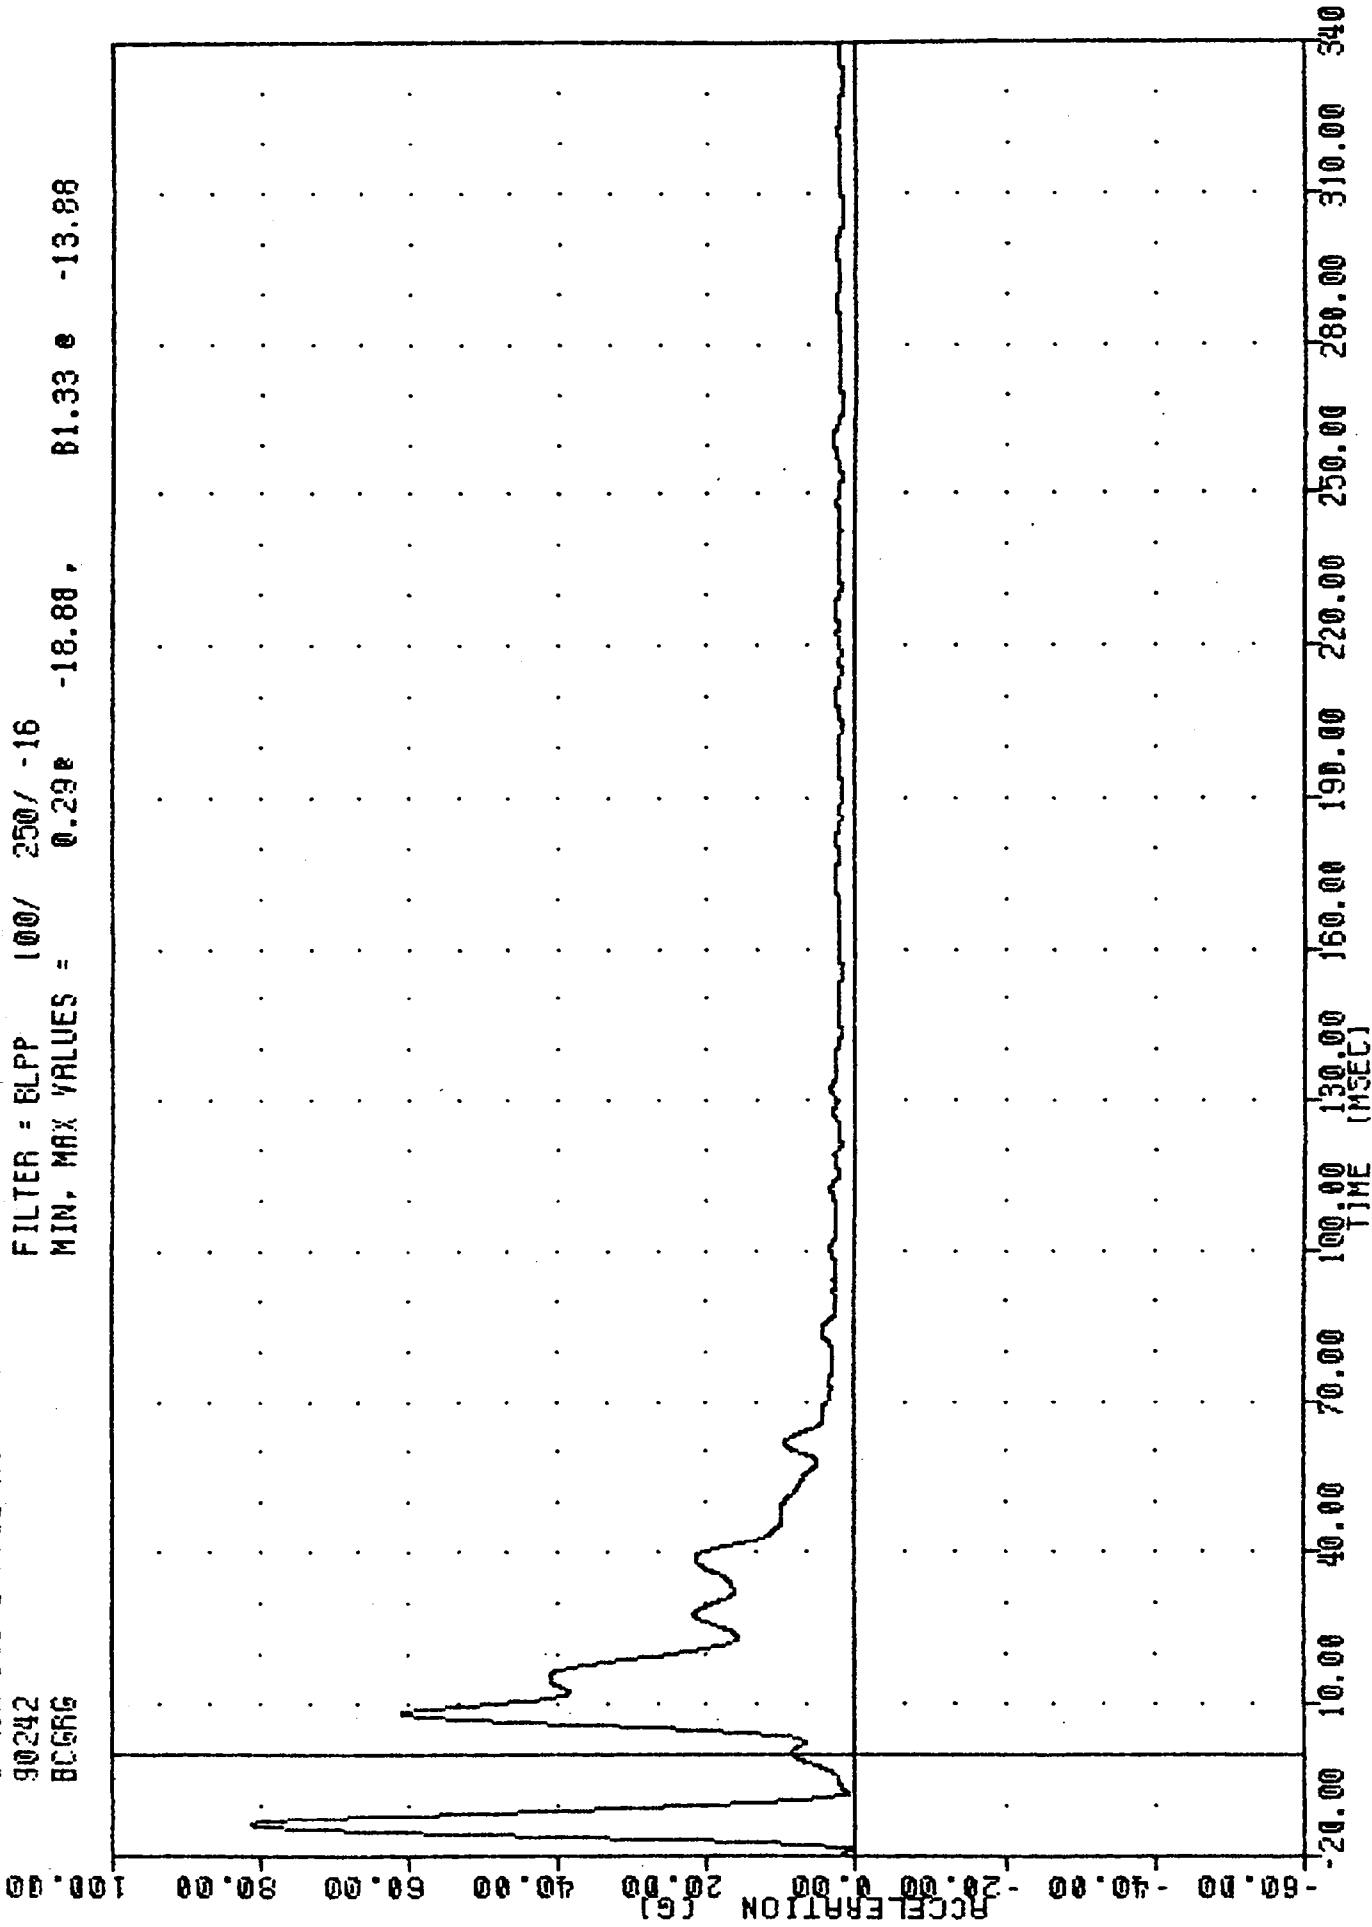
CONTOURED MOVING BARRIER INTO FORD ESCORT AT 39.8 MPH #4
MOVING BARRIER CENTER OF GRAVITY RESULTANT ACCELERATION

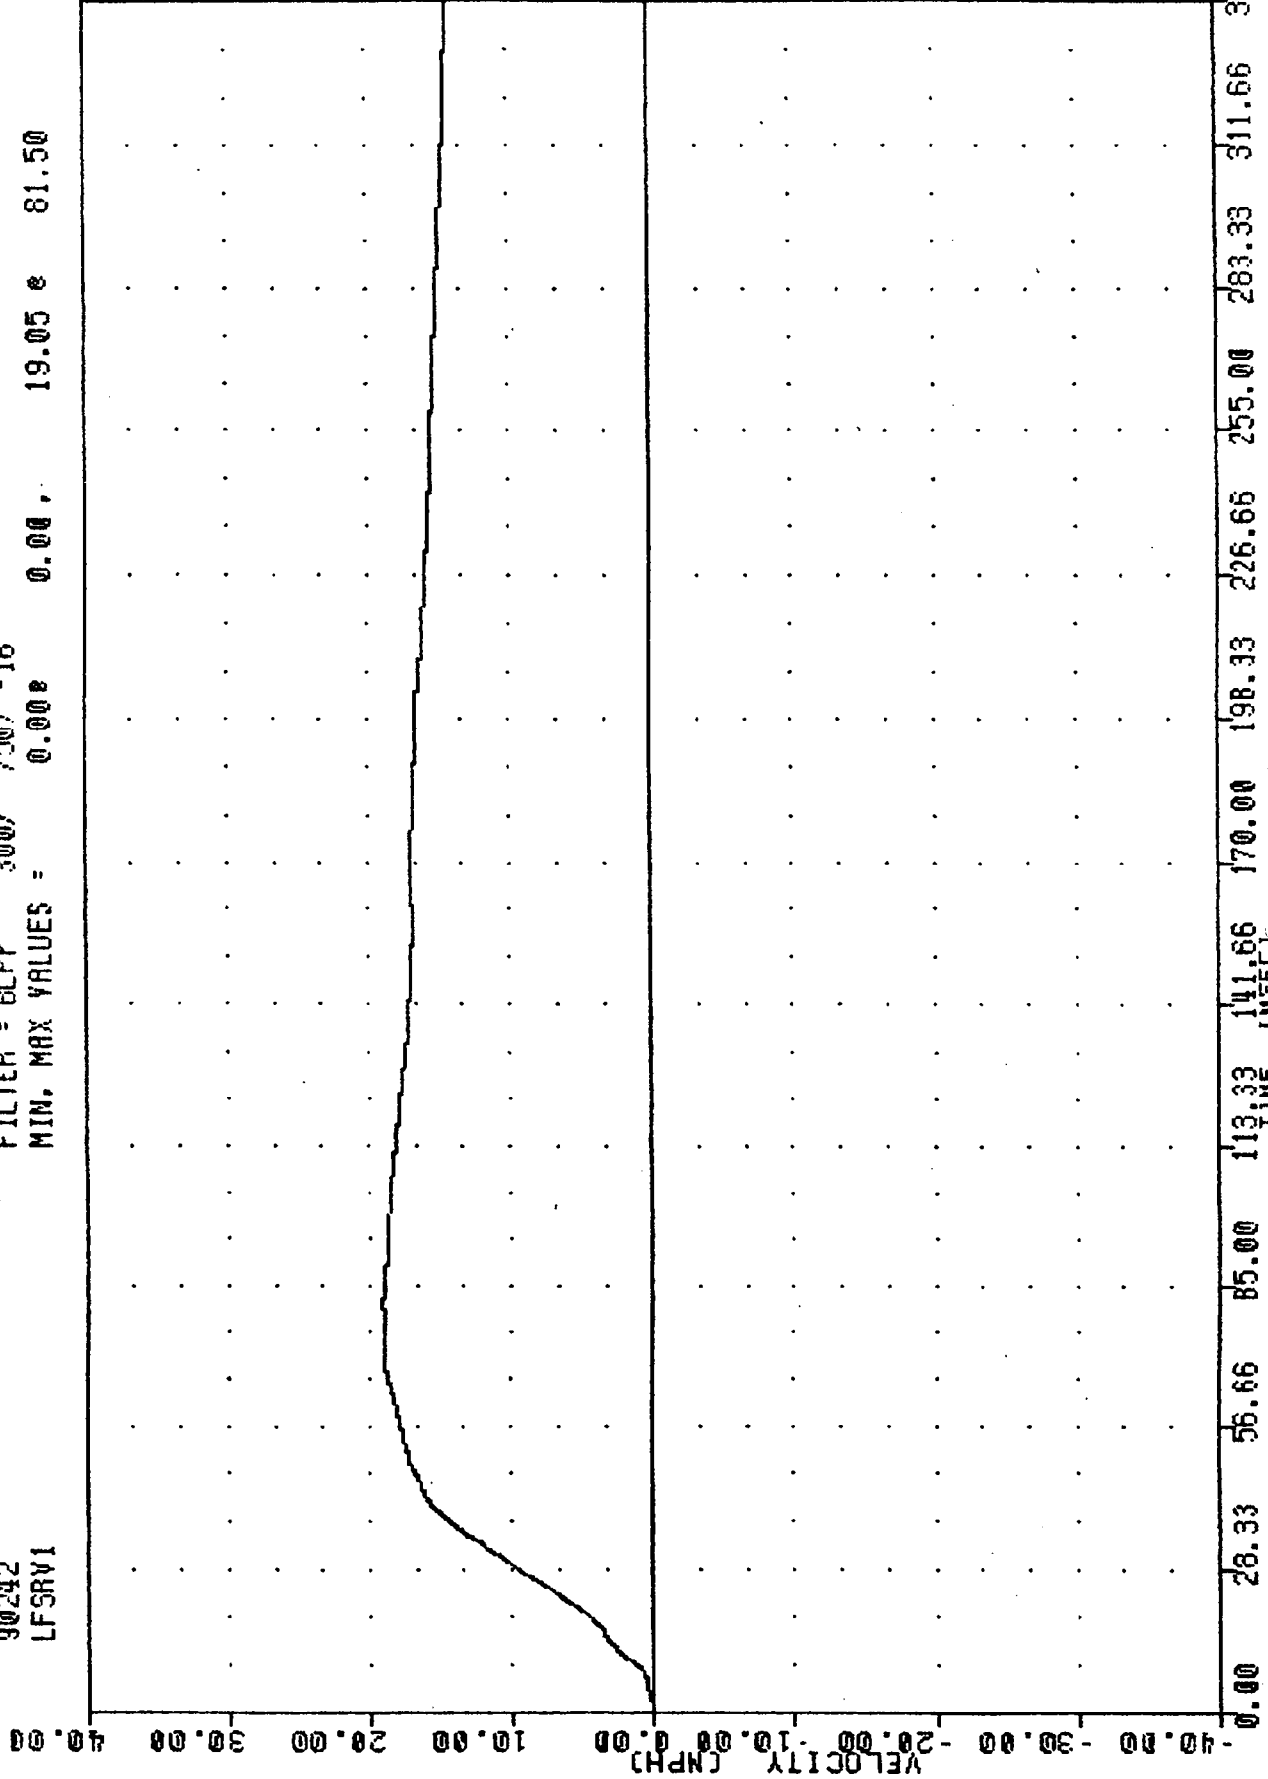
CONTOURED MOVING BARRIER INTO FORD ESCORT AT 39.8 MPH #4
 LEFT FRONT SILL RESULTANT VELOCITY

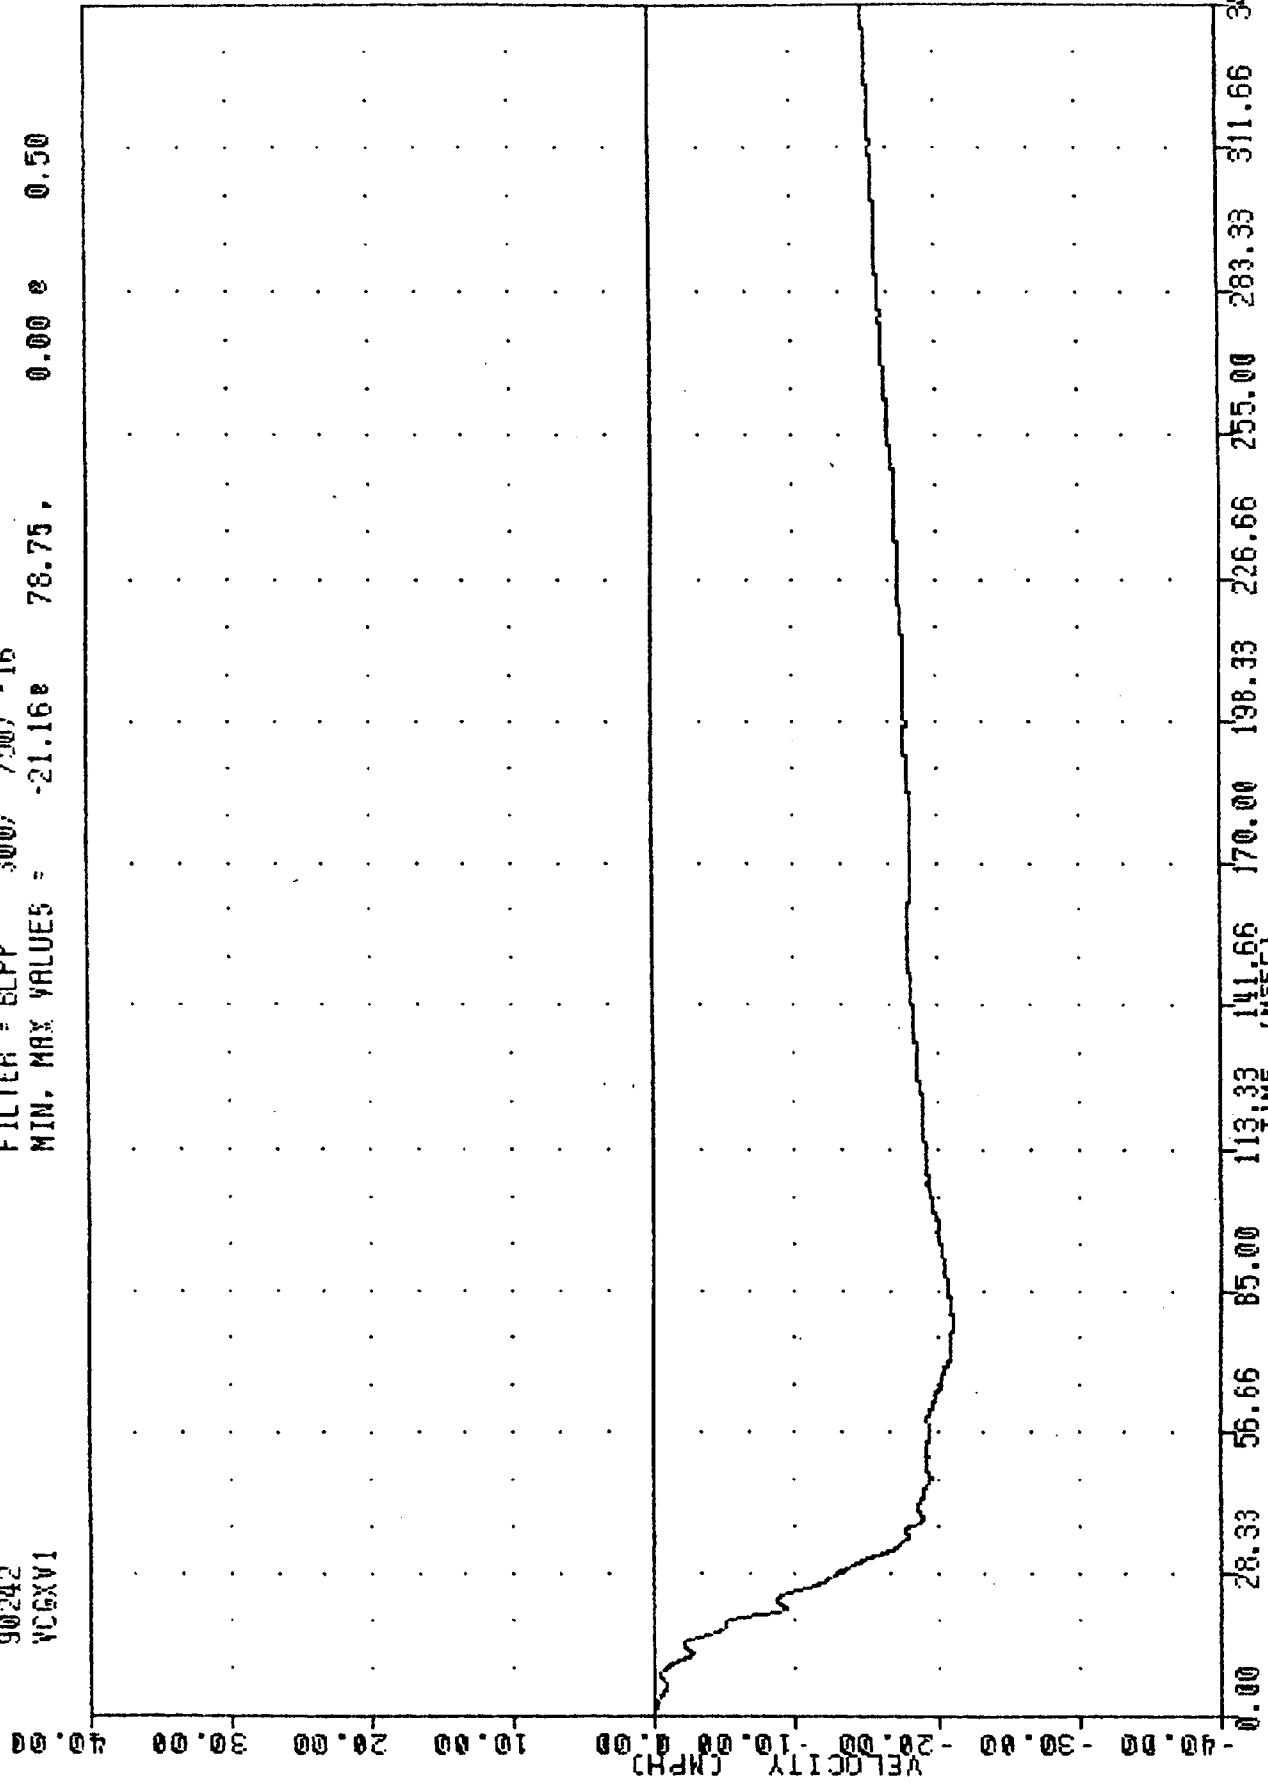
CONToured MOVING BARRIER INTO FORD ESCORT AT 39.8 MPH *4
 VEHICLE CG X-AXIS VELOCITY (IMPACT DIRECTION)

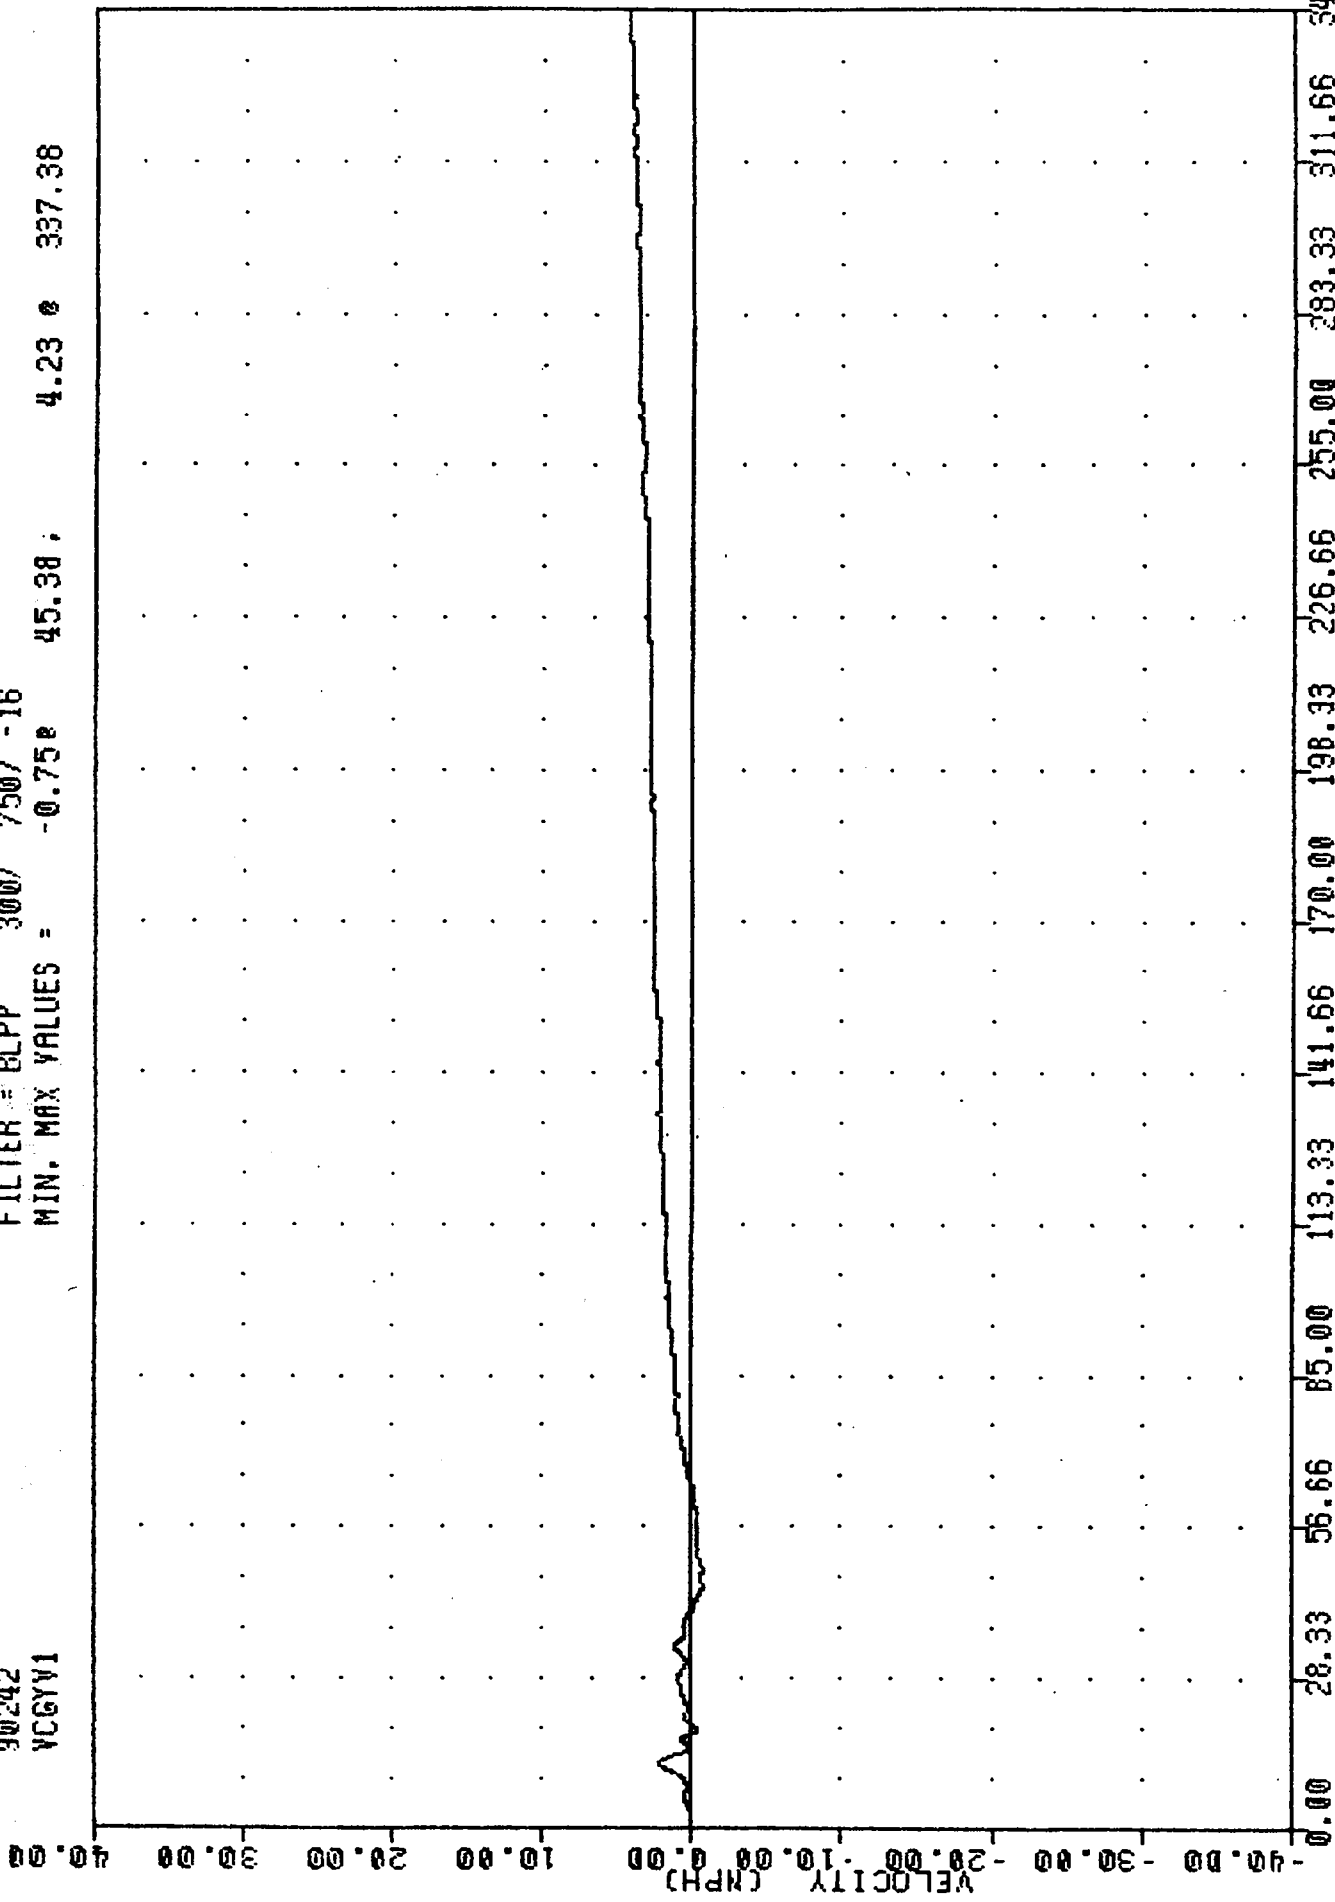
CONTOURED MOVING BARRIER INTO FORD ESCORT AT 39.8 MPH #4
 VEHICLE CG Y-AXIS VELOCITY (PERPENDICULAR TO IMPACT DIRECTION)

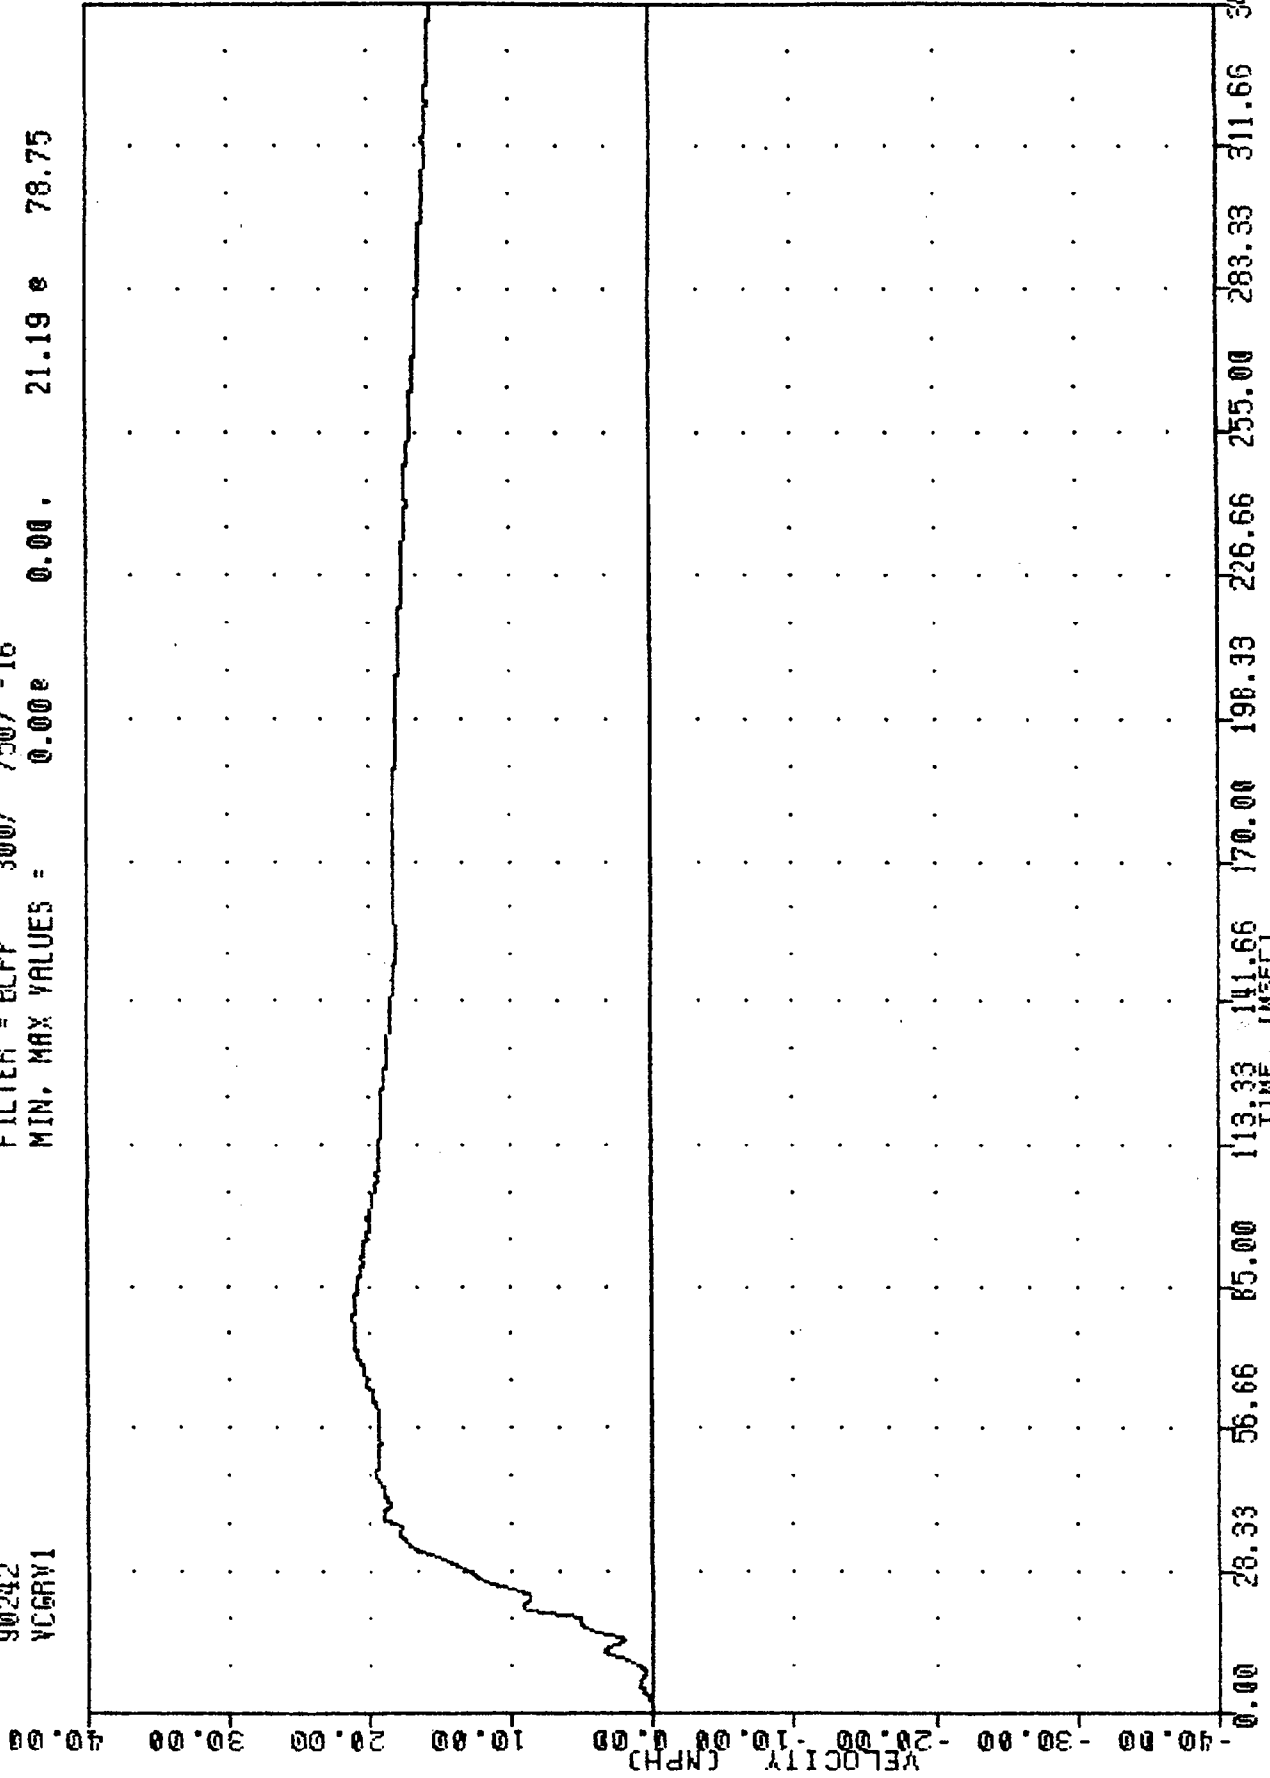
CONTOURED MOVING BARRIER INTO FORD ESCORT AT 39.8 MPH #4
 VEHICLE CG RESULTANT VELOCITY

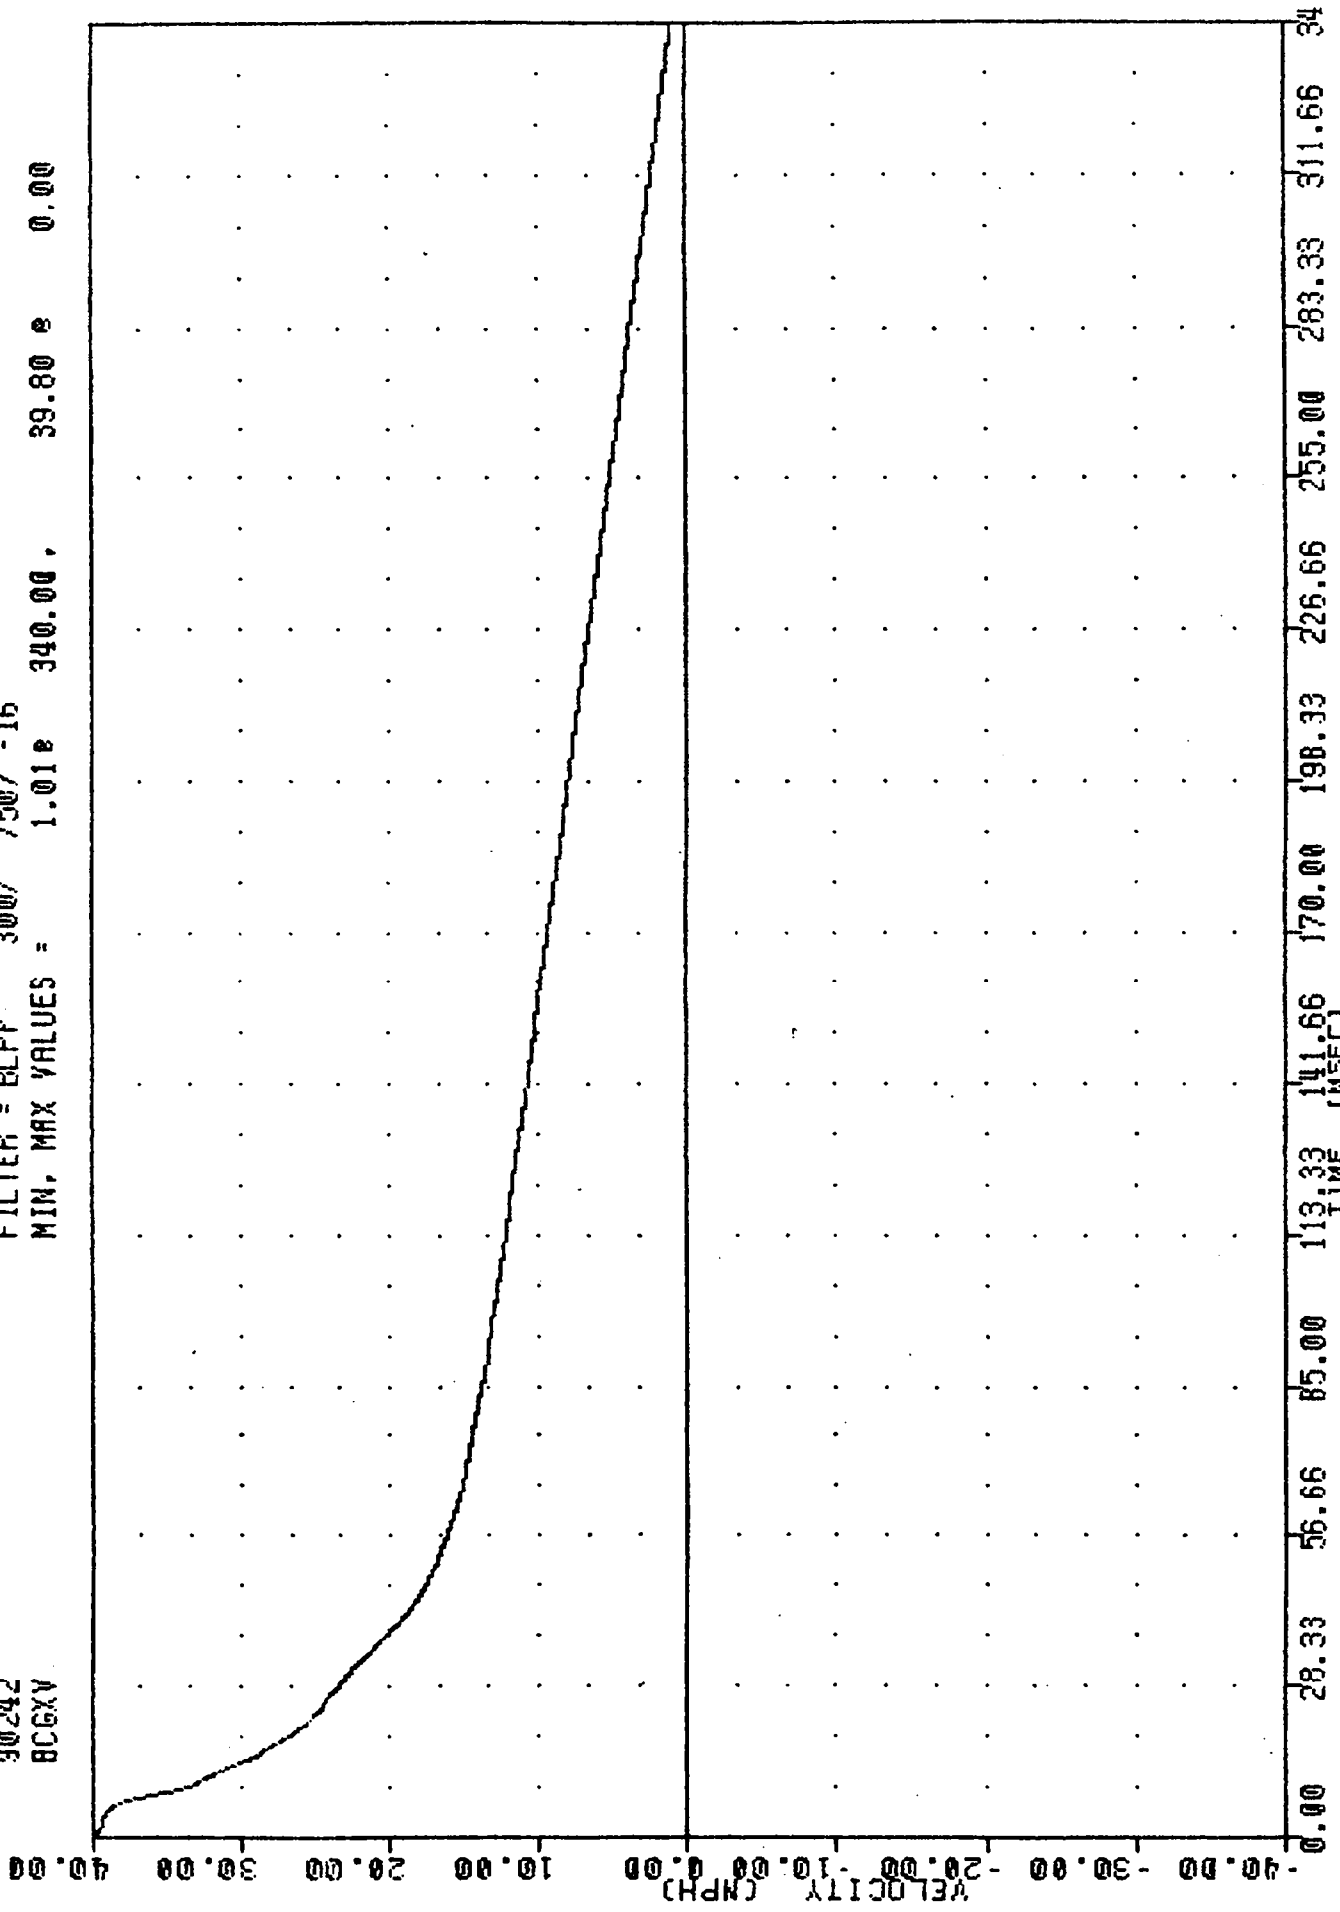
CONTOURED MOVING BARRIER INTO FORD ESCORT AT 39.8 MPH #4
 MOVING BARRIER CENTER OF GRAVITY X-AXIS VELOCITY

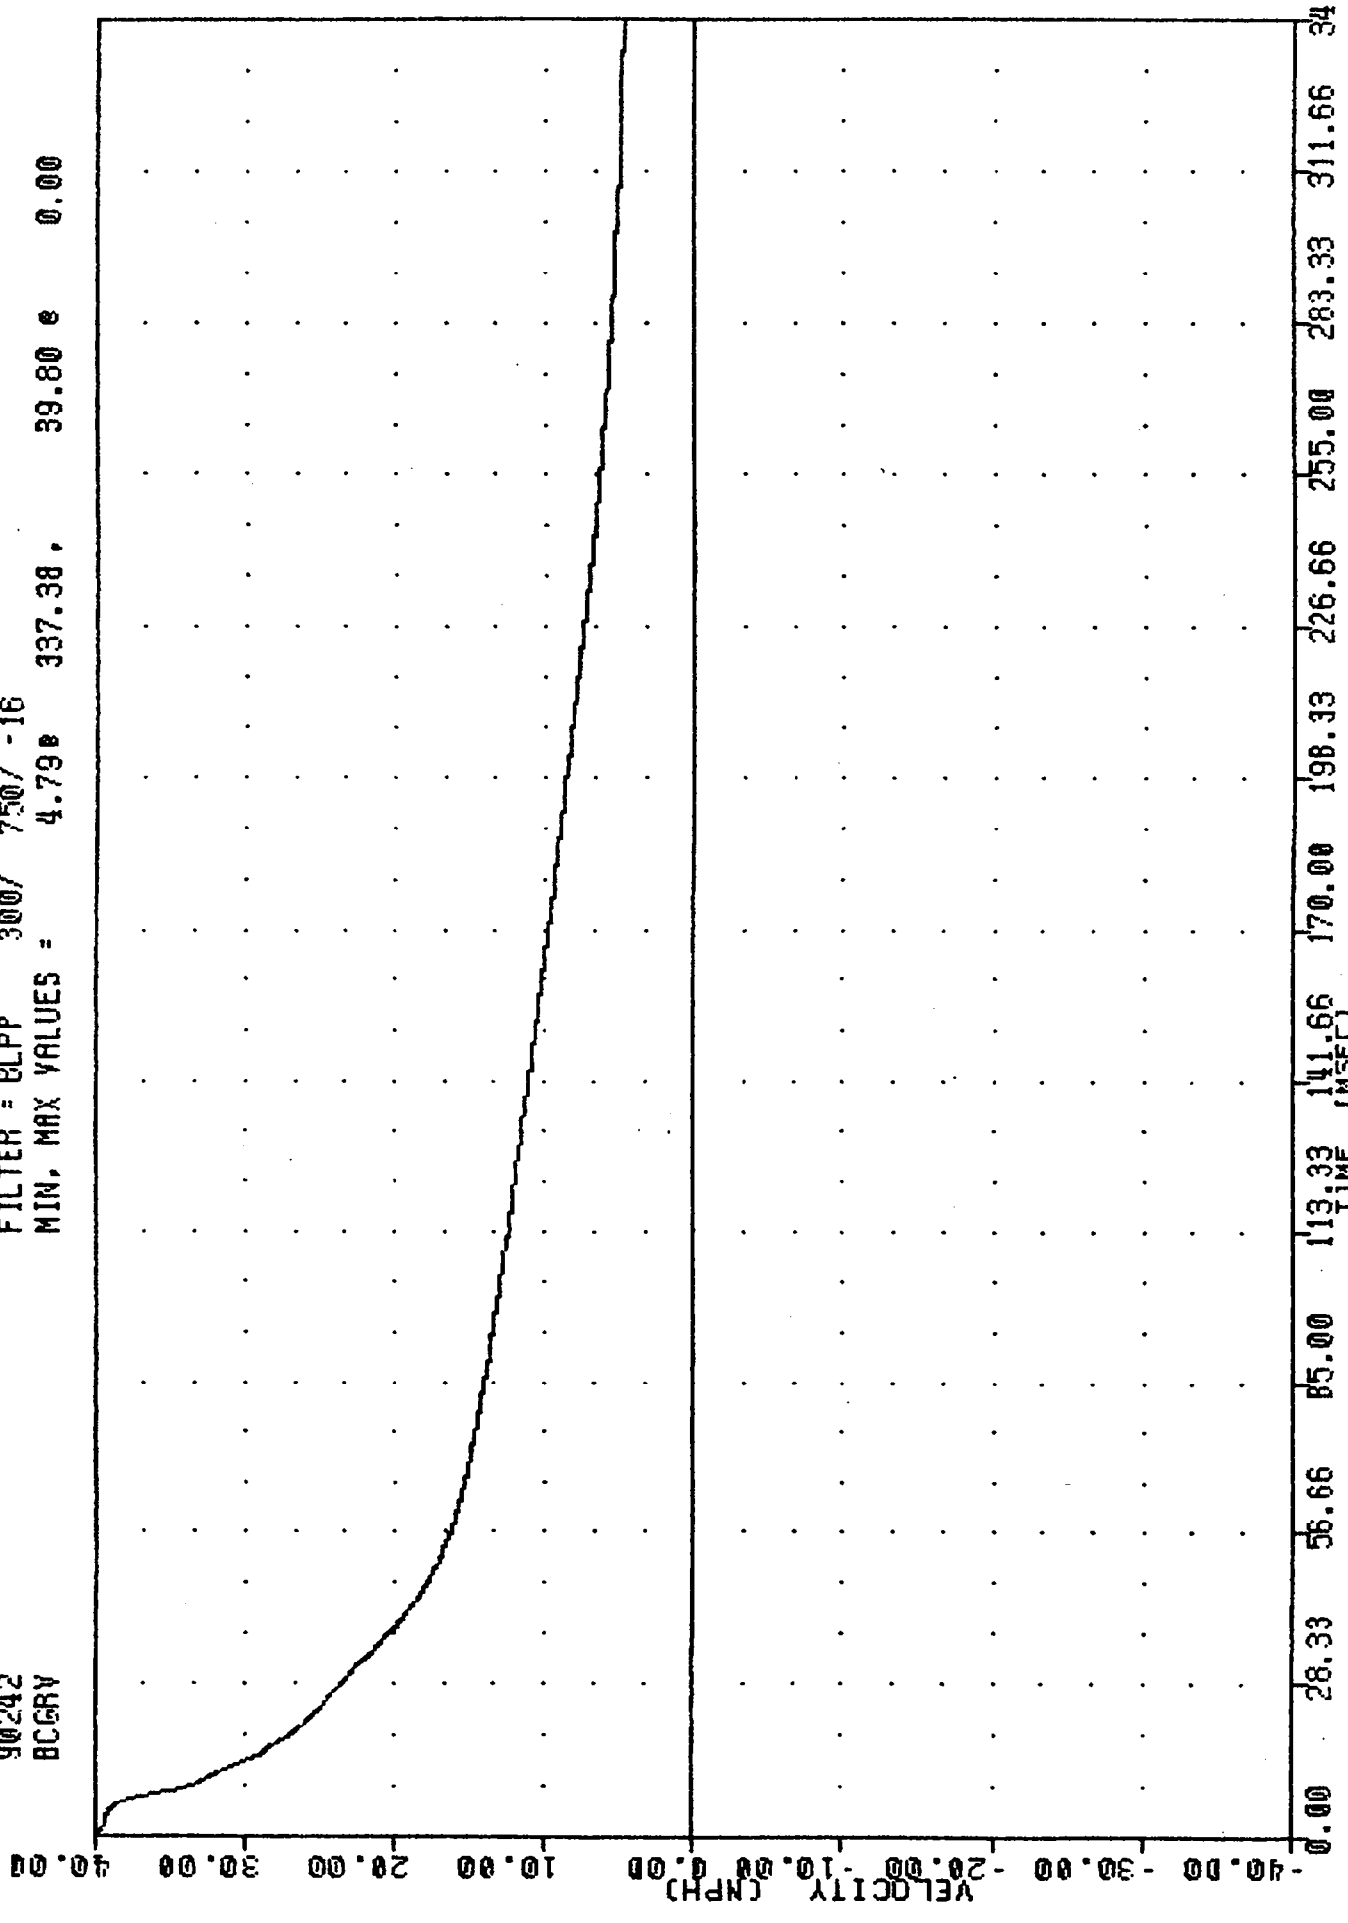
CONTOURED MOVING BARRIER INTO FORD ESCORT AT 39.8 MPH *4
 MOVING BARRIER CENTER OF GRAVITY RESULTANT VELOCITY
