**DOT HS 807 774  
Final Report**

**November 1990**

# **Final Report of 315° Contoured Moving Barrier Impact Into a 1984 Oldsmobile Delta 88 2-Door Sedan in Support of Crash III Damage Algorithm Reformation**

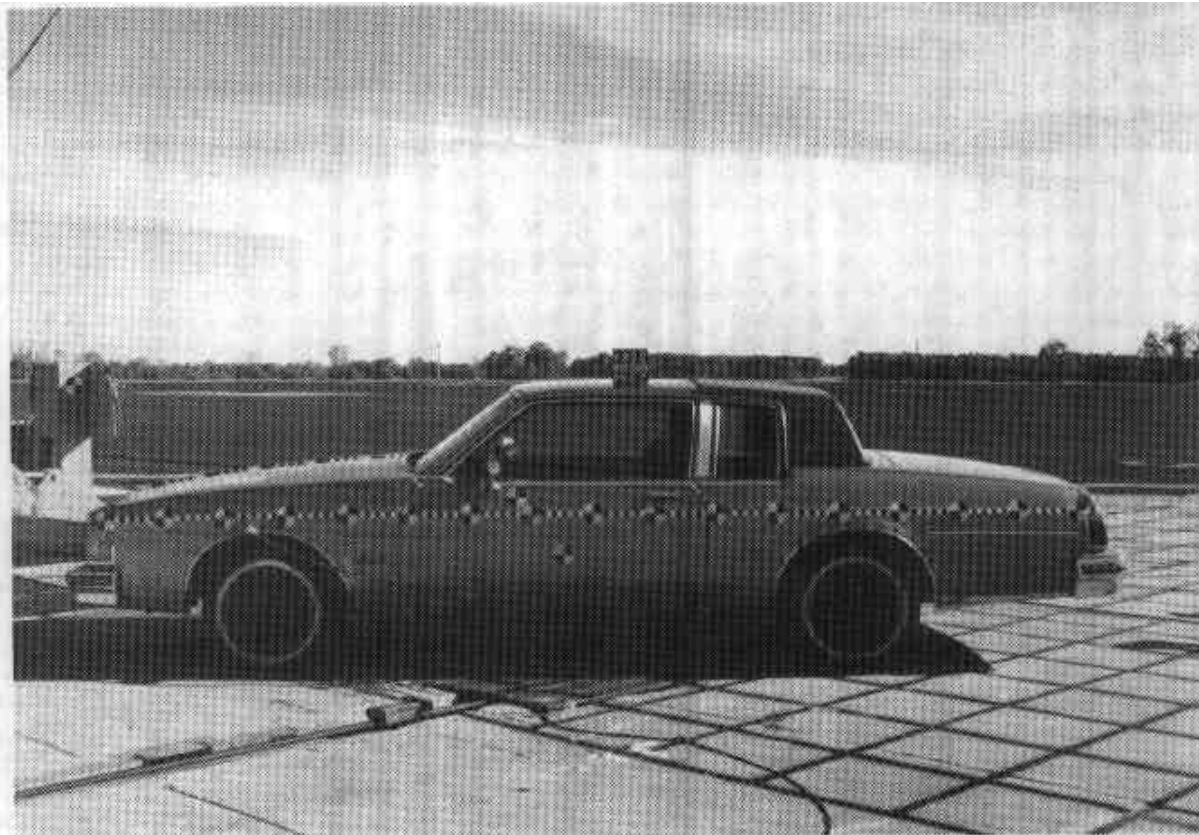
Figure A-2. POST-TEST FRONT VIEW

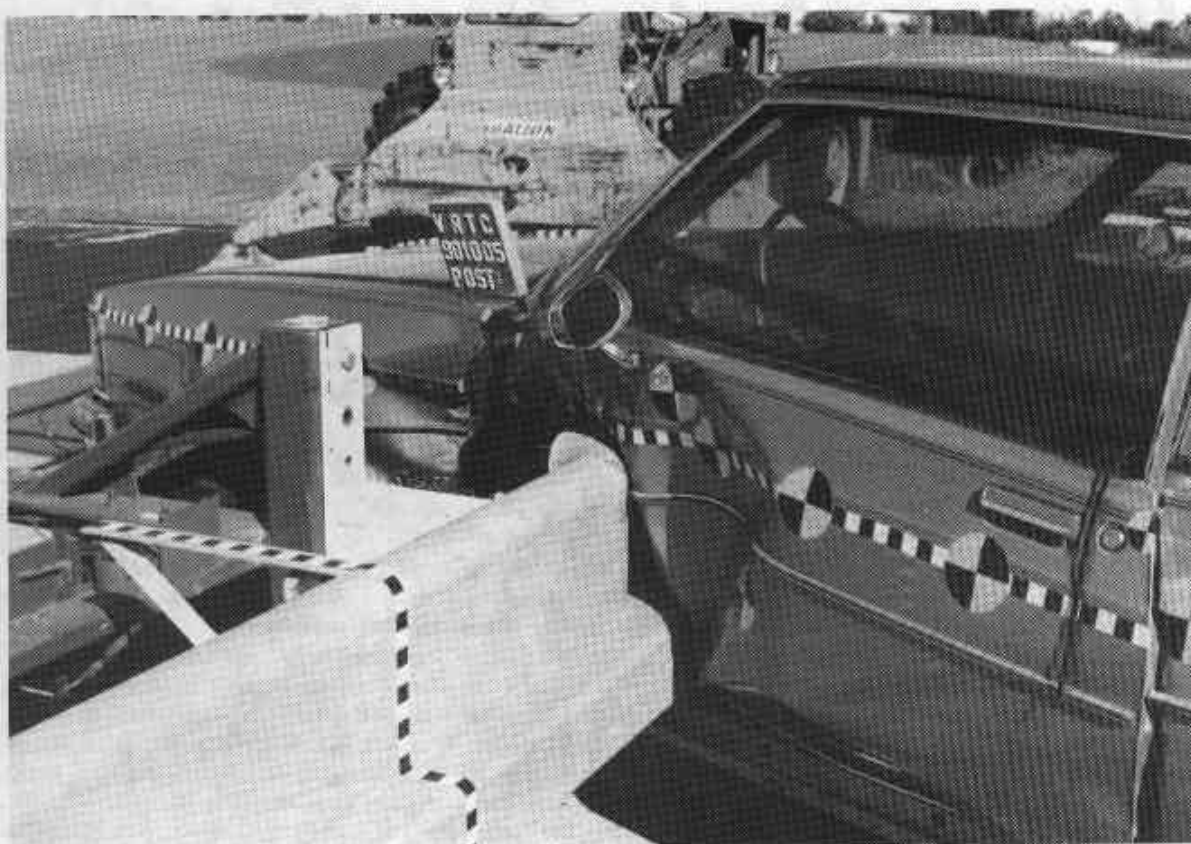
Figure A-5. POST-TEST LEFT SIDE CLOSE-UP - VIEW 1

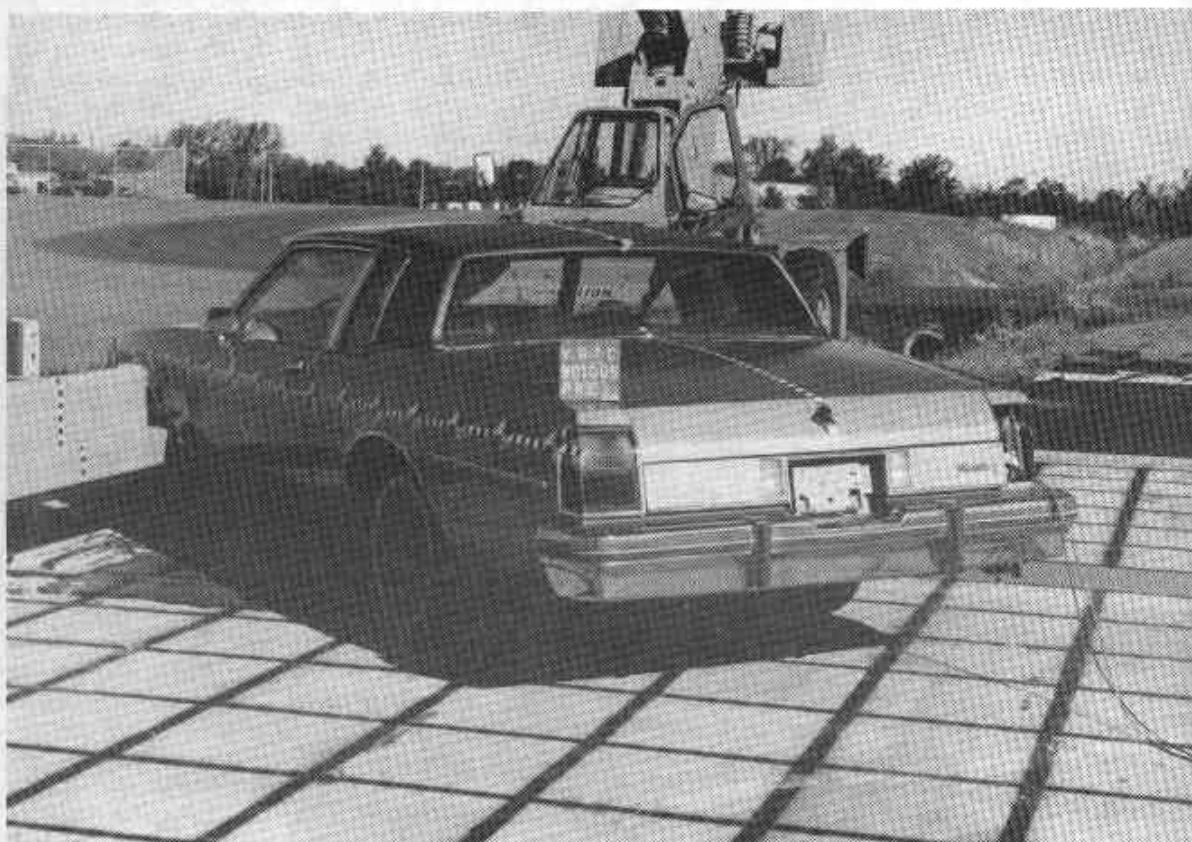
Figure A-8. POST-TEST RIGHT SIDE VIEW

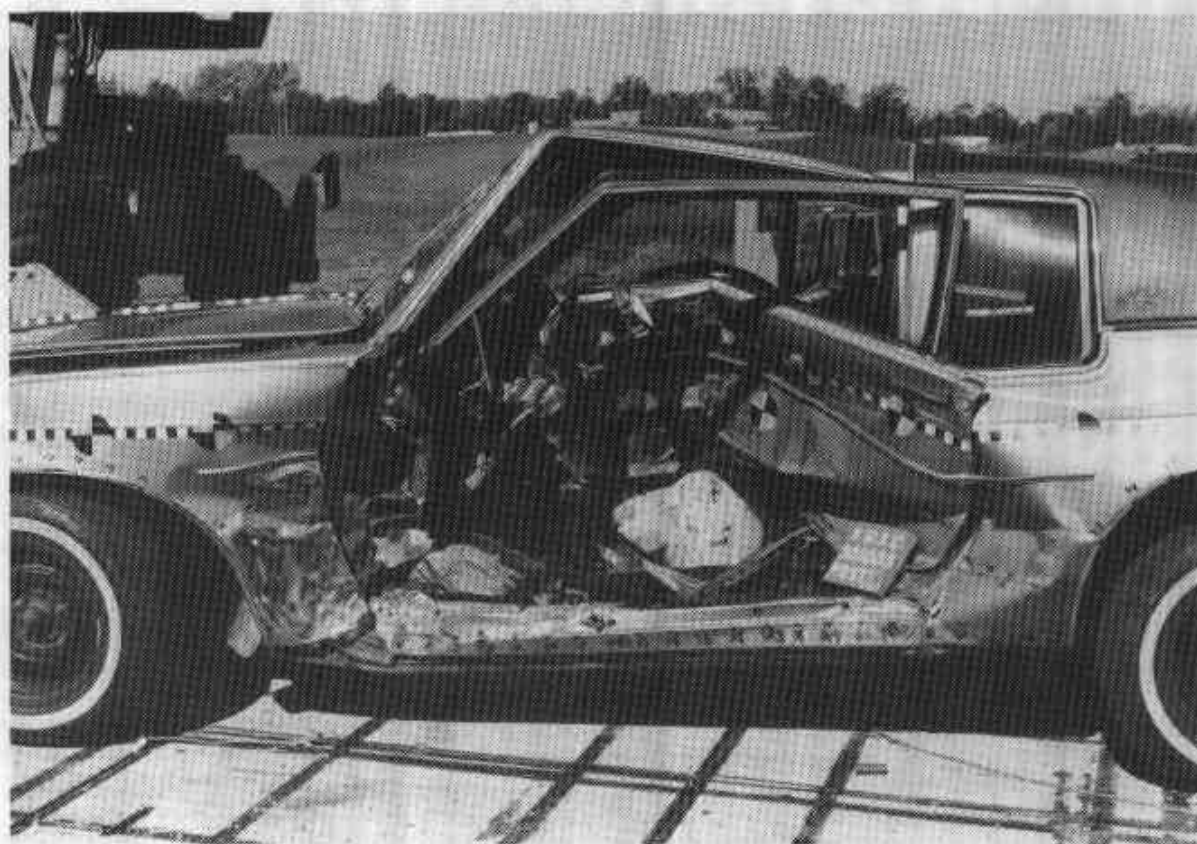
Figure A-3. POST-TEST LEFT SIDE VIEW

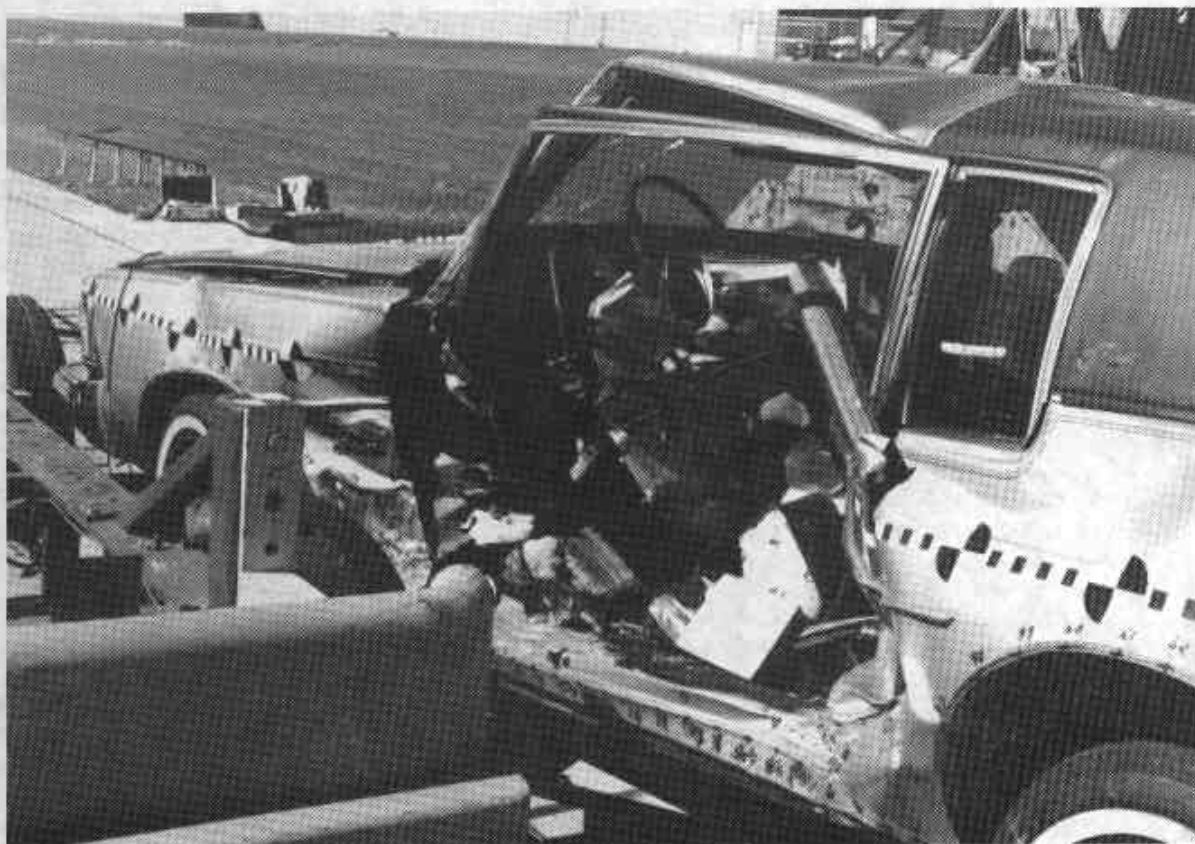
Figure A-4. POST-TEST LEFT SIDE CLOSE-UP - VIEW 1

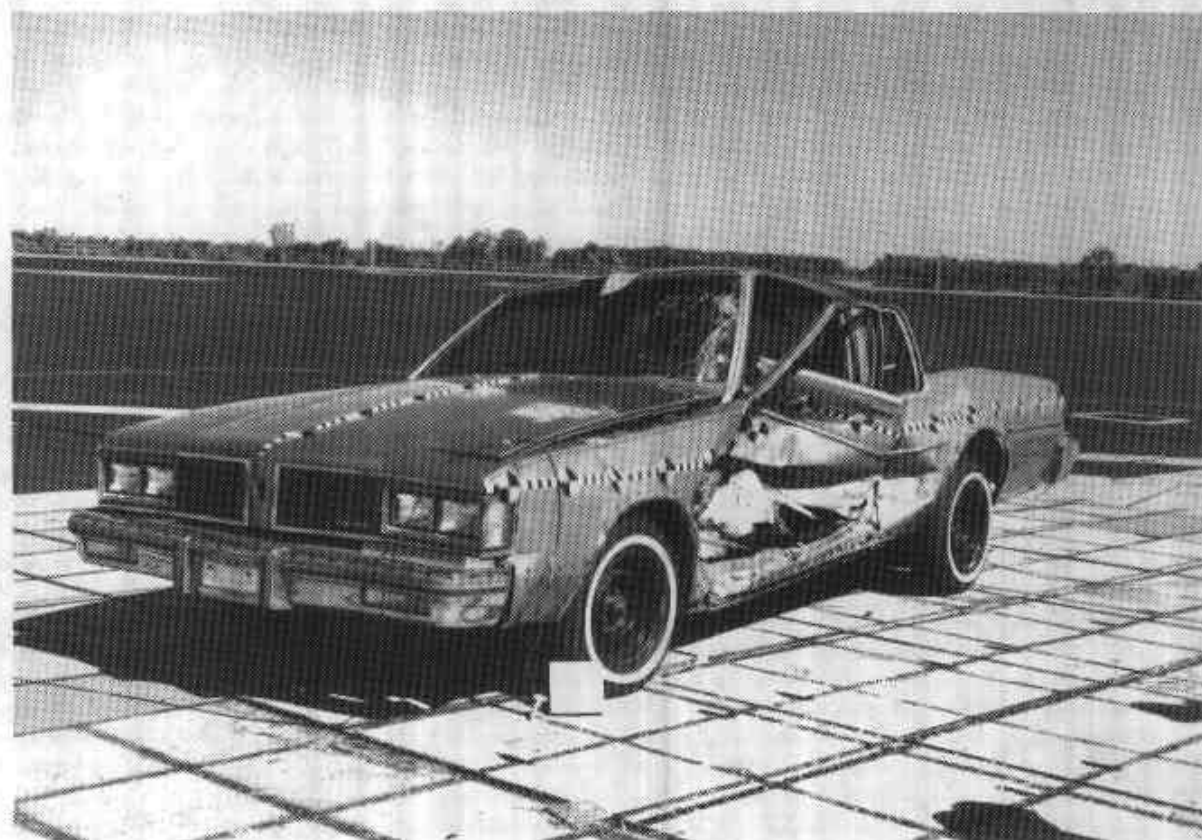
Figure A-7. POST-TEST LEFT REAR THREE-QUARTER VIEW

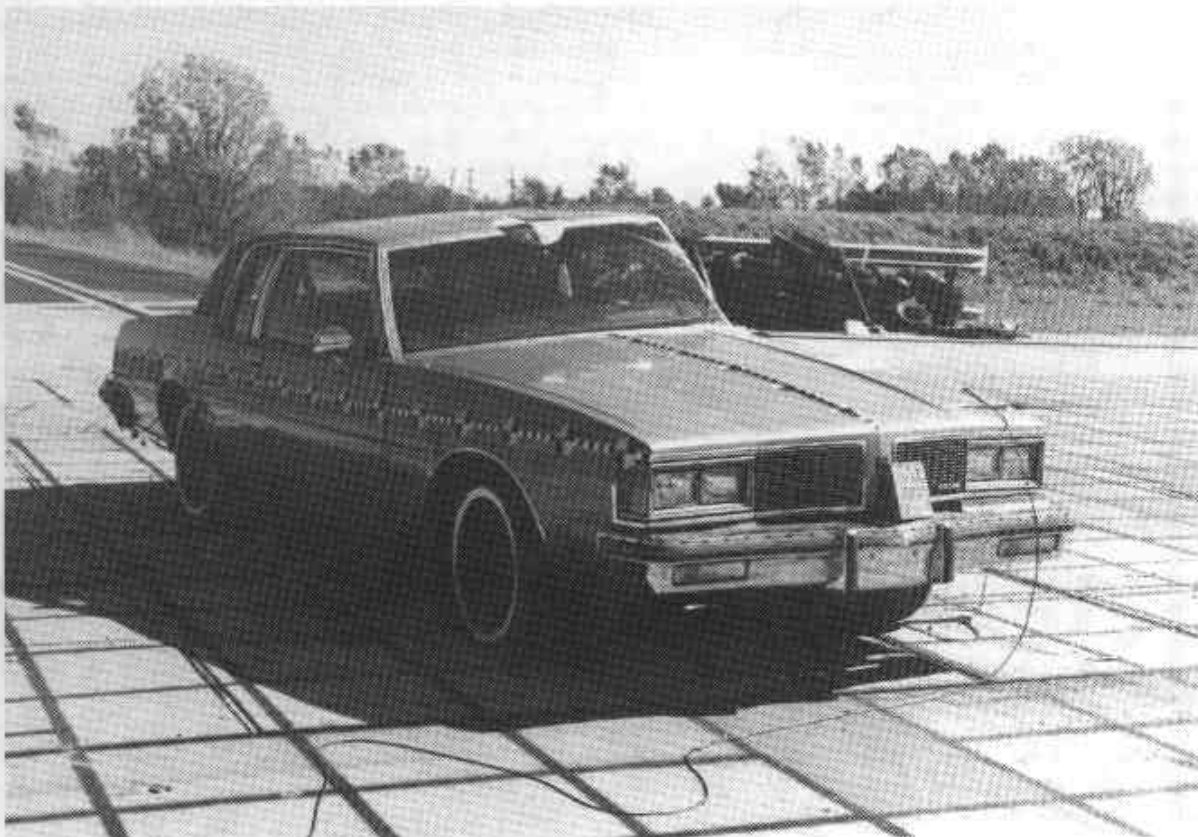
Figure A-8. POST-TEST LEFT FRONT THREE-QUARTER VIEW
