U.S. Department
of Transportation
**National Highway
Traffic Safety
Administration**

**DOT HS 807 772
Final Report**

Final Report of 315° Contoured Moving Barrier Impact Into a 1982 Audi 5000 4-Door Sedan in Support of Crash III Damage Algorithm Reformation

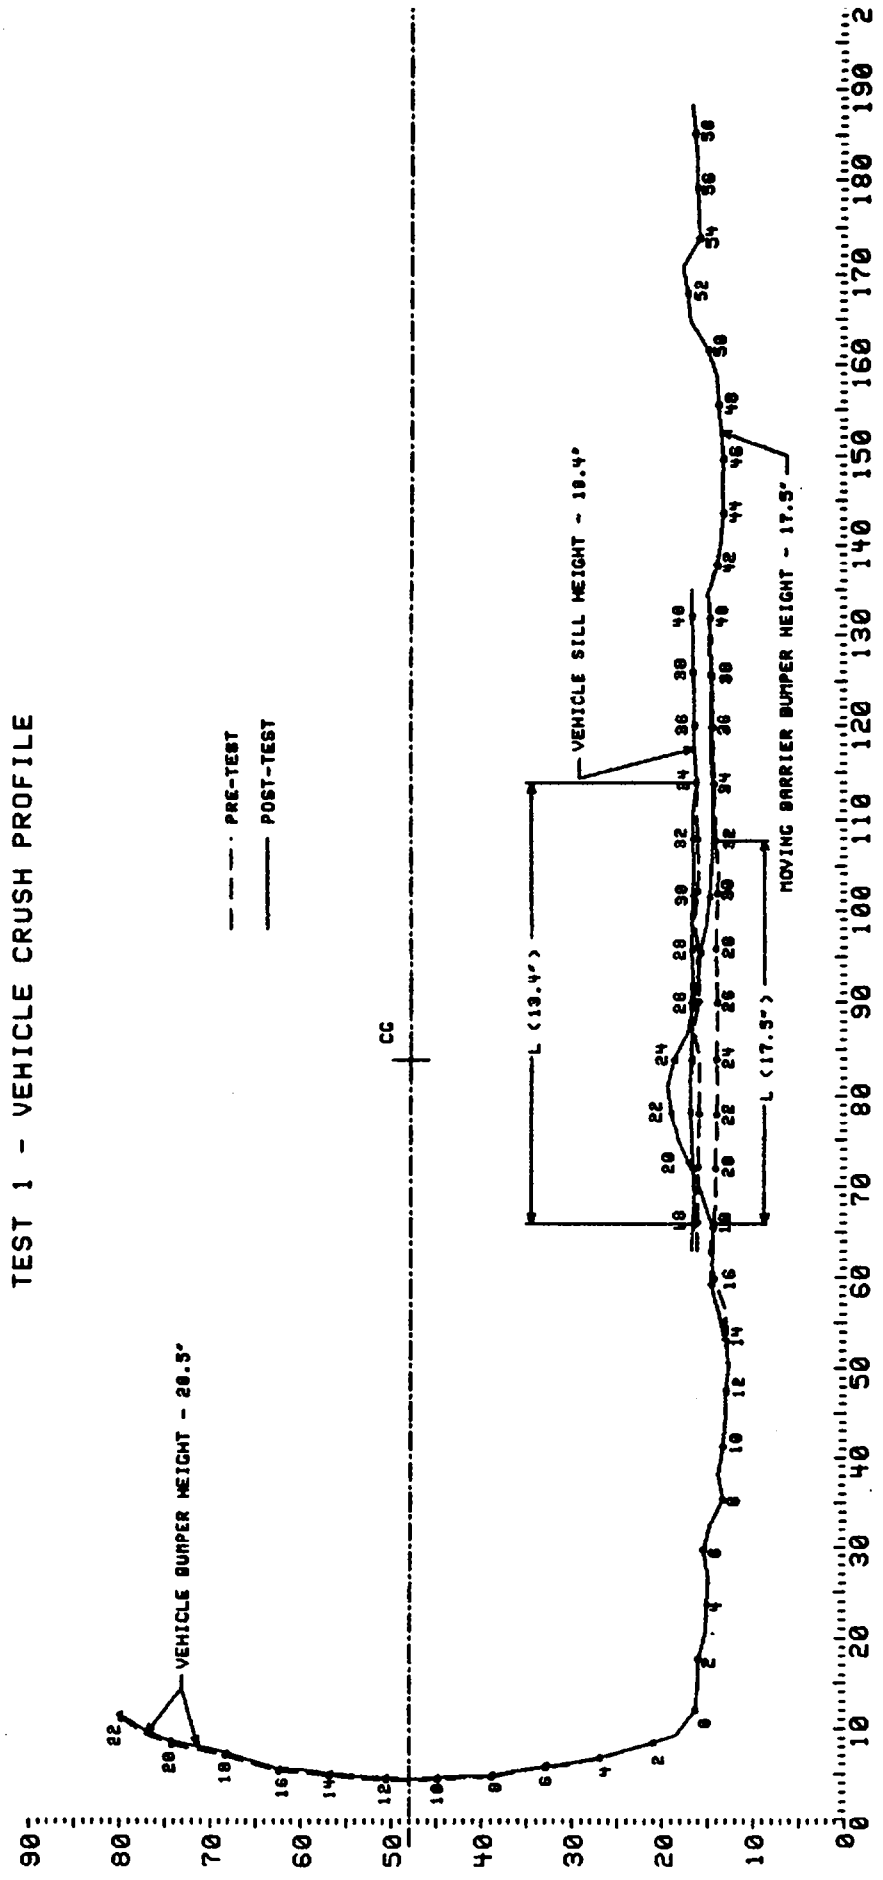
TEST 1 - VEHICLE CRUSH PROFILE

A reference line was constructed connecting the end points of the vehicle's damaged surface. Six equally spaced points were defined along the reference line and labeled C1 through C6 (or S1 through S6 for sill height crush) with the rearmost point of the damaged surface defined as C1 (or S1) and the forwardmost point defined as C6 (or S6). The actual crush distance is a measurement taken perpendicular to and from the reference line at each point (C1 through C6 or S1 through S6) to the vehicle's damaged surface.

NOTE: L INDICATES THE LENGTH OF THE DAMAGED SURFACE

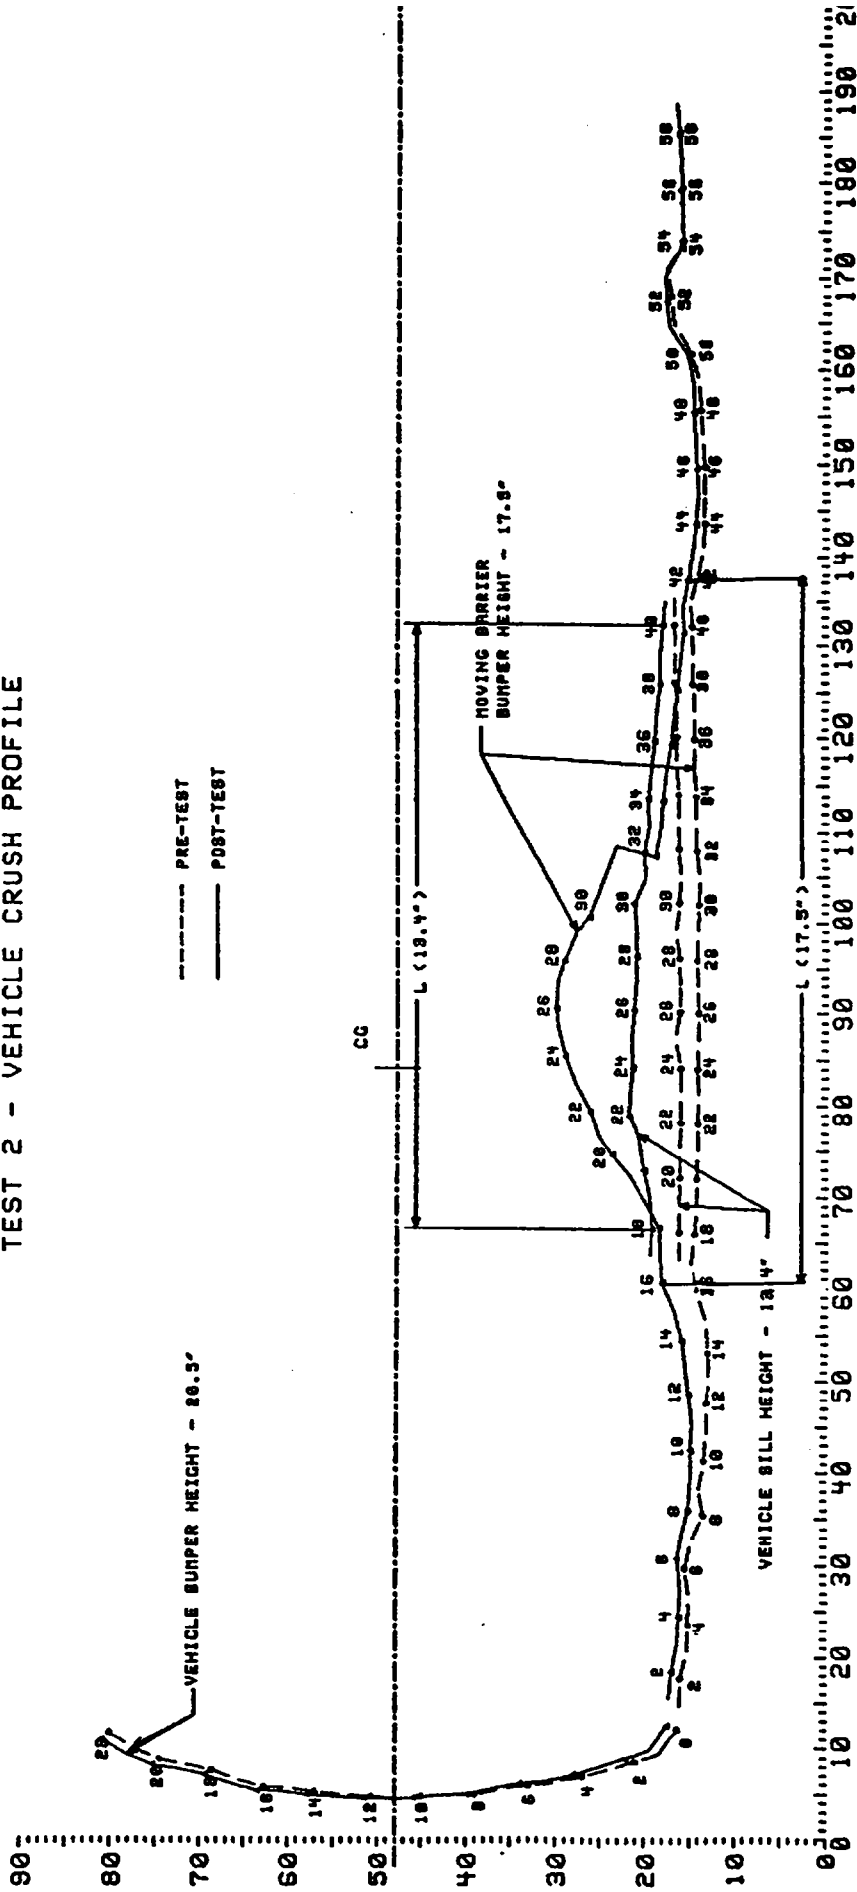
TEST 2 - VEHICLE CRUSH PROFILE

A reference line was constructed connecting the end points of the vehicle's damaged surface. Six equally spaced points were defined along the reference line and labeled C1 through C6 (or S1 through S6 for sill height crush) with the rearmost point of the damaged surface defined as C1 (or S1) and the forwardmost point defined as C6 (or S6). The actual crush distance is a measurement taken perpendicular to and from the reference line at each point (C1 through C6 or S1 through S6) to the vehicle's damaged surface.

NOTE: L INDICATES THE LENGTH OF THE DAMAGED SURFACE

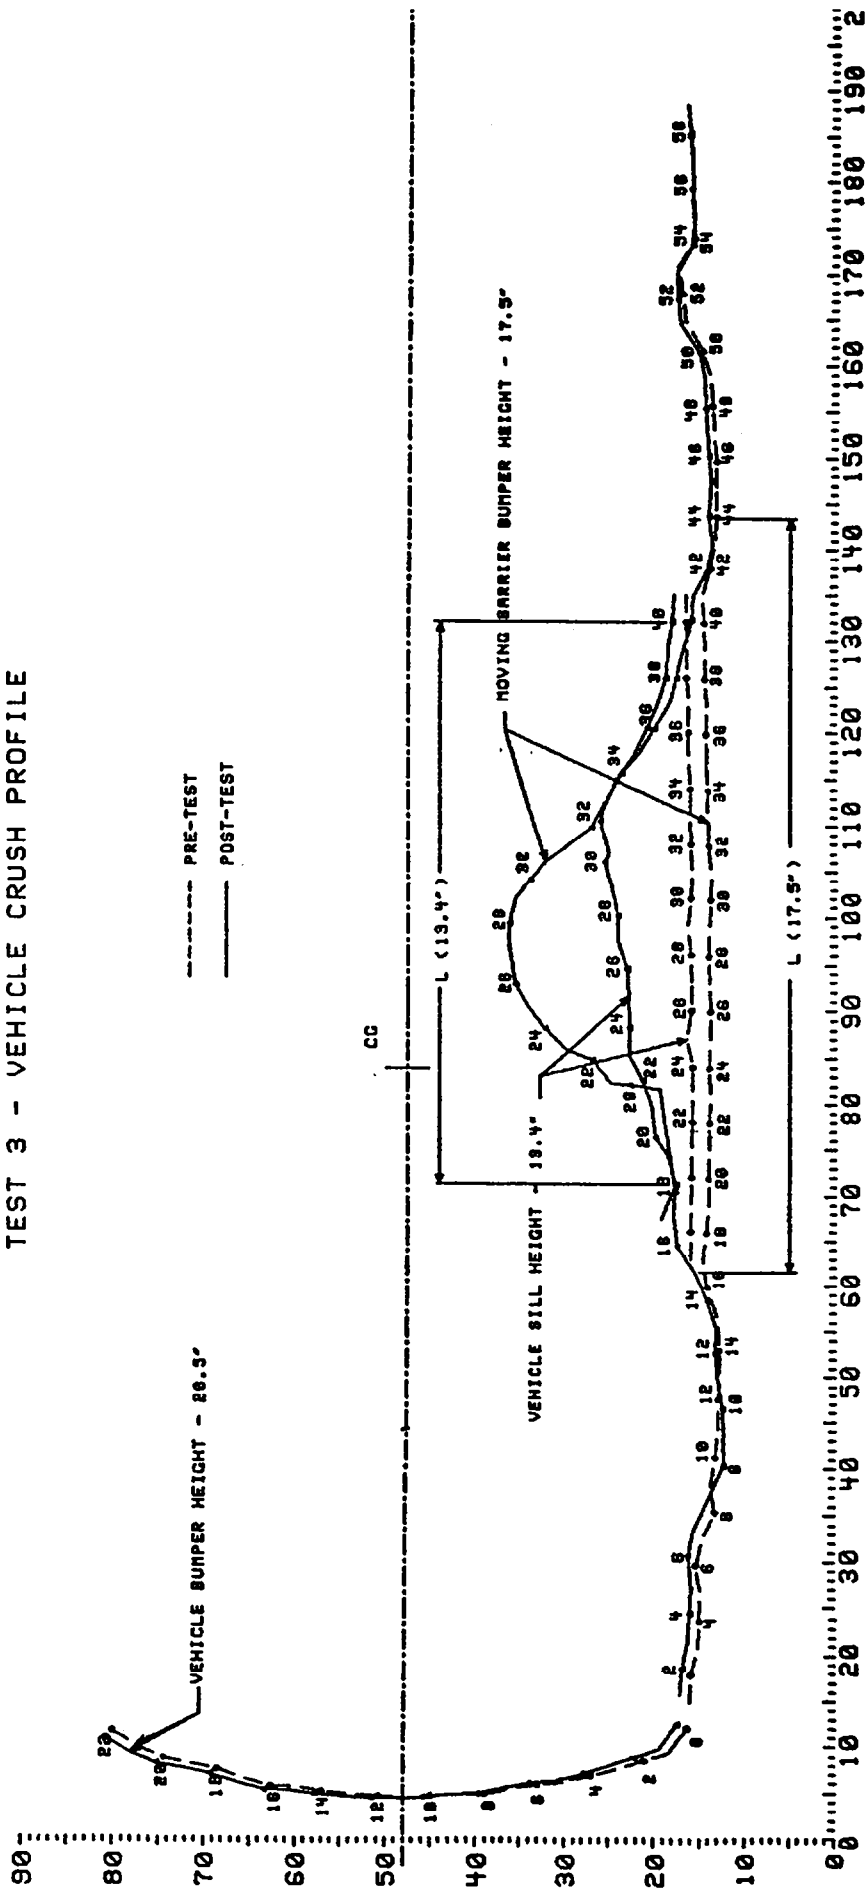
TEST 3 - VEHICLE CRUSH PROFILE

A reference line was constructed connecting the end points of the vehicle's damaged surface. Six equally spaced points were defined along the reference line and labeled C1 through C6 (or S1 through S6 for sill height crush) with the rearmost point of the damaged surface defined as C1 (or S1) and the forwardmost point defined as C6 (or S6). The actual crush distance is a measurement taken perpendicular to and from the reference line at each point (C1 through C6 or S1 through S6) to the vehicle's damaged surface.

NOTE: L INDICATES THE LENGTH OF THE DAMAGED SURFACE

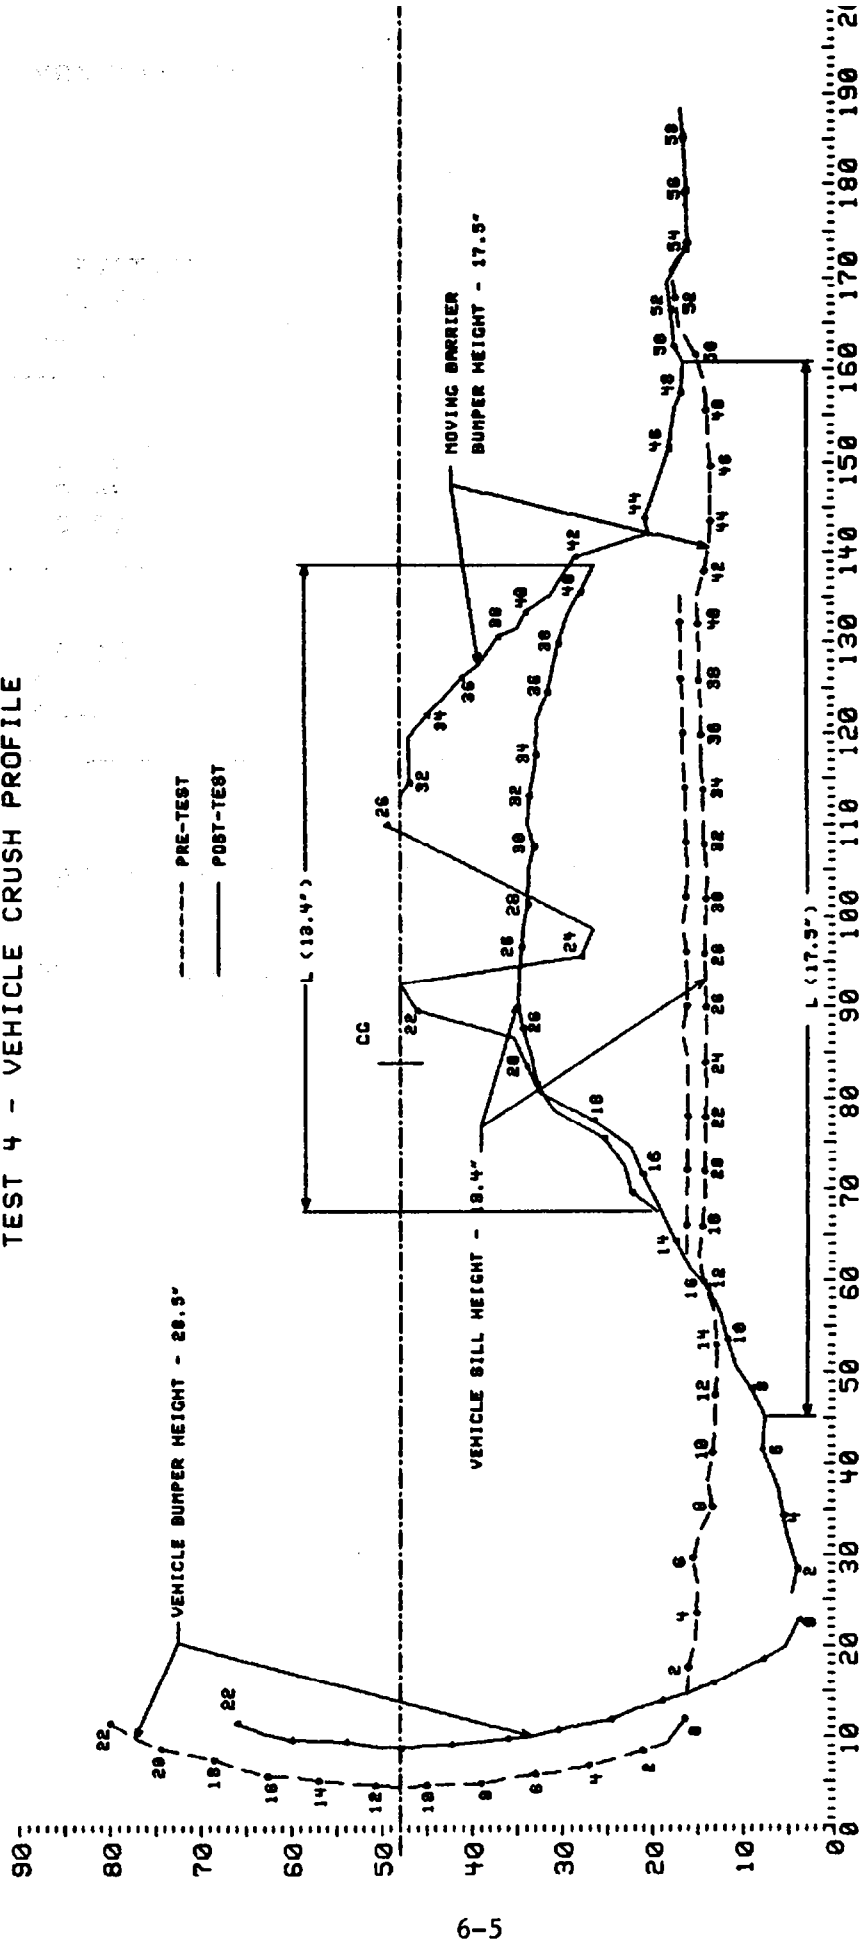
TEST 4 - VEHICLE CRUSH PROFILE

A reference line was constructed connecting the end points of the vehicle's damaged surface. Six equally spaced points were defined along the reference line and labeled C1 through C6 (or S1 through S6 for sill height crush) with the rearmost point of the damaged surface defined as C1 (or S1) and the forwardmost point defined as C6 (or S6). The actual crush distance is a measurement taken perpendicular to and from the reference line at each point (C1 through C6 or S1 through S6) to the vehicle's damaged surface.

NOTE: L INDICATES THE LENGTH OF THE DAMAGED SURFACE

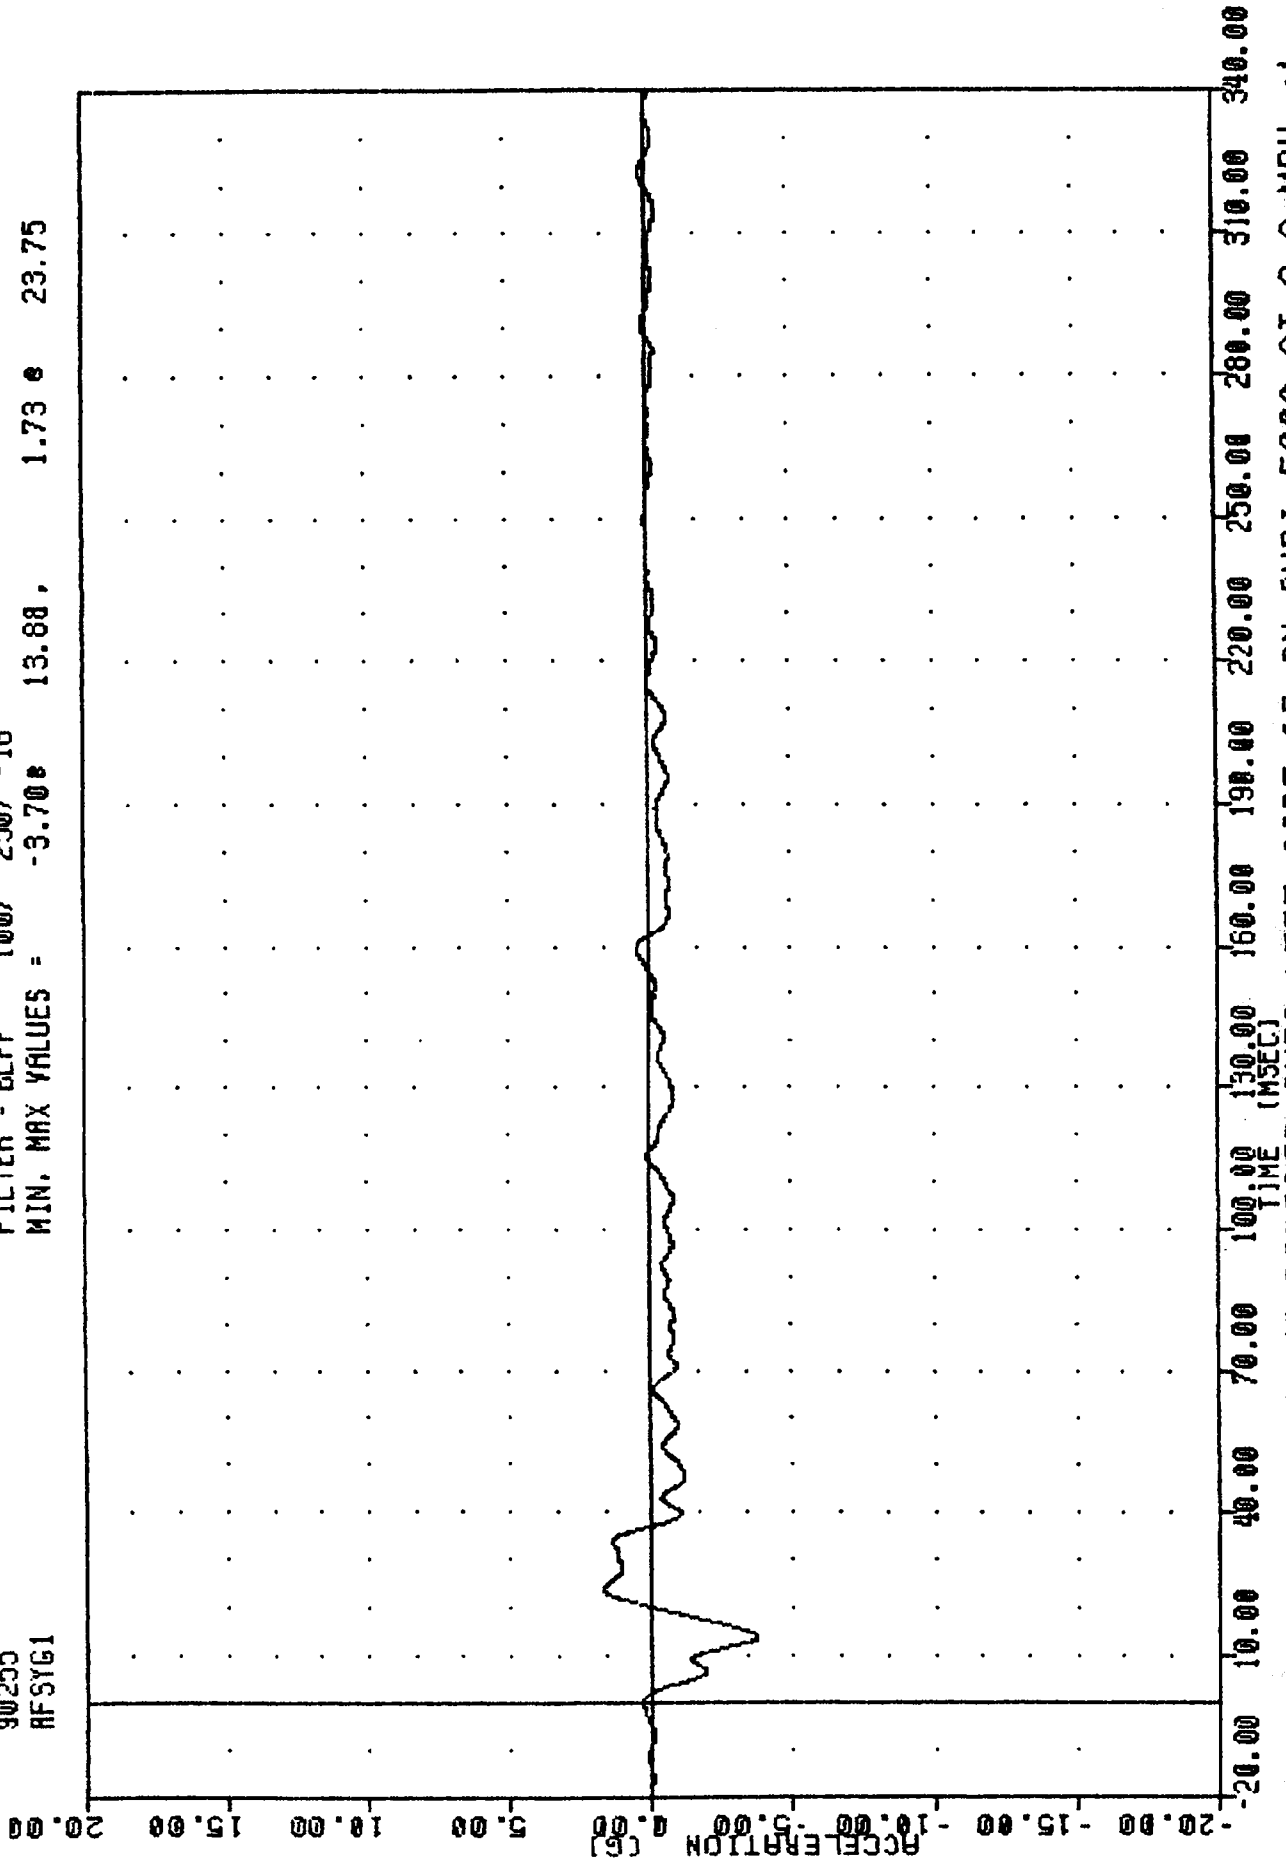
CONTOURED MOVING BARRIER INTO LEFT SIDE OF AN AUDI 5000 AT 9.8 MPH *1
RIGHT FRONT SILL Y-AXIS ACCELERATION

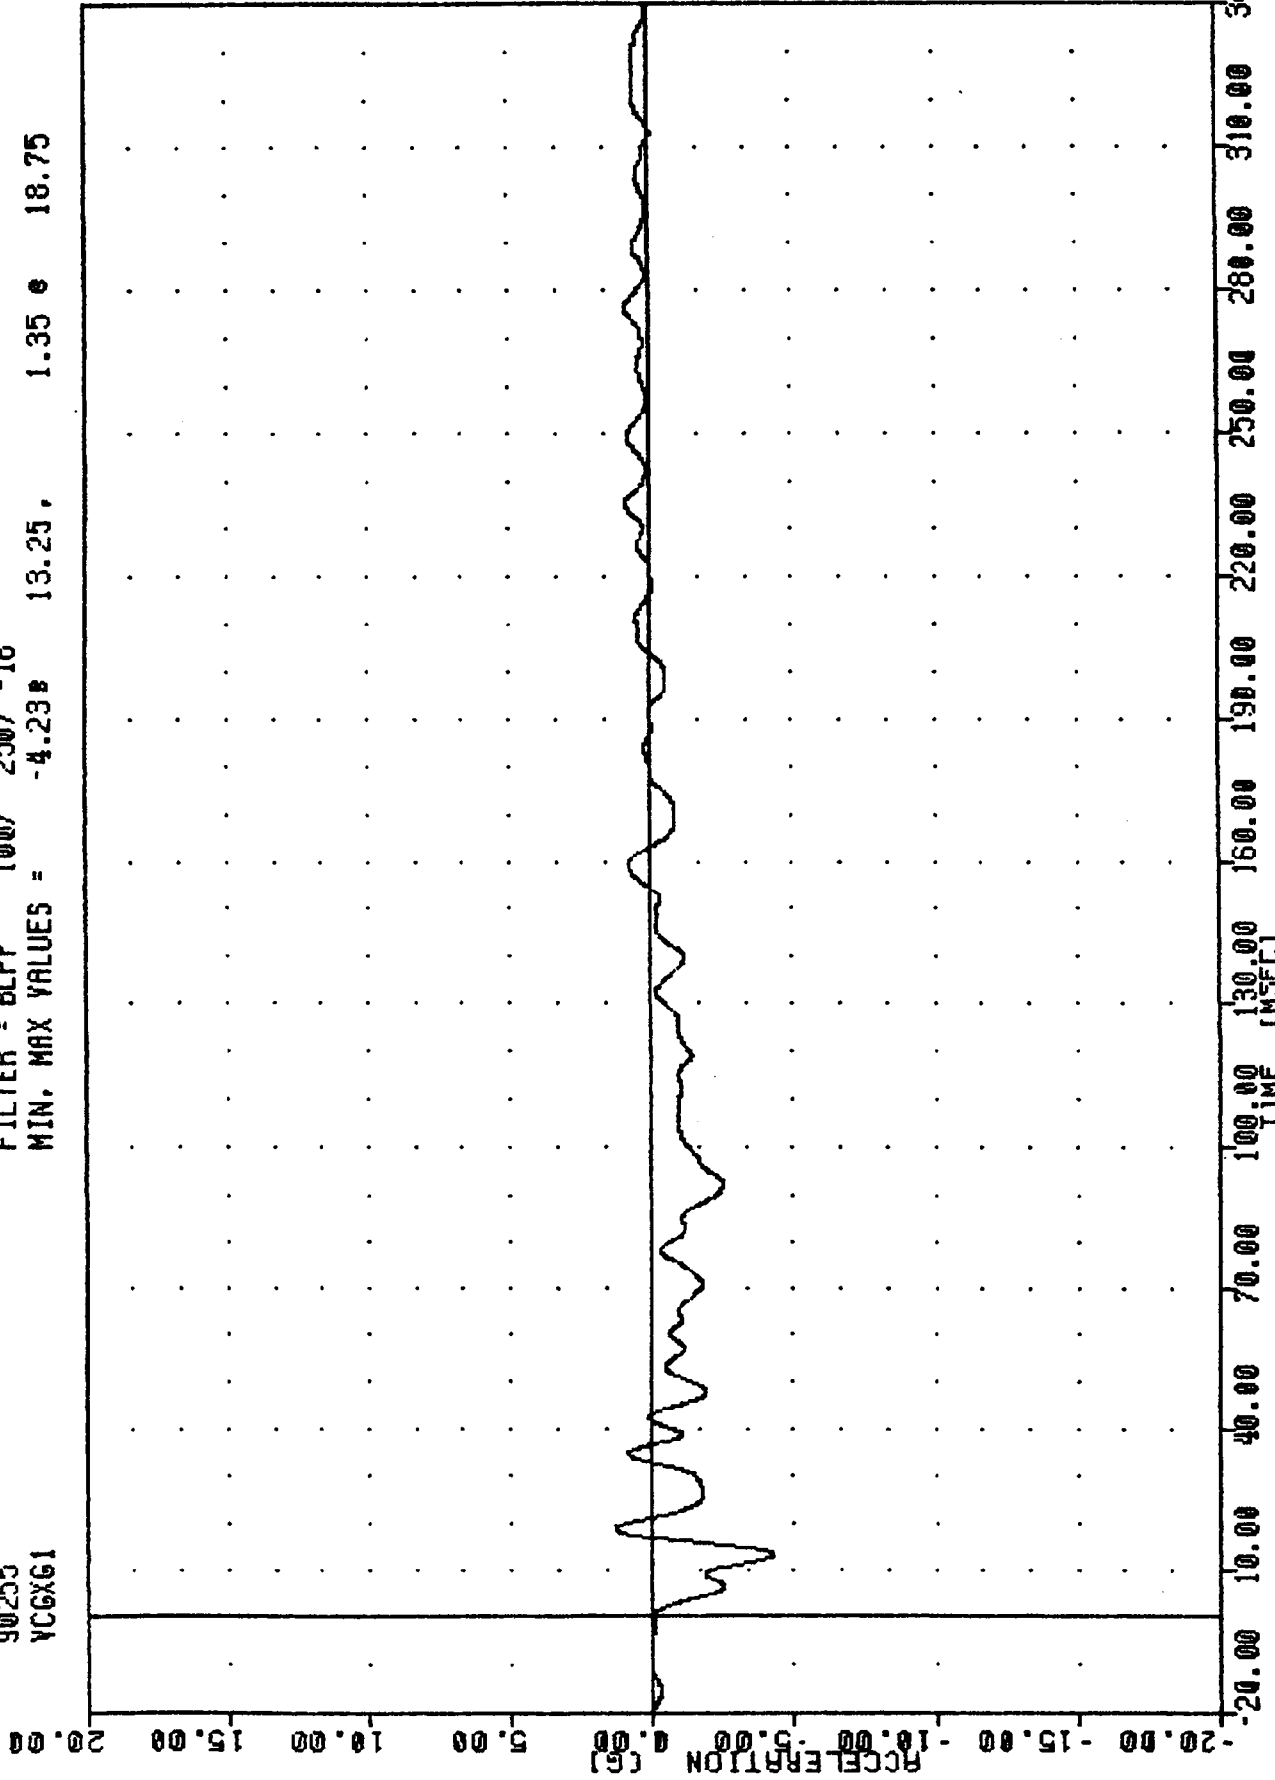
CONTOURED MOVING BARRIER INTO LEFT SIDE OF AN AUDI 5000 AT 9.8 MPH #1
 VEHICLE CG X-AXIS ACCELERATION (IMPACT DIRECTION)

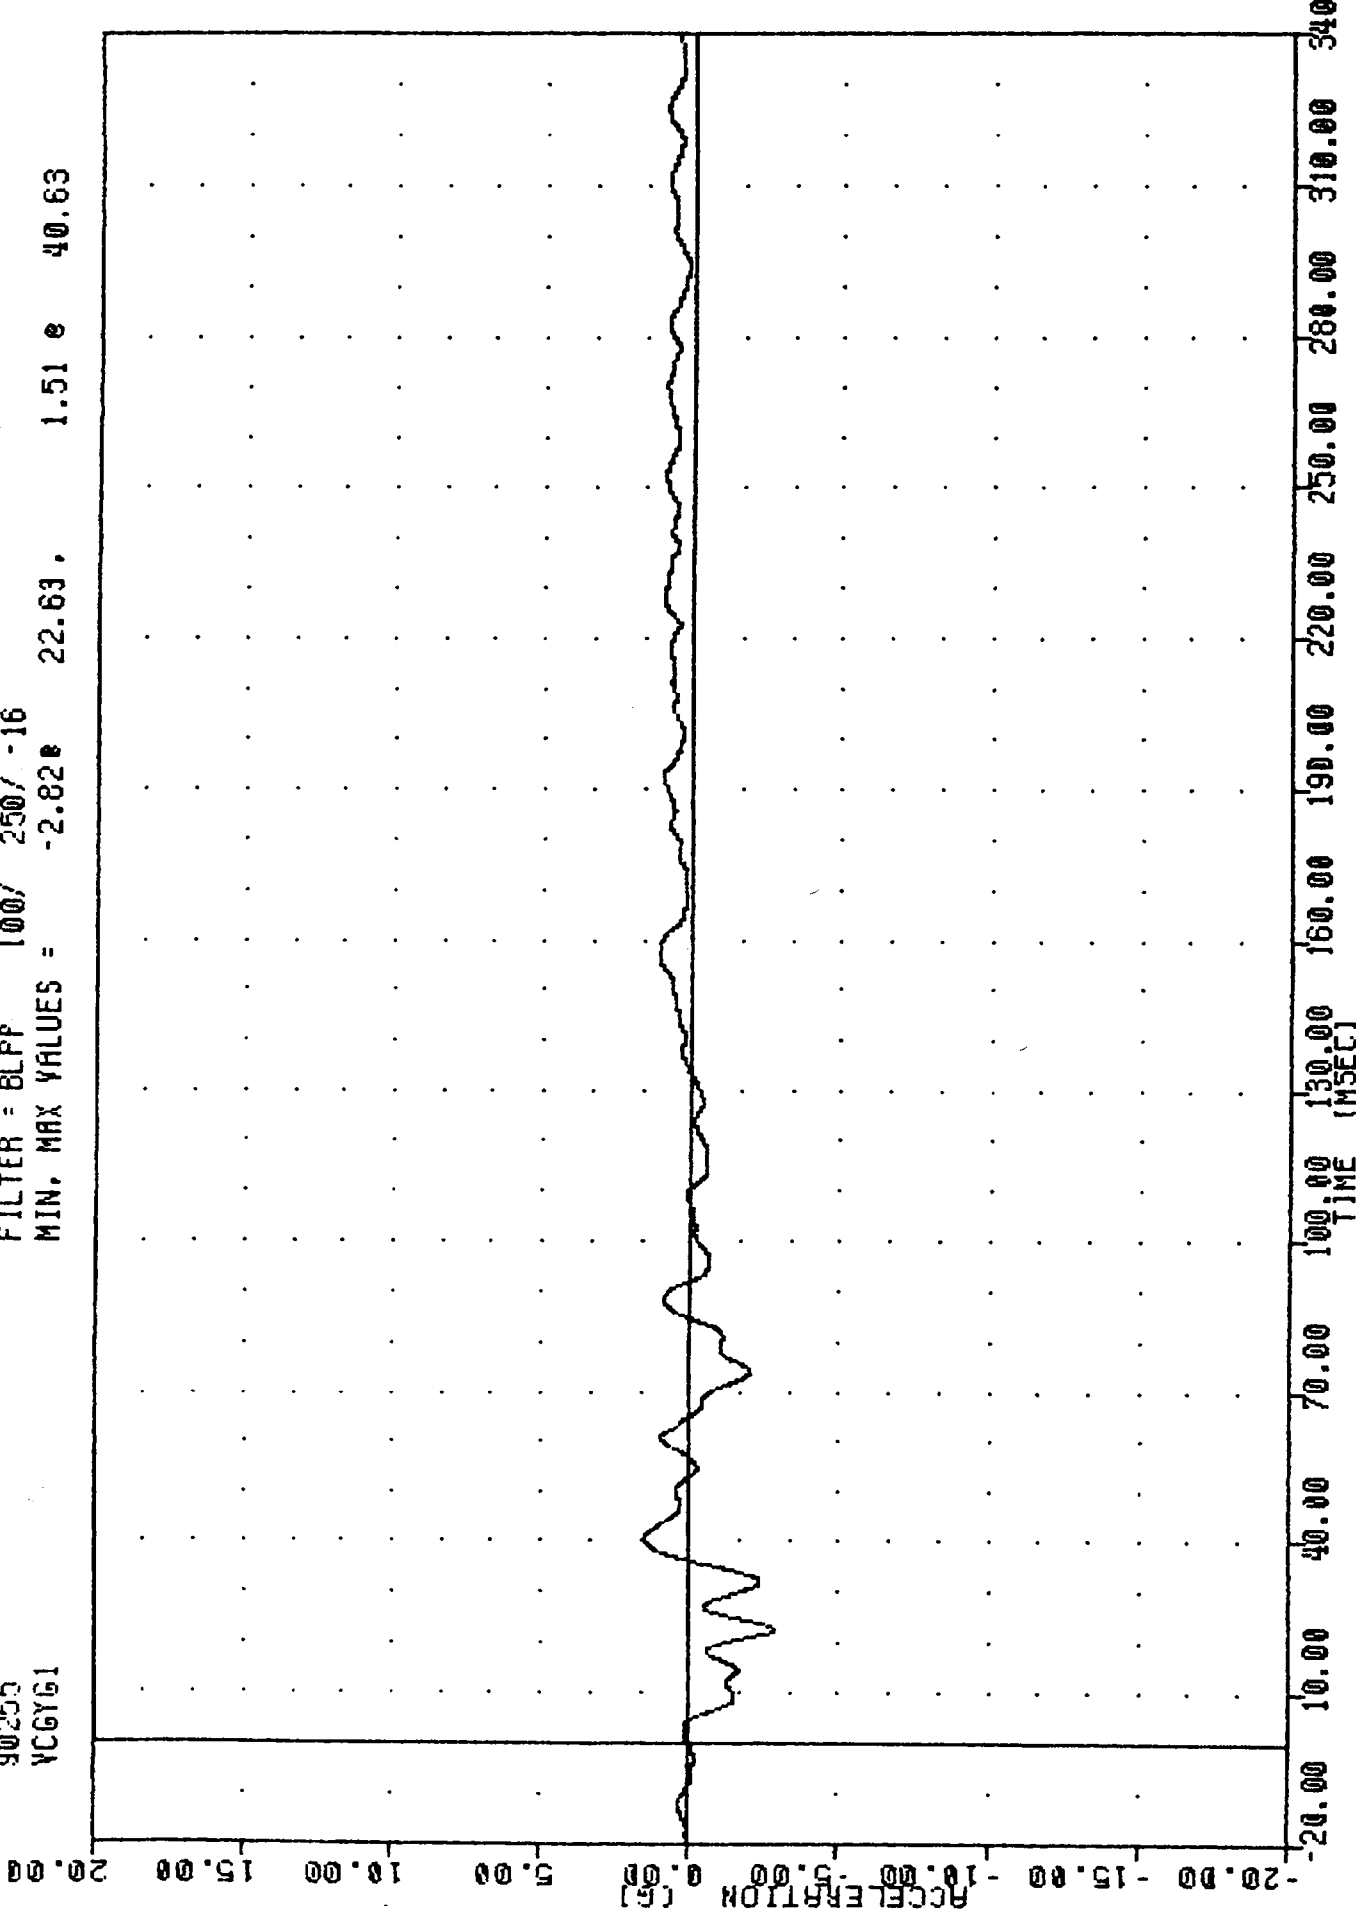
CONTOURED MOVING BARRIER INTO LEFT SIDE OF AN AUDI 5000 AT 9.8 MPH #1
VEHICLE CG Y-AXIS ACCELERATION (PERPENDICULAR TO IMPACT DIRECTION)

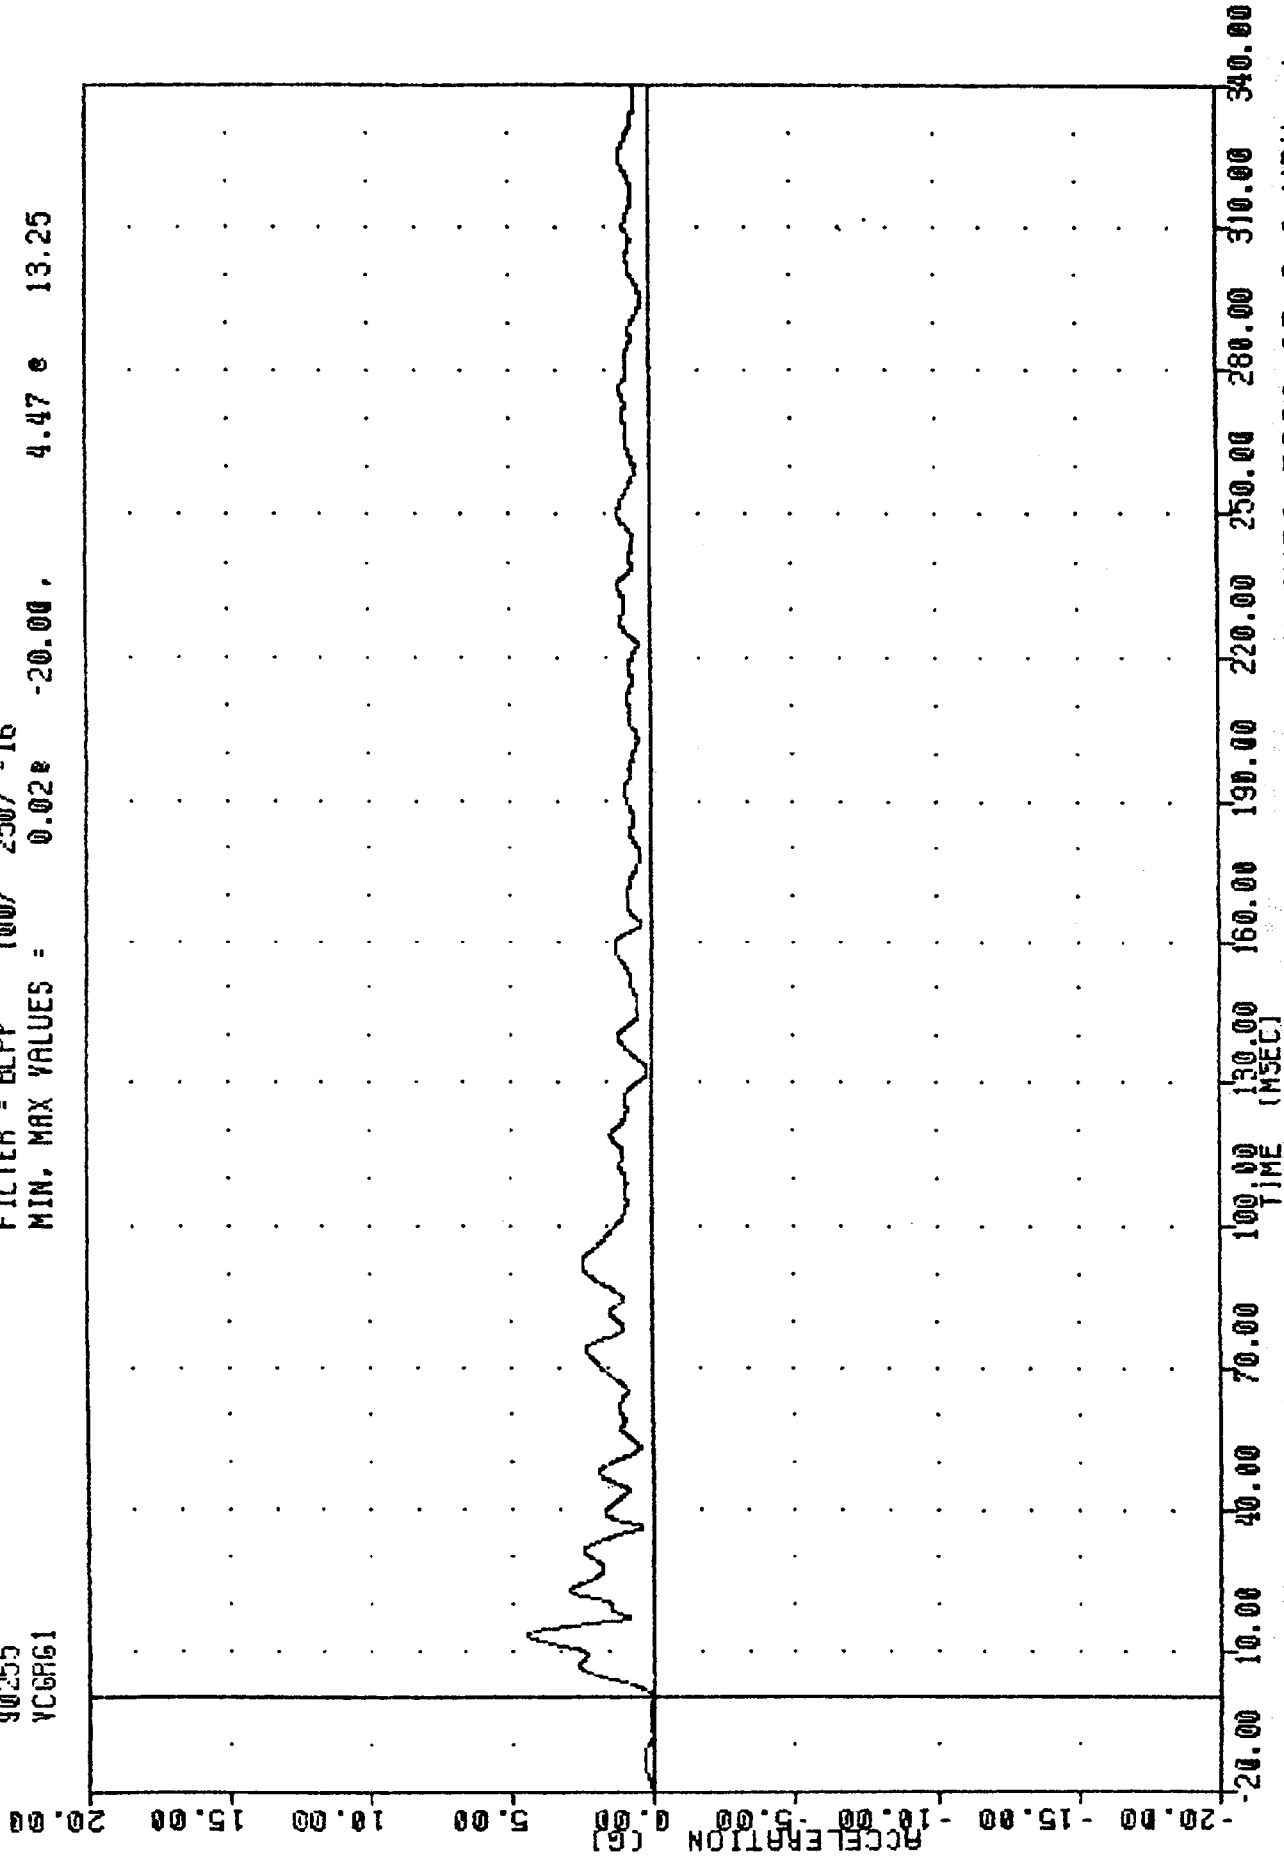
CONTOURED MOVING BARRIER INTO LEFT SIDE OF AN AUDI 5000 AT 9.8 MPH ±1
VEHICLE CG RESULTANT ACCELERATION

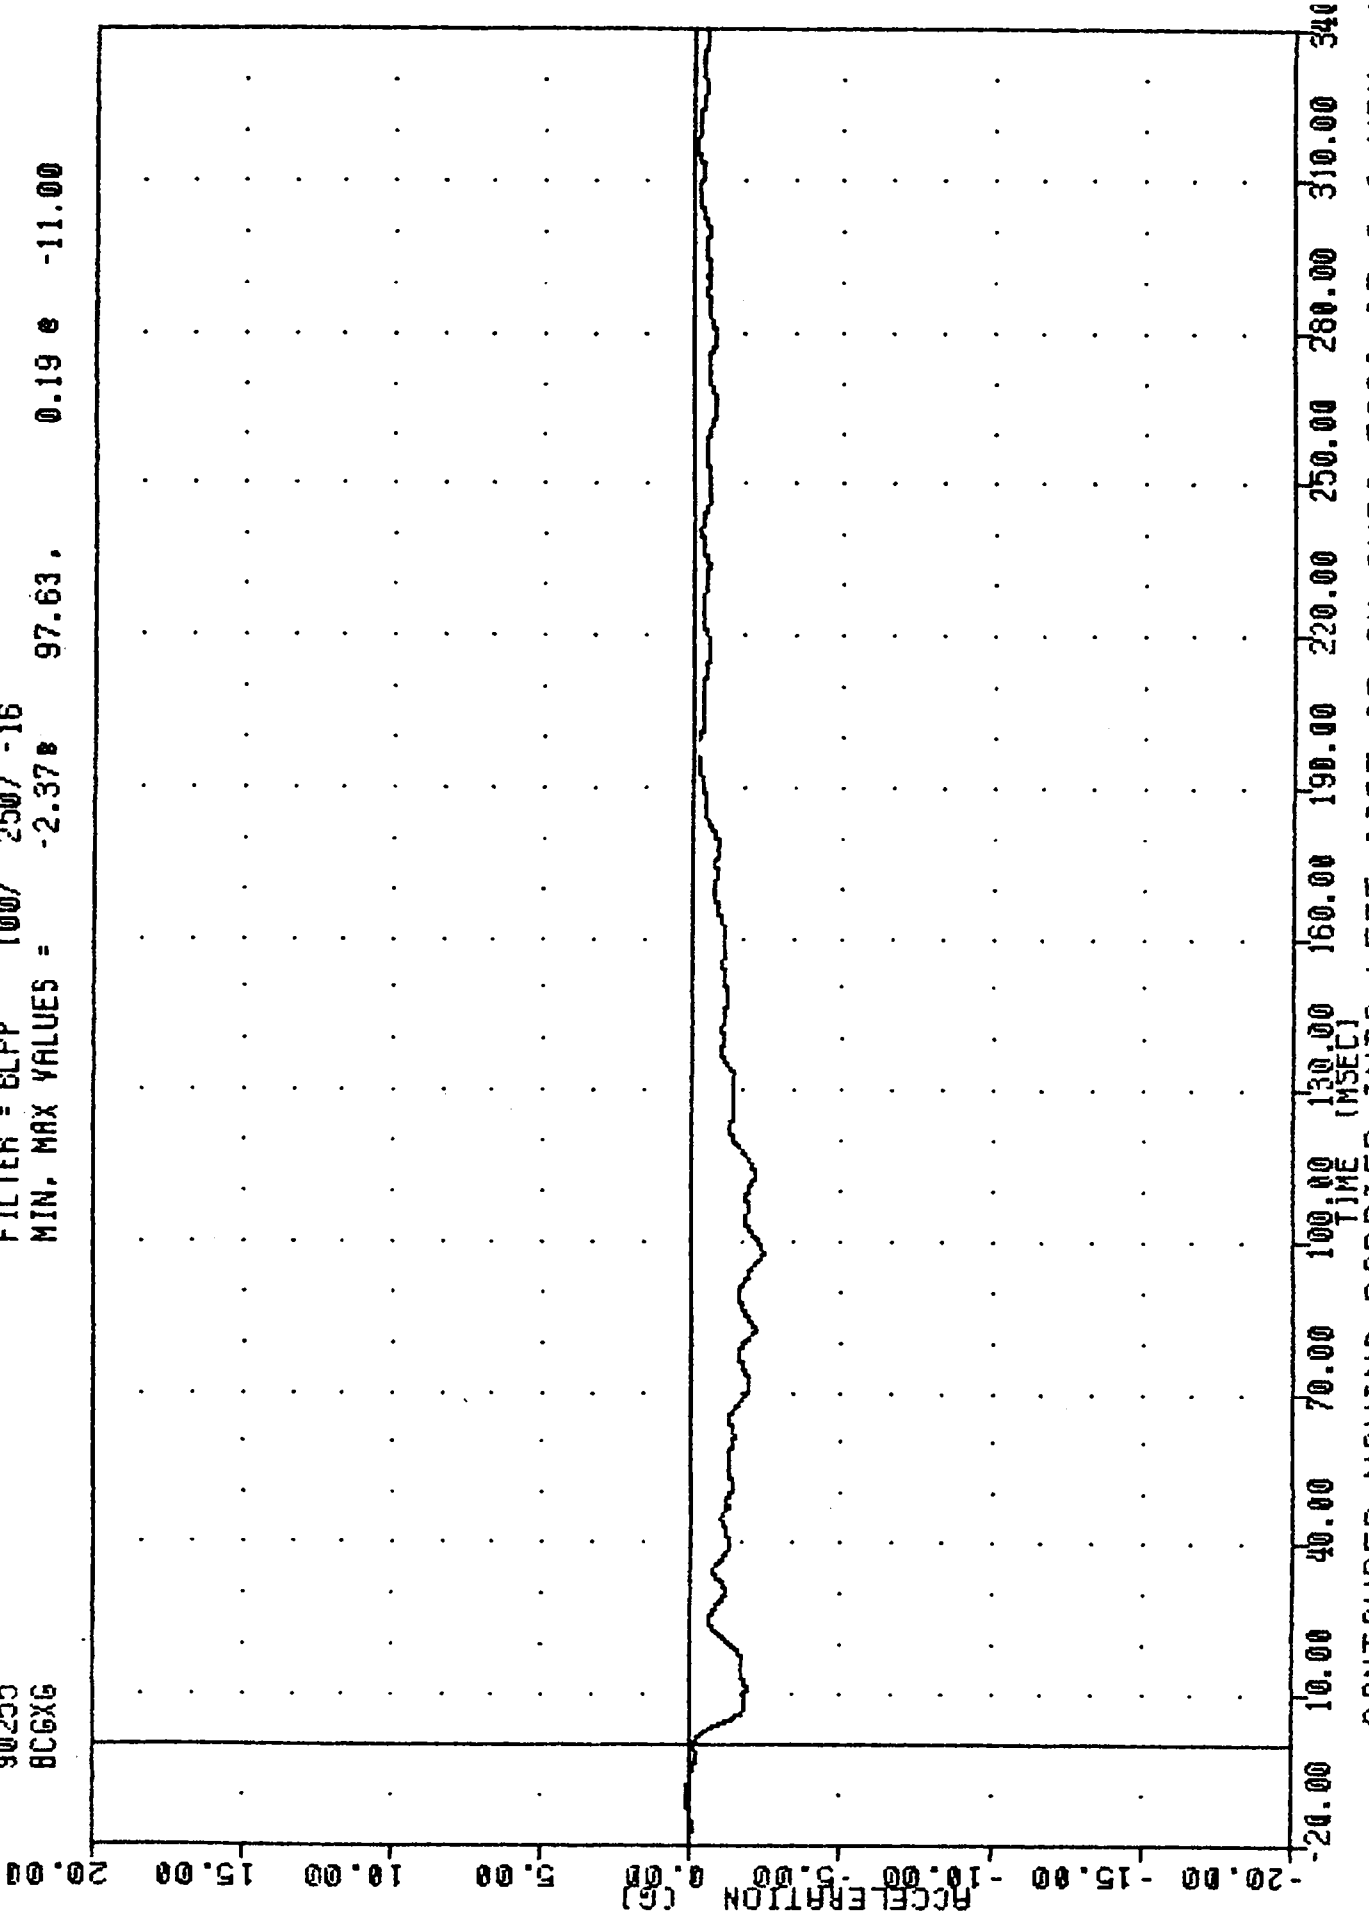
CONToured MOVING BARRIER INTO LEFT SIDE OF AN AUDI 5000 AT 9.8 MPH *1
MOVING BARRIER CENTER OF GRAVITY X-AXIS ACCELERATION

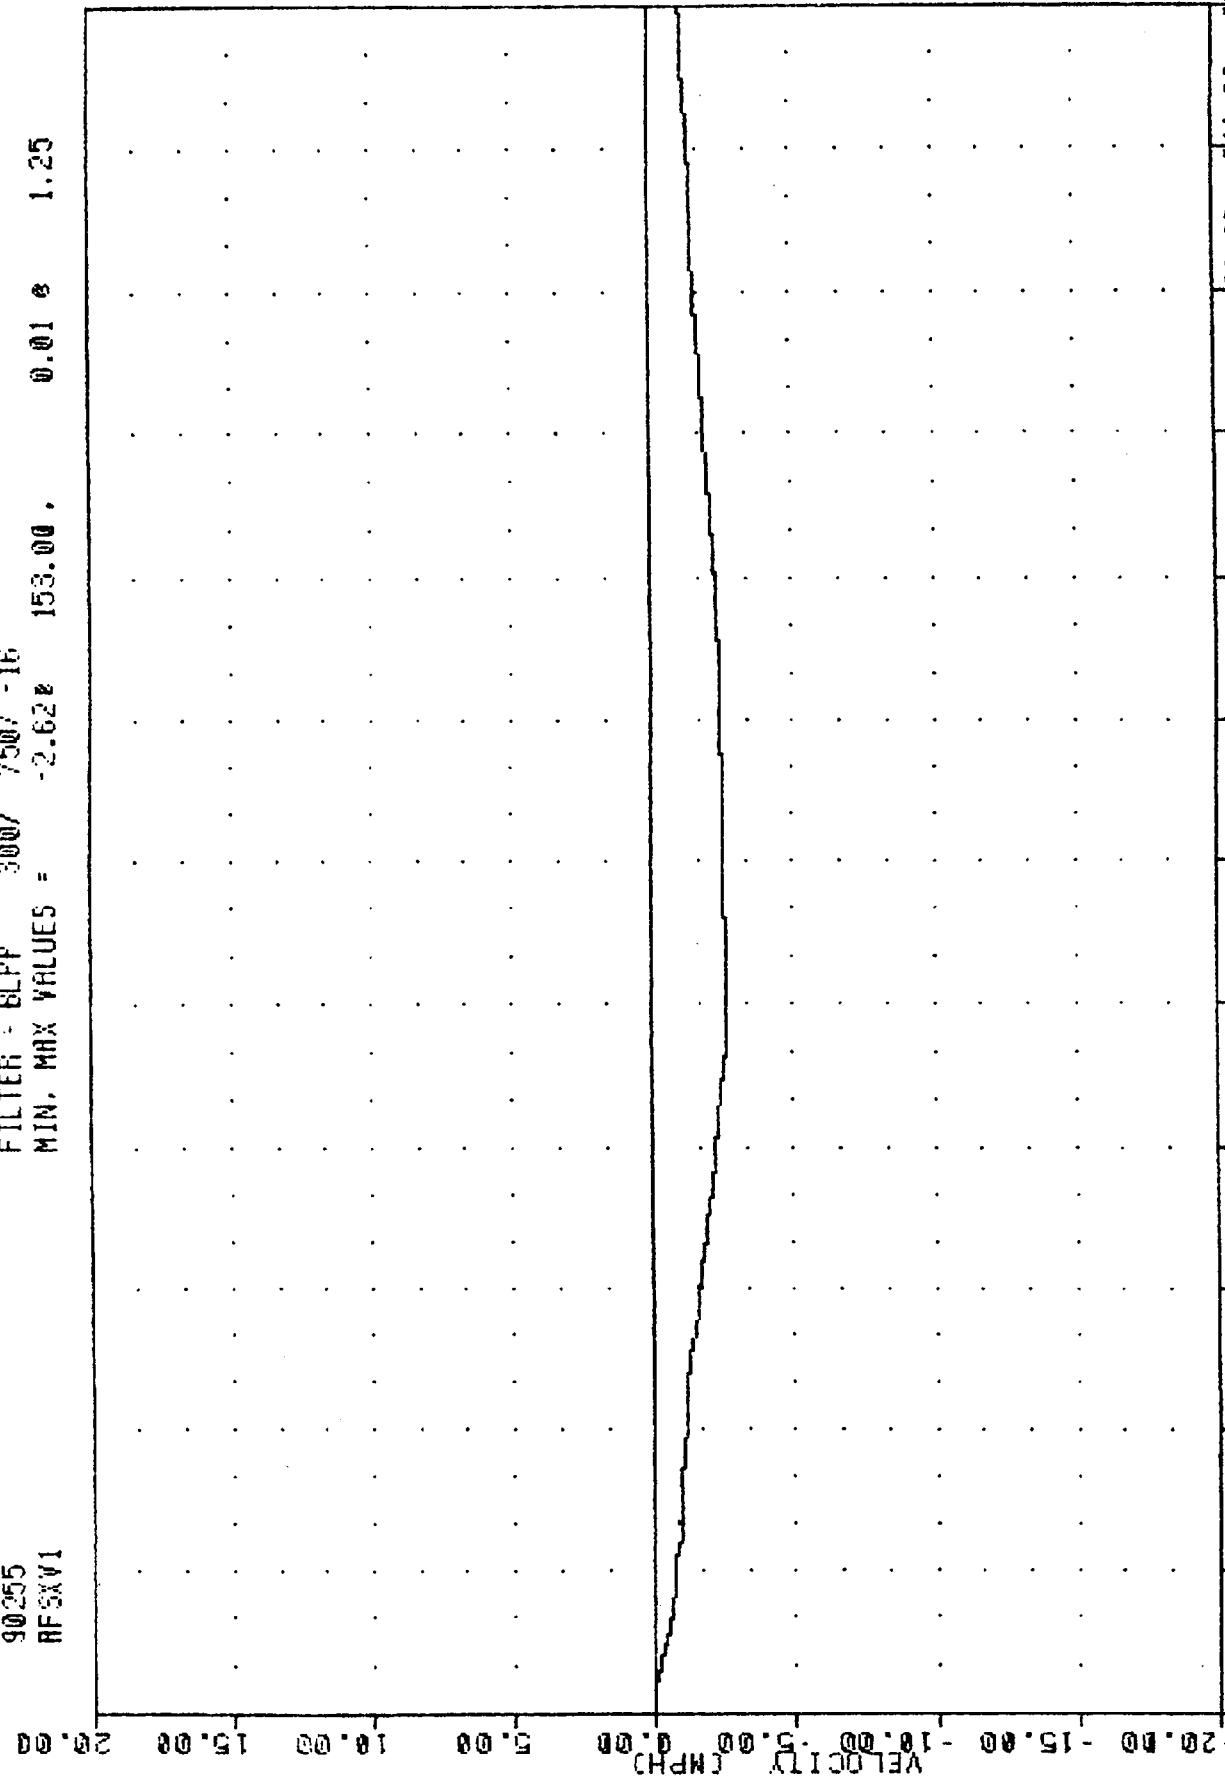
CONTOURED MOVING BARRIER INTO LEFT SIDE OF AN AUDI 5000 AT 9.8 MPH *1
 RIGHT FRONT SILL X-AXIS VELOCITY
