U.S. Department
of Transportation
**National Highway
Traffic Safety
Administration**

**DOT HS 807 772
Final Report**

Final Report of 315° Contoured Moving Barrier Impact Into a 1982 Audi 5000 4-Door Sedan in Support of Crash III Damage Algorithm Reformation

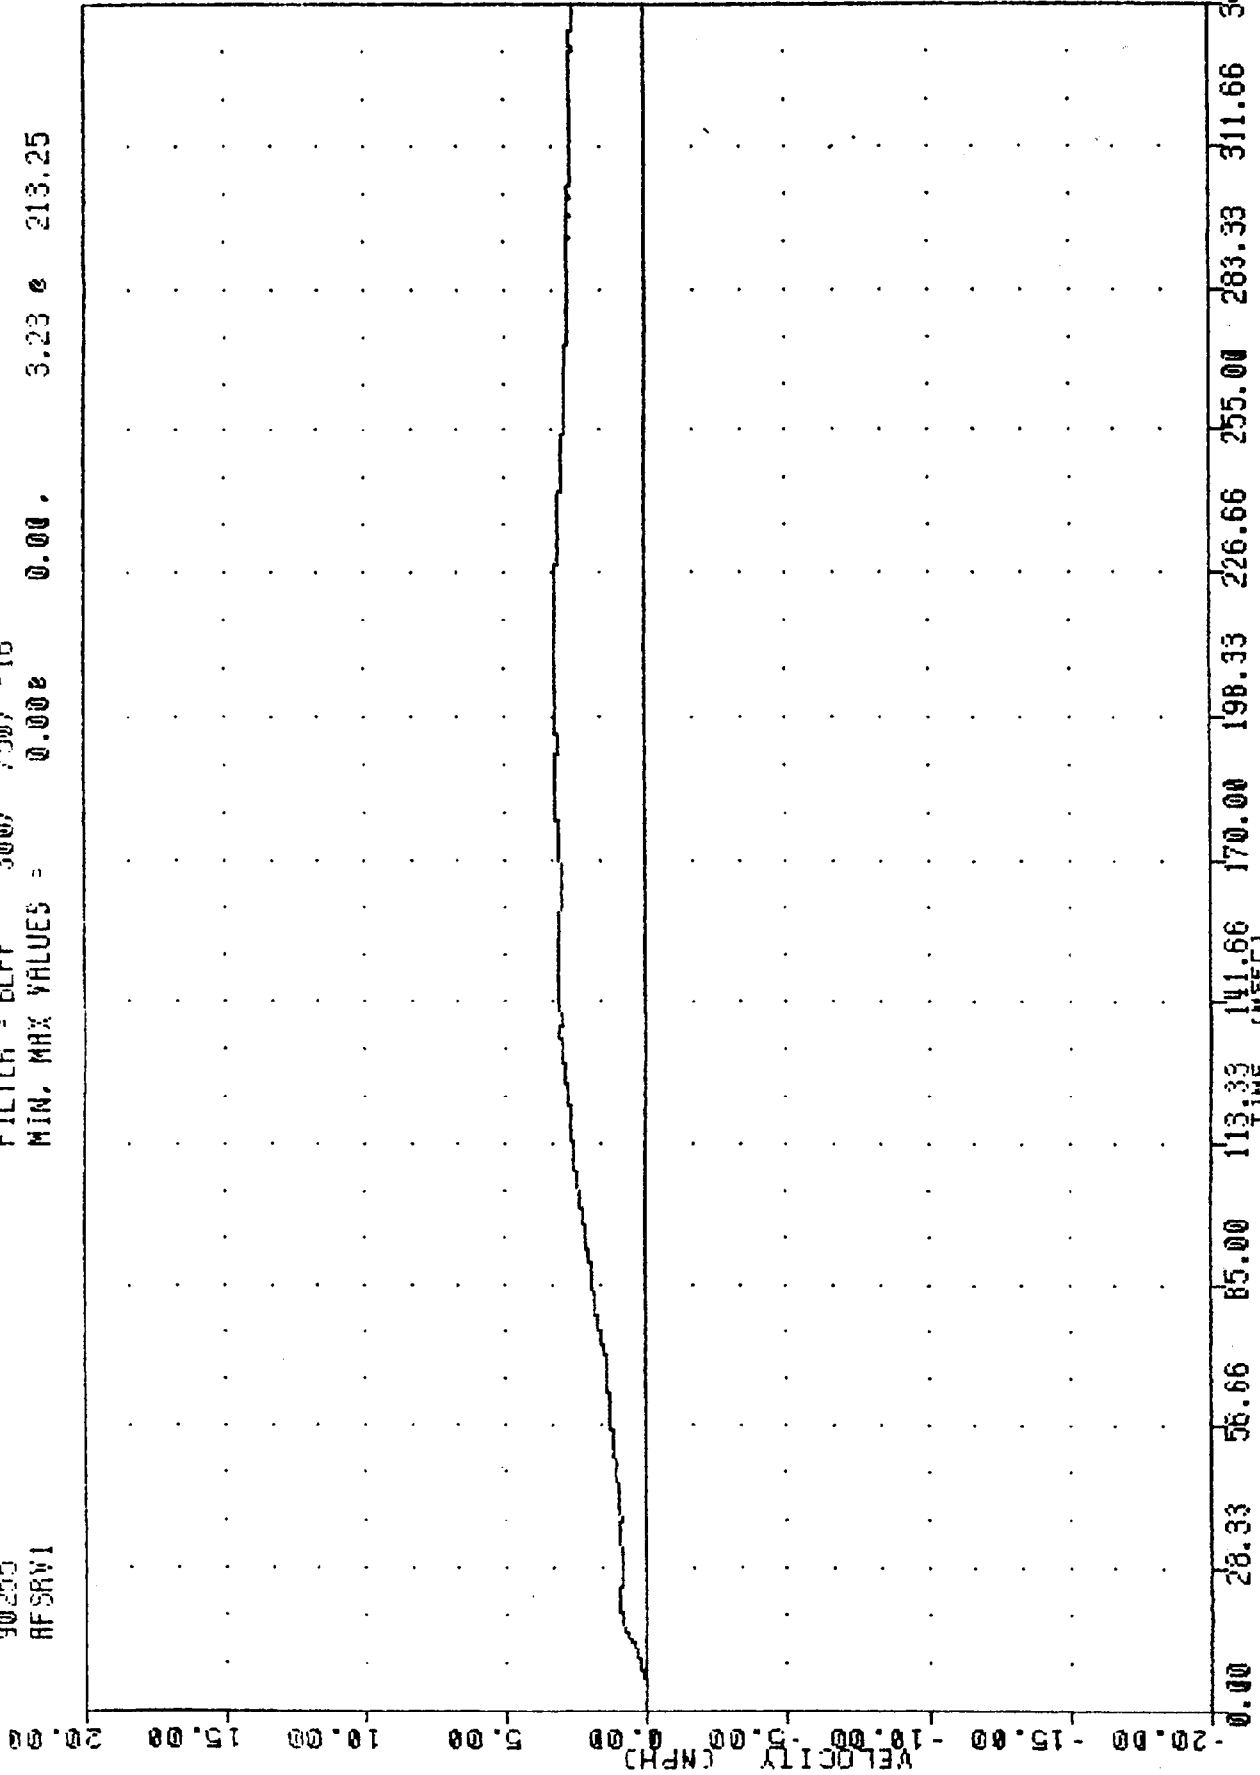
CONTOURED MOVING BARRIER INTO LEFT SIDE OF AN AUDI 5000 AT 9.8 MPH #1
 RIGHT FRONT SILL RESULTANT VELOCITY

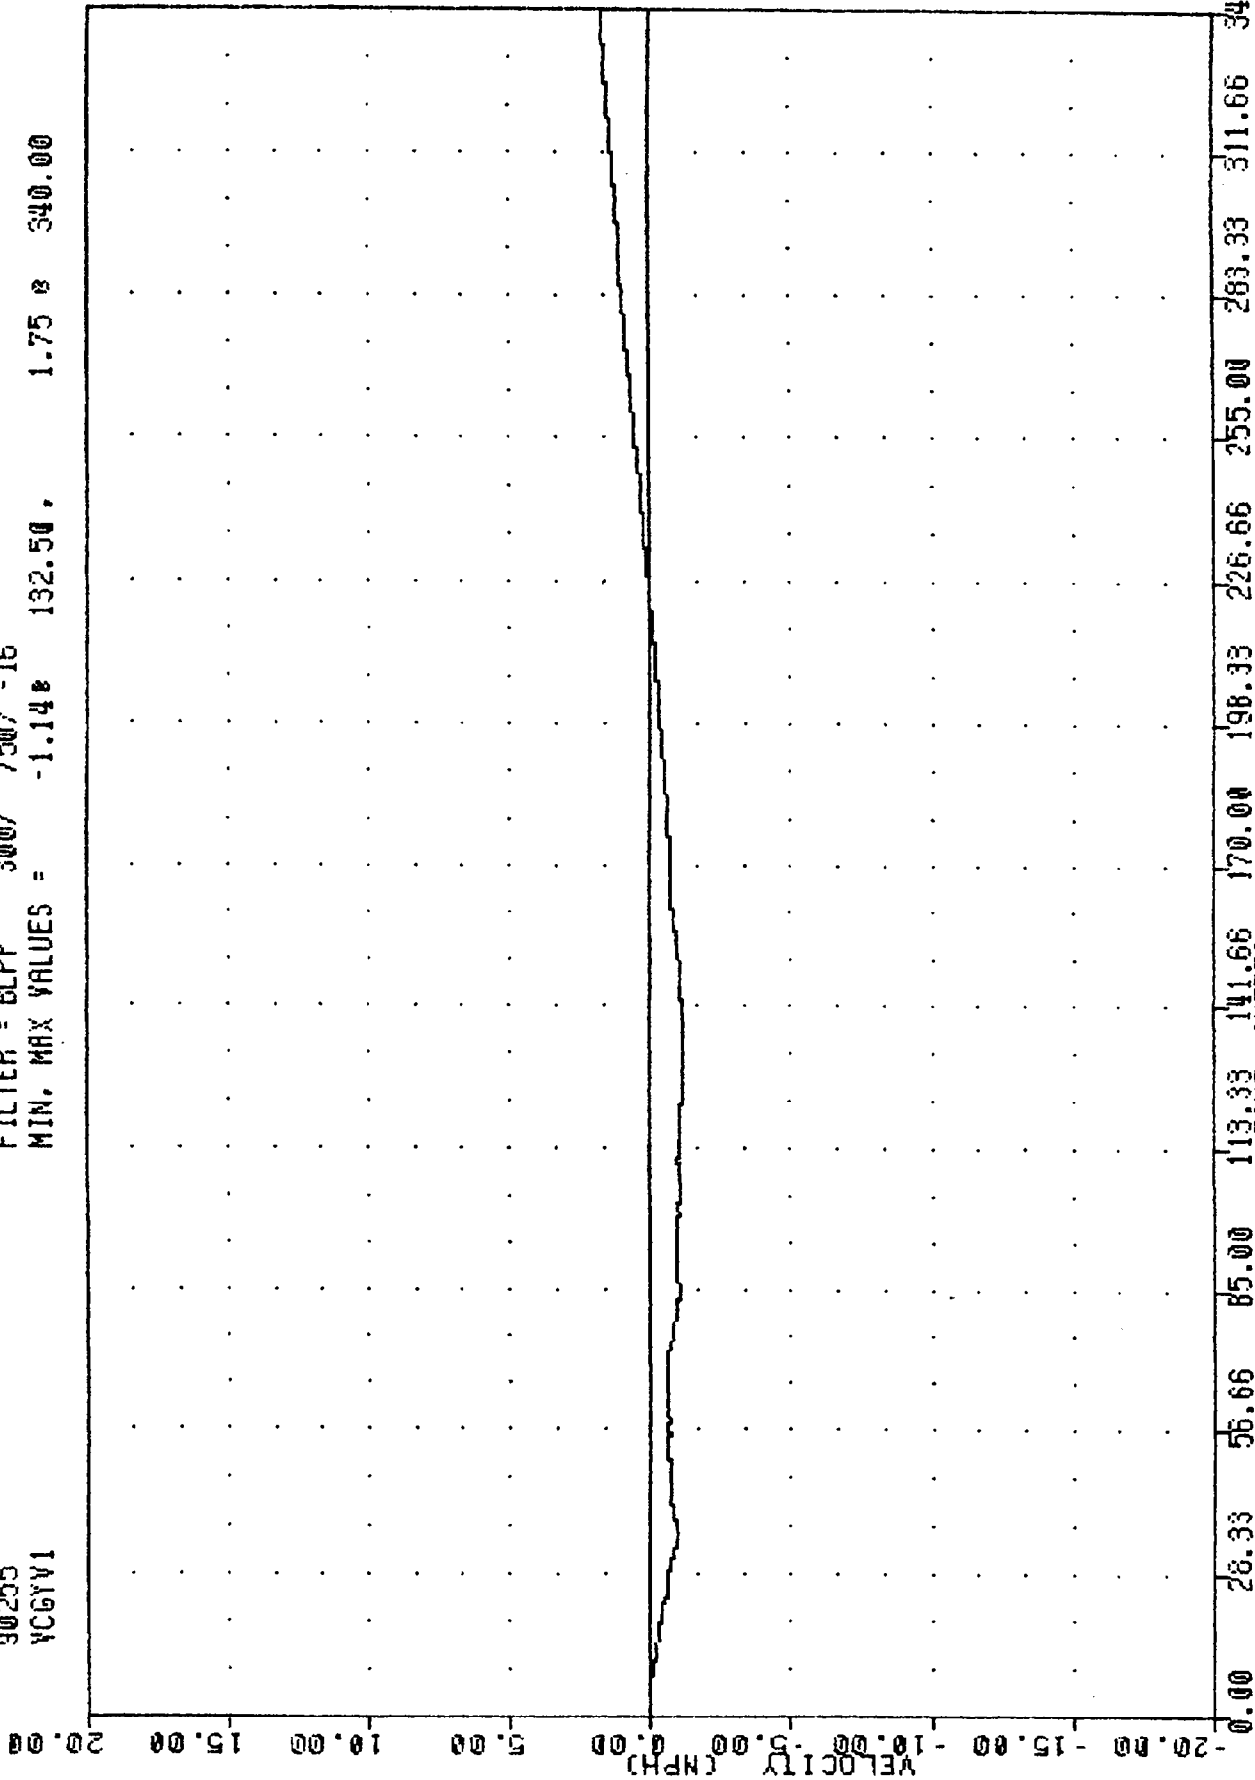
CONTOURED MOVING BARRIER INTO LEFT SIDE OF AN AUDI 5000 AT 9.8 MPH *1
 VEHICLE CG Y-AXIS VELOCITY (PERPENDICULAR TO IMPACT DIRECTION)

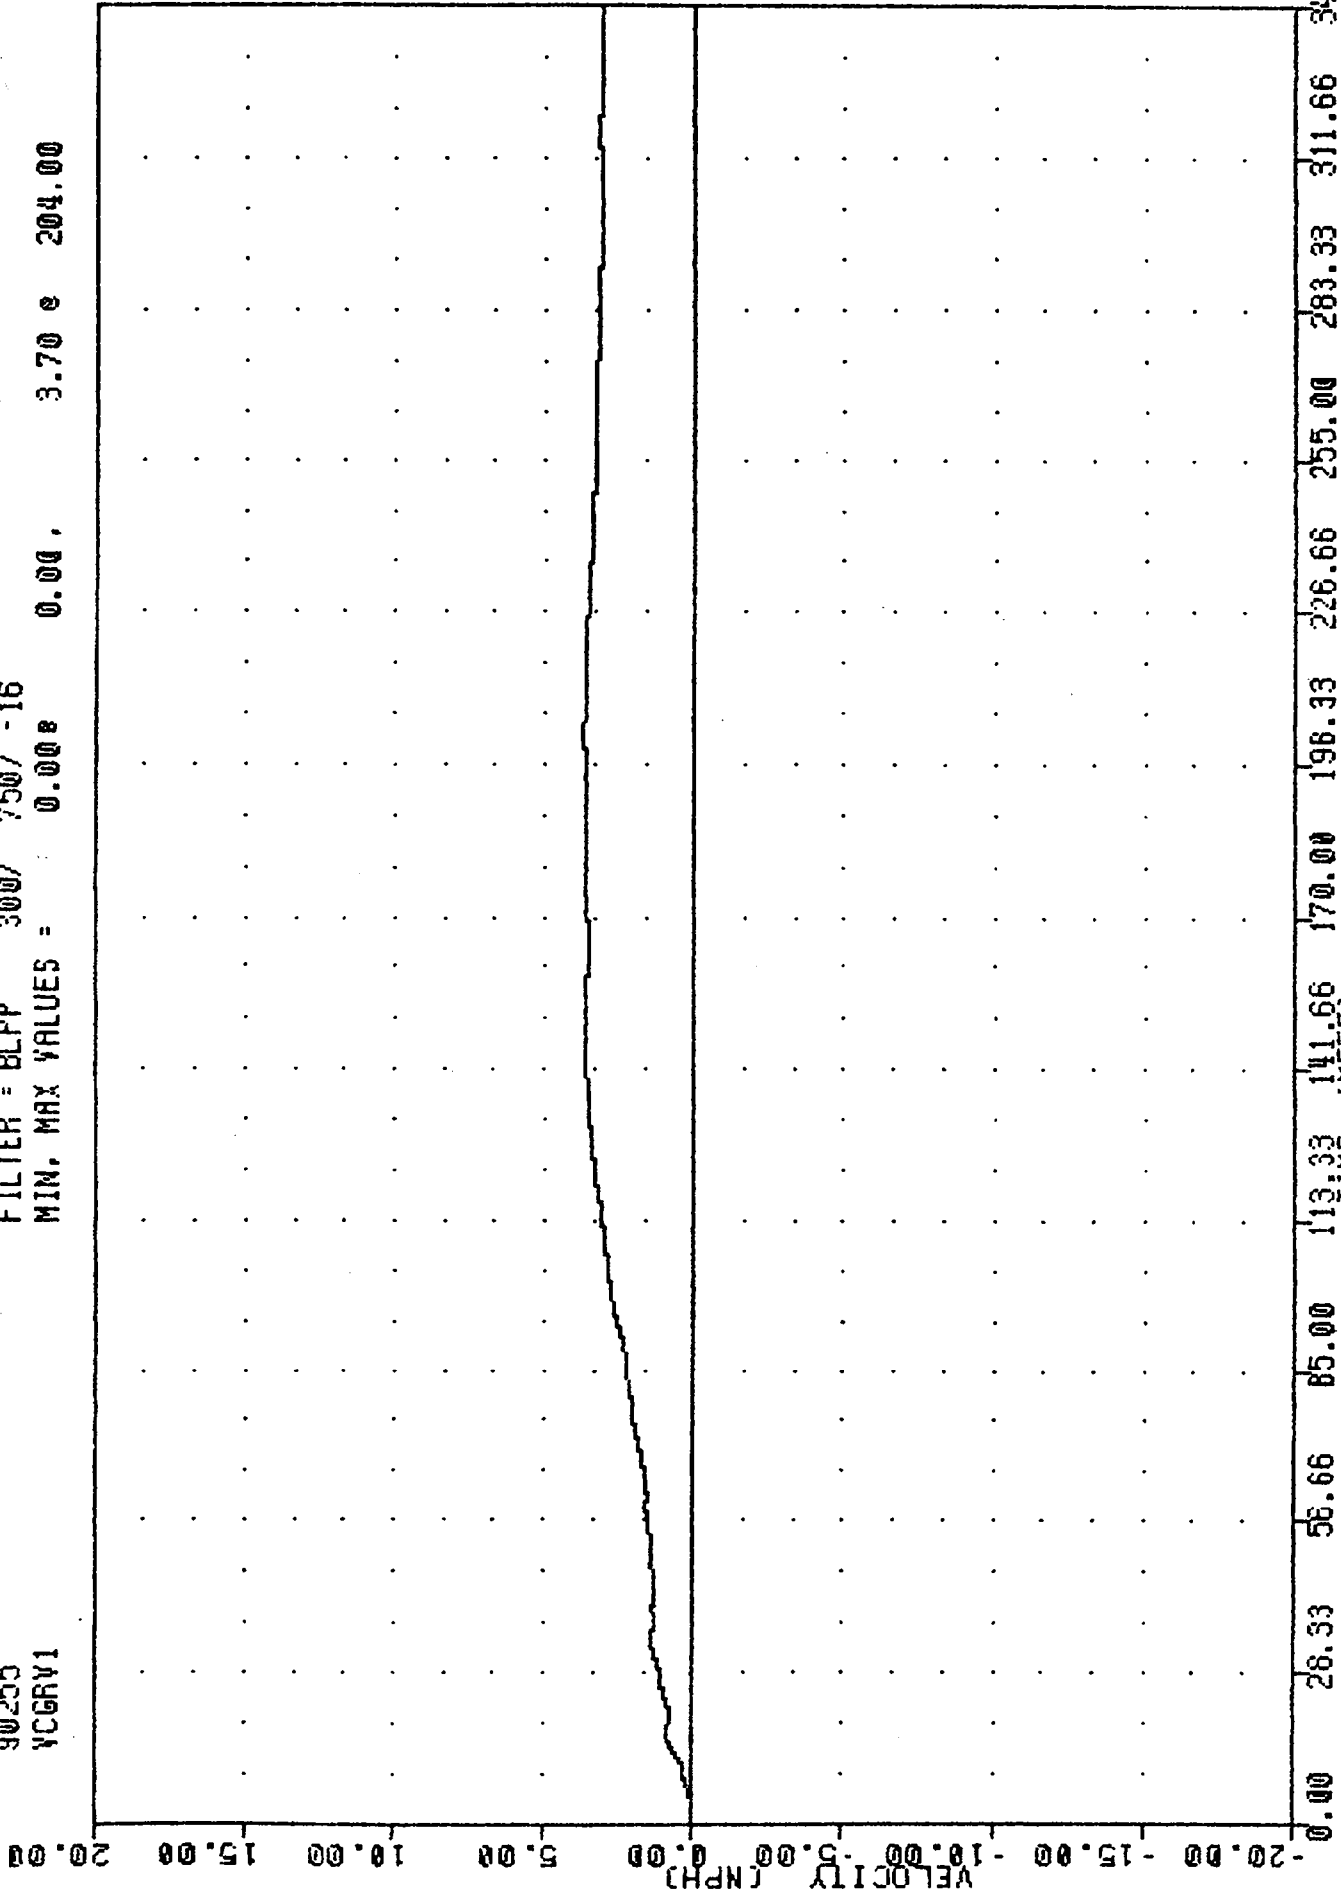
CONTOURED MOVING BARRIER INTO LEFT SIDE OF AN AUDI 5000 AT 9.8 MPH ±1
 VEHICLE CG RESULTANT VELOCITY

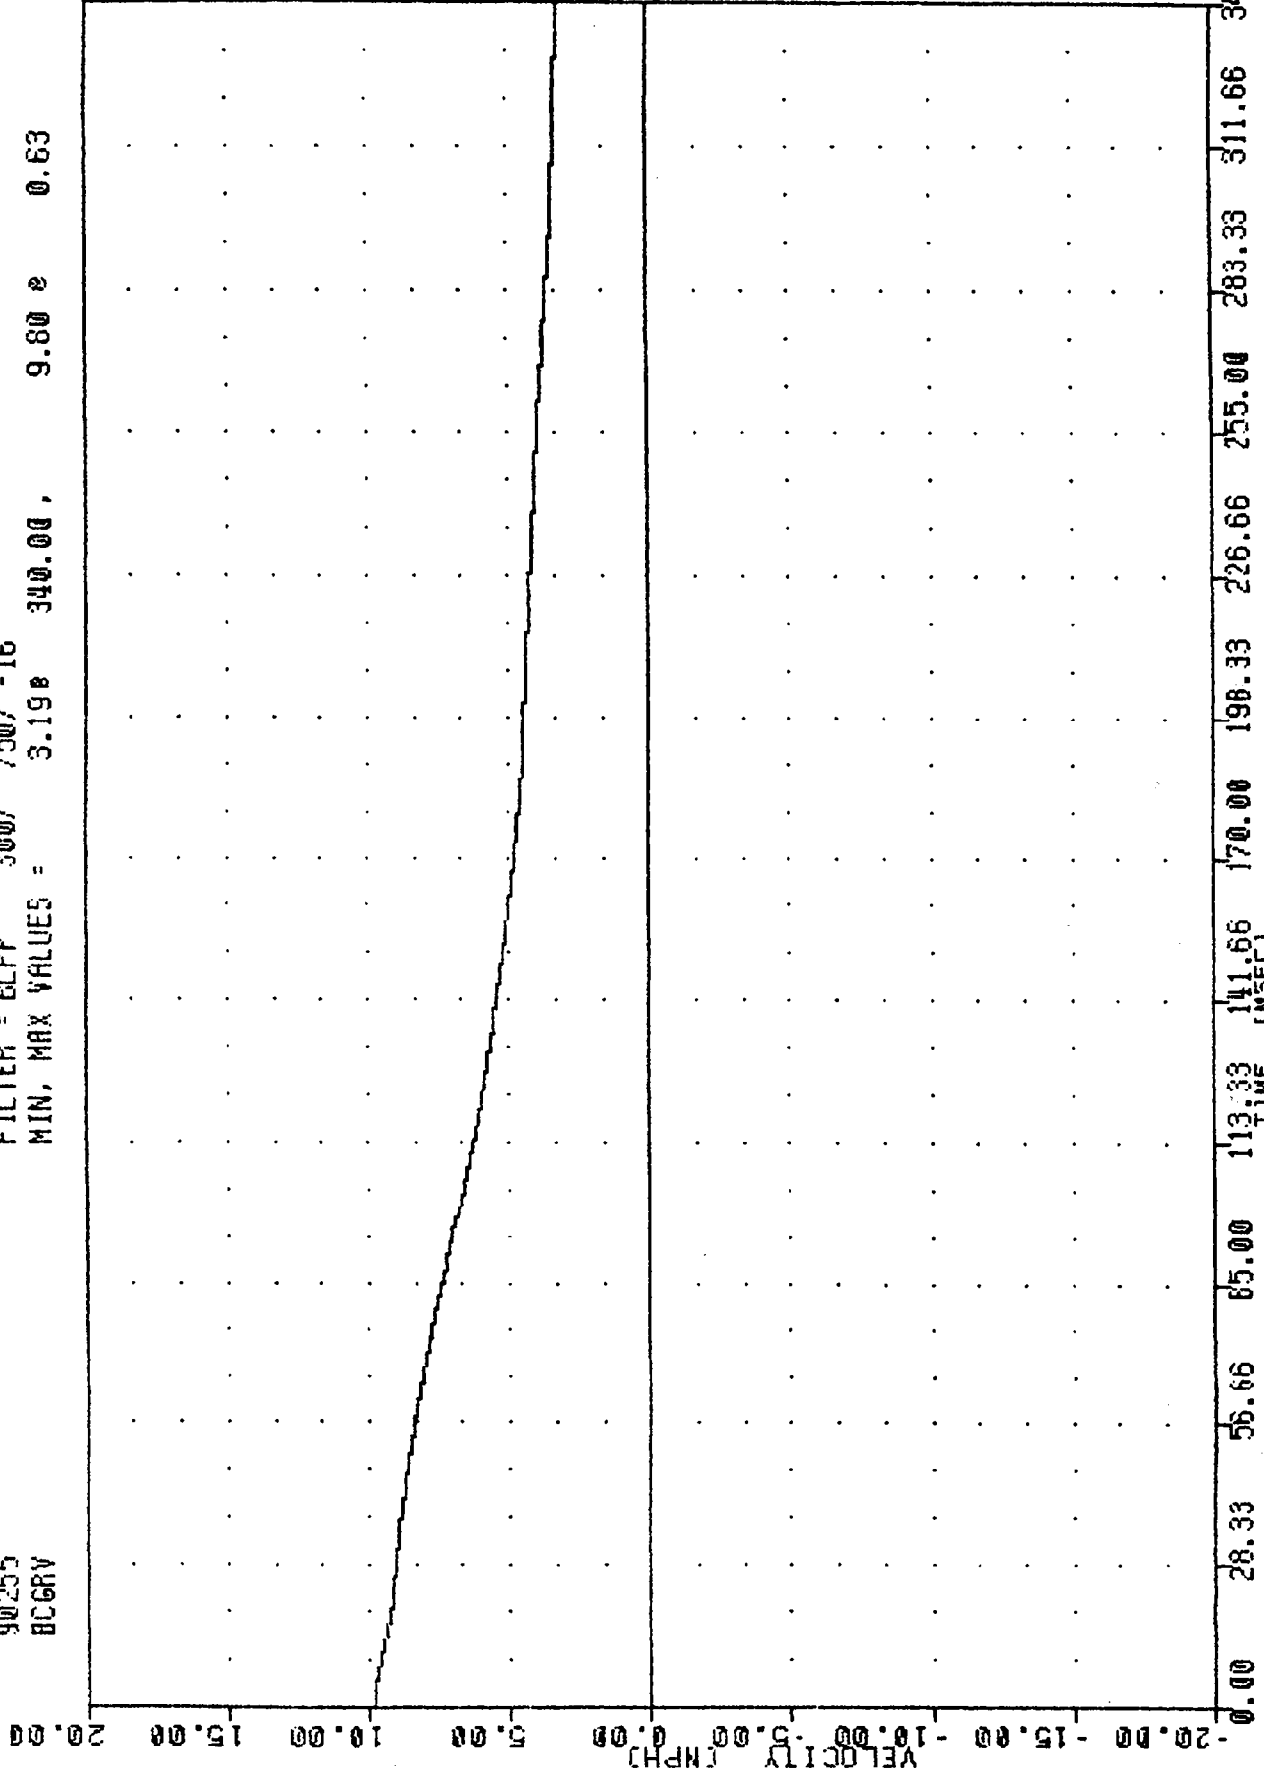
CONTOURED MOVING BARRIER INTO LEFT SIDE OF AN AUDI 5000 AT 9.8 MPH *1
 MOVING BARRIER CENTER OF GRAVITY RESULTANT VELOCITY

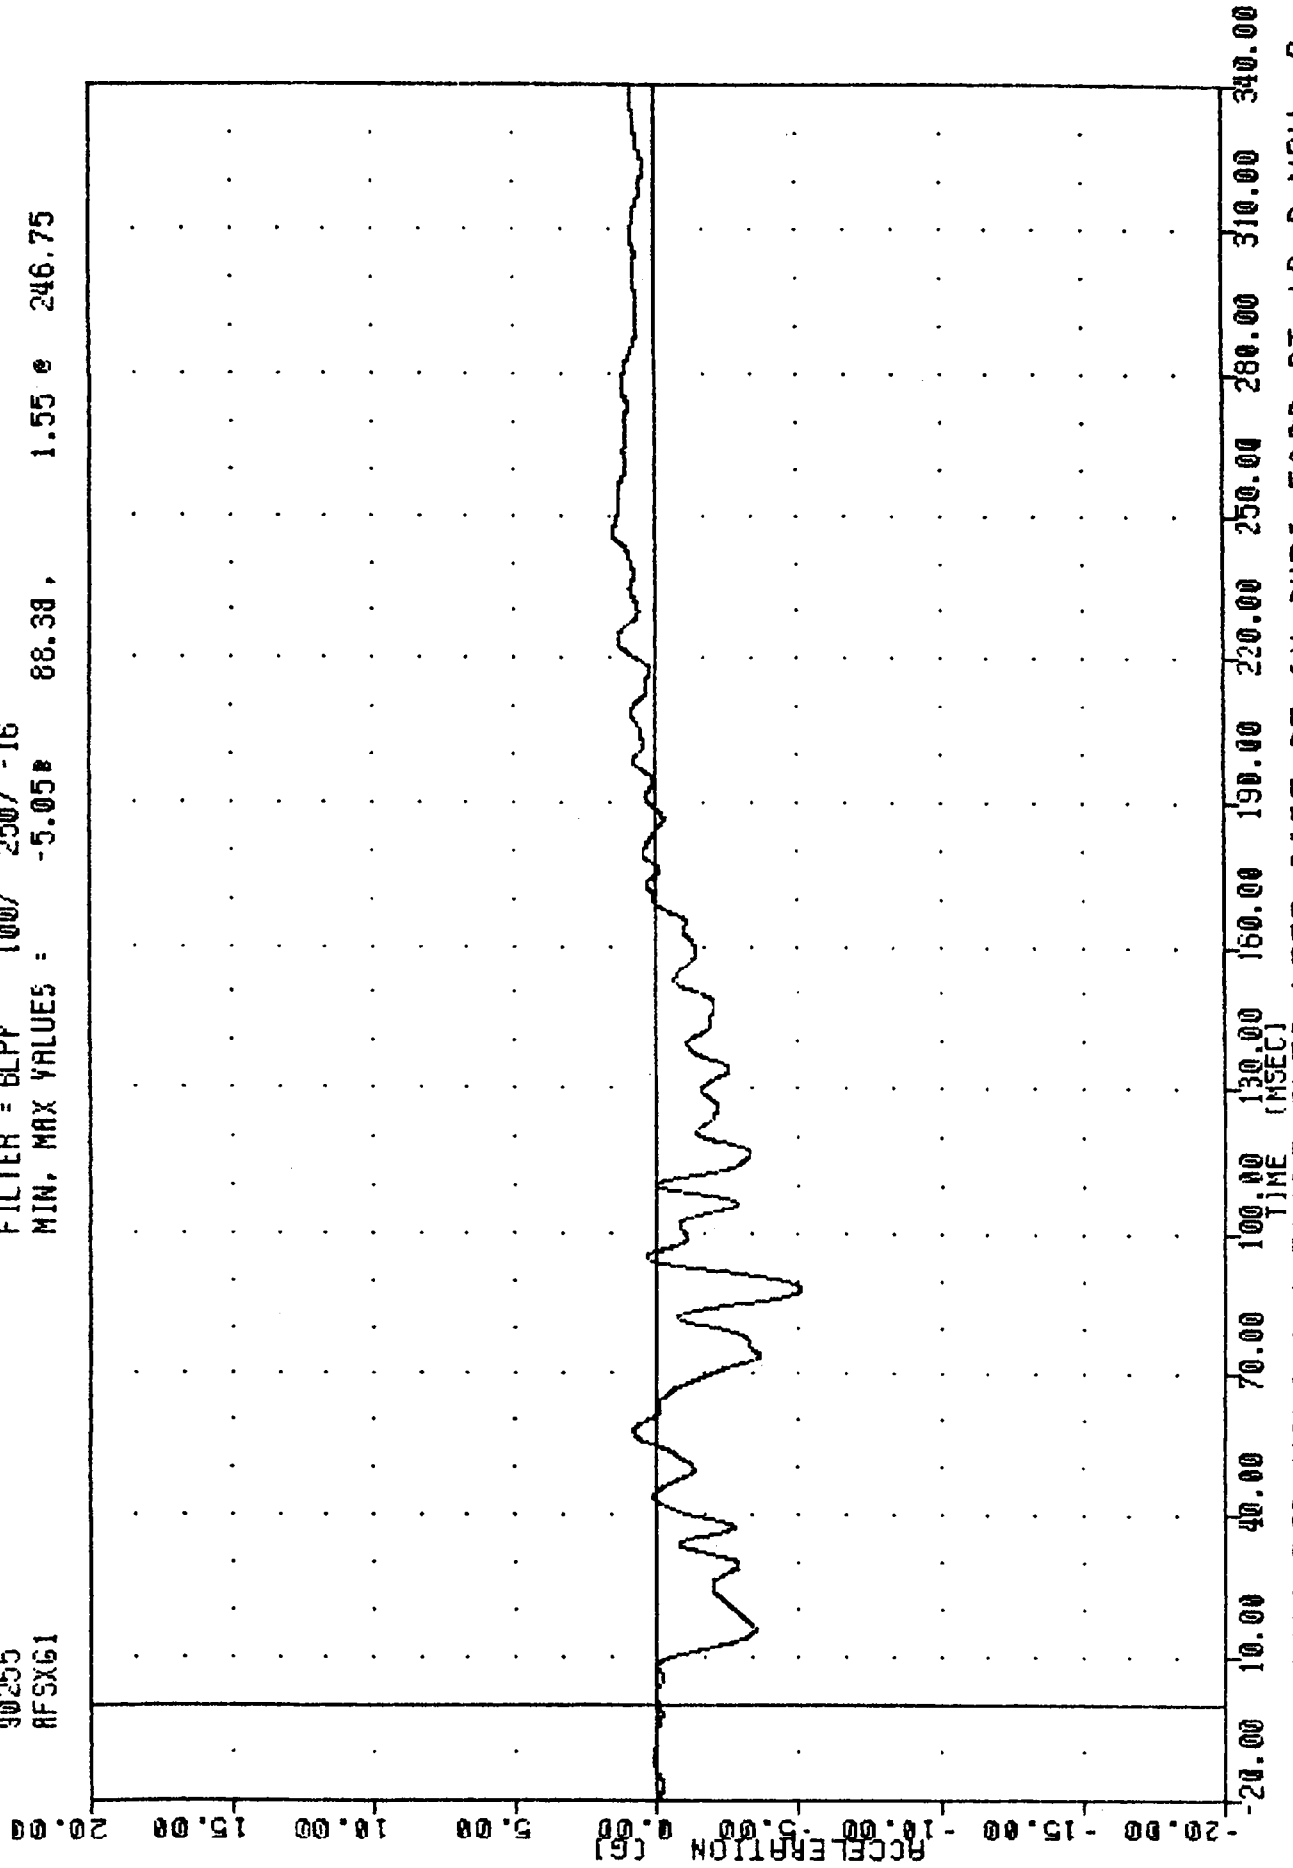
CONTOURED MOVING BARRIER INTO LEFT SIDE OF AN AUDI 5000 AT 19.8 MPH #2
RIGHT FRONT SILL X-AXIS ACCELERATION

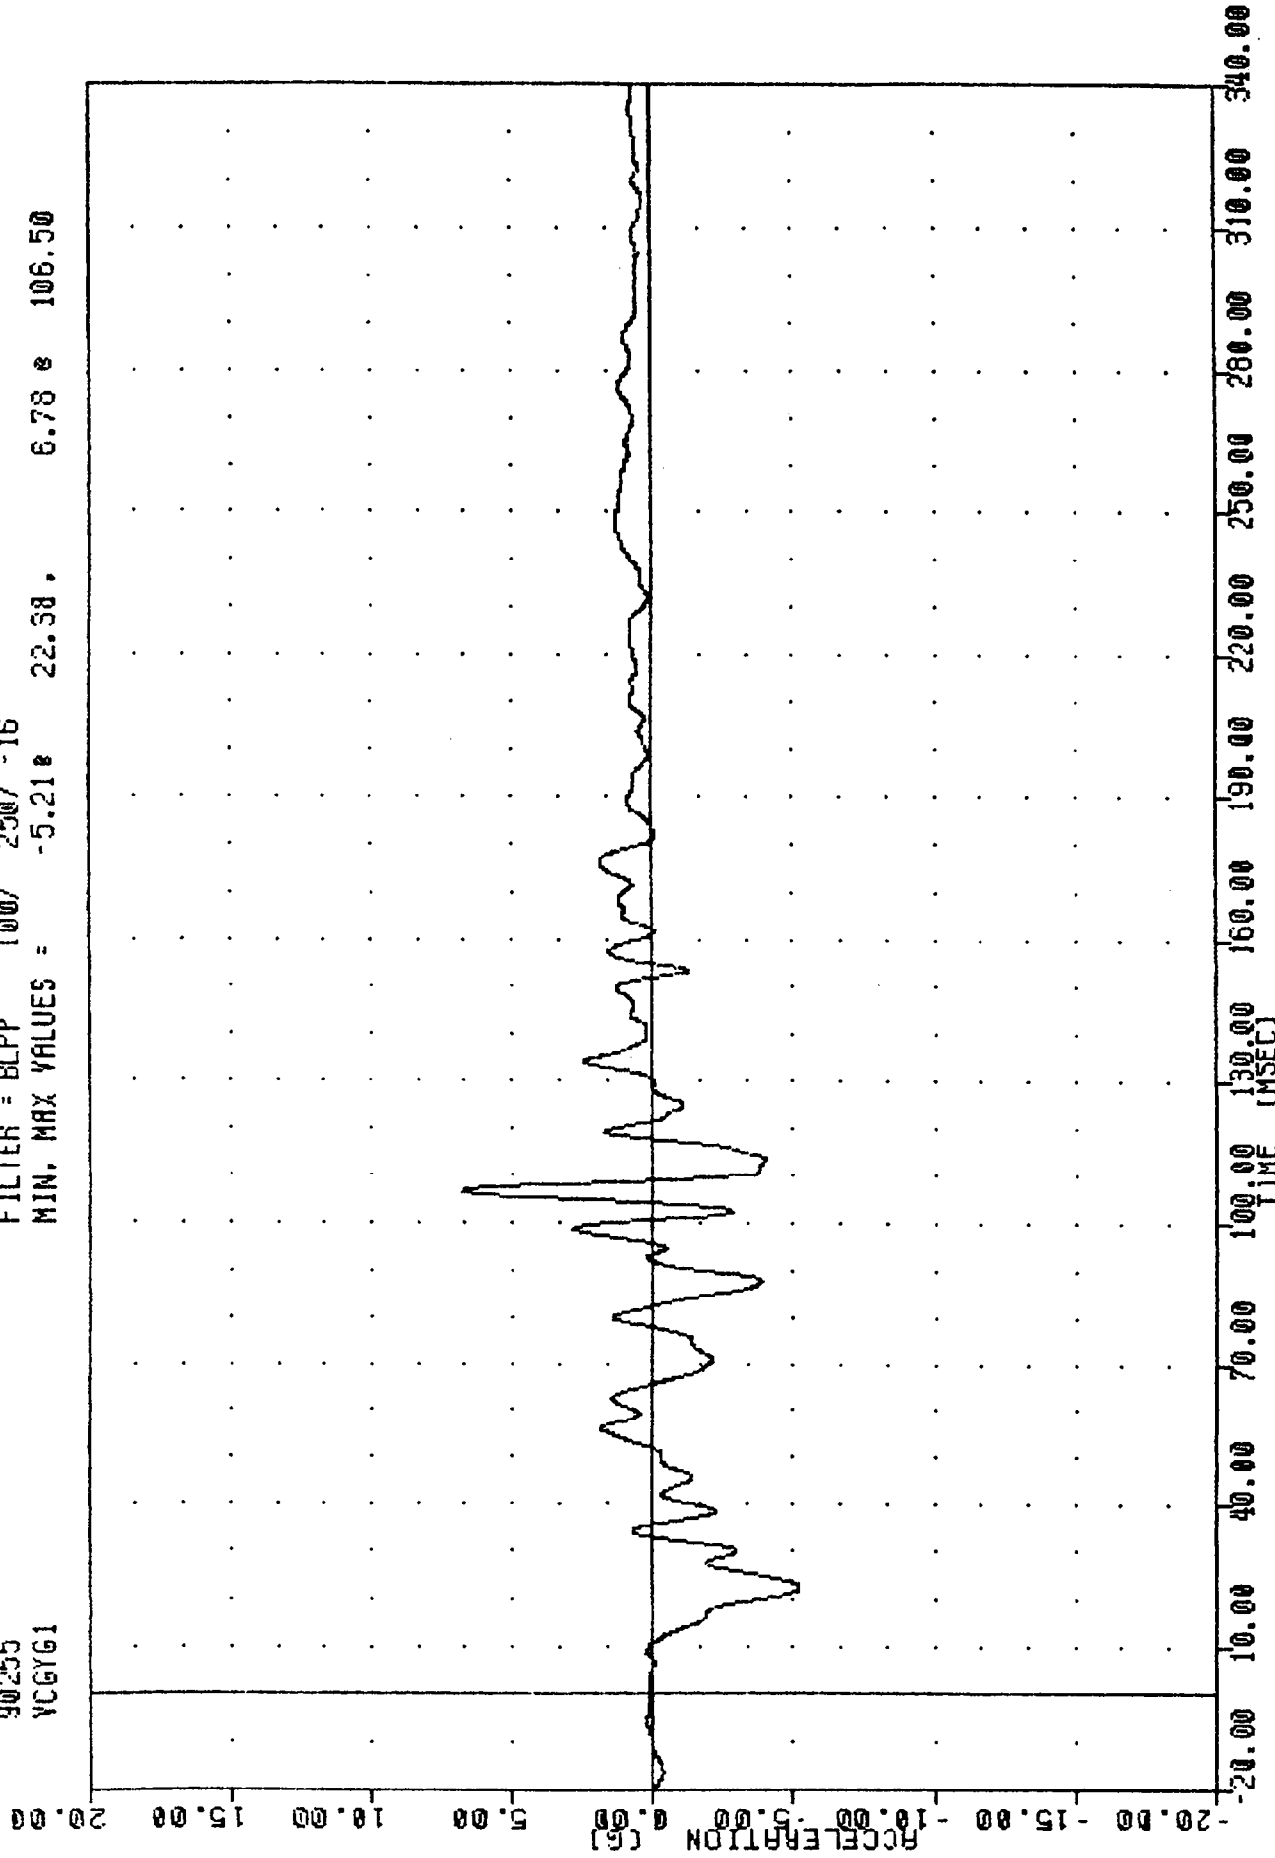
CONToured MOVING BARRIER INTO LEFT SIDE OF AN AUDI 5000 AT 19.8 MPH #2
VEHICLE CG Y-AXIS ACCELERATION (PERPENDICULAR TO IMPACT DIRECTION)

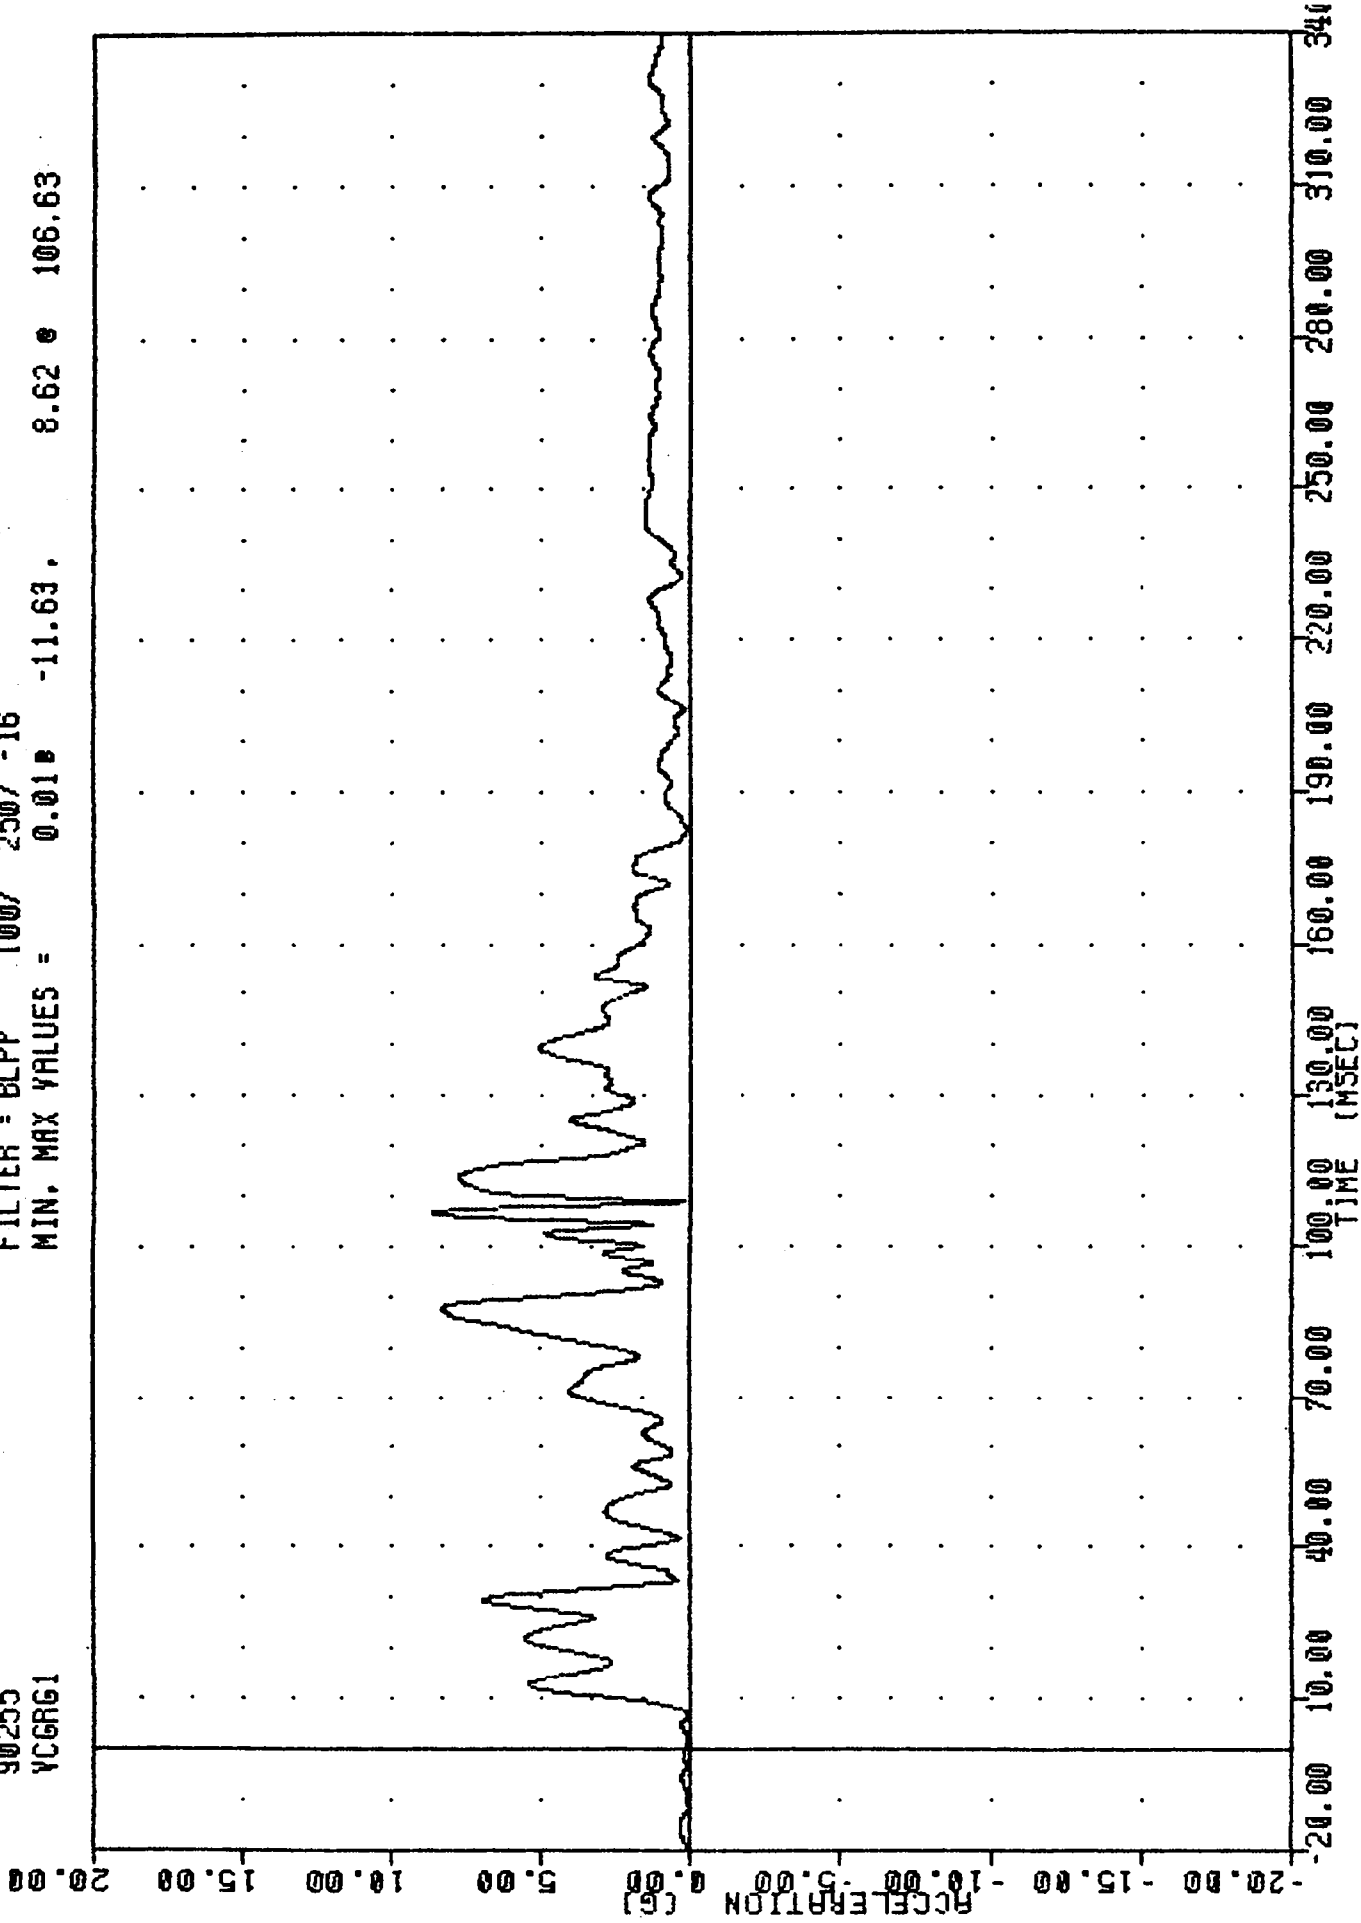
CONTOURED MOVING BARRIER INTO LEFT SIDE OF AN AUDI 5000 AT 19.8 MPH
VEHICLE CG RESULTANT ACCELERATION

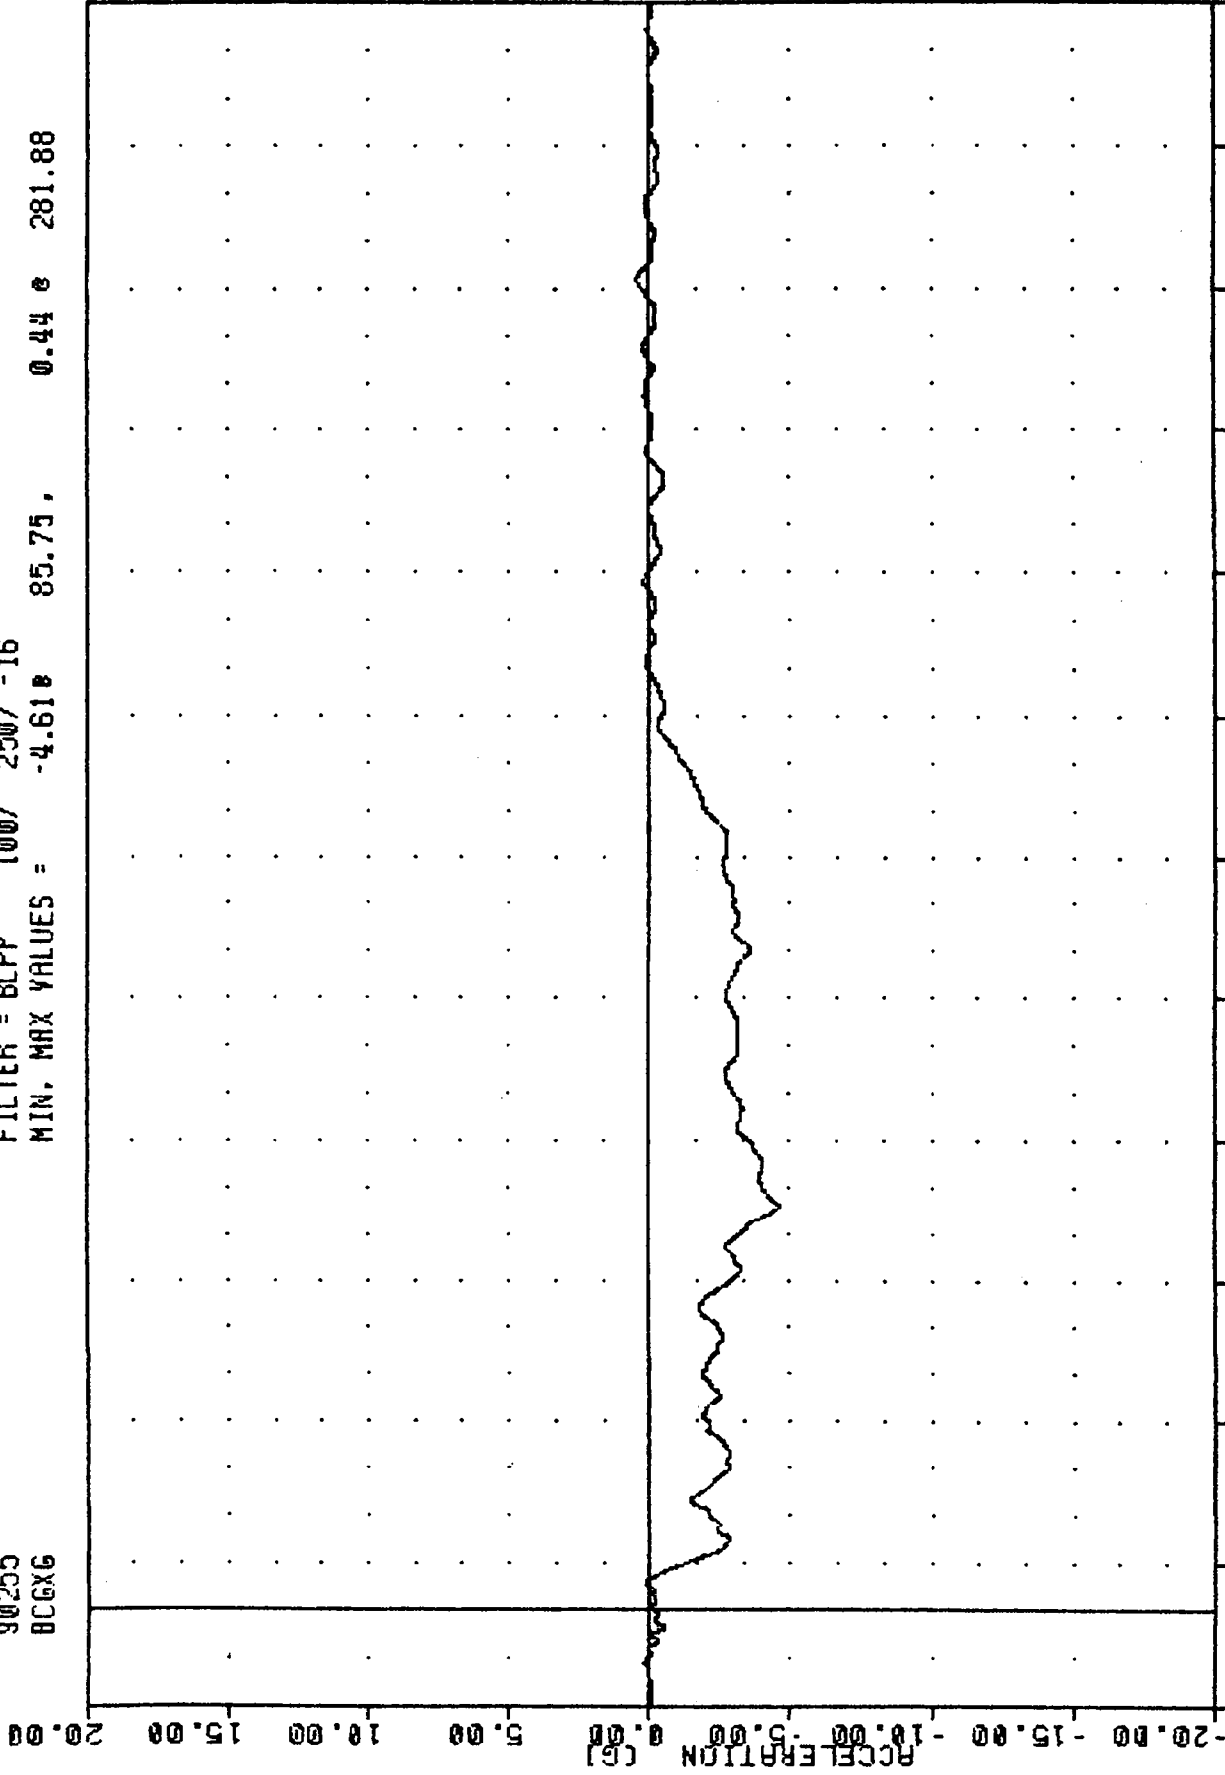
CONTOURED MOVING BARRIER INTO LEFT SIDE OF AN AUDI 5000 AT 19.8 MPH #2
 MOVING BARRIER CENTER OF GRAVITY X-AXIS ACCELERATION

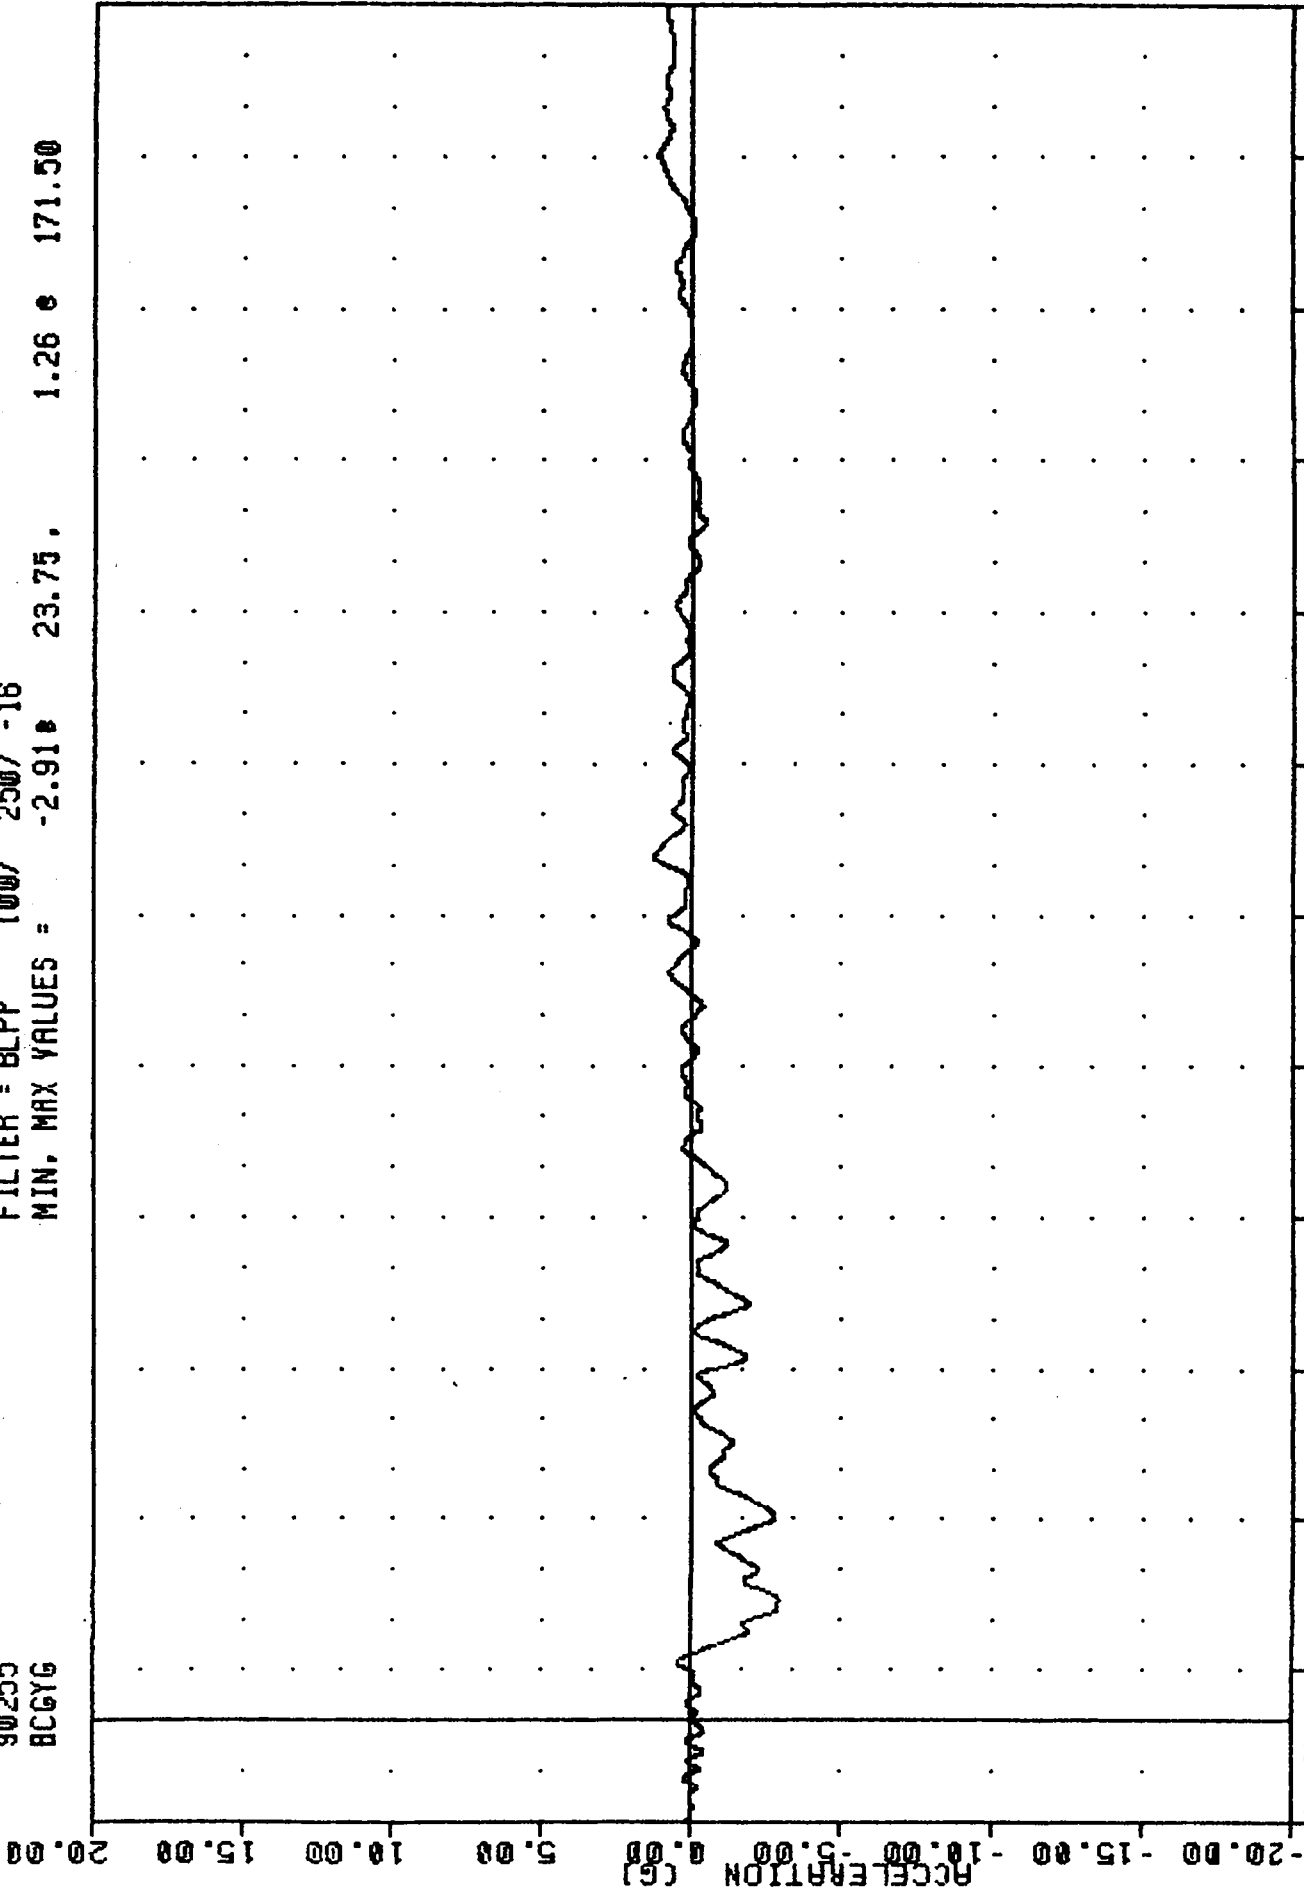
CONTOURED MOVING BARRIER INTO LEFT SIDE OF AN AUDI 5000 AT 19.8 MPH #1
MOVING BARRIER CENTER OF GRAVITY Y-AXIS ACCELERATION
