U.S. Department
of Transportation
**National Highway
Traffic Safety
Administration**

**DOT HS 807 772
Final Report**

Final Report of 315° Contoured Moving Barrier Impact Into a 1982 Audi 5000 4-Door Sedan in Support of Crash III Damage Algorithm Reformation

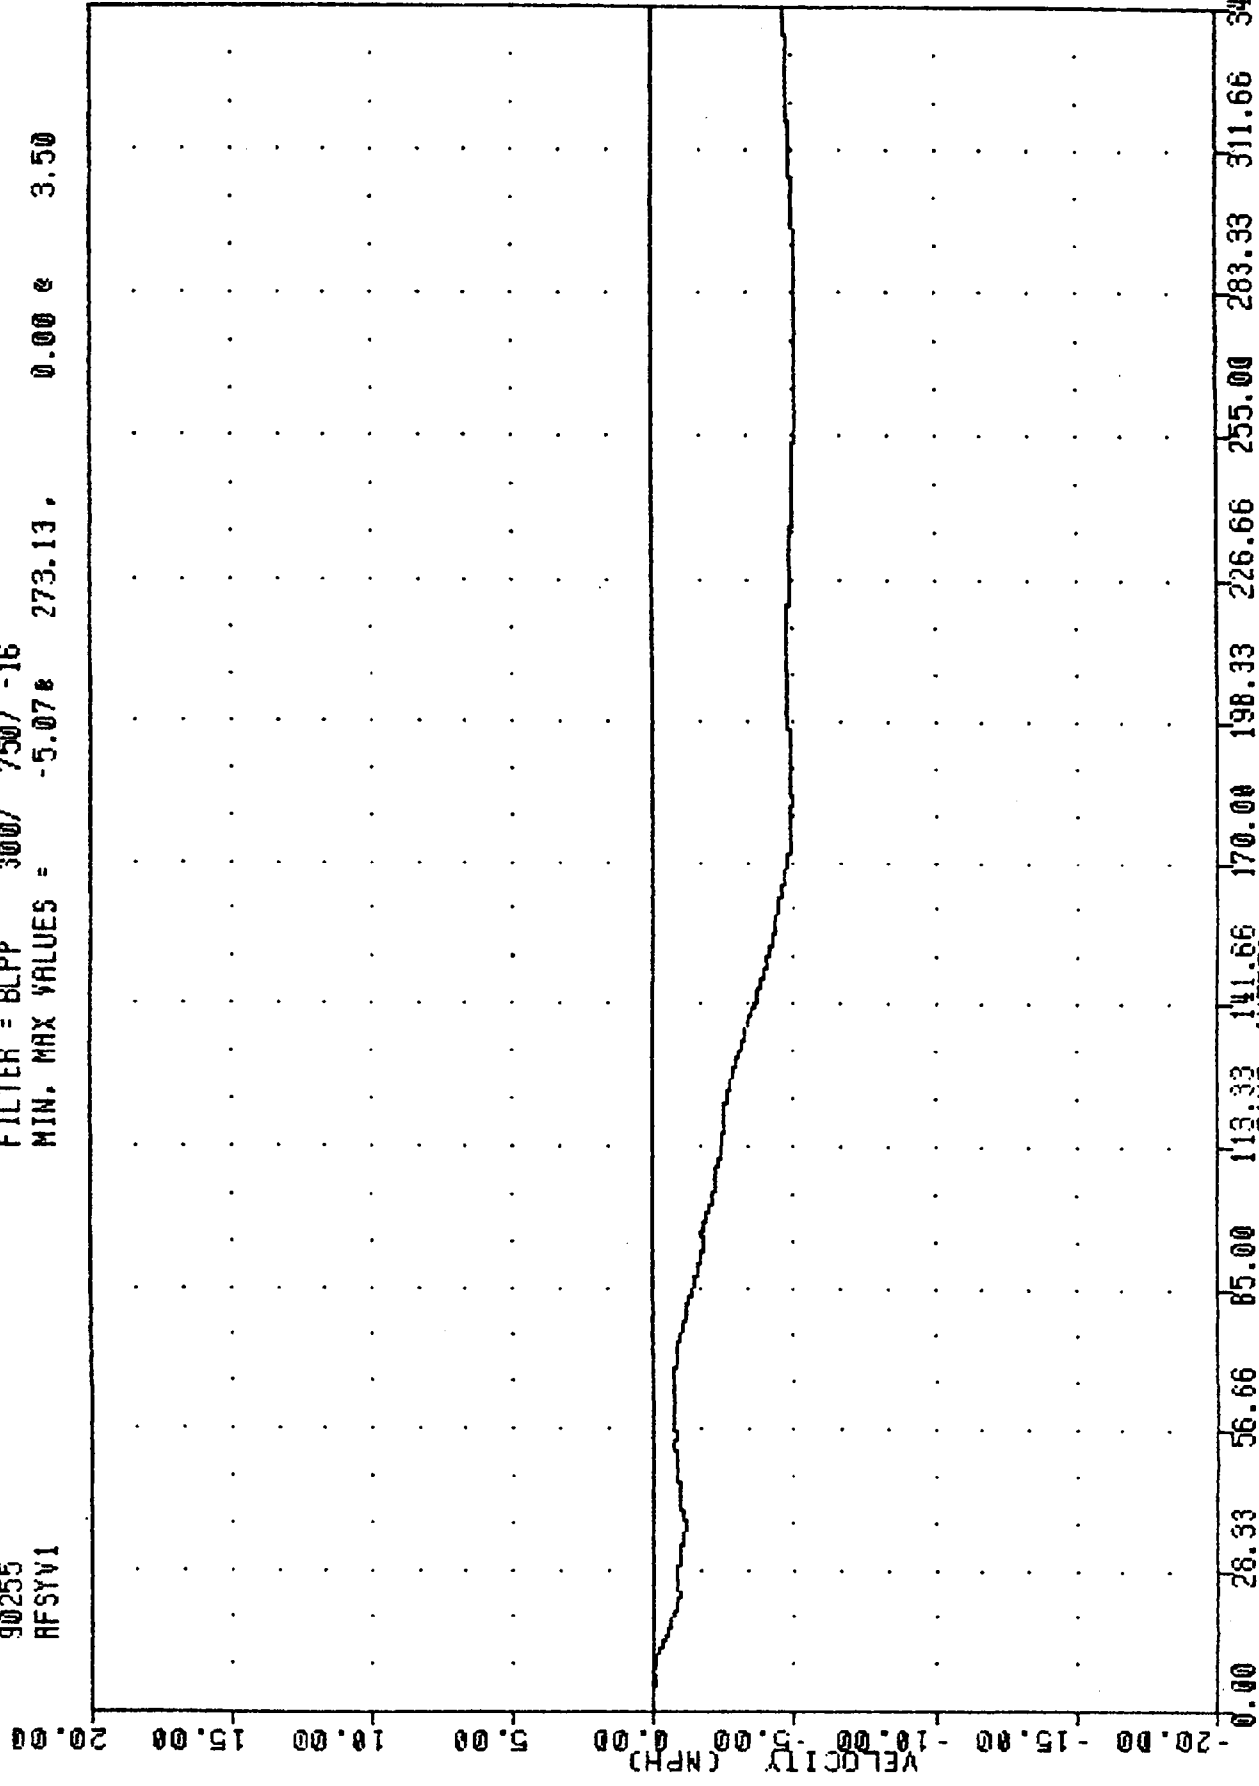
CONTOURED MOVING BARRIER INTO LEFT SIDE OF AN AUDI 5000 AT 19.8 MPH #2
 RIGHT FRONT SILL Y-AXIS VELOCITY

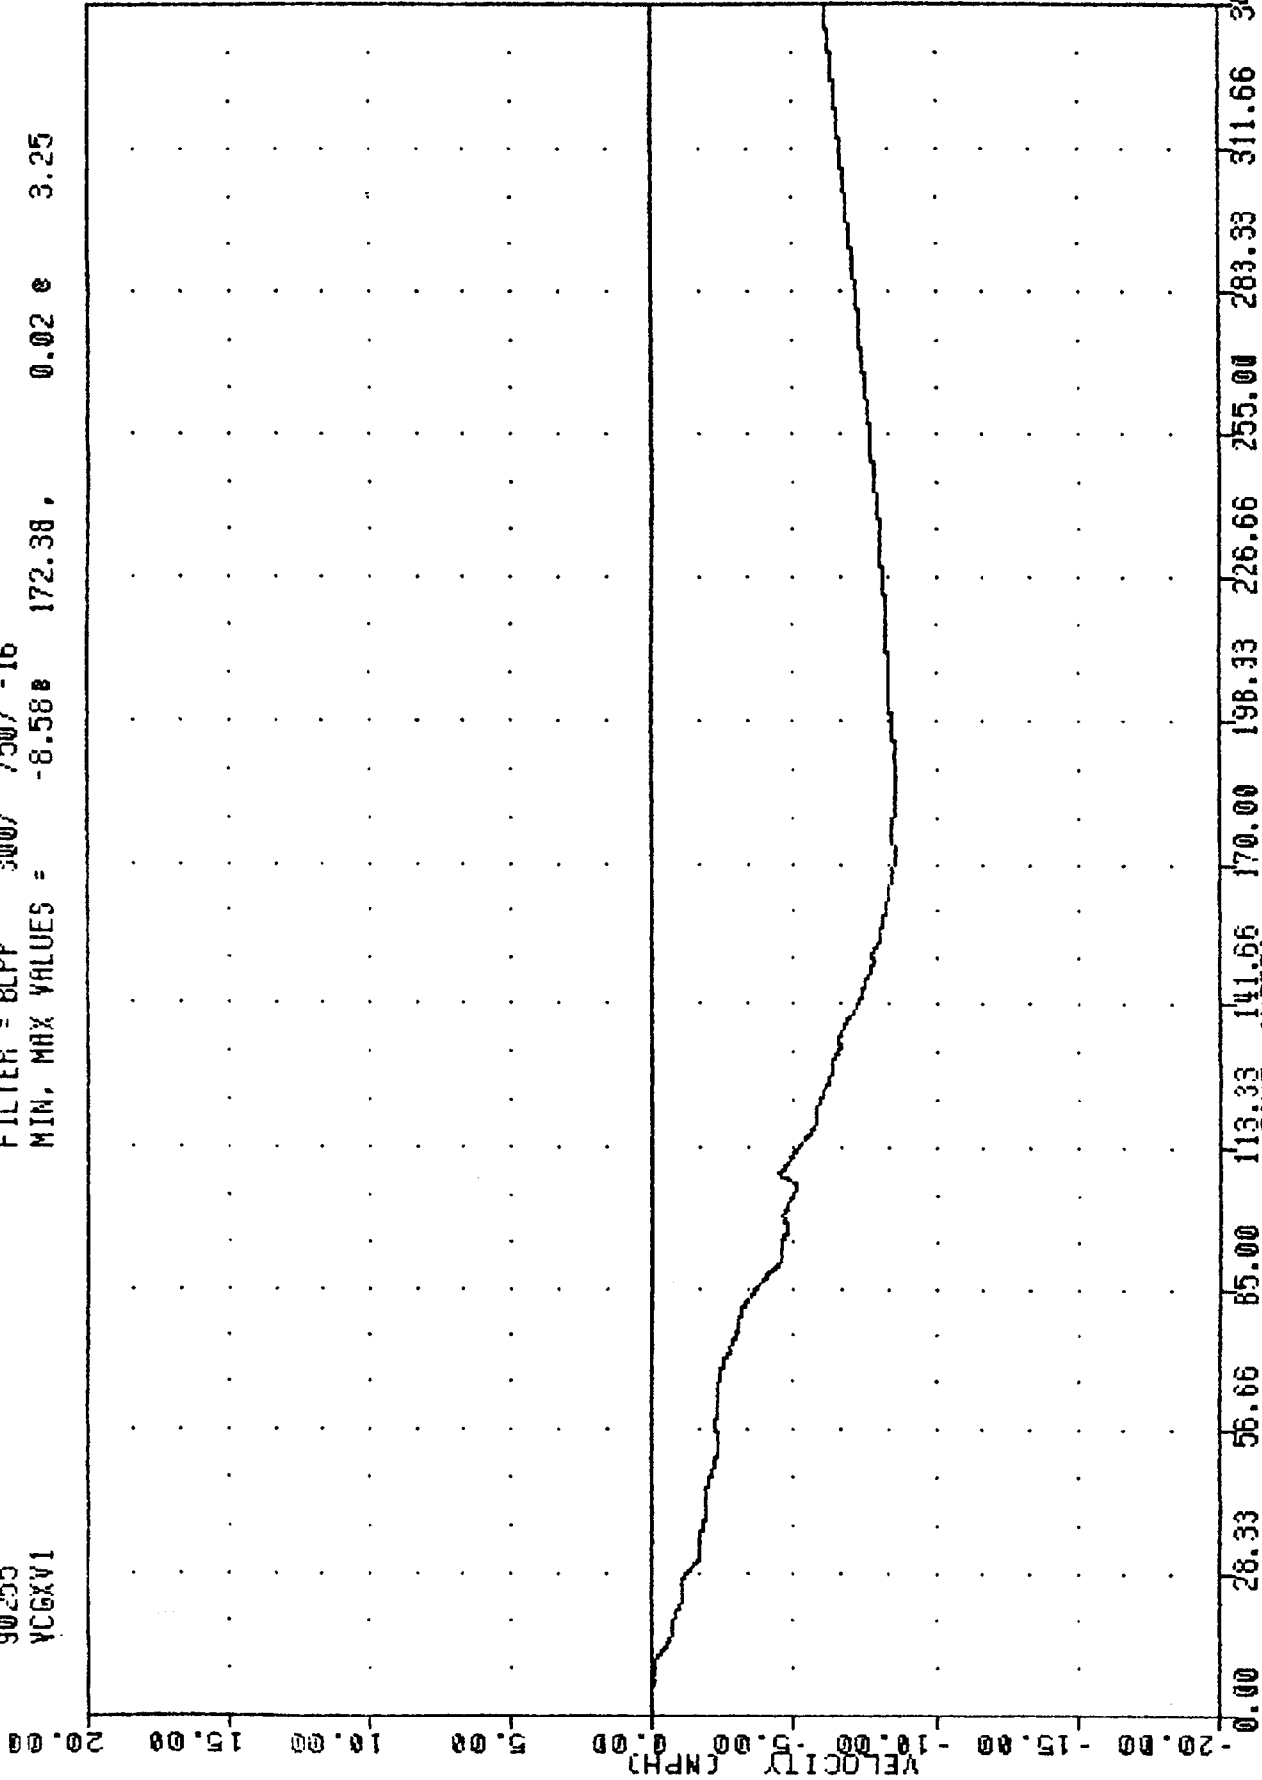
CONTOURED MOVING BARRIER INTO LEFT SIDE OF AN AUDI 5000 AT 19.8 MPH #2
 VEHICLE CG X-AXIS VELOCITY (IMPACT DIRECTION)

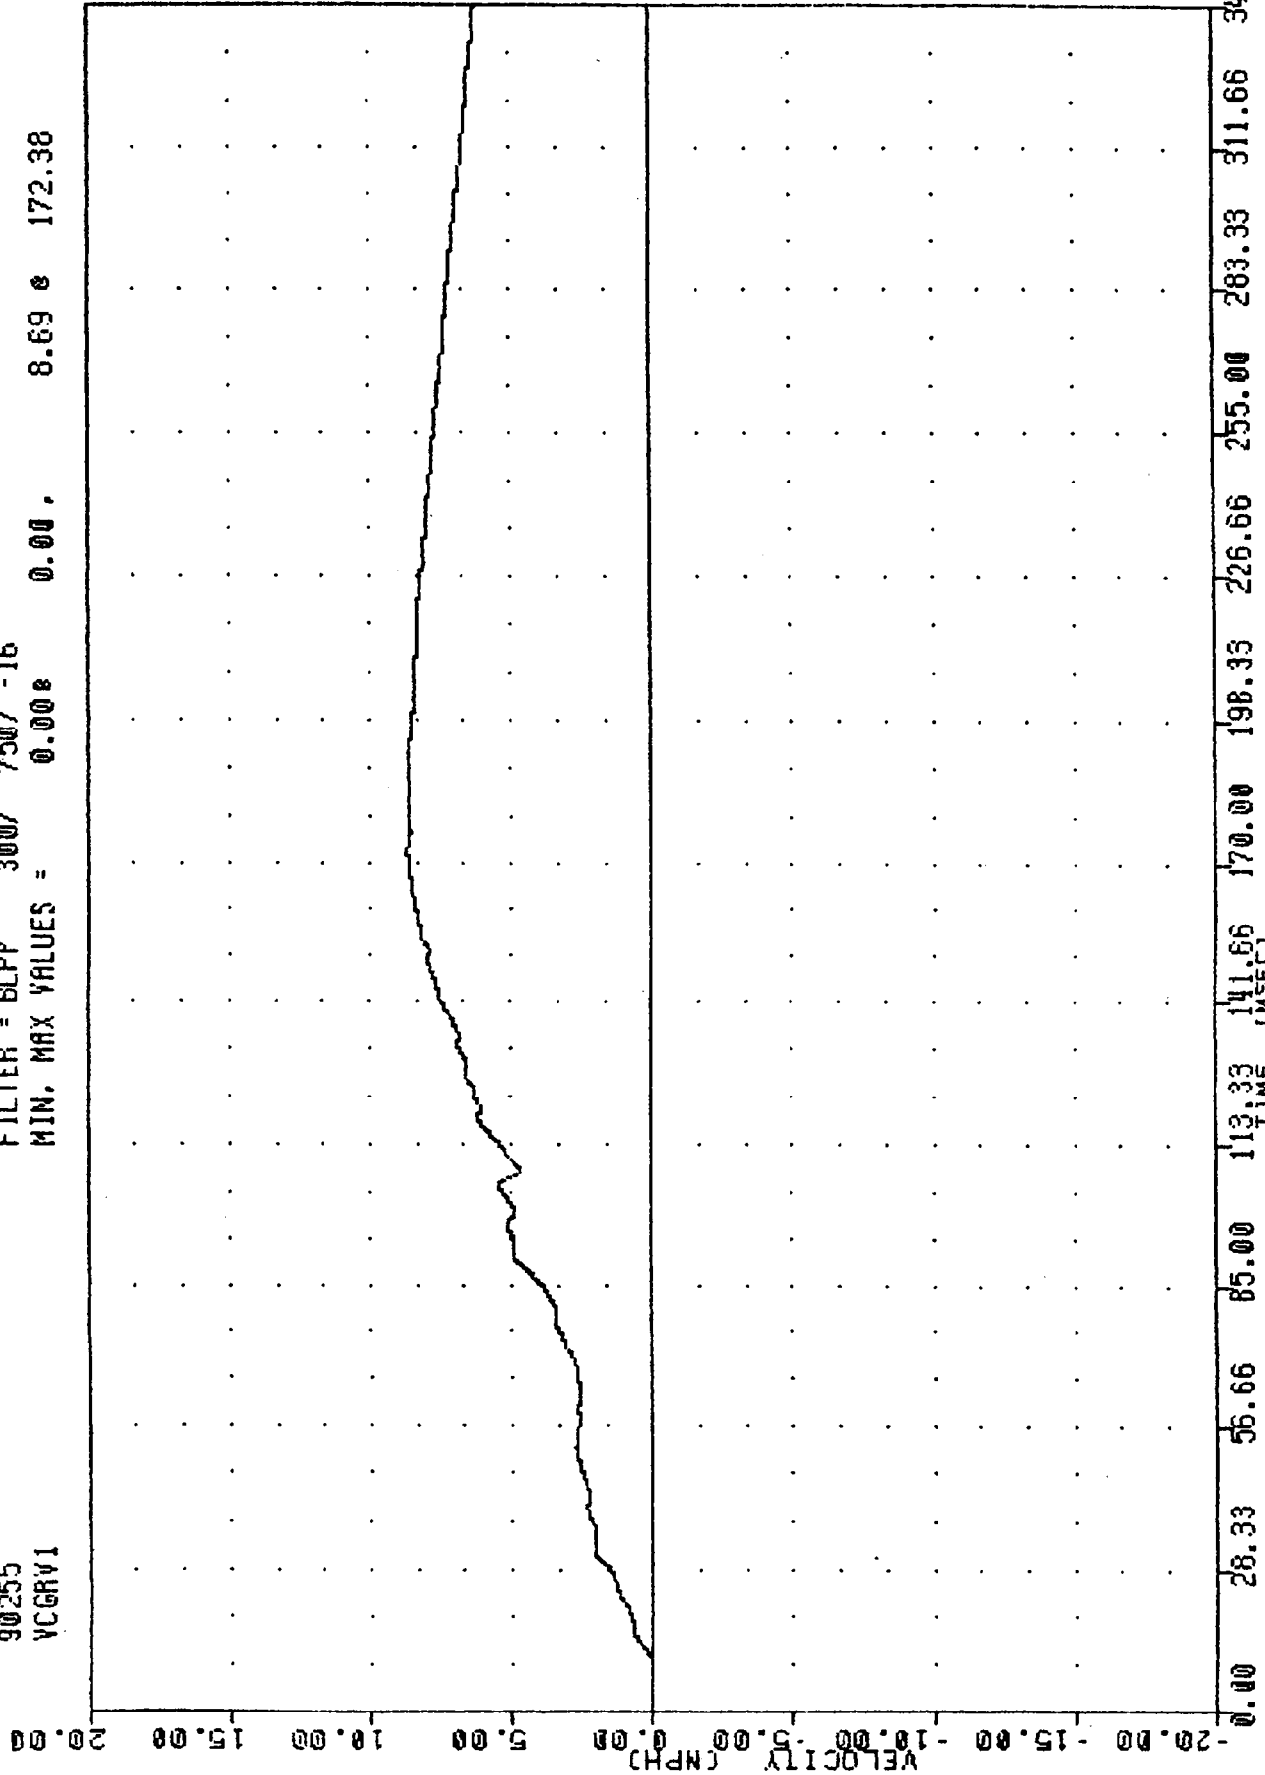
CONTOURED MOVING BARRIER INTO LEFT SIDE OF AN AUDI 5000 AT 19.8 MPH *2
 VEHICLE CG RESULTANT VELOCITY

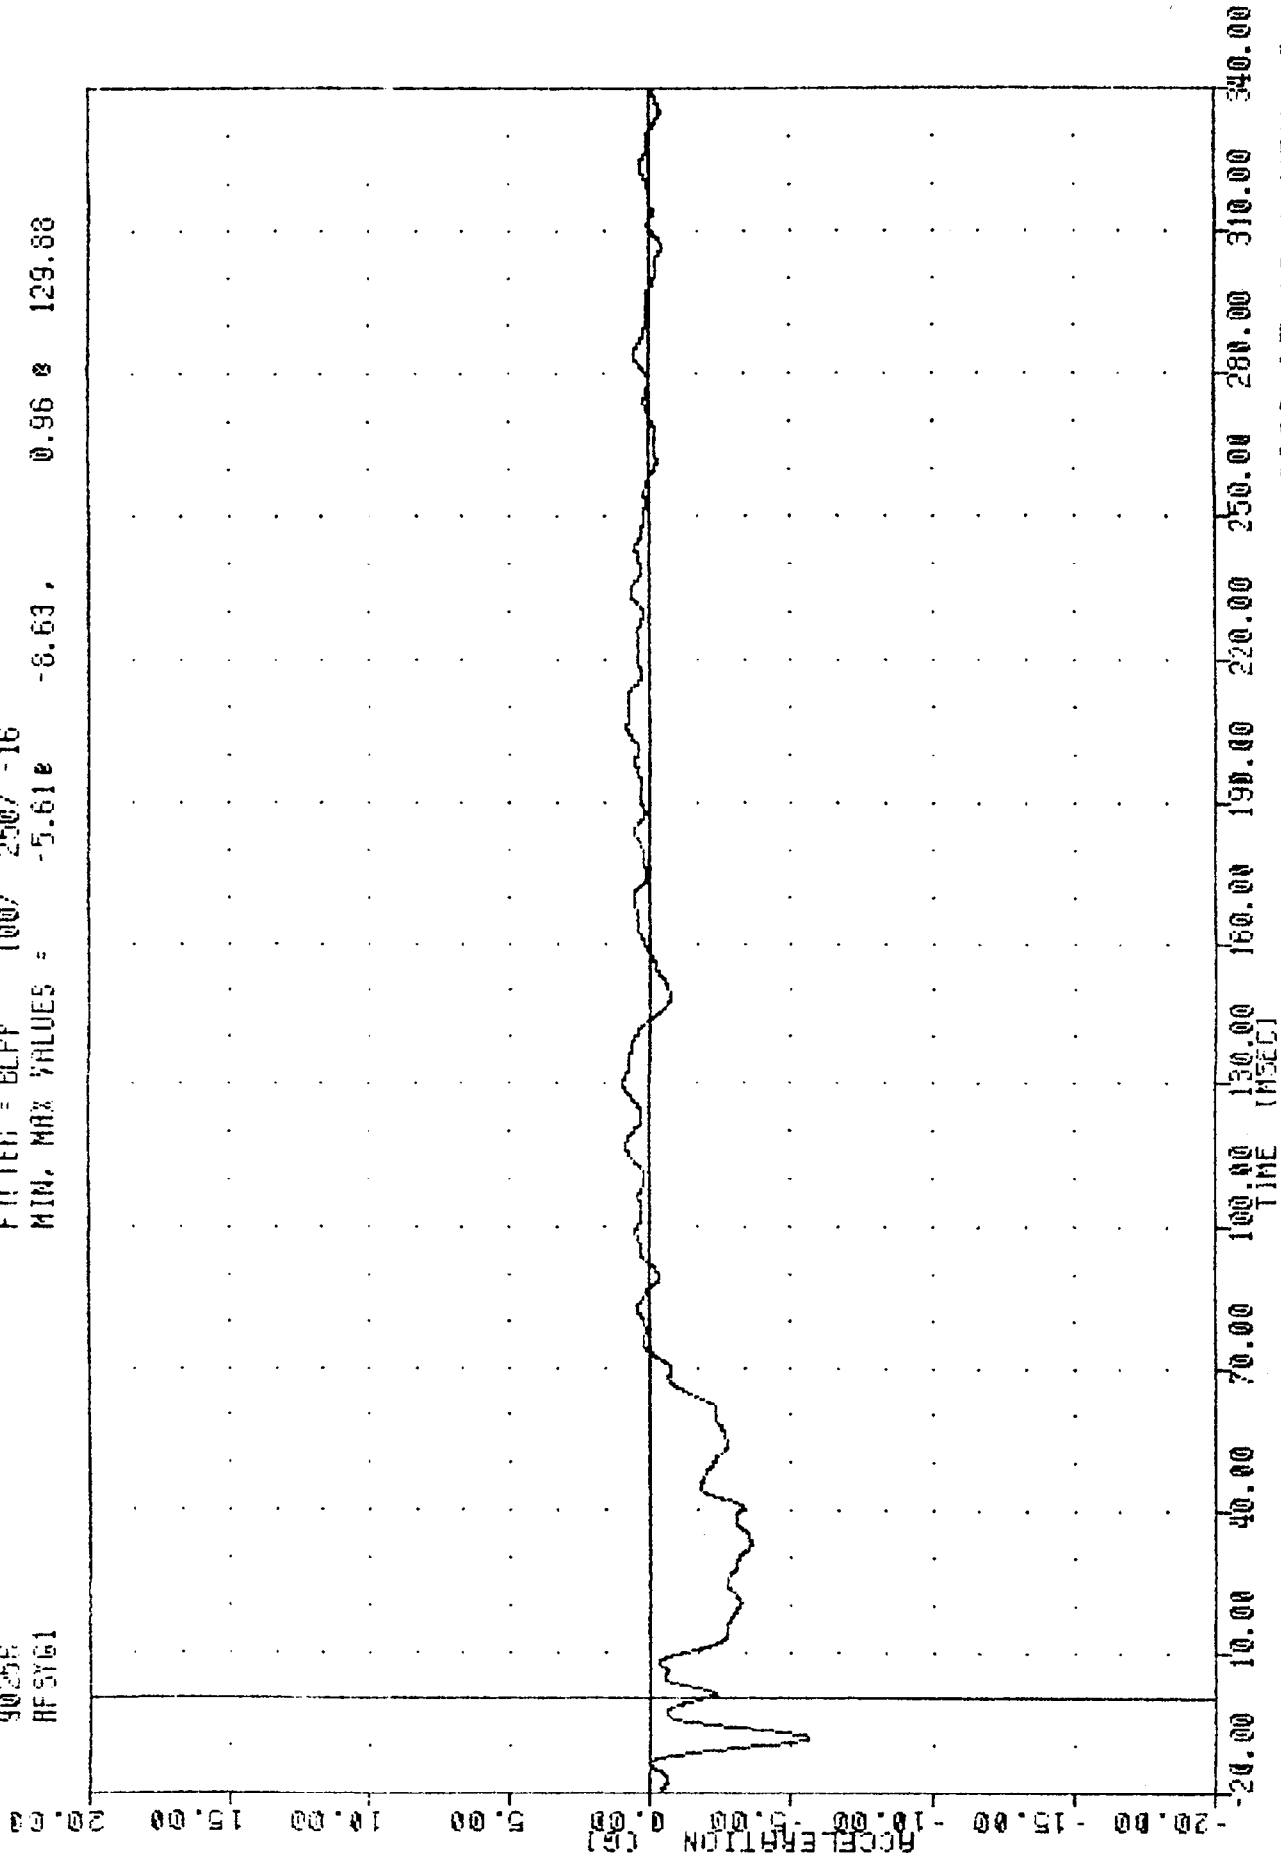
CONTOURED MOVING BARRIER INTO LEFT SIDE OF AN AUDI 5000 AT 19.9 MPH #3
 RIGHT FRONT SILL Y-AXIS ACCELERATION

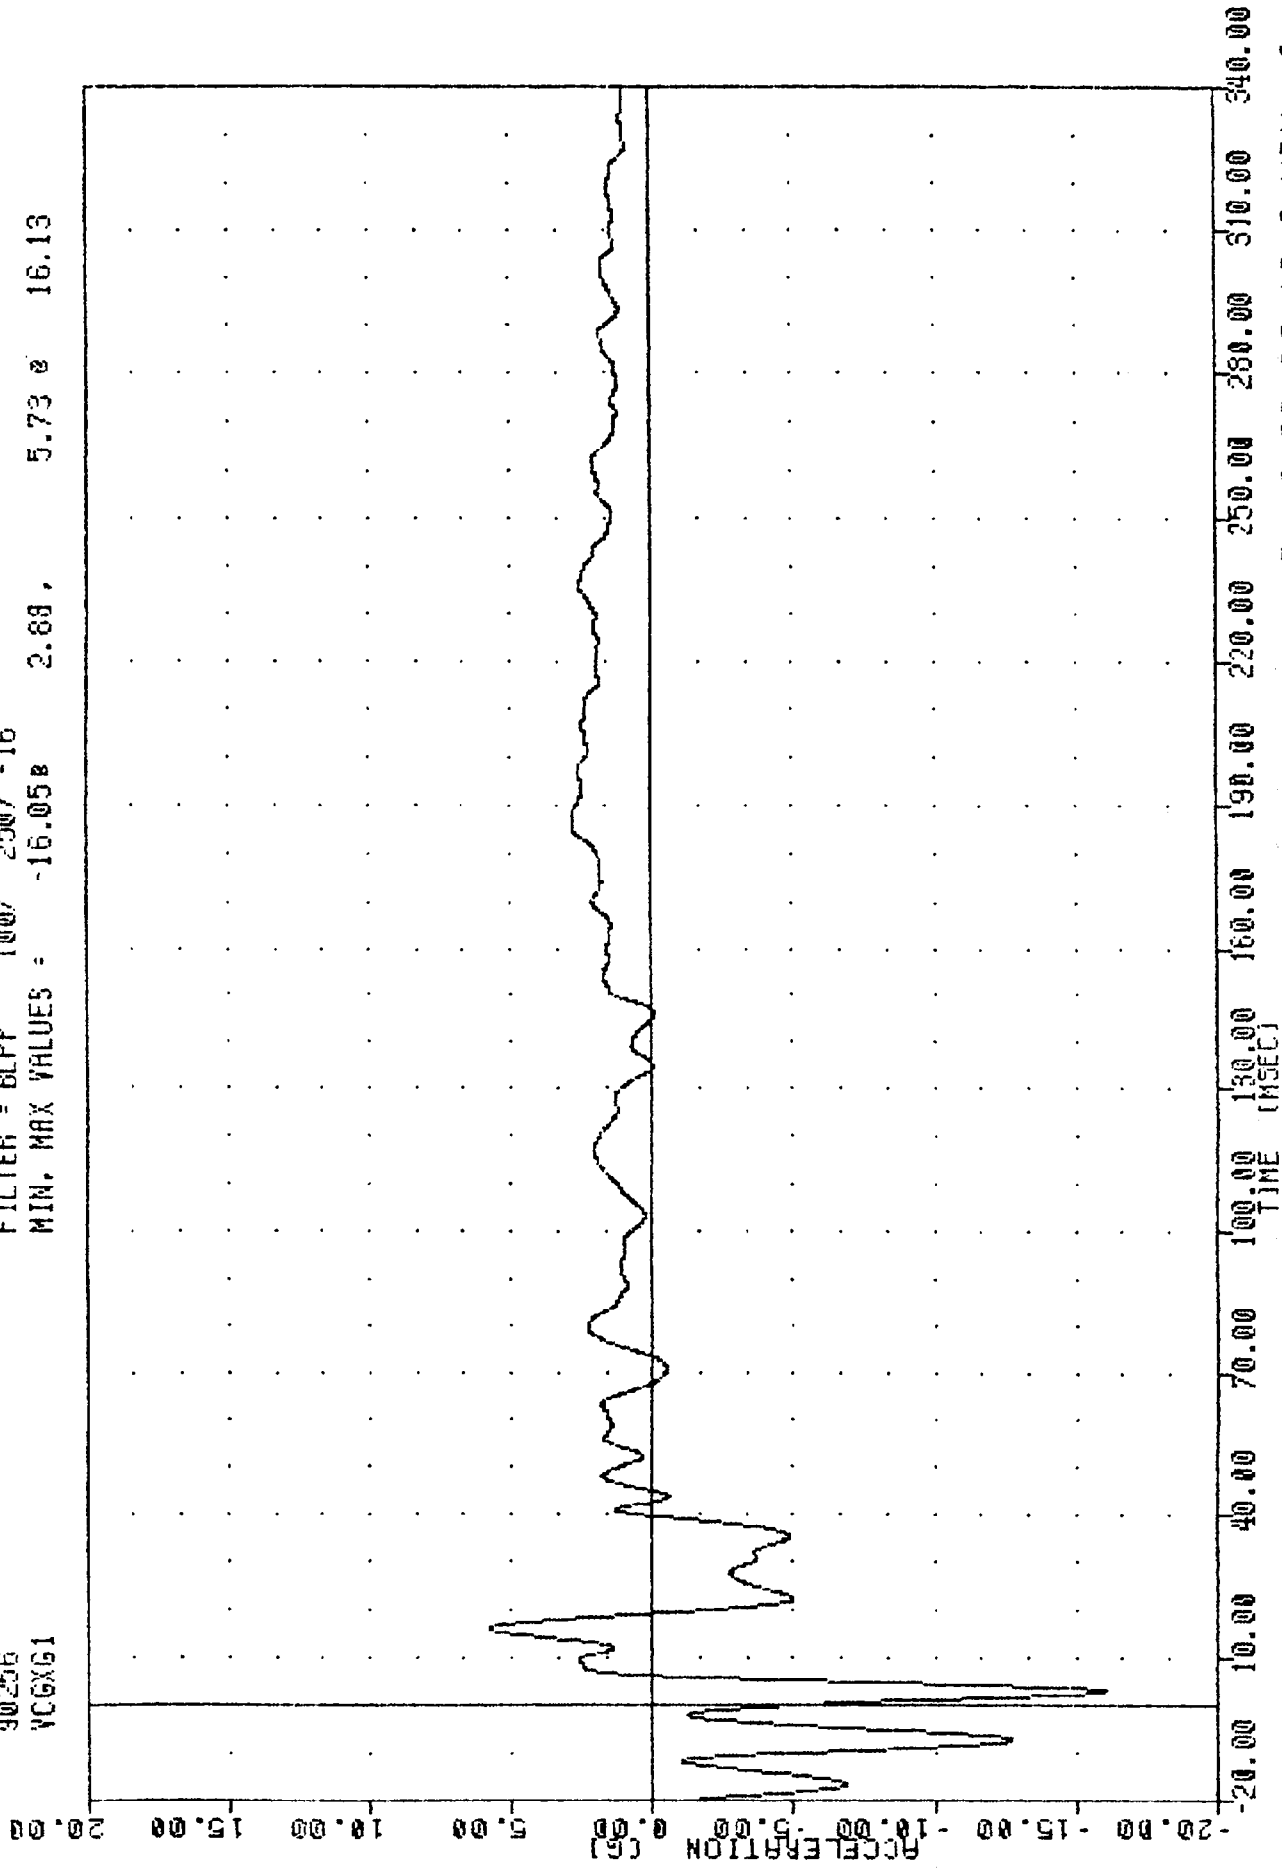
CONTOURED MOVING BARRIER INTO LEFT SIDE OF AN AUDI 5000 AT 19.9 MPH #3
VEHICLE CG X-AXIS ACCELERATION (IMPACT DIRECTION)

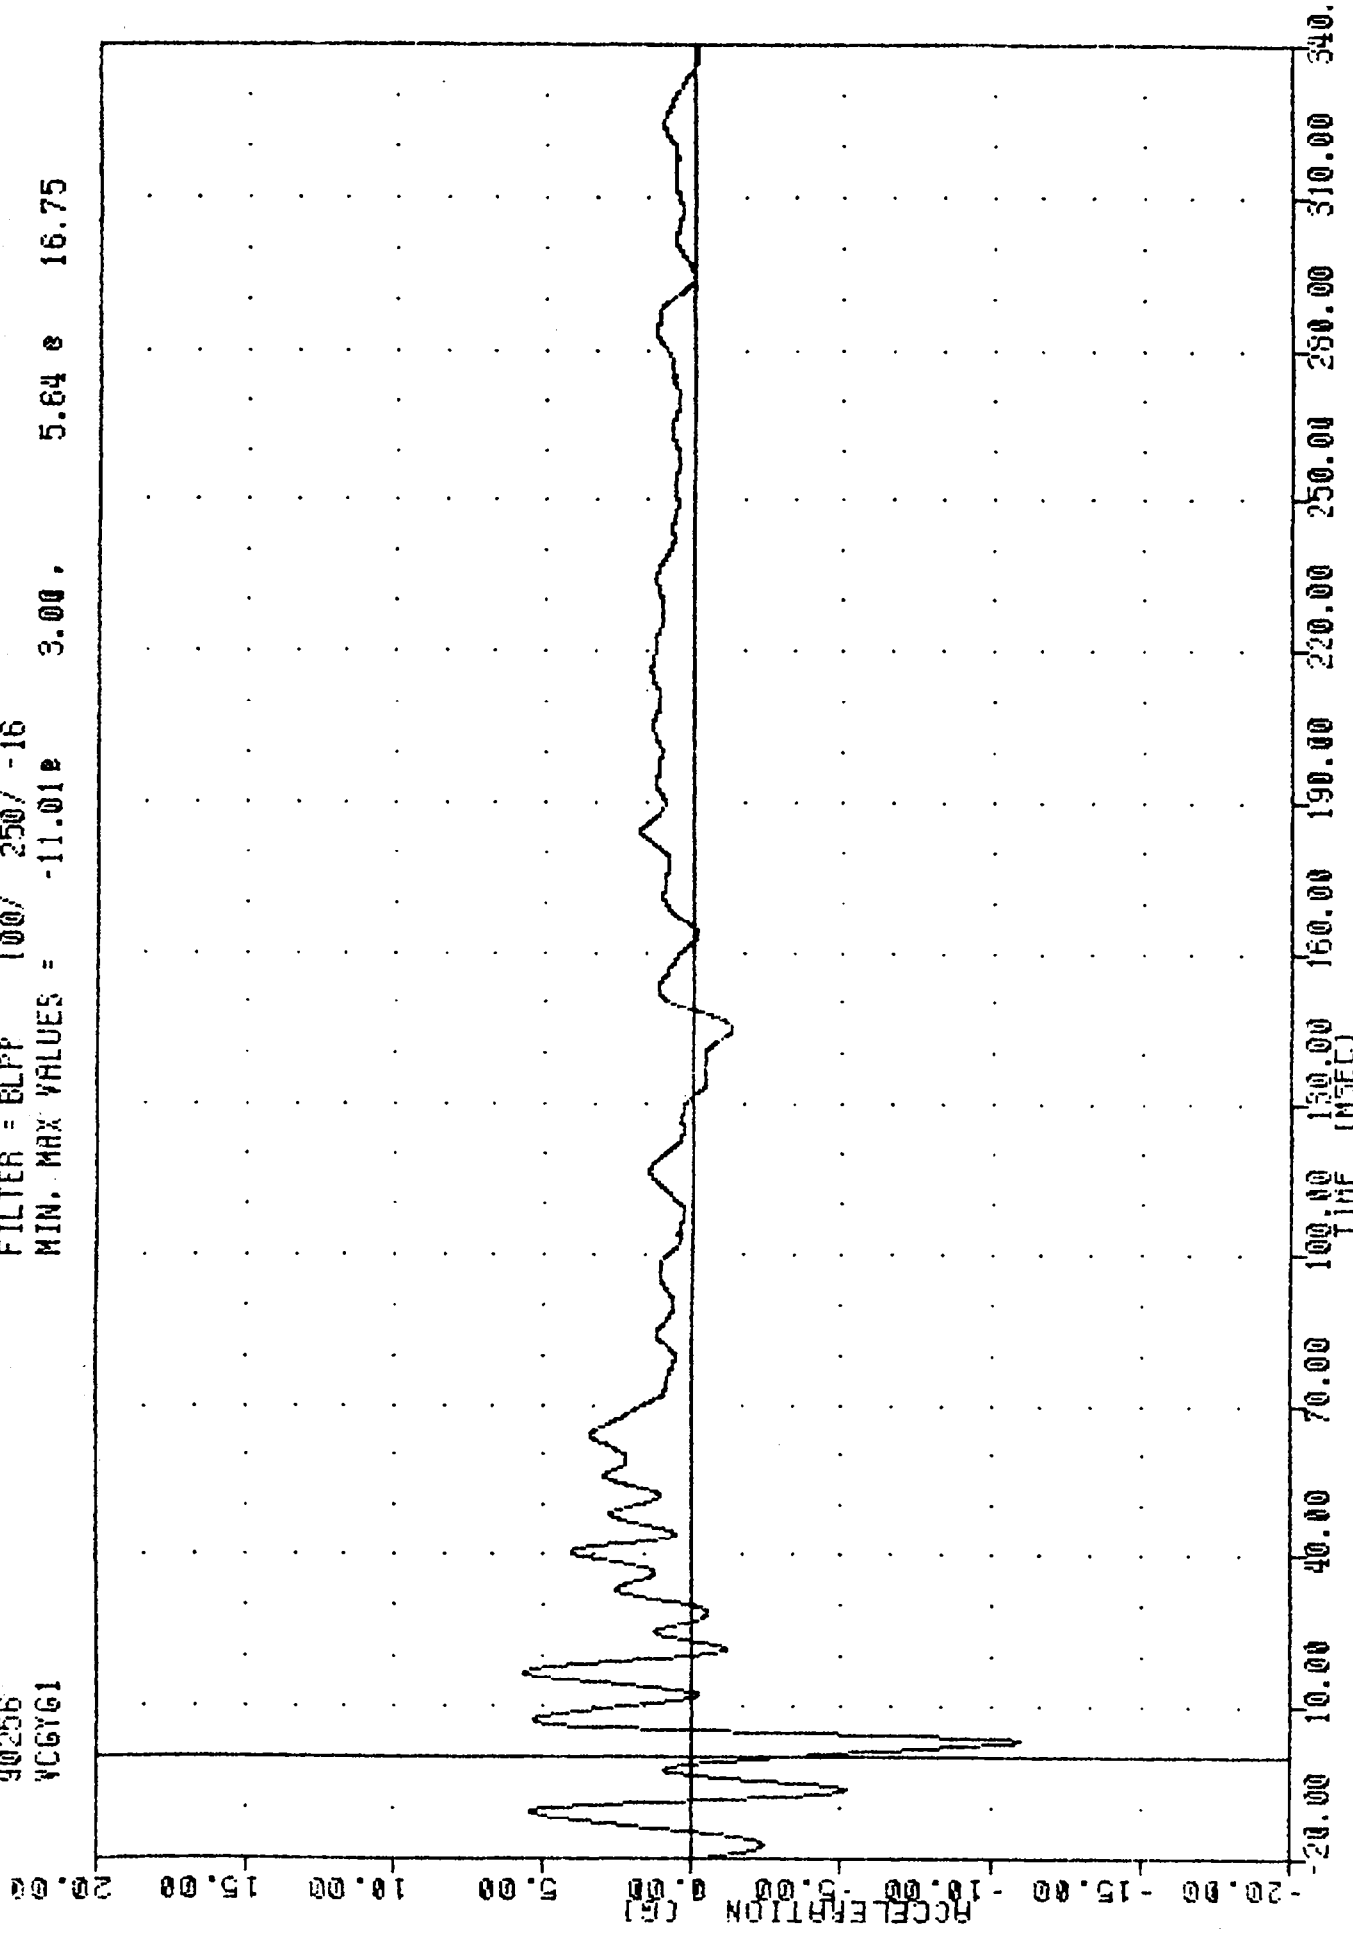
CONToured MOVING BARRIER INTO LEFT SIDE OF AN AUDI 5000 AT 19.9 MPH *S
VEHICLE CG Y-AXIS ACCELERATION (PERPENDICULAR TO IMPACT DIRECTION)

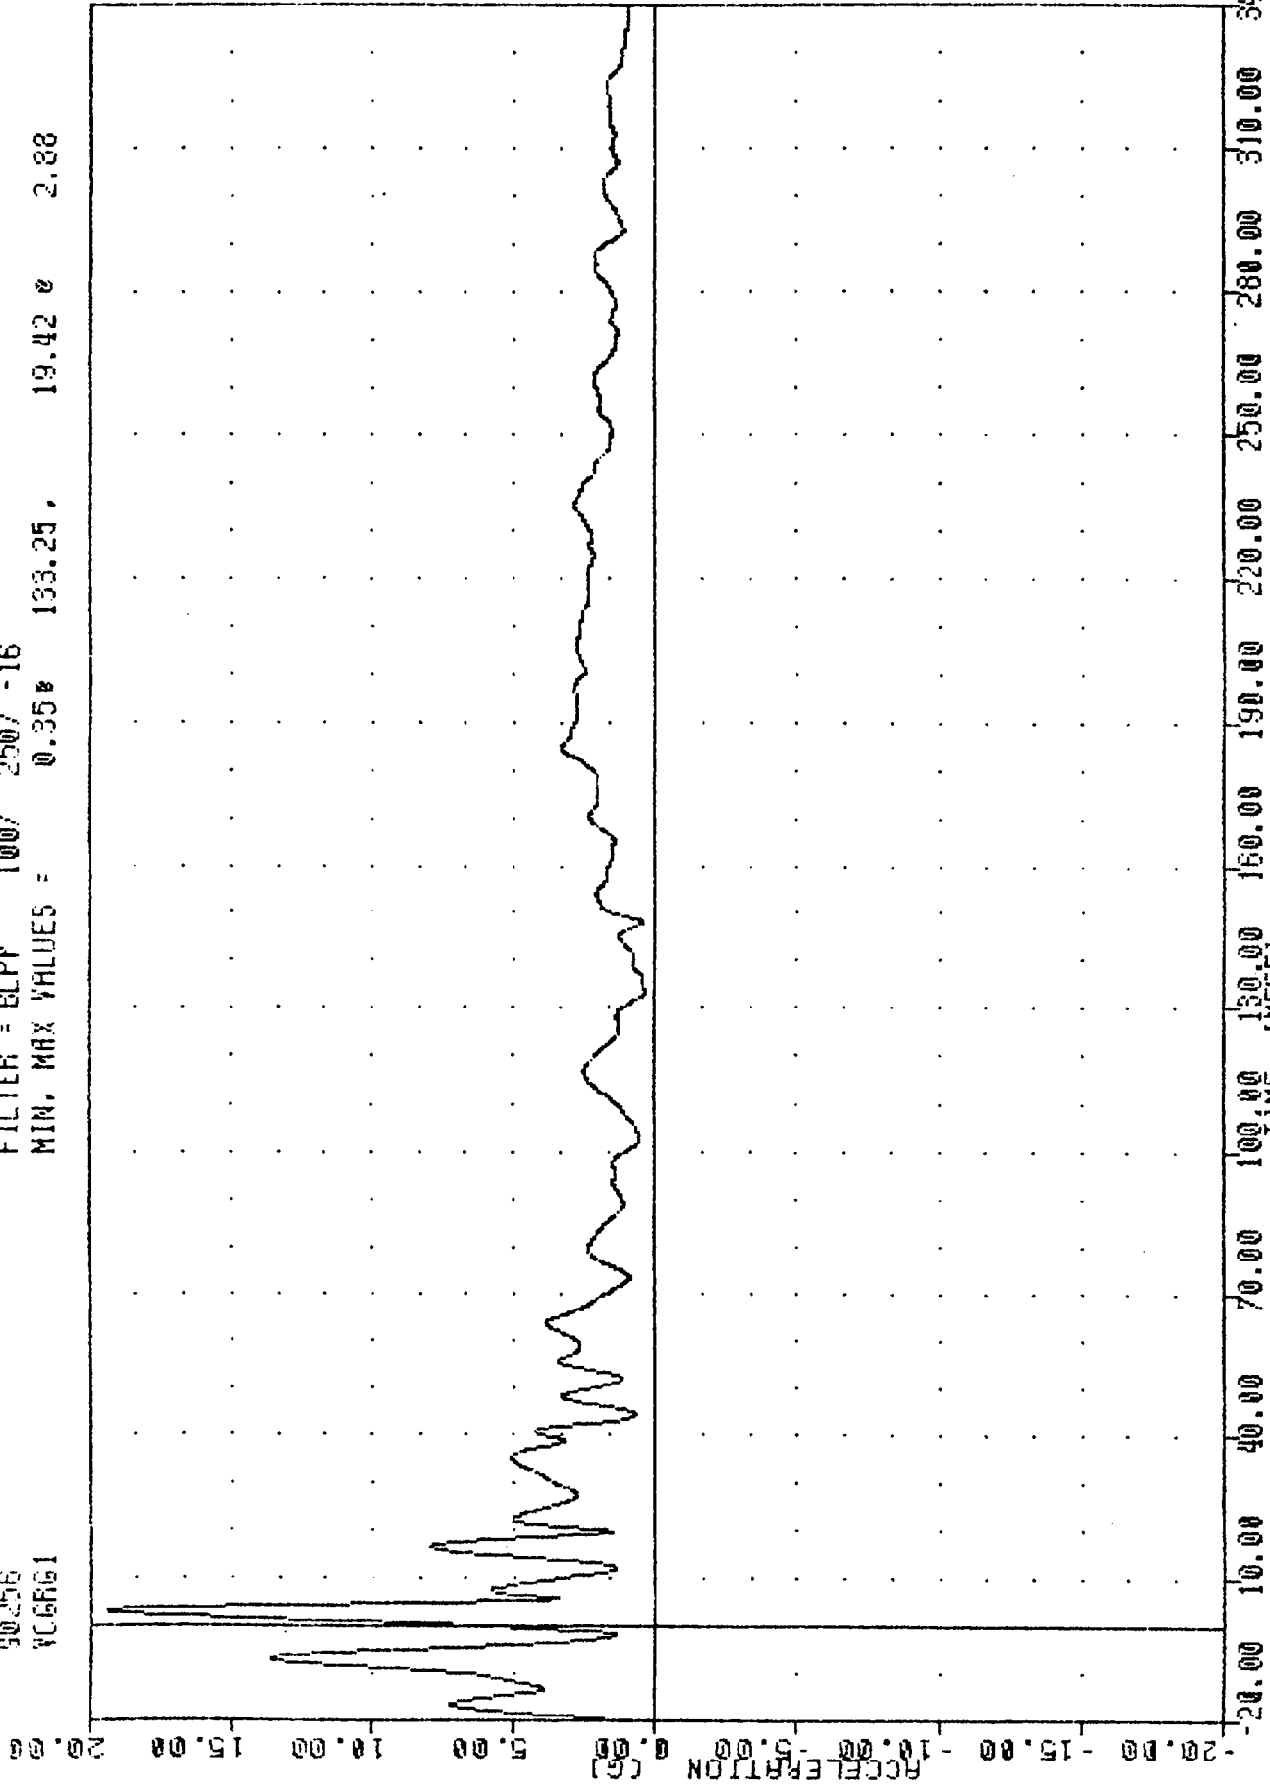
CONTOURED MOVING BARRIER INTO LEFT SIDE OF AN AUDI 5000 AT 19.9 MPH #3
 VEHICLE CG RESULTANT ACCELERATION

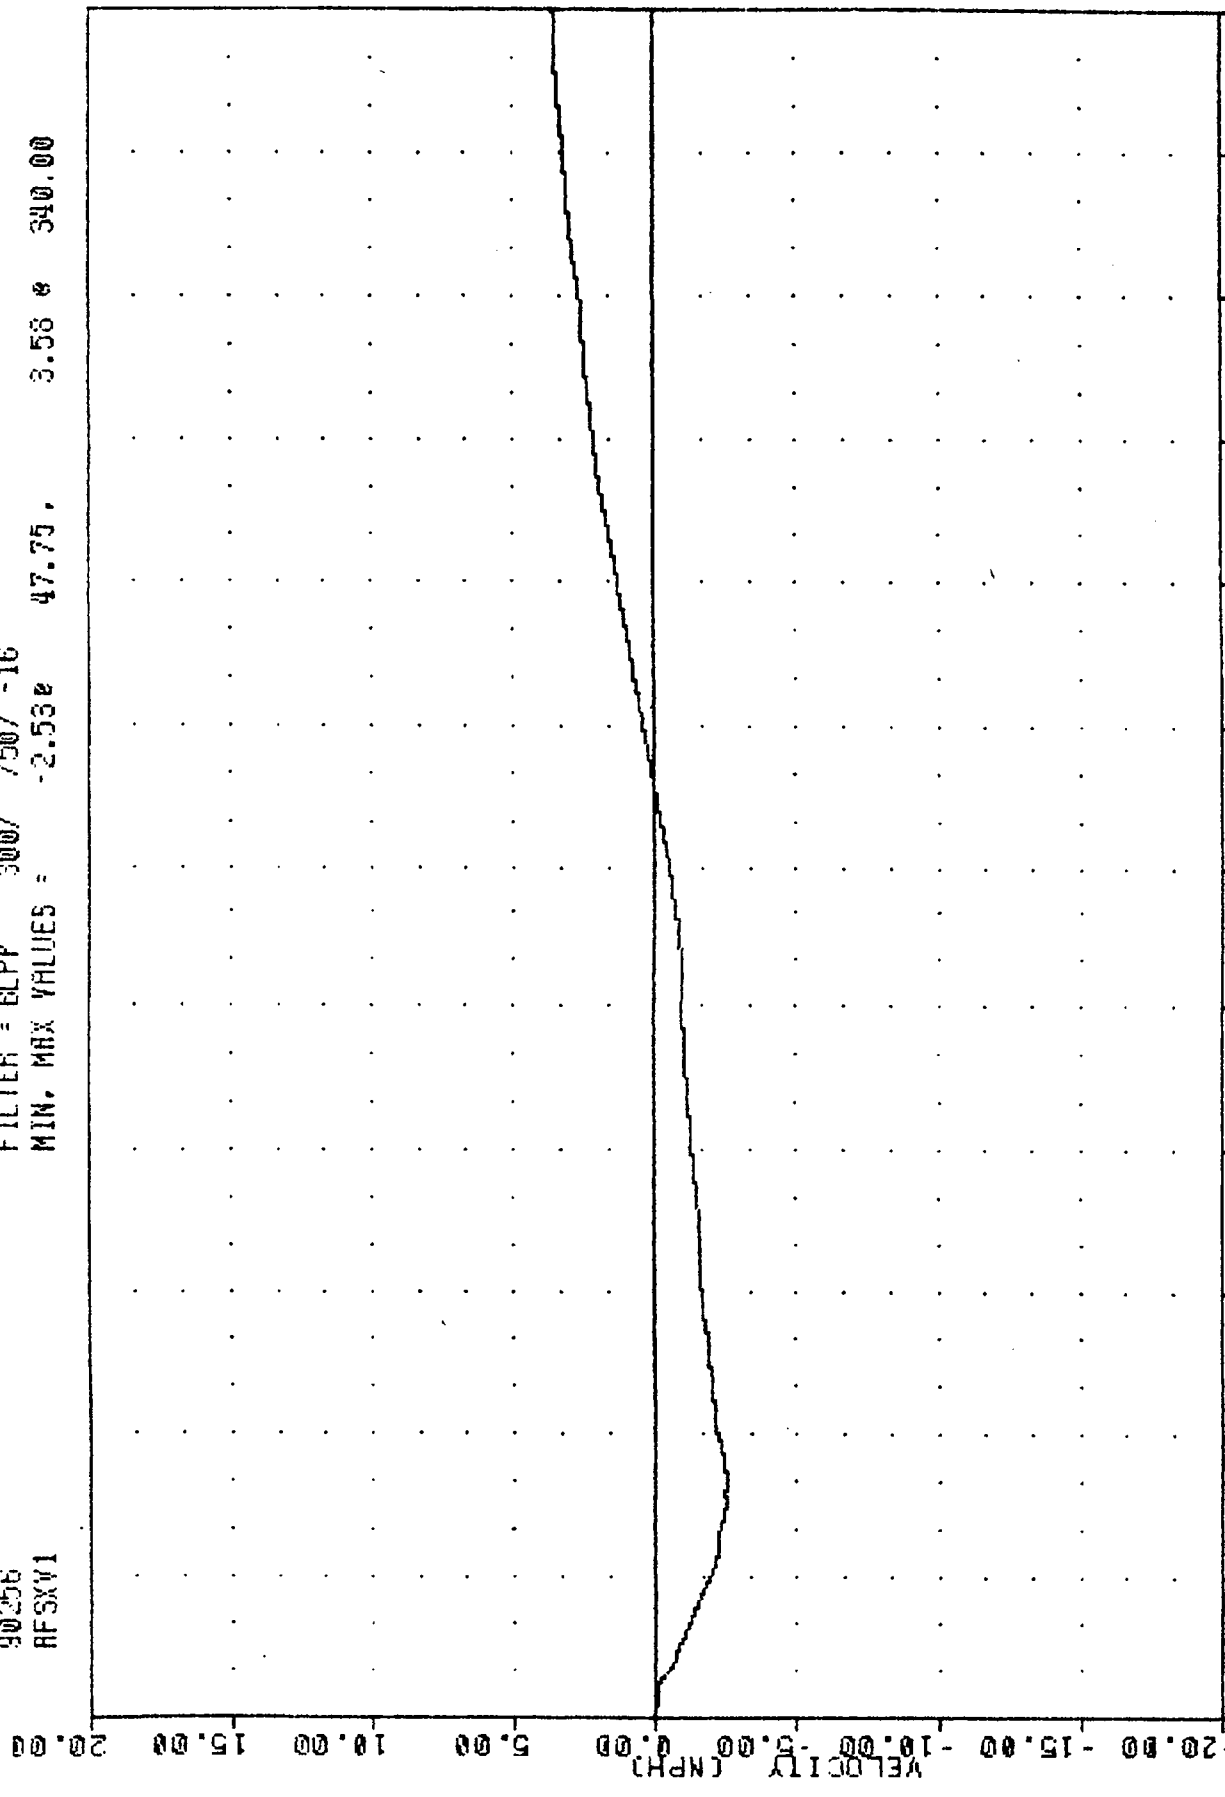
CONTOURED MOVING BARRIER INTO LEFT SIDE OF AN AUDI 5000 AT 19.9 MPH *3
 RIGHT FRONT SILL X-AXIS VELOCITY

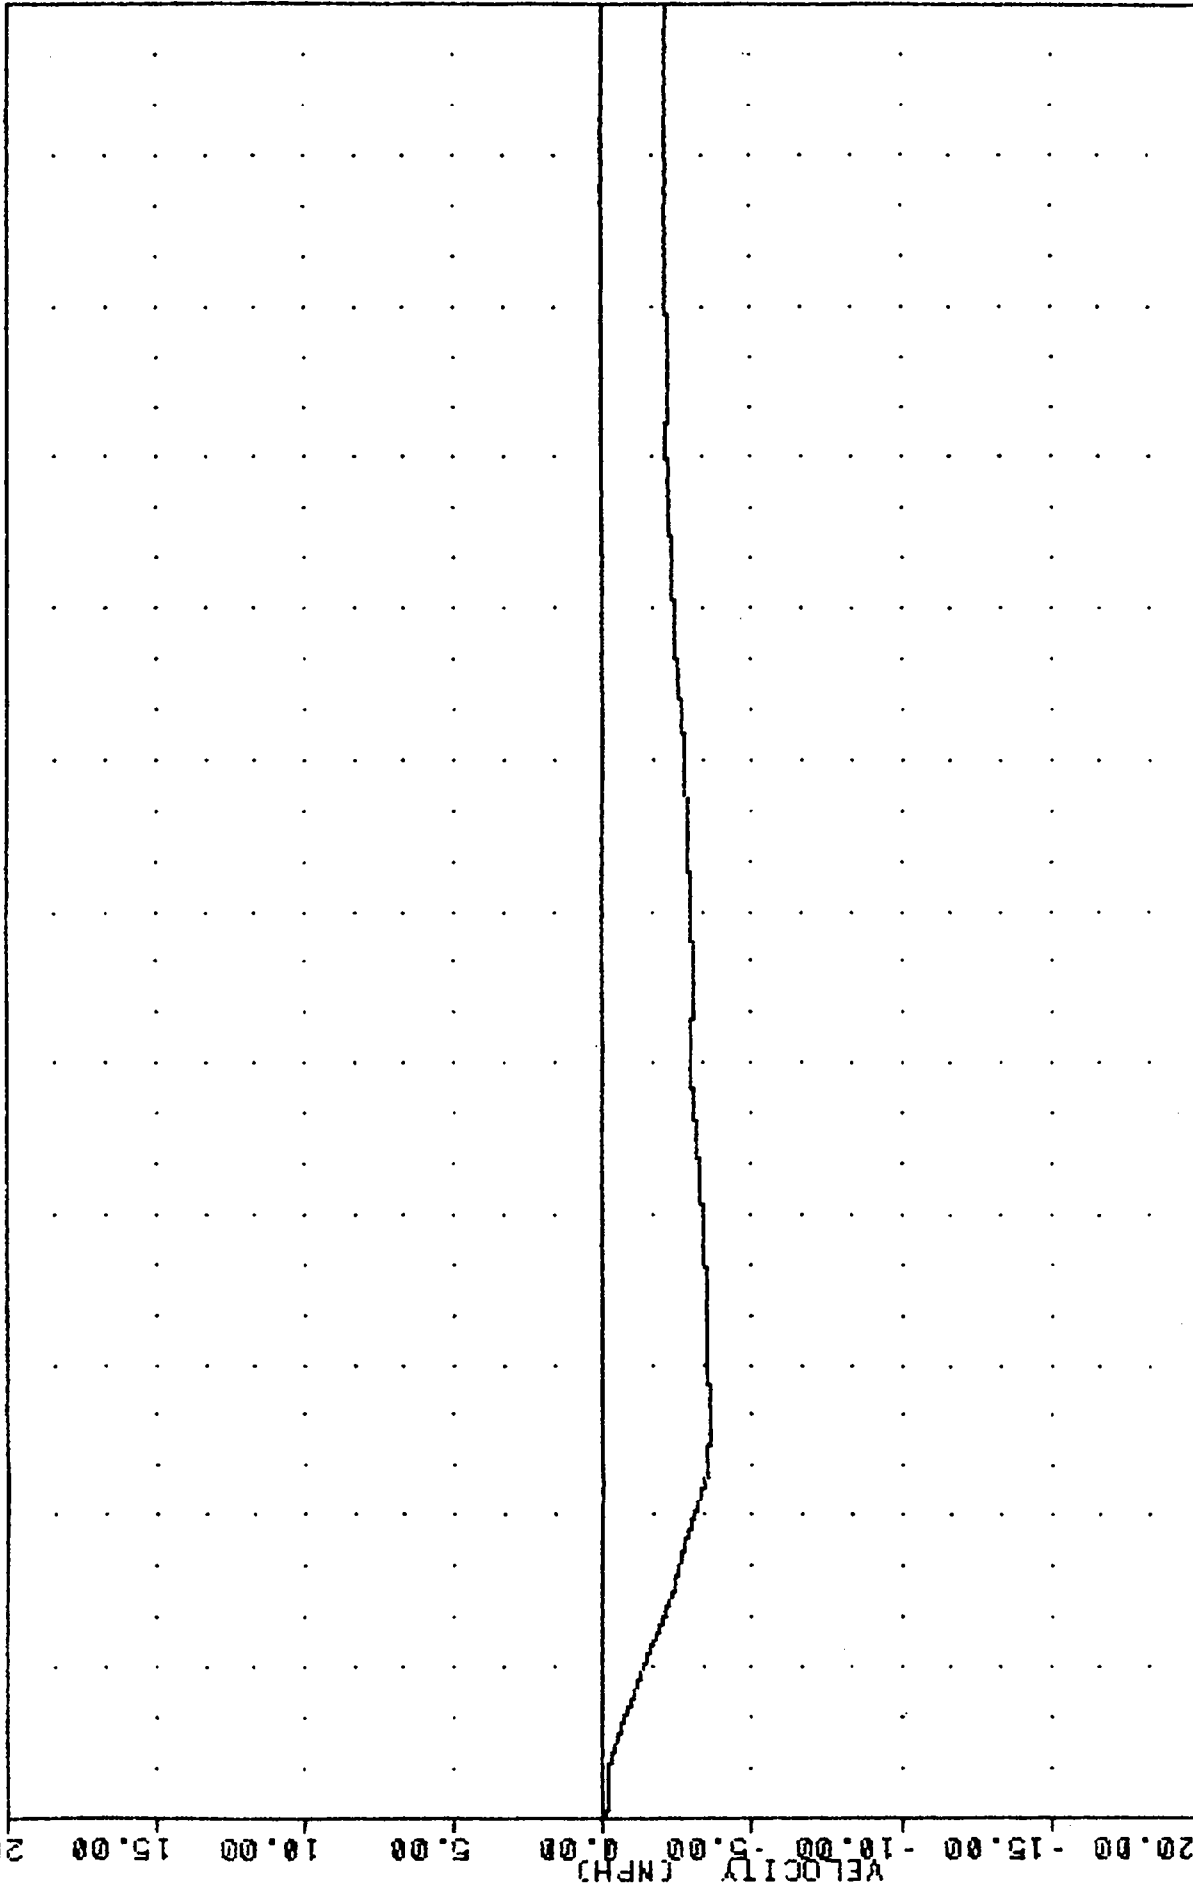
B51

CONTOURED MOVING BARRIER INTO LEFT SIDE OF AN AUDI 5000 AT 19.9 MPH
RIGHT FRONT SILL Y-AXIS VELOCITY
