U.S. Department
of Transportation
**National Highway
Traffic Safety
Administration**

**DOT HS 807 772
Final Report**

Final Report of 315° Contoured Moving Barrier Impact Into a 1982 Audi 5000 4-Door Sedan in Support of Crash III Damage Algorithm Reformation

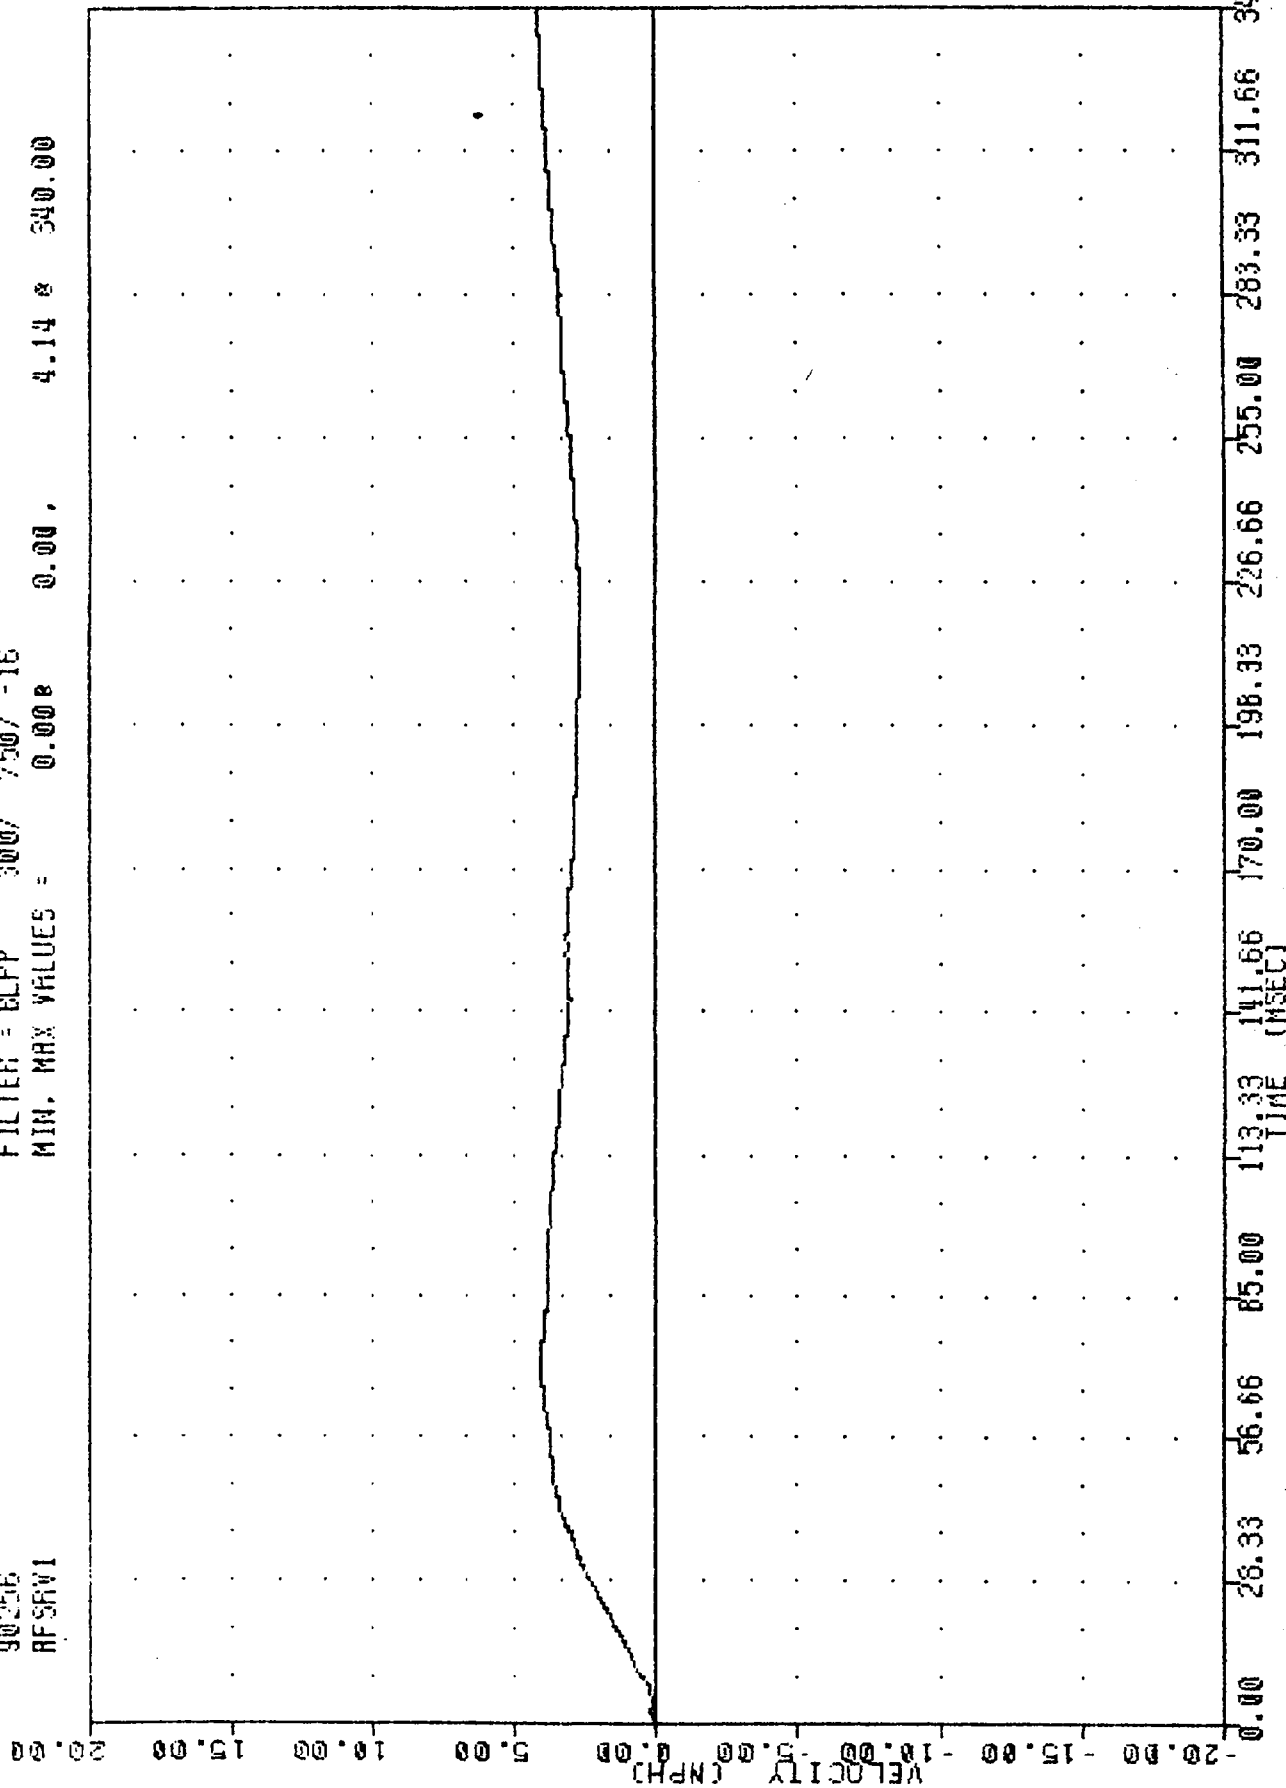
CONToured MOVING BARRIER INTO LEFT SIDE OF AN AUDI 5000 AT 19.9 MPH *3
 RIGHT FRONT SILL RESULTANT VELOCITY

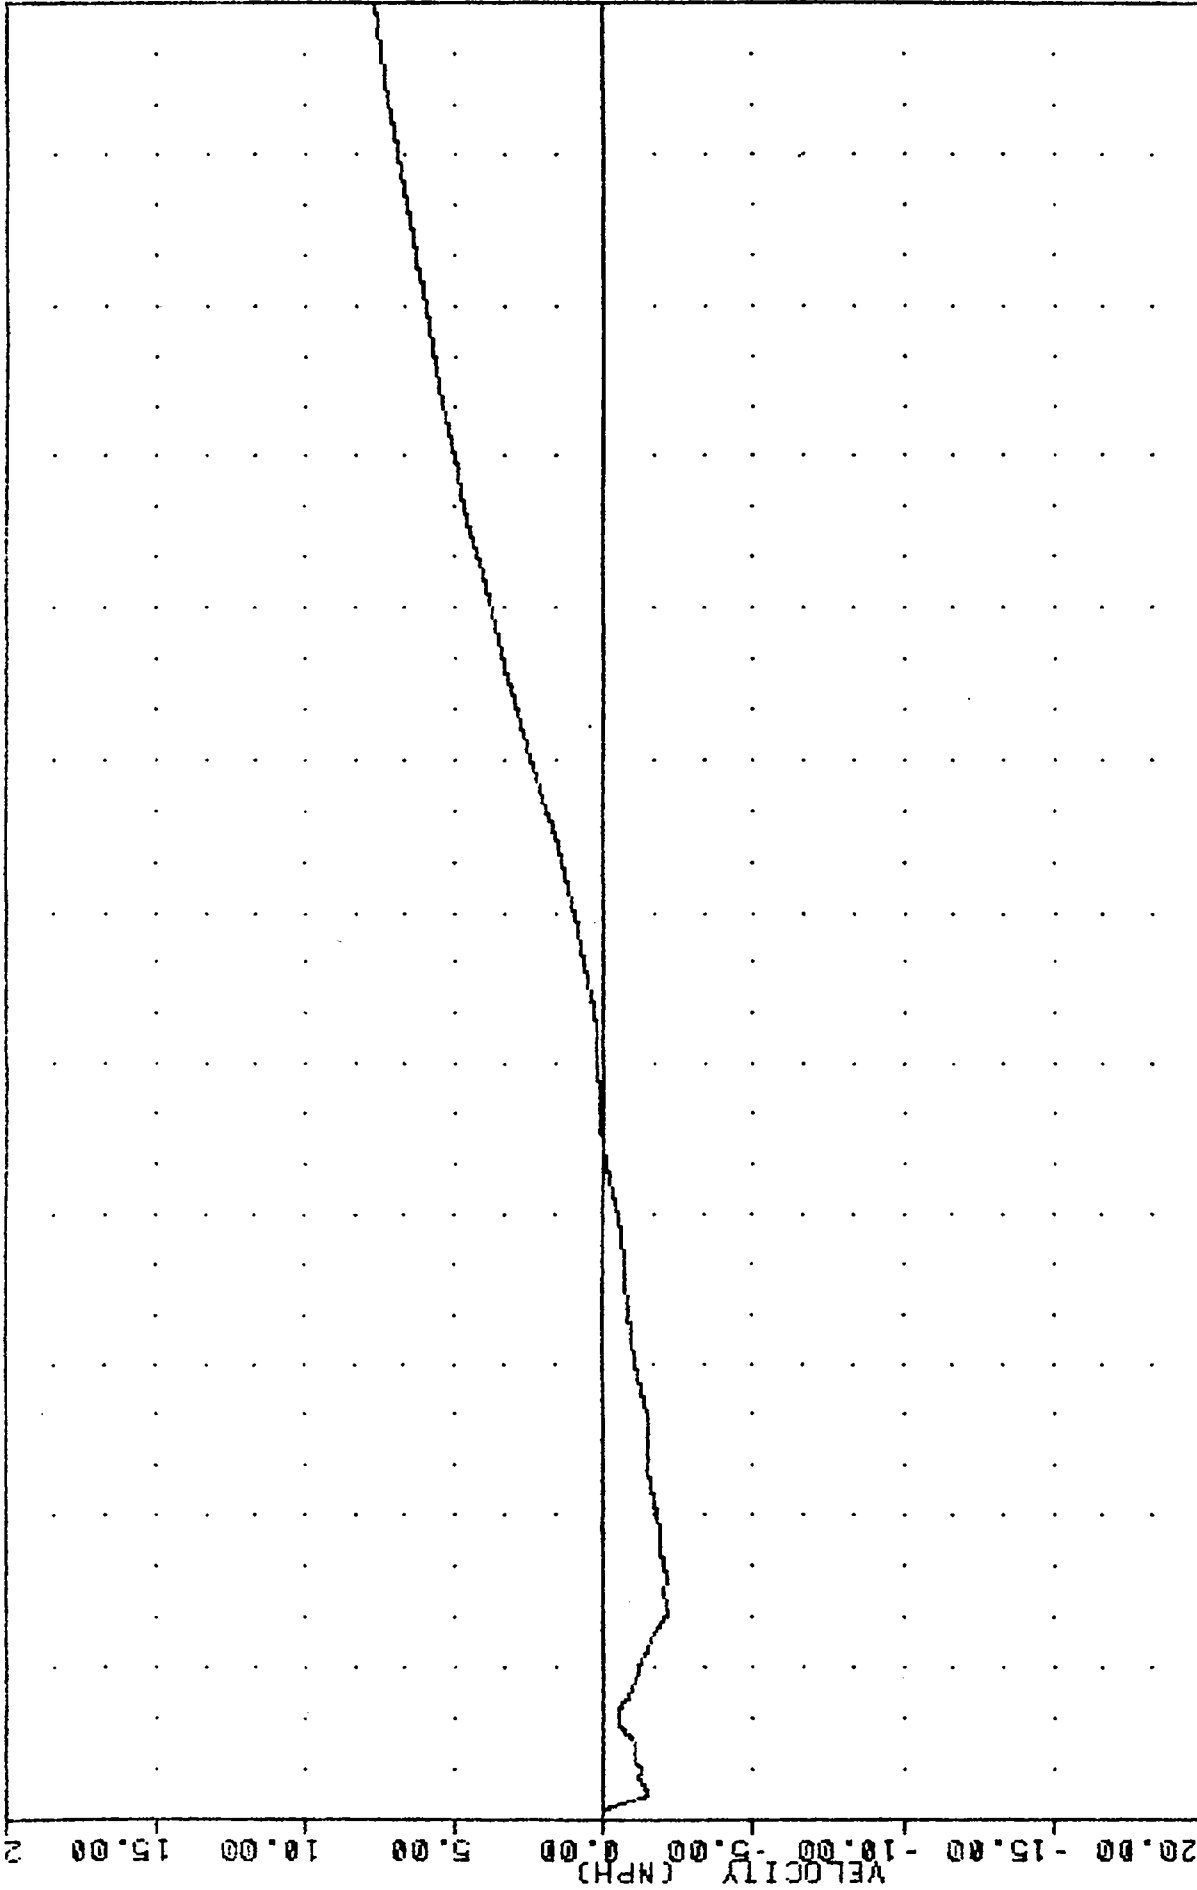
B53

CONToured MOVING BARRIER INTO LEFT SIDE OF AN AUDI 5000 AT 19.9 MPH
VEHICLE CG X-AXIS VELOCITY (IMPACT DIRECTION)

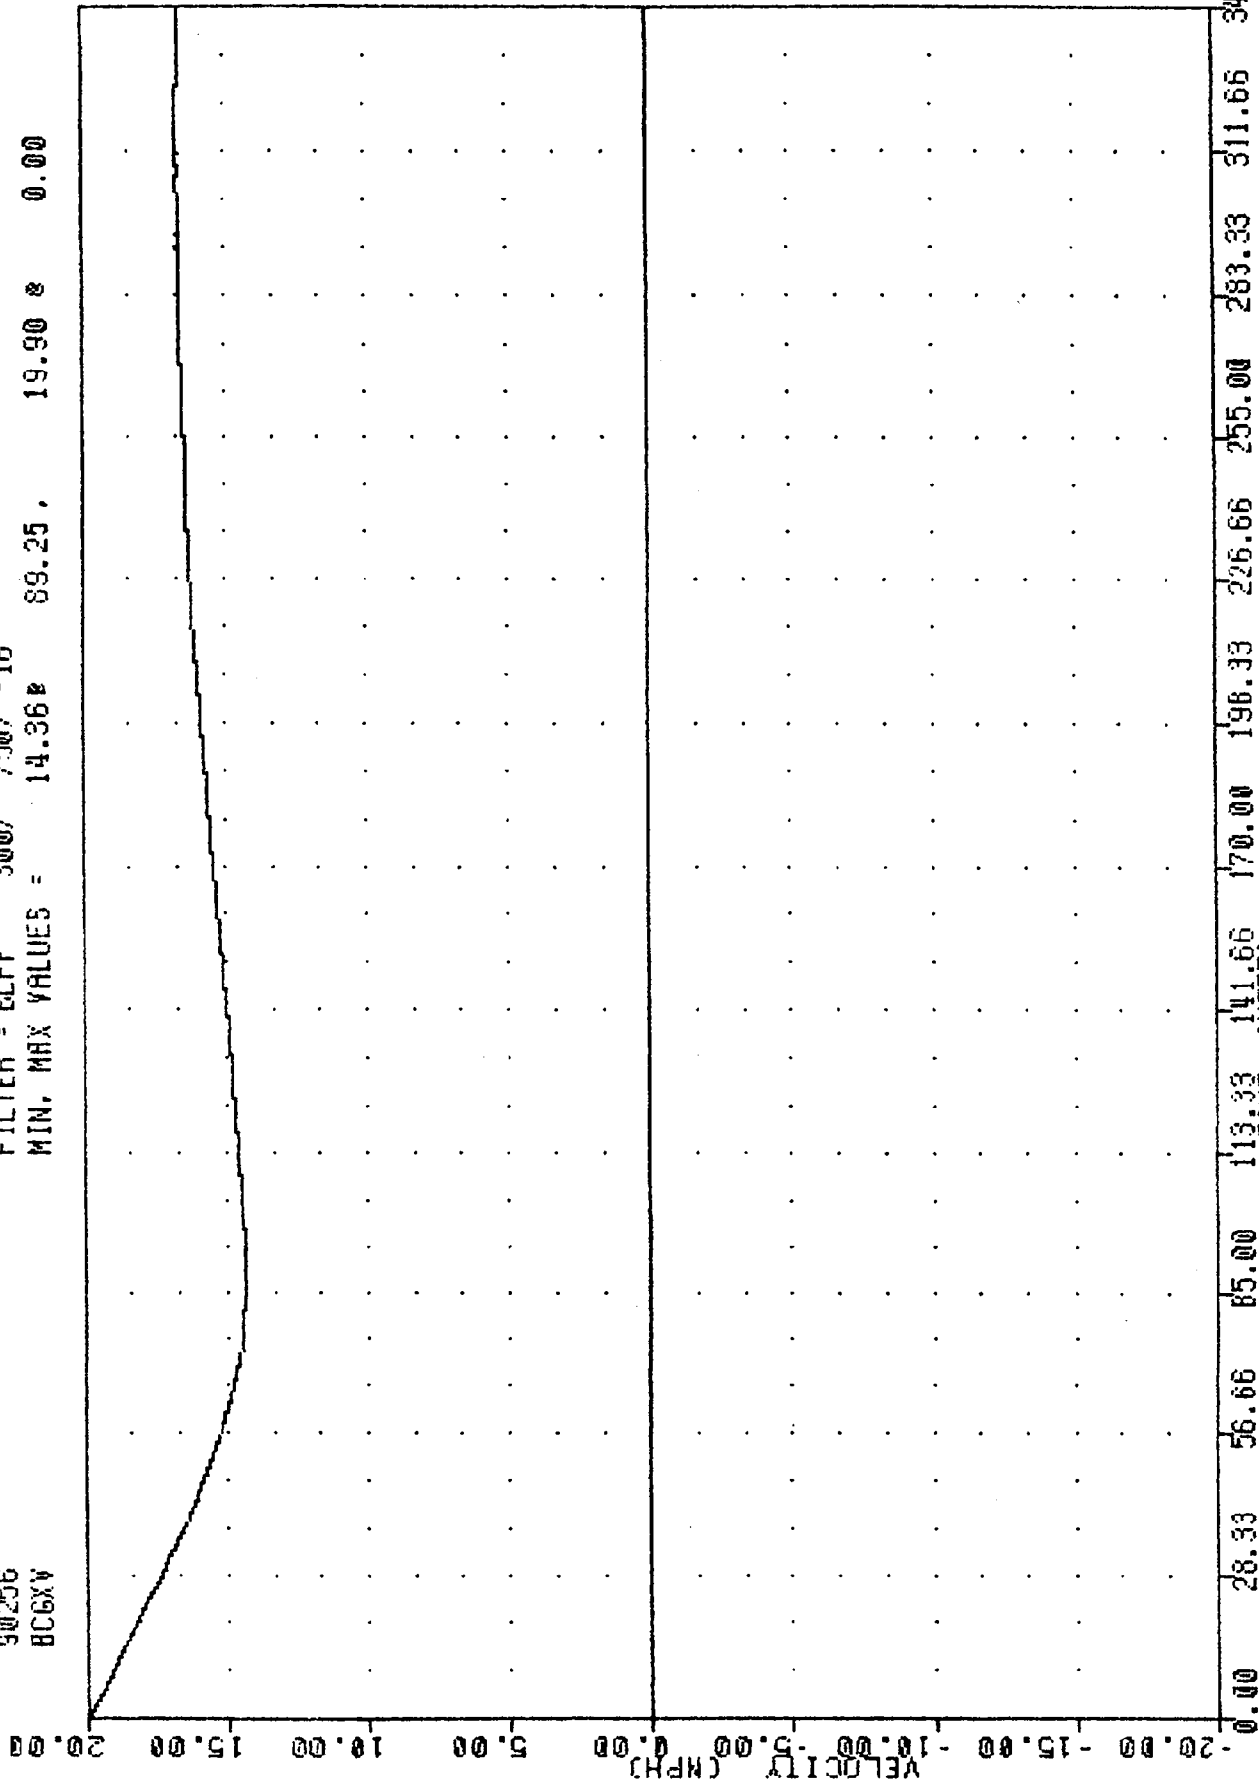
CONTOURED MOVING BARRIER INTO LEFT SIDE OF AN AUDI 5000 AT 19.9 MPH #3
 MOVING BARRIER CENTER OF GRAVITY X-AXIS VELOCITY

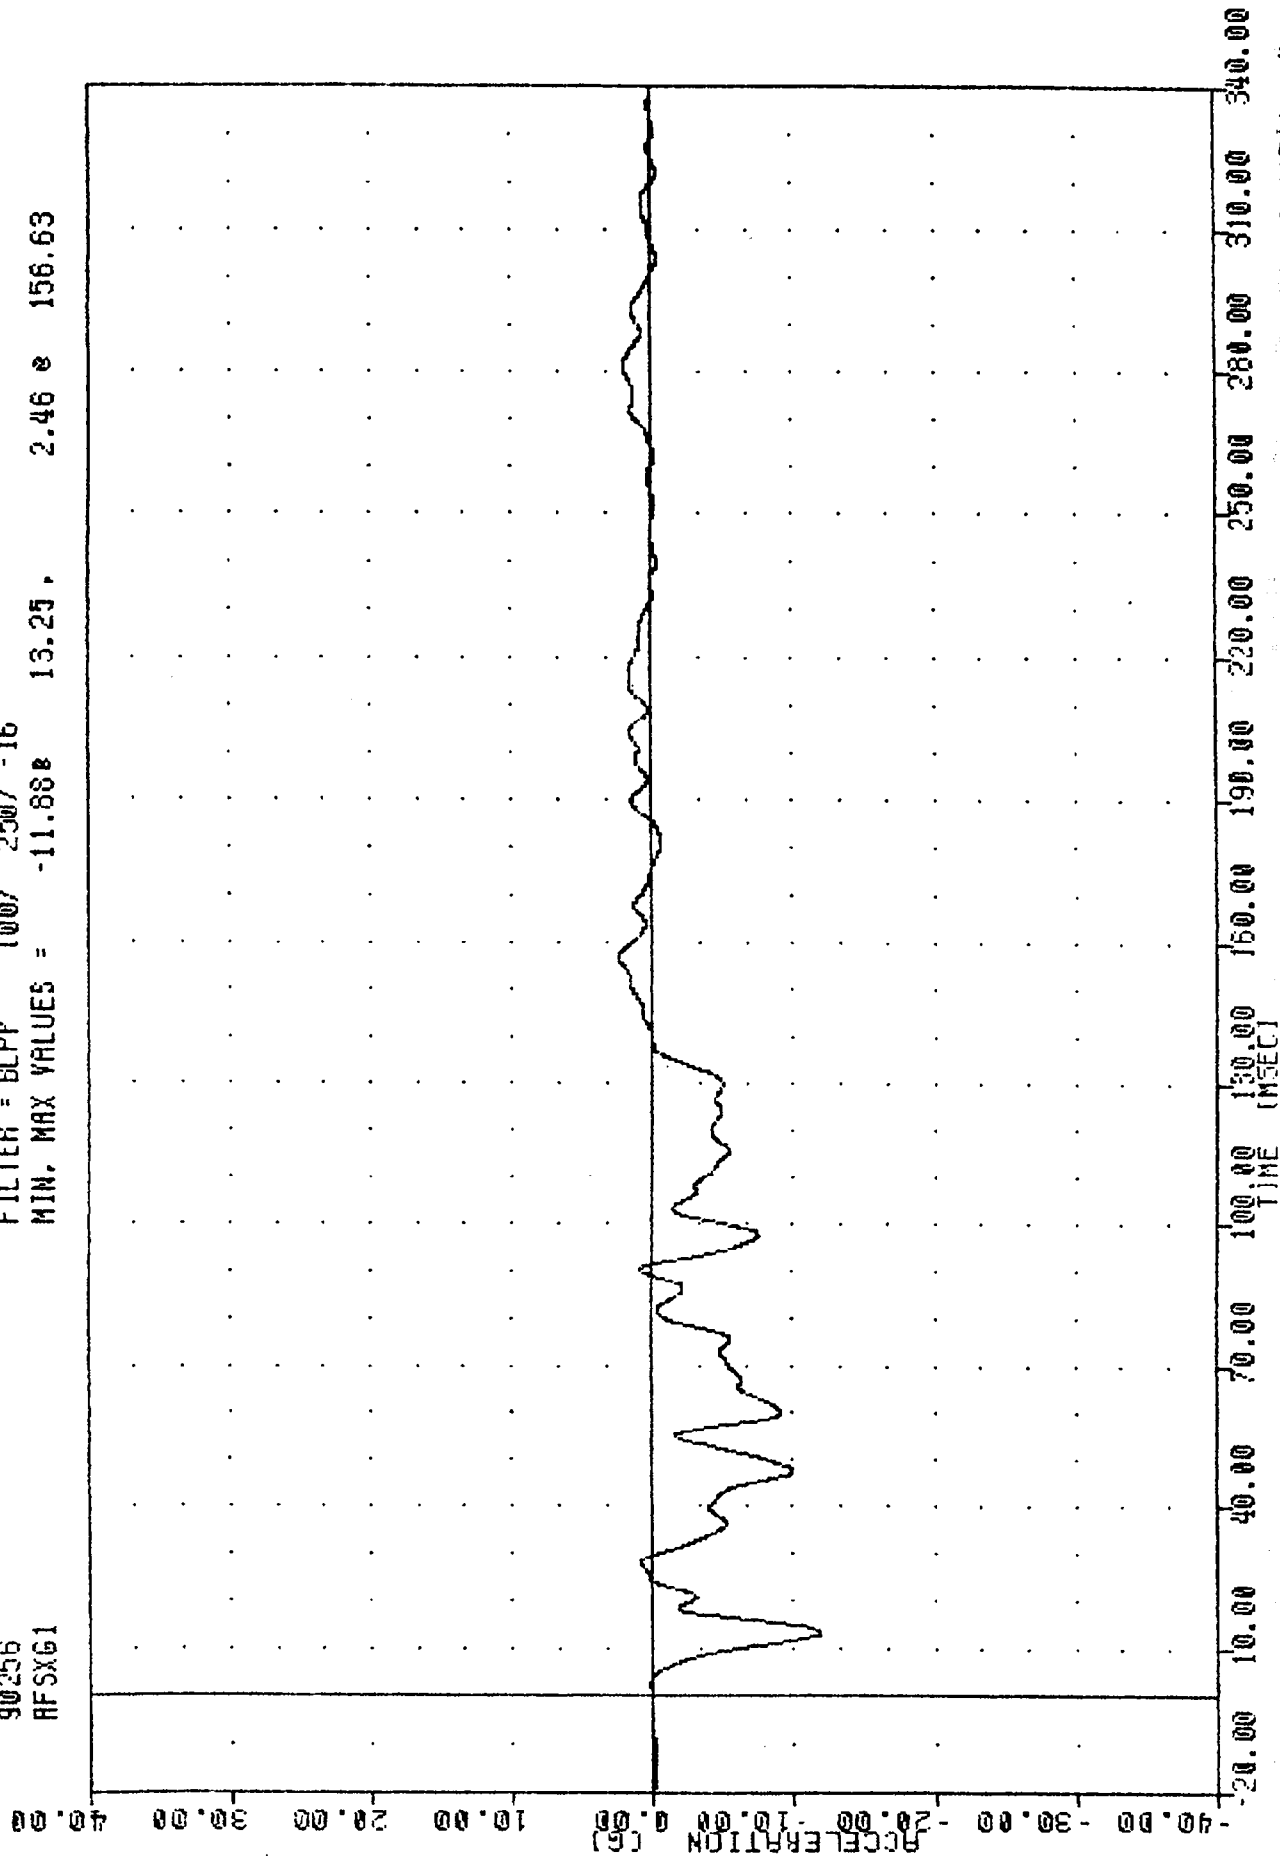
CONTOURED MOVING BARRIER INTO LEFT SIDE OF AN AUDI 5000 AT 45.0 MPH #4
RIGHT FRONT STILL X-AXIS ACCELERATION

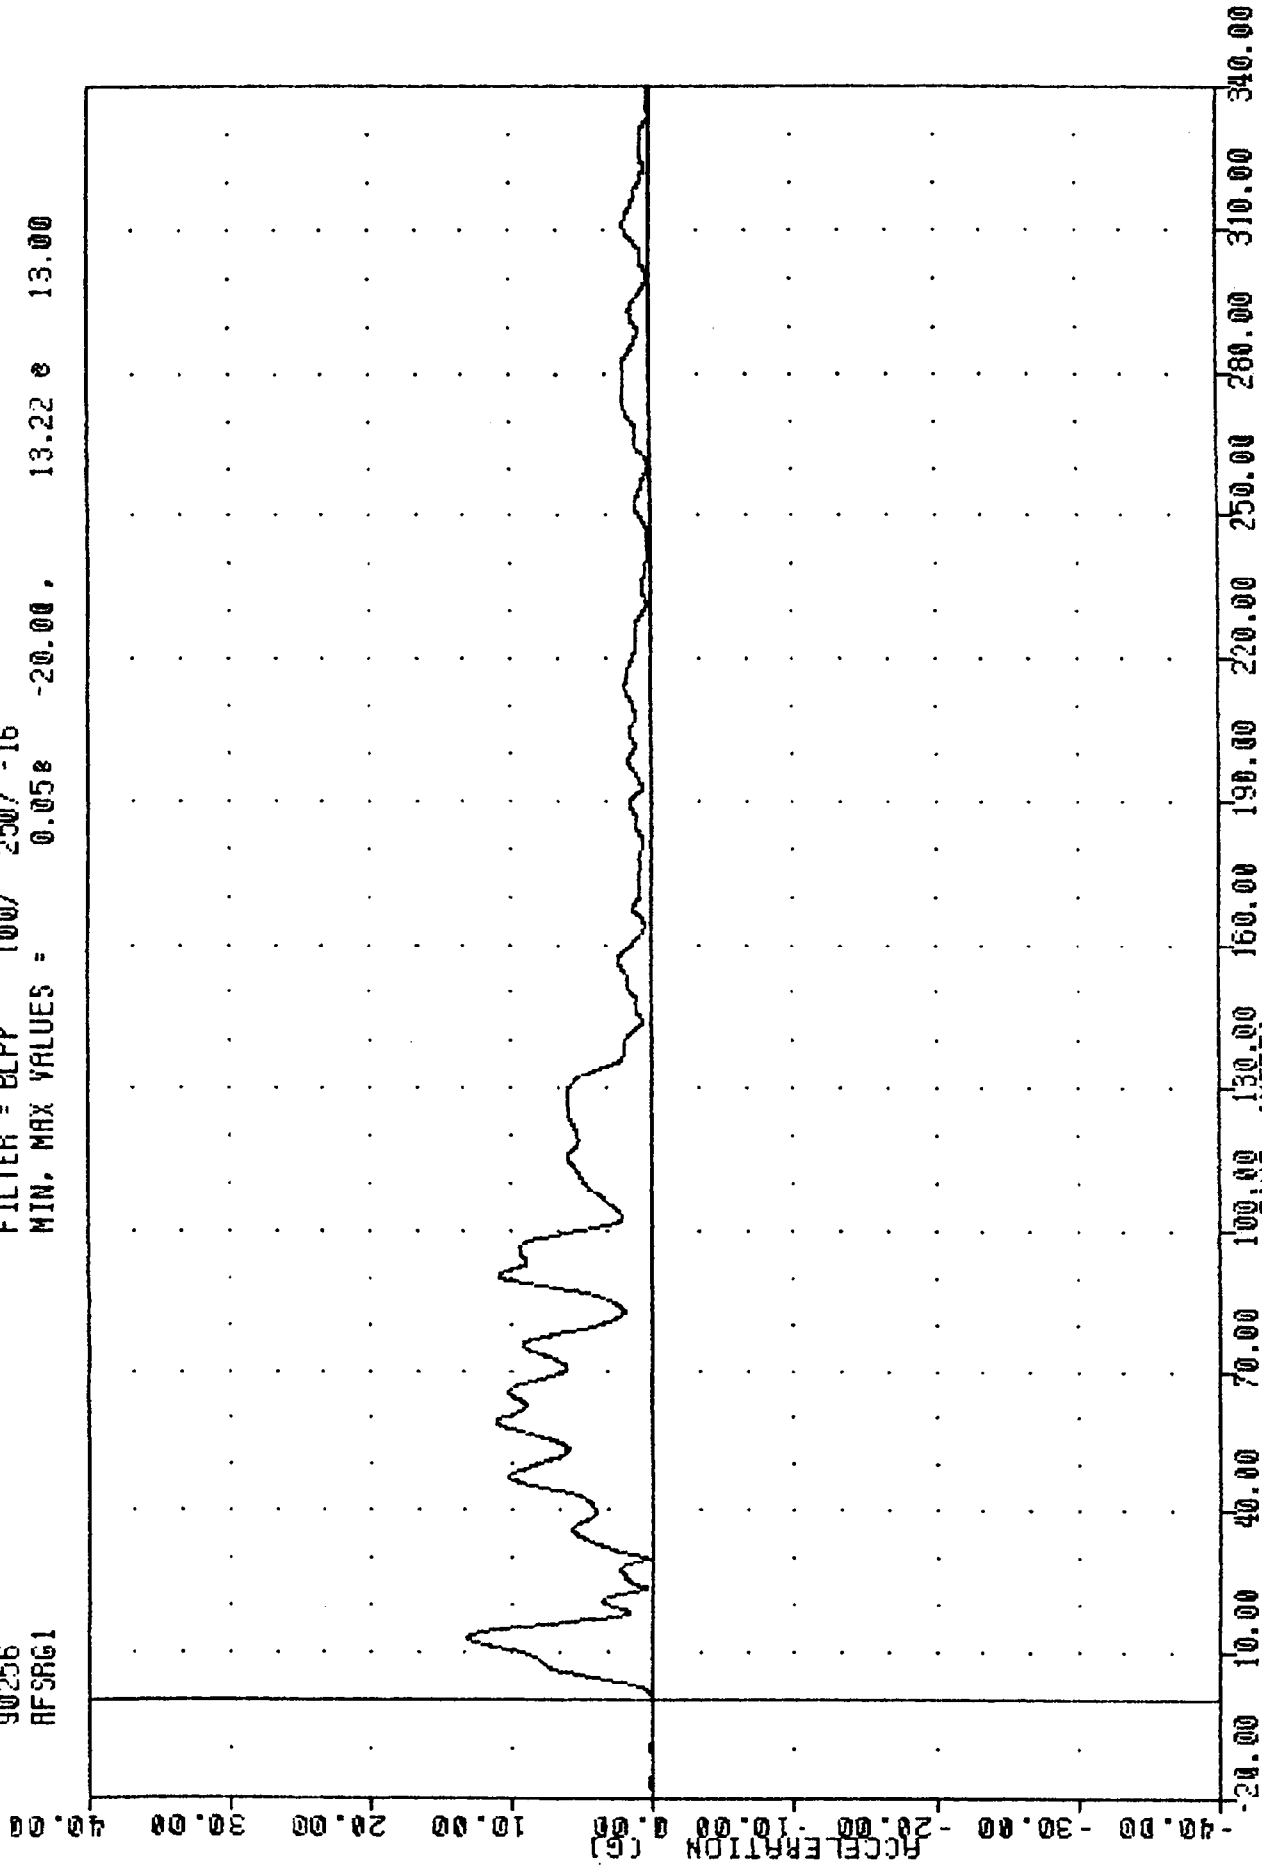
CONTOURED MOVING BARRIER INTO LEFT SIDE OF AN AUDI 5000 AT 45.0 MPH #4
 RIGHT FRONT SILL RESULTANT ACCELERATION

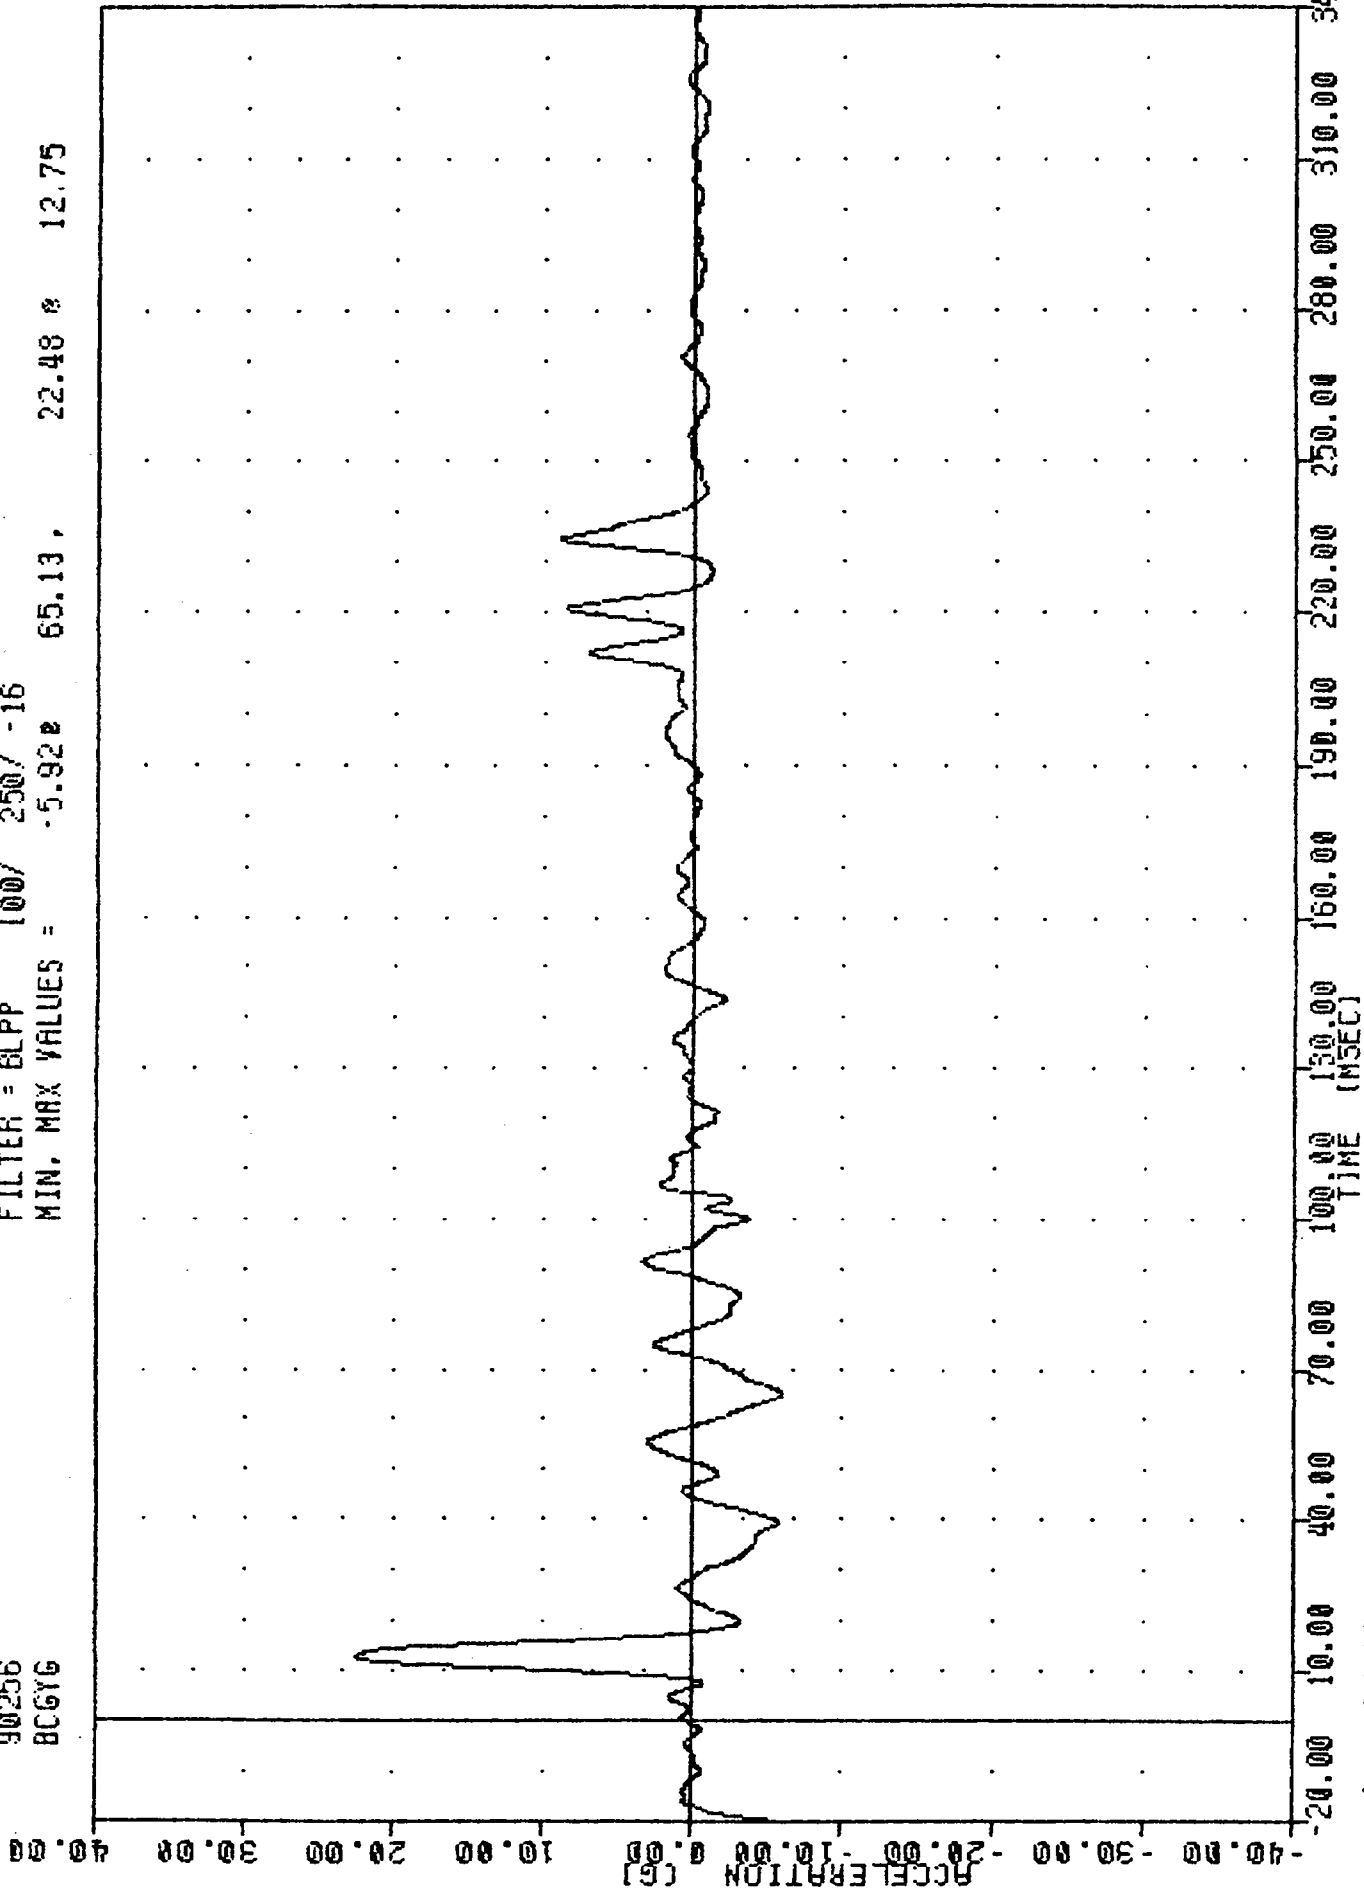
CONTOURED MOVING BARRIER INTO LEFT SIDE OF AN AUDI 5000 AT 45.0 MPH #4
MOVING BARRIER CENTER OF GRAVITY Y-AXIS ACCELERATION

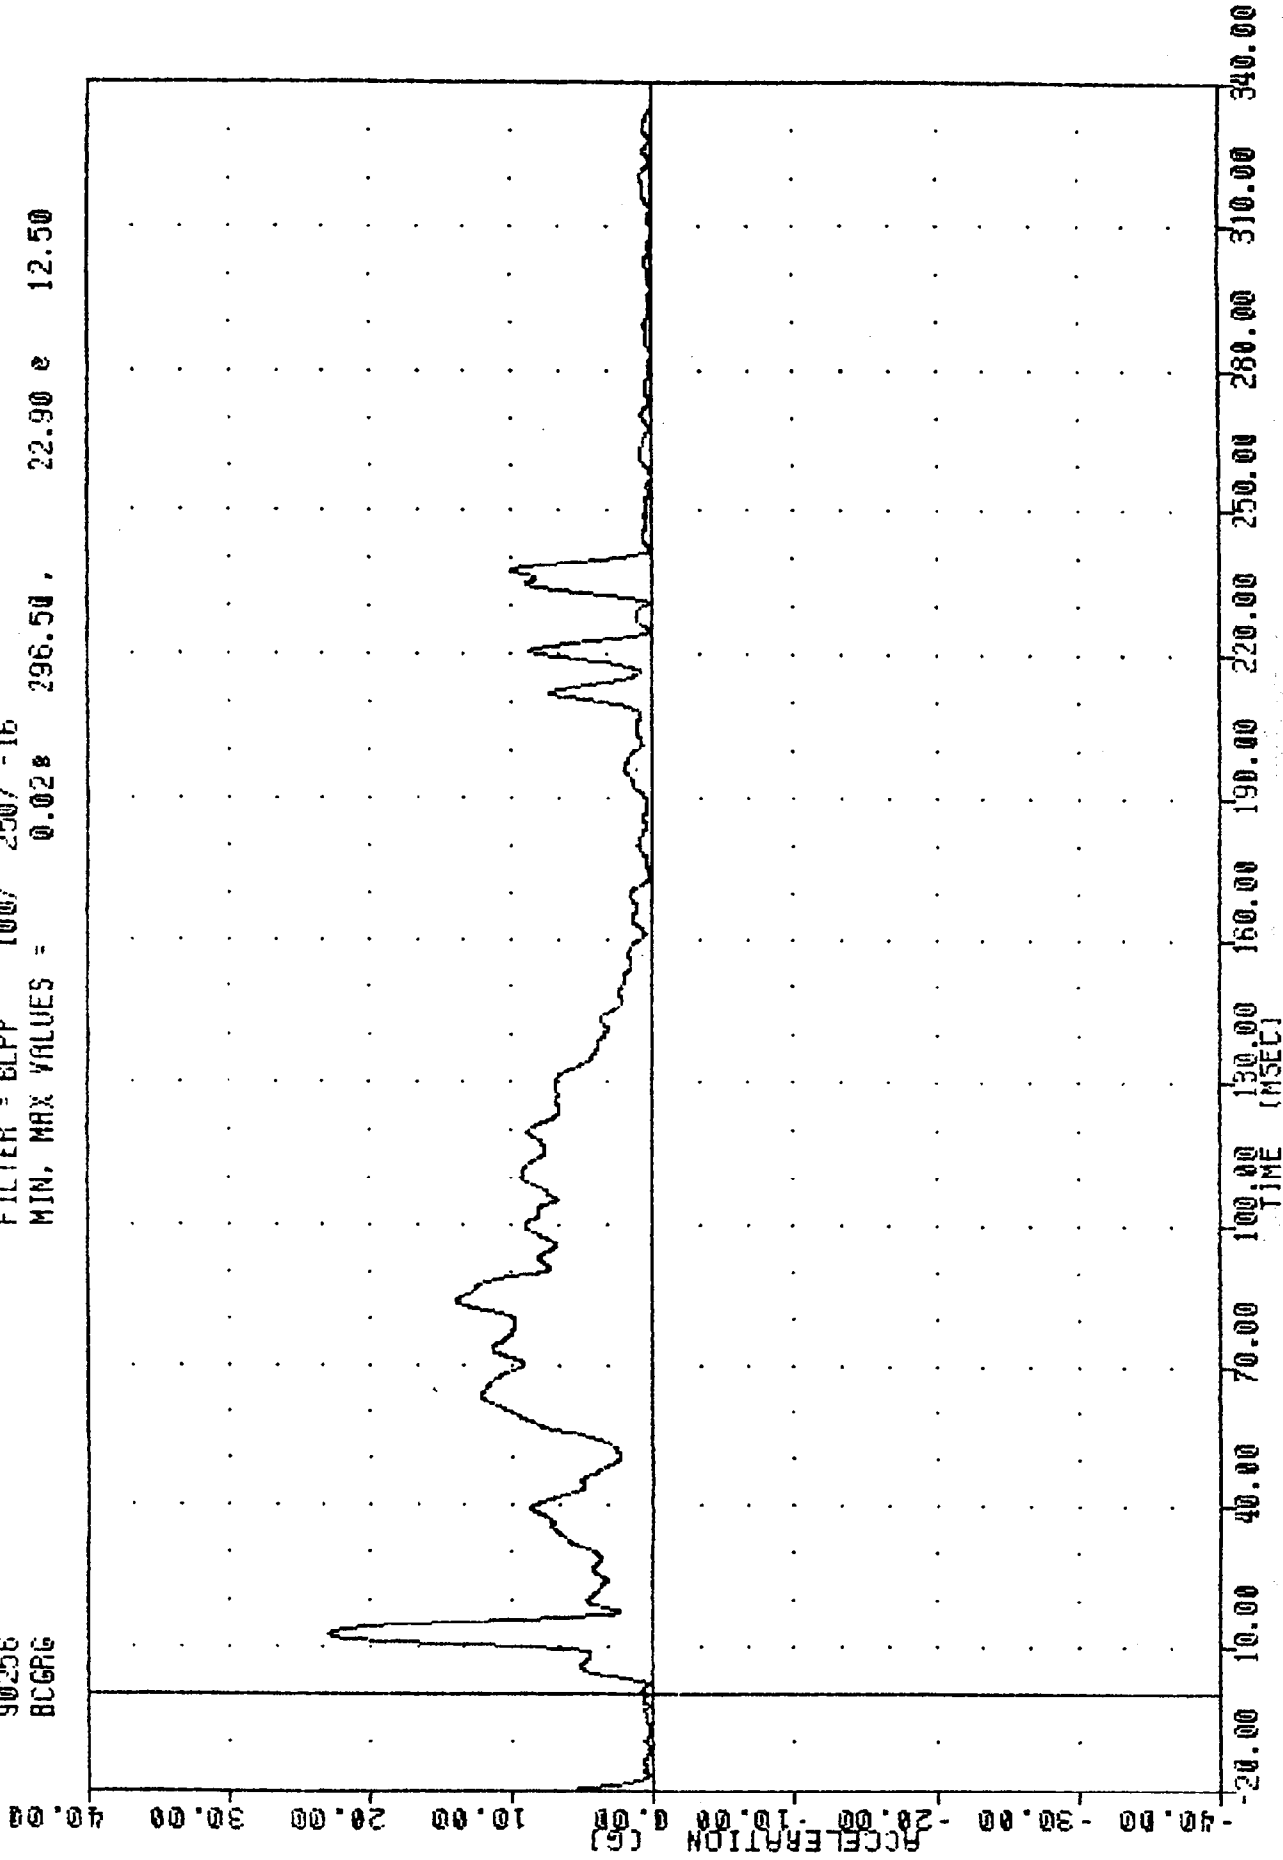
CONTOURED MOVING BARRIER INTO LEFT SIDE OF AN AUDI 5000 AT 45.0 MPH #4
MOVING BARRIER CENTER OF GRAVITY RESULTANT ACCELERATION

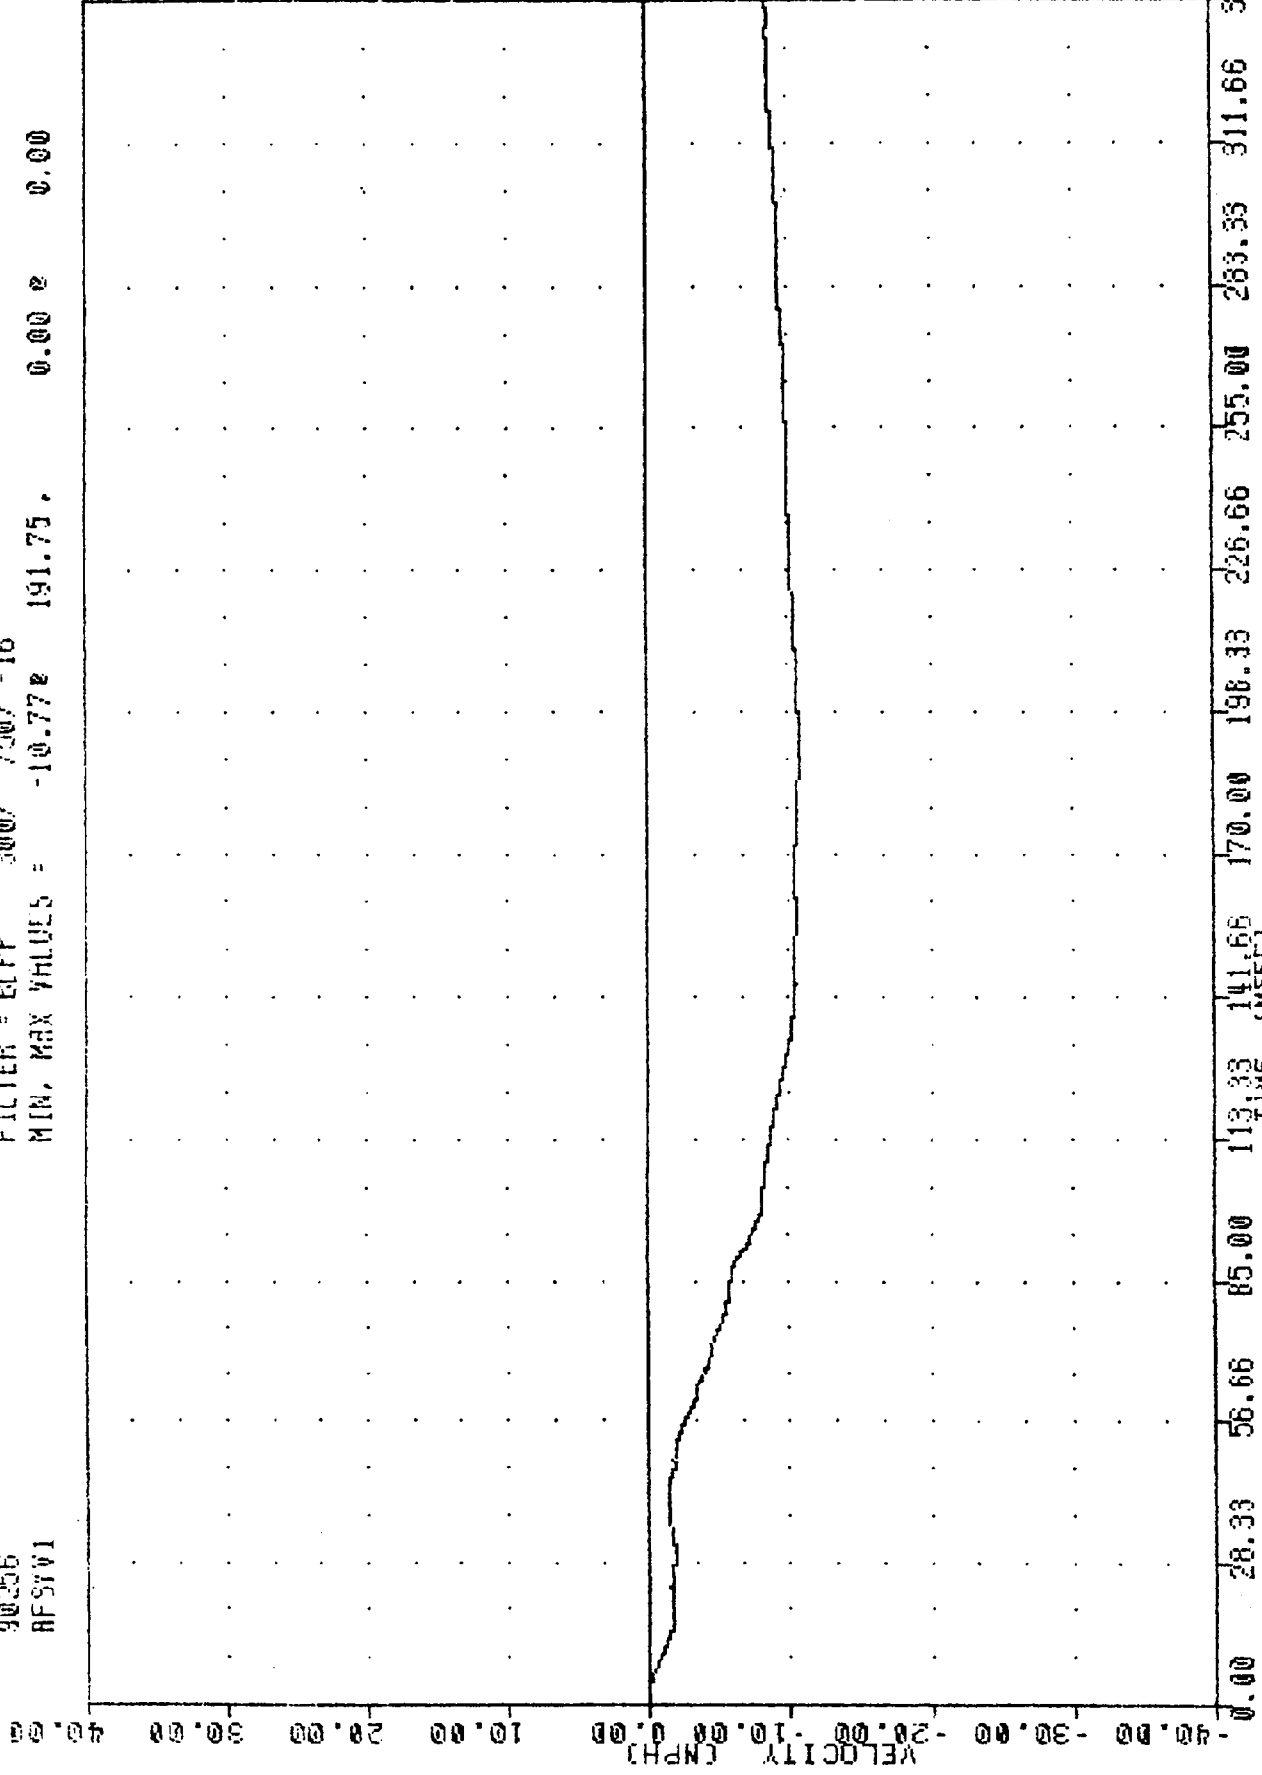
CONTOURED MOVING BARRIER INTO LEFT SIDE OF AN AUDI 5000 AT 45.0 MPH #4
 RIGHT FRONT SILL Y-AXIS VELOCITY

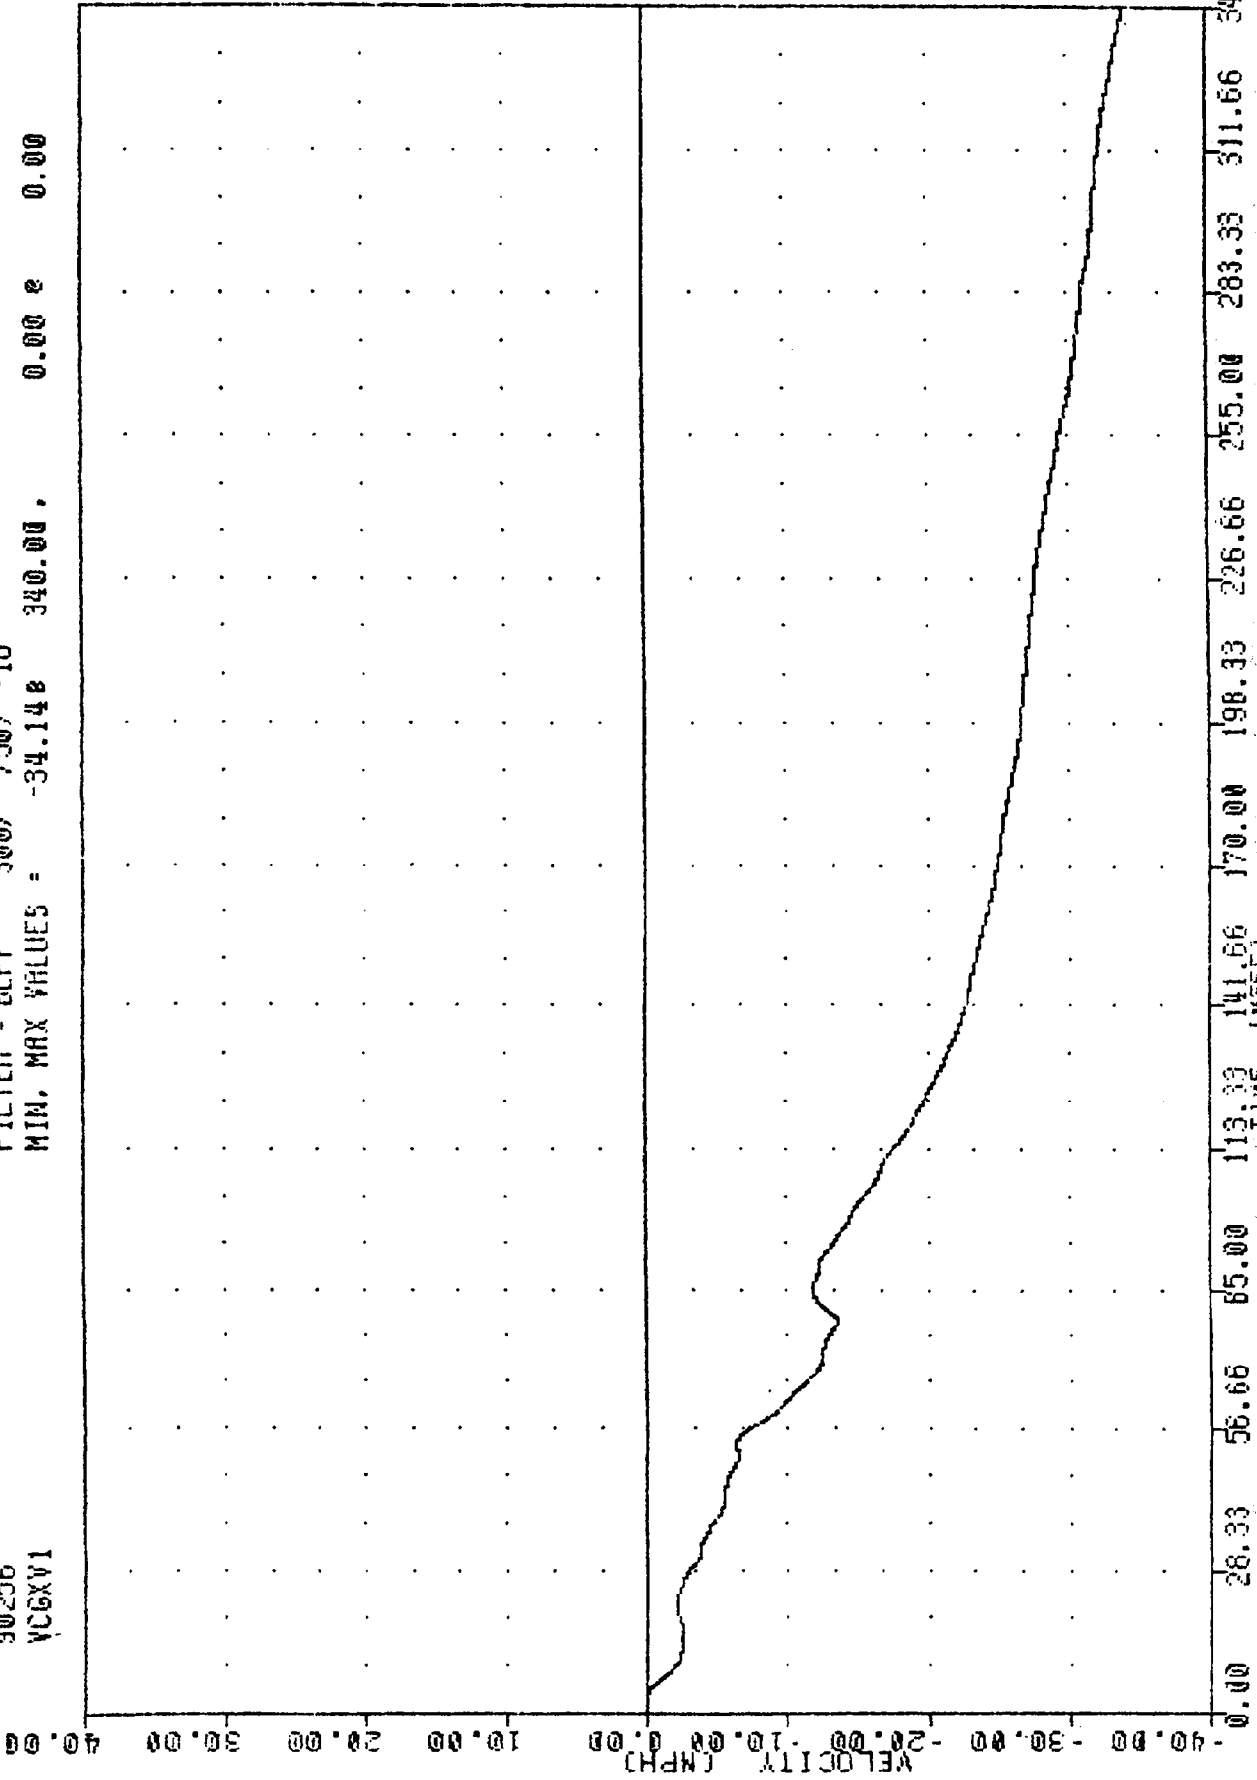
CONTOURED MOVING BARRIER INTO LEFT SIDE OF AN AUDI 5000 AT 45.0 MPH *4
 , VEHICLE CG X-AXIS VELOCITY (IMPACT DIRECTION)
