U.S. Department
of Transportation
**National Highway
Traffic Safety
Administration**

**DOT HS 807 772
Final Report**

Final Report of 315° Contoured Moving Barrier Impact Into a 1982 Audi 5000 4-Door Sedan in Support of Crash III Damage Algorithm Reformation

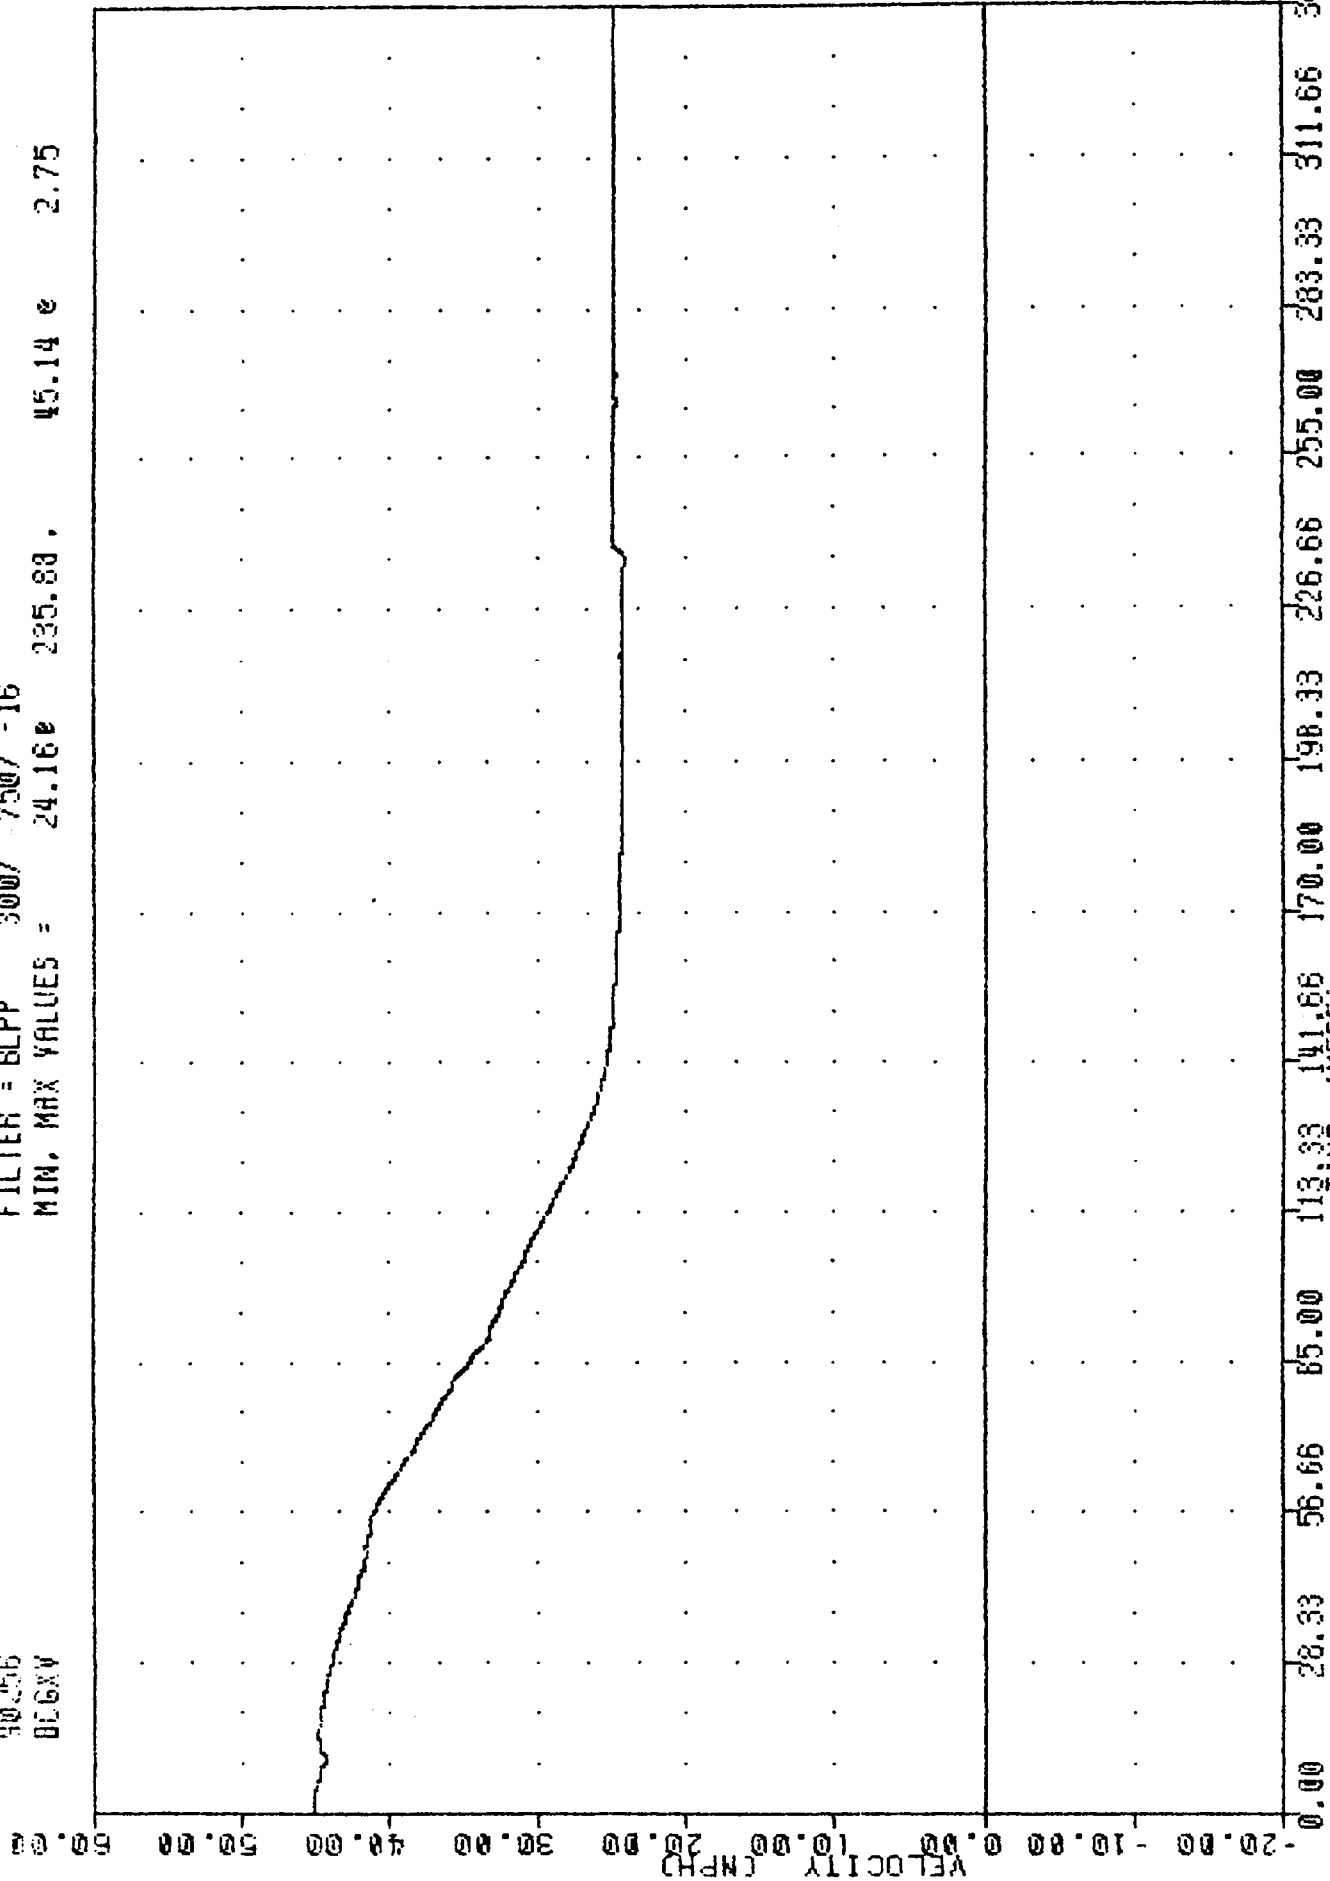
CONTOURED MOVING BARRIER INTO LEFT SIDE OF AN AUDI 5000 AT 45.0 MPH
MOVING BARRIER CENTER OF GRAVITY X-AXIS VELOCITY

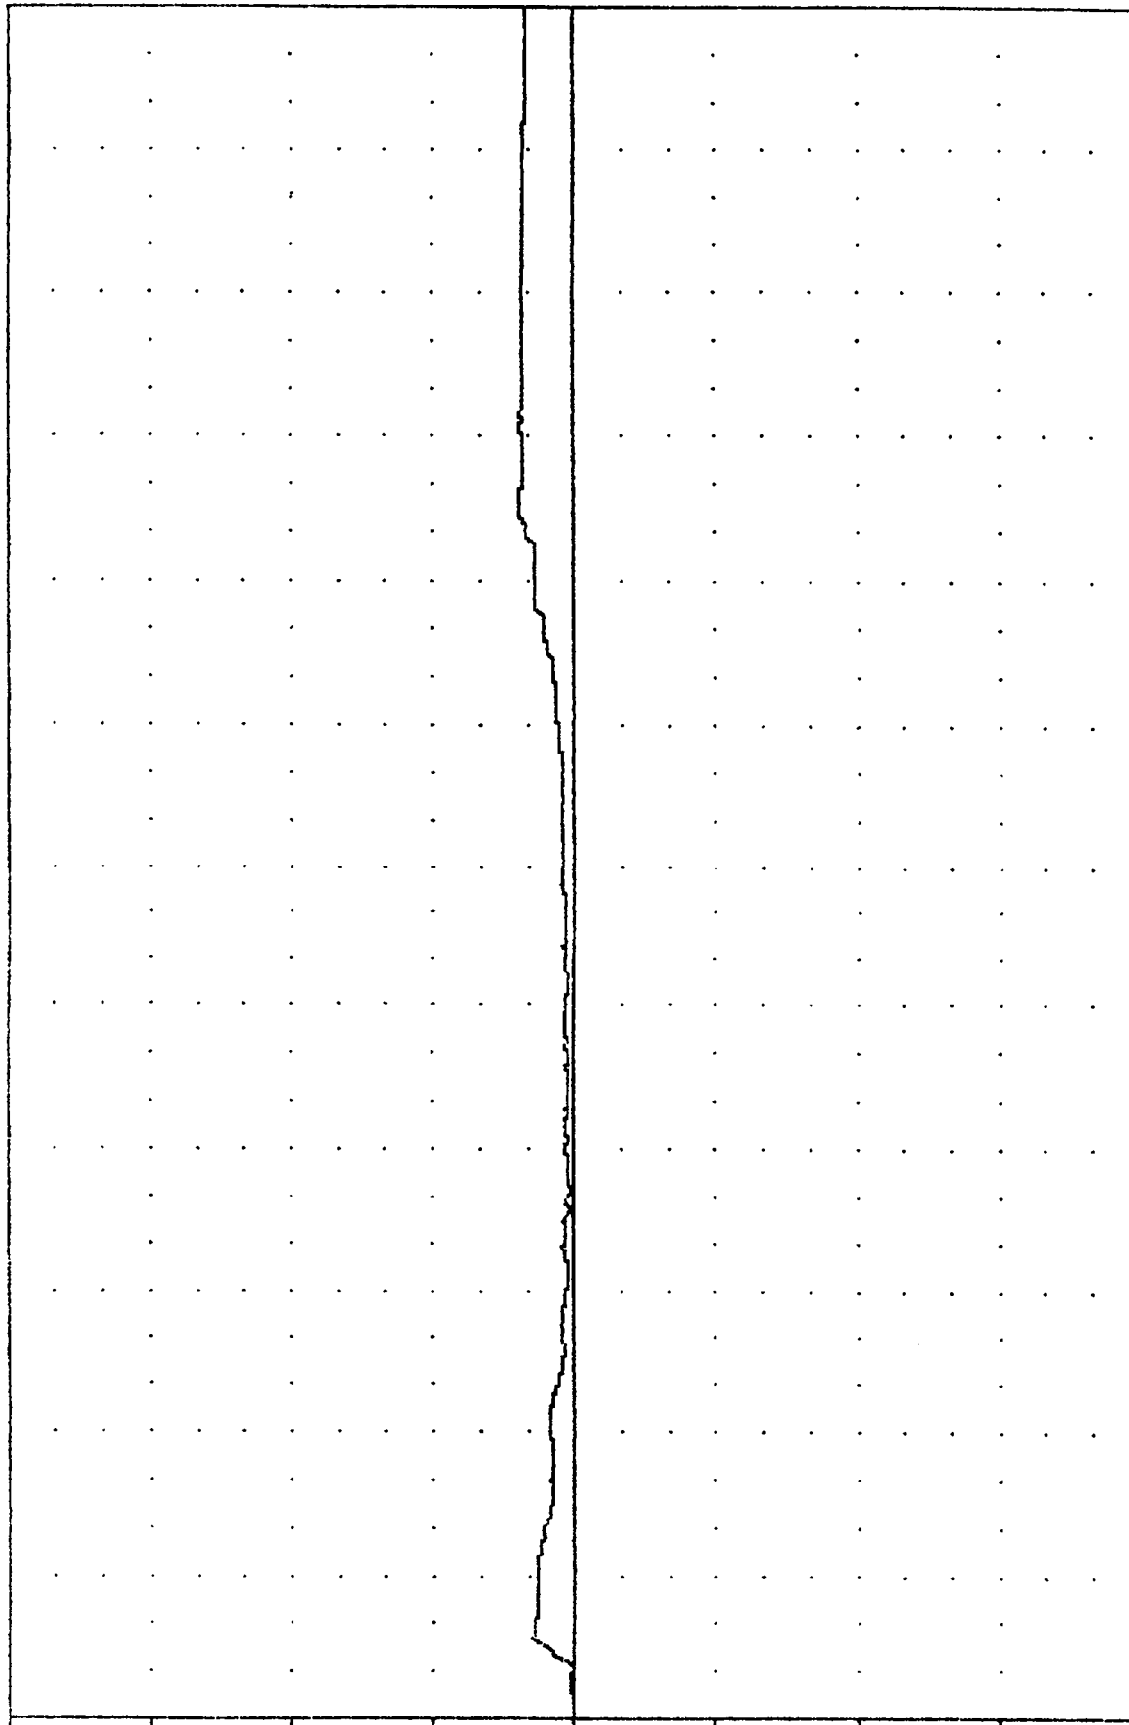
CONTOURED MOVING BARRIER INTO LEFT SIDE OF AN AUDI 5000 AT 45.0 MPH *4
MOVING BARRIER CENTER OF GRAVITY Y-AXIS VELOCITY
