VEHICLE SAFETY COMPLIANCE TESTING  
FOR OCCUPANT CRASH PROTECTION,  
WINDSHIELD MOUNTING, WINDSHIELD ZONE  
INTRUSION, AND FUEL SYSTEM INTEGRITY

1992 HYUNDAI ELANTRA

NHTSA NO. CN0501

FINAL REPORT

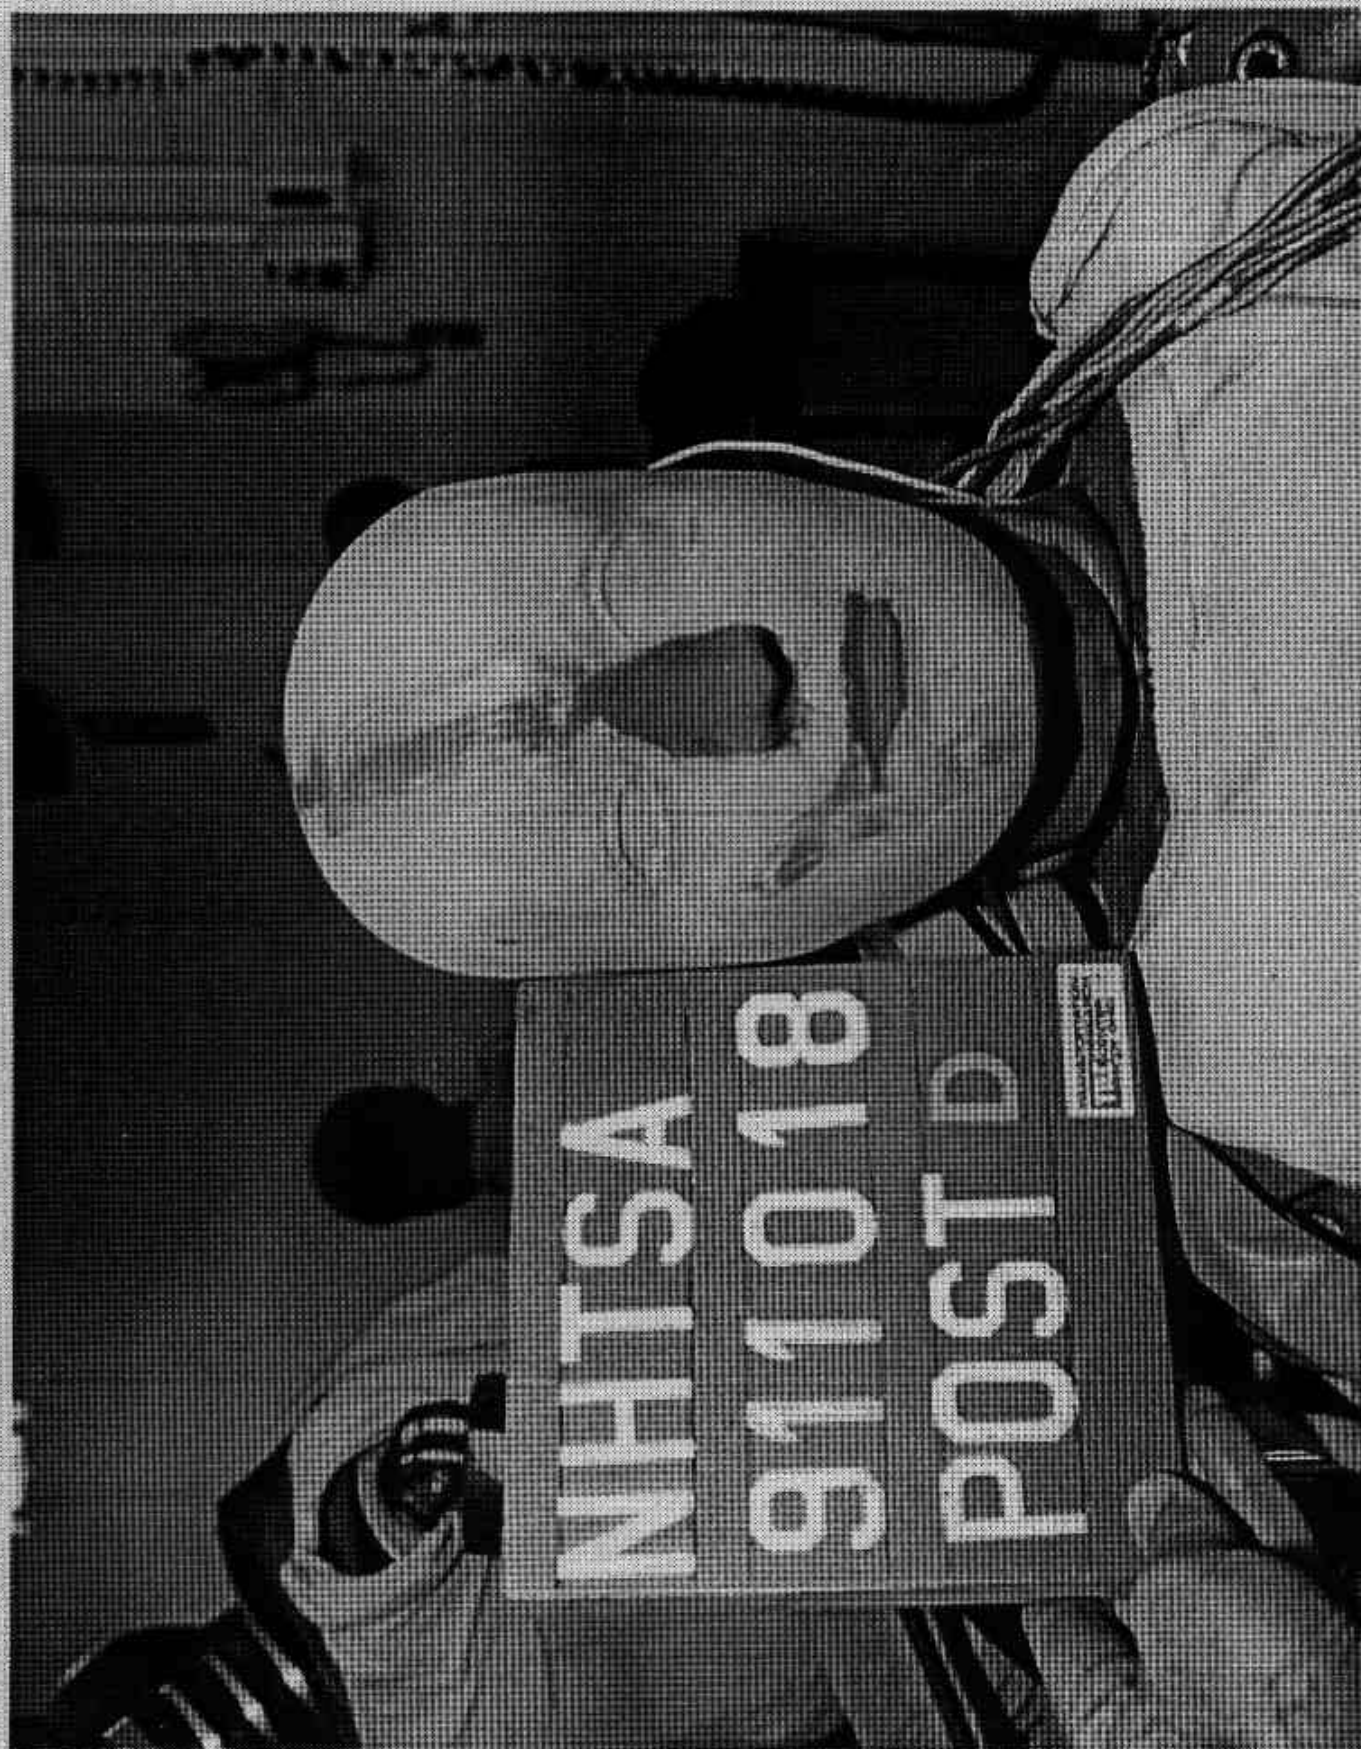
FIGURE A-36. POST-TEST DRIVER DUMMY HEAD CONTACT VIEW
