**VEHICLE SAFETY COMPLIANCE TESTING FOR OCCUPANT CRASH PROTECTION,  
WINDSHIELD MOUNTING, WINDSHIELD ZONE INTRUSION (PARTIAL)  
AND FUEL SYSTEM INTEGRITY**

**TOYOTA MOTOR CORPORATION  
1992 TOYOTA CAMRY  
4-DOOR SEDAN**

NHTSA NUMBER: CN5104

CALSPAN TEST NUMBER: 7953-3

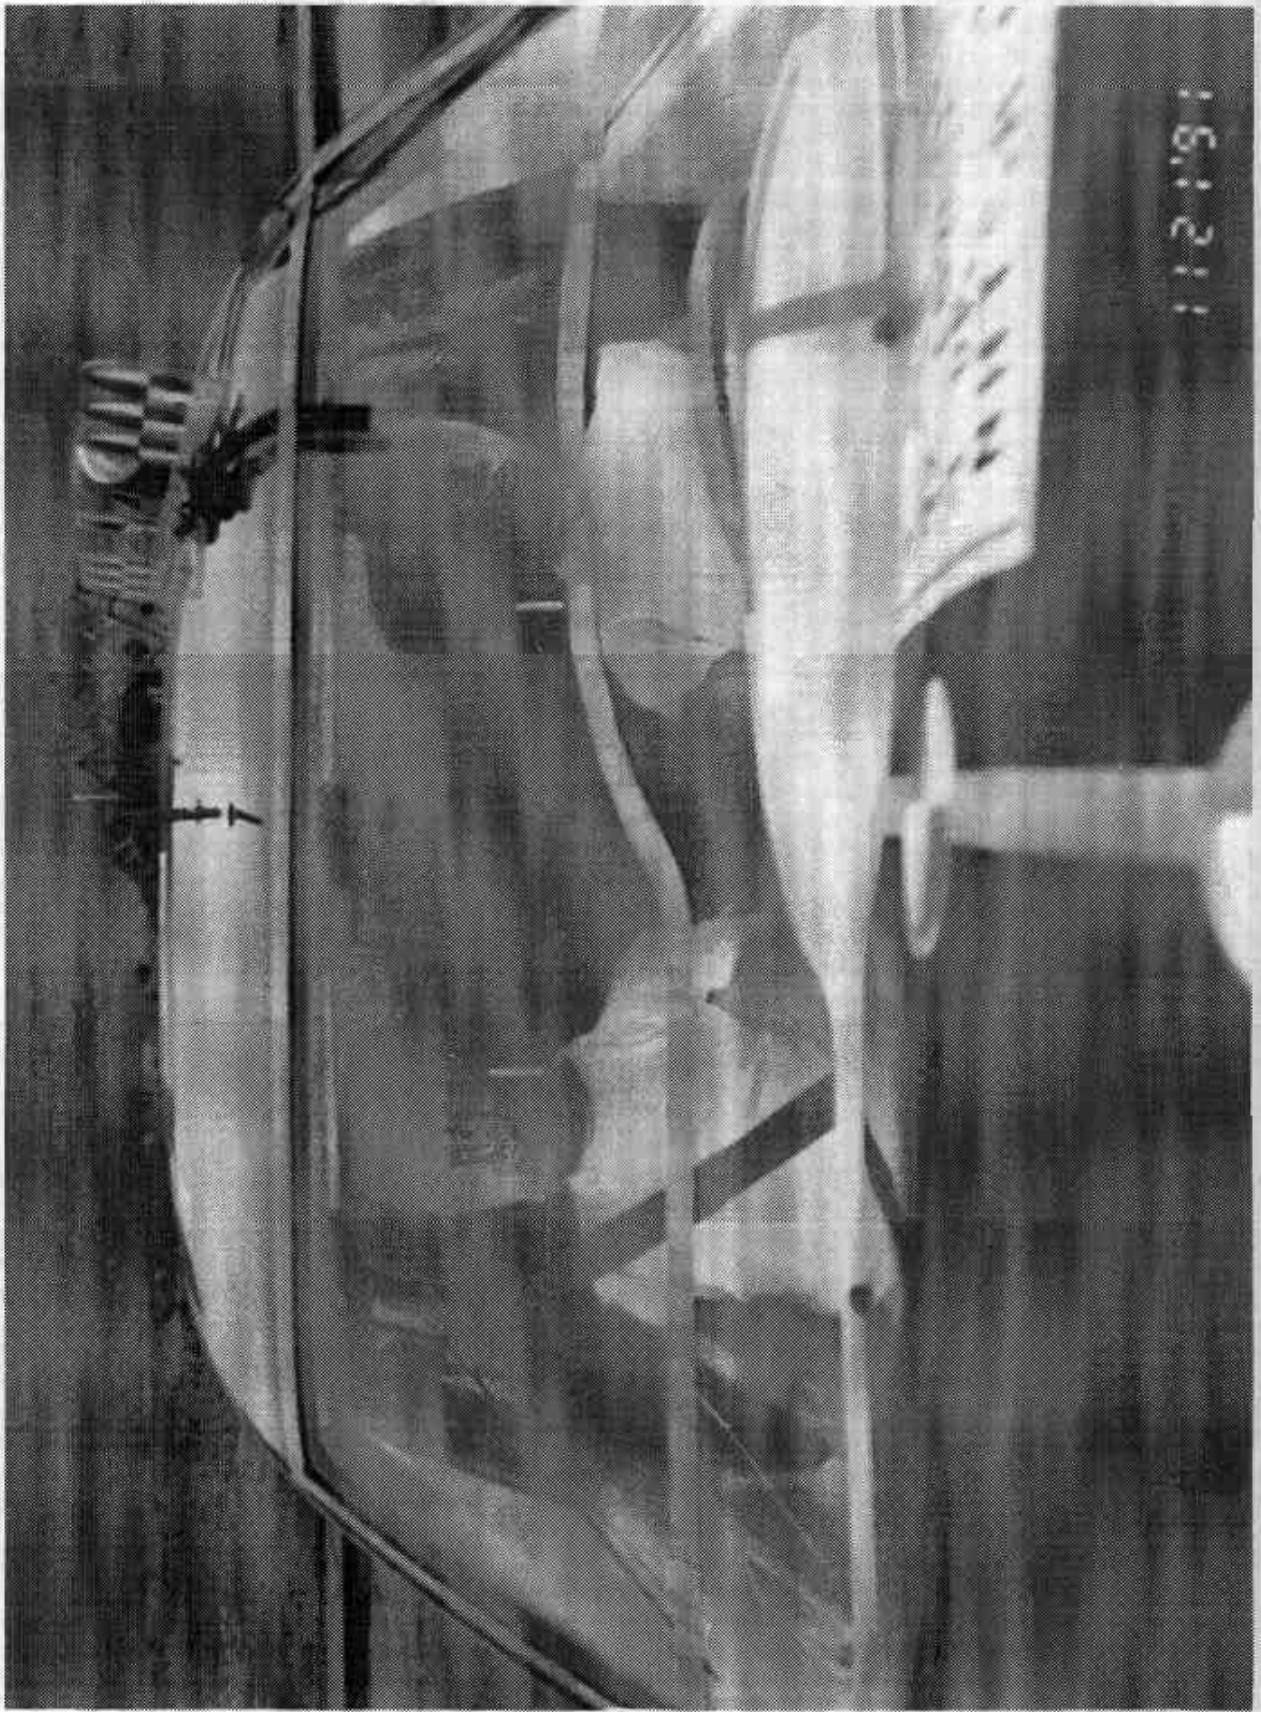
GLAZING DAMAGE: Windshield cracked near right side "A" pillar.

Figure A-13 POST-TEST WINDSHIELD VIEW
