CALSPAN REPORT NUMBER: 7942-5

VEHICLE-TO-VEHICLE FRONTAL 60% OVERLAP  
36 MPH IMPACT OF A 1991 DODGE DYNASTY  
4-DOOR SEDAN AND A  
1991 HONDA ACCORD DX 4-DOOR SEDAN

CALSPAN TEST NUMBER: Y43-5-1148

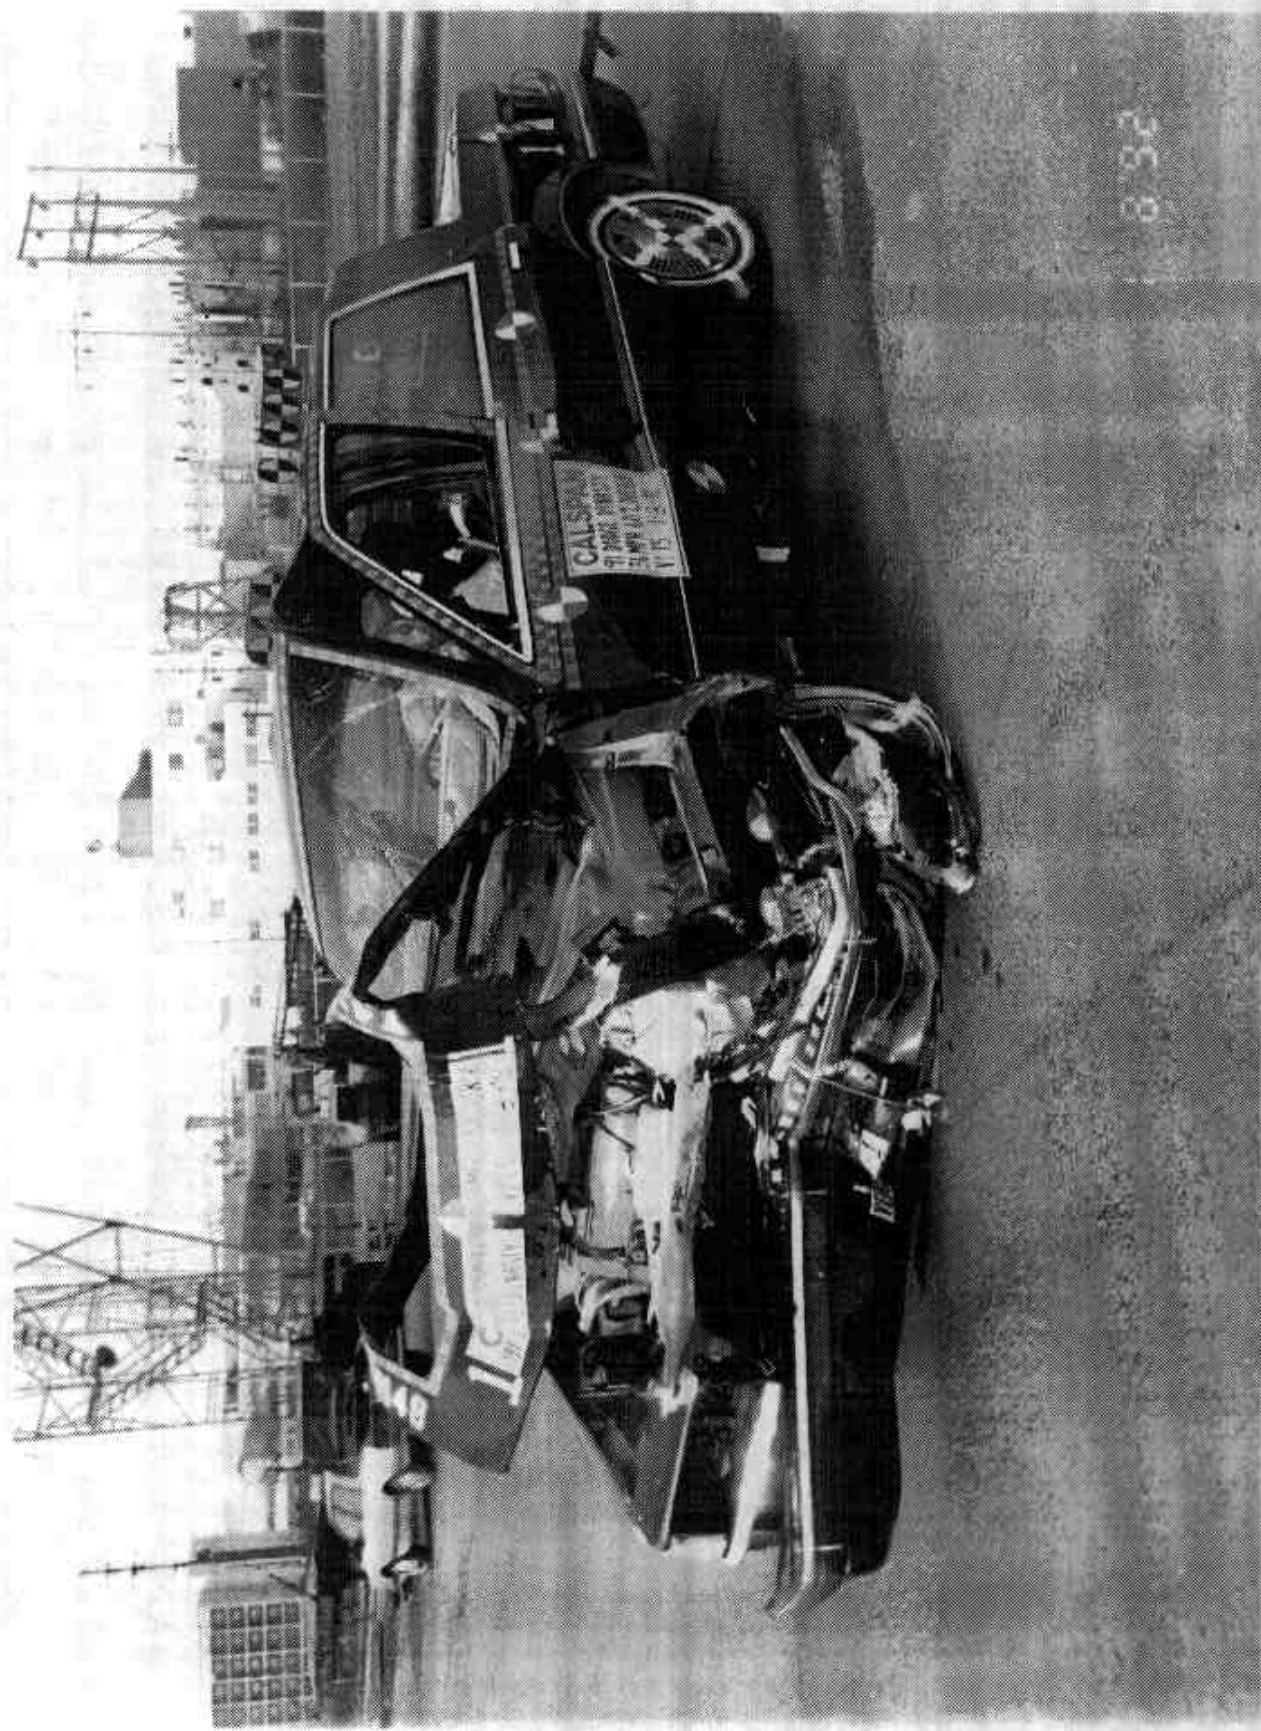
Figure A-21 VEHICLE 1 POST-TEST FRONT LEFT THREE QUARTER VIEW

Roof rail deformed along front left side of vehicle\*.  
 Windshield severely cracked.  
 Floor pan under driver seat and left side floor sill were severely deformed.

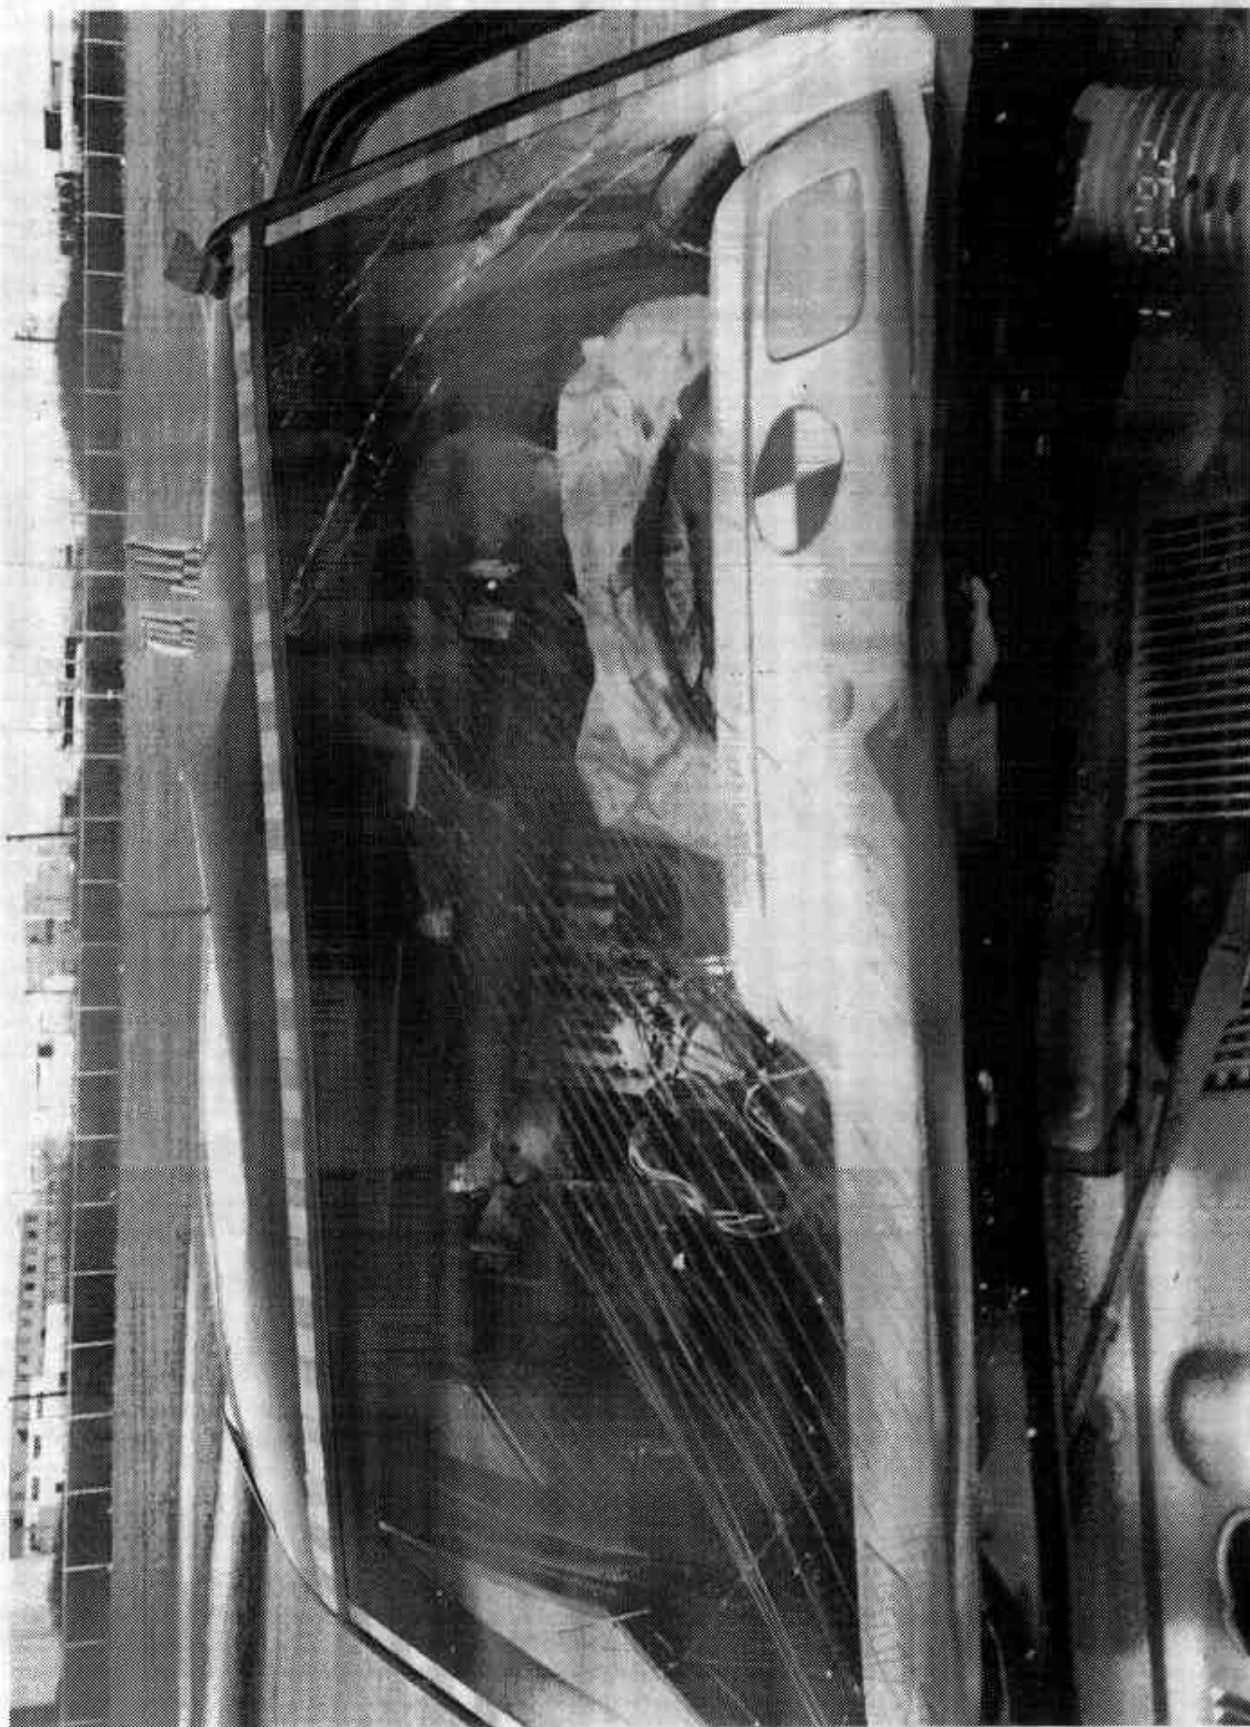
Figure A-23 VEHICLE 1 POST-TEST WINDSHIELD VIEW

Windshield severely cracked.
