VEHICLE SAFETY COMPLIANCE TESTING  
FOR OCCUPANT CRASH PROTECTION,  
WINDSHIELD MOUNTING, WINDSHIELD ZONE  
INTRUSION, AND FUEL SYSTEM INTEGRITY

1992 FORD CROWN VICTORIA

NHTSA NO. CN0206

TRC TEST NO. 920122

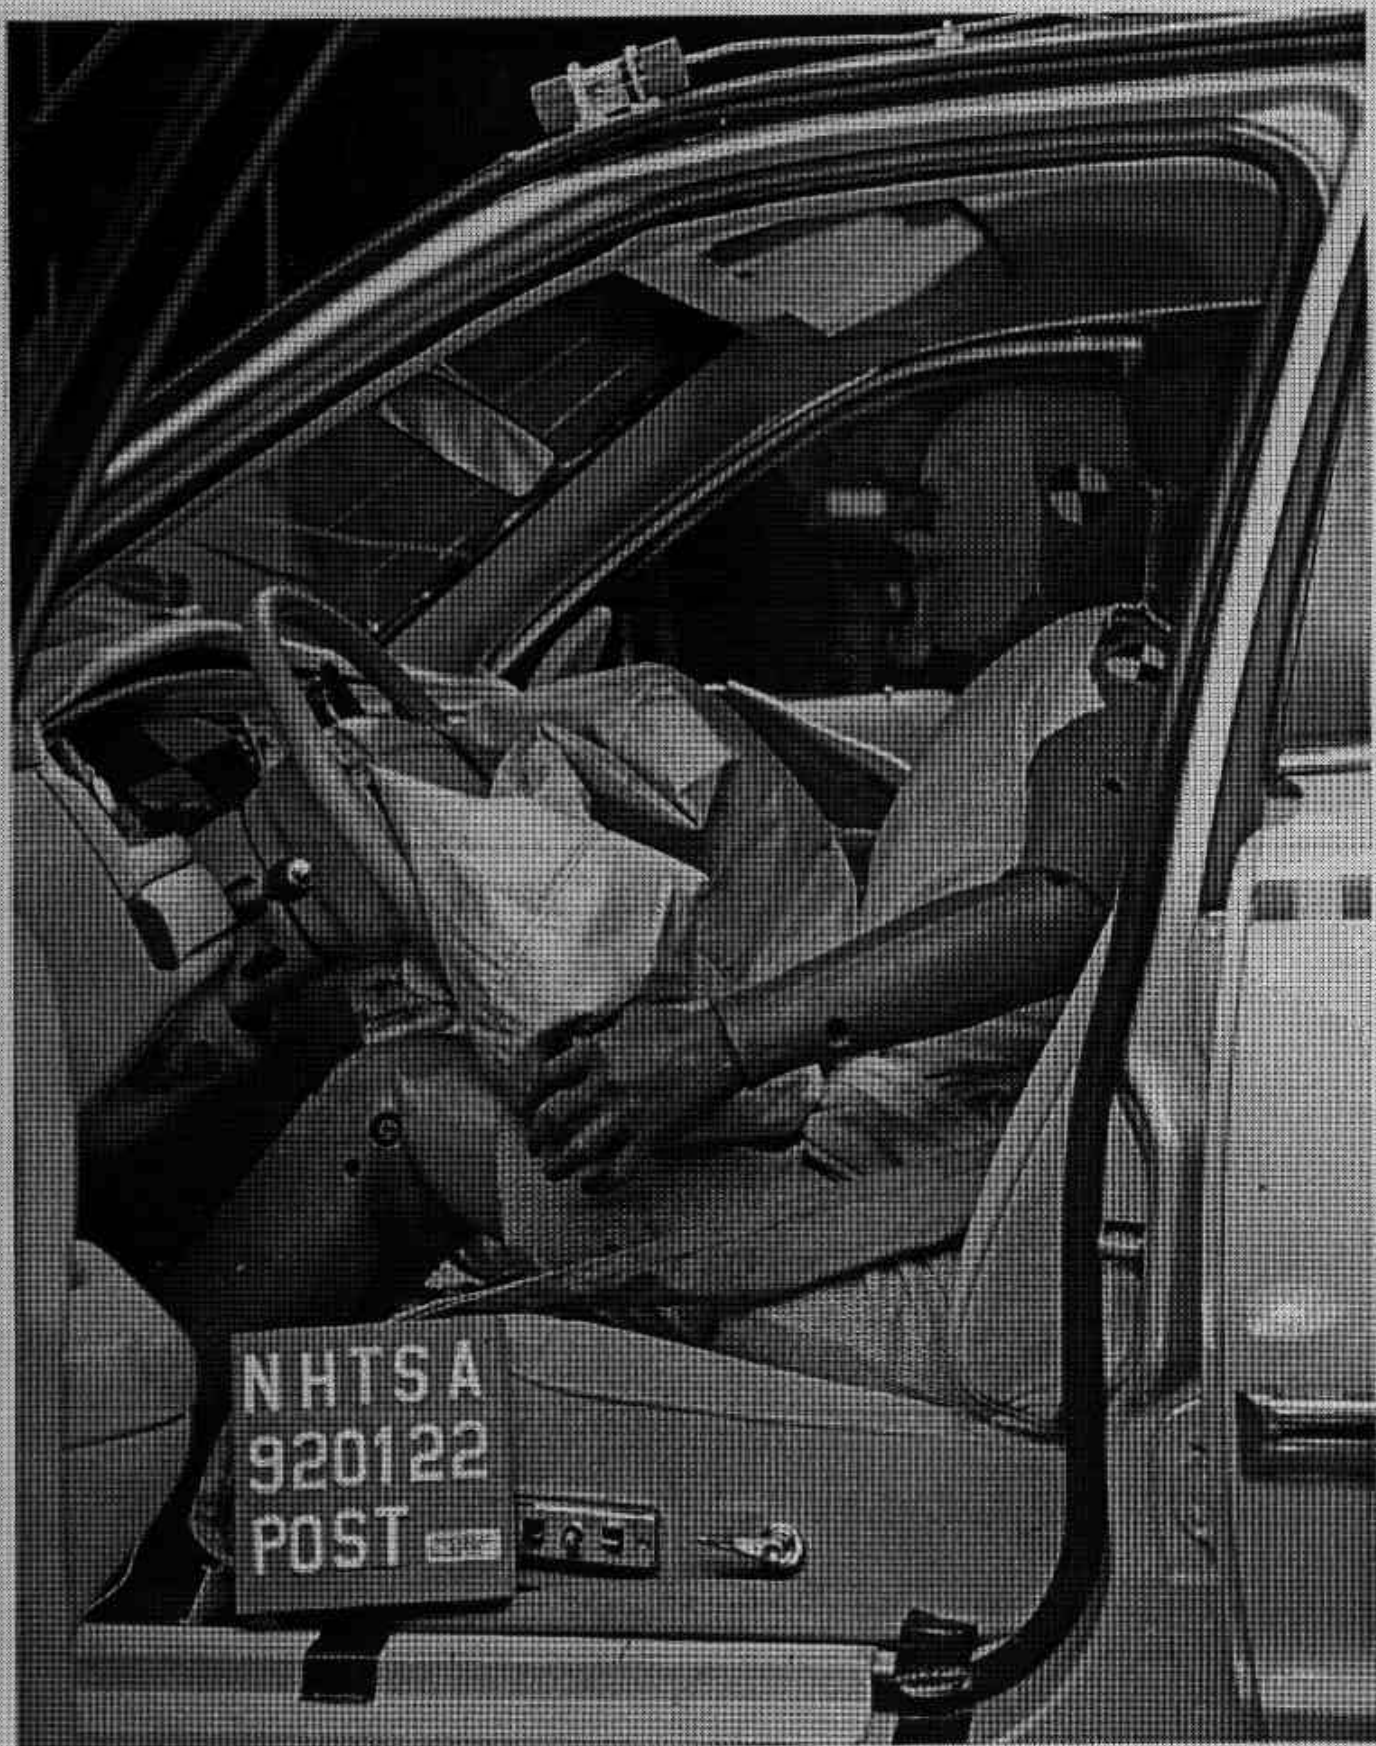
FIGURE A-33. POST-TEST DRIVER DUMMY & VEHICLE INTERIOR - VIEW 1

The driver's sunvisor mirror was cracked during the  
impact. Steering column was separated completely  
from the shear capsules & was displaced approximately  
1.7 inches forward.
