**SIDE IMPACT PROTECTION  
IN PRODUCTION VEHICLES**

**MDB-TO-VEHICLE SIDE IMPACT TEST OF  
A 27<sup>0</sup> CRABBED MOVING DEFORMABLE BARRIER  
TO A 1989 COLT VISTA  
AT 33.5 MPH**

TEST REPORT

4. Title and Subtitle  
 SIDE IMPACT PROTECTION IN PRODUCTION VEHICLE  
 MDB-TO-VEHICLE SIDE IMPACT TEST OF A 27° CRABBED  
 MOVING DEFORMABLE BARRIER TO A 1989 COLT VISTA  
 AT 33.5 MPH, NHTSA NO. RK0302

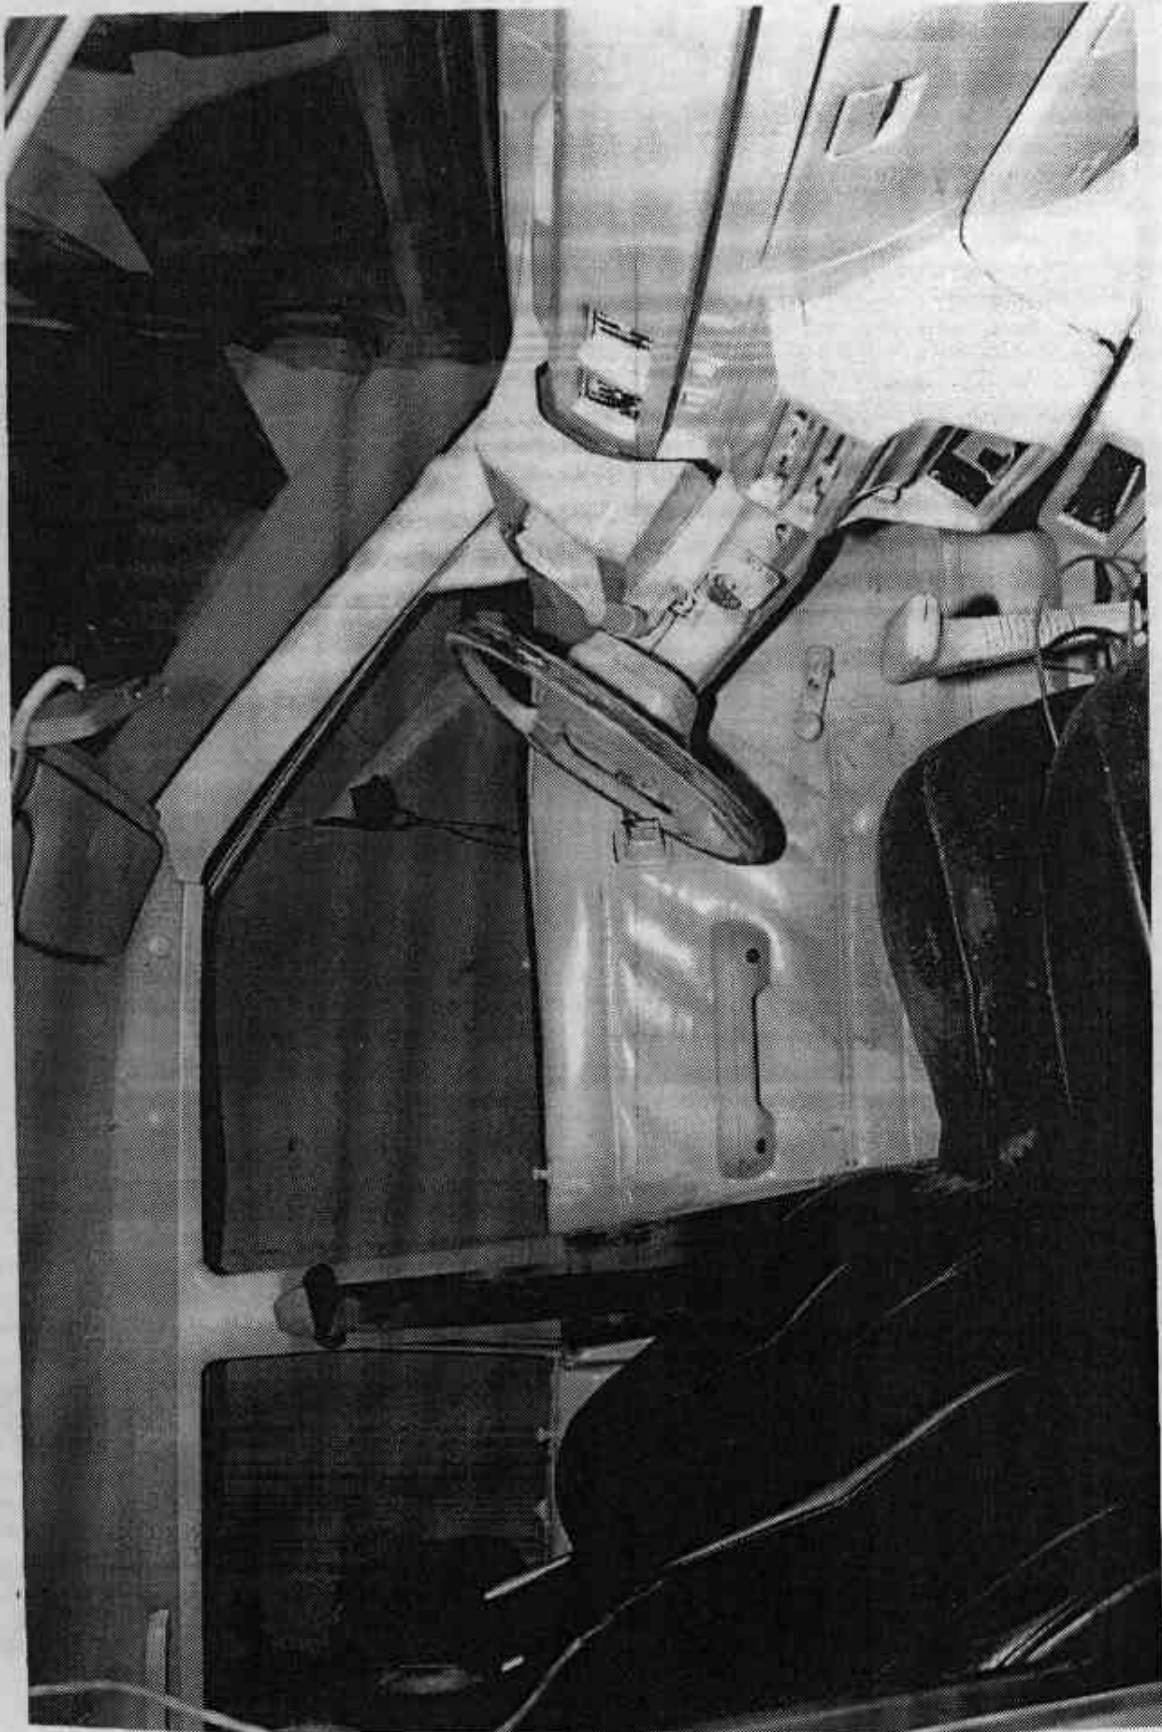
FIGURE A-16. DRIVER POSITION INTERIOR - POSTTEST

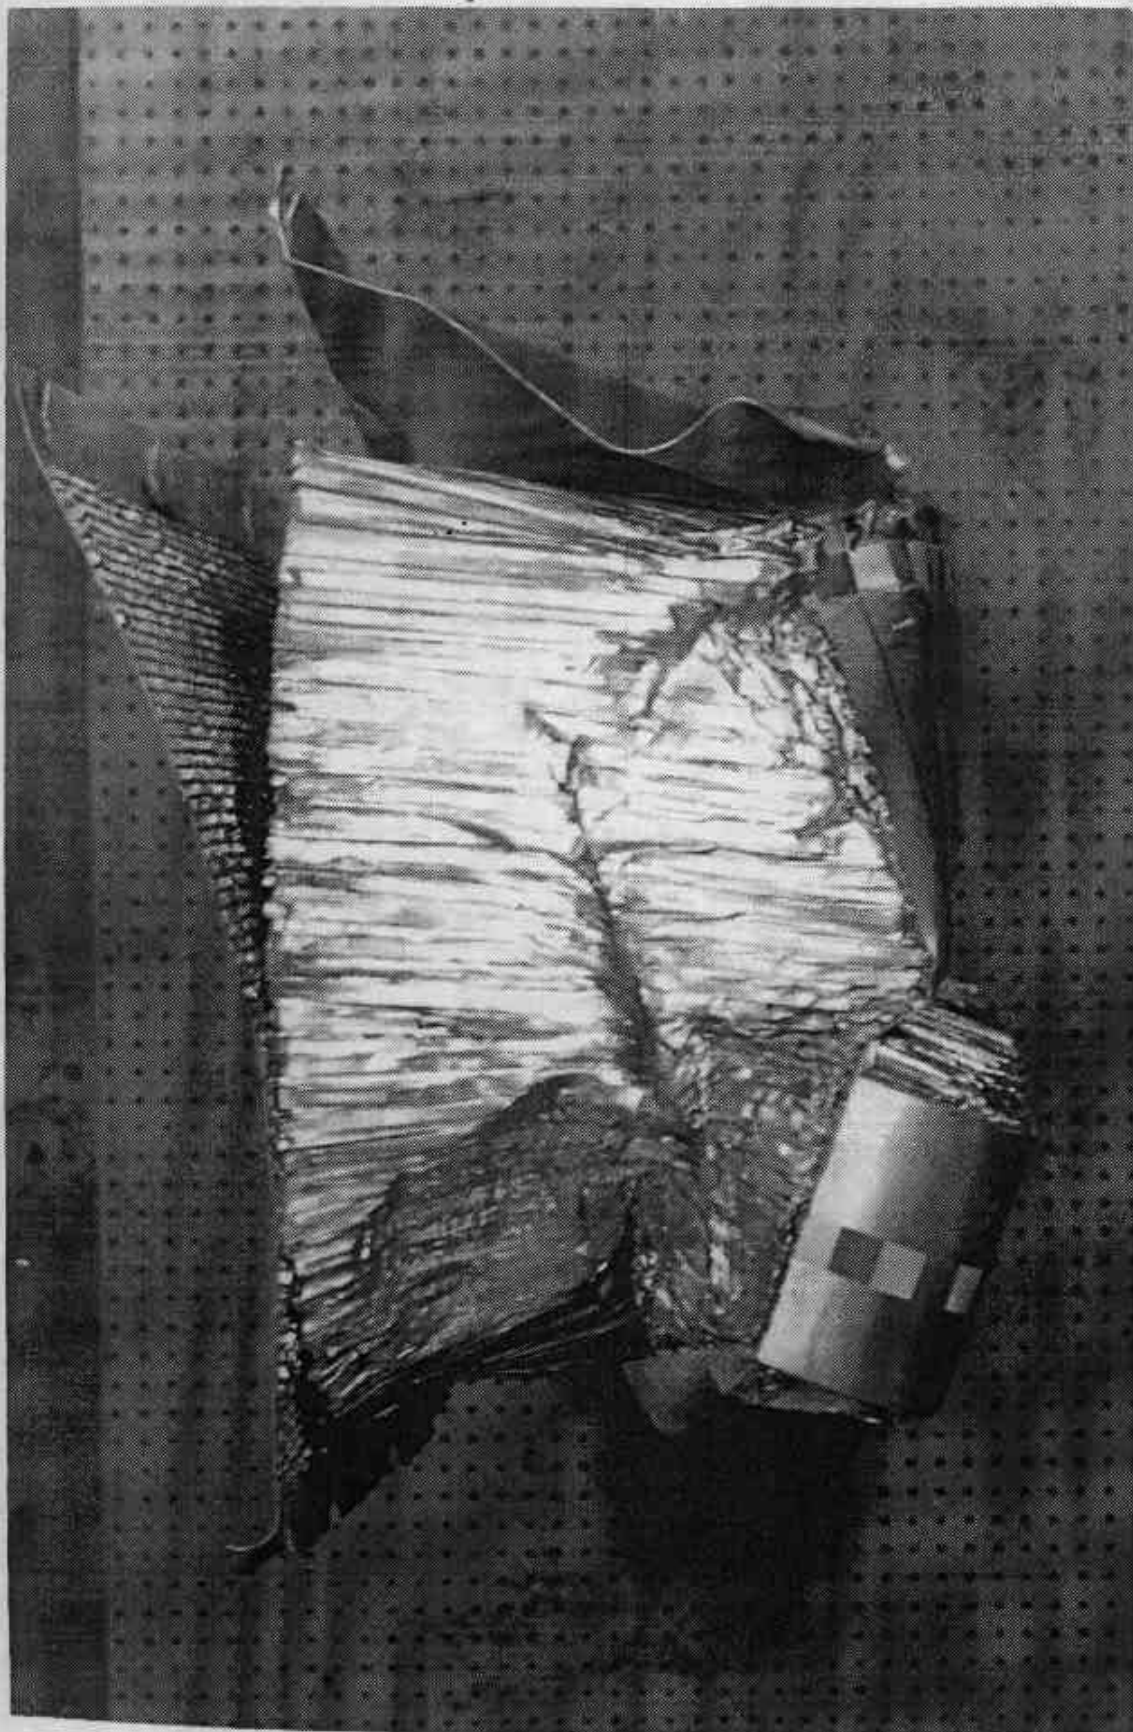
FIGURE A-25 MDB FACE, VIEW NO. 1 - POSTTEST

The MDB impacted the test vehicle and was stopped by the remote brake system to prevent a second impact. The aluminum deformable barrier received minor damage with a maximum crush of 4.0 inches on the lower right-hand corner. The MDB face wedged into the 1989 Colt Vista and had to be pried out. The honey comb MDB face separated from the 26 degree crabbed sled at the mounting bolts. The crush details for the MDB are given in Table 3-7.

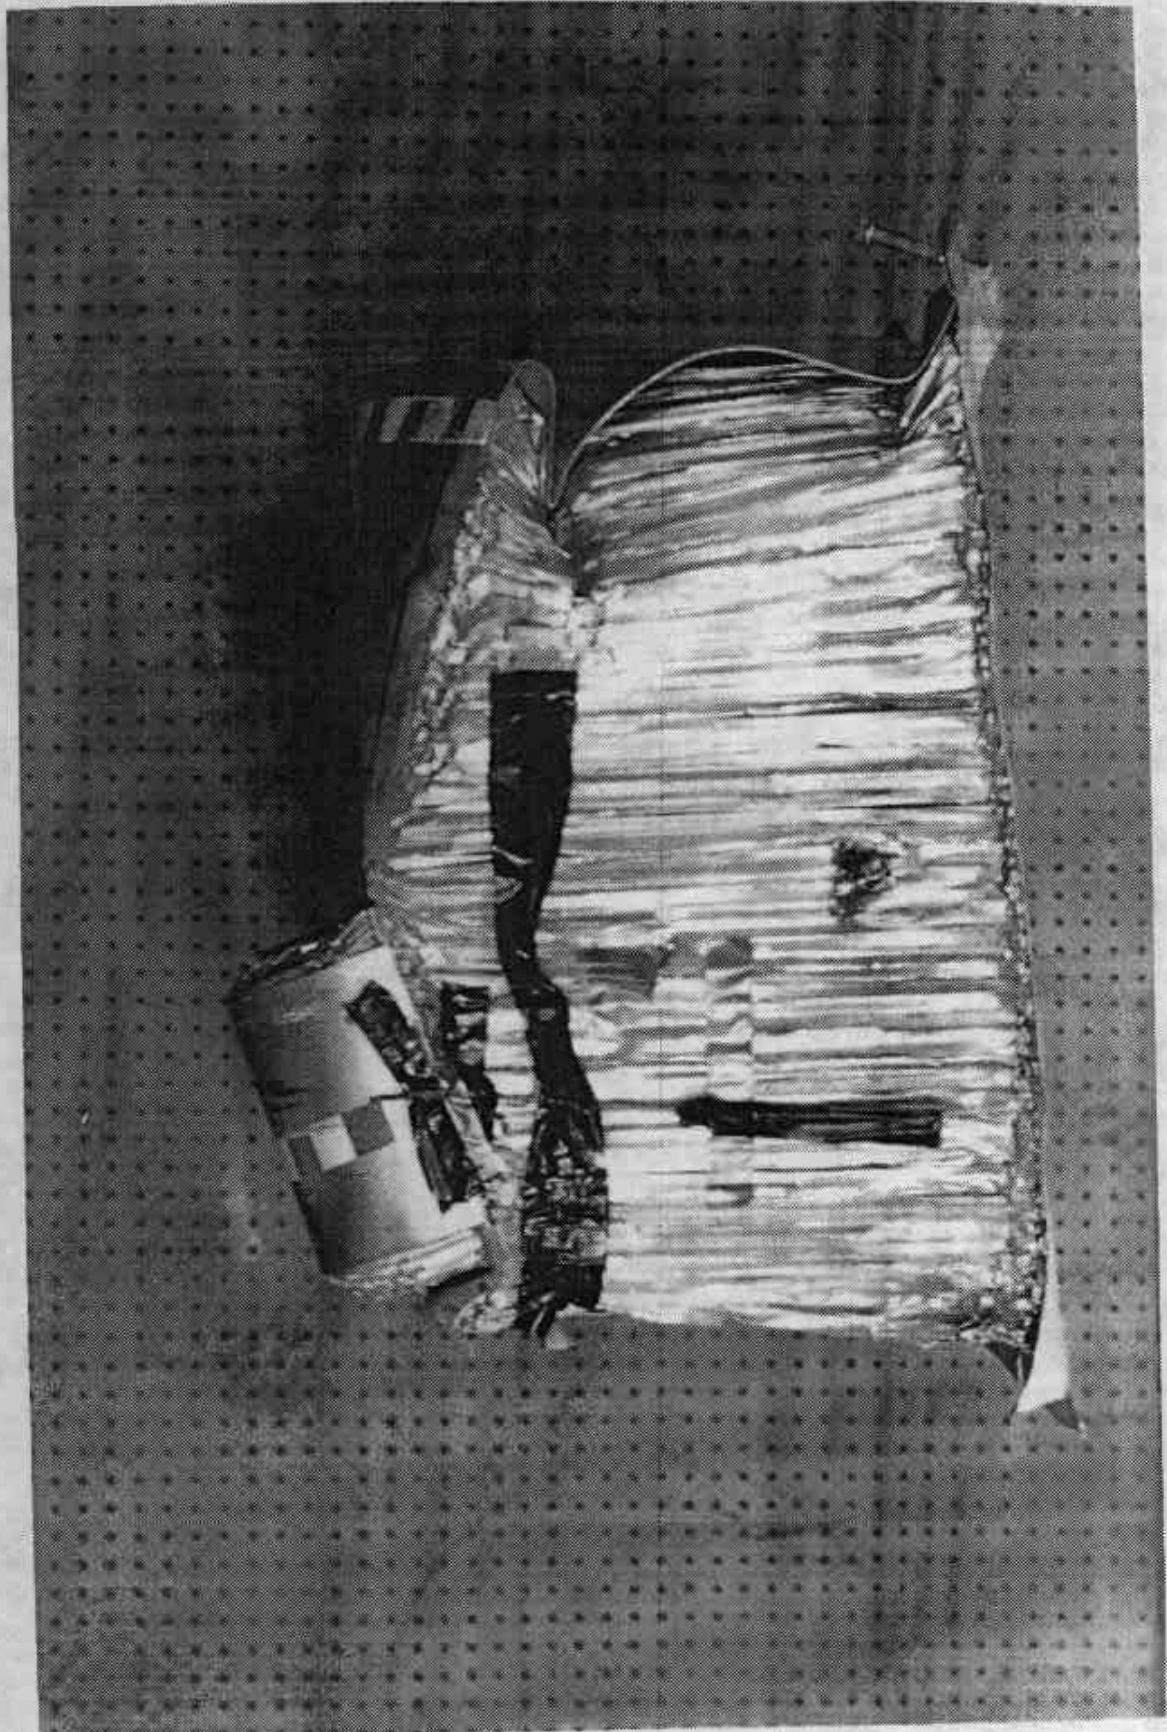
FIGURE A-26 MDB FACE, VIEW NO. 2 - POSTTEST
