REPORT NOS. 208-TRC-92-009
212-TRC-92-009
301-TRC-92-009

VEHICLE SAFETY COMPLIANCE TESTING
FOR OCCUPANT CRASH PROTECTION,
WINDSHIELD MOUNTING, WINDSHIELD ZONE
INTRUSION, AND FUEL SYSTEM INTEGRITY

FORD MOTOR COMPANY
1992 FORD EXPLORER
SPORT UTILITY VEHICLE
NHTSA NO. CN0209
TRC TEST NO. 920205

FINAL REPORT

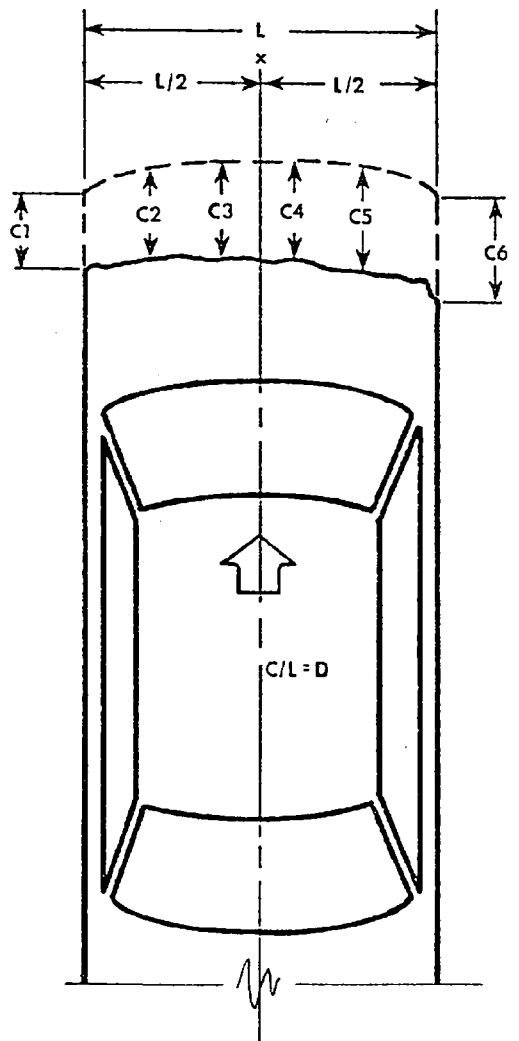
FIGURE 3

VEHICLE ACCELEROMETER PLACEMENT

The test vehicle was instrumented with seven (7) accelerometers to measure longitudinal axis accelerations. The vehicle's specified impact velocity range was 28.9 to 29.9 mph. The vehicle impacted a flat frontal barrier.

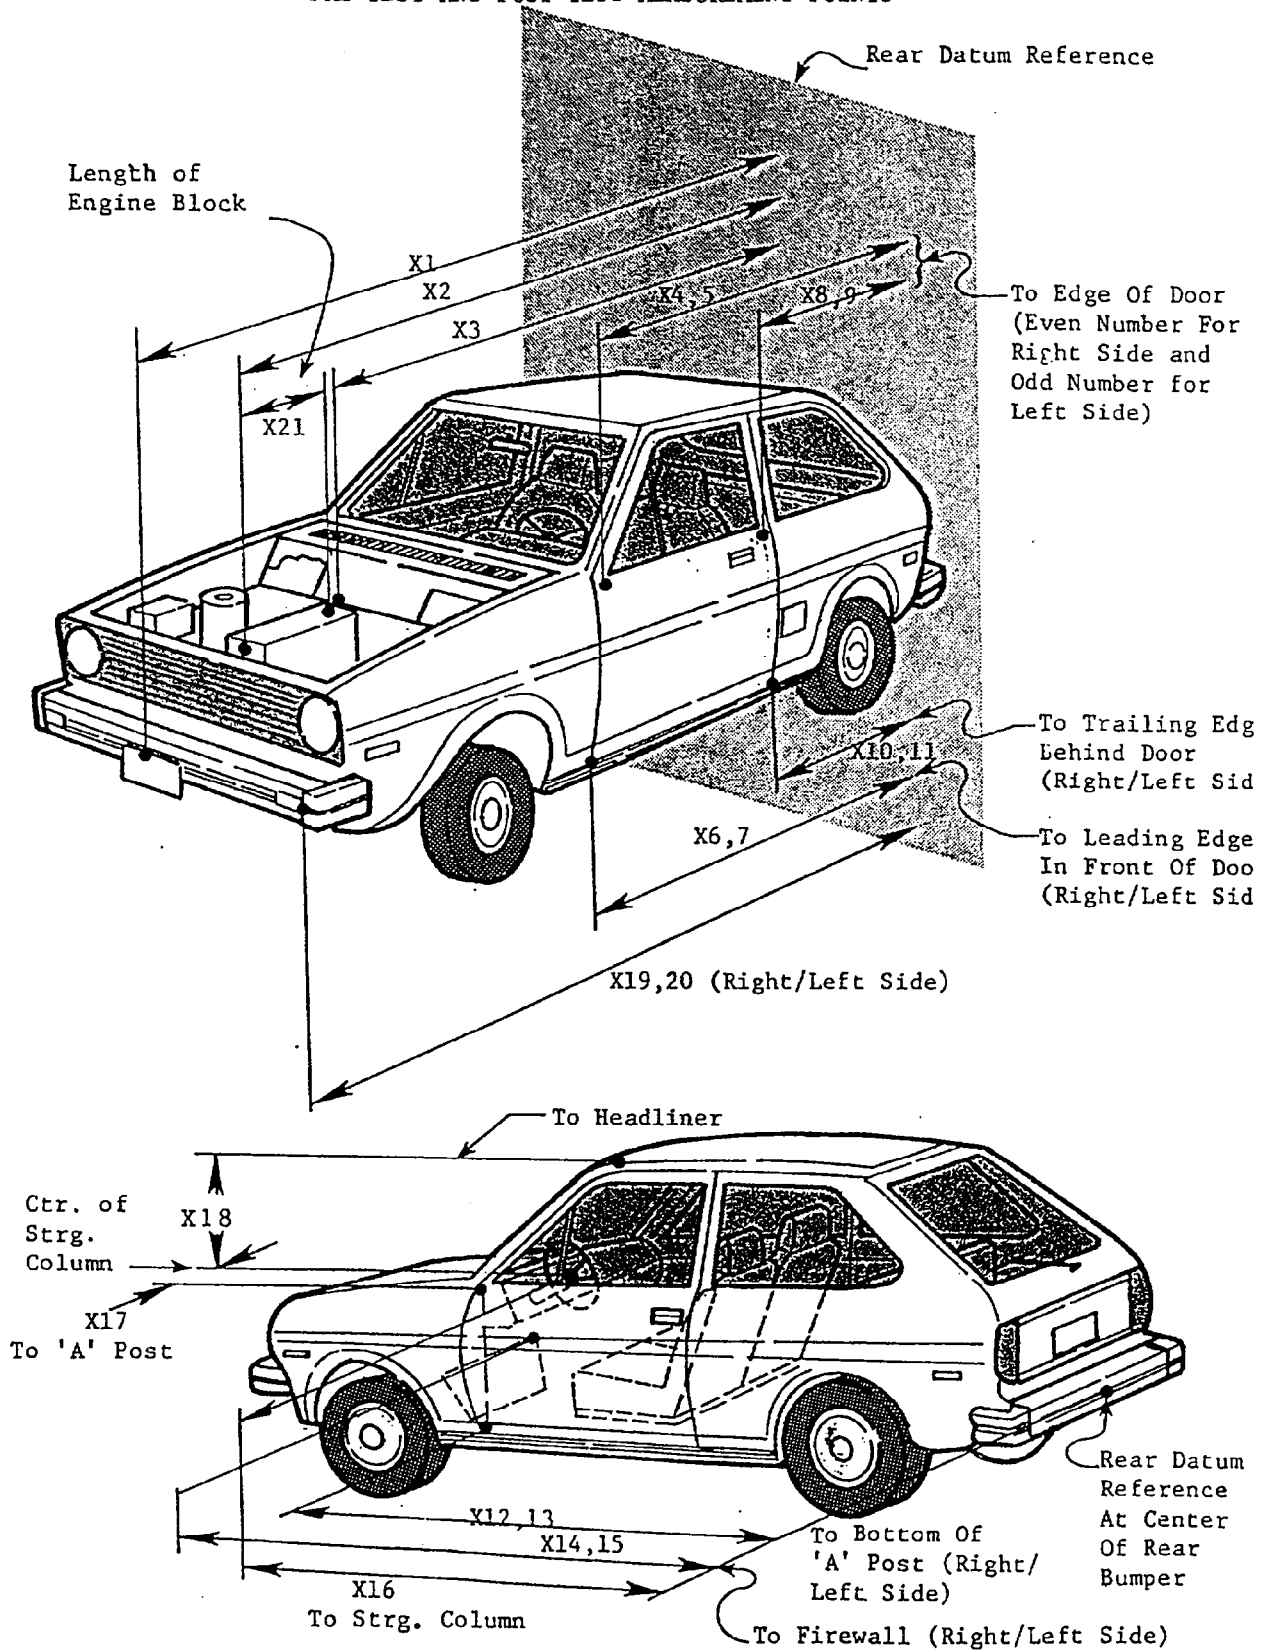
FIGURE 7

PRE-TEST AND POST-TEST MEASUREMENT POINTS

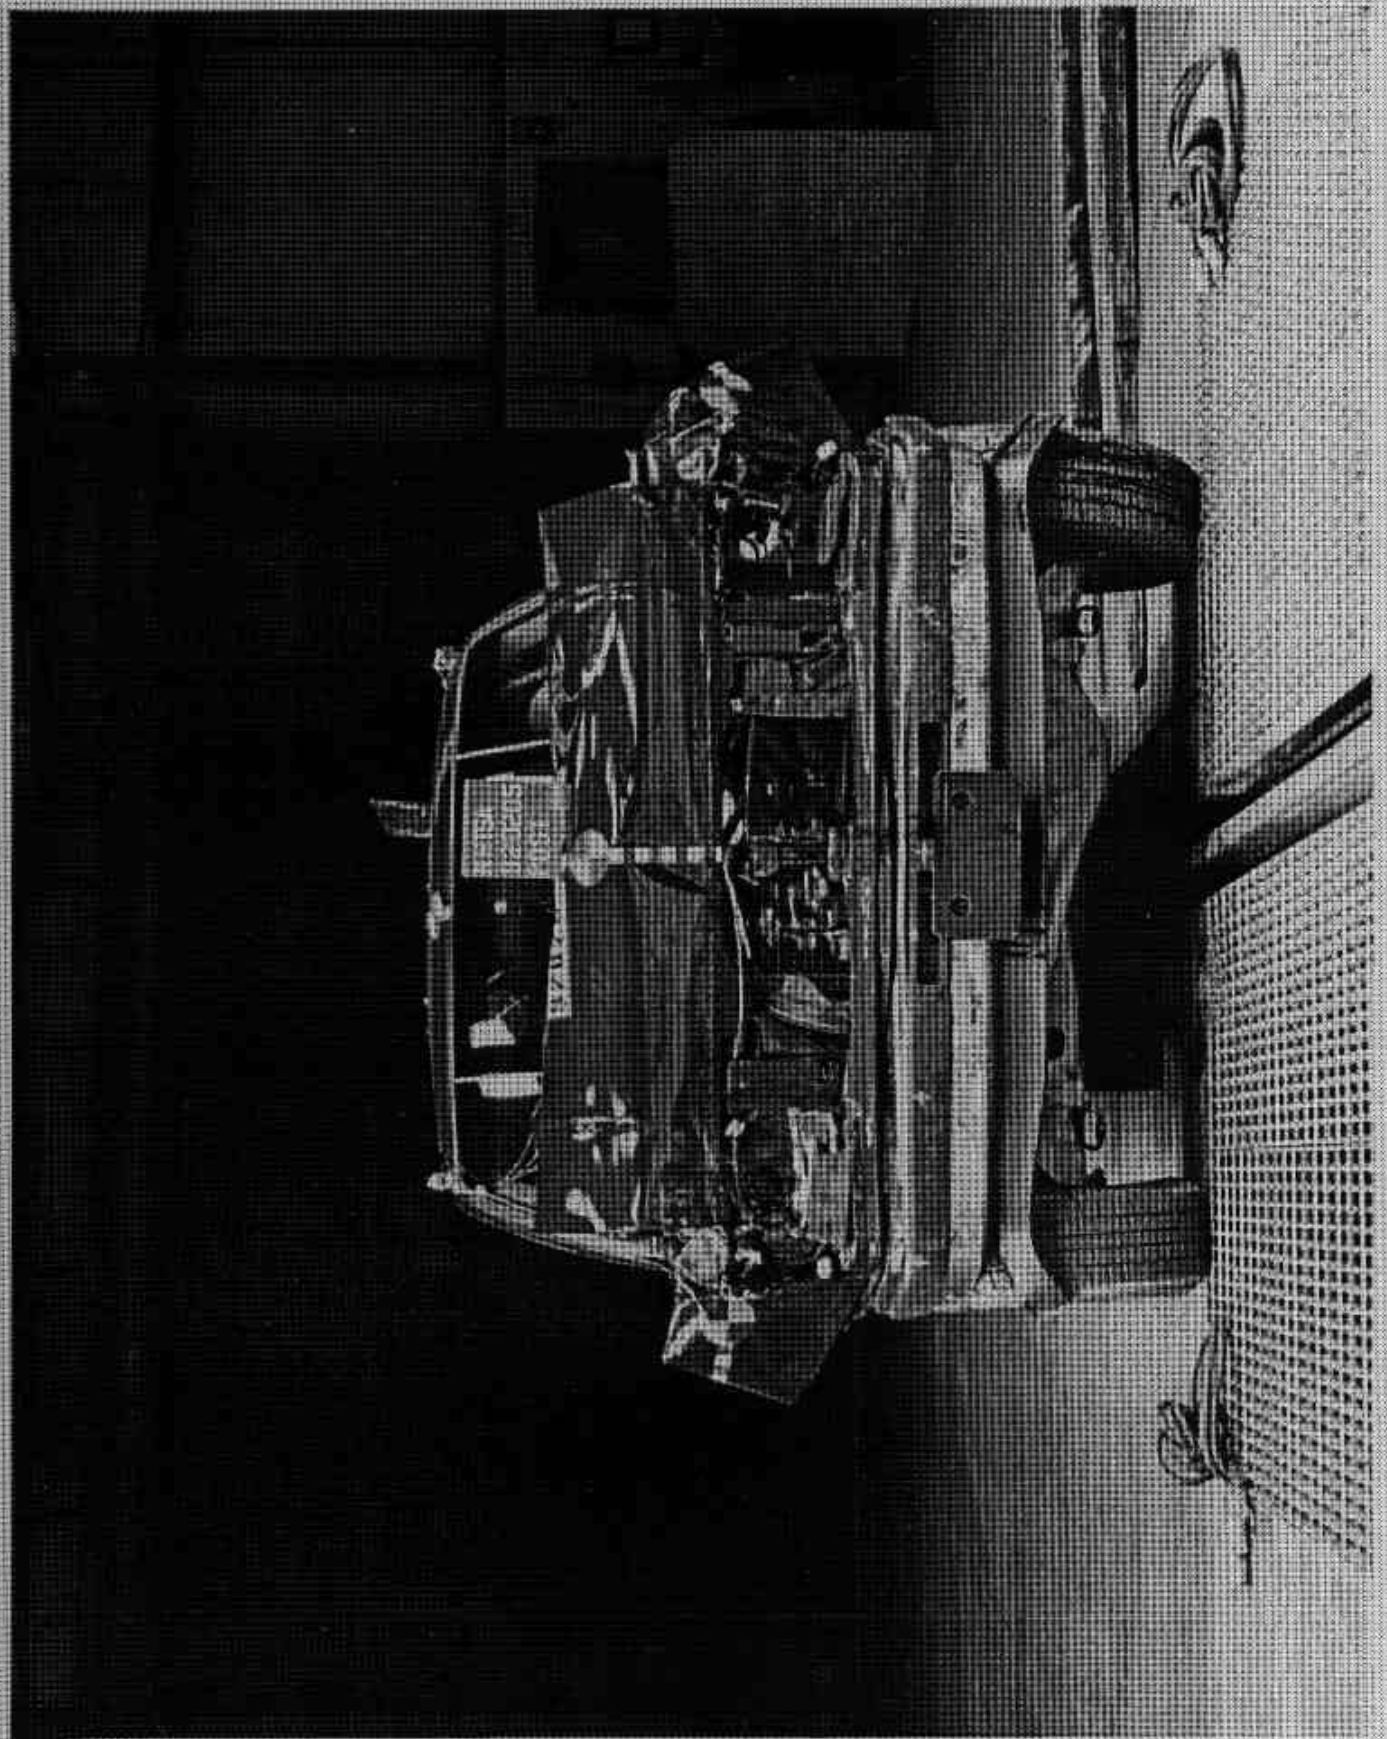
FIGURE A-2. POST-TEST FRONT VIEW

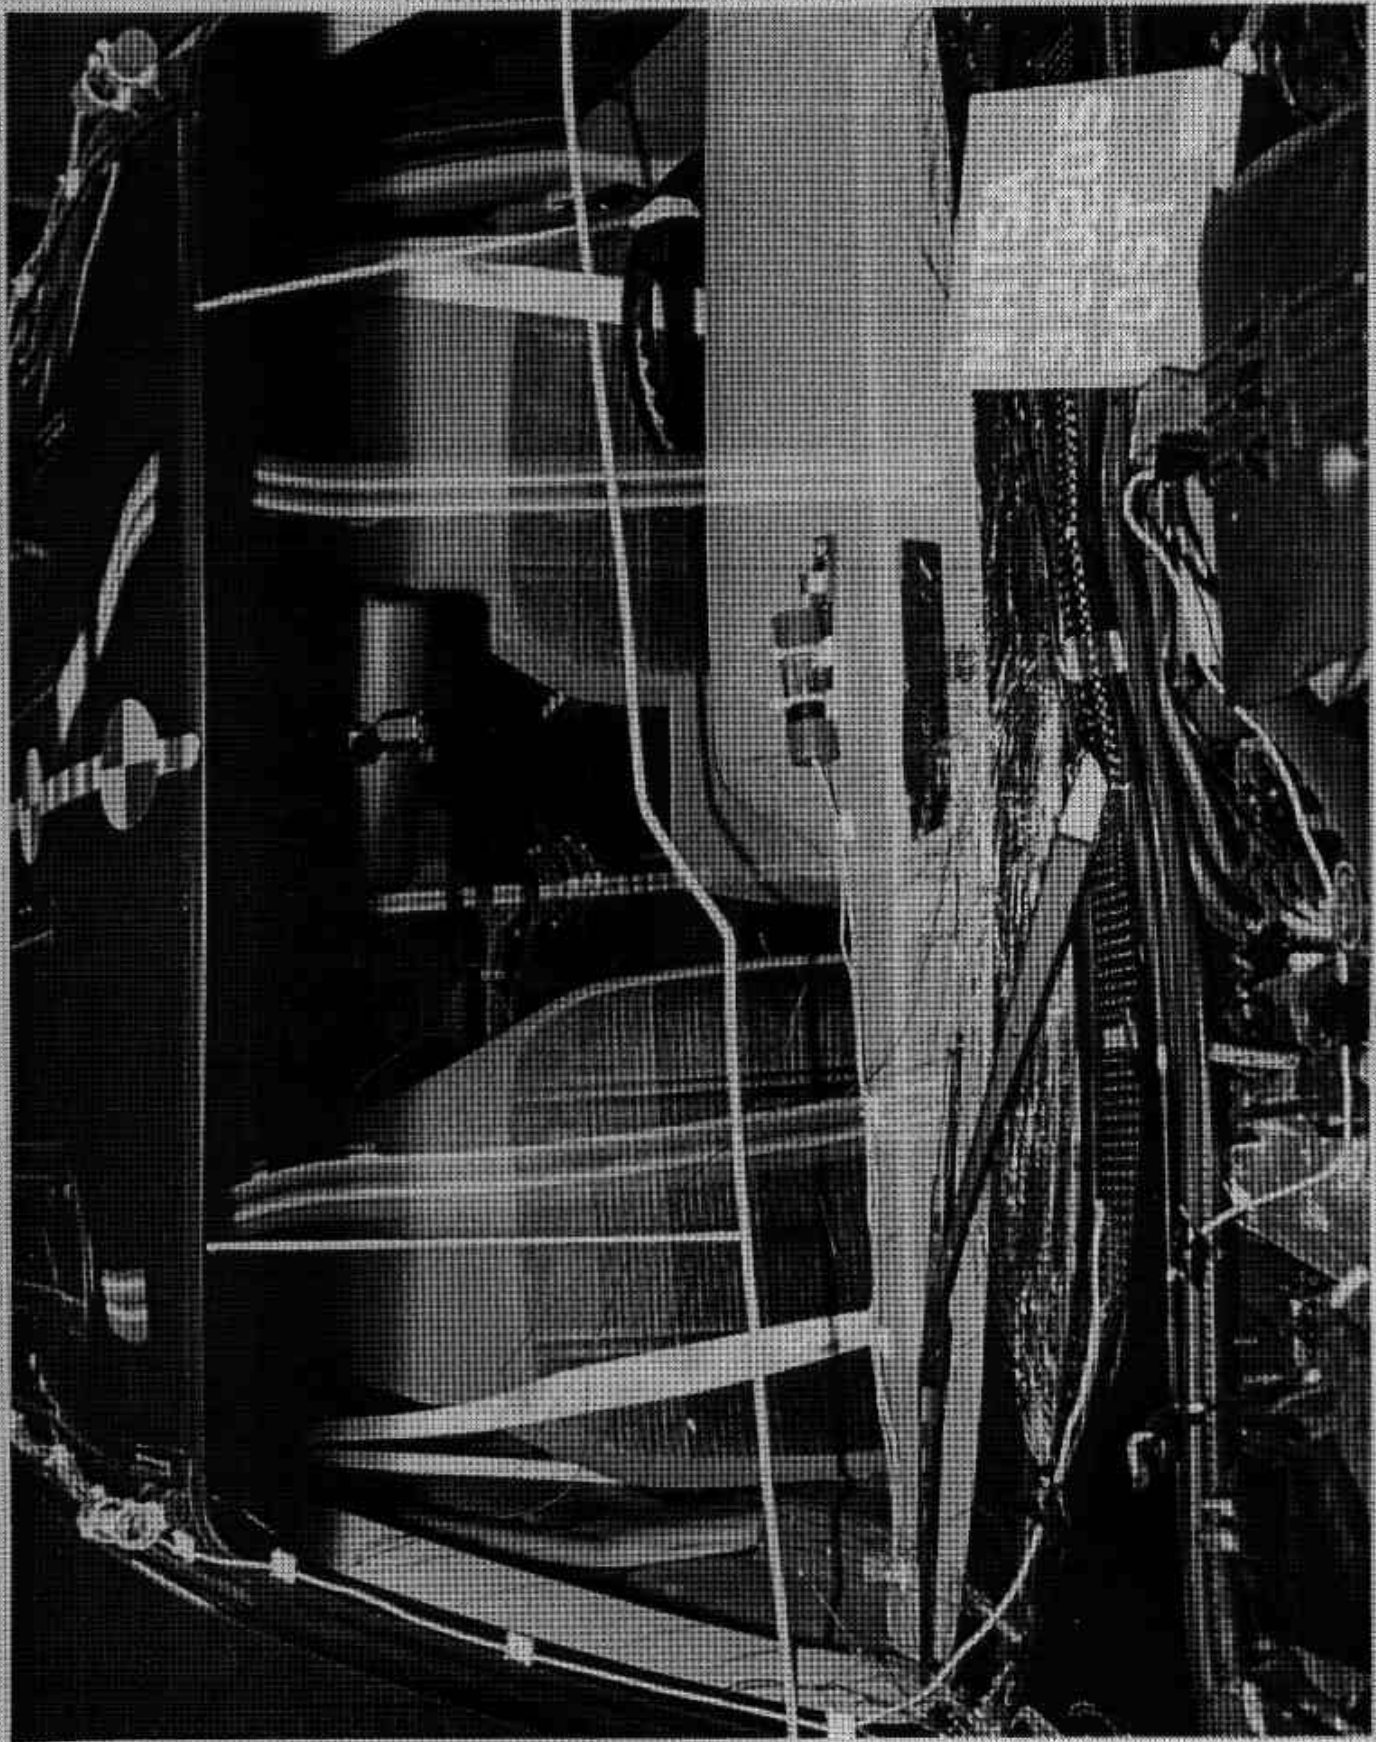
FIGURE A-14. POST-TEST WINDSHIELD VIEW
A-15

There was no loss of windshield periphery retention.

There was no intrusion through the windshield.

The entire windshield was cracked upon impact.

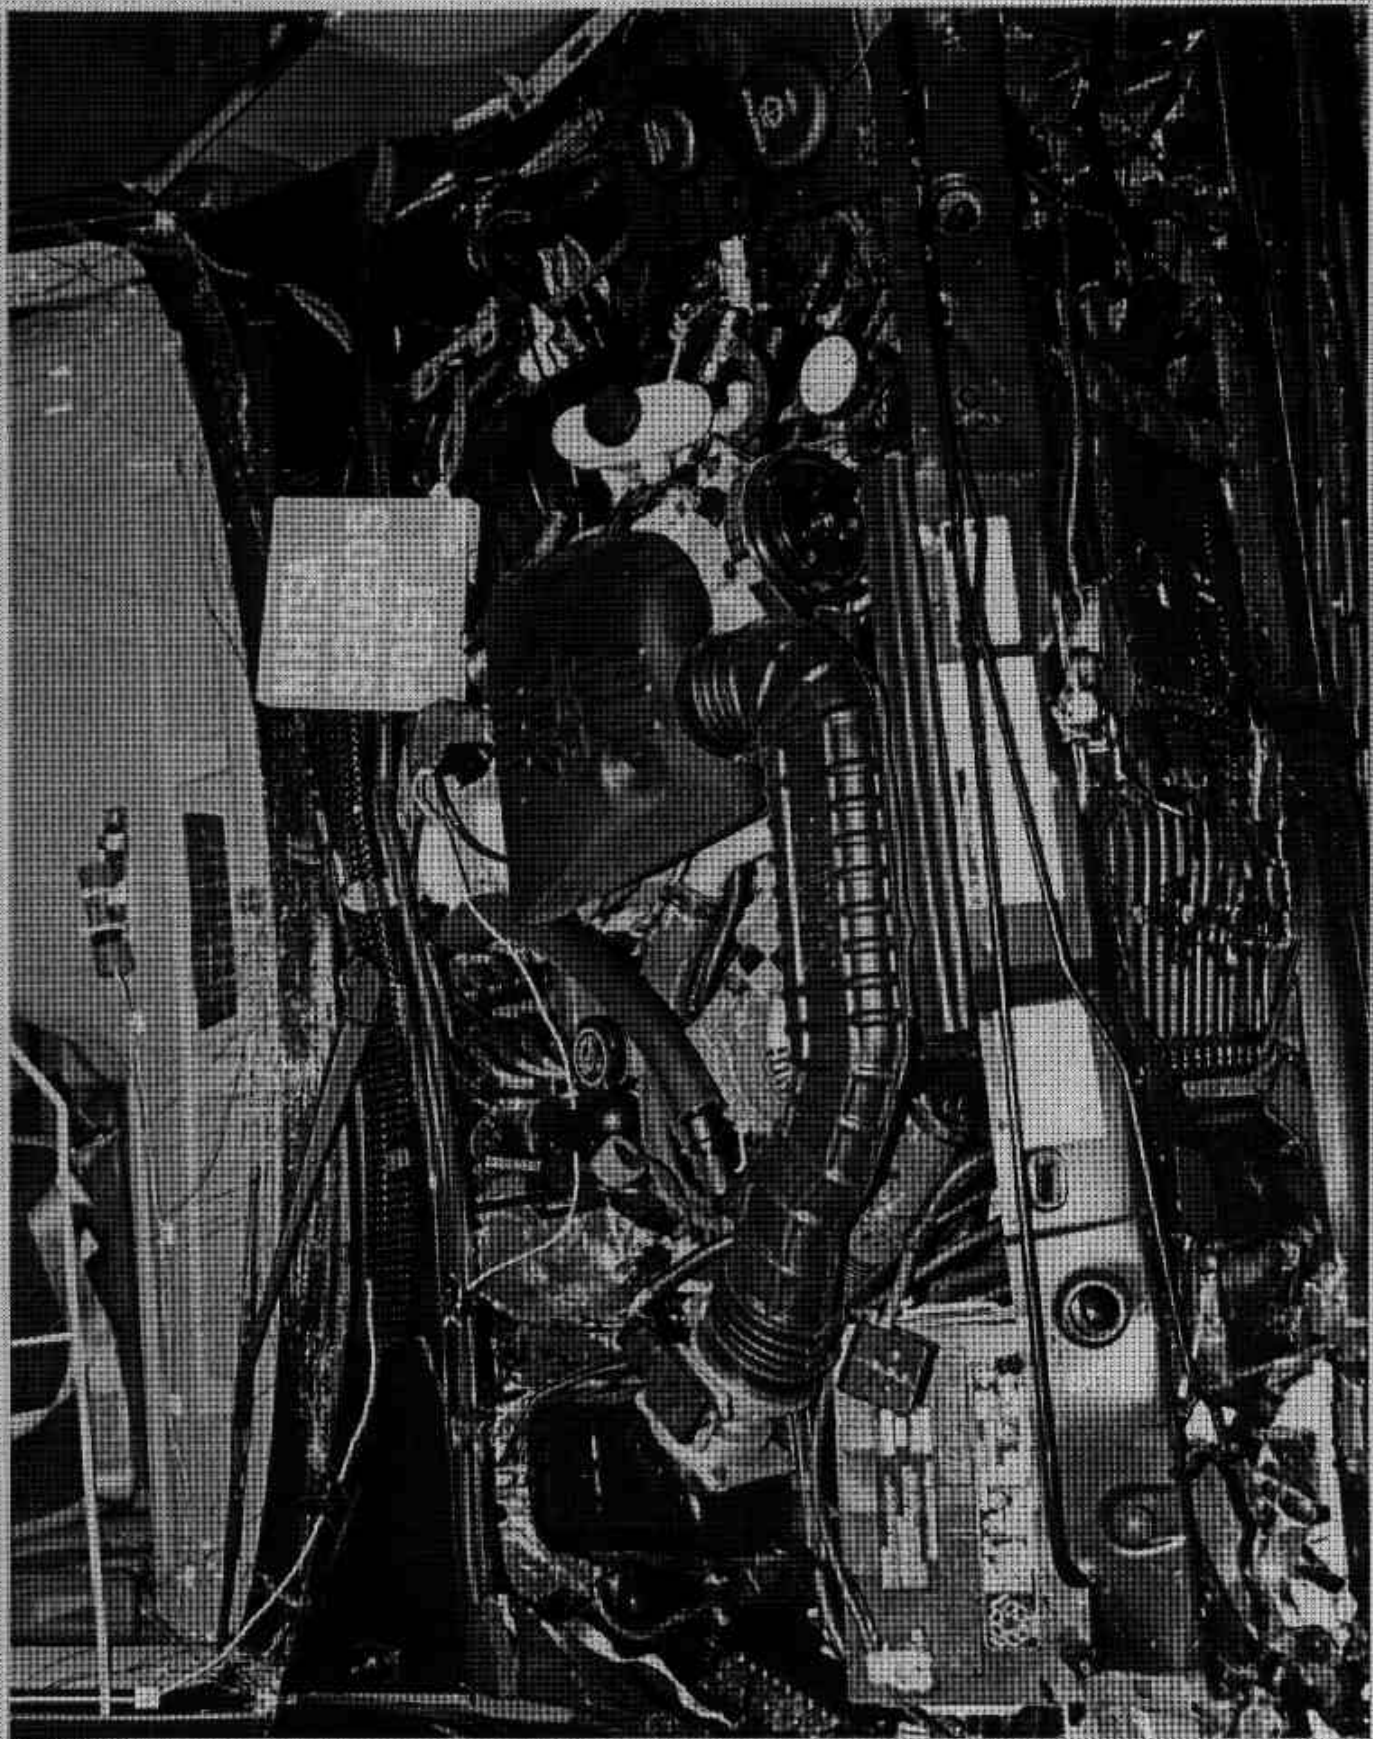
FIGURE A-16. POST-TEST ENGINE COMPARTMENT VIEW
A-17

The engine top X-axis accelerometer, ENGXG1, lost data after 12 milliseconds due to the vehicle's crush cutting the accelerometer cable.

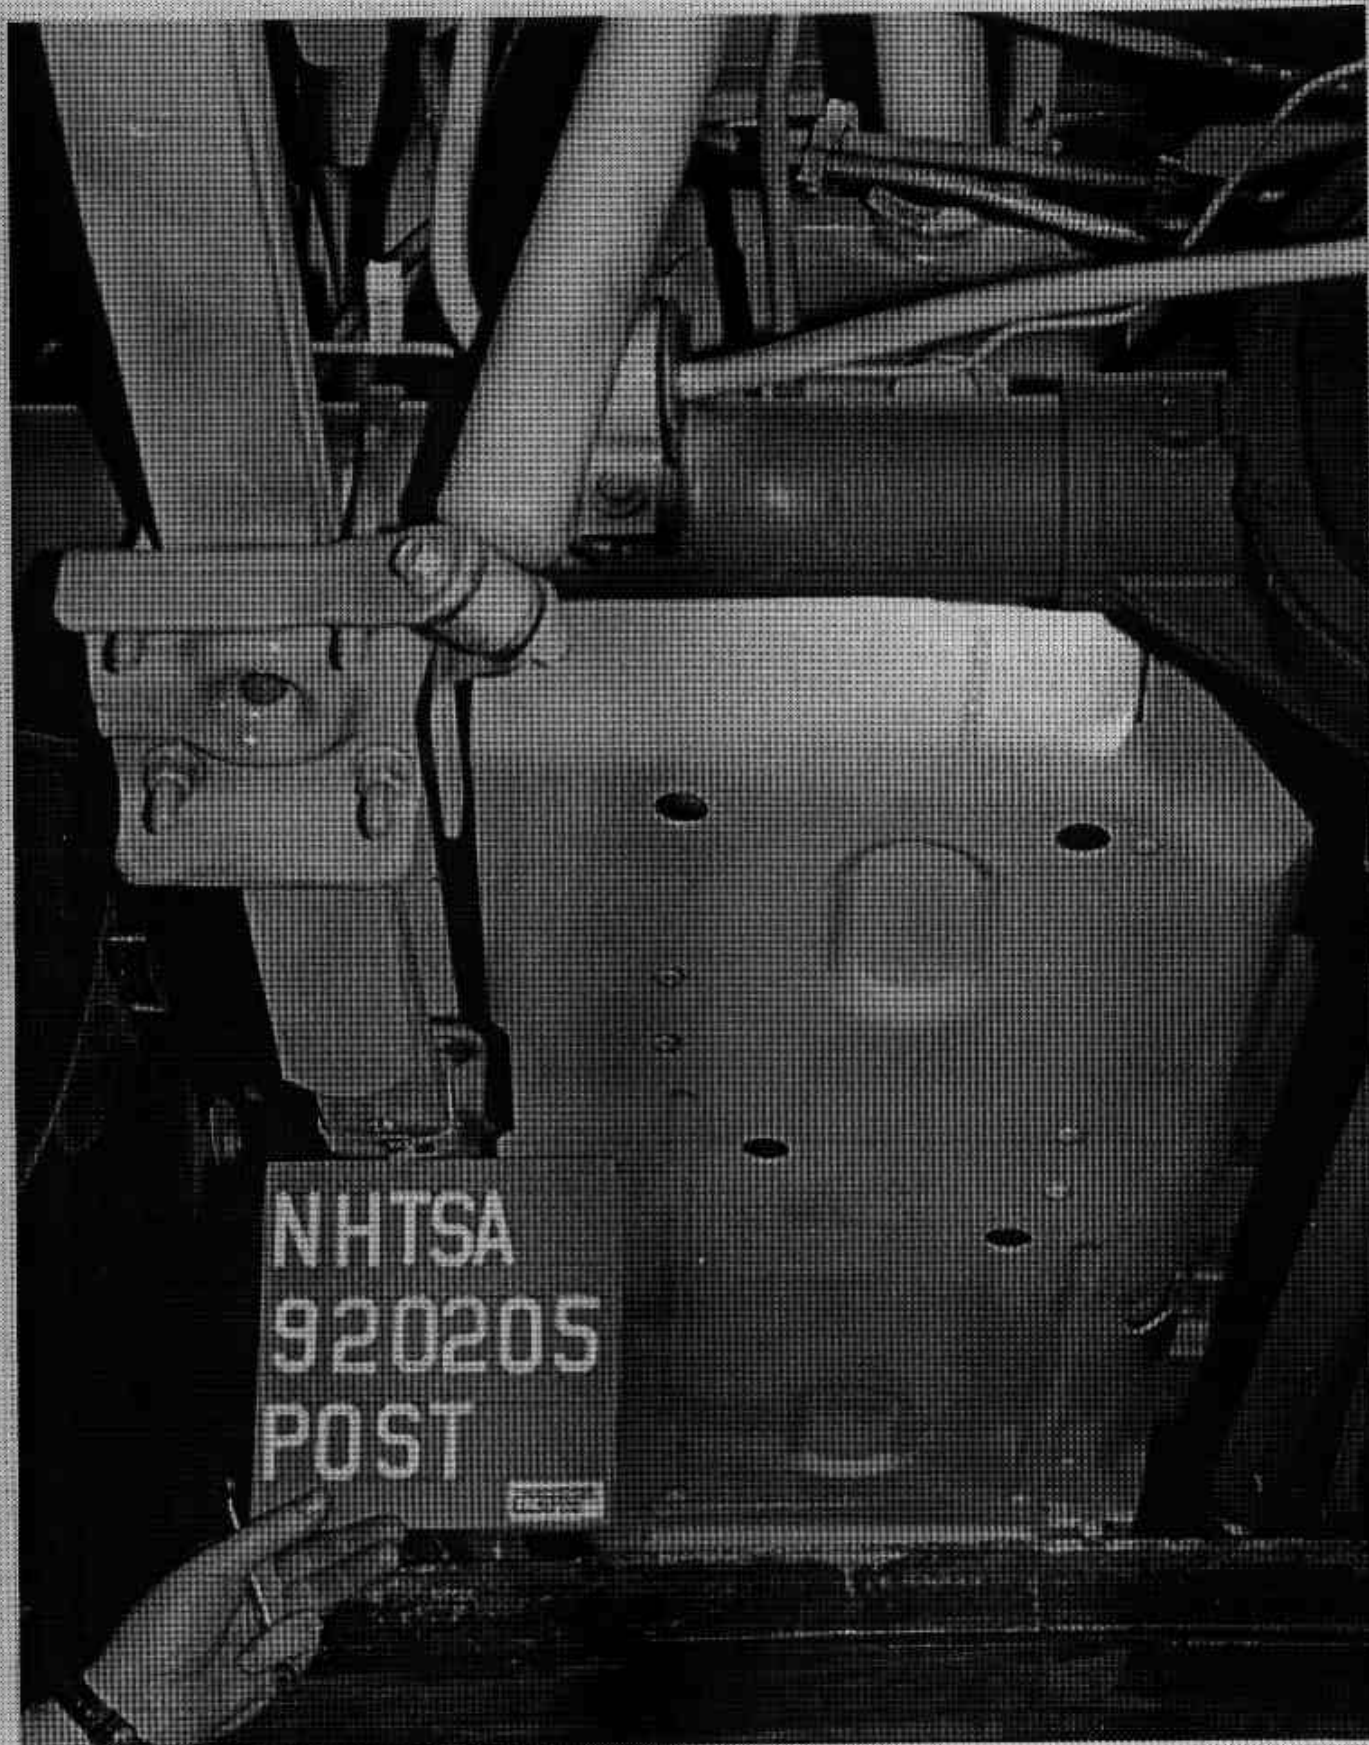
FIGURE A-22. POST-TEST FUEL TANK VIEW
A-23

No fluid spilled from the vehicle's fuel system following the crash test event or during the static rollover test.

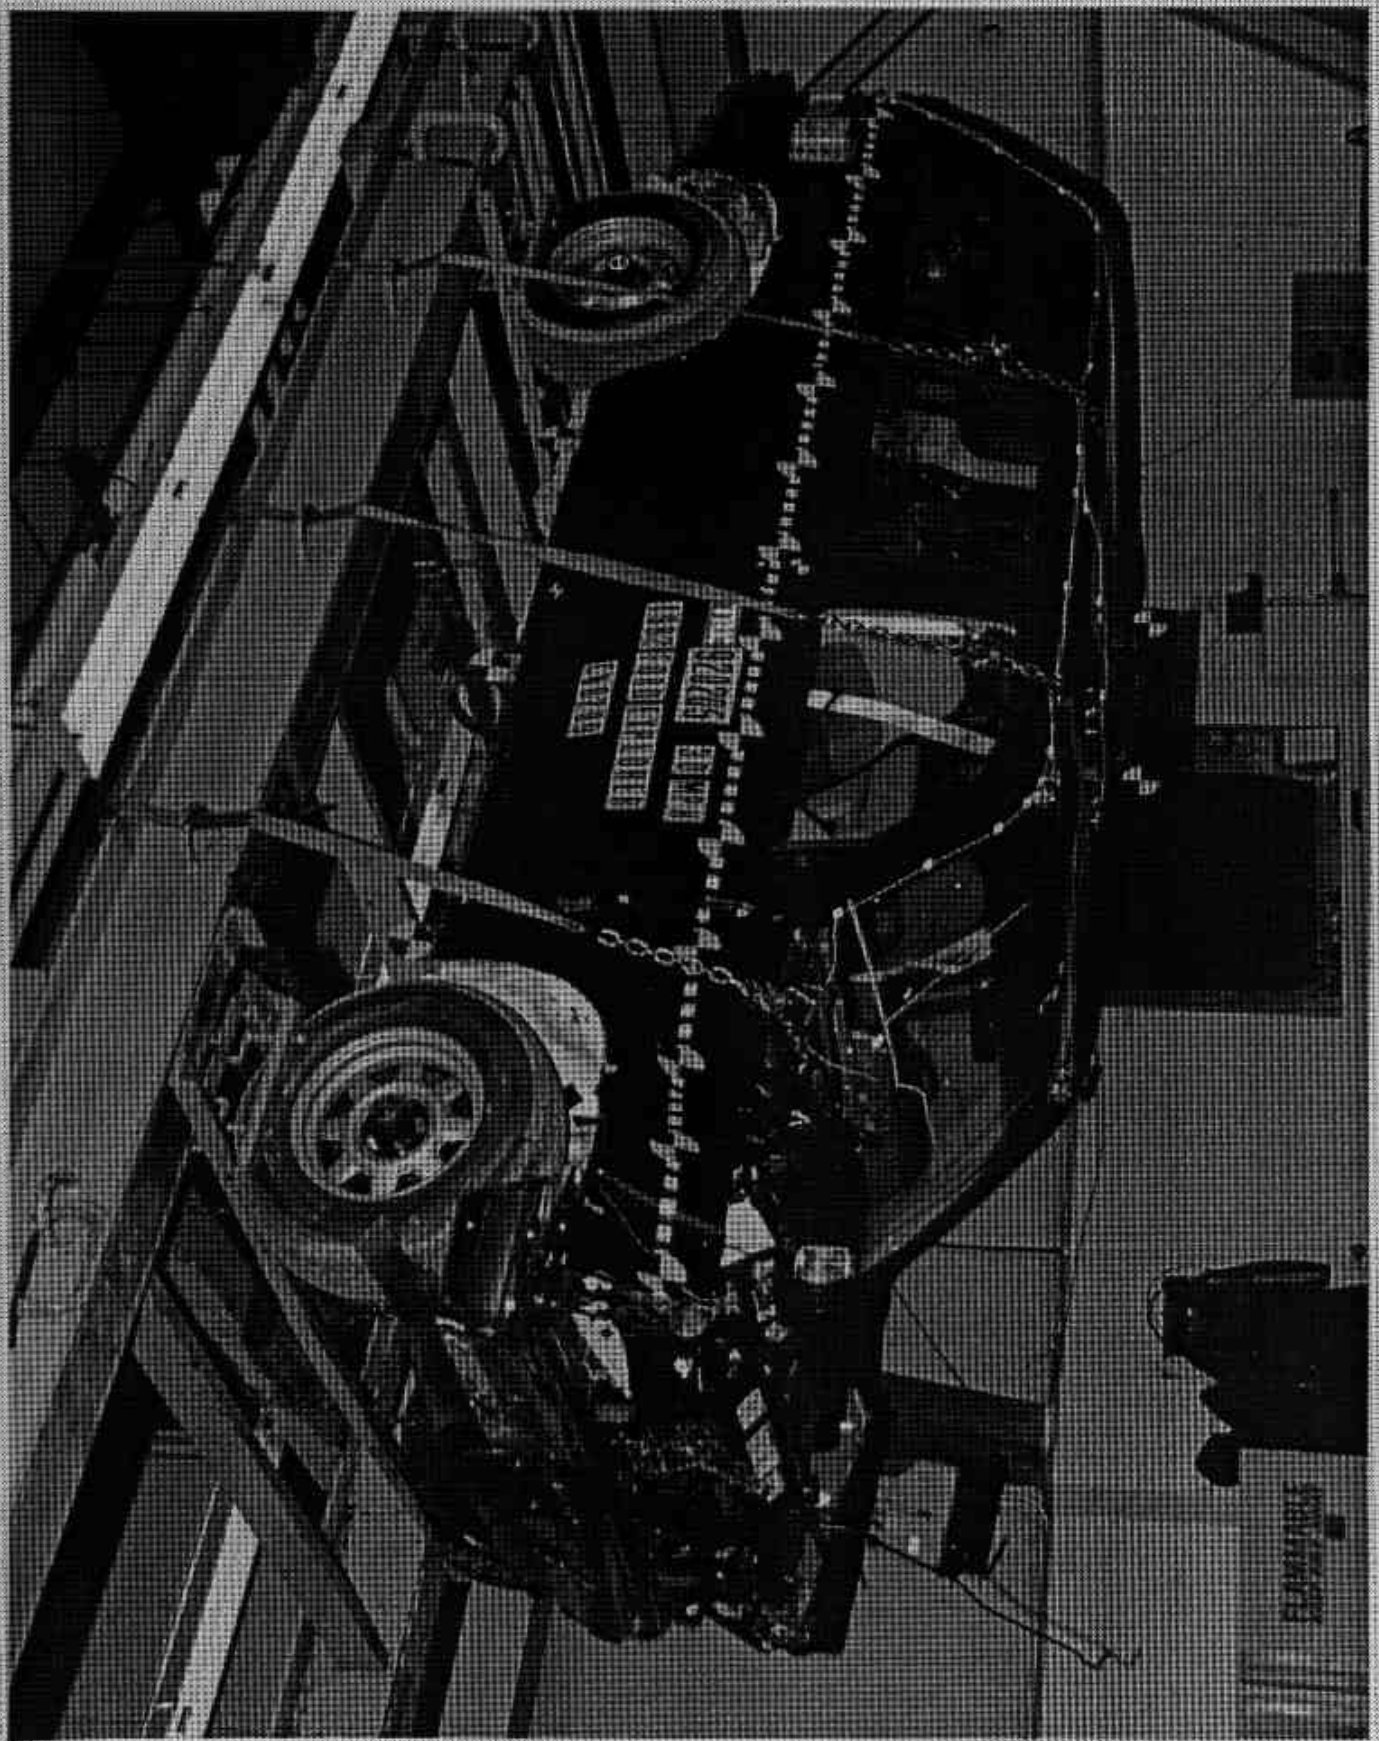
FIGURE A-46. POST-TEST VEHICLE ON STATIC ROLLOVER MACHINE VIEW

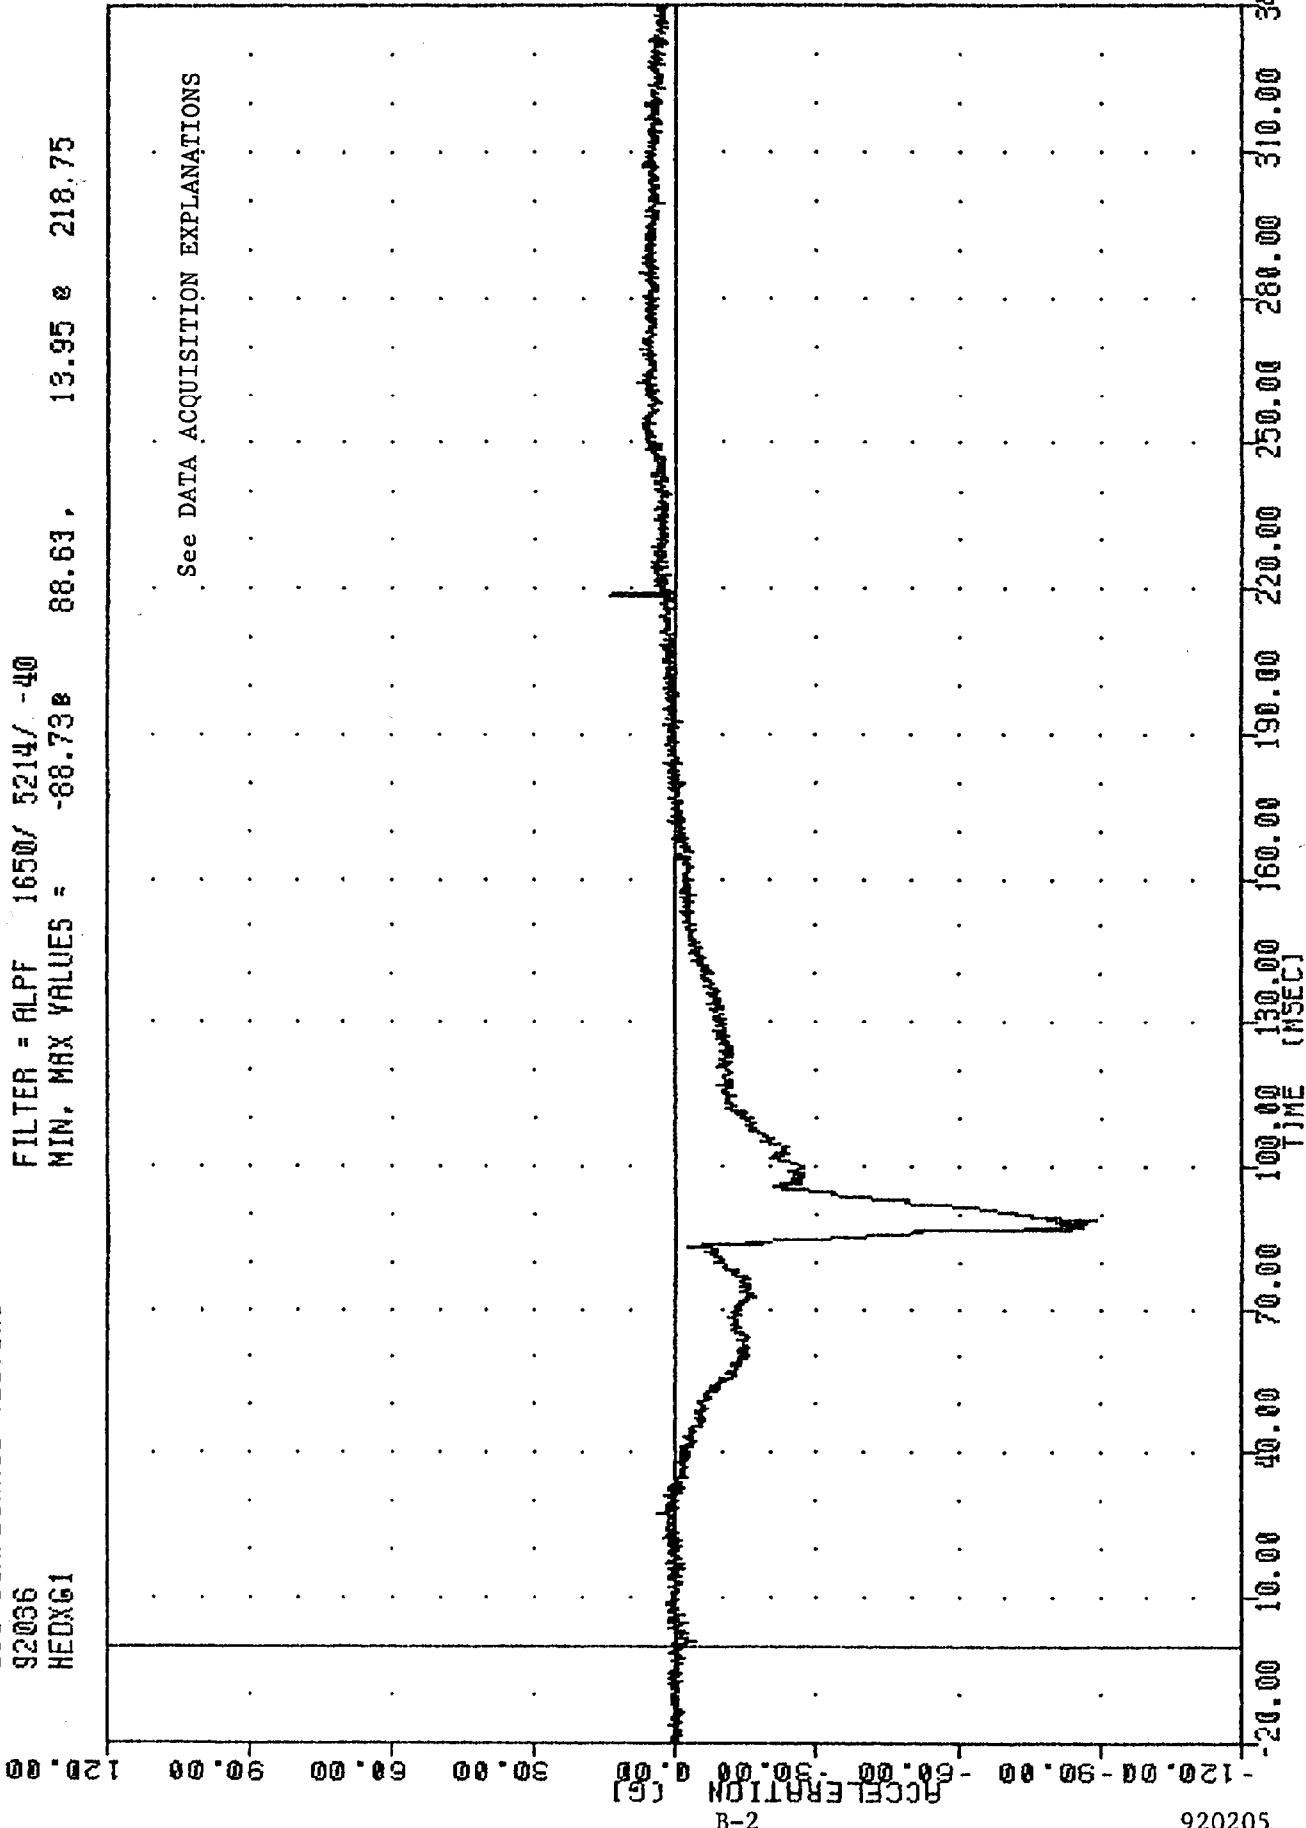
FILTER = ALPF 1650/ 5214/ -40
MIN. MAX VALUES = -88.73 88.63 , 13.95 218.75

1992 FORD EXPLORER INTO FLAT FRONTAL BARRIER
DRIVER HEAD X-AXIS ACCELERATION

HEDXG1, driver's head X-axis acceleration, spike at 219 milliseconds

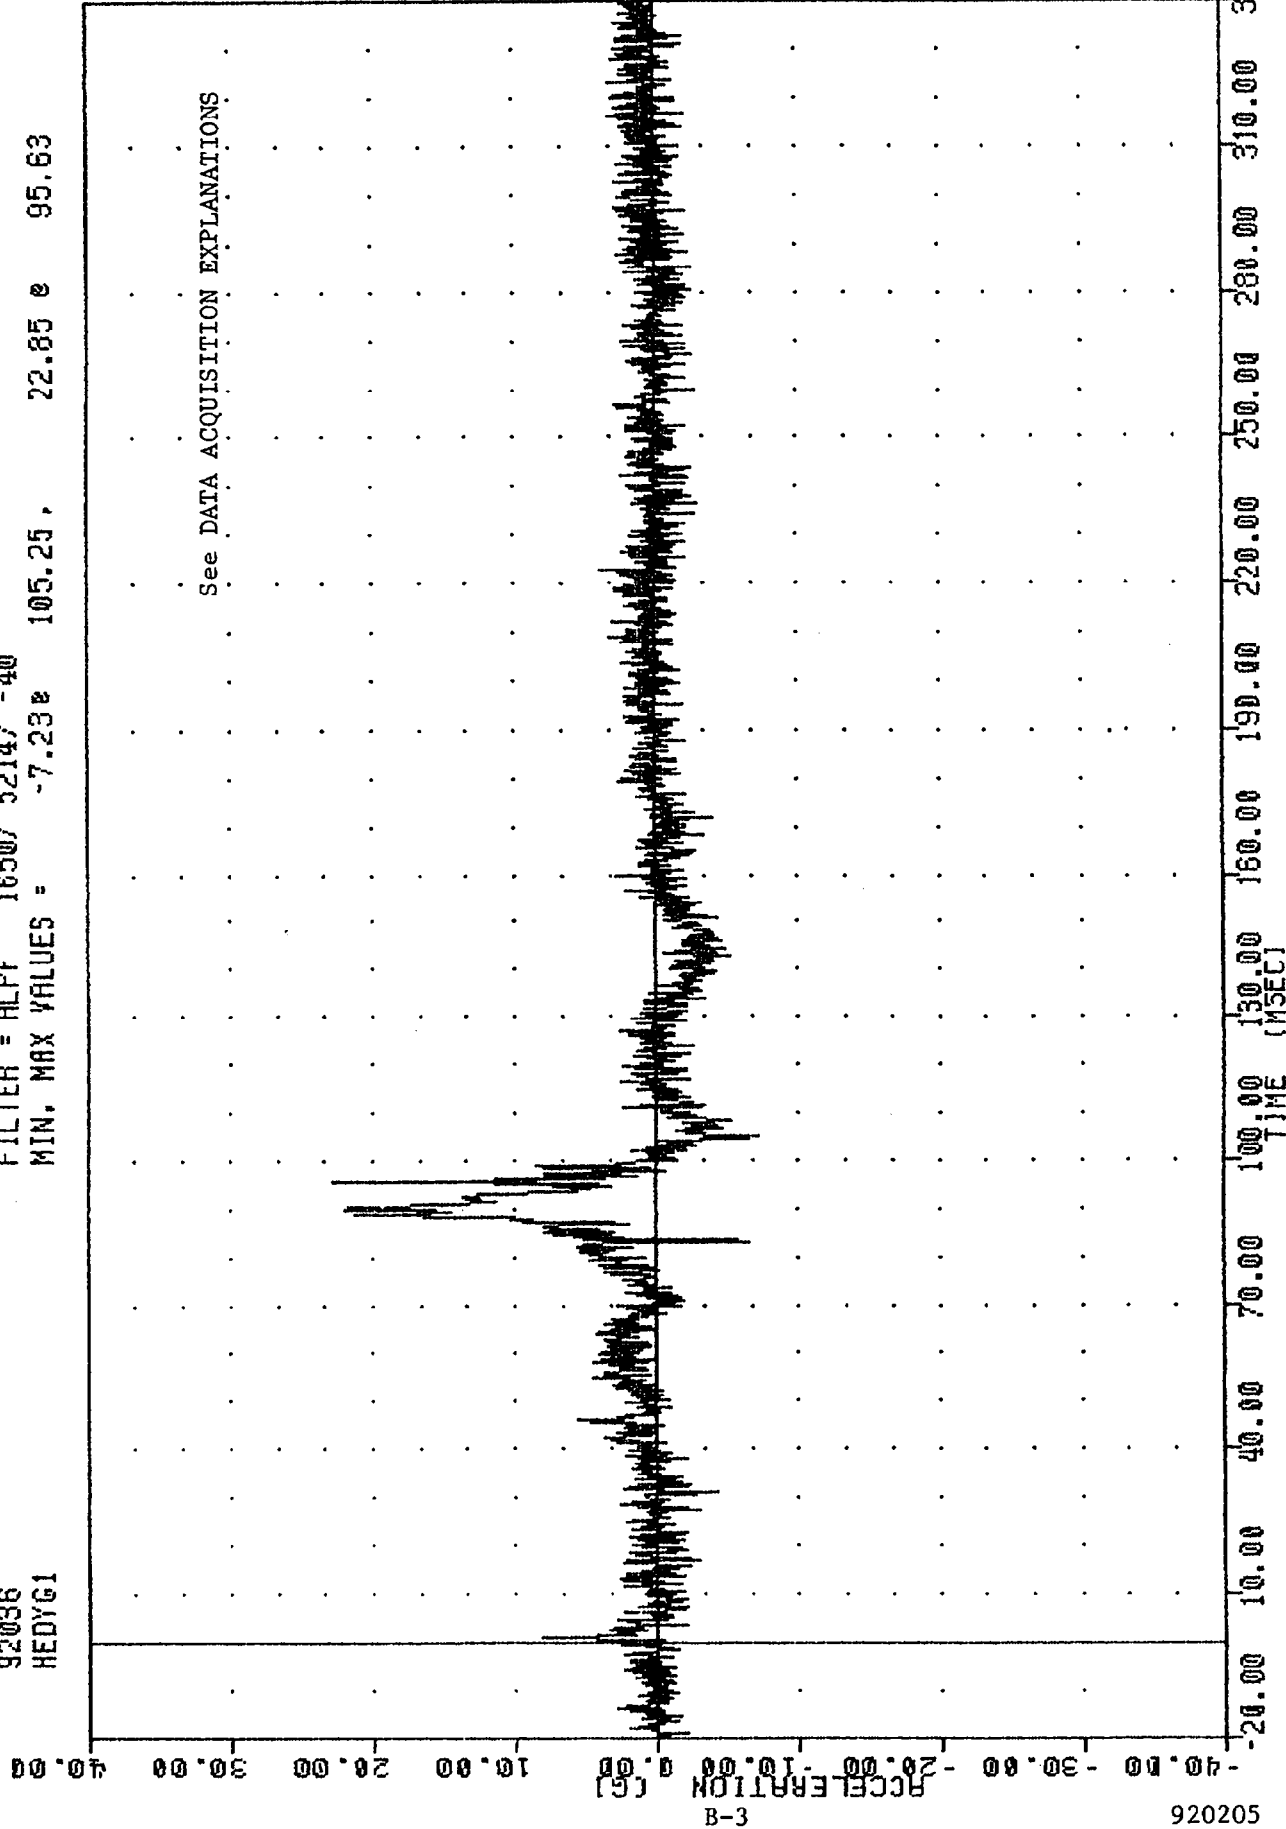
FILTER = ALPF 1650/ 5214/ -40
MIN. MAX VALUES = -7.23e 22.85 e 95.63

1992 FORD EXPLORER INTO FLAT FRONTAL BARRIER
DRIVER HEAD Y-AXIS ACCELERATION

HEDYG1, driver's head Y-axis acceleration, spike at 96 milliseconds

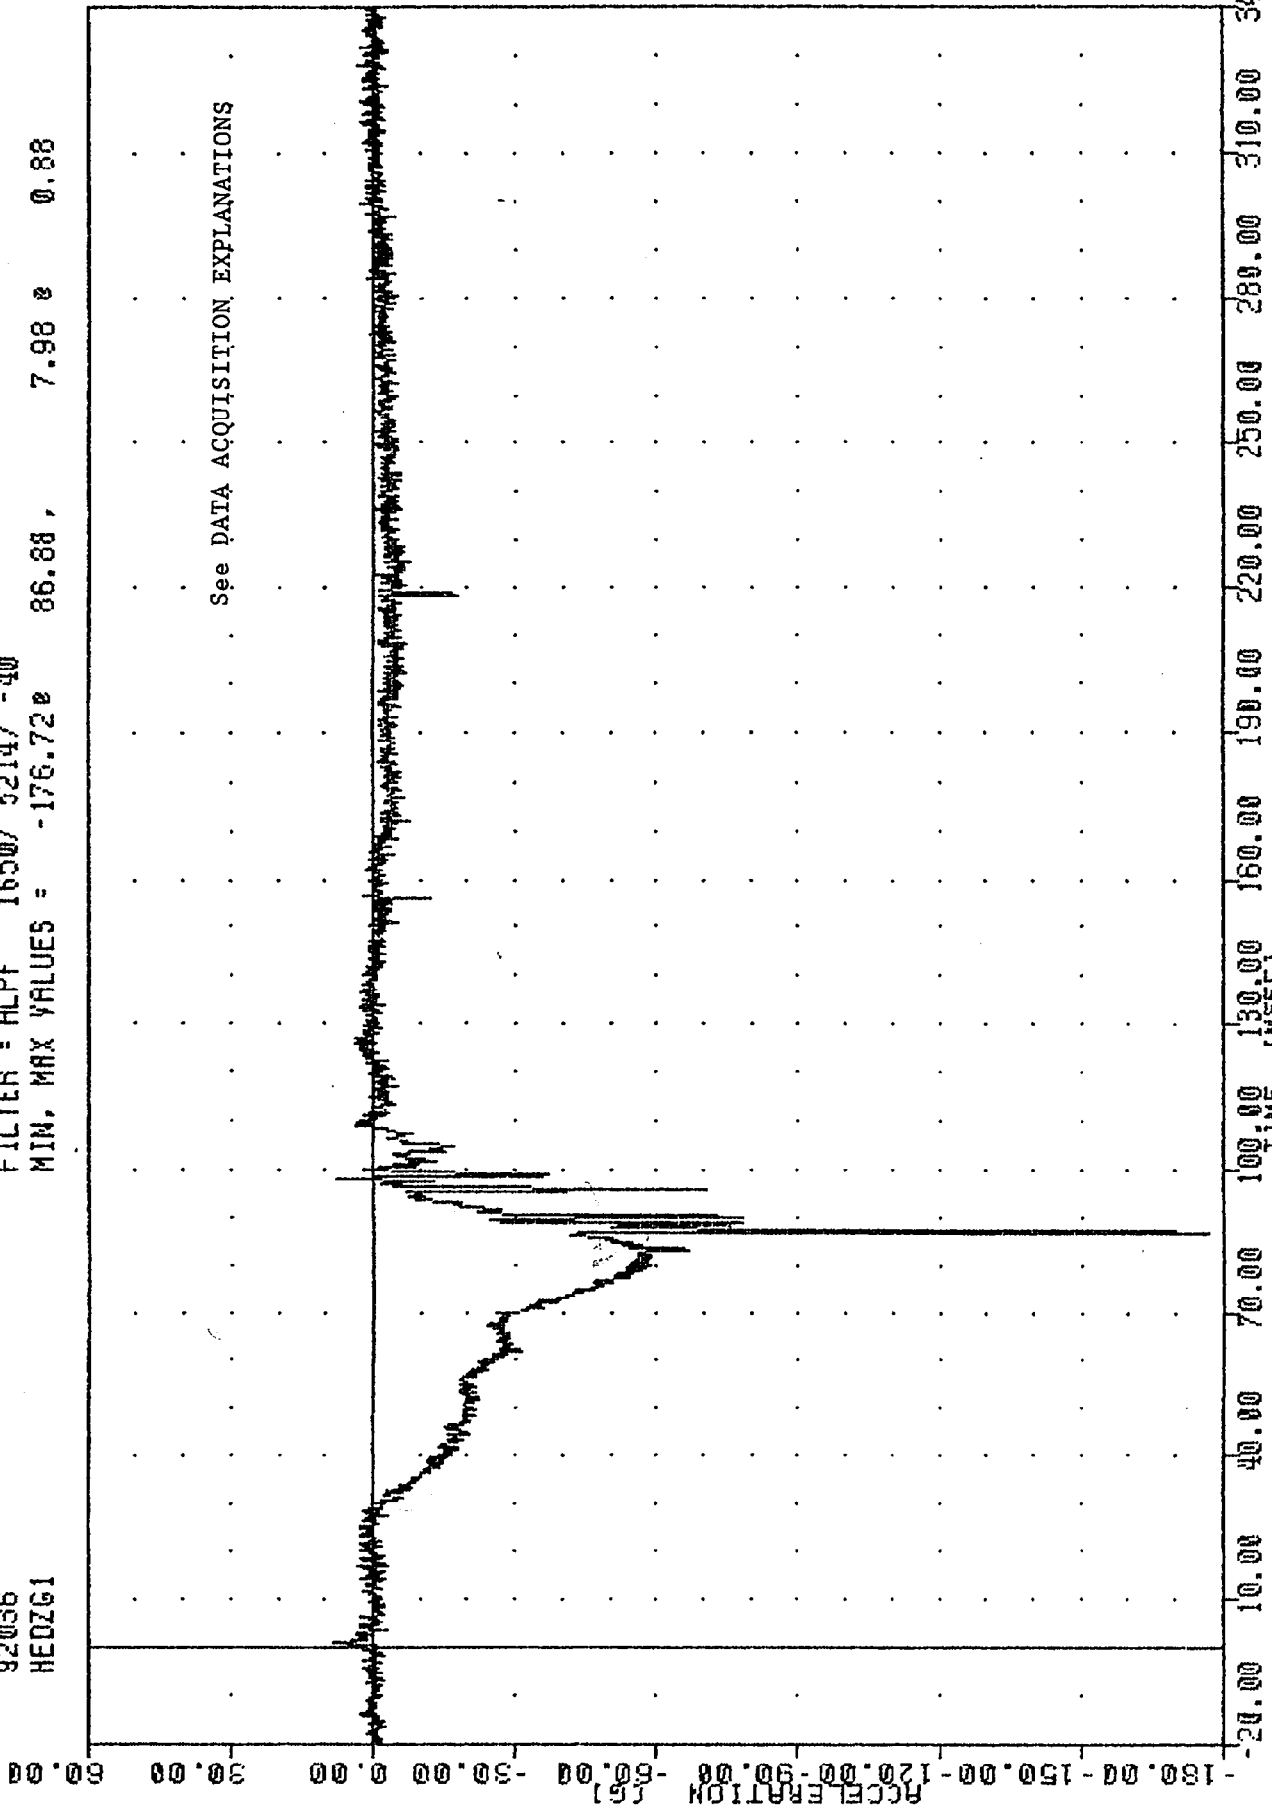
FILTER = ALPF 1650/ 5214/ -40
MIN, MAX VALUES = -176.72e 86.88 , 7.98 e 0.88

1992 FORD EXPLORER INTO FLAT FRONTAL BARRIER
DRIVER HEAD Z-AXIS ACCELERATION

HEDZG1, driver's head Z-axis acceleration, spikes at 87, 96, 99, 156,
and 219 milliseconds
