REPORT NOS. 208-TRC-92-009
212-TRC-92-009
301-TRC-92-009

VEHICLE SAFETY COMPLIANCE TESTING
FOR OCCUPANT CRASH PROTECTION,
WINDSHIELD MOUNTING, WINDSHIELD ZONE
INTRUSION, AND FUEL SYSTEM INTEGRITY

FORD MOTOR COMPANY
1992 FORD EXPLORER
SPORT UTILITY VEHICLE
NHTSA NO. CN0209
TRC TEST NO. 920205

FINAL REPORT

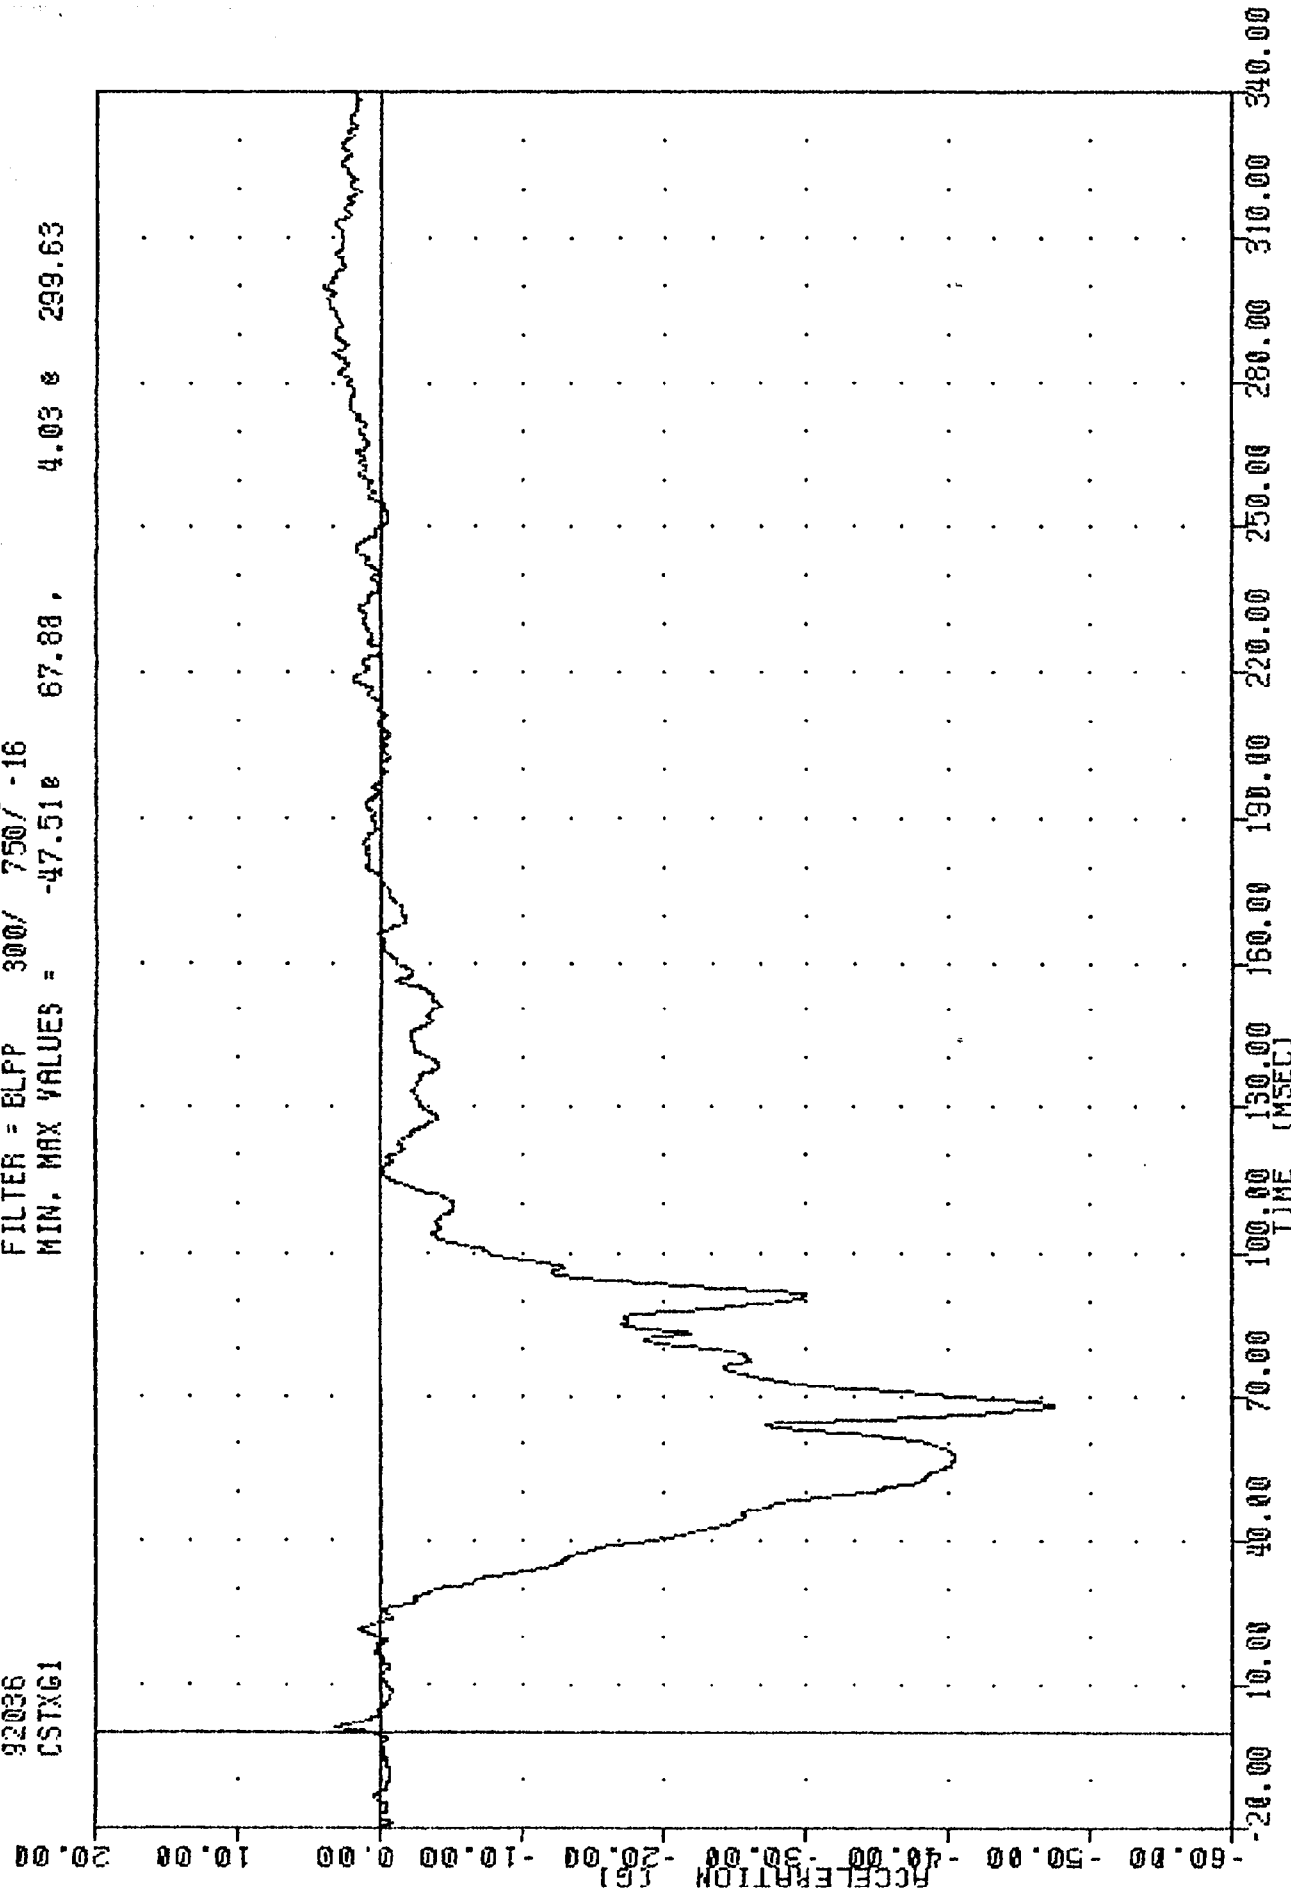
FILTER = BLPP 300/ 750/ -16
MIN. MAX VALUES = -47.51e 67.88, 4.03 e 299.63

1992 FORD EXPLORER INTO FLAT FRONTAL BARRIER
DRIVER CHEST X-AXIS ACCELERATION

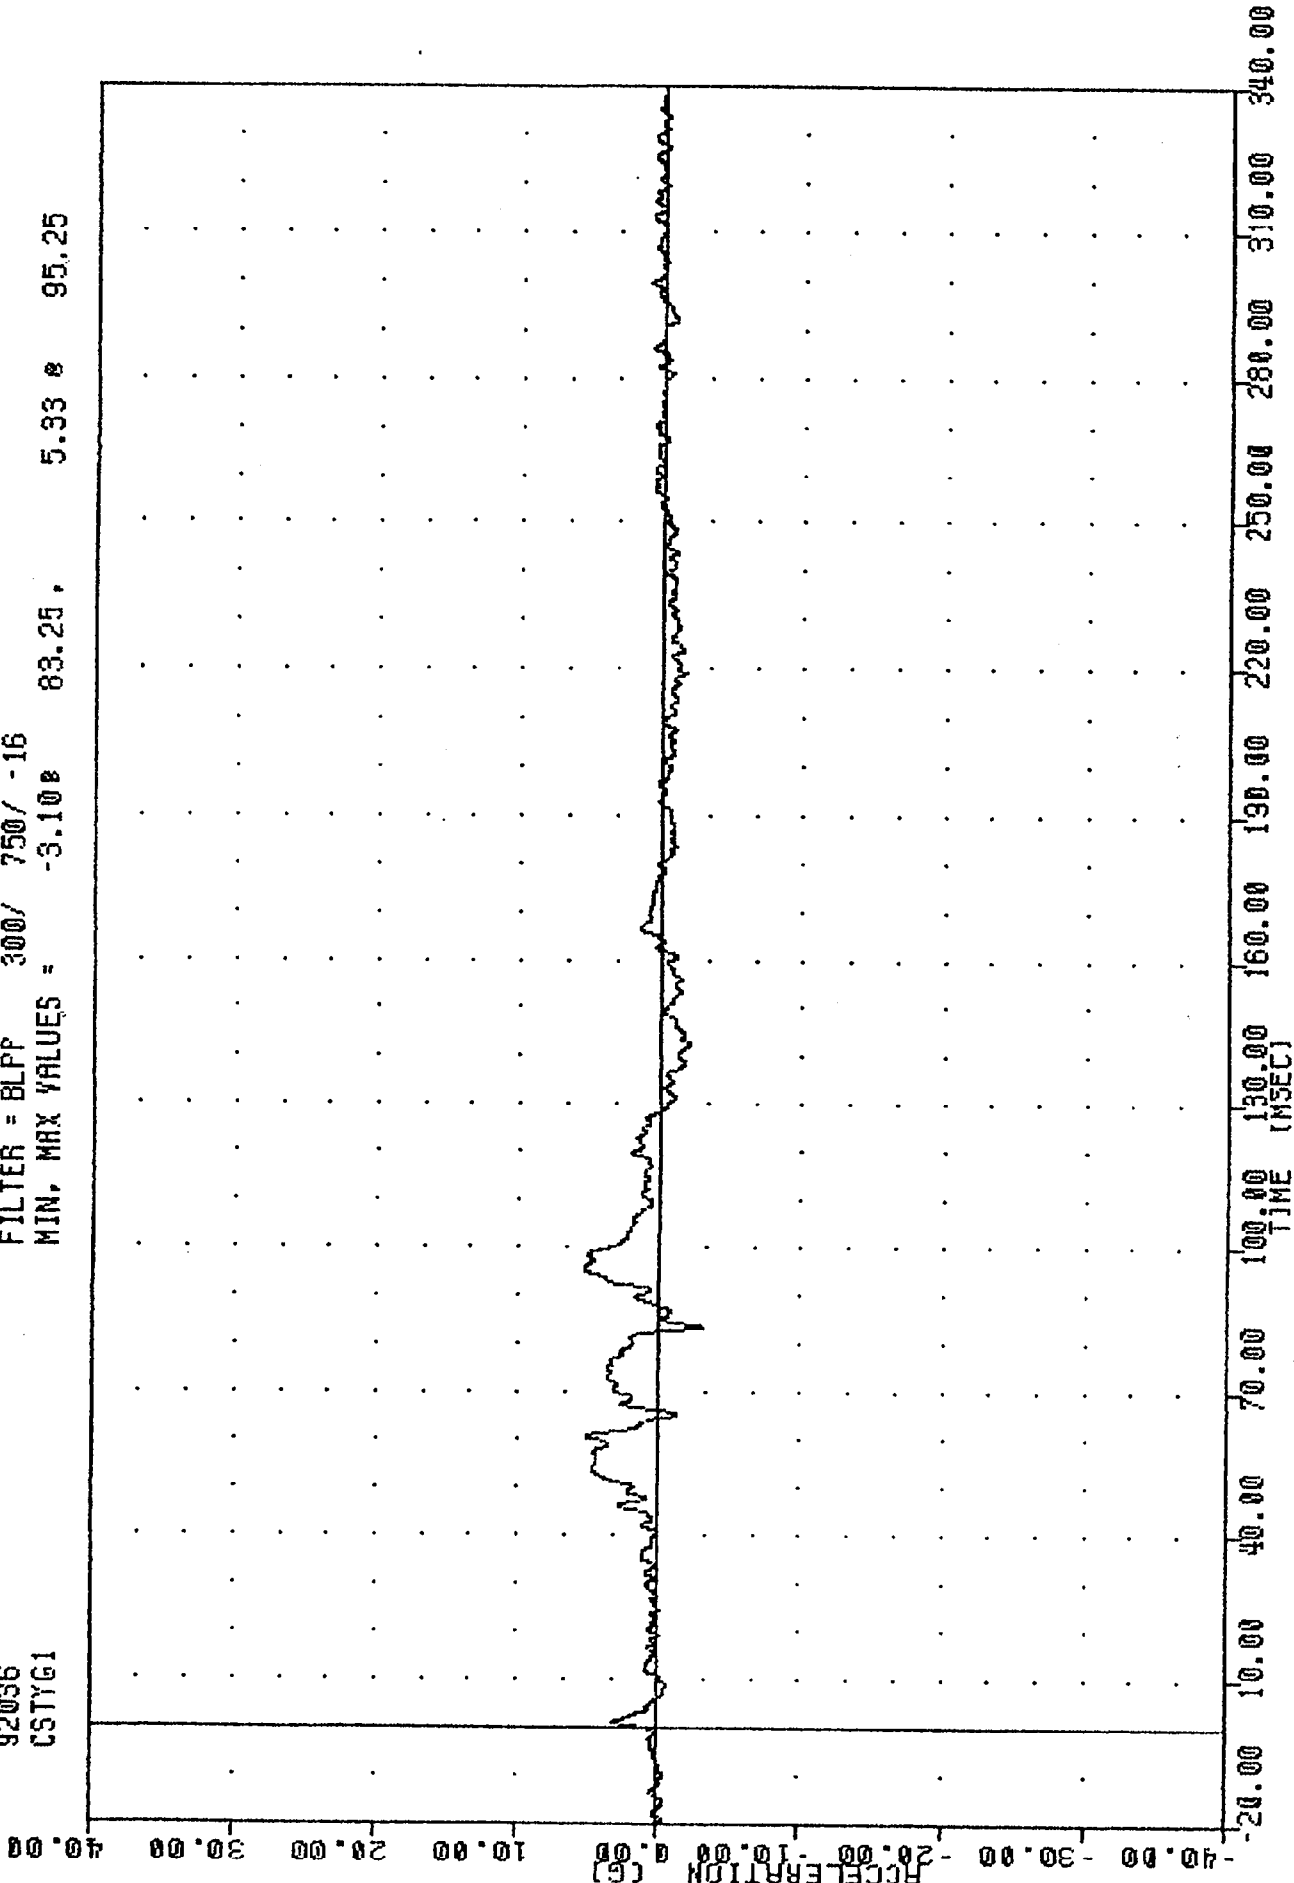
FILTER = BLPF 300/ 750/ -16
MIN, MAX VALUES = -3.108 83.25, 5.33 95.25

1992 FORD EXPLORER INTO FLAT FRONTAL BARRIER
DRIVER CHEST Y-AXIS ACCELERATION

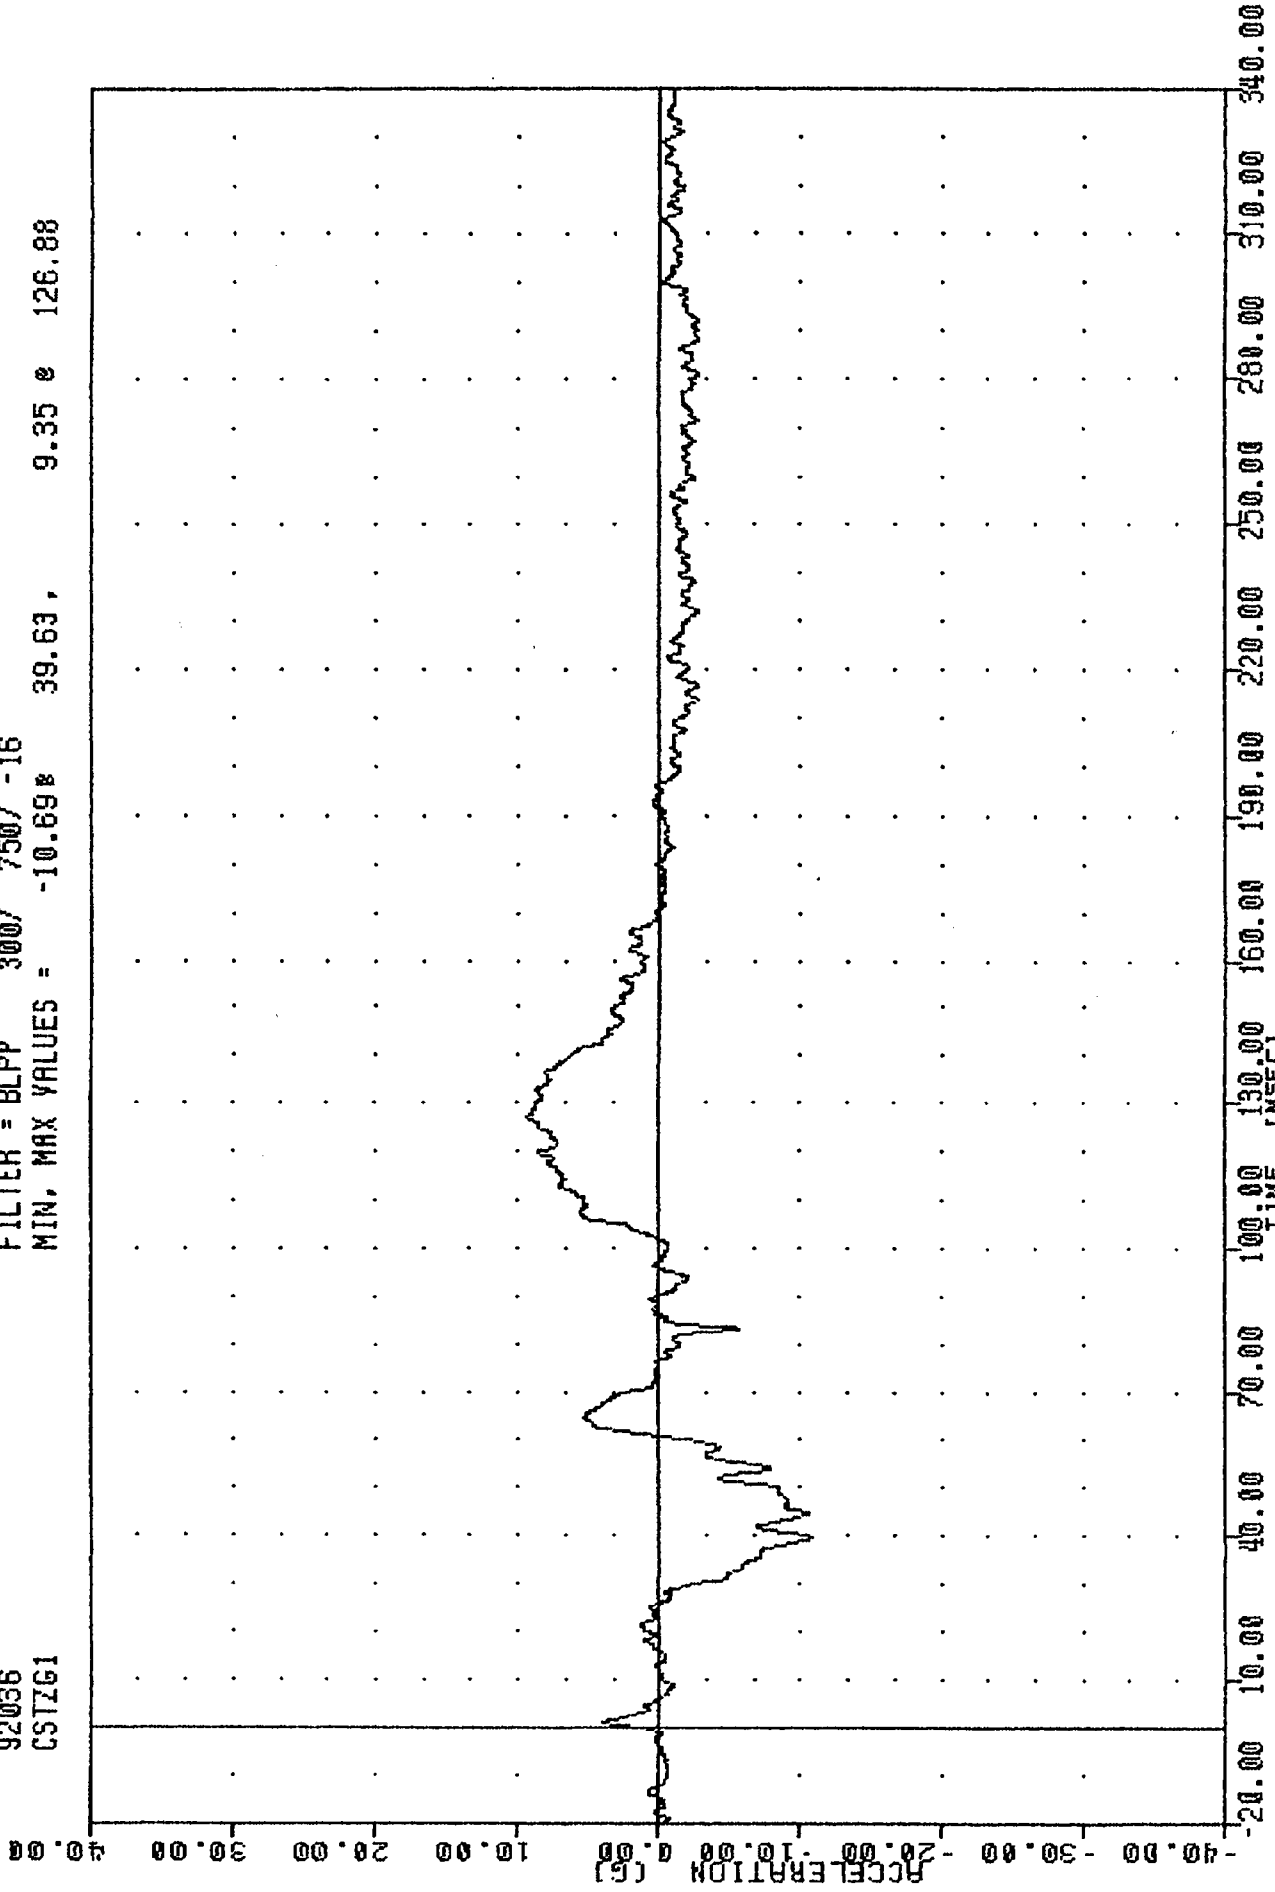
FILTER = BLPP 300/ 750/ -16
MIN, MAX VALUES = -10.69% 39.63, 9.35 e 126.88

1992 FORD EXPLORER INTO FLAT FRONTAL BARRIER
DRIVER CHEST Z-AXIS ACCELERATION

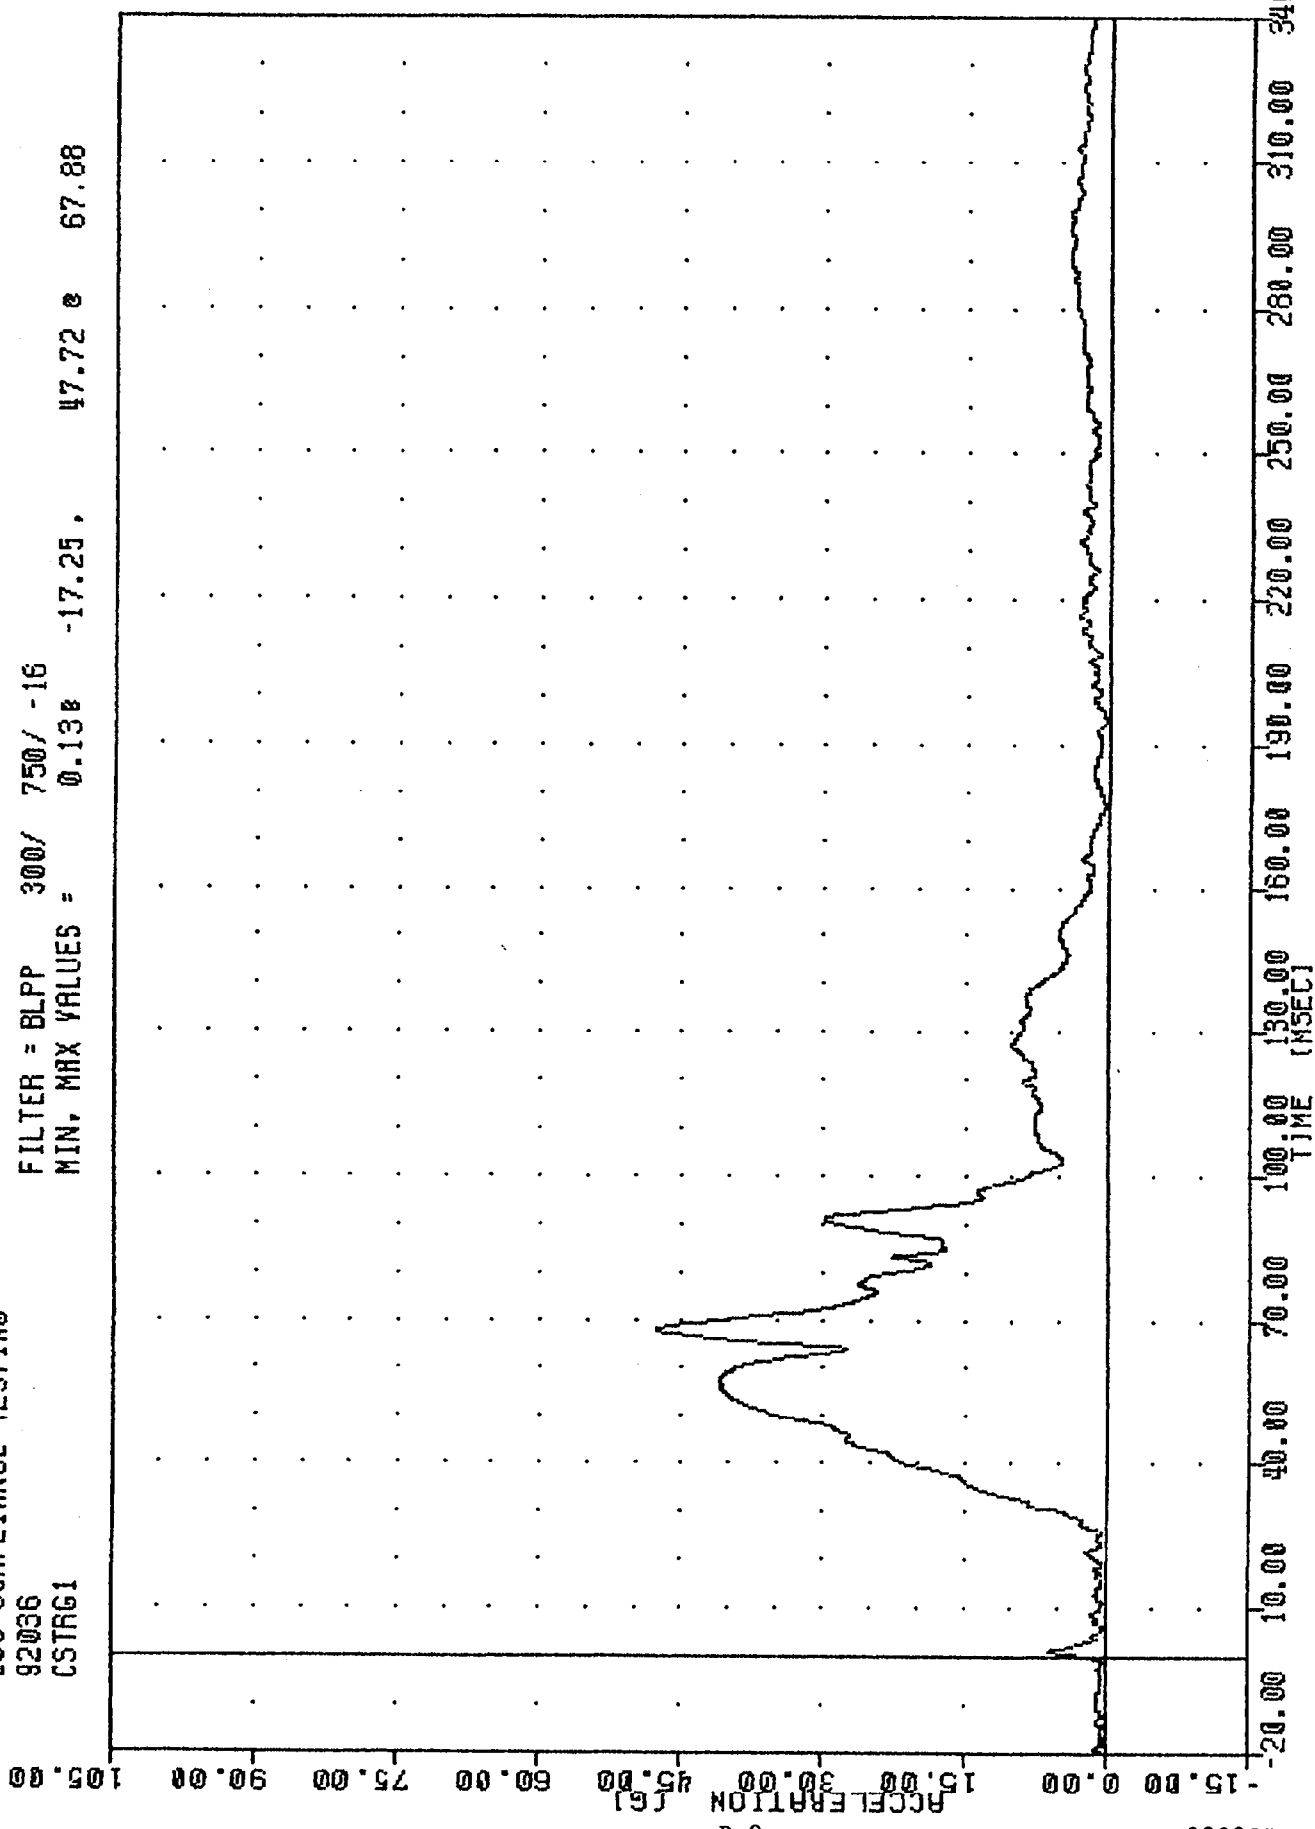
FILTER = BLPP 300/ 750/ -16
MIN, MAX VALUES = 0.138 -17.25, 47.72 e 67.88

1992 FORD EXPLORER INTO FLAT FRONTAL BARRIER
DRIVER CHEST RESULTANT ACCELERATION

The driver's head injury criteria (HIC) was 740. (See DATA ACQUISITION EXPLANATIONS.) The driver's chest maximum resultant acceleration with three (3) milliseconds minimum duration was 43.1 g. The driver's left and right femur maximum axial forces were 620 pounds and 427 pounds, respectively.

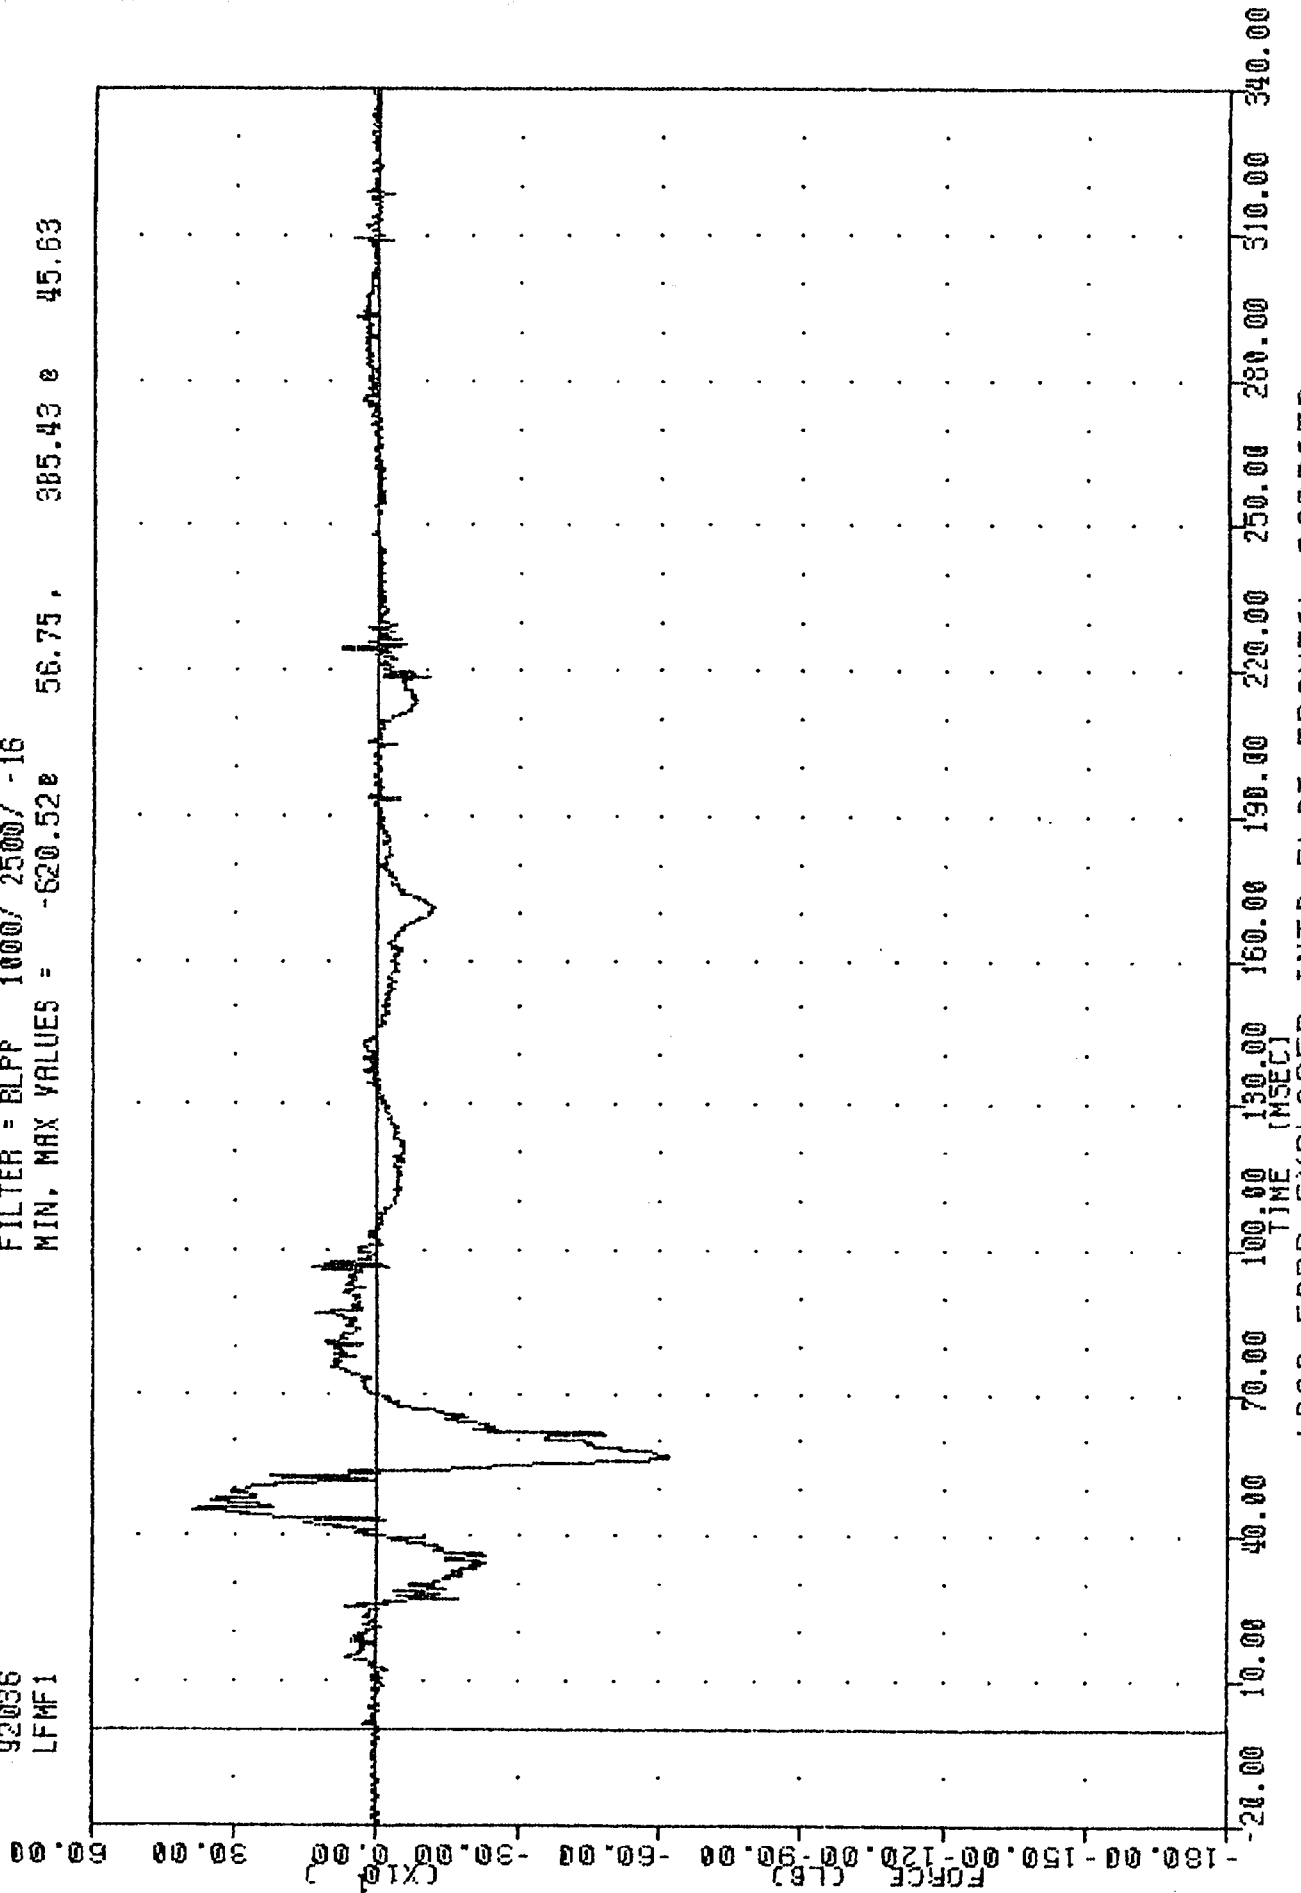
FILTER = BLPP 1000/ 2500/ -16
MIN. MAX VALUES = -620.52e 385.43 e 45.63

1992 FORD EXPLORER INTO FLAT FRONTAL BARRIER
DRIVER LEFT FEMUR FORCE

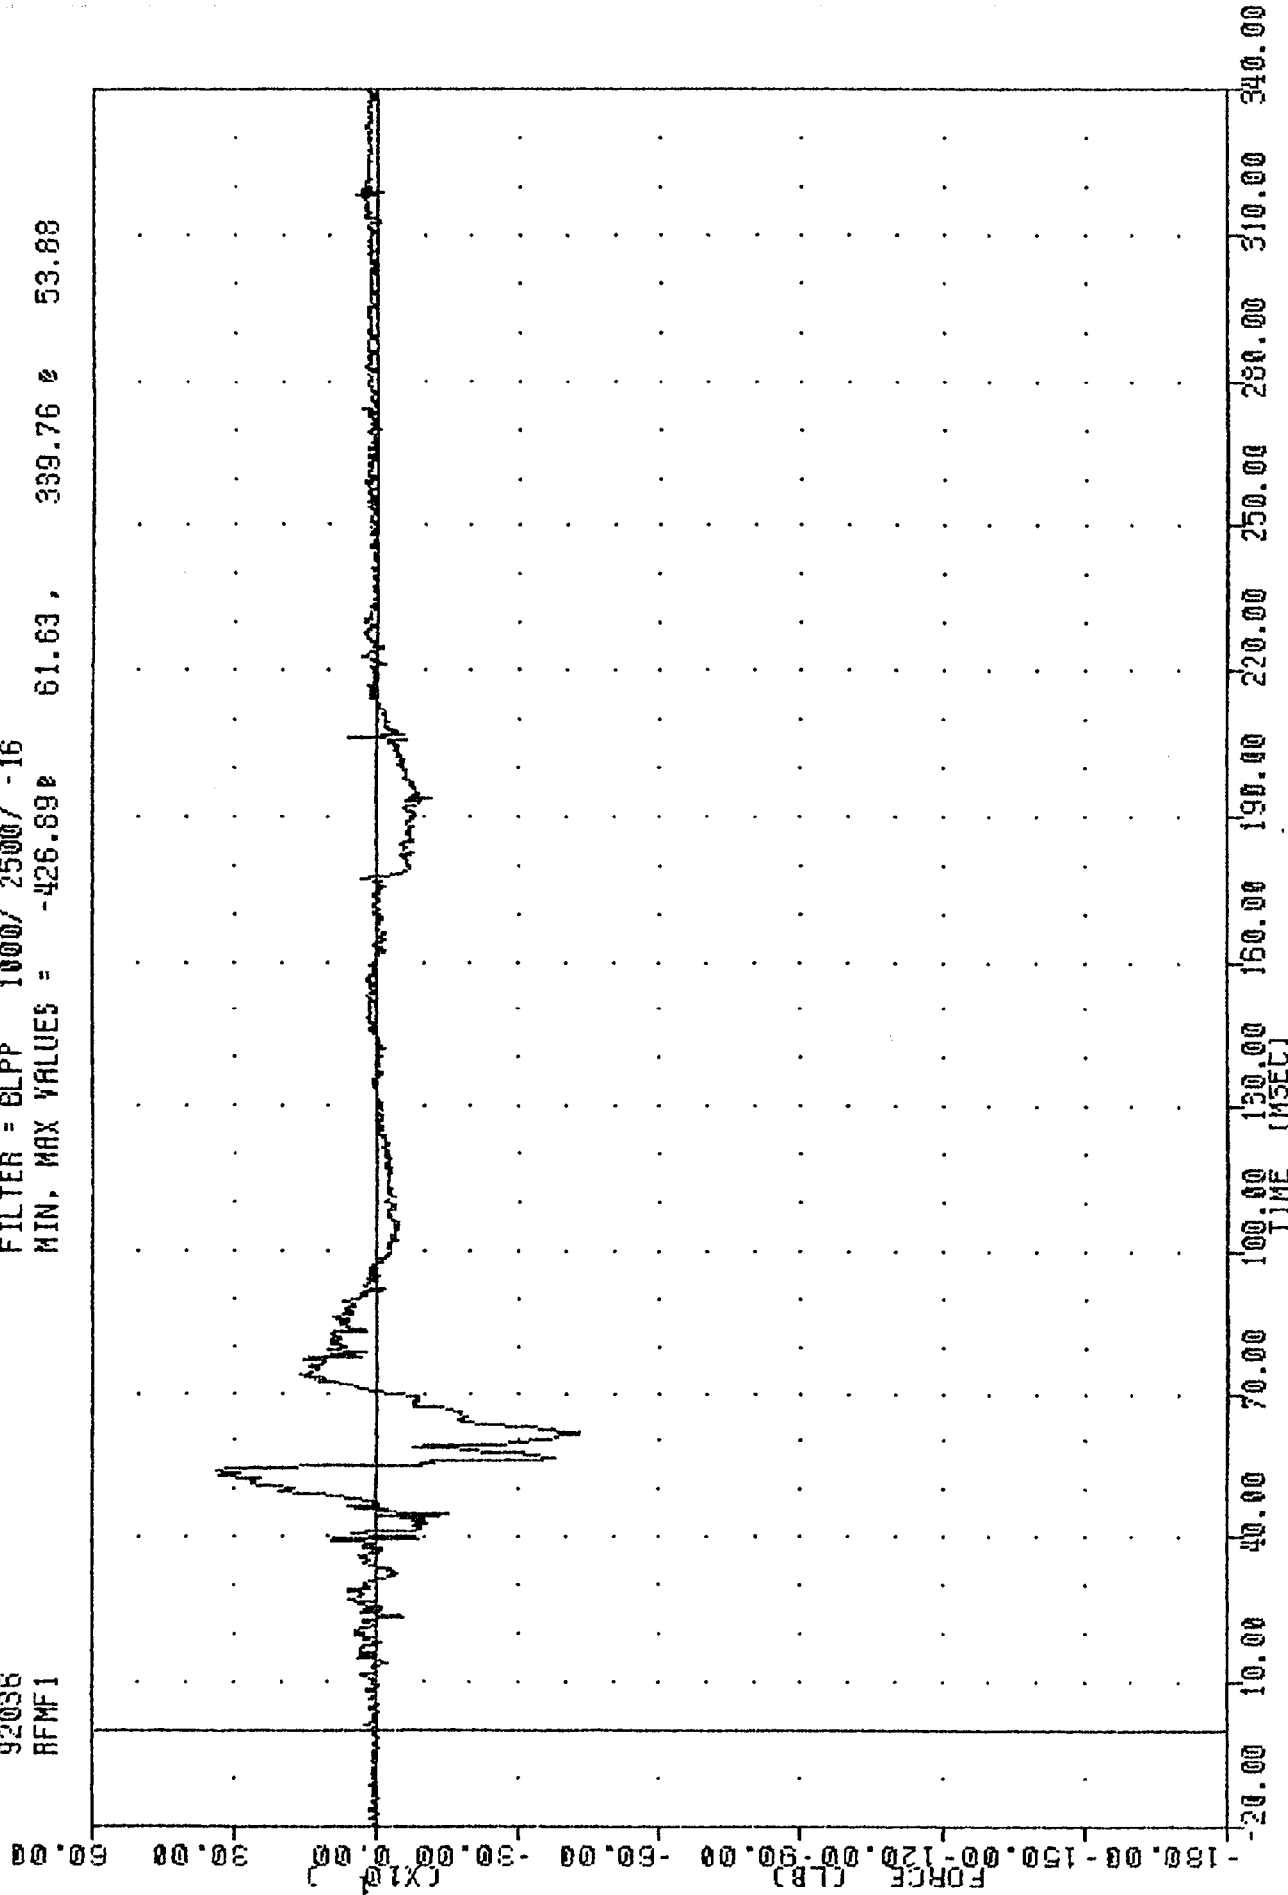
FILTER = 6LPP 1000/ 2500/ -16
MIN, MAX VALUES = -426.89e 61.63, 339.76 e 53.88

1992 FORD EXPLORER INTO FLAT FRONTAL BARRIER
DRIVER RIGHT FEMUR FORCE

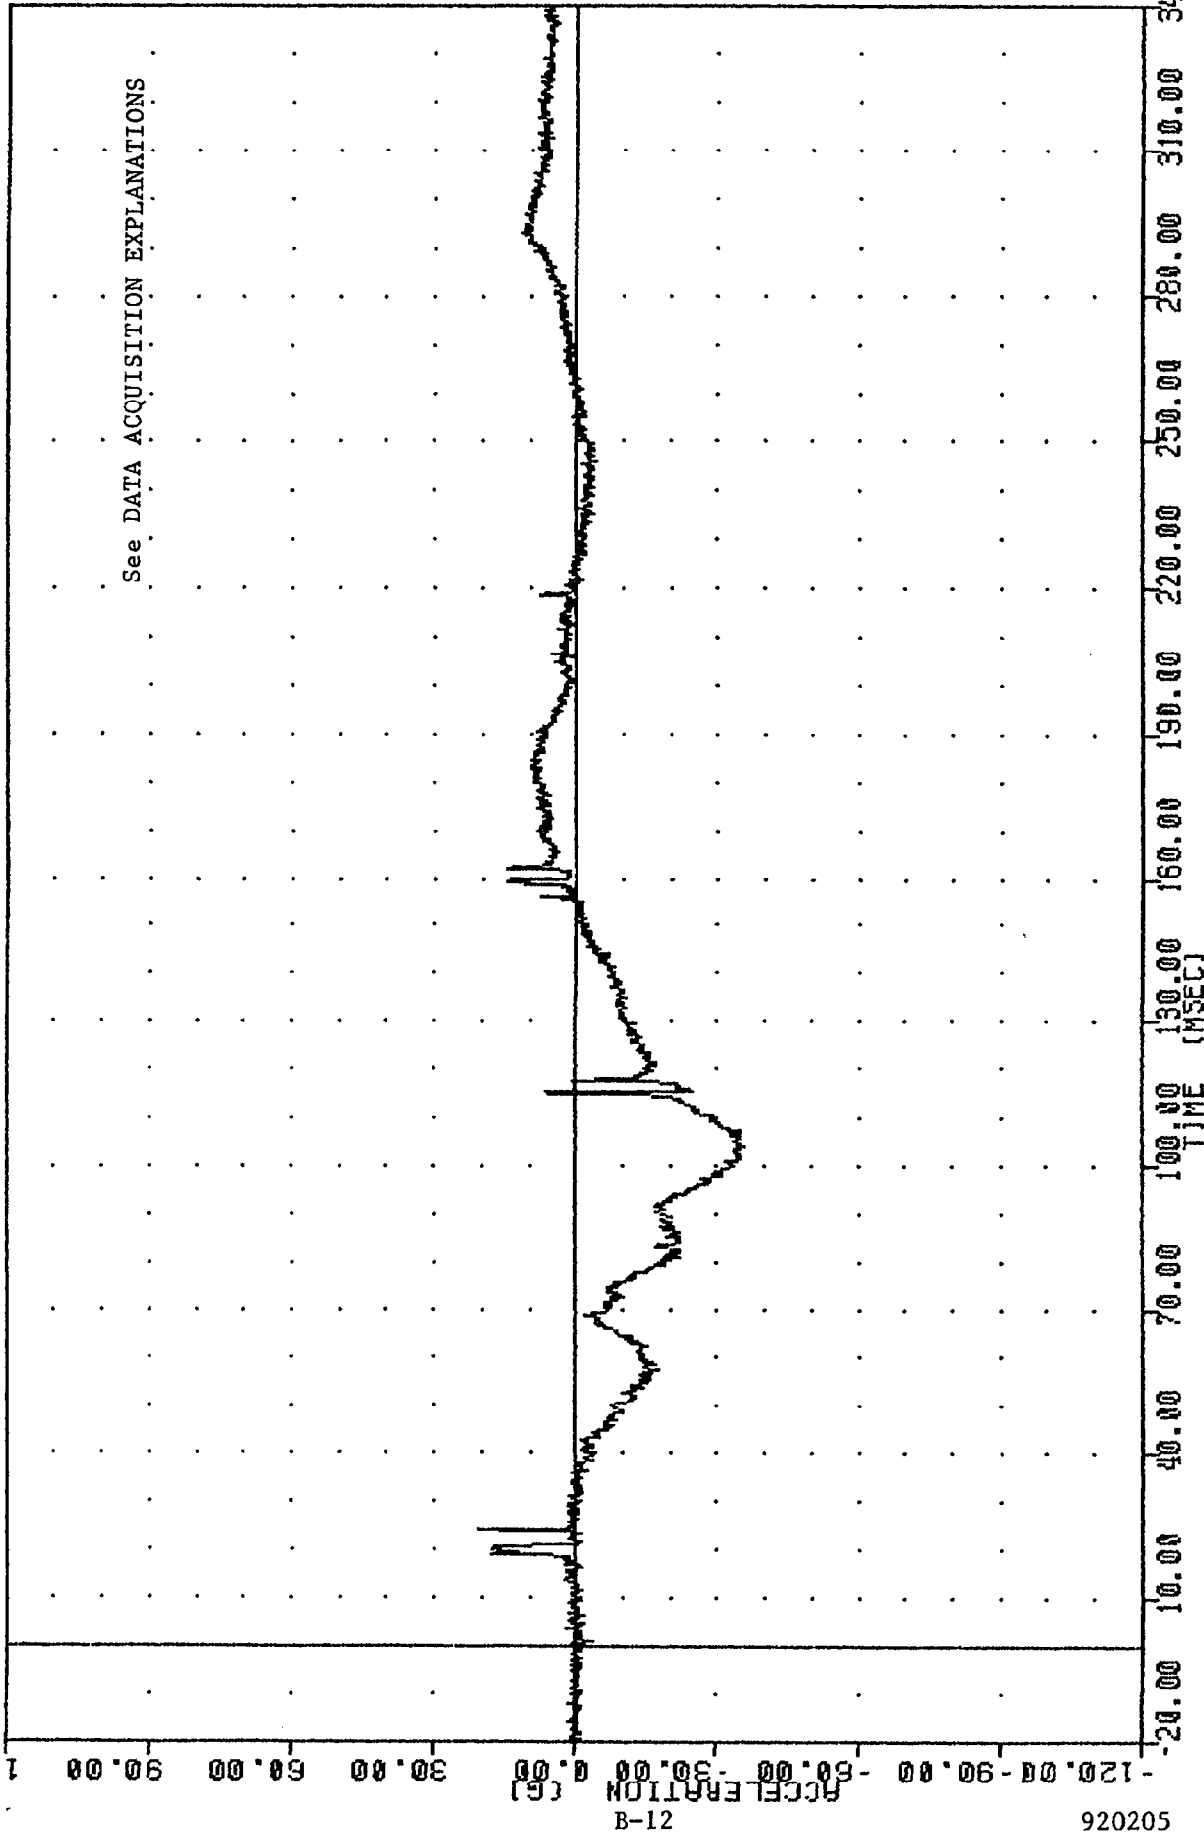
B-12

TRC , 920205
200 COMPLIANCE TESTING
92036
HEDXG2

FILTER = ALPF 1650/ 5214/ -40
MIN. MAX VALUES = -35.38e 104.25, 20.30 e 24.13

See DATA ACQUISITION EXPLANATIONS

HEDXG2, right front passenger's head X-axis acceleration, spikes at 20,
115, and 160 milliseconds

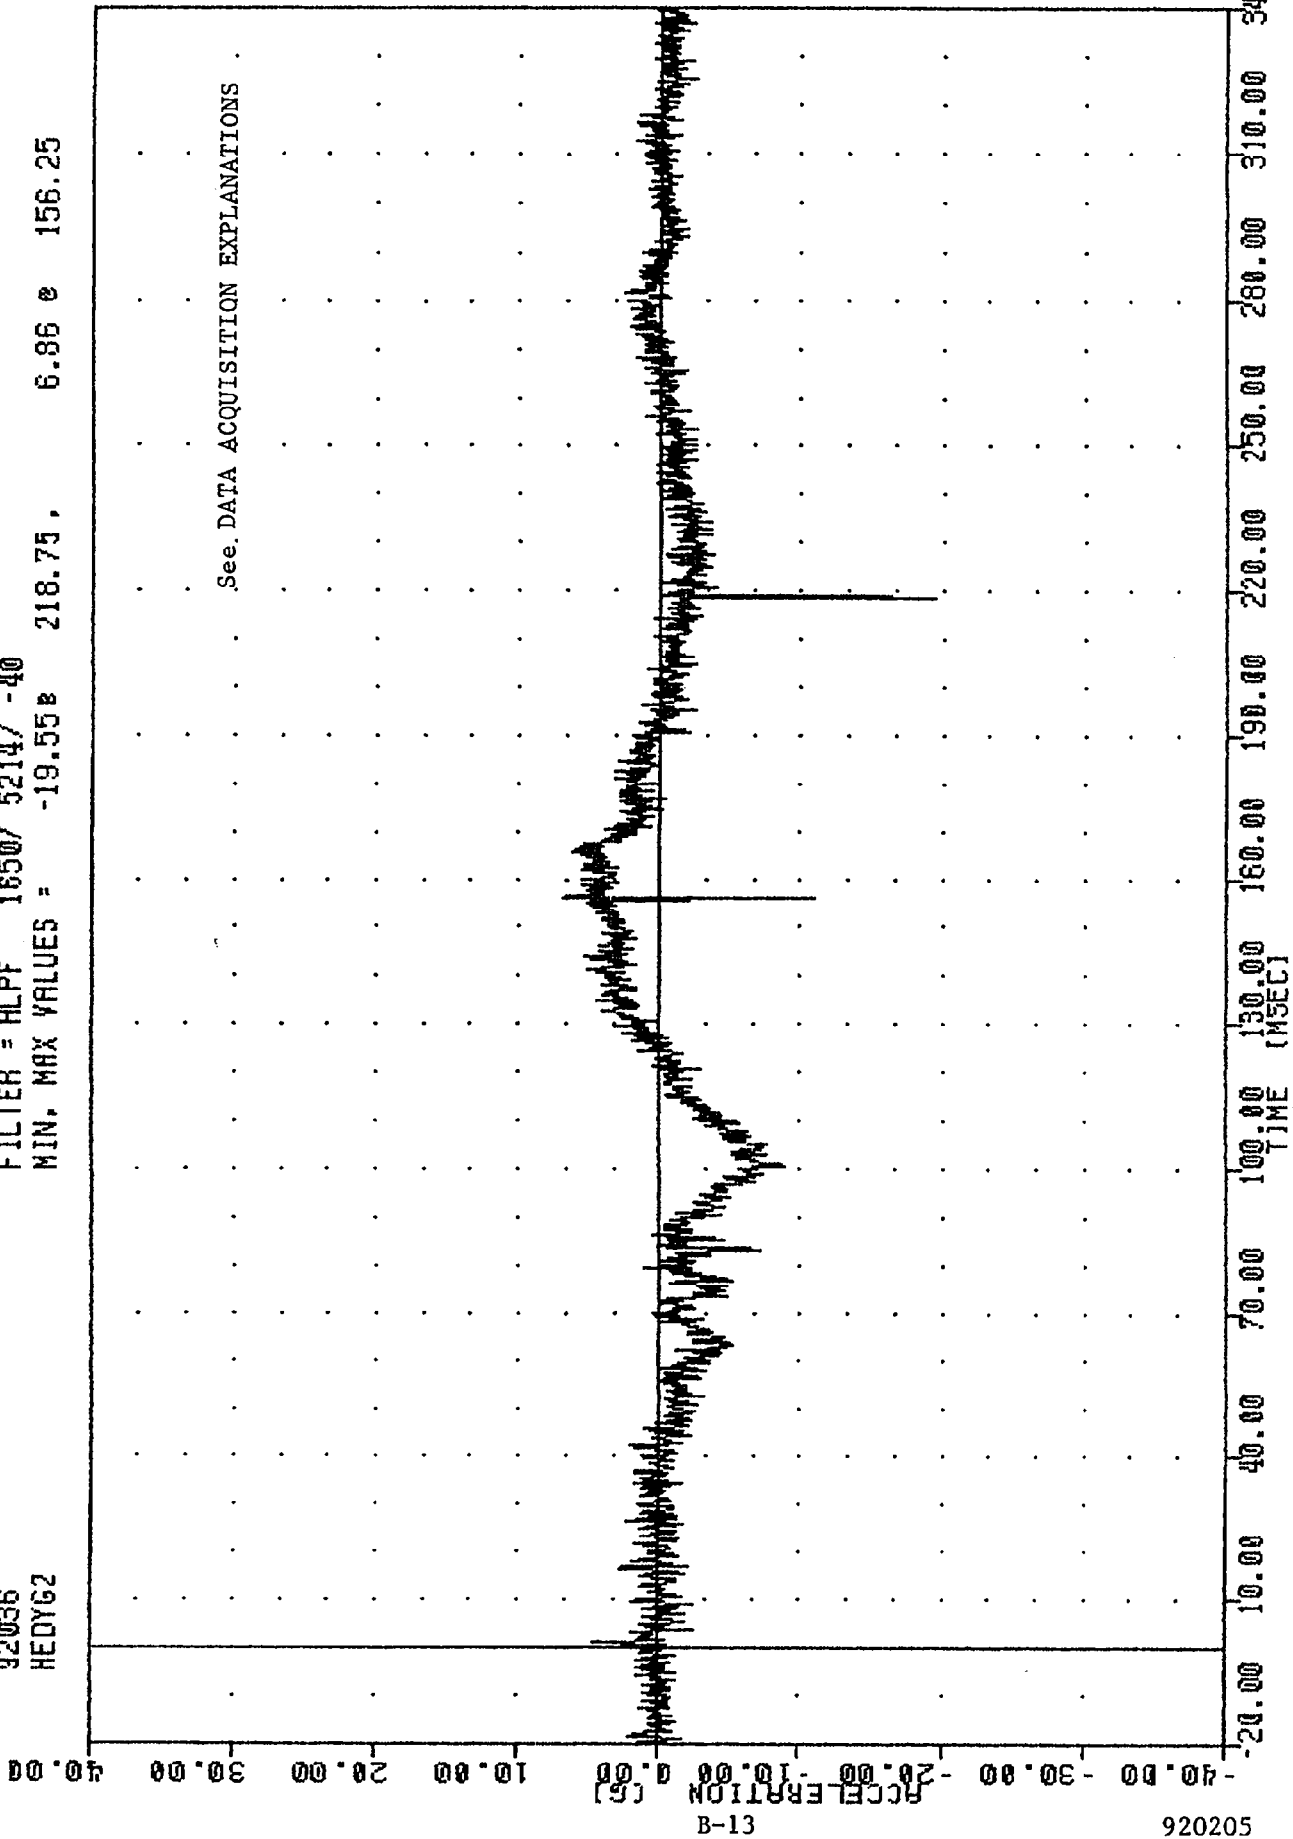
B-13

TRC 920205
208 COMPLIANCE TESTING
92036
HEDYG2

FILTER = ALPF 1650/ 5214/ -40
MIN. MAX VALUES = -19.55e 218.75 . 6.86 e 156.25

HEDYG2, right front passenger's head Y-axis acceleration, spikes at 156
and 219 milliseconds

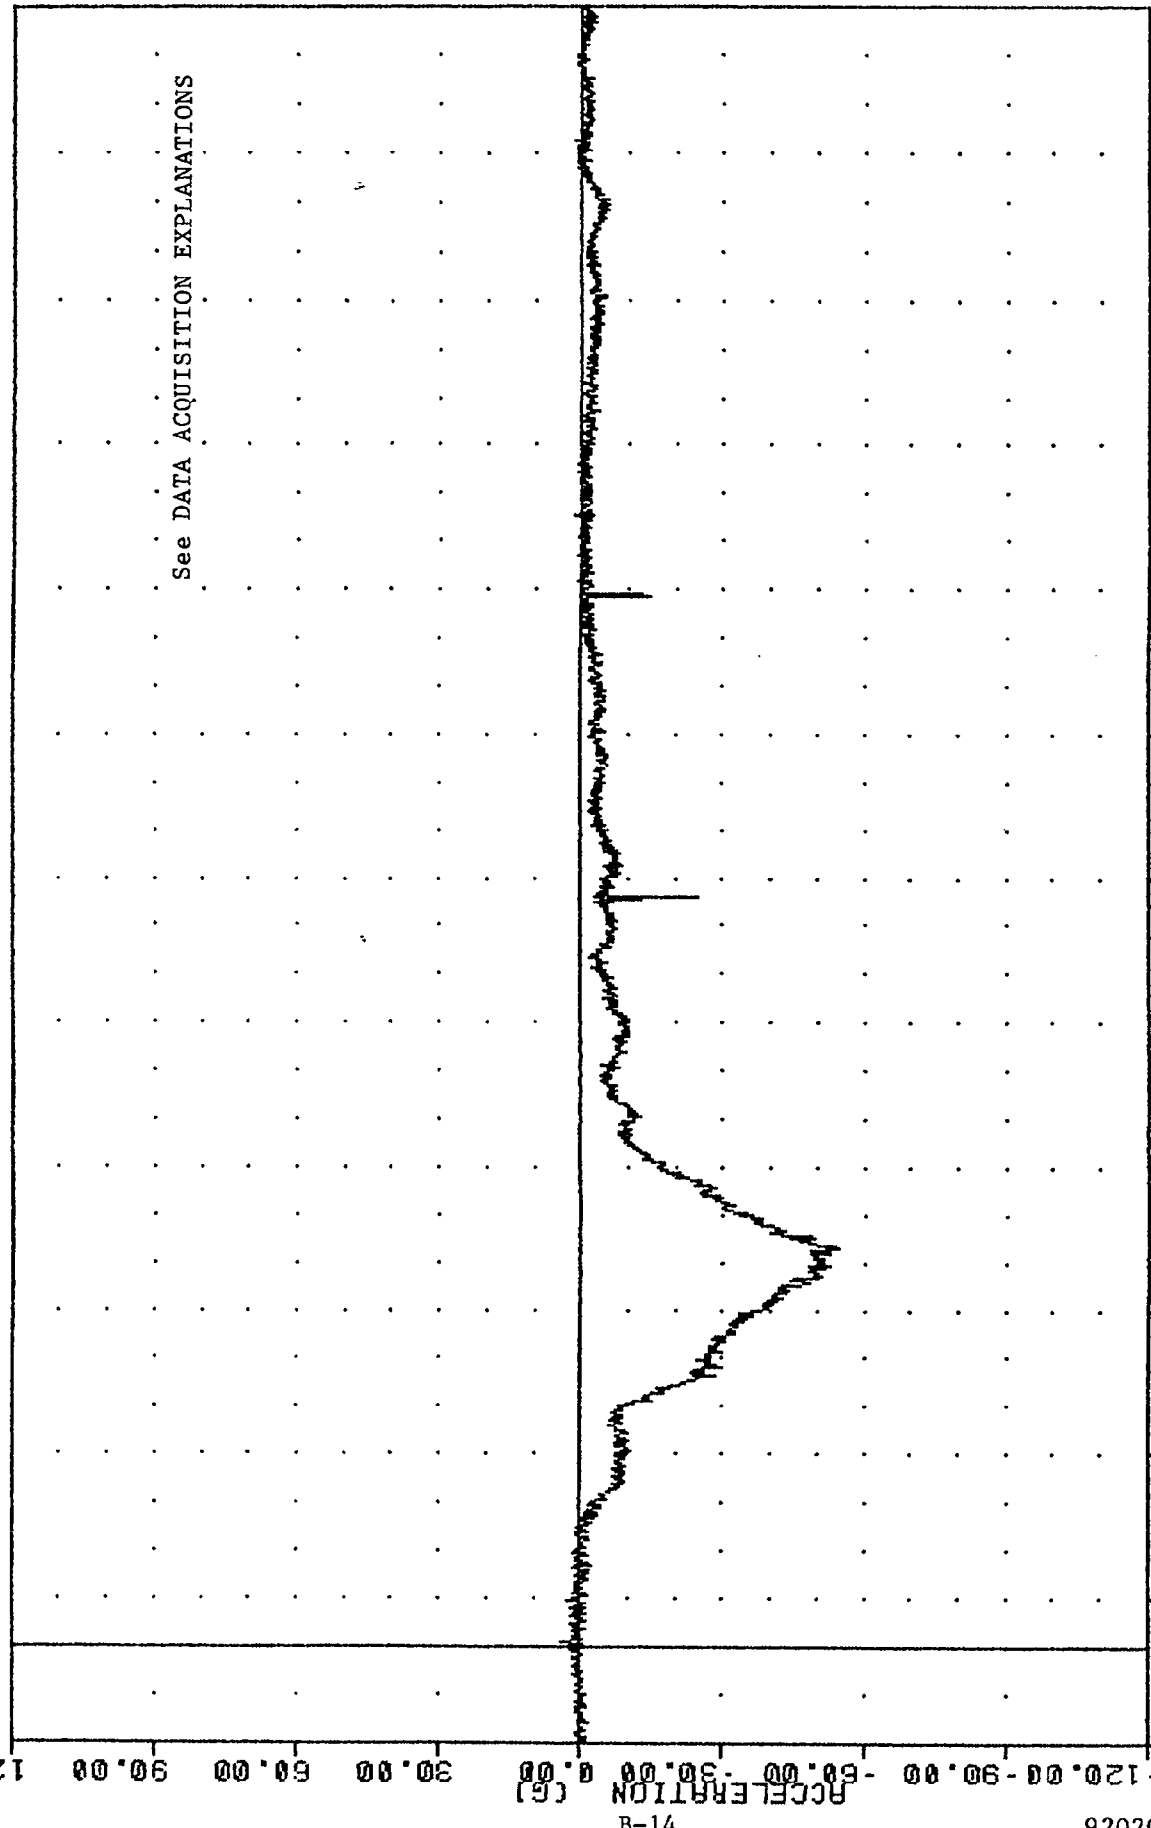
FILTER = ALPF 1650/ 5214/ -40
MIN. MAX VALUES = -54.76e 82.88, 4.29 e 0.88

See DATA ACQUISITION EXPLANATIONS

1992 FORD EXPLORER INTO FLAT FRONTAL BARRIER
RIGHT FRONT PASSENGER HEAD Z-AXIS ACCELERATION

HEDZG2, right front passenger's head Z-axis acceleration, spikes at 156
and 219 milliseconds
