REPORT NOS. 208-TRC-92-009
212-TRC-92-009
301-TRC-92-009

VEHICLE SAFETY COMPLIANCE TESTING
FOR OCCUPANT CRASH PROTECTION,
WINDSHIELD MOUNTING, WINDSHIELD ZONE
INTRUSION, AND FUEL SYSTEM INTEGRITY

FORD MOTOR COMPANY
1992 FORD EXPLORER
SPORT UTILITY VEHICLE
NHTSA NO. CN0209
TRC TEST NO. 920205

FINAL REPORT

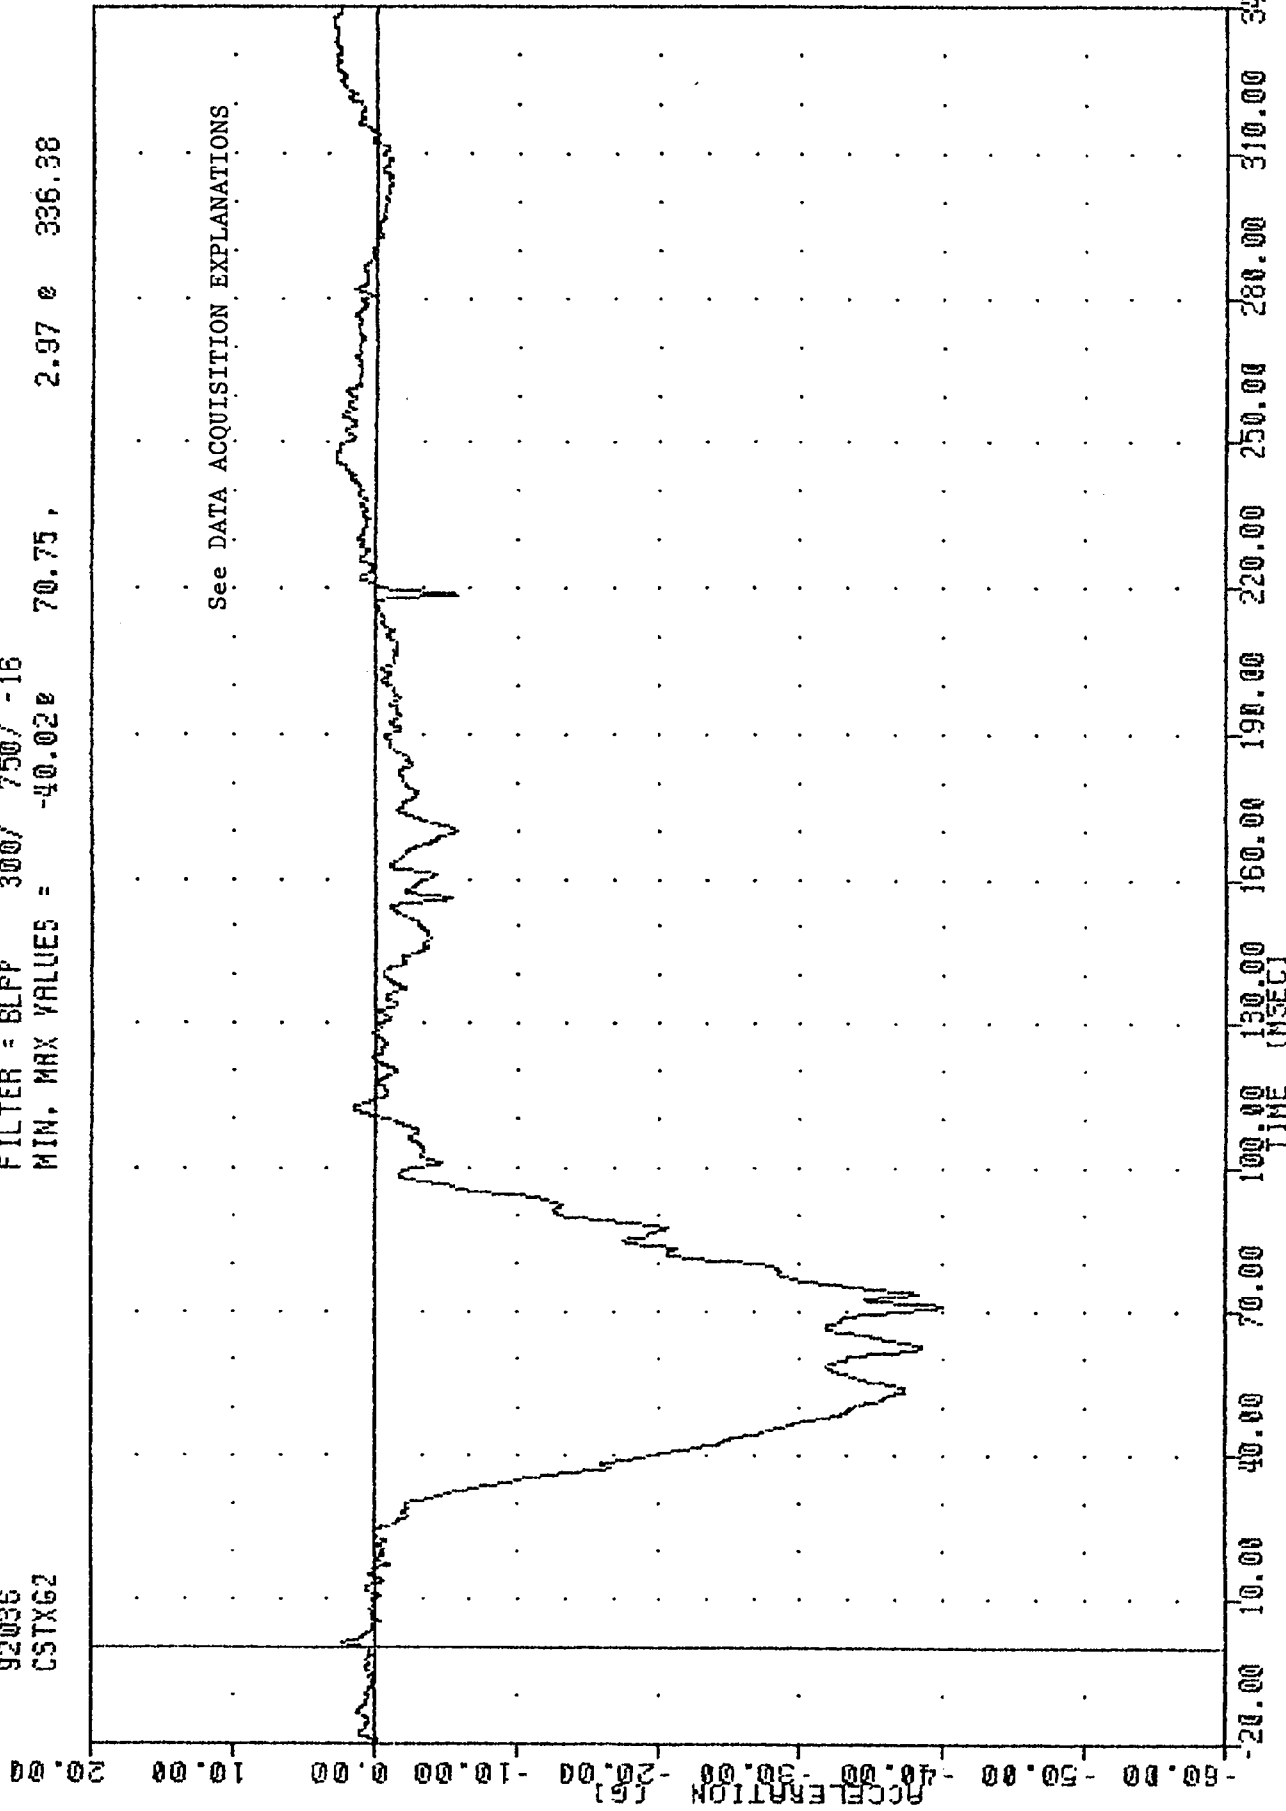
FILTER = BLPP 300/ 750/ -16
MIN. MAX VALUES = -40.02e 70.75 , 2.97 e 336.38

1992 FORD EXPLORER INTO FLAT FRONTAL BARRIER
RIGHT FRONT PASSENGER CHEST X-AXIS ACCELERATION

CSTXG2, right front passenger's chest X-axis acceleration, spikes at
156 and 219 milliseconds

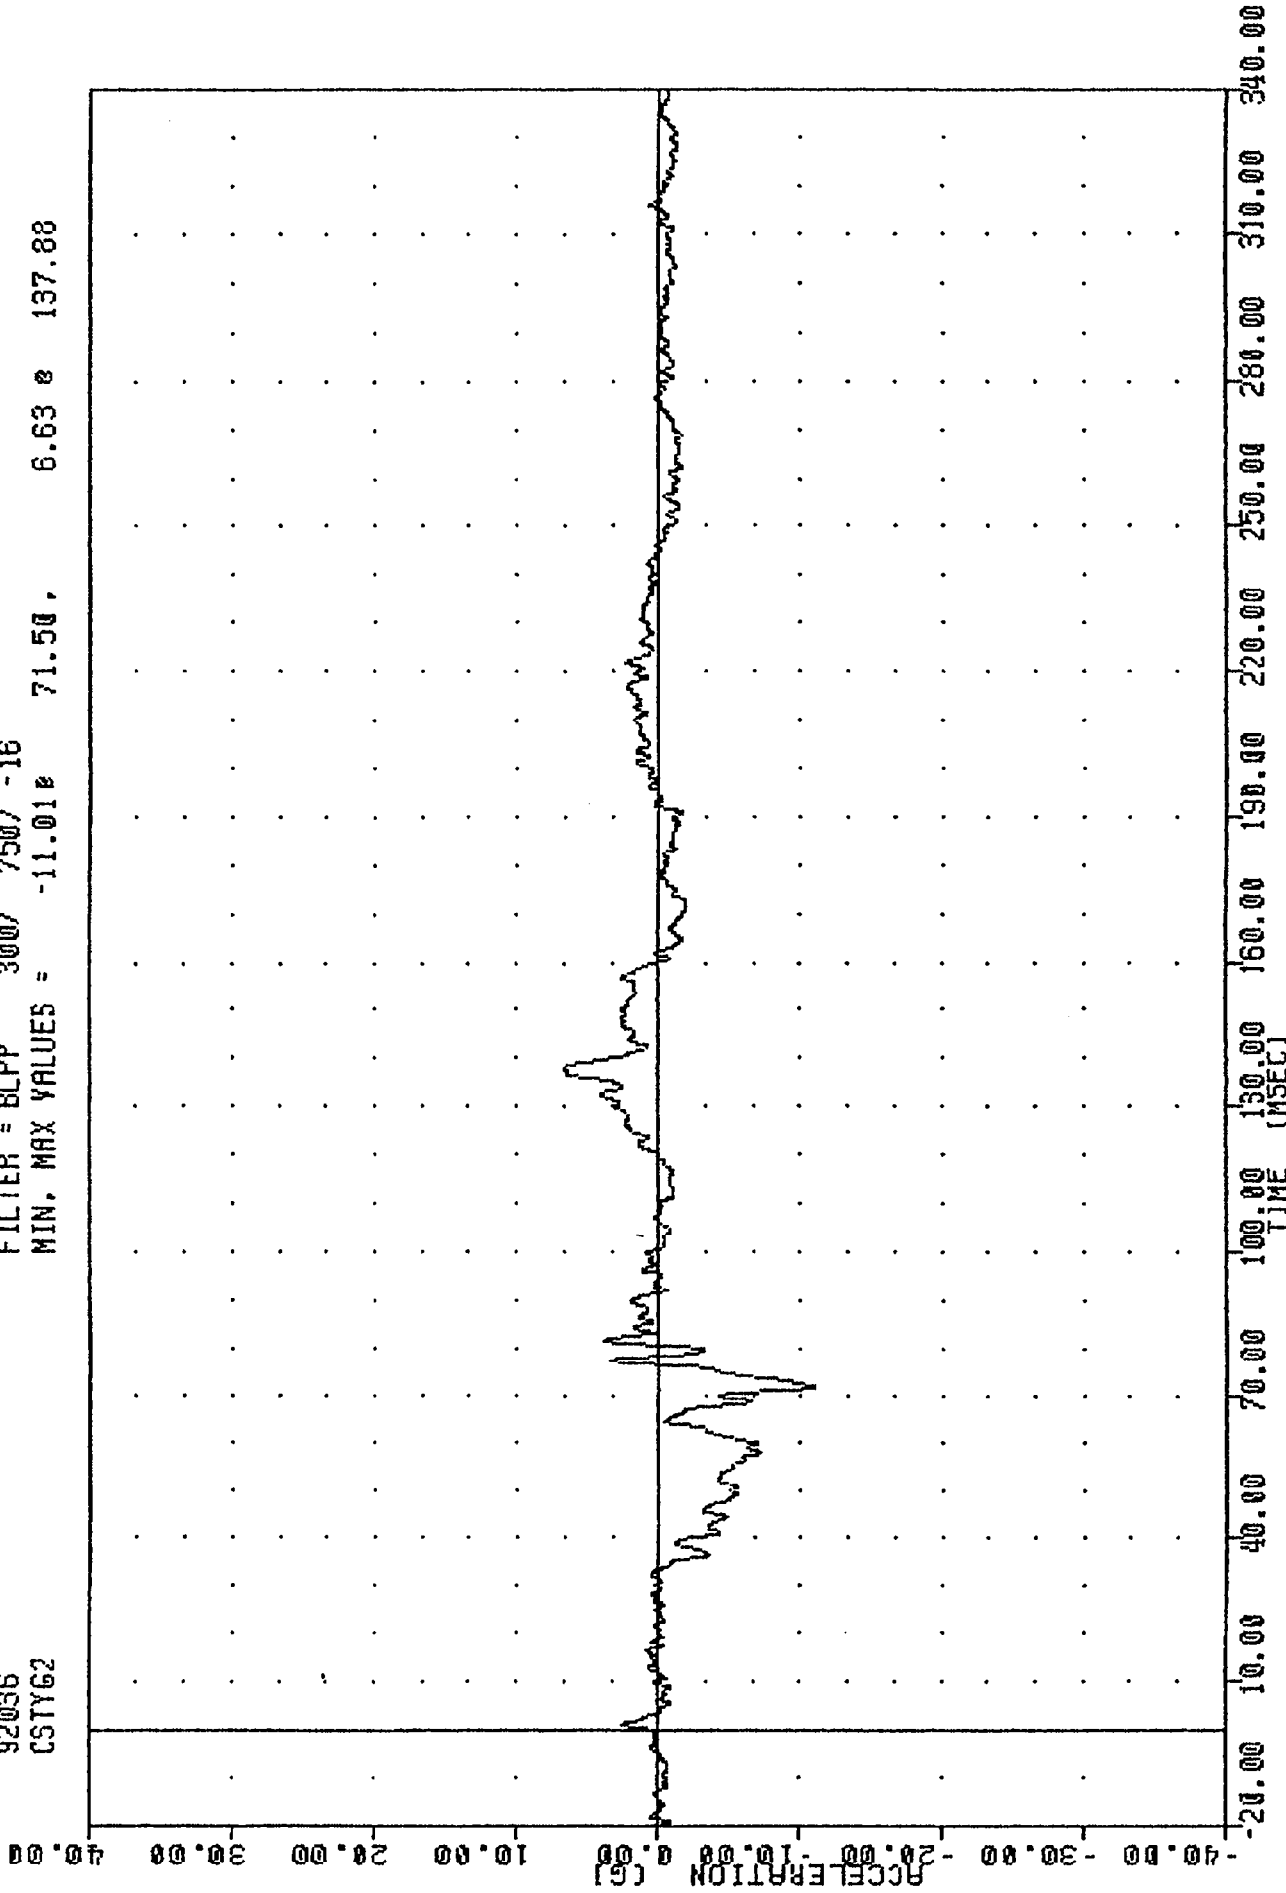
FILTER = BLPP 300/ 750/ -16
MIN. MAX VALUES = -11.01e 71.50, 6.63 e 137.88

1992 FORD EXPLORER INTO FLAT FRONTAL BARRIER
RIGHT FRONT PASSENGER CHEST Y-AXIS ACCELERATION

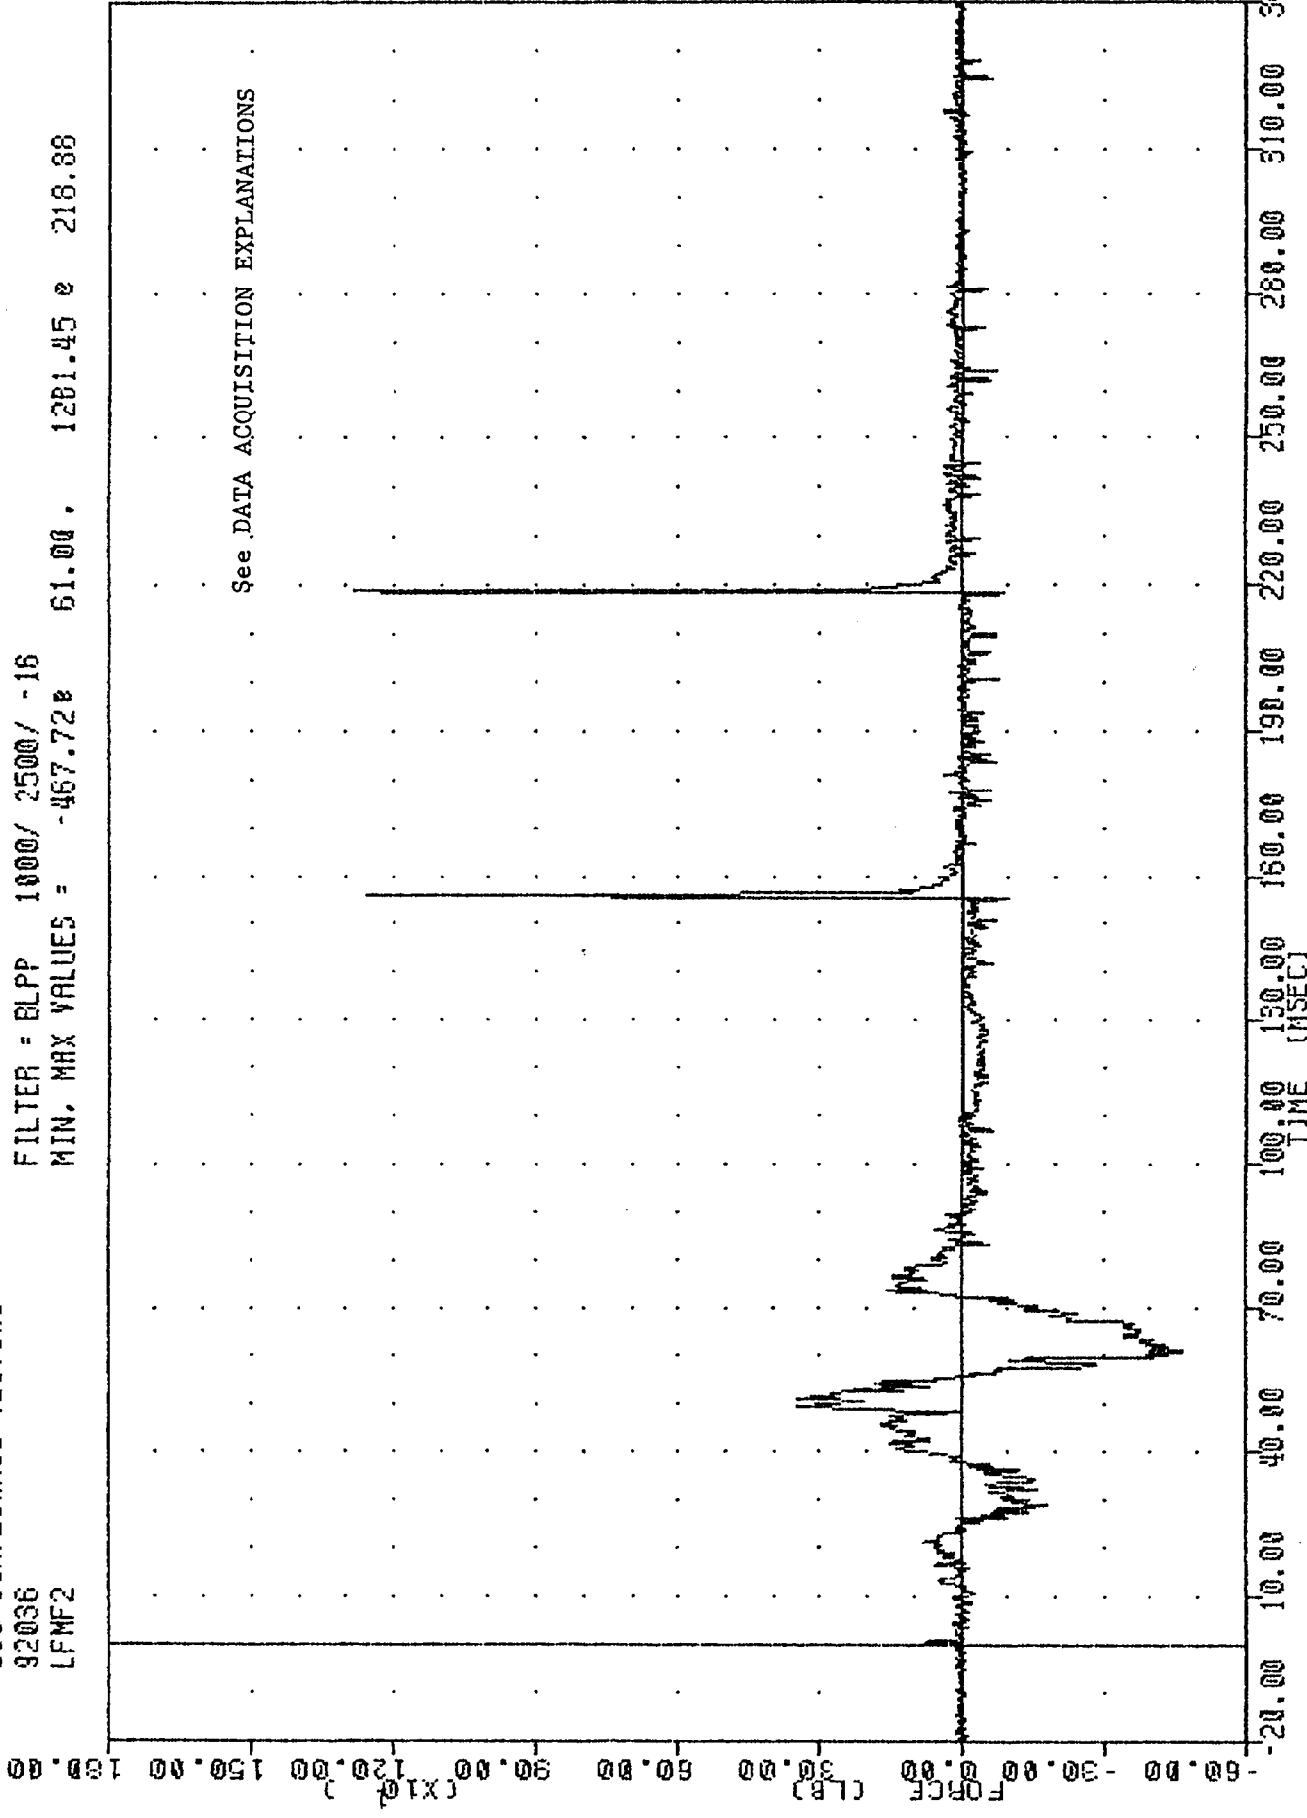
FILTER = BLPP 1000/ 2500/ -16
MIN. MAX VALUES = -467.72 e 1281.45 e 218.88

1992 FORD EXPLORER INTO FLAT FRONTAL BARRIER
RIGHT FRONT PASSENGER LEFT FEMUR FORCE

LFMF2, right front passenger's left femur force, spikes at 156 and 219
milliseconds

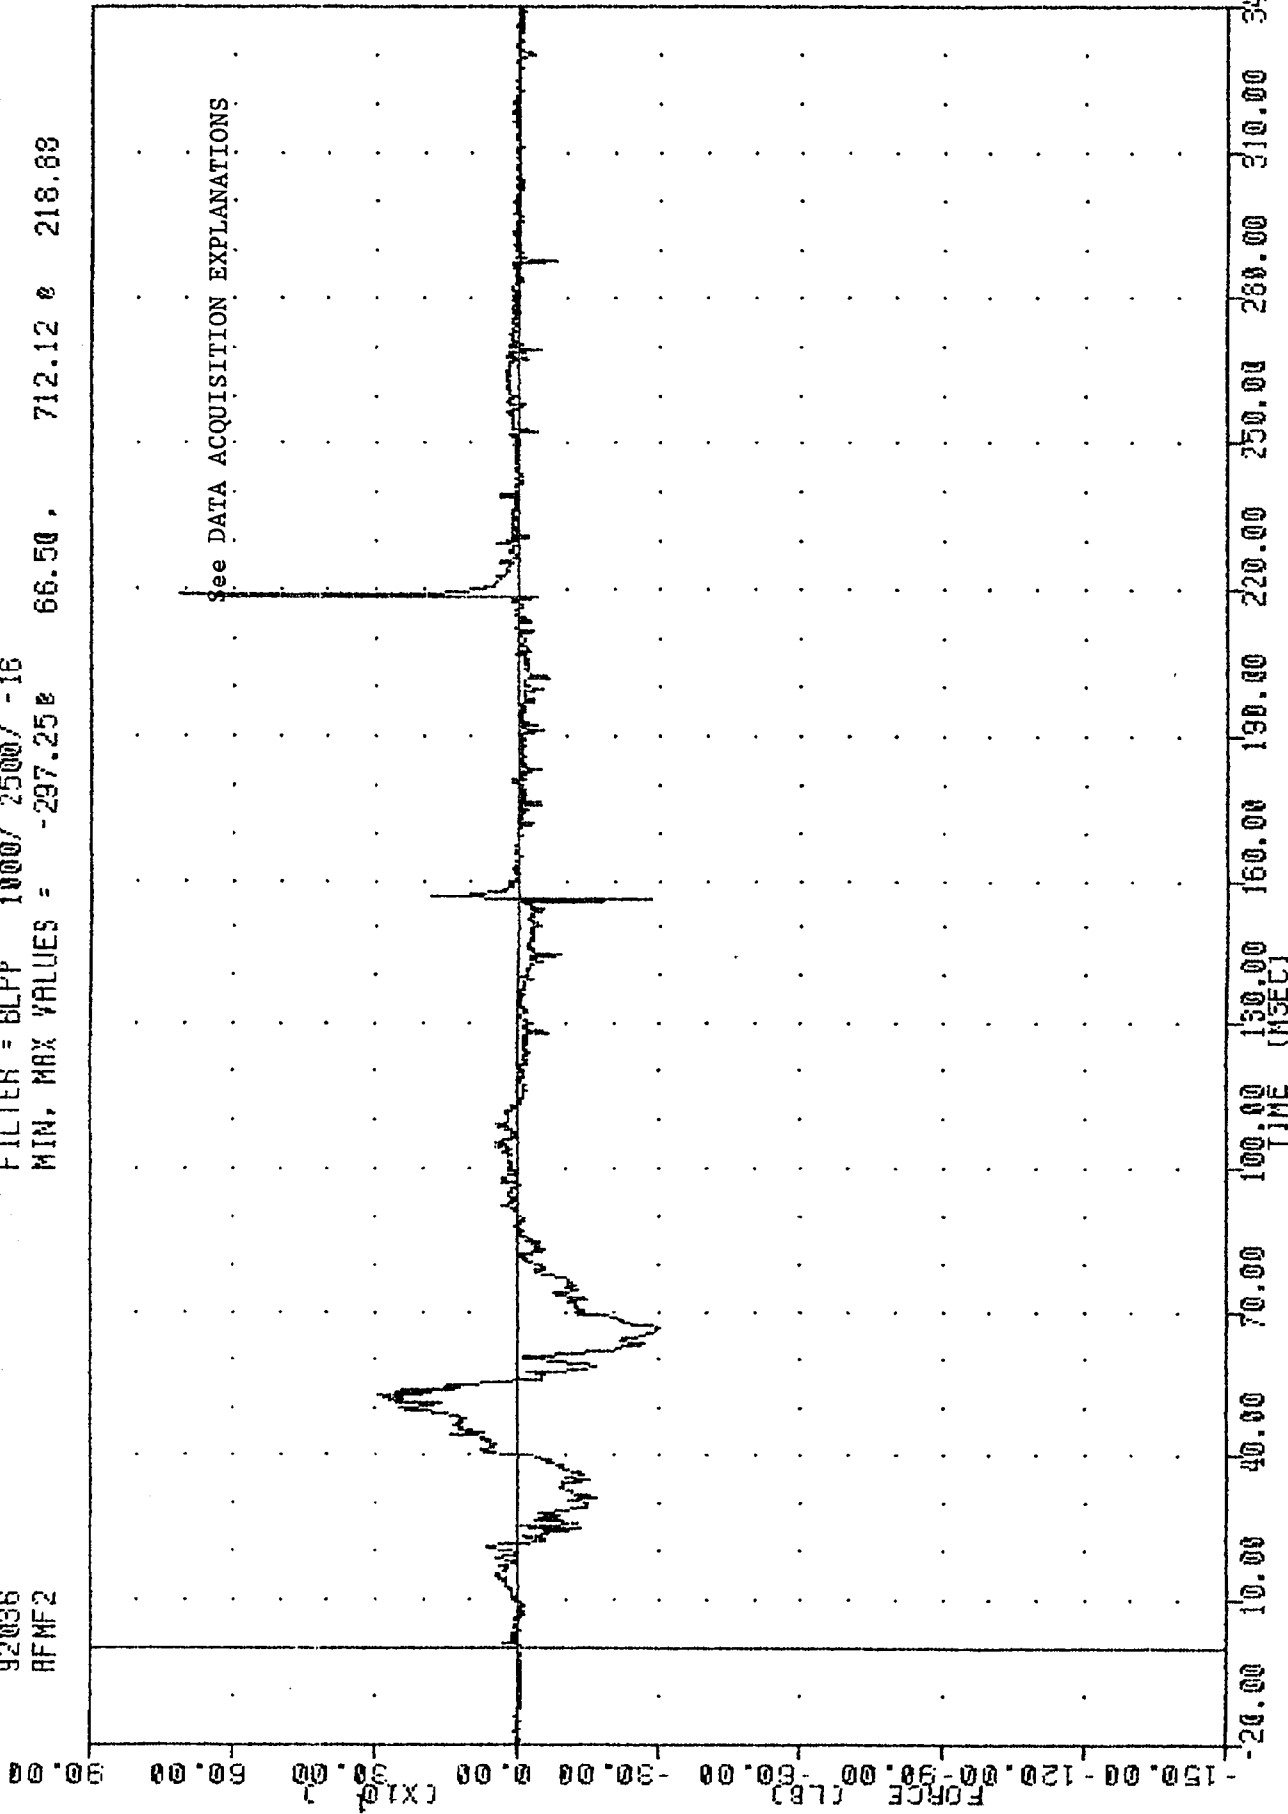
FILTER = BLPP 1000/ 2500/ -18
MIN. MAX VALUES = -297.250 66.50 , 712.12 0 218.68

1992 FORD EXPLORER INTO FLAT FRONTAL BARRIER
RIGHT FRONT PASSENGER RIGHT FEMUR FORCE

RFMF2, right front passenger's right femur force, spikes at 156 and 219
milliseconds

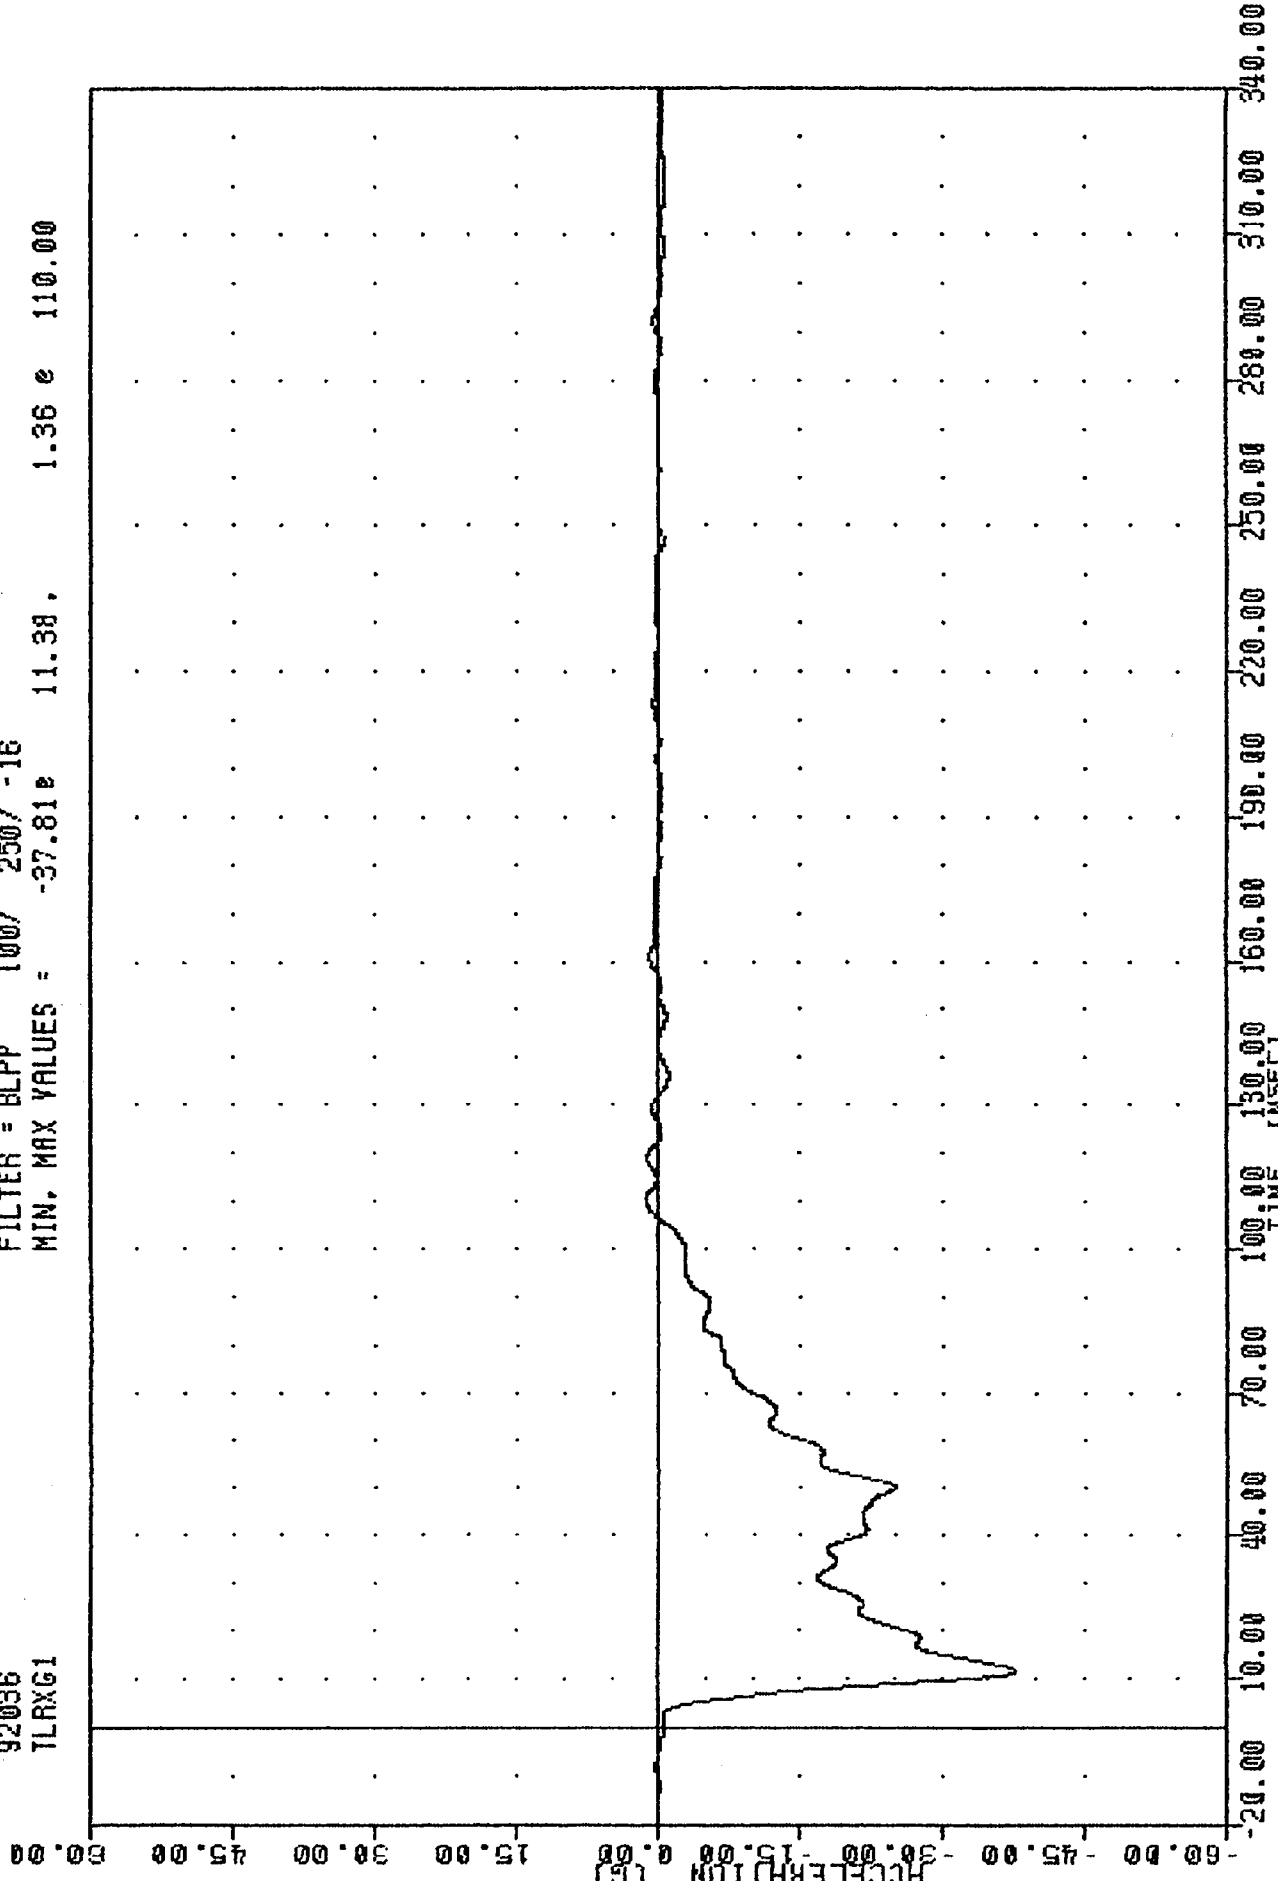
FILTER = BLPP 100/ 250/ -16
MIN, MAX VALUES = -37.81e 11.38, 1.36 e 110.00

1992 FORD EXPLORER INTO FLAT FRONTAL BARRIER
LEFT REAR SEAT X-AXIS ACCELERATION

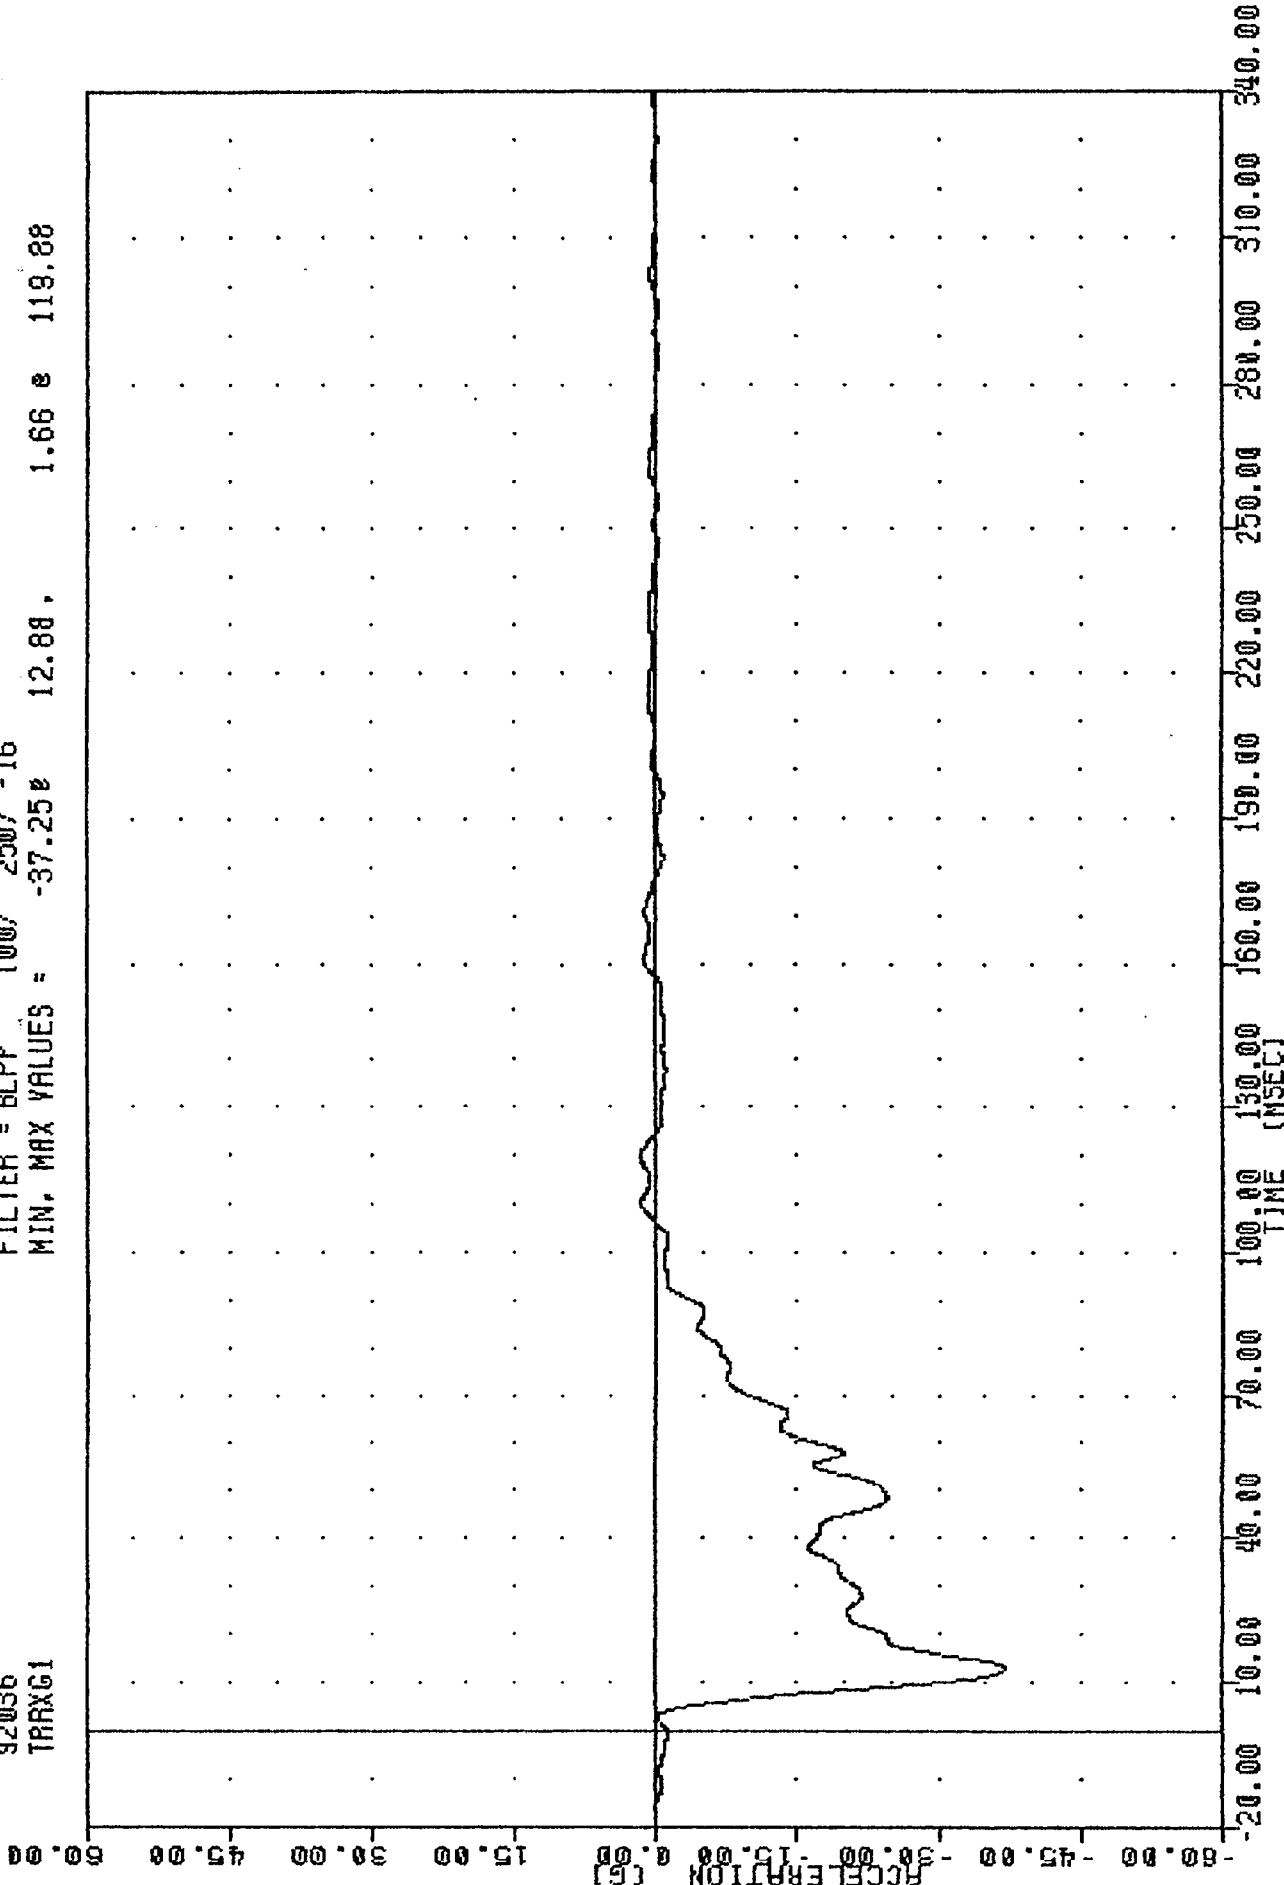
FILTER = BLPP 100/ 250/ -16
MIN. MAX VALUES = -37.25% 12.88, 1.66 e 118.88

1992 FORD EXPLORER INTO FLAT FRONTAL BARRIER
RIGHT REAR SEAT X-AXIS ACCELERATION

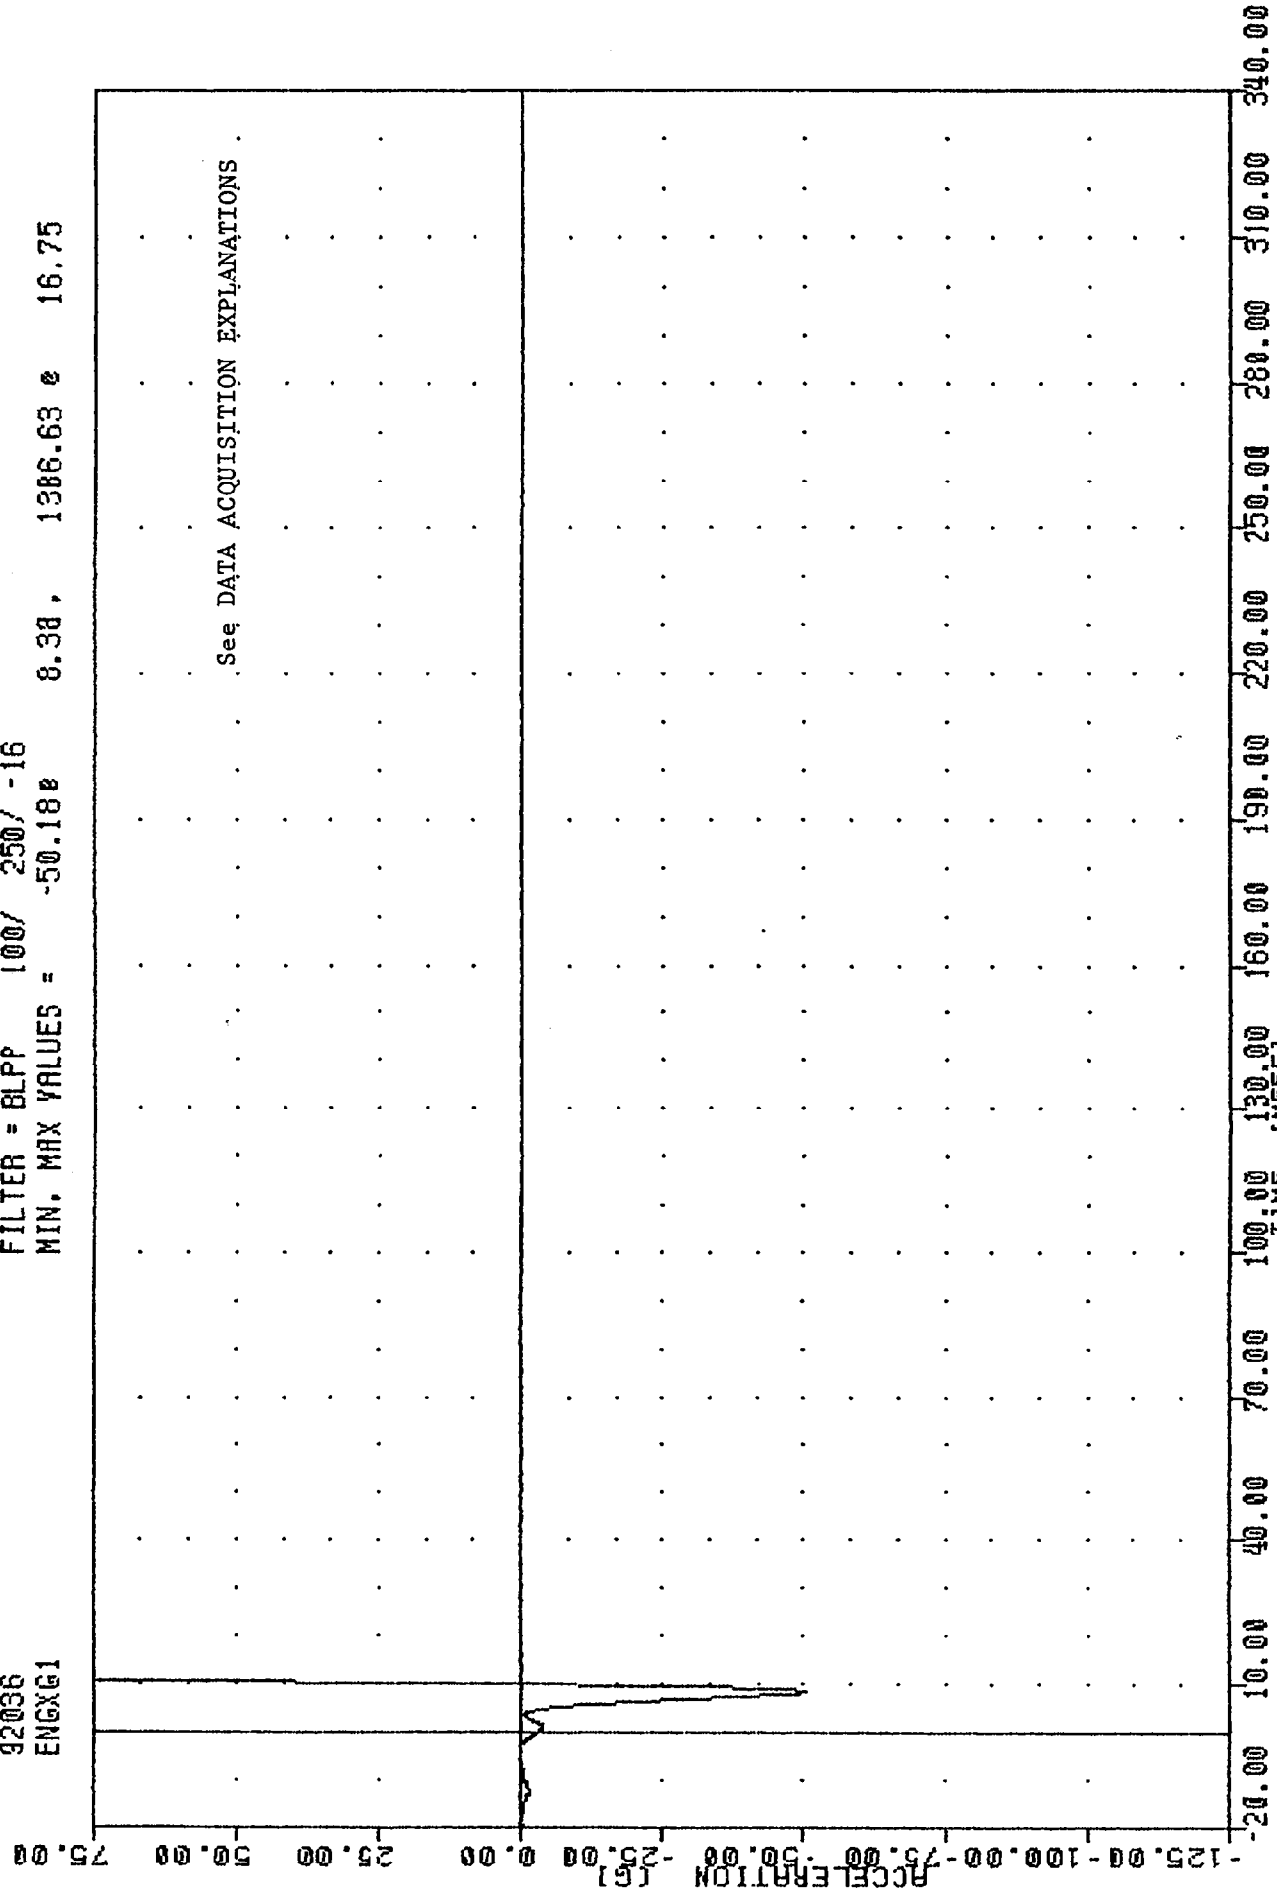
FILTER = 8LPP 100/ 250/ -16
 MIN. MAX VALUES = -50.18e 8.38 1386.63 e 16.75

1992 FORD EXPLORER INTO FLAT FRONTAL BARRIER
 ENGINE TOP X-AXIS ACCELERATION

The engine top X-axis accelerometer, ENGXG1, lost data after 12 milliseconds due to the vehicle's crush cutting the accelerometer cable.

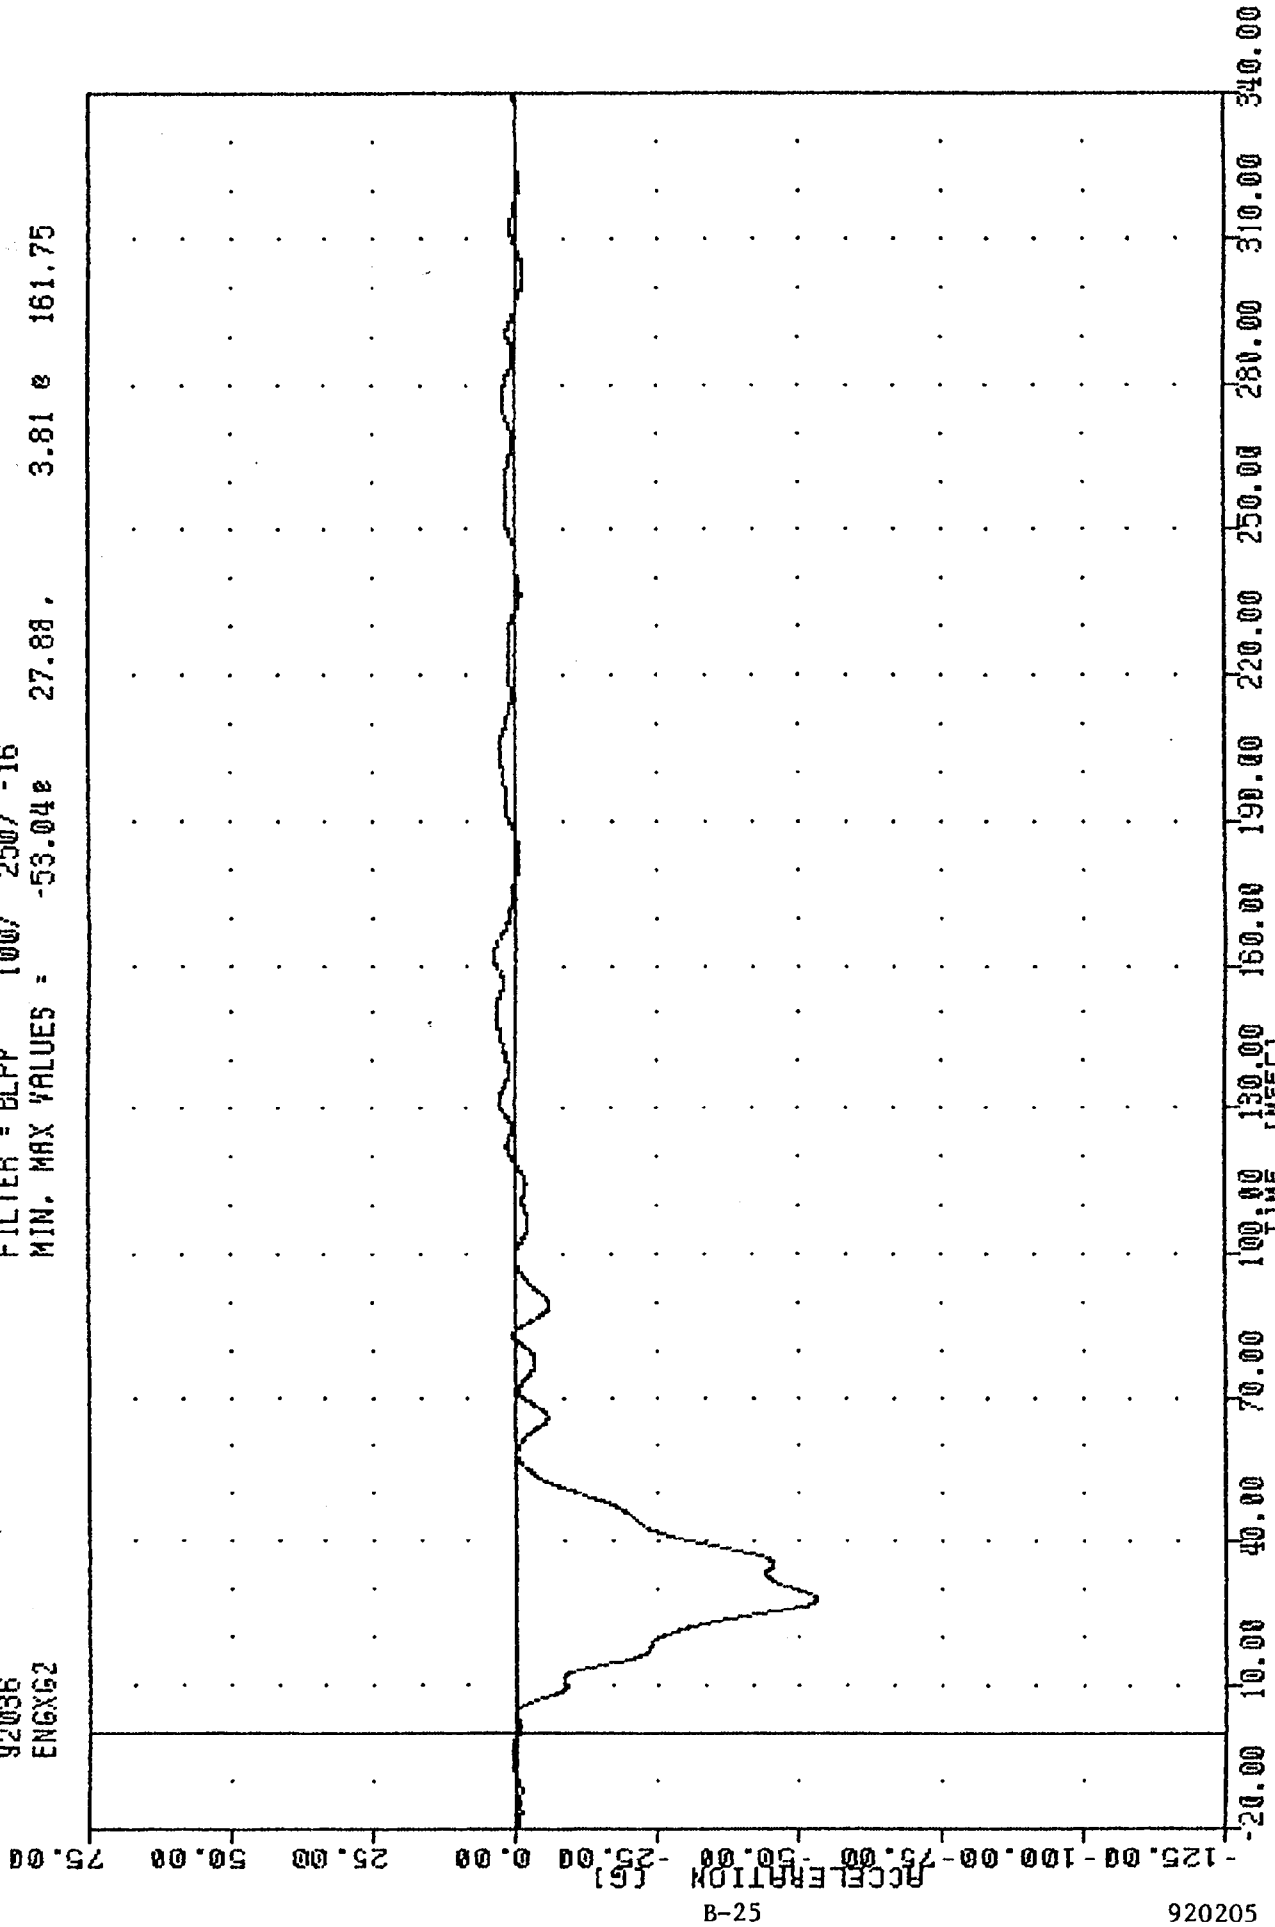
FILTER = BLPP 100/ 250/ -16
MIN. MAX VALUES = -53.04e 27.88, 3.81 e 161.75

1992 FORD EXPLORER INTO FLAT FRONTAL BARRIER
ENGINE BOTTOM X-AXIS ACCELERATION

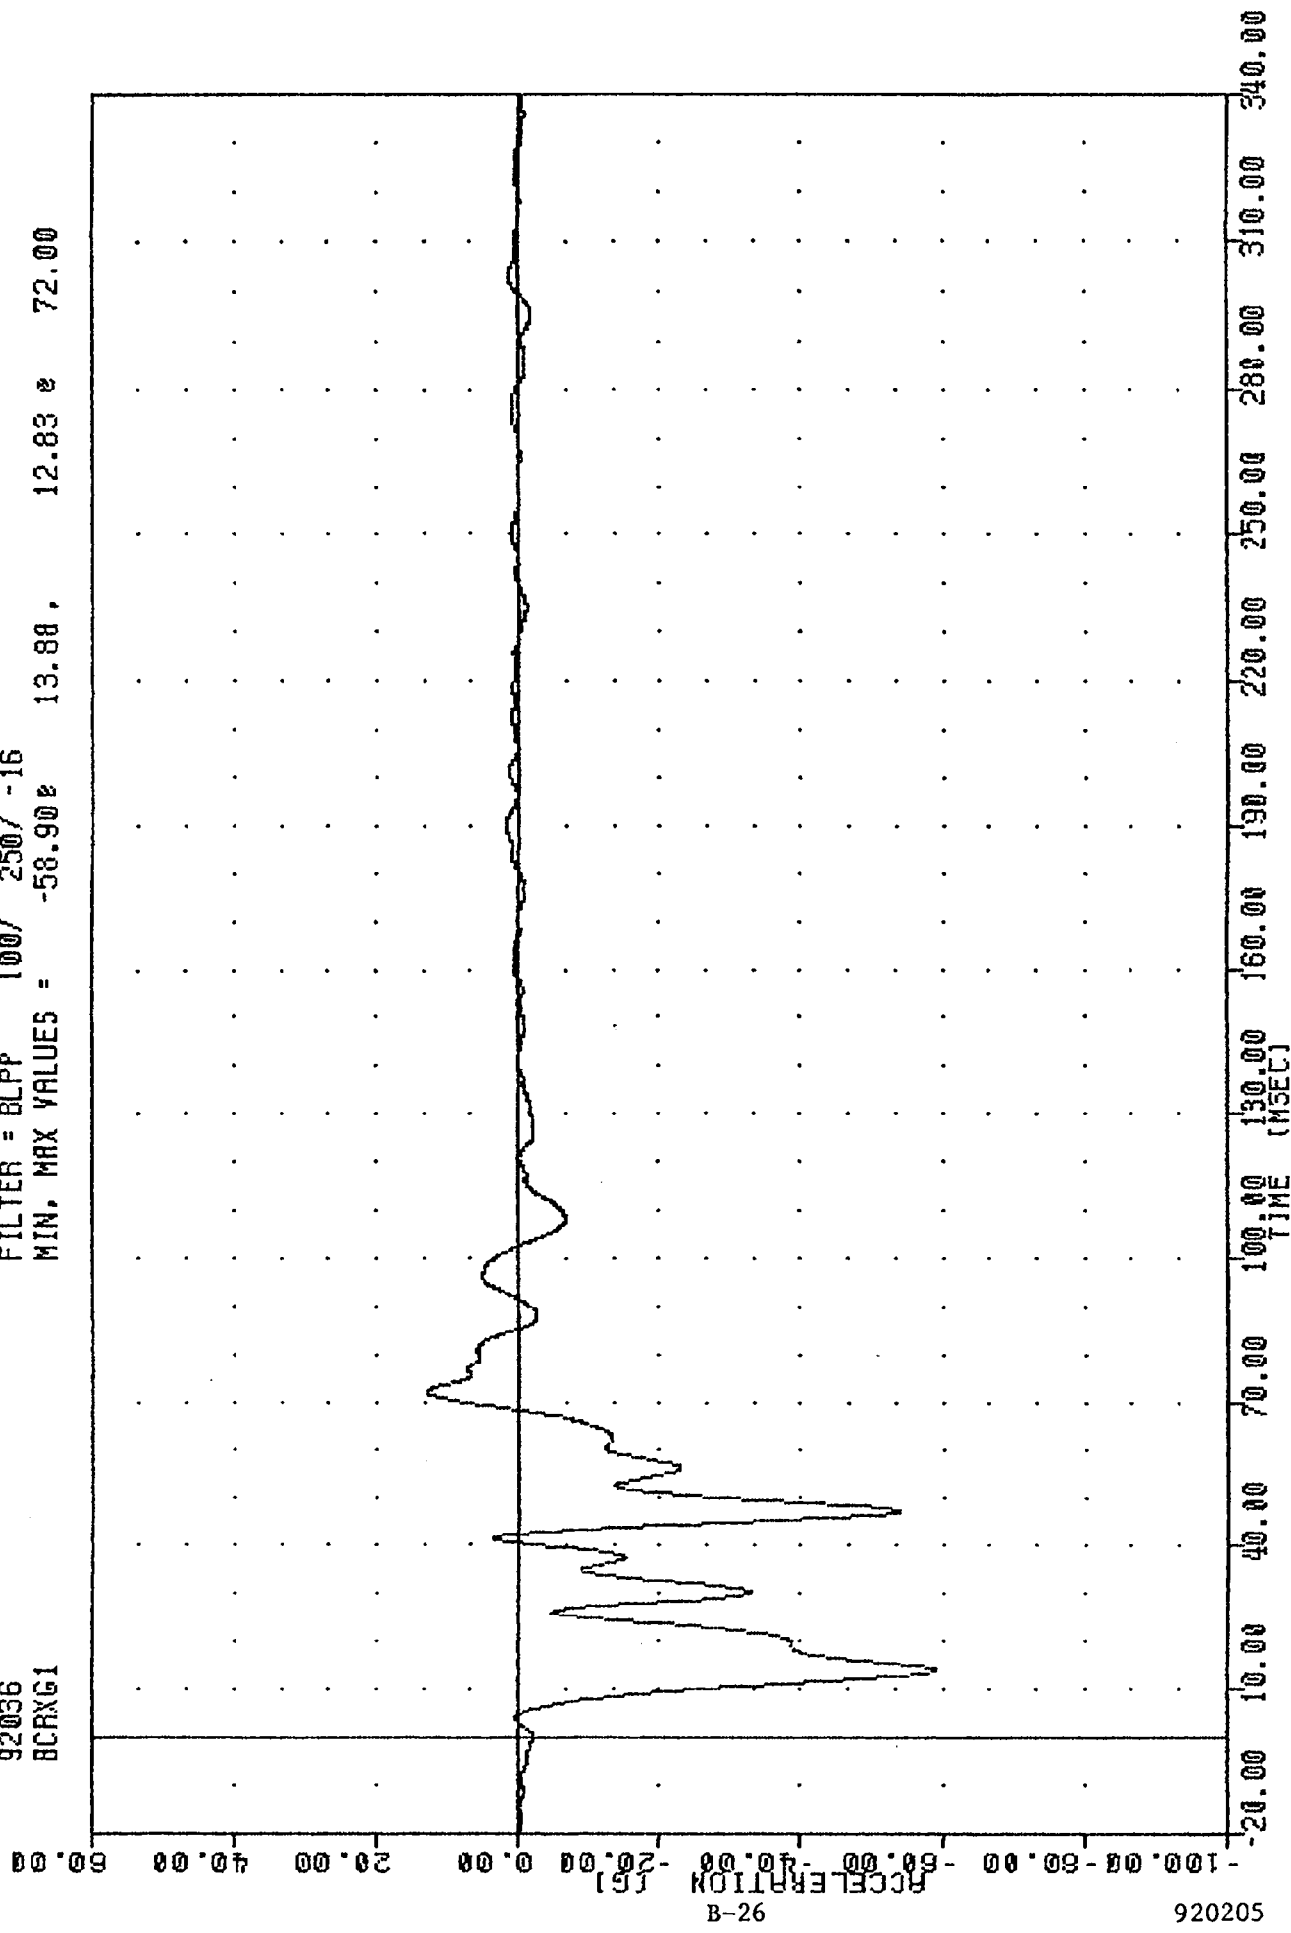
FILTER = BLPP 100/ 250/ -16
MIN. MAX VALUES = -58.90% 13.88, 12.83 e 72.00

1992 FORD EXPLORER INTO FLAT FRONTAL BARRIER
RIGHT BRAKE CALIPER X-AXIS ACCELERATION
