REPORT NOS. 208-TRC-92-009
212-TRC-92-009
301-TRC-92-009

VEHICLE SAFETY COMPLIANCE TESTING
FOR OCCUPANT CRASH PROTECTION,
WINDSHIELD MOUNTING, WINDSHIELD ZONE
INTRUSION, AND FUEL SYSTEM INTEGRITY

FORD MOTOR COMPANY
1992 FORD EXPLORER
SPORT UTILITY VEHICLE
NHTSA NO. CN0209
TRC TEST NO. 920205

FINAL REPORT

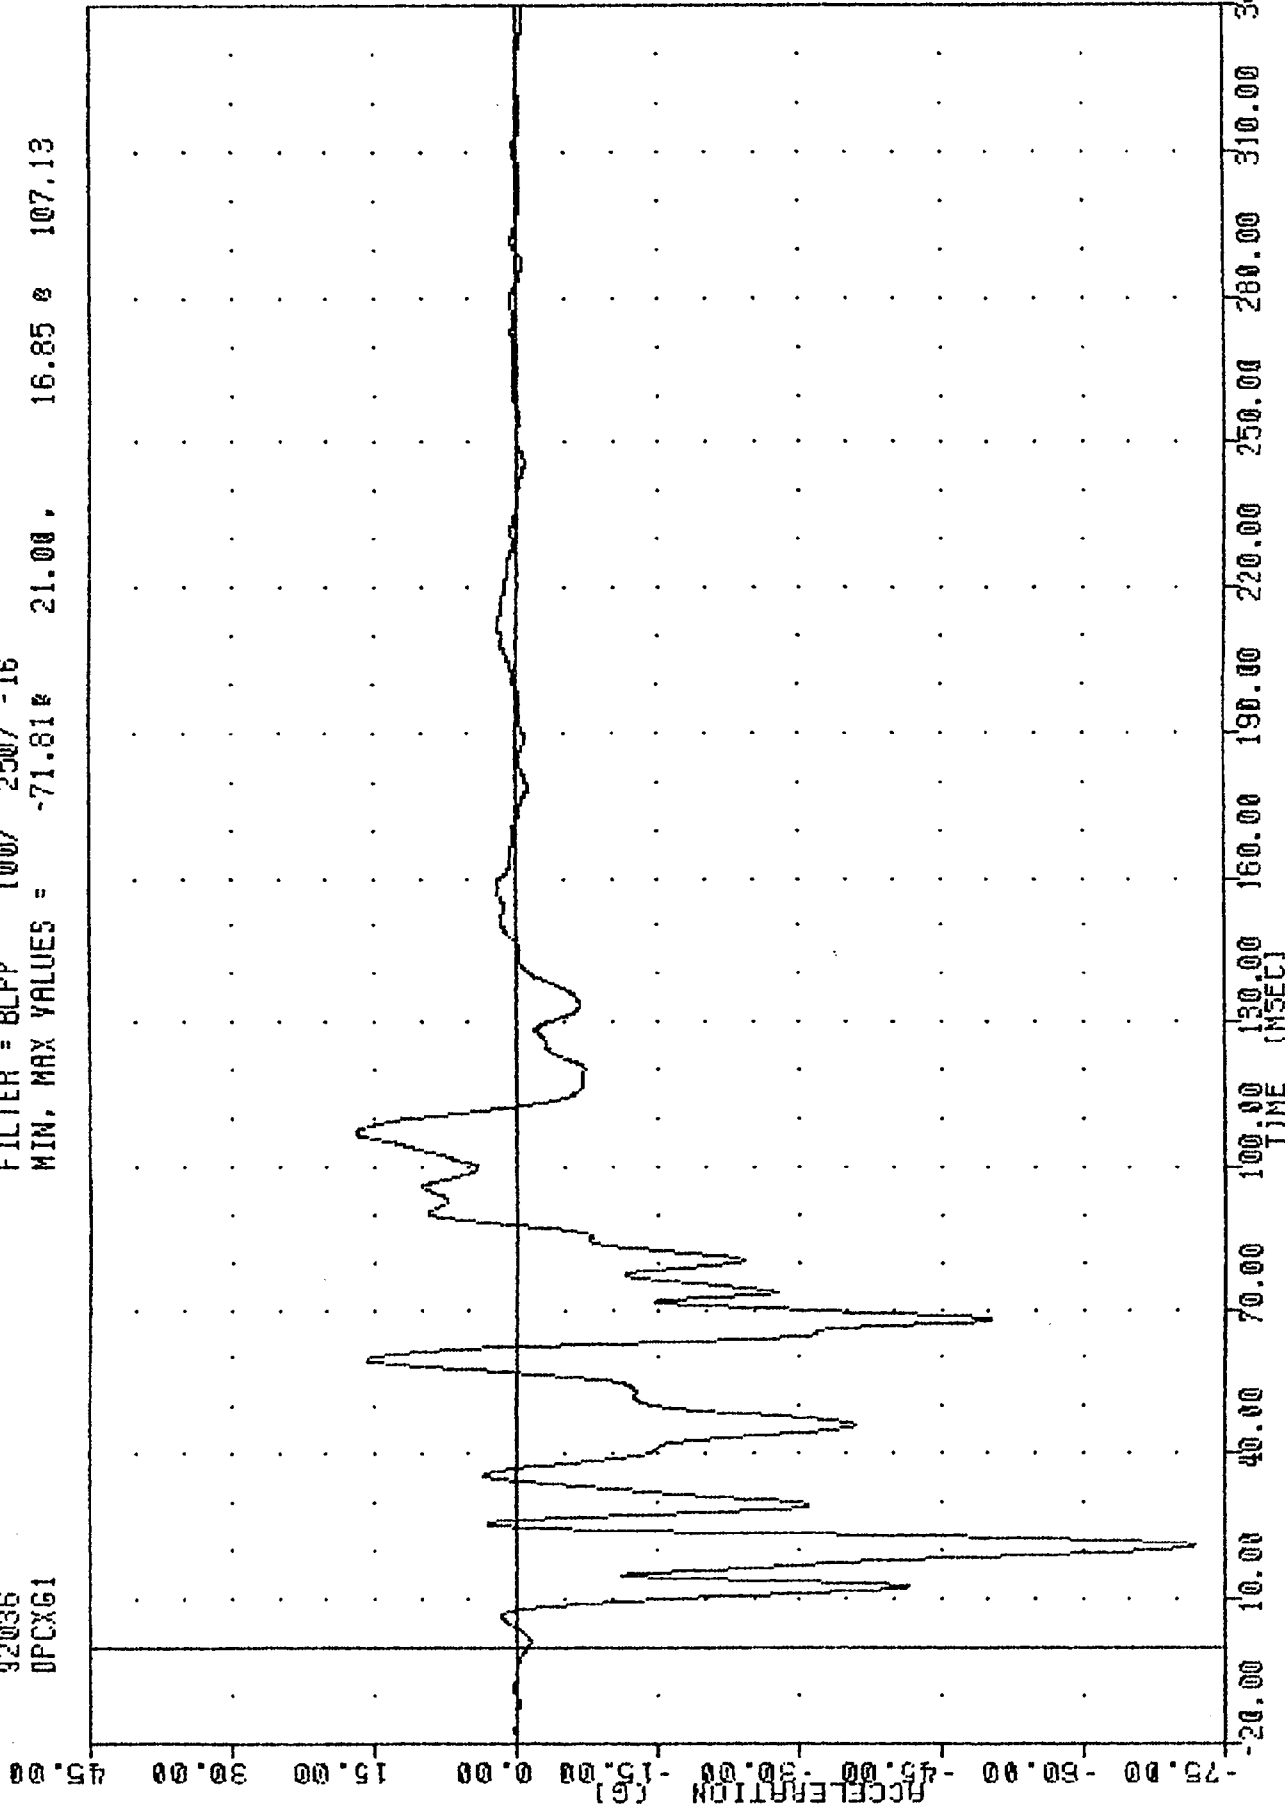
FILTER = BLPP 100/ 250/ -16
MIN. MAX VALUES = -71.81% 21.00 , 16.85 % 107.13

1992 FORD EXPLORER INTO FLAT FRONTAL BARRIER
INSTRUMENT PANFI CENTER X-AXIS ACCELERATION
