VEHICLE SAFETY COMPLIANCE TESTING
FOR OCCUPANT CRASH PROTECTION,
WINDSHIELD MOUNTING, WINDSHIELD ZONE
INTRUSION, AND FUEL SYSTEM INTEGRITY

ISUZU MOTORS, LTD.
1992 ISUZU PICKUP
NHTSA NO. CN5701
TRC TEST NO. 920520

TRANSPORTATION RESEARCH CENTER INC.
10820 STATE ROUTE 347
EAST LIBERTY, OHIO 43319

JUNE 5, 1992
FINAL REPORT

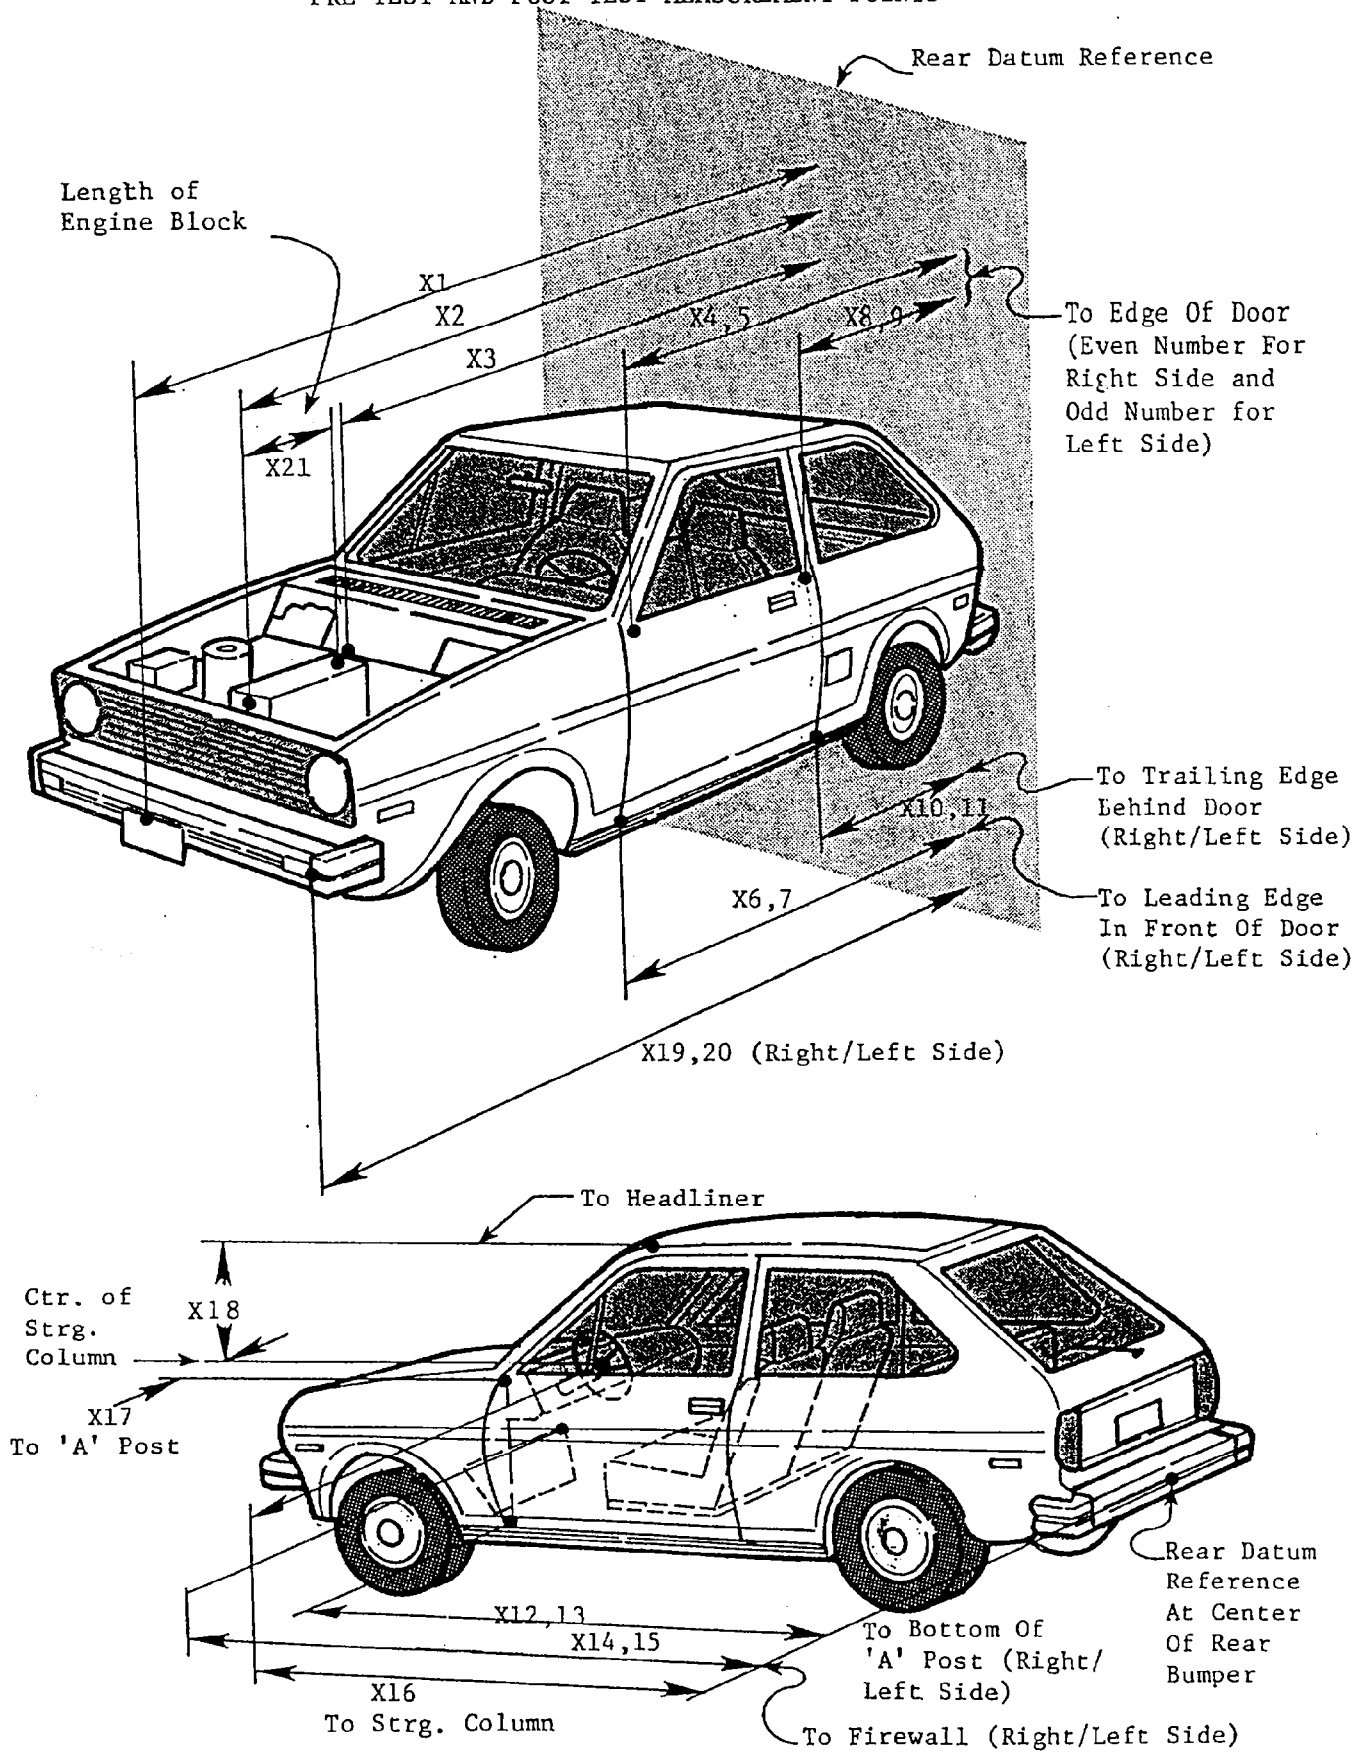
FIGURE 7

PRE-TEST AND POST-TEST MEASUREMENT POINTS

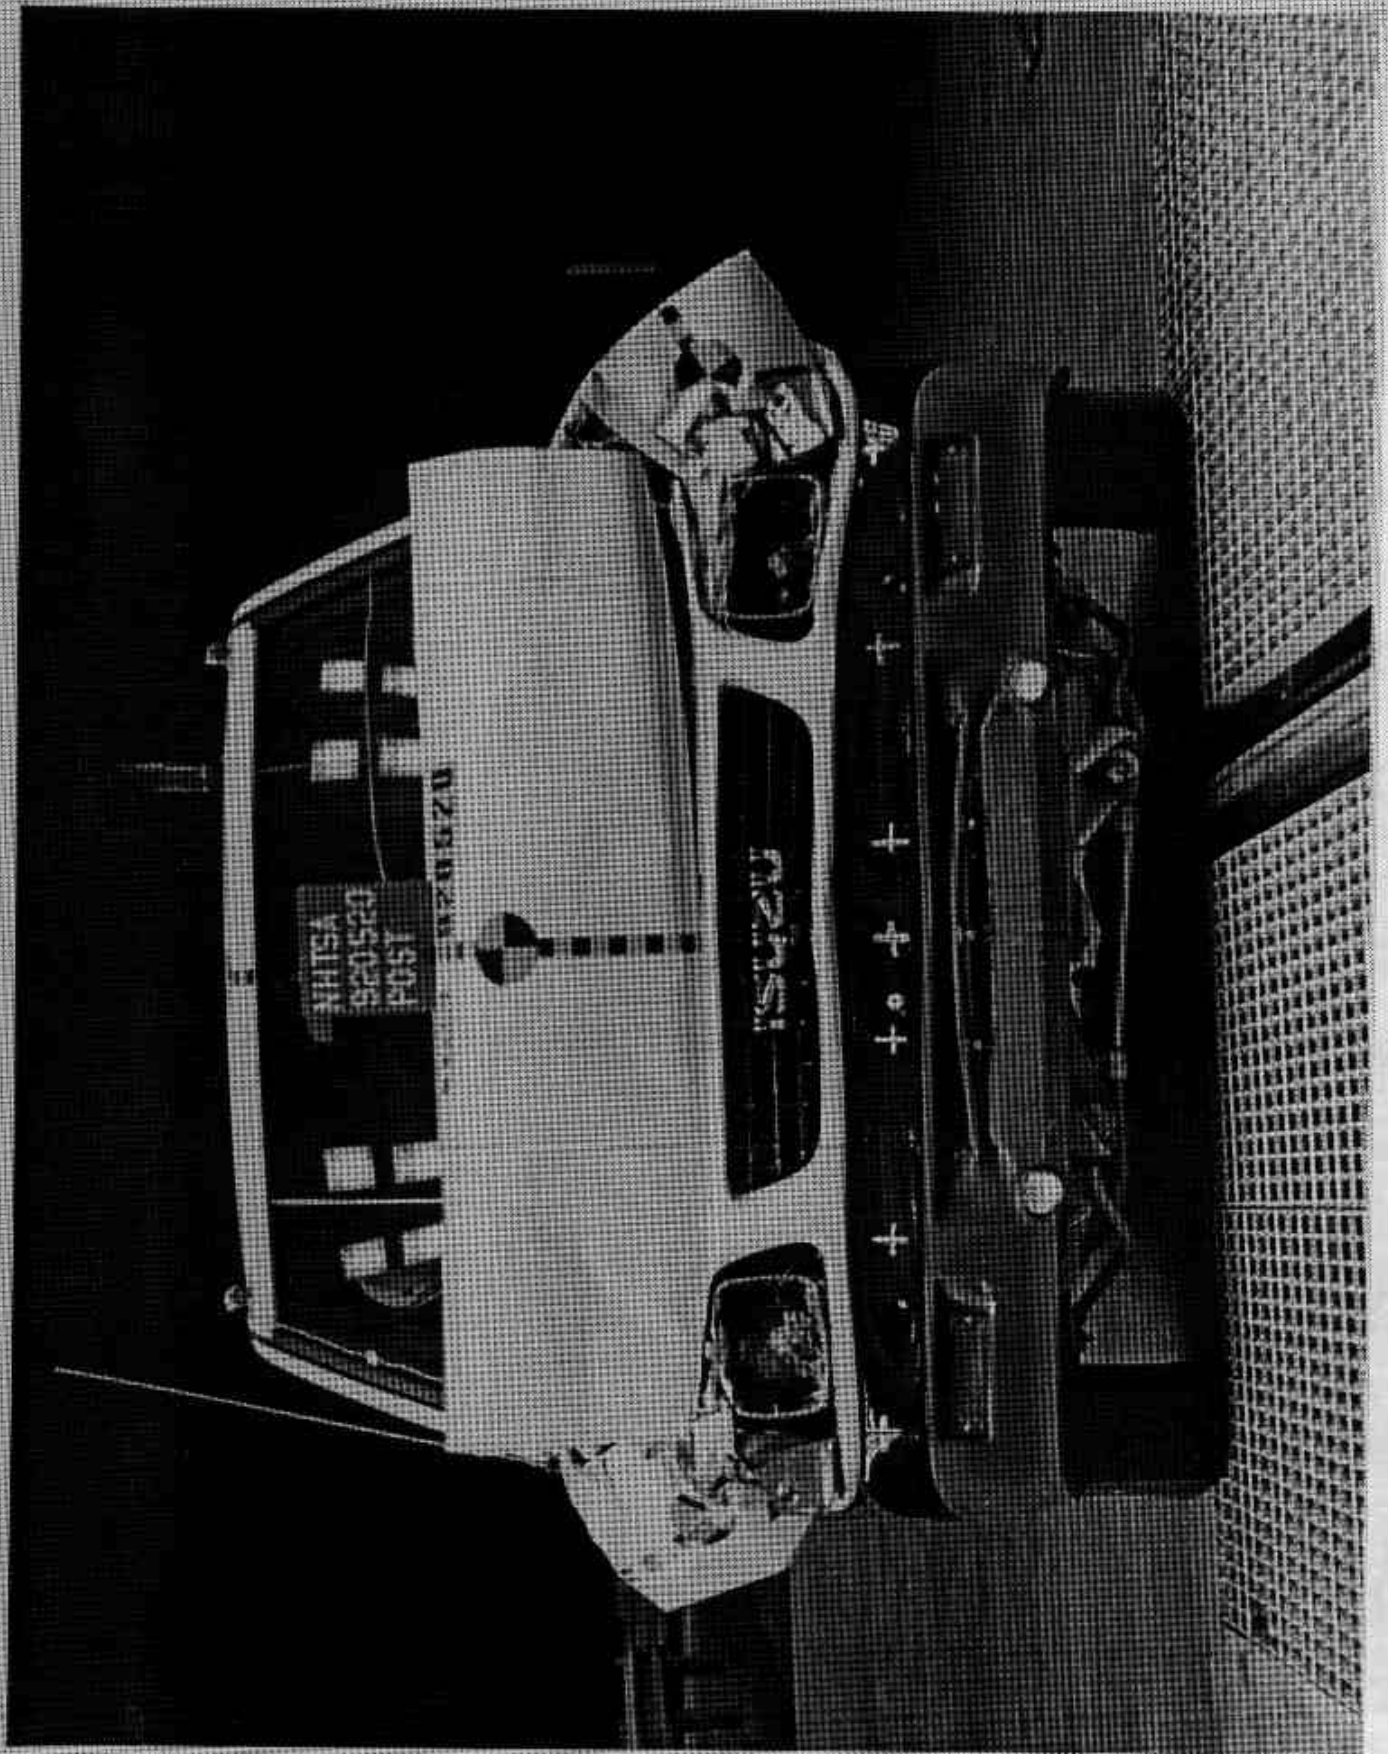
FIGURE A-2, POST-TEST FRONT VIEW

The test vehicle was equipped with a 2.3 liter, inline engine, manual transmission, power steering, and power brakes. The vehicle's test weight was 3421 pounds. The vehicle's impact speed was 29.5 mph. The vehicle's maximum static crush was 13.6 inches.

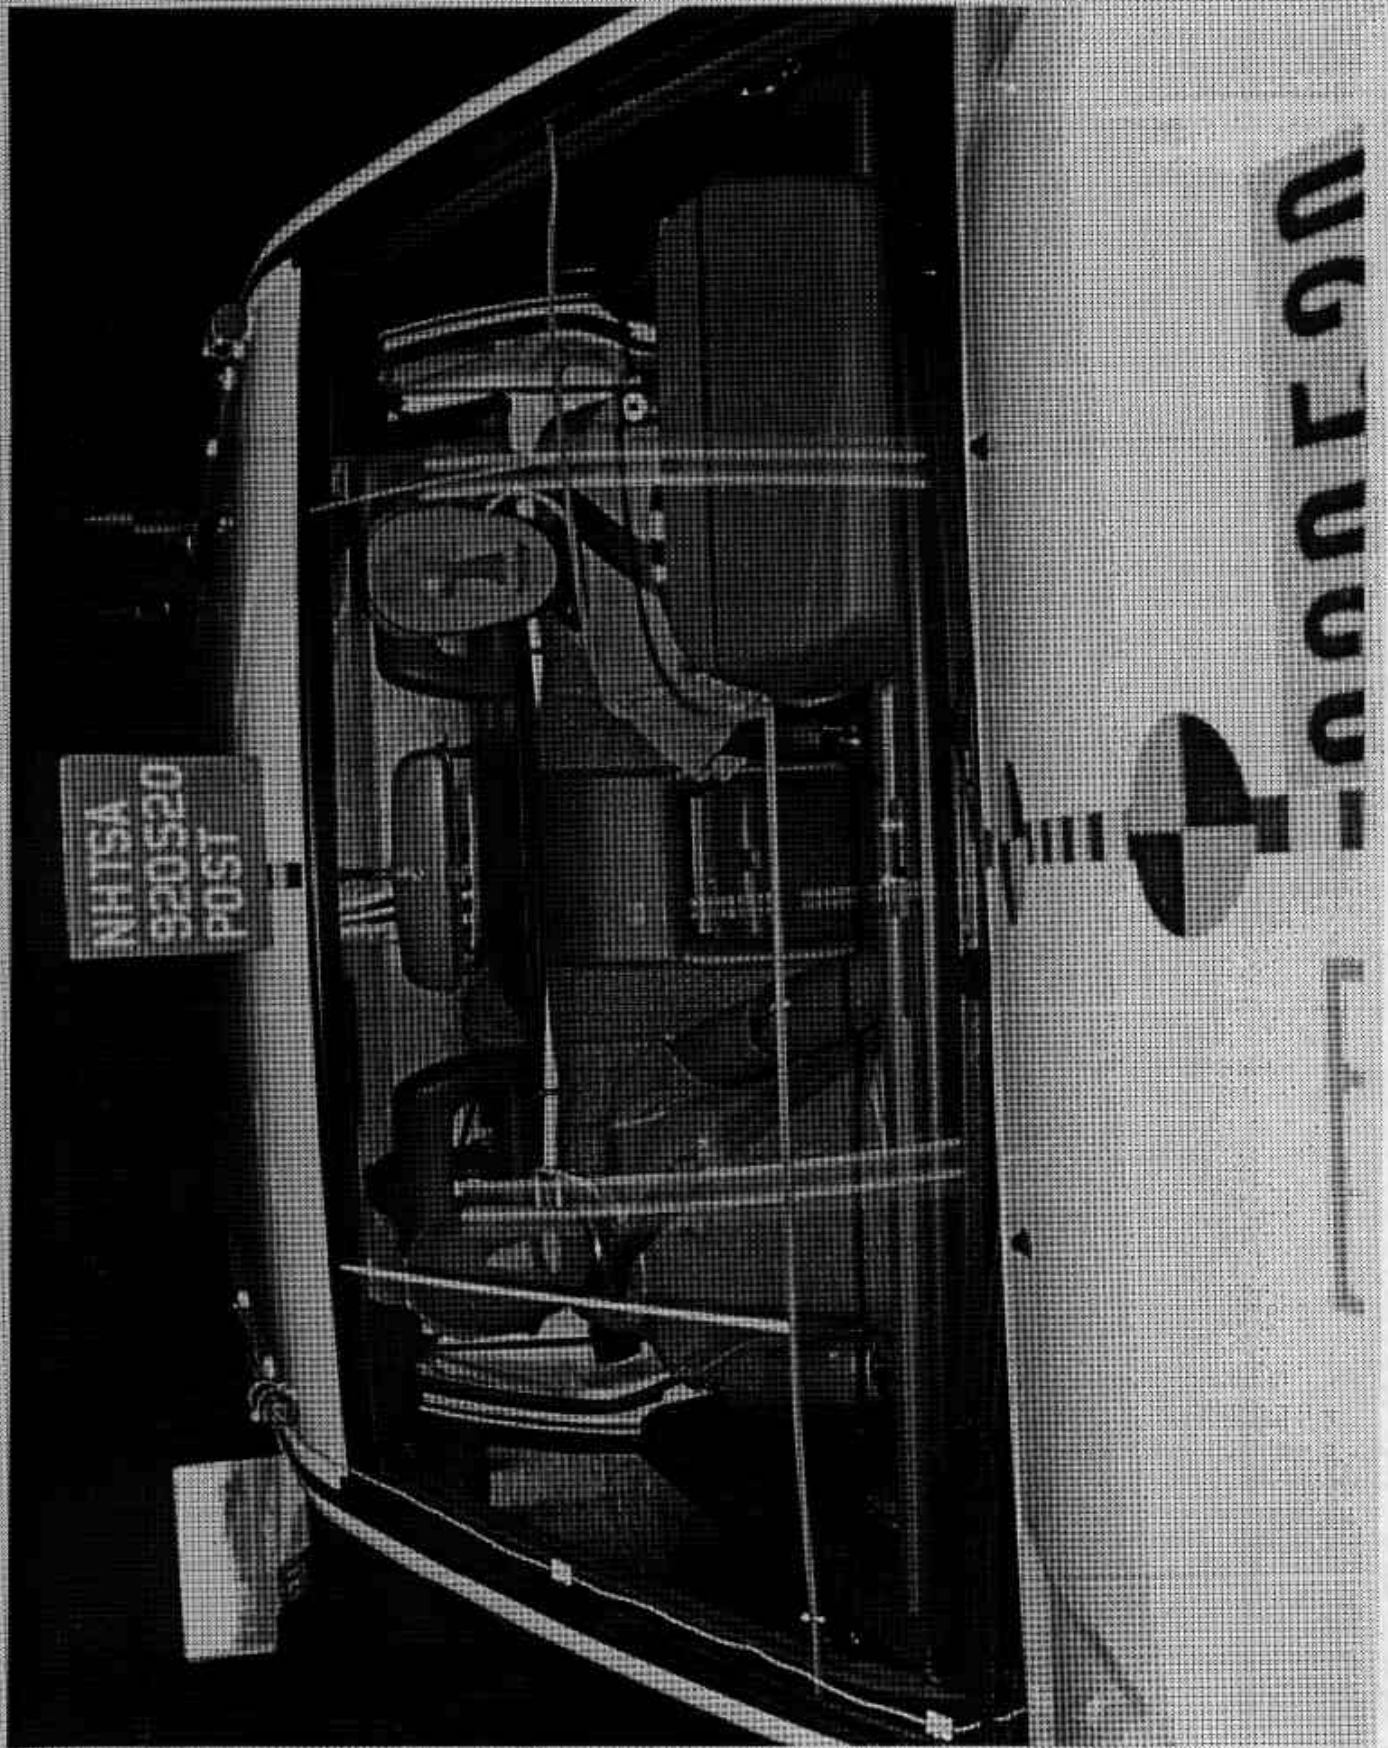
FIGURE A-14. POST-TEST WINDSHIELD VIEW
A-15

There was no loss of windshield periphery retention.

There was no intrusion through the windshield.

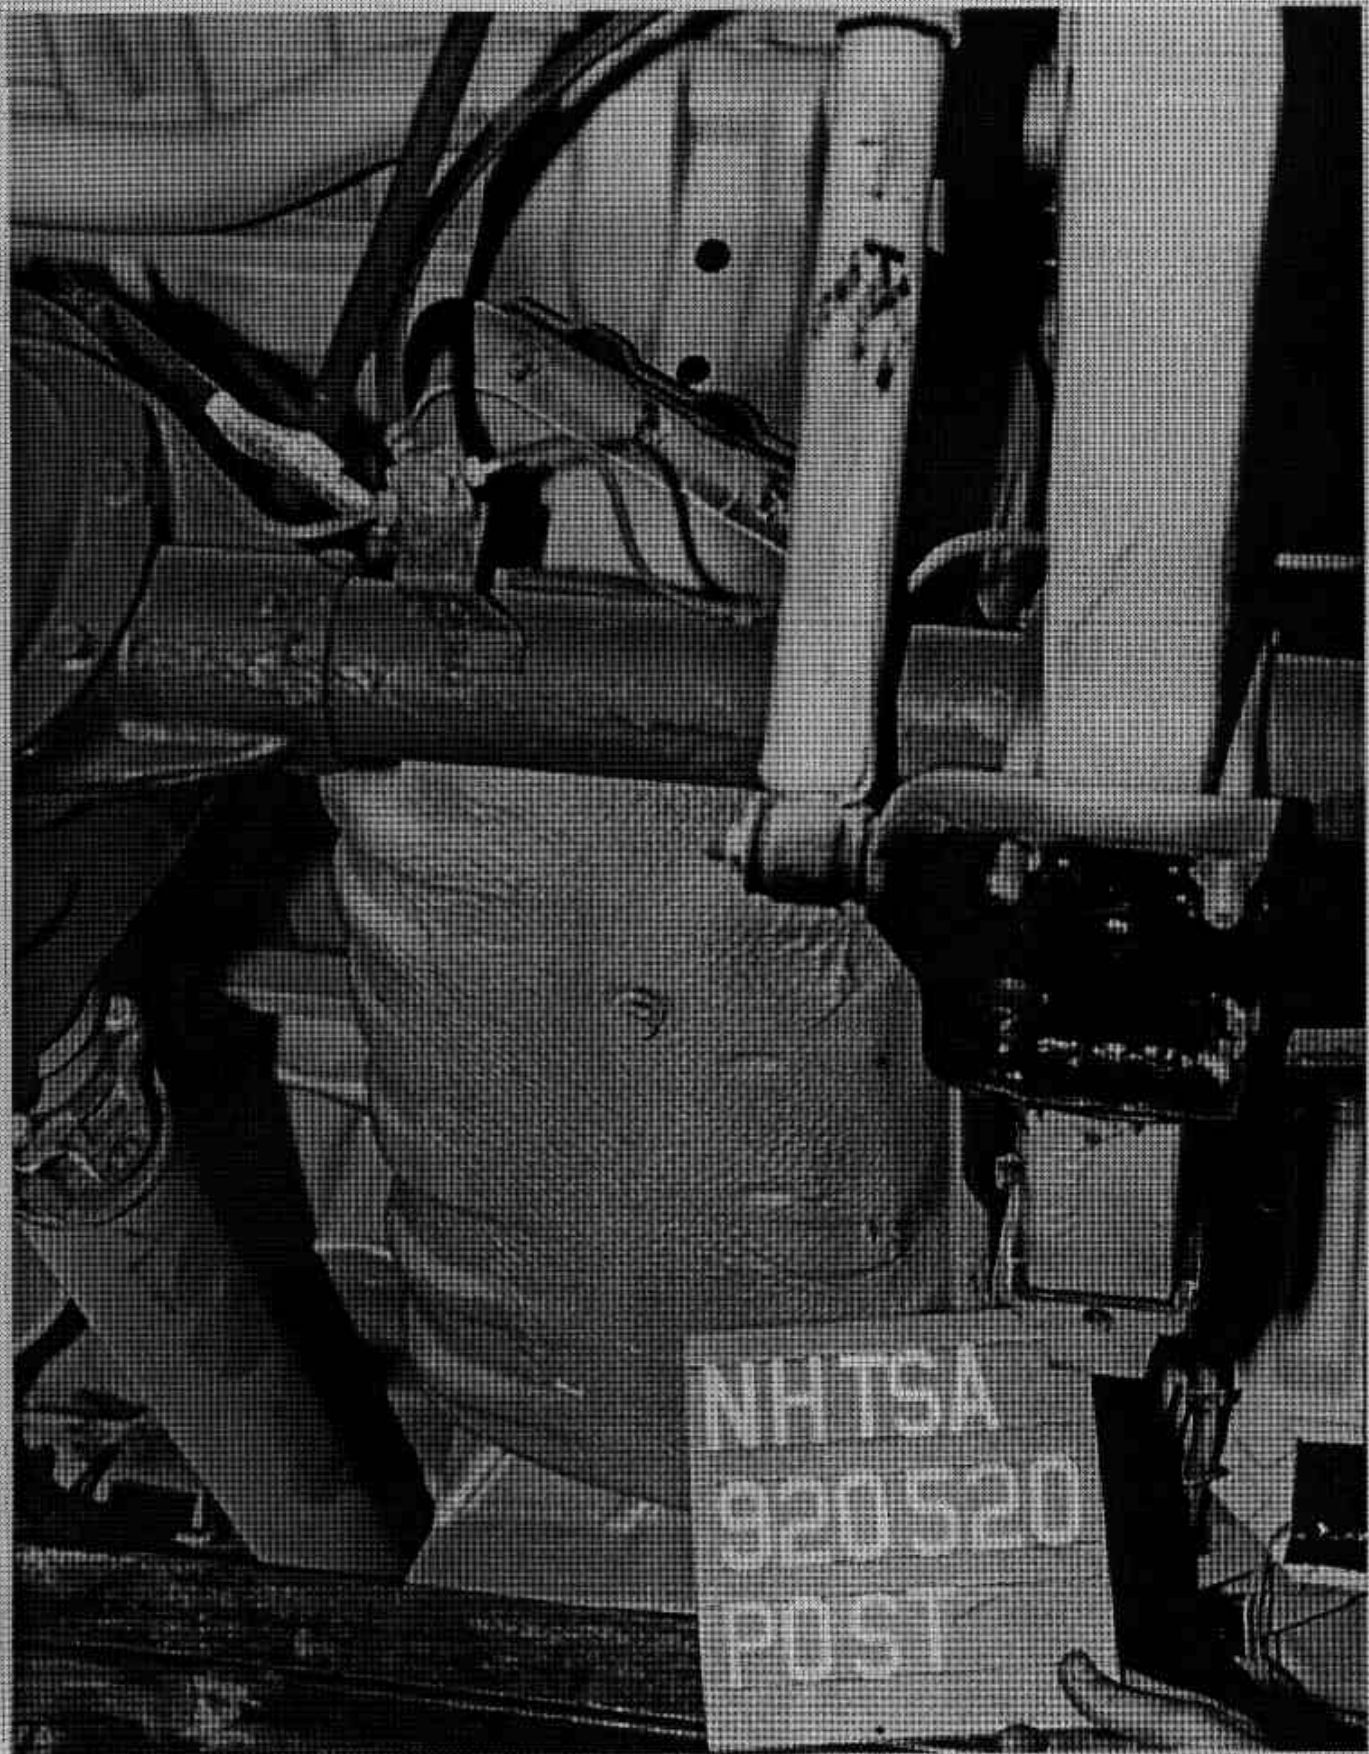
FIGURE A-22. POST-TEST FUEL TANK VIEW

No fluid spilled from the vehicle's fuel system following the crash test event or during the static rollover test.

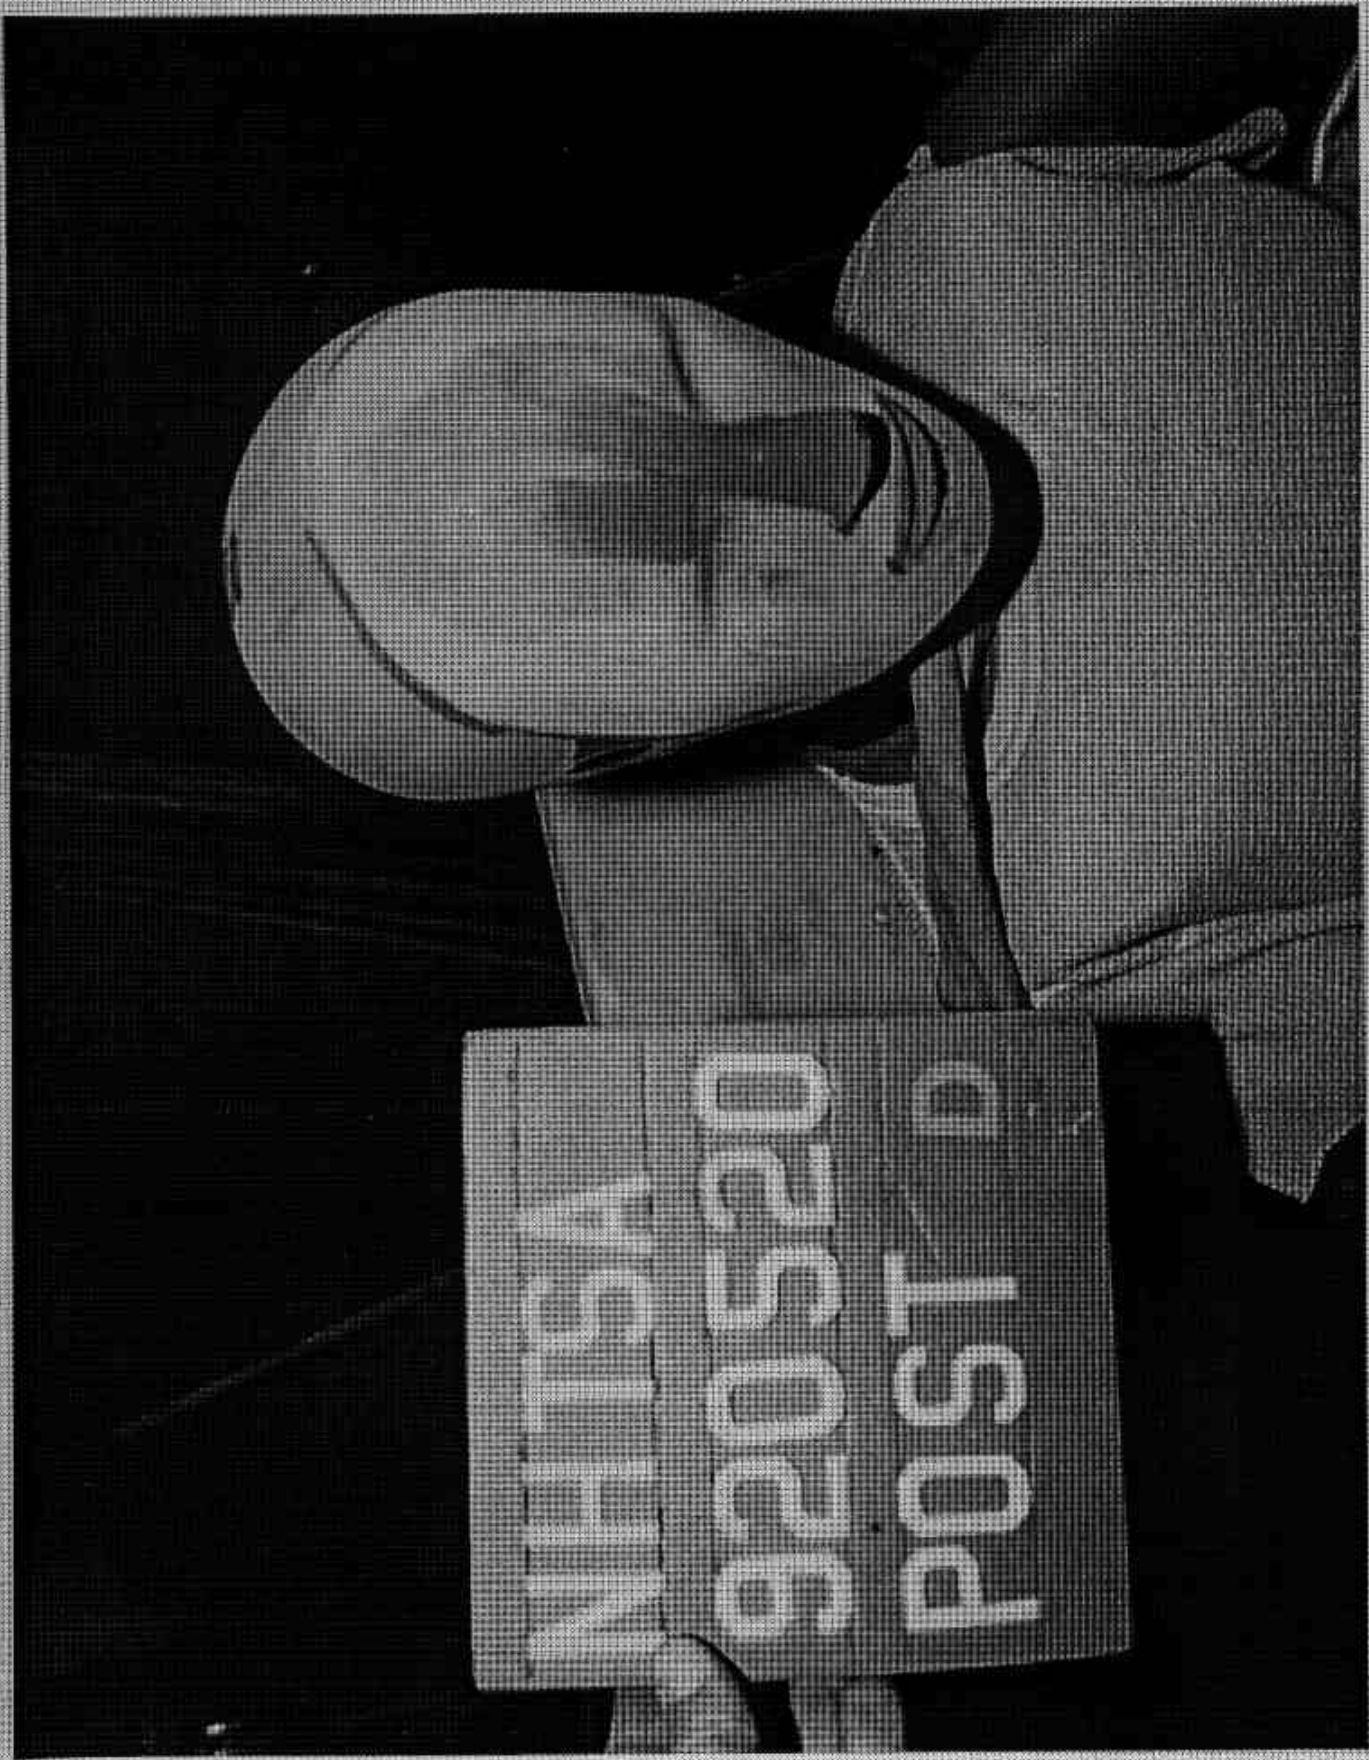
FIGURE A-40. POST-TEST DRIVER DUMMY HEAD CONTACT VIEW

The driver's head injury criteria (HIC) was 714. The driver's chest maximum resultant acceleration with three (3) milliseconds minimum duration was 53.3 g. The driver's chest maximum deflection was 2.1 inches. The driver's left and right femur maximum axial forces were 366 pounds and 430 pounds, respectively.

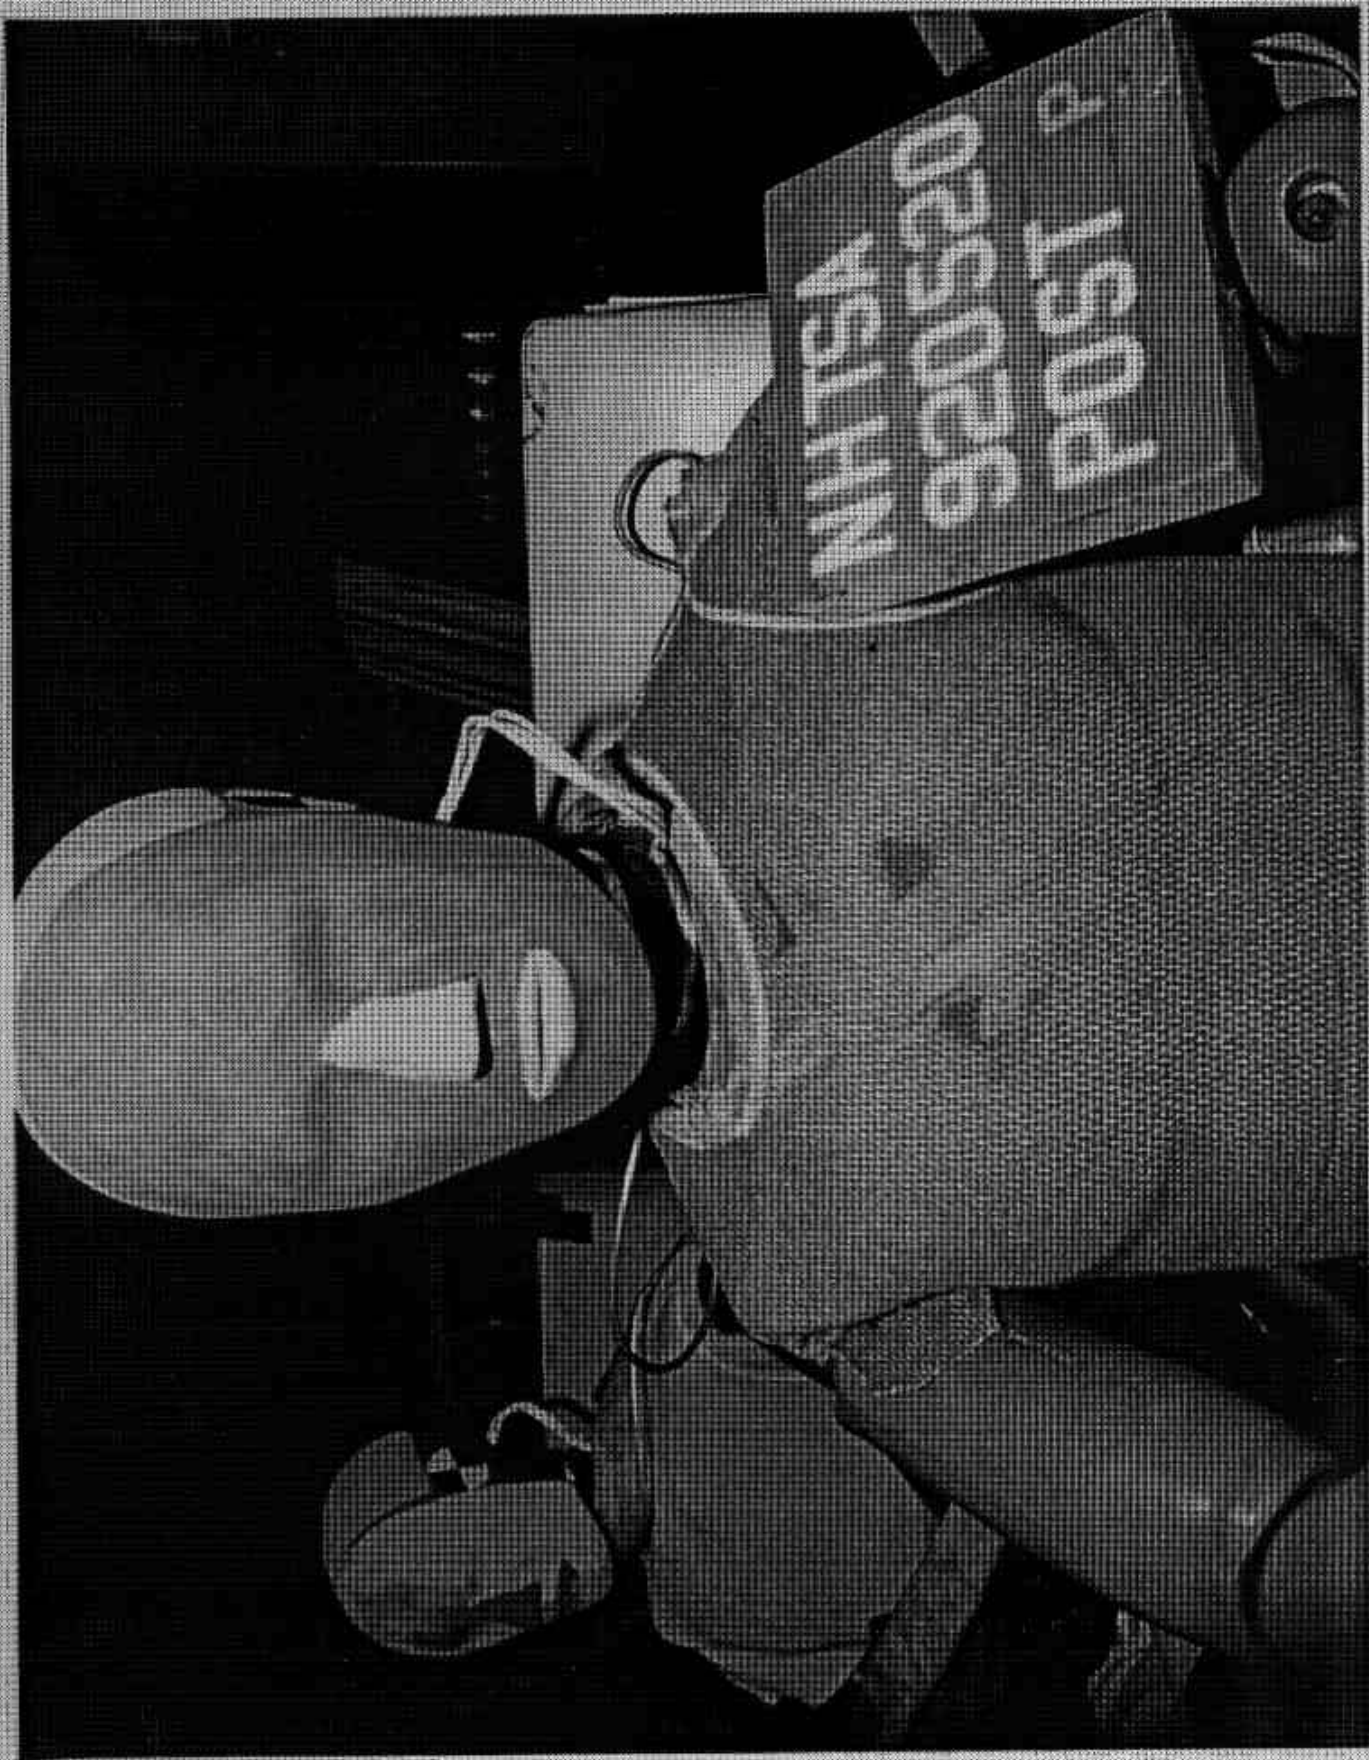
FIGURE A-44. POST-TEST PASSENGER DUMMY HEAD CONTACT VIEW

The right front passenger's HIC was 719. The right front passenger's chest maximum resultant acceleration with three (3) milliseconds minimum duration was 54.6 g. The right front passenger's chest maximum deflection was 1.6 inches. The right front passenger's left and right femur maximum axial forces were 160 pounds and 575 pounds, respectively.

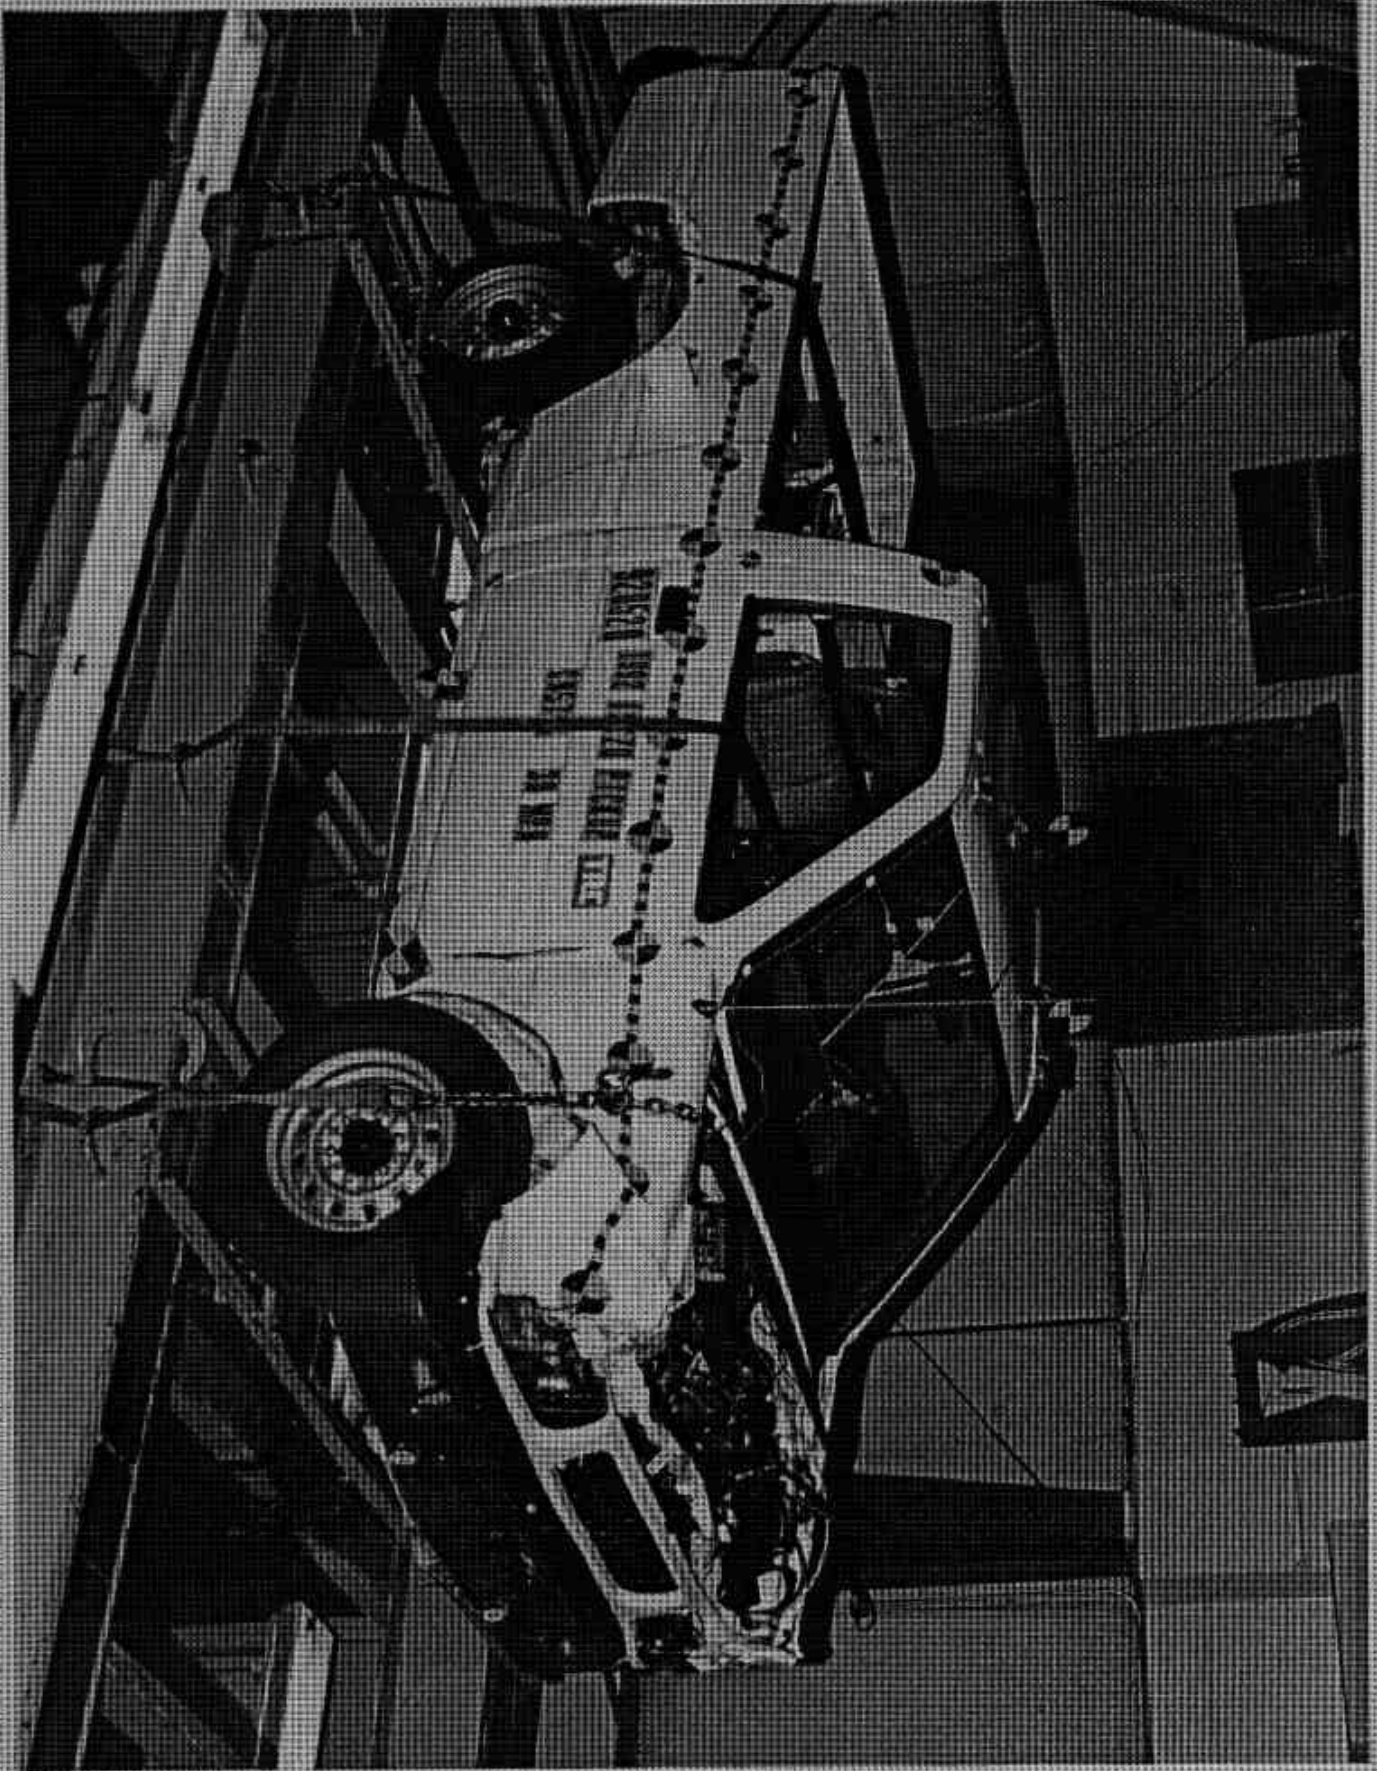
FIGURE A-48. POST-TEST VEHICLE ON STATIC ROLLOVER MACHINE VIEW

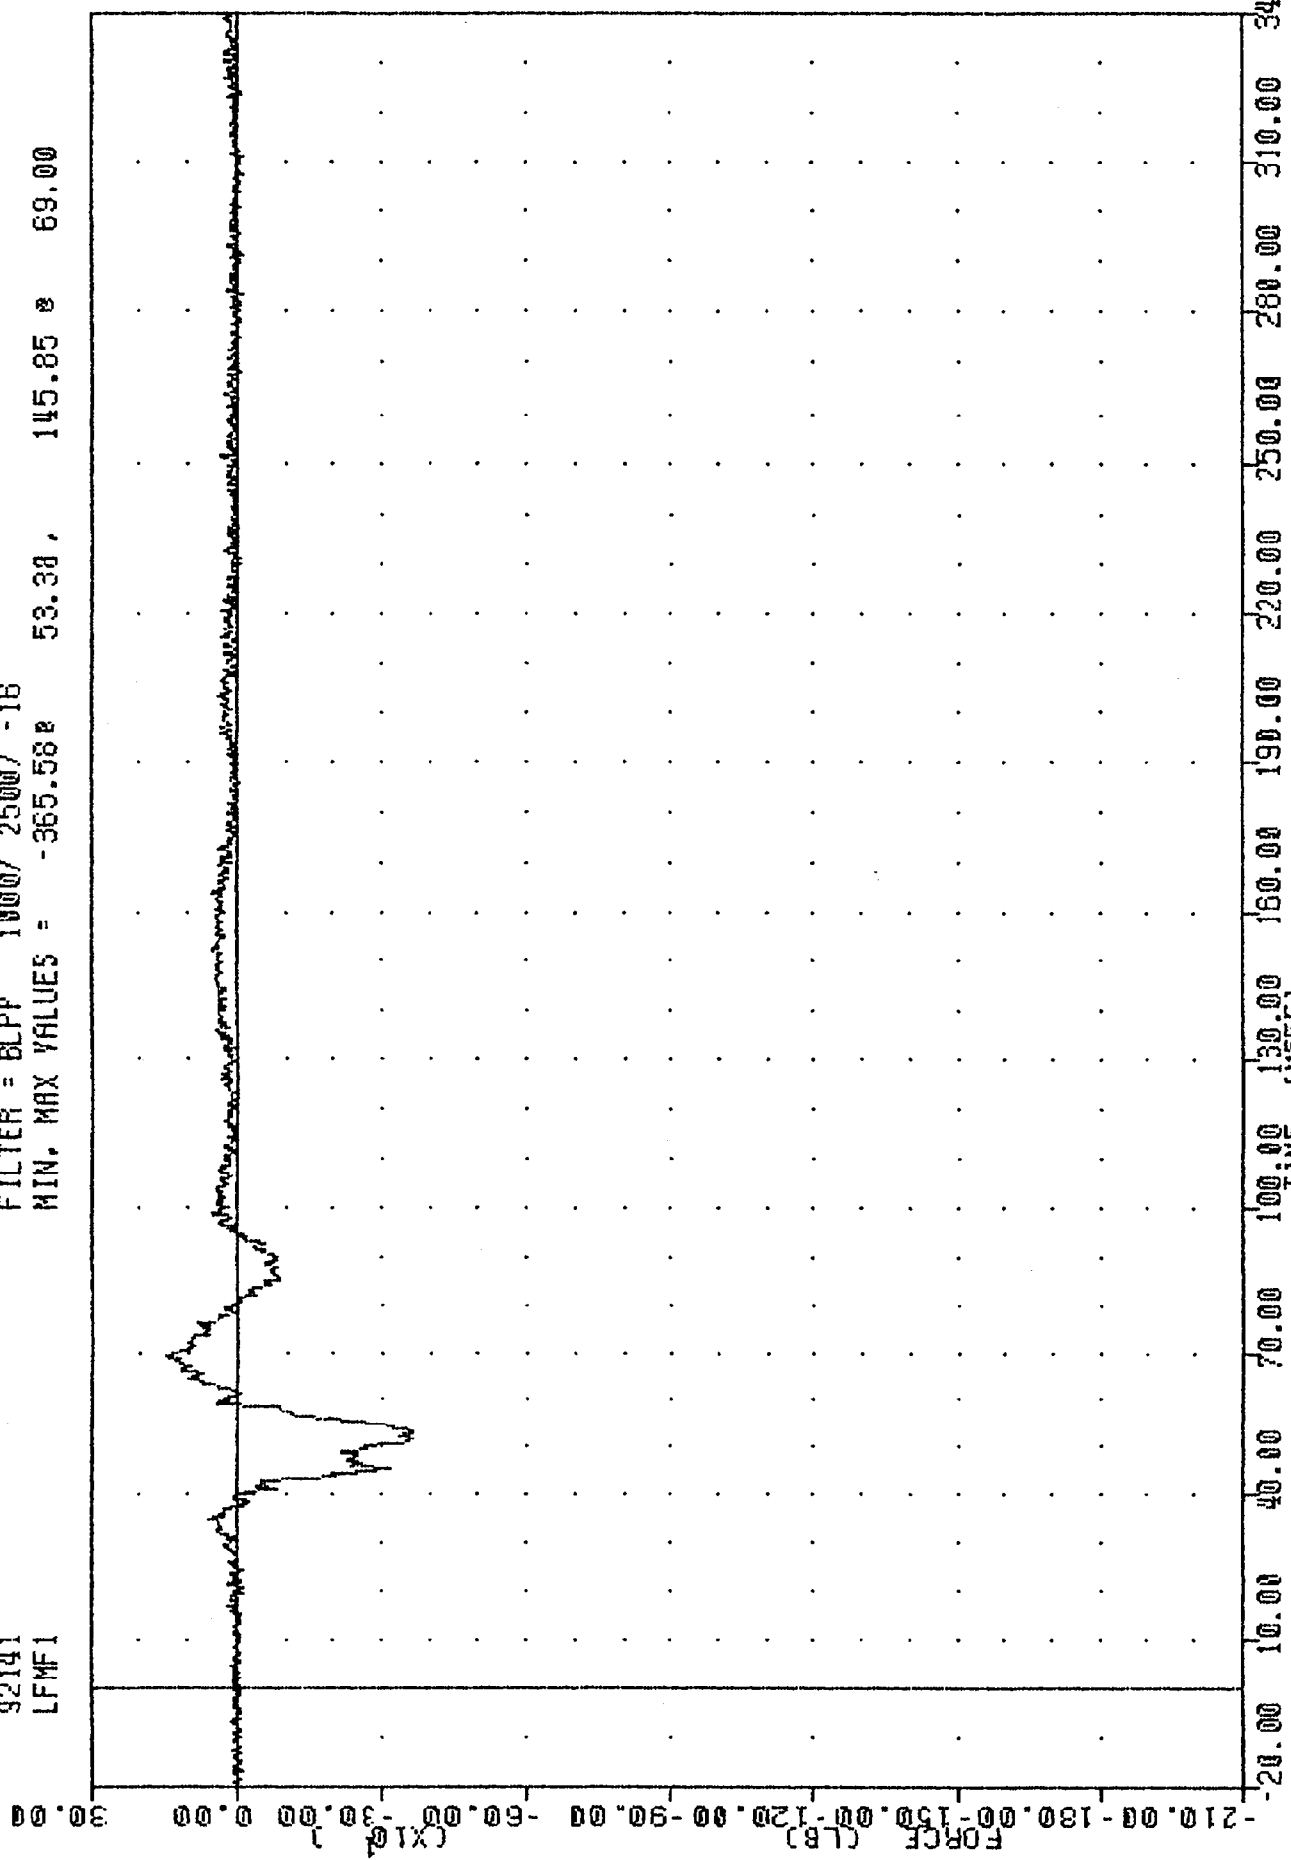
FILTER = BLPP 1000/ 2500/ -18
MIN. MAX VALUES = -365.58e 53.38 , 145.85 e 69.00

1992 ISUZU PICKUP INTO FLAT FRONTAL BARRIER
DRIVER LEFT FEMUR FORCE

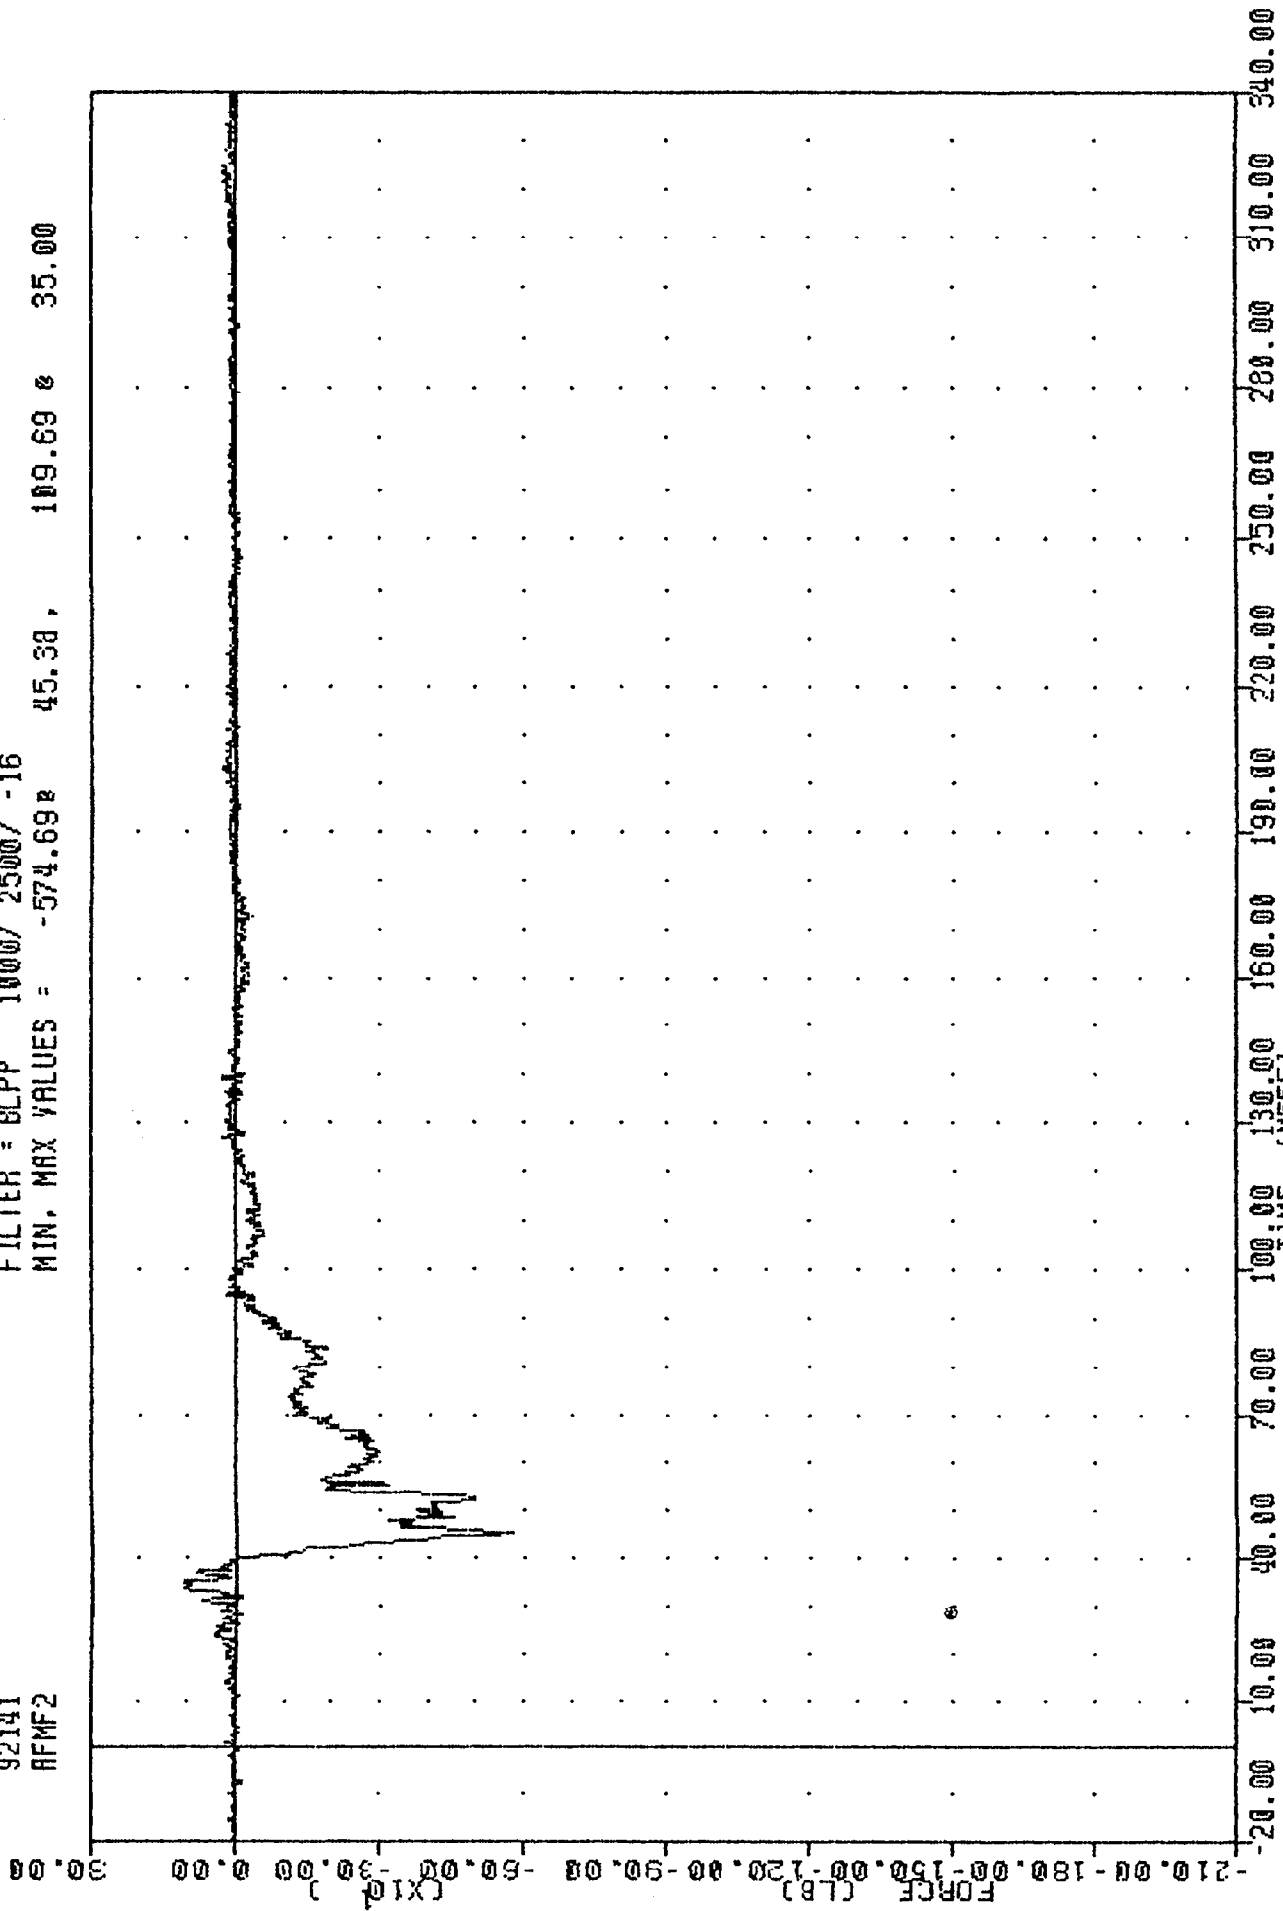
FILTER = BLPP 1000/ 2500/ -16
MIN. MAX VALUES = -574.69B 45.38 , 109.69 e 35.00

1992 ISUZU PICKUP INTO FLAT FRONTAL BARRIER
RIGHT FRONT PASSENGER RIGHT FEMUR FORCE
