REPORT NO.: MSE-92-02-TR1086-02

**SIDE IMPACT PROTECTION STUDY
IN PRODUCTION VEHICLES
MDB-TO-VEHICLE SIDE IMPACT TEST OF
A 27⁰ CRABBED MOVING DEFORMABLE BARRIER
TO A 1989 FORD RANGER XLT PICKUP
AT 33.0 MPH**

NHTSA NO.: RK0600

FINAL REPORT

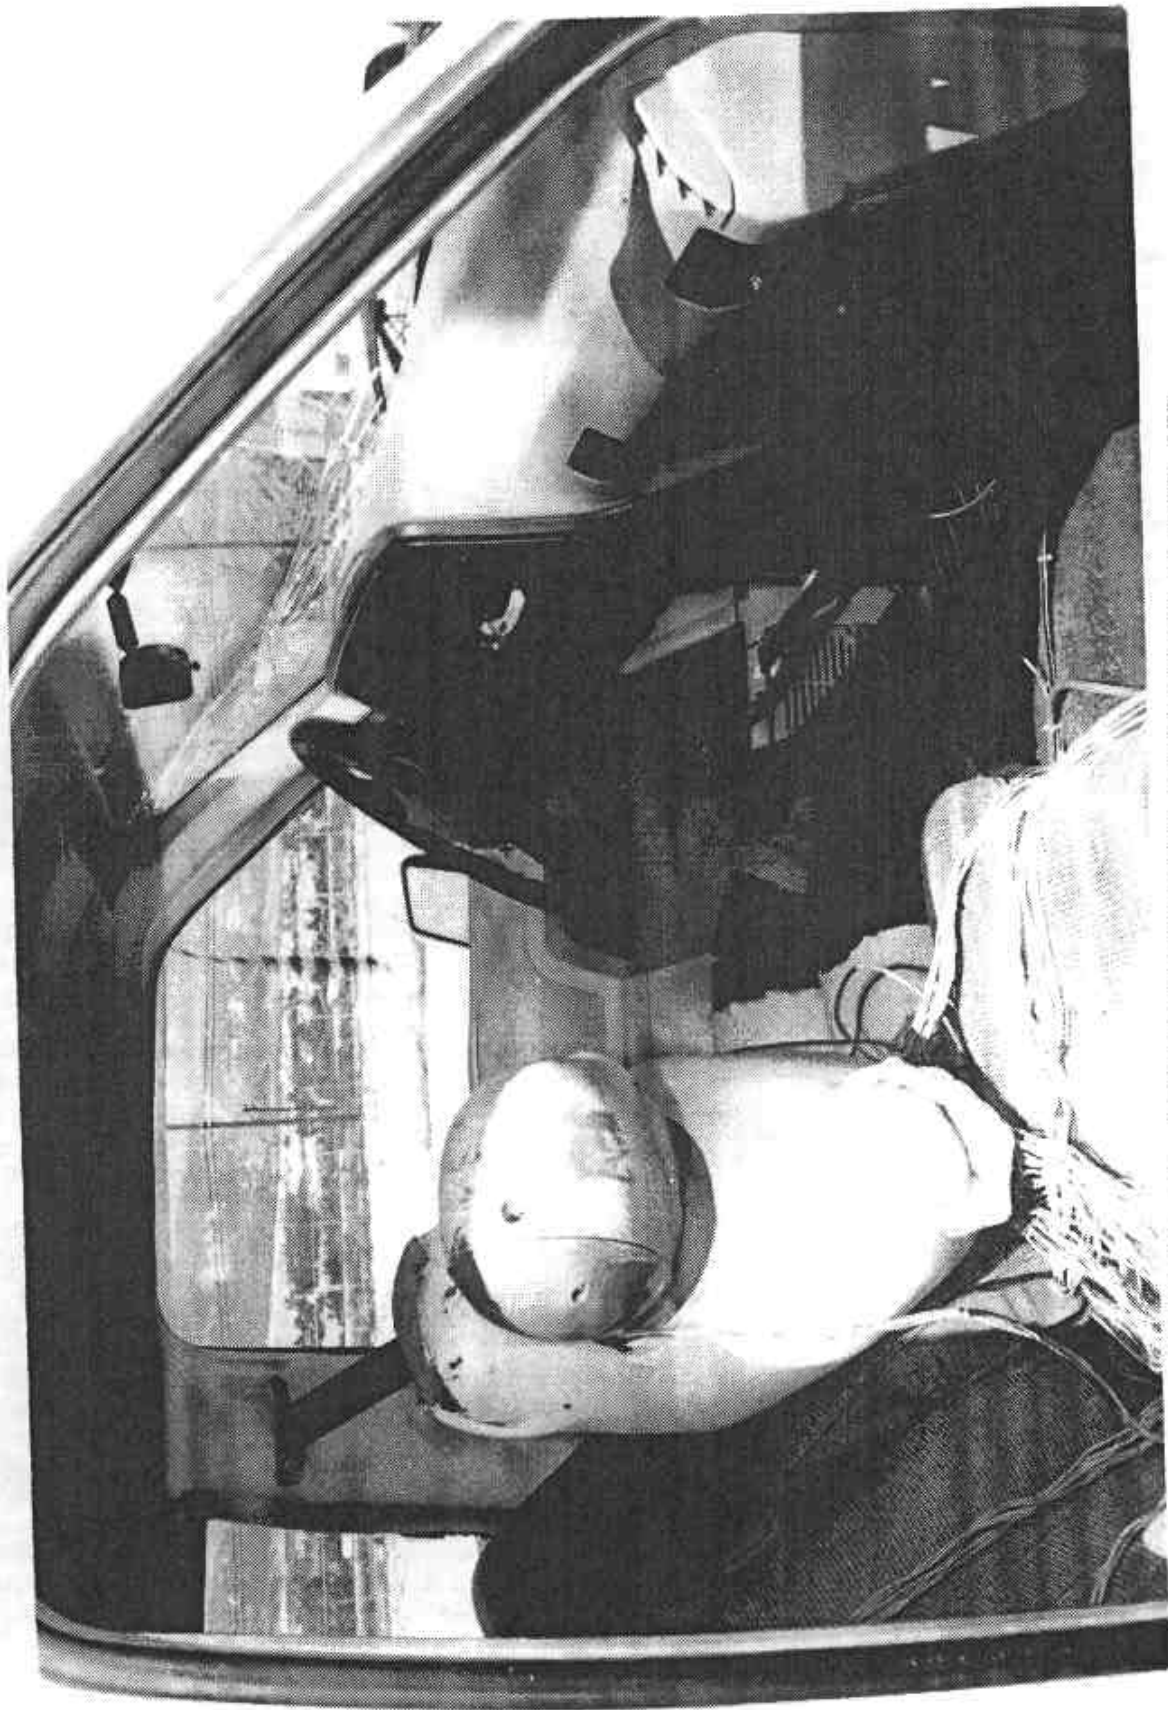
FIGURE 5-19 POSTTEST OCCUPANT COMPARTMENT DRIVER SID

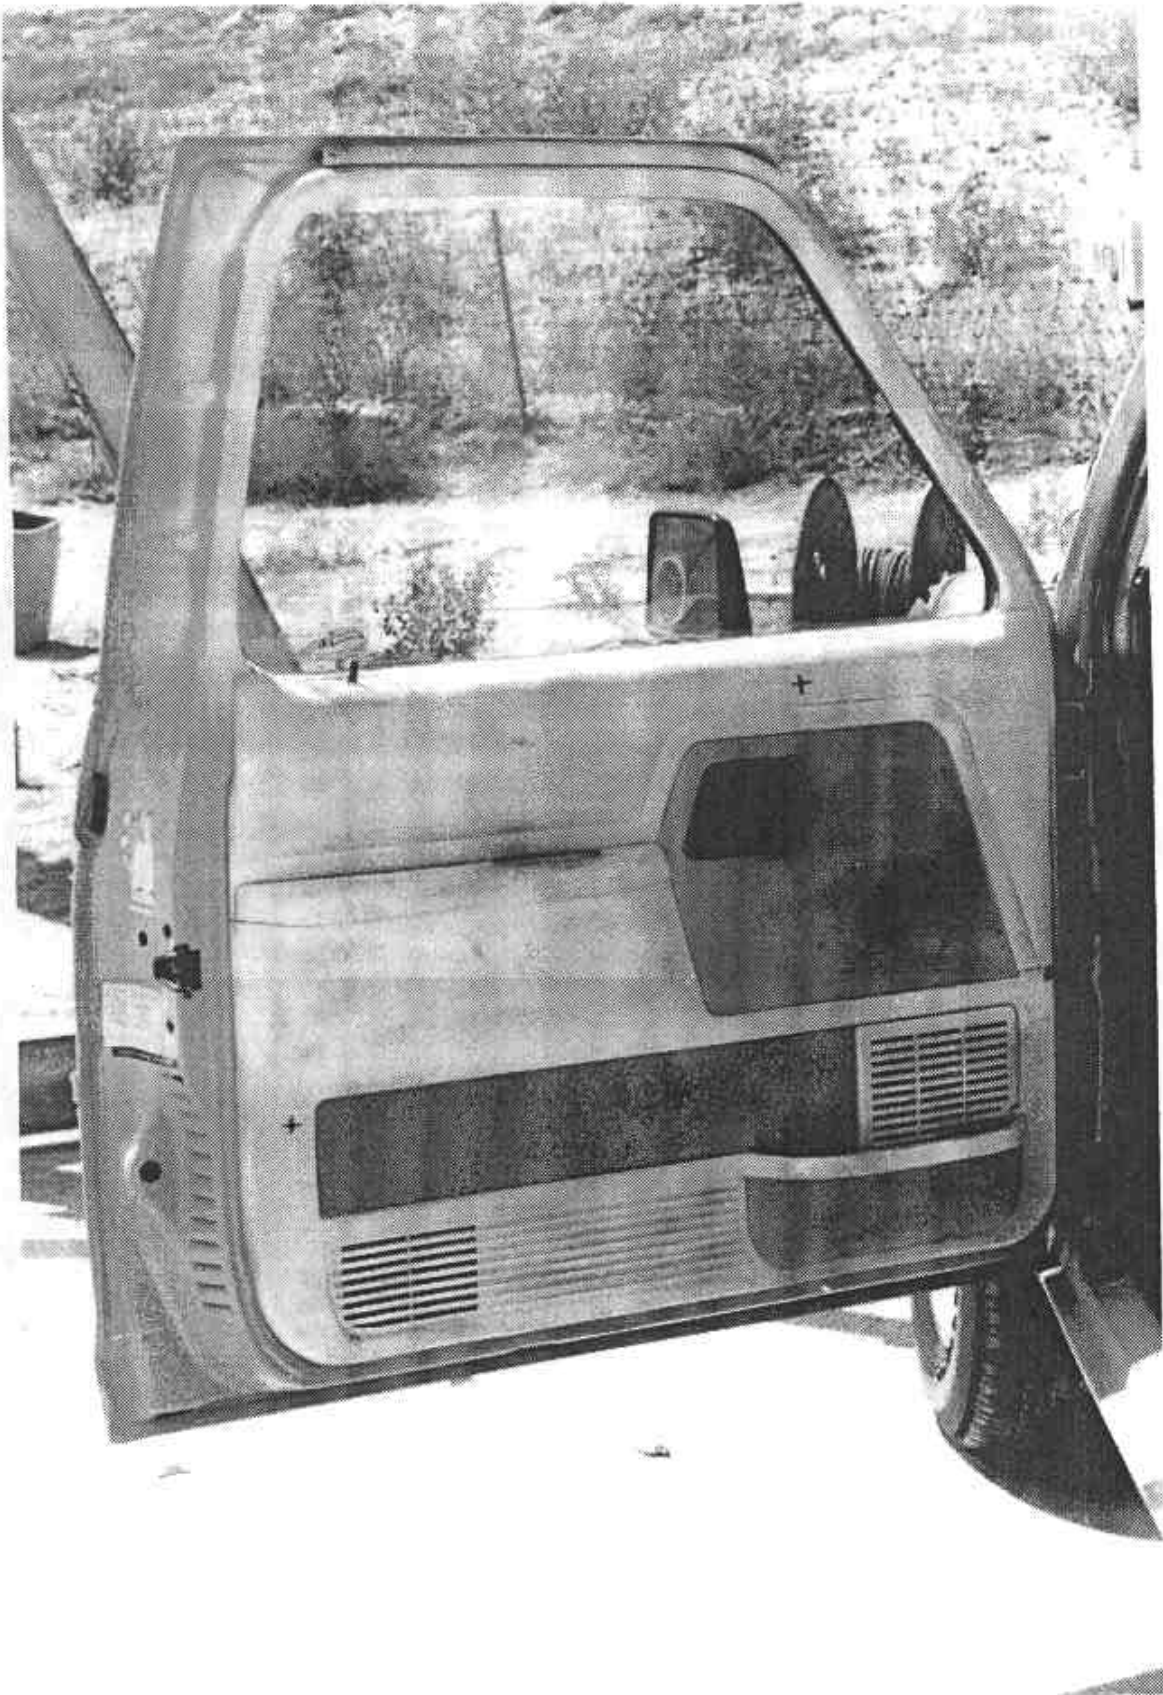
FIGURE 5-24 DRIVER DOOR ACCELEROMETERS INSTALLED, DOOR PANEL IN PLACE-PRETEST
