**SIDE IMPACT PROTECTION STUDY  
IN PRODUCTION VEHICLES  
MDB-TO-VEHICLE SIDE IMPACT TEST OF  
A 27<sup>0</sup> CRABBED MOVING DEFORMABLE BARRIER  
TO A 1989 SUZUKI SIDEKICK  
AT 33.0 MPH**

**NHTSA NO.: RK0504**

**MOBILITY SYSTEMS AND EQUIPMENT COMPANY  
9920 LA CIENEGA BOULEVARD SUITE 708  
INGLEWOOD, CALIFORNIA 90301**

FINAL REPORT

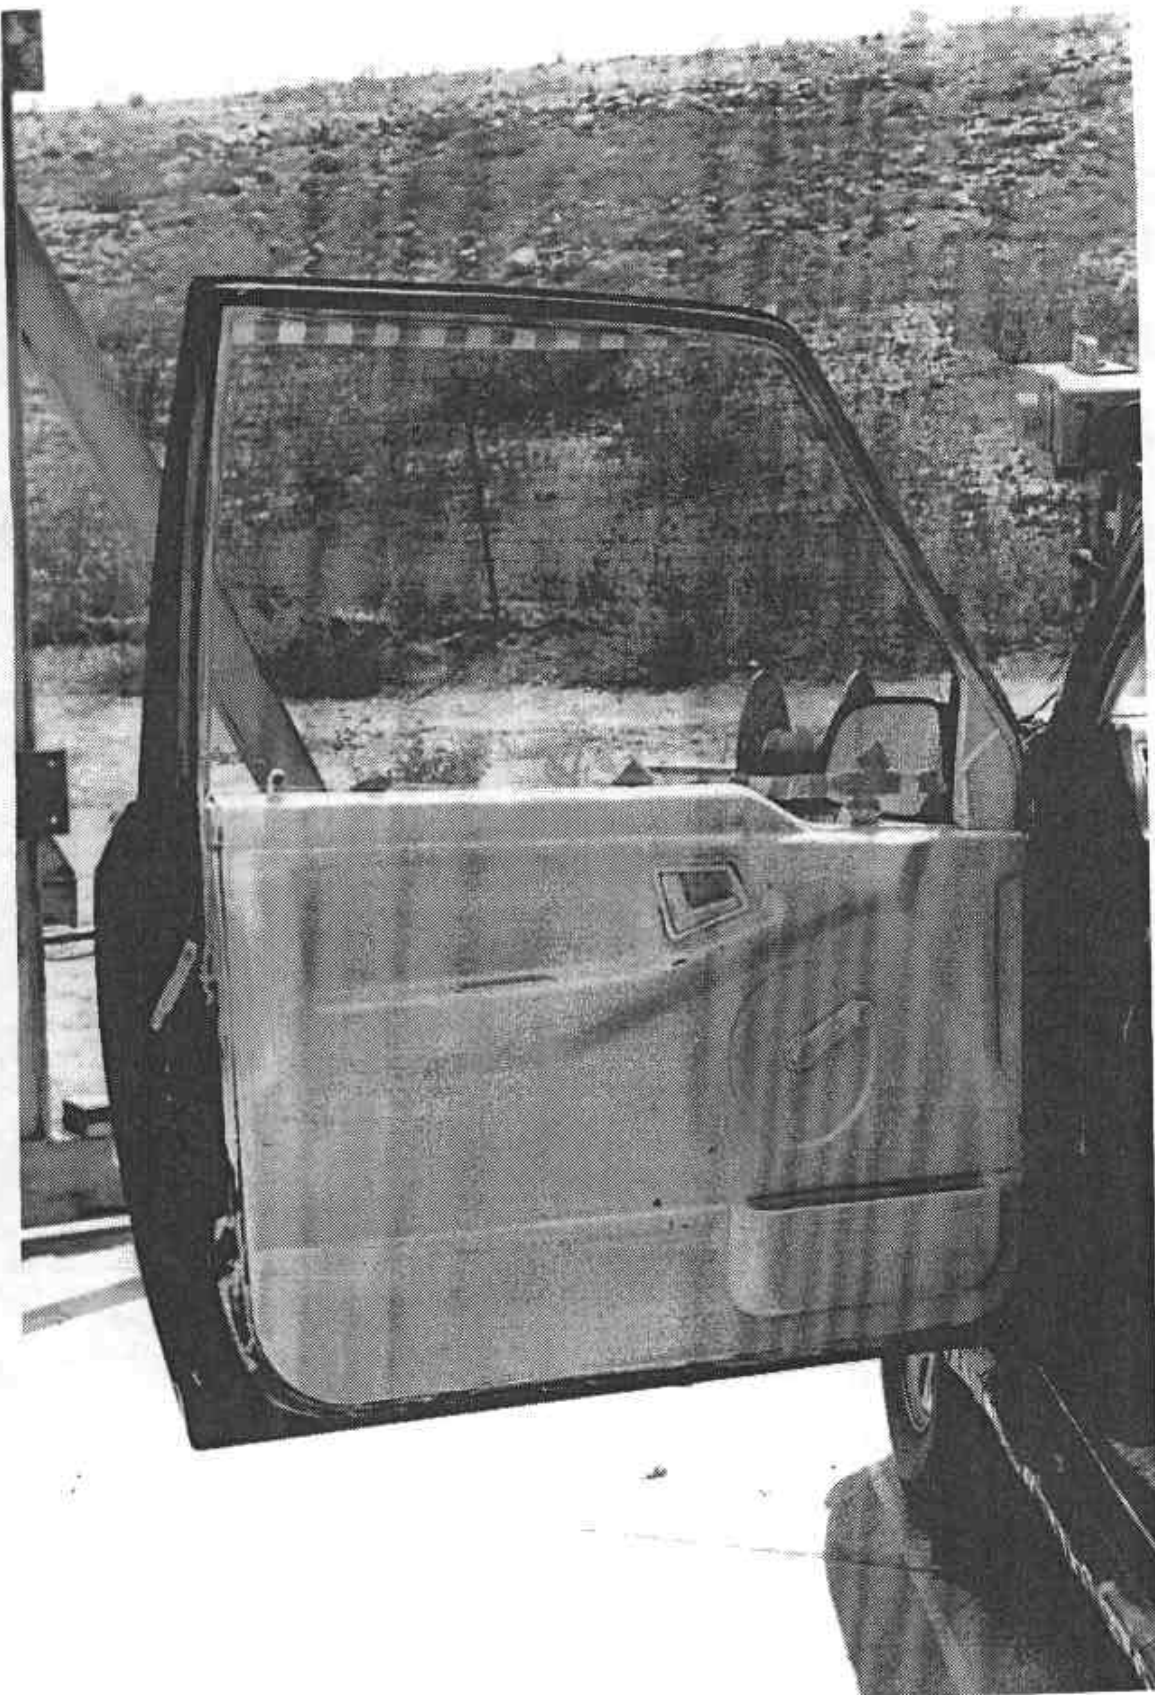
FIGURE 5-24 DRIVER DOOR ACCELEROMETERS INSTALLED, DOOR PANEL IN PLACE-PRETEST

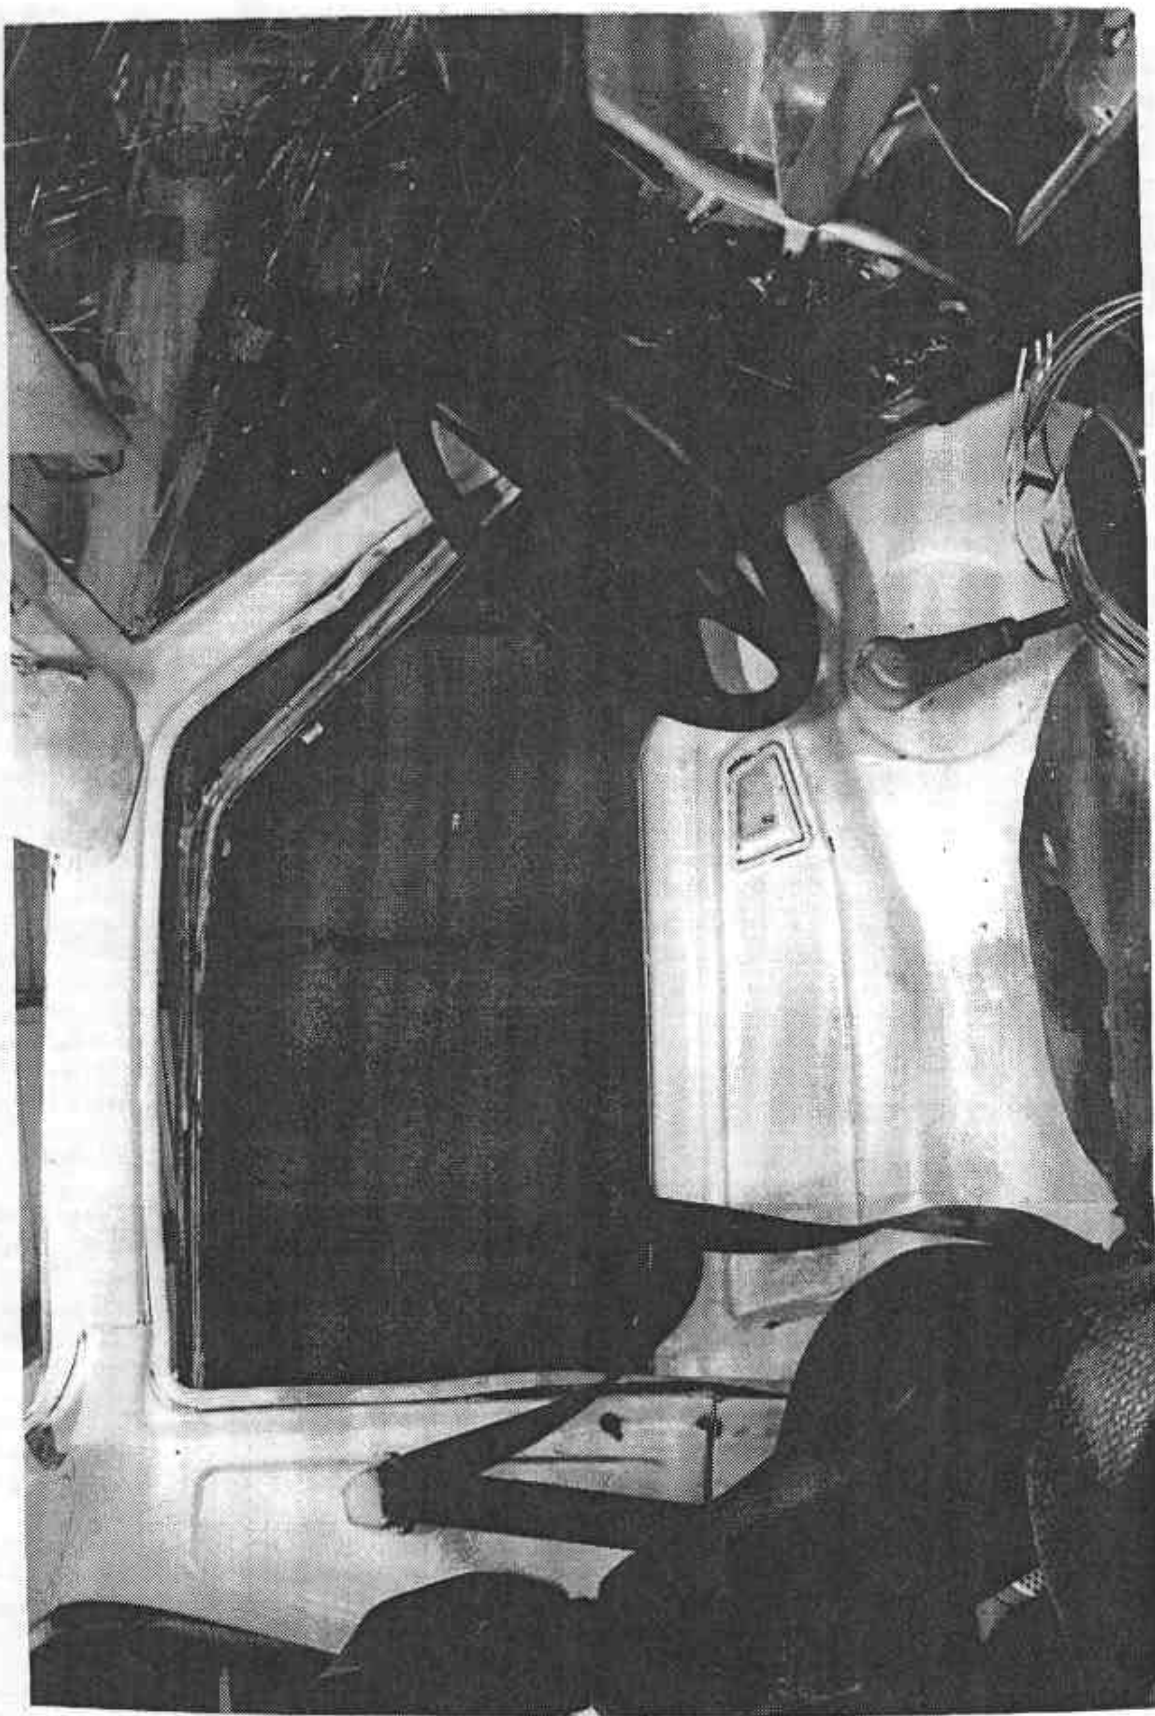
FIGURE 5-25 DRIVER SEATING POSITION - POSTTEST

Other Notable Impact Effect: Driver's seat adjustor right rear anchor point failed. Both of SID's legs were broken above the knee. Some deformation to right side of vehicle aft of door.
