REPORT NO.: MSE-92-05-TR1086-05

**SIDE IMPACT PROTECTION STUDY
IN PRODUCTION VEHICLES
MDB-TO-VEHICLE SIDE IMPACT TEST OF
A 27⁰ CRABBED MOVING DEFORMABLE BARRIER
TO A 1990 FORD F-150 PICKUP
AT 33.0 MPH**

NHTSA NO.: RL0601

FINAL REPORT

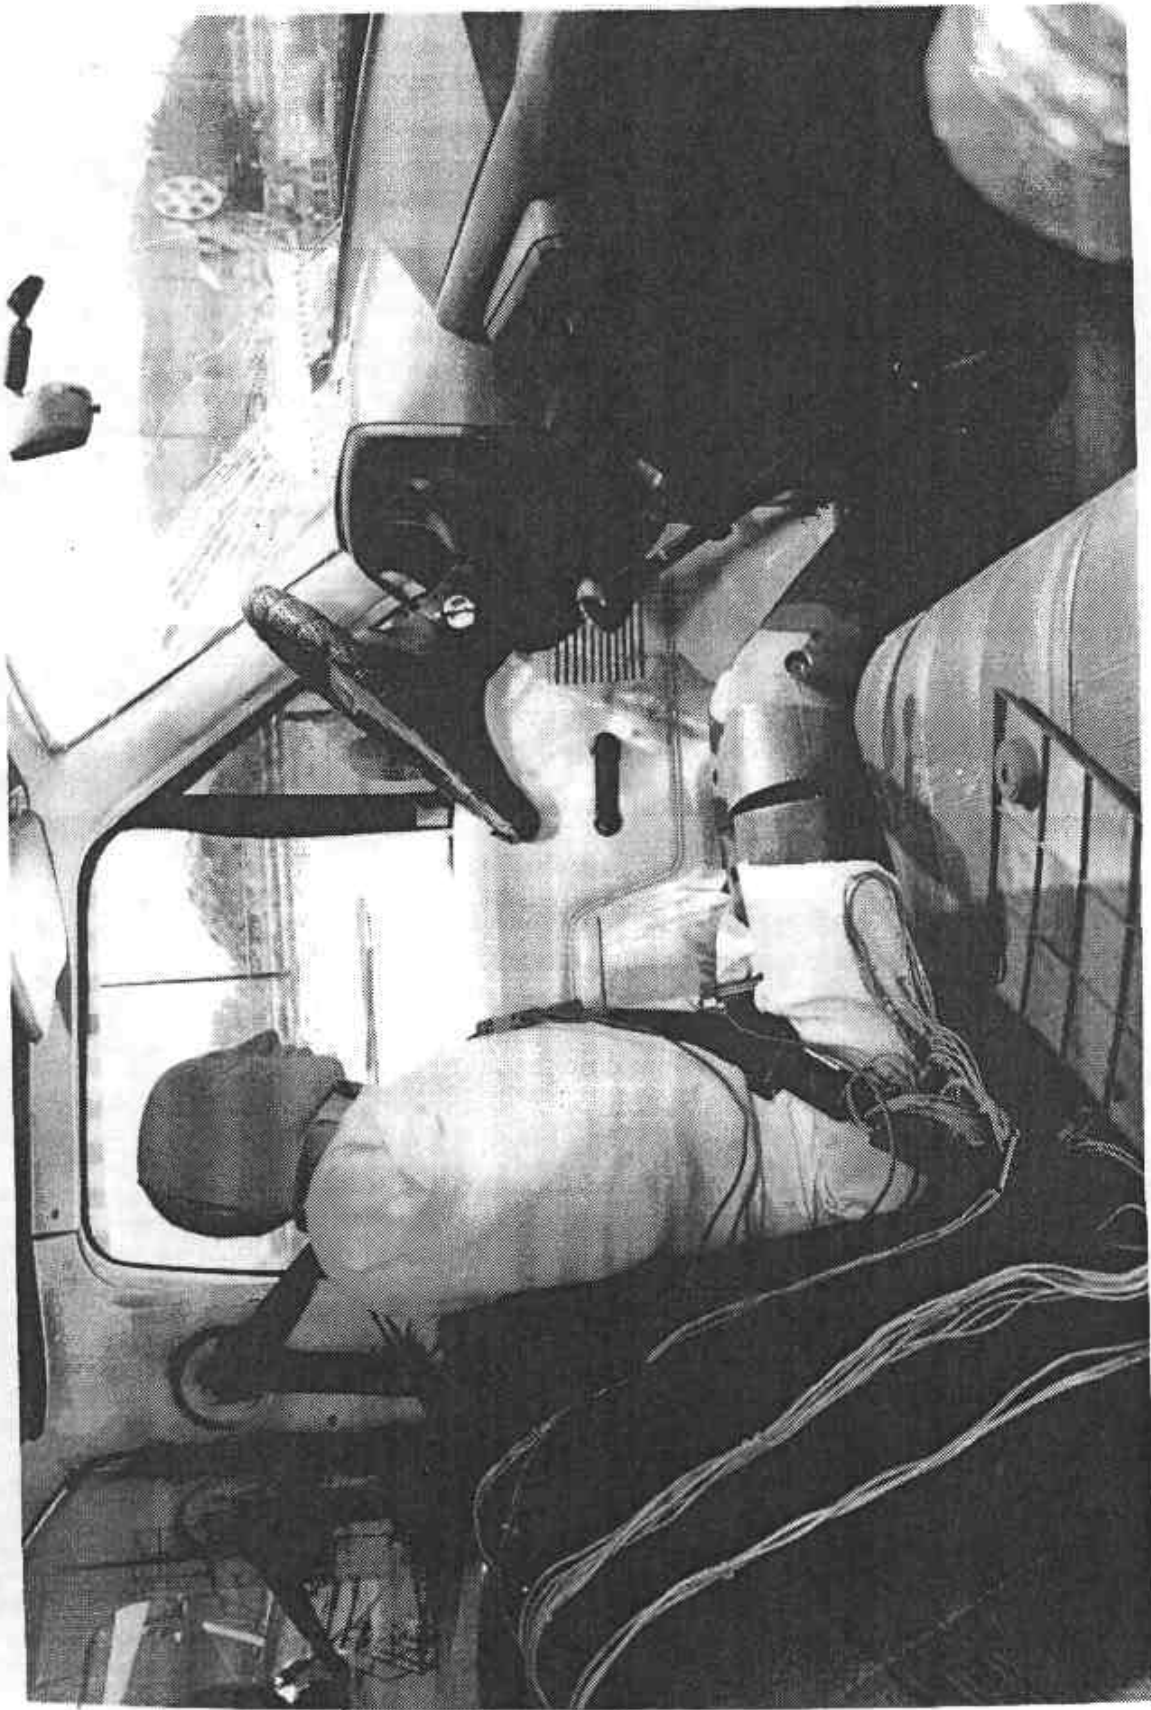
FIGURE 5-19 POSTTEST OCCUPANT COMPARTMENT SHOWING DRIVER SID
