**SIDE IMPACT PROTECTION STUDY  
IN PRODUCTION VEHICLES  
MDB-TO-VEHICLE SIDE IMPACT TEST OF  
A 27° CRABBED MOVING DEFORMABLE BARRIER  
TO A 1989 ISUZU TROOPER, 4 WHEEL DRIVE  
AT 33.0 MPH**

**NHTSA NO.: RK0505**

**MOBILITY SYSTEMS AND EQUIPMENT COMPANY  
9920 LA CIENEGA BOULEVARD SUITE 708  
INGLEWOOD, CALIFORNIA 90301**

FINAL REPORT

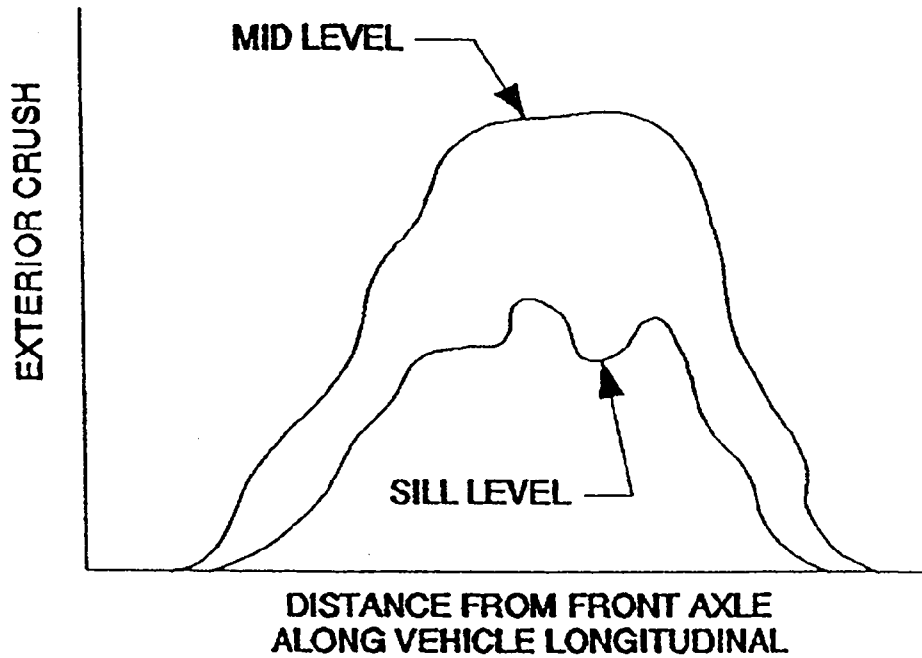
External Lateral Damage Profile (sample shown below)

Maximum Exterior Static Crush (provide External Damage Profile on next page):

1. LEVEL 1 (16.0 inches above ground) = 3.1 inches
2. LEVEL 2 (31.8 inches above ground) = 12.9 inches
3. LEVEL 3 (32.3 inches above ground) = 12.9 inches
4. LEVEL 4 (45.6 inches above ground) = 9.8 inches
5. LEVEL 5 (65.0 inches above ground) = -7.9 inches

Maximum Post Test Intrusion = 12.9 inches

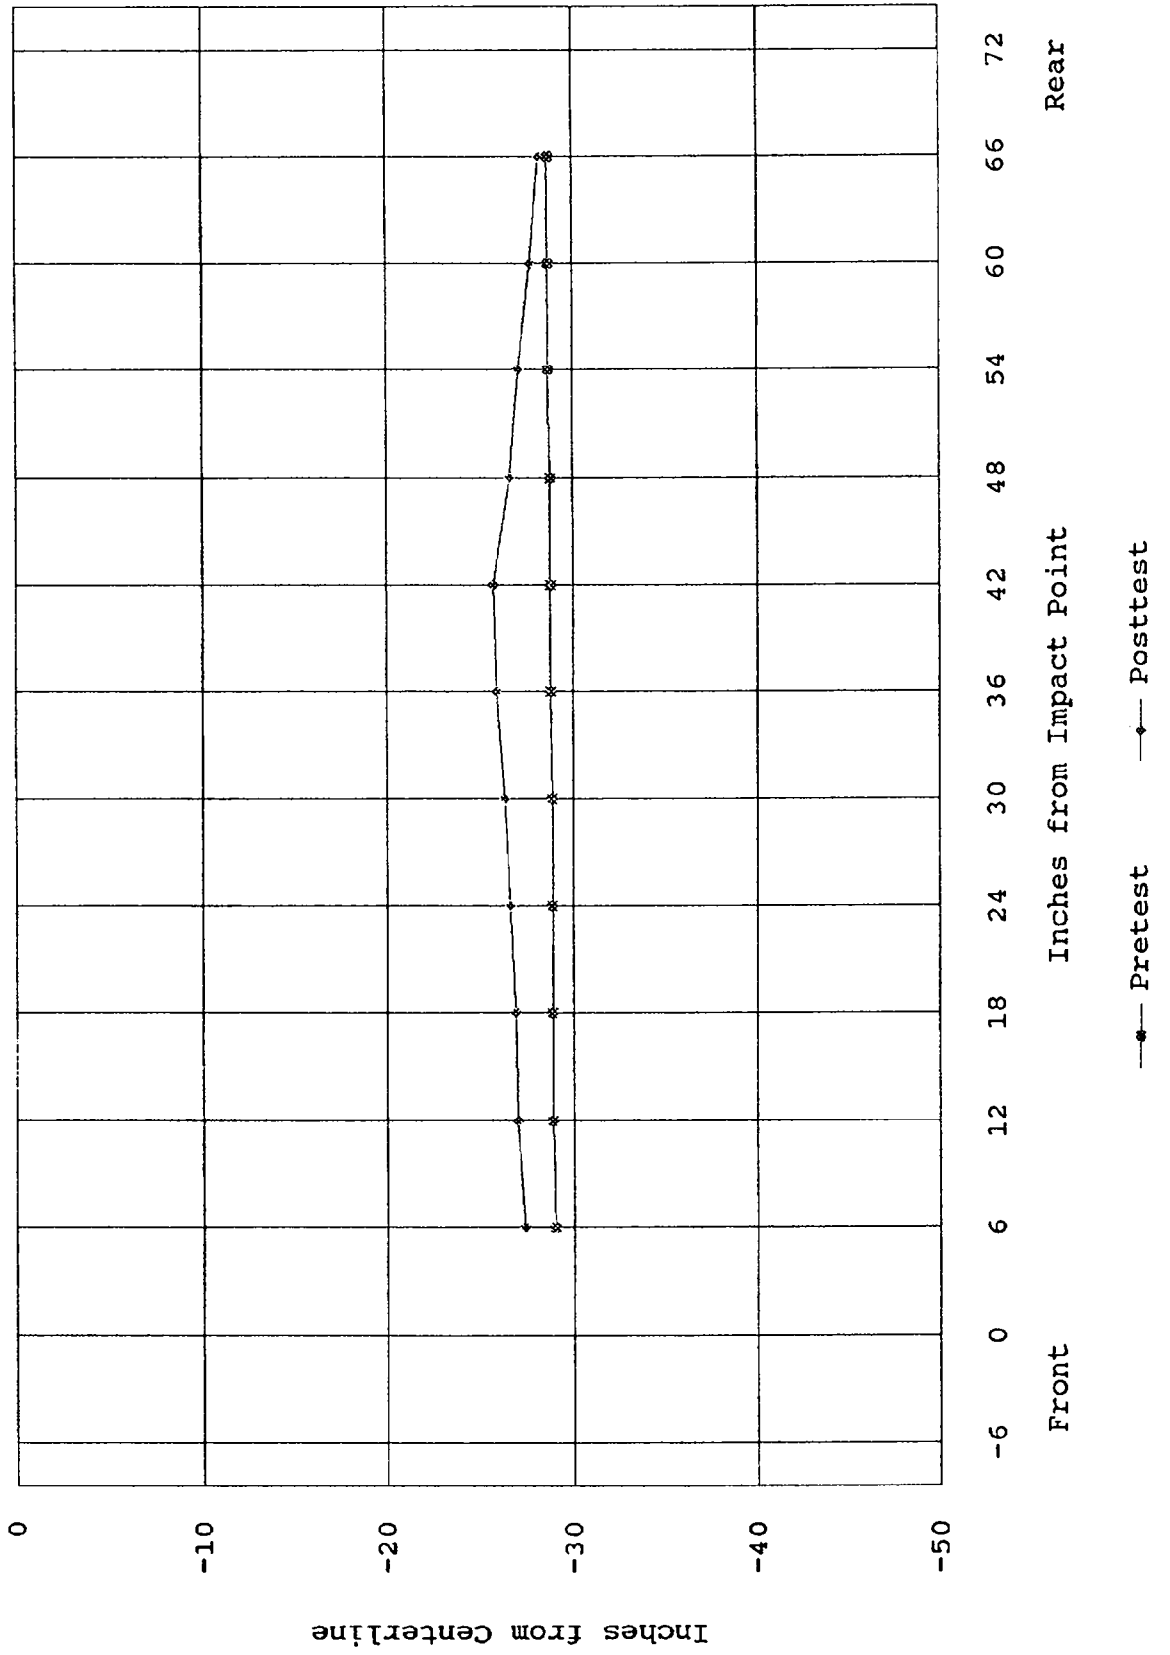
Pretest and Posttest Exterior Profile

Level 1 - Sill Top Height - 16.0" Above Ground Level

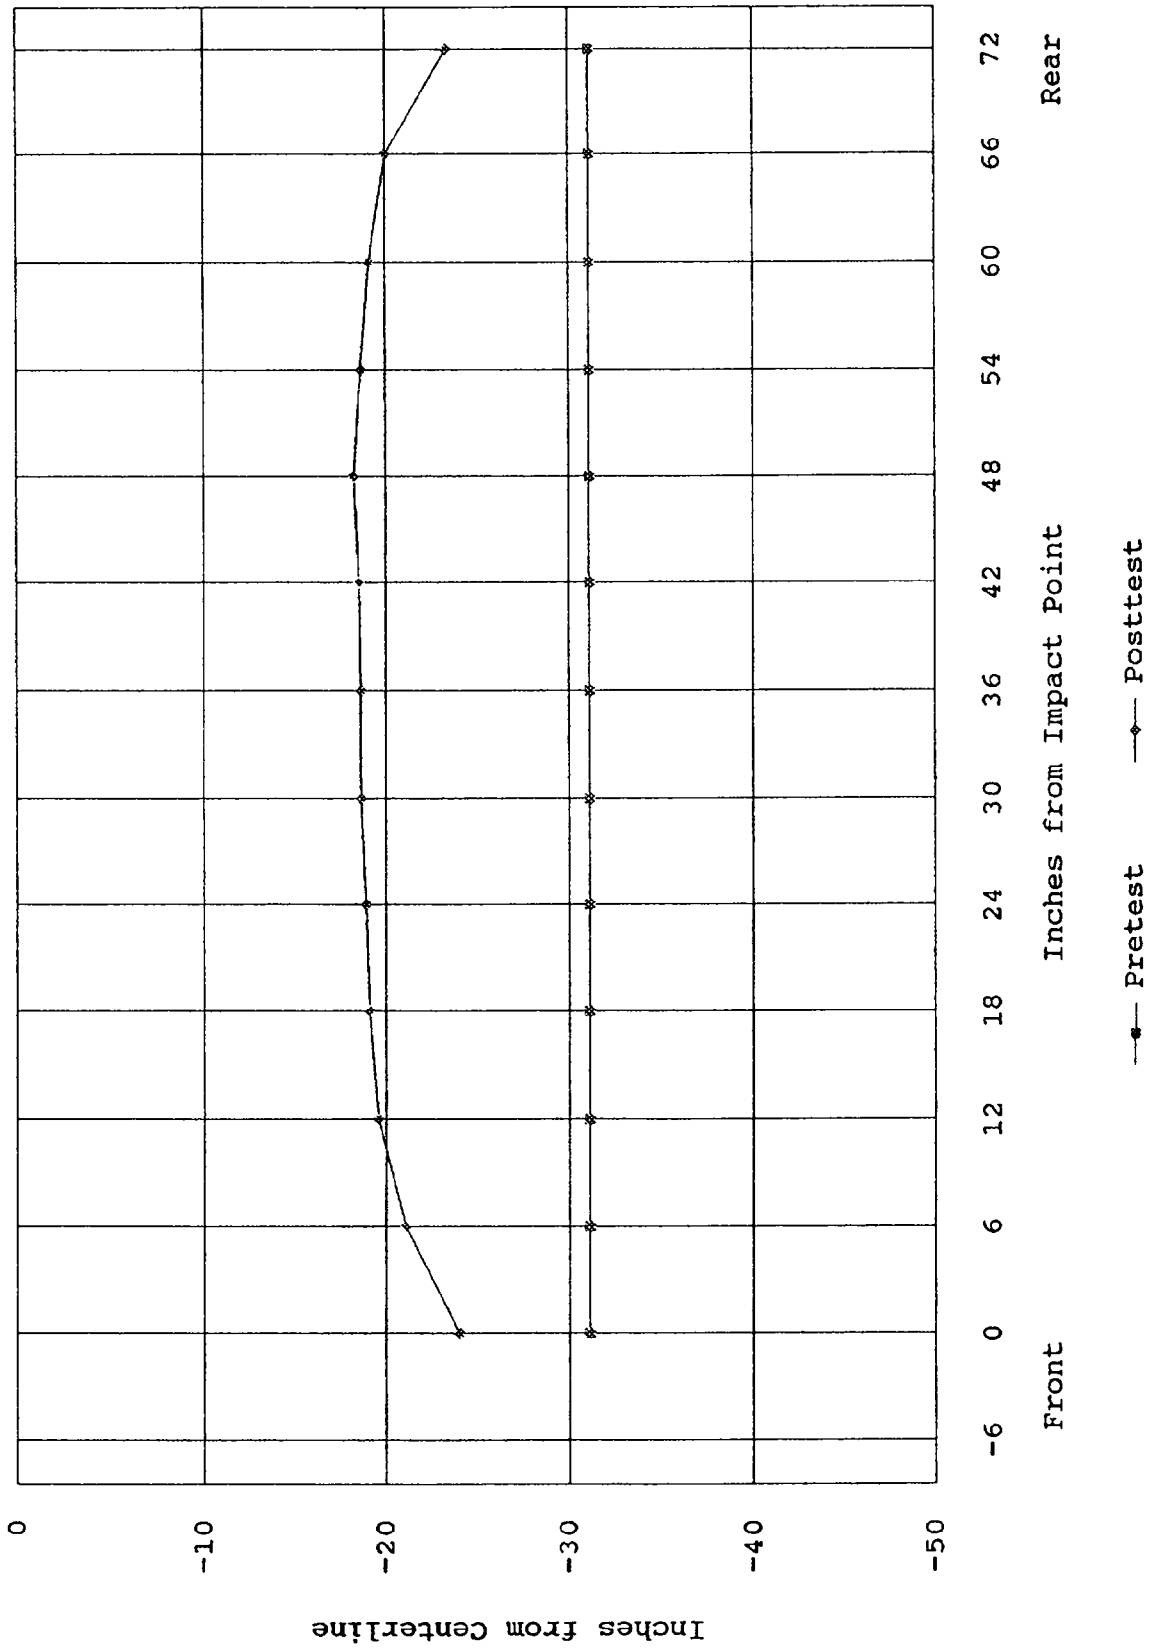
Pretest and Posttest Exterior Profile

Level 2 - Occupant H-point - 31.8" Above Ground Level

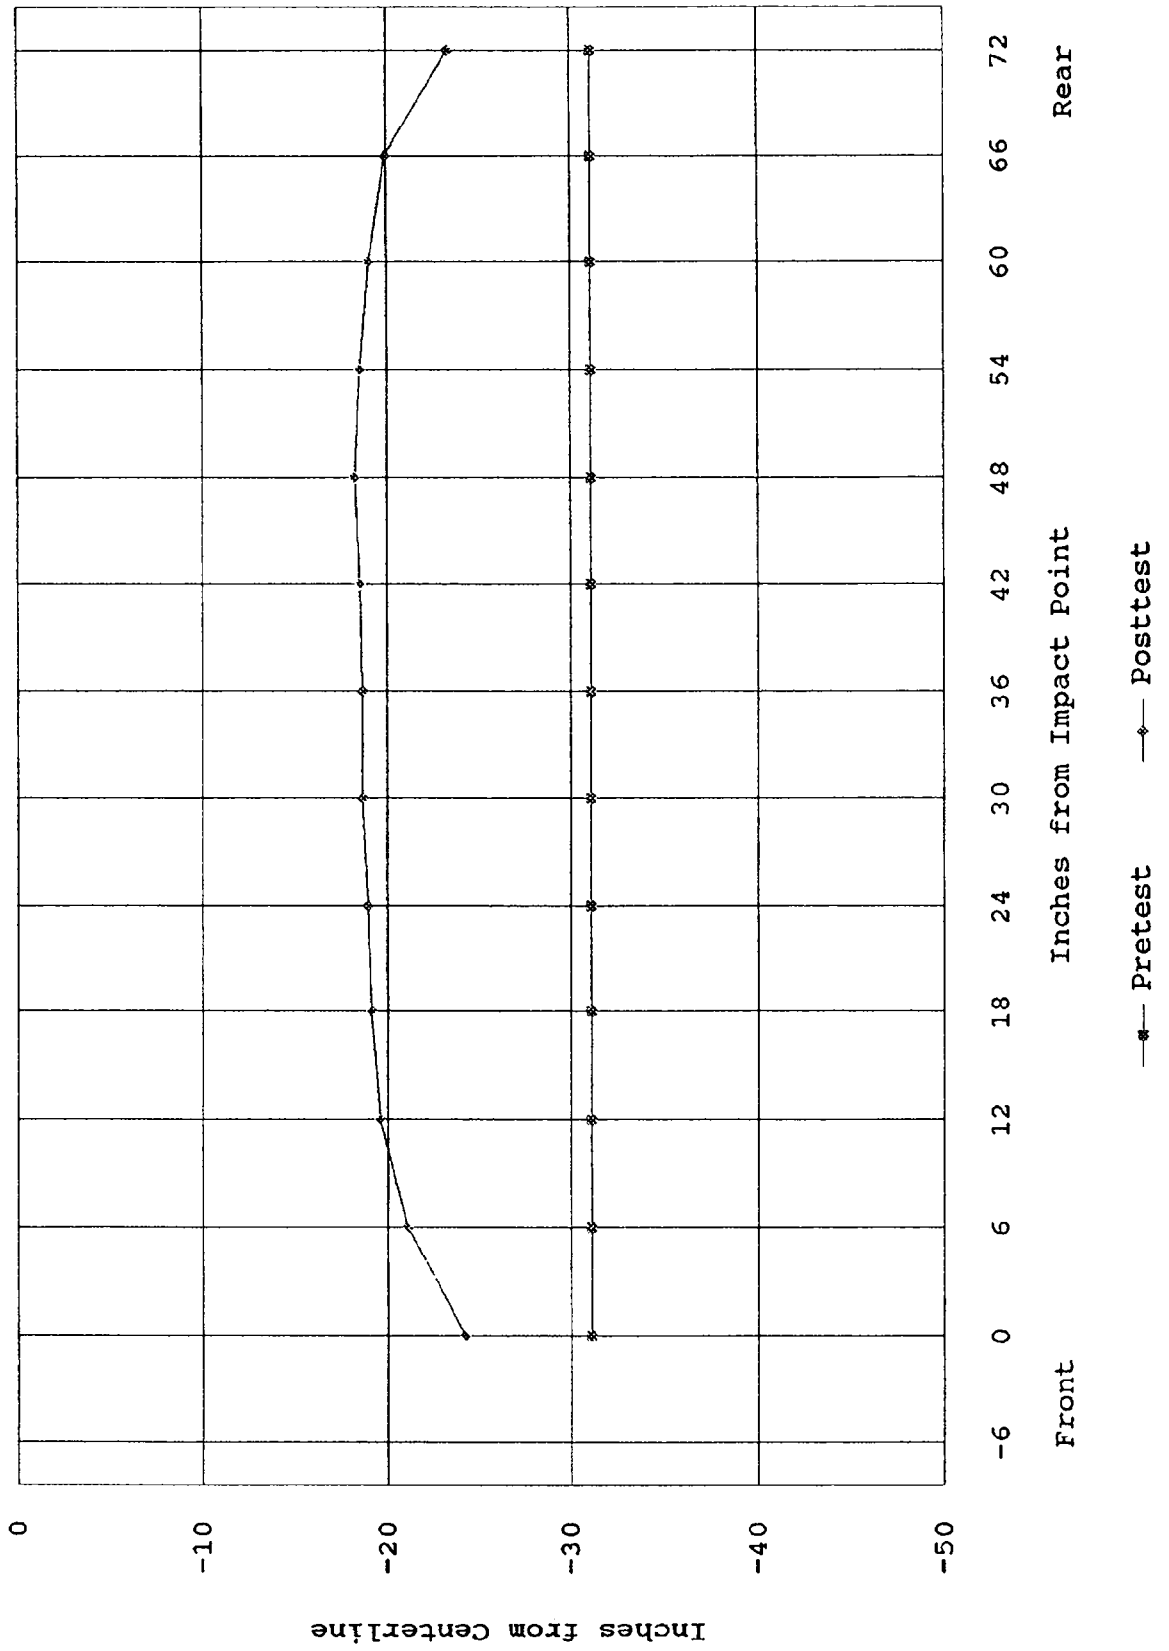
Pretest and Posttest Exterior Profile  
 Level 3 - Mid-door - 32.3" Above Ground Level

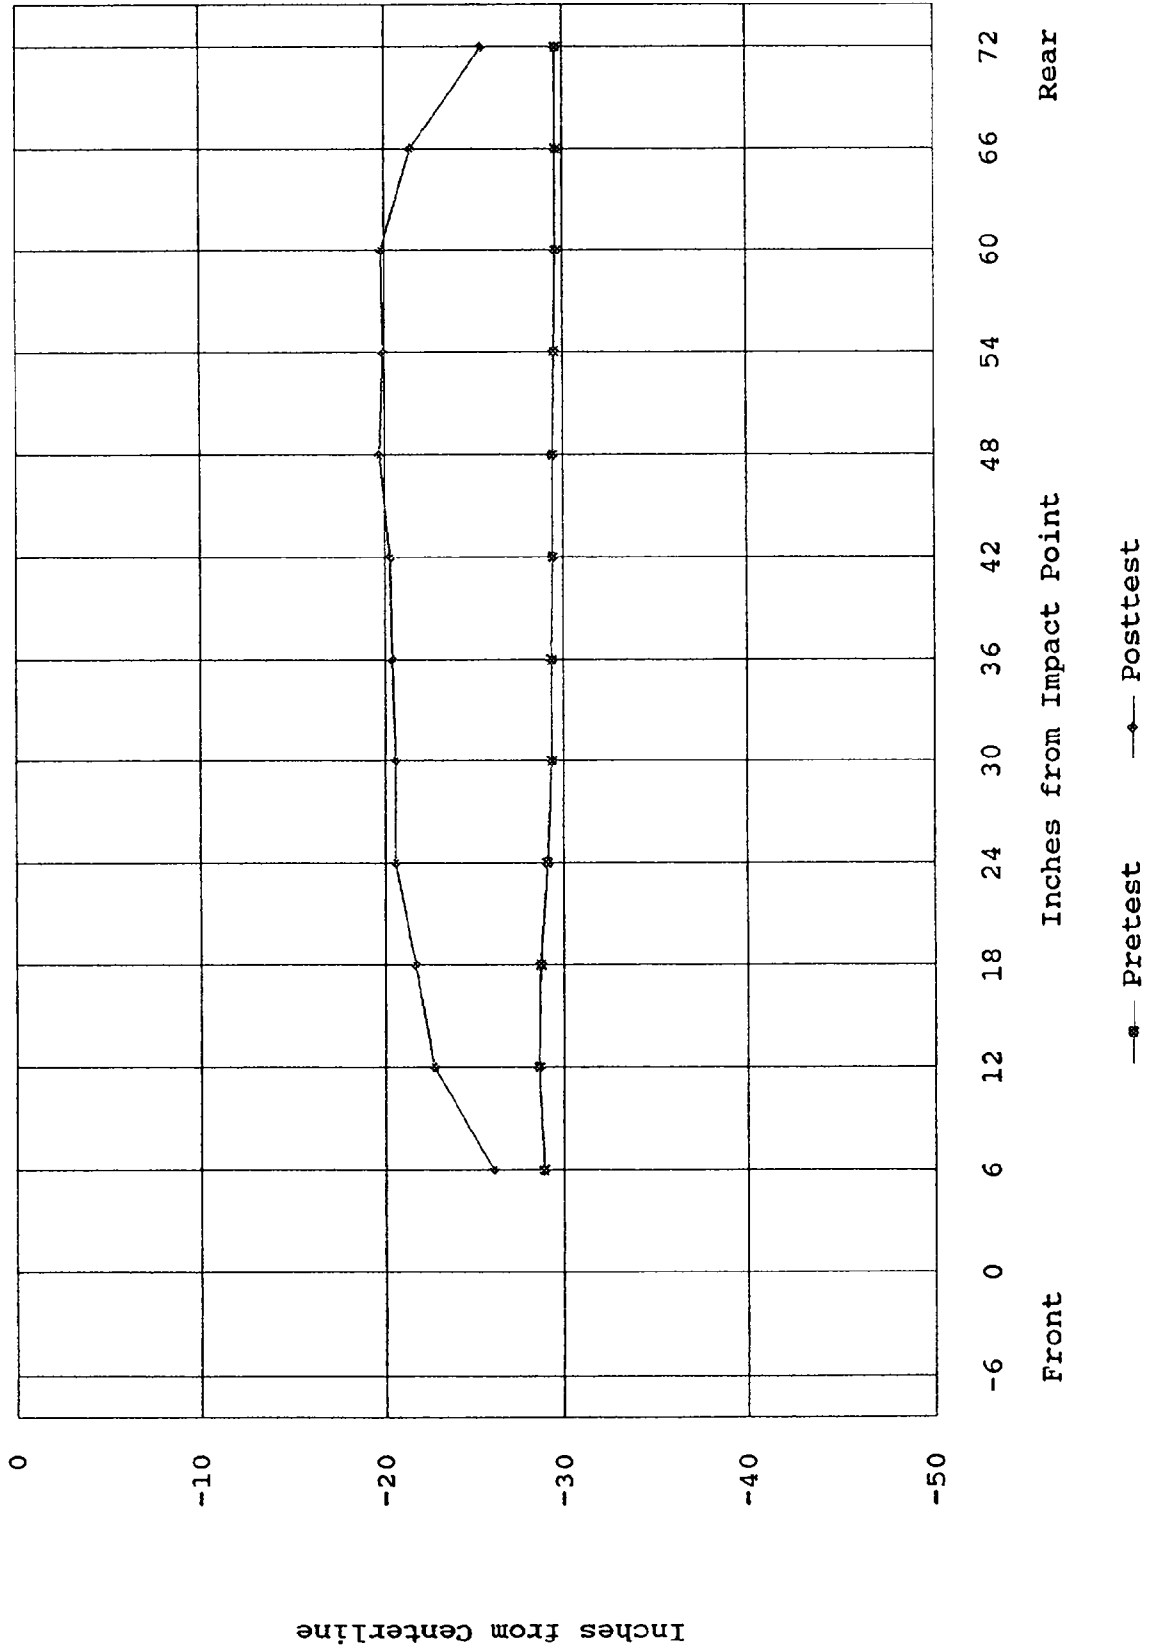
Pretest and Posttest Exterior Profile

Level 4 - Window Sill - 45.6" Above Ground Level

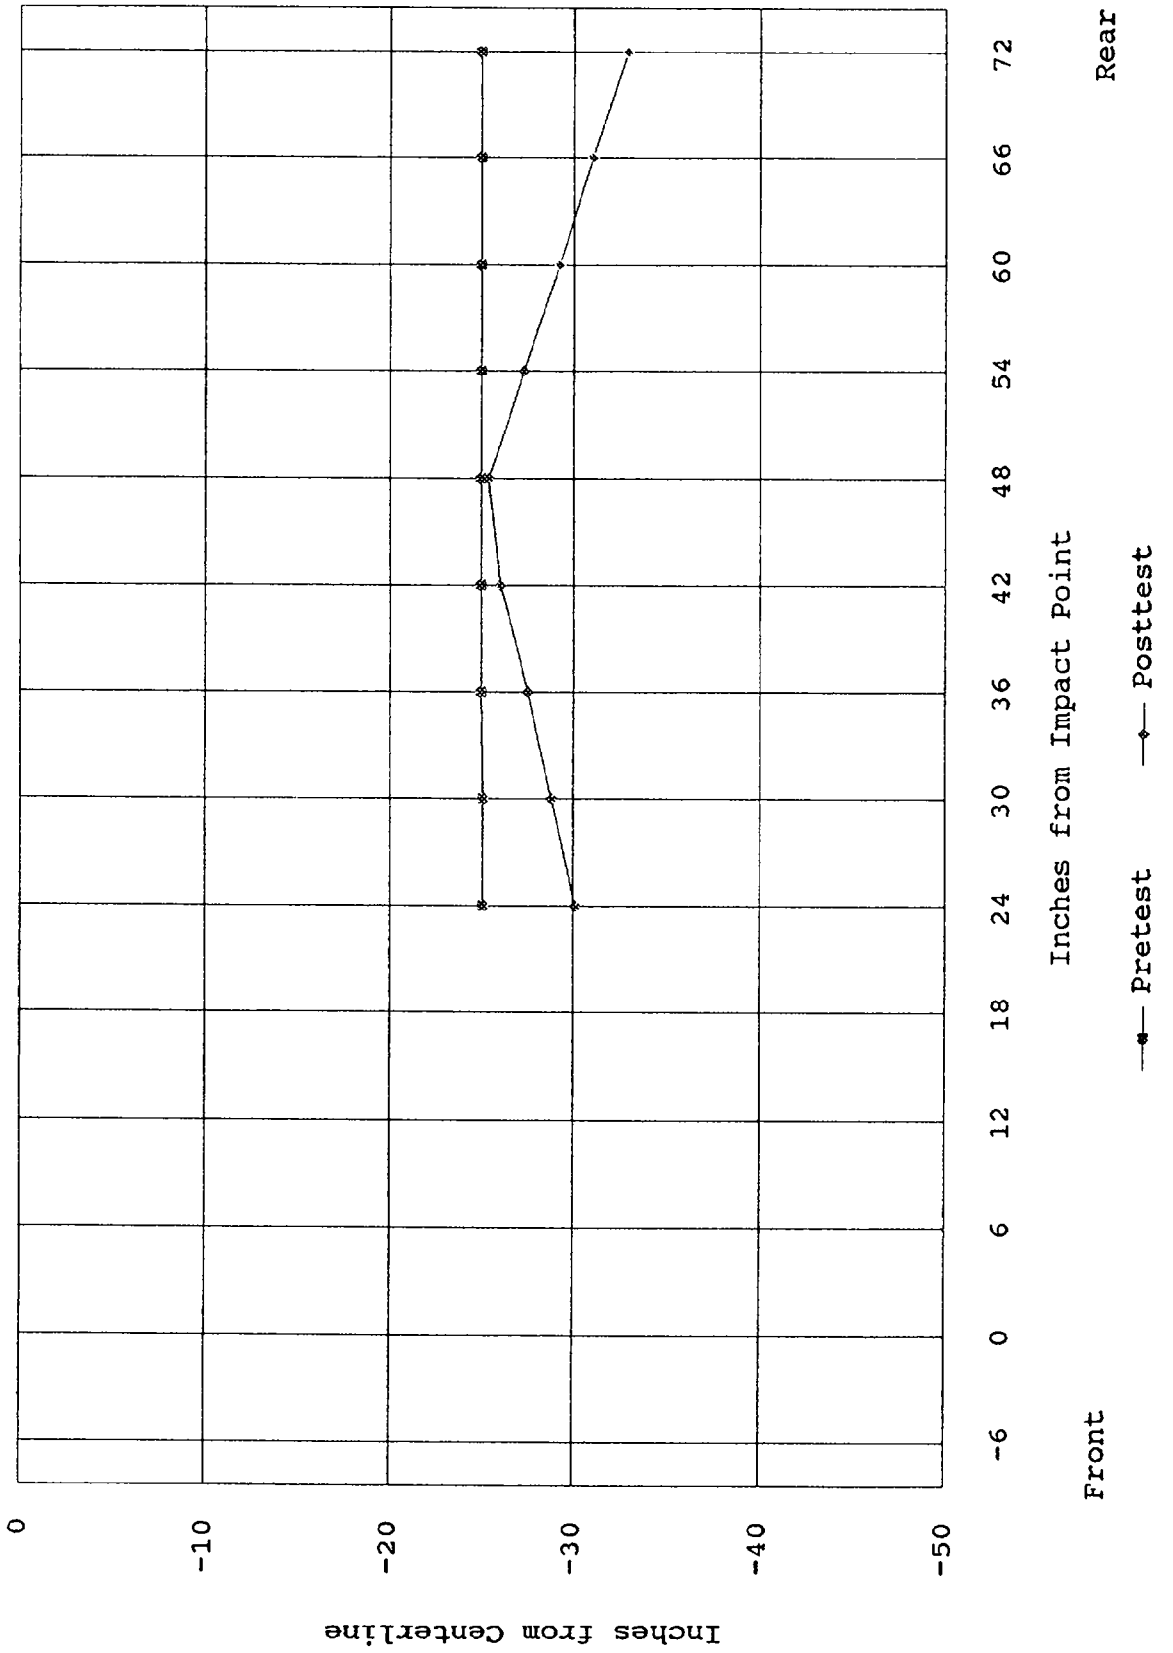
Pretest and Posttest Exterior Profile

Level 5 - Window Top - 65.0" Above Ground Level

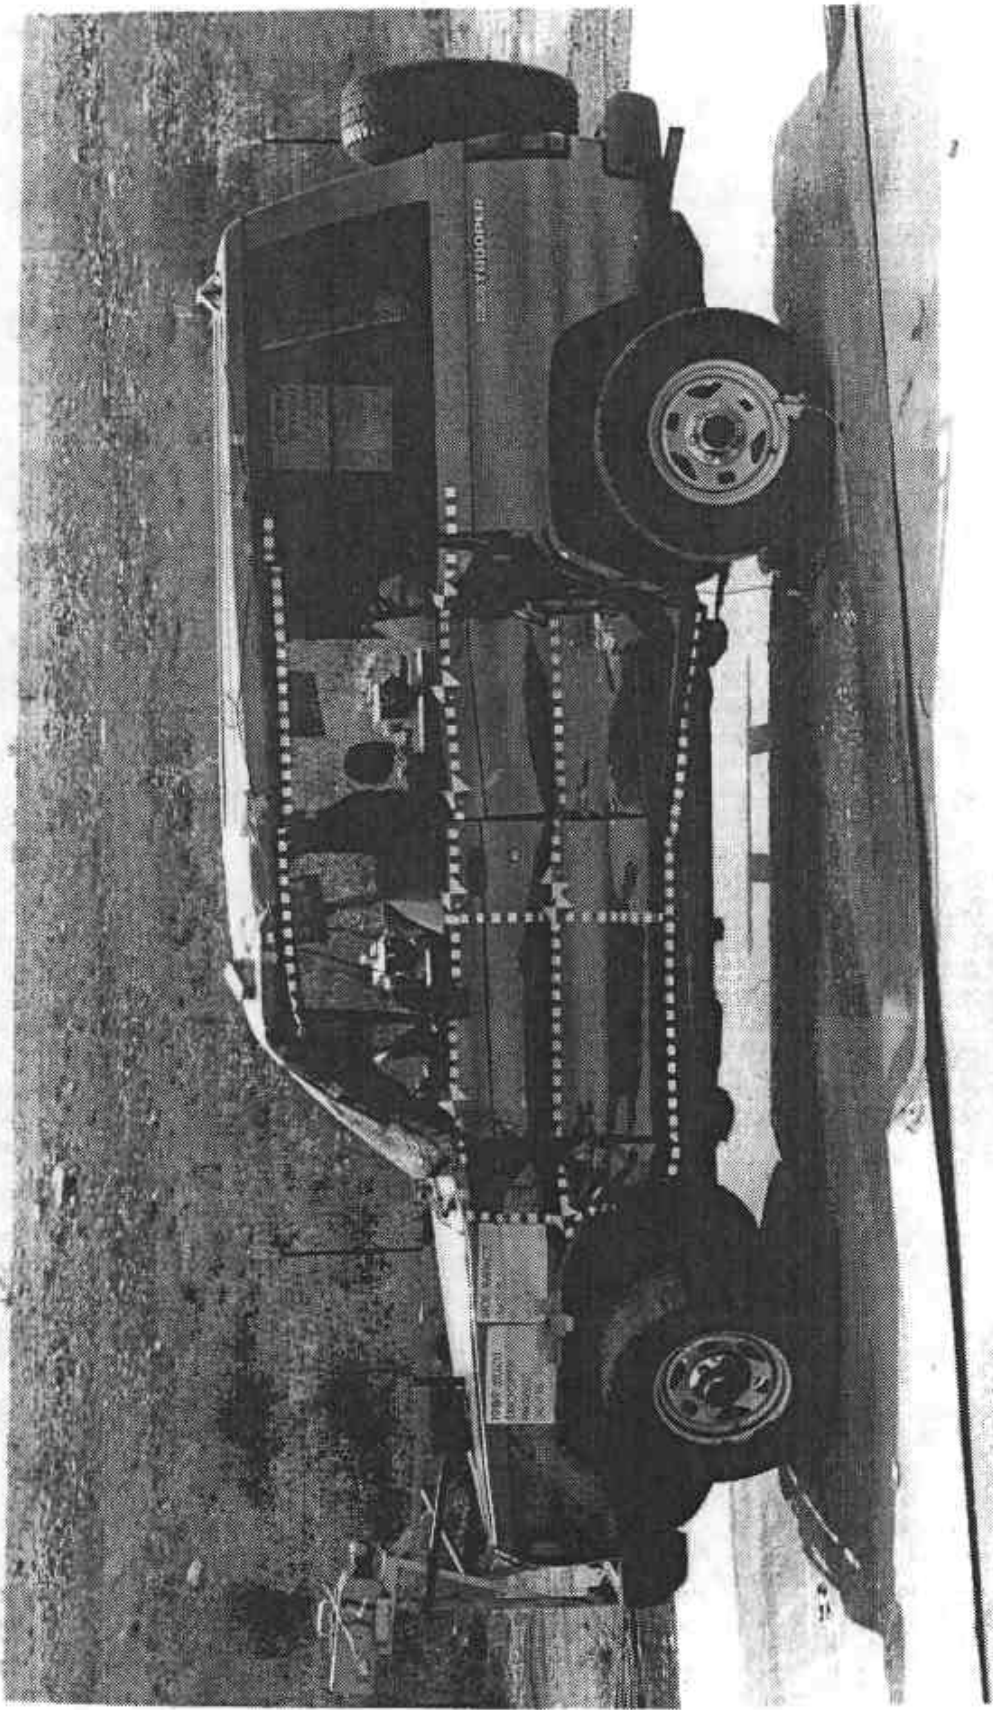
FIGURE 5-6 POSTTEST STRUCK SIDE VIEW OF TEST VEHICLE

Glazing Breakage: All impact side door windows shattered, windshield cracked but remain intact.

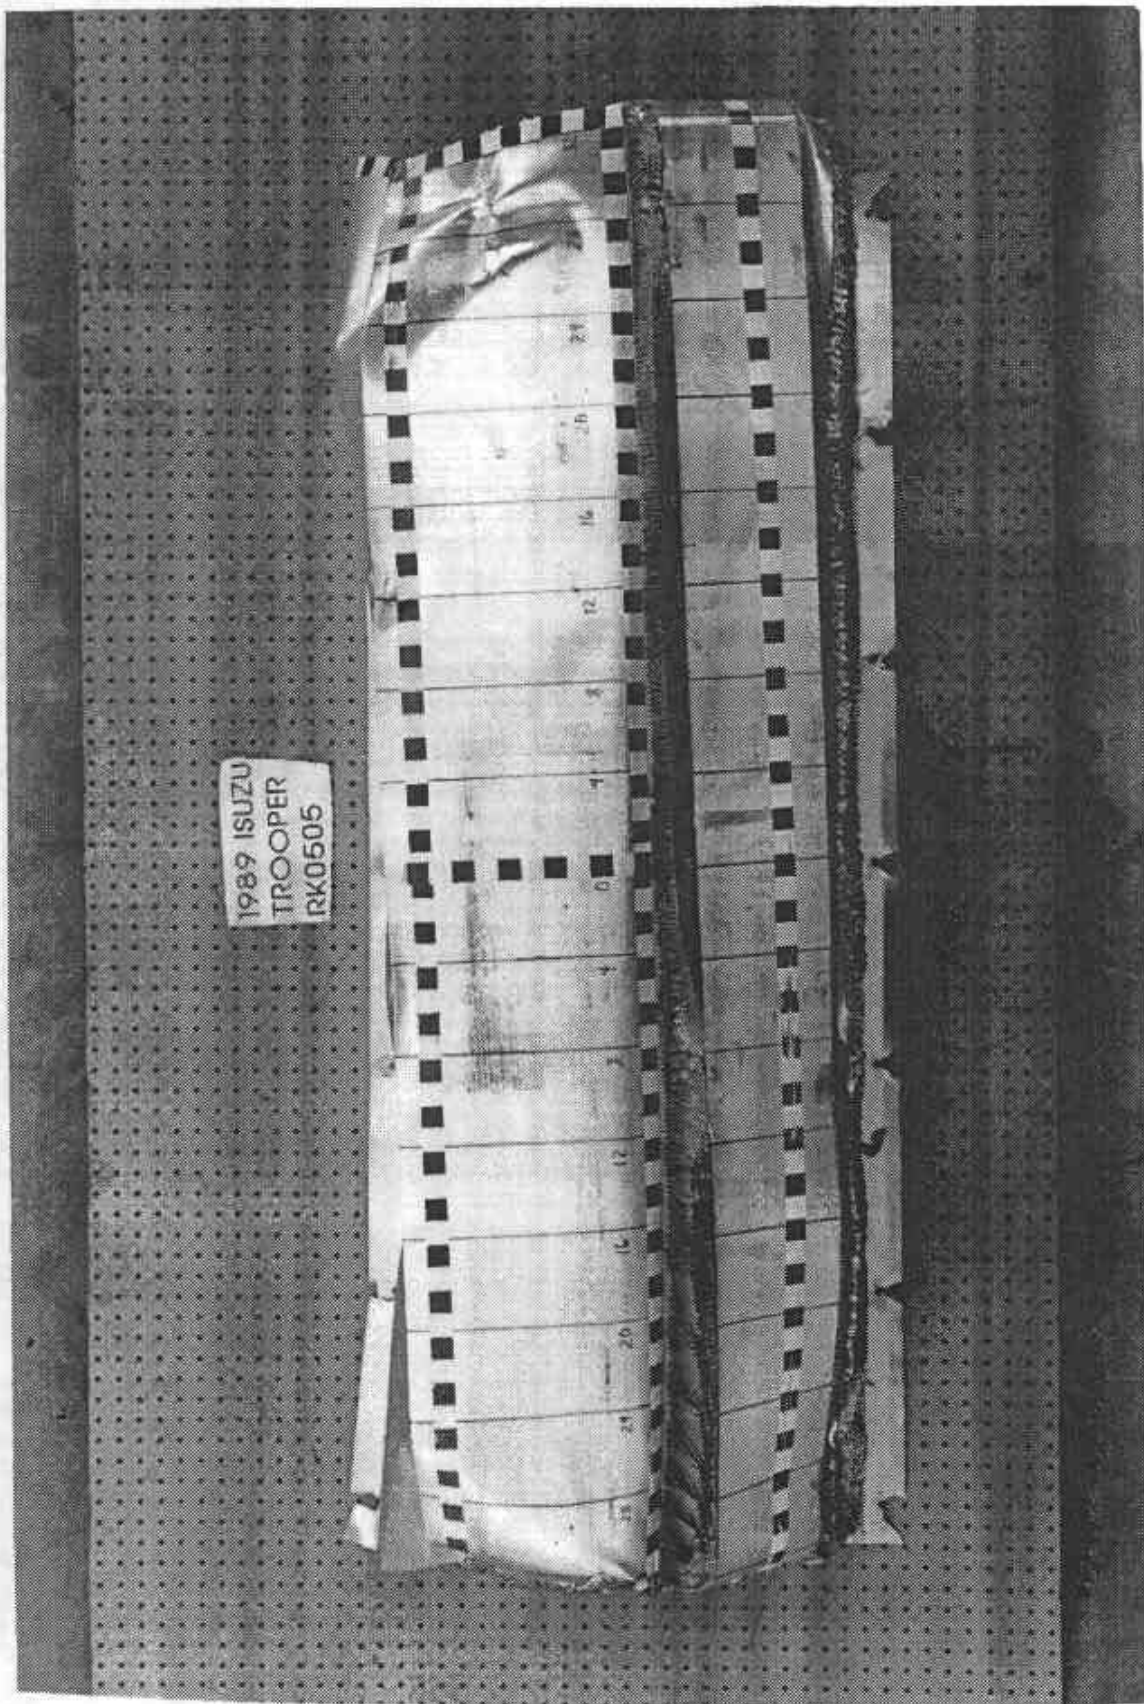
FIGURE 5-8 POSTTEST FRONTAL VIEW OF MDB IMPACT FACE

1. ROW A at bumper level = 7.1 inches
2. ROW B at midstack level = 3.2 inches
3. ROW C at top of stack level = 4.1 inches

The MDB impacted the test vehicle and was stopped by the remote brake system to prevent a second impact. The aluminum deformable barrier received more damage than usual due to contact with the rear wall of the cab and front wall of the bed. The maximum crush was 7.3 inches on the right side of the bumper.

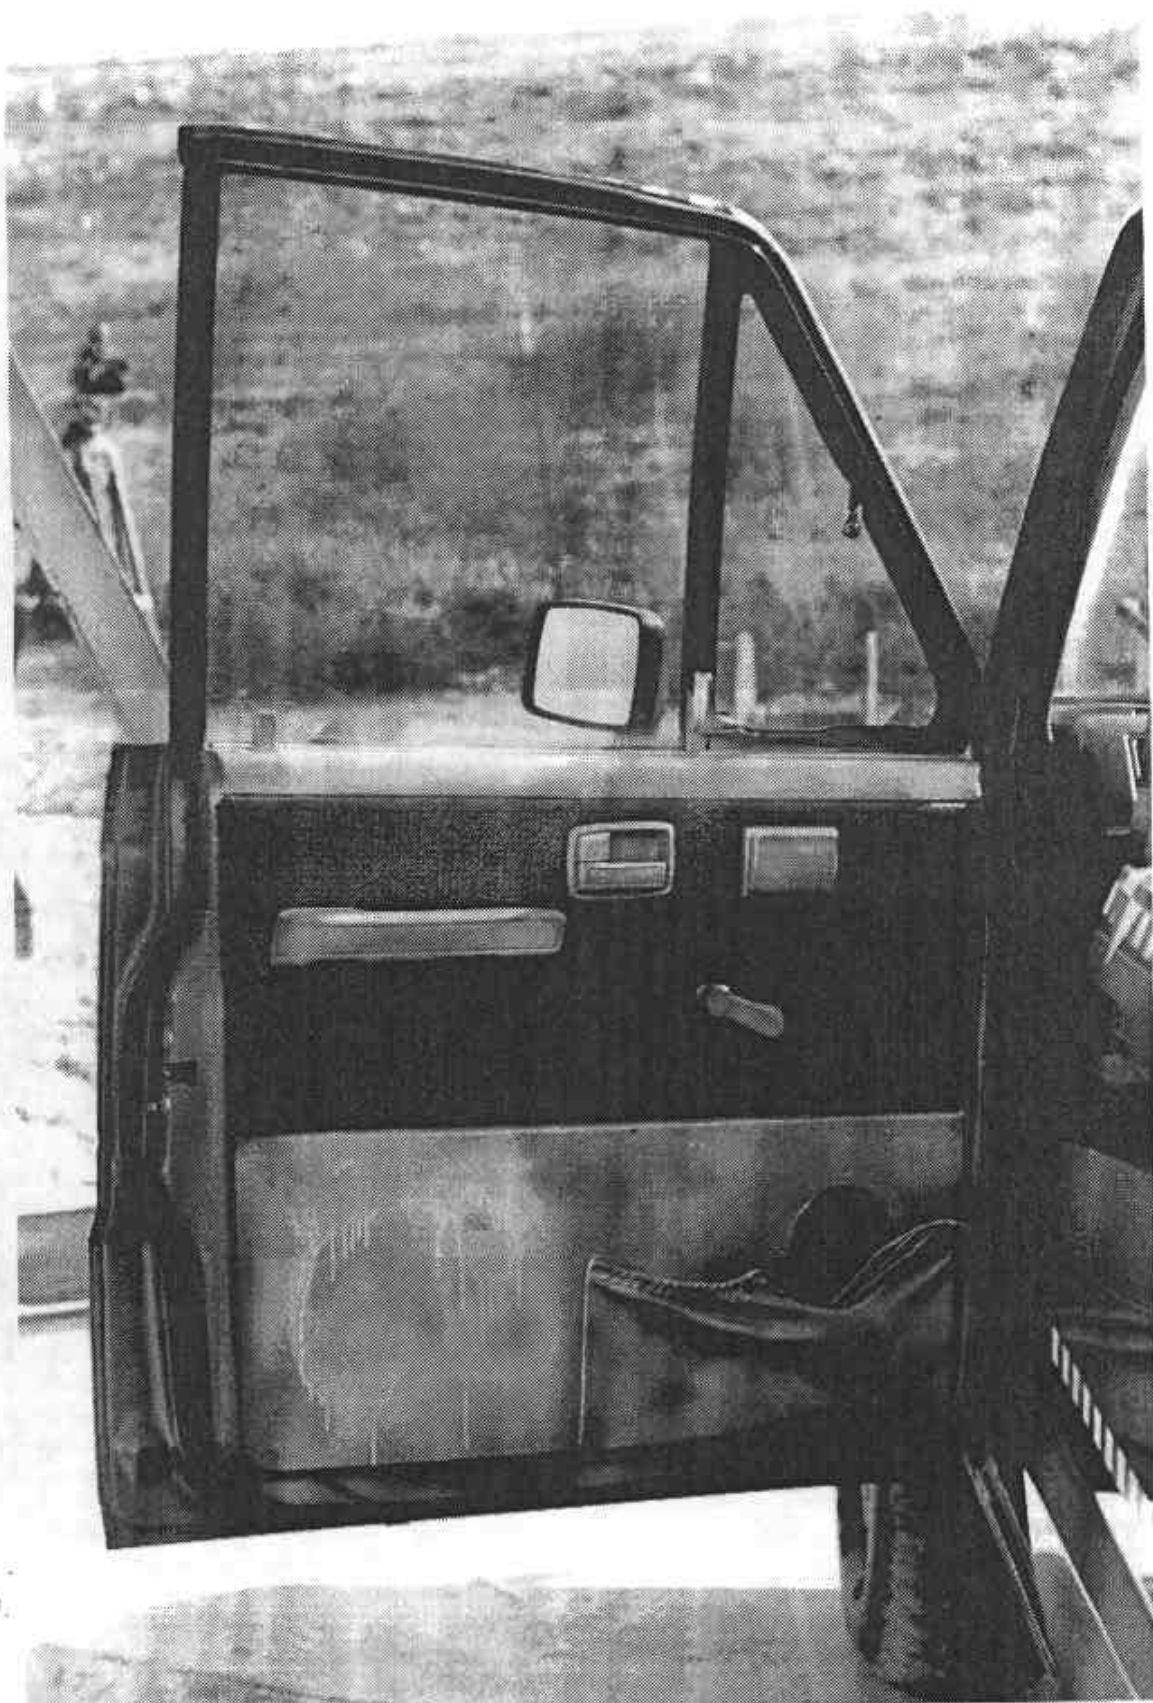
FIGURE 5-26 DRIVER DOOR ACCELEROMETER LOCATIONS

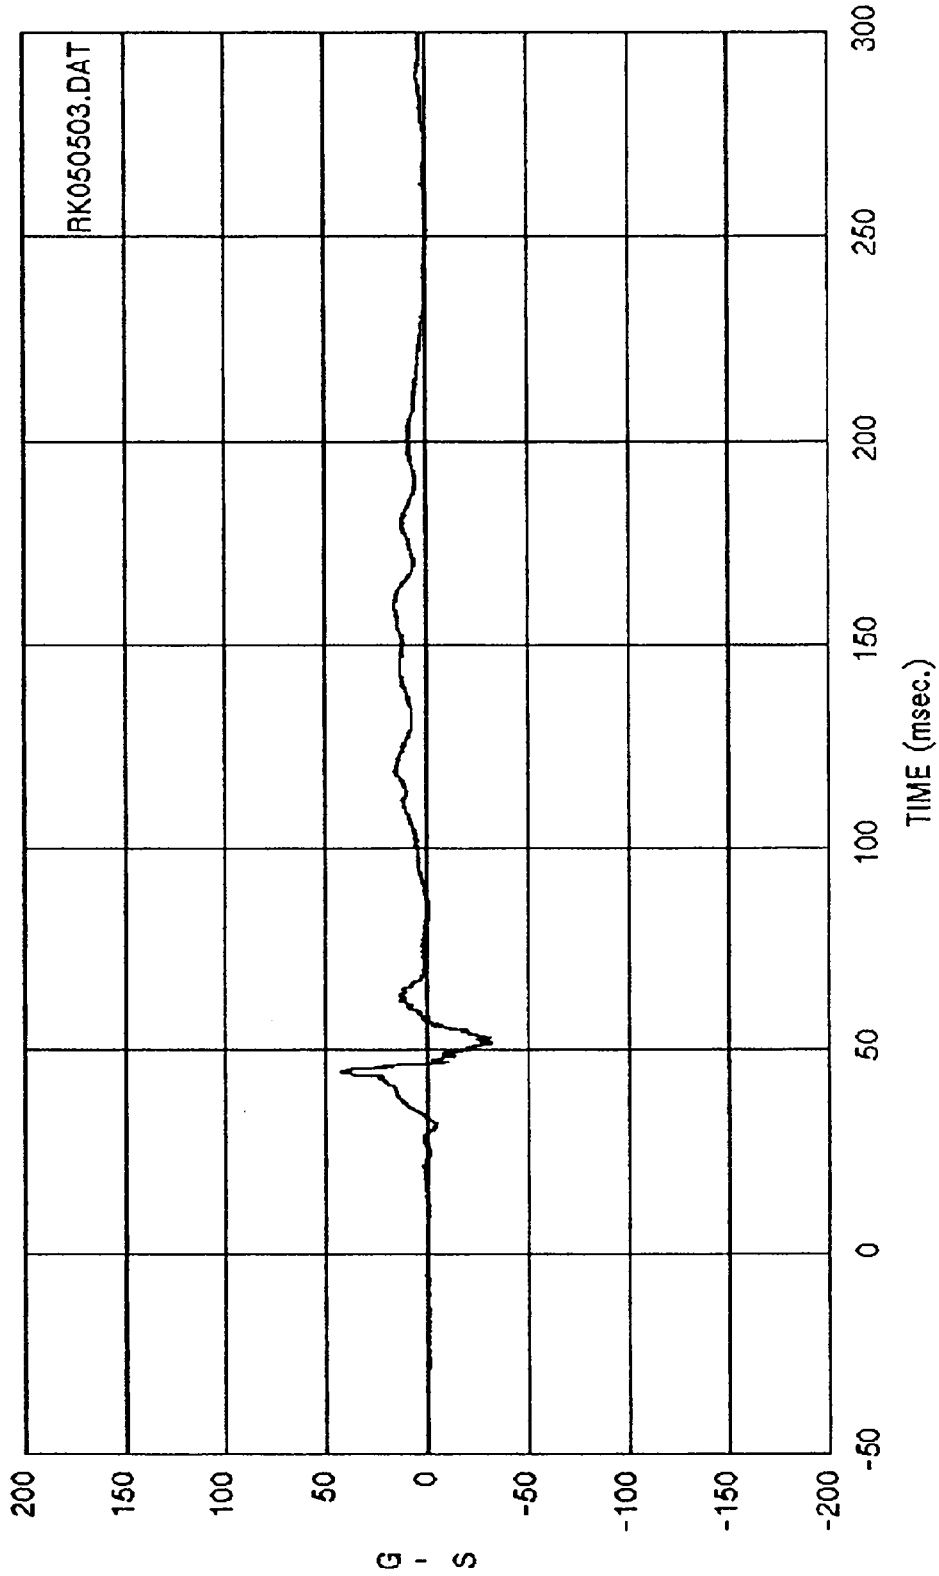
Curve: Driver Head acceleration -- Z axis Filter: SAE CLASS 1000 Max = 52.231 Min = -32.230

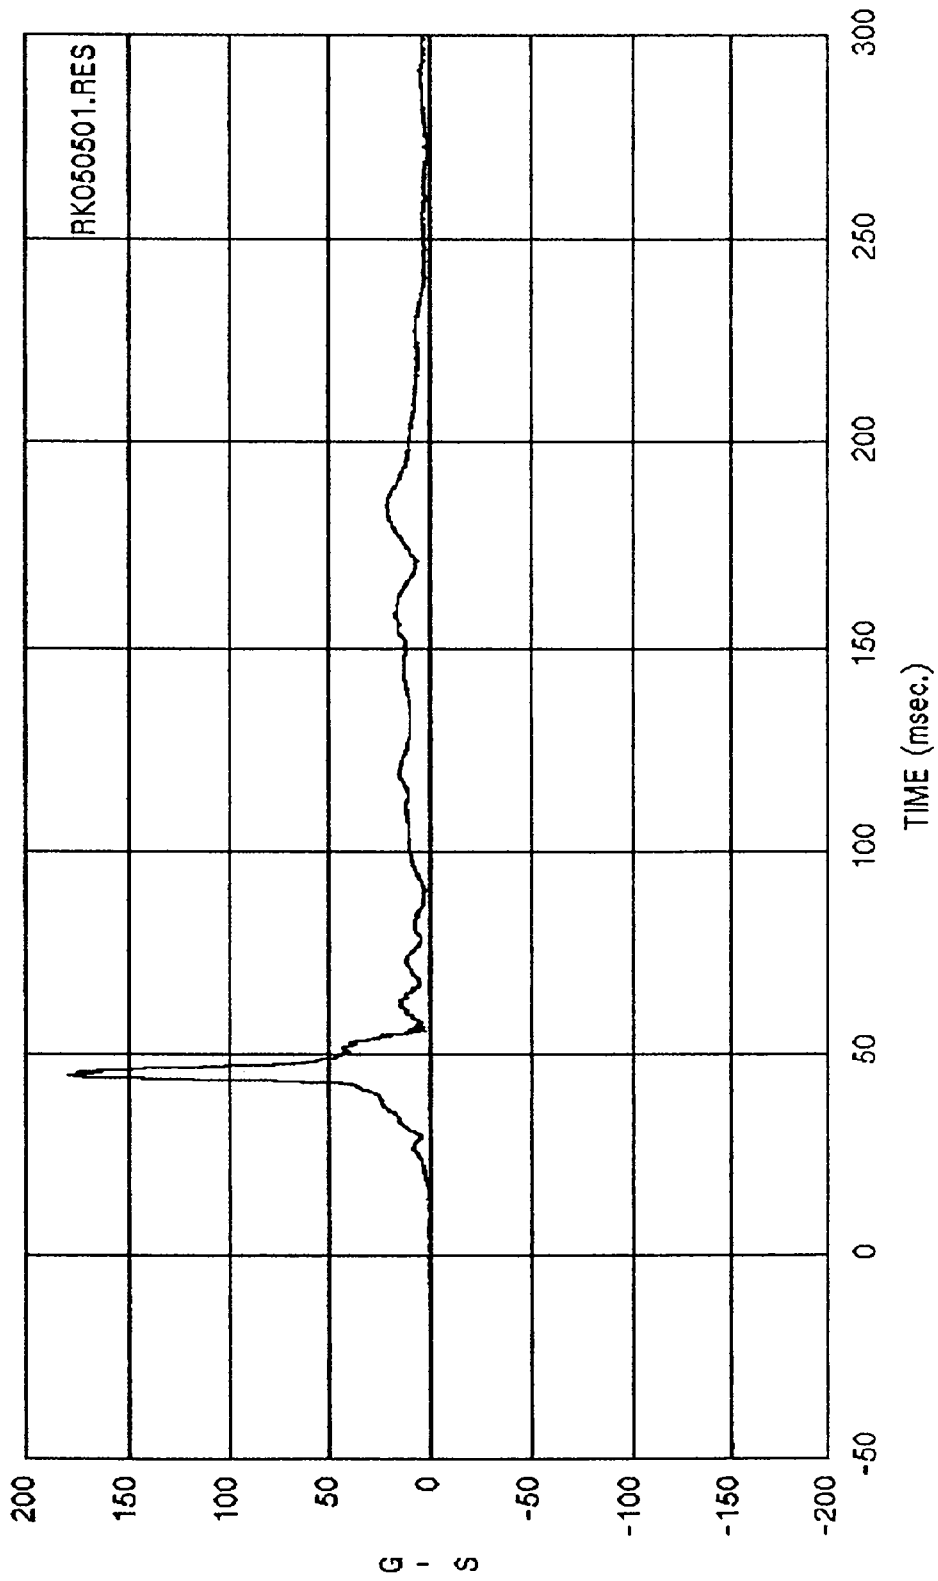
Curve: Driver head resultant acceleration Filter: SAE CLASS 1000 Max = 184.18 Min = .11429

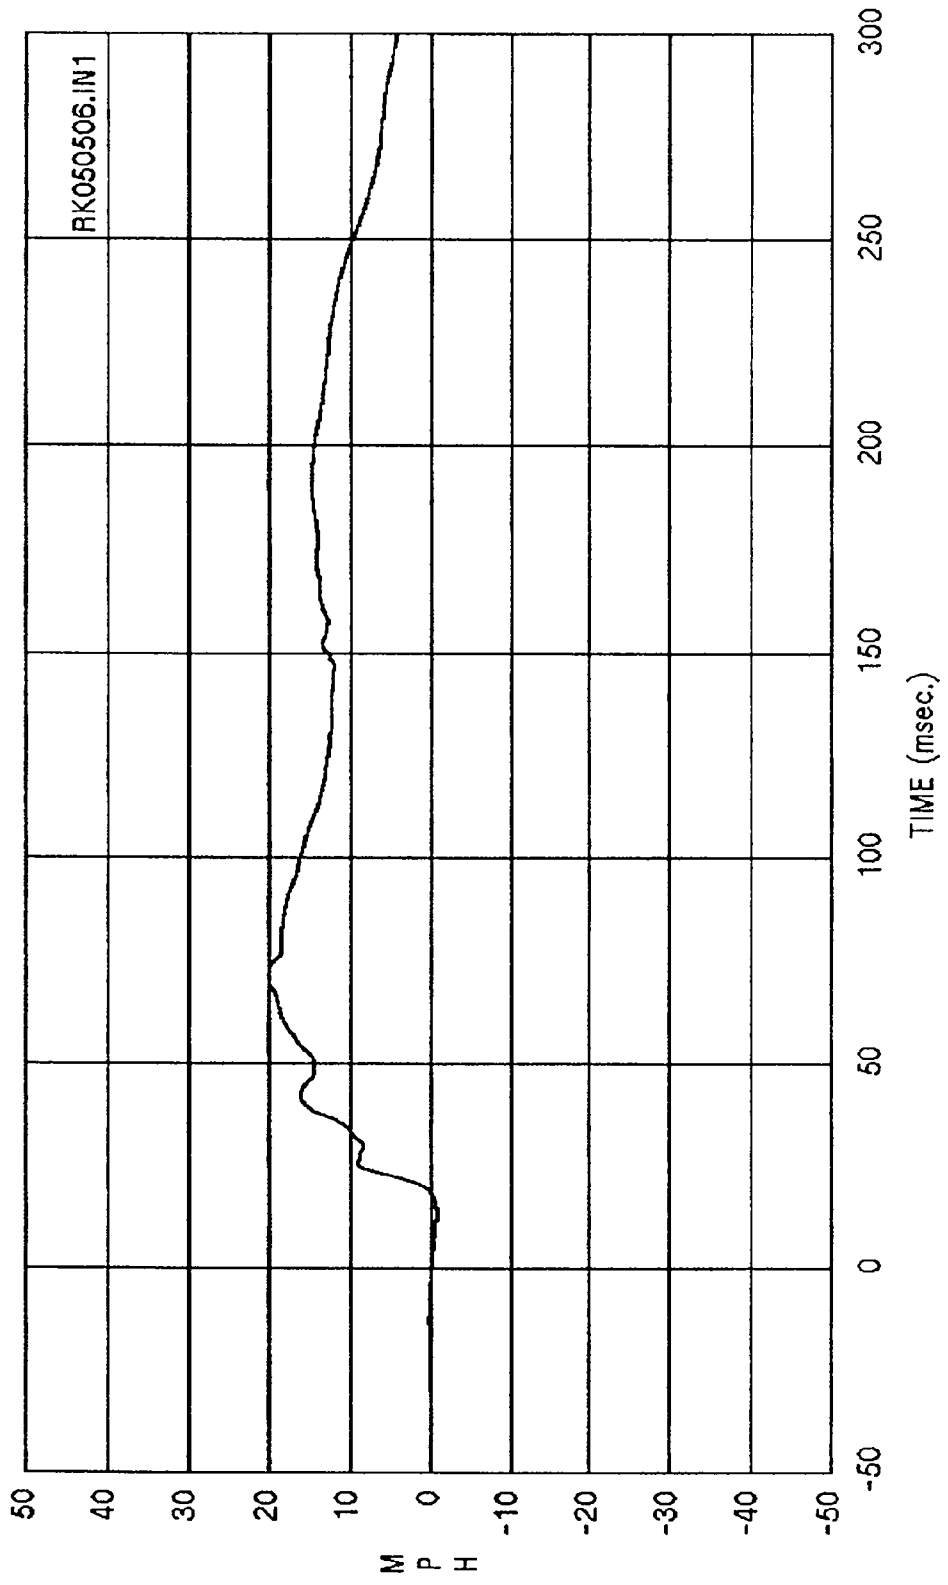
Curve: Driver upper rib delta V -- Primary Filter: SAE CLASS 180 Max = 20.172 Min = -.64904

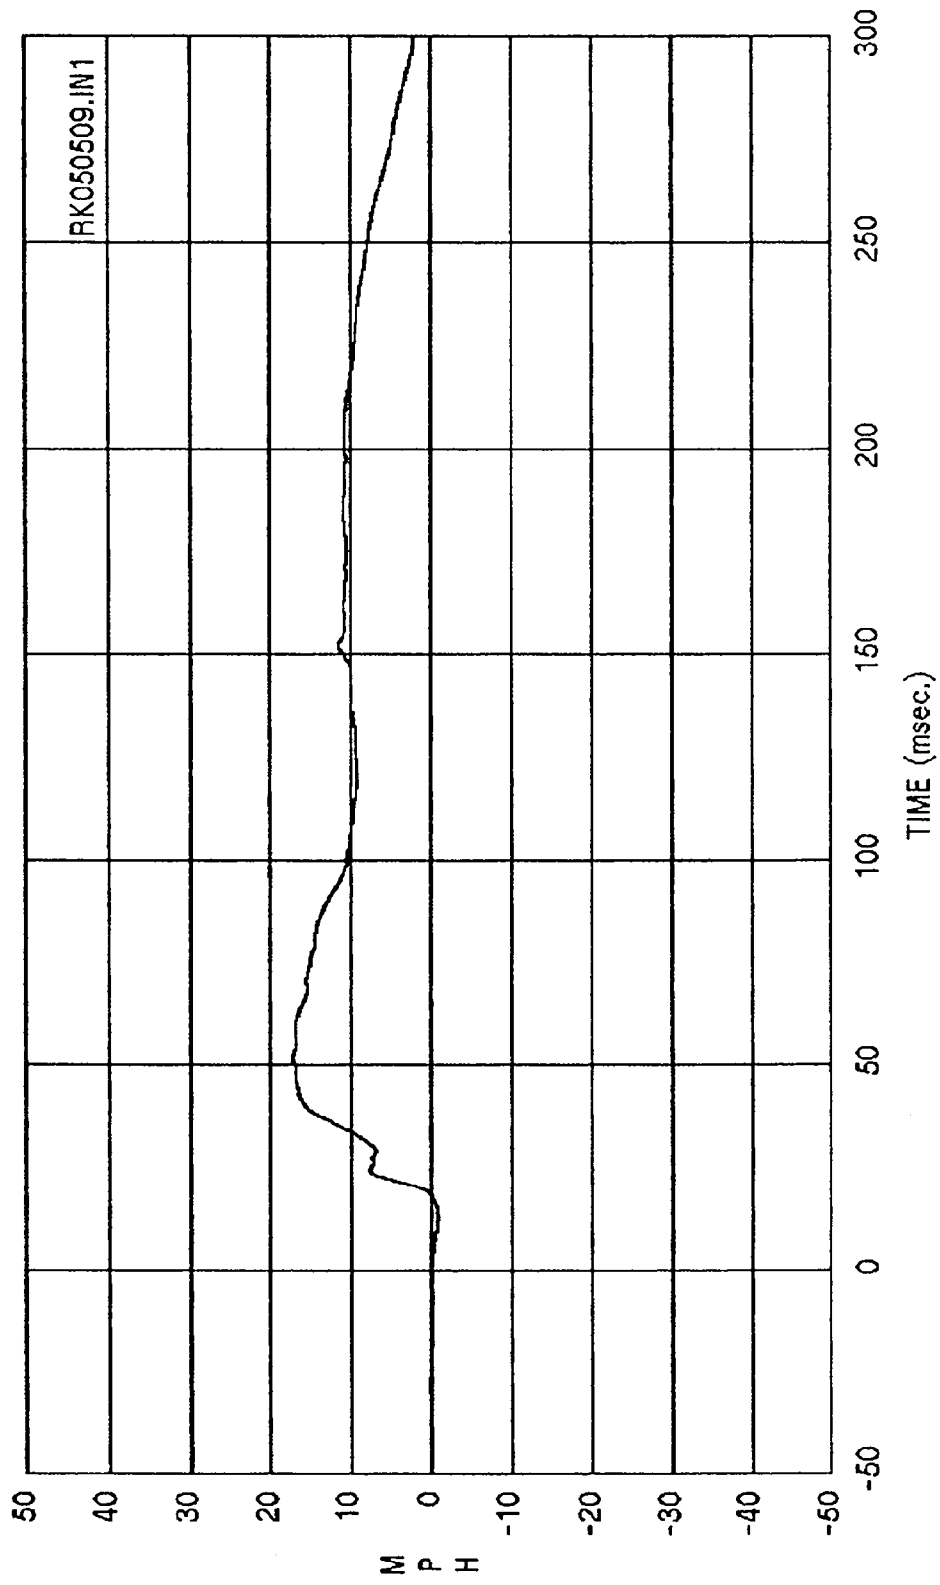
Curve: Driver lower rib delta V -- Redundant Filter: SAE CLASS 180 Max = 17.332 Min = -7.8310
