**SIDE IMPACT PROTECTION STUDY  
IN PRODUCTION VEHICLES  
MDB-TO-VEHICLE SIDE IMPACT TEST OF  
A 27° CRABBED MOVING DEFORMABLE BARRIER  
TO A 1989 ISUZU TROOPER, 4 WHEEL DRIVE  
AT 33.0 MPH**

**NHTSA NO.: RK0505**

**MOBILITY SYSTEMS AND EQUIPMENT COMPANY  
9920 LA CIENEGA BOULEVARD SUITE 708  
INGLEWOOD, CALIFORNIA 90301**

FINAL REPORT

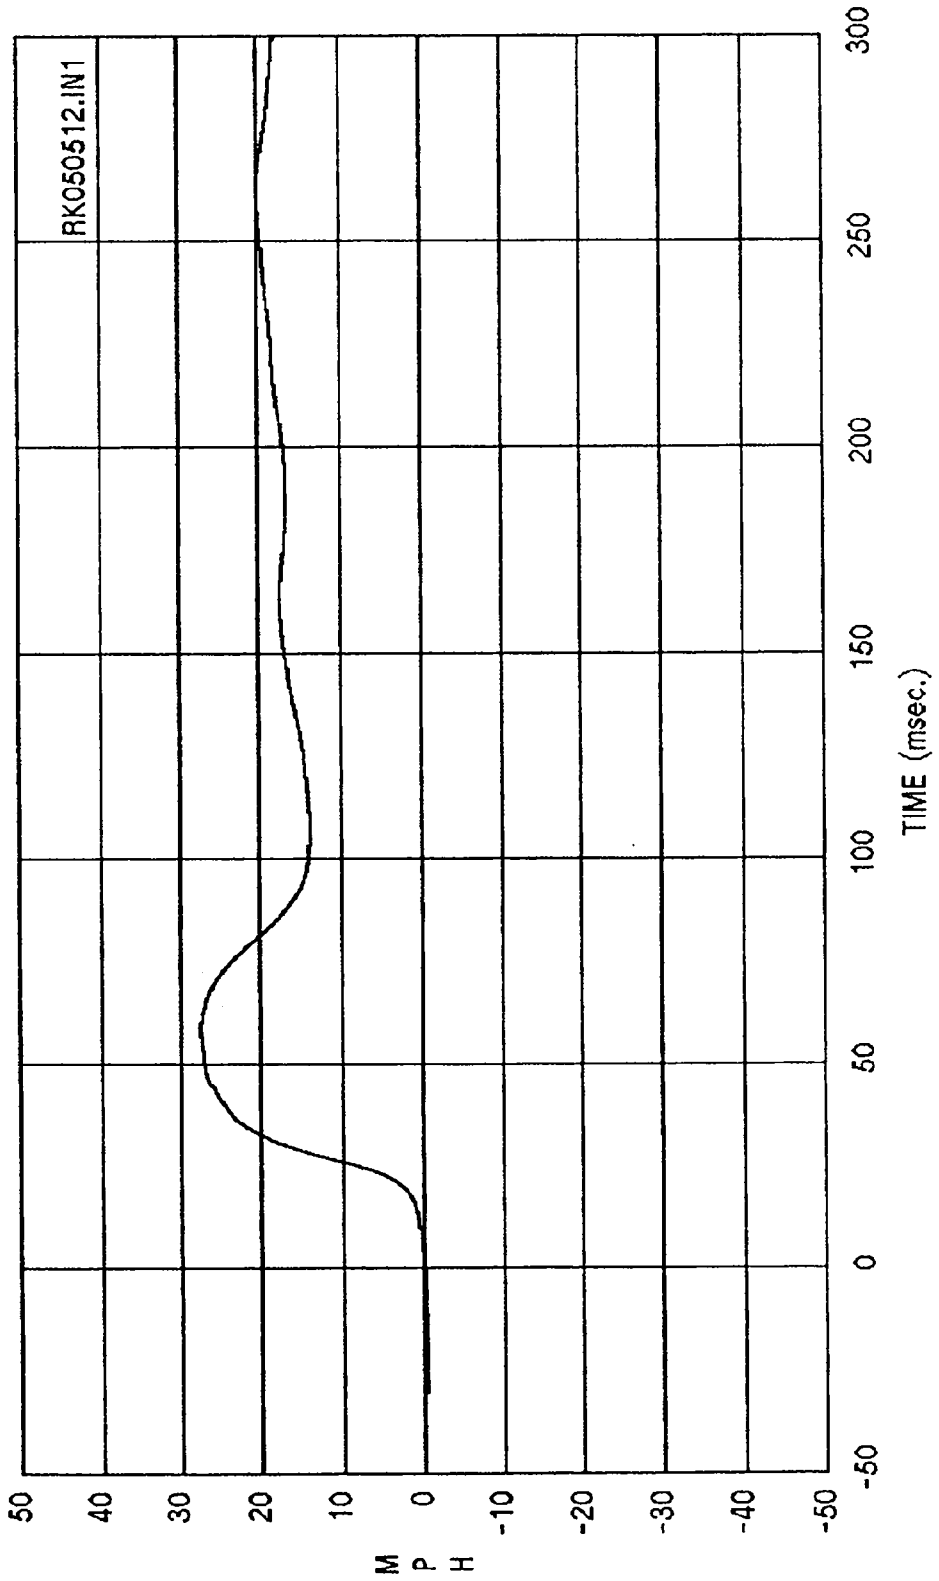
Curve: Driver pelvis delta V Filter: SAE CLASS 180 Max = 27.541 Min = 13.970

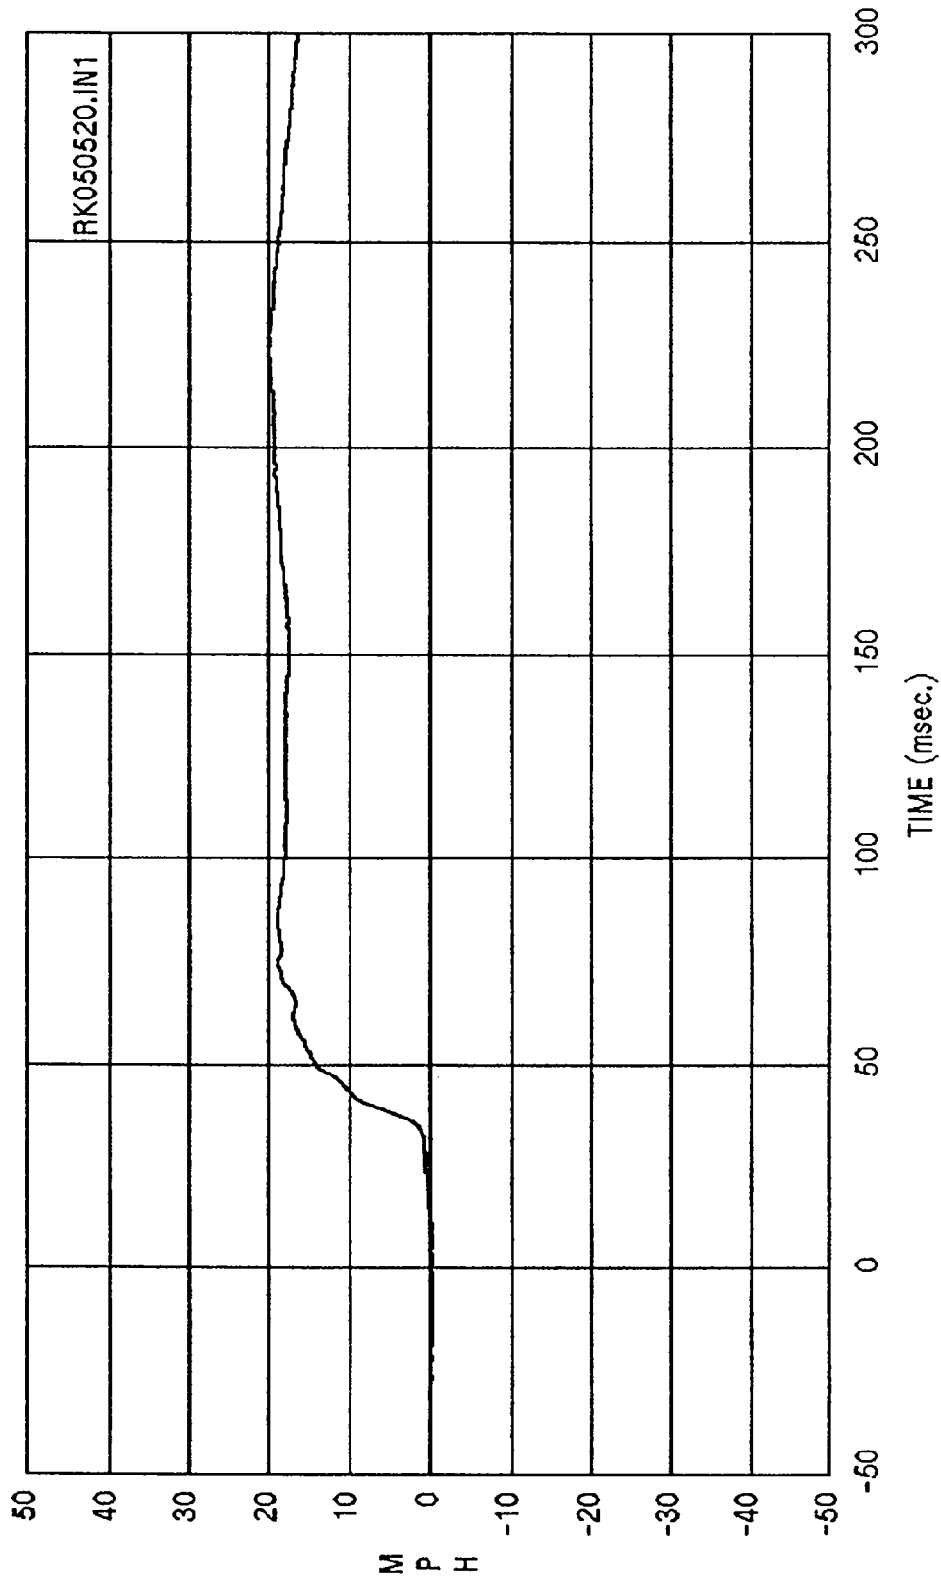
Curve: Passenger upper rib delta V -- Primary Filter: SAE CLASS 180 Max = 20.085 Min = -.13701

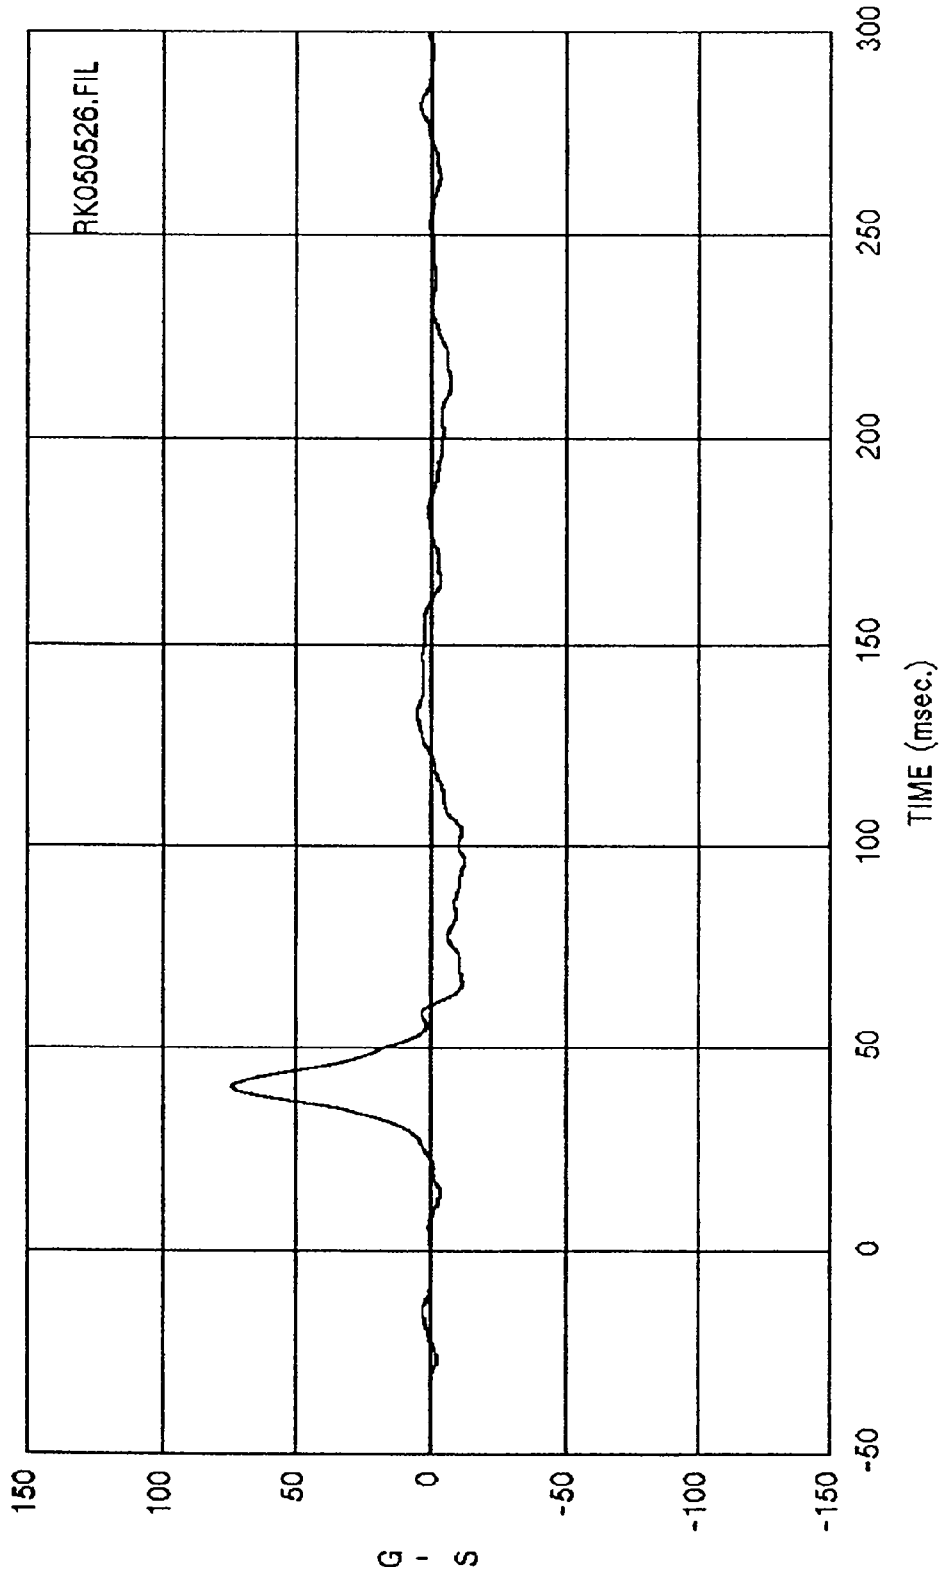
Curve: Passenger pelvis acceleration Filter: FIR 100 Max = 74.396 Min = -12.407

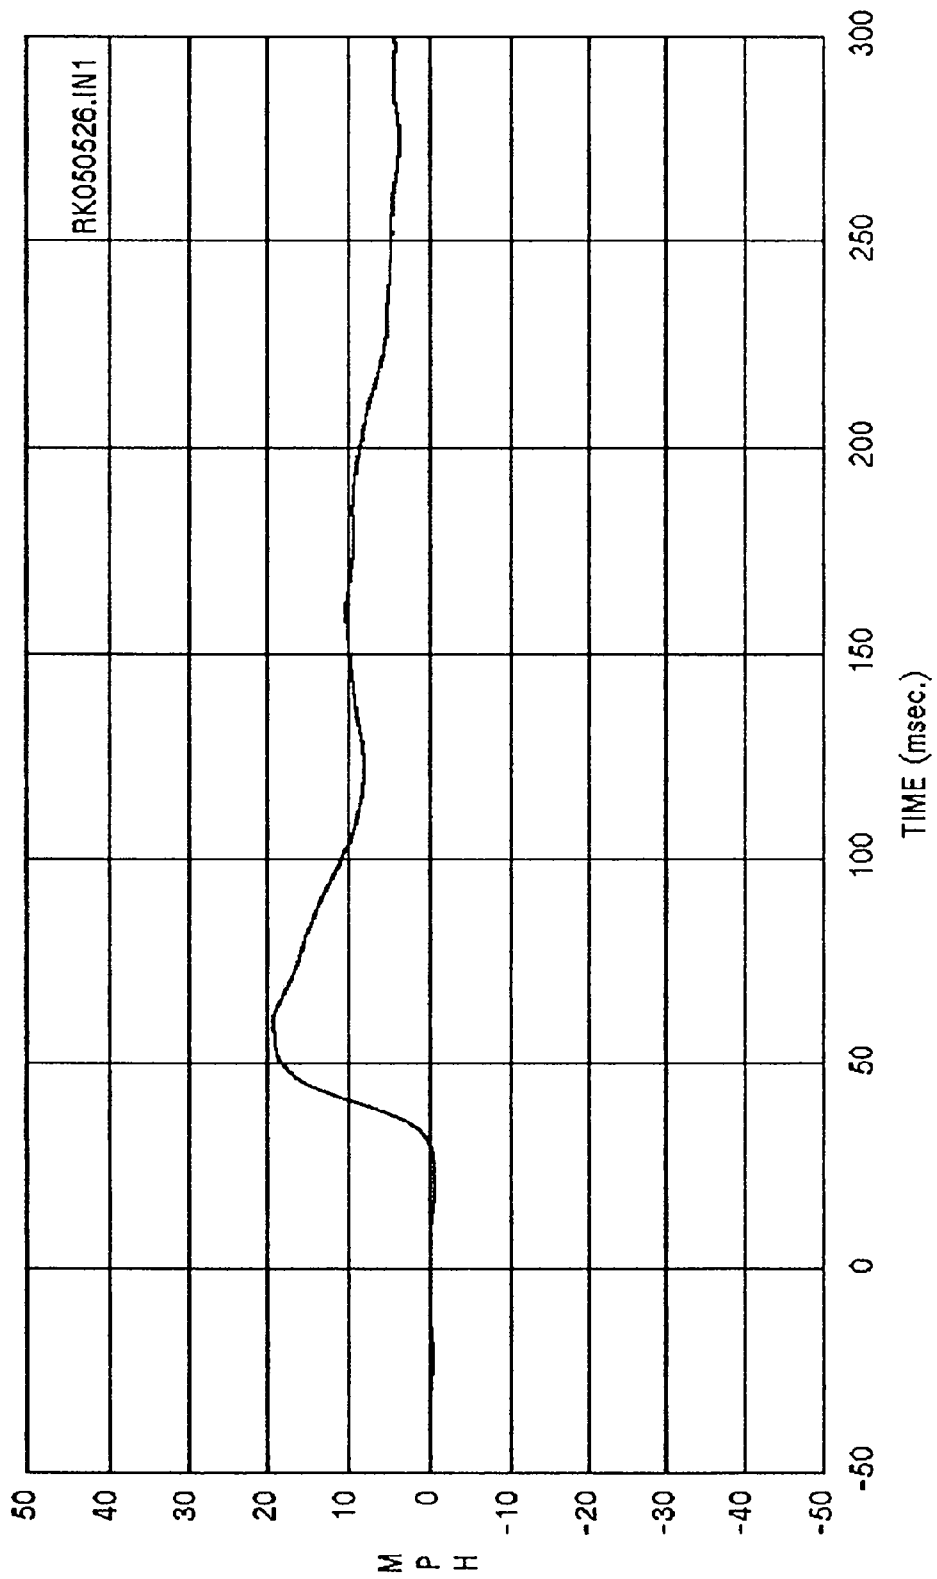
Curve: Passenger pelvis delta V Filter: SAE CLASS 180 Max = 19.394 Min = -.56393

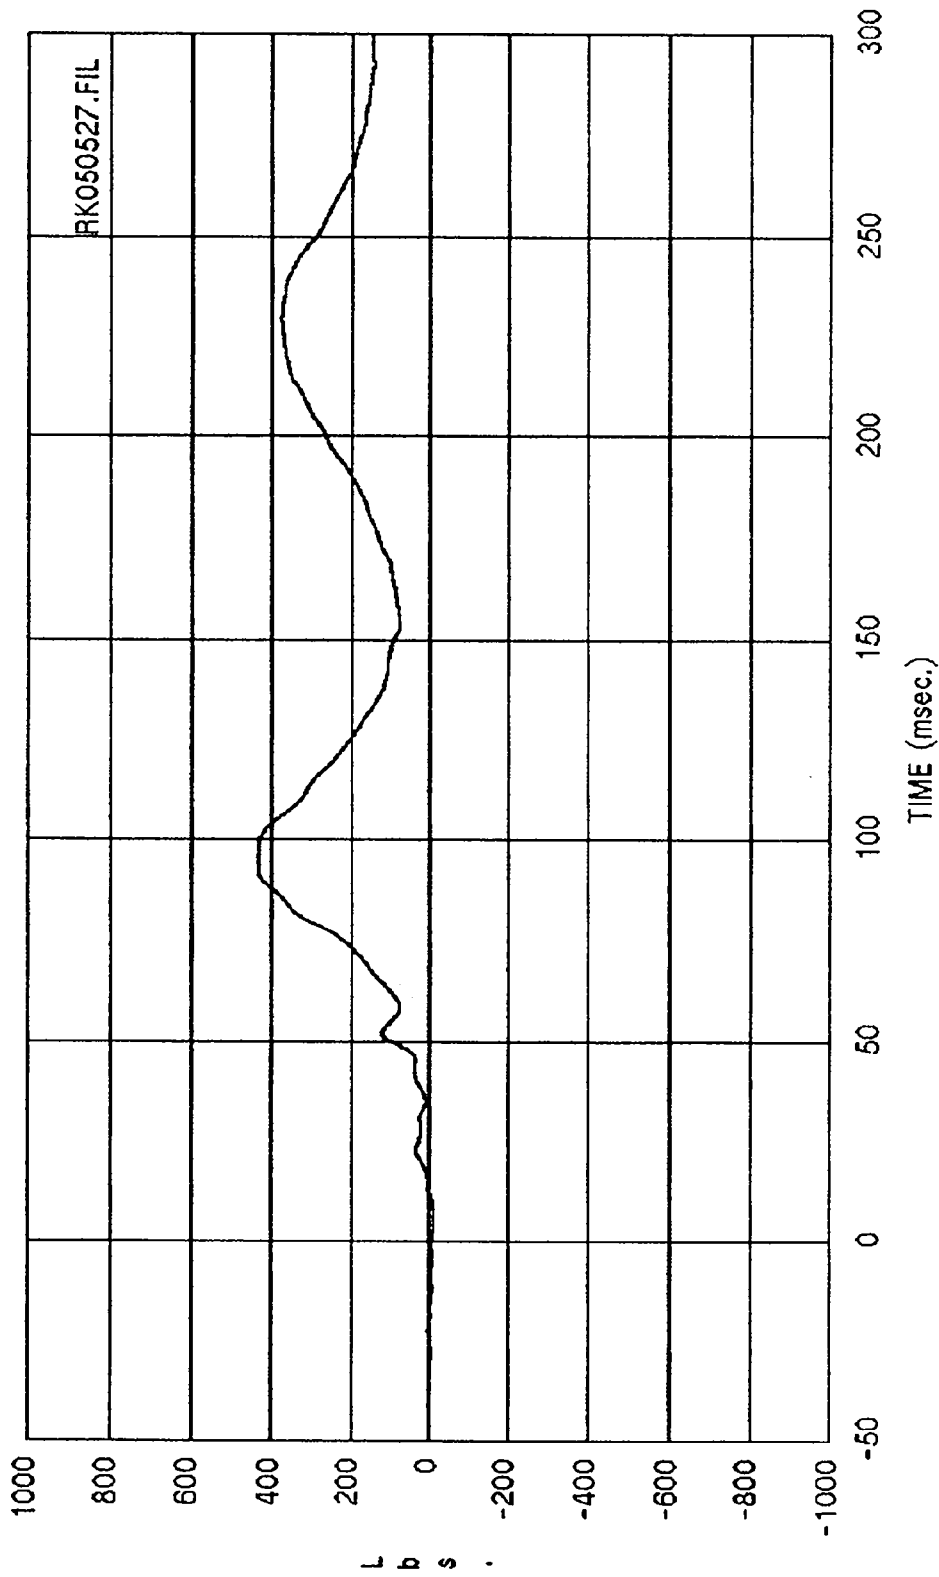
Curve: Passenger lap belt load Filter: SAE CLASS 60 Max = 436.97 Min = -10.573

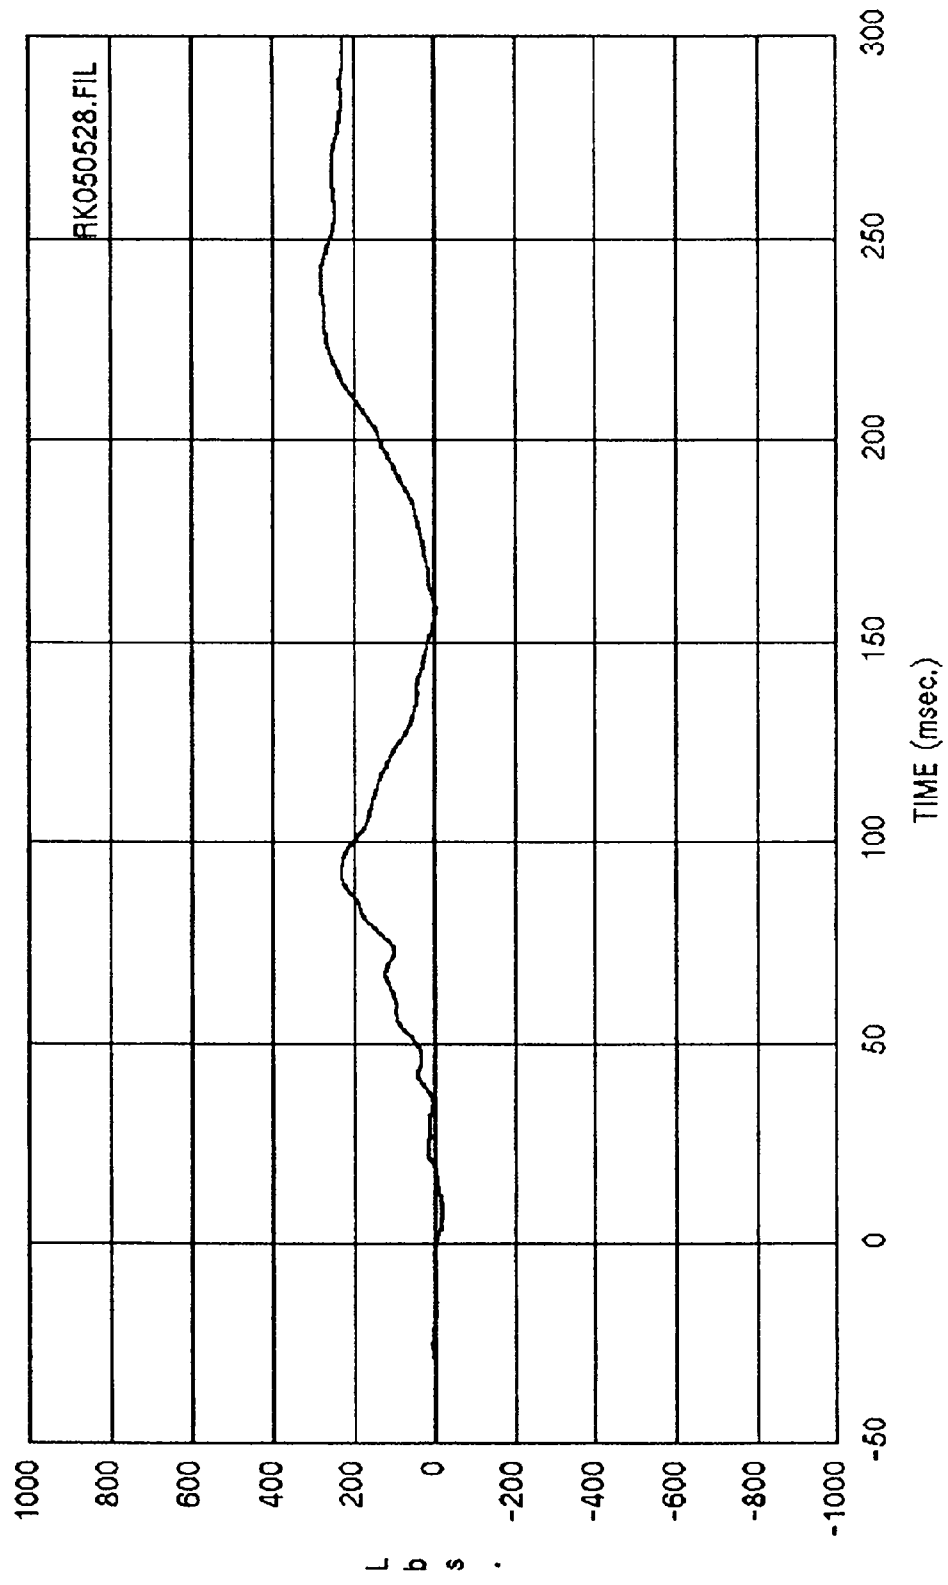
Curve: Passenger shoulder belt load Filter: SAE CLASS 60 Max = 283.24 Min = -16.443

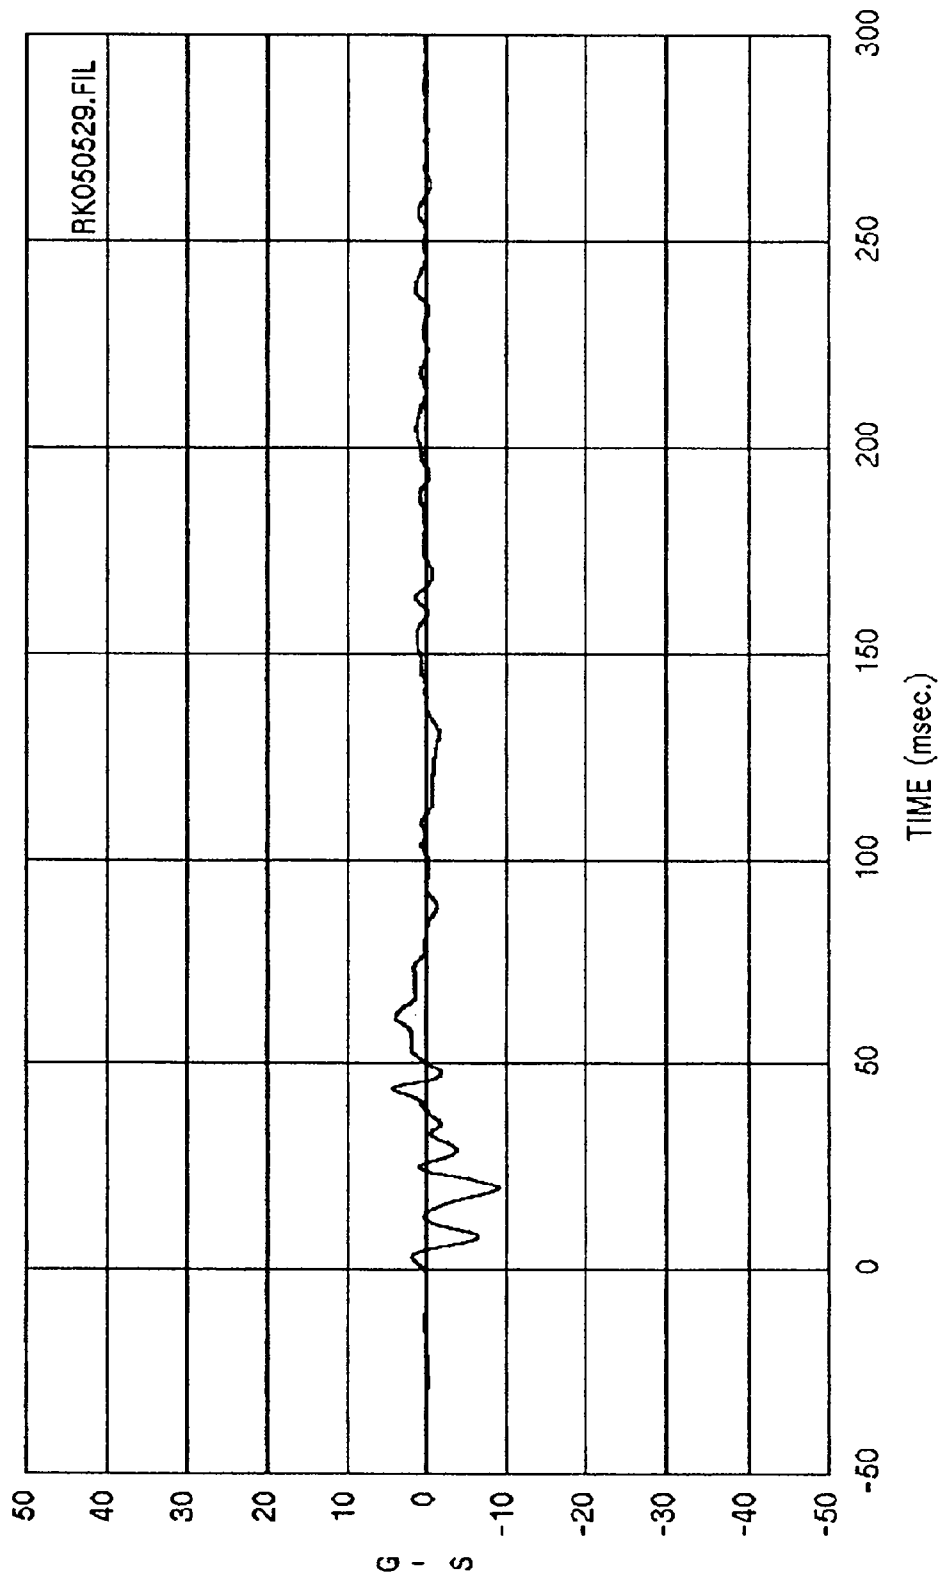
Curve: Front seat right sill acceleration -- X axis Filter: SAE CLASS 60 Max = 4.3797 Min = -9.0793

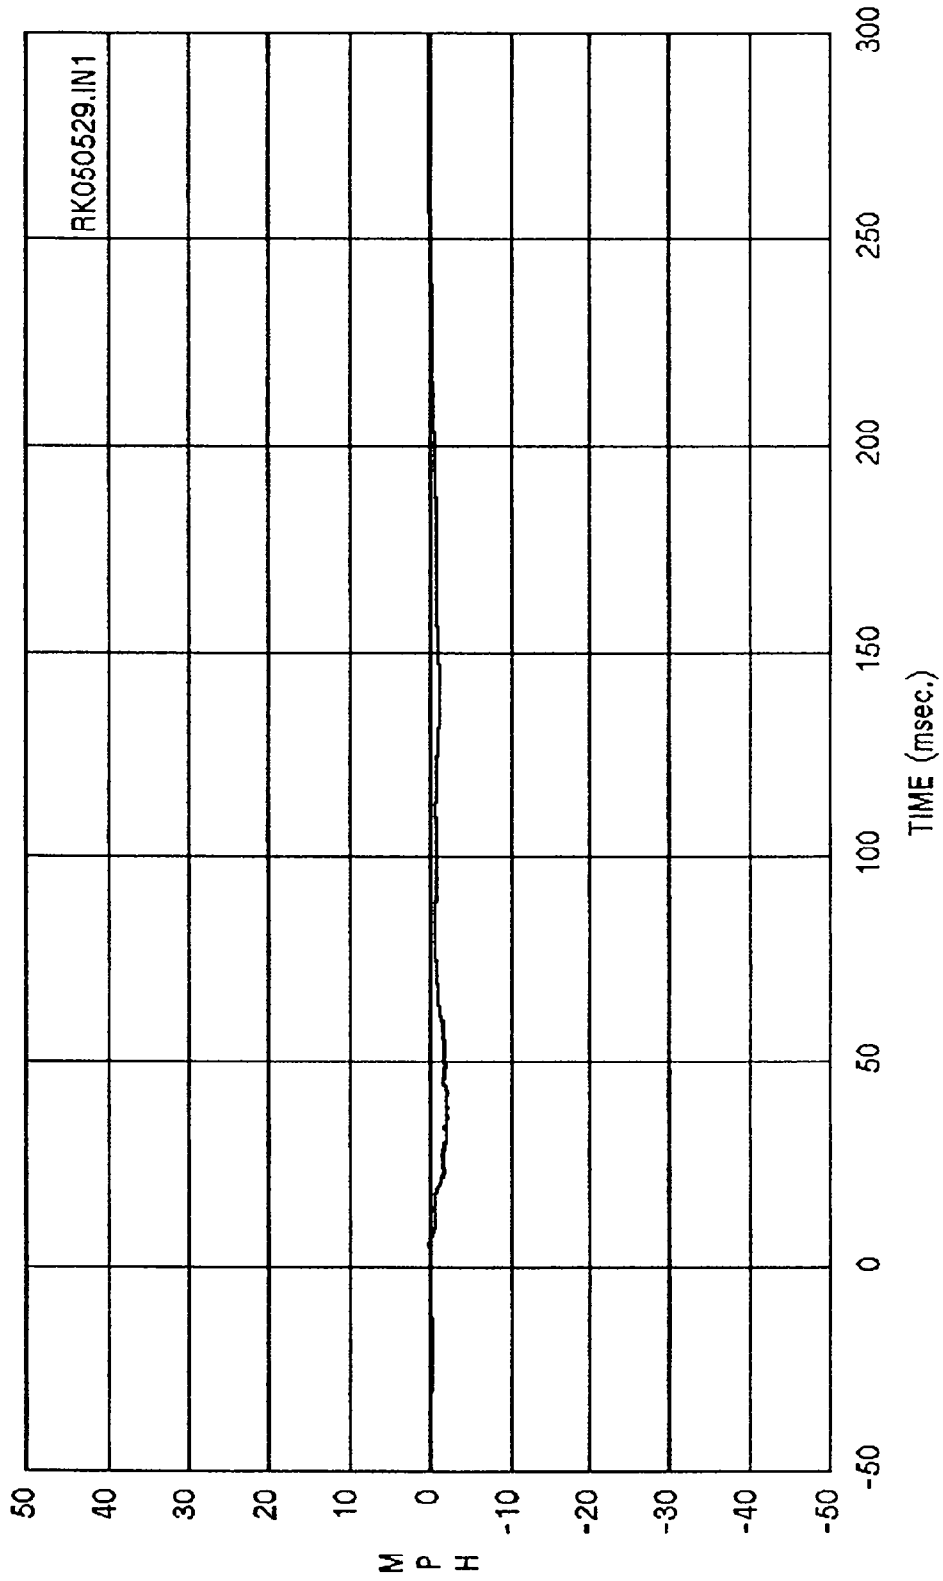
Curve: Front seat right sill delta V -- X axis Filter: SAE CLASS 180 Max = .34836 Min = -1.9111

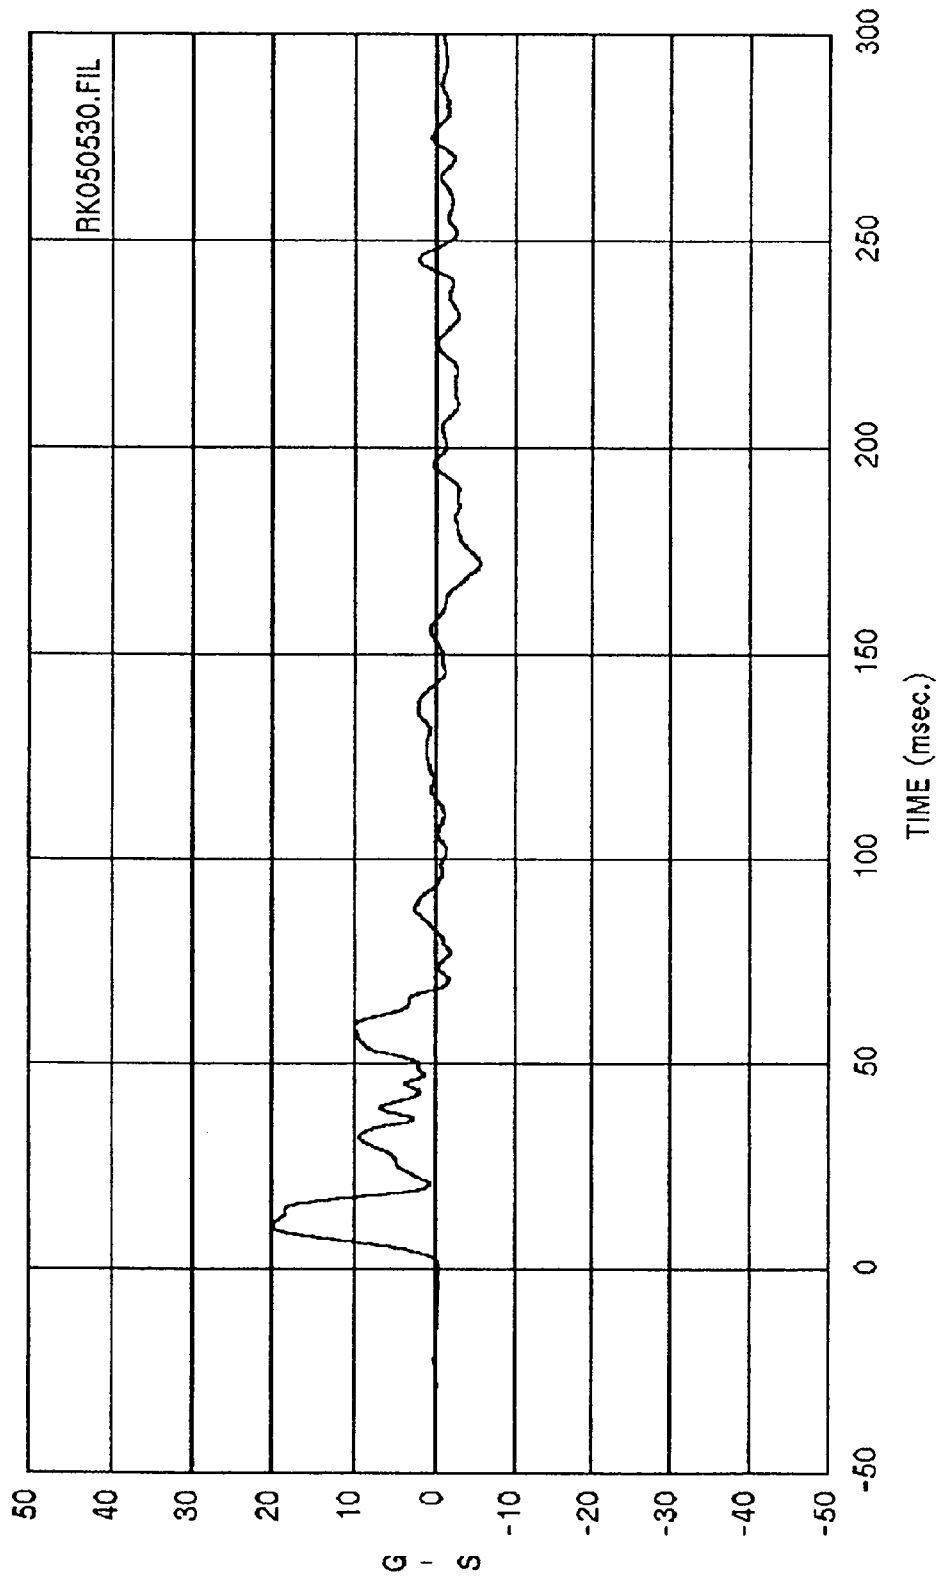
Curve: Front seat right sill acceleration -- Y axis Filter: SAE CLASS 60 Max = 20.053 Min = -5.6825

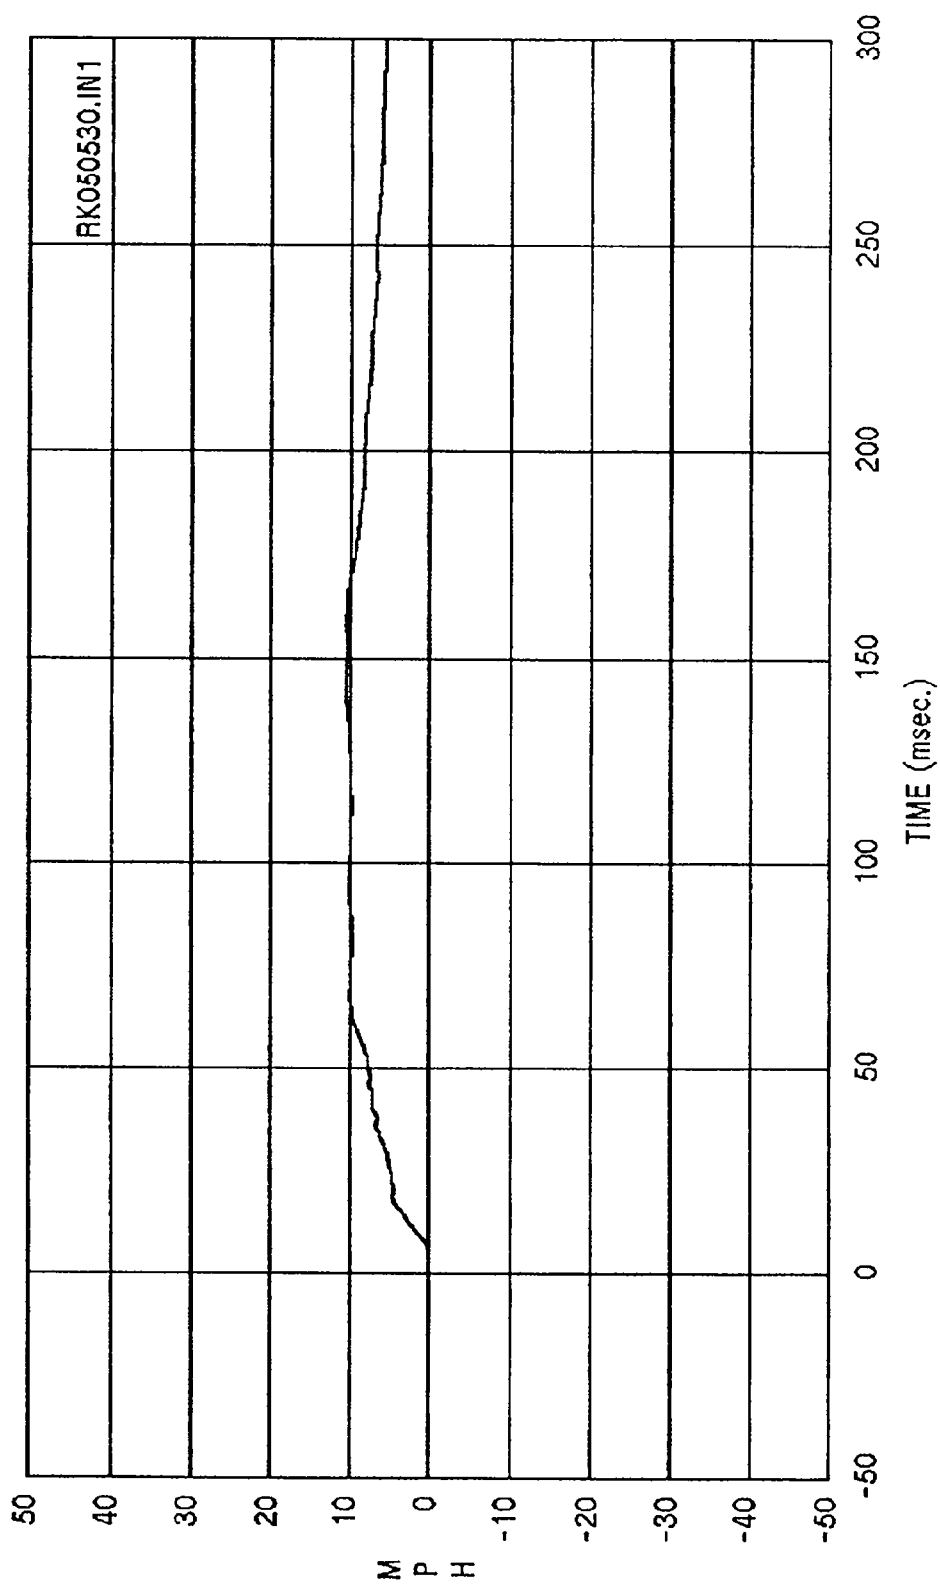
Curve: Front seat right sill delta Y -- Y axis Filter: SAE CLASS 180 Max = 10.563 Min = -.87740E-01

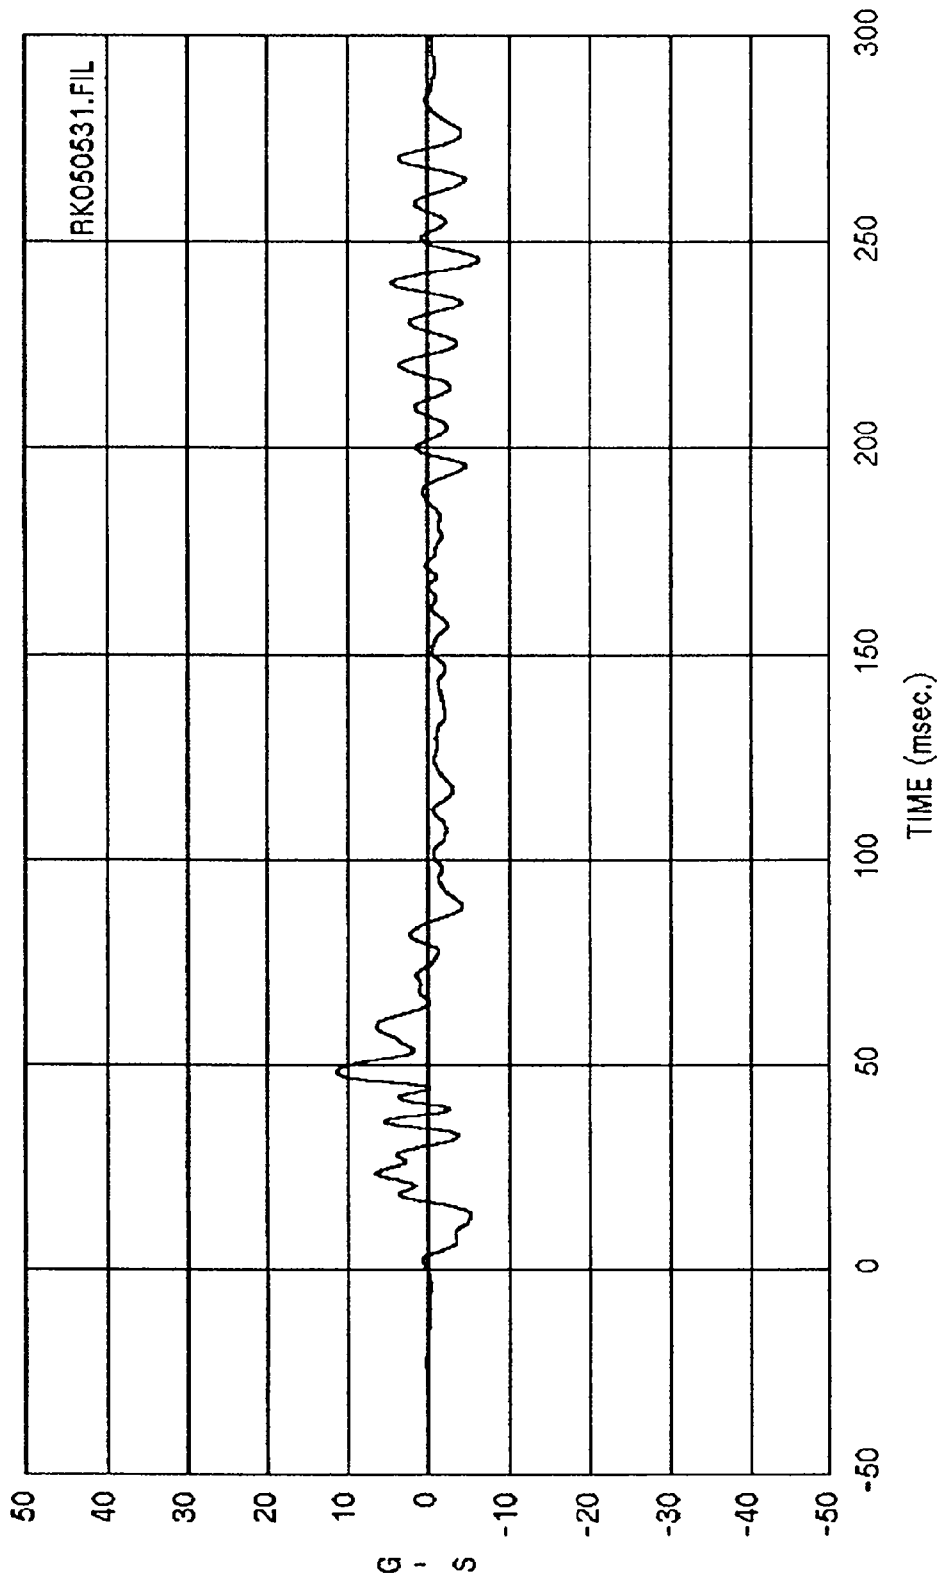
Curve: Front seat right sill acceleration -- Z axis Filter: SAE CLASS 60 Max = 11.485 Min = -6.3101

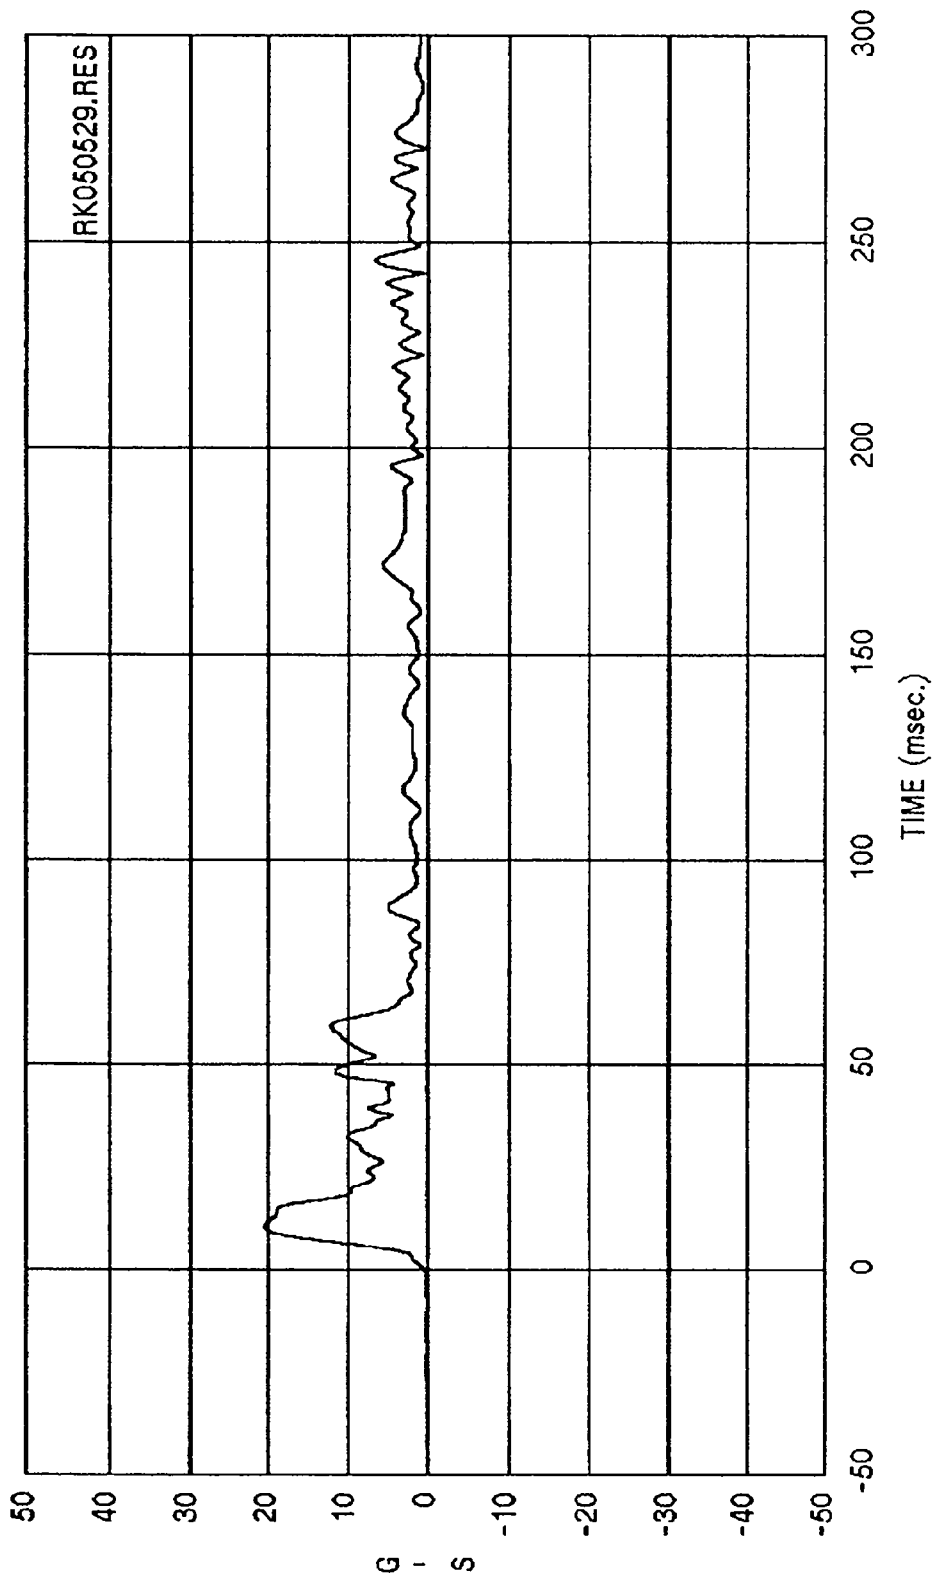
Curve: Front seat right sill resultant acceleration    Filter: SAE CLASS 60    Max = 20.602    Min = .26684

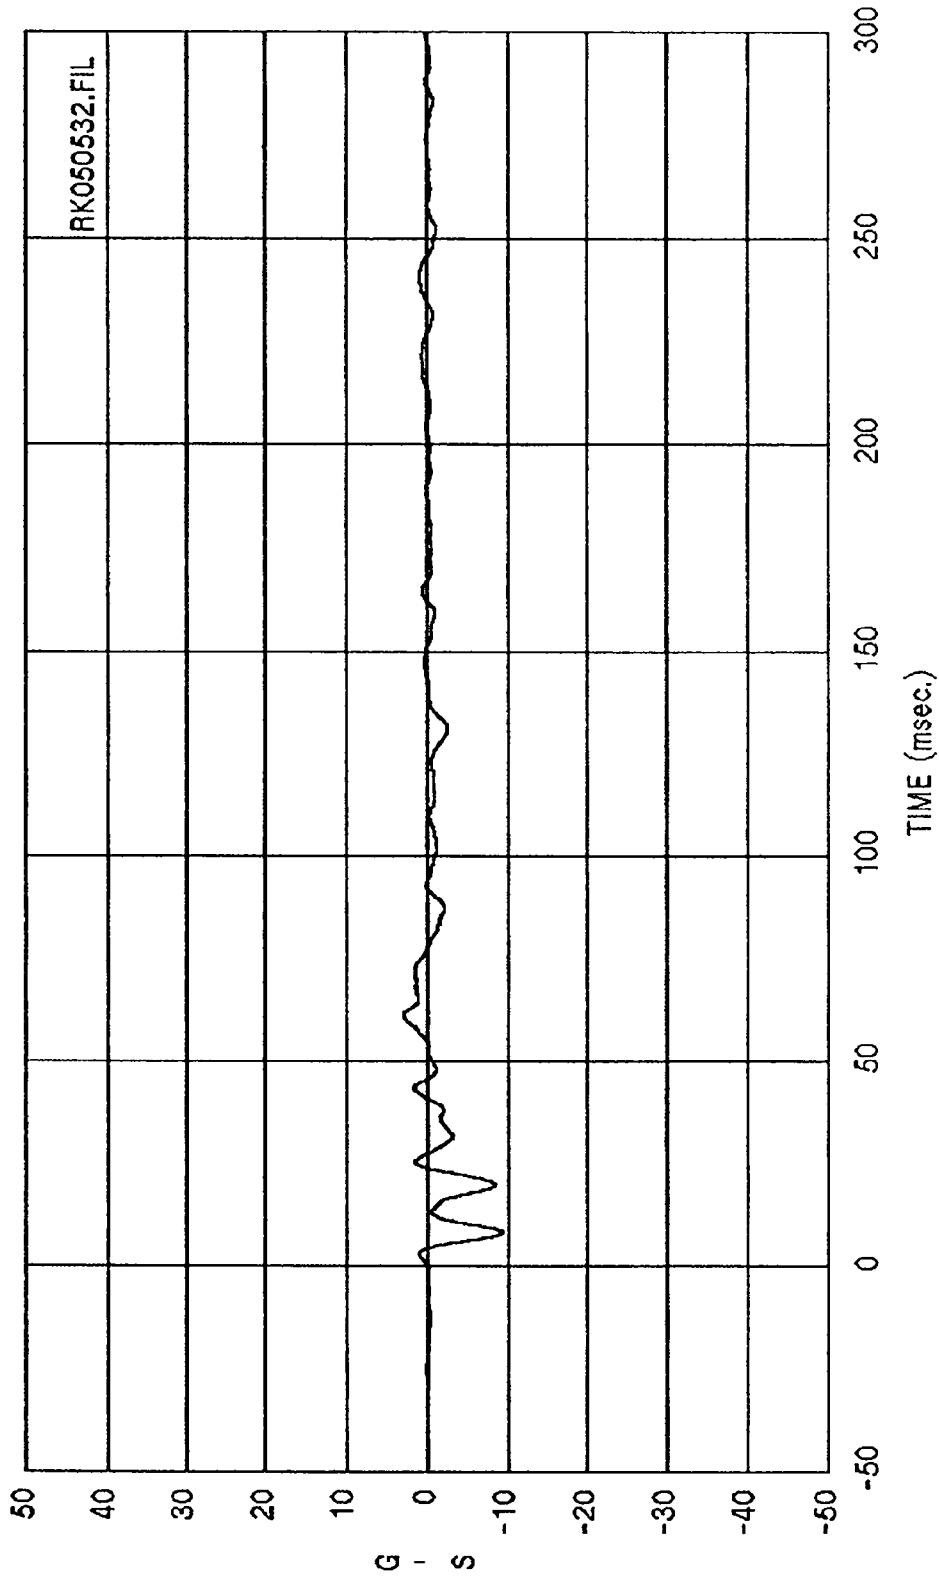
Curve: Rear seat right sill acceleration -- X axis Filter: SAE CLASS 60 Max = 2.9685 Min = -9.2152

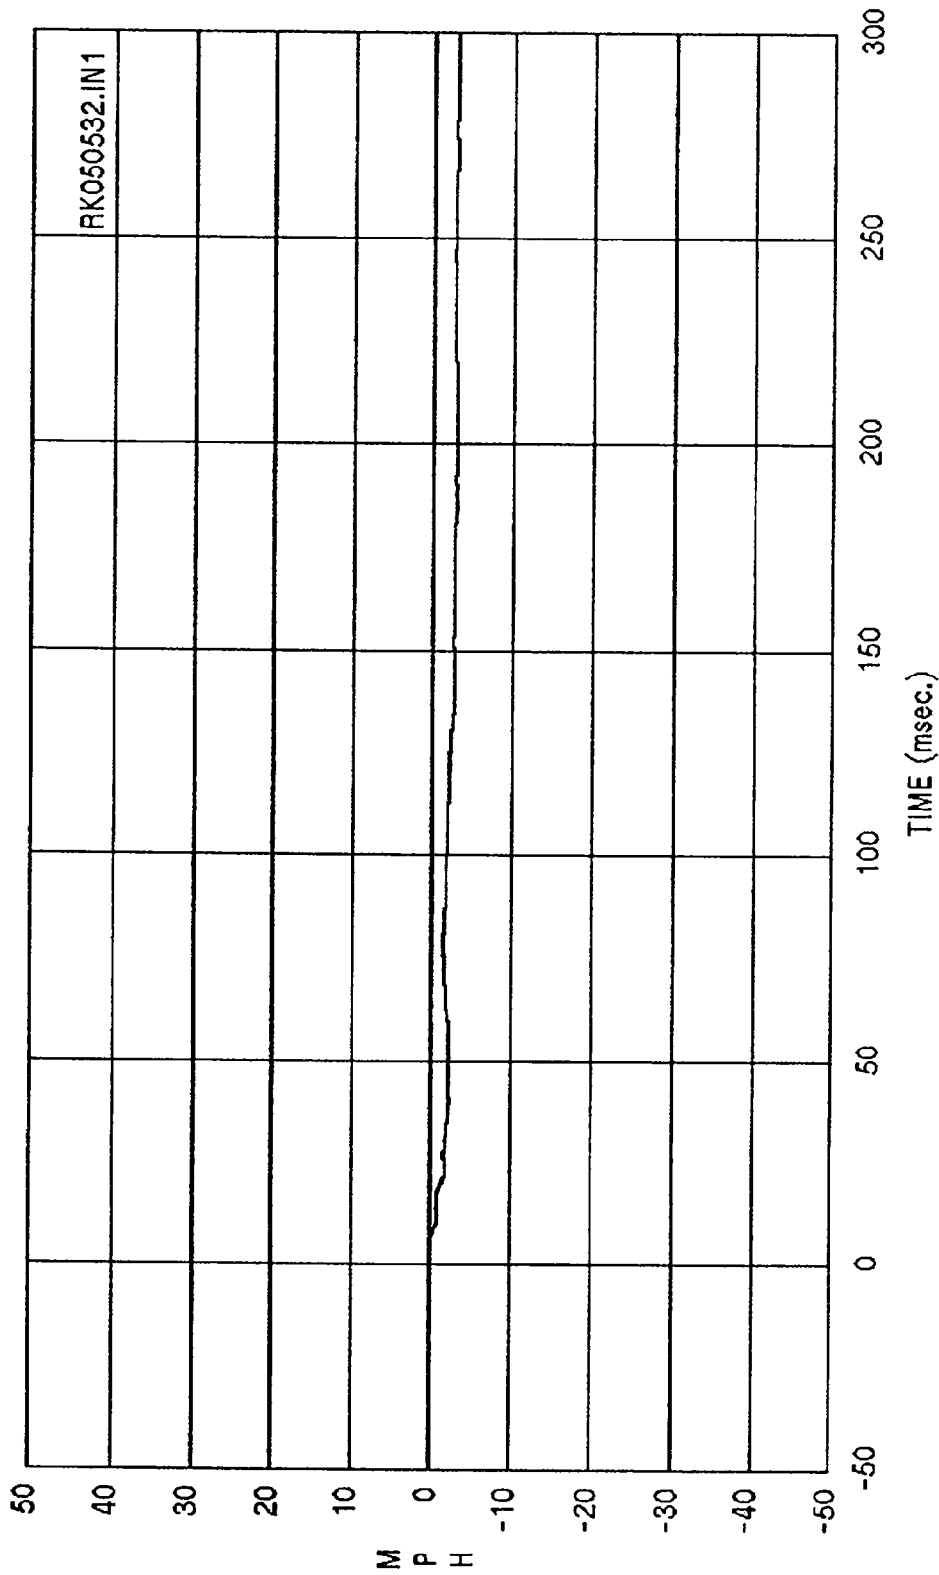
Curve: Rear seat right sill delta V -- X axis Filter: SAE CLASS 180 Max = .12035 Min = -2.9208

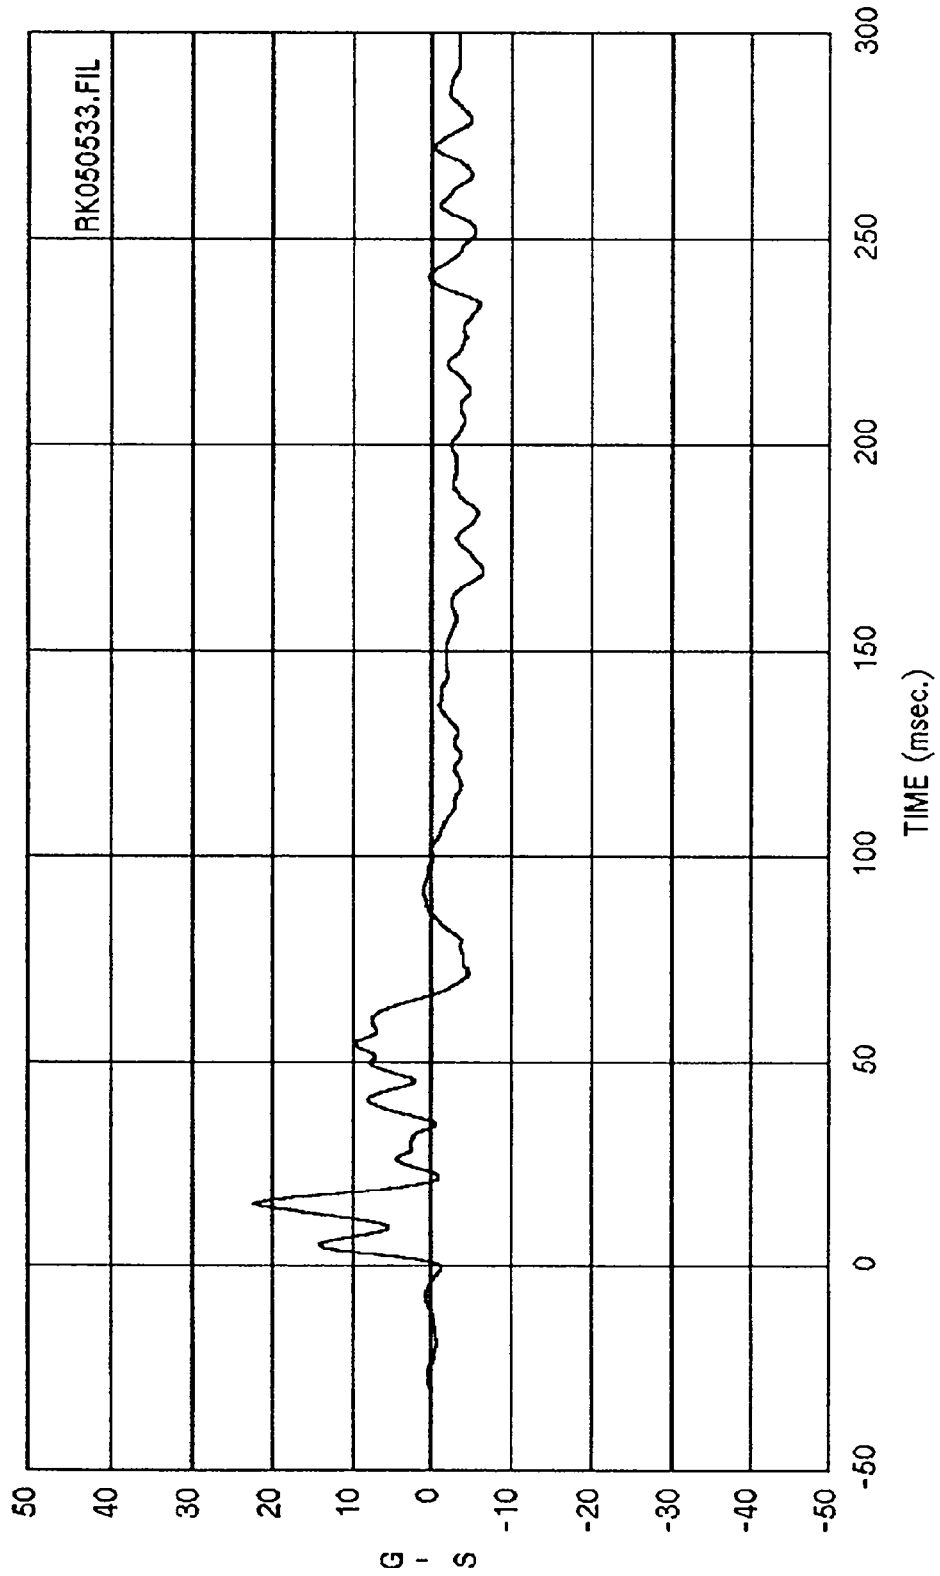
Curve: Rear seat right sill acceleration -- Y axis Filter: SAE CLASS 60 Max = 22.294 Min = -6.5479
