**SIDE IMPACT PROTECTION STUDY  
IN PRODUCTION VEHICLES  
MDB-TO-VEHICLE SIDE IMPACT TEST OF  
A 27° CRABBED MOVING DEFORMABLE BARRIER  
TO A 1989 ISUZU TROOPER, 4 WHEEL DRIVE  
AT 33.0 MPH**

**NHTSA NO.: RK0505**

**MOBILITY SYSTEMS AND EQUIPMENT COMPANY  
9920 LA CIENEGA BOULEVARD SUITE 708  
INGLEWOOD, CALIFORNIA 90301**

FINAL REPORT

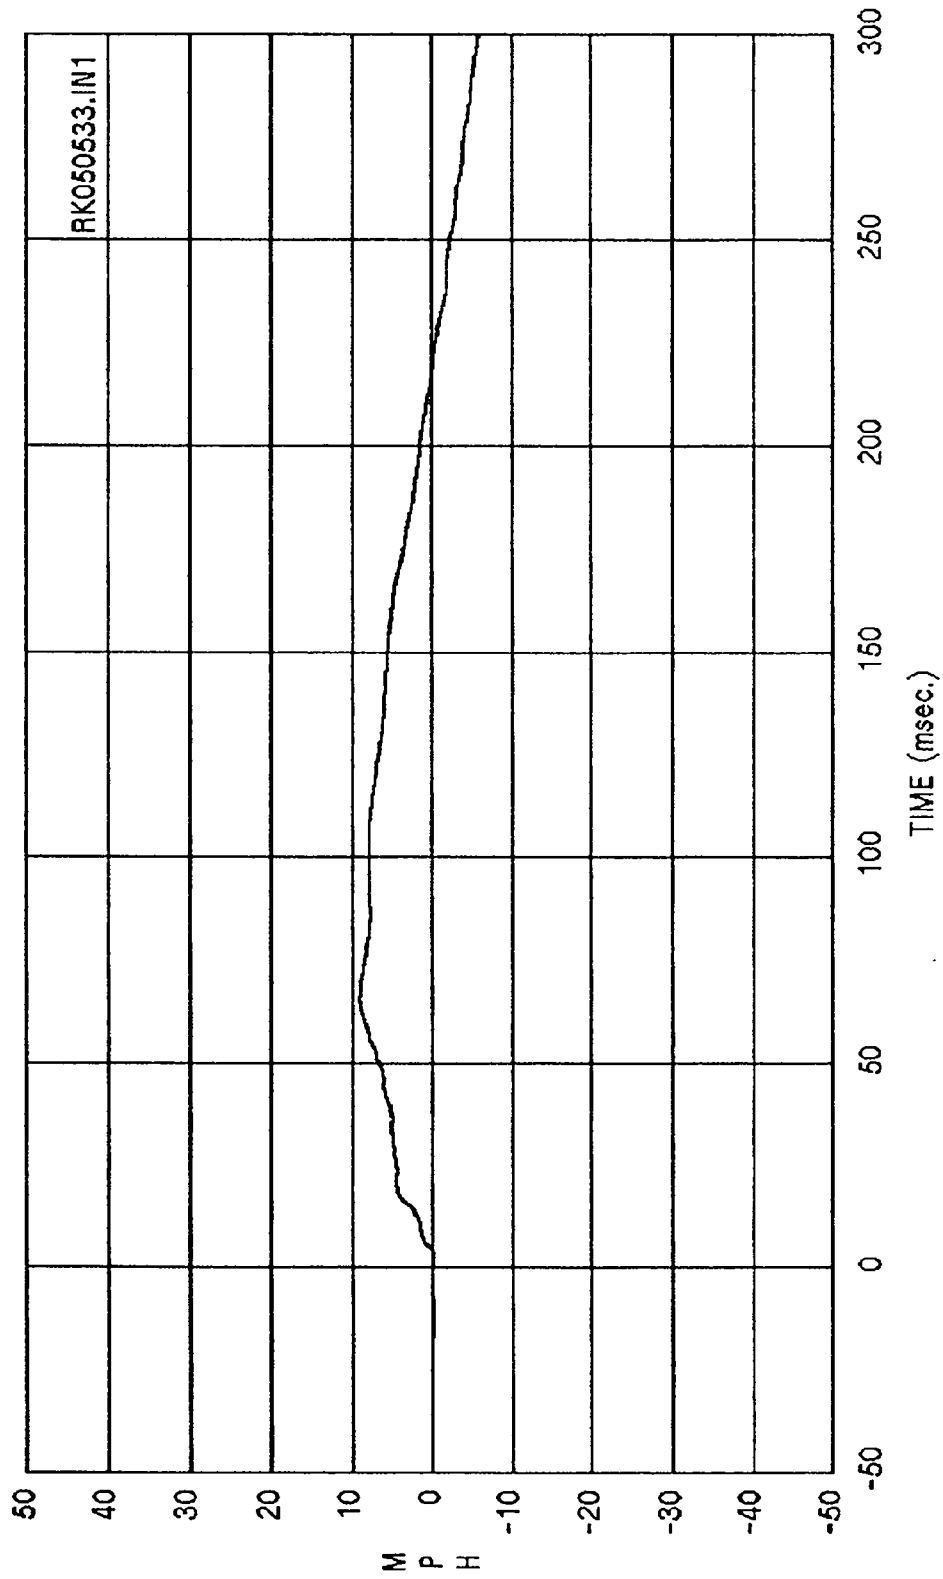
Curve: Rear seat right sill delta V -- Y axis Filter: SAE CLASS 180 Max = 9.1638 Min = -5.8462

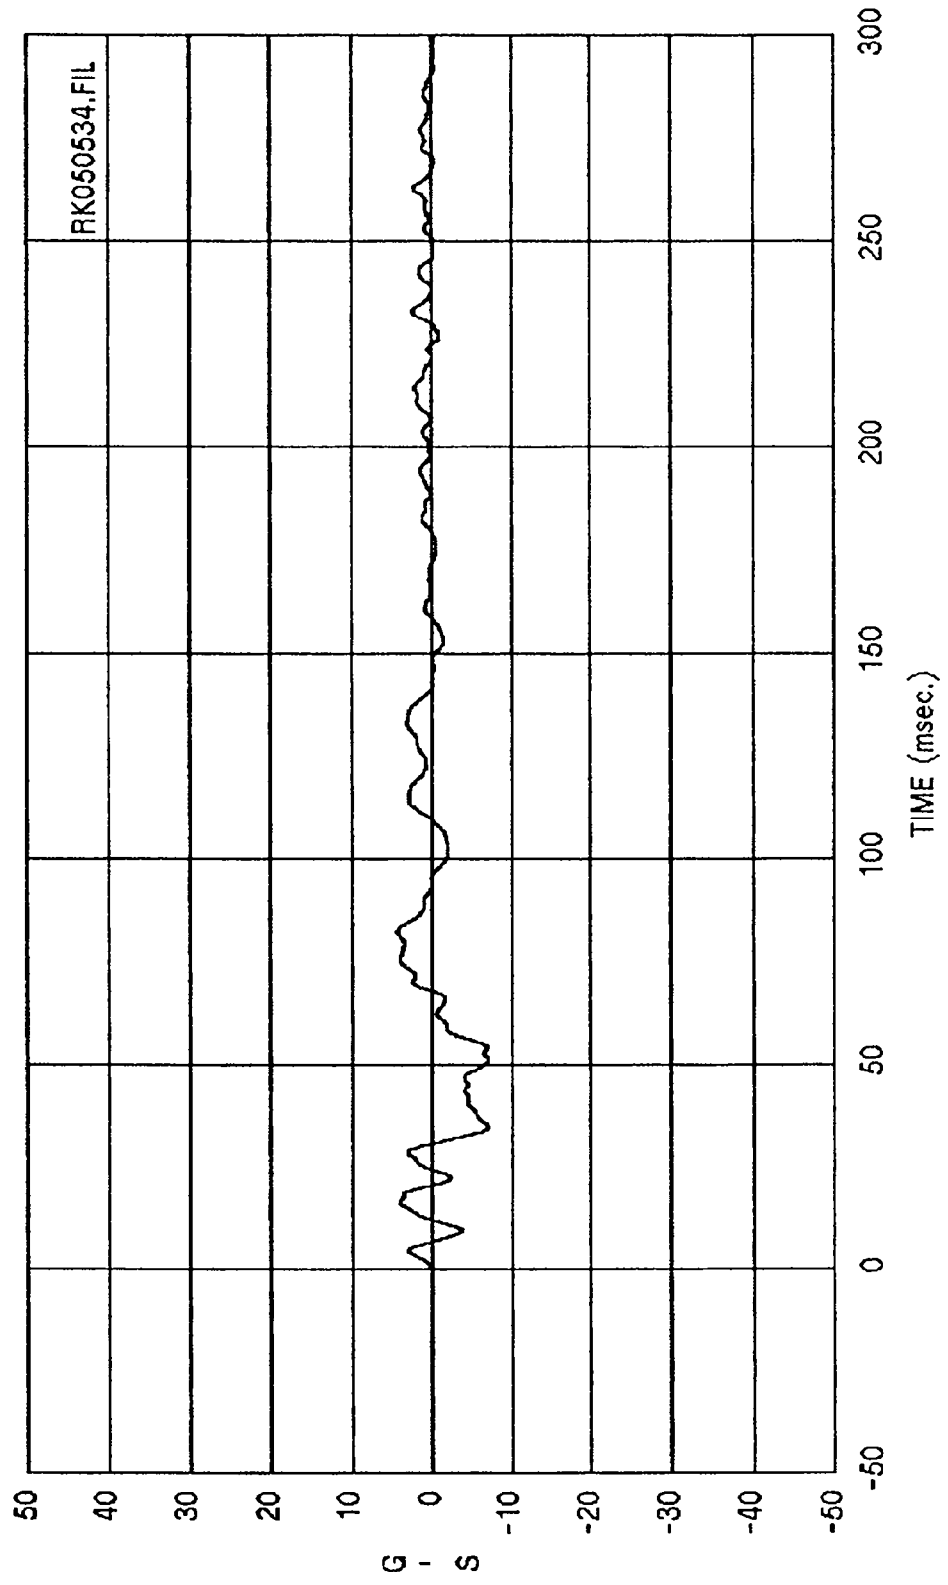
Curve: Rear seat right sill acceleration -- Z axis Filter: SAE CLASS 60 Max = 4.3120 Min = -7.1852

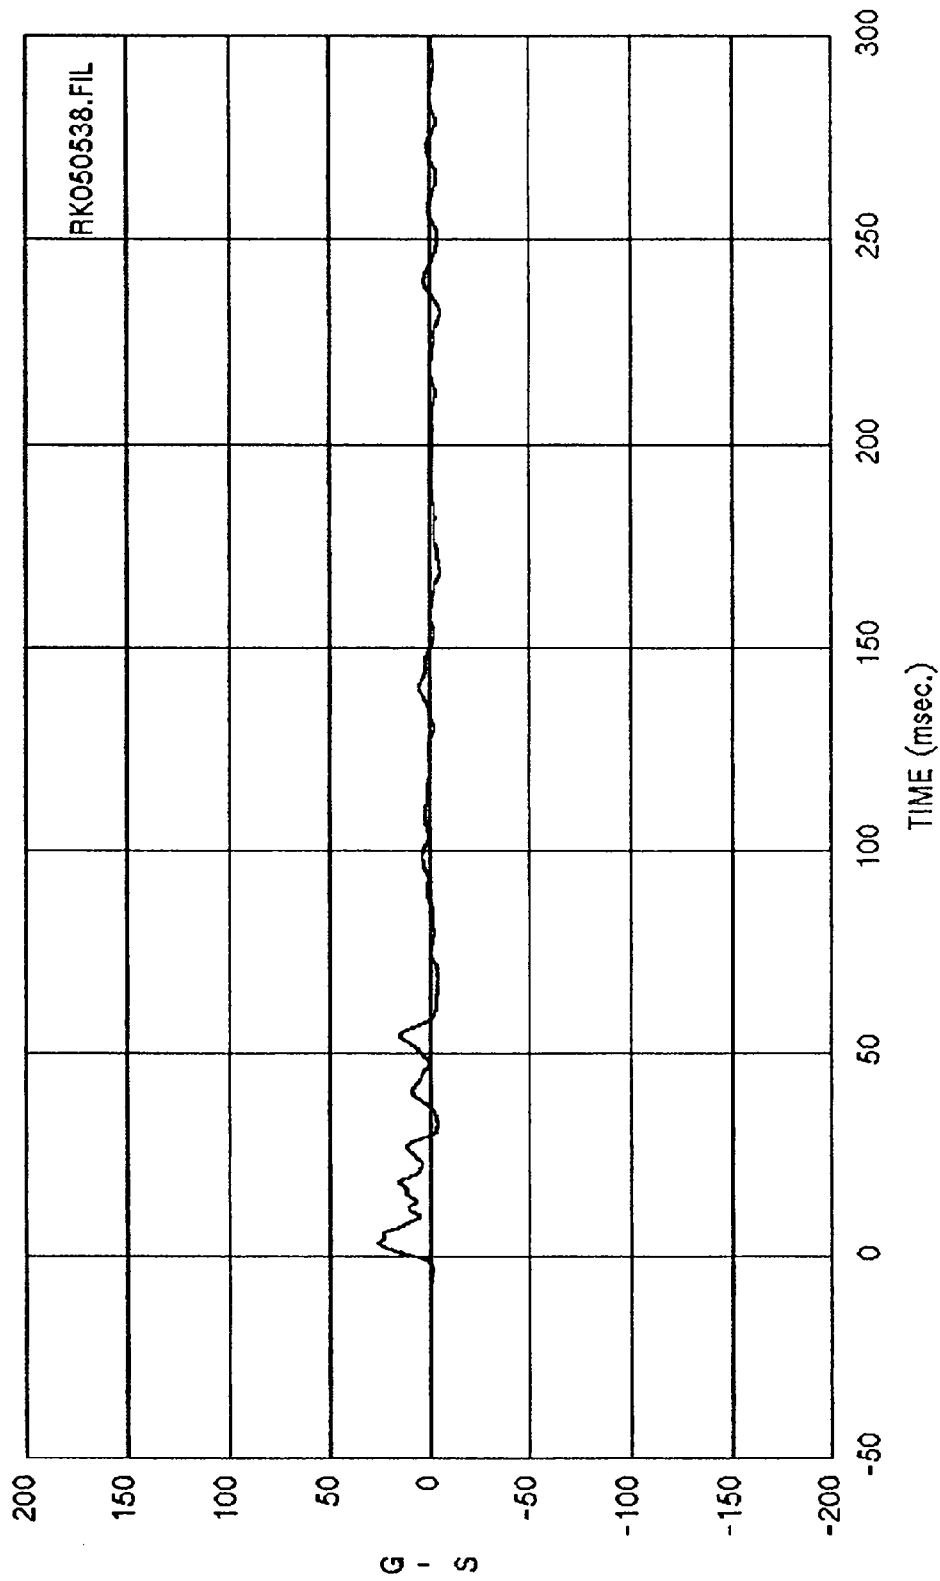
Curve: Rear seat left sill acceleration -- Y axis Filter: SAE CLASS 60 Max = 26.203 Min = -4.7949

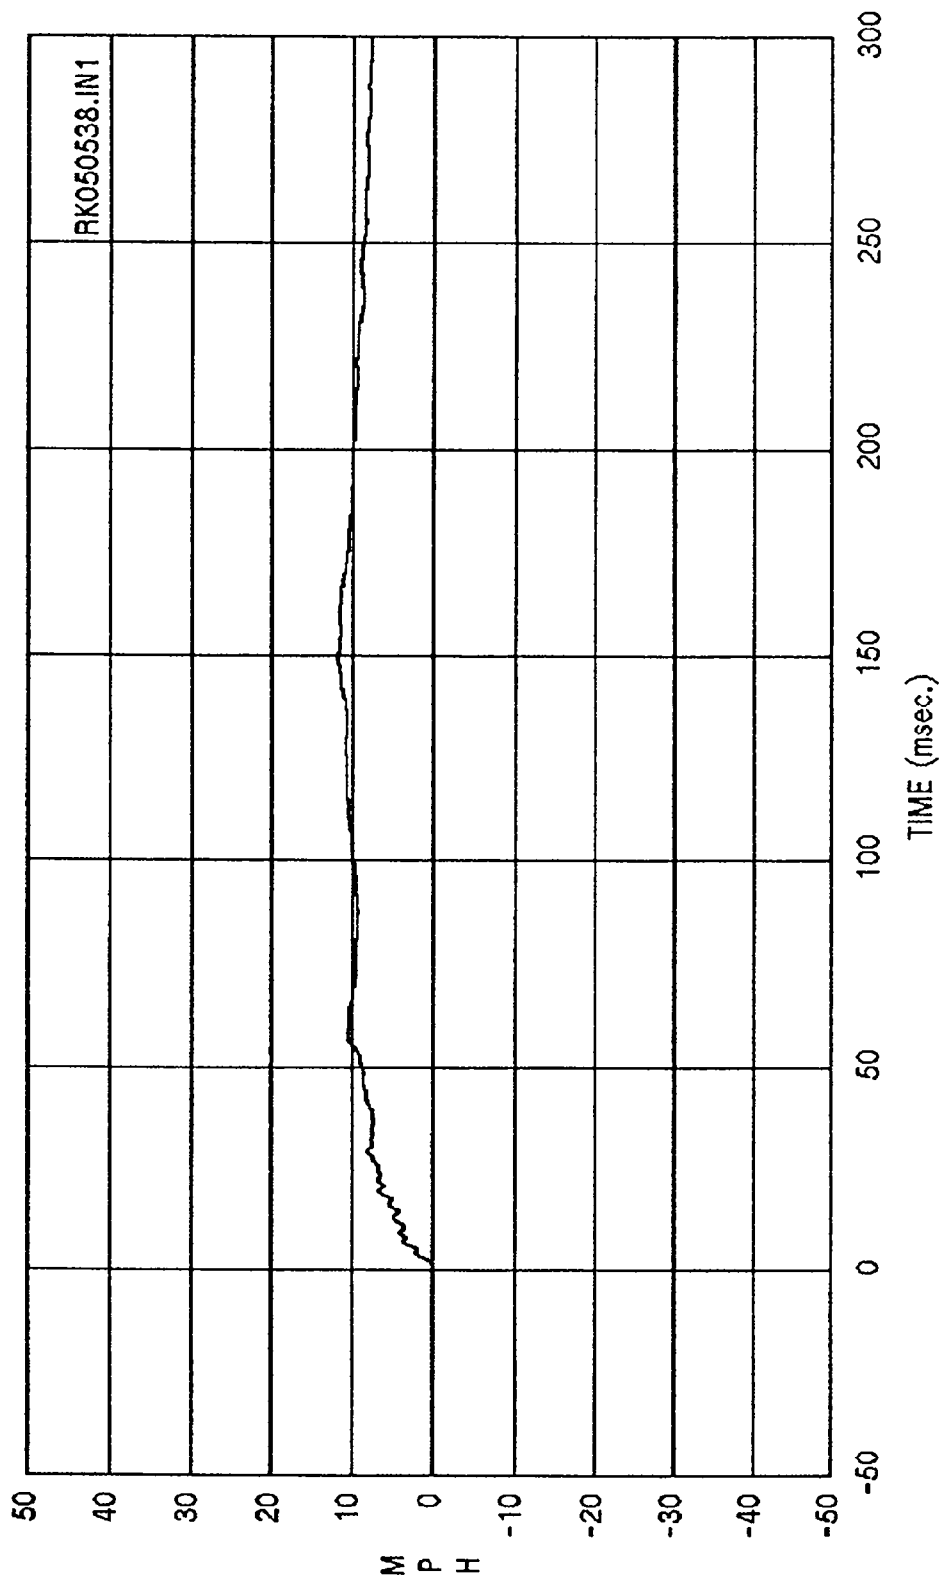
Curve: Rear seat left sill delta V -- Y axis Filter: SAE CLASS 180 Max = 11.784 Min = 1.8774

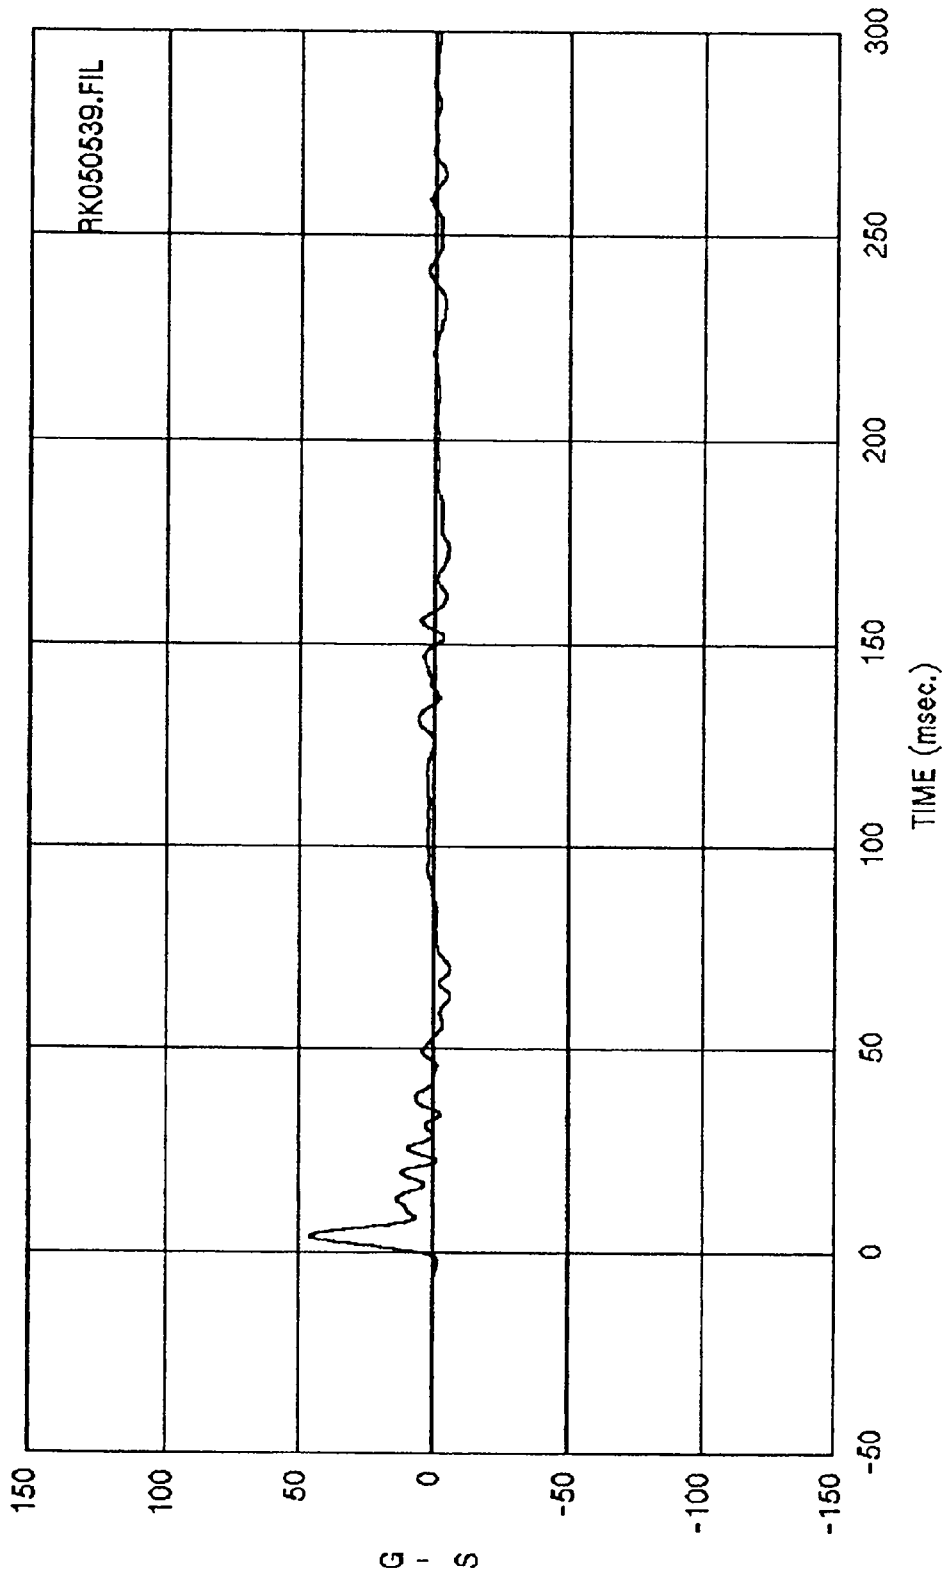
Curve: Front seat left SIII acceleration -- Y axis Filter: SAE CLASS 60 Max = 46.293 Min = -6.1773

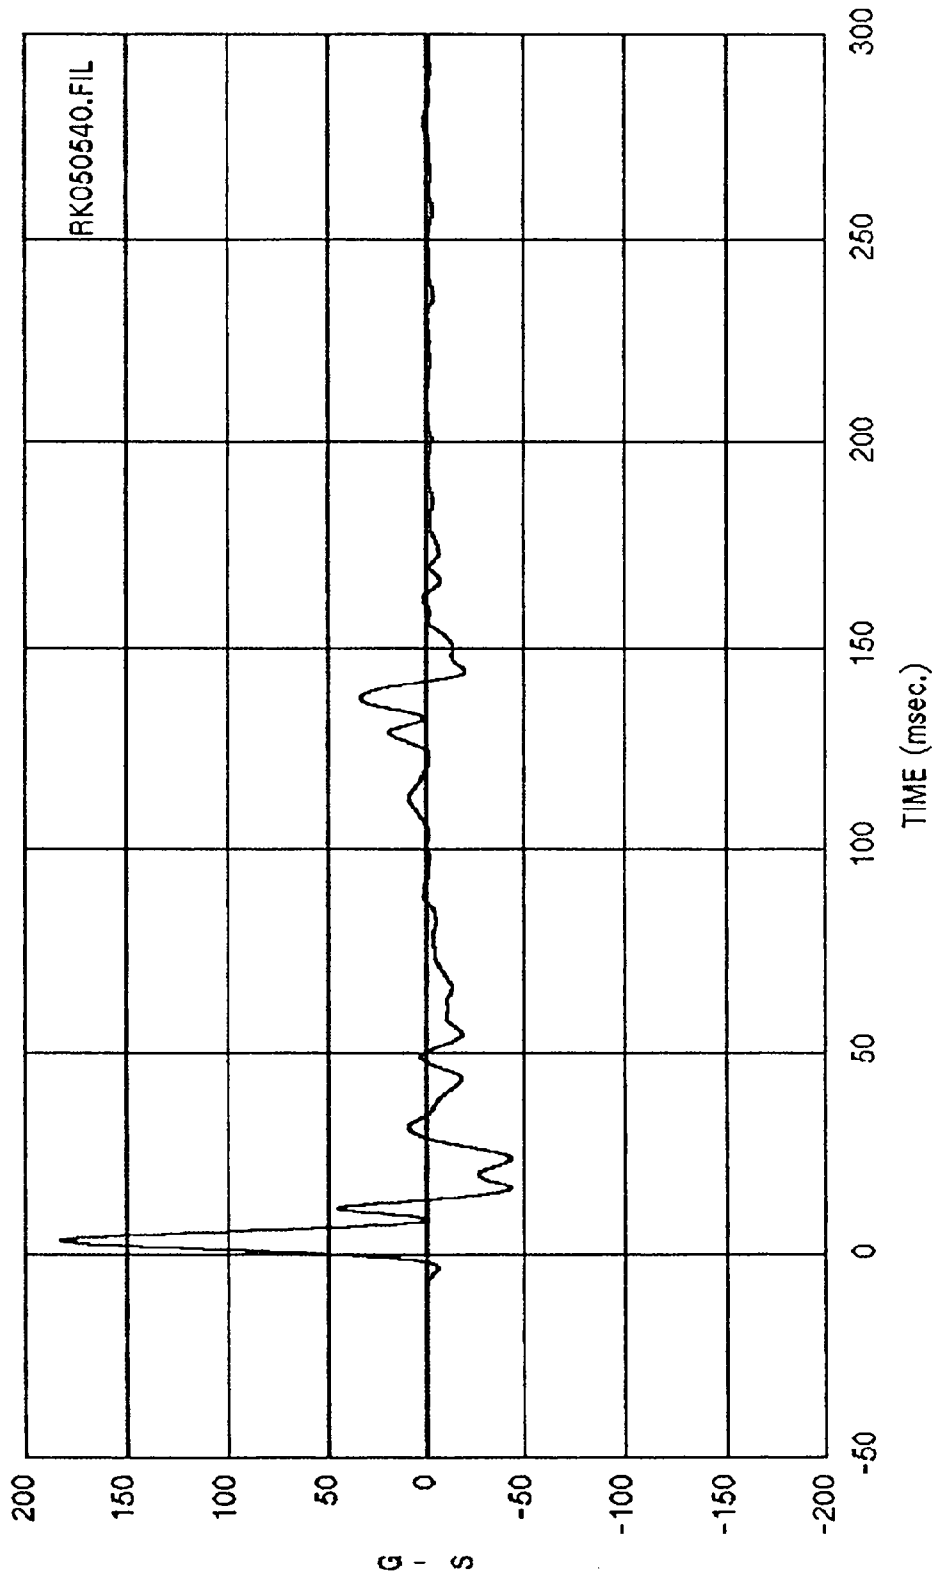
Curve: Left front door at centerline -- Y axis Filter: SAE CLASS 60 Max = 182.85 Min = -43.287

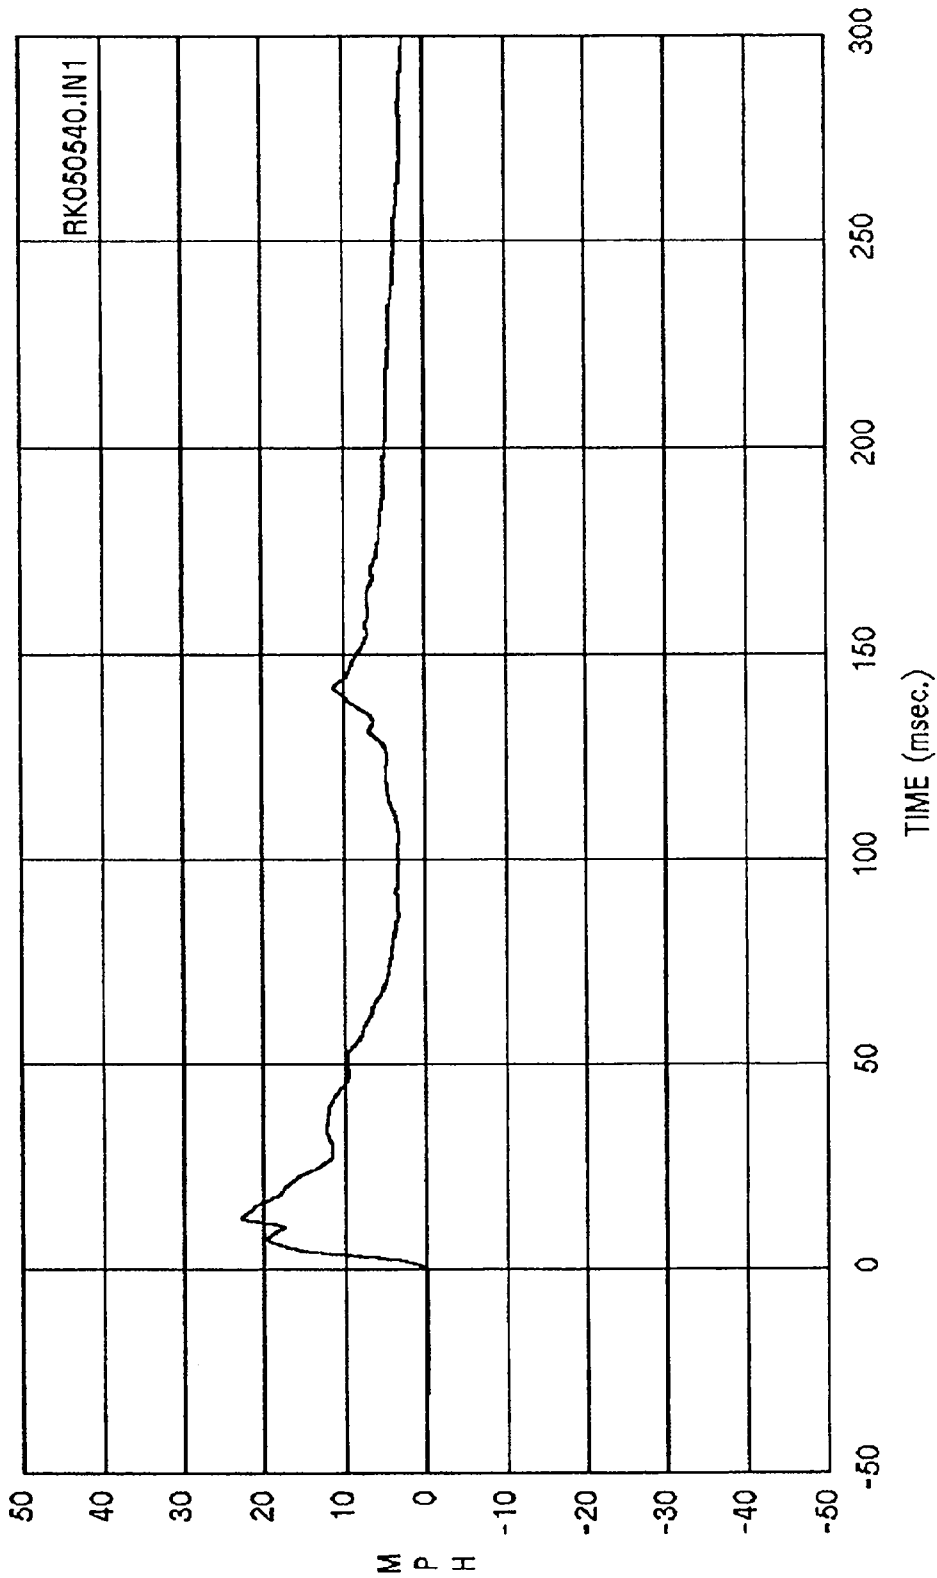
Curve: Left front door at centerline -- Y axis Filter: SAE CLASS 180 Max = 22.988 Min = 2.5298

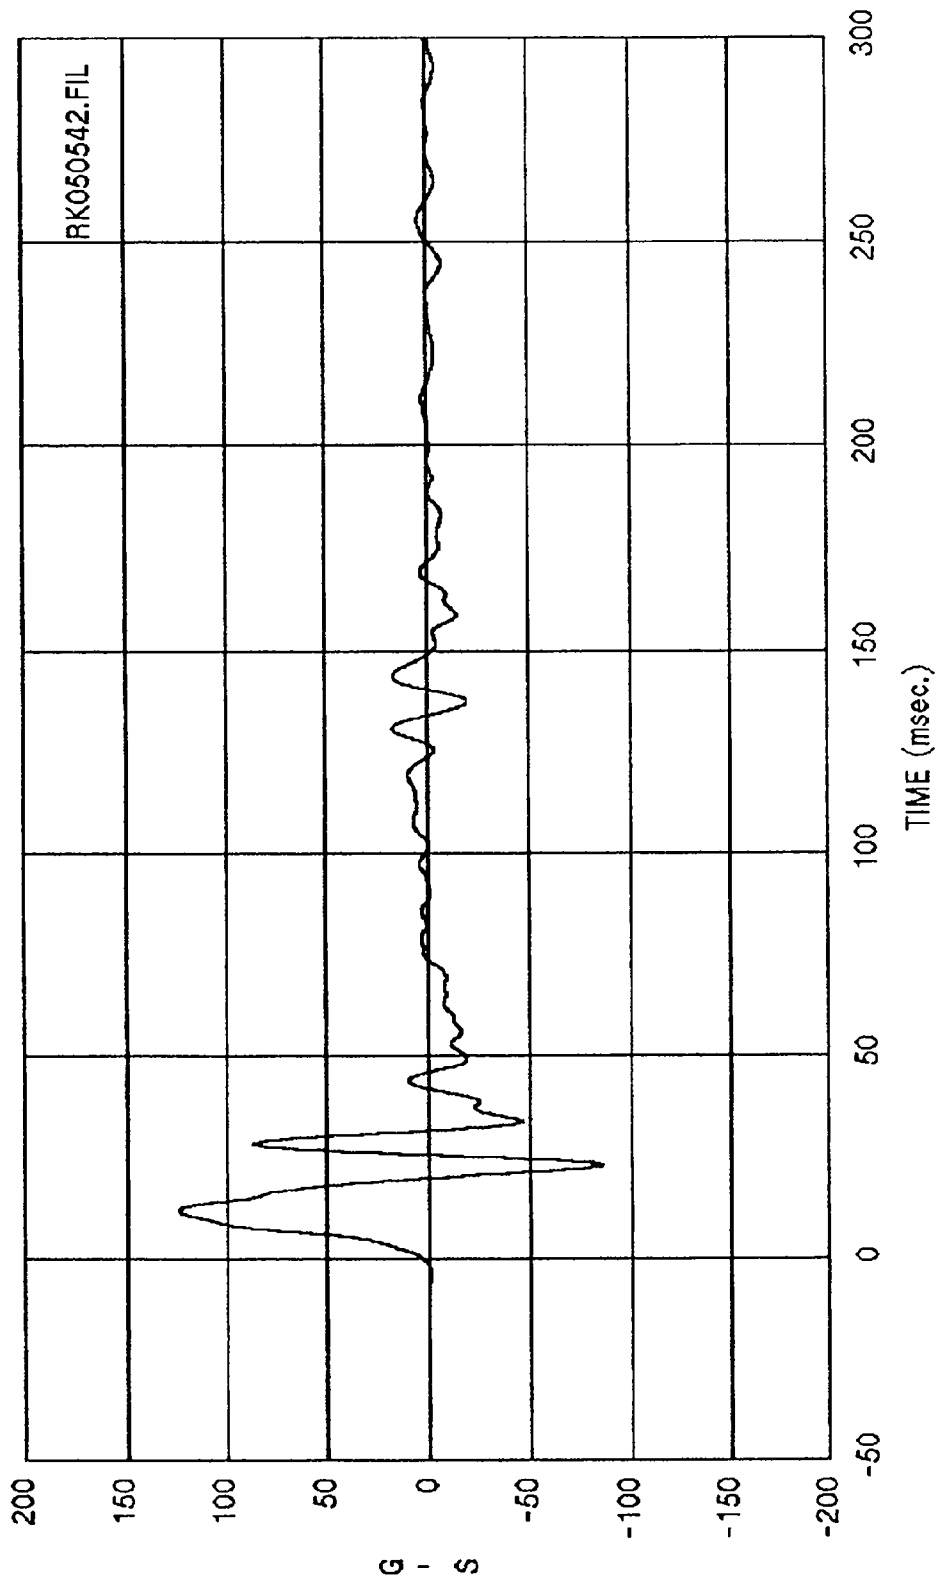
Curve: Left front door at mid-rear -- Y axis Filter: SAE CLASS 60 Max = 124.64 Min = -86.053

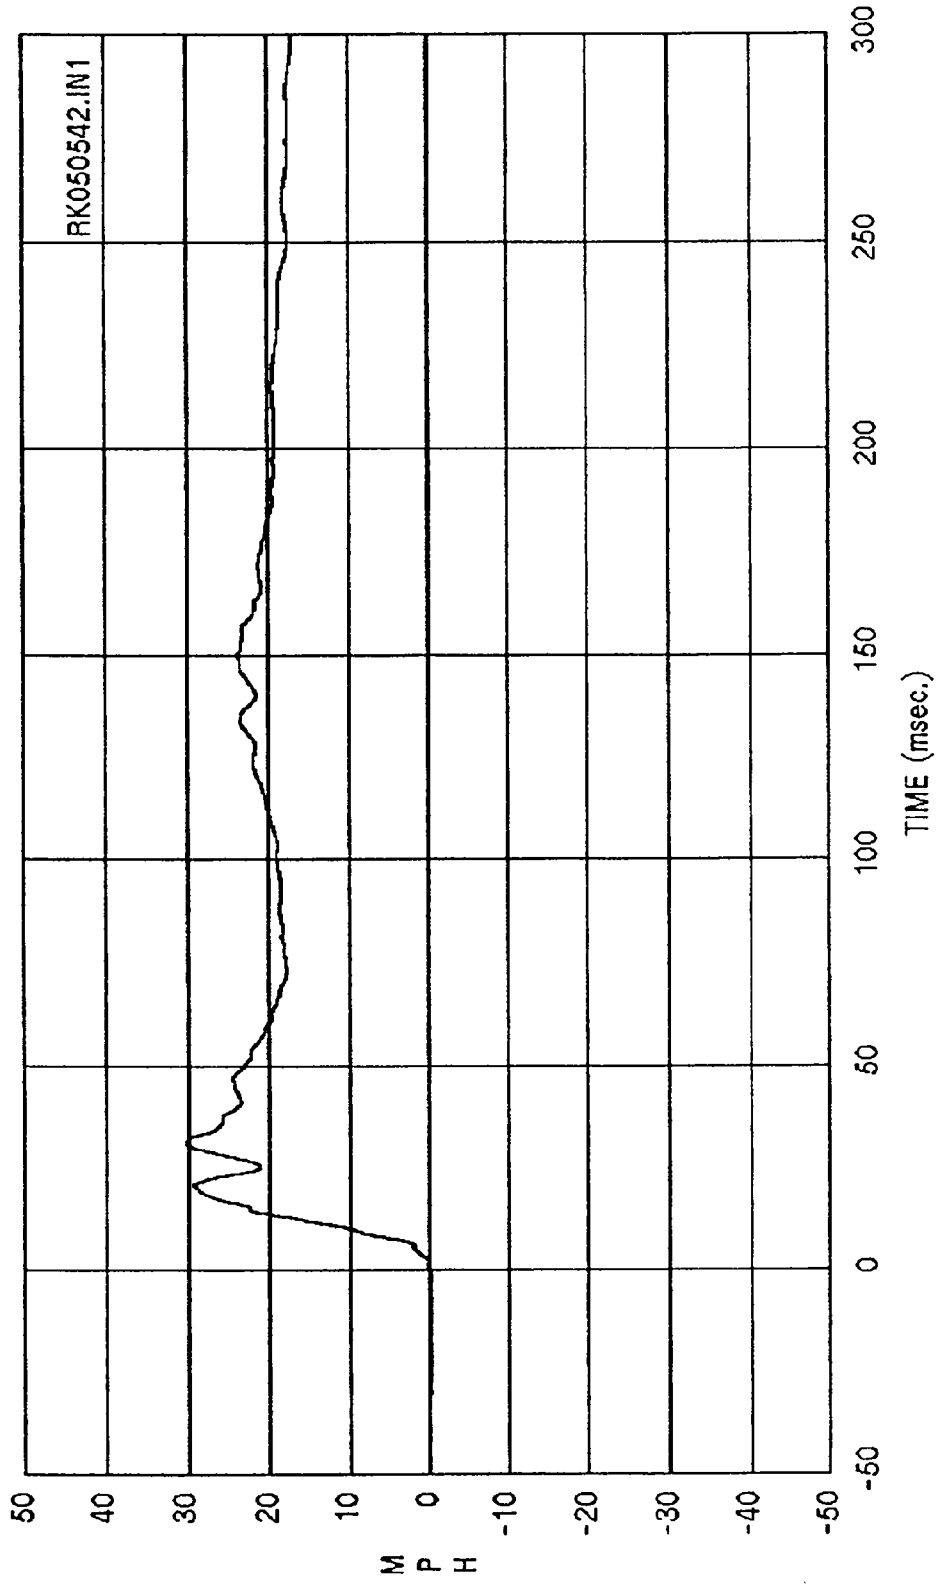
Curve: Left front door at mid-rear -- Y axis Filter: SAE CLASS 180 Max = 30.224 Min = .93993E-

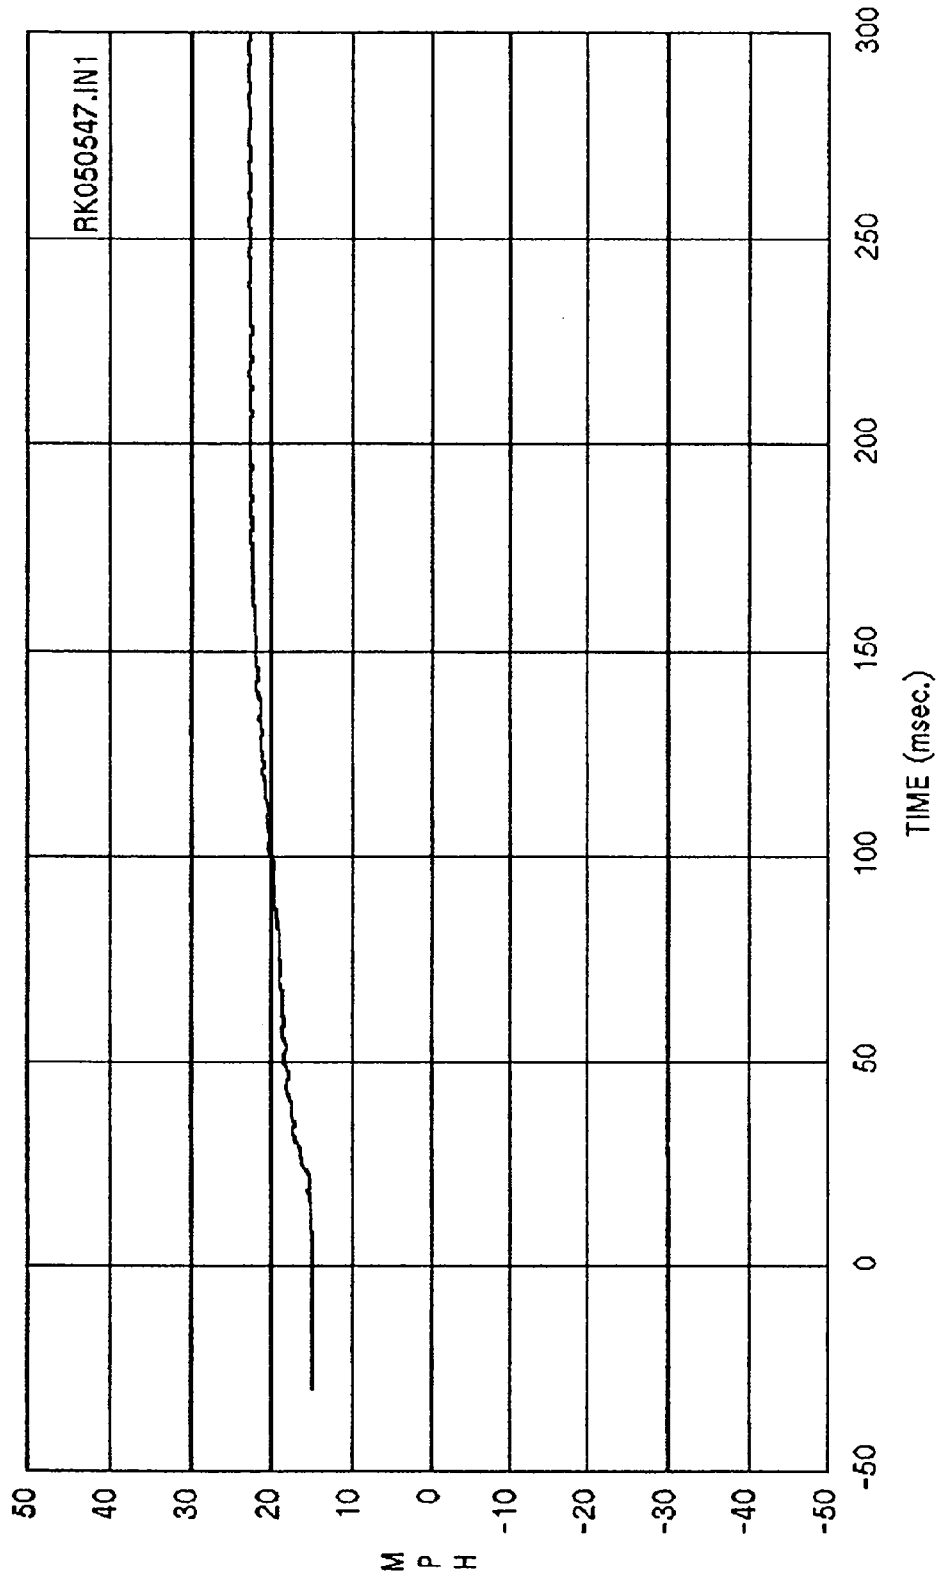
Curve: M.D.B. C/G delta V -- Y axis Filter: SAE CLASS 180 Max = 22.912 Min = 14.980

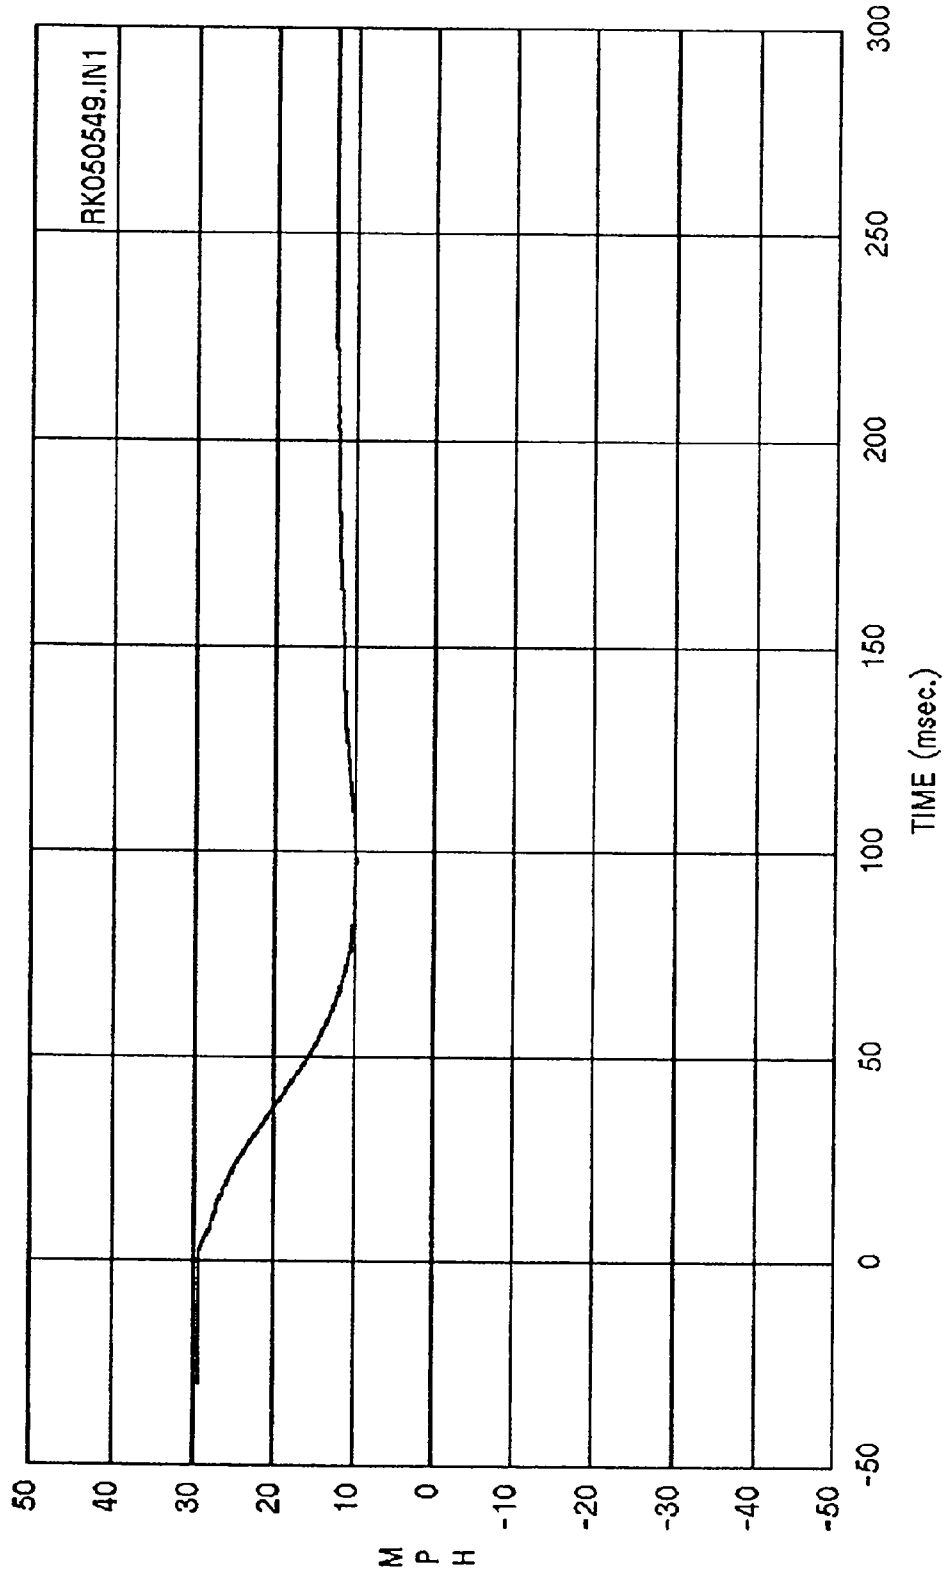
Curve: M.D.B. rear C/G delta V -- X axis Filter: SAE CLASS 180 Max = 29.423 Min = 9.8955

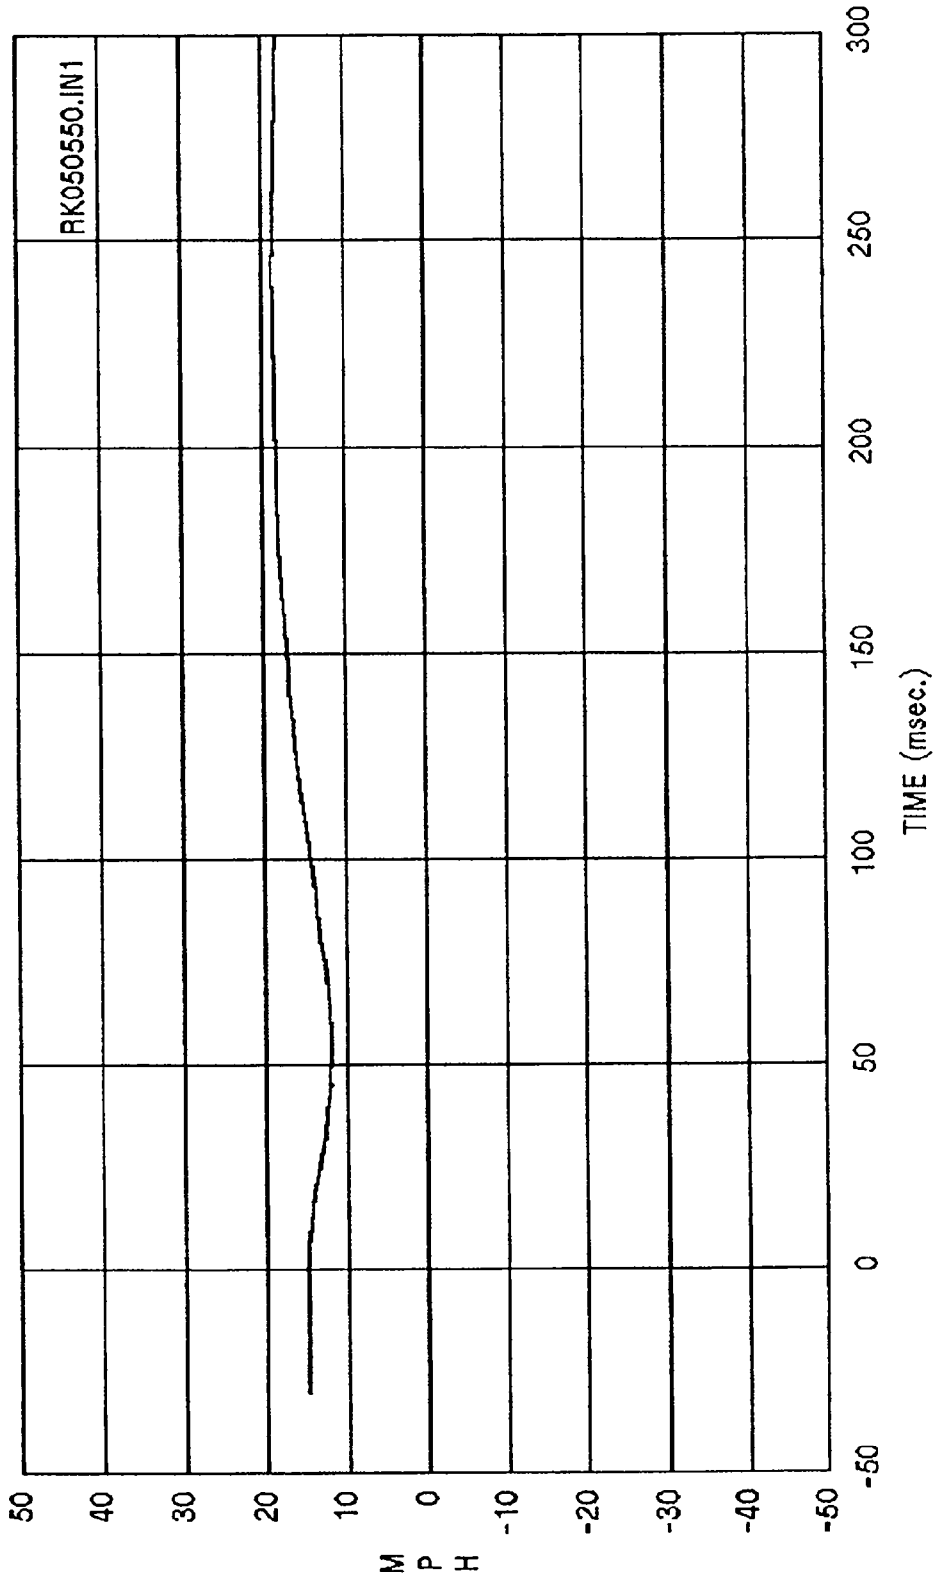
Curve: M.D.B. rear C/G delta V -- Y axis Filter: SAE CLASS 180 Max = 18.898 Min = 12.035
