REPORT NO.: MSE-92-07-TR1086-07

**SIDE IMPACT PROTECTION STUDY  
IN PRODUCTION VEHICLES  
MDB-TO-VEHICLE SIDE IMPACT TEST OF  
A 27<sup>0</sup> CRABBED MOVING DEFORMABLE BARRIER  
TO A 1989 MITSUBISHI MIGHTY MAX, PICKUP  
AT 33.0 MPH**

**NHTSA NO.: RK5600**

FINAL REPORT

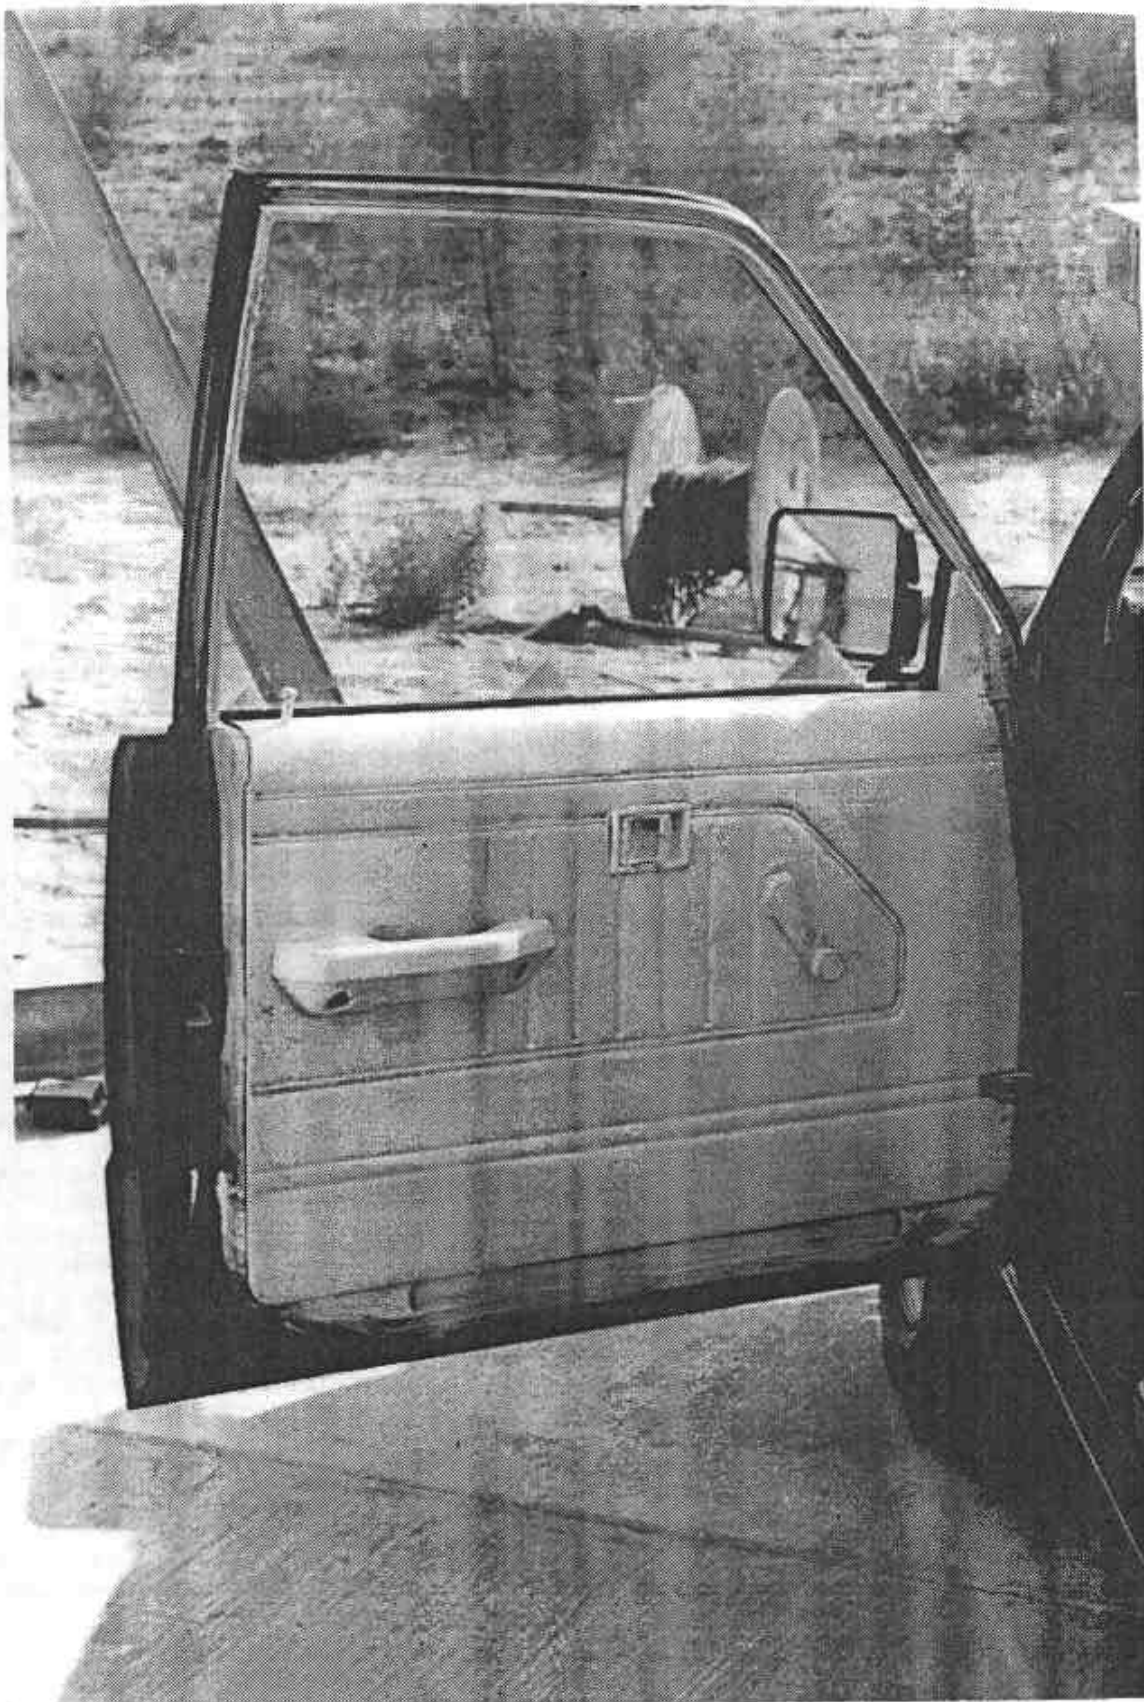
FIGURE 5-24 DRIVER DOOR ACCELEROMETERS INSTALLED, DOOR PANEL IN PLACE-PRETEST
