REPORT NO.: MSE-92-08-TR1086-08

**SIDE IMPACT PROTECTION STUDY
IN PRODUCTION VEHICLES
MDB-TO-VEHICLE SIDE IMPACT TEST OF
A 27⁰ CRABBED MOVING DEFORMABLE BARRIER
TO A 1989 MAZDA MPV
AT 33.0 MPH**

NHTSA NO.: RK5400

FINAL REPORT

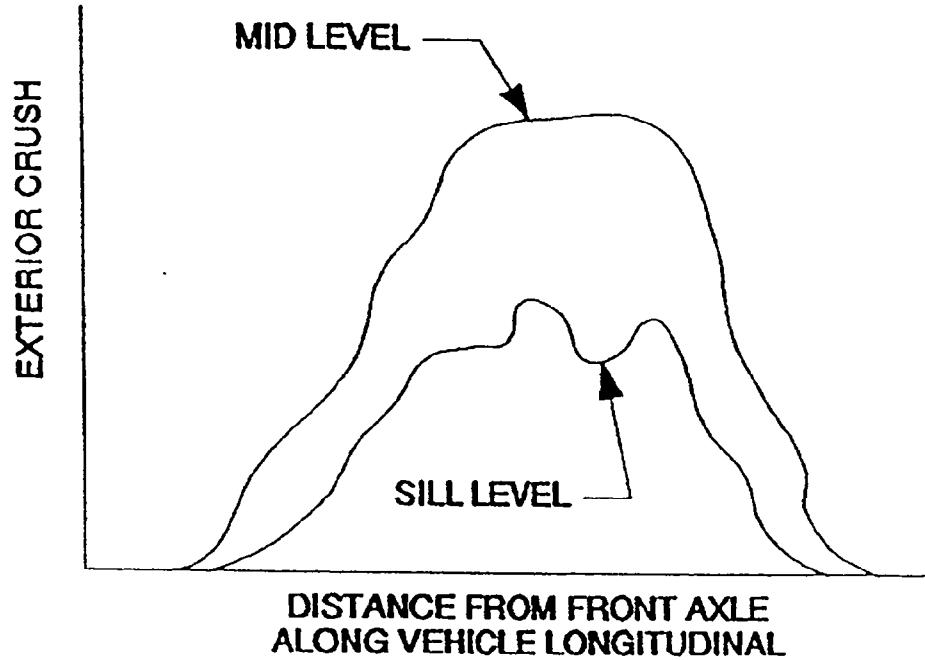
External Lateral Damage Profile (sample shown below)

1. LEVEL 1 (12.1 inches above ground) = 6.8 inches
2. LEVEL 2 (29.3 inches above ground) = 18.9 inches
3. LEVEL 3 (29.8 inches above ground) = 18.7 inches
4. LEVEL 4 (44.0 inches above ground) = 13.7 inches
5. LEVEL 5 (61.6 inches above ground) = 3.9 inches

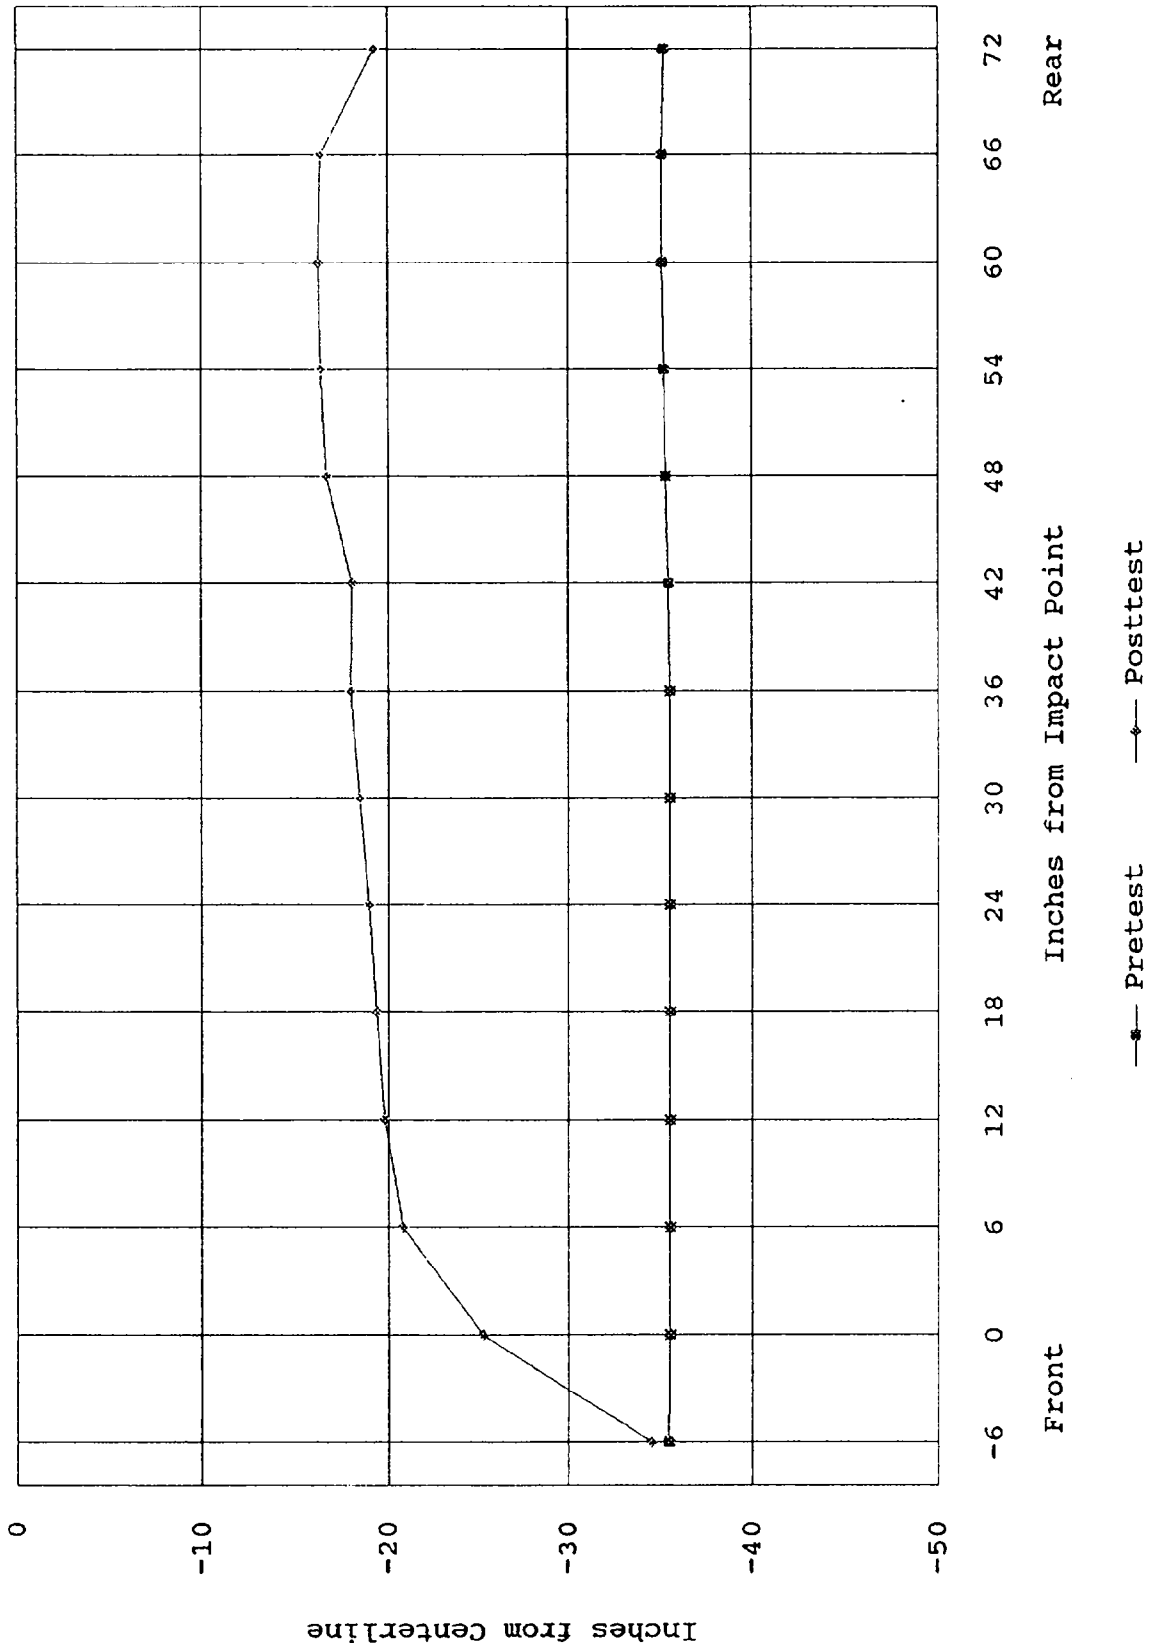
INCHES FROM IMPACT POINT	POSTTEST (Inches)	PRETEST (Inches)	STATIC CRUSH (Inches)
-6 Inches	<u>13.4</u>	<u>12.5</u>	<u>0.9</u>
0 (Impact Point)	<u>22.8</u>	<u>12.4</u>	<u>10.4</u>
6 Inches	<u>27.2</u>	<u>12.4</u>	<u>14.8</u>
12 Inches	<u>28.2</u>	<u>12.4</u>	<u>15.8</u>
18 Inches	<u>28.6</u>	<u>12.4</u>	<u>16.2</u>
24 Inches	<u>29.0</u>	<u>12.4</u>	<u>16.6</u>
30 Inches	<u>29.5</u>	<u>12.4</u>	<u>17.1</u>
36 Inches	<u>30.0</u>	<u>12.4</u>	<u>17.6</u>
42 Inches	<u>29.9</u>	<u>12.5</u>	<u>17.4</u>
48 Inches	<u>31.3</u>	<u>12.6</u>	<u>18.7</u>
54 Inches	<u>31.6</u>	<u>12.7</u>	<u>18.9</u>
60 Inches	<u>31.7</u>	<u>12.8</u>	<u>18.9</u>
66 Inches	<u>31.6</u>	<u>12.8</u>	<u>18.8</u>
72 Inches	<u>28.7</u>	<u>12.7</u>	<u>16.0</u>

Level 2 - Occupant H-point - 29.3" Above Ground Level

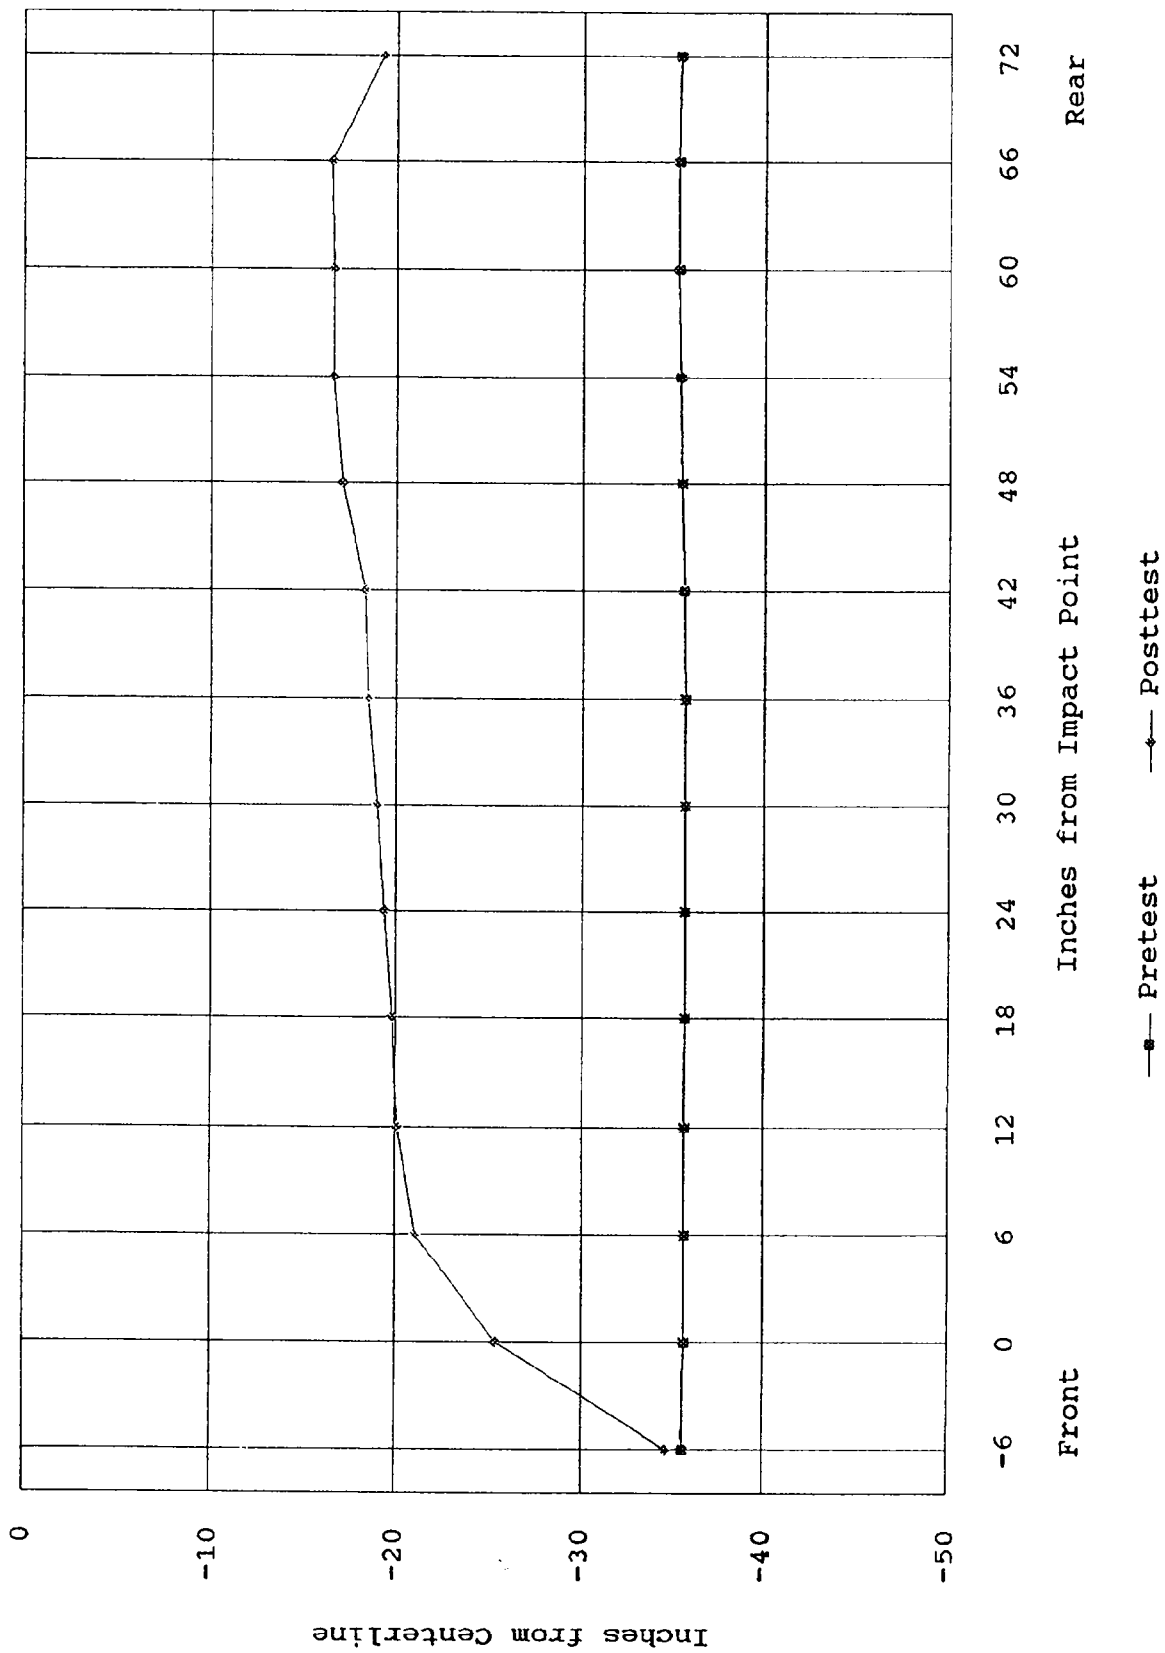
INCHES FROM IMPACT POINT	POSTTEST (Inches)	PRETEST (Inches)	STATIC CRUSH (Inches)
-6 Inches	<u>13.4</u>	<u>12.5</u>	<u>0.9</u>
0 (Impact Point)	<u>22.6</u>	<u>12.4</u>	<u>10.2</u>
6 Inches	<u>26.9</u>	<u>12.4</u>	<u>14.5</u>
12 Inches	<u>27.9</u>	<u>12.4</u>	<u>15.5</u>
18 Inches	<u>28.2</u>	<u>12.4</u>	<u>15.8</u>
24 Inches	<u>28.6</u>	<u>12.4</u>	<u>16.2</u>
30 Inches	<u>29.0</u>	<u>12.4</u>	<u>16.6</u>
36 Inches	<u>29.5</u>	<u>12.4</u>	<u>17.1</u>
42 Inches	<u>29.7</u>	<u>12.5</u>	<u>17.2</u>
48 Inches	<u>30.9</u>	<u>12.6</u>	<u>18.3</u>
54 Inches	<u>31.4</u>	<u>12.7</u>	<u>18.7</u>
60 Inches	<u>31.4</u>	<u>12.8</u>	<u>18.6</u>
66 Inches	<u>31.5</u>	<u>12.8</u>	<u>18.7</u>
72 Inches	<u>28.7</u>	<u>12.7</u>	<u>16.0</u>

Level 3 - Mid-door - 29.8" Above Ground Level

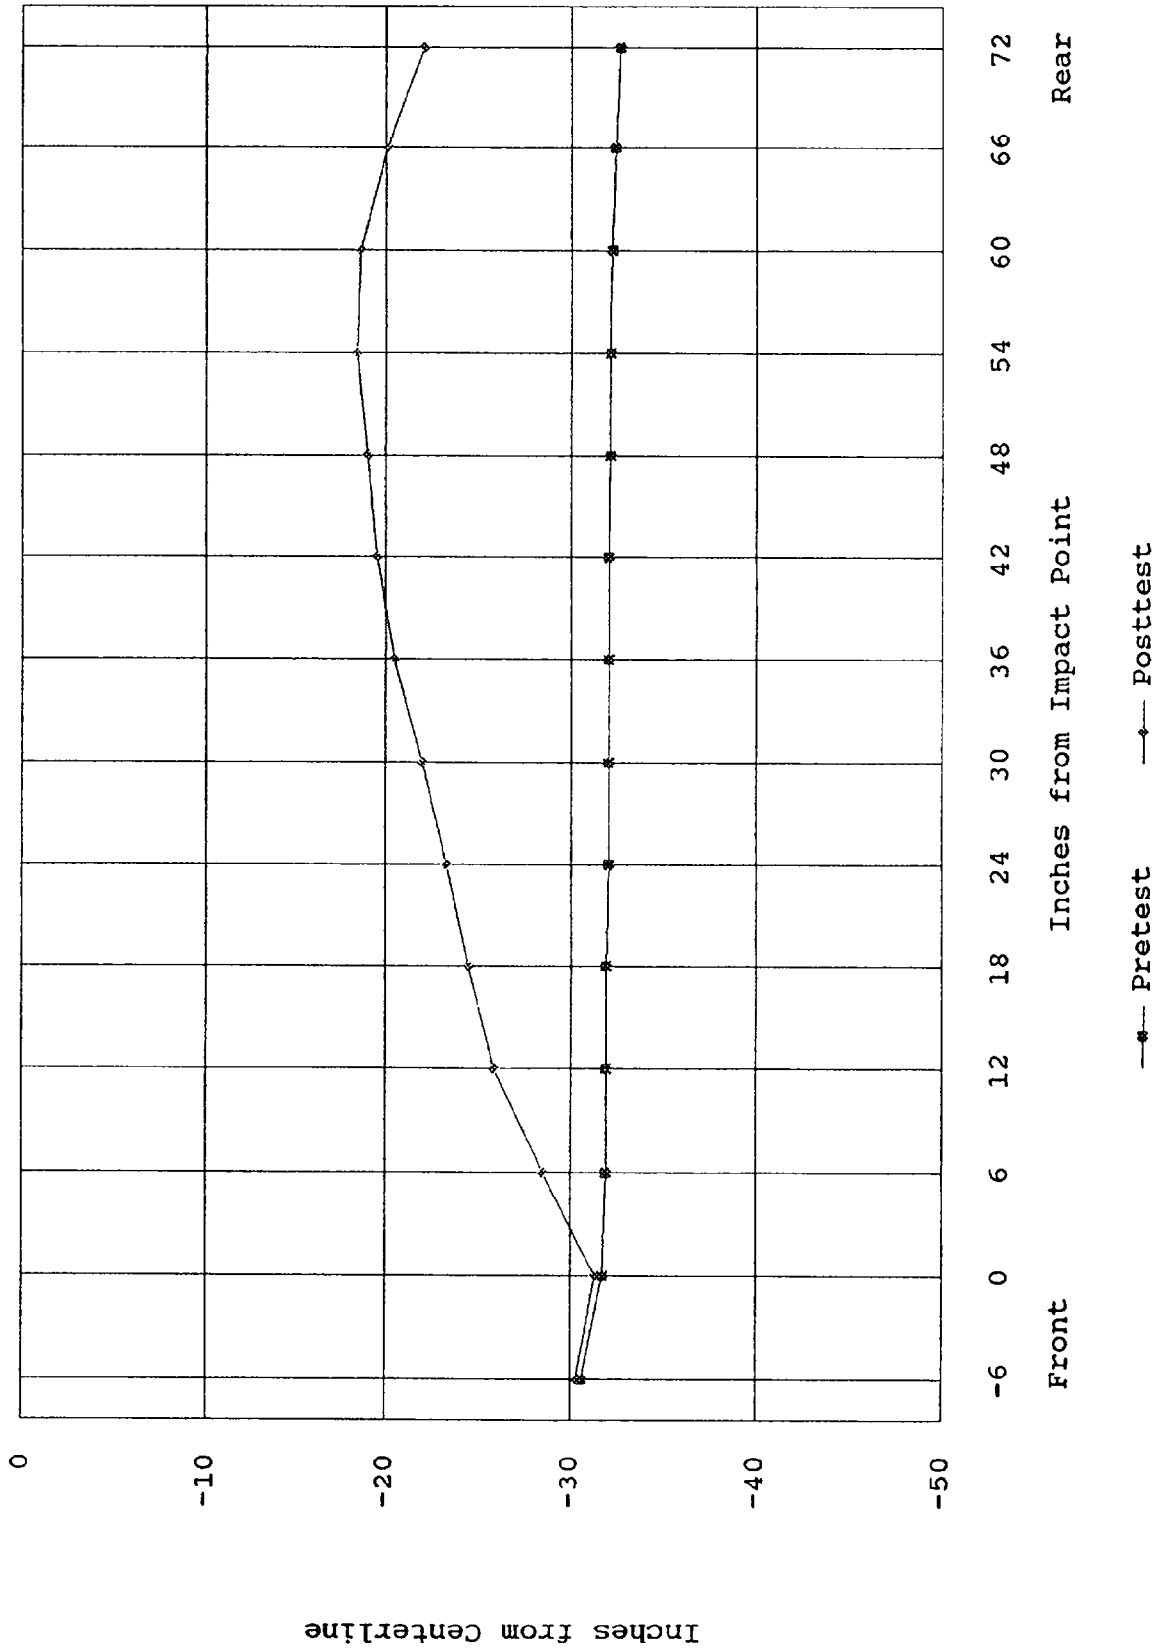
INCHES FROM IMPACT POINT	POSTTEST (Inches)	PRETEST (Inches)	STATIC CRUSH (Inches)
-6 Inches	<u>17.7</u>	<u>17.4</u>	<u>0.3</u>
0 (Impact Point)	<u>16.7</u>	<u>16.3</u>	<u>0.4</u>
6 Inches	<u>19.5</u>	<u>16.1</u>	<u>3.4</u>
12 Inches	<u>22.1</u>	<u>16.1</u>	<u>6.0</u>
18 Inches	<u>23.5</u>	<u>16.1</u>	<u>7.4</u>
24 Inches	<u>24.7</u>	<u>16.0</u>	<u>8.7</u>
30 Inches	<u>26.0</u>	<u>16.0</u>	<u>10.0</u>
36 Inches	<u>27.5</u>	<u>16.0</u>	<u>11.5</u>
42 Inches	<u>28.5</u>	<u>16.0</u>	<u>12.5</u>
48 Inches	<u>29.0</u>	<u>15.9</u>	<u>13.1</u>
54 Inches	<u>29.6</u>	<u>15.9</u>	<u>13.7</u>
60 Inches	<u>29.4</u>	<u>15.8</u>	<u>13.6</u>
66 Inches	<u>27.9</u>	<u>15.6</u>	<u>12.3</u>
72 Inches	<u>25.9</u>	<u>15.4</u>	<u>10.5</u>

Level 4 - Window Sill - 44.0" Above Ground Level

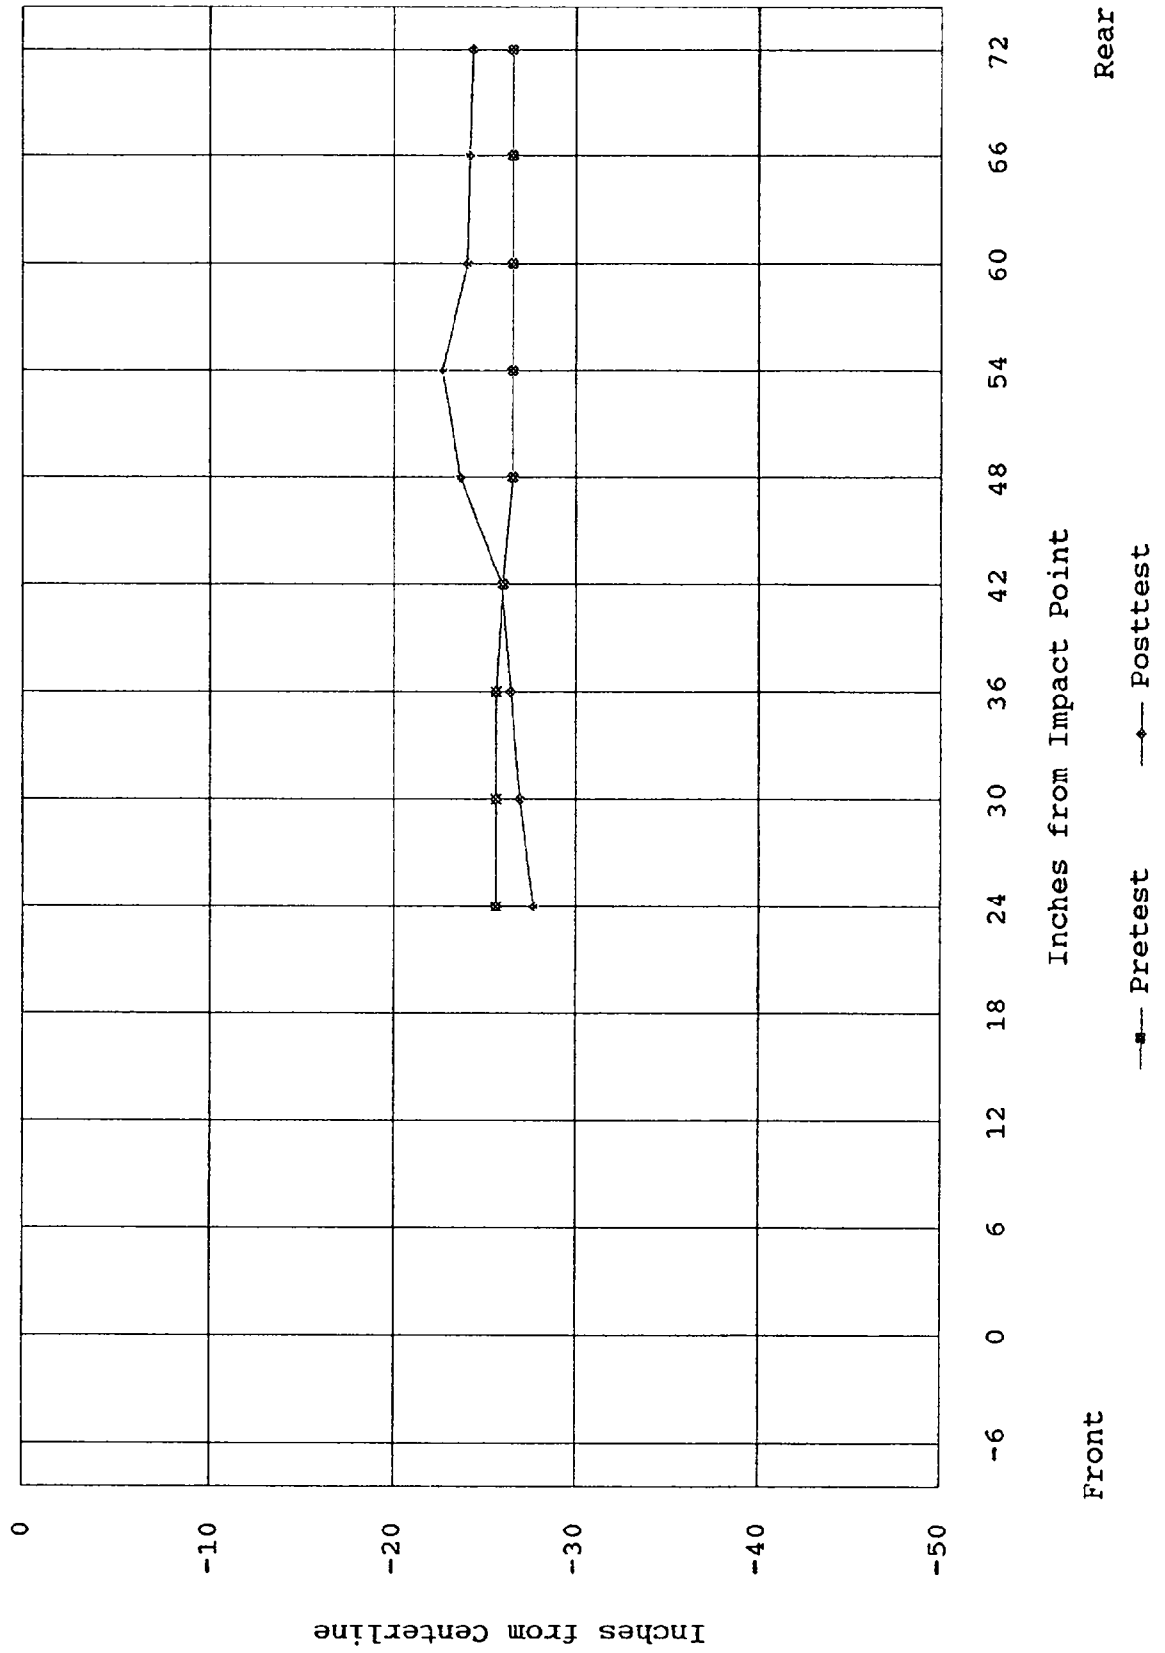
INCHES FROM IMPACT POINT	POSTTEST (Inches)	PRETEST (Inches)	STATIC CRUSH (Inches)
-6 Inches	<u>0.0</u>	<u>0.0</u>	<u>0.0</u>
0 (Impact Point)	<u>0.0</u>	<u>0.0</u>	<u>0.0</u>
6 Inches	<u>0.0</u>	<u>0.0</u>	<u>0.0</u>
12 Inches	<u>0.0</u>	<u>0.0</u>	<u>0.0</u>
18 Inches	<u>0.0</u>	<u>0.0</u>	<u>0.0</u>
24 Inches	<u>20.3</u>	<u>22.3</u>	<u>-2.0</u>
30 Inches	<u>21.0</u>	<u>22.3</u>	<u>-1.3</u>
36 Inches	<u>21.5</u>	<u>22.3</u>	<u>-0.8</u>
42 Inches	<u>22.0</u>	<u>21.9</u>	<u>0.1</u>
48 Inches	<u>24.3</u>	<u>21.4</u>	<u>2.9</u>
54 Inches	<u>25.3</u>	<u>21.4</u>	<u>3.9</u>
60 Inches	<u>23.9</u>	<u>21.4</u>	<u>2.5</u>
66 Inches	<u>23.8</u>	<u>21.4</u>	<u>2.4</u>
72 Inches	<u>23.6</u>	<u>21.4</u>	<u>2.2</u>

Level 5 - Window Top - 61.6" Above Ground Level

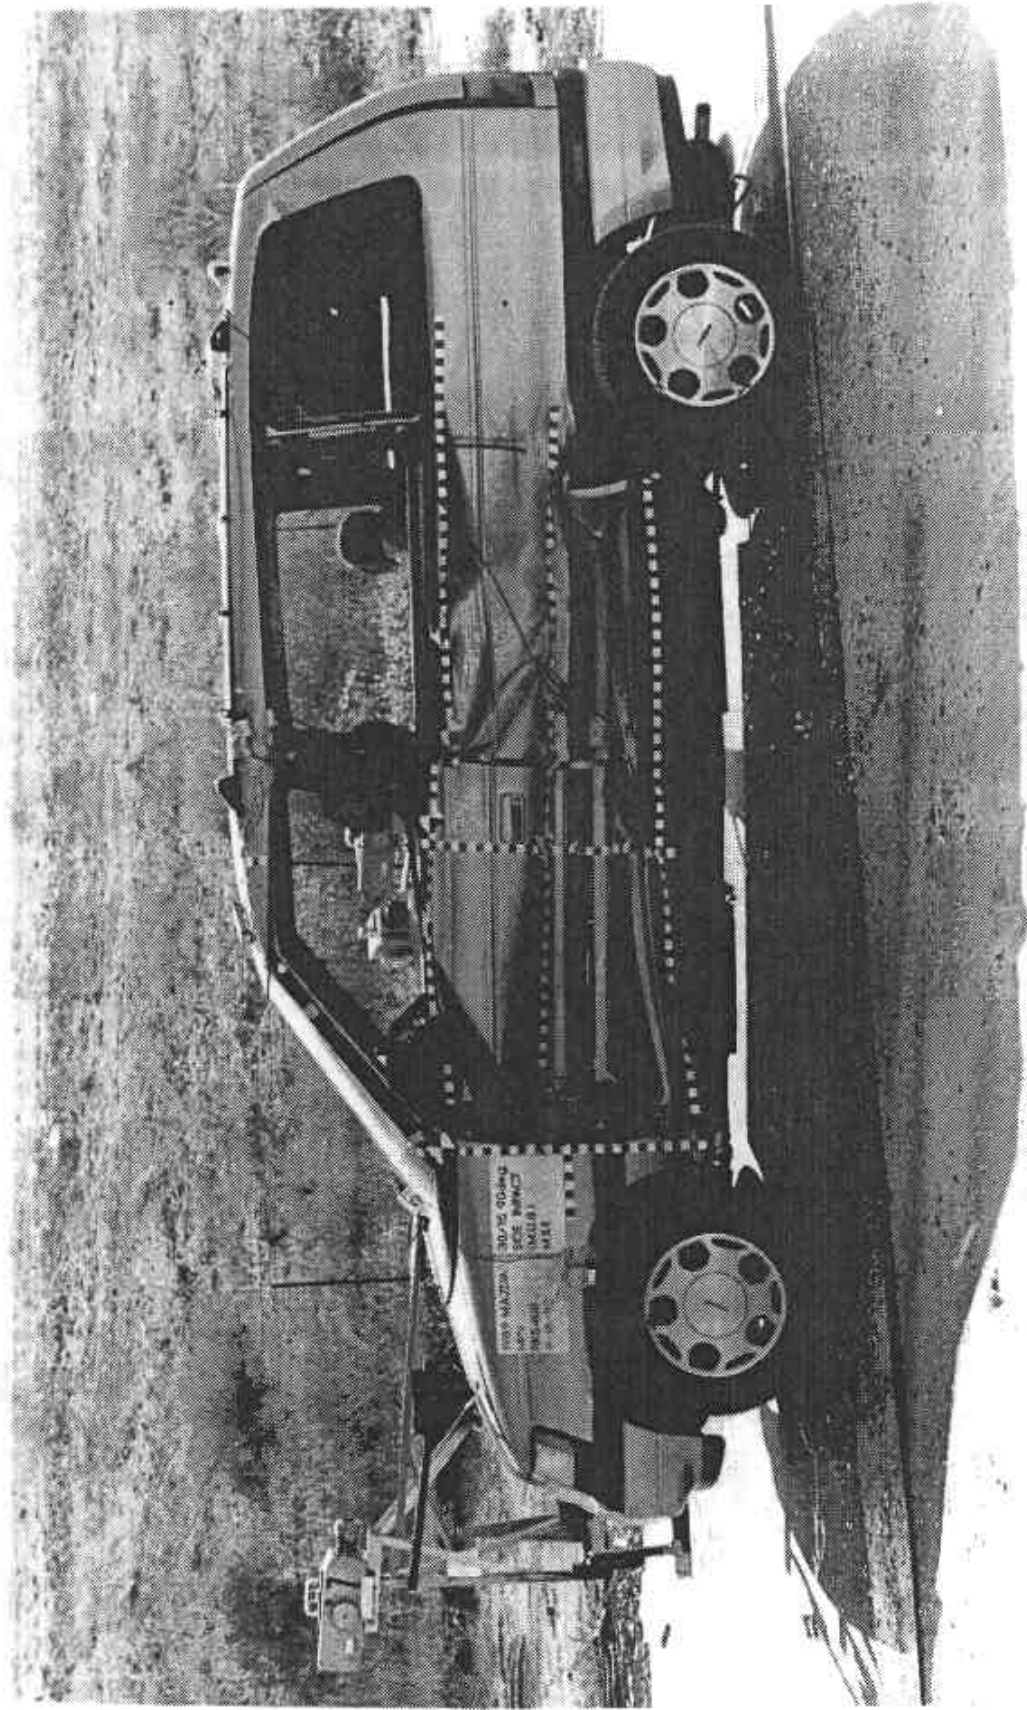
FIGURE 5-6 POSTTEST STRUCK SIDE VIEW OF TEST VEHICLE

Pillar Failure: B-pillar cracked at bottom about 3 inches aft of the front edge and the outboard edge separated from the sill along 4 inches at that point

The MDB impacted the 1989 Mazda MPV at a height that was above the sill. The MDB face was positioned such that the bottom of the face was 18 inches above the ground. As a result, the MDB created extensive deformation to the left side door and "B" pillar. Both hinges on the driver side door failed. The door and sidewall contacted the SIDs at the lower and mid torso before the SID began to move. The contact to the lower and mid torso, started the SIDS heads to rotate in the counterclockwise direction. The front SIDS head impacted the seat belt. The passenger SID's head impacted its own shoulder and grazed the window sill. Its right foot appeared to get wedged under the front seat, causing the leg to break between the femur and knee. Both SIDs then rebounded in a rotating clock wise motion. The seat belts halted any further motion. Both SIDs ended up sitting in an upright position and facing forward.

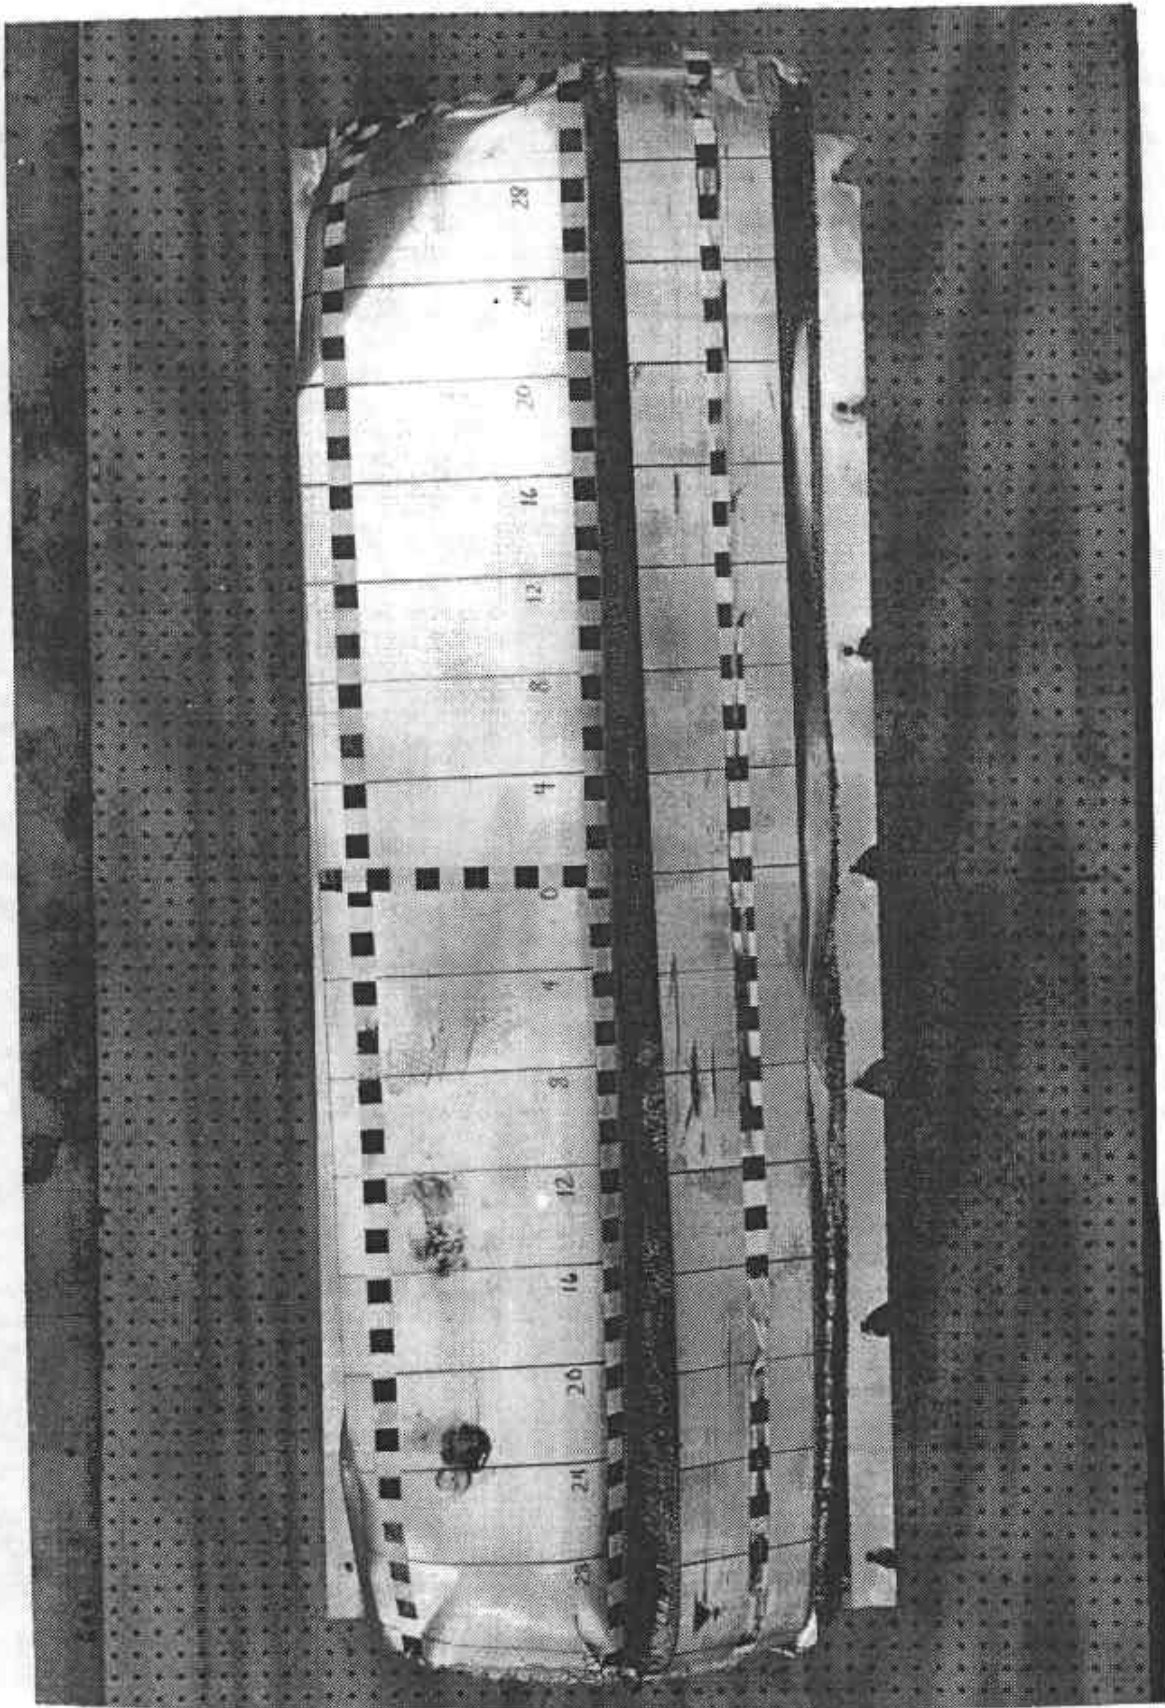
FIGURE 5-8 POSTTEST FRONTAL VIEW OF MDB IMPACT FACE

1. ROW A at bumper level = 4.7 inches
2. ROW B at midstack level = 1.5 inches
3. ROW C at top of stack level = 4.3 inches

The MDB impacted the test vehicle and was stopped by the remote brake system to prevent a second impact. The aluminum deformable barrier received minor damage with a maximum crush of 4.7 inches on the left side of the bumper. The crush details for the MDB are given in Data Sheet No. 7.

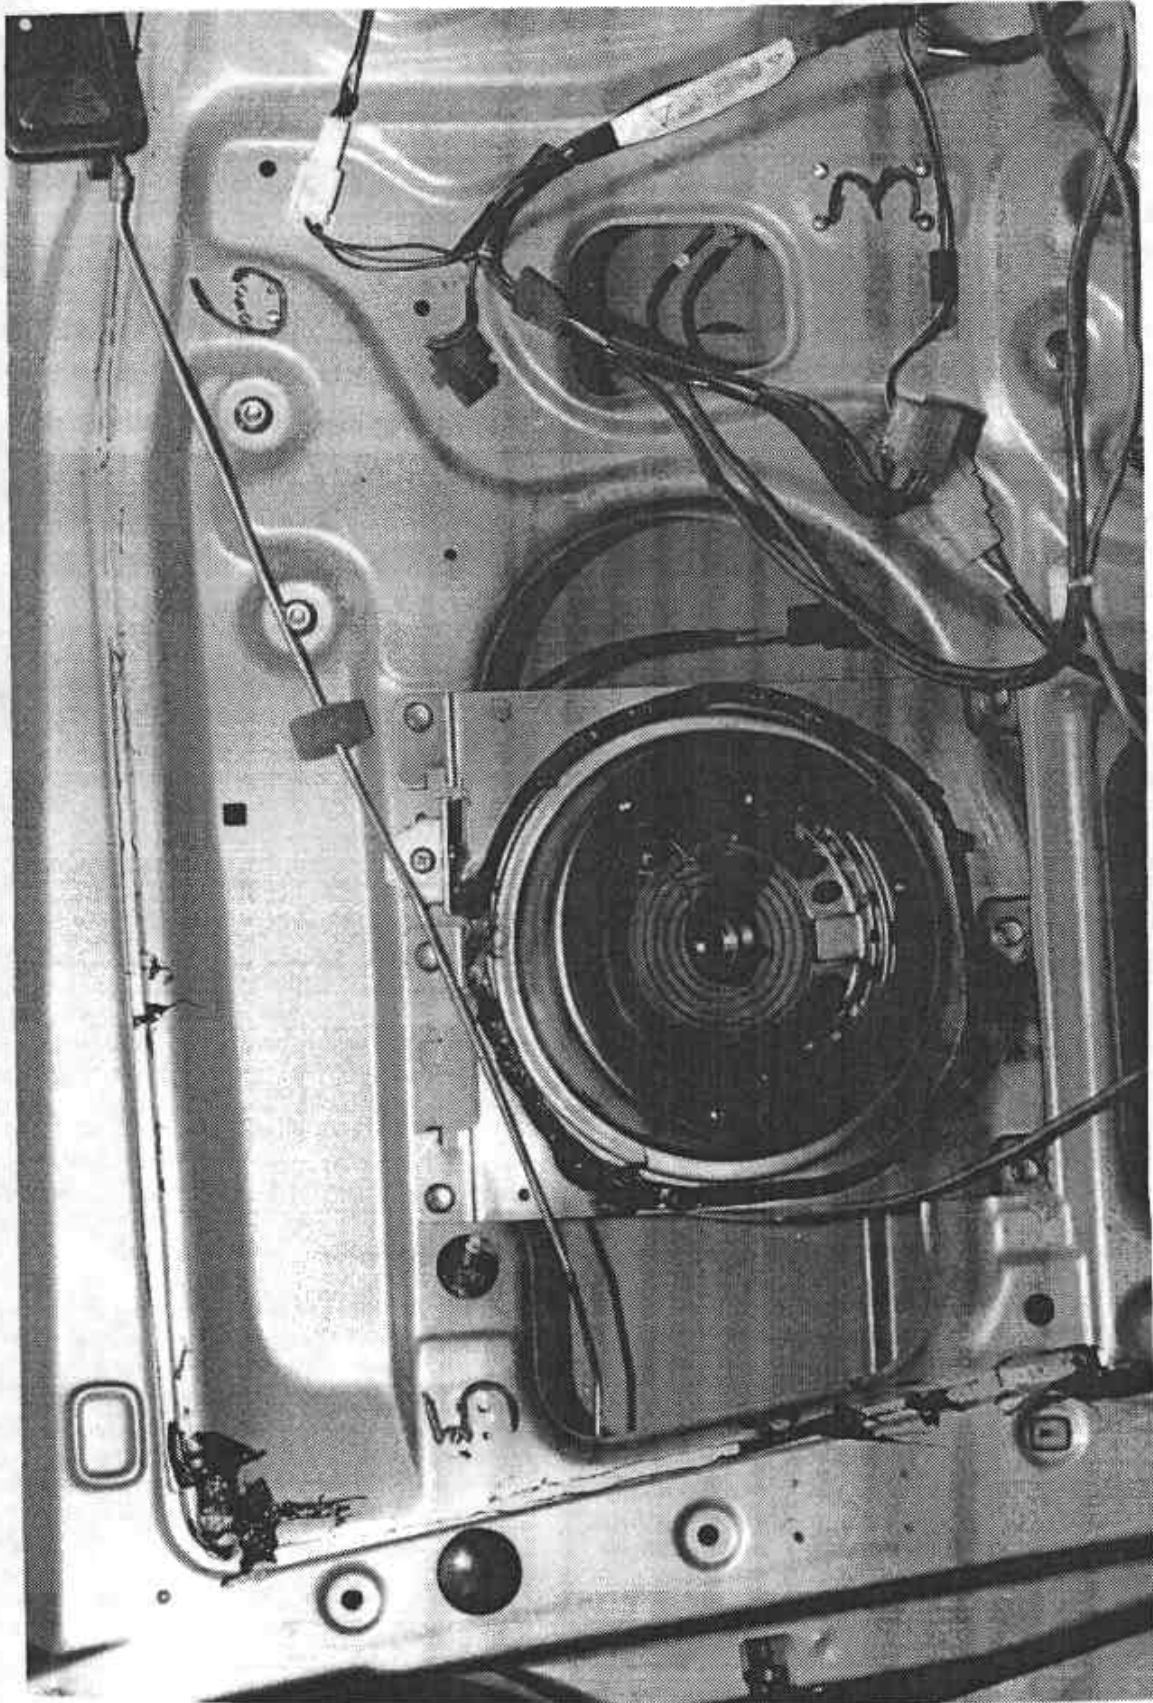
FIGURE 5-25 DRIVER DOOR ACCELEROMETER LOCATIONS

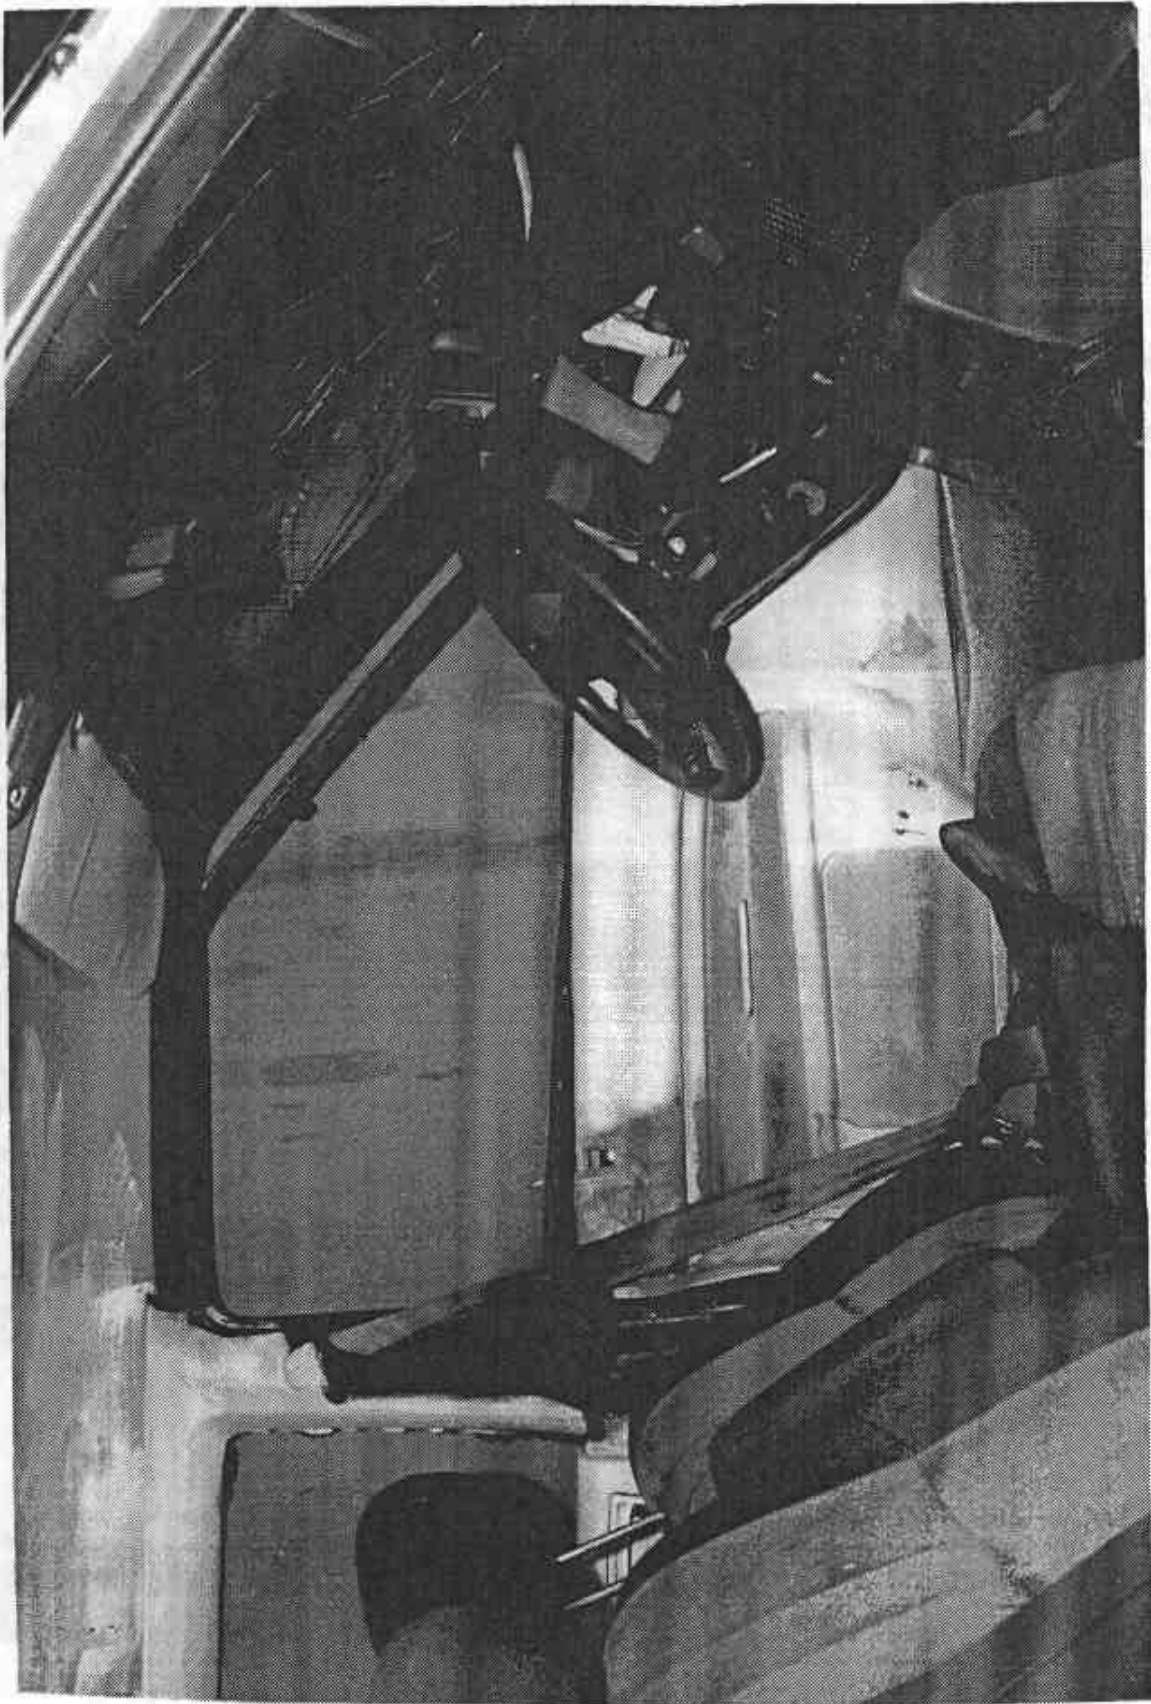
FIGURE 5-27 POSTTEST DRIVER DOOR INTERIOR VIEW

<p>The door on the struck side of the vehicle separated from the body at the hinges. The opposite doors did not open during side impact event.</p>							DRIVER	PASS	Left Upper Rib (LUR) Accel., g	81.6	90.6	Left Lower Rib (LLR) Accel., g	69.2	85.1	Lower Spine (T) Accel., g	62.8	80.6	12			Thoracic Trauma Index (TTI)	72.2	85.6	d			Pelvis (PEV) Accel., g	79.7	110.6
	DRIVER	PASS																											
Left Upper Rib (LUR) Accel., g	81.6	90.6																											
Left Lower Rib (LLR) Accel., g	69.2	85.1																											
Lower Spine (T) Accel., g	62.8	80.6																											
12																													
Thoracic Trauma Index (TTI)	72.2	85.6																											
d																													
Pelvis (PEV) Accel., g	79.7	110.6																											
17. Key Words OCCUPANT RESPONSE, MDB, SIDE IMPACT, TTI, SIDE IMPACT DUMMY (SID) MOVING BARRIER CRASH TESTING 1989 MAZDA MPV			18. Distribution Statement COPIES OF THIS REPORT ARE AVAILABLE FROM: DEPARTMENT OF TRANSPORTATION National Highway Traffic Safety Administration Technical Reference Division, Room 5108 400 Seventh Street, SW Washington, DC 20590																										
19. Security Classif. (of this report) UNCLASSIFIED		20. Security Classif. (of this page) UNCLASSIFIED		21. No. of Pages 178	22. Price

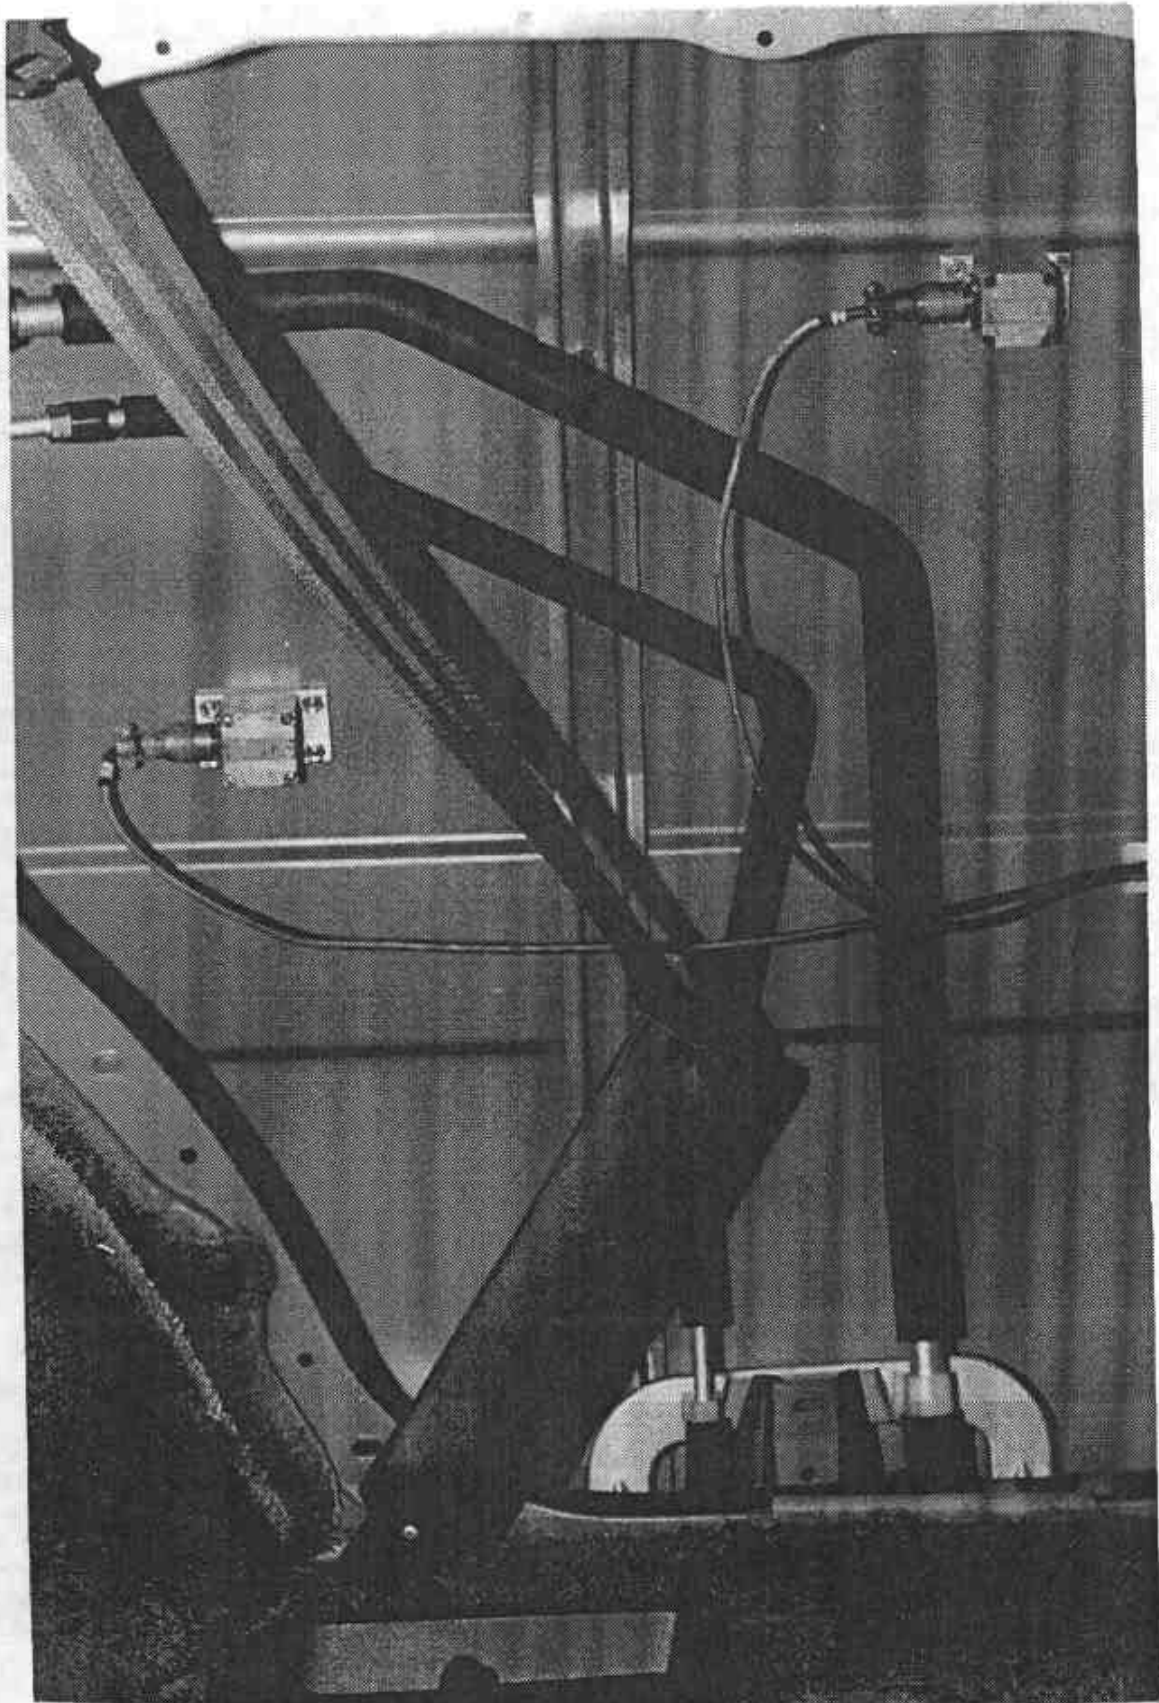
FIGURE 5-28 PRETEST PASSENGER SIDEWALL INTERIOR SHOWING ACCELEROMETER LOCATIONS

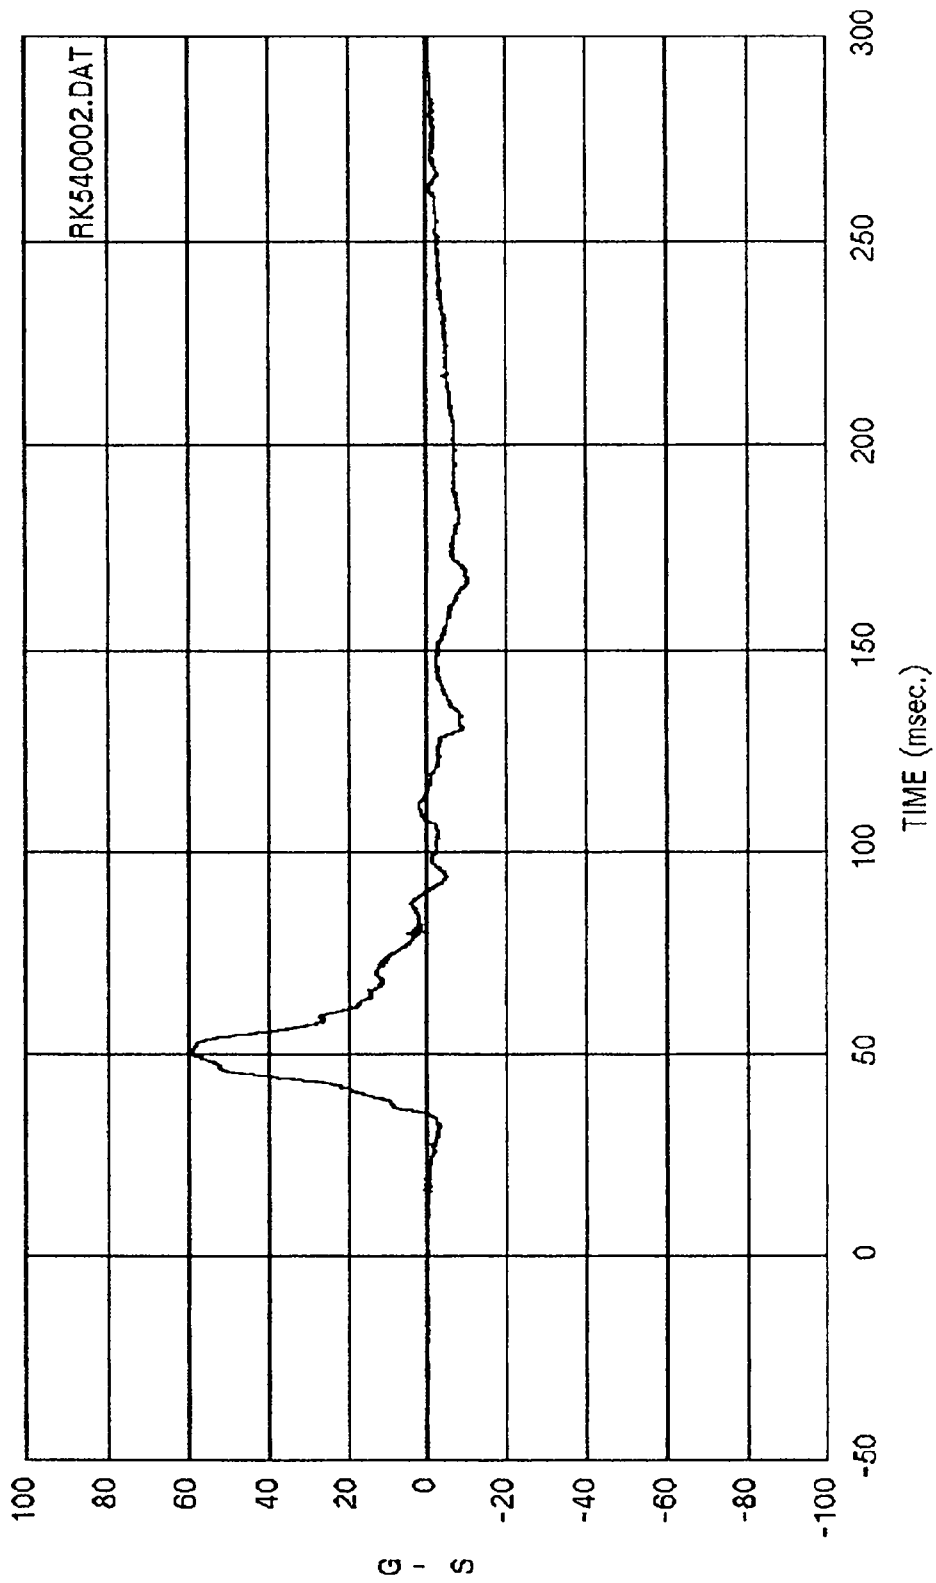
Curve: Driver Head acceleration -- Y axis Filter: SAE CLASS 1000 Max = 59.341 Min = -10.339

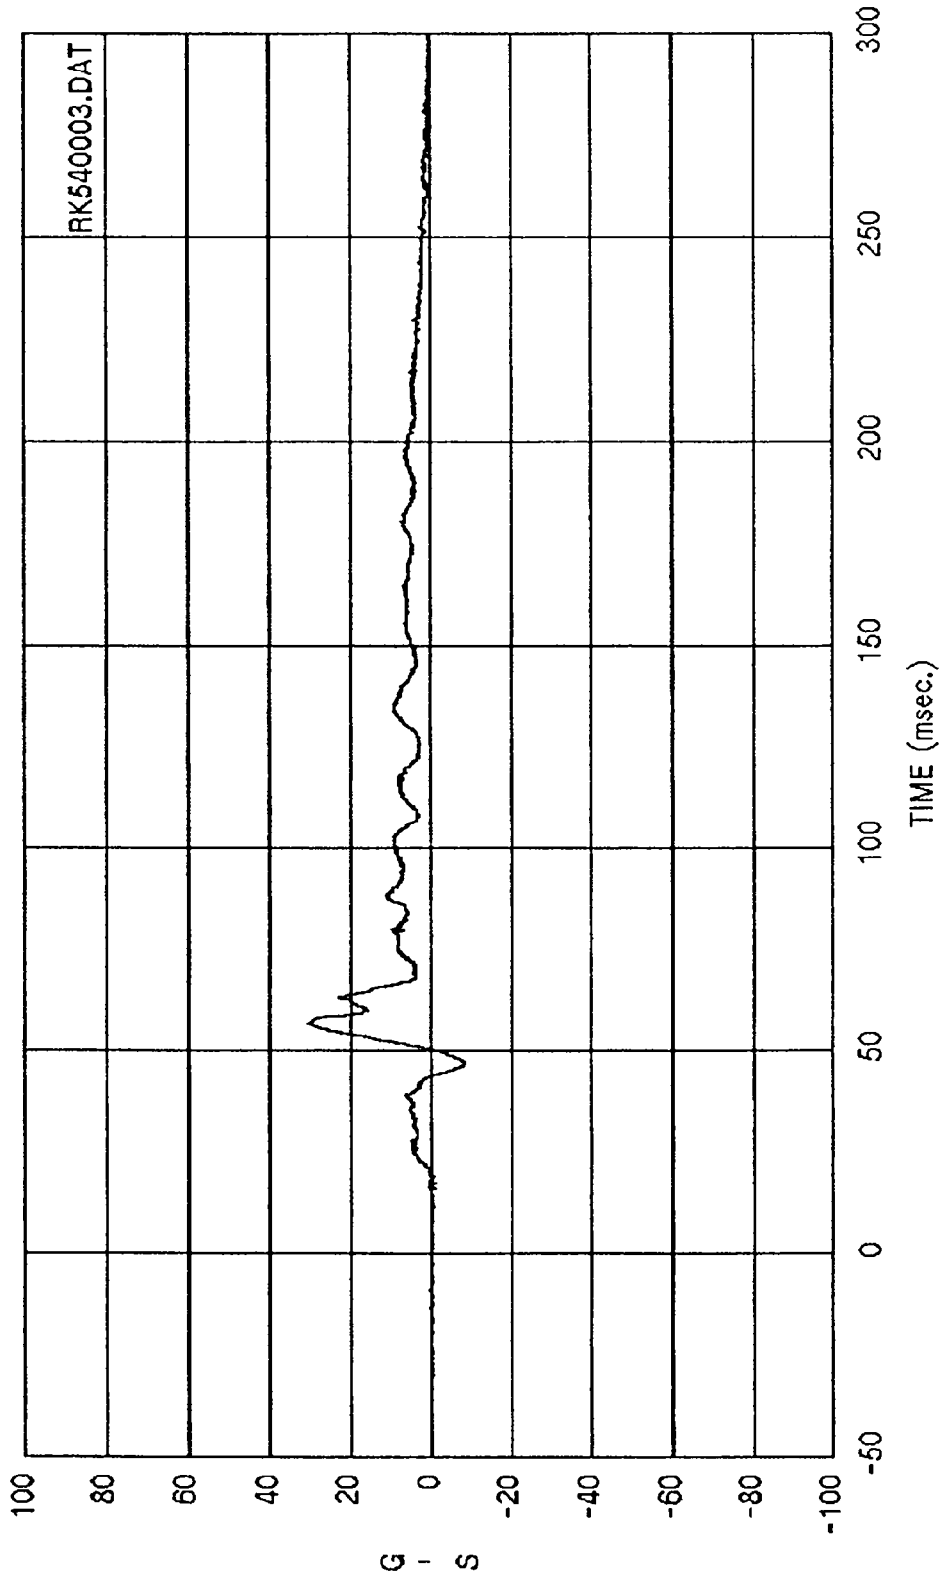
Curve: Driver Head acceleration -- Z axis Filter: SAE CLASS 1000 Max = 30.906 Min = -8.3871
