REPORT NO.: MSE-92-08-TR1086-08

**SIDE IMPACT PROTECTION STUDY
IN PRODUCTION VEHICLES
MDB-TO-VEHICLE SIDE IMPACT TEST OF
A 27⁰ CRABBED MOVING DEFORMABLE BARRIER
TO A 1989 MAZDA MPV
AT 33.0 MPH**

NHTSA NO.: RK5400

FINAL REPORT

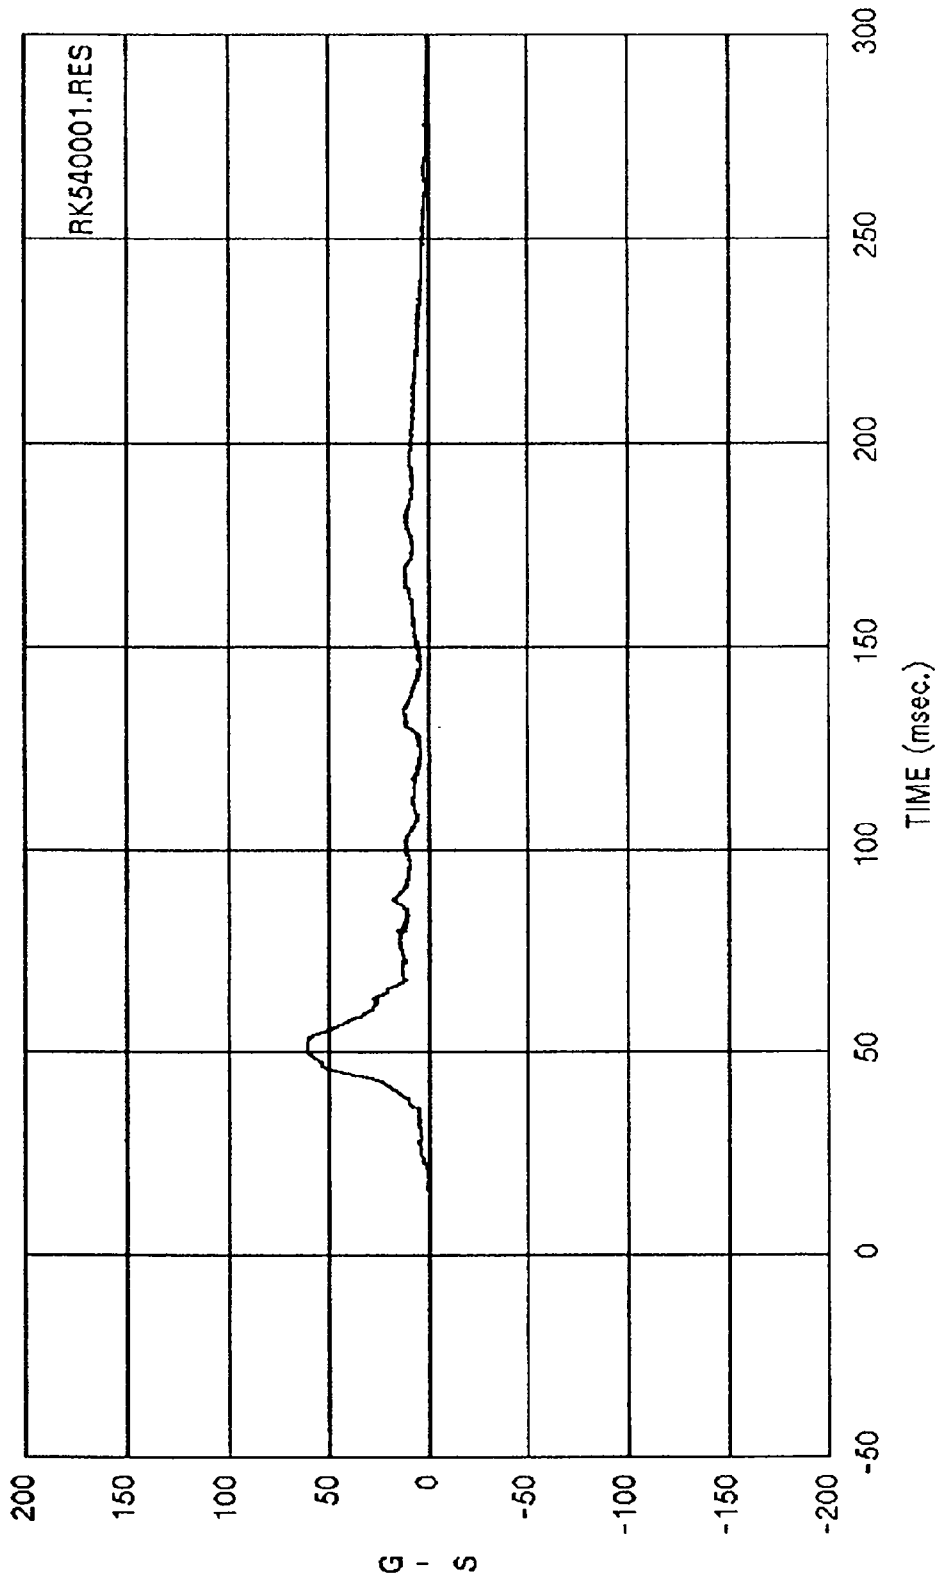
Curve: Driver head resultant acceleration Filter: SAE CLASS 1000 Max = 61.417 Min = .00000

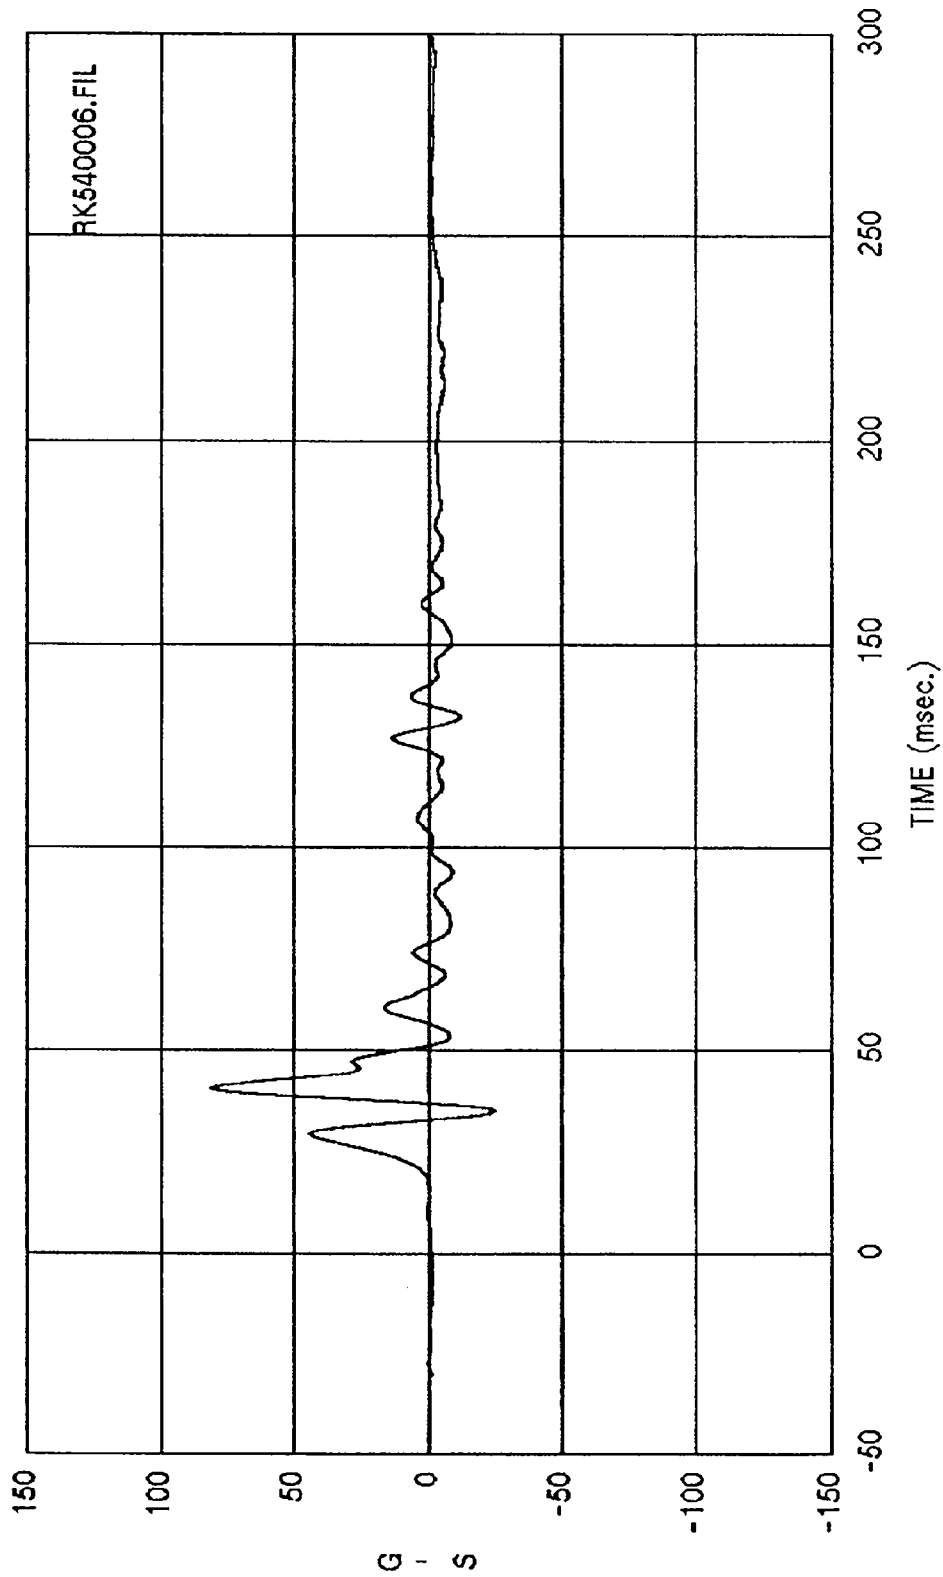
Curve: Driver upper rib acceleration -- Primary Filter: FIR 100 Max = 81.602 Min = -24.395

<table><tr> <th style="width: 60%;"></th> <th style="width: 20%; text-align: center;">DRIVER</th> <th style="width: 20%; text-align: center;">PASS</th> </tr><tr> <td>Left Upper Rib (LUR) Accel., g</td> <td style="text-align: center;">81.6</td> <td style="text-align: center;">90.6</td> </tr></table>

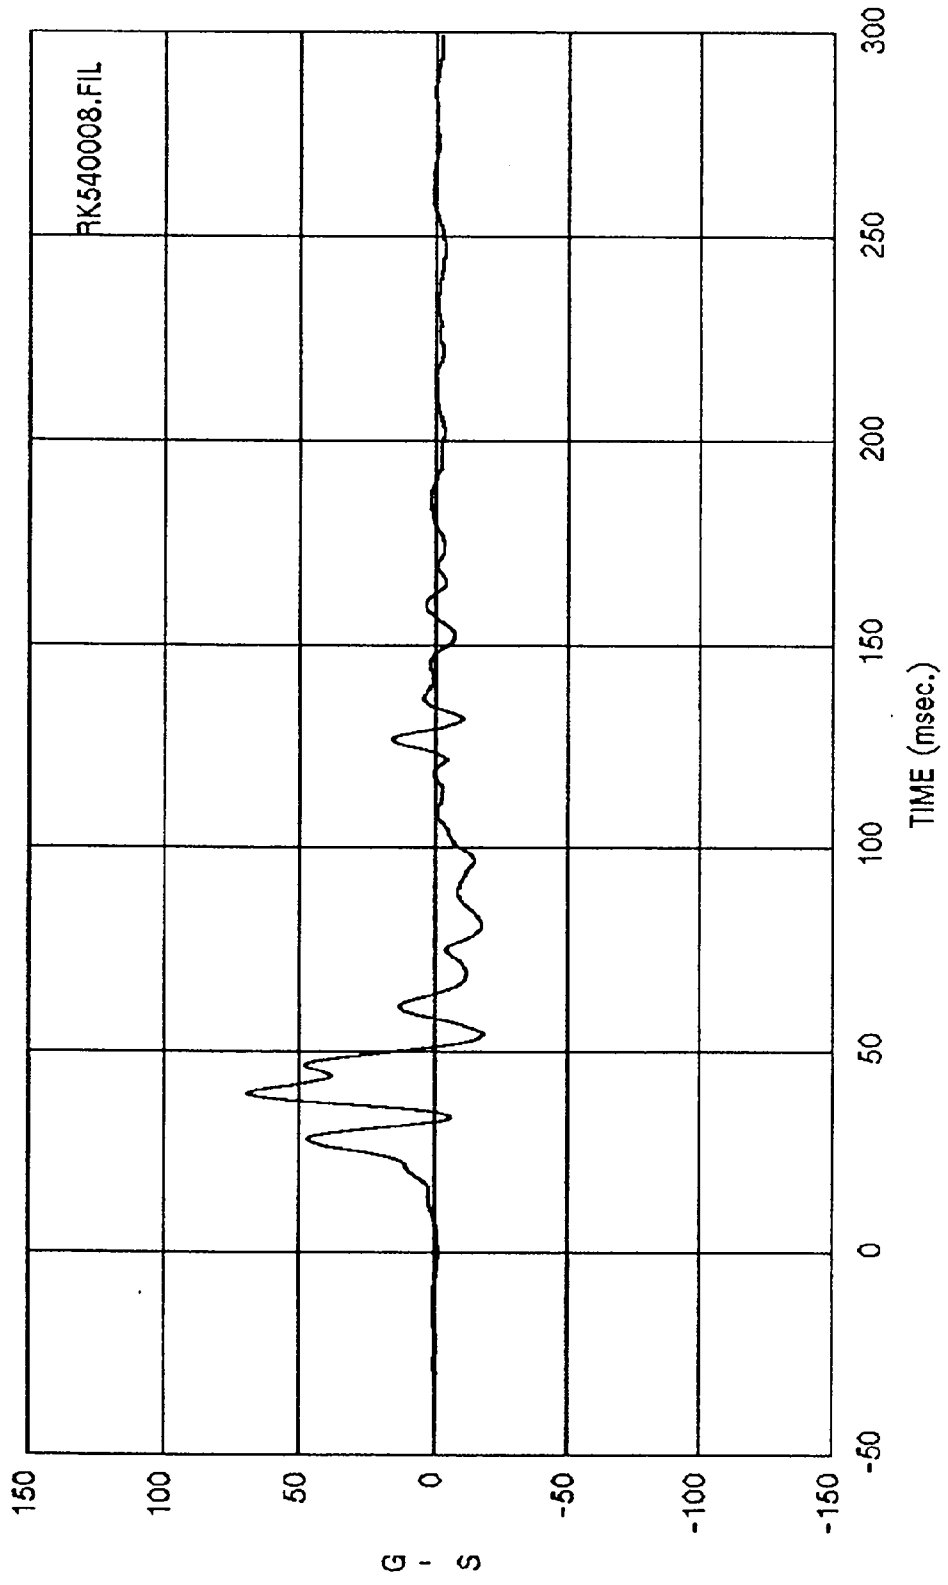
Curve: Driver lower rib acceleration -- Primary Filter: FIR 100 Max = 69.193 Min = -17.532

<table><tr> <th style="width: 60%;"></th> <th style="width: 20%; text-align: center;">DRIVER</th> <th style="width: 20%; text-align: center;">PASS</th> </tr><tr> <td>Left Lower Rib (LLR) Accel., g</td> <td style="text-align: center;">69.2</td> <td style="text-align: center;">85.1</td> </tr></table>

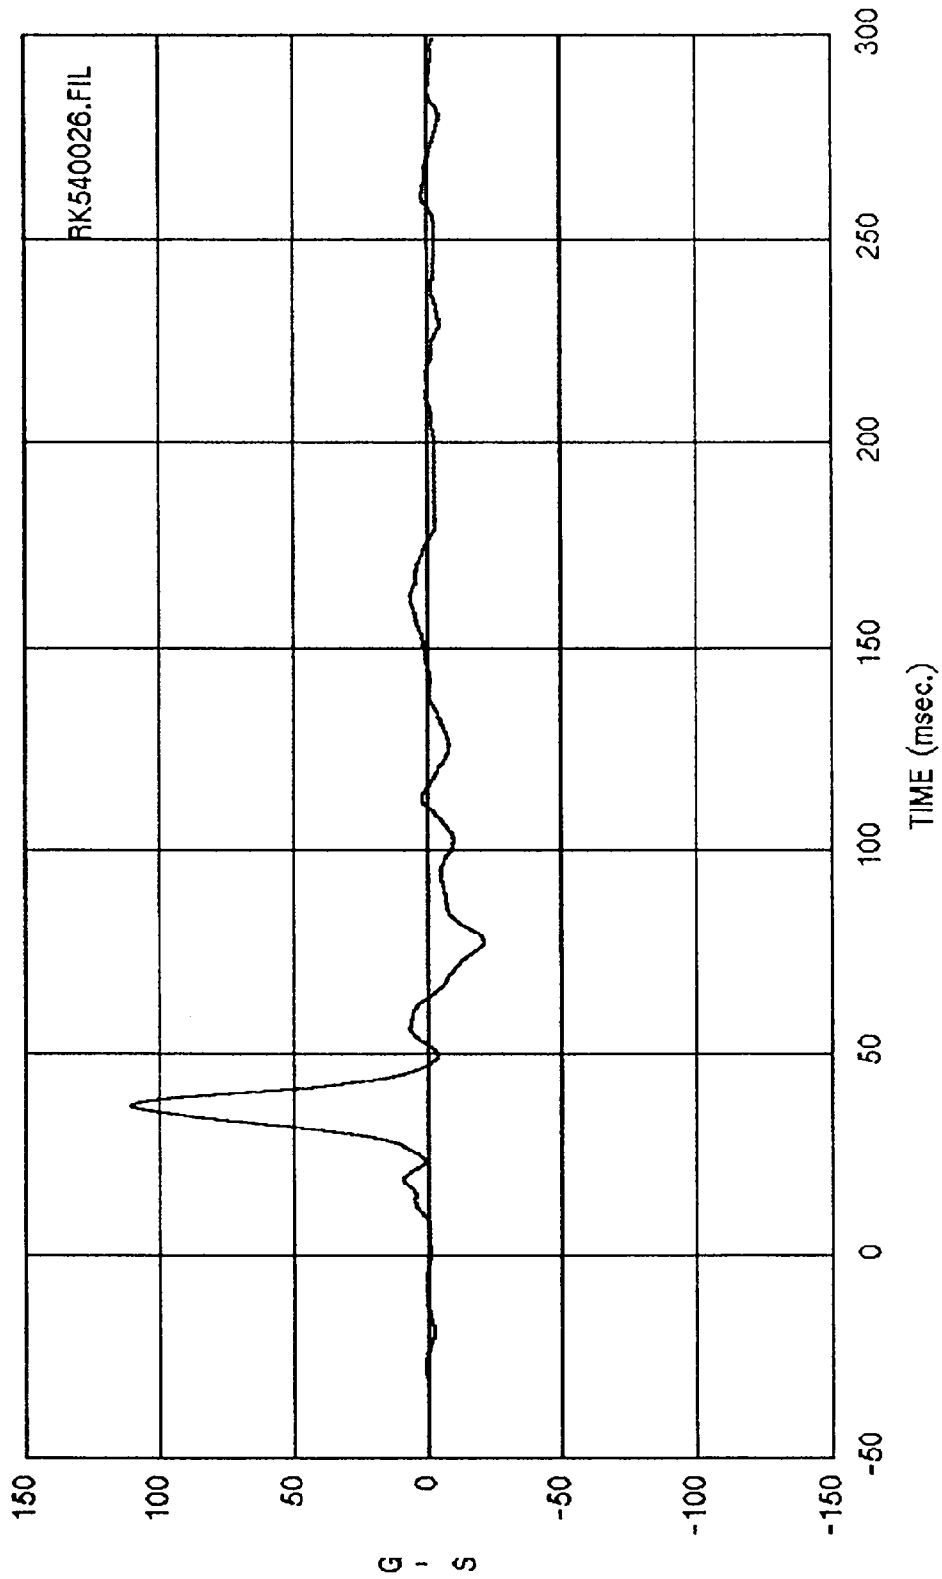
Curve: Passenger pelvis acceleration Filter: FIR 100 Max = 110.62 Min = -21.208

<table><tr> <th style="width: 60%;"></th> <th style="width: 20%; text-align: center;">DRIVER</th> <th style="width: 20%; text-align: center;">PASS</th> </tr><tr> <td>Pelvis (PEV) Accel., g</td> <td style="text-align: center;">79.7</td> <td style="text-align: center;">110.6</td> </tr></table>

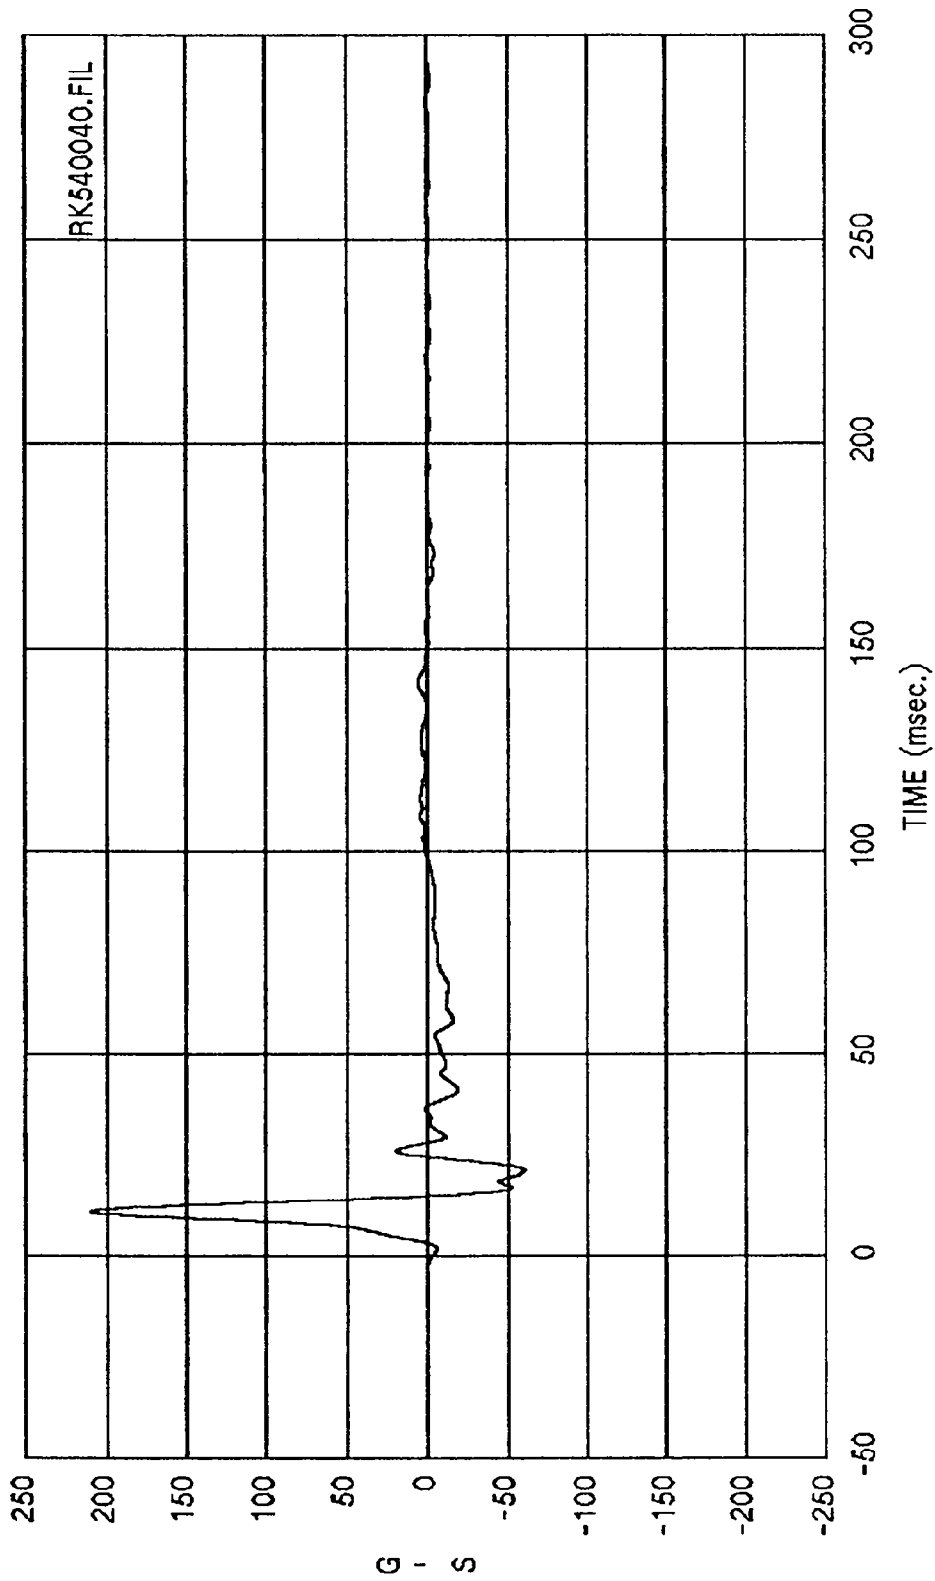
Curve: Left front door at centerline -- Y axis Filter: SAE CLASS 60 Max = 210.44 Min = -60.151

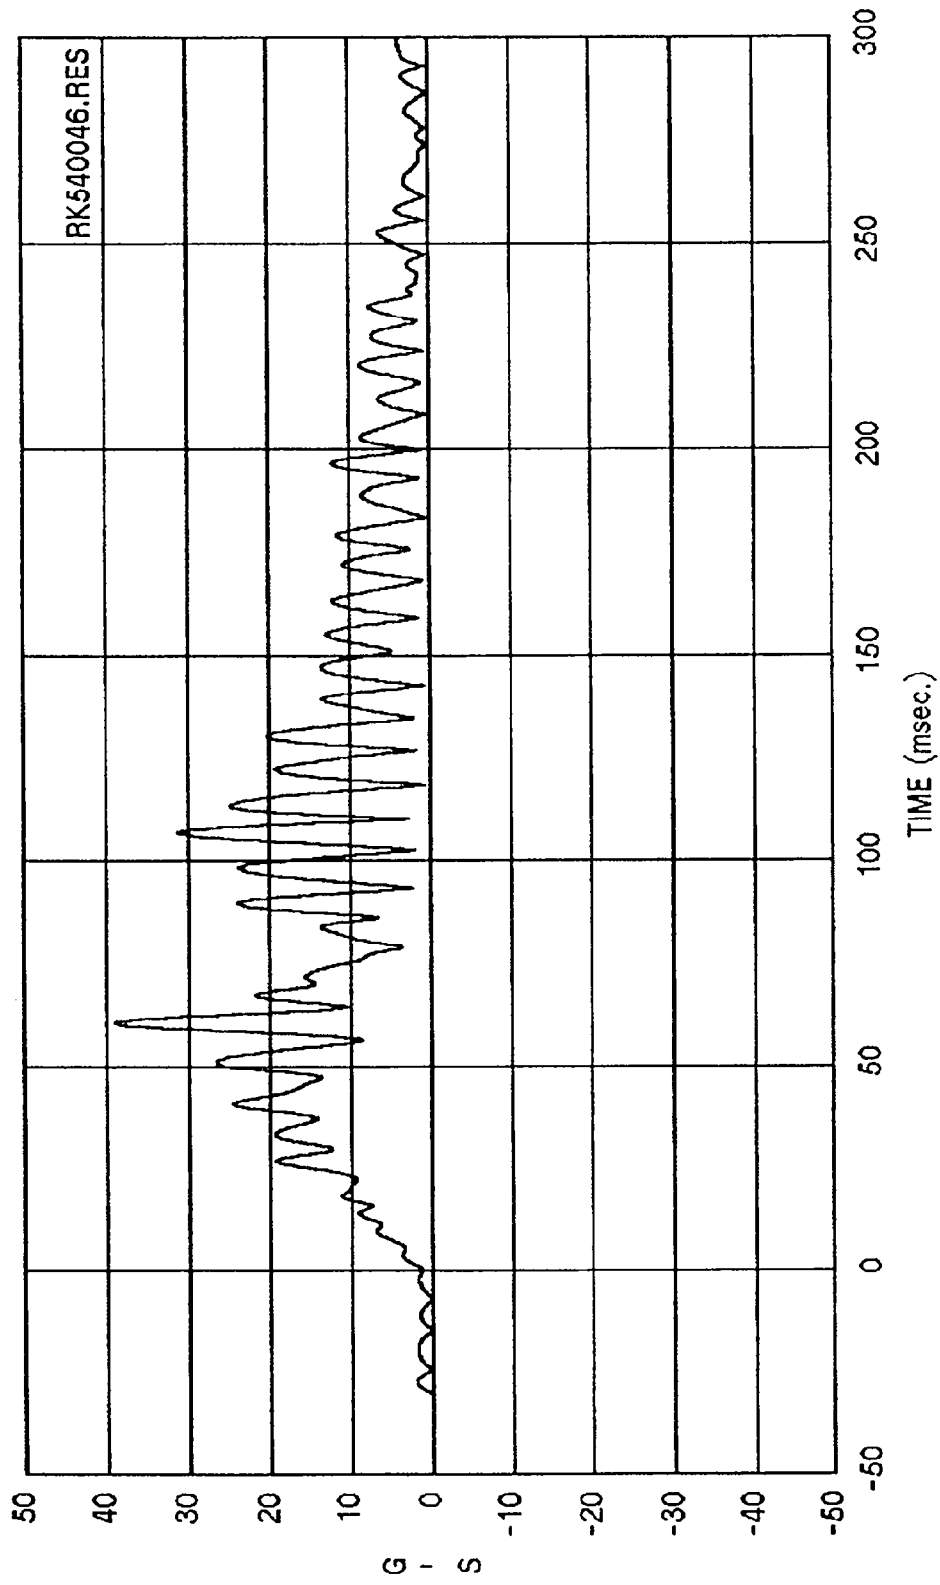
Curve: M.D.B. C/G resultant acceleration Filter: SAE CLASS 60 Max = 39.093 Min = .22776
