VEHICLE SAFETY COMPLIANCE TESTING  
FOR OCCUPANT CRASH PROTECTION,  
WINDSHIELD MOUNTING, WINDSHIELD ZONE  
INTRUSION, AND FUEL SYSTEM INTEGRITY

1993 MITSUBISHI 3000 GT

NHTSA NO. CP5601

FINAL REPORT

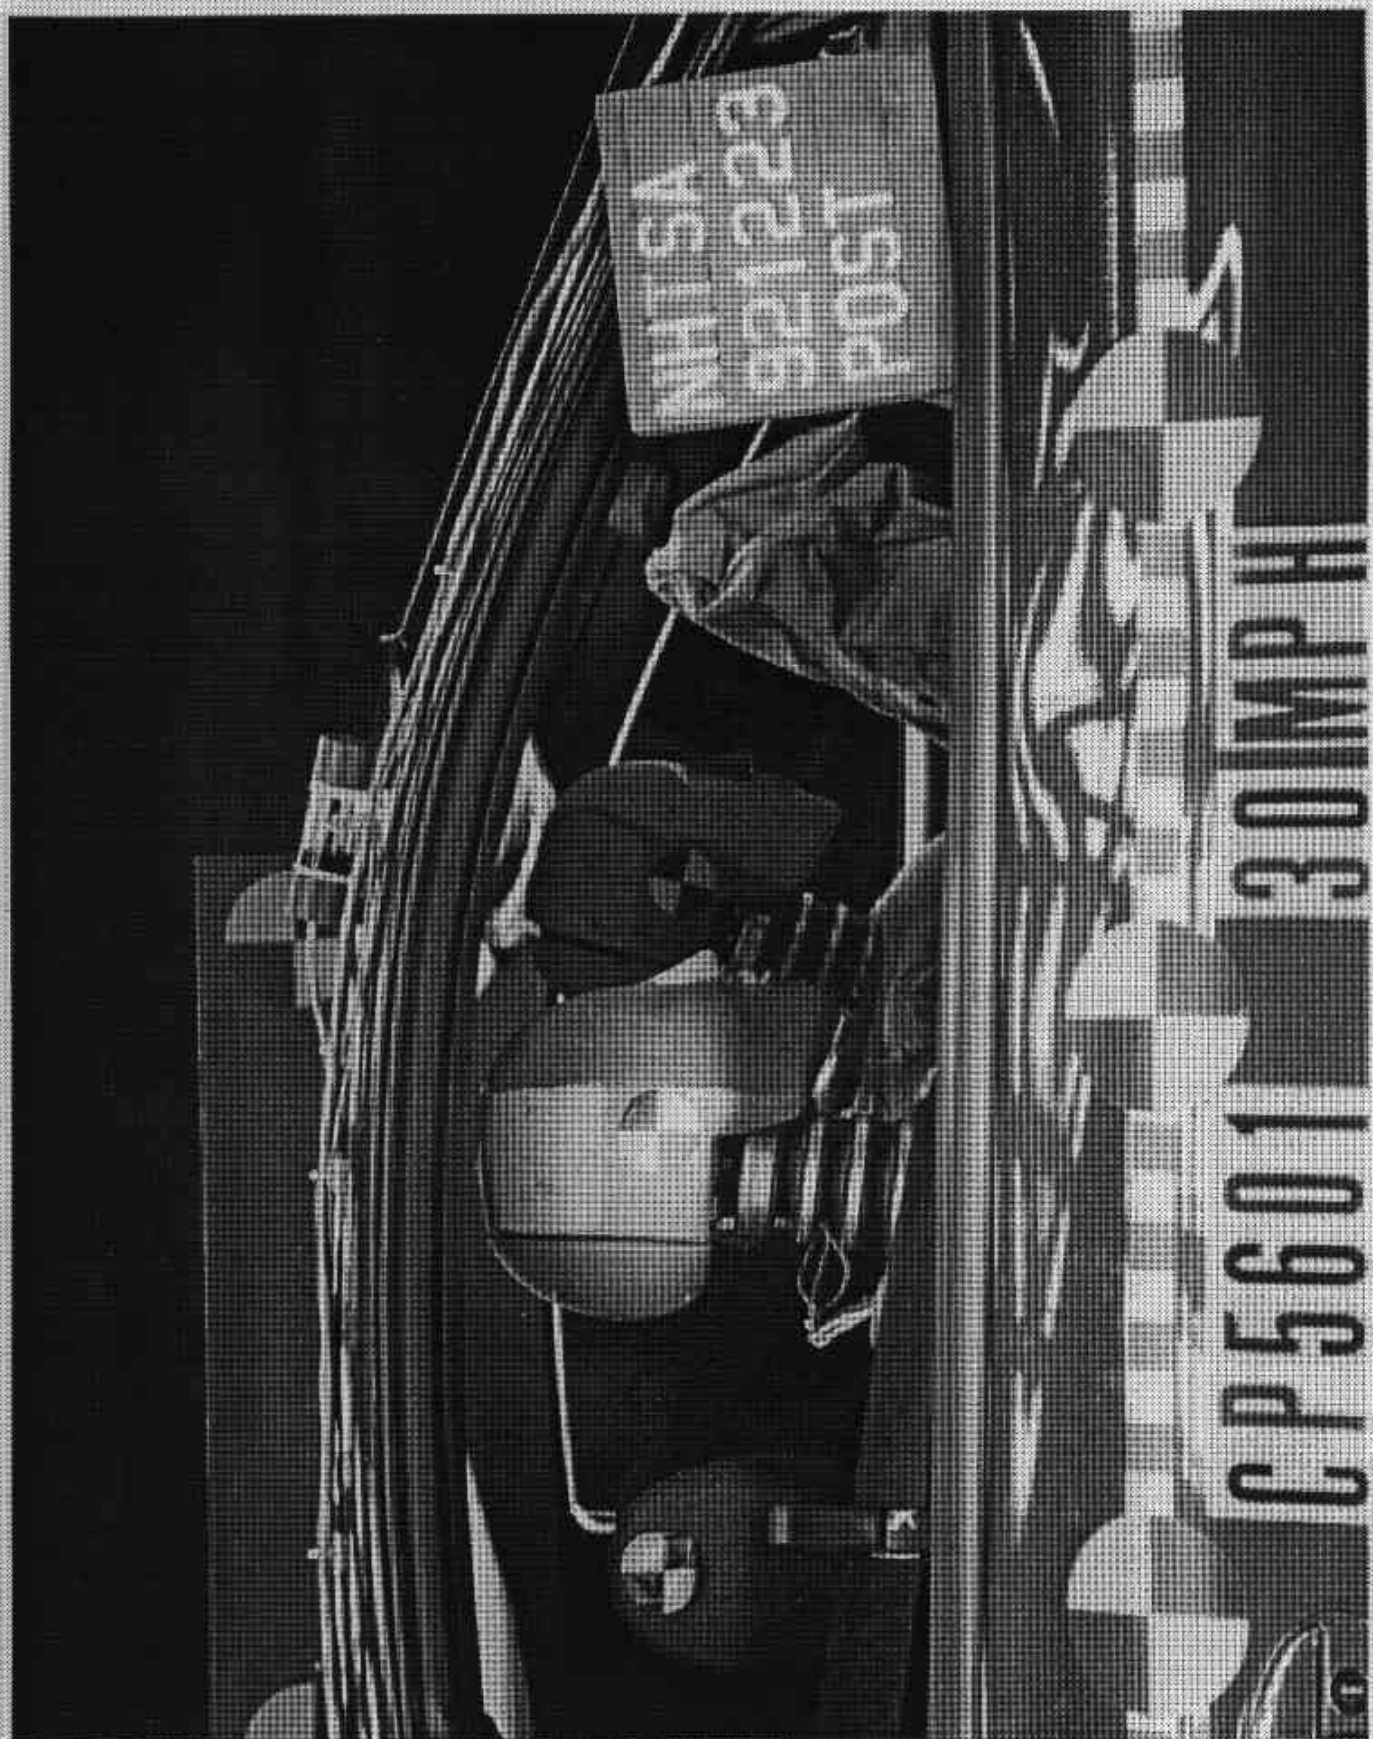
FIGURE A-30. POST-TEST PASSENGER DUMMY POSITION VIEW

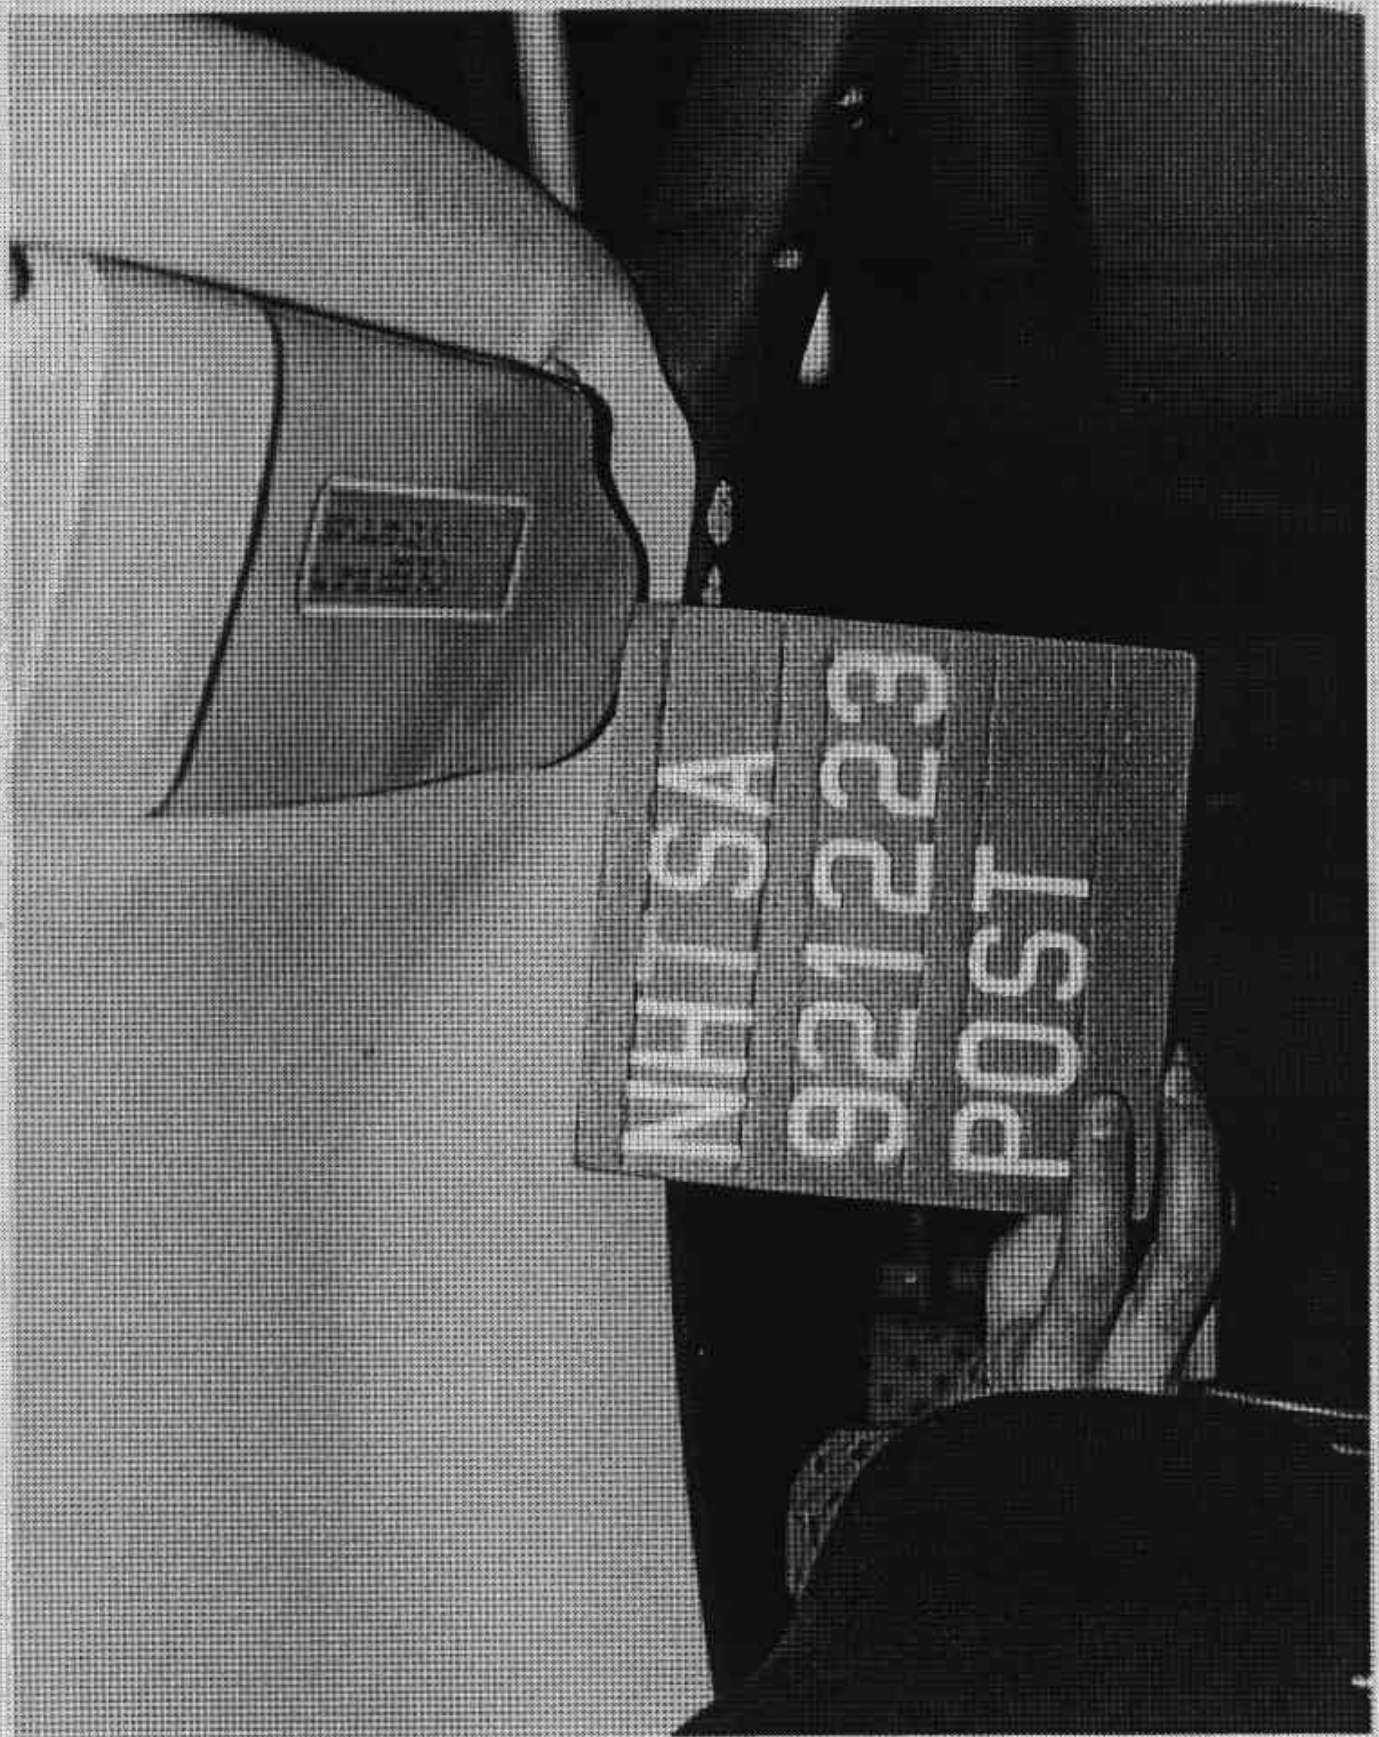
FIGURE A-41. POST-TEST DRIVER DUMMY HEAD CONTACT - VIEW 3

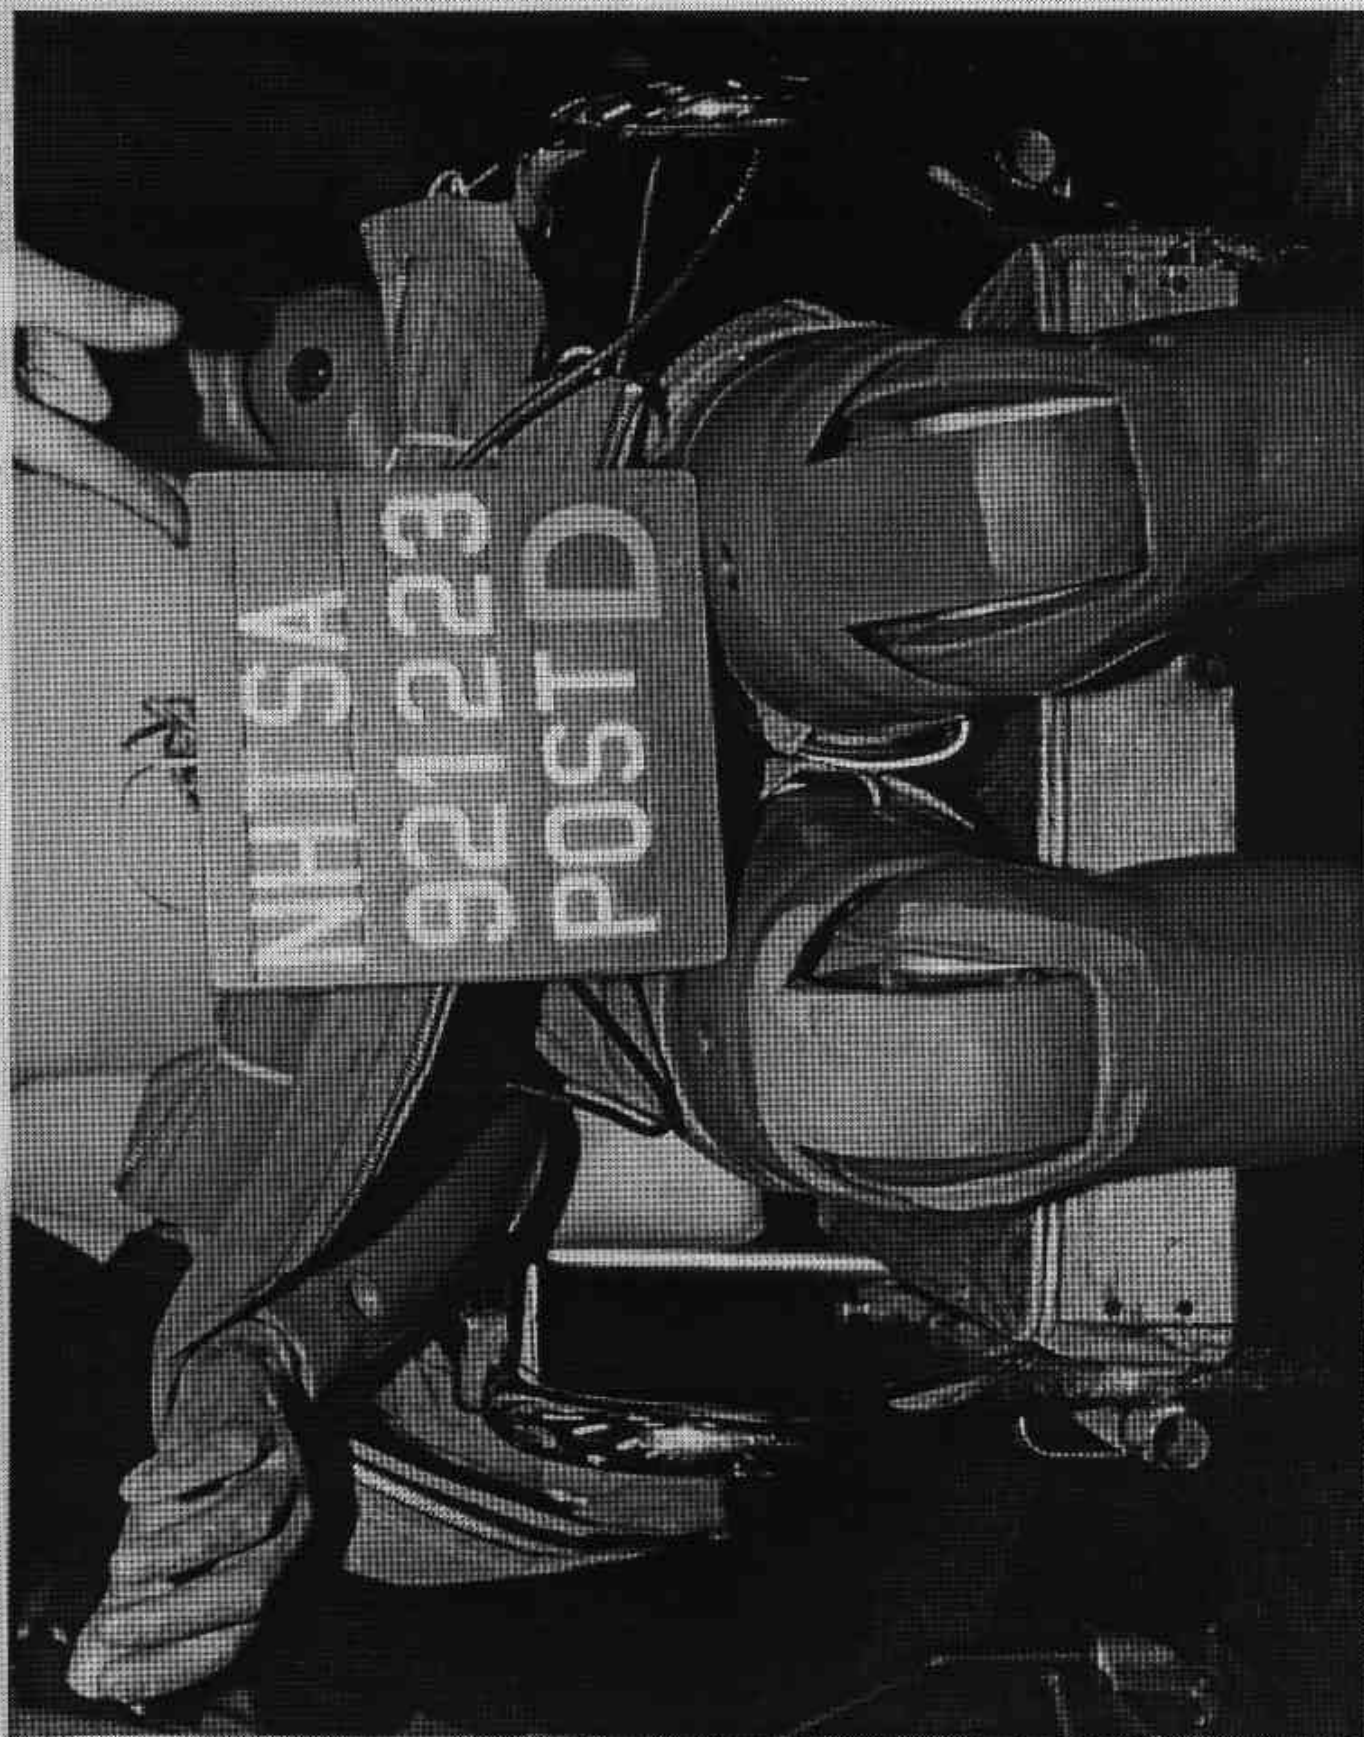
FIGURE A-42. POST-TEST DRIVER DUMMY KNEE CONTACT - VIEW 1

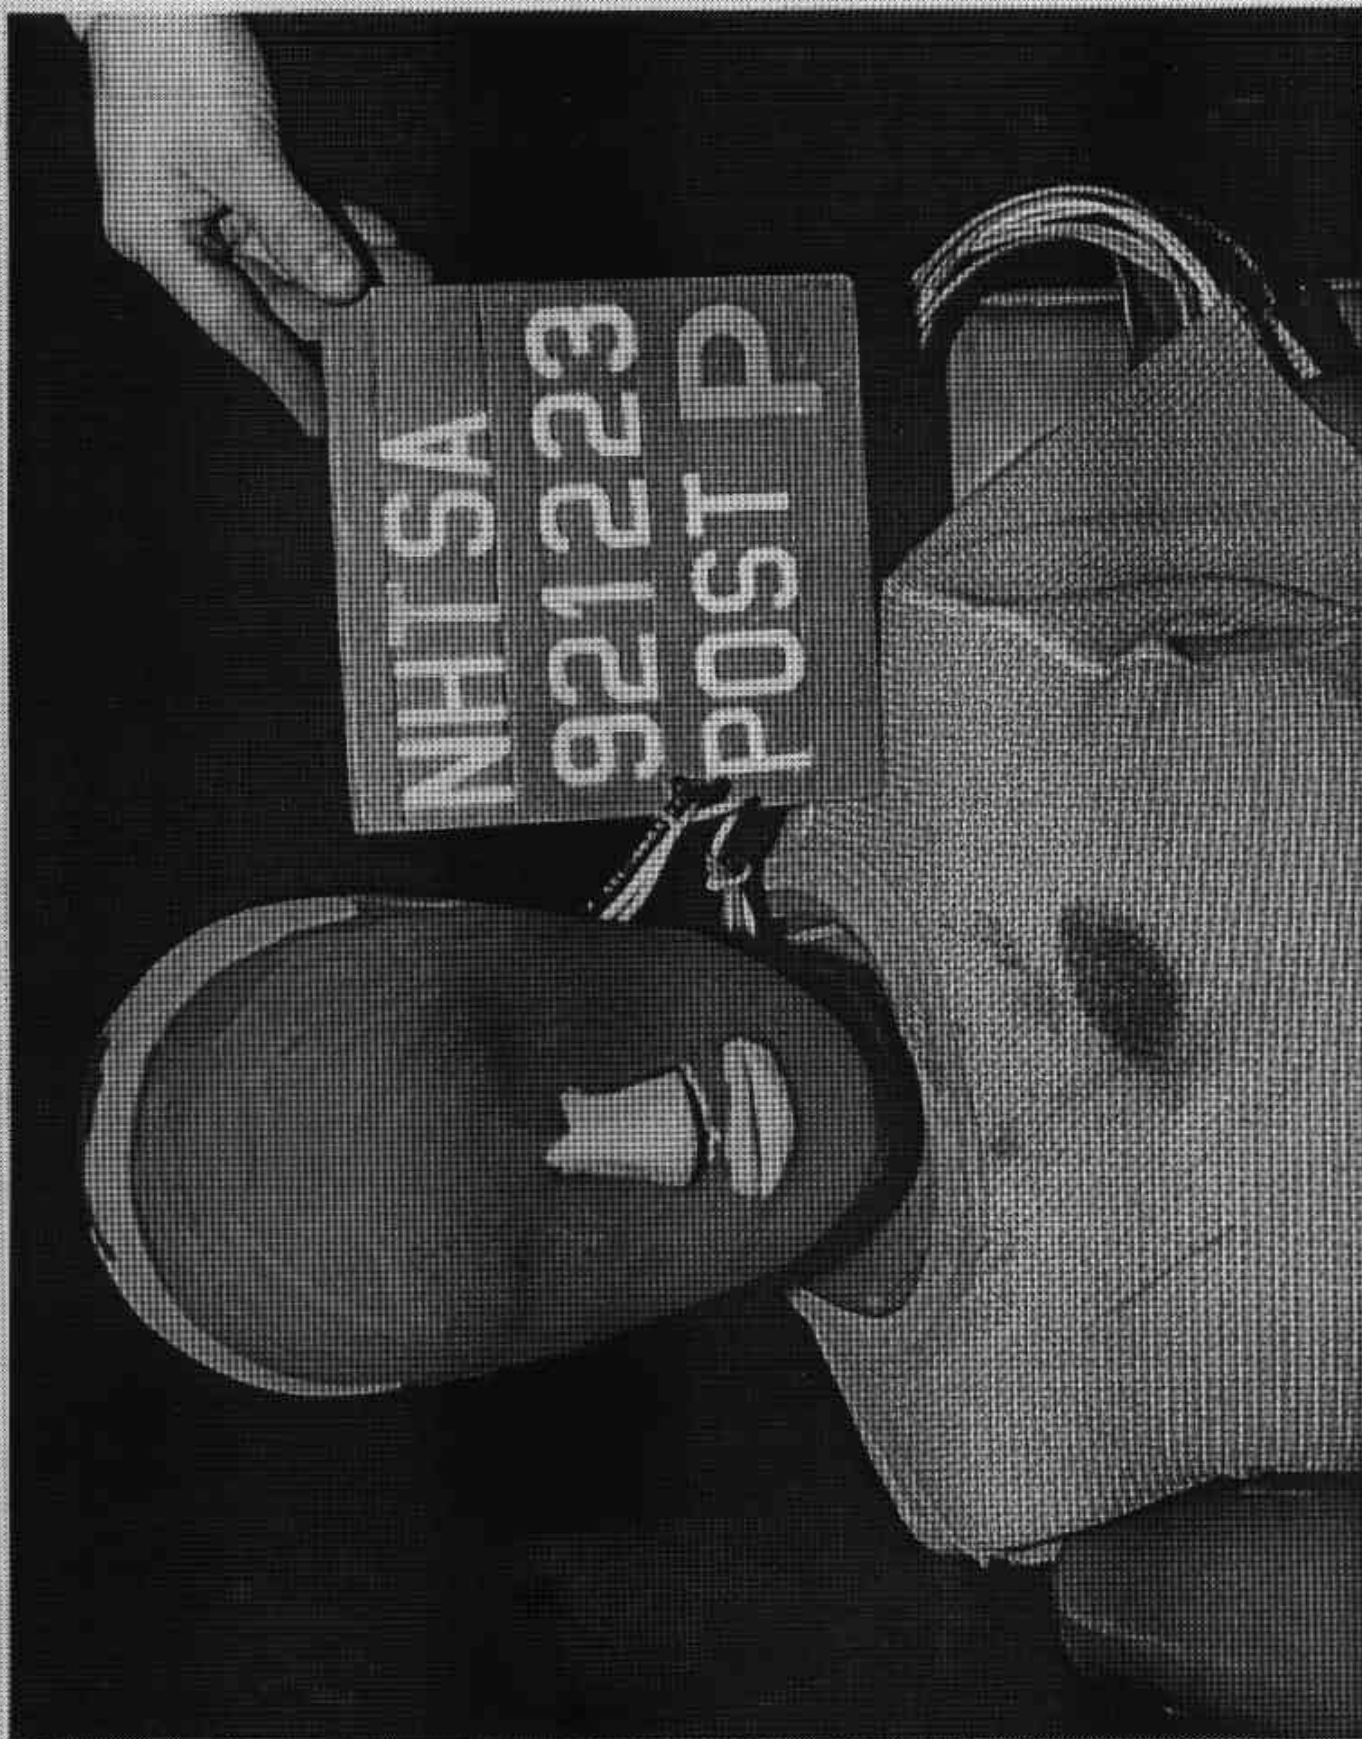
FIGURE A-45. POST-TEST PASSENGER DUMMY HEAD CONTACT VIEW
