DOT HS 807 915
Final Report

April 1992

Final Report of a 1985 Ford Tempo 4-Door Sedan Into a Pole Barrier in Support of Crash III Damage Algorithm Reformulation

PURPOSE AND TEST SUMMARY

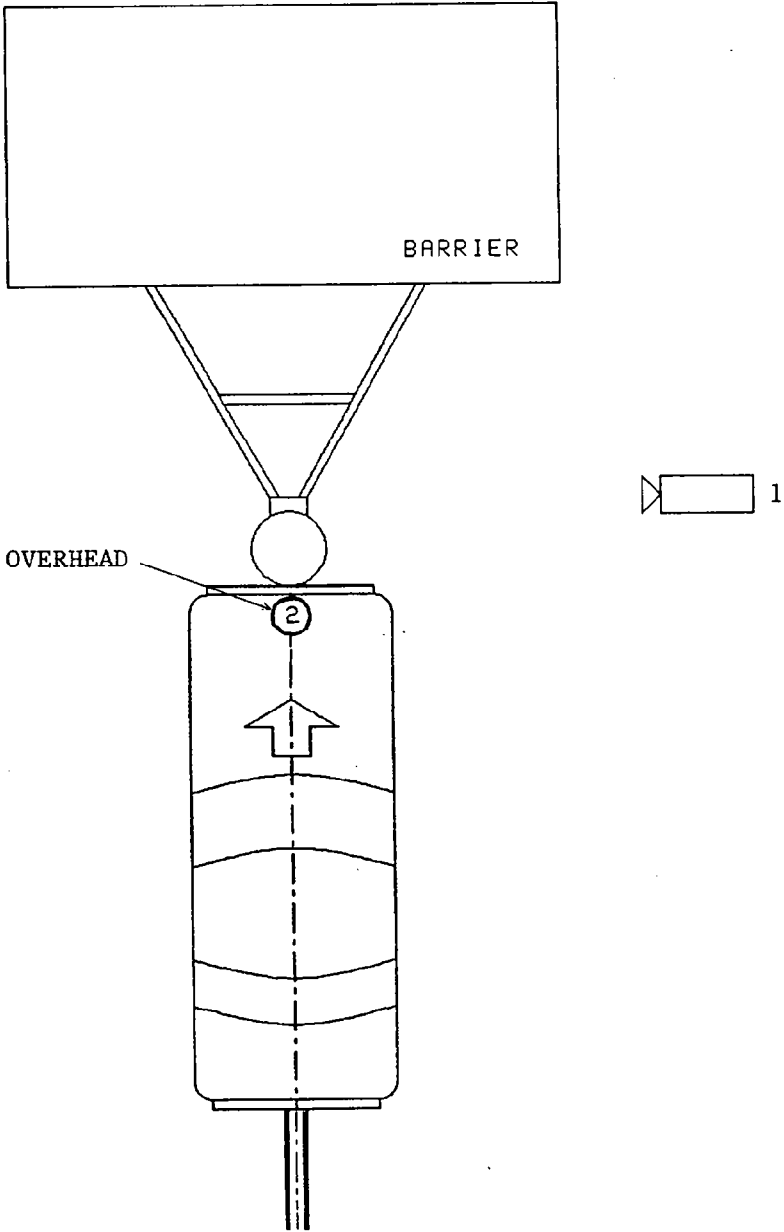
CAMERA POSITIONS

The crash test event was recorded by two (2) high-speed motion picture cameras.

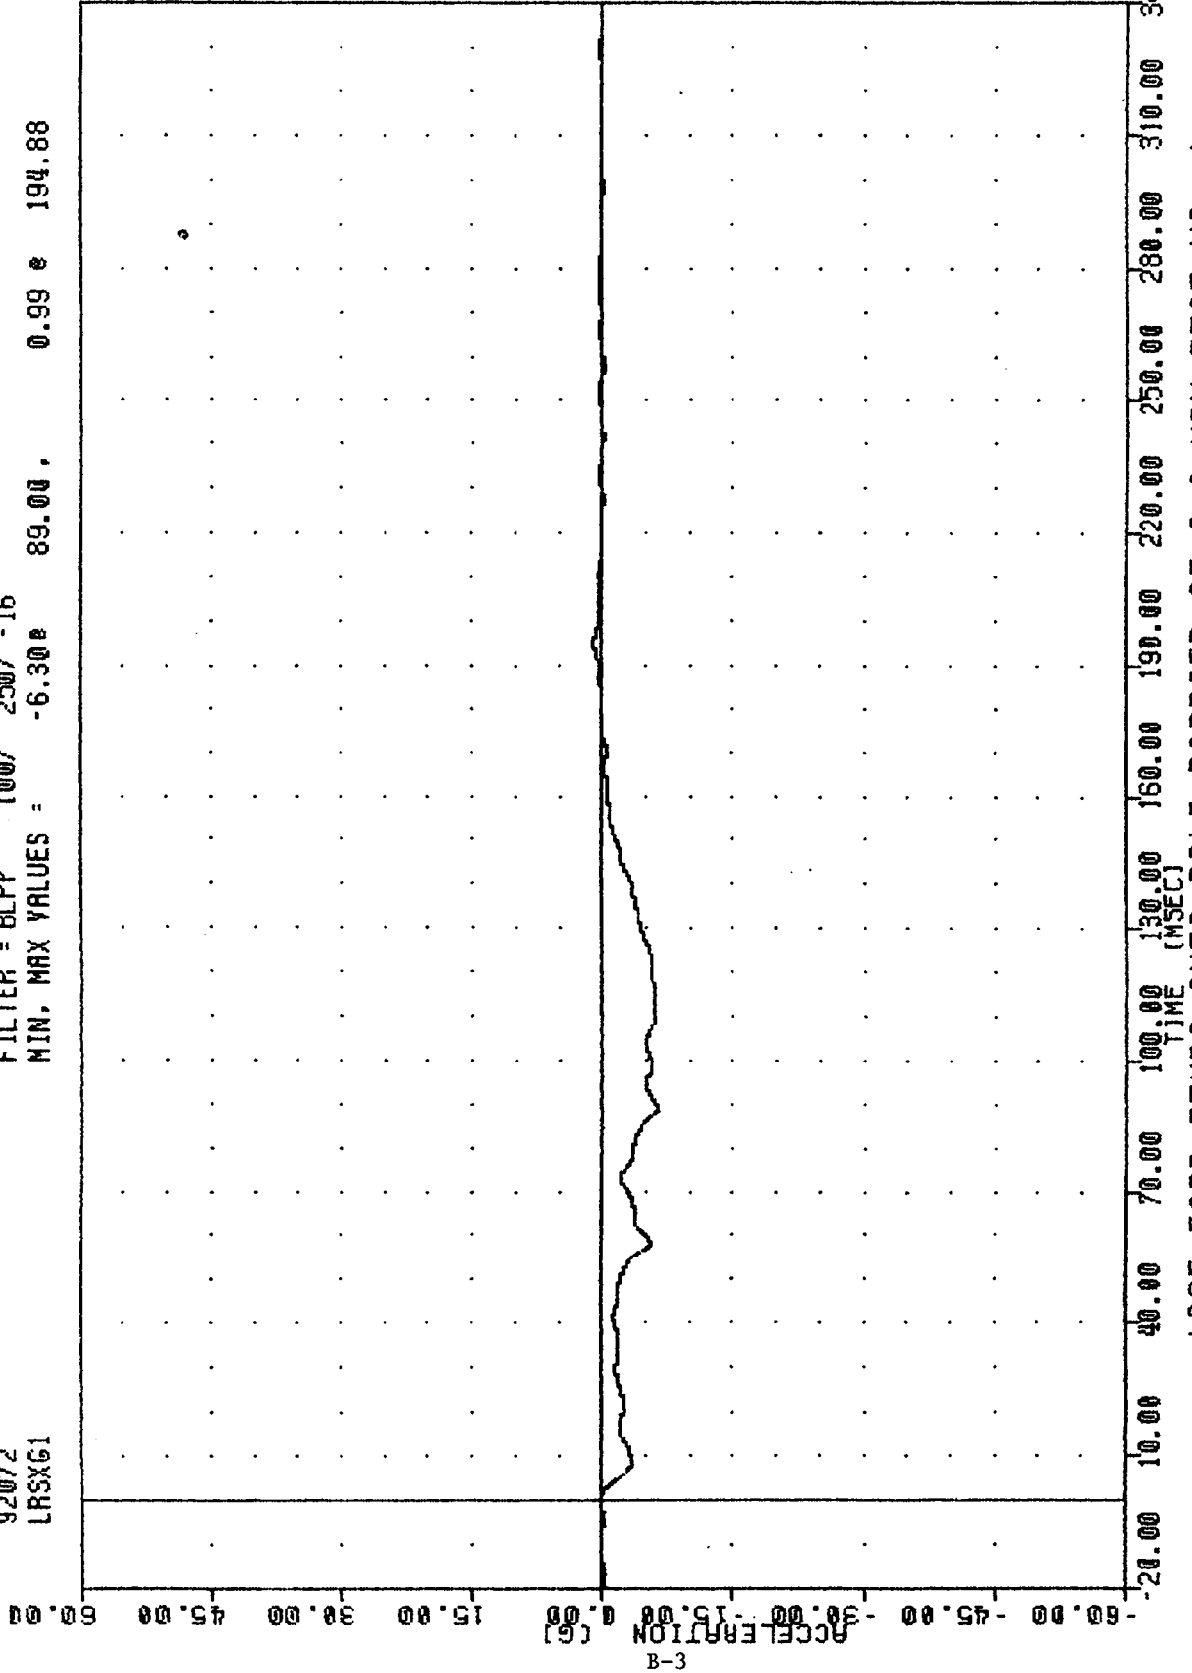
FILTER = BLPP 100/ 250/ -16
MIN. MAX VALUES = -6.30e 89.00 , 0.99 e 194.88

1985 FORD TEMPO INTO POLE BARRIER AT 9.6 MPH TEST NO. 1
LEFT REAR SILL X-AXIS ACCELERATION

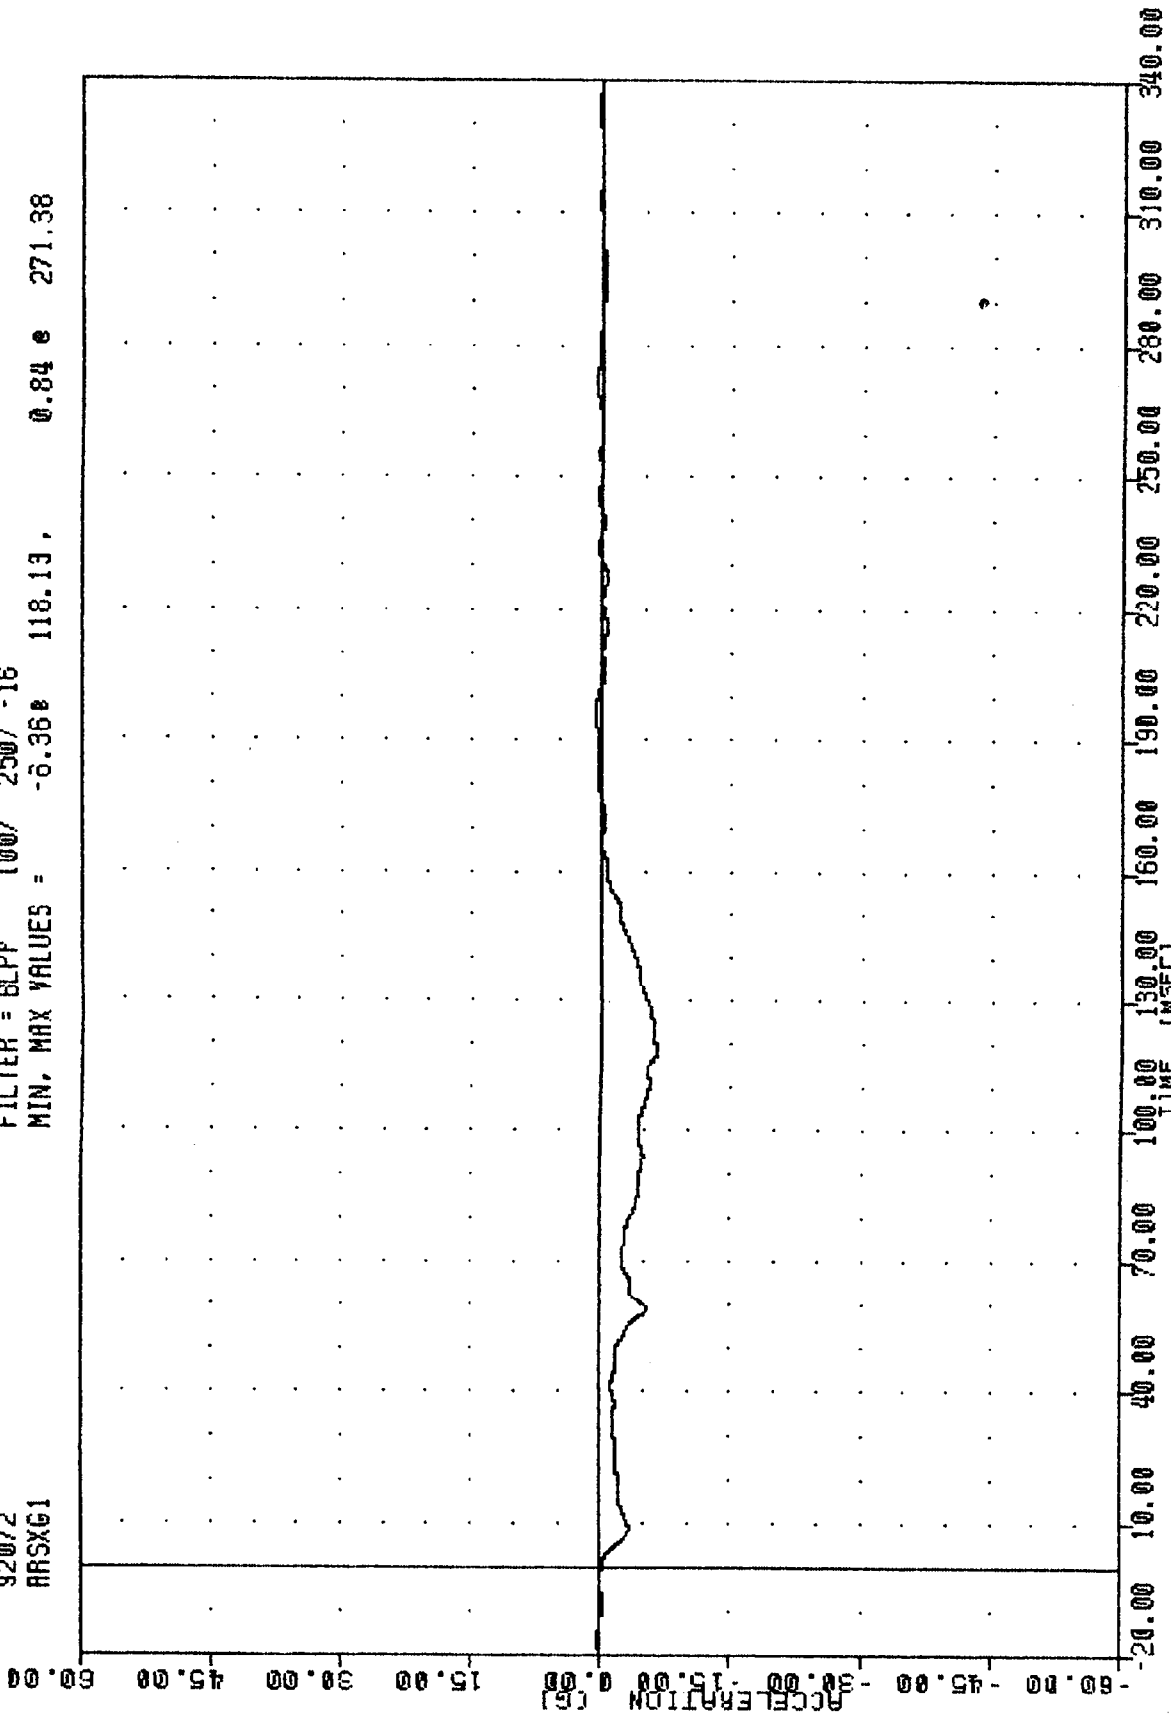
FILTER = BLPP 100/ 250/ -16
MIN. MAX VALUES = -0.36 118.13 0.84 271.38

1985 FORD TEMPO INTO POLE BARRIER AT 9.6 MPH TEST NO. 1
RIGHT REAR SILL X-AXIS ACCELERATION

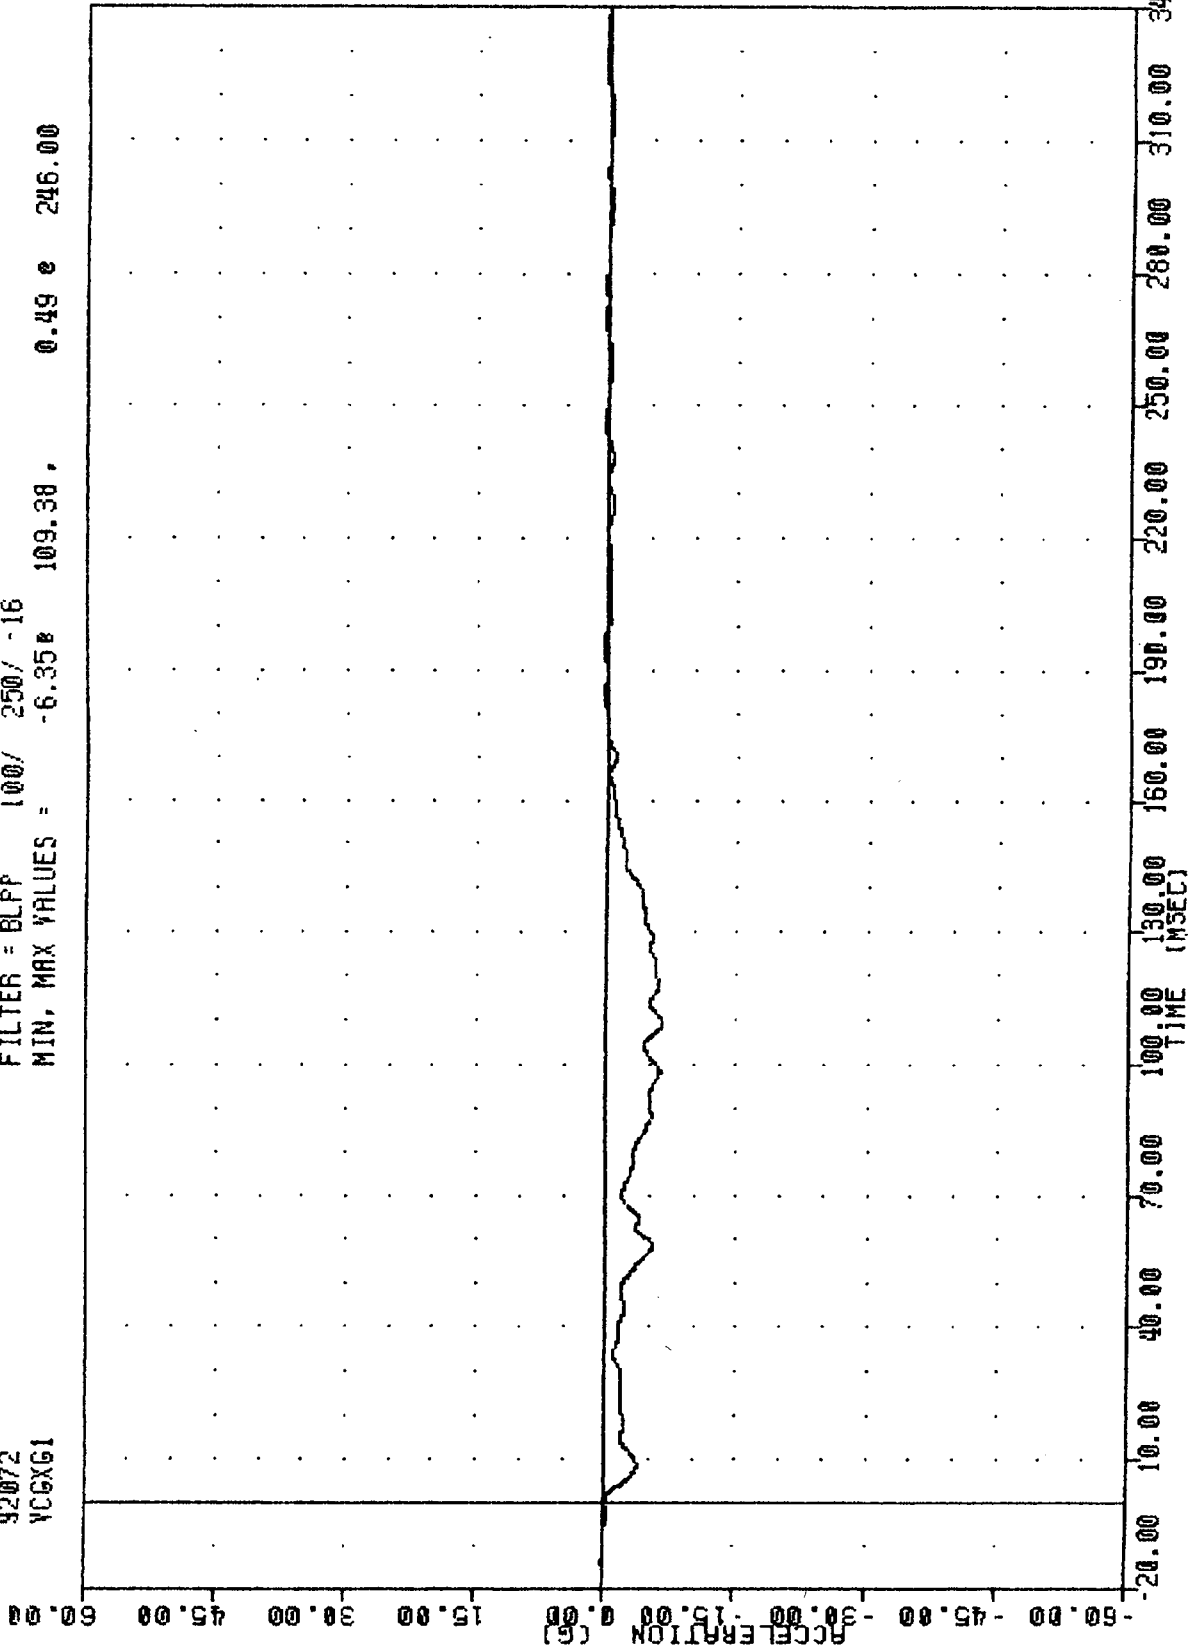
FILTER = BLPP 100/ 250/ -16
MIN, MAX VALUES = -6.35 109.38, 0.49 e 246.00

1985 FORD TEMPO INTO POLE BARRIER AT 9.6 MPH TEST NO. 1
VEHICLE CG X-AXIS ACCELERATION

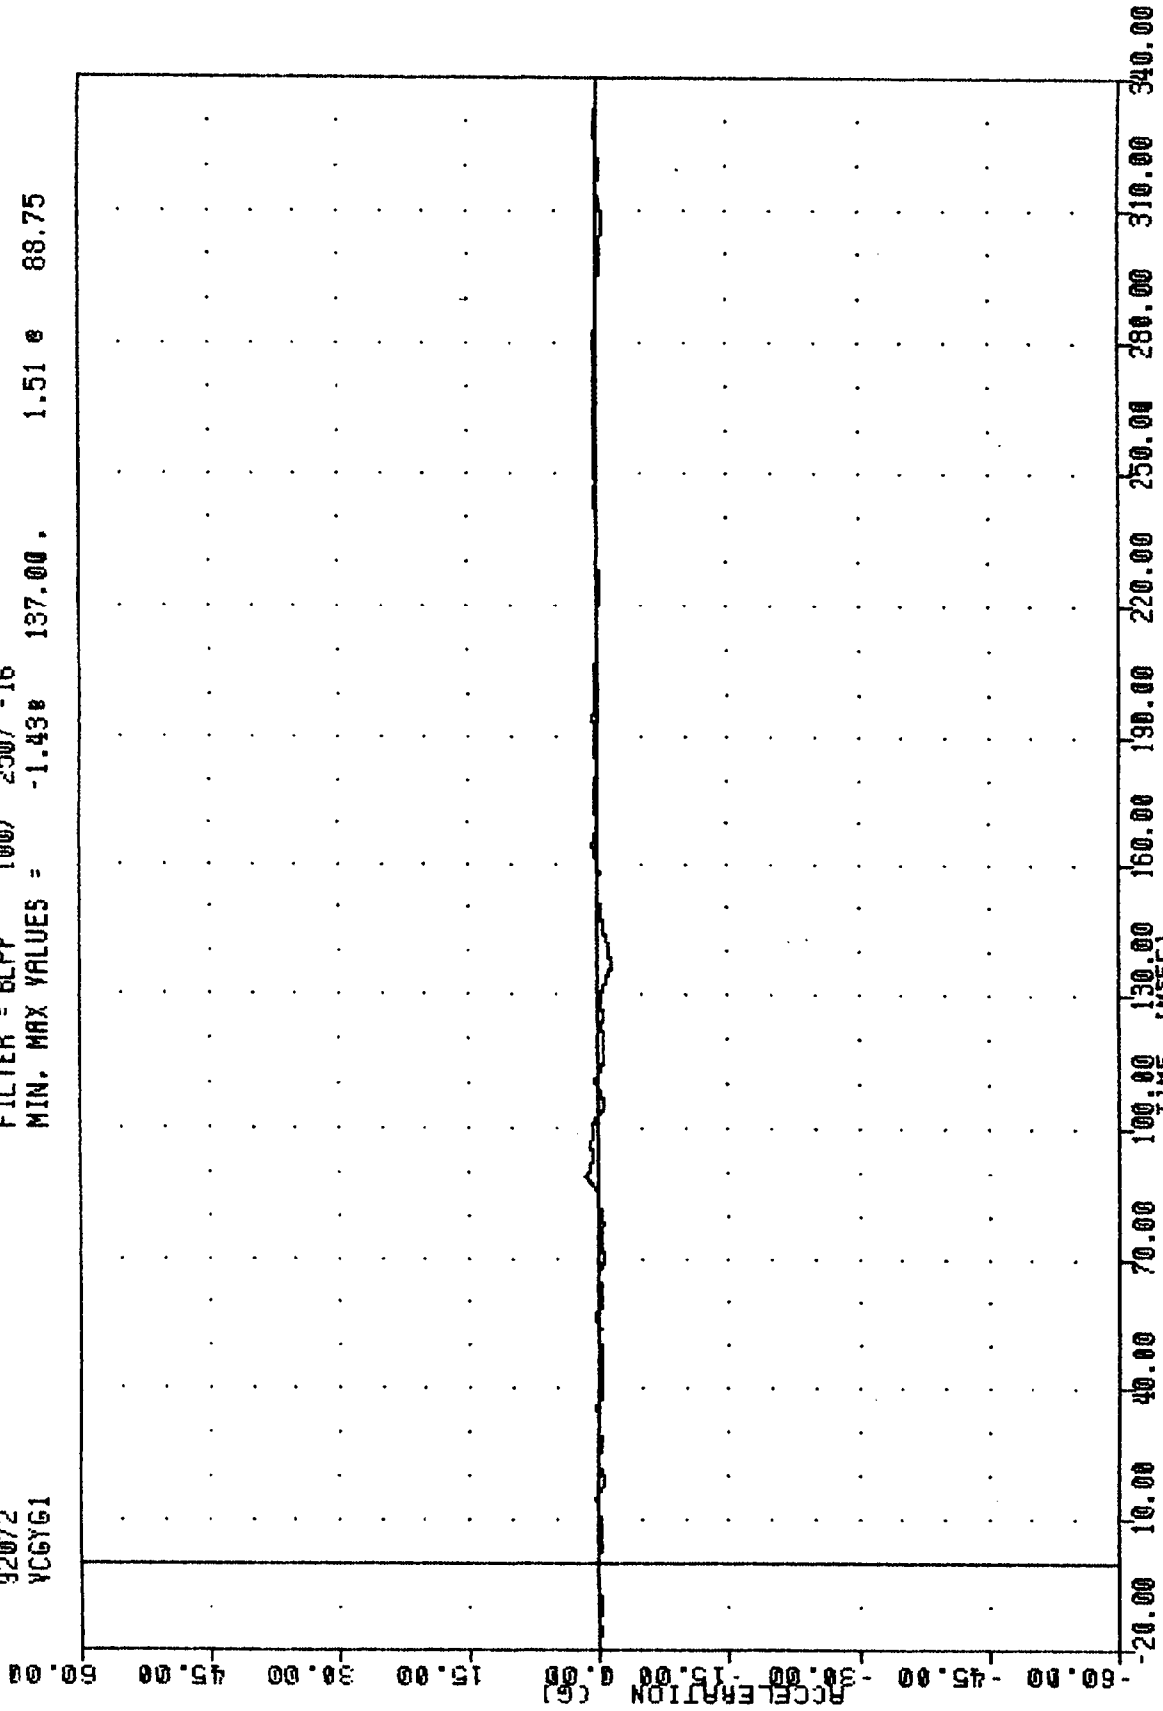
FILTER = BLPP 100/ 250/ -16
 MIN. MAX VALUES = -1.43e 137.00 . 1.51 e 88.75

1985 FORD TEMPO INTO POLE BARRIER AT 9.6 MPH TEST NO. 1
 VEHICLE CG Y-AXIS ACCELERATION

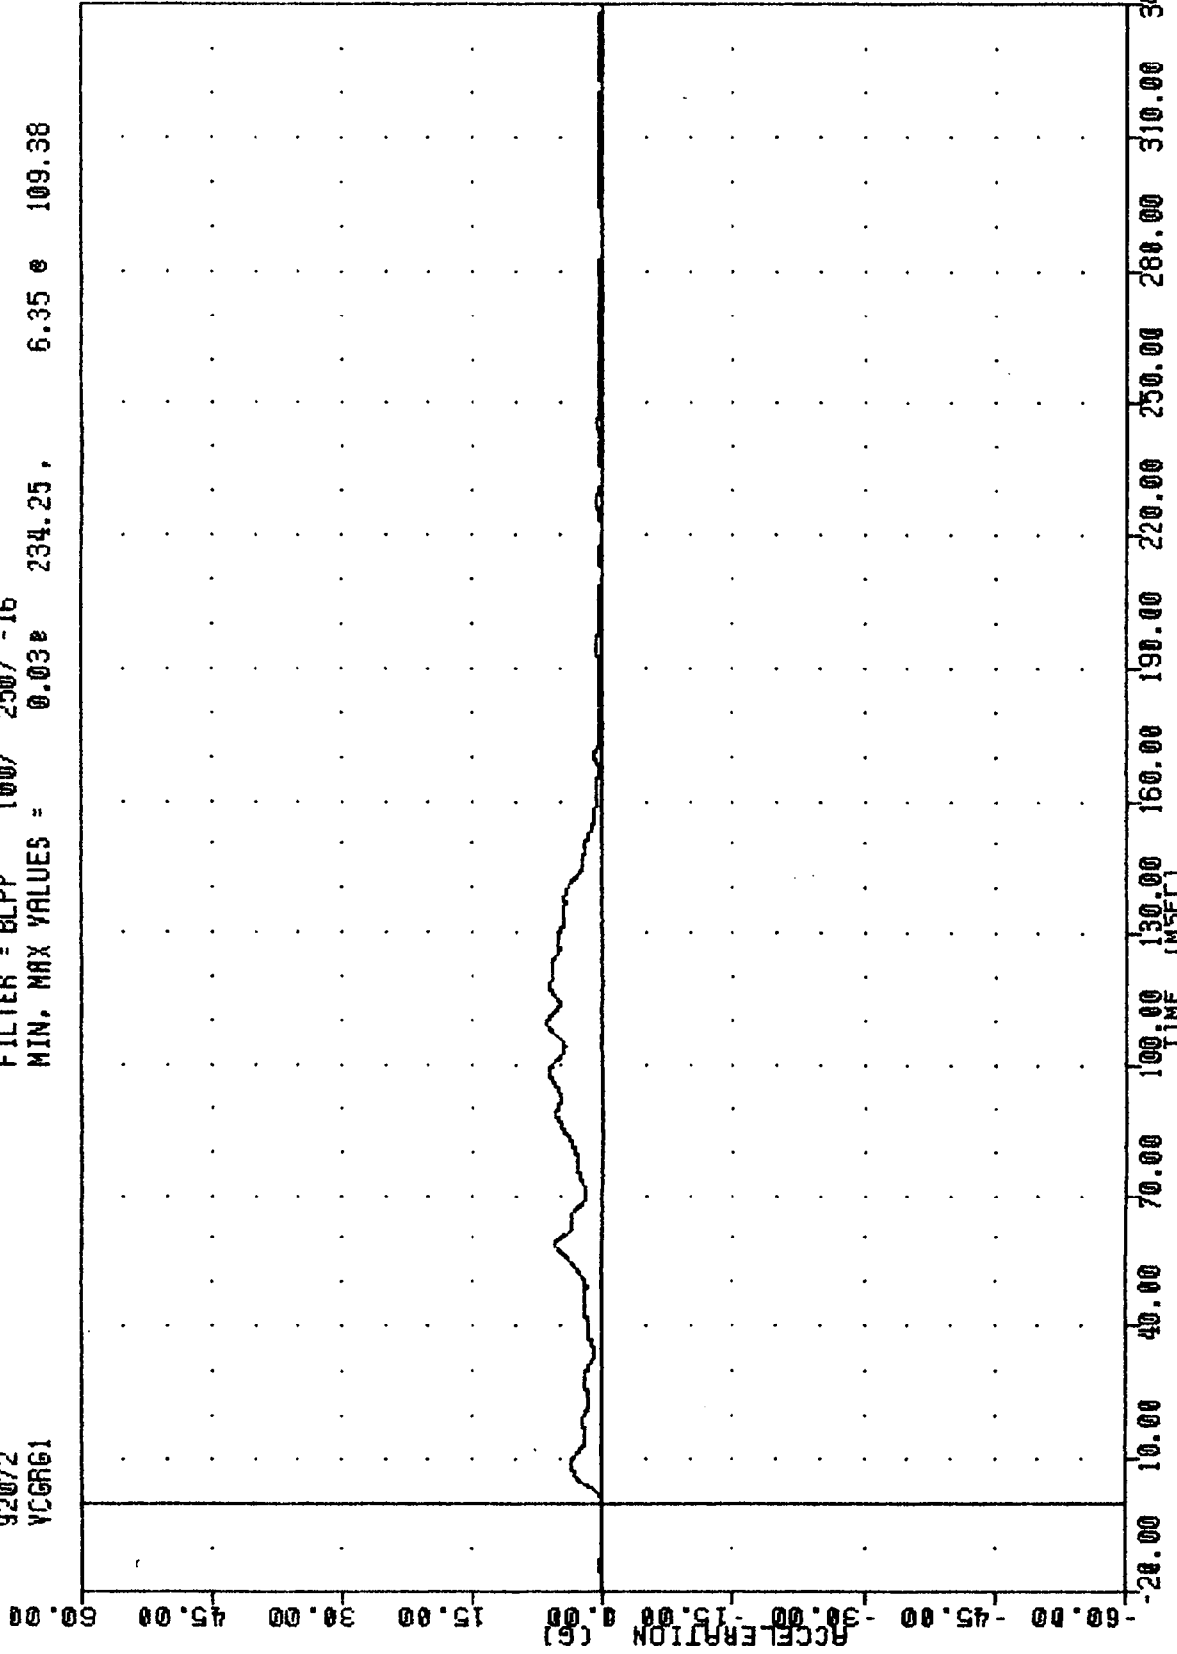
FILTER = BLPP 100/ 250/ -16
MIN, MAX VALUES = 0.03e 234.25, 6.35 e 109.38

1985 FORD TEMPO INTO POLE BARRIER AT 9.6 MPH TEST NO. 1
VEHICLE CG RESULTANT ACCELERATION

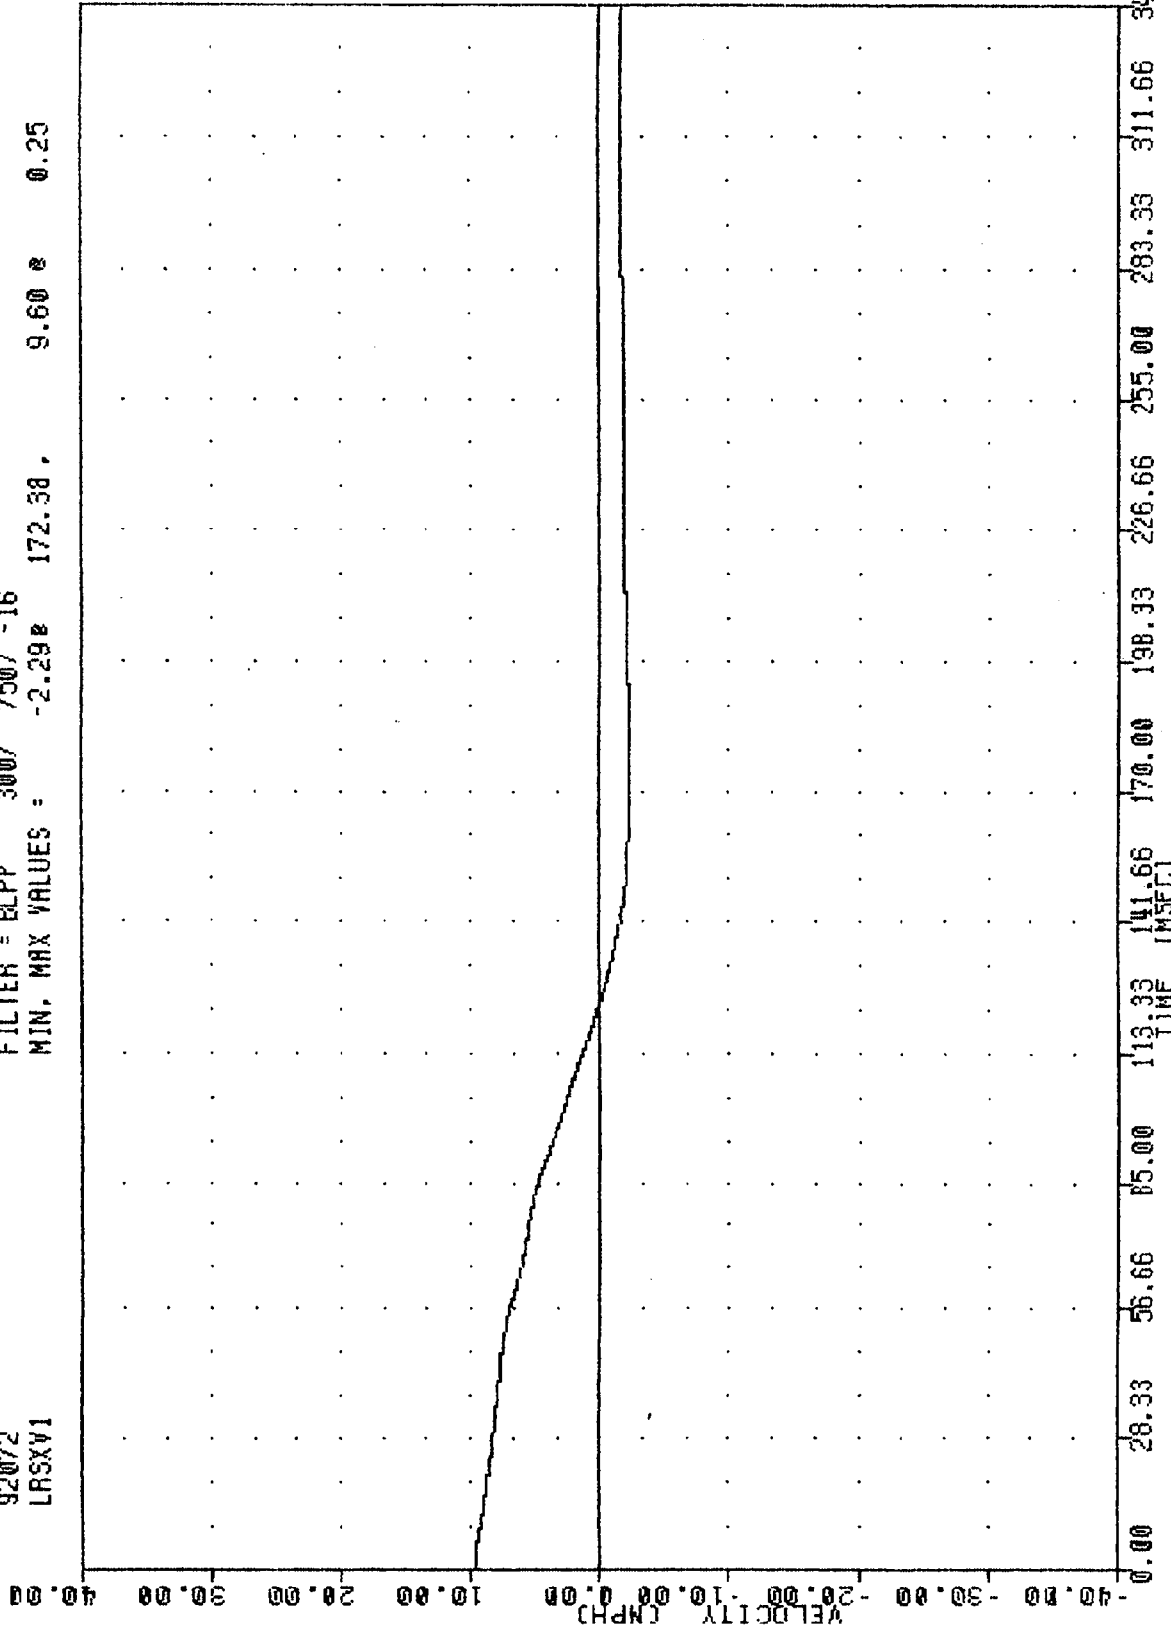
FILTER = BLPP 300/ 750/ -16
 MIN, MAX VALUES : -2.29E 172.38, 9.60 E 0.25

1985 FORD TEMPO INTO POLE BARRIER AT 9.6 MPH TEST NO. 1
 LEFT REAR SILL X-AXIS VELOCITY

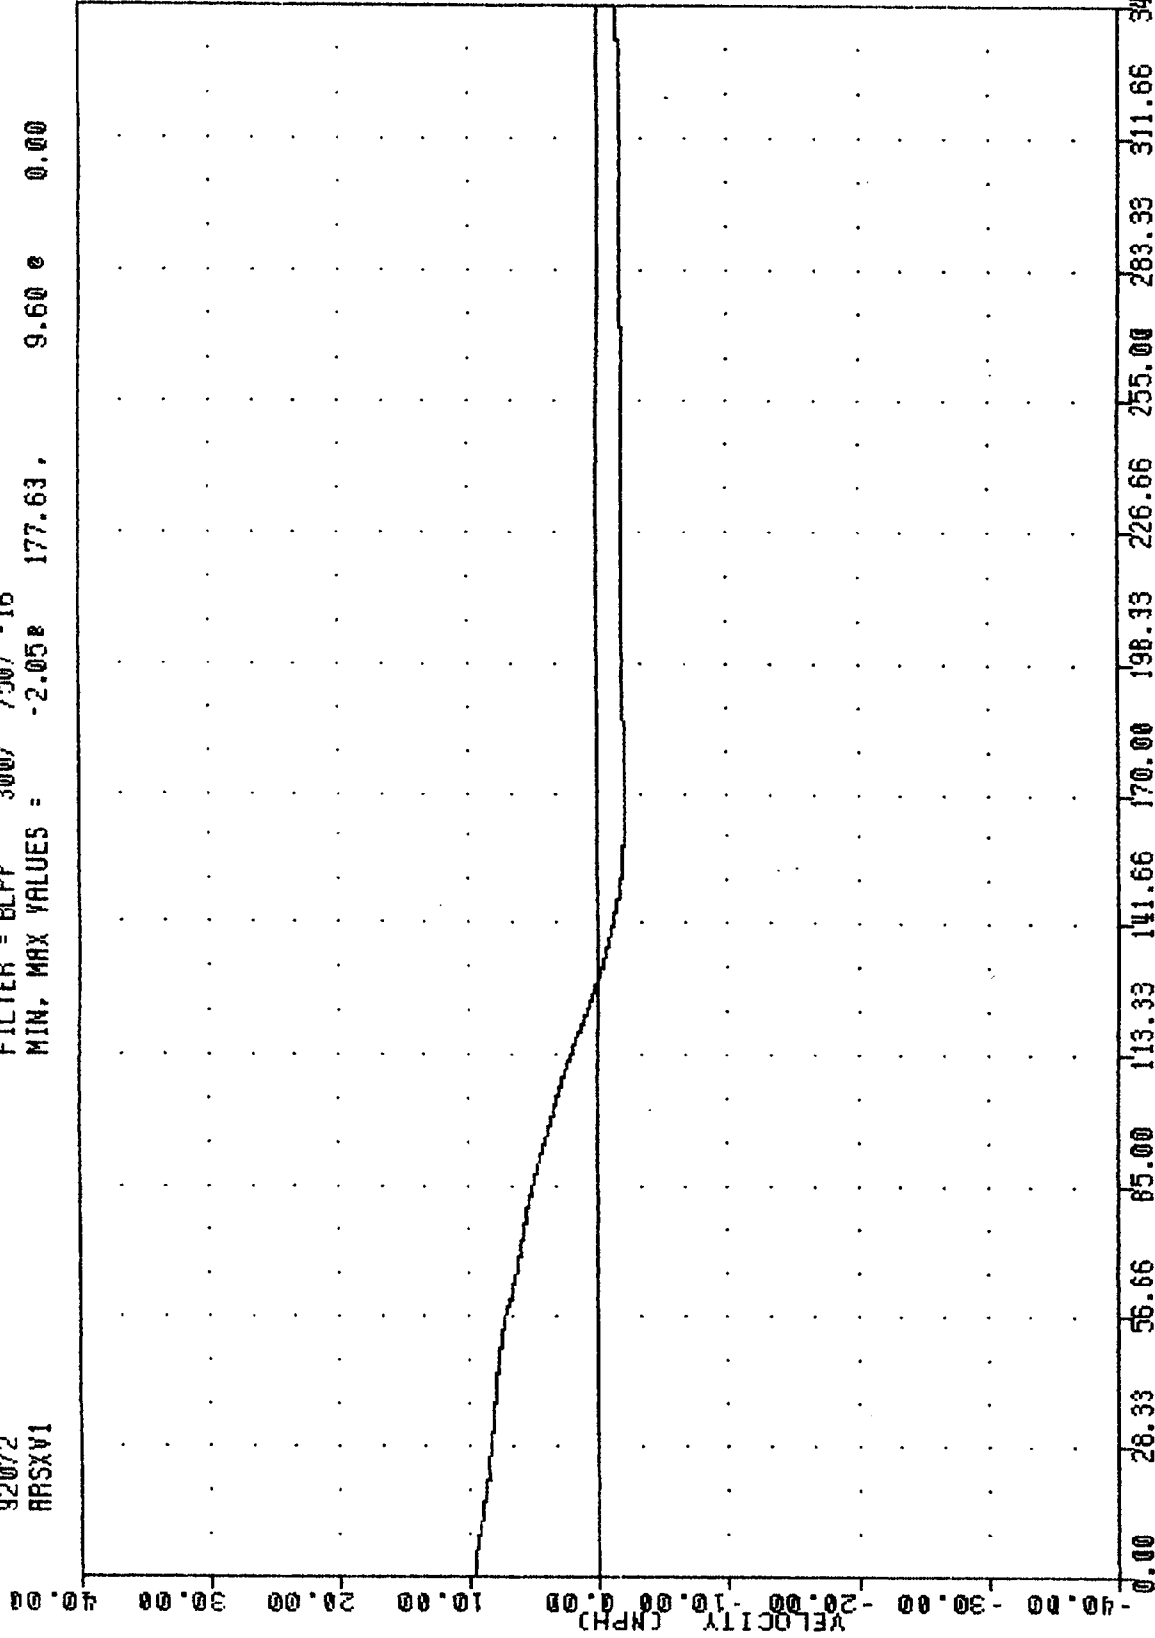
FILTER = BLPP 300/ 750/ -16
 MIN. MAX VALUES = -2.05B 177.63, 9.60 e 0.00

1985 FORD TEMPO INTO POLE BARRIER AT 9.6 MPH TEST NO. 1
 RIGHT REAR SILL X-AXIS VELOCITY

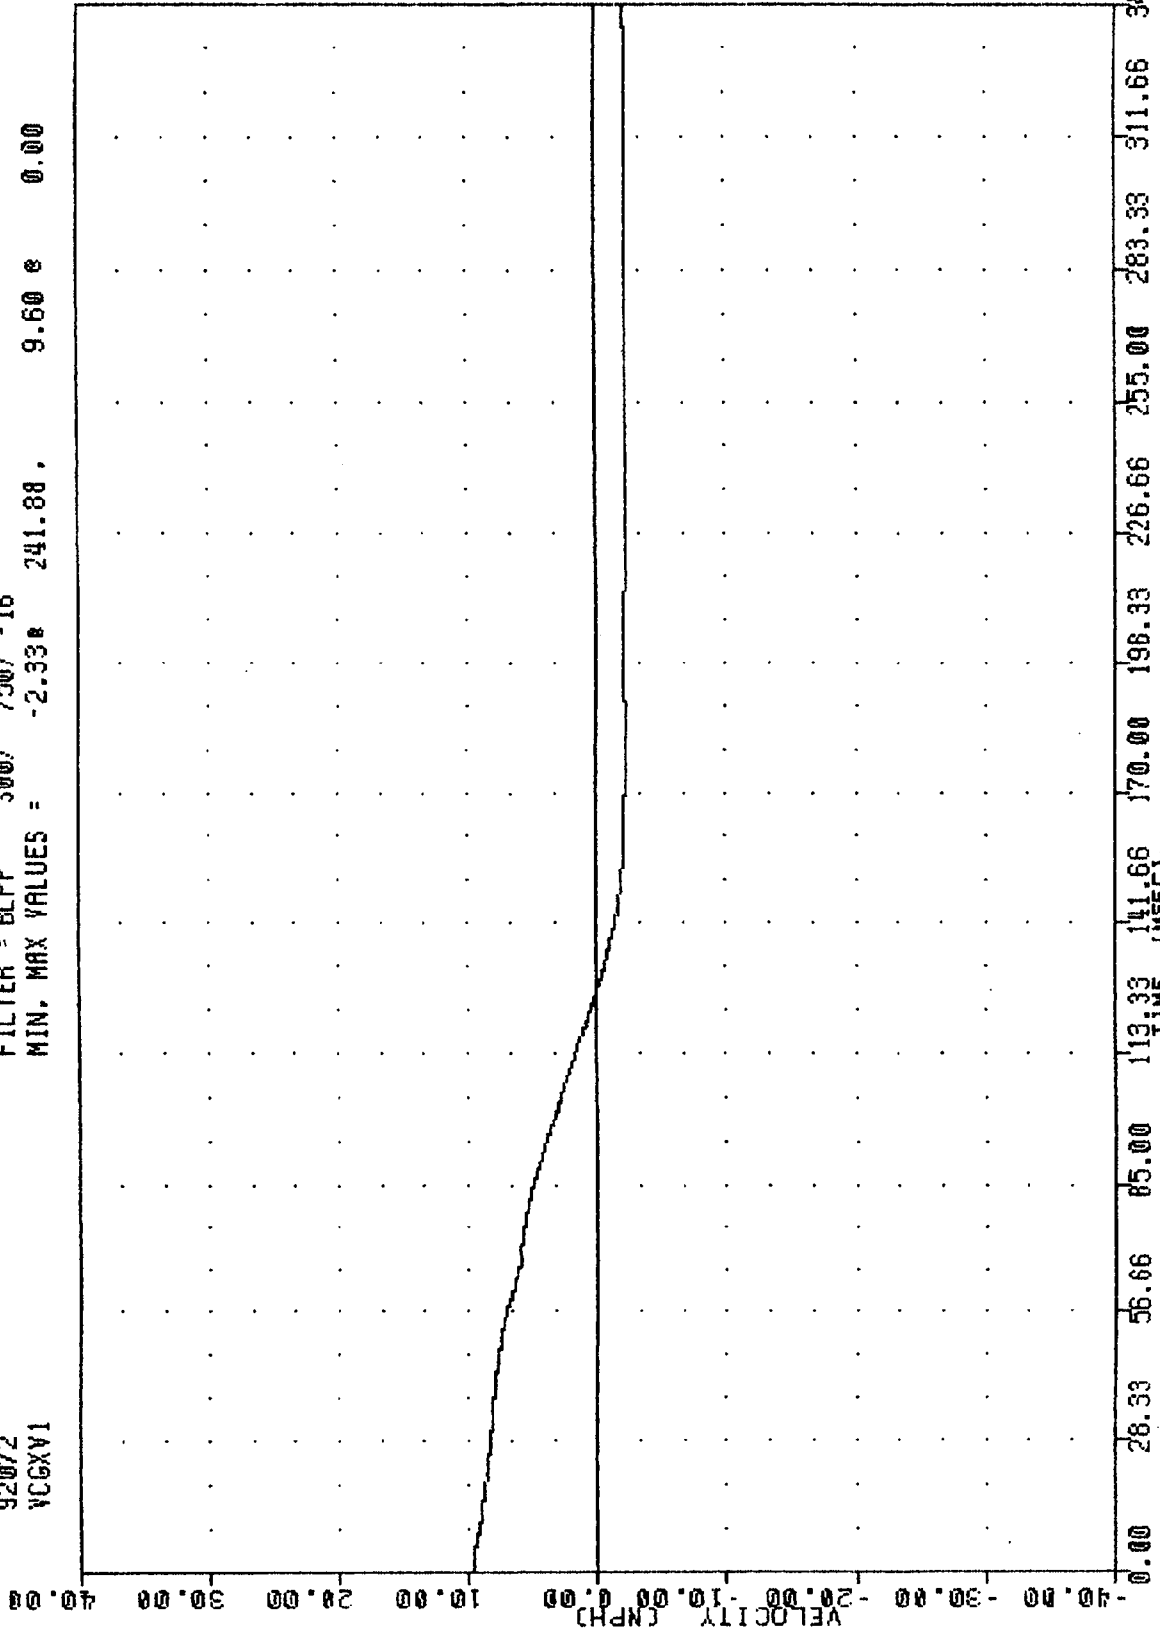
FILTER = BLPP 300/ 750/ -16
 MIN. MAX VALUES = -2.33# 241.88, 9.60 # 0.00

1985 FORD TEMPO INTO POLE BARRIER AT 9.6 MPH TEST NO. 1
 VEHICLE CG X-AXIS VELOCITY

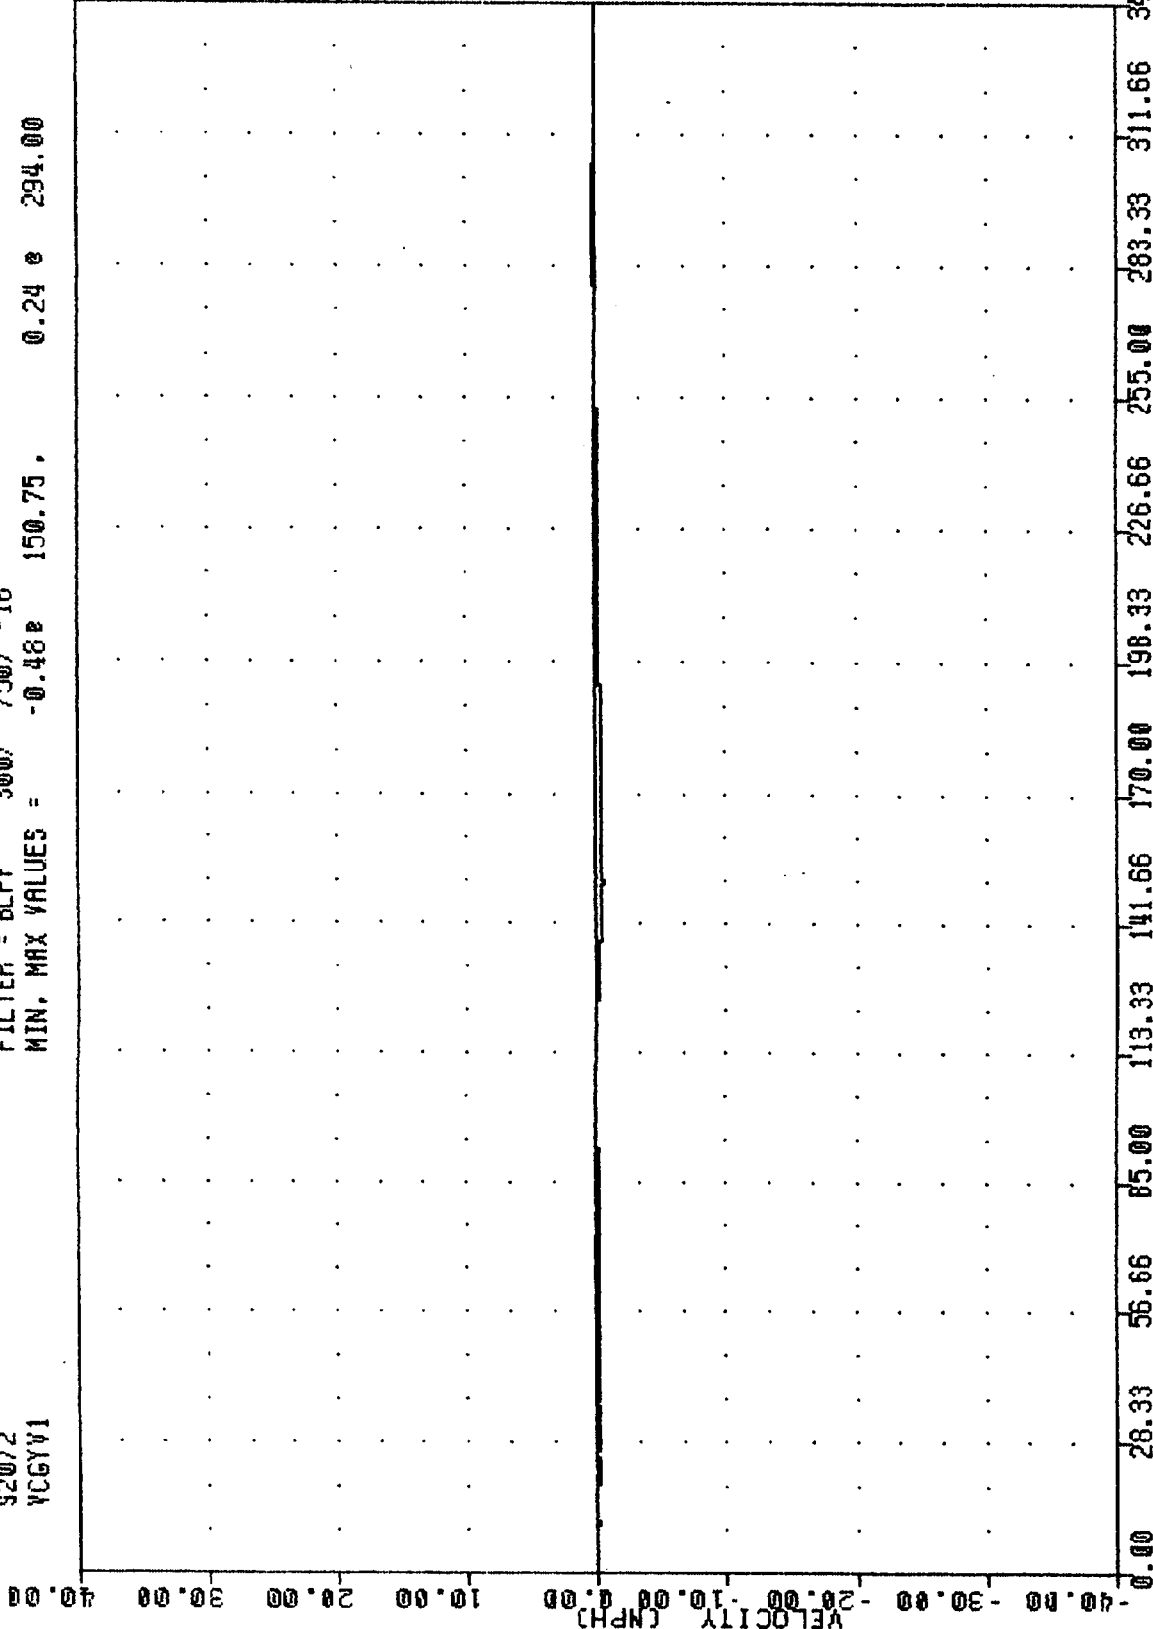
FILTER = BLPP 300/ 750/ -16
 MIN. MAX VALUES = -0.48 150.75 , 0.24 294.00

1985 FORD TEMPO INTO POLE BARRIER AT 9.6 MPH TEST NO. 1
 VEHICLE CG Y-AXIS VELOCITY

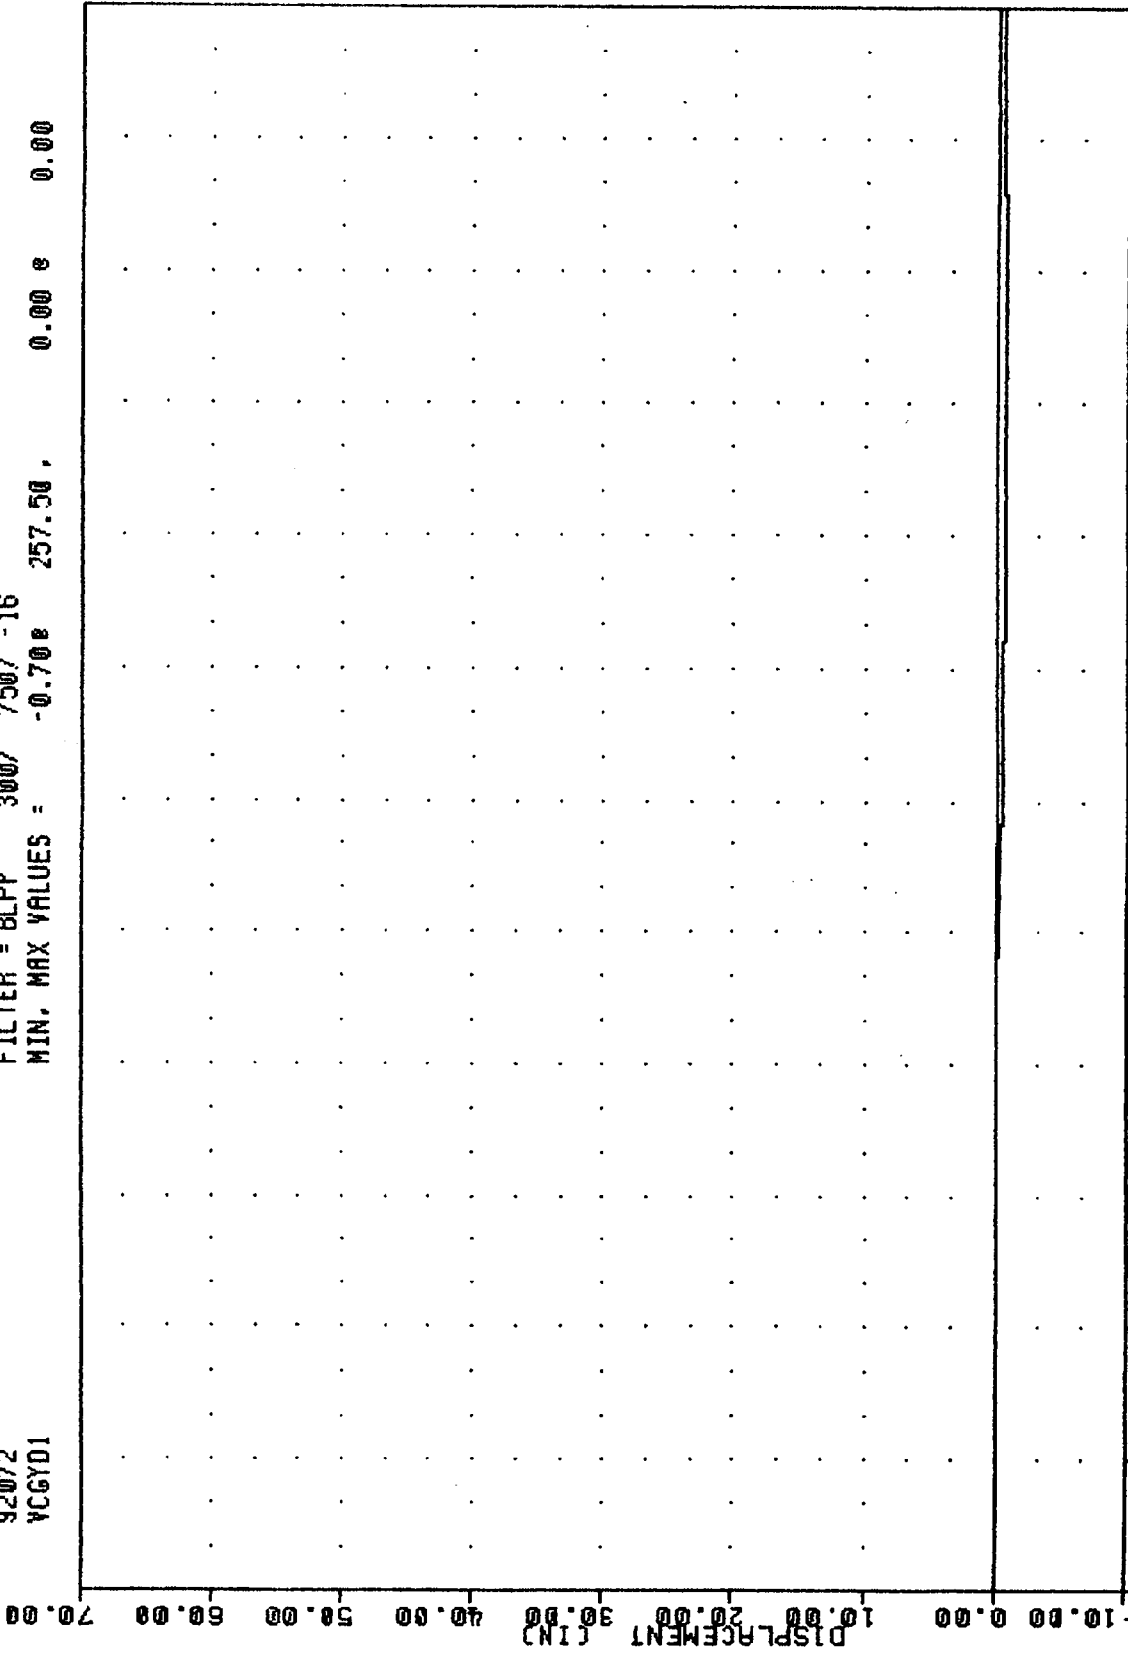
FILTER = BLPP 300/ 750/ -16
 MIN, MAX VALUES = -0.70e 0.00 e 0.00

1985 FORD TEMPO INTO POLE BARRIER AT 9.6 MPH TEST NO. 1
 VEHICLE CG Y-AXIS DISPLACEMENT

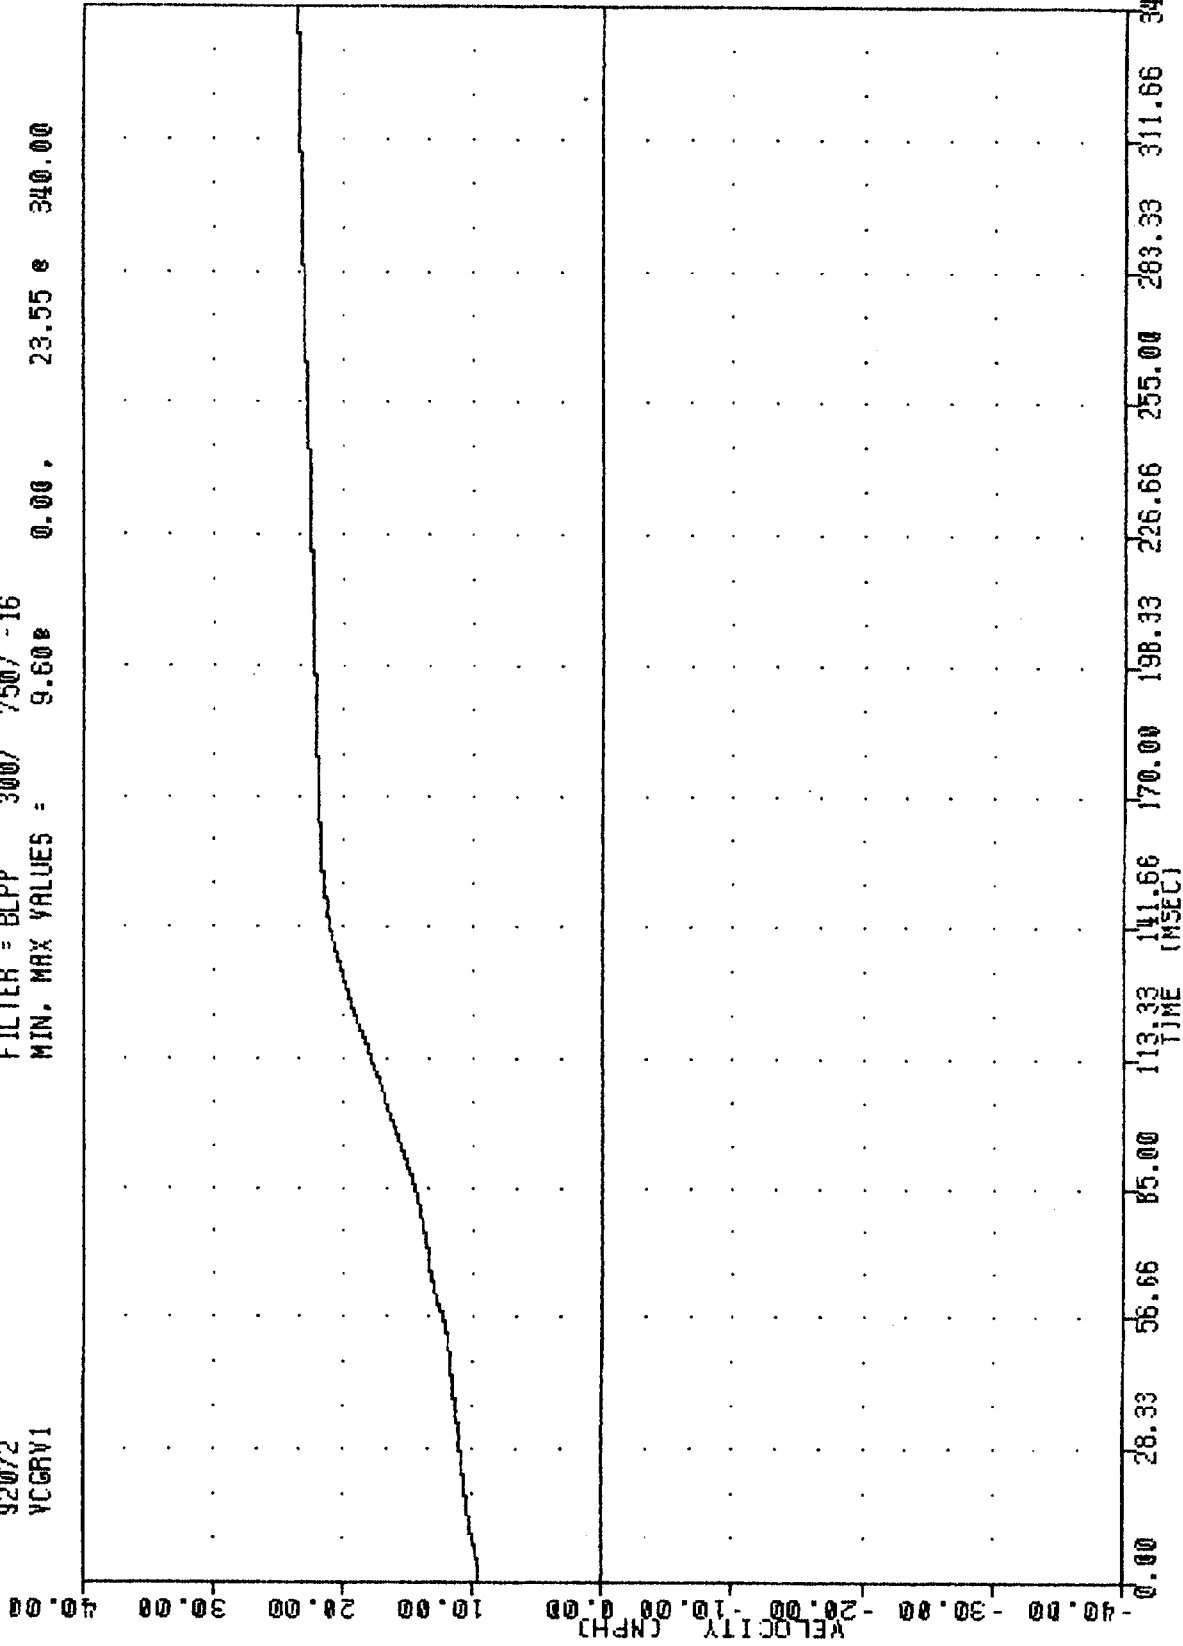
FILTER = BLPP 300/ 750/ -16
 MIN. MAX VALUES = 0.00 , 23.55 e 340.00

1985 FORD TEMPO INTO POLE BARRIER AT 9.6 MPH TEST NO. 1
 VEHICLE CG RESULTANT VELOCITY
