DOT HS 807 915
Final Report

April 1992

Final Report of a 1985 Ford Tempo 4-Door Sedan Into a Pole Barrier in Support of Crash III Damage Algorithm Reformulation

PURPOSE AND TEST SUMMARY

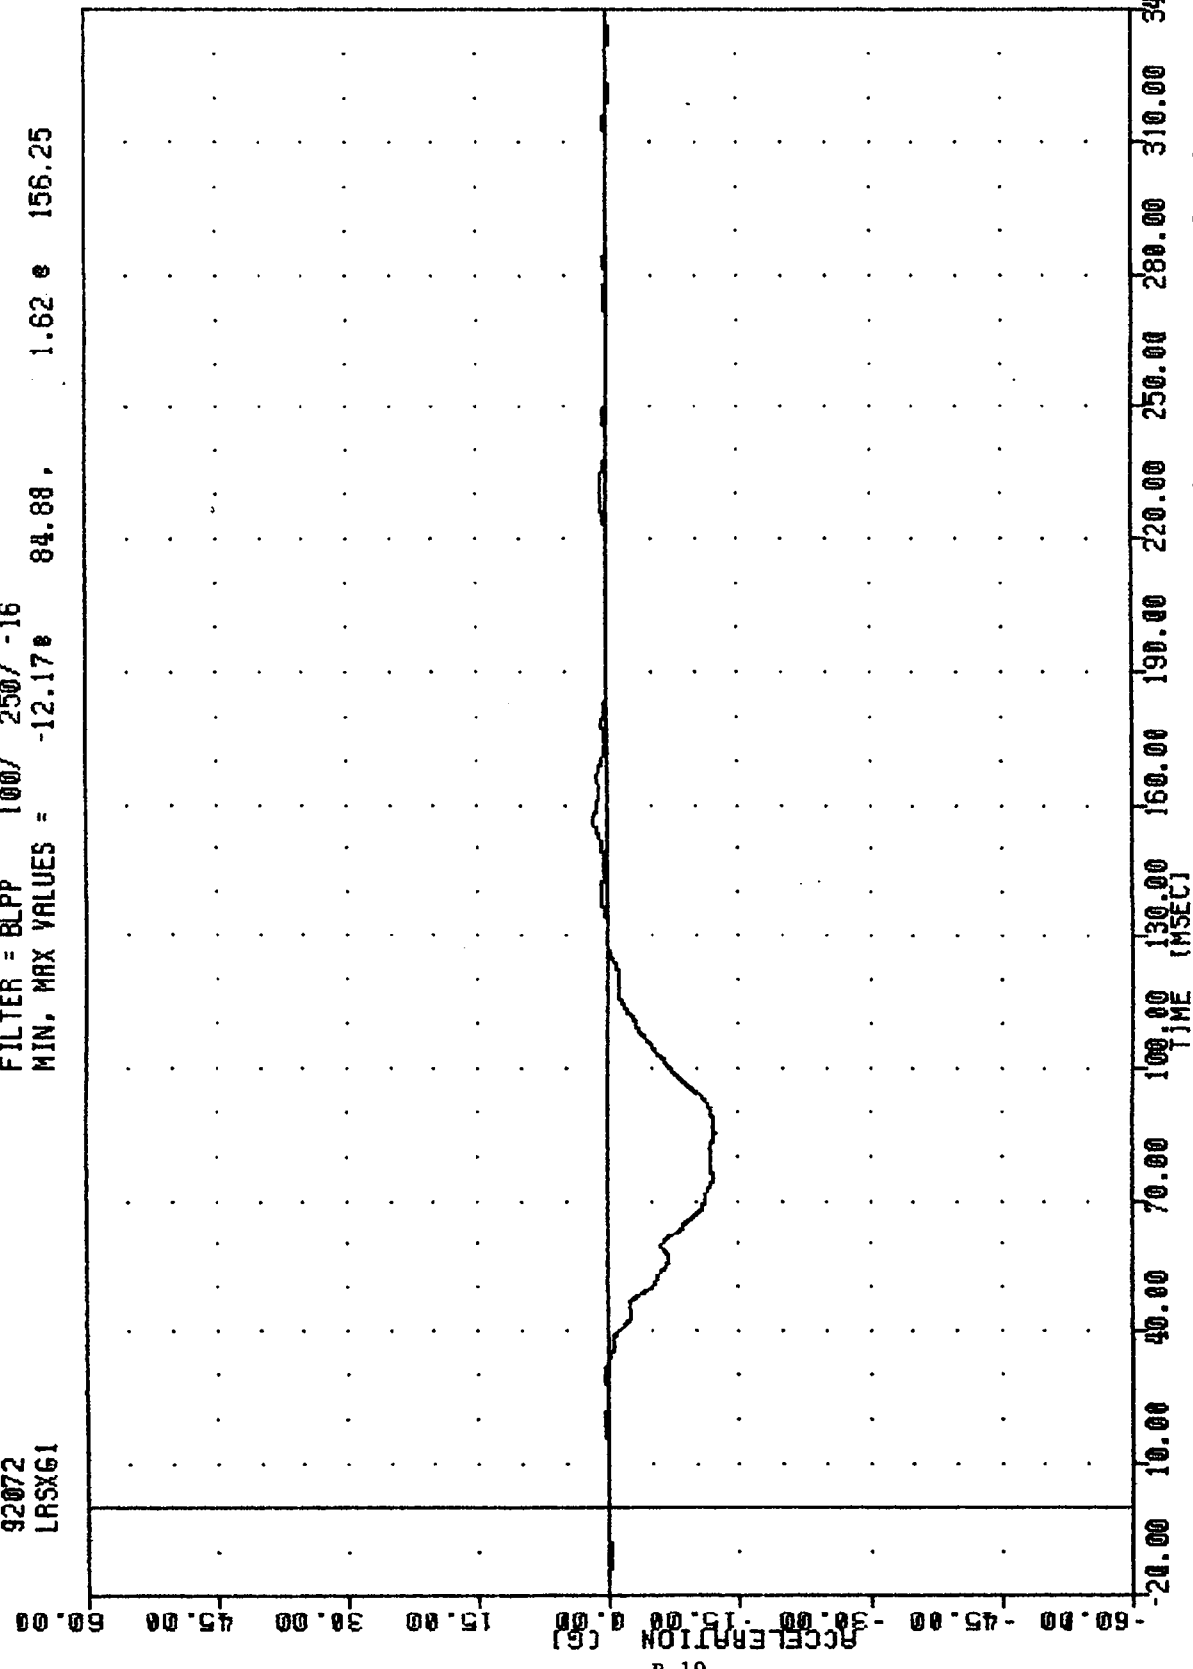
FILTER = BLPP 100/ 250/ -16
 MIN. MAX VALUES = -12.17e 84.88. 1.62 e 156.25

1985 FORD TEMPO INTO POLE BARRIER AT 9.6 MPH TEST NO. 2
 LEFT REAR SILL X-AXIS ACCELERATION

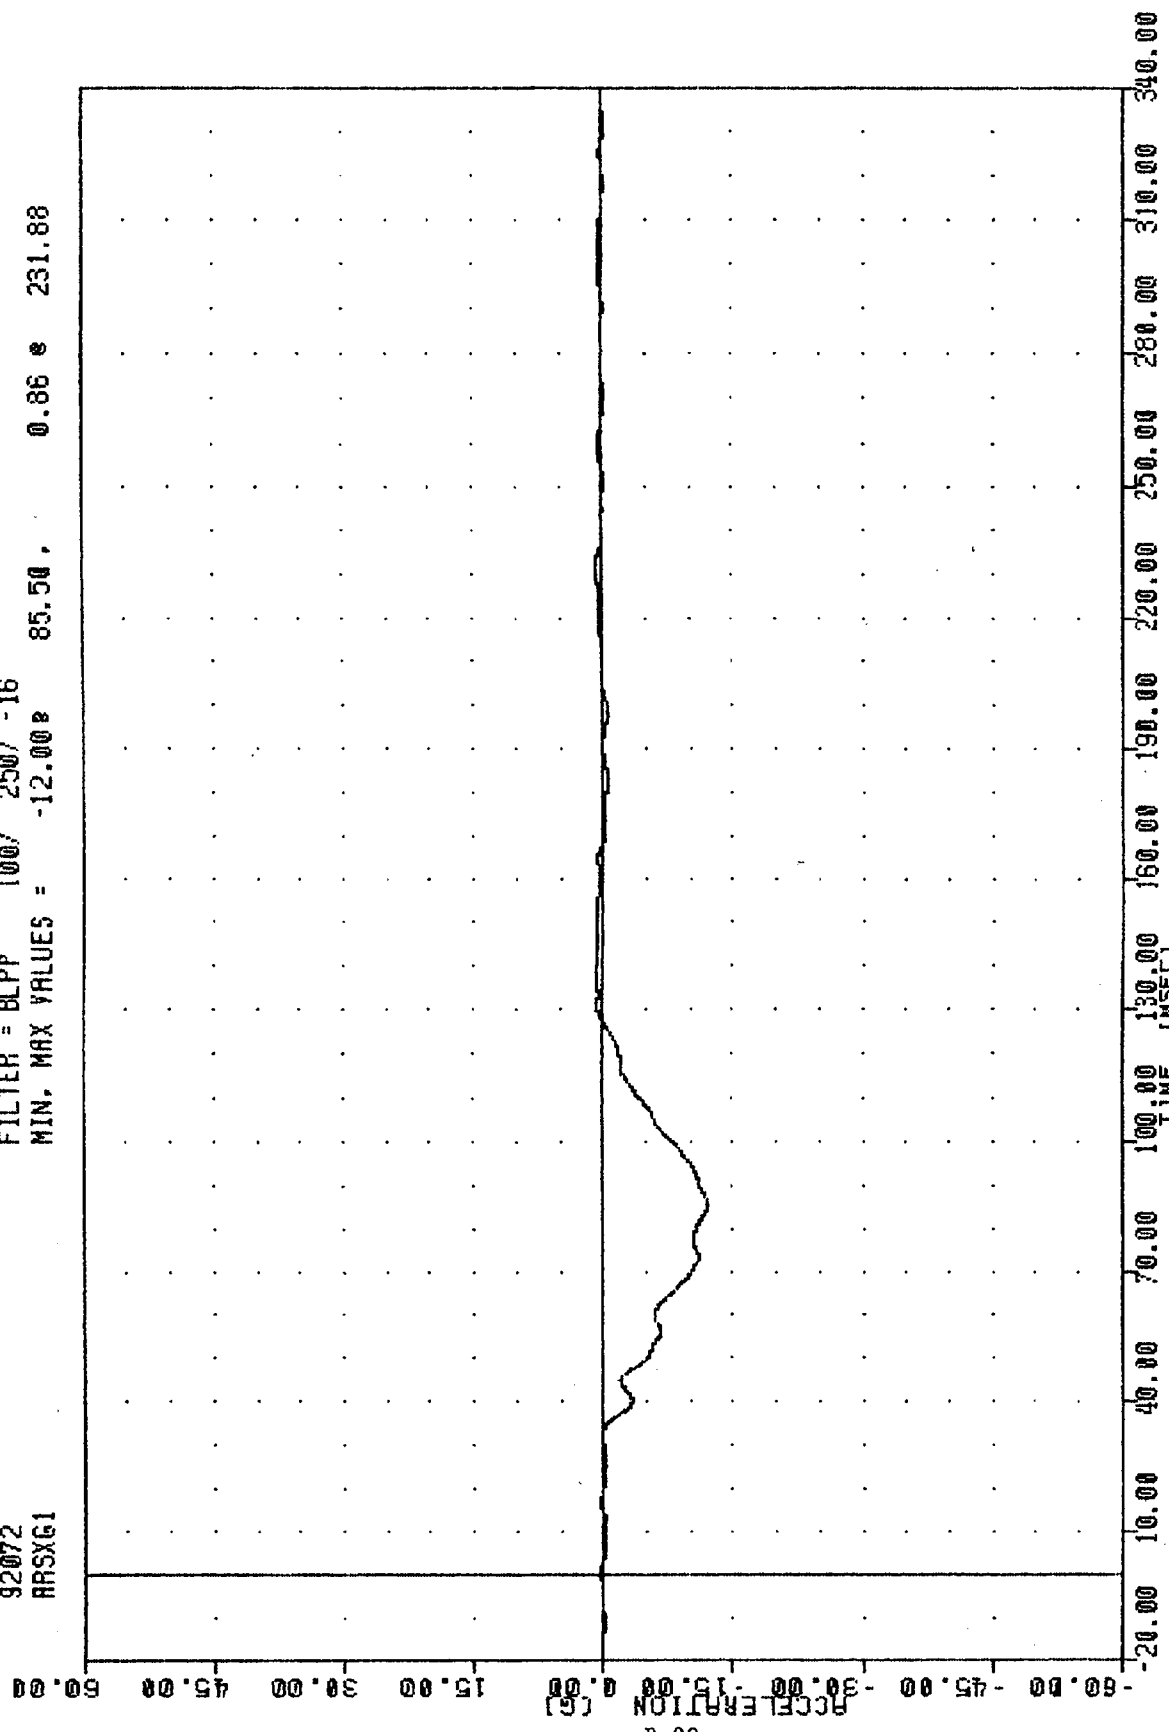
FILTER = BLPP 100/ 250/ -16
MIN. MAX VALUES = -12.00 85.50 0.86 e 231.88

1985 FORD TEMPO INTO POLE BARRIER AT 9.6 MPH TEST NO. 2
RIGHT REAR SILL X-AXIS ACCELERATION

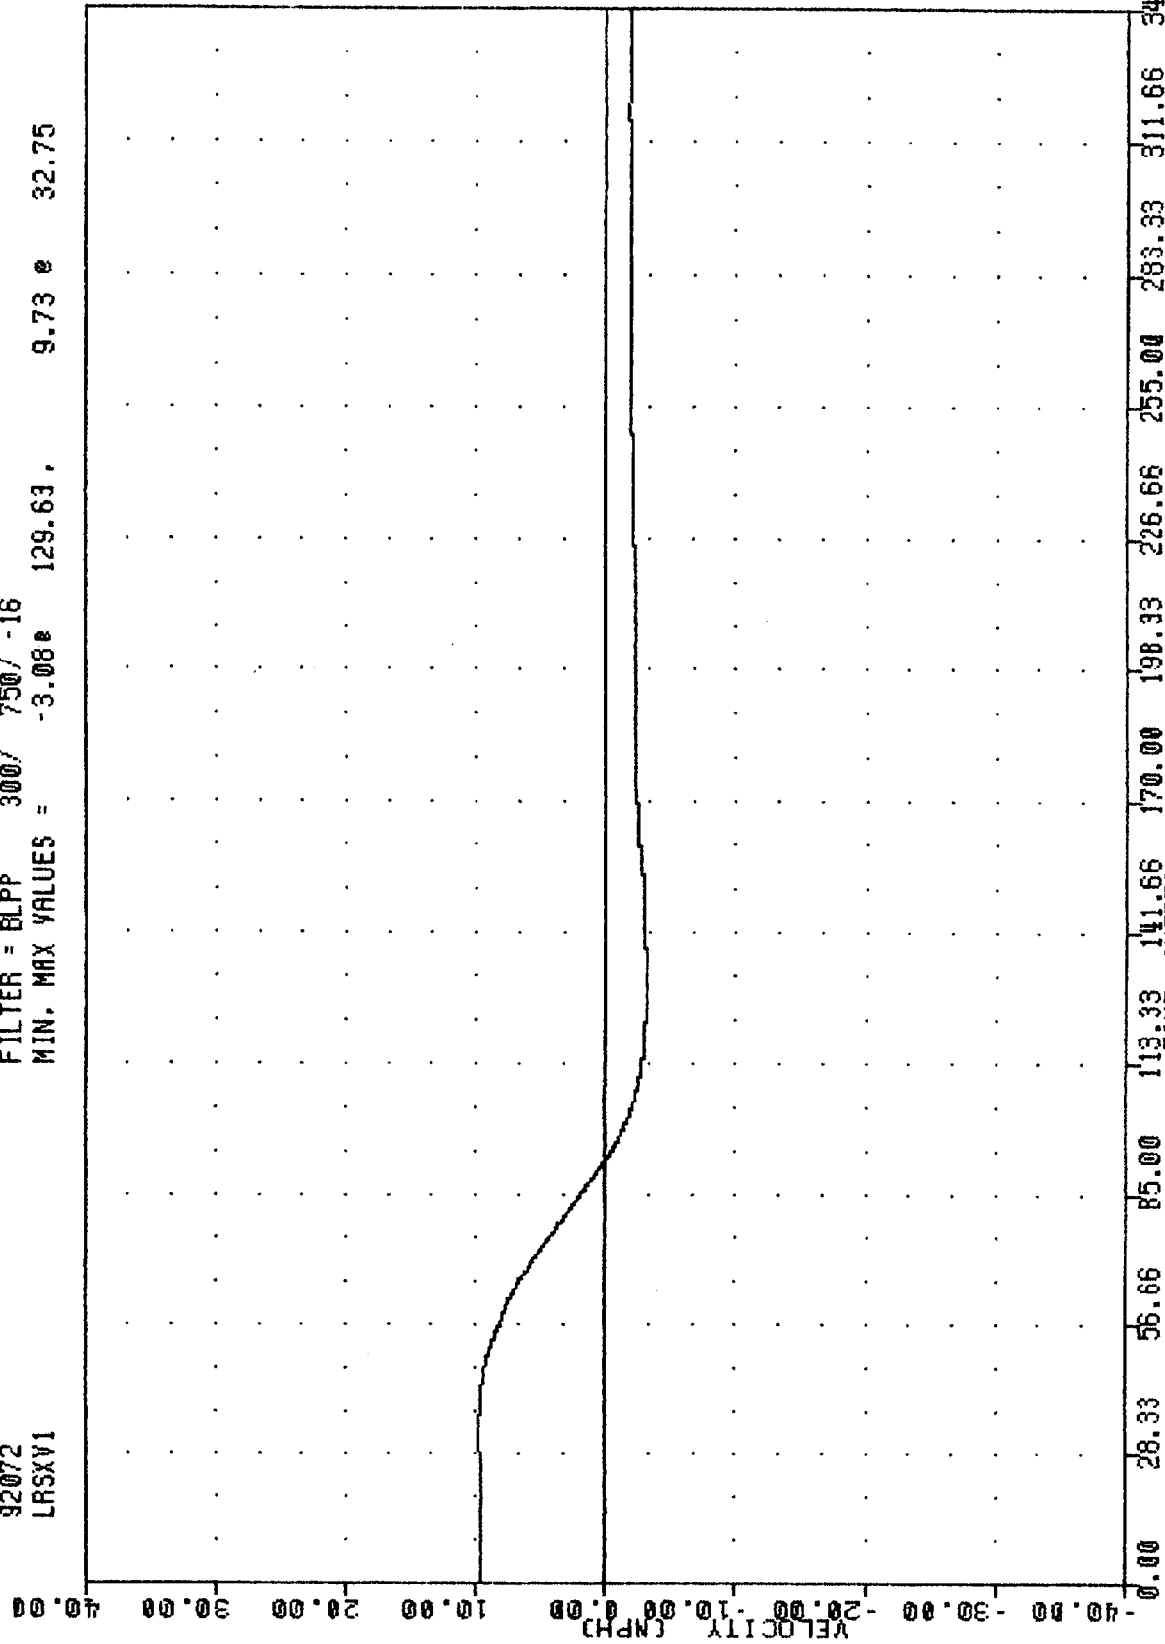
FILTER = BLPP 300/ 750/ -16
 MIN. MAX VALUES = -3.08e 129.63, 9.73 e 32.75

1985 FORD TEMPO INTO POLE BARRIER AT 9.6 MPH TEST NO. 2
 LEFT REAR SILL X-AXIS VELOCITY

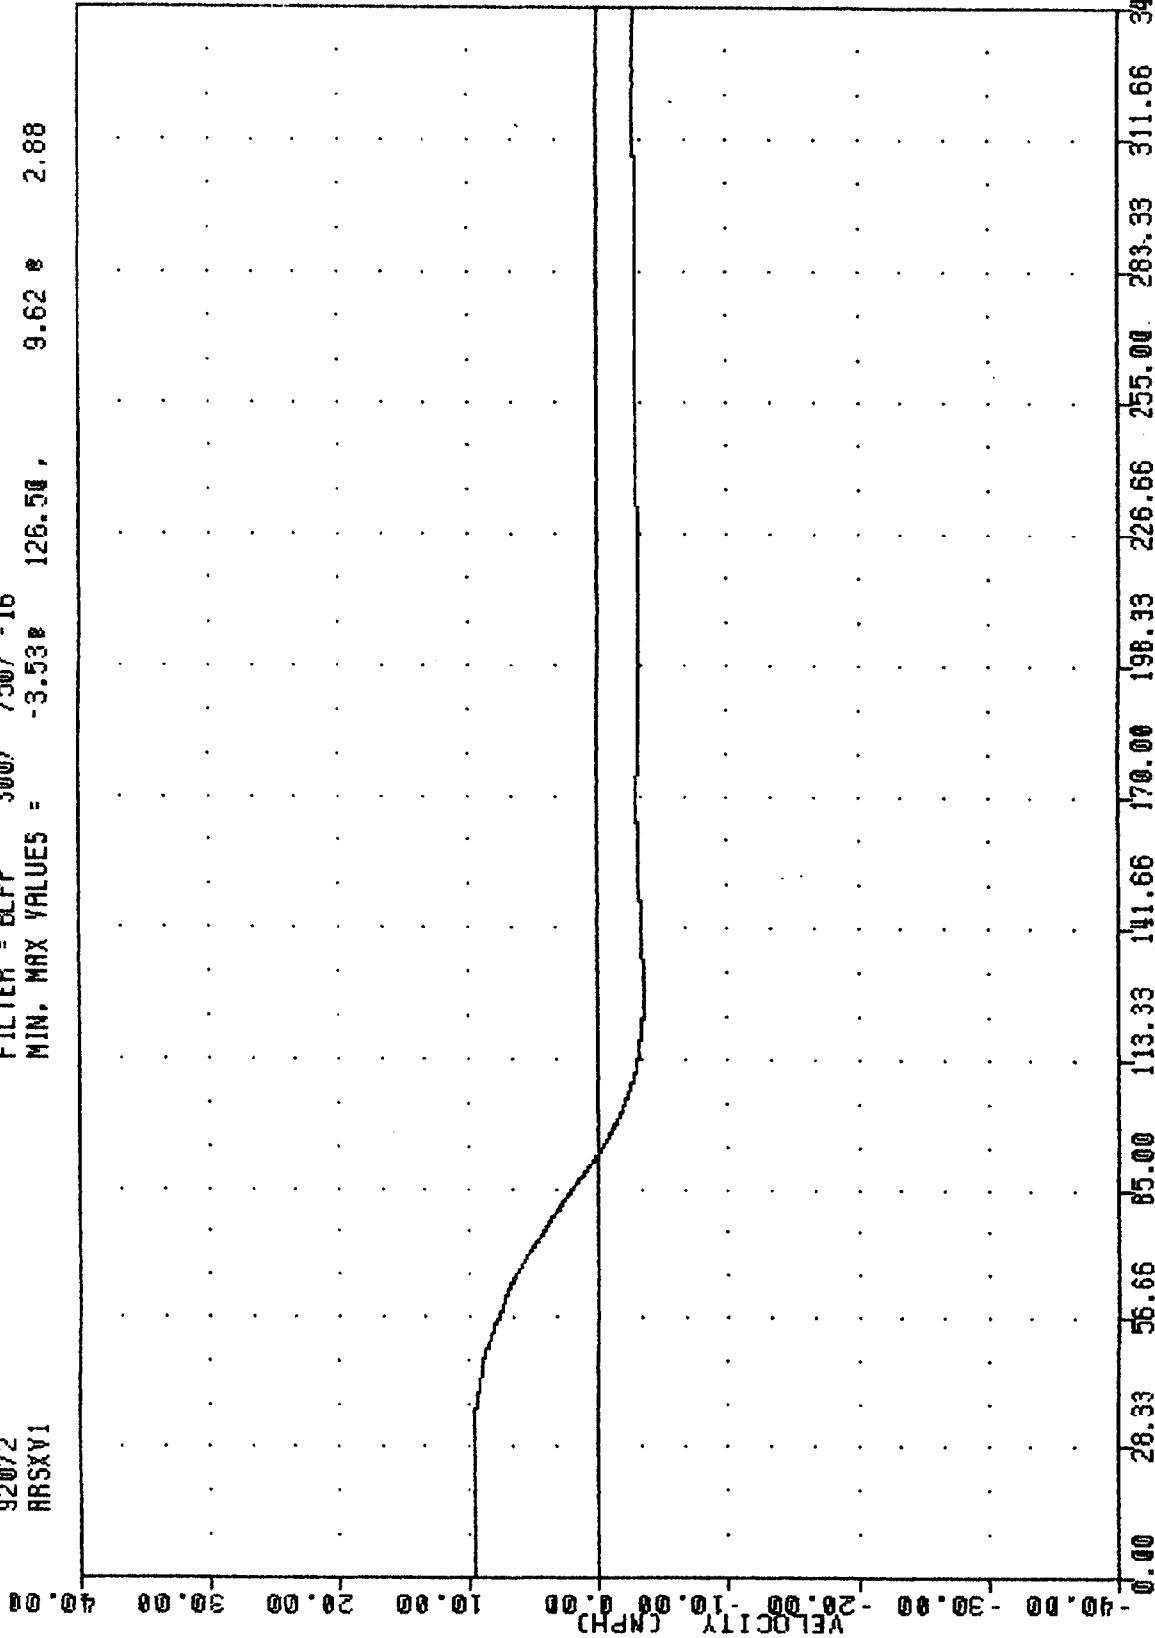
FILTER = BLPP 300/ 750/ -16
 MIN. MAX VALUES = -3.53 126.50 , 9.62 2.88

1985 FORD TEMPO INTO POLE BARRIER AT 9.6 MPH TEST NO. 2
 RIGHT REAR SILL X-AXIS VELOCITY

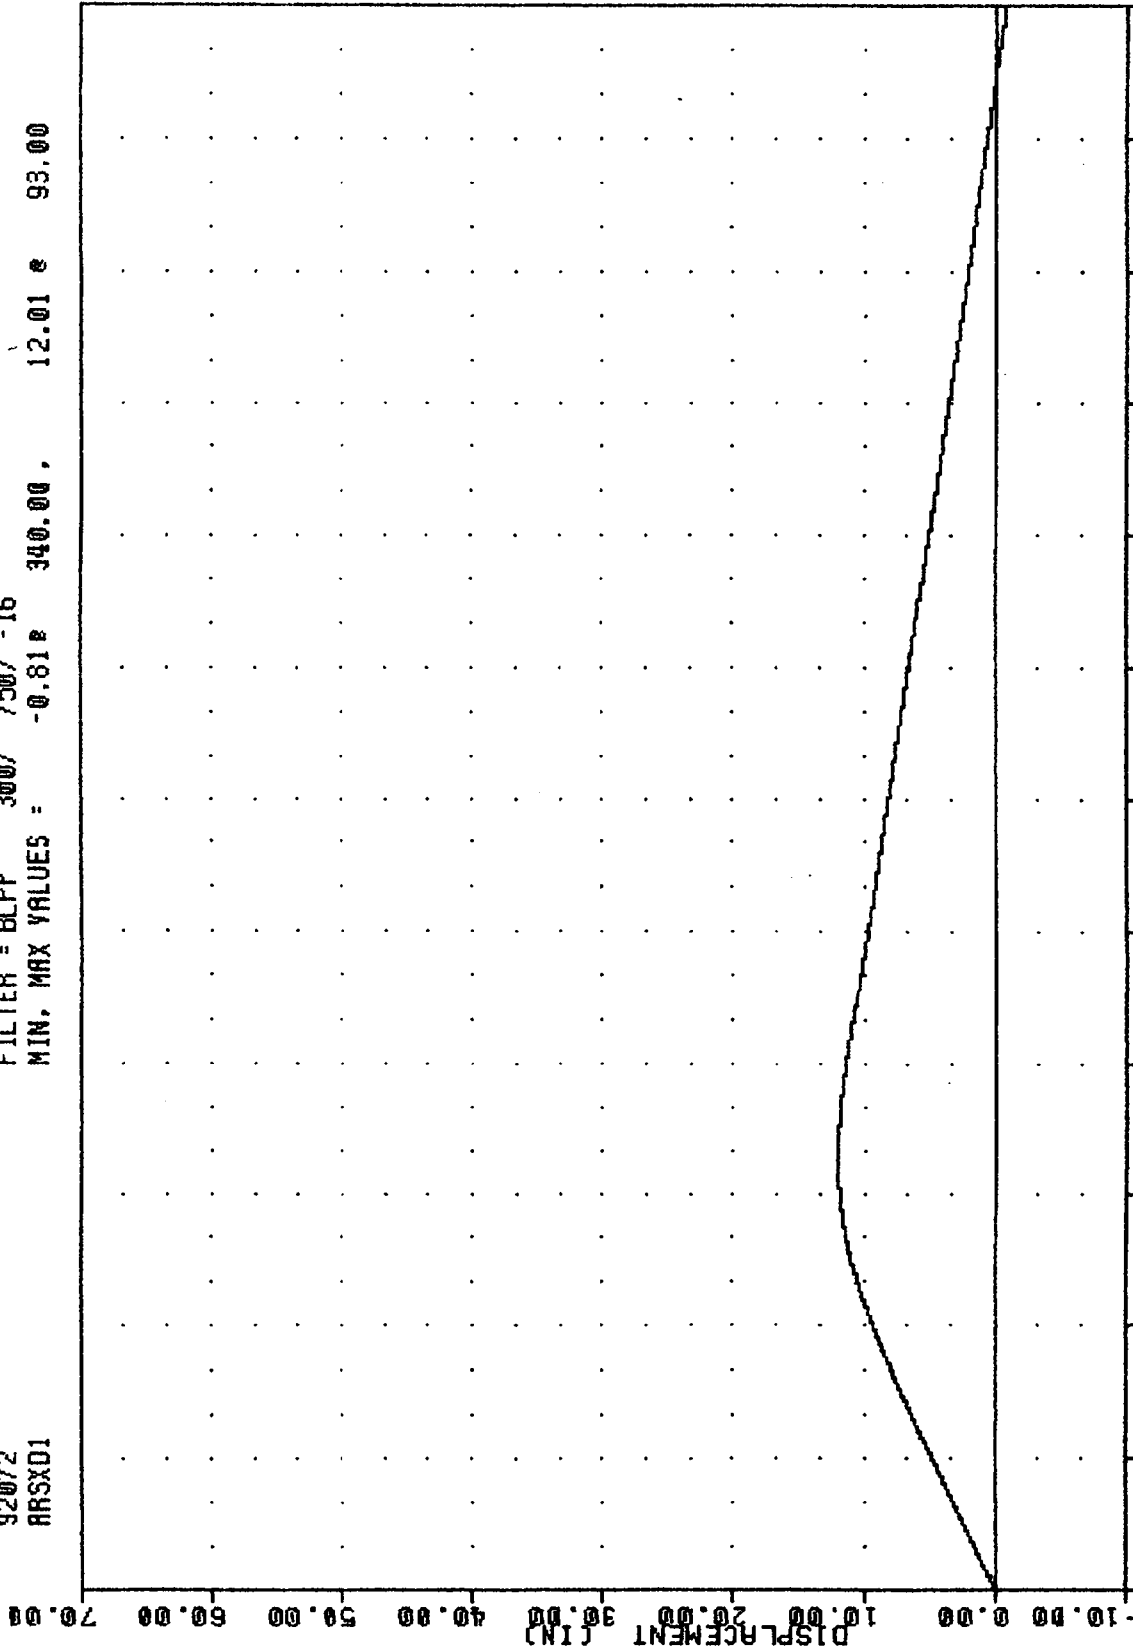
FILTER = BLPP 300/ 750/ -16
 MIN. MAX VALUES = -0.81B 340.00 . 12.01 e 93.00

1985 FORD TEMPO INTO POLE BARRIER AT 9.6 MPH TEST NO. 2
 RIGHT REAR SILL X-AXIS DISPLACEMENT

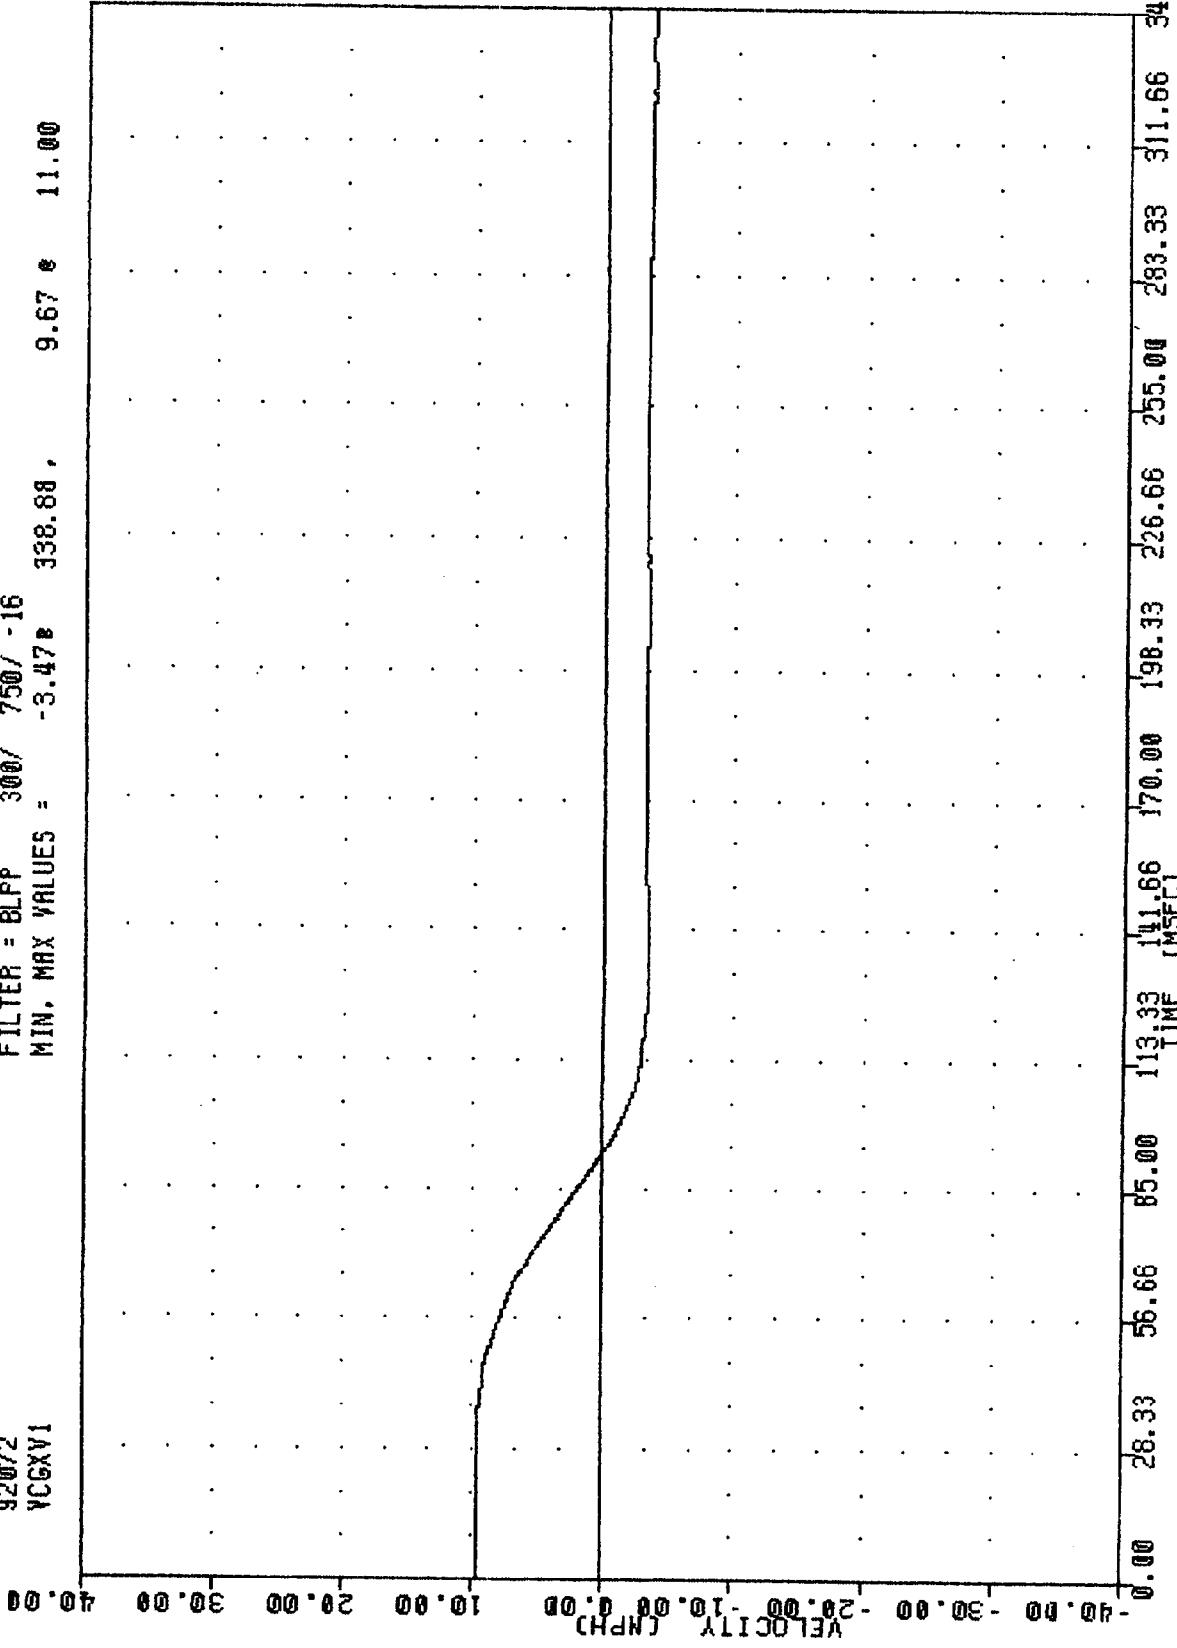
FILTER = BLPP 300/ 750/ -16
 MIN. MAX VALUES = -3.47 9.67 * 11.00

1985 FORD TEMPO INTO POLE BARRIER AT 9.6 MPH TEST NO. 2
 VEHICLE CG X-AXIS VELOCITY

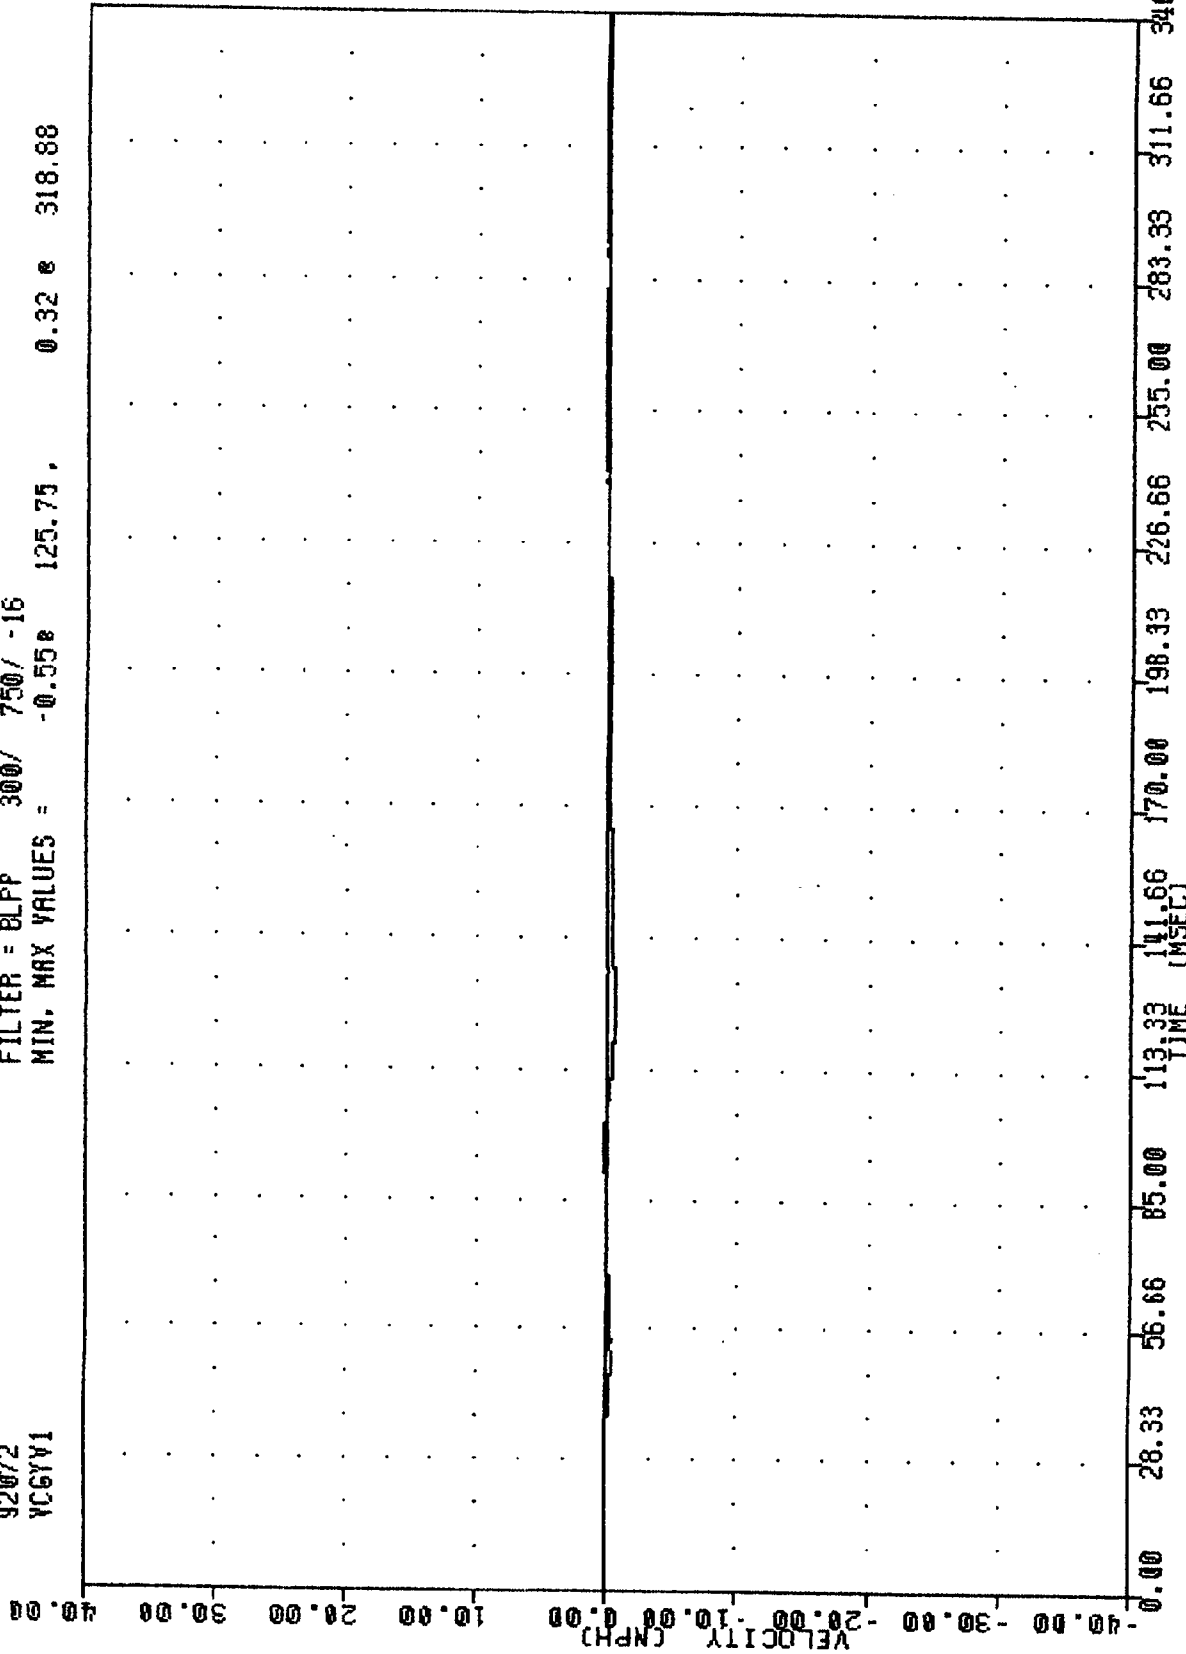
FILTER = BLPP 300/ 750/ -16
 MIN. MAX VALUES = -0.55e 125.75, 0.32 e 318.88

1985 FORD TEMPO INTO POLE BARRIER AT 9.6 MPH TEST NO. 2
 VEHICLE CG Y-AXIS VELOCITY

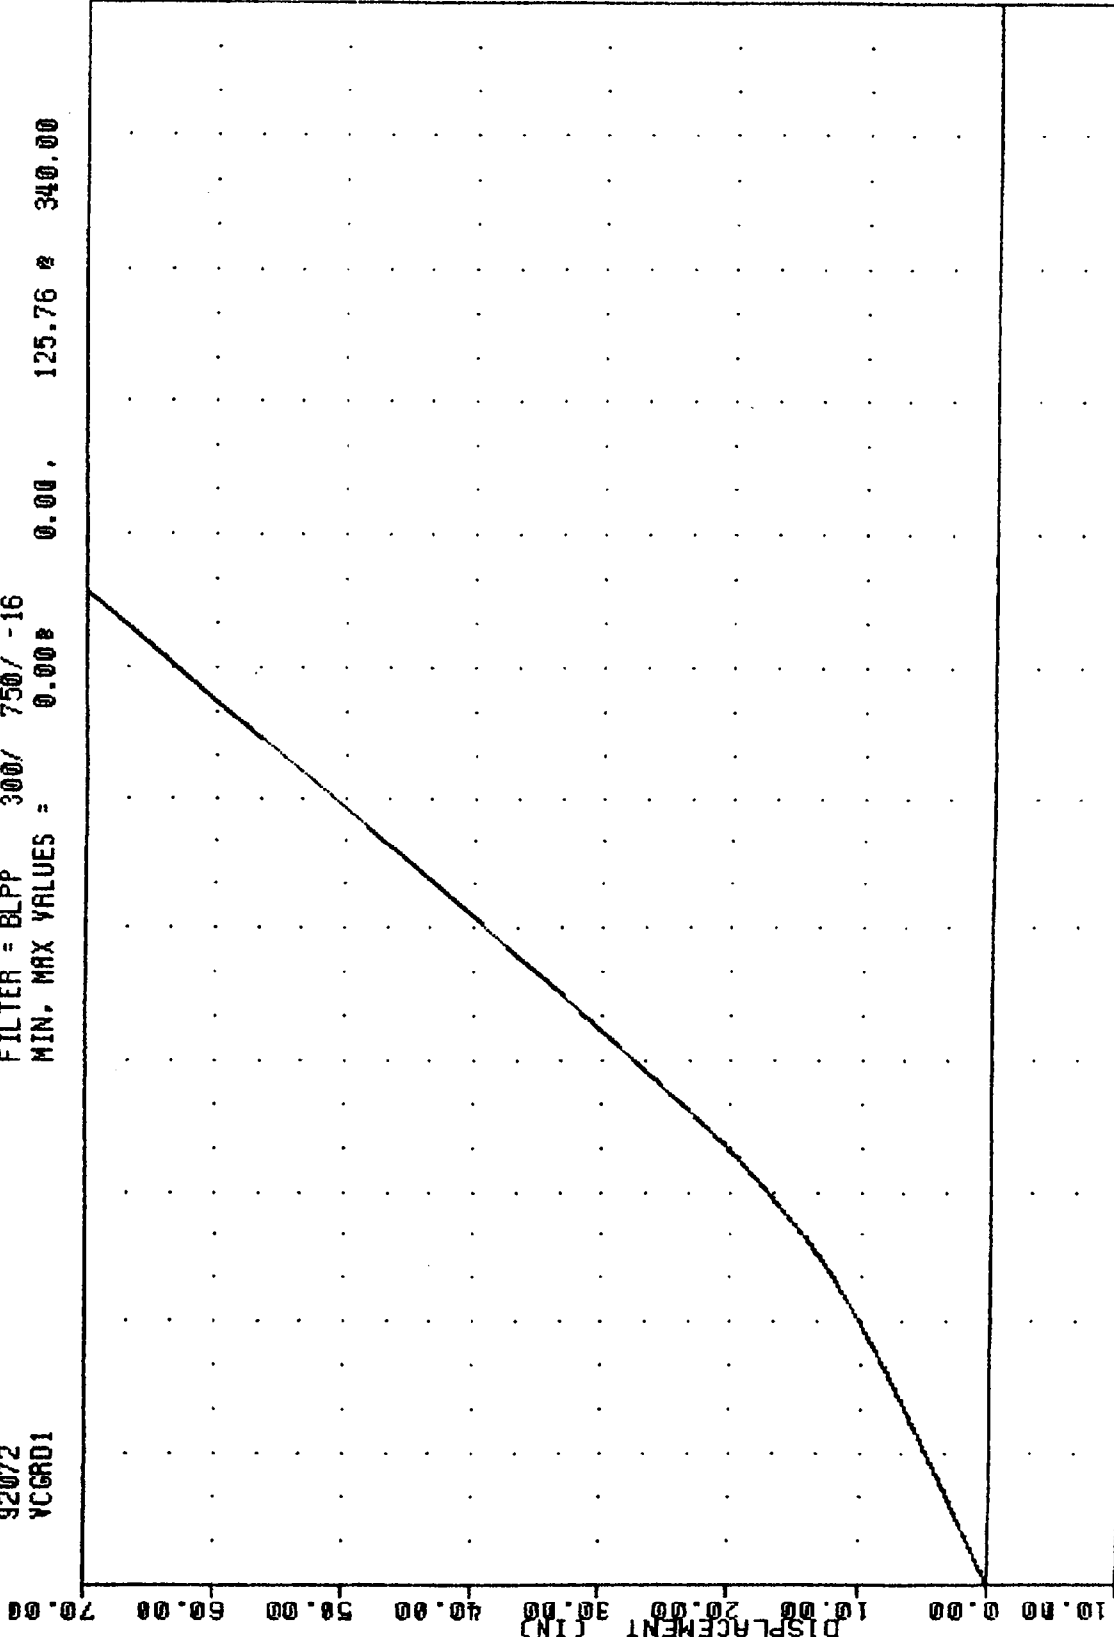
FILTER = BLPP 300/ 750/ -16
 MIN. MAX VALUES = 0.00 0.00 125.76 340.00

0.00 26.33 56.66 85.00 113.33 141.66 170.00 198.33 226.66 255.00 283.33 311.66 340.00
 TIME (MSEC)
 1985 FORD TEMPO INTO POLE BARRIER AT 9.6 MPH TEST NO. 2
 VEHICLE CG RESULTANT DISPLACEMENT

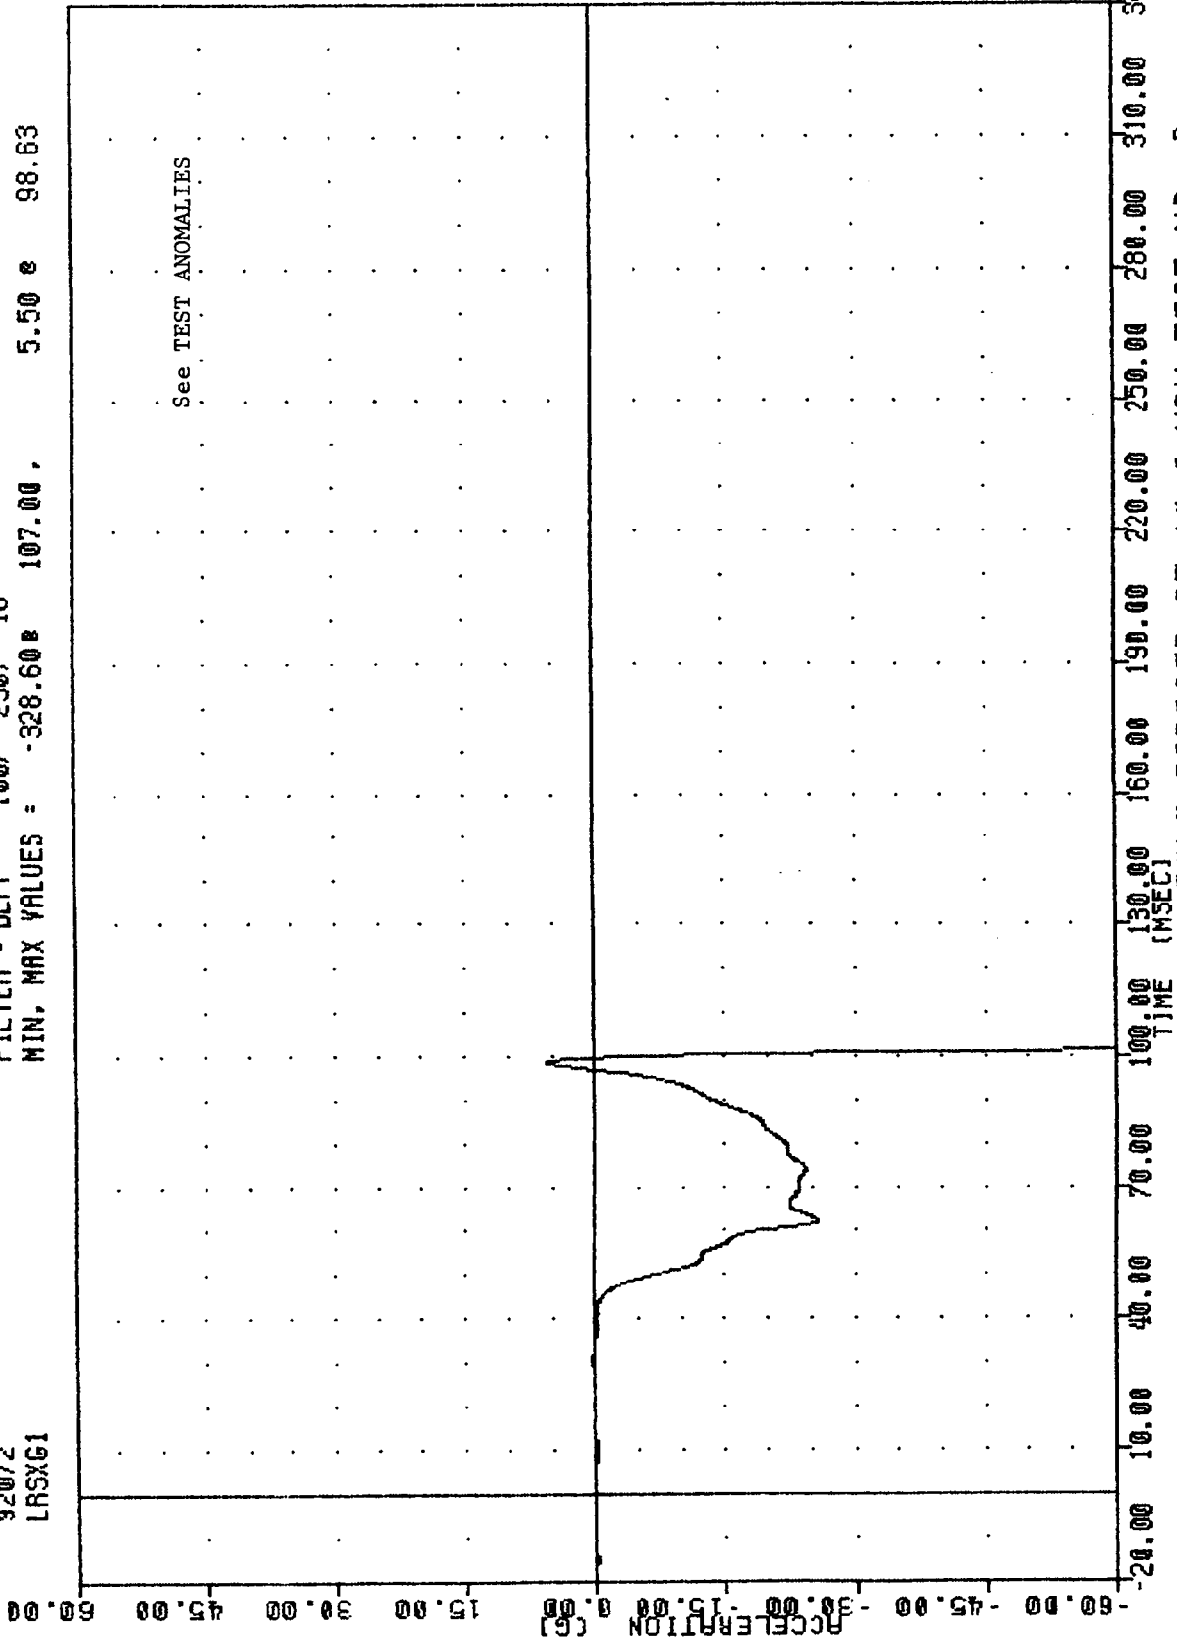
FILTER = BLPP 100/ 250/ -16
MIN, MAX VALUES = -328.60 107.00 , 5.50 e 98.63

1985 FORD TEMPO INTO POLE BARRIER AT 14.8 MPH TEST NO. 3
LEFT REAR SILL X-AXIS ACCELERATION

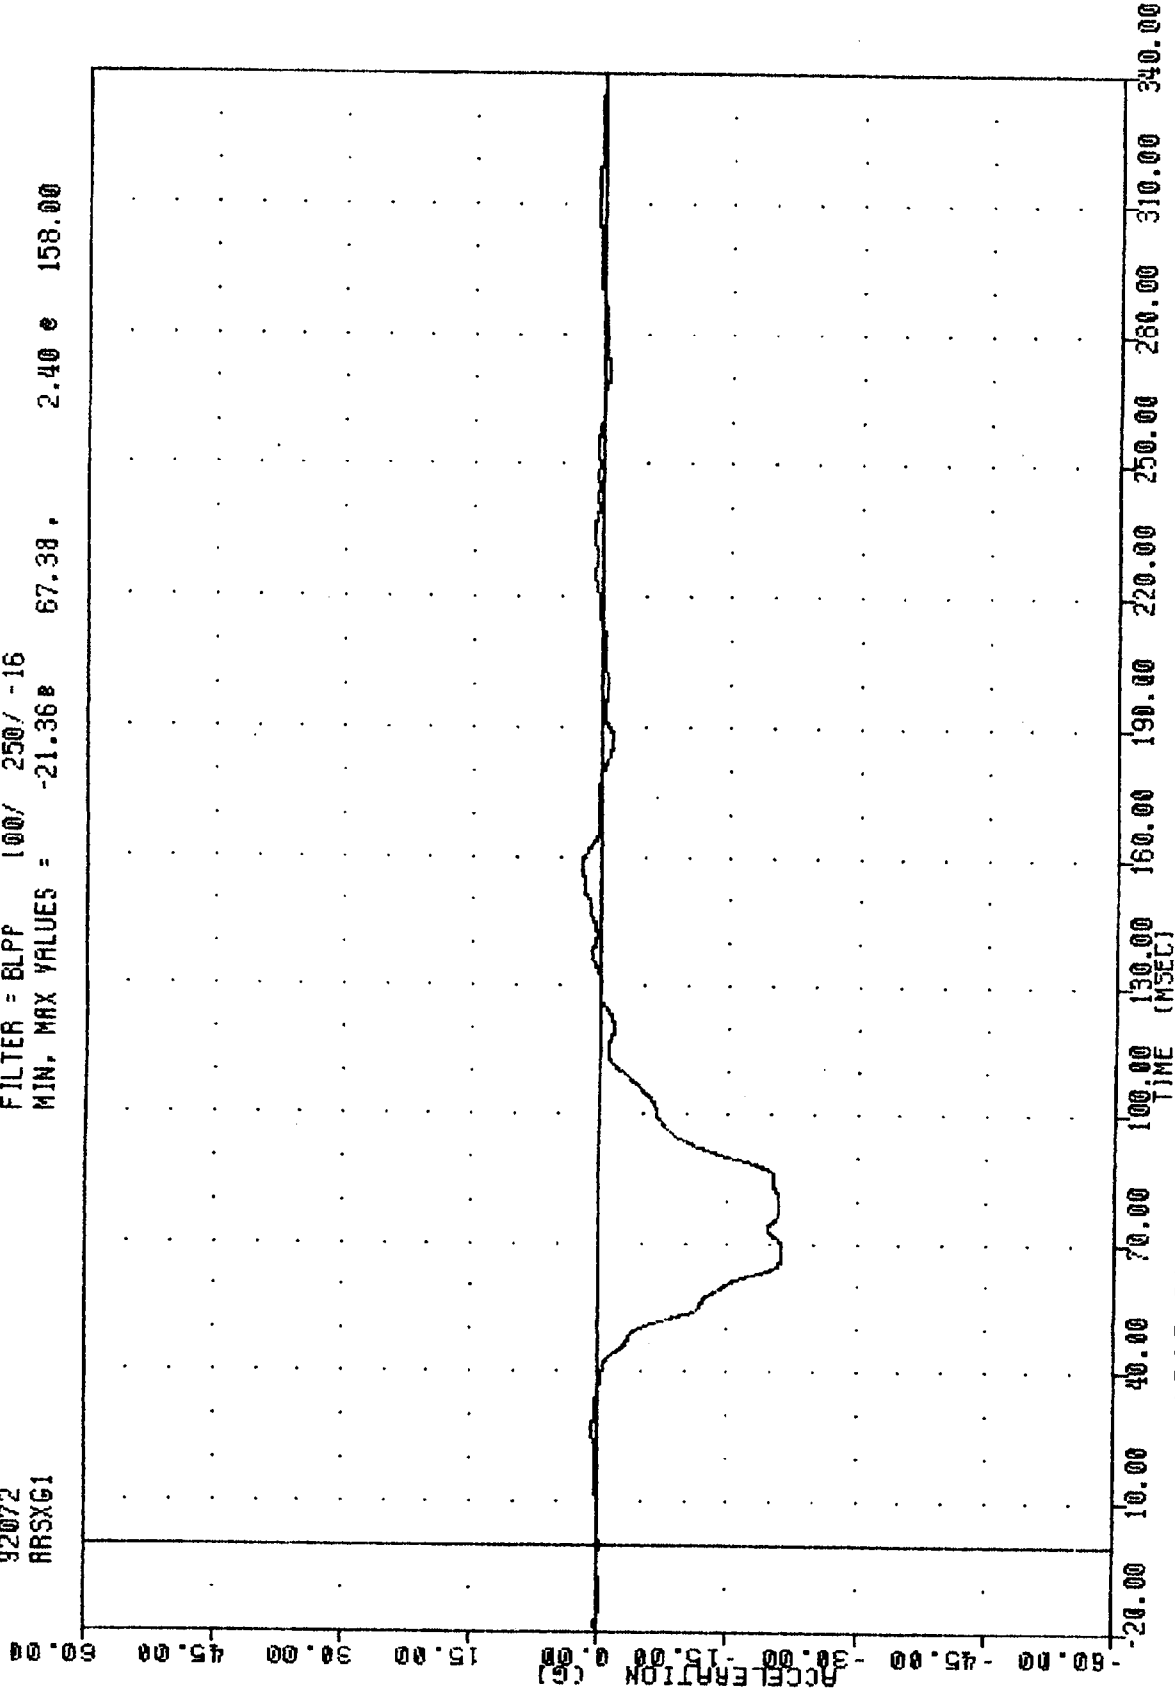
FILTER = BLPP 100/ 250/ -16
MIN, MAX VALUES = -21.36 67.38 2.40 e 158.00

1985 FORD TEMPO INTO POLE BARRIER AT 14.8 MPH TEST NO. 3
RIGHT REAR SILL X-AXIS ACCELERATION

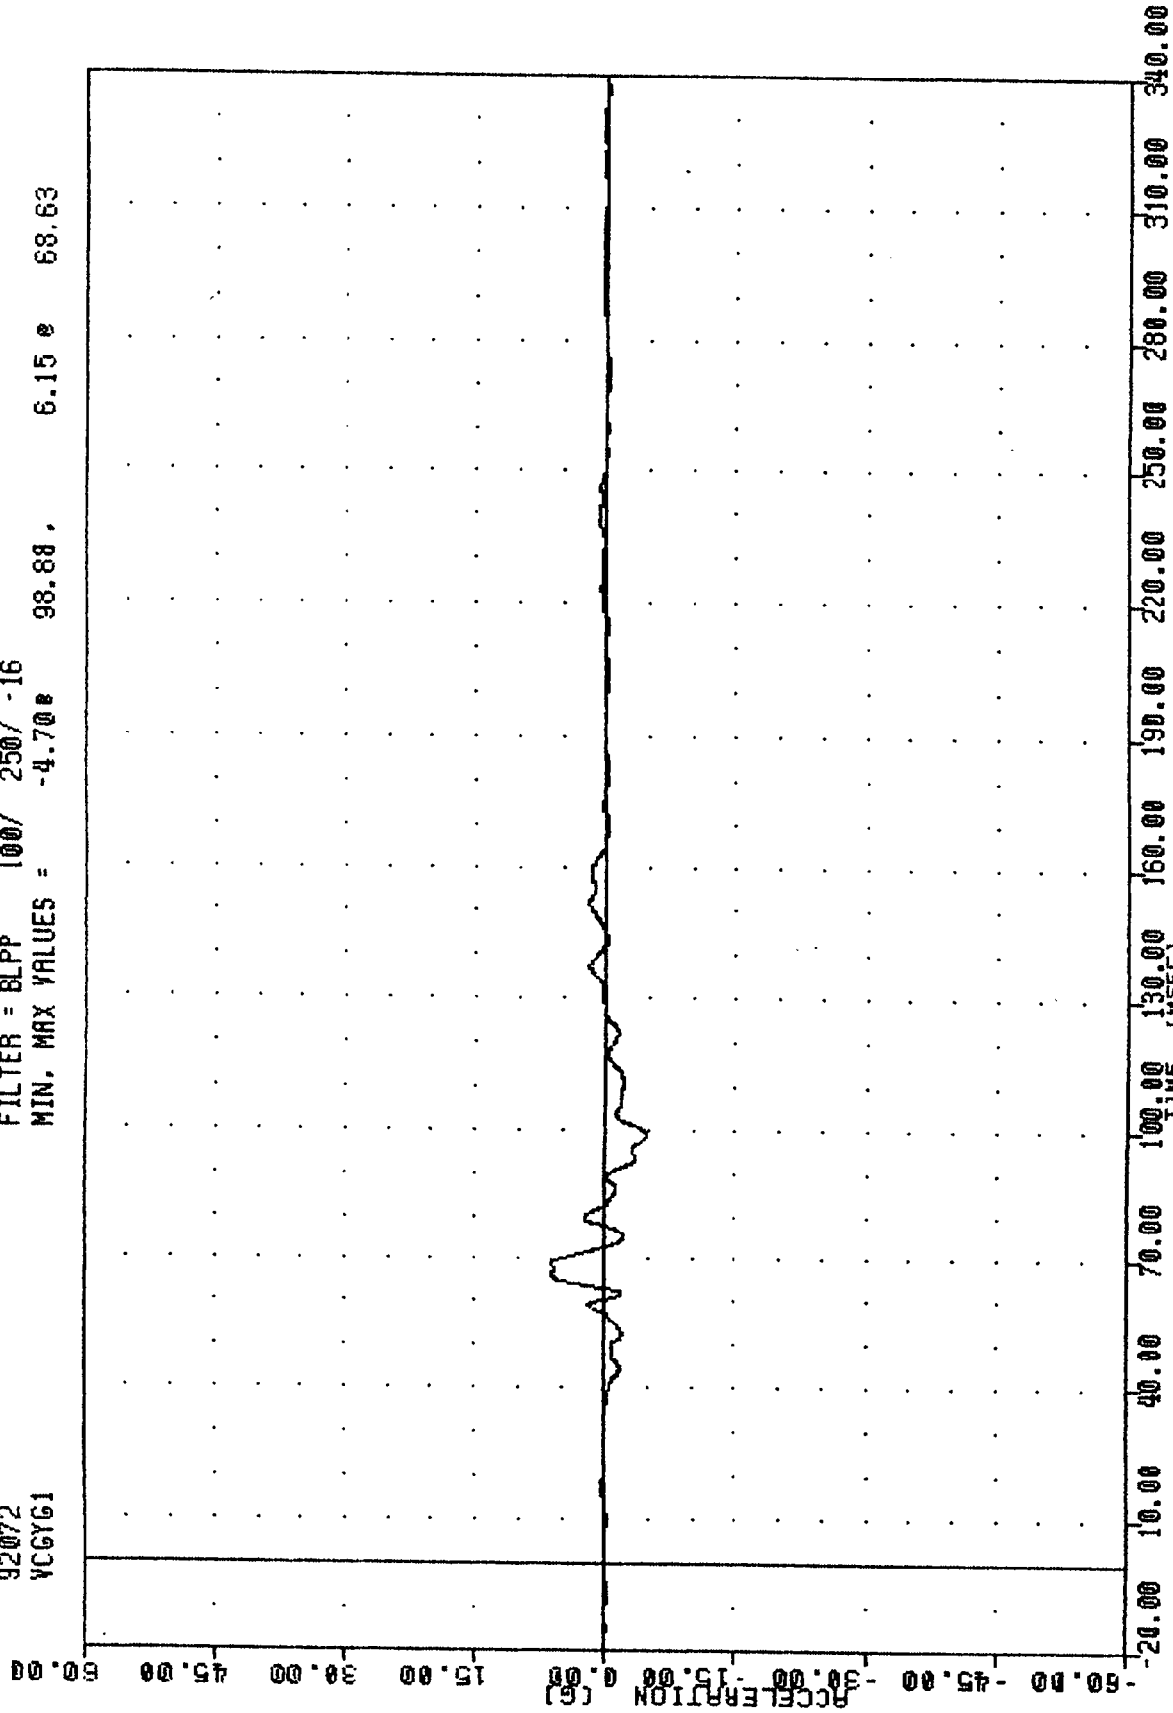
FILTER = BLPP 100/ 250/ -16
MIN. MAX VALUES = -4.70e 98.88 , 6.15 e 68.63

1985 FORD TEMPO INTO POLE BARRIER AT 14.8 MPH TEST NO. 3
VEHICLE CG Y-AXIS ACCELERATION
