DOT HS 807 915
Final Report

April 1992

Final Report of a 1985 Ford Tempo 4-Door Sedan Into a Pole Barrier in Support of Crash III Damage Algorithm Reformulation

PURPOSE AND TEST SUMMARY

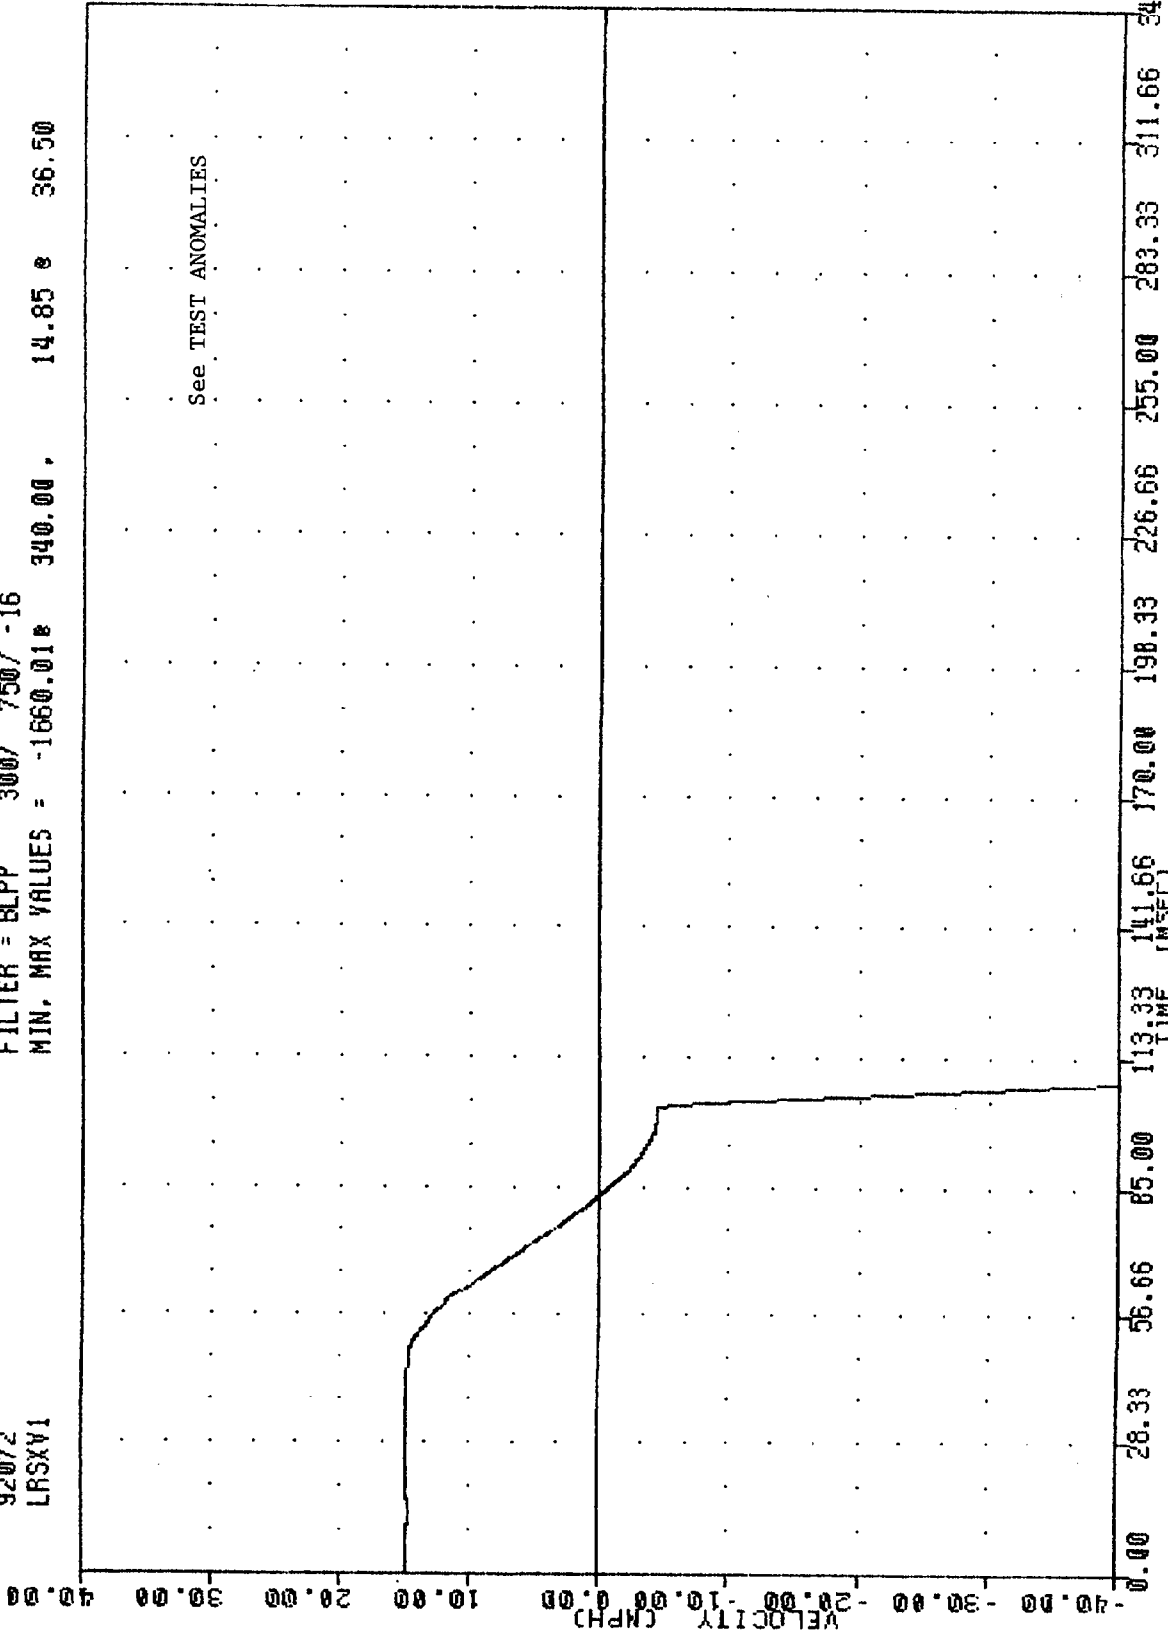
FILTER = BLPP 300/ 750/ -16
 MIN. MAX VALUES = -1660.01 340.00 14.85 36.50

1985 FORD TEMPO INTO POLE BARRIER AT 14.8 MPH TEST NO. 3
 LEFT REAR SILL X-AXIS VELOCITY

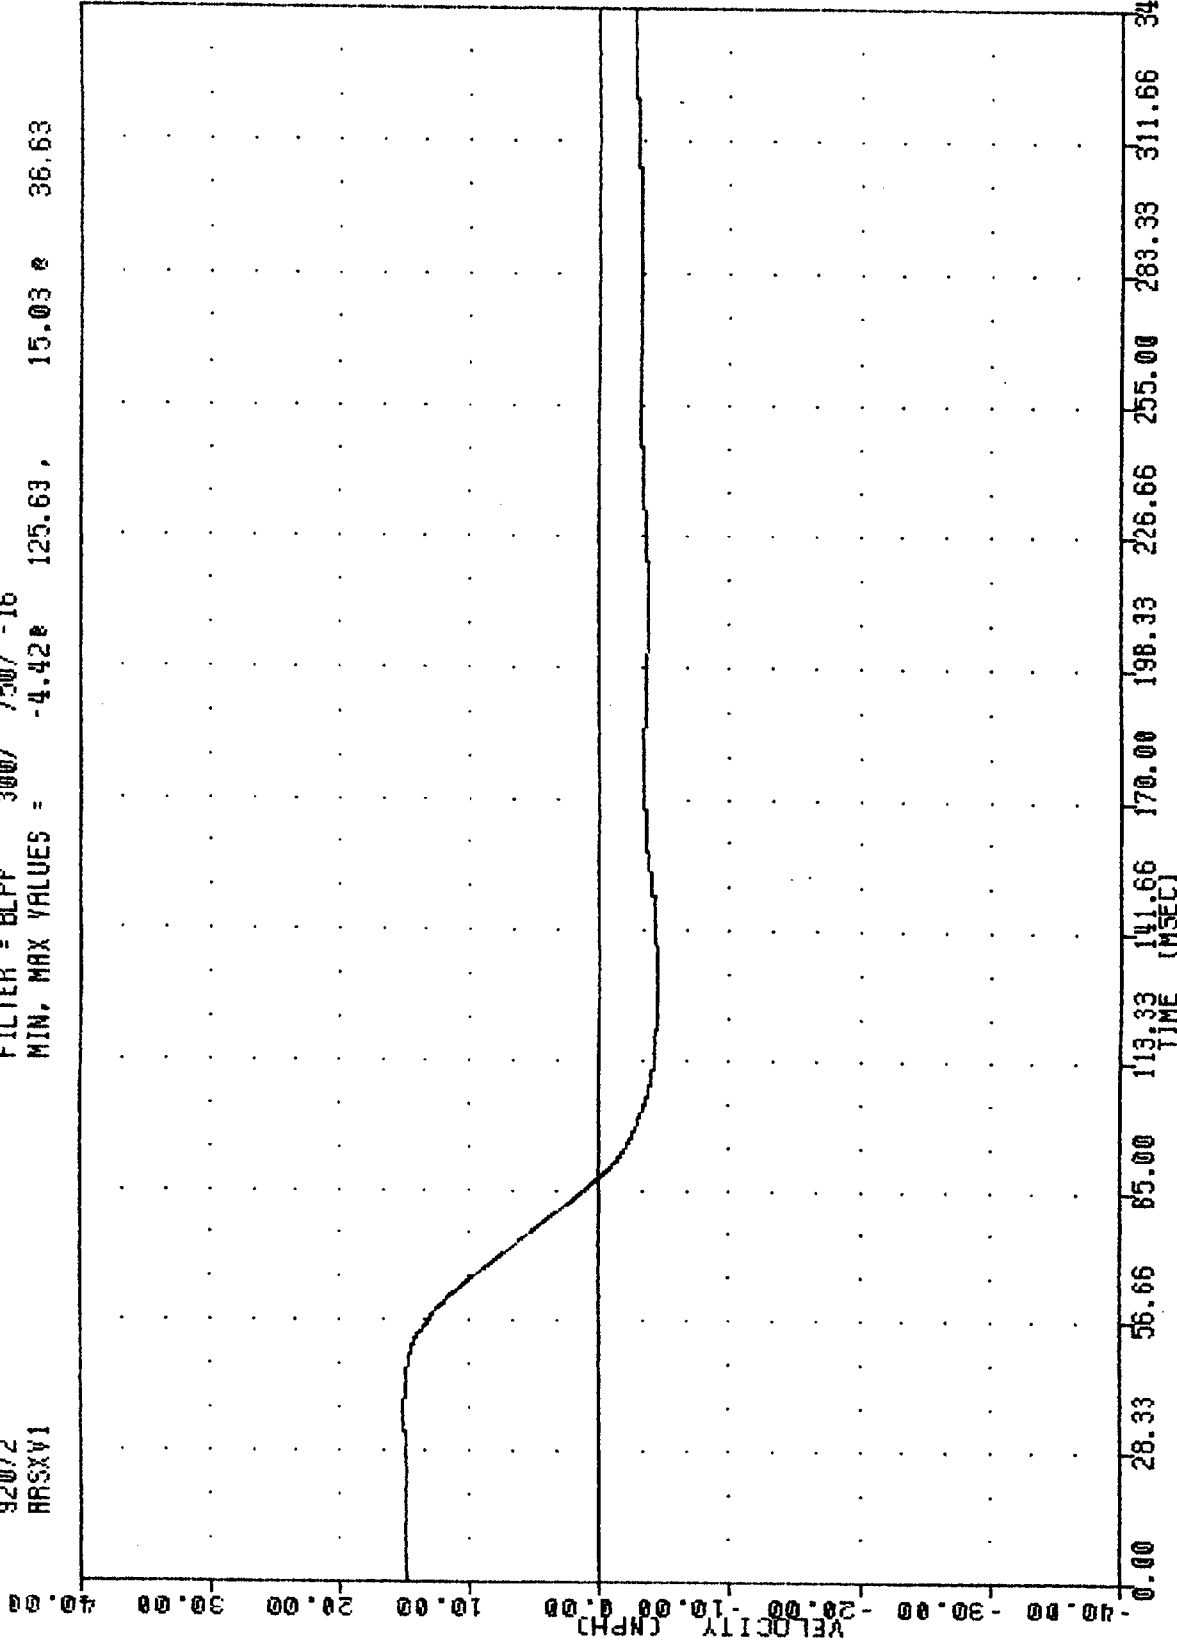
FILTER = BLPP 300/ 750/ -16
 MIN. MAX VALUES = -4.42e 125.63, 15.03 e 36.63

1985 FORD TEMPO INTO POLE BARRIER AT 14.8 MPH TEST NO. 3
 RIGHT REAR SILL X-AXIS VELOCITY

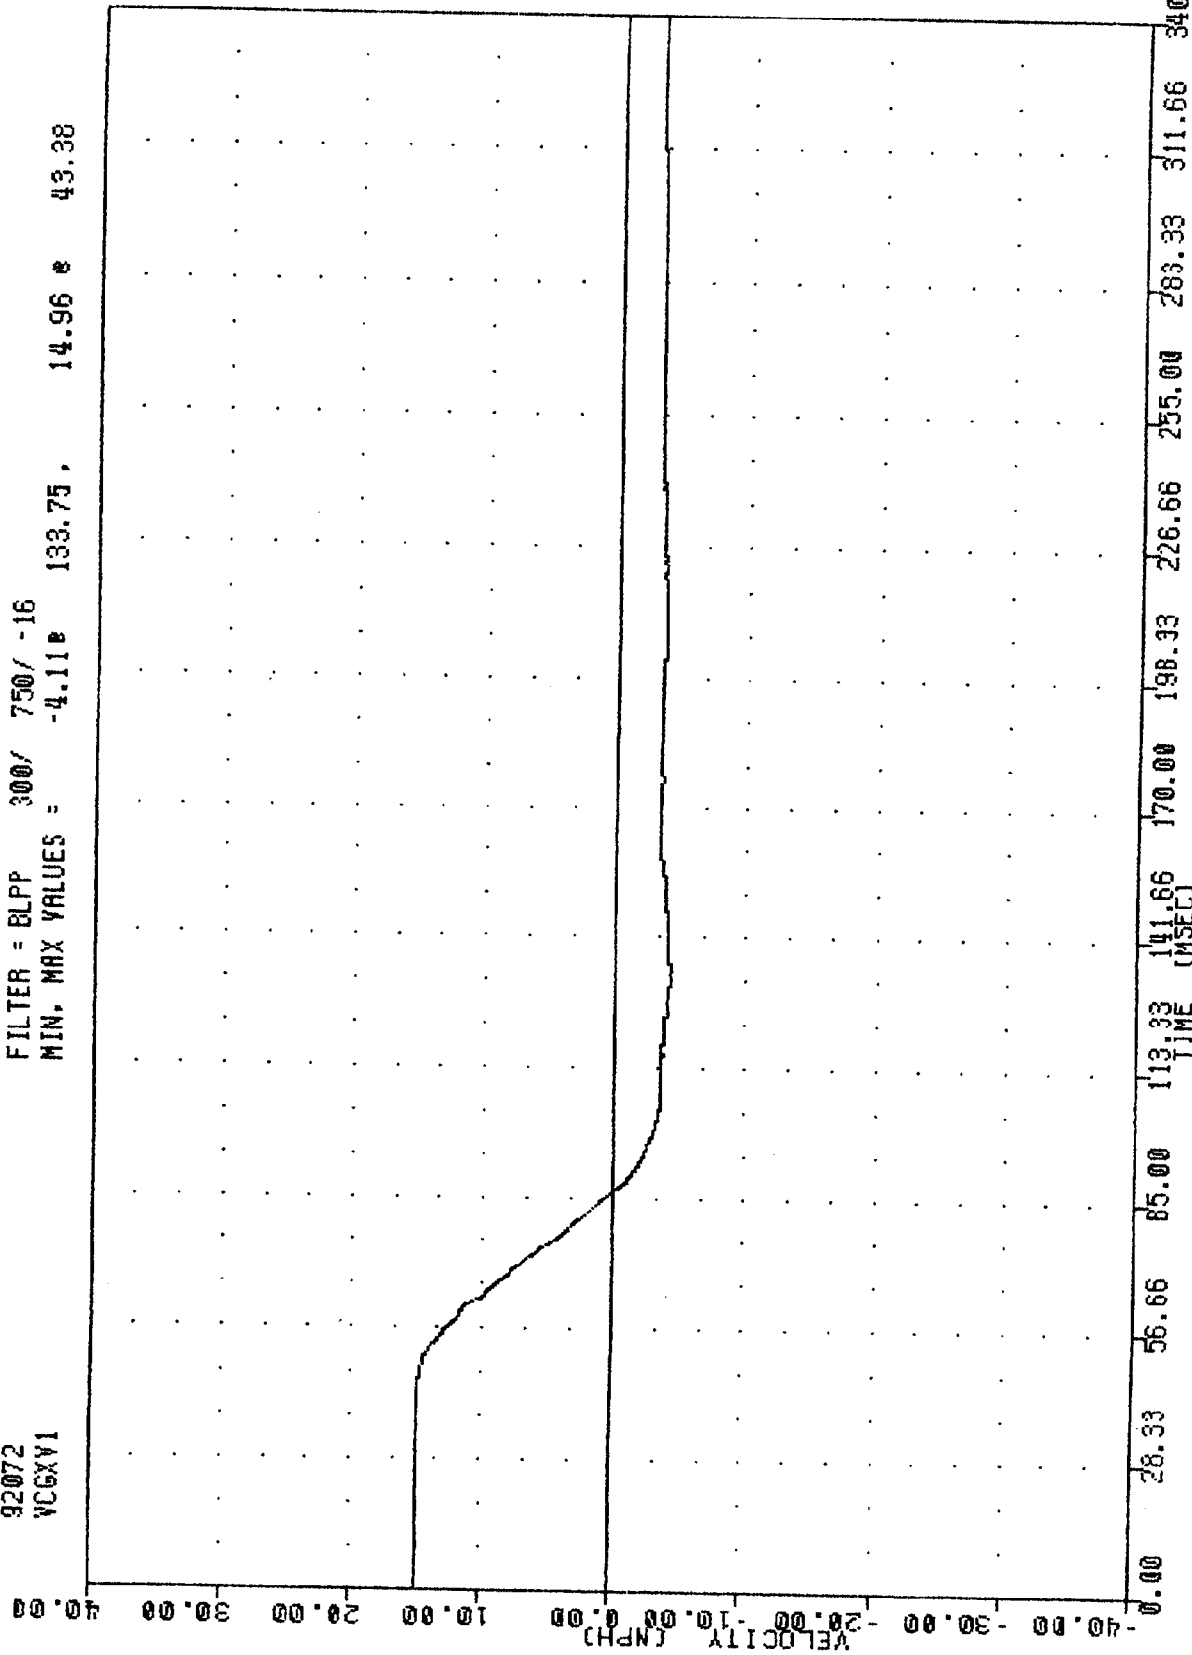
FILTER = BLPP 300/ 750/ -16
 MIN. MAX VALUES = -4.11e 133.75, 14.96 e 43.38

1985 FORD TEMPO INTO POLE BARRIER AT 14.8 MPH TEST NO. 3
 VEHICLE CG X-AXIS VELOCITY

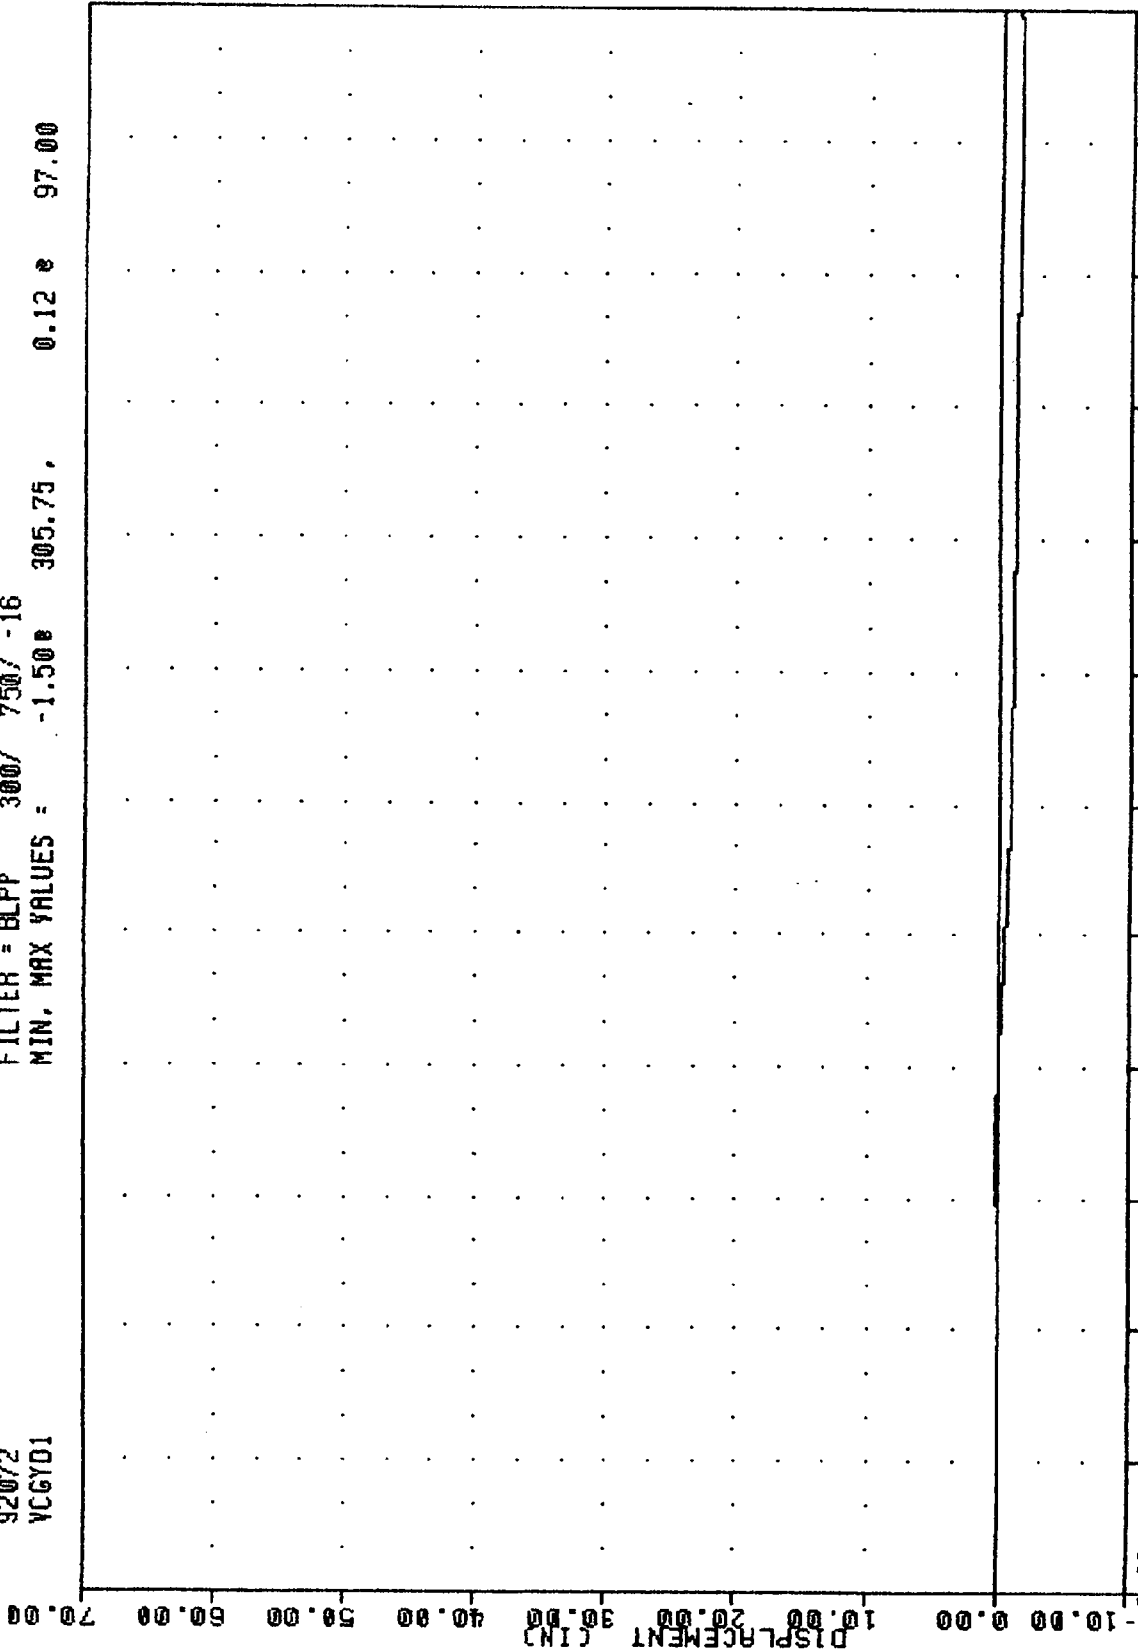
FILTER = BLPP 300/ 750/ -16
 MIN. MAX VALUES = -1.500 305.75, 0.12 e 97.00

1985 FORD TEMPO INTO POLE BARRIER AT 14.8 MPH TEST NO. 3
 VEHICLE CG Y-AXIS DISPLACEMENT

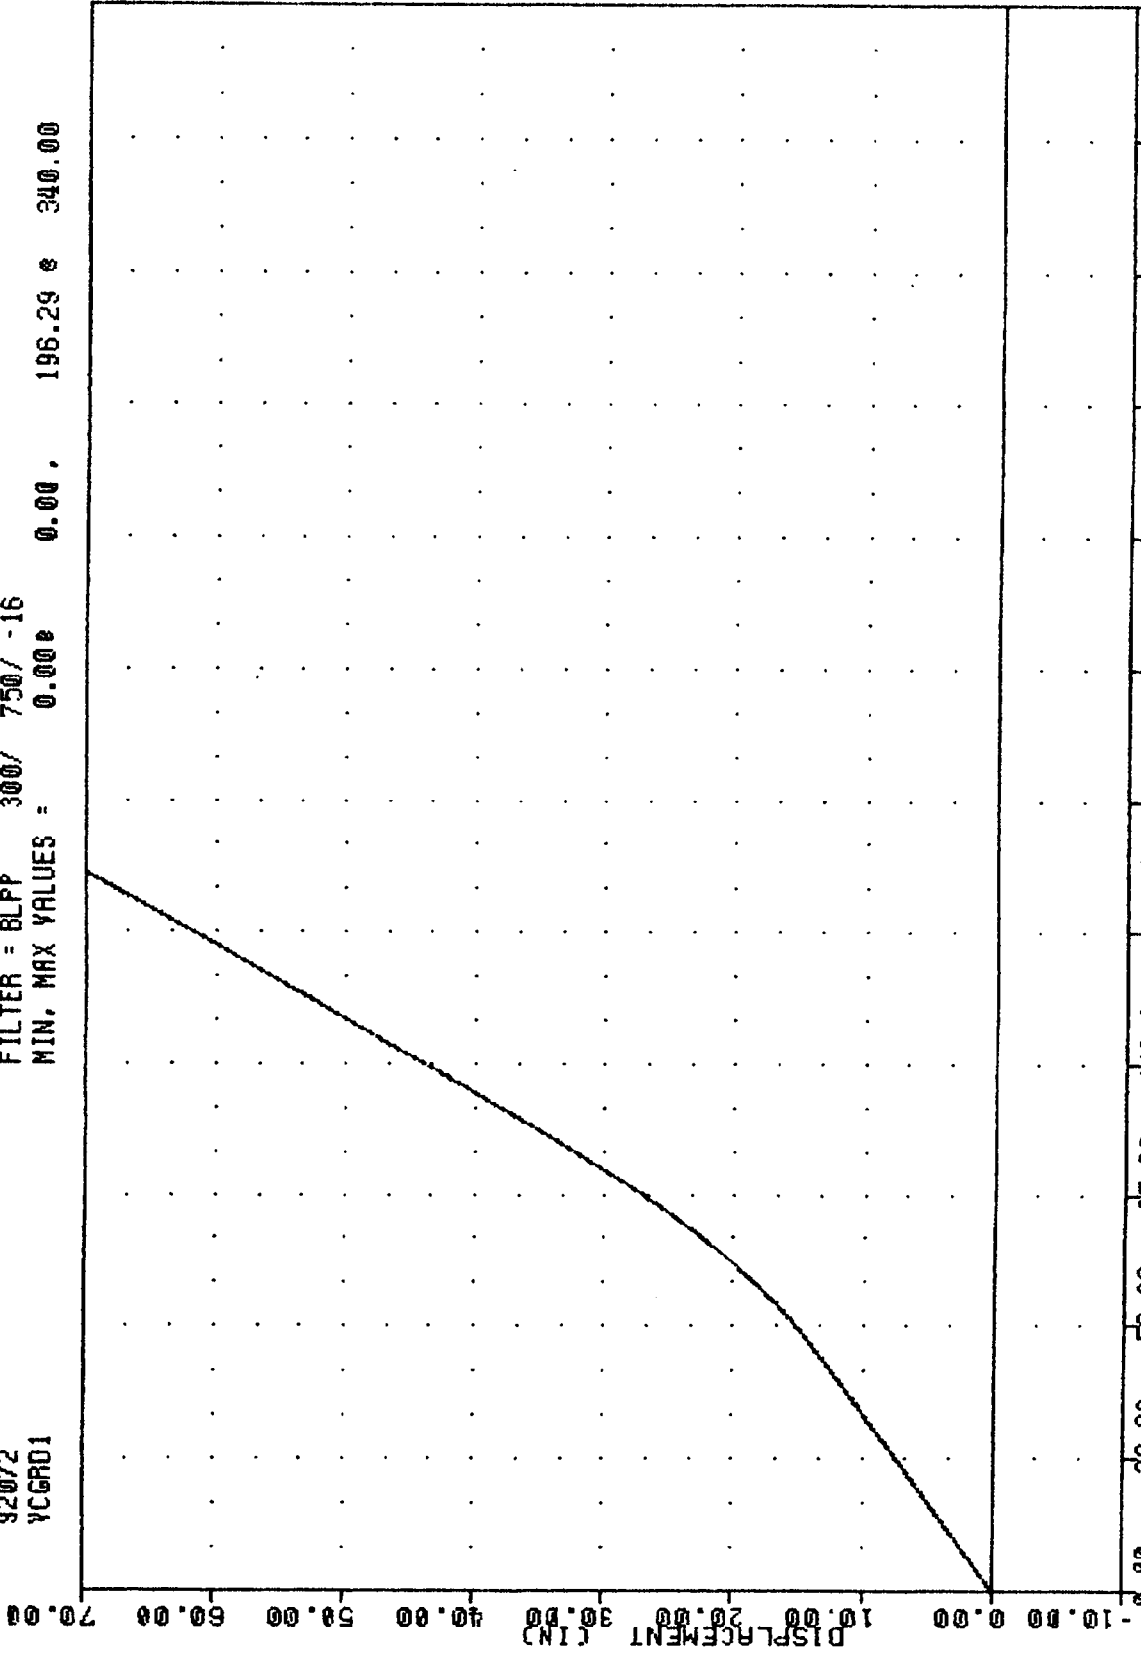
FILTER = BLPP 300/ 750/ -16
 MIN, MAX VALUES = 0.000 0.00, 196.29 e 340.00

1985 FORD TEMPO INTO POLE BARRIER AT 14.8 MPH TEST NO. 3
 VEHICLE CG RESULTANT DISPLACEMENT

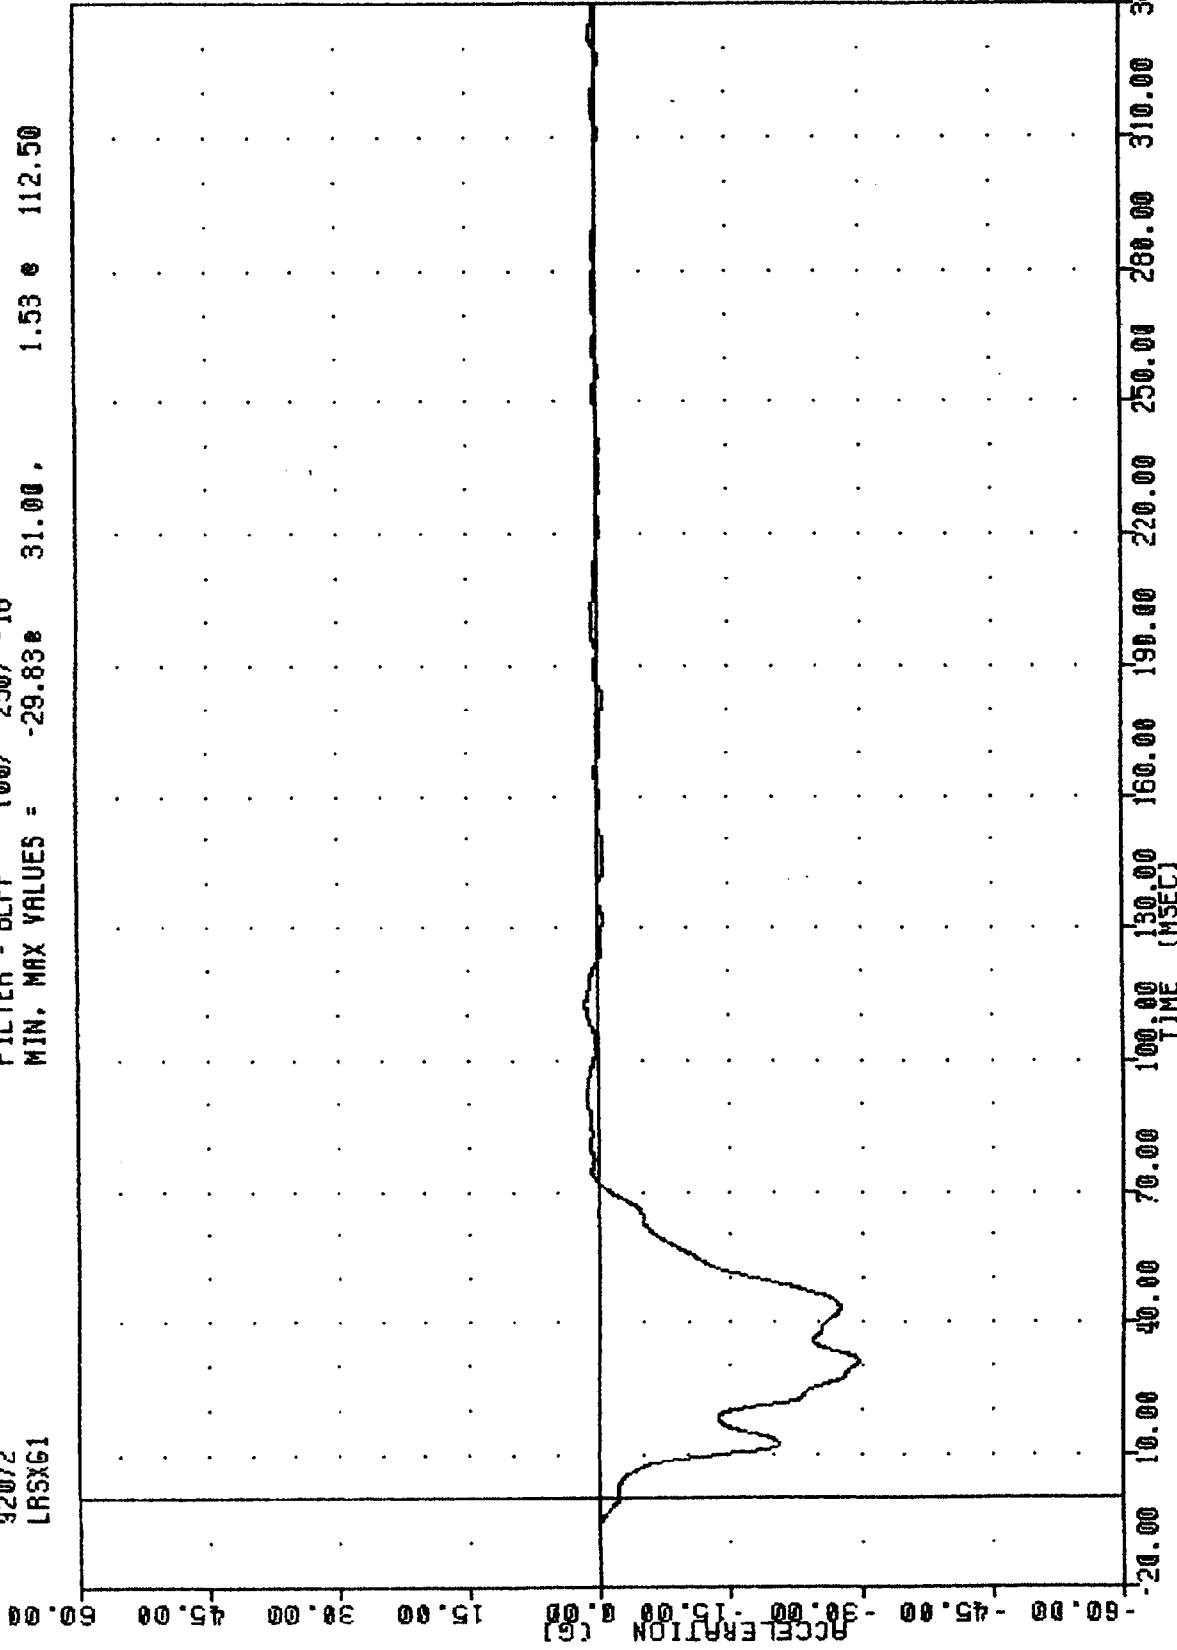
FILTER = BLPP 100/ 250/ -16
MIN. MAX VALUES = 31.00, 1.53 e 112.50

1985 FORD TEMPO INTO POLE BARRIER AT 20.0 MPH TEST NO. 4
LEFT REAR SILL X-AXIS ACCELERATION

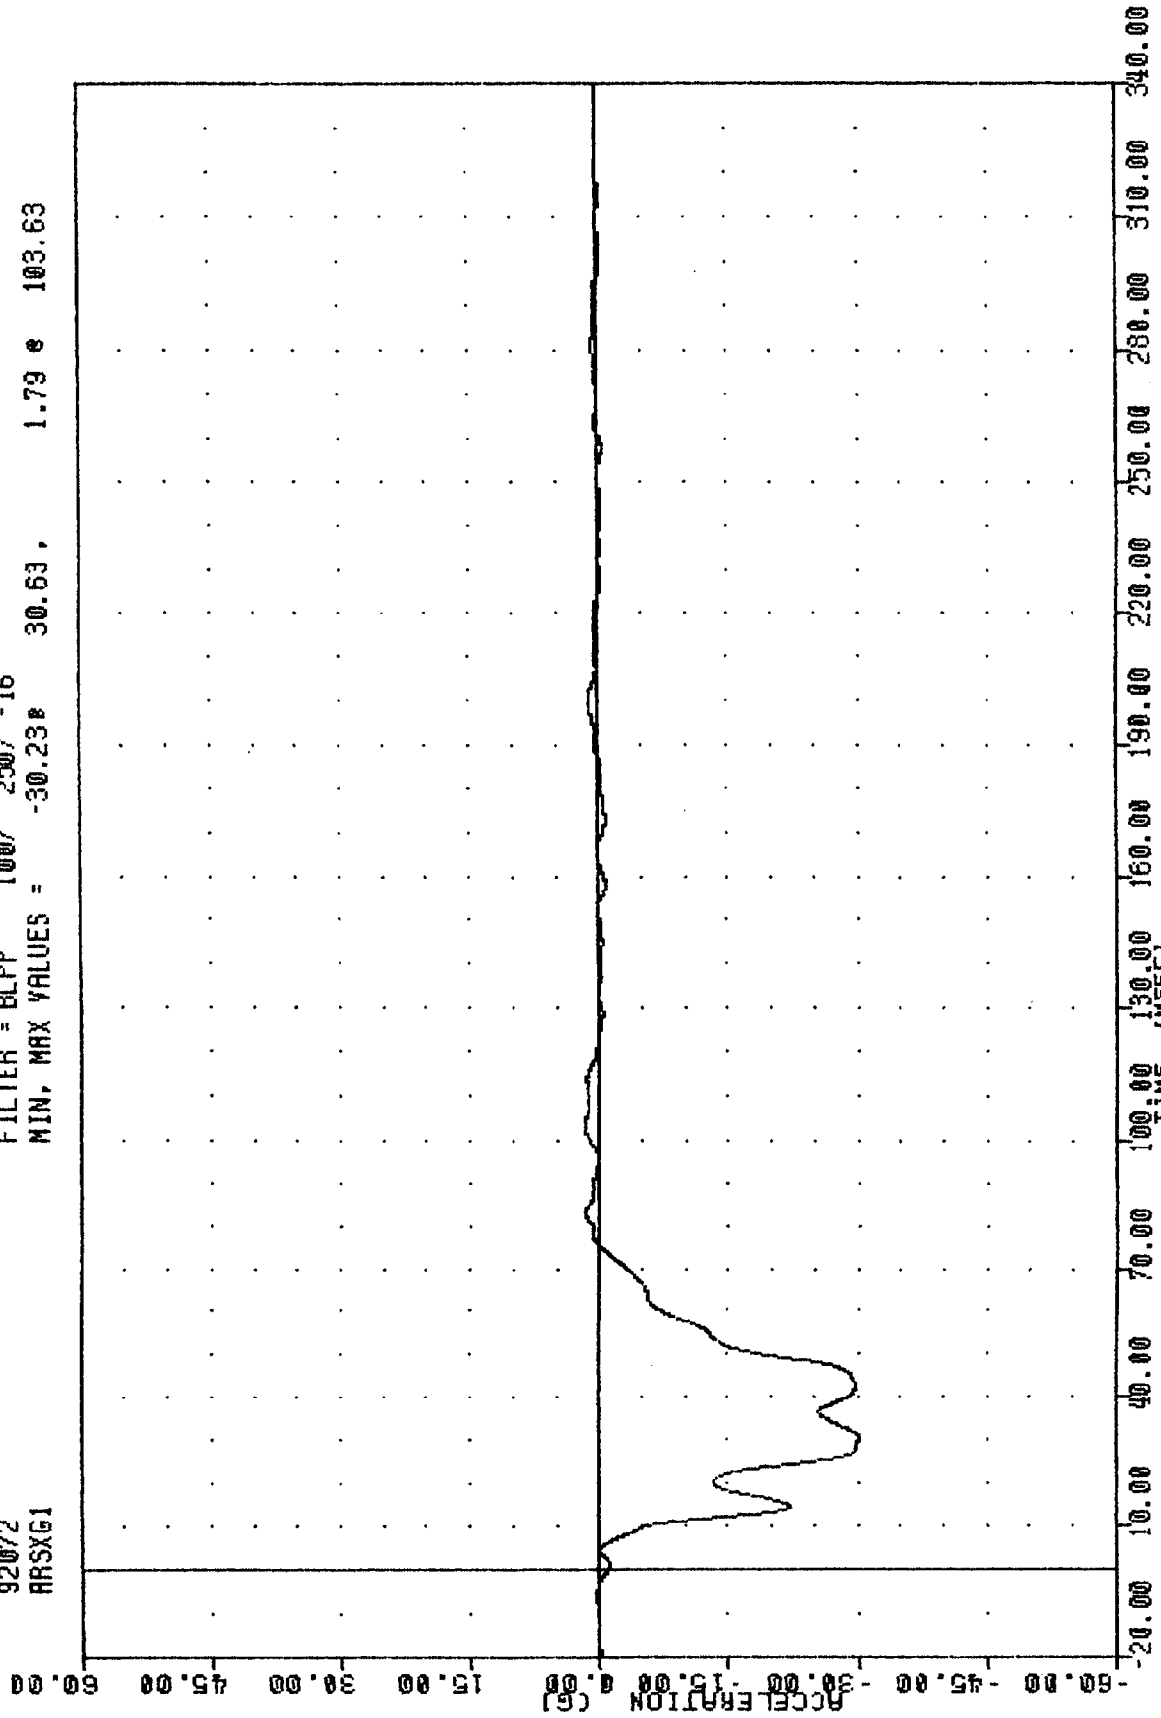
FILTER = BLPP 100/ 250/ -16
MIN, MAX VALUES = -30.23 30.63, 1.79 e 103.63

1985 FORD TEMPO INTO POLE BARRIER AT 20.0 MPH TEST NO. 4
RIGHT REAR SILL X-AXIS ACCELERATION

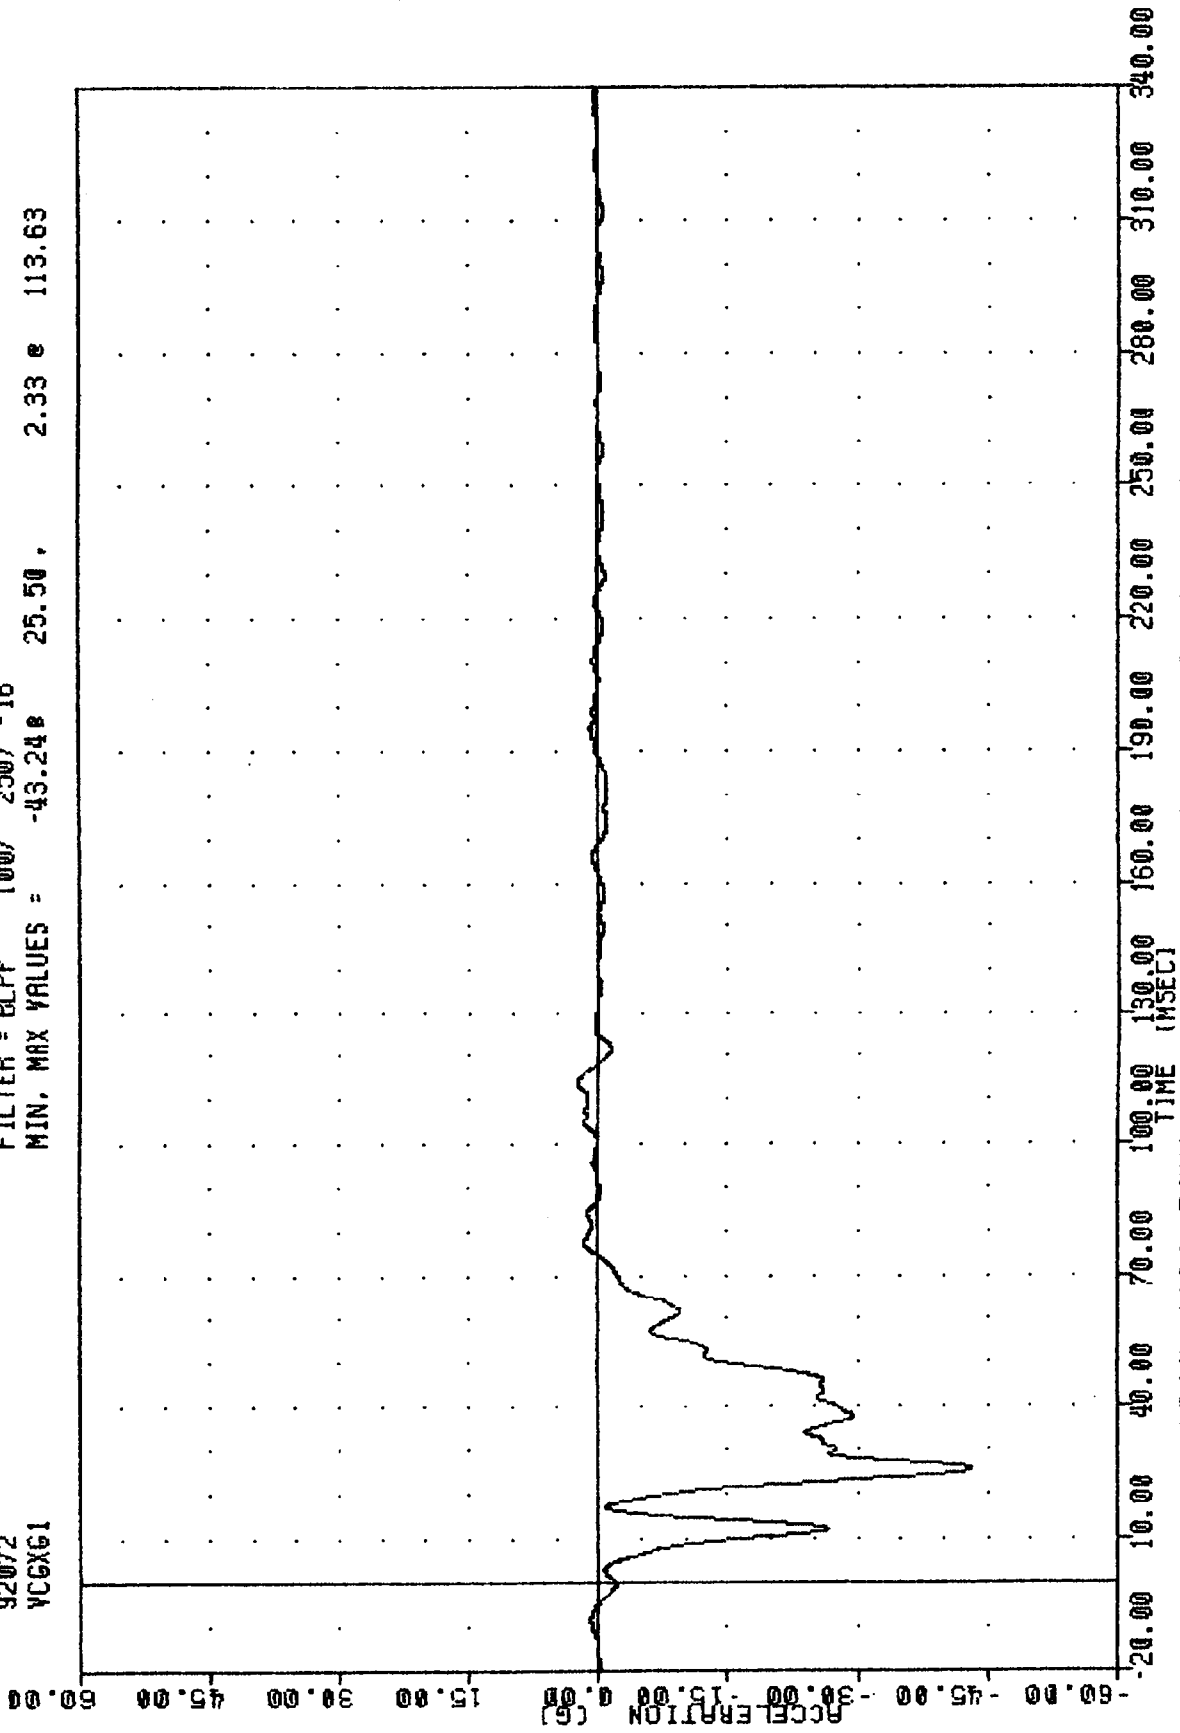
FILTER = BLPF 100/ 250/ -16
MIN, MAX VALUES = -43.248 25.50 , 2.33 e 113.63

1985 FORD TEMPO INTO POLE BARRIER AT 20.0 MPH TEST NO. 4
VEHICLE CG X-AXIS ACCELERATION

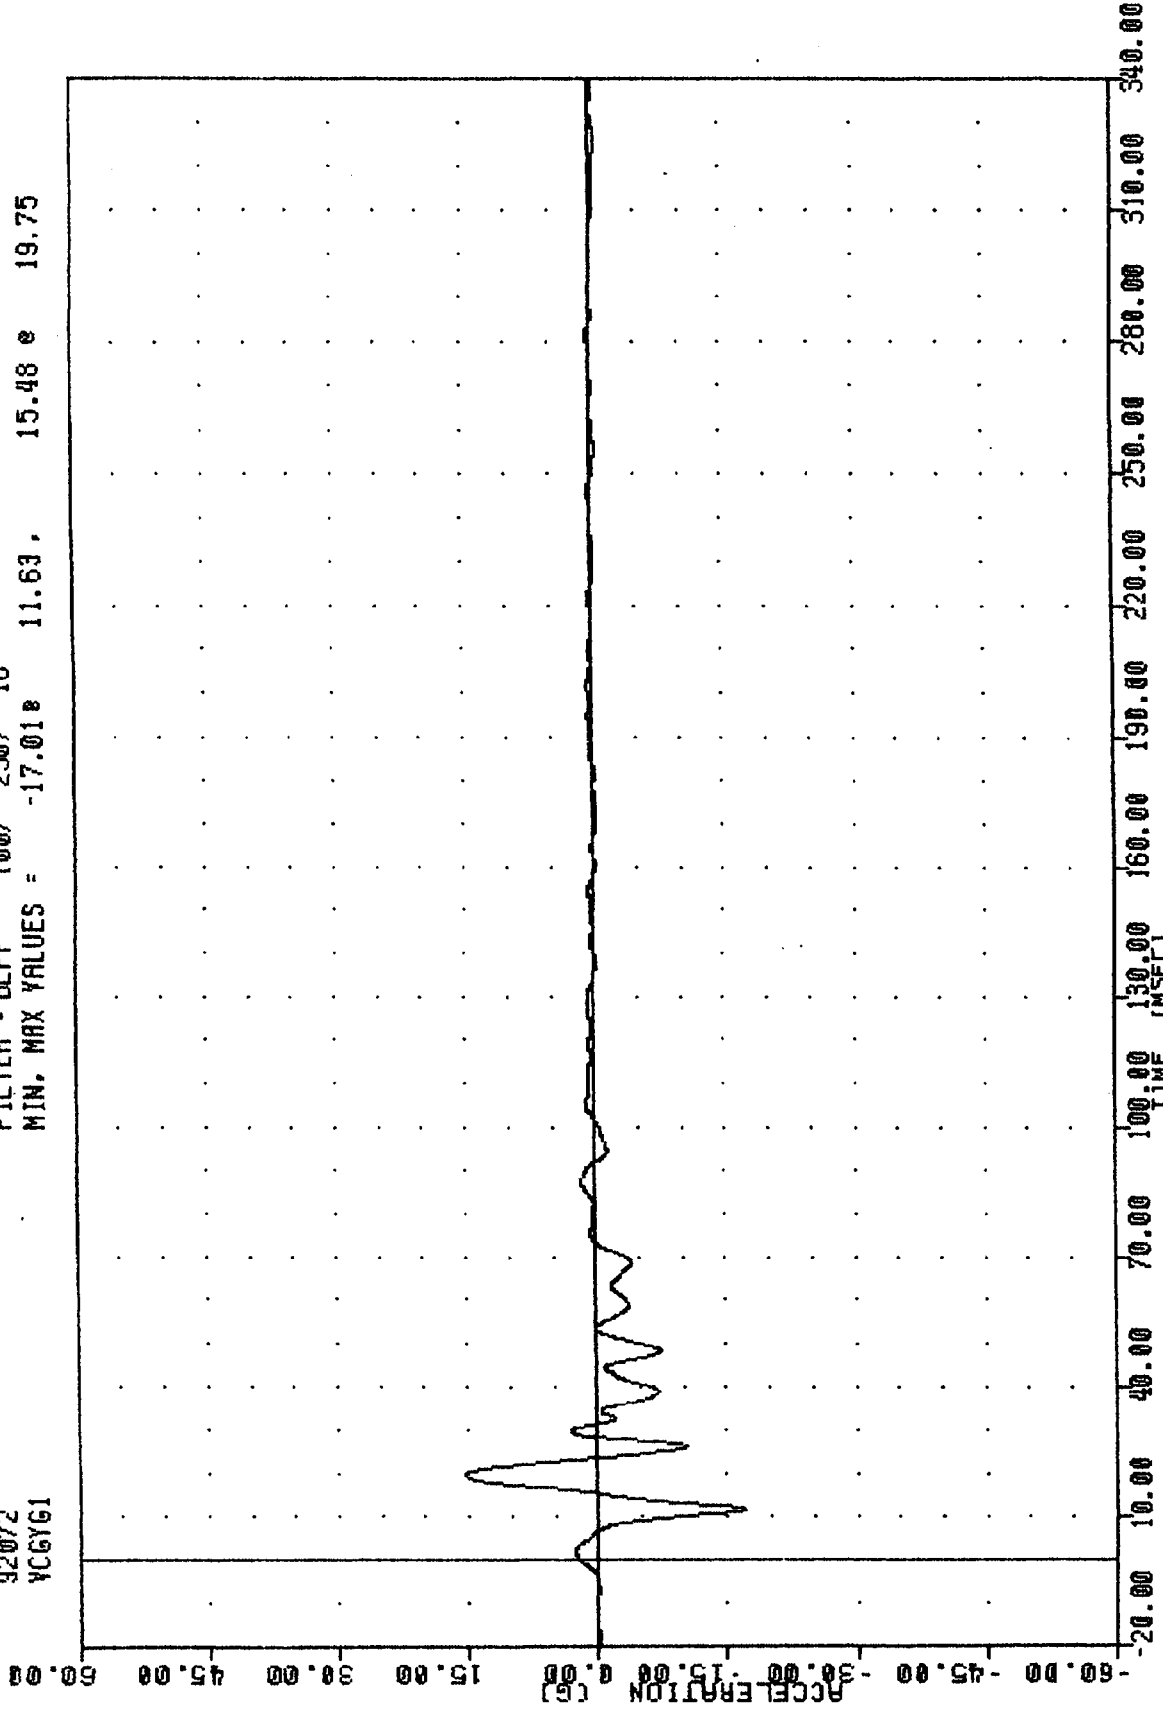
FILTER = BLPP 100/ 250/ -16
MIN, MAX VALUES = -17.018 11.63, 15.48 e 19.75

1985 FORD TEMPO INTO POLE BARRIER AT 20.0 MPH TEST NO. 4
VEHICLE CG Y-AXIS ACCELERATION

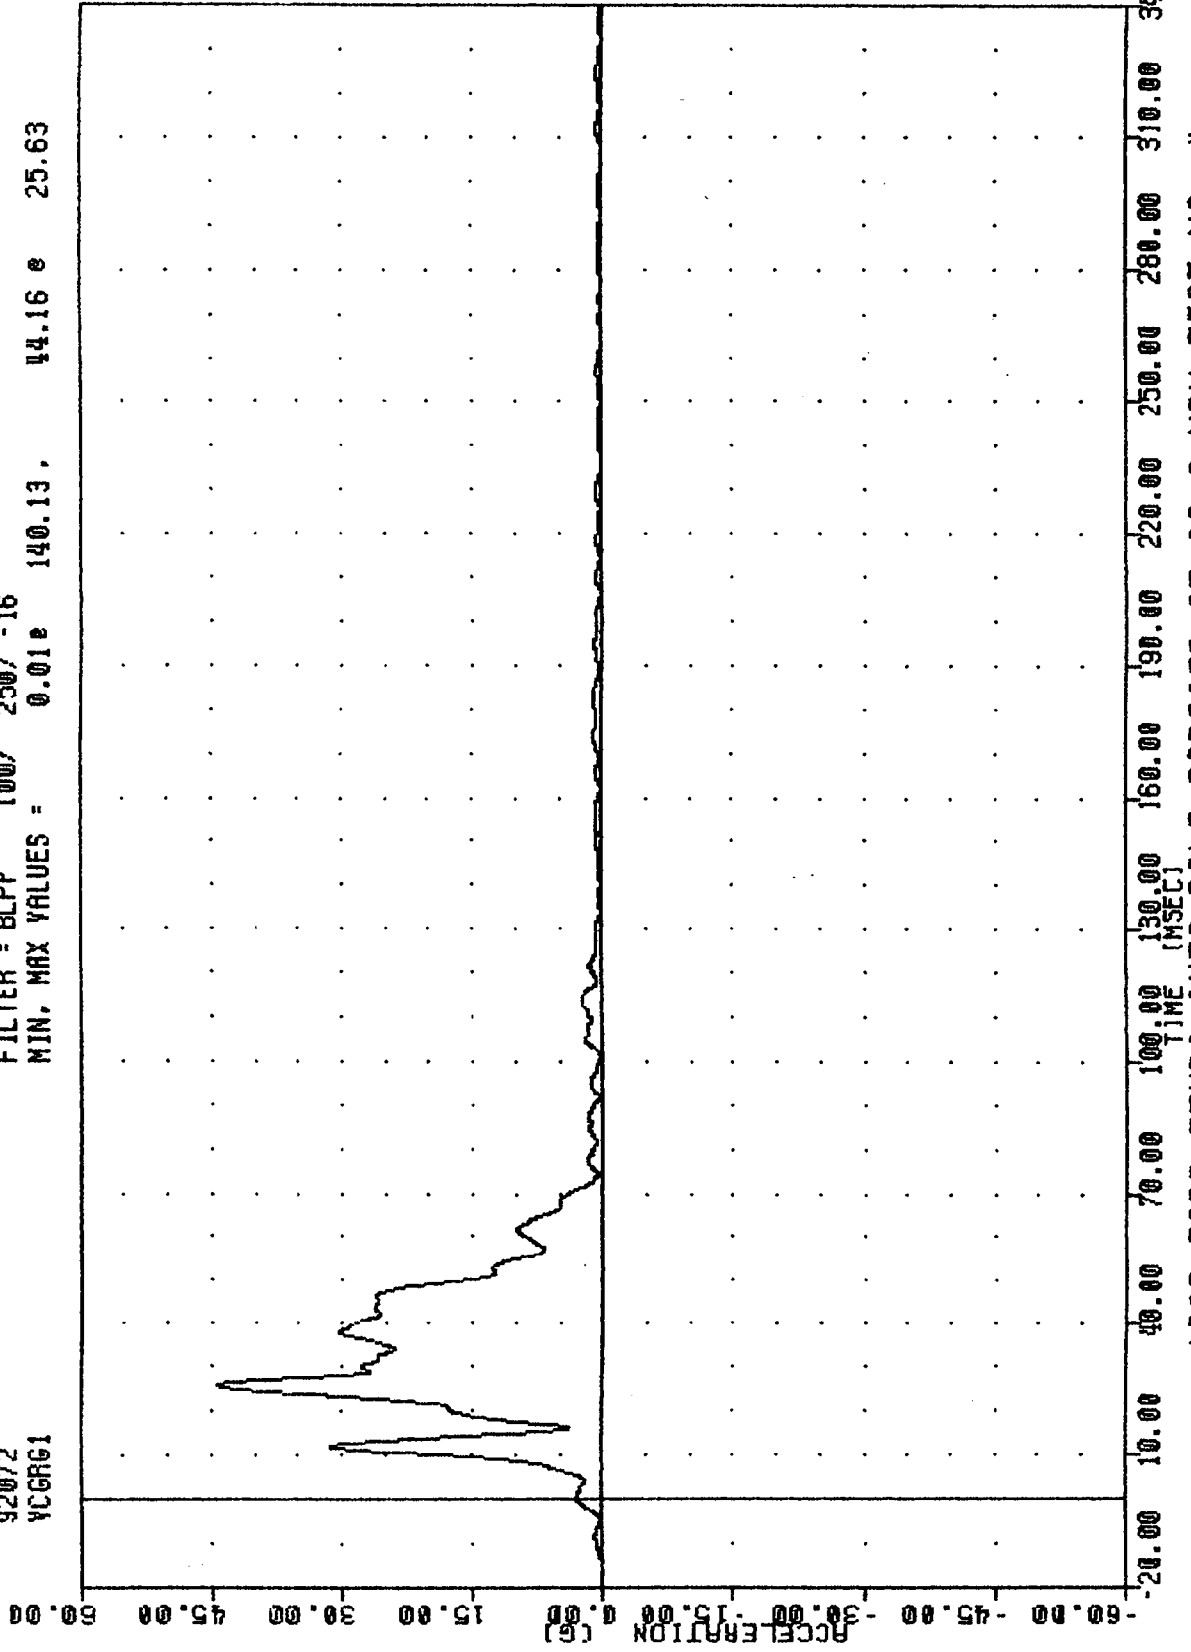
FILTER = BLPP 100/ 250/ -16
MIN, MAX VALUES = 0.01e 140.13, 44.16 e 25.63

1985 FORD TEMPO INTO POLE BARRIER AT 20.0 MPH TEST NO. 4
VEHICLE CG RESULTANT ACCELERATION

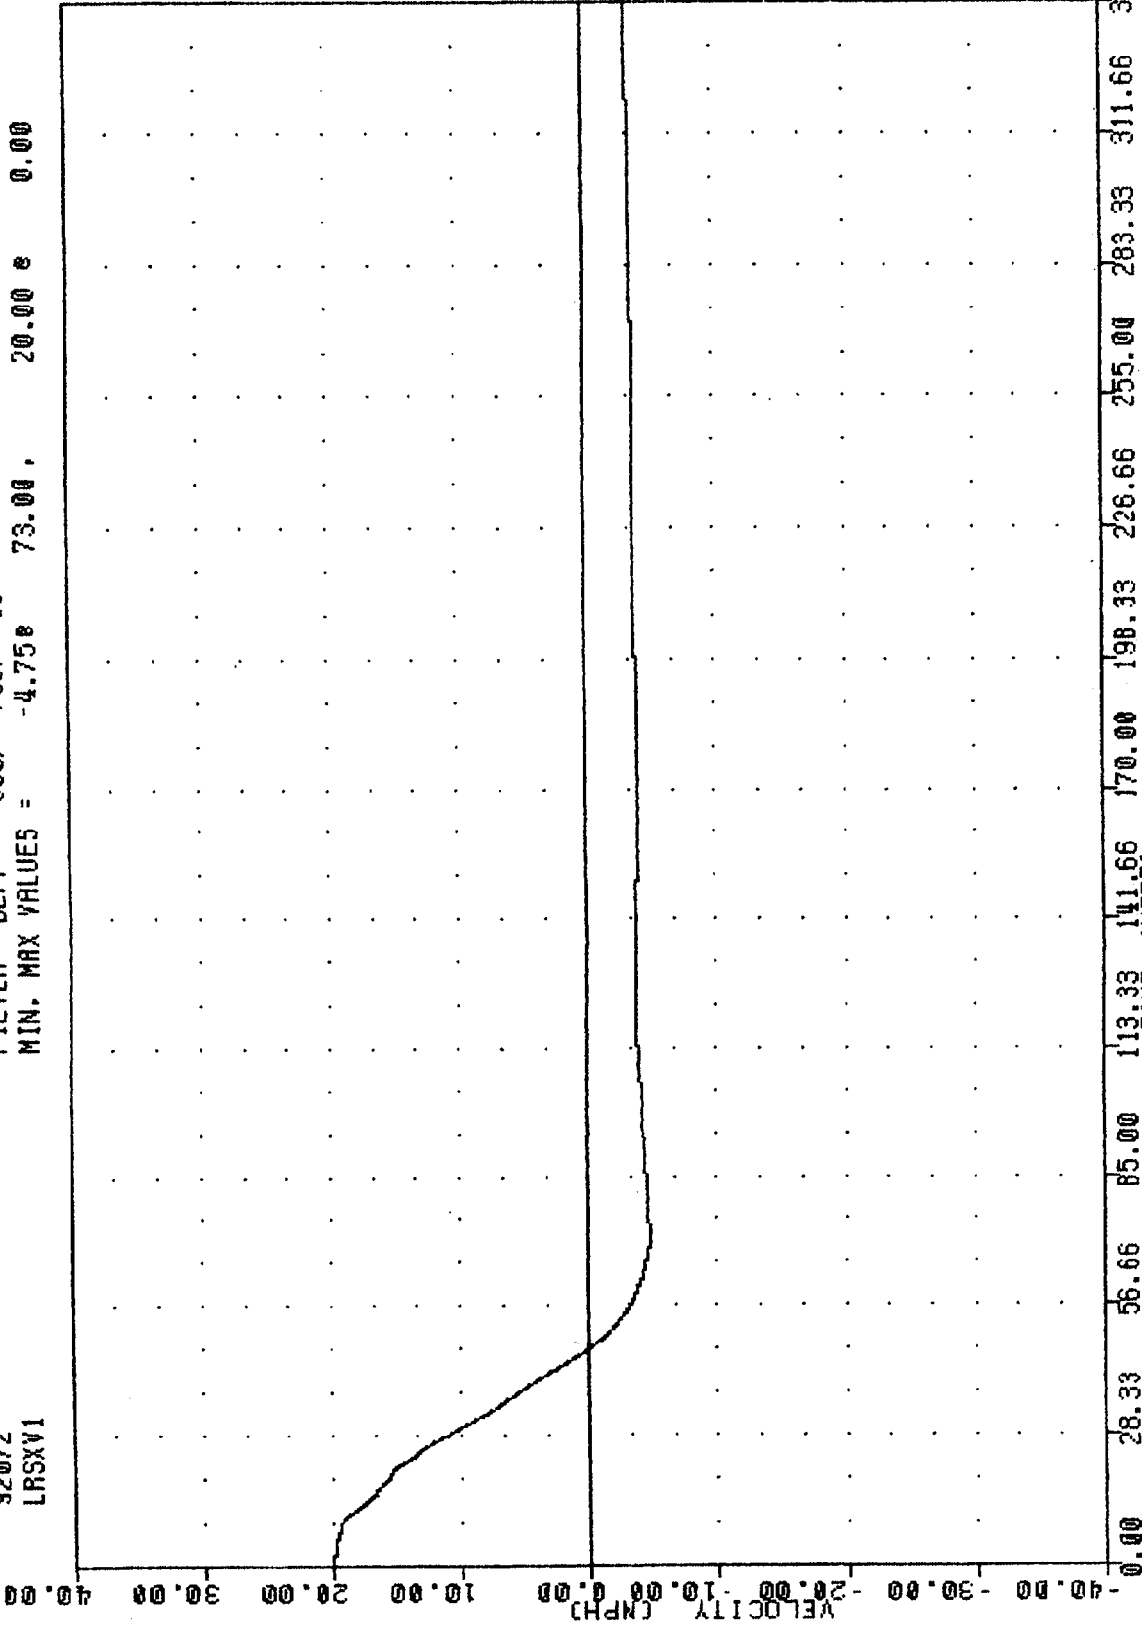
FILTER = BLPP 300/ 750/ -16
 MIN. MAX VALUES = -4.75e 73.00 , 20.00 e 0.00

1985 FORD TEMPO INTO POLE BARRIER AT 20.0 MPH TEST NO. 4
 LEFT REAR SILL X-AXIS VELOCITY
