DOT HS 807 915
Final Report

April 1992

Final Report of a 1985 Ford Tempo 4-Door Sedan Into a Pole Barrier in Support of Crash III Damage Algorithm Reformulation

PURPOSE AND TEST SUMMARY

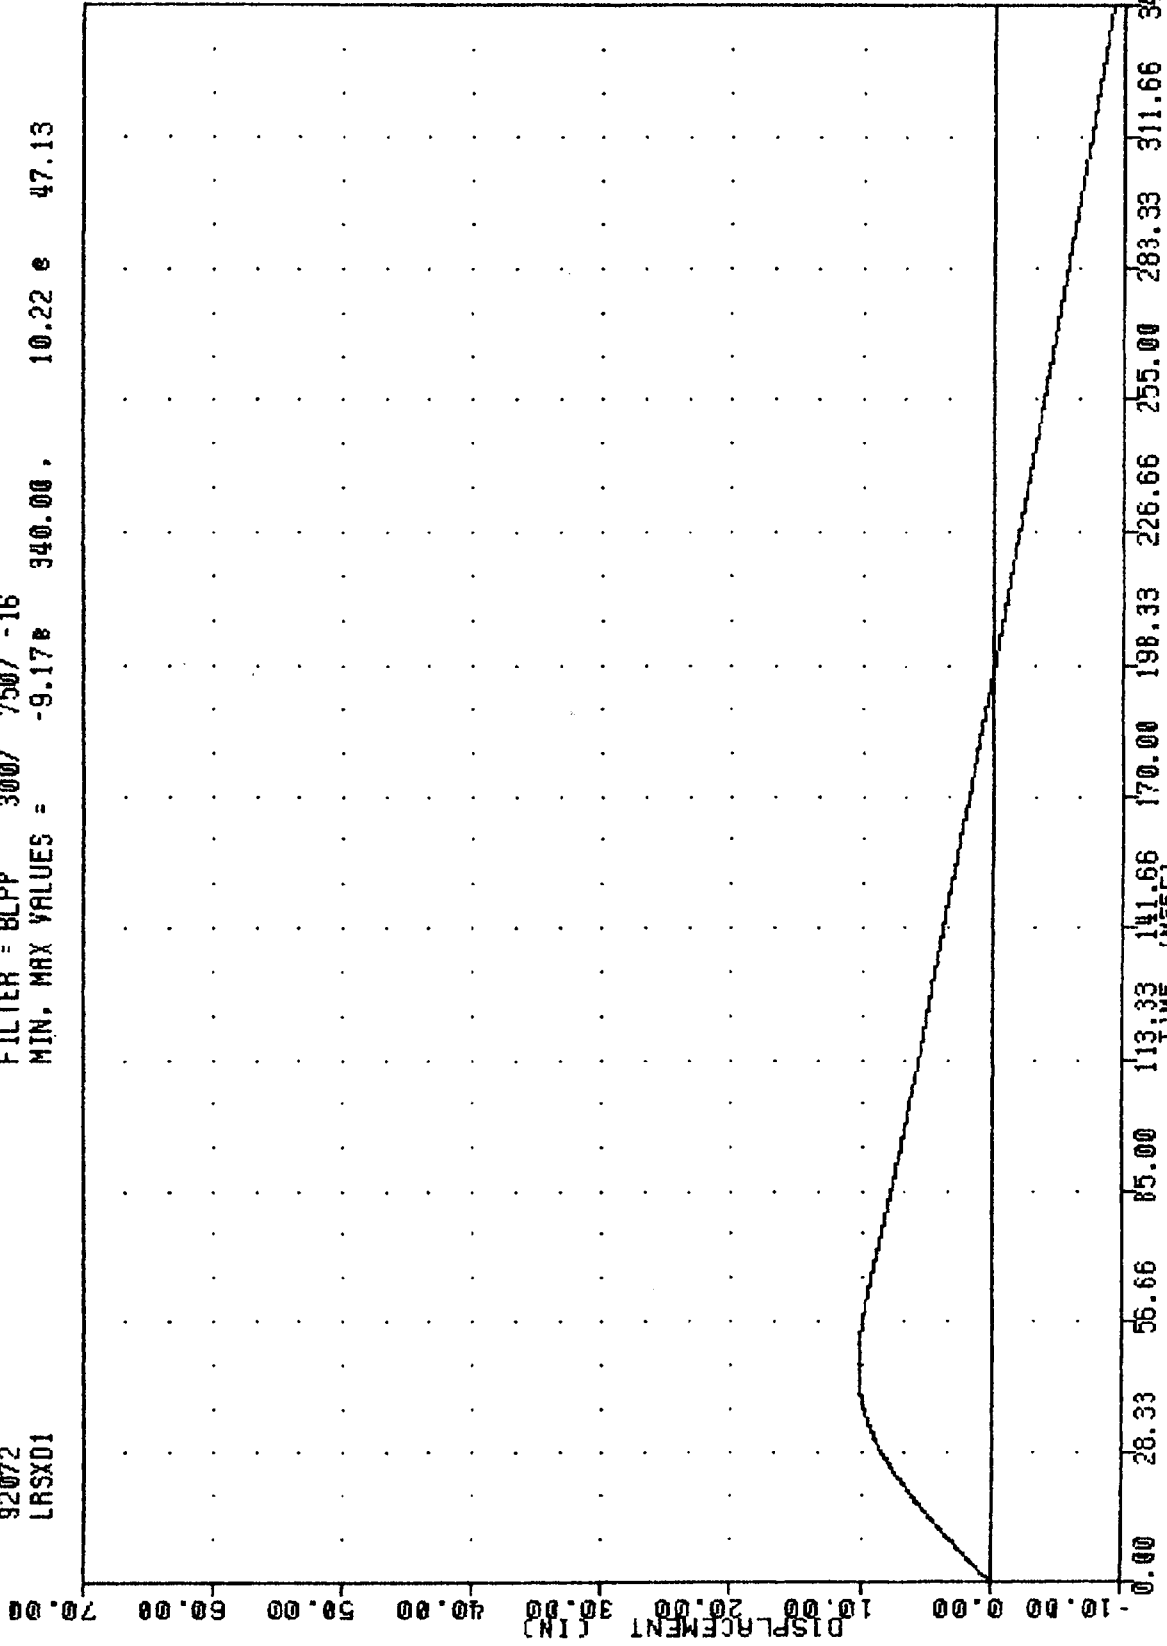
FILTER = BLPP 300/ 750/ -16
MIN. MAX VALUES = -9.17 340.00 10.22 47.13

1985 FORD TEMPO INTO POLE BARRIER AT 20.0 MPH TEST NO. 4
LEFT REAR SILL X-AXIS DISPLACEMENT

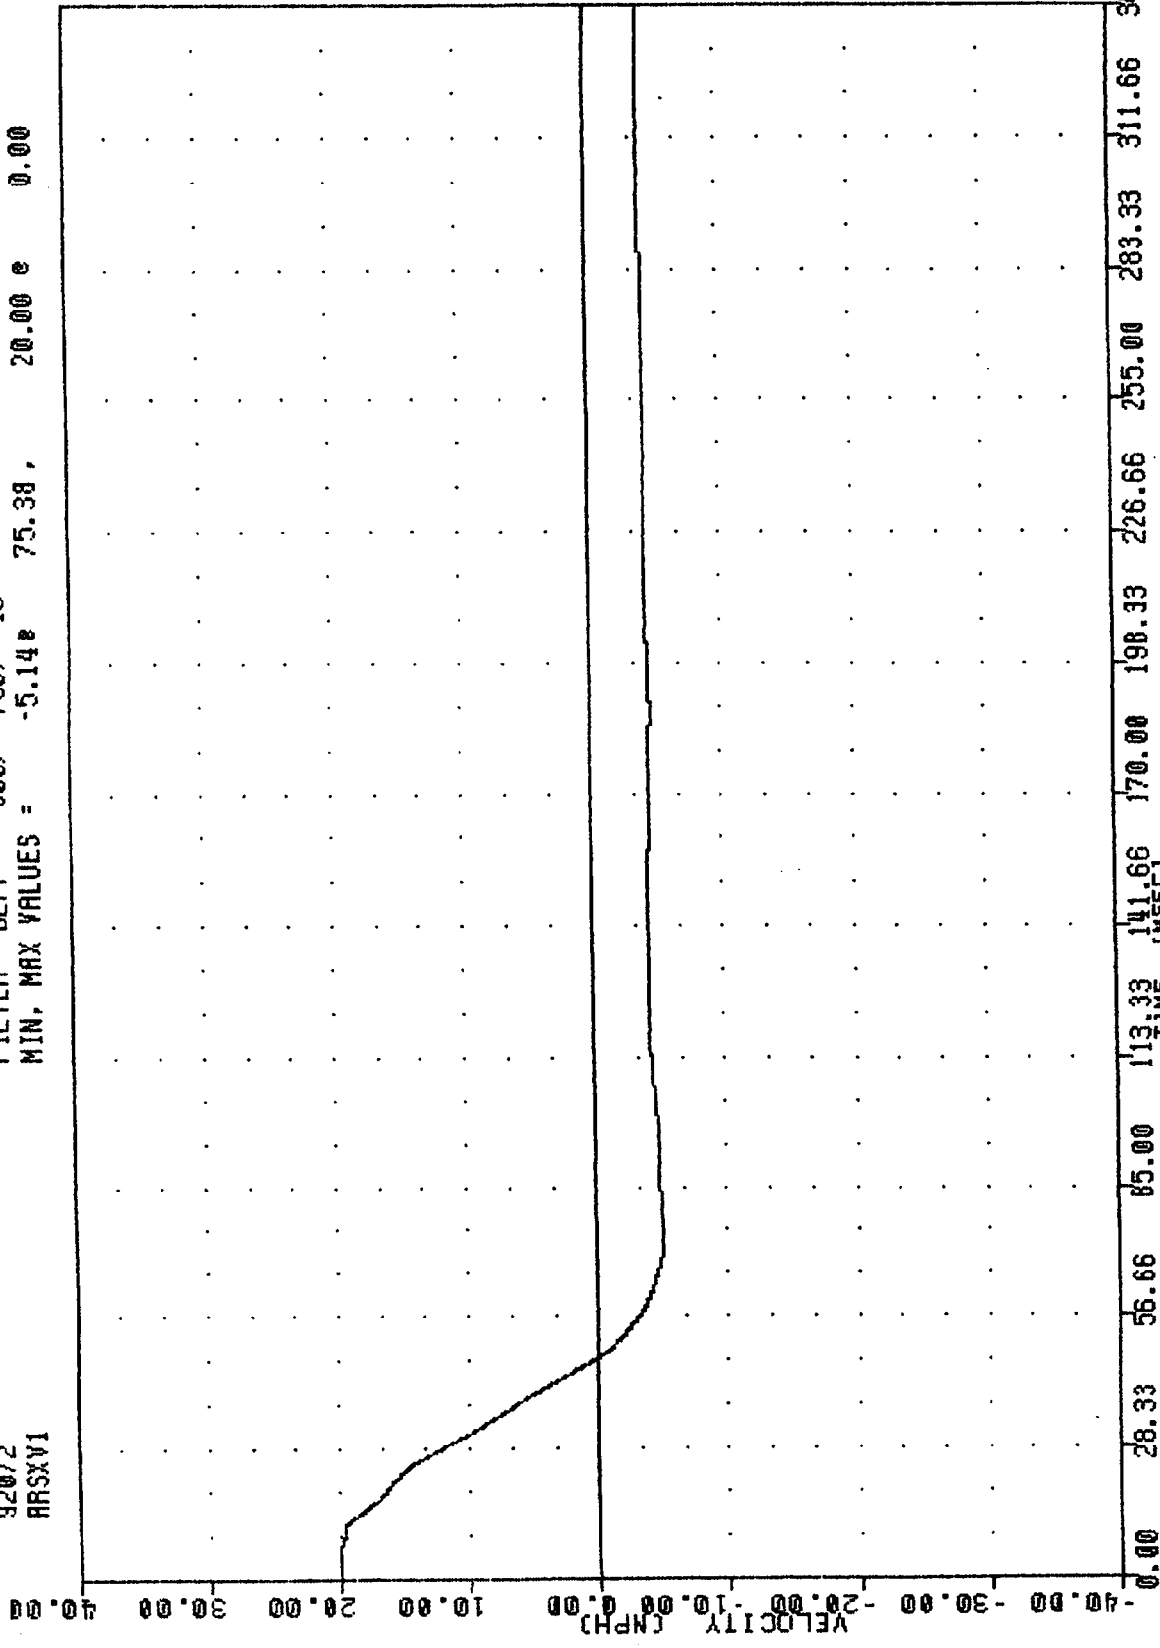
FILTER = BLPP 300/ 750/ -16
 MIN. MAX VALUES = -5.14e 20.00 e 0.00

1985 FORD TEMPO INTO POLE BARRIER AT 20.0 MPH TEST NO. 4
 RIGHT REAR SILL X-AXIS VELOCITY

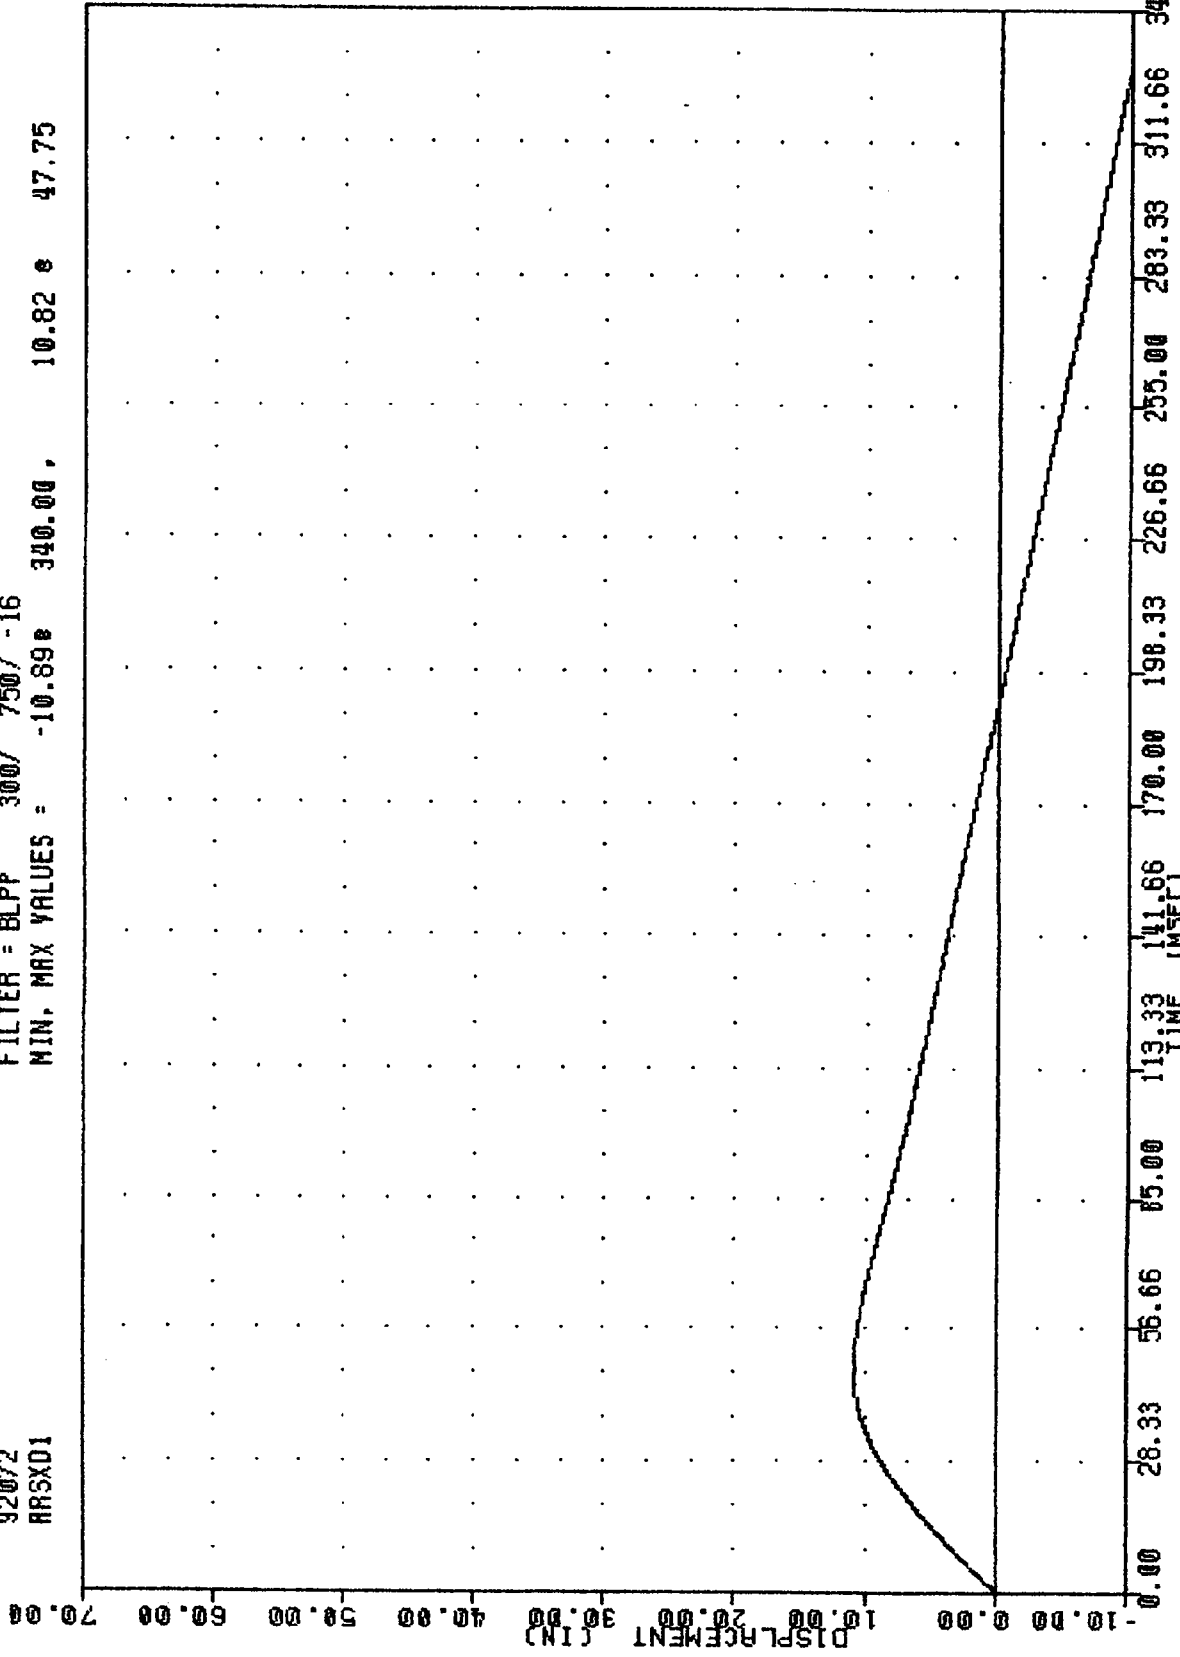
FILTER = BLPP 300/ 750/ -16
 MIN. MAX VALUES = -10.89e 340.00, 10.82 e 47.75

1985 FORD TEMPO INTO POLE BARRIER AT 20.0 MPH TEST NO. 4
 RIGHT REAR SILL X-AXIS DISPLACEMENT

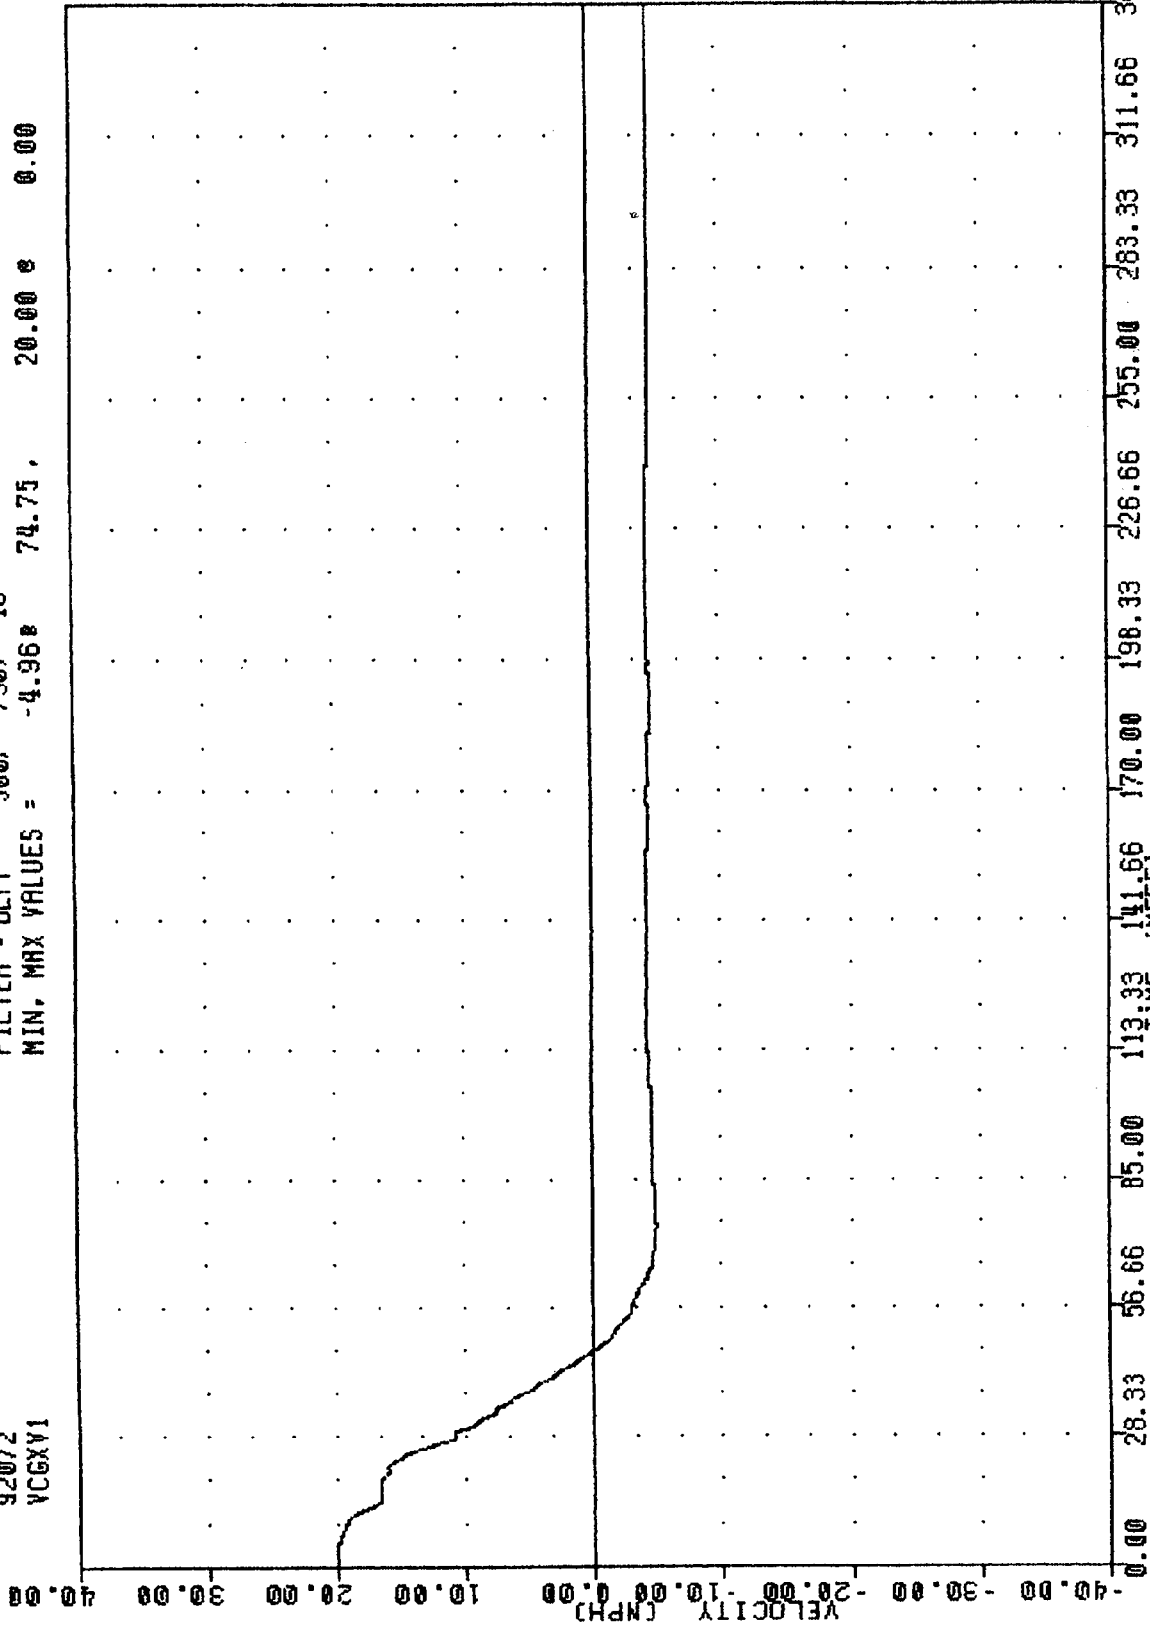
FILTER = BLPP 300/ 750/ -16
 MIN, MAX VALUES = -4.96 74.75 20.00 0.00

1985 FORD TEMPO INTO POLE BARRIER AT 20.0 MPH TEST NO. 4
 VEHICLE CG X-AXIS VELOCITY

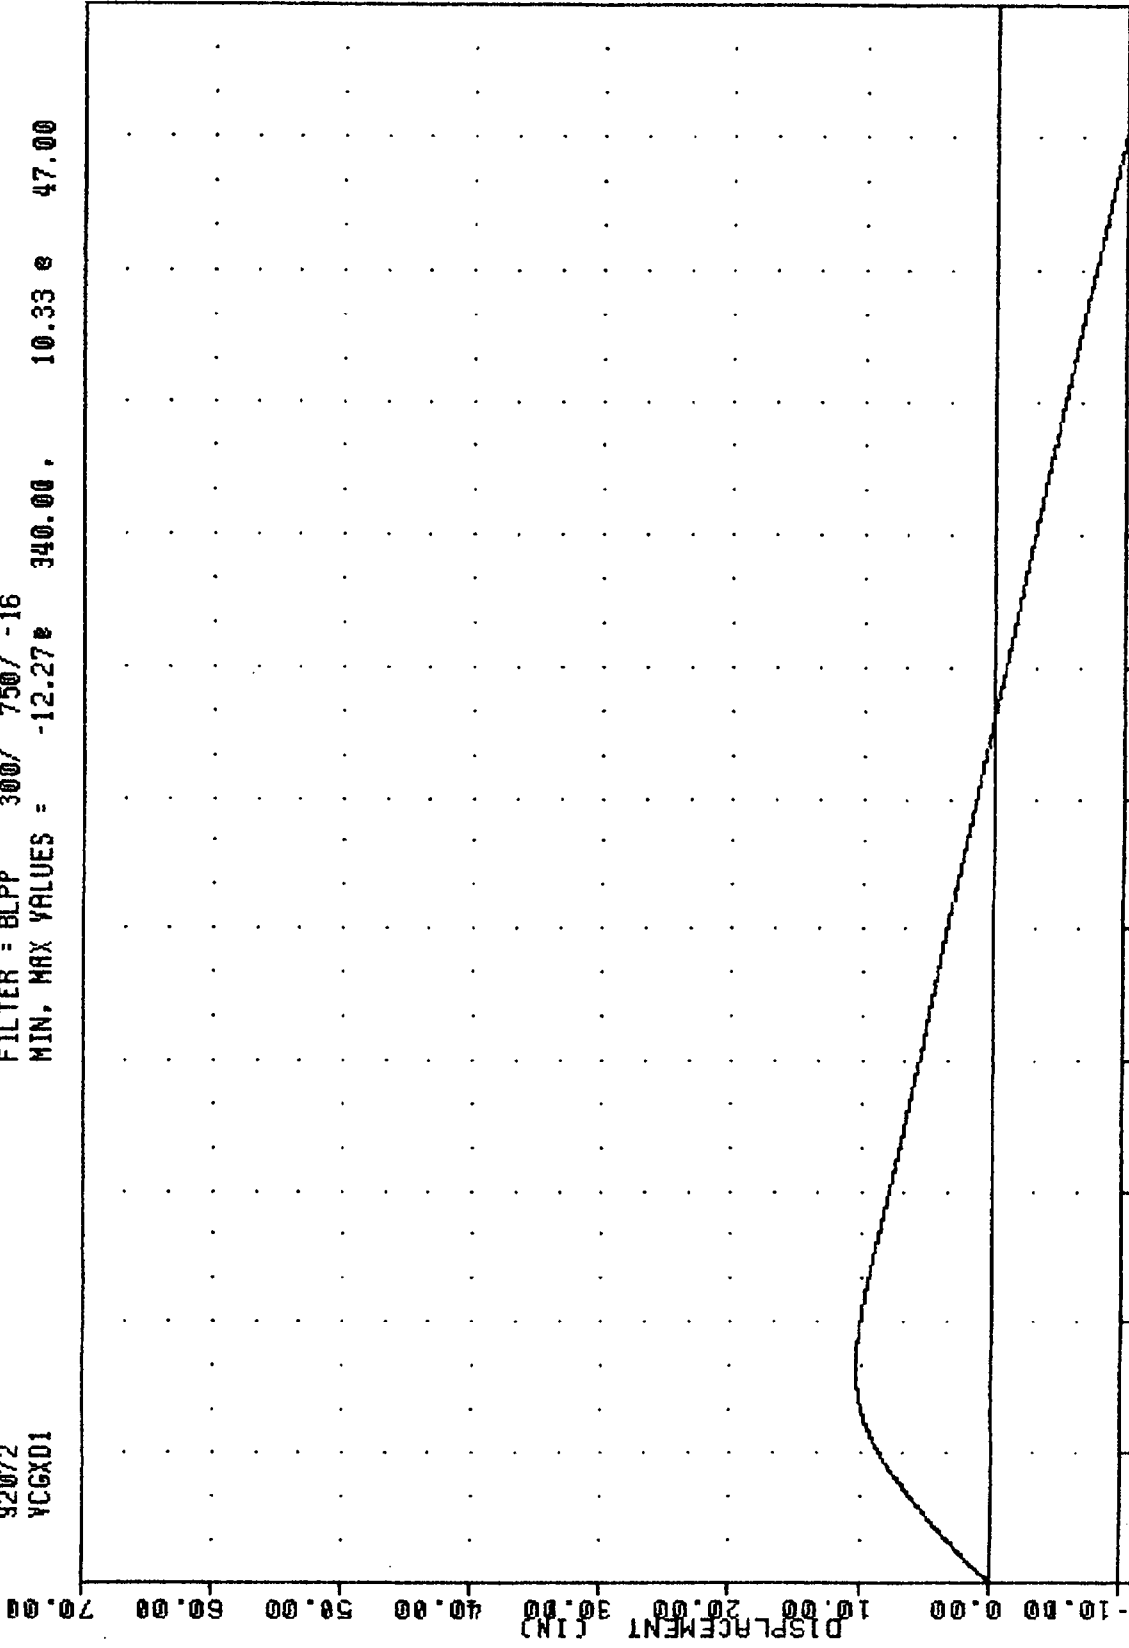
FILTER = BLPP 300/ 750/ -16
 MIN, MAX VALUES = -12.27 e 340.00, 10.33 e 47.00

1985 FORD TEMPO INTO POLE BARRIER AT 20.0 MPH TEST NO. 4
 VEHICLE CG X-AXIS DISPLACEMENT

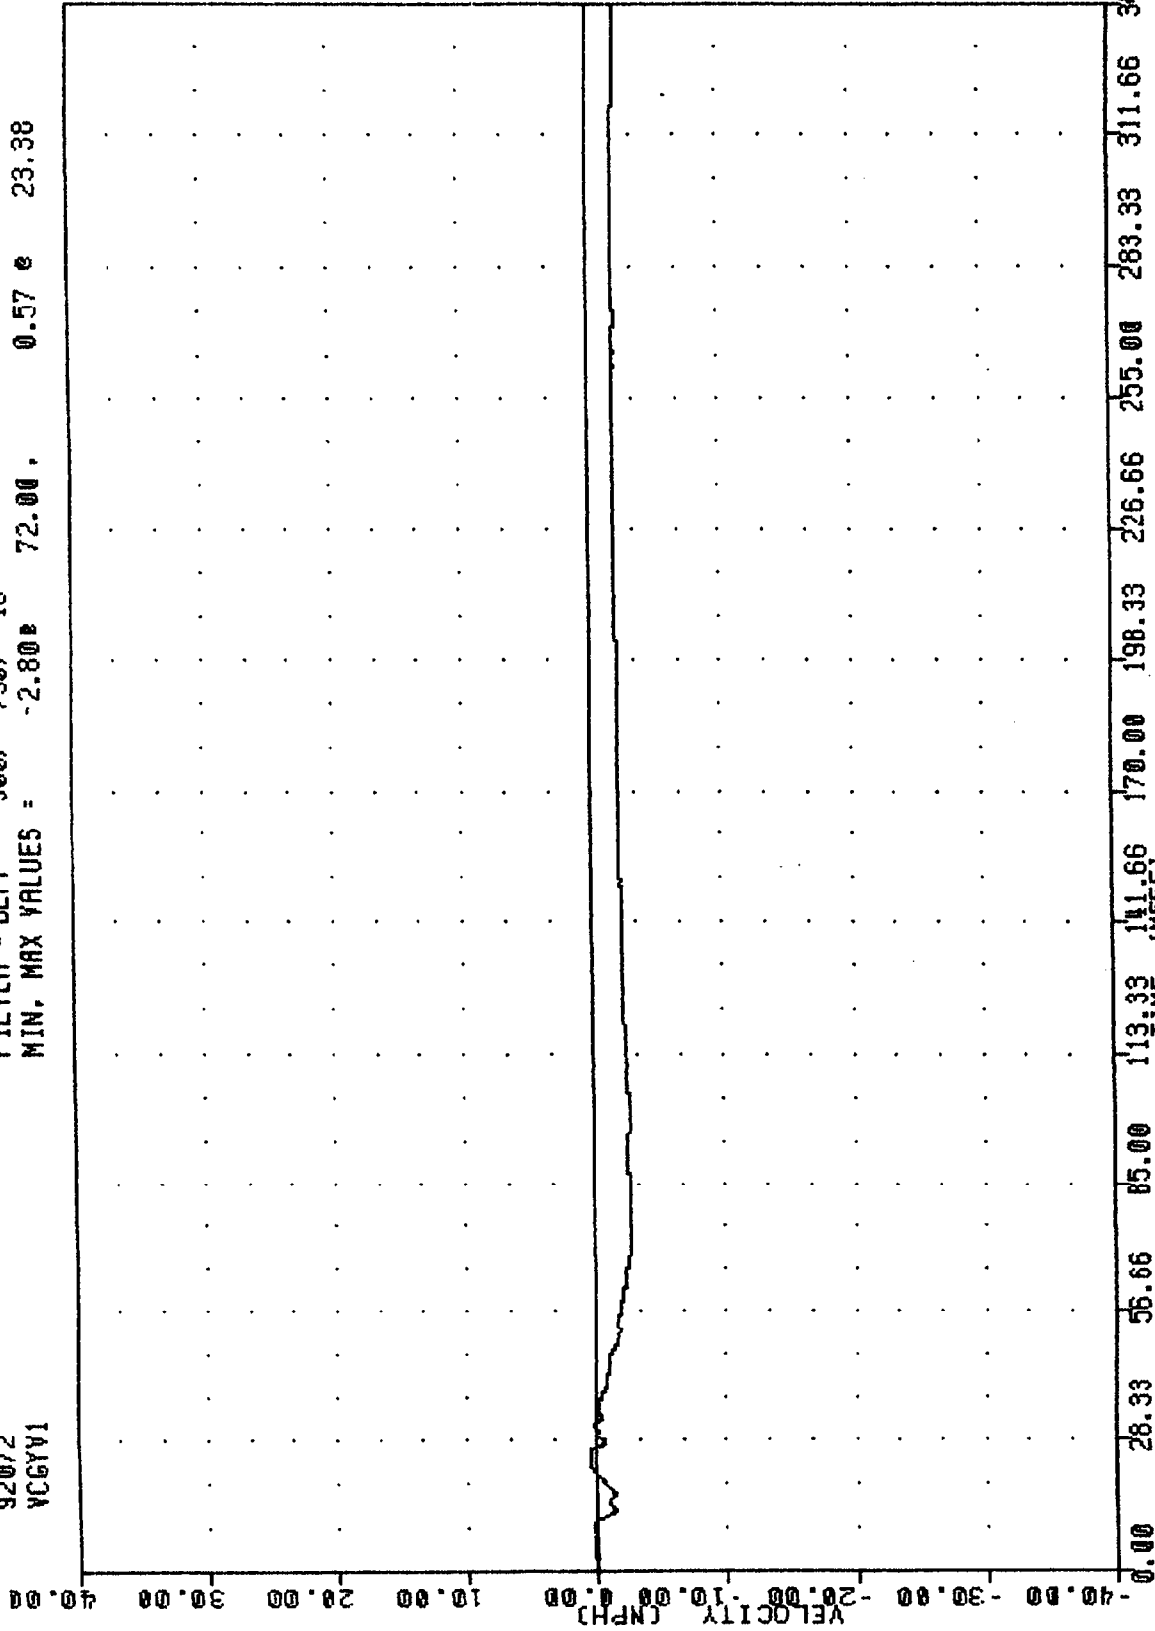
FILTER = BLPP 300/ 750/ -16
 MIN, MAX VALUES = -2.80 72.00 0.57 e 23.38

1985 FORD TEMPO INTO POLE BARRIER AT 20.0 MPH TEST NO. 4
 VEHICLE CG Y-AXIS VELOCITY

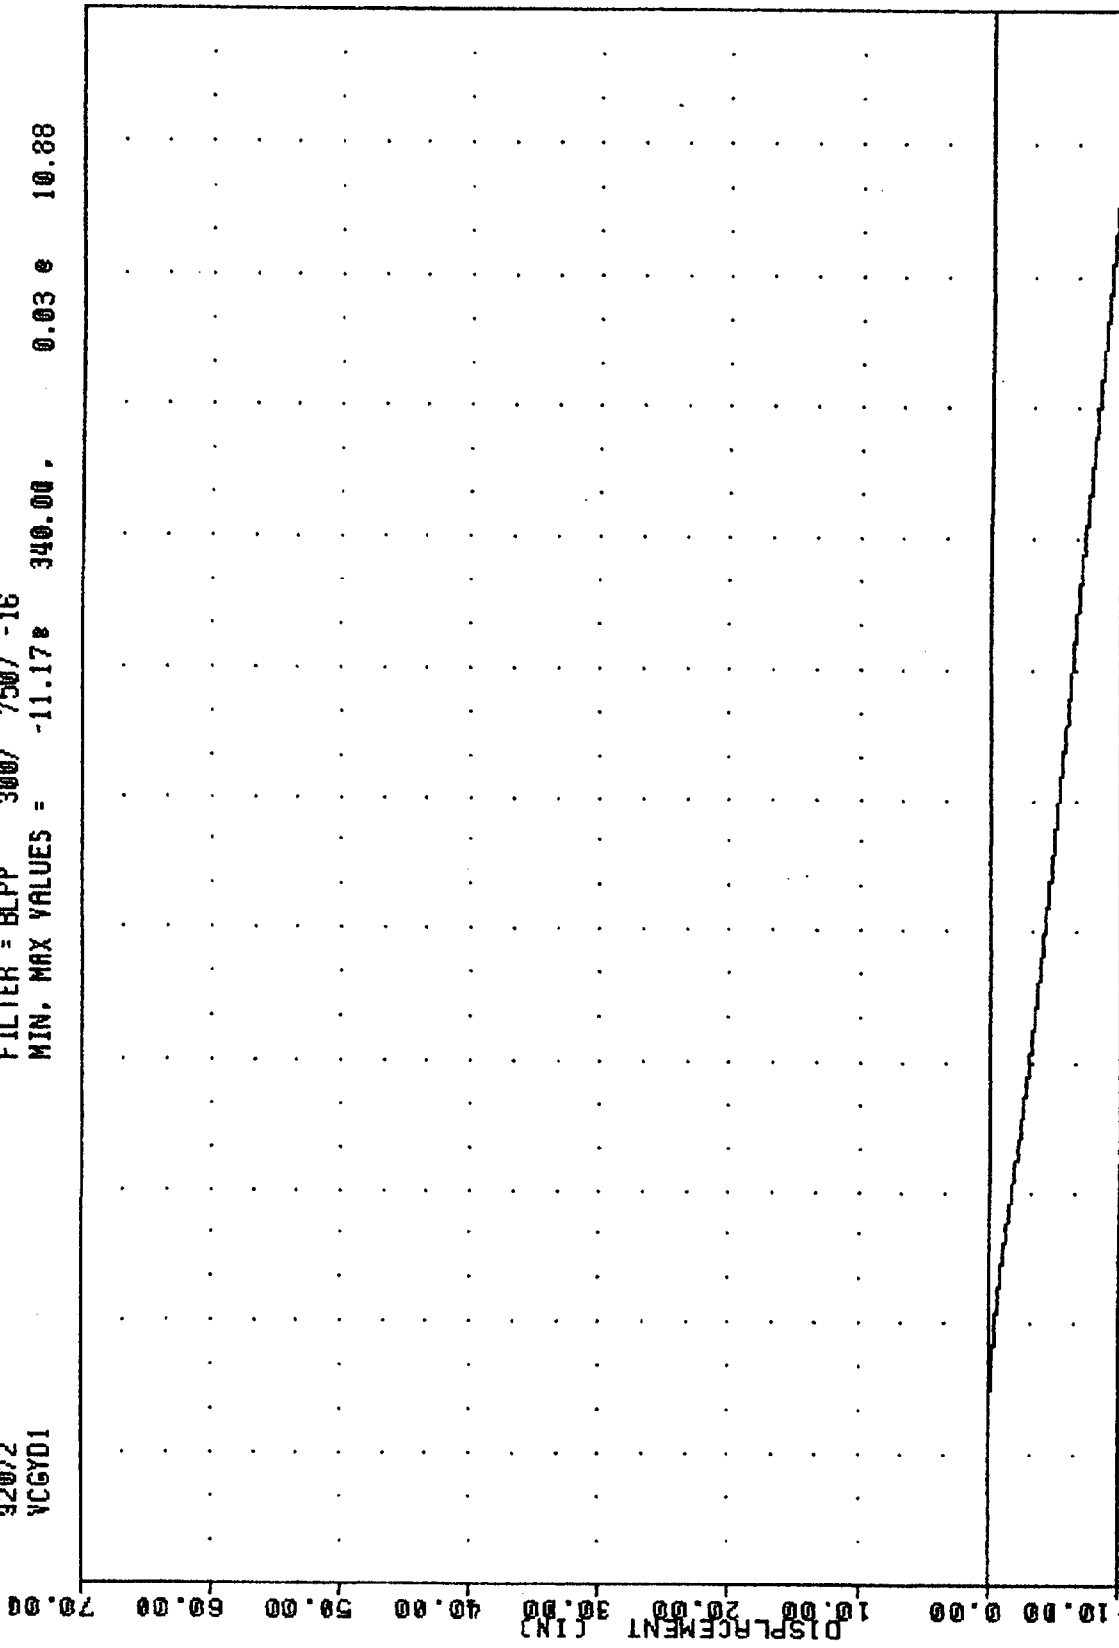
FILTER = BLPP 300/ 750/ -16
 MIN. MAX VALUES = -11.17e 340.00 . 0.03 e 10.88

DISPLACEMENT (IN)
 TIME (MSEC)
 1985 FORD TEMPO INTO POLE BARRIER AT 20.0 MPH TEST NO. 4
 VEHICLE CG Y-AXIS DISPLACEMENT

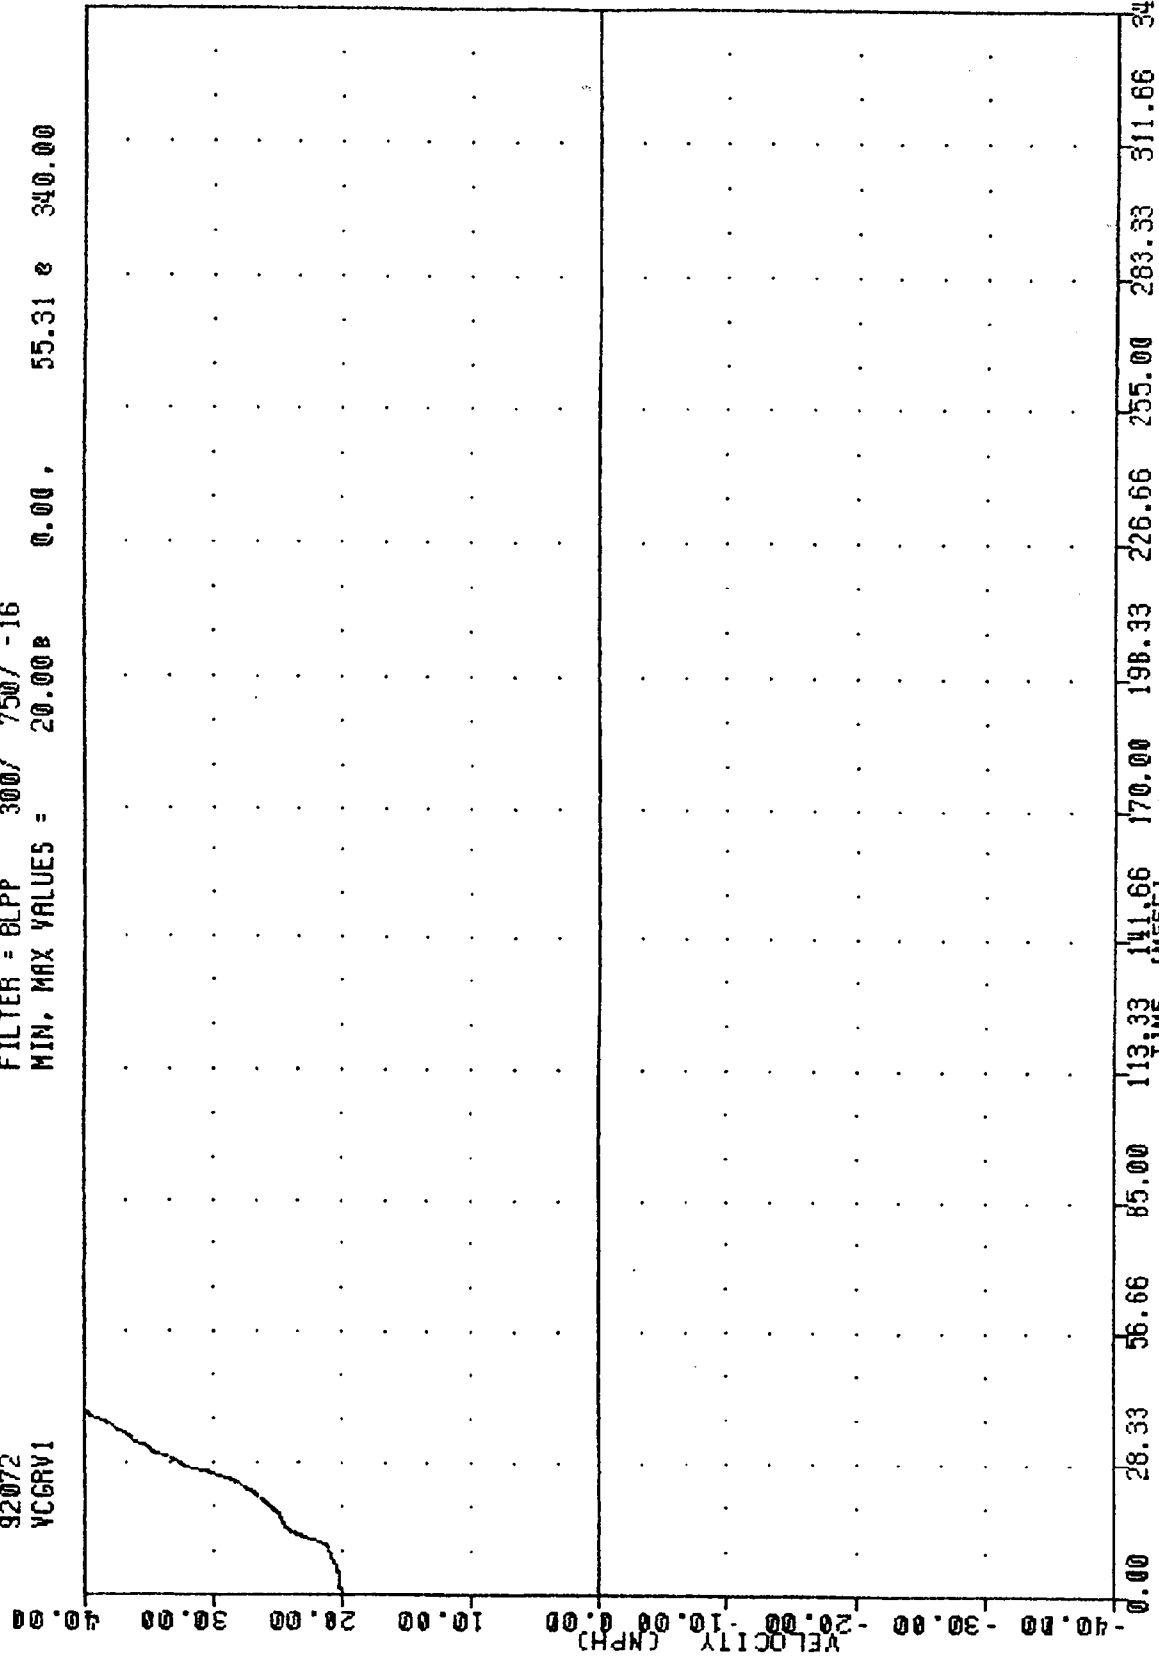
FILTER = BLPP 300/ 750/ -16
 MIN, MAX VALUES = 20.00B 0.00 , 55.31 e 340.00

1985 FORD TEMPO INTO POLE BARRIER AT 20.0 MPH TEST NO. 4
 VEHICLE CG RESULTANT VELOCITY

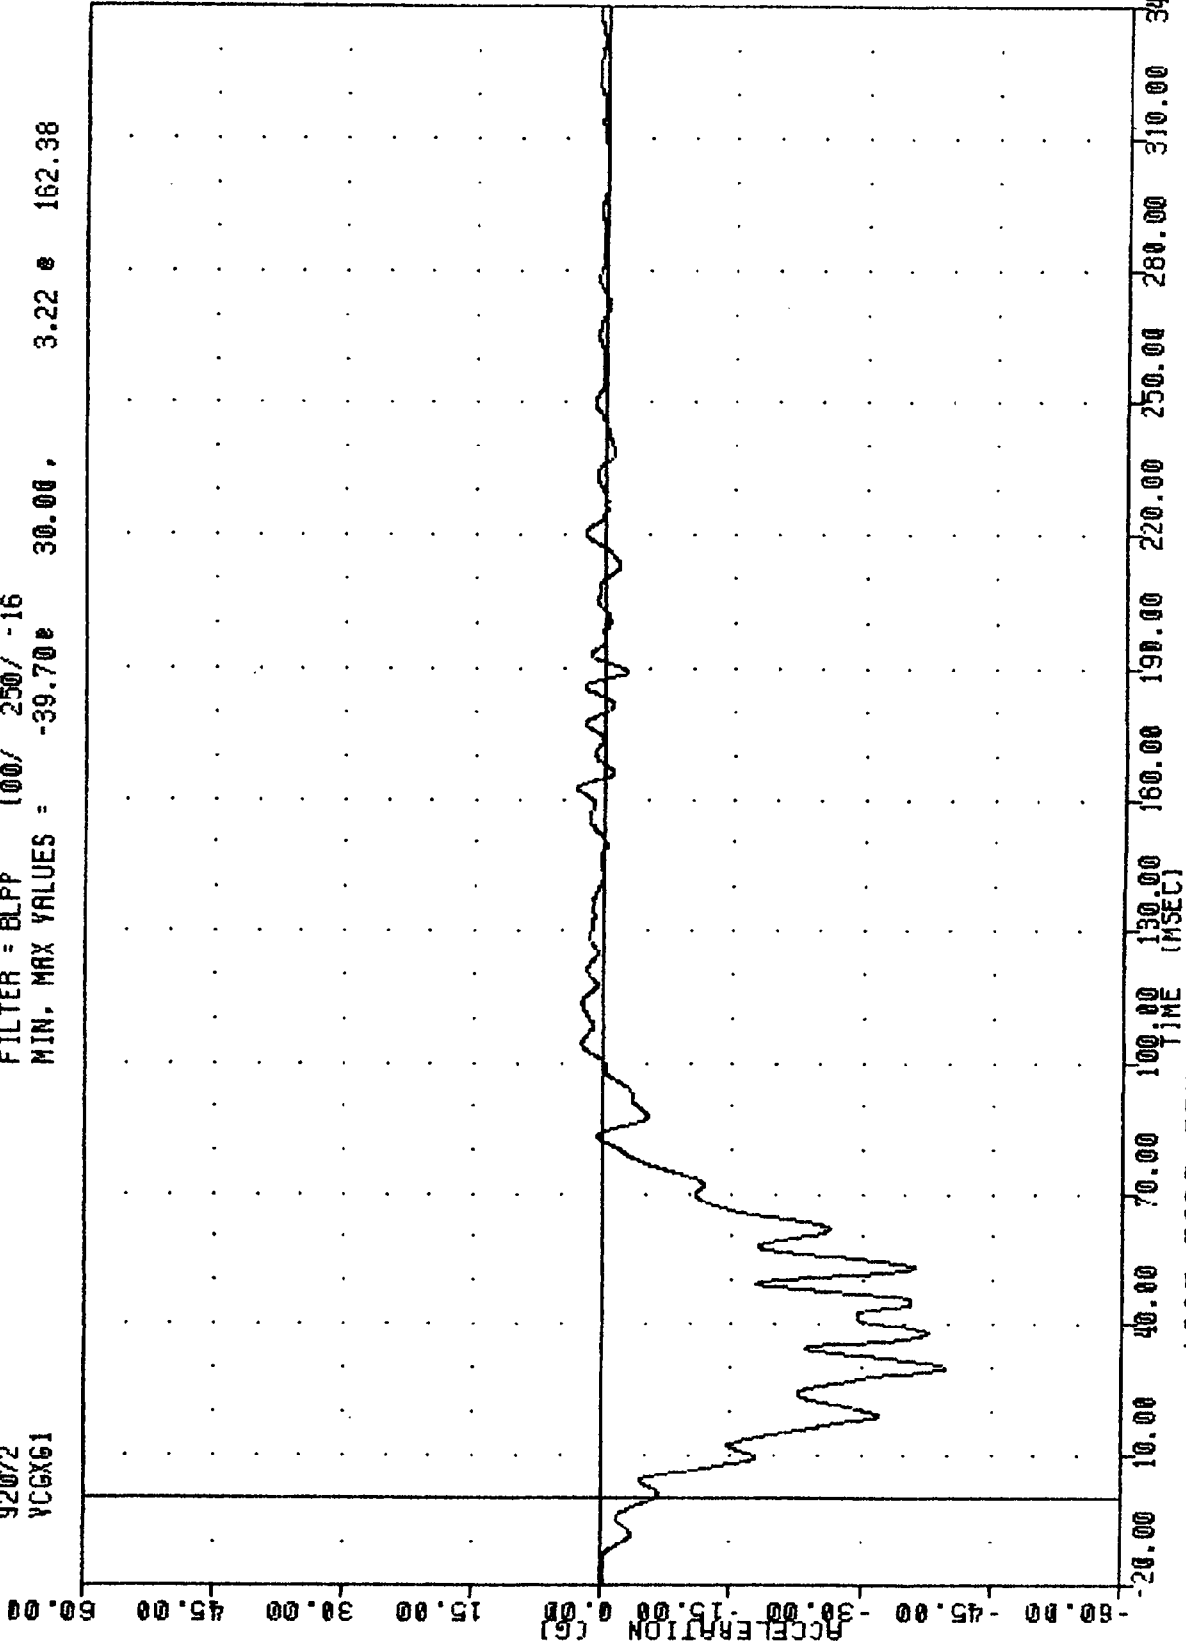
FILTER = BLPP 100/ 250/ -16
MIN. MAX VALUES = -39.70e 30.00, 3.22 e 162.38

1985 FORD TEMPO INTO POLE BARRIER AT 35.1 MPH TEST NO. 5
VEHICLE CG X-AXIS ACCELERATION

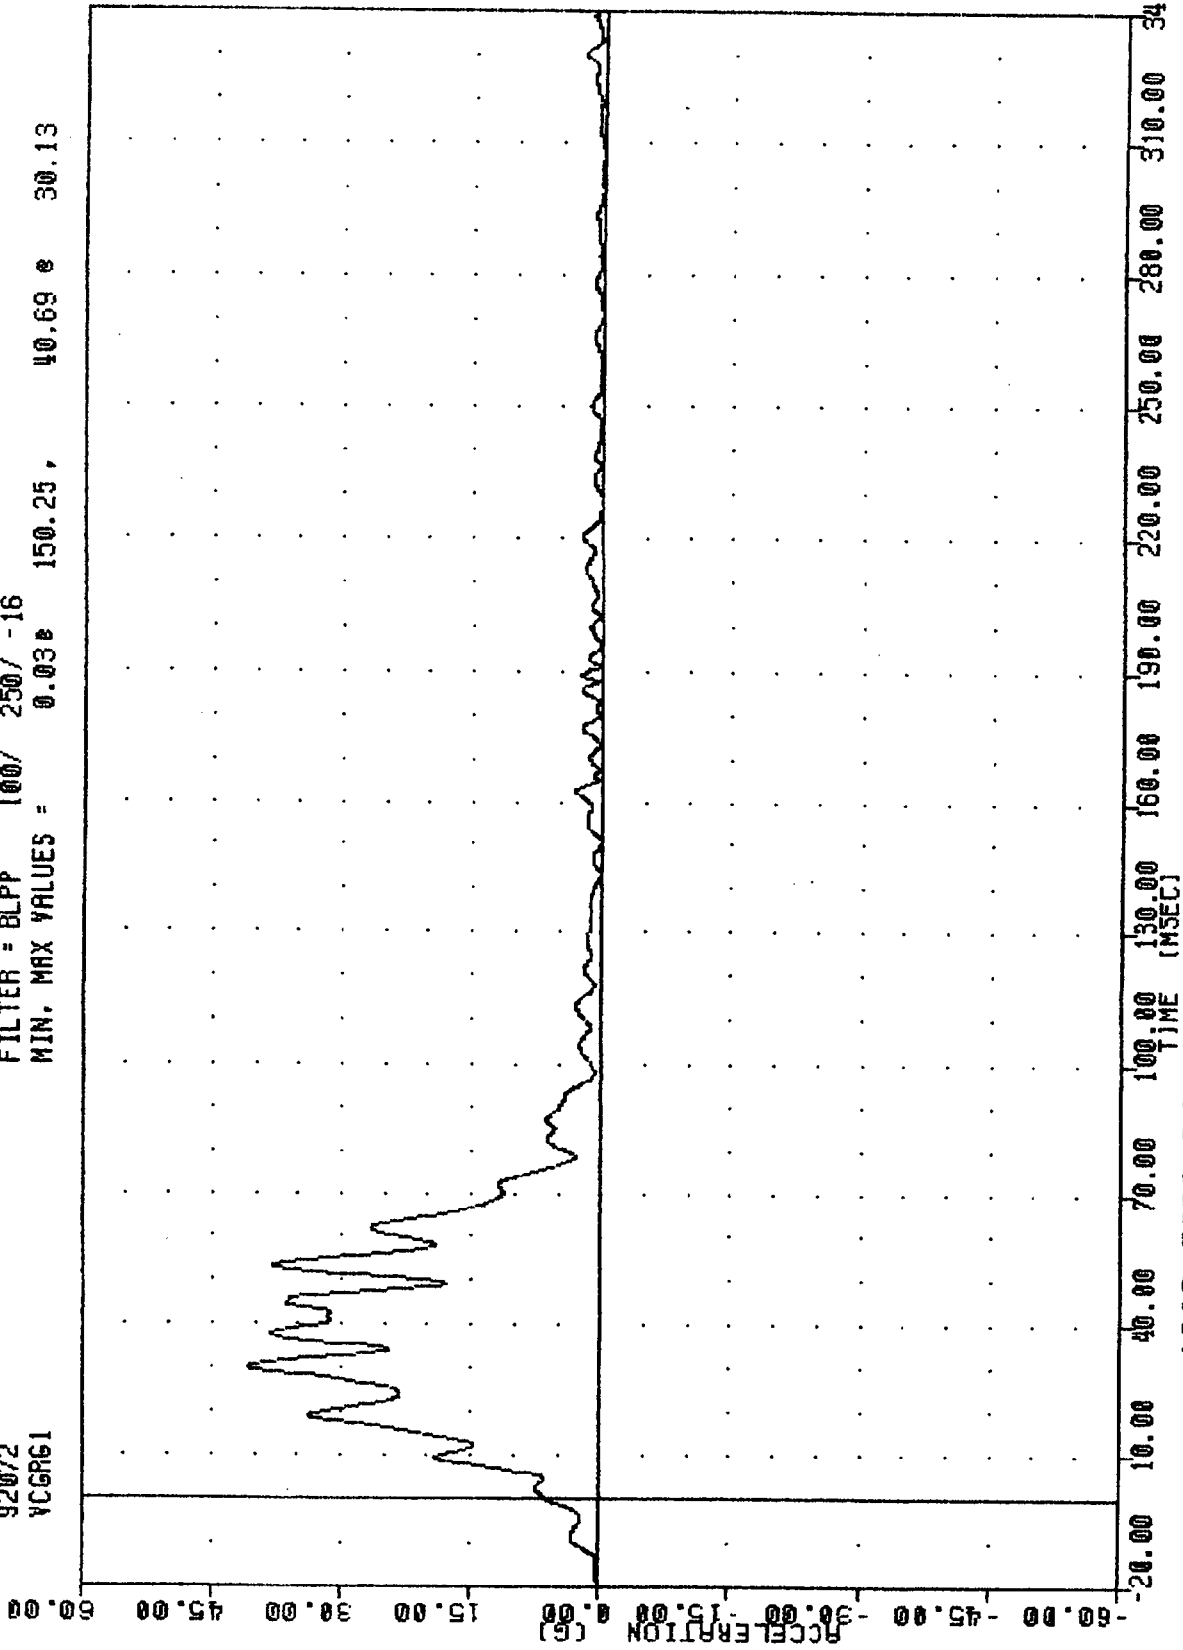
FILTER = BLPP 100/ 250/ -16
MIN. MAX VALUES = 0.03 150.25, 40.69 30.13

1985 FORD TEMPO INTO POLE BARRIER AT 35.1 MPH TEST NO. 5
VEHICLE C6 RESULTANT ACCELERATION

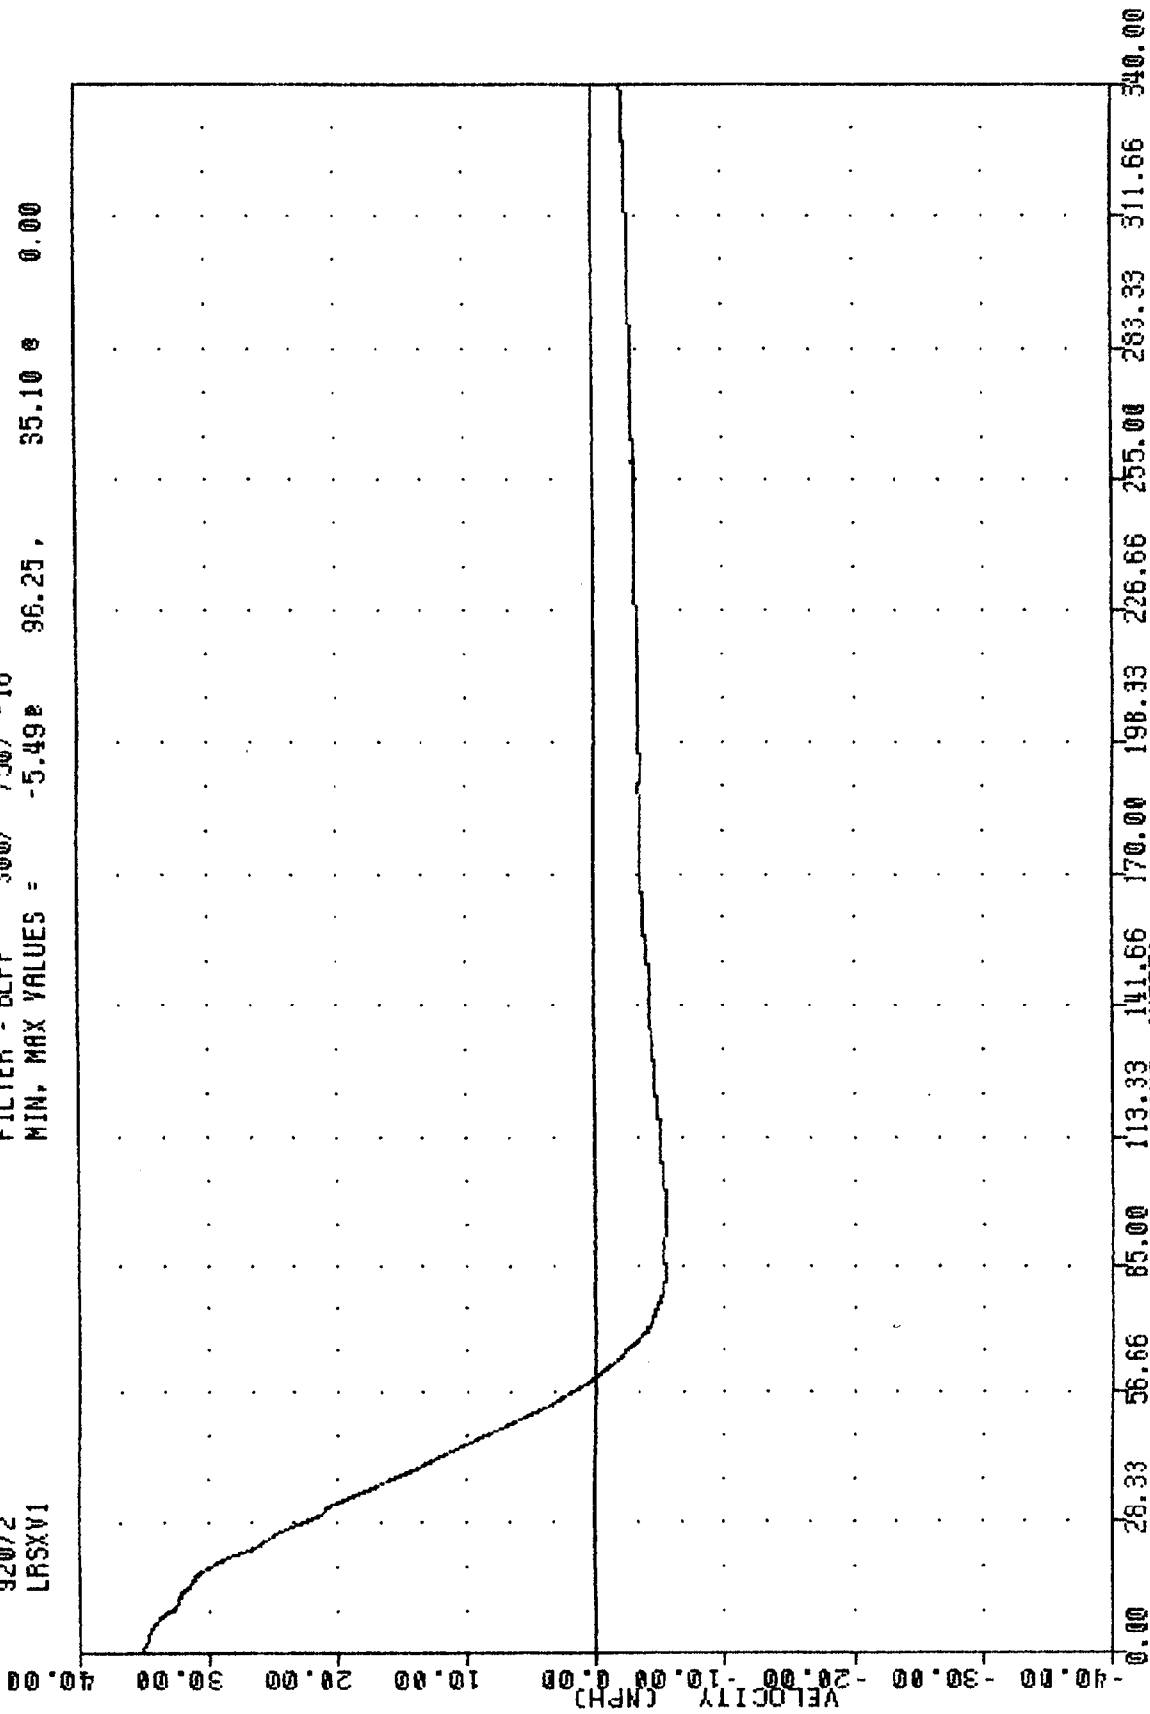
FILTER = BLPP 300/ 750/ -16
 MIN. MAX VALUES = -5.49e 96.25, 35.10 e 0.00

1985 FORD TEMPO INTO POLE BARRIER AT 35.1 MPH TEST NO. 5
 LEFT REAR SILL X-AXIS VELOCITY
