DOT HS 807 915
Final Report

April 1992

Final Report of a 1985 Ford Tempo 4-Door Sedan Into a Pole Barrier in Support of Crash III Damage Algorithm Reformulation

PURPOSE AND TEST SUMMARY

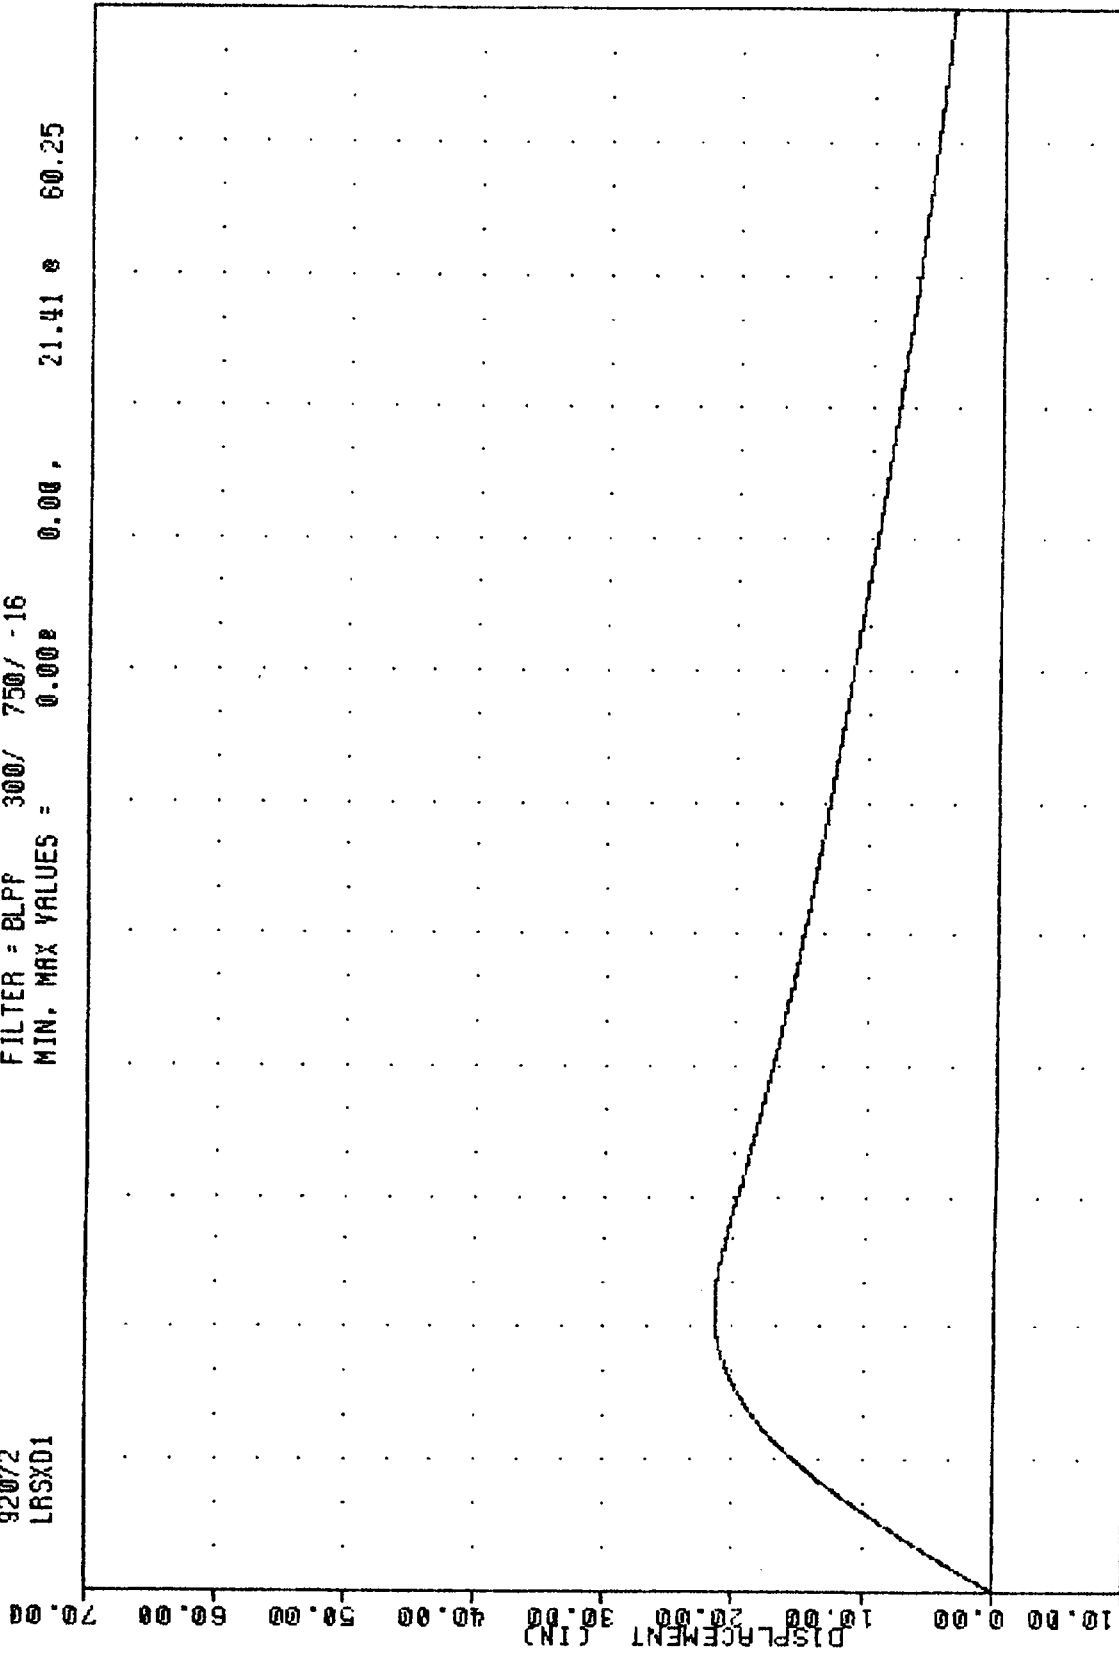
FILTER = BLPP 300/ 750/ -16
 MIN. MAX VALUES = 0.00P 0.00, 21.41 @ 60.25

1985 FORD TEMPO INTO POLE BARRIER AT 35.1 MPH TEST NO. 5
 LEFT REAR SILL X-AXIS DISPLACEMENT

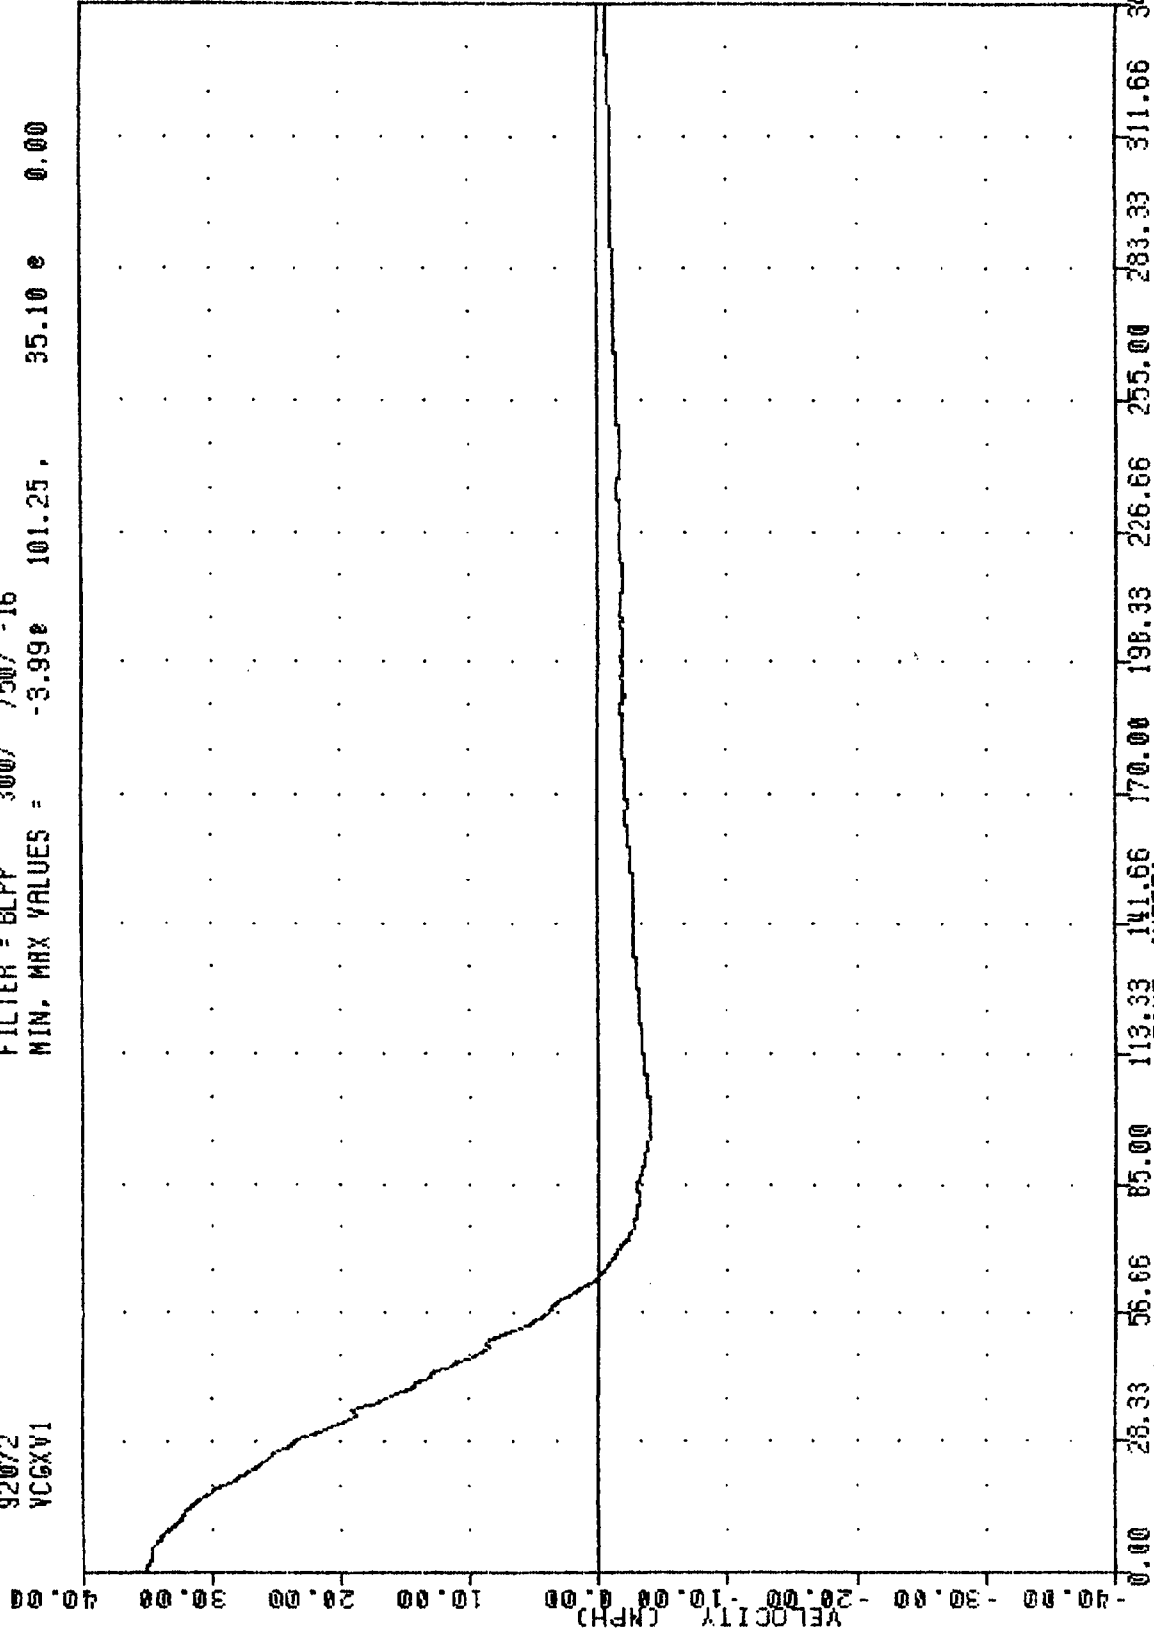
FILTER = BLPP 300/ 750/ -16
 MIN, MAX VALUES = -3.99e 101.25, 35.10 e 0.00

1985 FORD TEMPO INTO POLE BARRIER AT 35.1 MPH TEST NO. 5
 VEHICLE CG X-AXIS VELOCITY

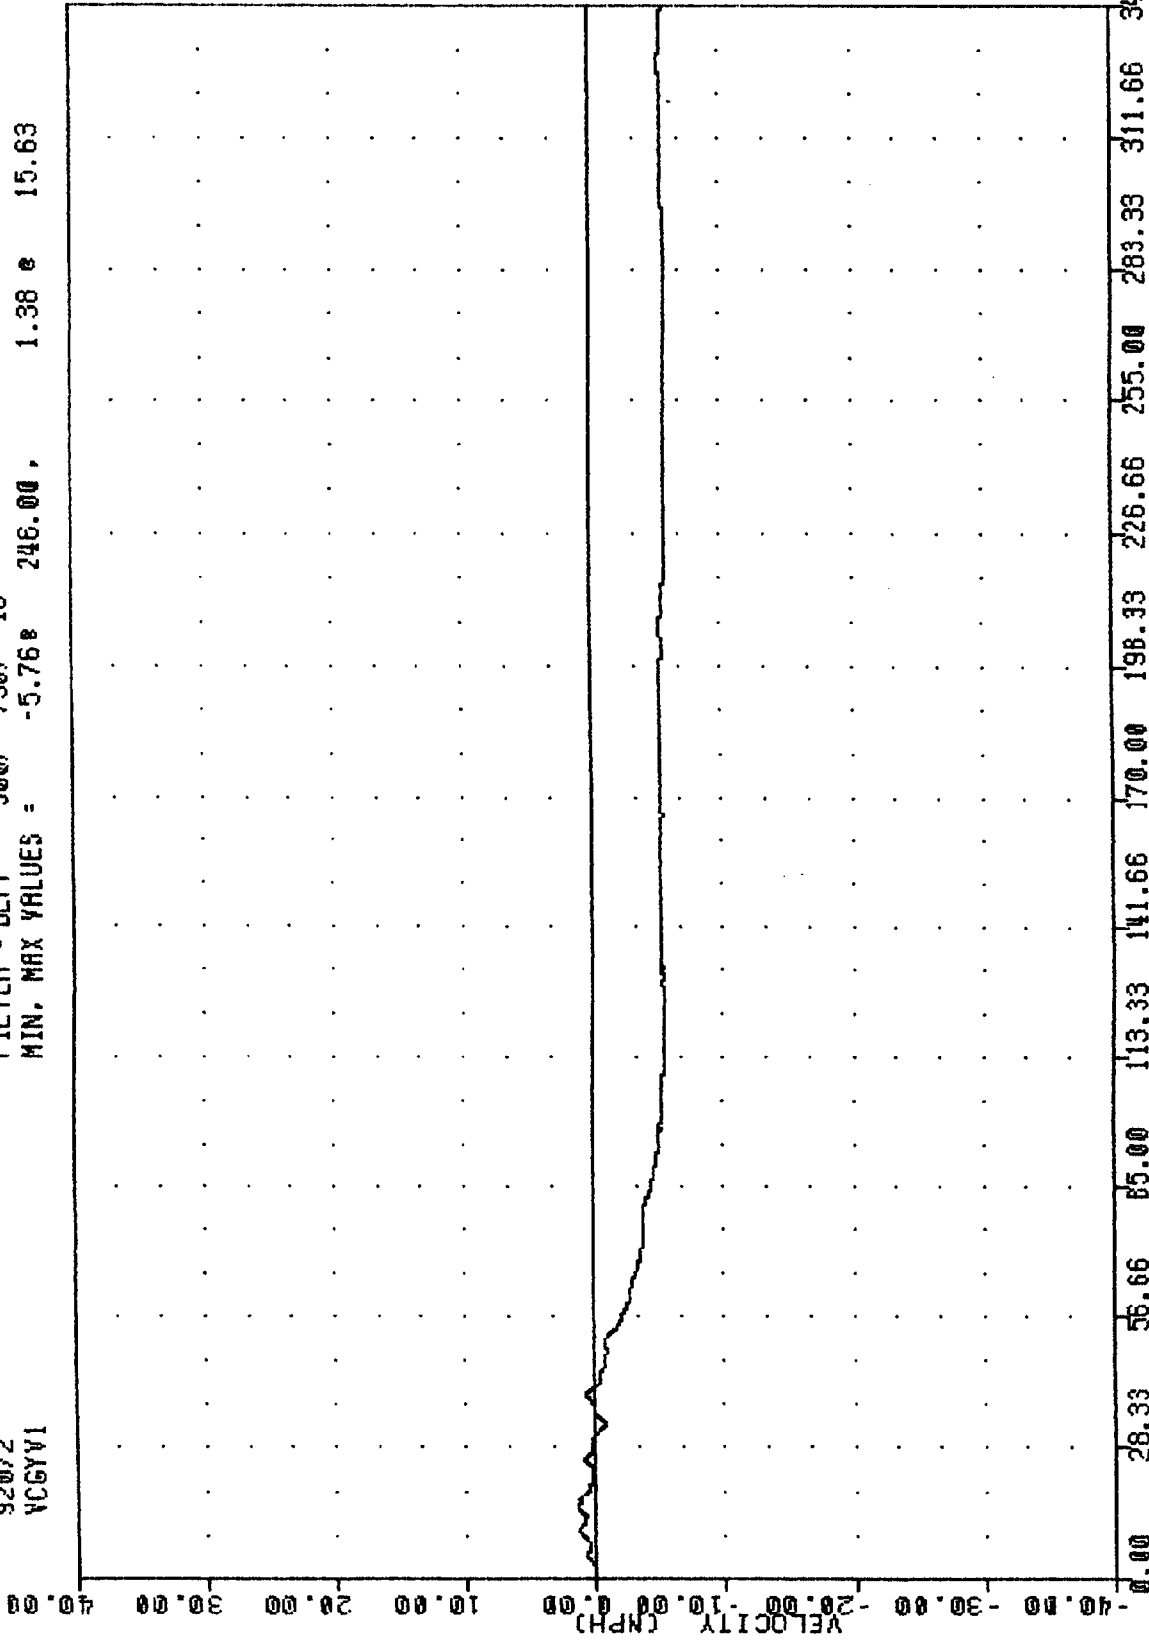
FILTER = BLPP 300/ 750/ -16
 MIN, MAX VALUES = -5.76e 246.00 , 1.38 e 15.63

1985 FORD TEMPO INTO POLE BARRIER AT 35.1 MPH TEST NO. 5
 VEHICLE CG Y-AXIS VELOCITY

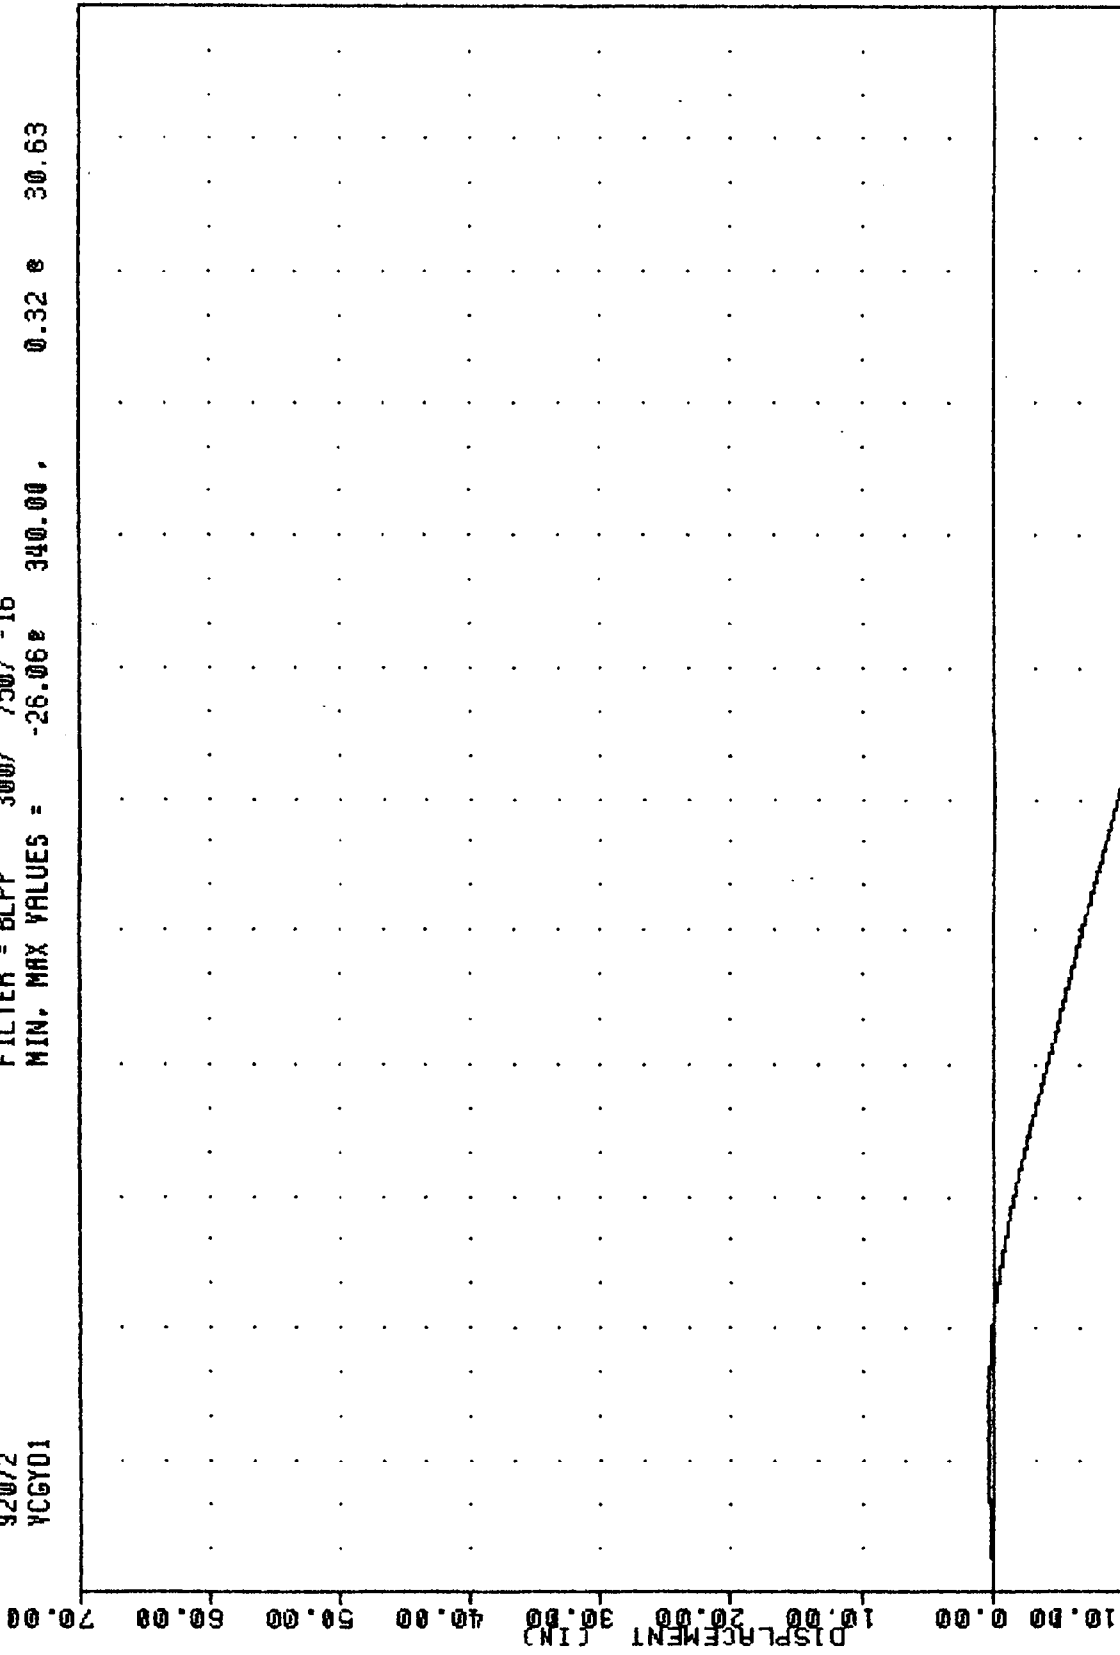
FILTER = BLPP 300/ 750/ -16
 MIN. MAX VALUES = -26.06 340.00 , 0.32 30.63

1985 FORD TEMPO INTO POLE BARRIER AT 35.1 MPH TEST NO. 5
 VEHICLE CG Y-AXIS DISPLACEMENT

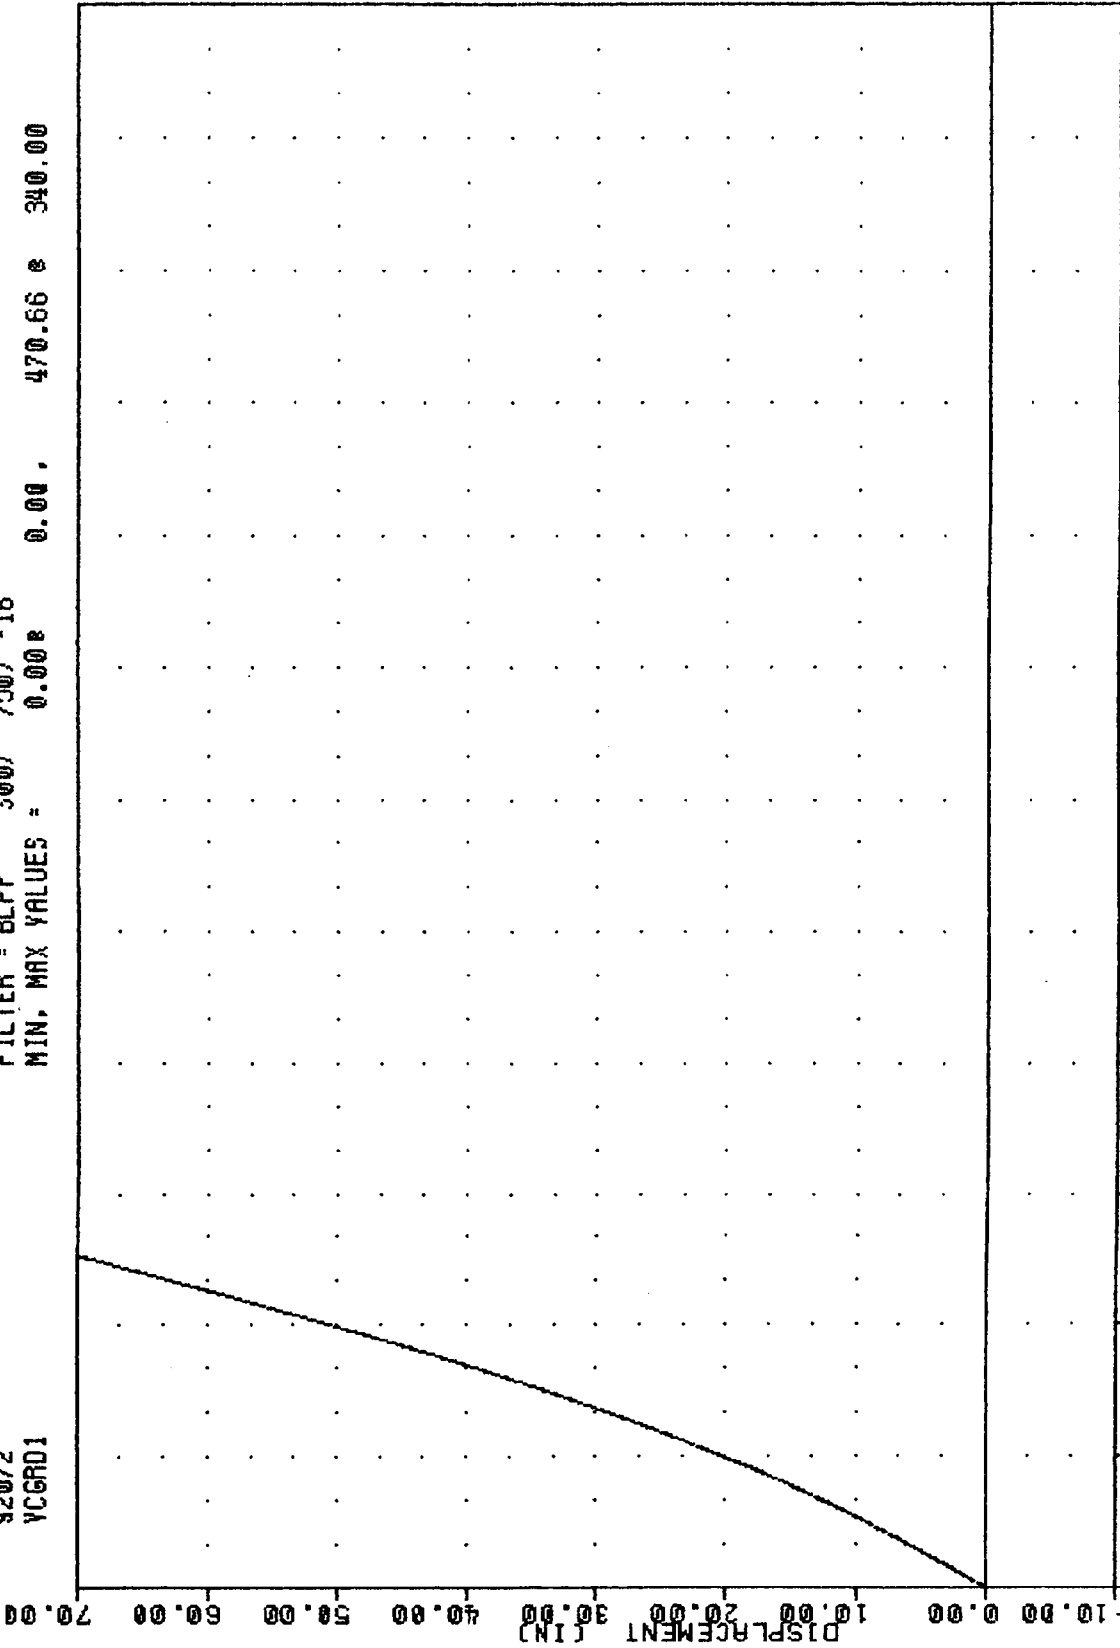
FILTER = BLPP 300/ 750/ -16
 MIN. MAX VALUES = 0.00 0.00 470.66 e 340.00

0.00 28.33 56.66 85.00 113.33 141.66 170.00 198.33 226.66 255.00 283.33 311.66 340.00
 TIME (MSEC)
 1985 FORD TEMPO INTO POLE BARRIER AT 35.1 MPH TEST NO. 5
 VEHICLE CG RESULTANT DISPLACEMENT
