**OFFICE OF MARKET INCENTIVES  
SIDE IMPACT PROTECTION STUDY  
PASSENGER CARS**

**1992 VOLVO 940 GLS, 4-DOOR SEDAN**

**NHTSA NO.: MN5901**

**FINAL REPORT**

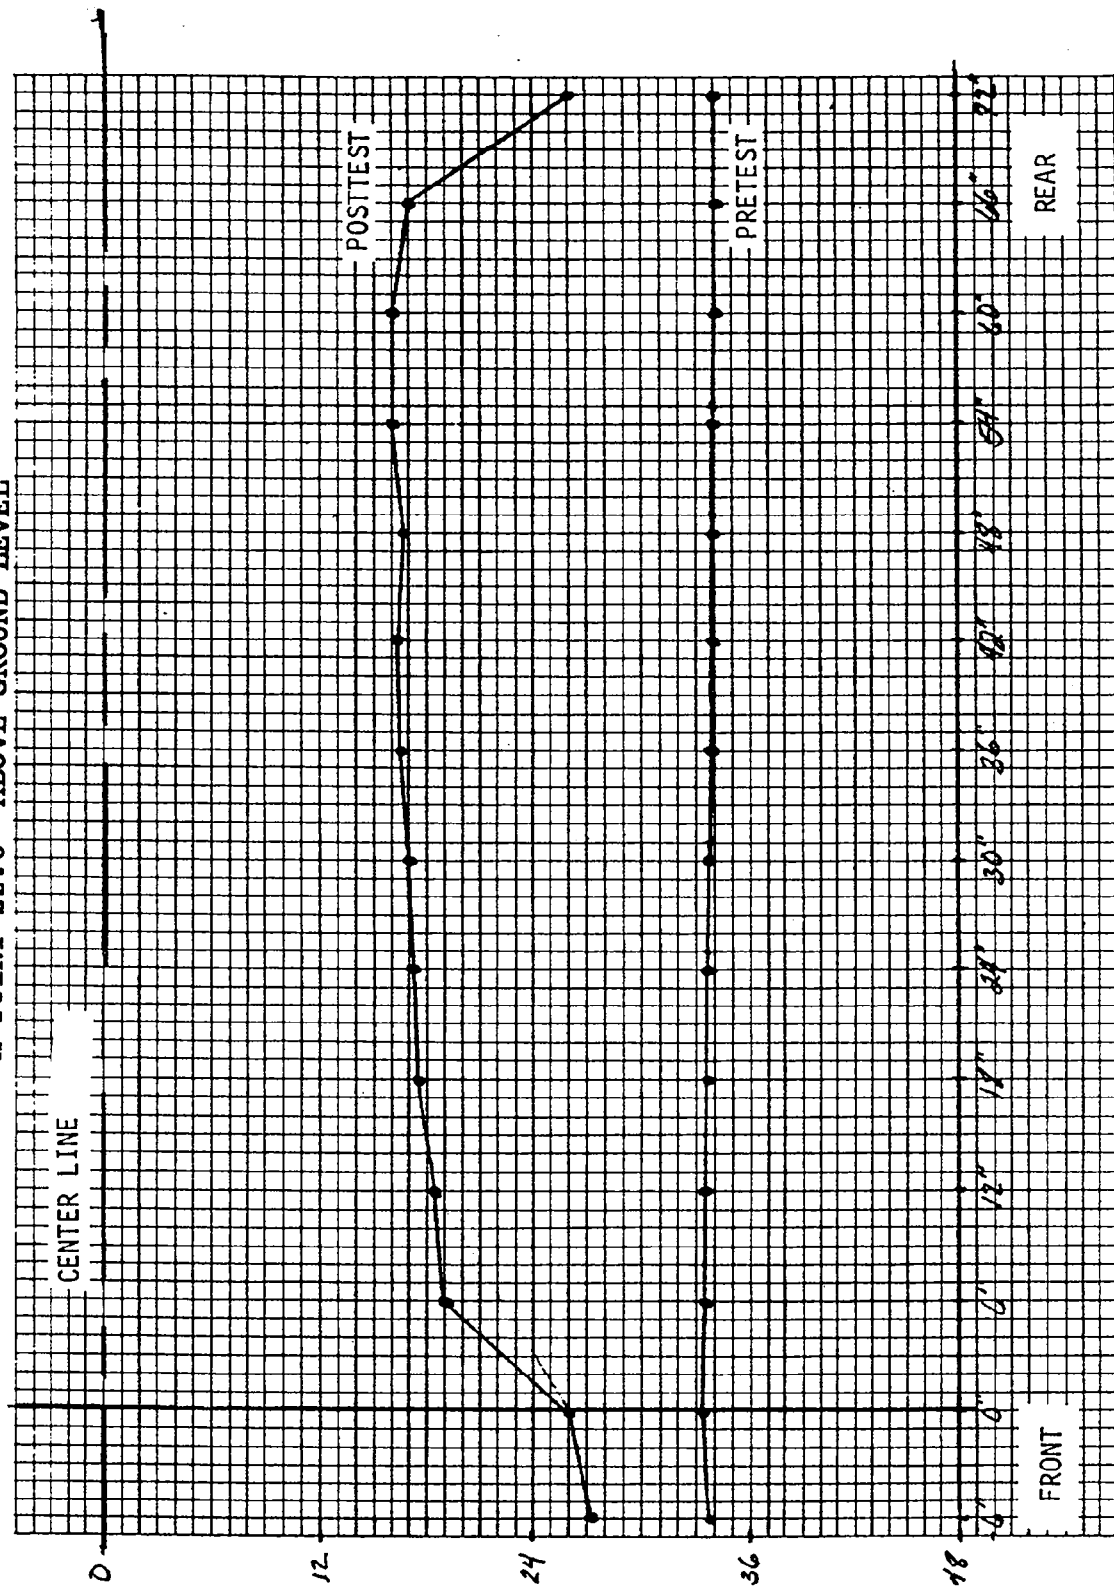
FIGURE 3-4B PRE AND POSTTEST EXTERIOR PROFILE AT LEVEL 2  
H-POINT 22.0" ABOVE GROUND LEVEL

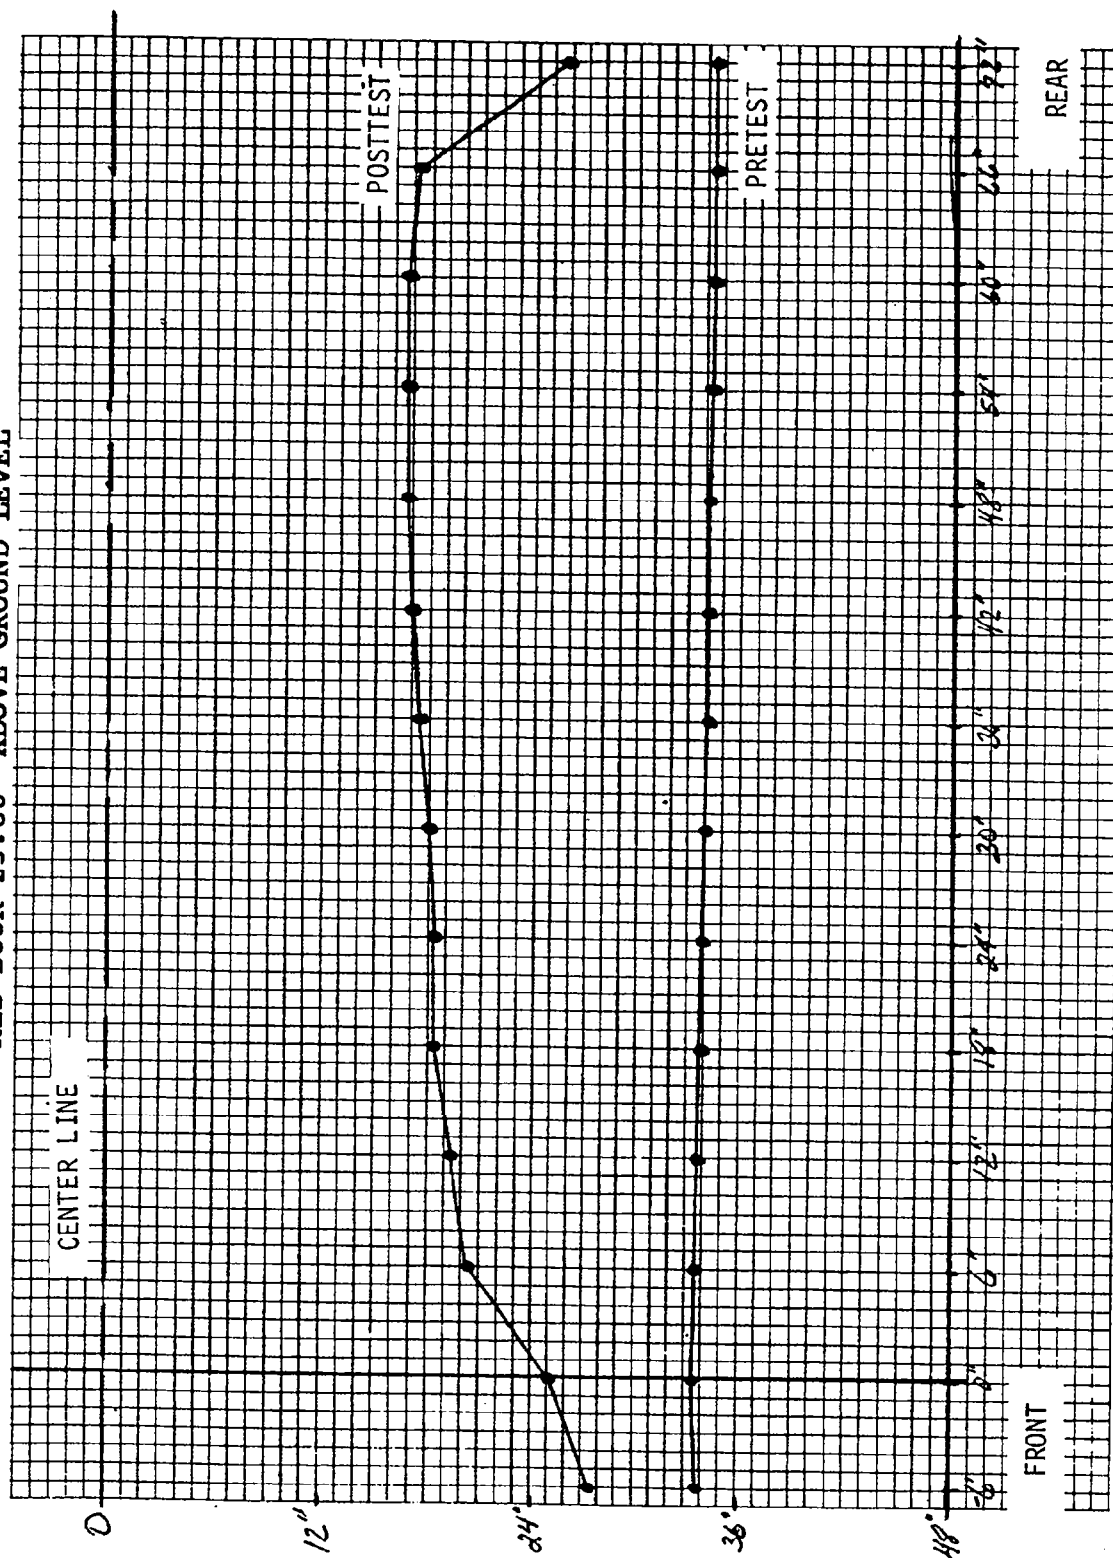
FIGURE 3-4C PRE AND POSTTEST EXTERIOR PROFILE AT LEVEL 3  
MID DOOR 23.60" ABOVE GROUND LEVEL

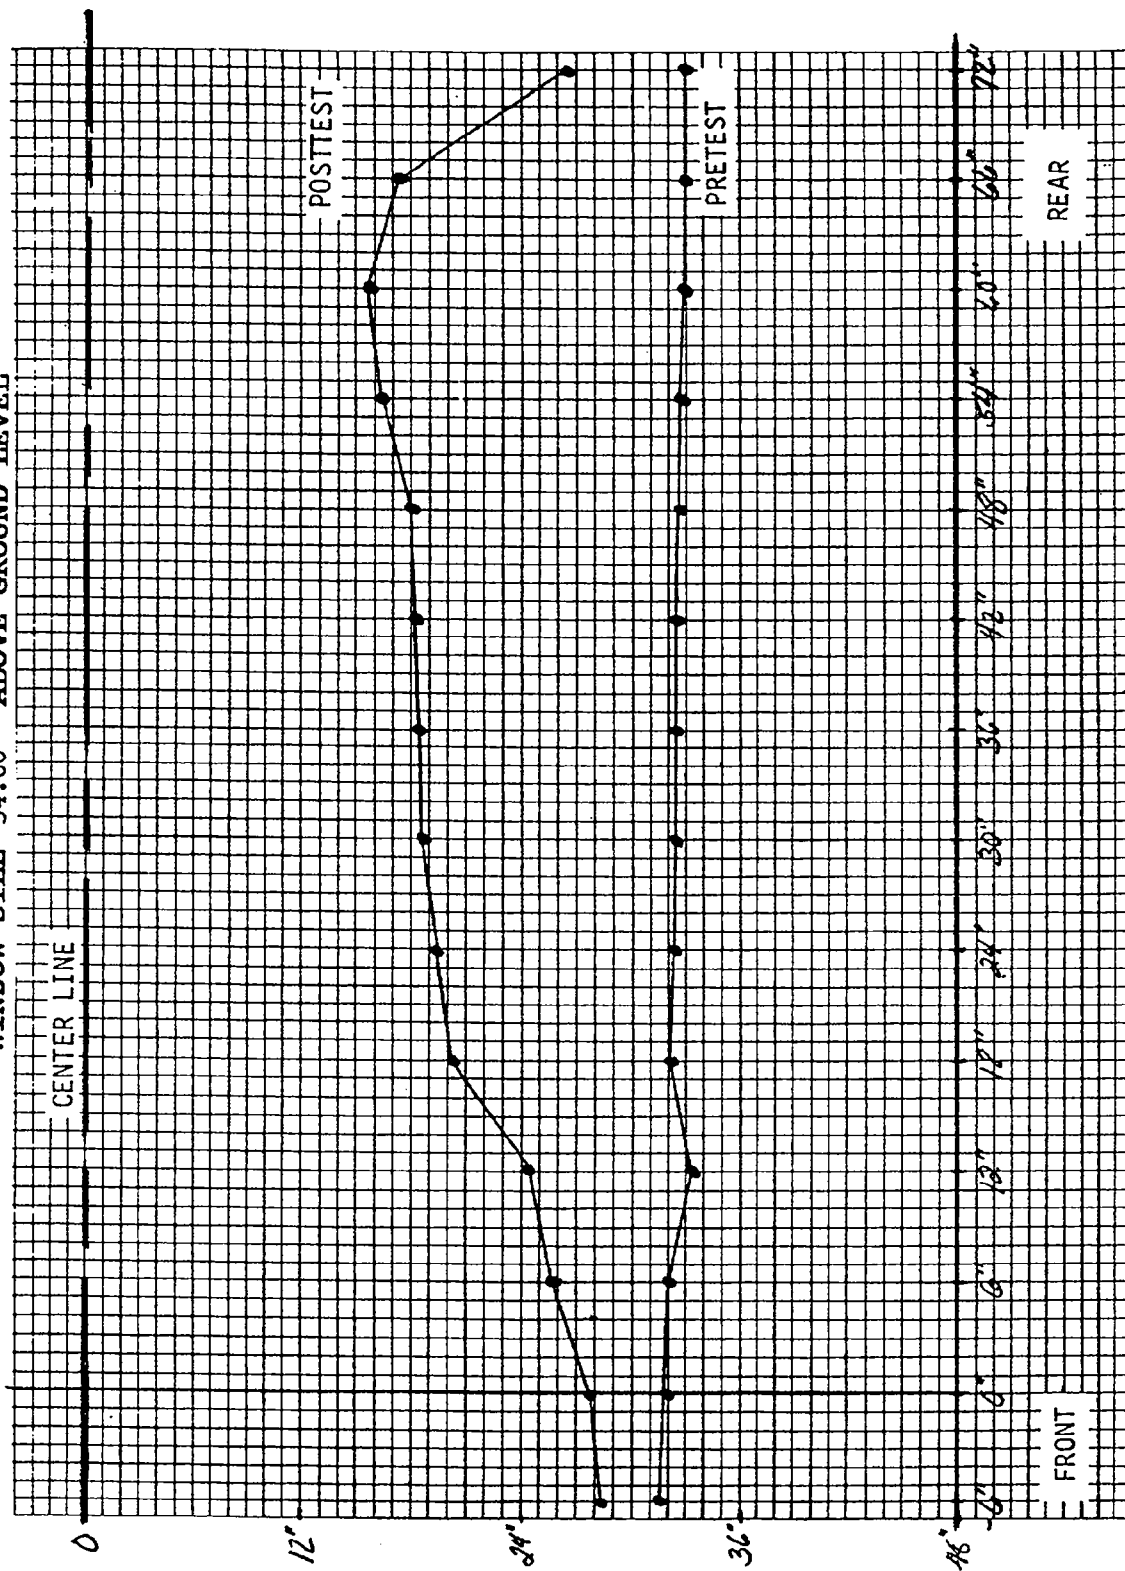
FIGURE 3-4D PRE AND POSTTEST EXTERIOR PROFILE AT LEVEL 4  
WINDOW SILL 34.60' ABOVE GROUND LEVEL

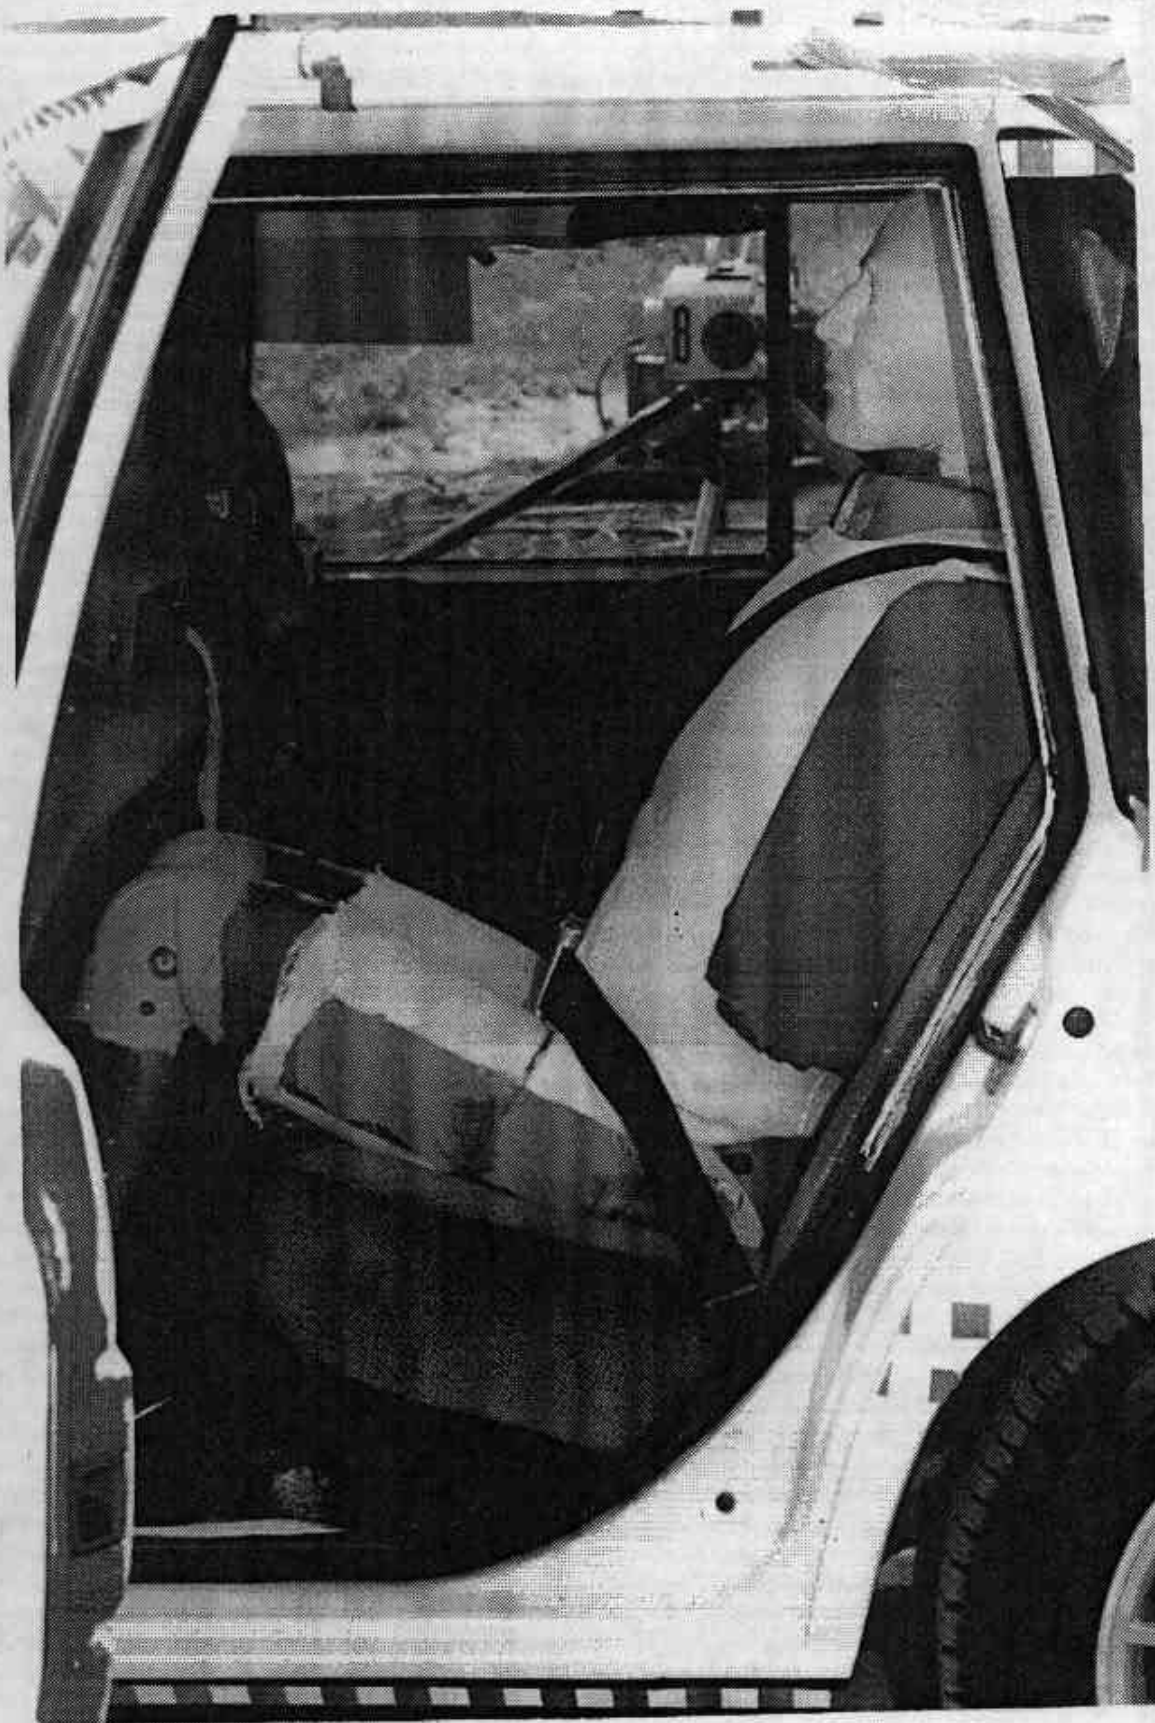
FIGURE 5-19 POSTTEST OCCUPANT COMPARTMENT DRIVER SIDE
