REPORT NUMBER: CAL-92-01

OFFICE OF MARKET INCENTIVES
SIDE IMPACT PROTECTION STUDY
PASSENGER CARS

1992 FORD CROWN VICTORIA
4-DOOR SEDAN

FINAL REPORT

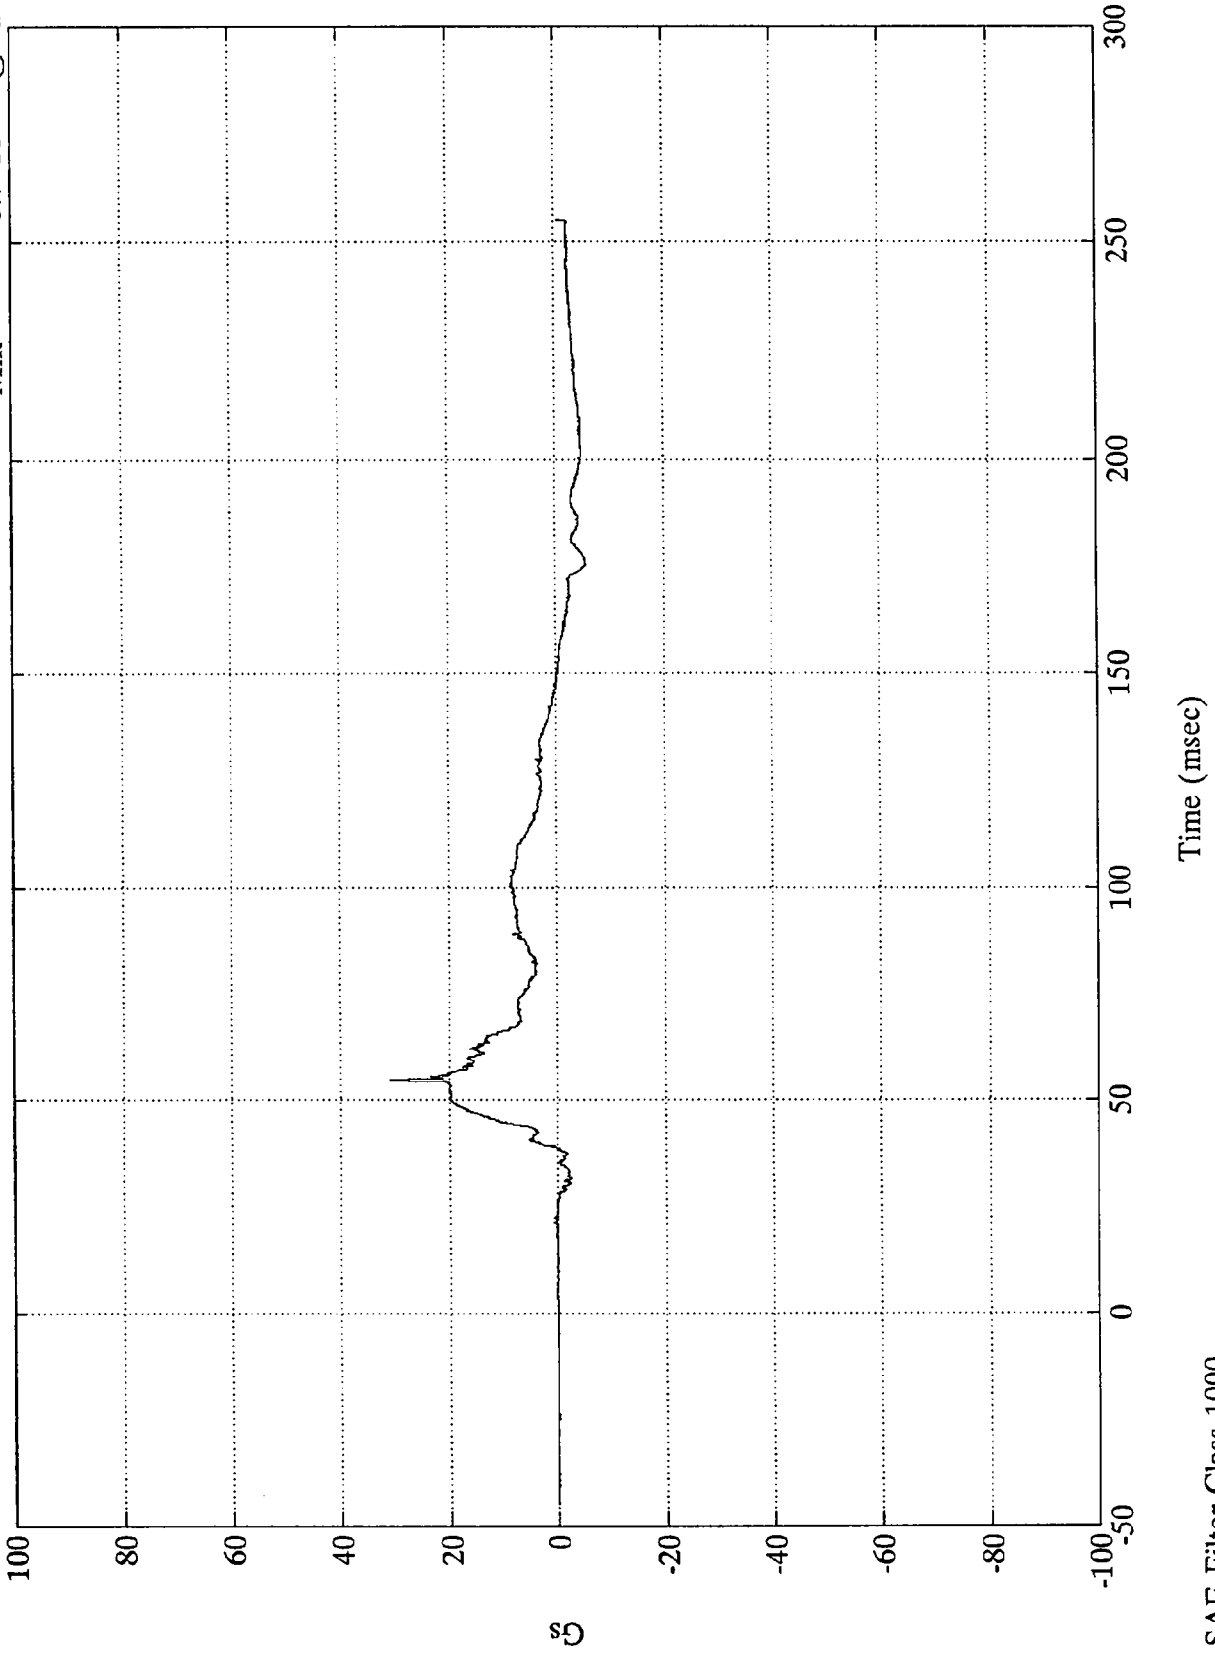
Max = 18.3 Gs @ 66.00 msec
Min = -2.4 Gs @ 248.63 msec

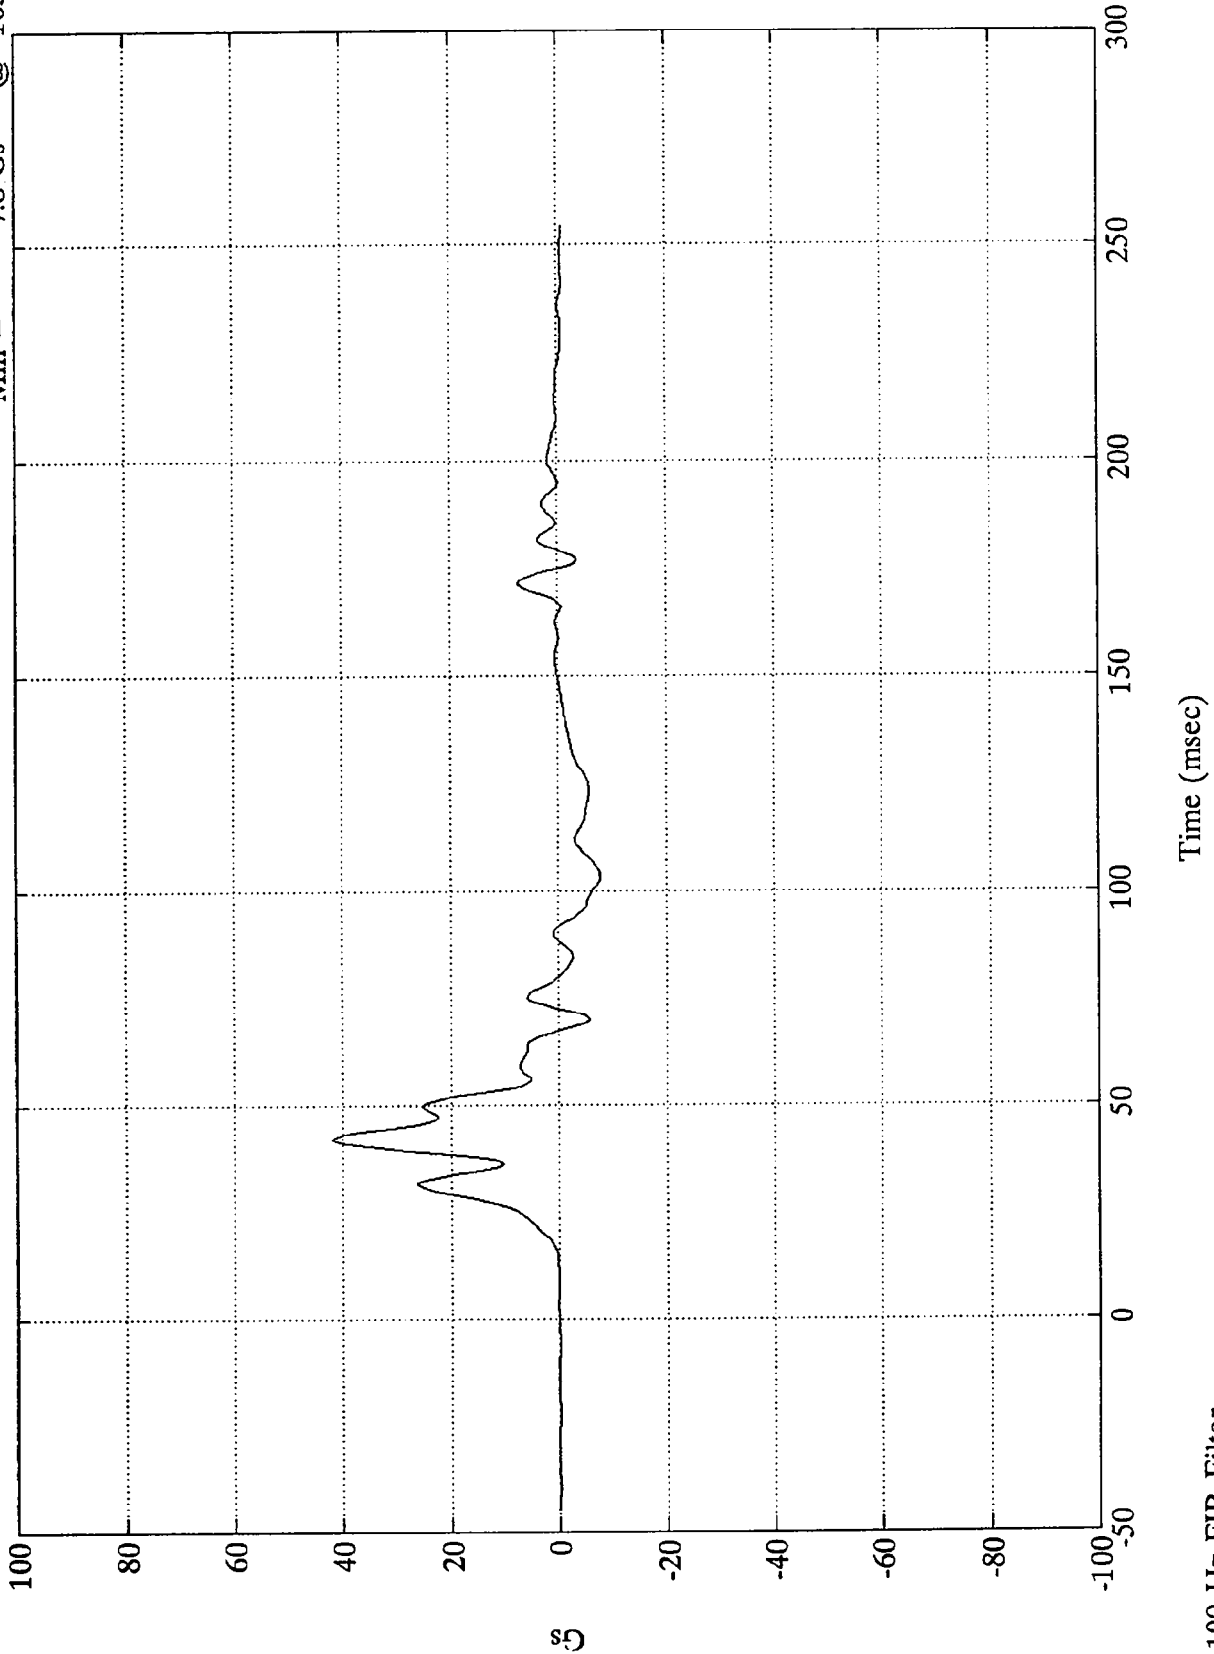
P1 Lower Rib Y

Max = 41.7 Gs @ 41.875 msec
Min = -7.8 Gs @ 103.75 msec

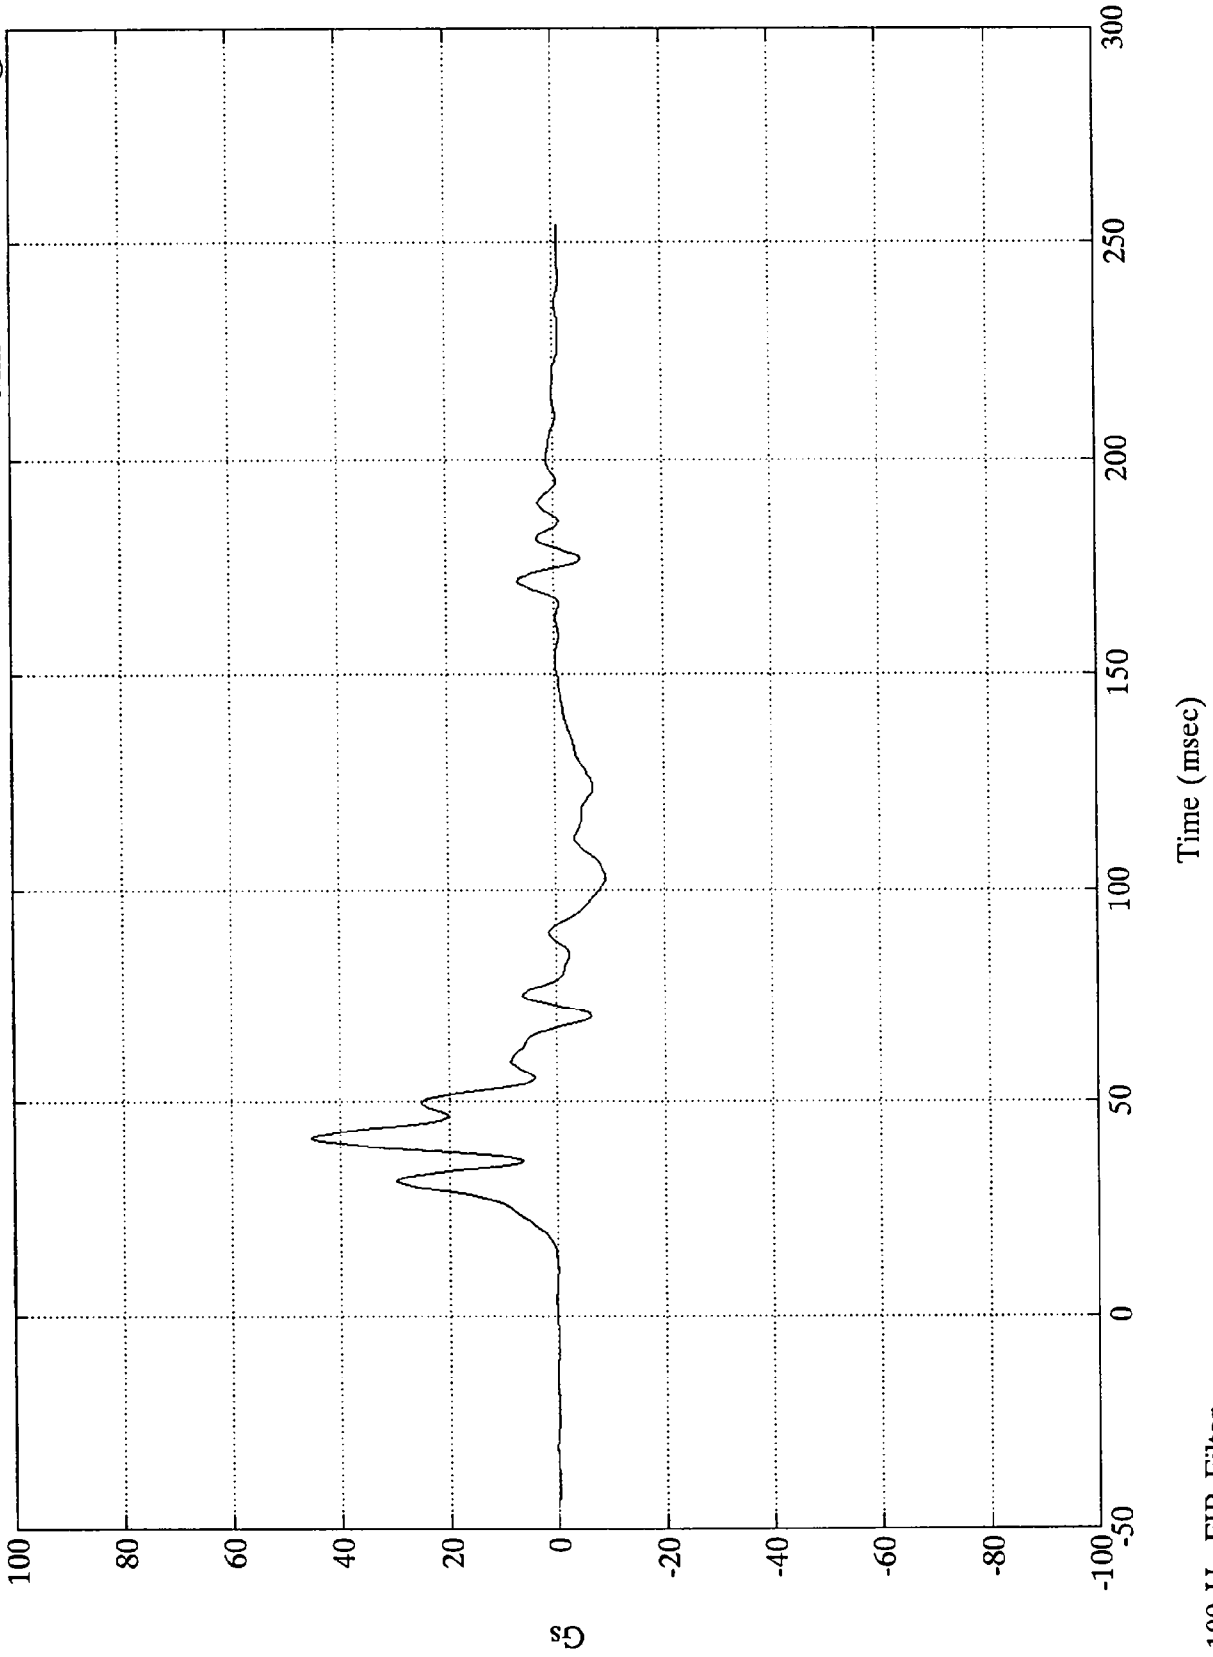
P1 Lower Rib Y(R)

Max = 45.4 Gs @ 41.250 msec
Min = -9.1 Gs @ 103.12 msec

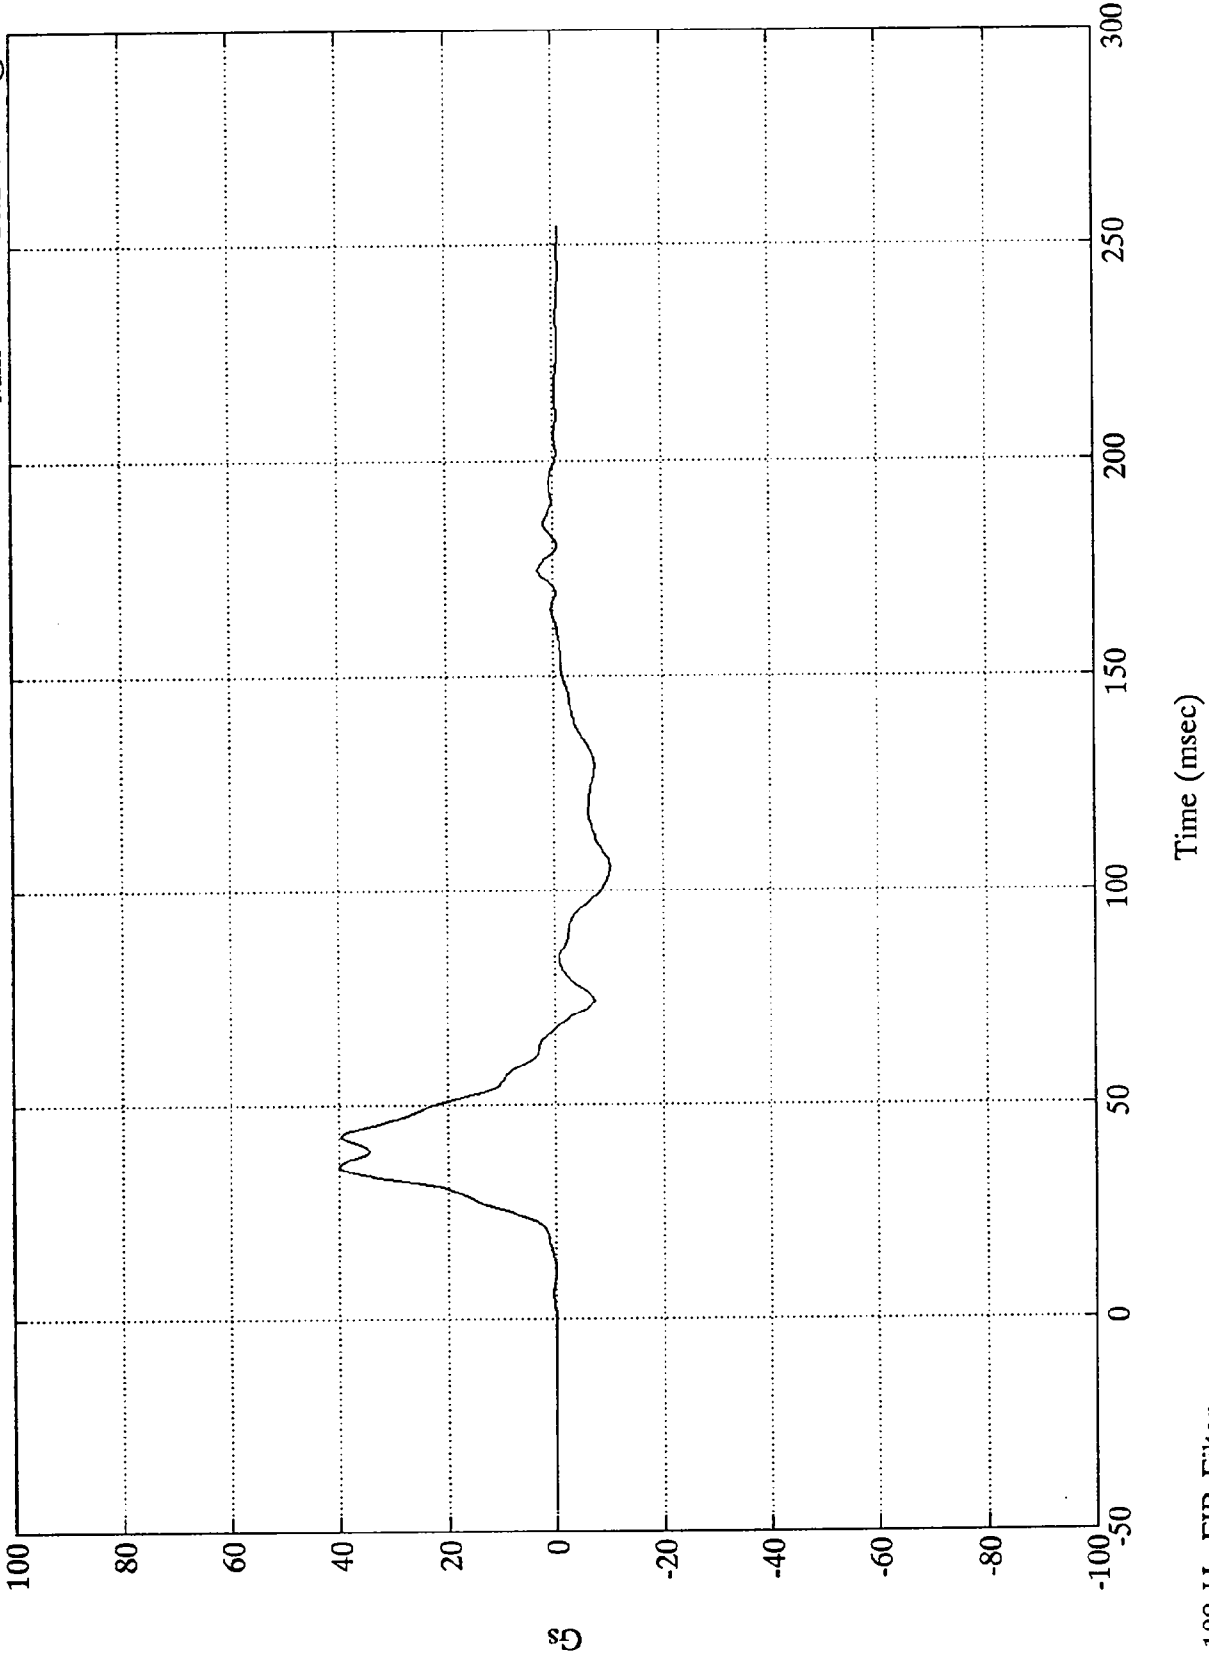
P1 Lower Spine Y

Max = 40.0 Gs @ 35.625 msec
Min = -10.2 Gs @ 105.62 msec

<table><tr> <th style="width: 50%;"></th> <th style="width: 25%; text-align: center;"><u>Driver SID</u></th> <th style="width: 25%; text-align: center;"><u>Left Rear SID</u></th> </tr><tr> <td>Lower Spine Acceleration</td> <td style="text-align: center;">40.0 g's</td> <td>after</td> </tr></table>

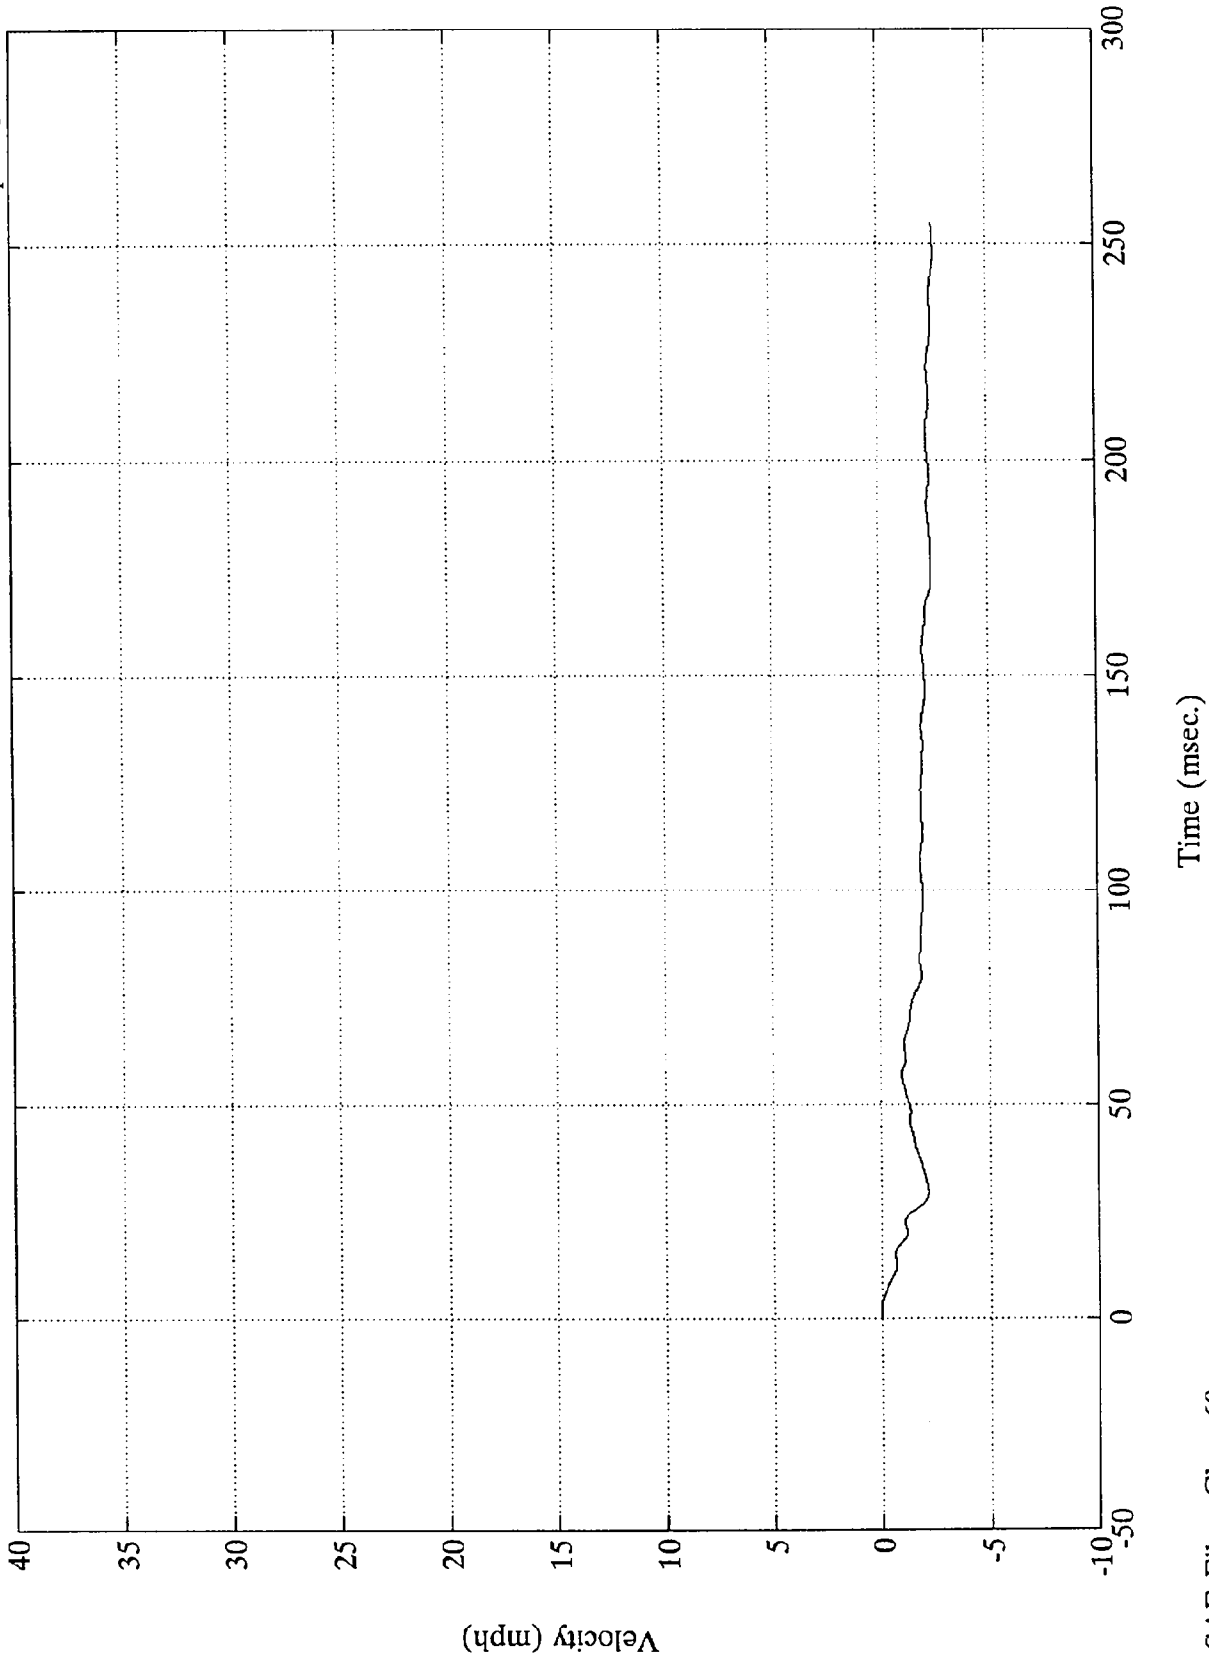
V1 Right Front Sill X

Max = 0.03 mph @ 2.16 msec
Min = -2.60 mph @ 247.68 msec

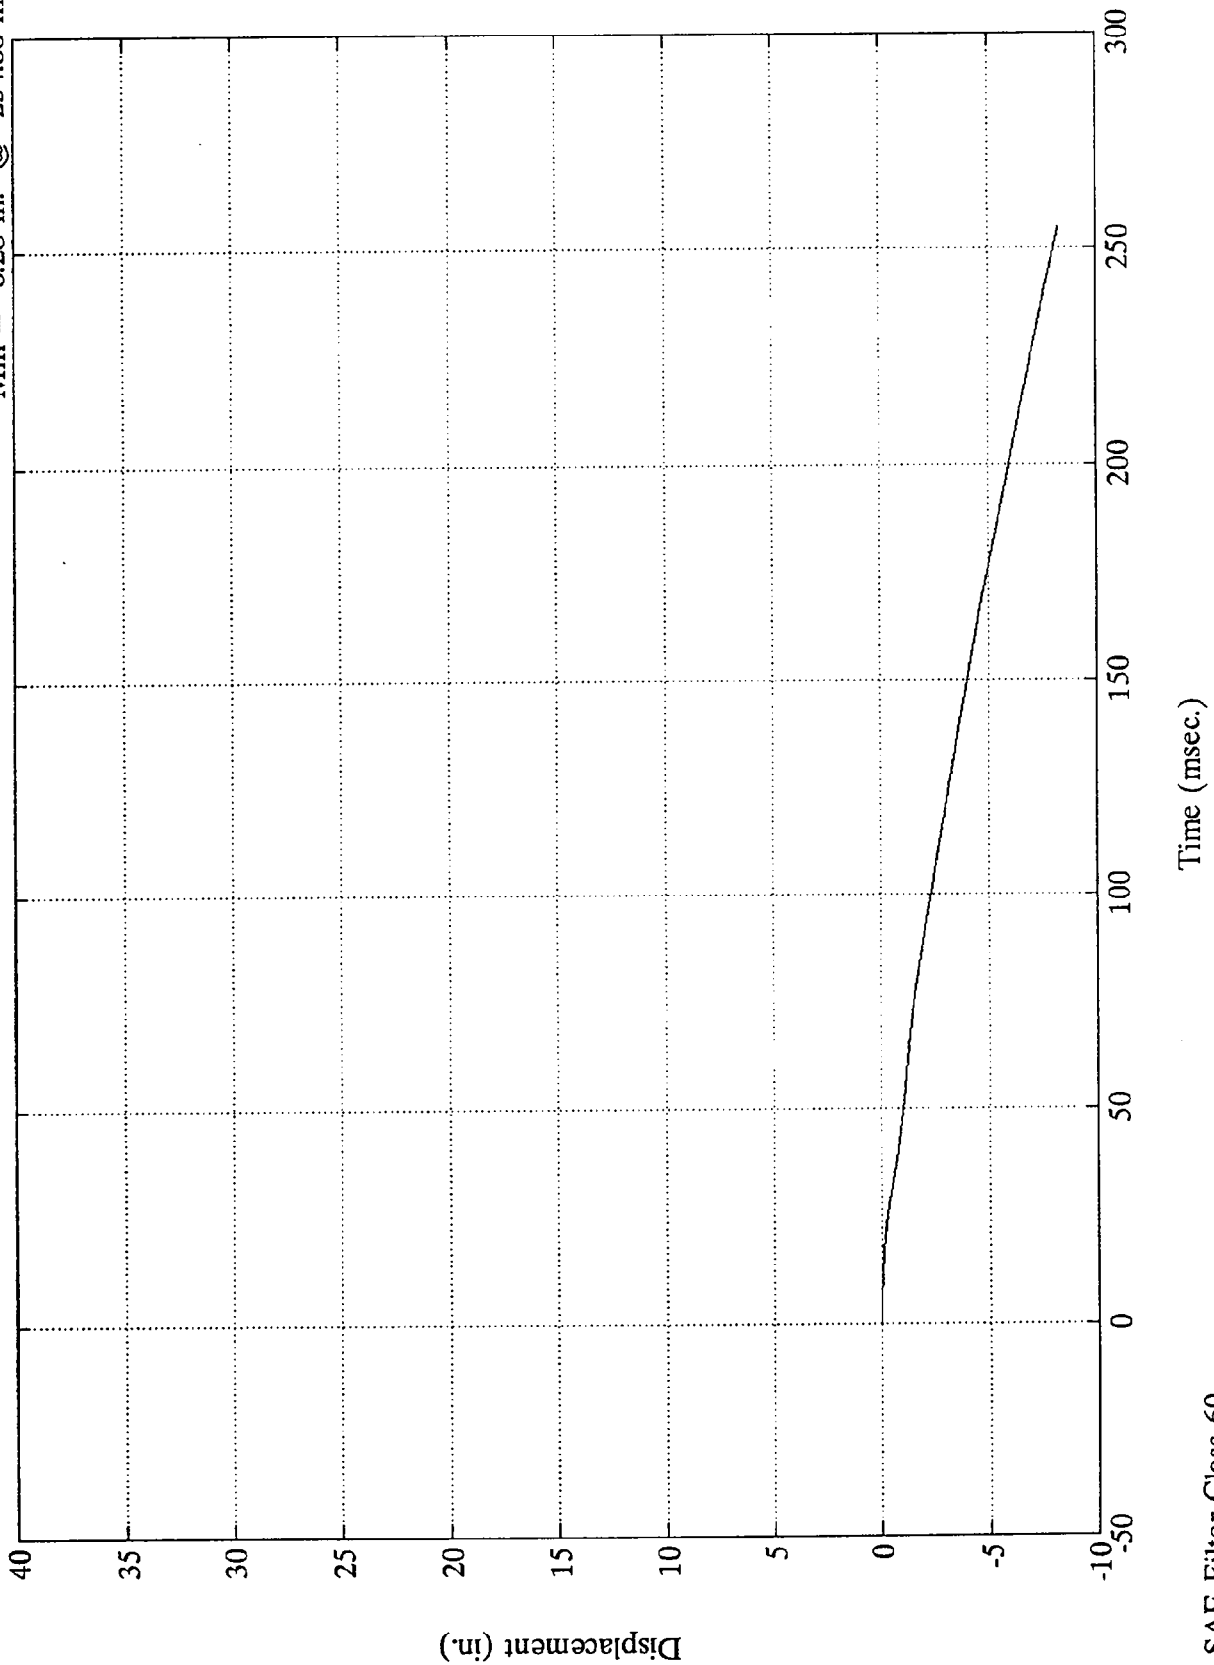
V1 Right Front Sill X

Max = 0.00 in. @ 3.84 msec
Min = -8.28 in. @ 254.88 msec

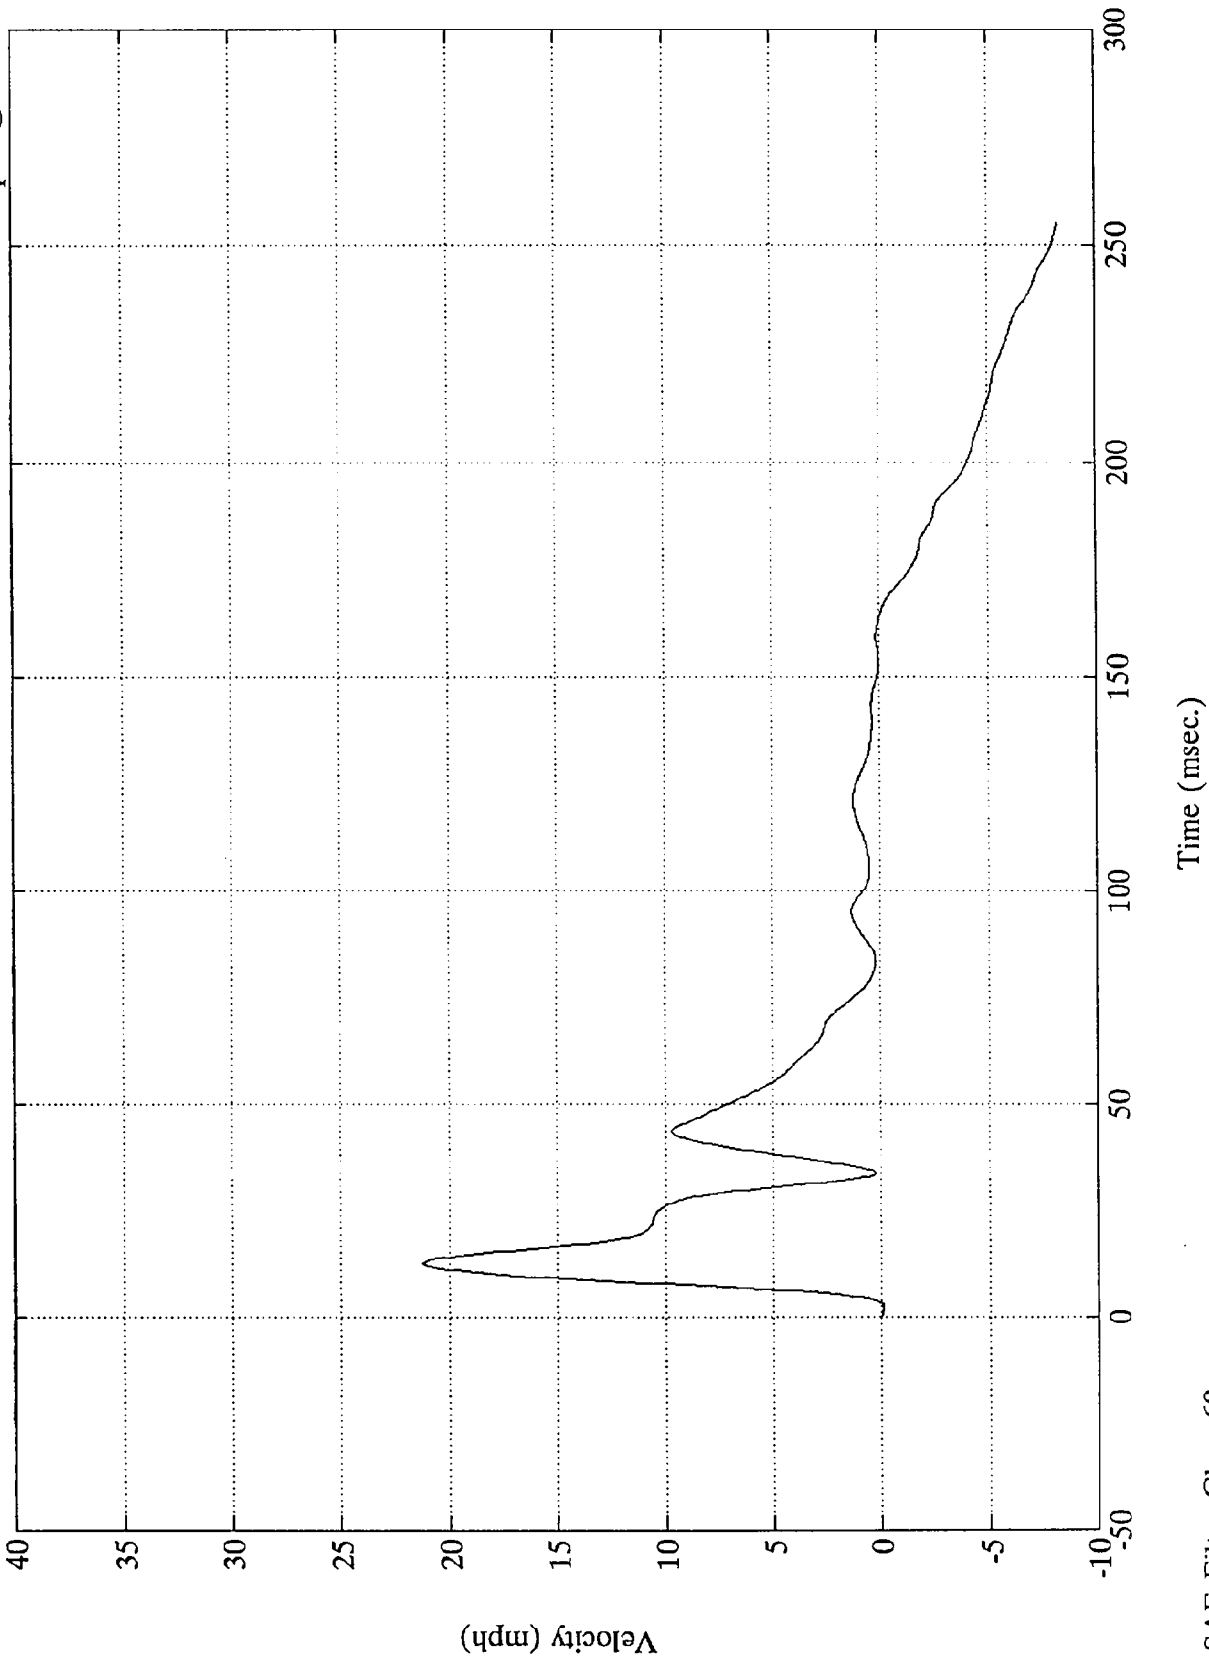
V1 L. Front Door Center Y

Max = 21.21 mph @ 12.48 msec
Min = -8.27 mph @ 254.88 msec

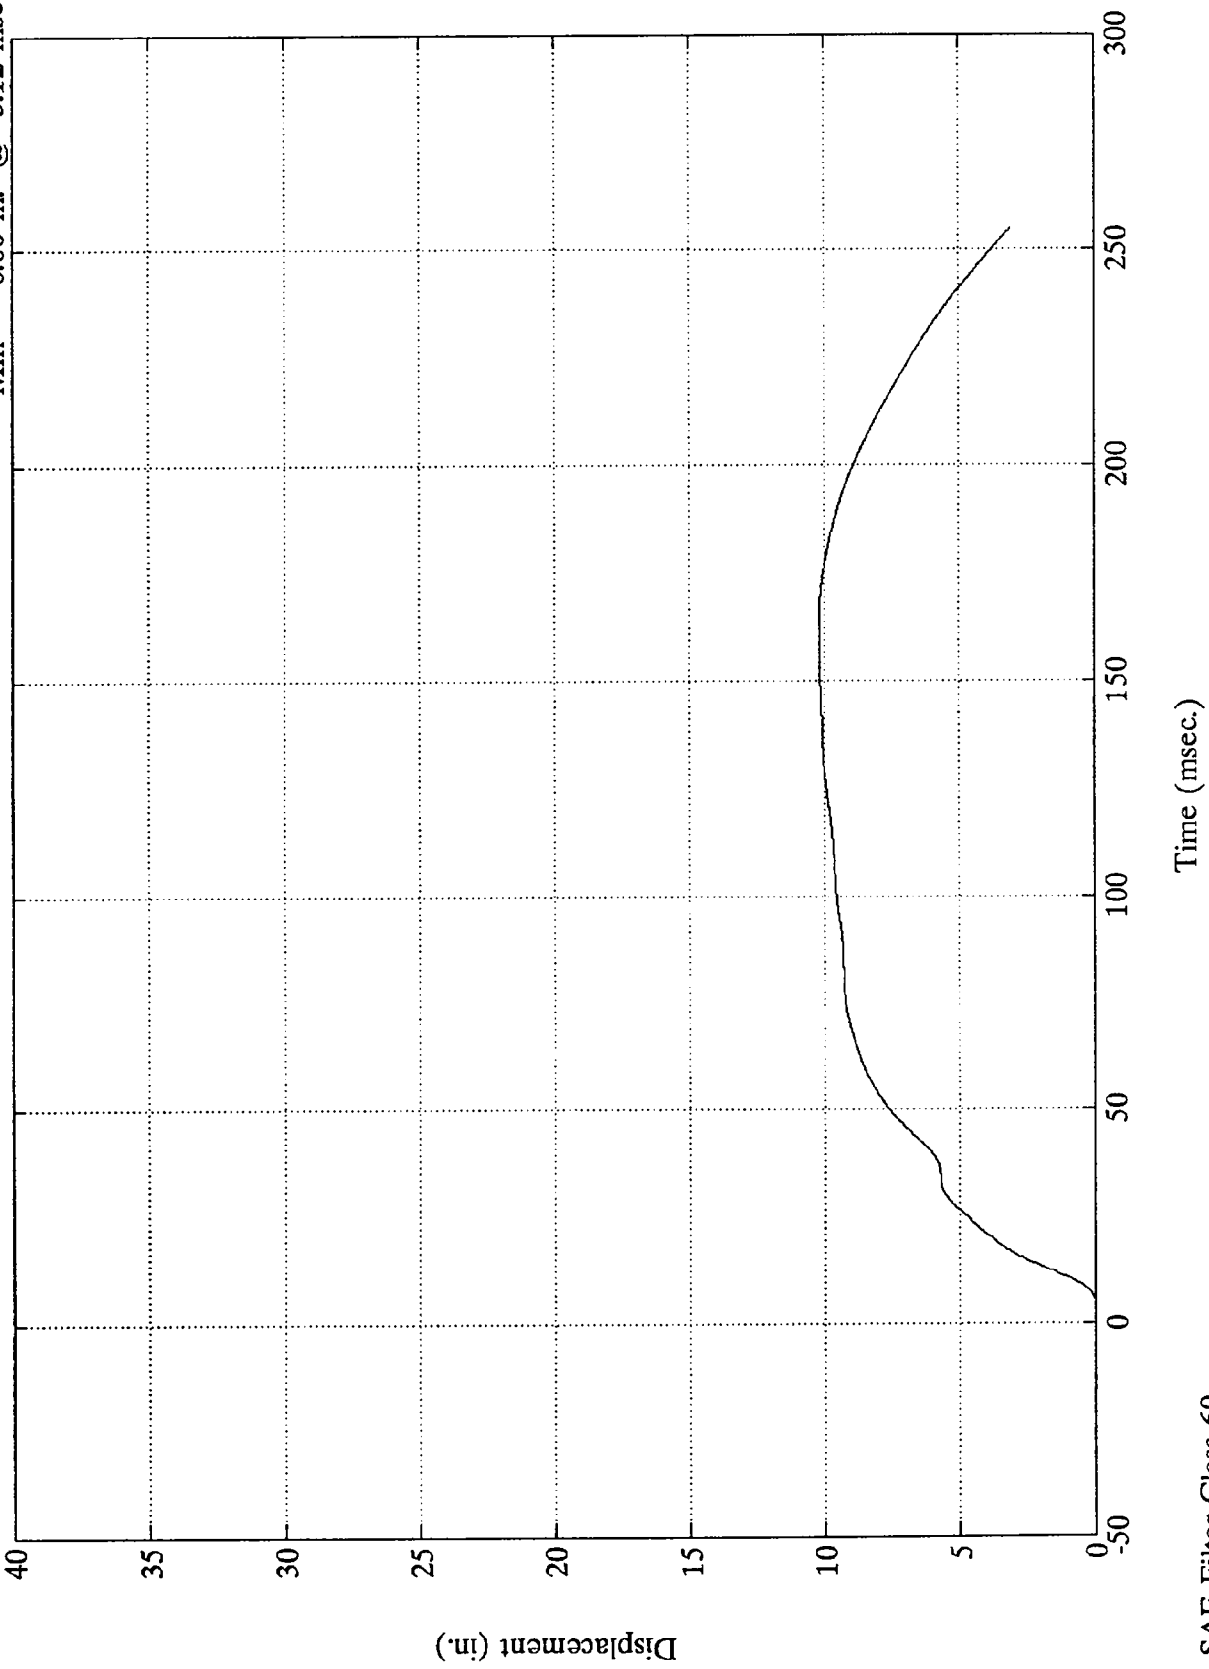
V1 L Front Door Center Y

Max = 10.16 in. @ 166.80 msec
Min = -0.00 in. @ 3.12 msec

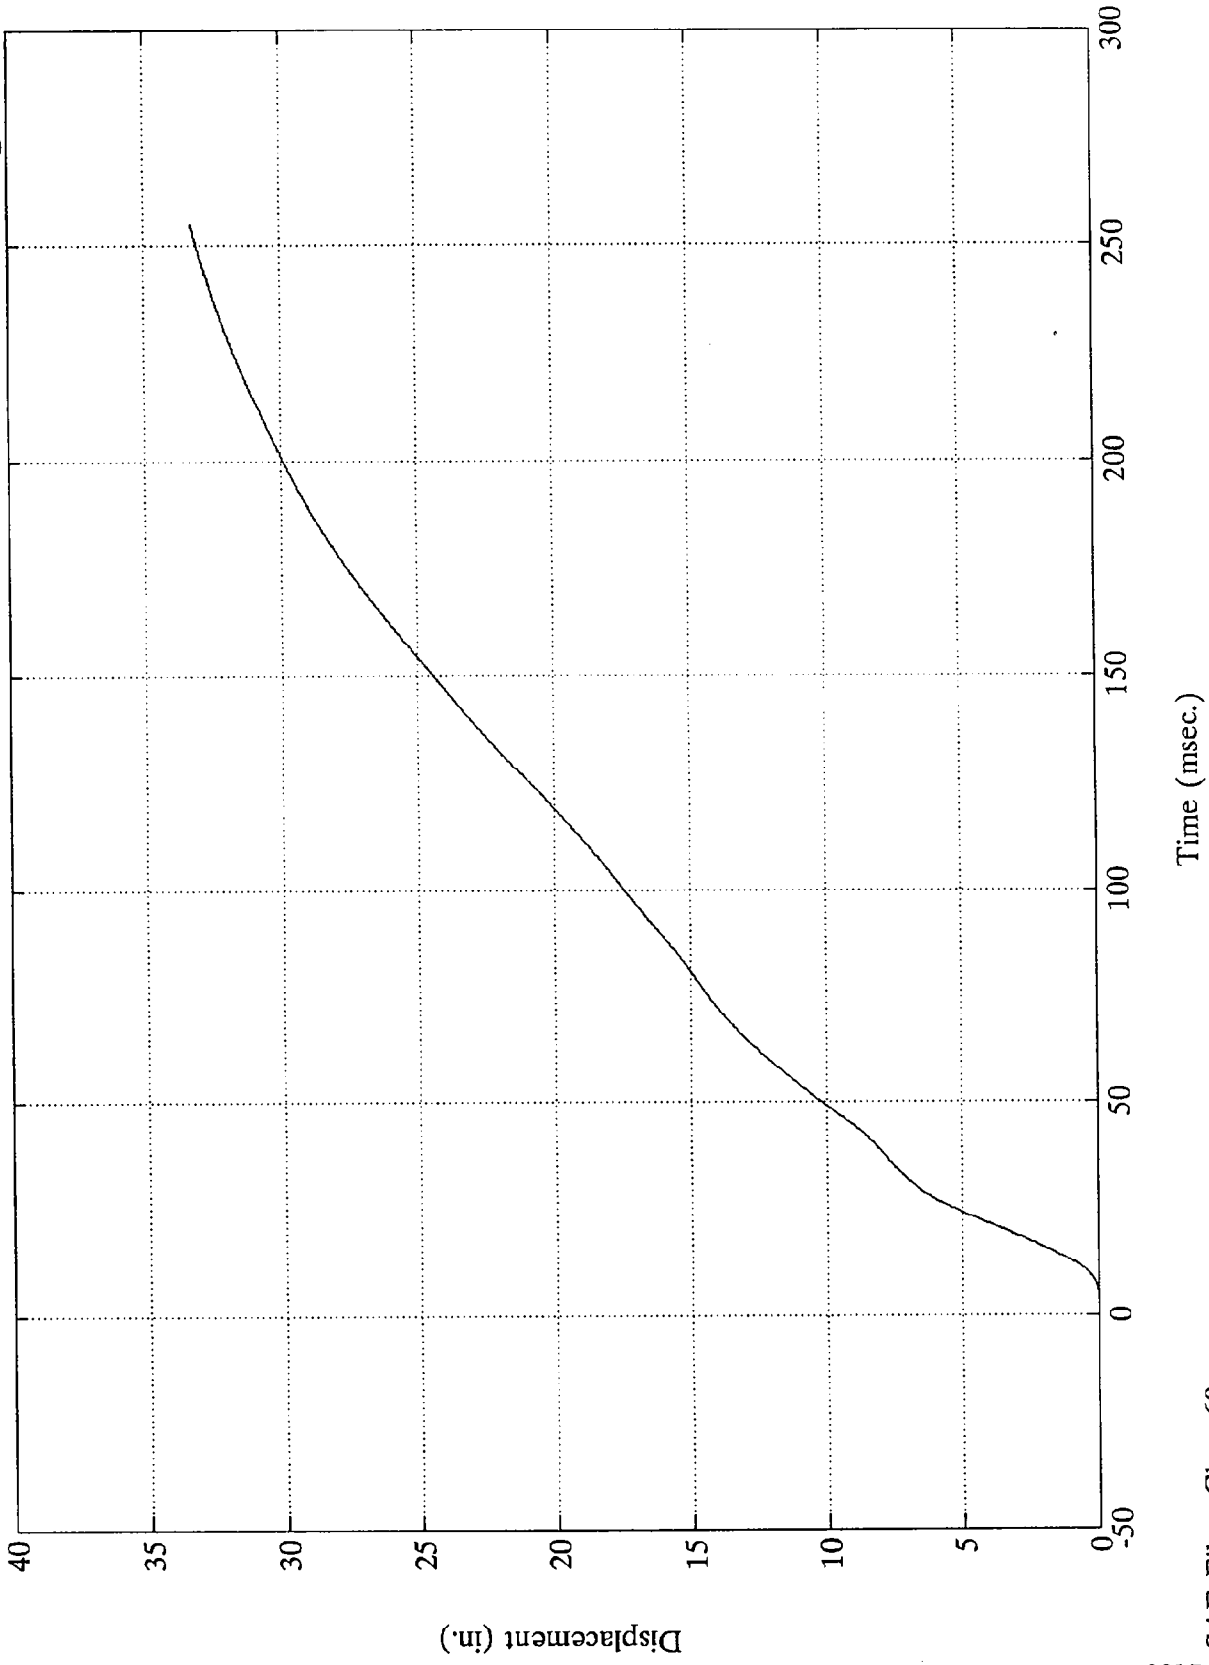
V1 L Front Door Mid Y

Max = 33.25 in. @ 254.88 msec
Min = -0.00 in. @ 1.20 msec
