**OFFICE OF MARKET INCENTIVES  
SIDE IMPACT PROTECTION STUDY  
PASSENGER CARS**

1992 NISSAN SENTRA, 4 DOOR SEDAN

NHTSA NO. MN5203

FINAL REPORT

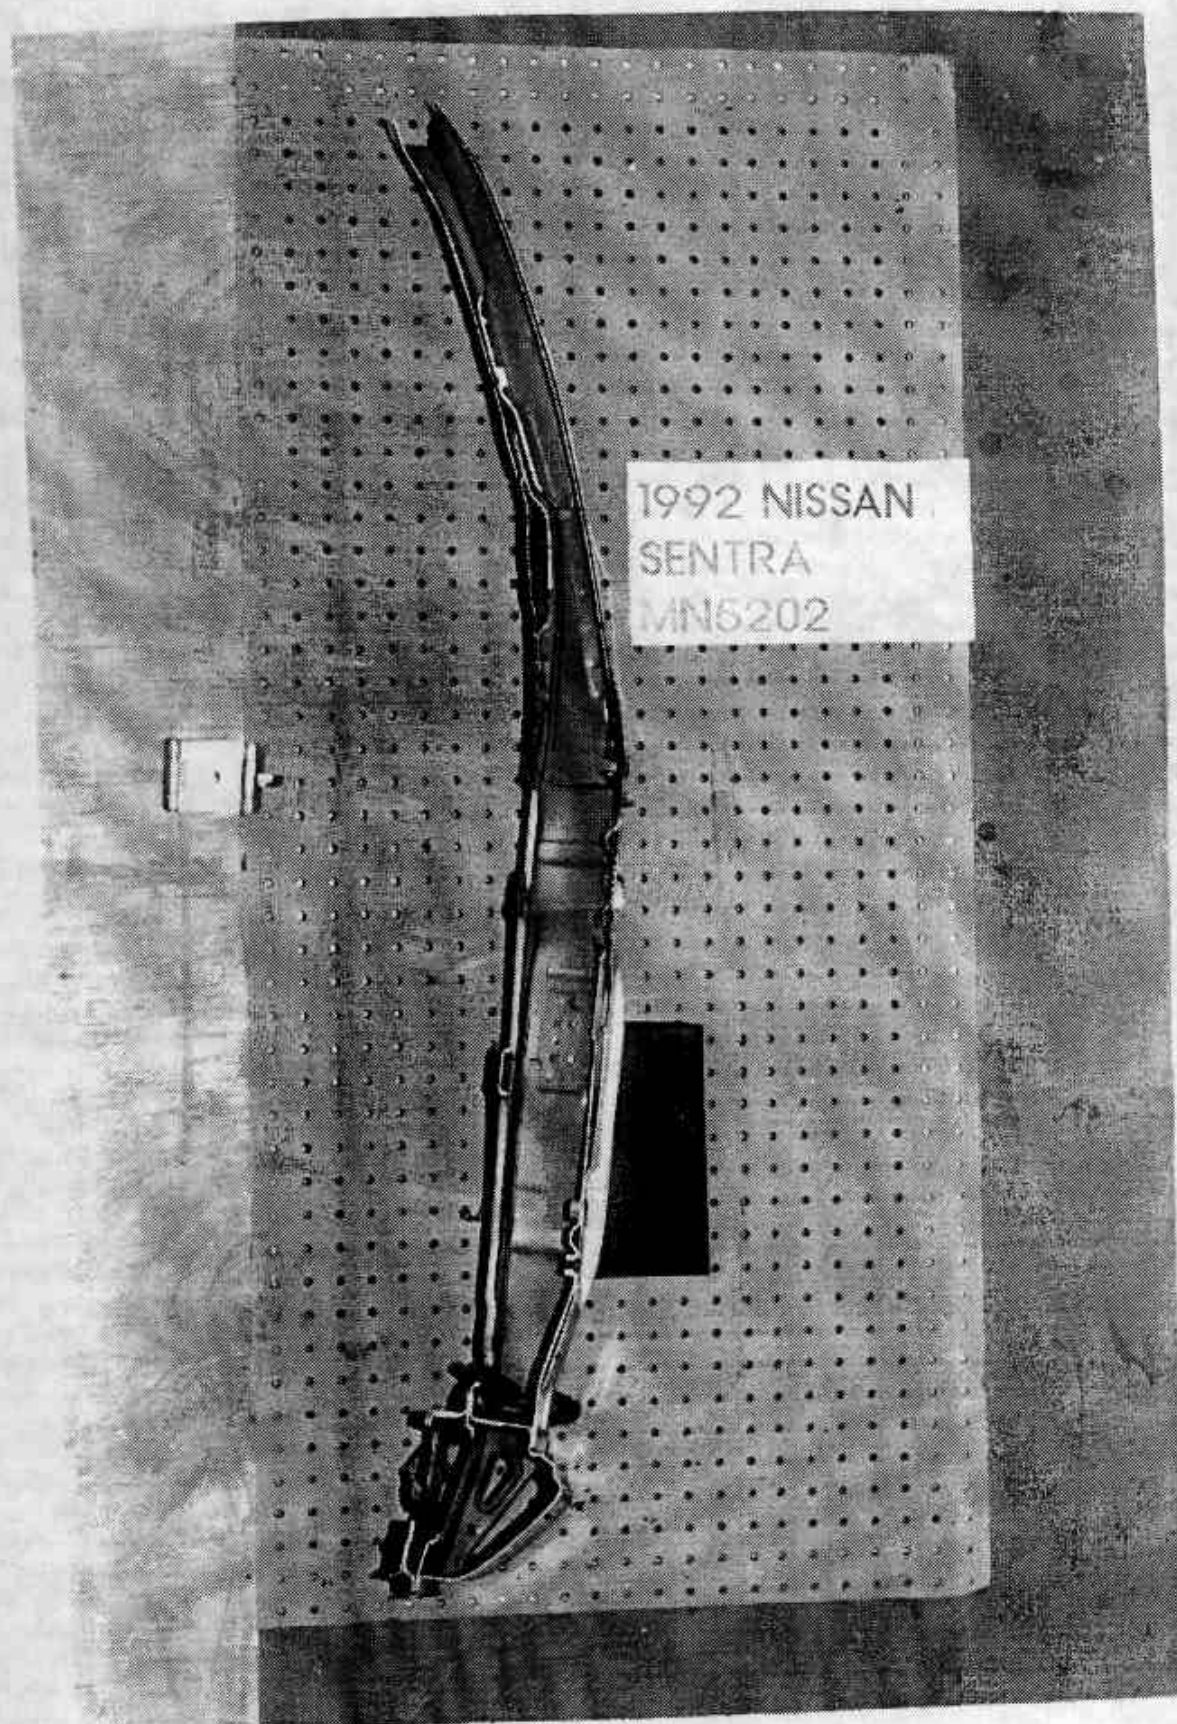
FIGURE 5-32 1992 NISSAN SENTRA, B-PILLAR CUTOUT - VIEW NO. 1

FIGURE 5-33 1992 NISSAN SENTRA, B-PILLAR CUTOUT - VIEW NO. 2

FIGURE 5-34 1992 NISSAN SENTRA, B-PILLAR CUTOUT - VIEW NO. 3

FIGURE 5-35 1992 NISSAN SENTRA, B-PILLAR CUTOUT - VIEW NO. 4

Pillar Failure: BOTTOM OF B-PILLAR SEPARATED FROM SILL ALONG 8 INCHES ON THE OUTBOARD AND REAR SIDES. BOTTOM OF C-PILLAR SEPARATED FROM SILL ALONG 1 INCH OUTBOARD SIDE.
