**OFFICE OF MARKET INCENTIVES  
SIDE IMPACT PROTECTION STUDY  
PASSENGER CARS**

1992 HONDA ACCORD, 4 DOOR SEDAN

NHTSA NO. MN5305

FINAL REPORT

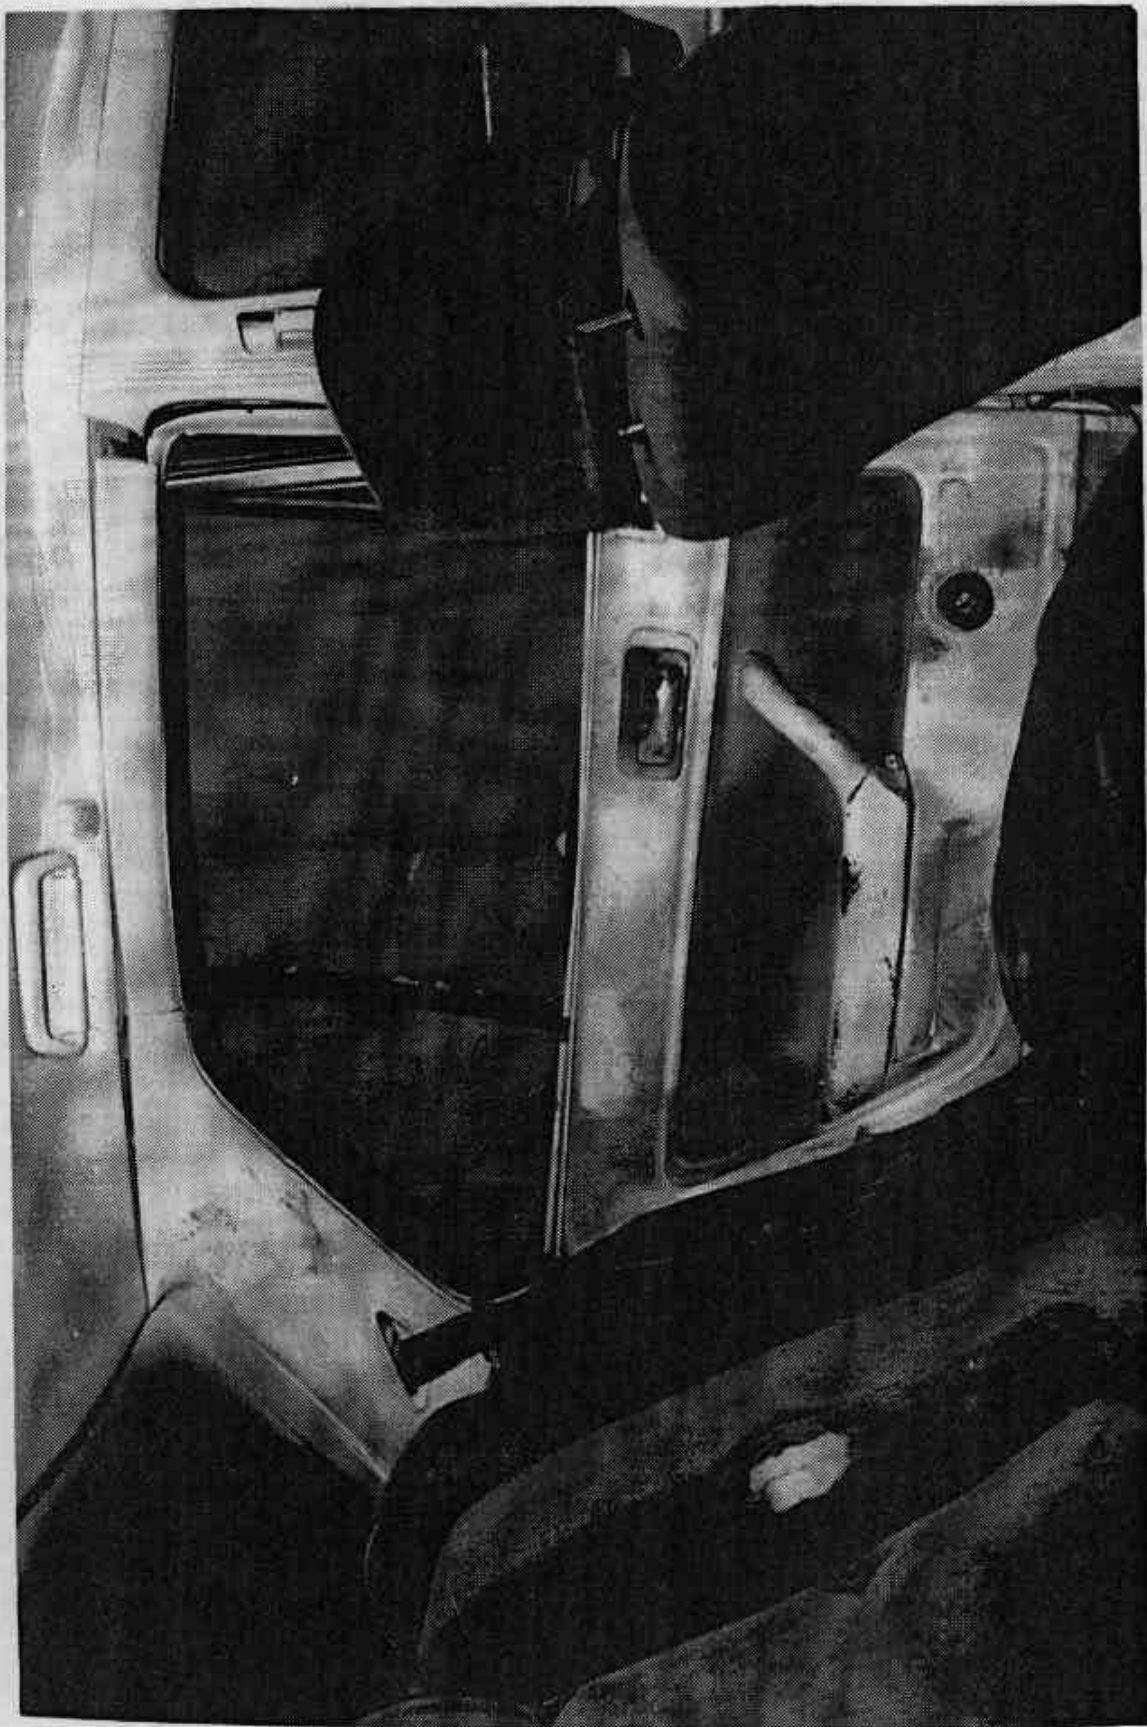
FIGURE 5-32 PASSENGER SEATING POSITION - POSTTEST

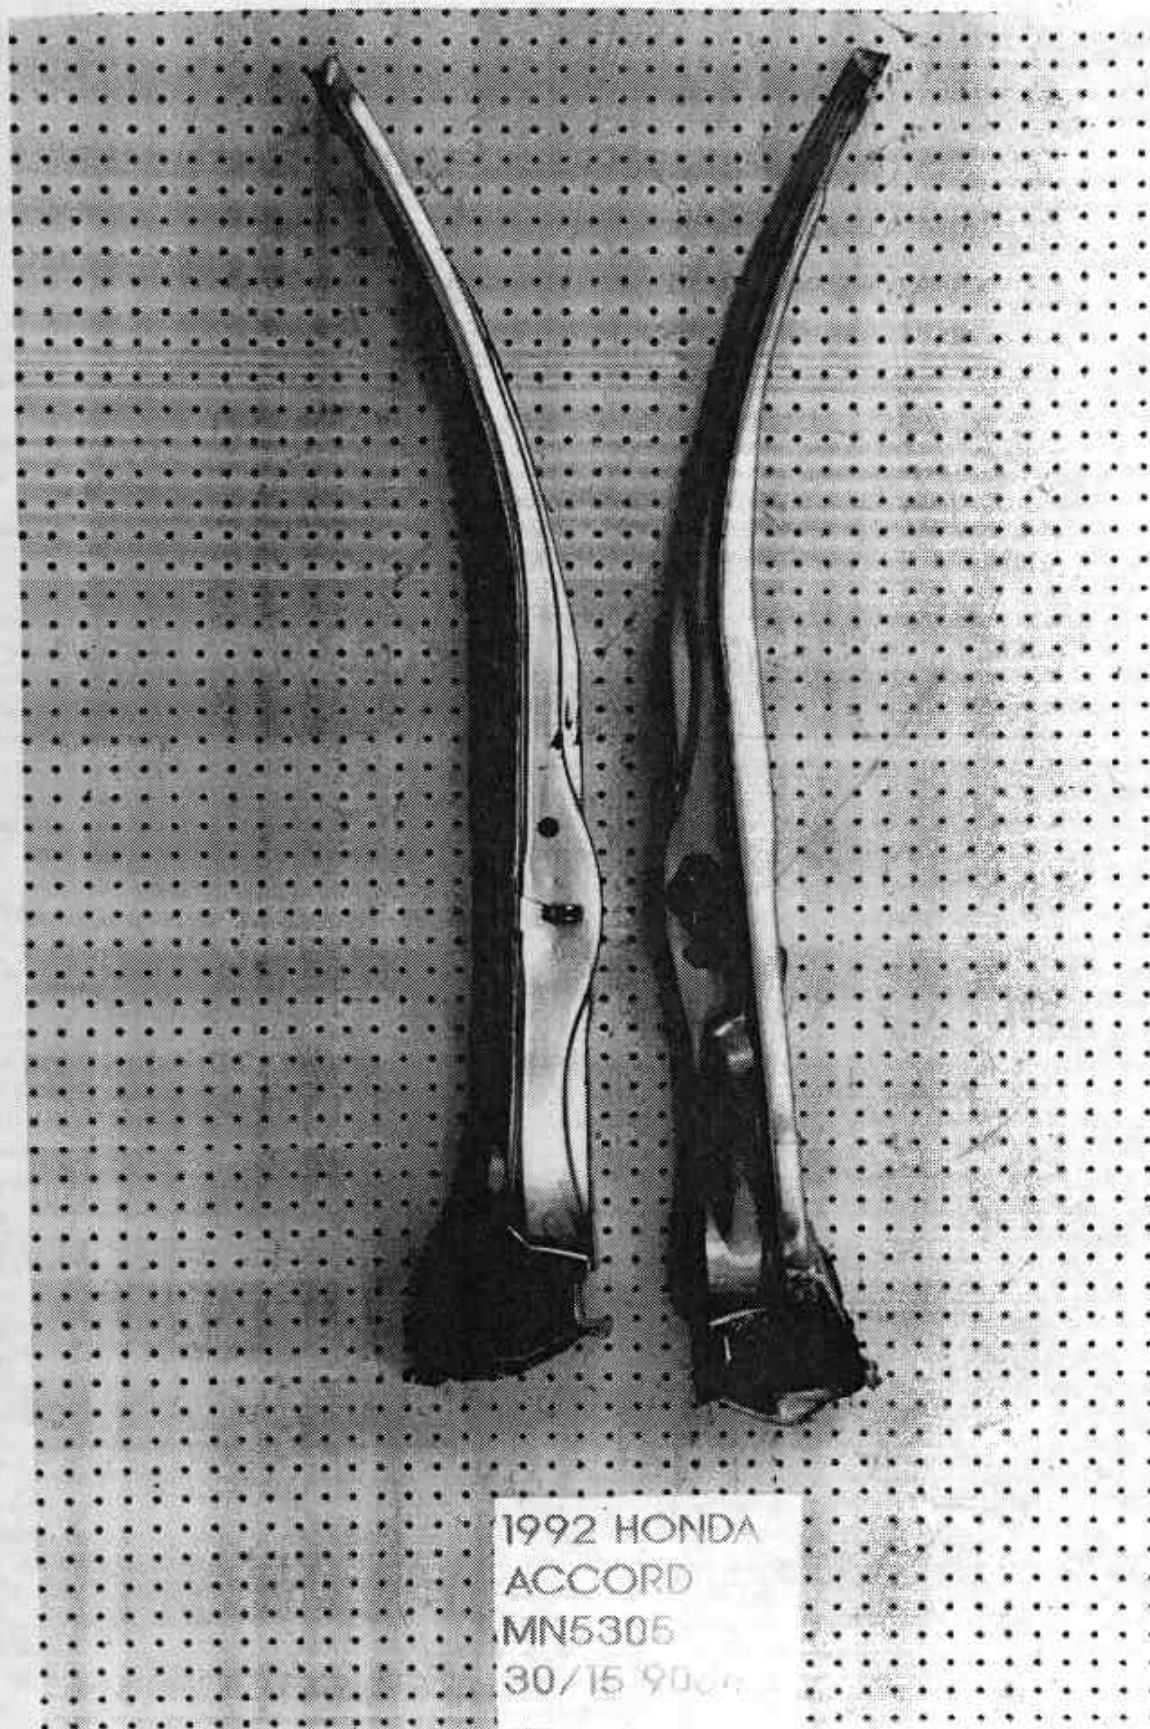
FIGURE 5-34 HONDA ACCORD, B-PILLAR CUTOUT - VIEW NO. 2  
83(b)
