**OFFICE OF MARKET INCENTIVES  
SIDE IMPACT PROTECTION STUDY  
PASSENGER CARS**

1992 CHEVROLET LUMINA, 4 DOOR SEDAN

NHTSA NO. MN0108

FINAL REPORT

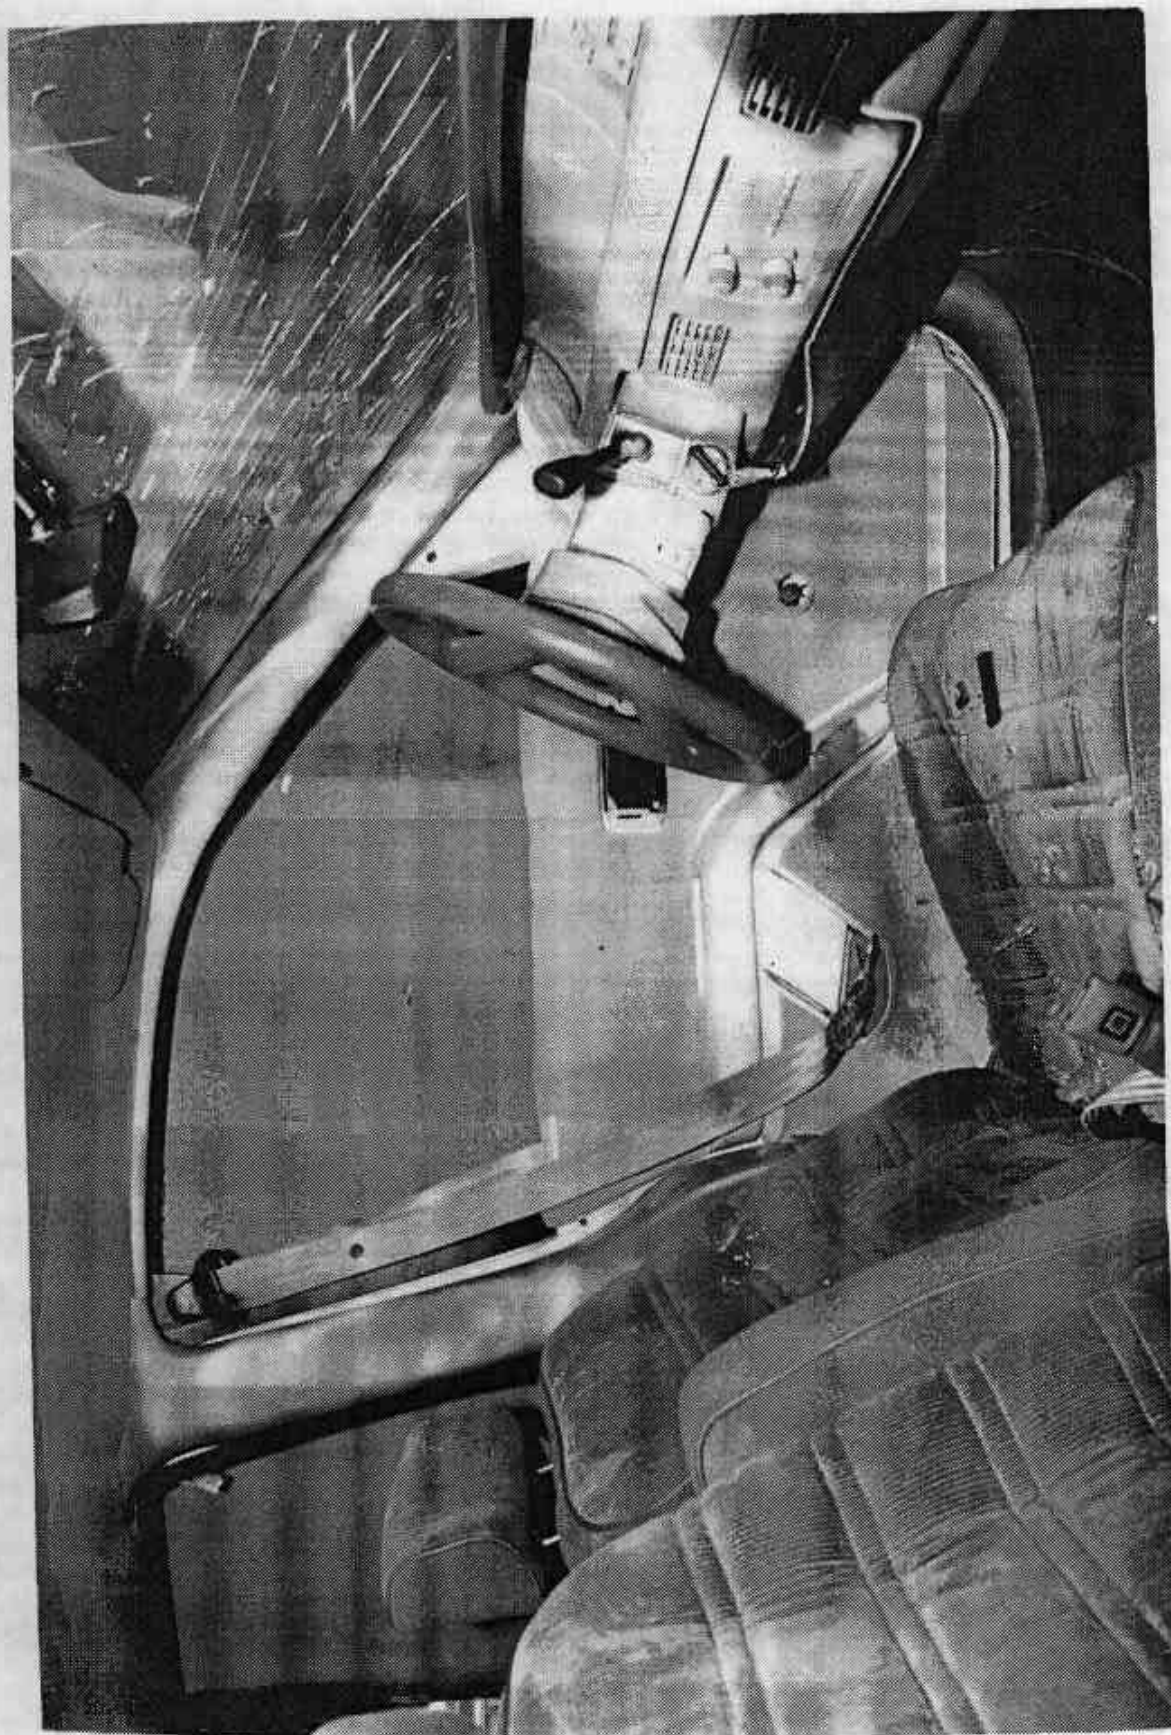
FIGURE 5-31 DRIVER SEATING POSITION - POSTTEST

Front Seat Cushion Movement: To the right

Front Seat Back Movement: To the right
