VEHICLE SAFETY COMPLIANCE TESTING FOR OCCUPANT CRASH PROTECTION,  
WINDSHIELD MOUNTING, WINDSHIELD ZONE INTRUSION (PARTIAL)  
AND FUEL SYSTEM INTEGRITY

SANTA FE VANS, INC.  
1993 GMC VANDURA  
7-PASSENGER CONVERSION VAN

NHTSA NUMBER: CP1302

CALSPAN TEST NUMBER: 8056-15

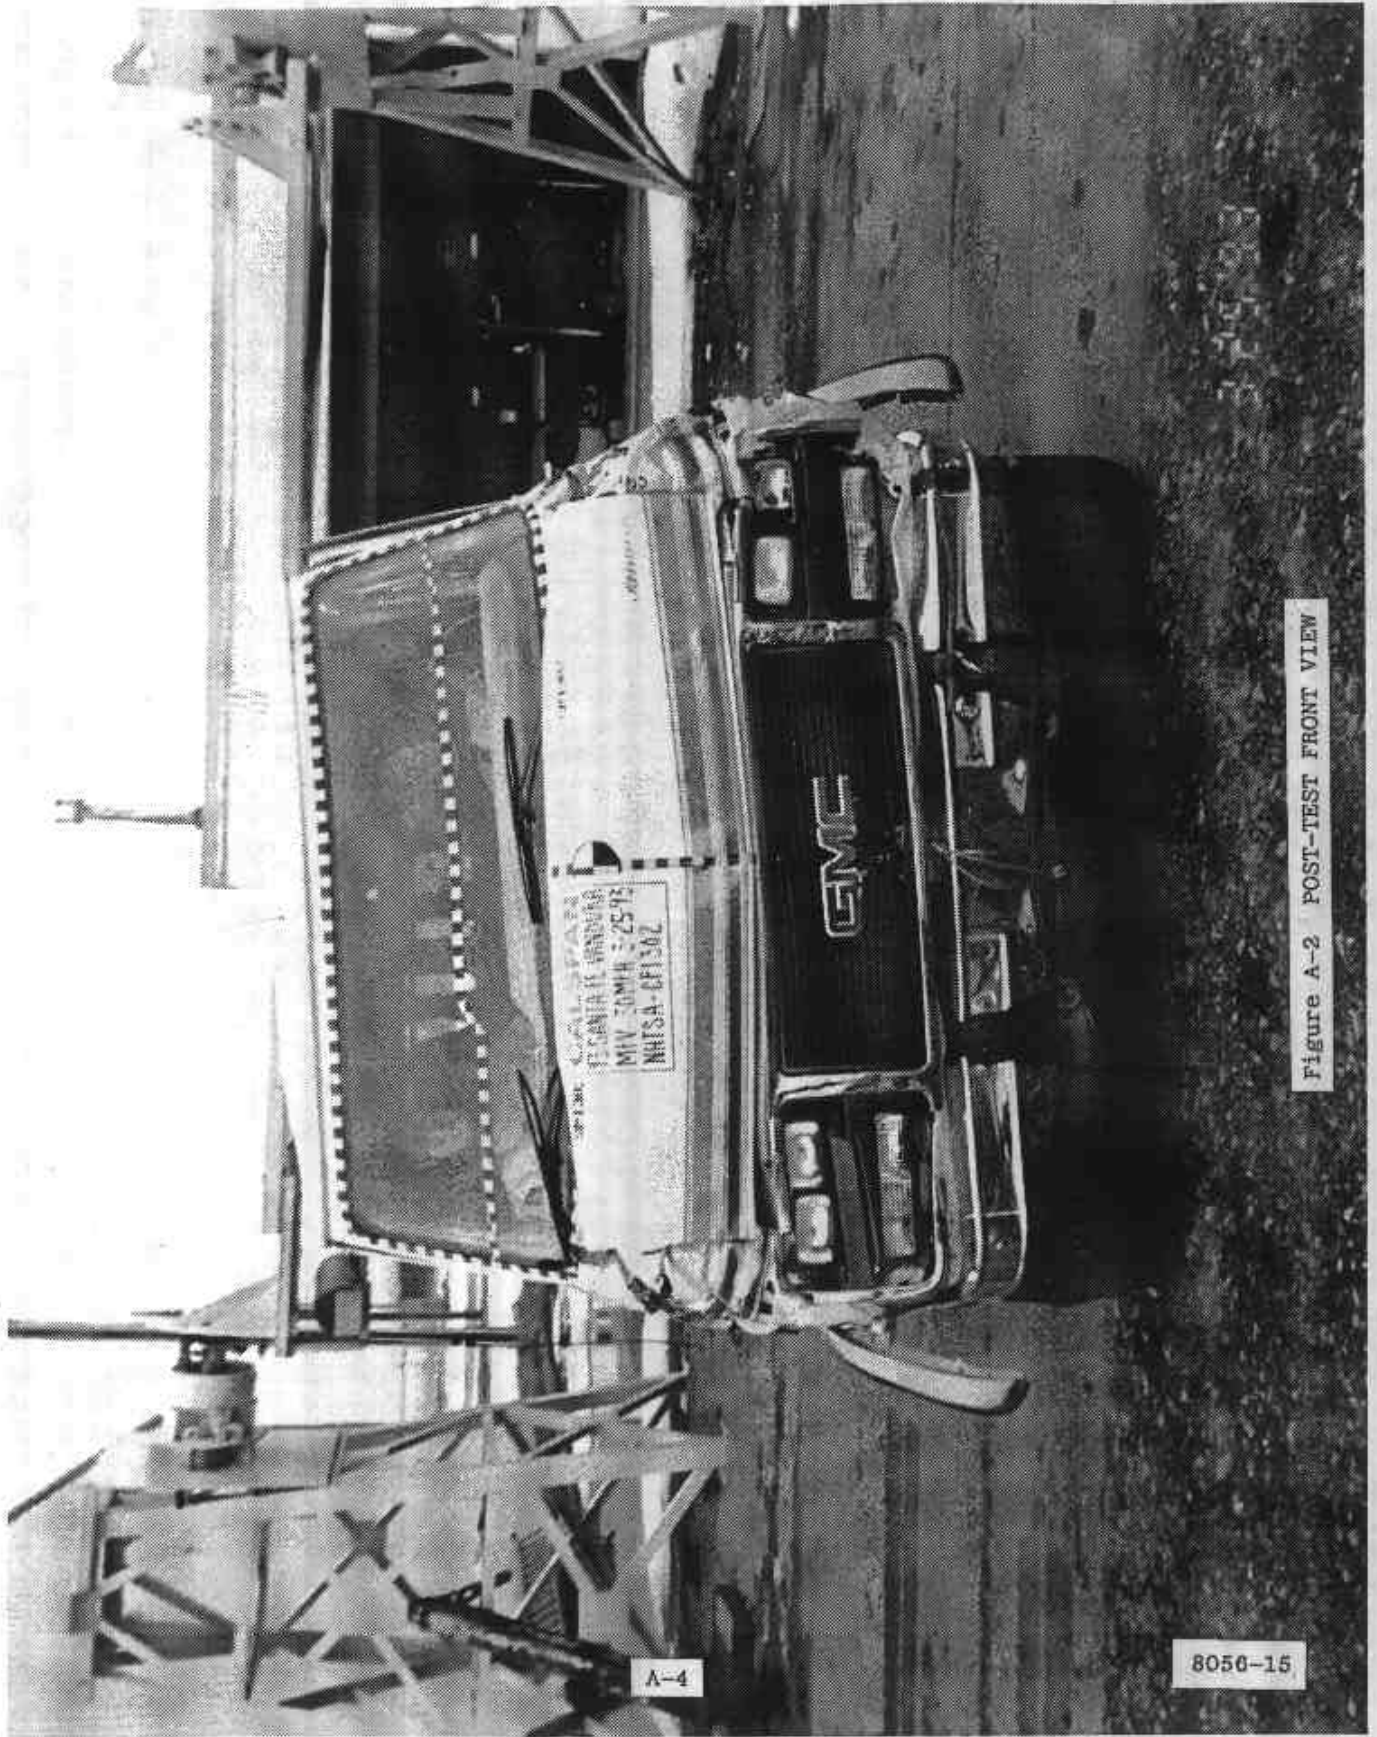
Figure A-2 POST-TEST FRONT VIEW

Maximum Static Crush: 16.5 inches

GLAZING DAMAGE: Windshield cracked throughout
