CALSPAN REPORT NUMBER: 8102-1

MOVING BARRIER FRONTAL IMPACT TEST
FOR FUEL SYSTEM INTEGRITY

GENERAL MOTORS CORPORATION
1993 CHEVROLET CORSICA
4-DOOR SEDAN

CALSPAN TEST NUMBER: Y47-010-1276

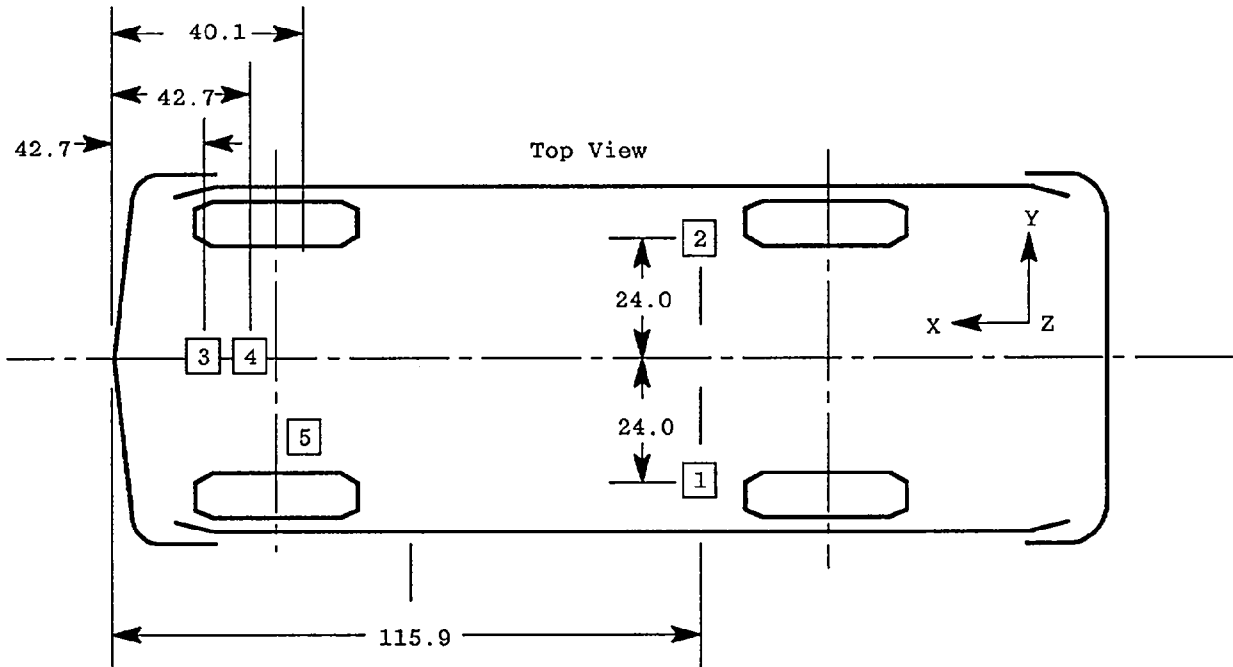
Figure 3
VEHICLE ACCELEROMETER LOCATIONS

ACCELEROMETER NUMBER*	ACCELEROMETER LOCATION	DIRECTION		
		X	Y	Z
1	Left Rear Seat Crossmember	✓		
2	Right Rear Seat Crossmember	✓		
3	Top of Engine	✓		
4	Bottom of Engine	✓		
5	Left Disc Brake Caliper	✓

*The accelerometer pack number can be correlated with the vehicle response data traces found in Appendix B.

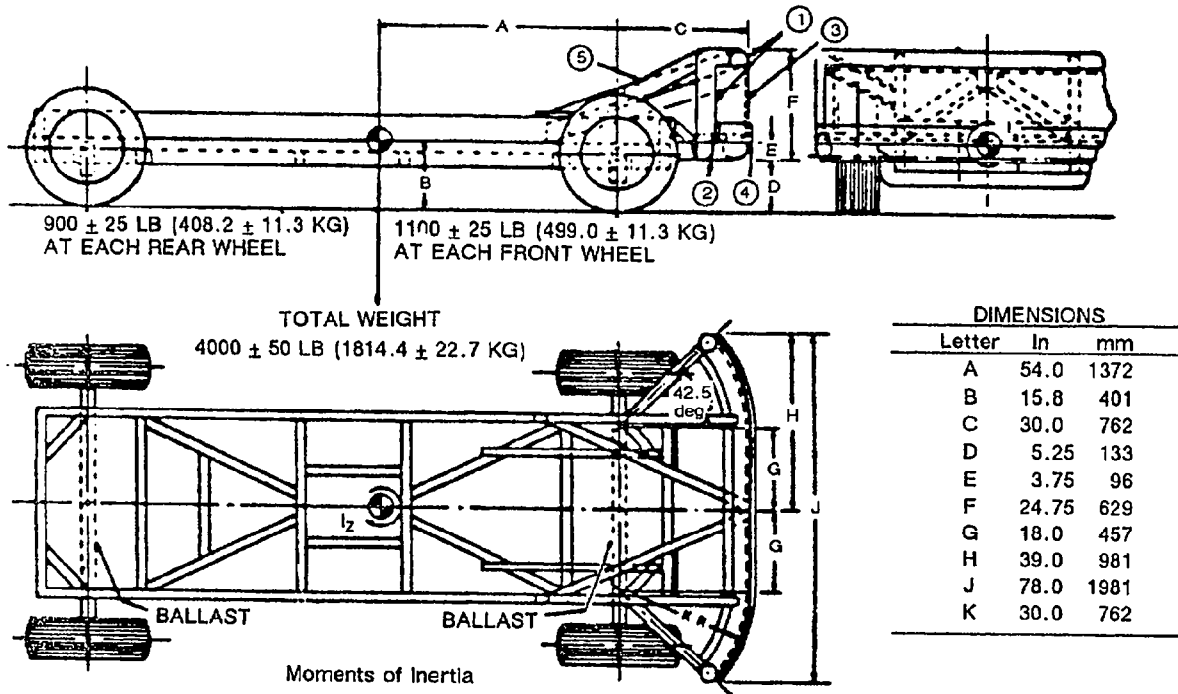
Figure 5a

COMMON CARRIAGE WITH CONTOURED IMPACT SURFACE ATTACHED

1. Upper frame 4.0 in dia x 0.25 in wall (102 mm dia x 6 mm wall) steel tubing (three sides).
2. Lower frame 6.0 in dia x 0.50 in wall (152 mm dia x 13 mm wall) steel tubing.
3. Face plate 0.75 in (19 mm) thick cold rolled steel.
4. Leading edge 1.0 x 4.0 in (25 x 102 mm) steel band, sharp edges broken
5. All inner reinforcements 4.0 x 2.0 x 0.19 in (102 x 51 x 5 mm) steel tubing.

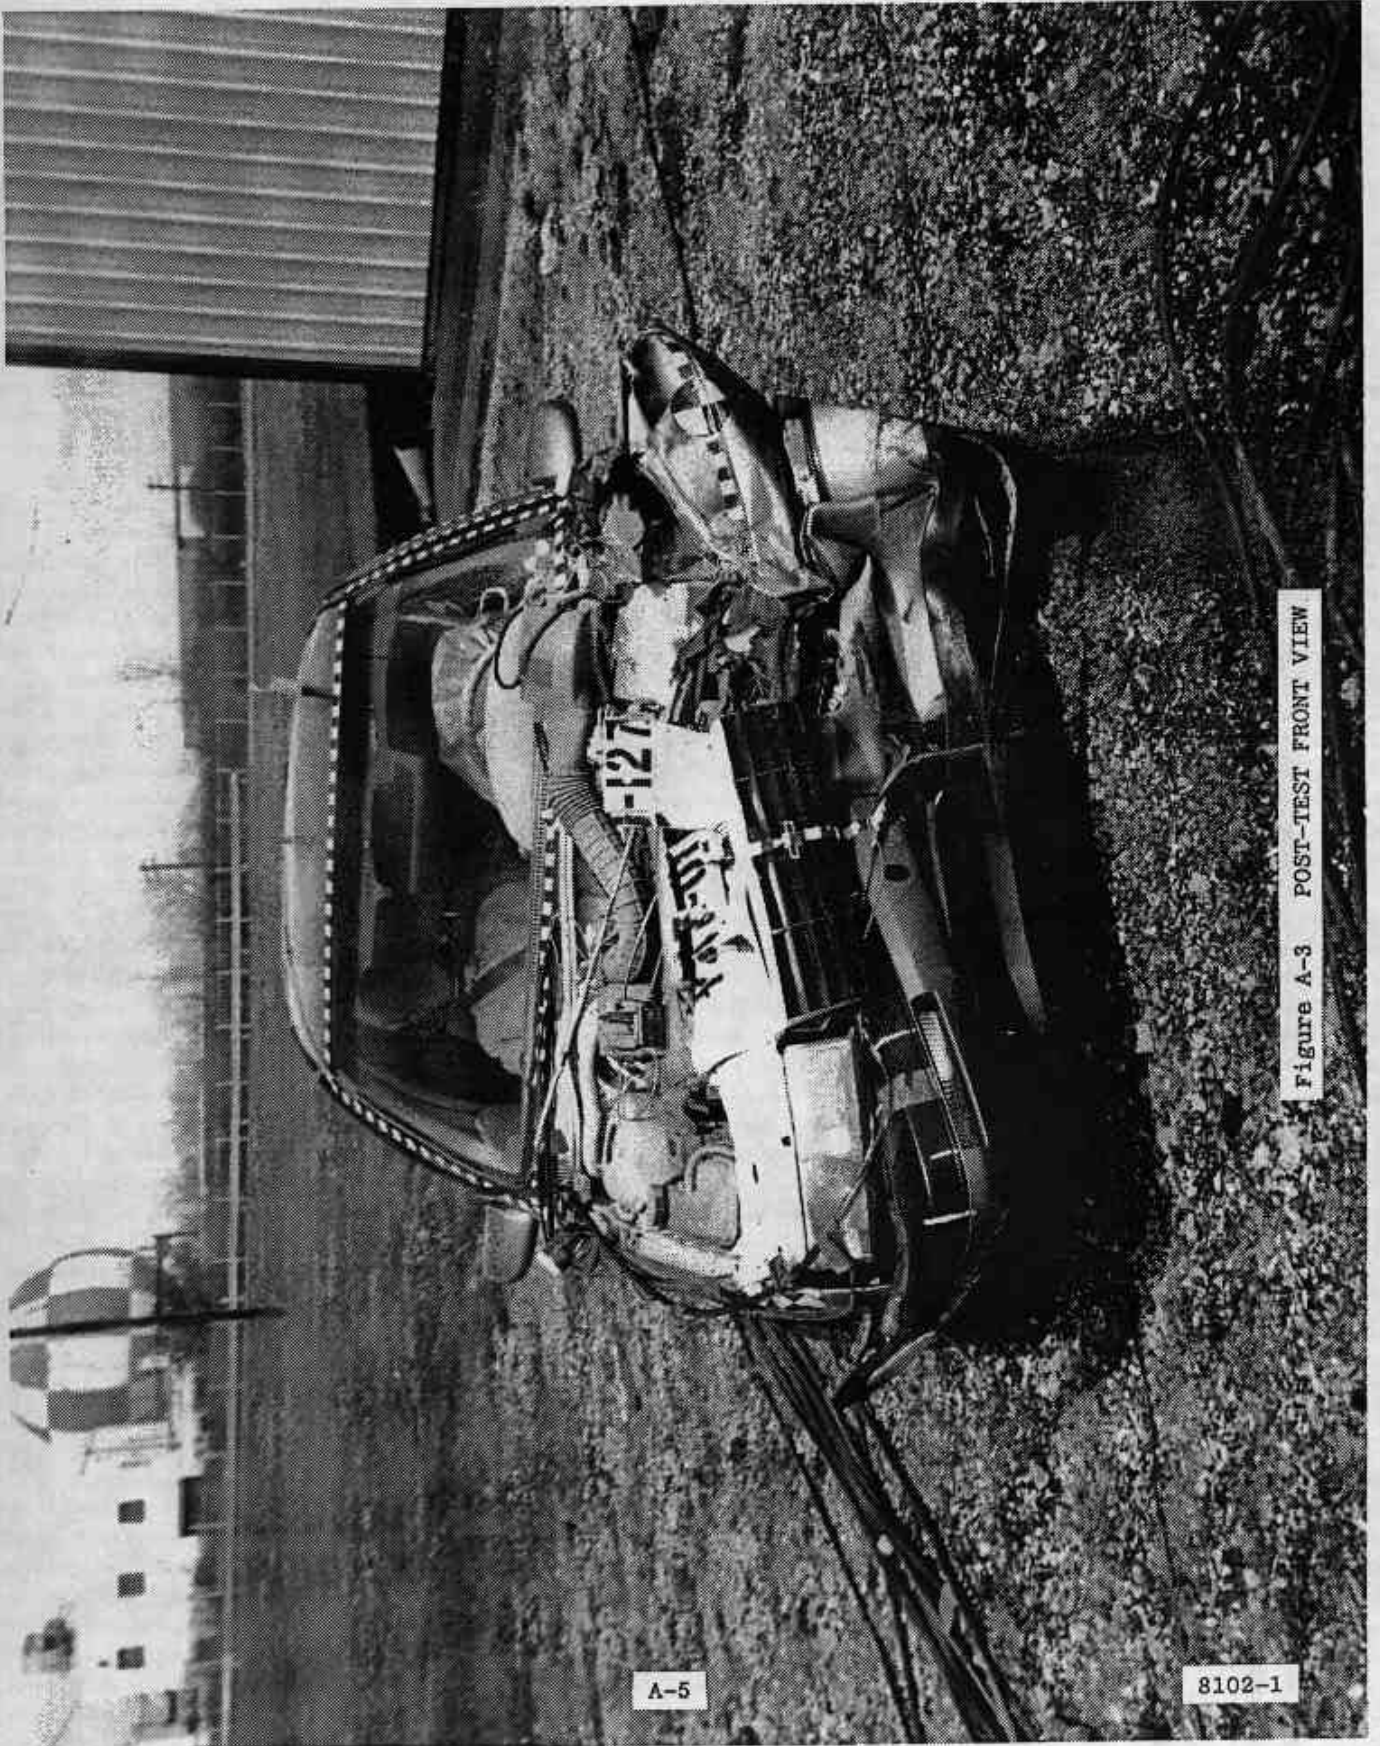
Figure A-3 POST-TEST FRONT VIEW

Pre-Test Right = 178.2; C/L = 183.0; Left = 178.6
 Post-Test Right = 180.7; C/L = 165.2; Left = 152.2
 Crush Right = -2.5; C/L = 17.8; Left = 26.0
 AVERAGE = 13.8 inches

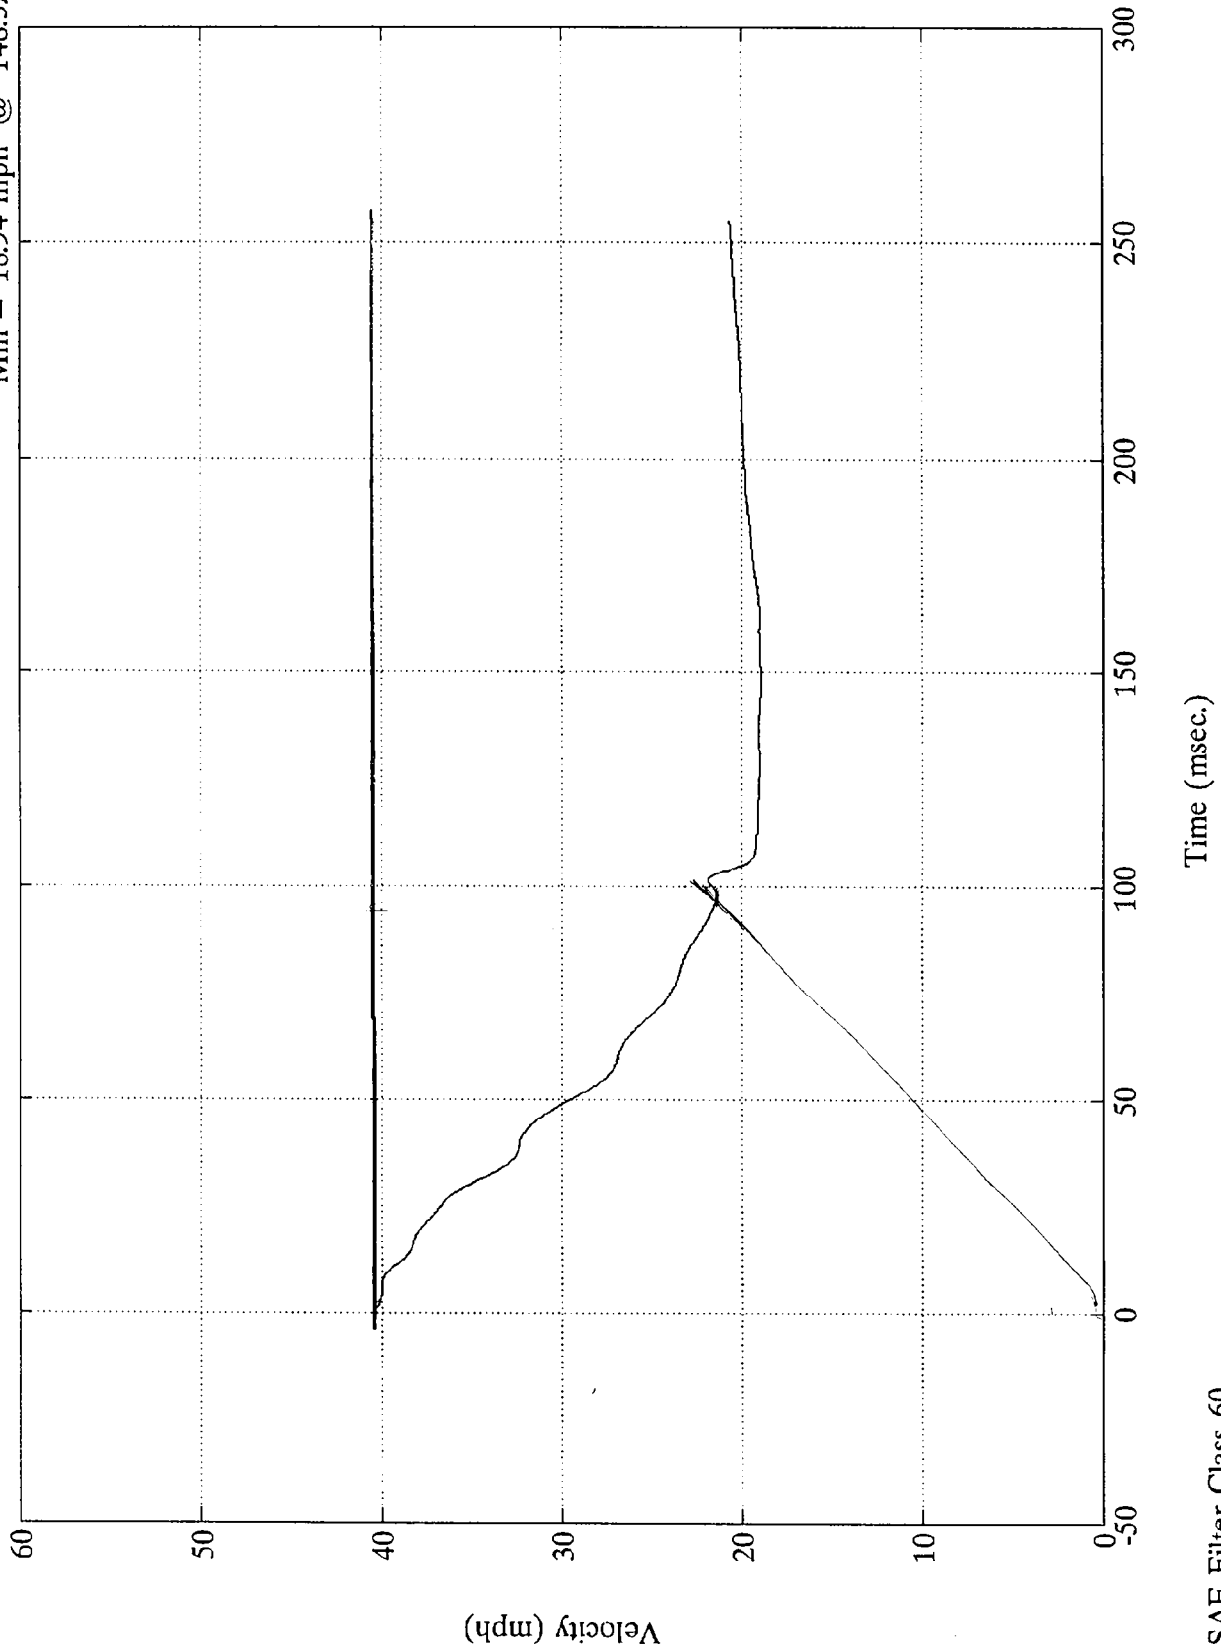
Barrier Left Rail (X)

Max = 40.50 mph @ -0.00 msec
Min = 18.94 mph @ 148.32 msec

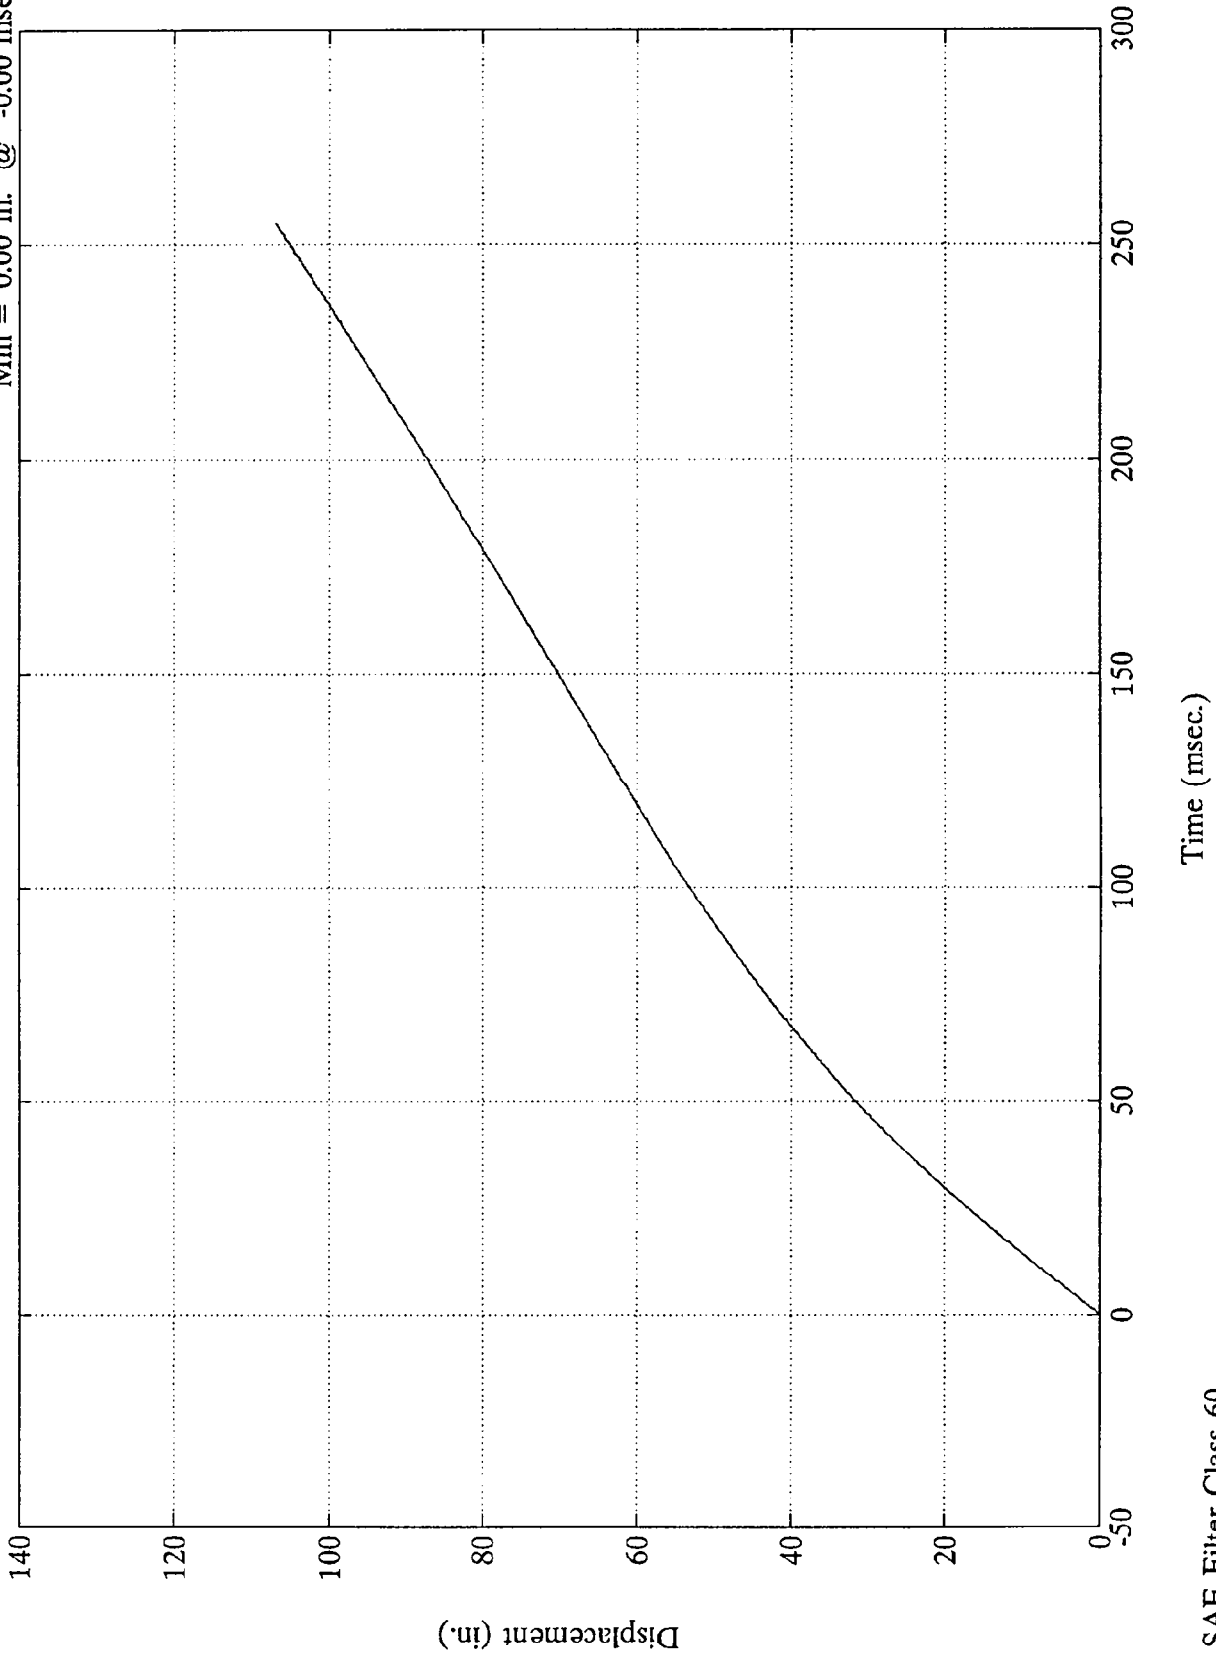
Barrier Left Rail (X)

Max = 106.80 in. @ 254.88 msec
Min = 0.00 in. @ -0.00 msec

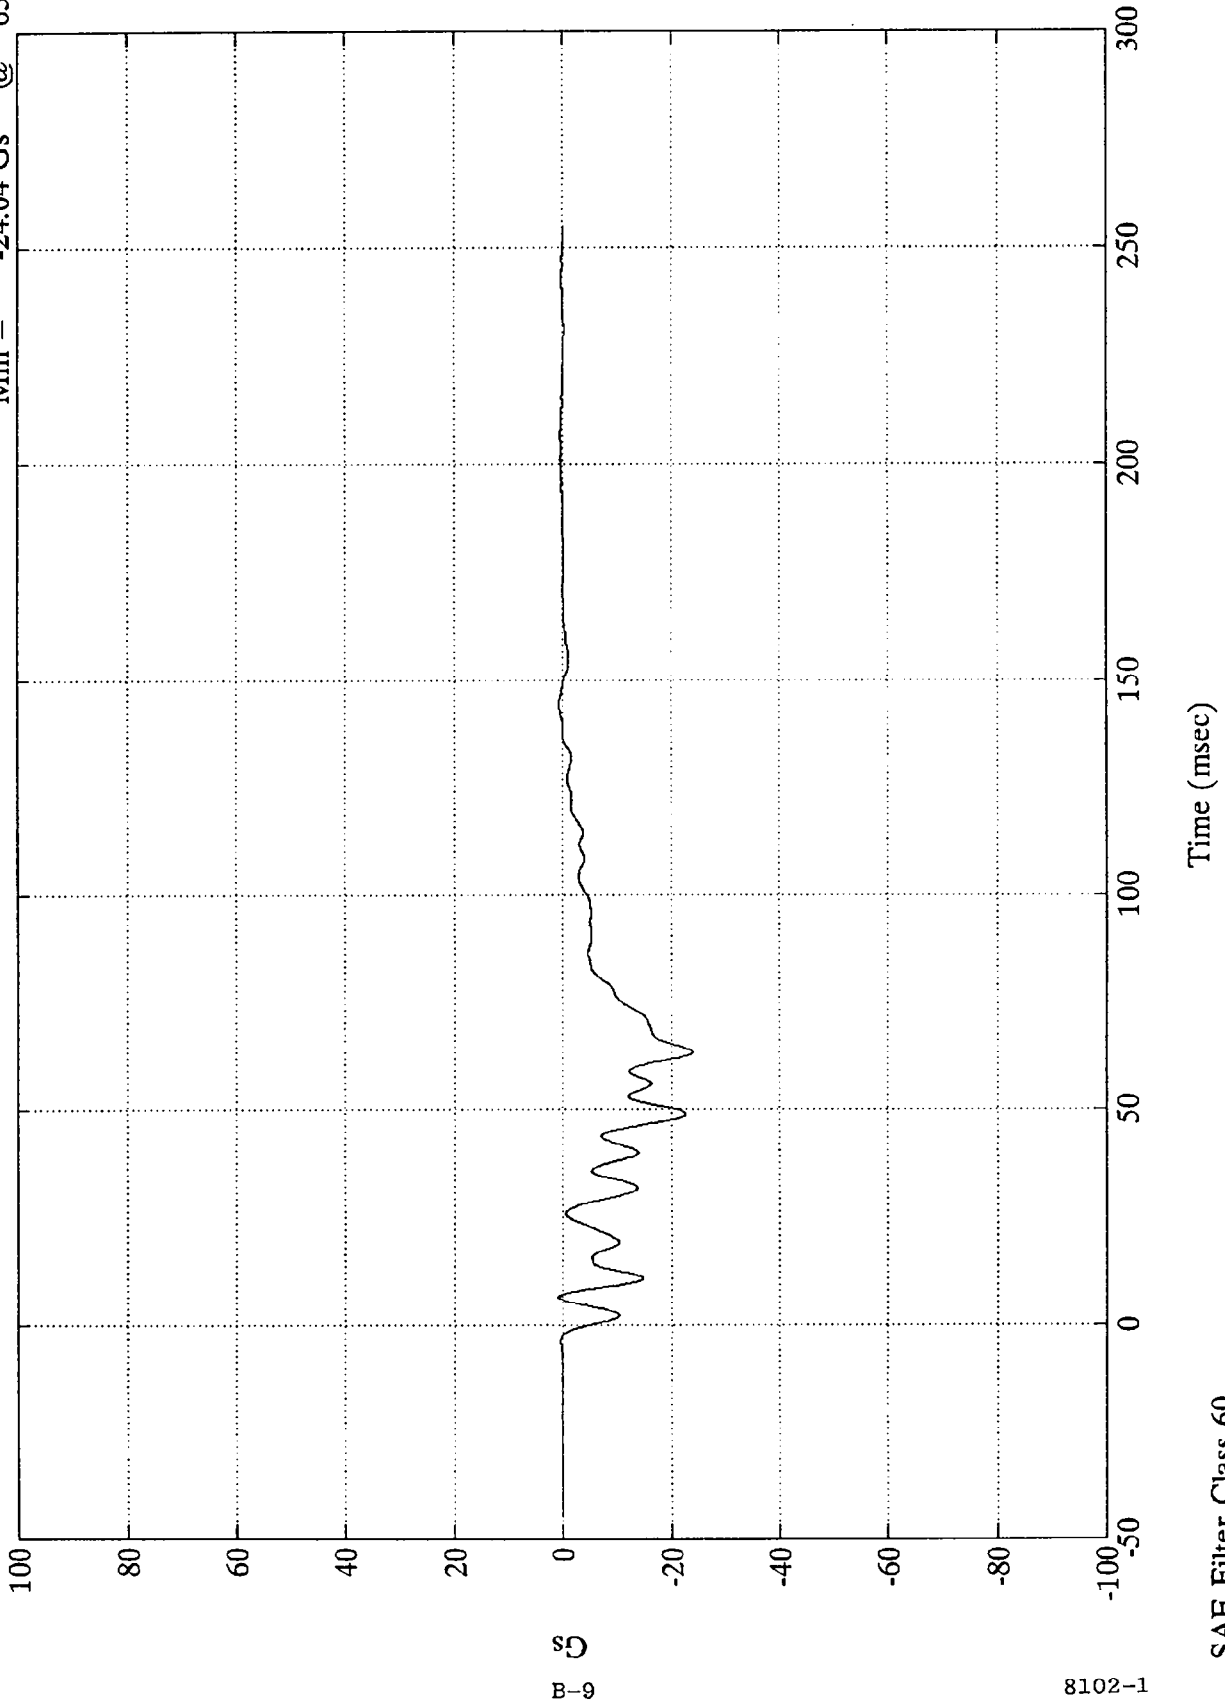
Acc. #1 Left Xmember

Max = .86 Gs @ 6.59 msec
Min = -24.04 Gs @ 63.35 msec

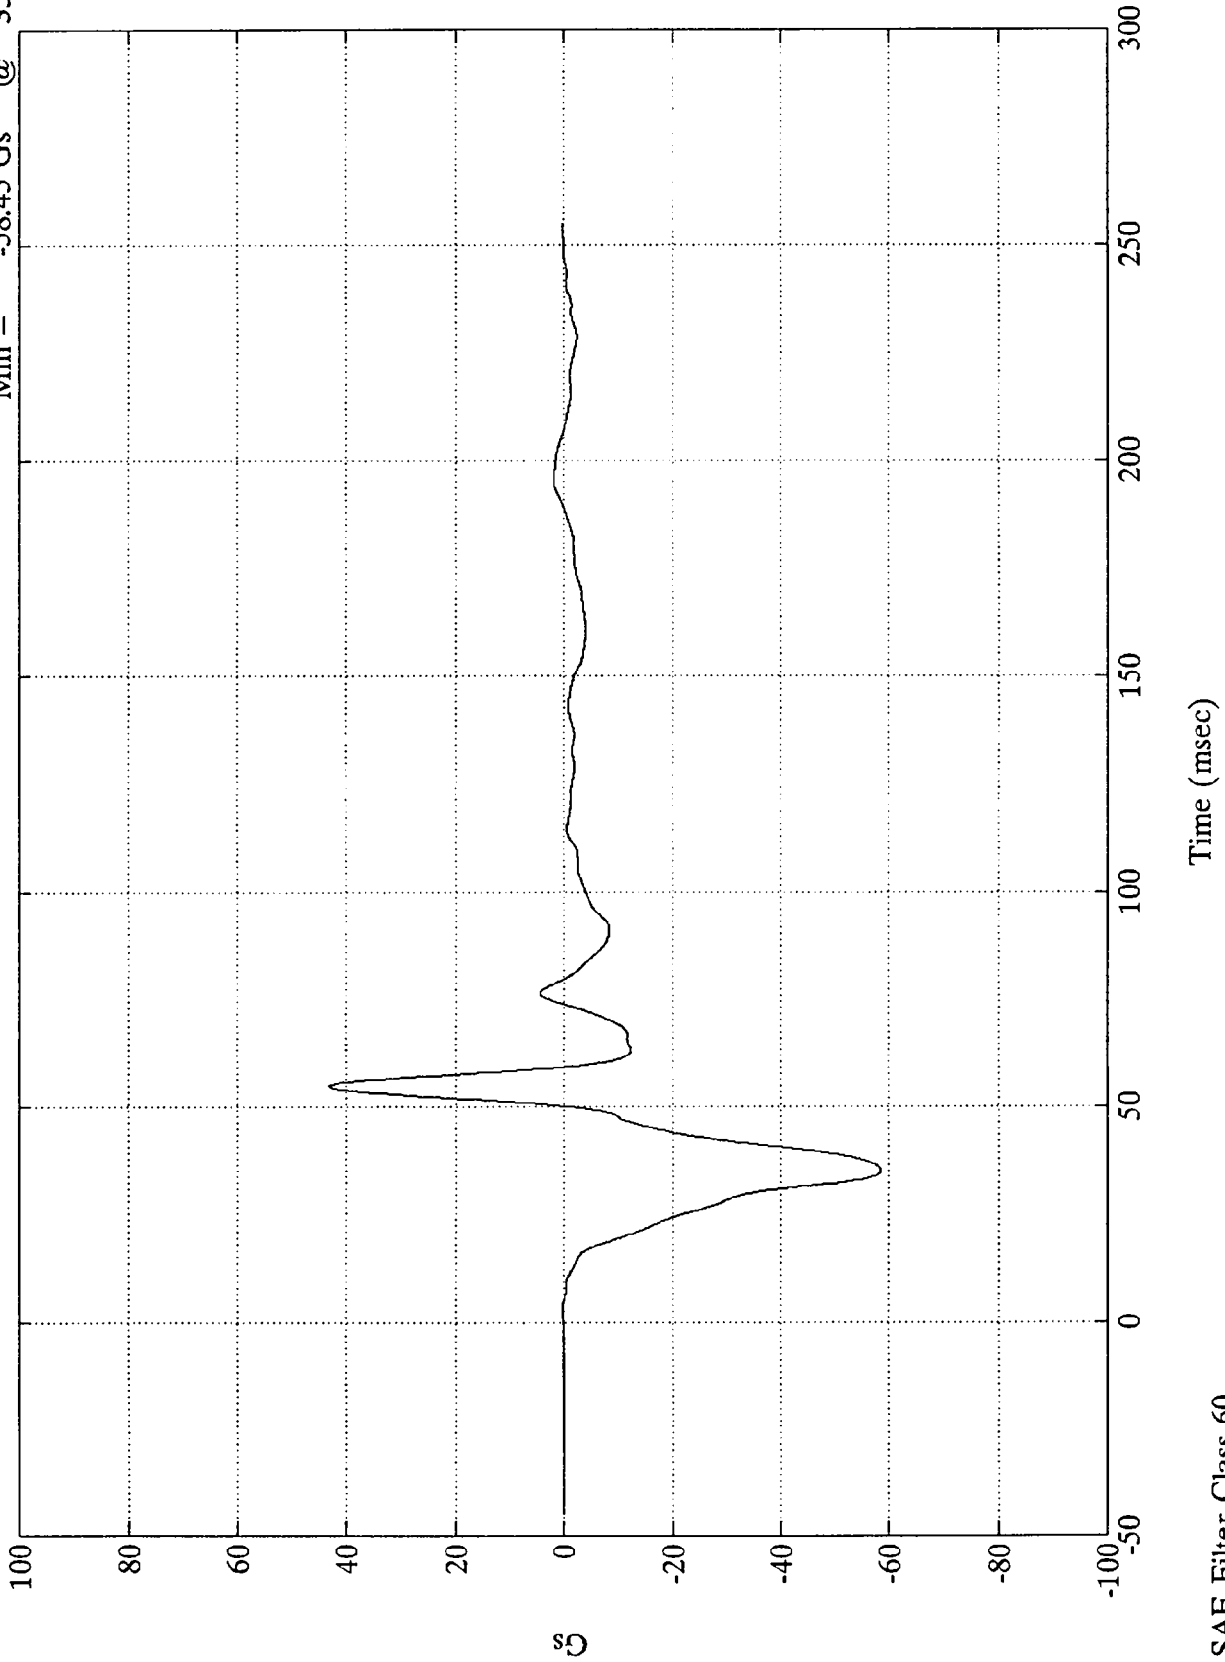
Acc. #3 Engine Top

Max = 43.27 Gs @ 54.84 msec
Min = -58.45 Gs @ 35.27 msec

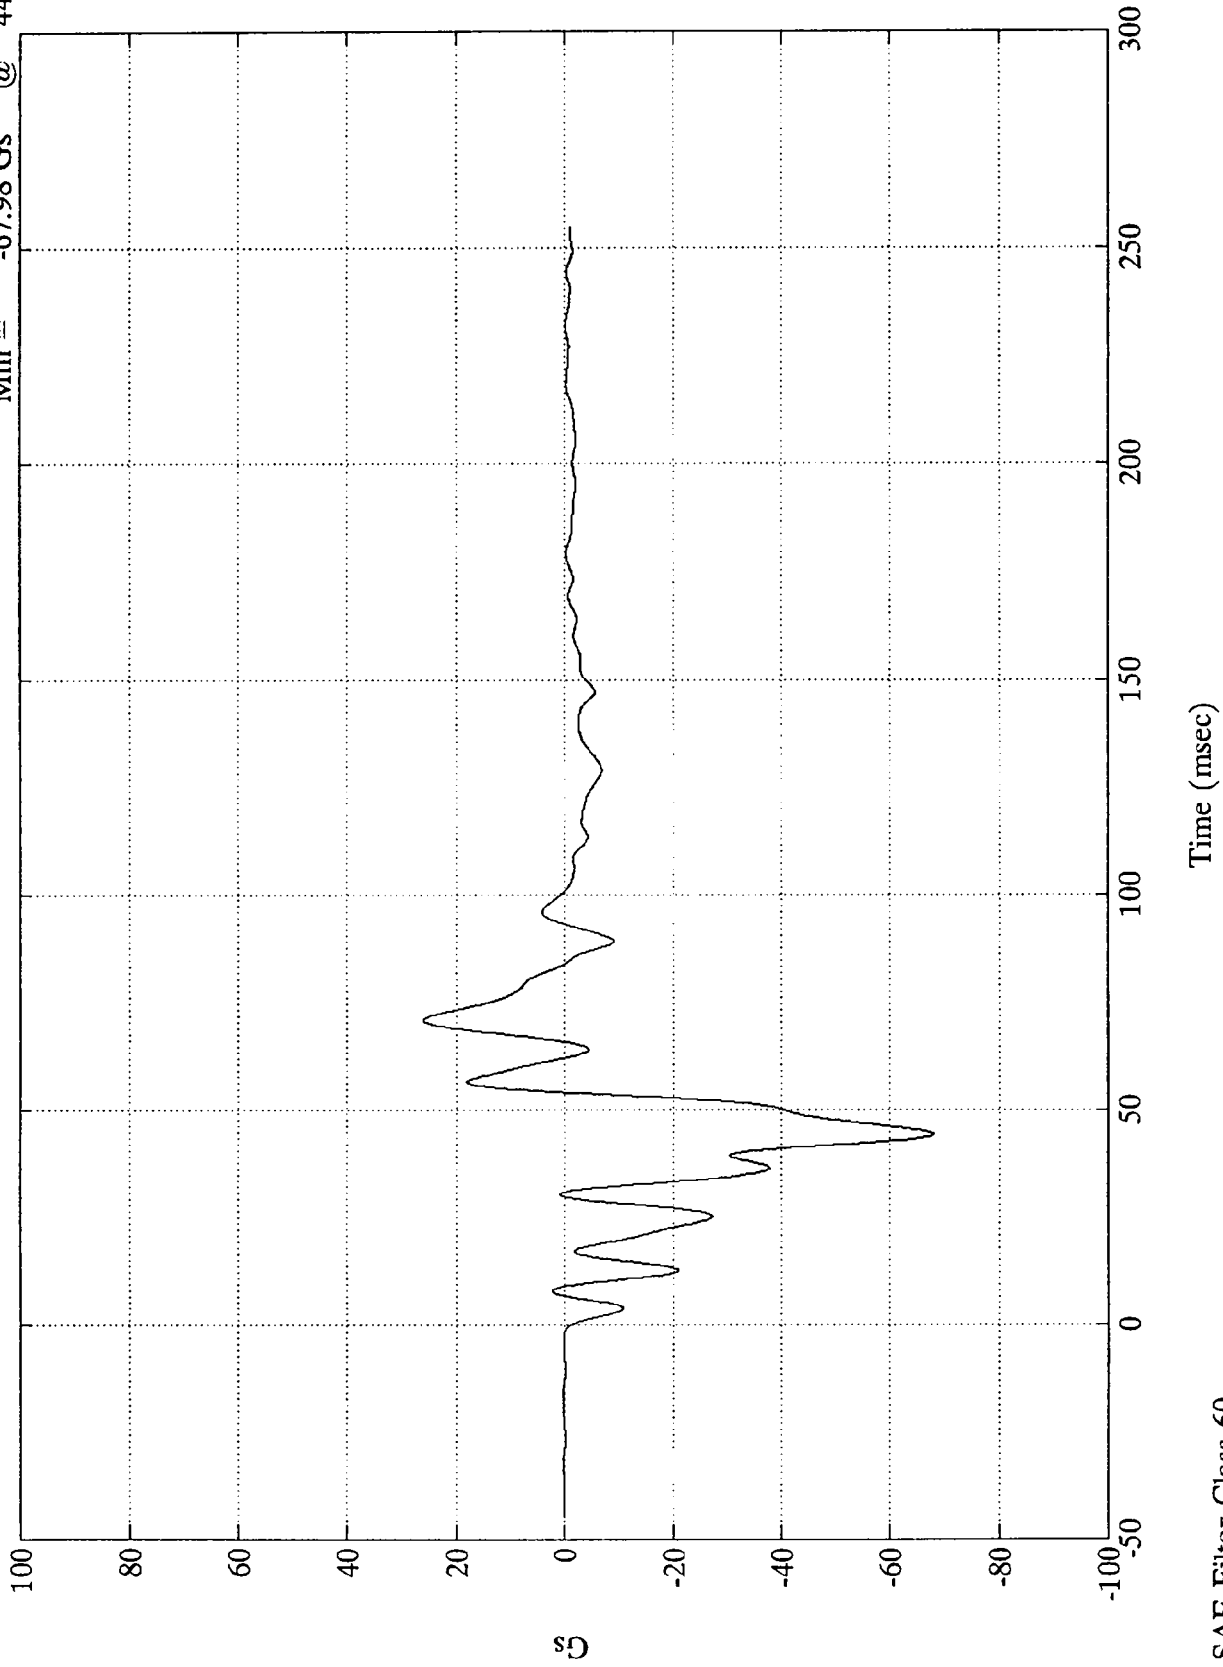
Acc. #5 Left Caliper

Max = 26.04 Gs @ 71.04 msec
Min = -67.98 Gs @ 44.39 msec

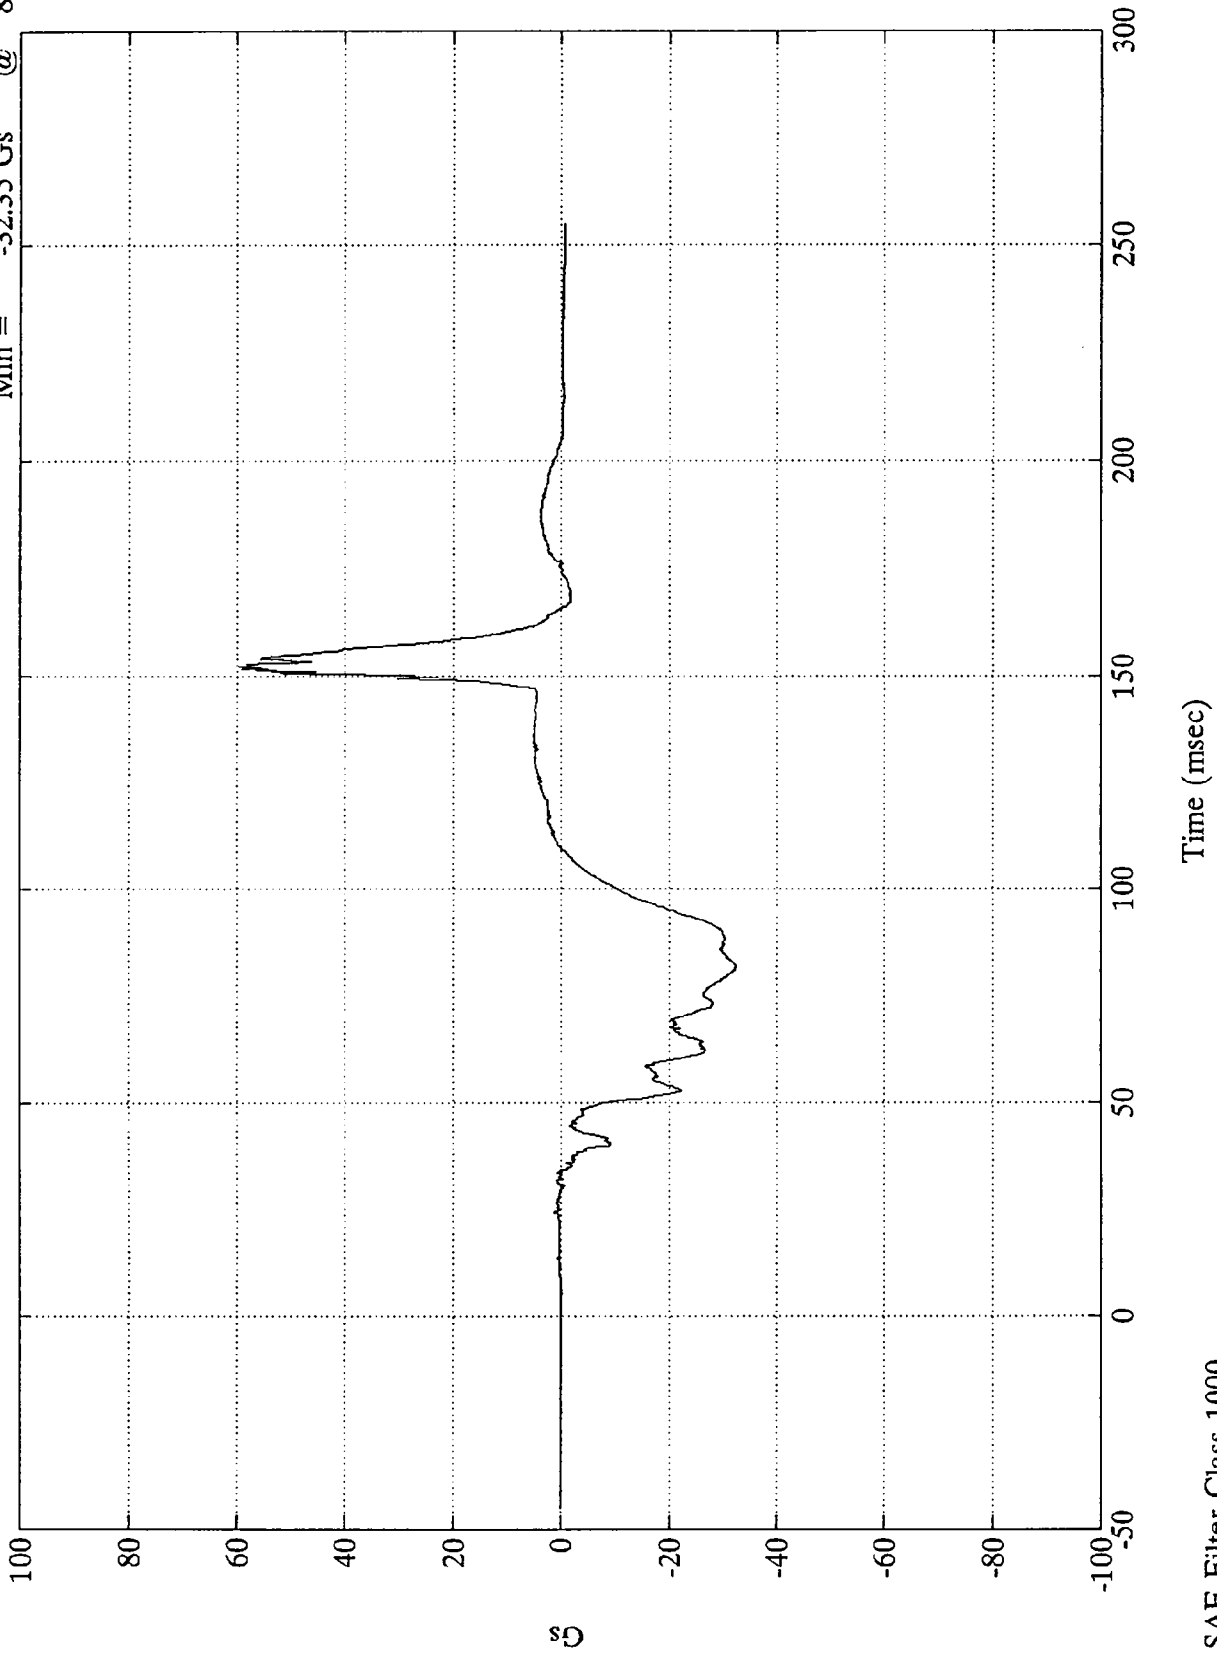
Pos. 1 Head X

Max = 59.50 Gs @ 152.27 msec
Min = -32.35 Gs @ 82.08 msec

MAXIMUM HEAD ACCELERATION (g's)			
	X	Y	Z	R
Position #1 - Driver	59.5	24.3	26.5	66.7
Position #2 - Passenger	-28.6	7.1	25.6	31.8

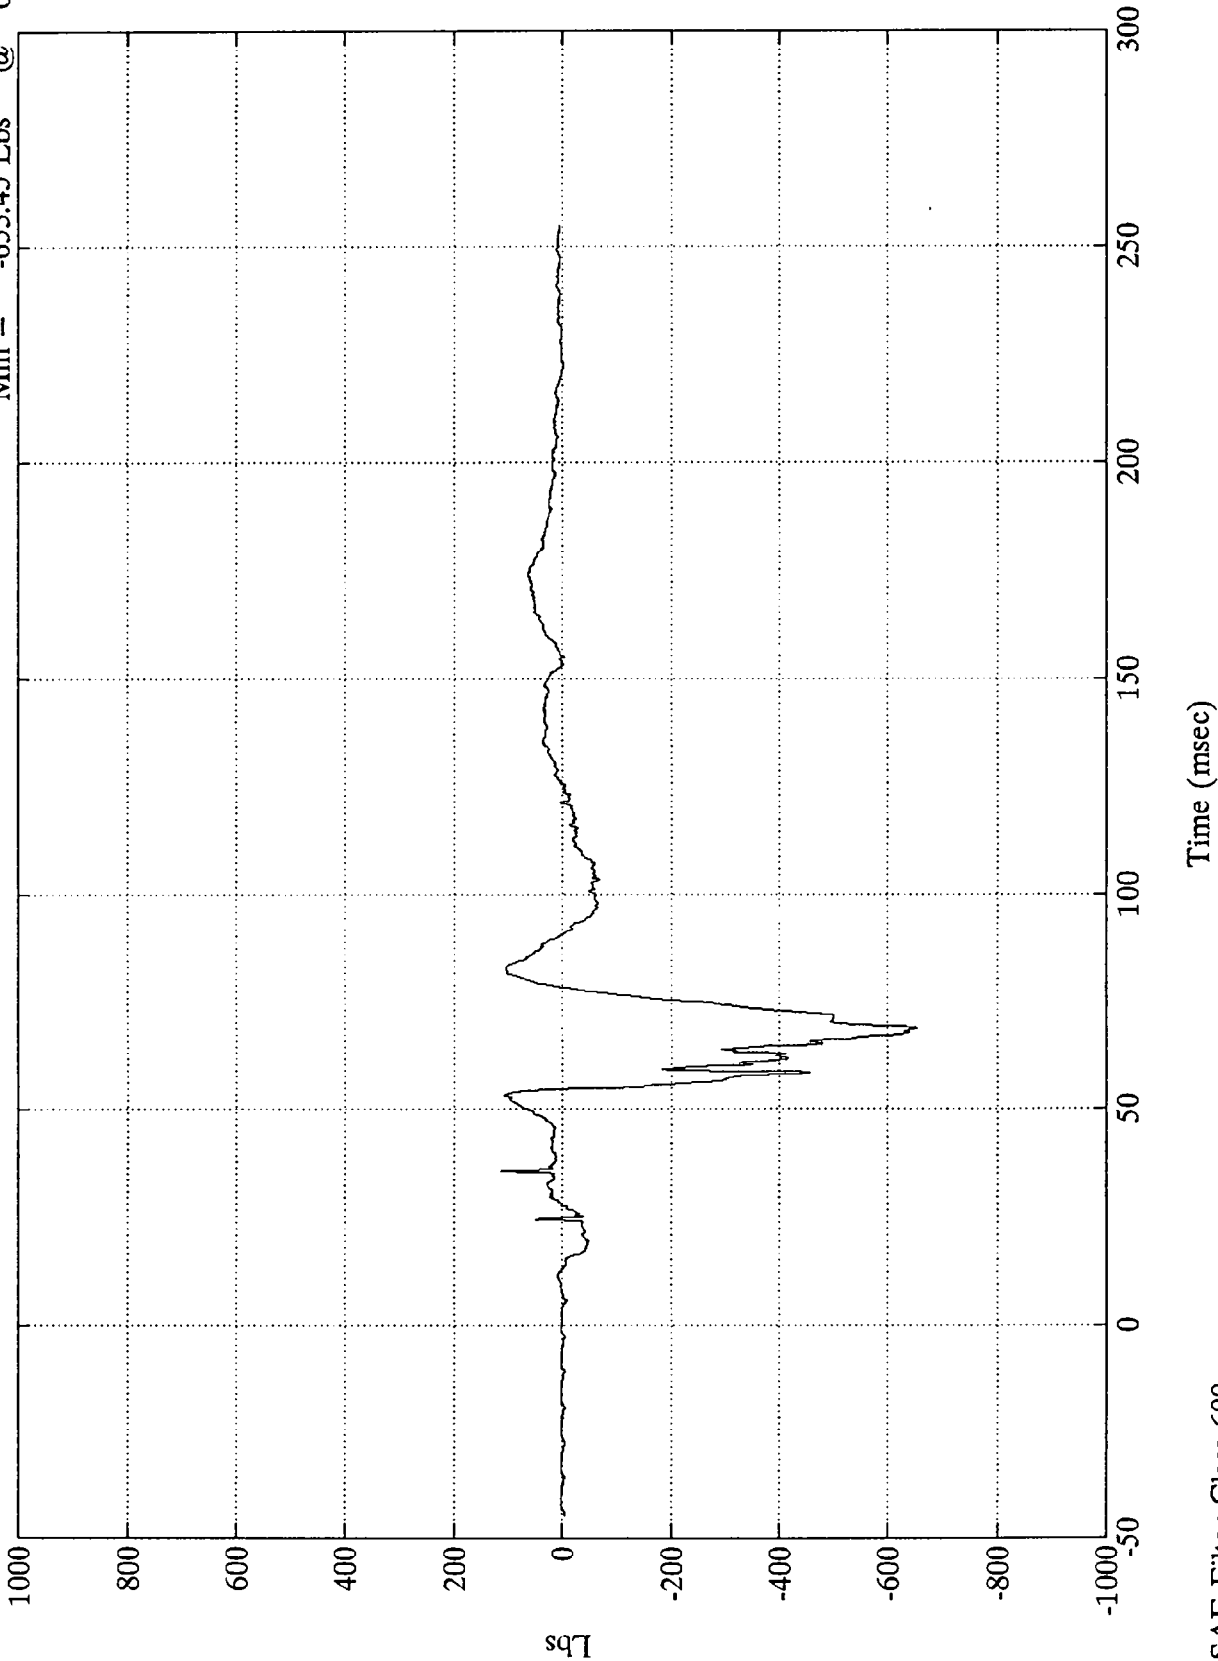
Pos. 1 Right Femur

Max = 114.17 Lbs @ 35.63 msec
Min = -653.45 Lbs @ 69.12 msec

The driver contacted the airbag and sustained a HIC of 173.2. The maximum chest deceleration over 3 milliseconds was 31.6 g's with 1.2 inch of deflection. The left femur load was -832.2 pounds and the right femur load was -653.4 pounds.

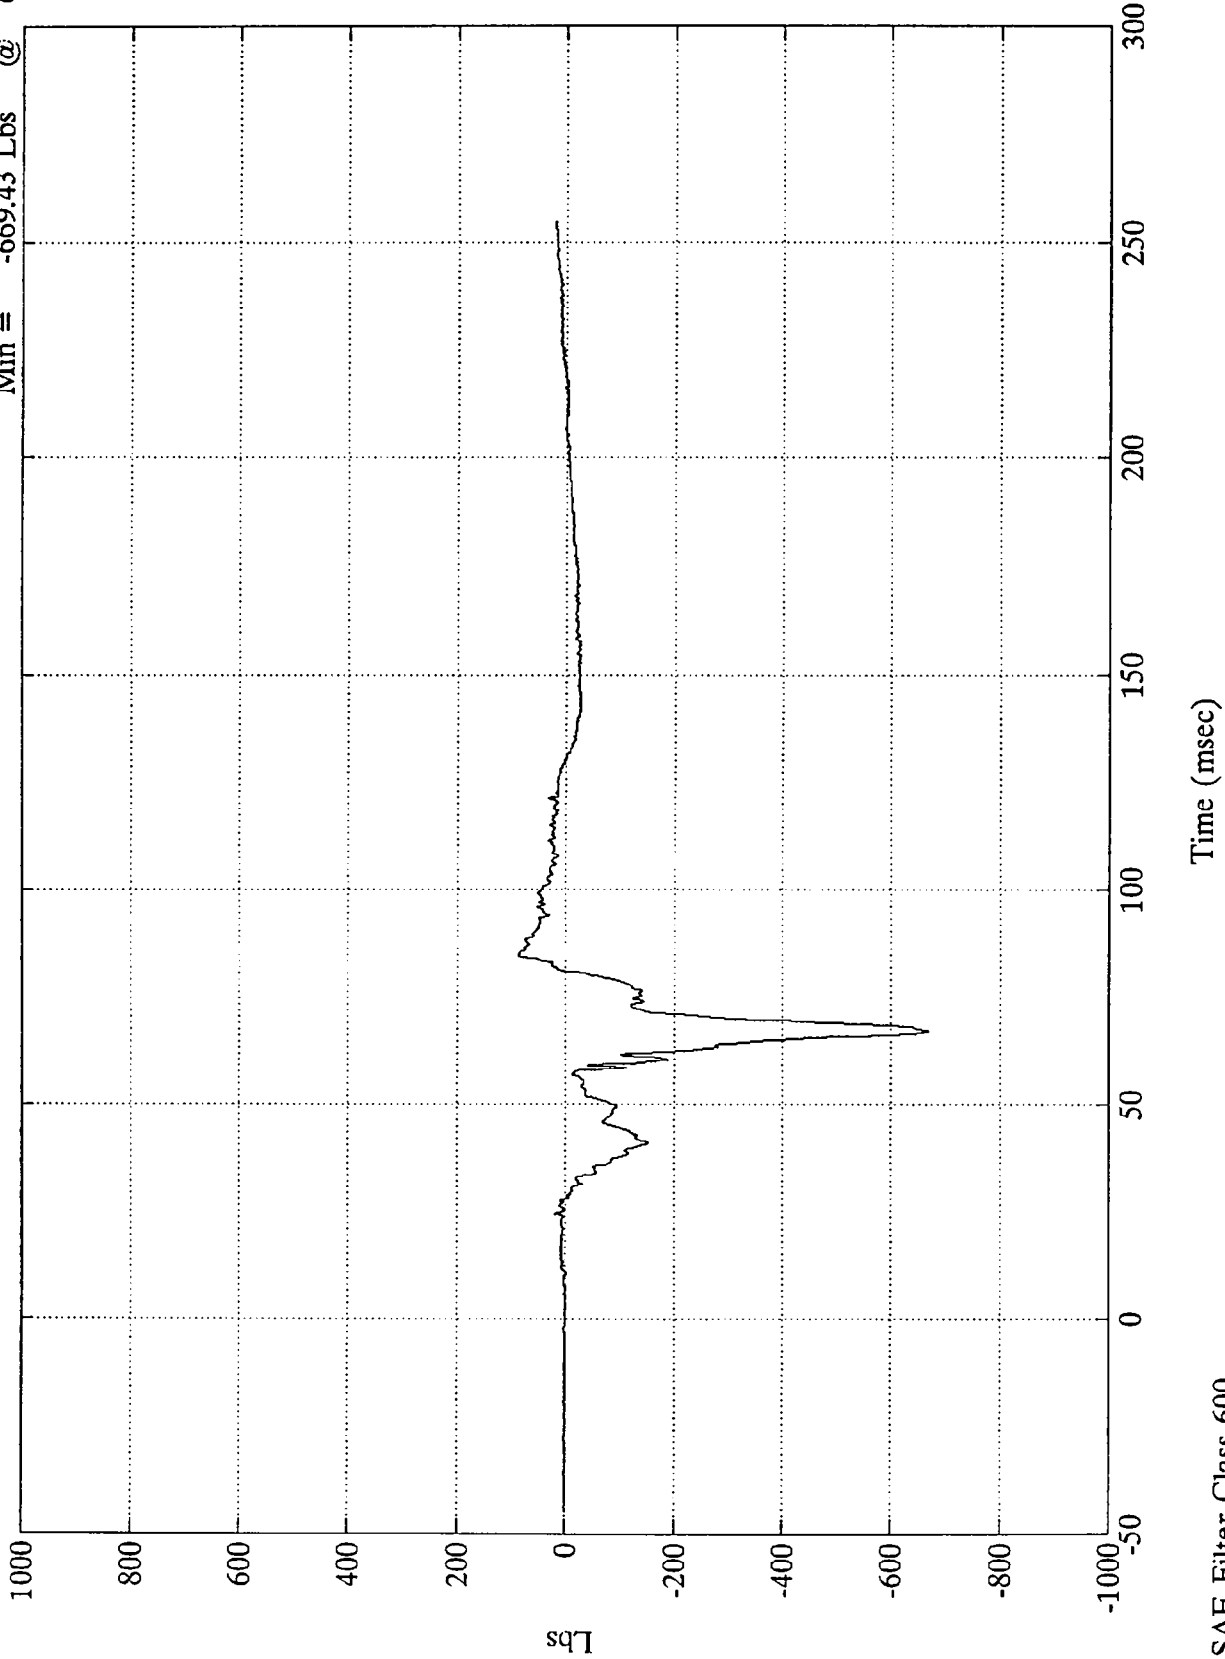
Max = 88.12 Lbs @
Min = -669.43 Lbs @

84.36 msec
67.19 msec

The passenger sustained a HIC of 167.9. The maximum chest deceleration over 3 milliseconds was 31.5 g's with 0.1 inches of deflection. The left femur load was -669.4 pounds and -215.1 pounds on the right femur.
