REPORT NO.: MGA-93-21403

SIDE IMPACT PROTECTION STUDY

1993 DODGE INTREPID  
4-DOOR SEDAN

FINAL REPORT

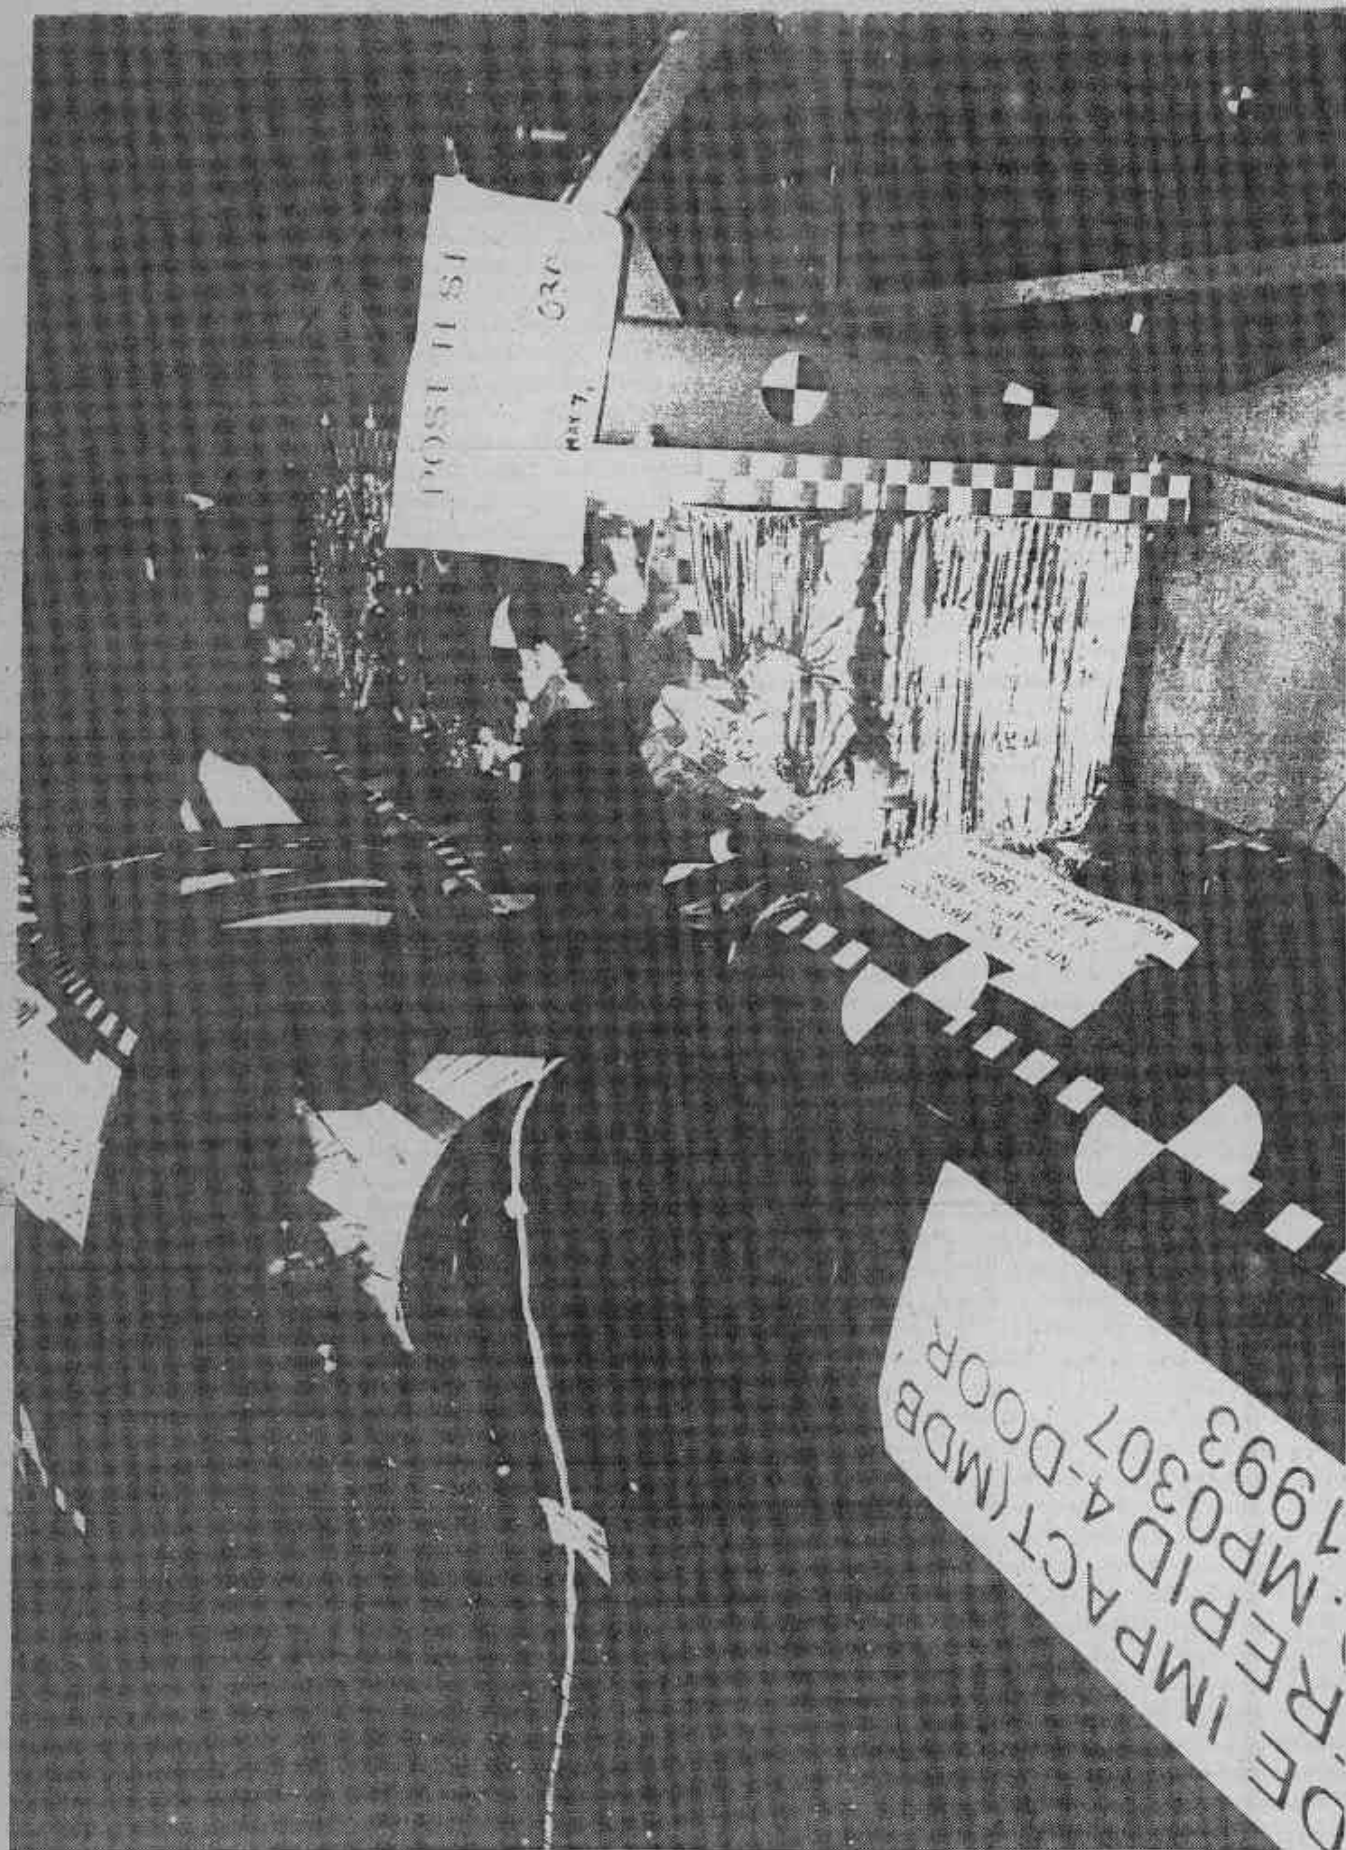
Photo No. A-8 - Post-Test MDB and Vehicle Left Side Front View
